Appendix A.21:

15b Royds Pl – VsVp 57326

Liquefaction Ejecta Case Histories for 2010-11 Canterbury Earthquakes

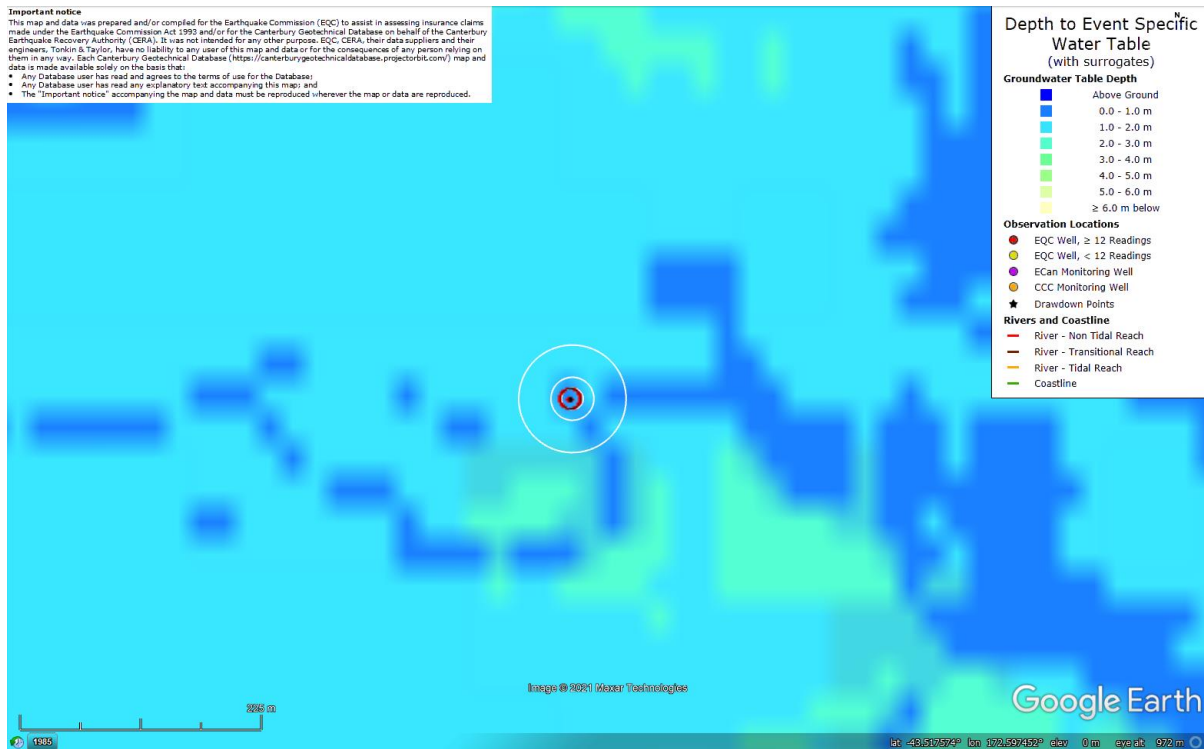
Figure 33: Depth to groundwater table for Dec-11 EQ.

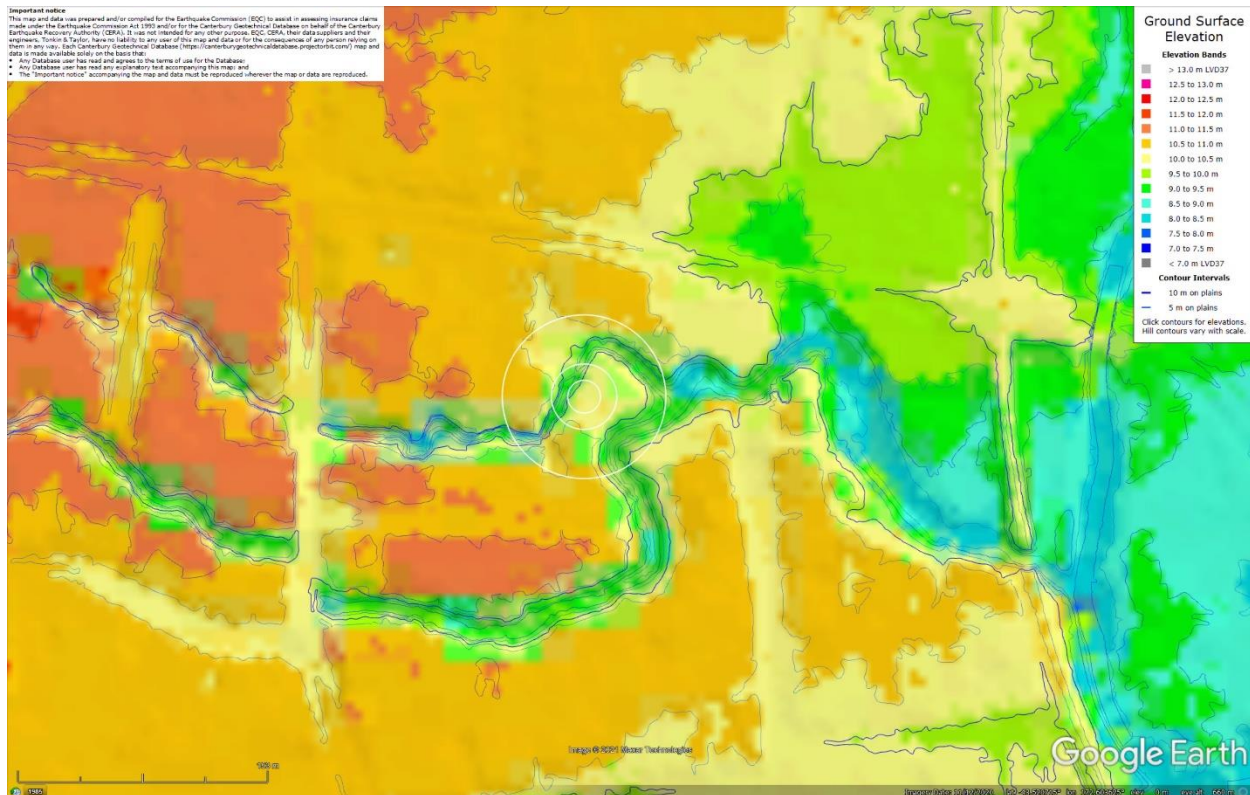
Figure 34: Ground surface elevation according to the Sep-11 LIDAR survey.

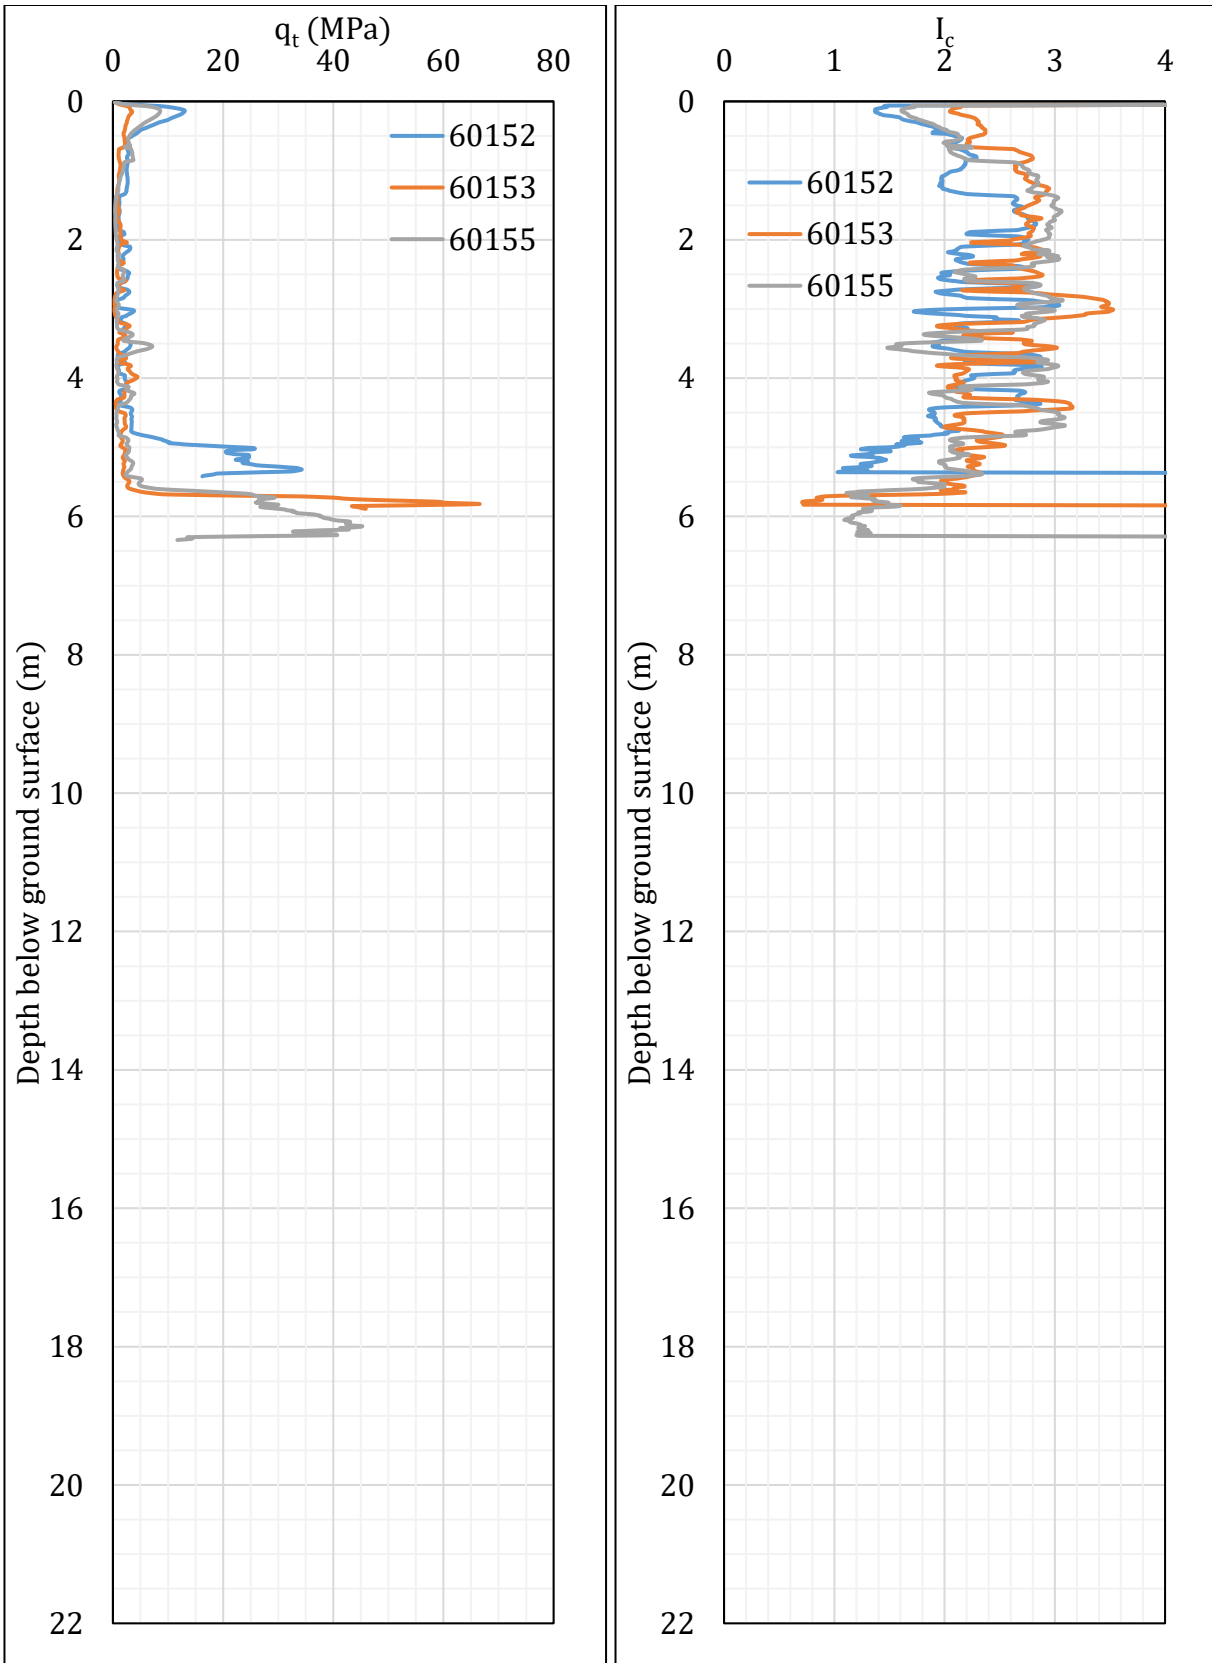
Figure 35: q_t and I_c profiles.

Note 6: The selection of CPTs for the area considered for settlement assessment (Figure 1) is based on the proximity of the CPTs to the considered areas. In accordance with that, the following table shows CPTs that were used for the volumetric settlement analysis in *Cliq v.3.0.3.2*, a CPT soil liquefaction software developed by GeoLogismiki. (The average volumetric settlements were reported in Table 8.)

Notes: $D_{FS<1}$ = Depth to the first liquefiable layer ($FS_L<1$) that is at least 200-mm thick, as determined by the Boulanger and Idriss (2016) liquefaction-triggering procedure ($P_L=50\%$, $C_{FC}=0.13$, and $I_{c,cutoff}=2.6$), and exported from *Cliq v.3.0.3.2*; undet. = the specified soil layer was not detected; Negligible settlement is assumed for a depth range from ~6 m to 20 m.
