Appendix A.27:

Avondale Park – VsVp 57187

## Liquefaction Ejecta Case Histories for 2010-11 Canterbury Earthquakes

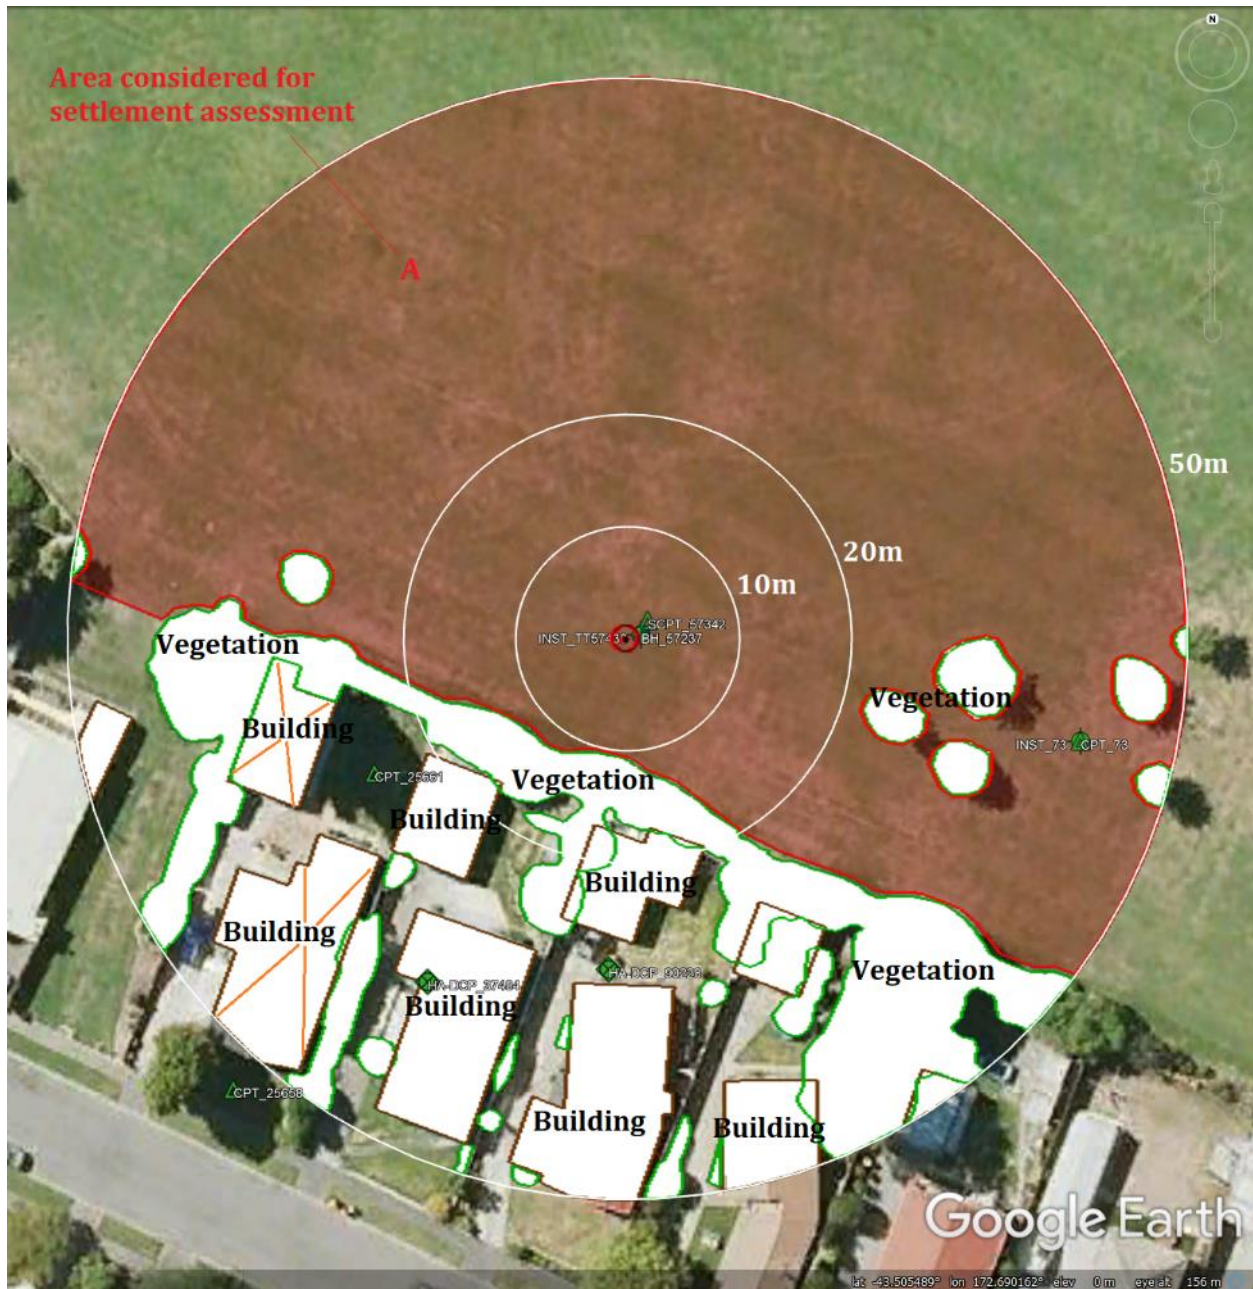
**Figure 1: Site plan with areas where ejecta-induced settlement is considered.**

**Note 1:** Patch A (outlined in red) in the free field was selected for settlement assessment as an area free of vegetation and structures. Other important factors considered in its selection were its proximity a CPT, a property subjected to addition and/or demolition of a structure, front yard/backyard alterations (e.g., ploughing, rubble, scrap), and aerial distribution of sediment ejecta. The LiDAR-based settlement analyses were not performed for any earthquake event due to the evident absence of ejecta from the site for the Sep-10 EQ, LiDAR flight errors, overestimation by liquefaction triggering procedures, and anthropogenic changes.

- $A_{E,cone,m}$  and  $H_{E,cone,m}$  are the area and the height of a conically shaped ejecta, respectively;
- $A_T$  is the total assessment area for a buffer being considered (Figure 1).

**Note 5:** The selection of CPTs for the area considered for settlement assessment (Figure 1) is based on the proximity of the CPTs to the considered areas. In accordance with that, the following table shows CPTs that were used for the volumetric settlement analysis in *Cliq* v.3.0.3.2, a CPT soil liquefaction software developed by GeoLogismiki. (The average volumetric settlements were reported in Table 8.)

**Note 6:** Based on the borehole log (BH 57237, Figure 1), the groundwater table is at a depth of 1.4 m below the ground surface. The soil profile consists of (1) sandy fill (SP) to a depth of 0.85 m, (2) organic silty topsoil (OL) to a depth of 1.2 m, (3) silt, ML, of the Christchurch formation to a depth of 2.4 m, (4) silty fine sand, SM, of the Christchurch formation to a depth of 2.9 m, (5) fine to medium sand, SP, of the Christchurch formation to a depth of 3.5 m, (6) silt, ML, to a depth of 3.25 m, (7) fine sand, SP, of the Christchurch formation to a depth of 4.5 m, (8) silt, ML, of the Christchurch formation to a depth of 5.05 m, (9) fine to medium sand, SP, of the Christchurch formation to a depth of 11.3 m, (10) silt, ML, of the Christchurch formation to a depth of 11.95 m, and (11) fine to medium sand, SP, of the Christchurch formation to a depth of 17.15 m. The sandy fill might be a result of the earthwork following the Jun-11 earthquake.

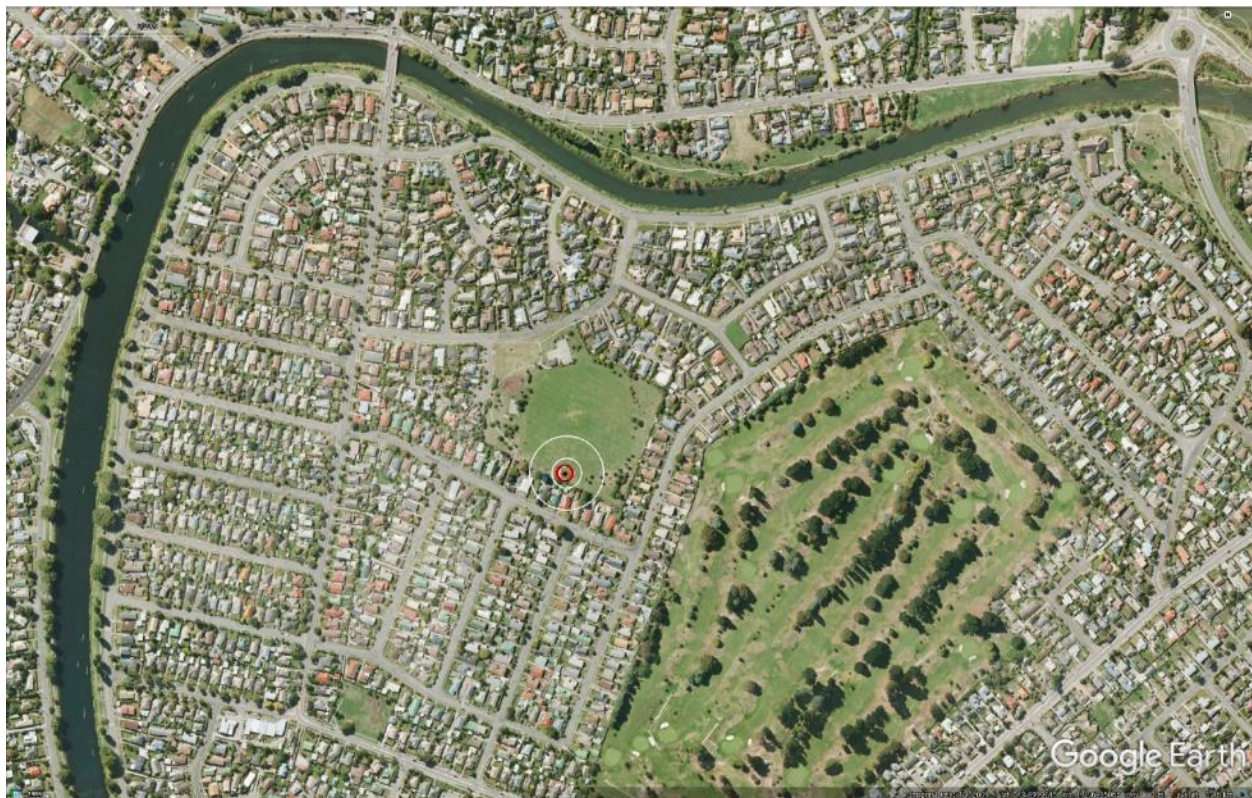
Figure 3: Position of the site relative to nearby free-face features.

Attribute	Yes/No			Description/Date	Symbol in Figure 1
	10-m Buffer	20-m Buffer	50-m Buffer		
Near a body of surface water or other free face features?	No	No	No	The center of the site is 370 m to the S from the Avon River that runs in the E-W direction. The Avon River is also 620 m to the W of the center of the site and here it runs in the S-N direction. The height of the free face is ~ 1.5 m.	NA
Lateral spreading observed during the CES?	No	No	No	No lateral spreading was observed by the mapping team. <sup>1</sup>	NA
Nearby buildings or structures?	No	Yes	Yes	Building coverage of the 10-m, 20-m, and 50-m buffers is 3% and 12%, respectively. The buildings are in the SW and SE quadrants of the two buffers.	White Fill + Brown Outline
Sloping land?	No	No	No	Flat land, open field + residential area	NA
Step changes in the ground surface?	No	No	No	NA	NA
Retaining walls?	No	No	No	NA	NA
Vegetation?	No	Yes	Yes	Trees and bushes cover 13% of both the 20- and 50-m buffers. They are in the SW and SE quadrants of the two buffers.	White Fill + Green Outline

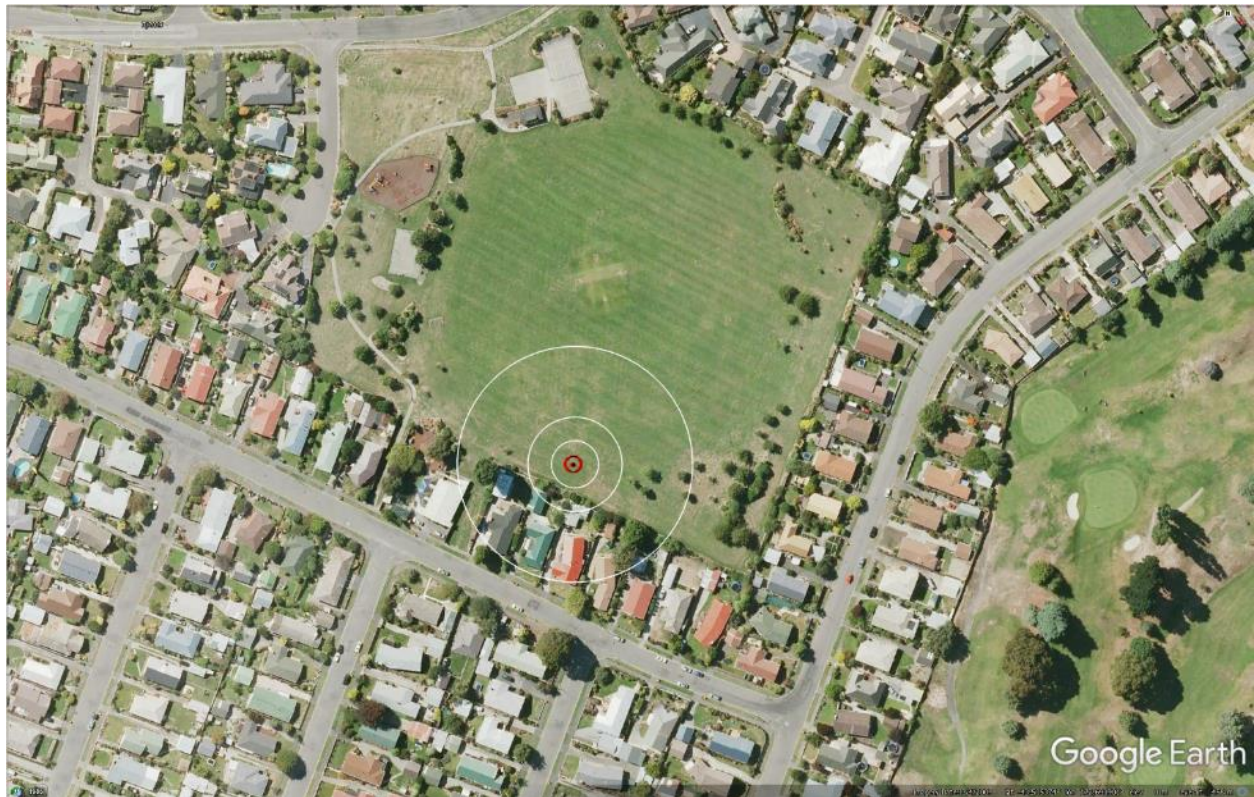
**Figure 4: Position of the site relative to nearby buildings and vegetation.**

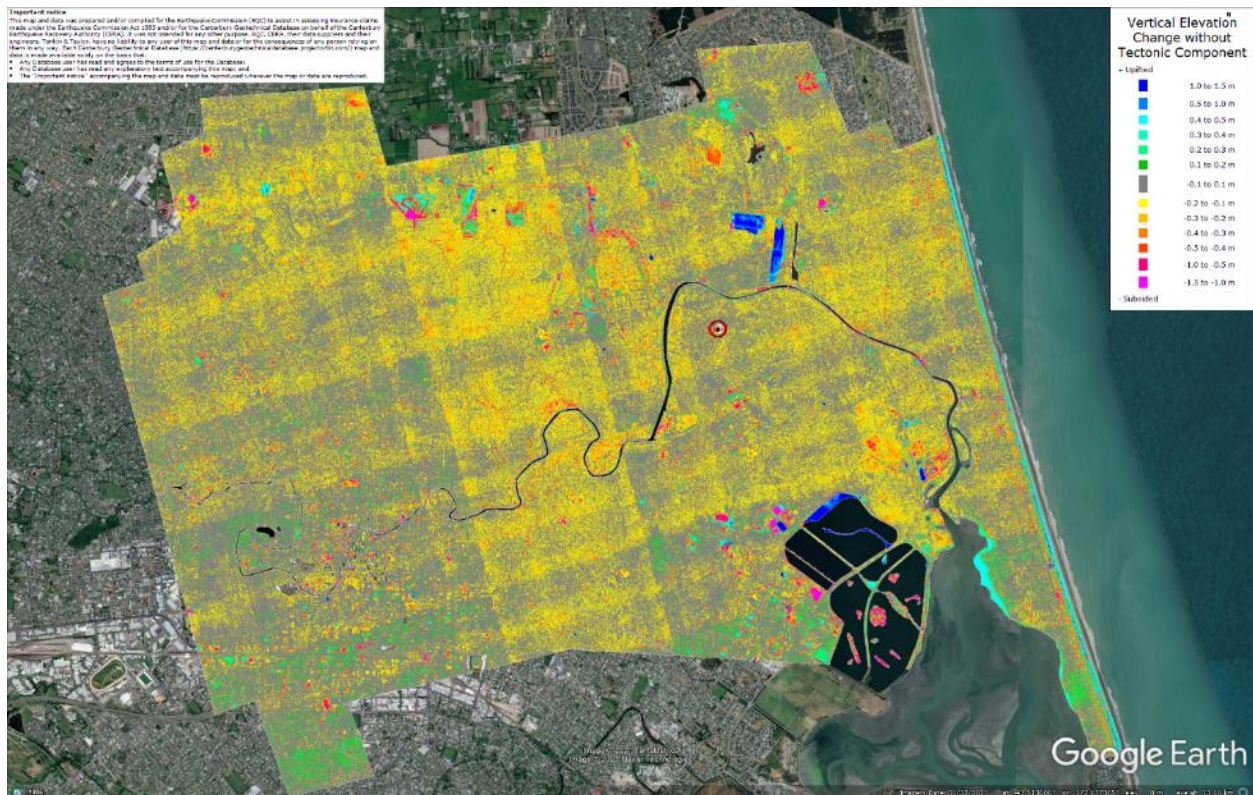
**Figure 23: Vertical Ground Movements (Surface – Tectonic) for Sep 2010 Earthquake – the site is in the apparent zone of overestimated ground surface subsidence (i.e., flight error band for Sep 2010).**

- $SE_{final}$  is based solely on  $SE_P$  for all EQ events.
- The Avondale Park site is in the apparent zone of higher ground surface subsidence for the Sep-10 EQ and the apparent zone of lower ground surface subsidence for the Feb-11 EQ (the underestimate of the ground surface elevation by the Sep 2010 LiDAR survey). The site is in the zone of accurate LPI prediction of liquefaction severity for the Sep-10 and slight LPI overprediction of liquefaction severity for the Feb-11 EQ (Maurer et al. 2014<sup>3</sup>). The LDAT property inspection reports are available for nearby properties; however, no measurements of the ejecta height were taken during the inspection. A ground photograph that shows remnants of ejecta at a nearby property is available.

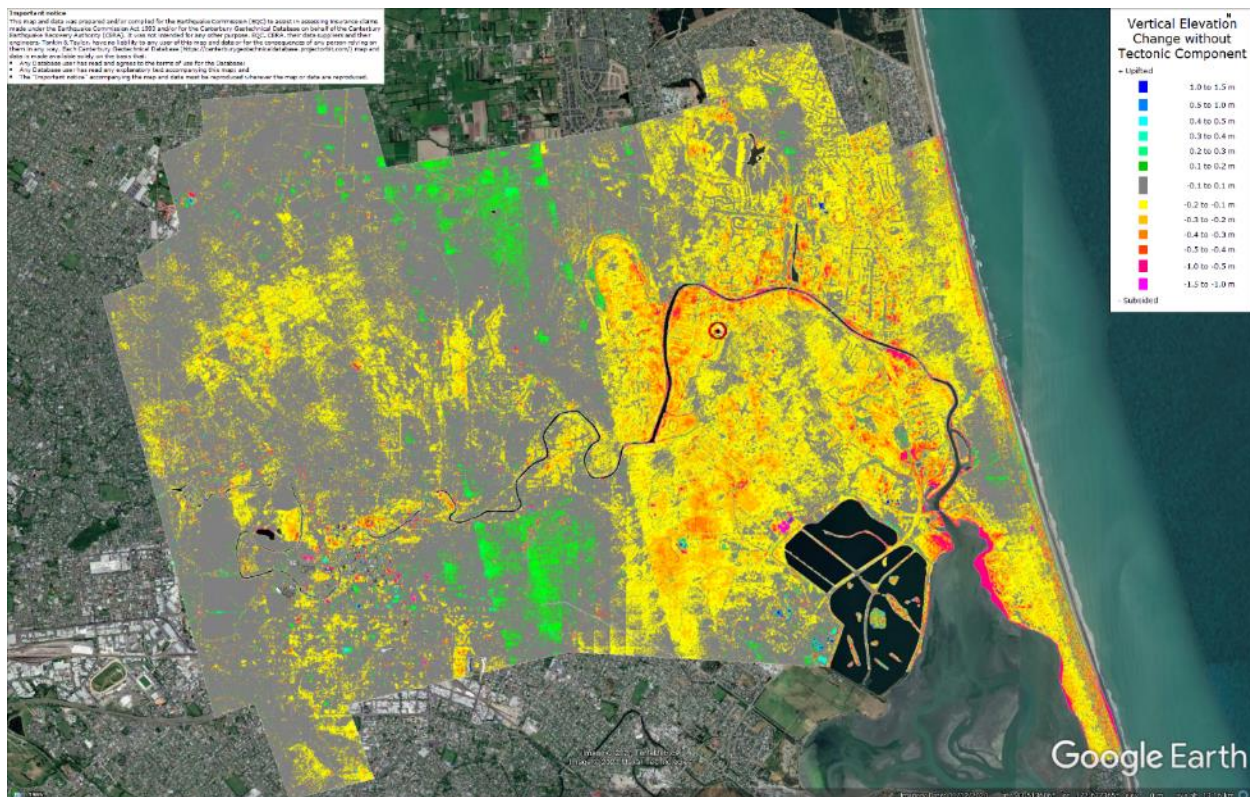
**Figure 24: Vertical Ground Movements (Surface – Tectonic) for Feb 2011 Earthquake – the site is in the apparent zone of underestimated ground surface subsidence (i.e., flight error band for Sep 2010).**

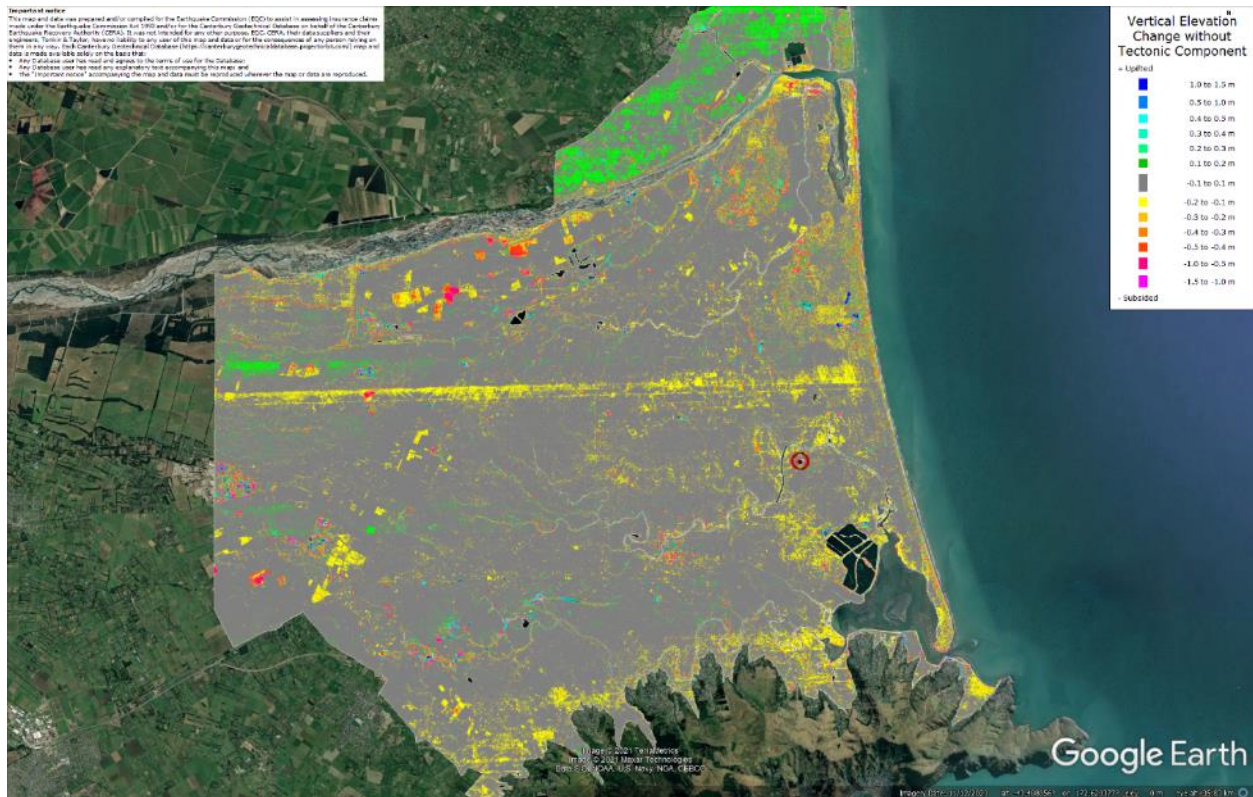
**Figure 25: Vertical Ground Movements (Surface – Tectonic) for June 2011 Earthquake – the site is not in the apparent zone of overestimated or underestimated ground surface subsidence.**

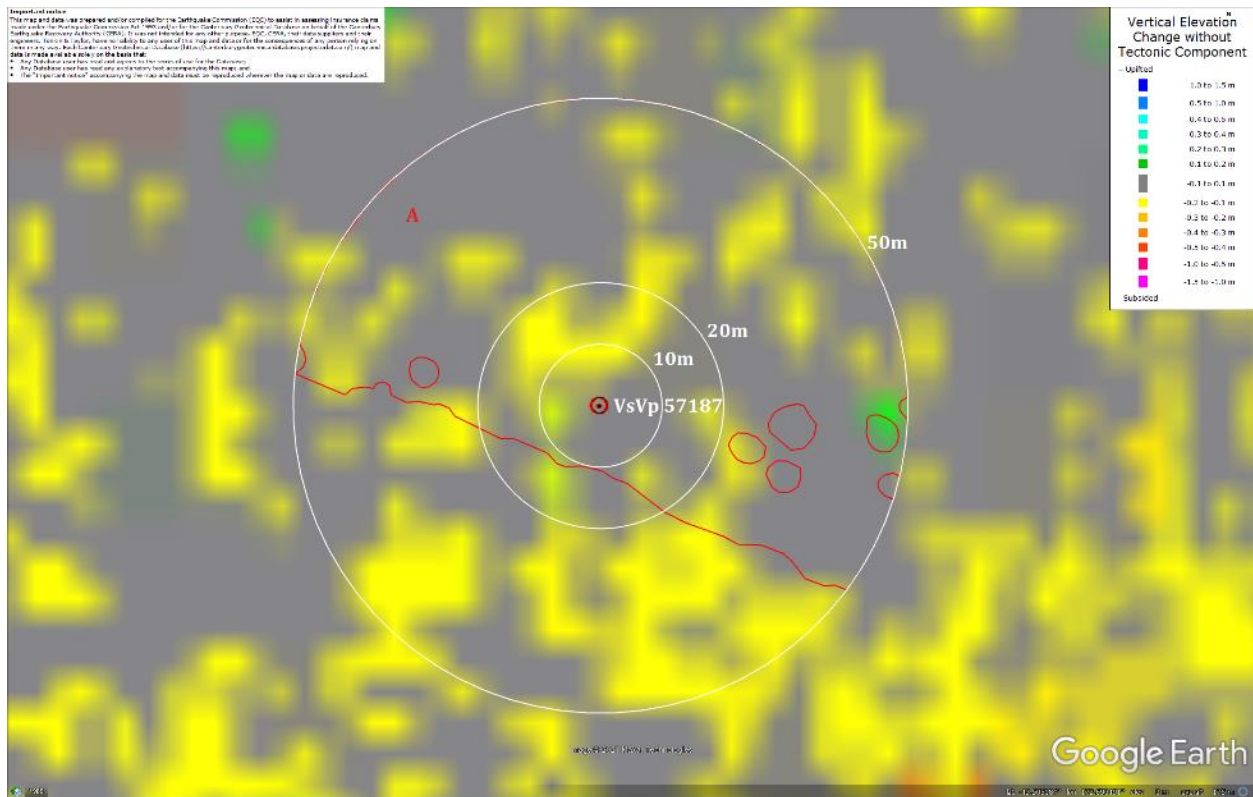
**Figure 27: Ground surface subsidence without tectonic component for Sep 2010 Earthquake according to the LiDAR DEM.**

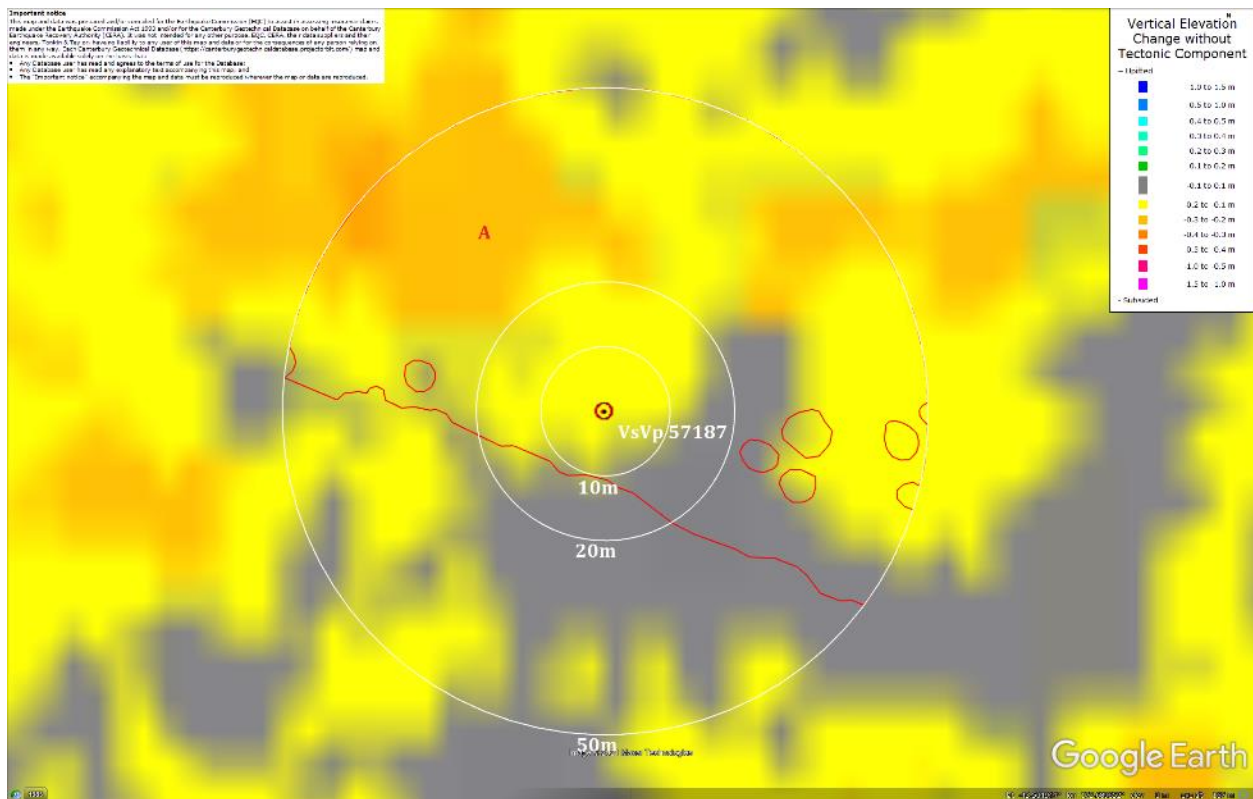
**Figure 28: Ground surface subsidence without tectonic component for Feb 2011 Earthquake according to the LiDAR DEM.**

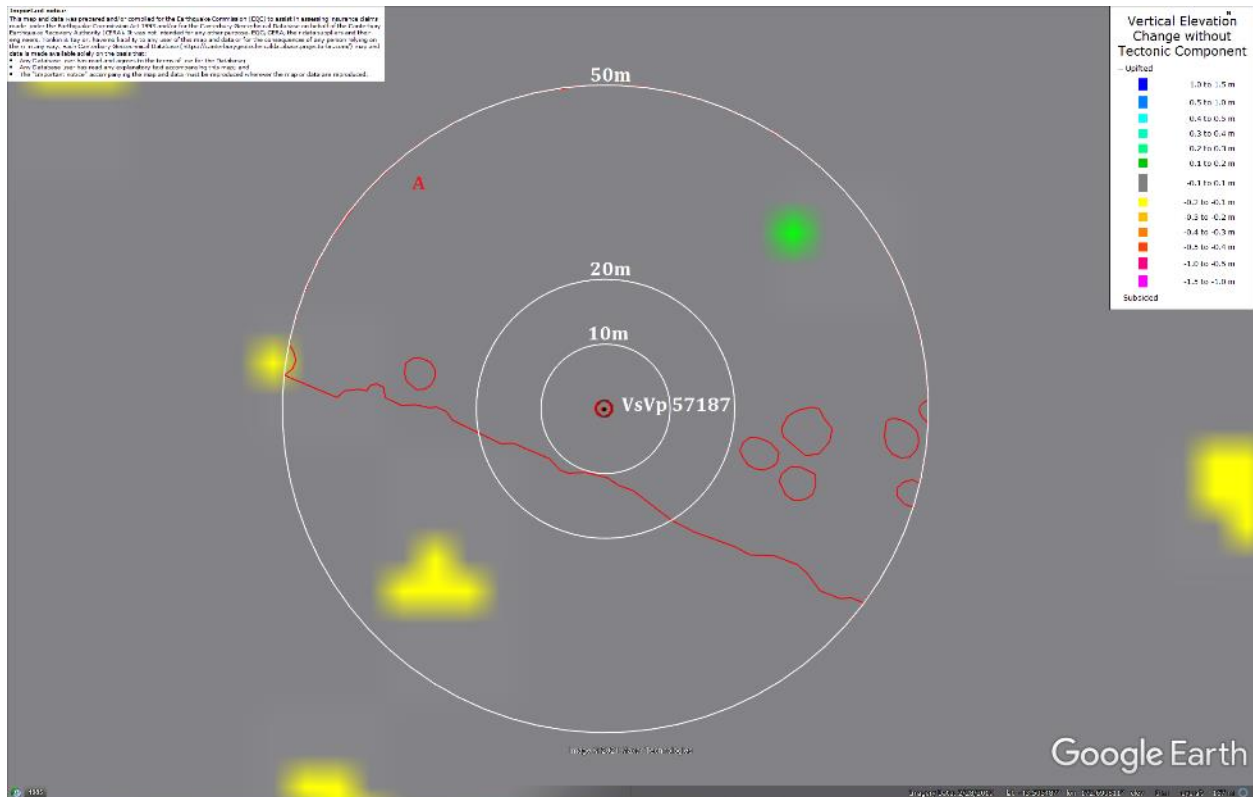
**Figure 29: Ground surface subsidence without tectonic component for June 2011 Earthquake according to the LiDAR DEM.**

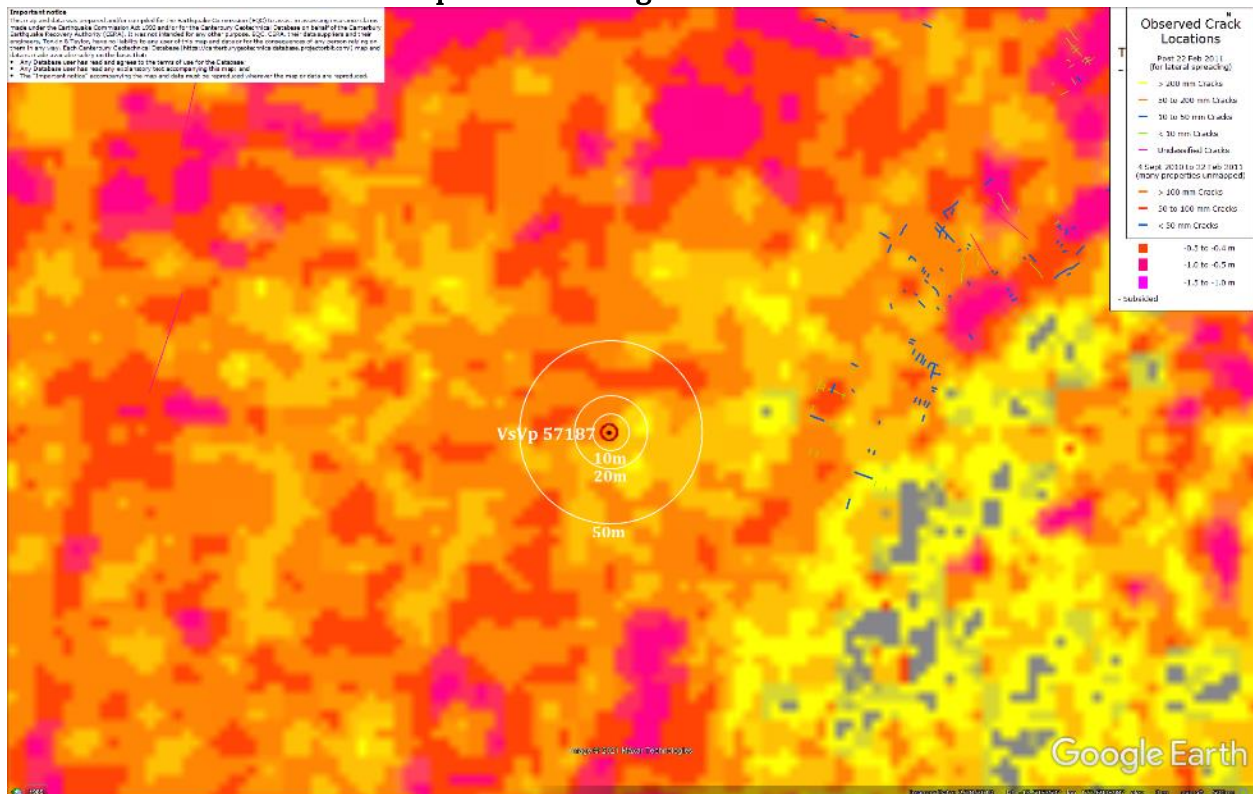
**Figure 30: No lateral spreading for Canterbury Earthquake Sequence.**

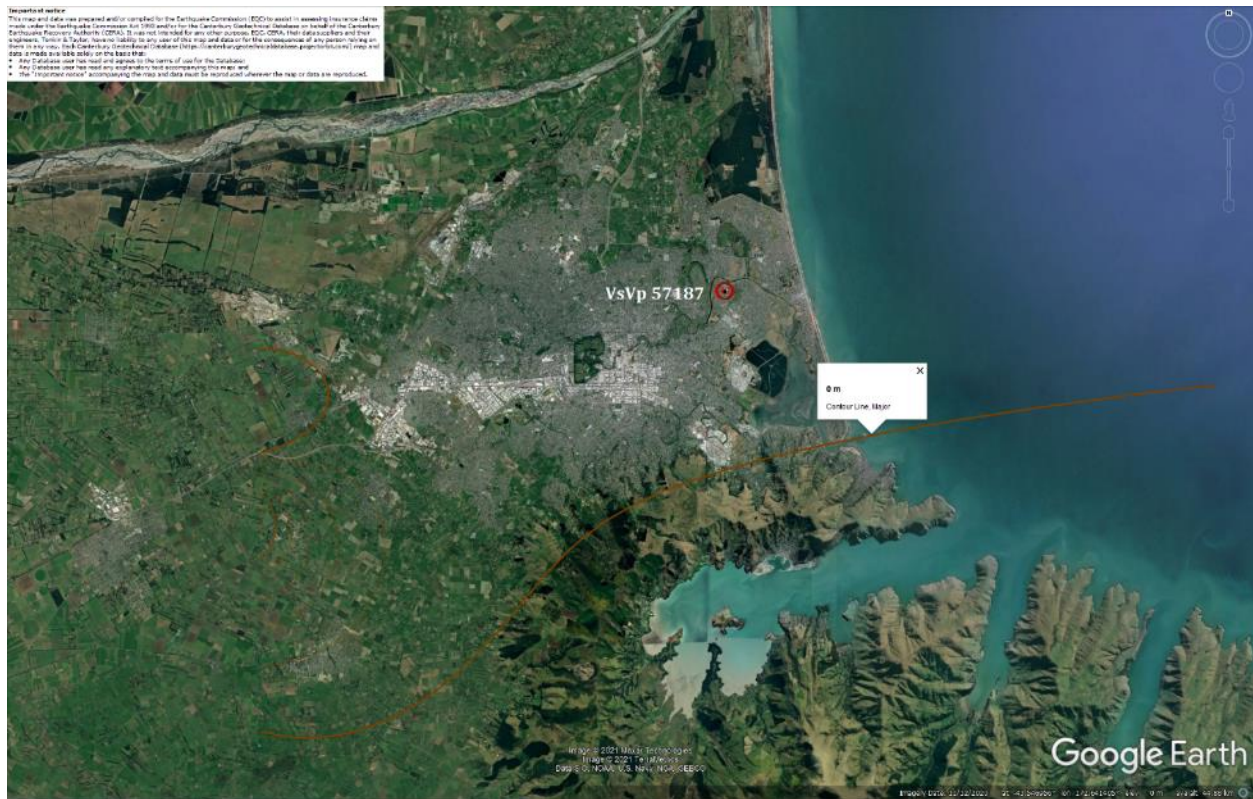
Figure 31: Vertical tectonic movements for Sep 2010 Earthquake.

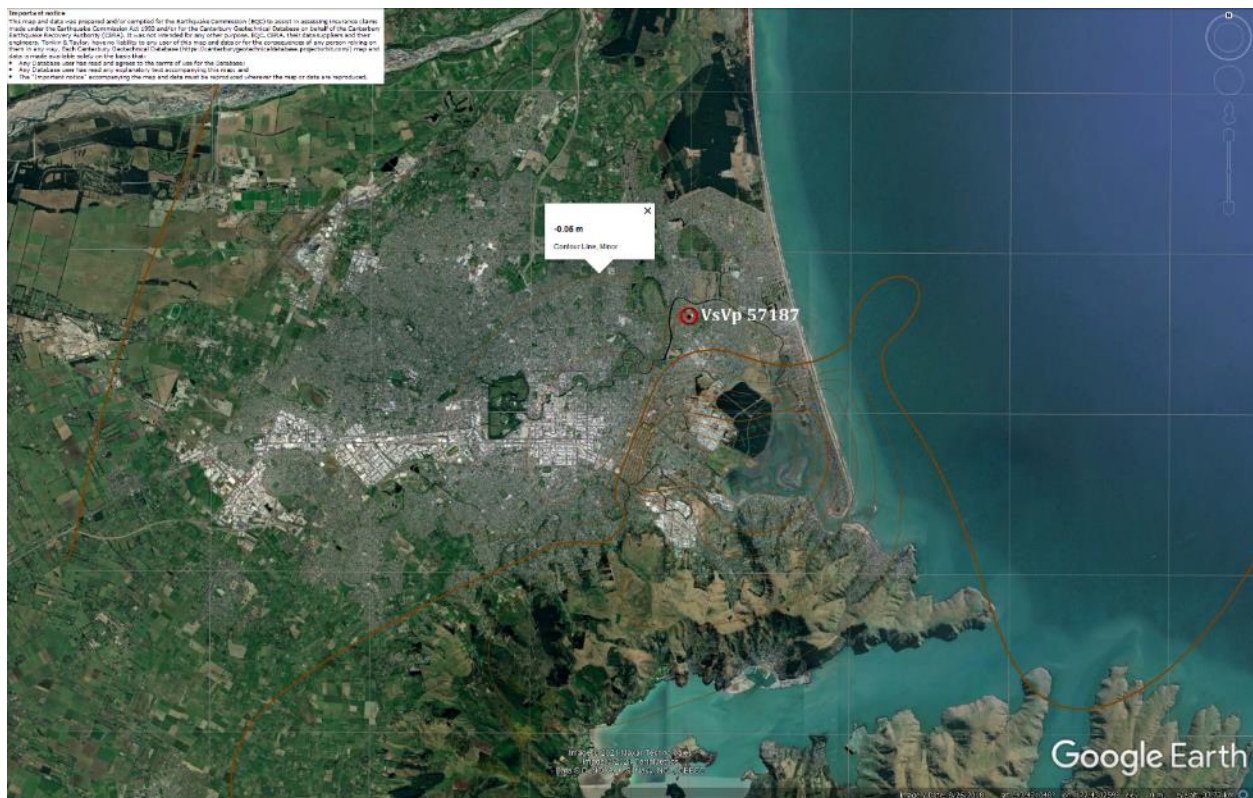
Figure 32: Vertical tectonic movements for Feb 2011 Earthquake.

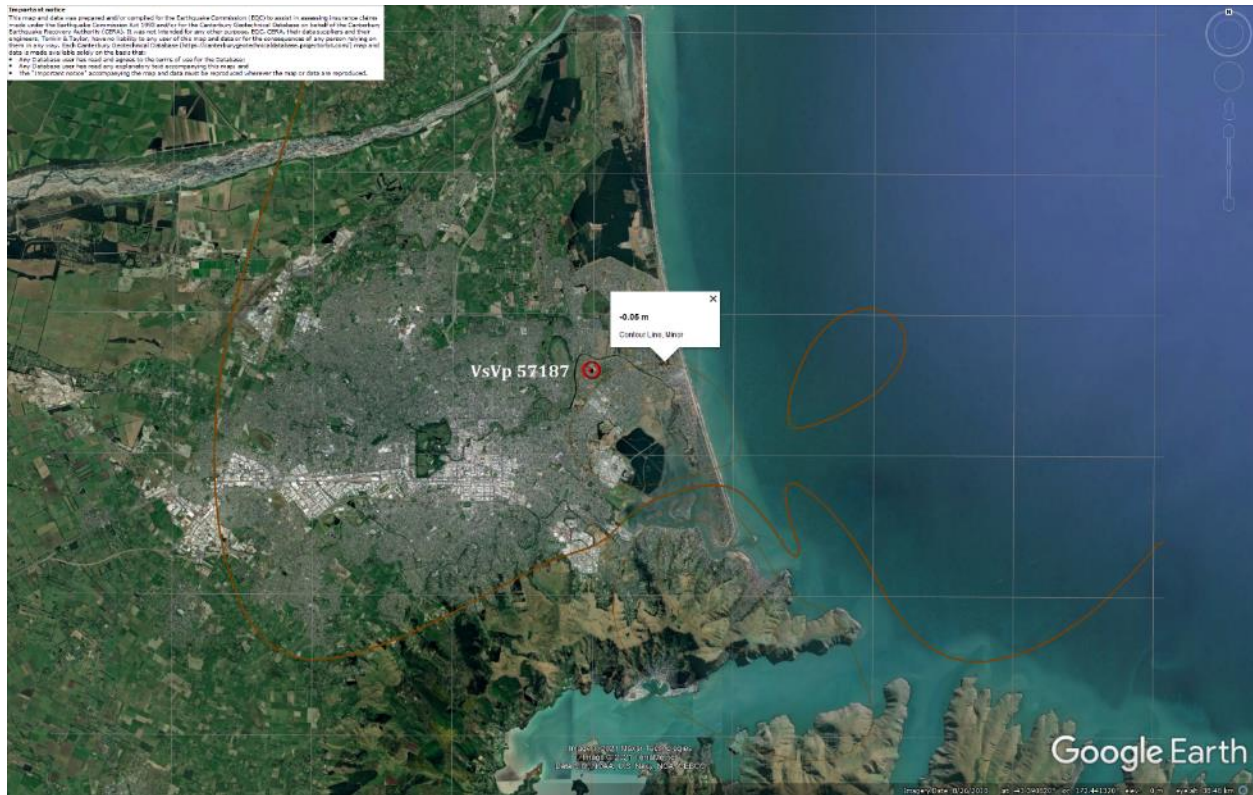
**Figure 33: Vertical tectonic movements for June 2011 Earthquake.**

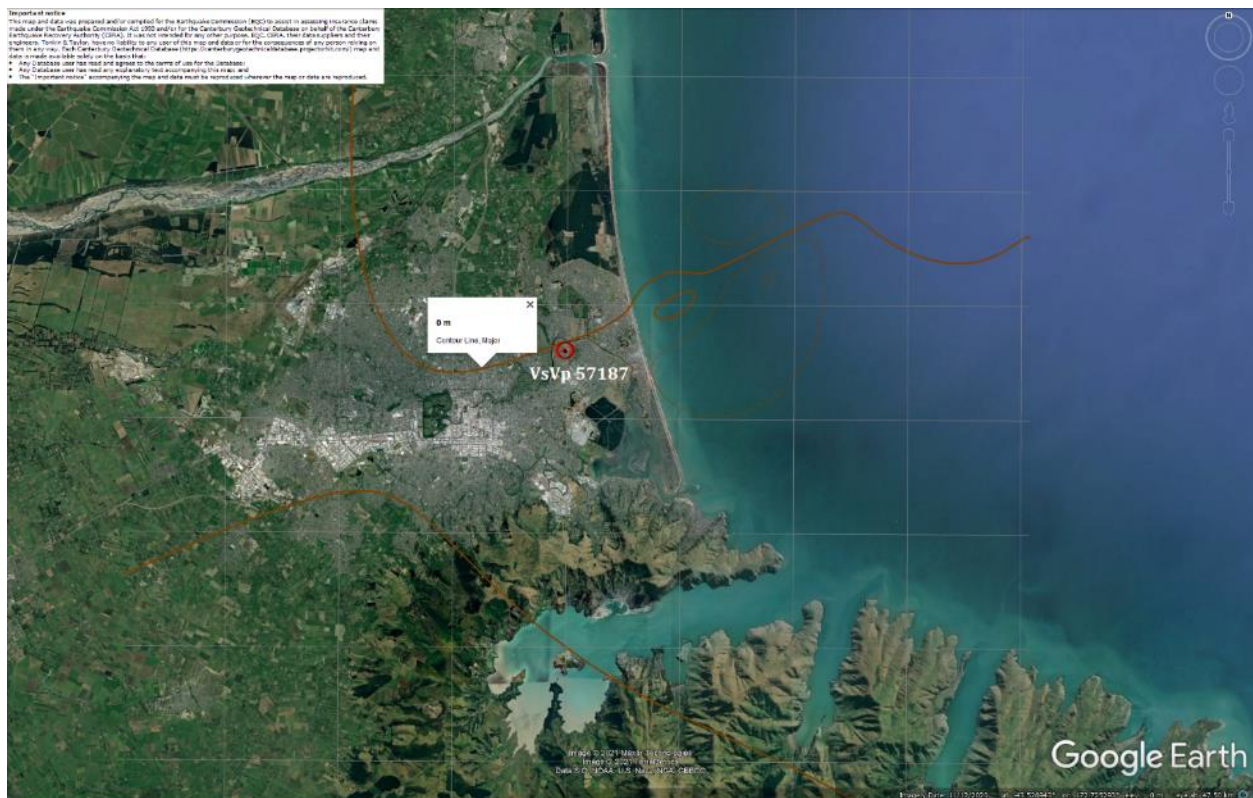
**Figure 34: Vertical tectonic movements for Dec 2011 Earthquake.**

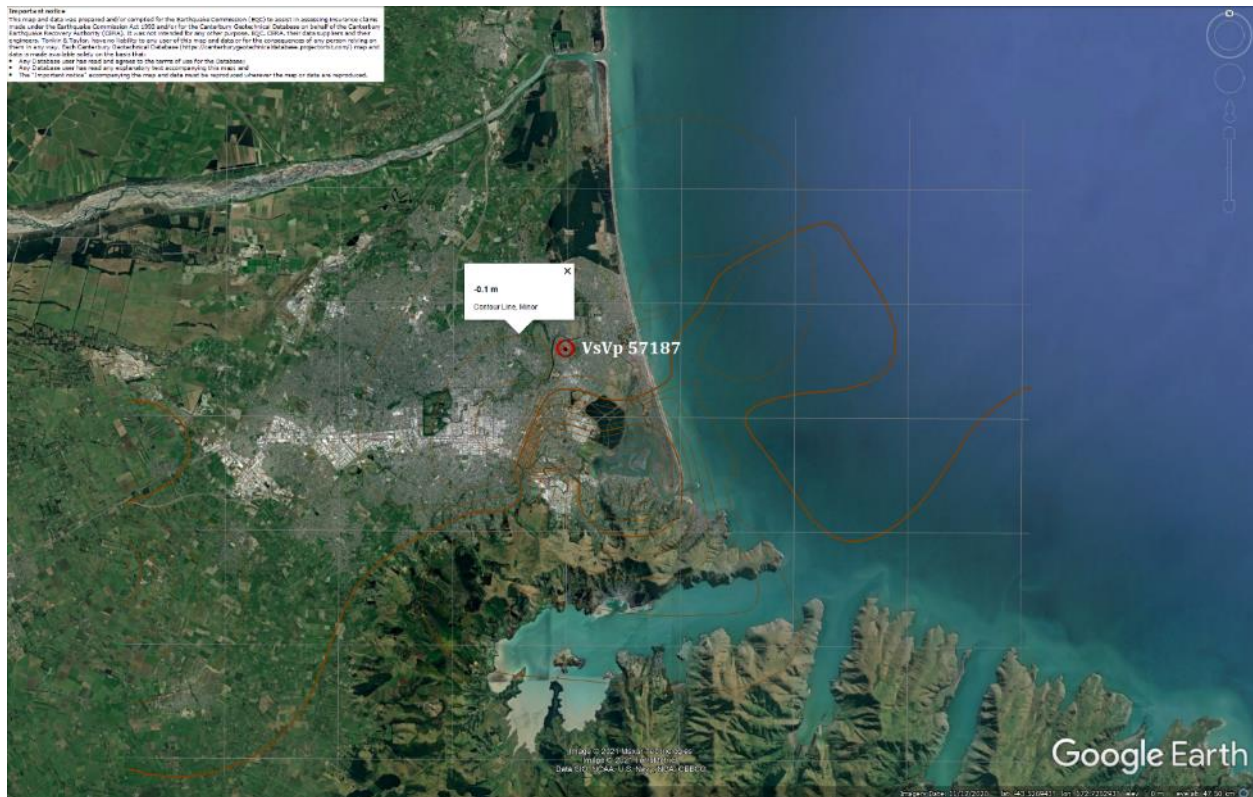
**Figure 35: Vertical tectonic movements for Canterbury Earthquake Sequence.**

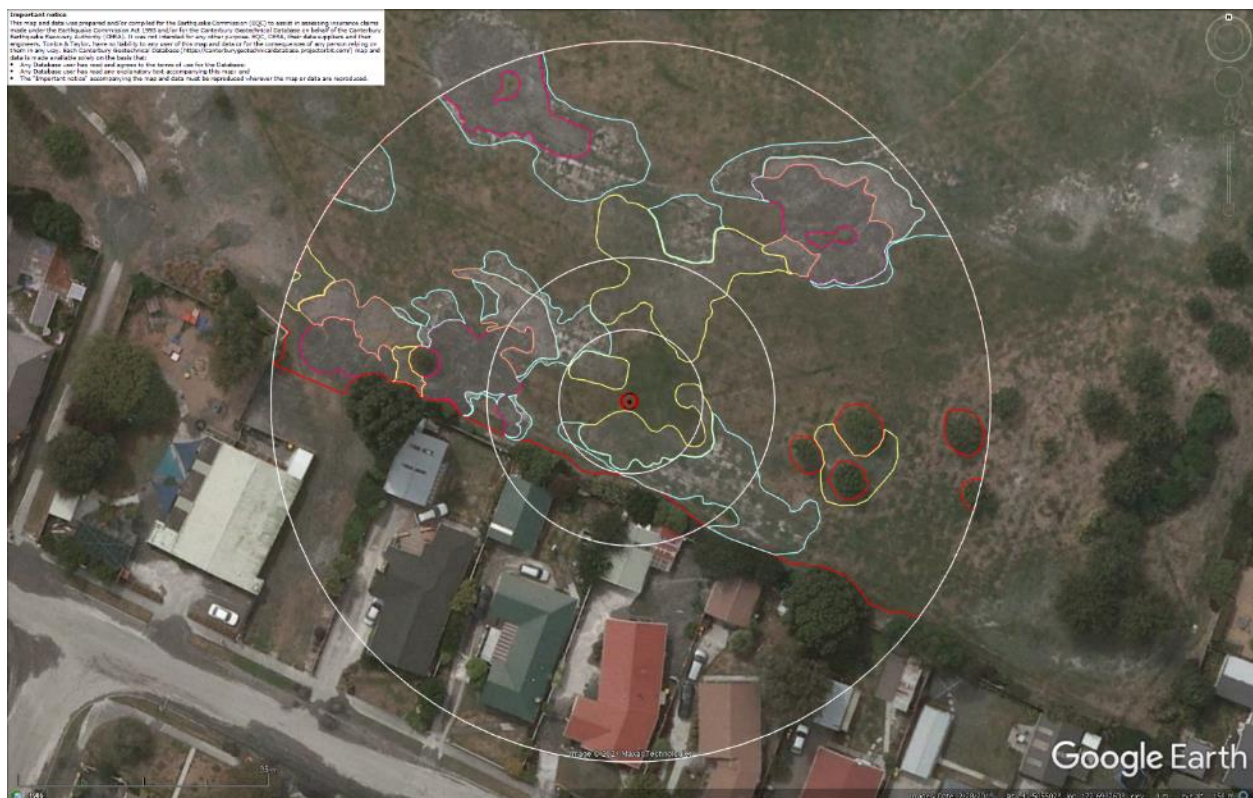
**Figure 36: Aerial photograph showing the ejecta outline at the site for Feb-11 EQ.**

**Note 3:** The values in Table 9 correspond to the coverage area of ejecta outlined in aerial photographs (Figures 36-38) and the lower and upper estimates of ejecta height based on geometrical approximations, ground photographs (Figure 39), and EQC LDAT property inspection reports. The ejecta-induced settlement using photographs and engineering judgment,  $S_{E,P}$ , is estimated as

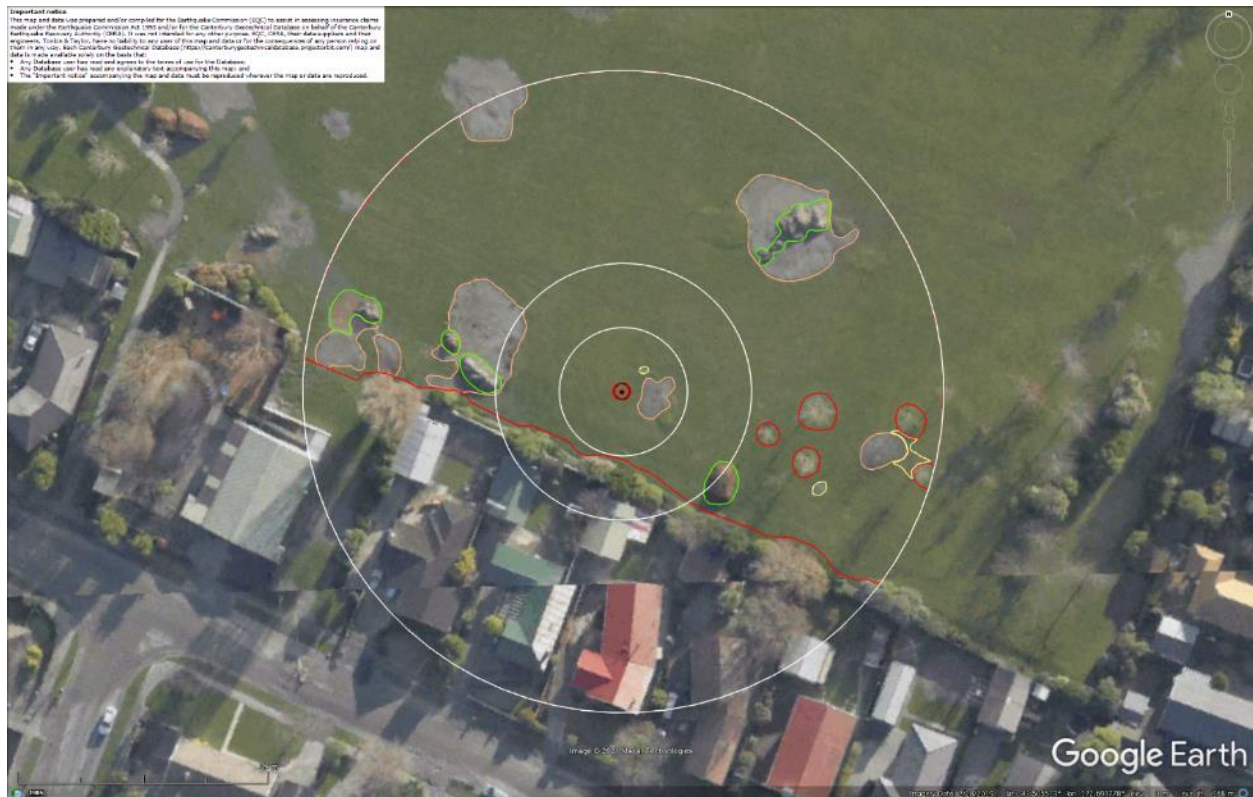
**Figure 37: Aerial photograph acquired on 14-15 Jun 2011 showing the ejecta outline at the site for Jun-11 EQ.**

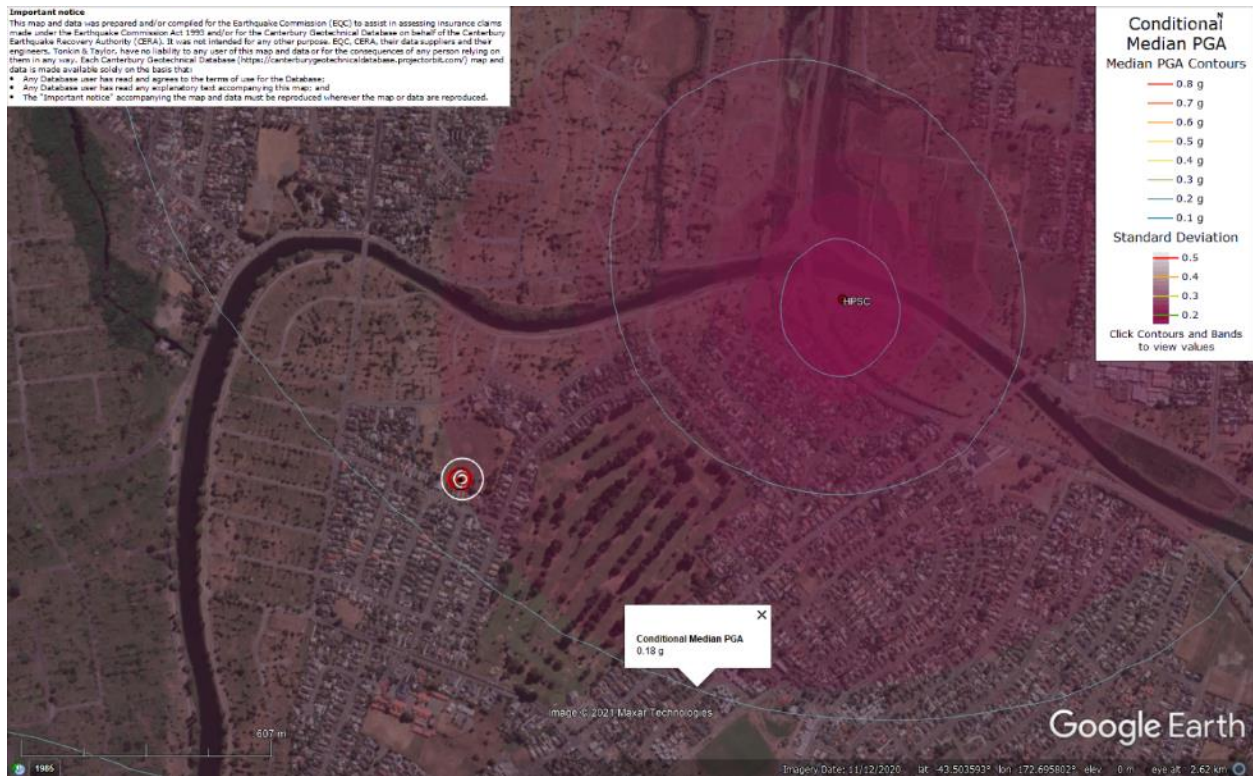
Figure 40: PGA for Sep-10 EQ (st. dev. = 0.275-0.325 ln units).

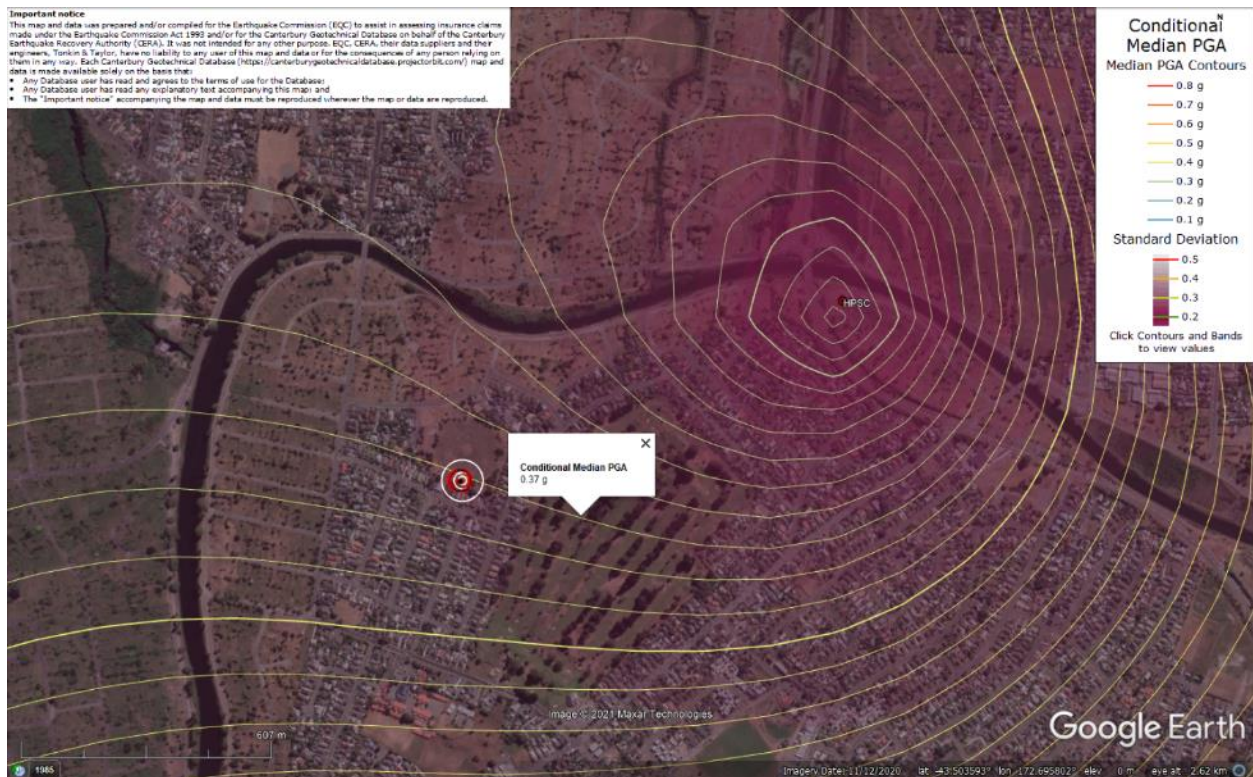
Figure 41: PGA for Feb-11 EQ (st. dev. = 0.300-0.325 ln units).

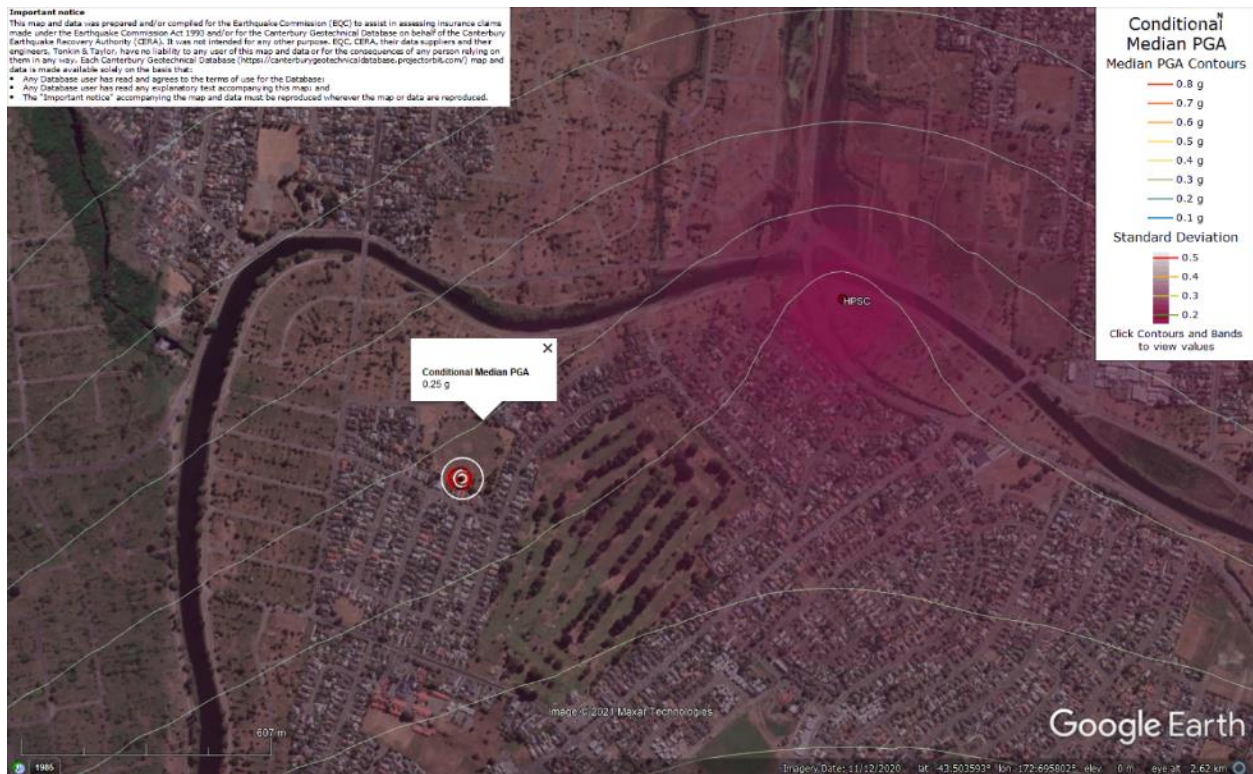
Figure 42: PGA for Jun-11 EQ (st. dev. = 0.325-0.350 ln units).
