Appendix A.27:

Avondale Park – VsVp 57187

## Liquefaction Ejecta Case Histories for 2010-11 Canterbury Earthquakes

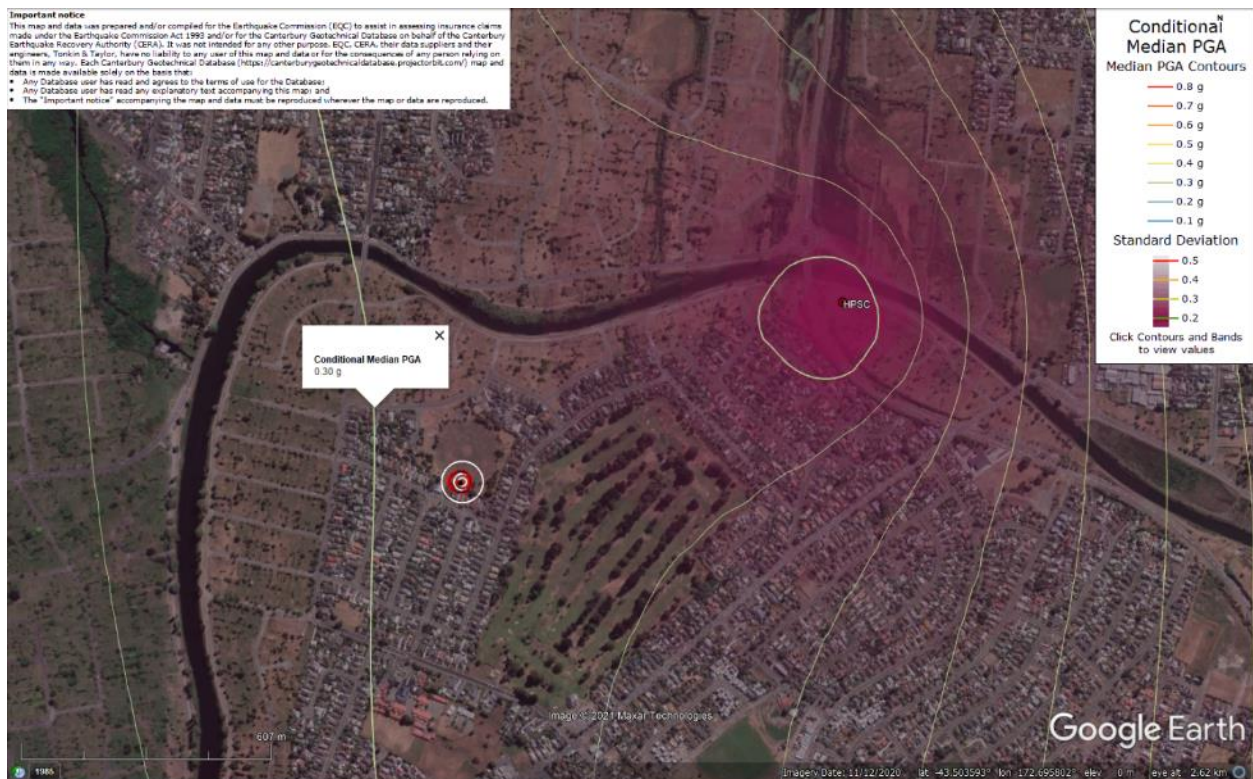
Figure 43: PGA for Dec-11 EQ (st. dev. = 0.325-0.375 ln units).

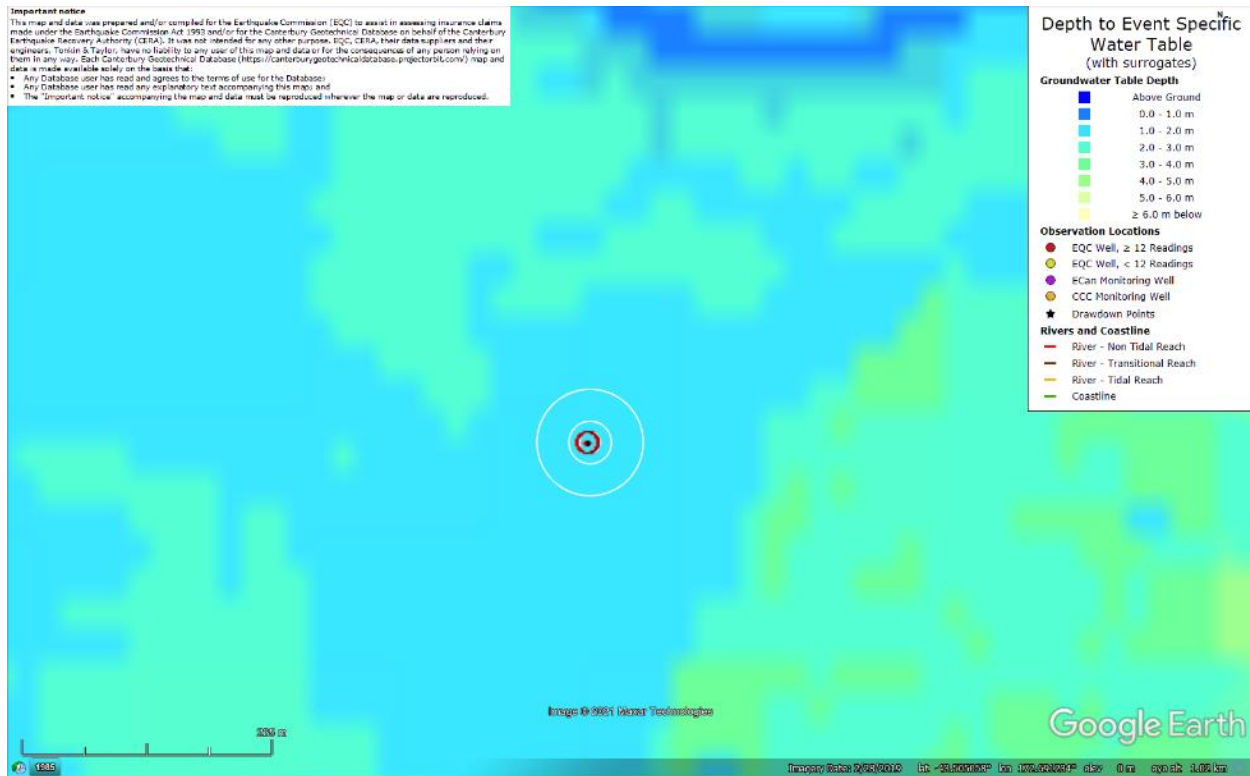
Figure 44: Depth to groundwater table for Sep-10 EQ.

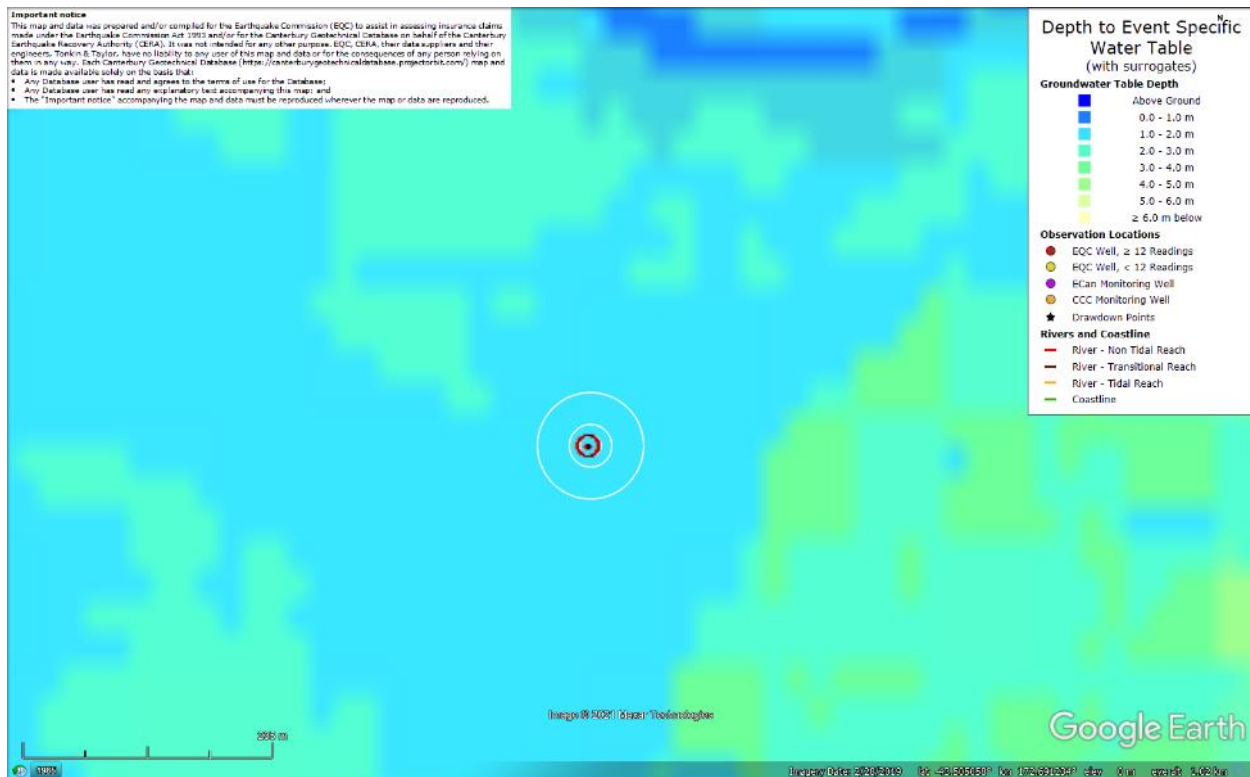
Figure 45: Depth to groundwater table for Feb-11 EQ.

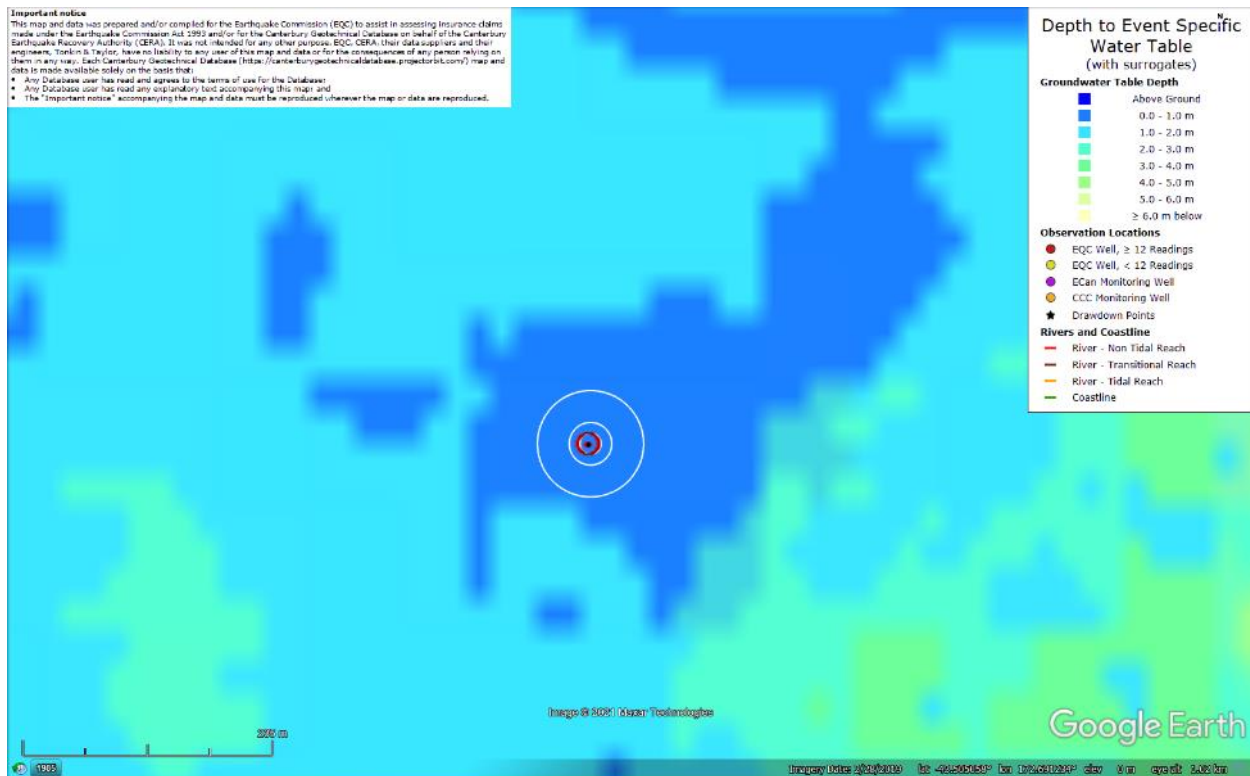
Figure 46: Depth to groundwater table for Jun-11 EQ.

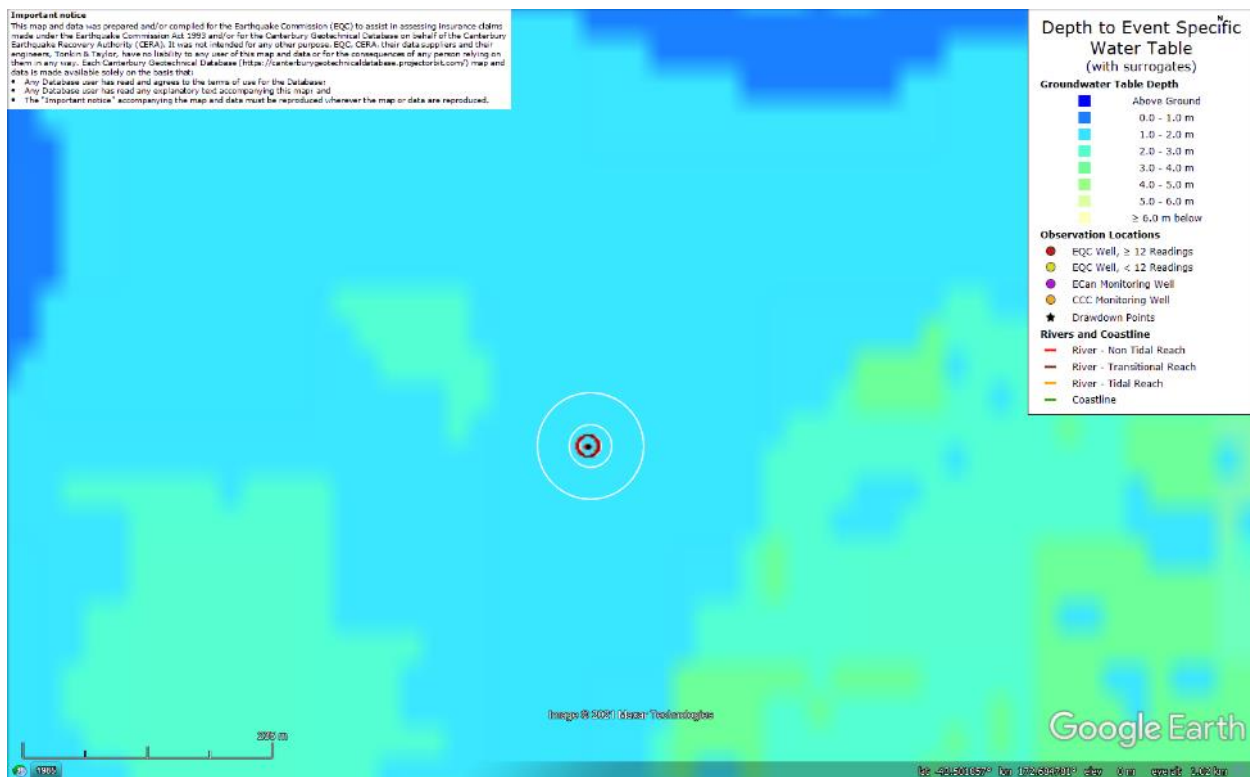
Figure 47: Depth to groundwater table for Dec-11 EQ.

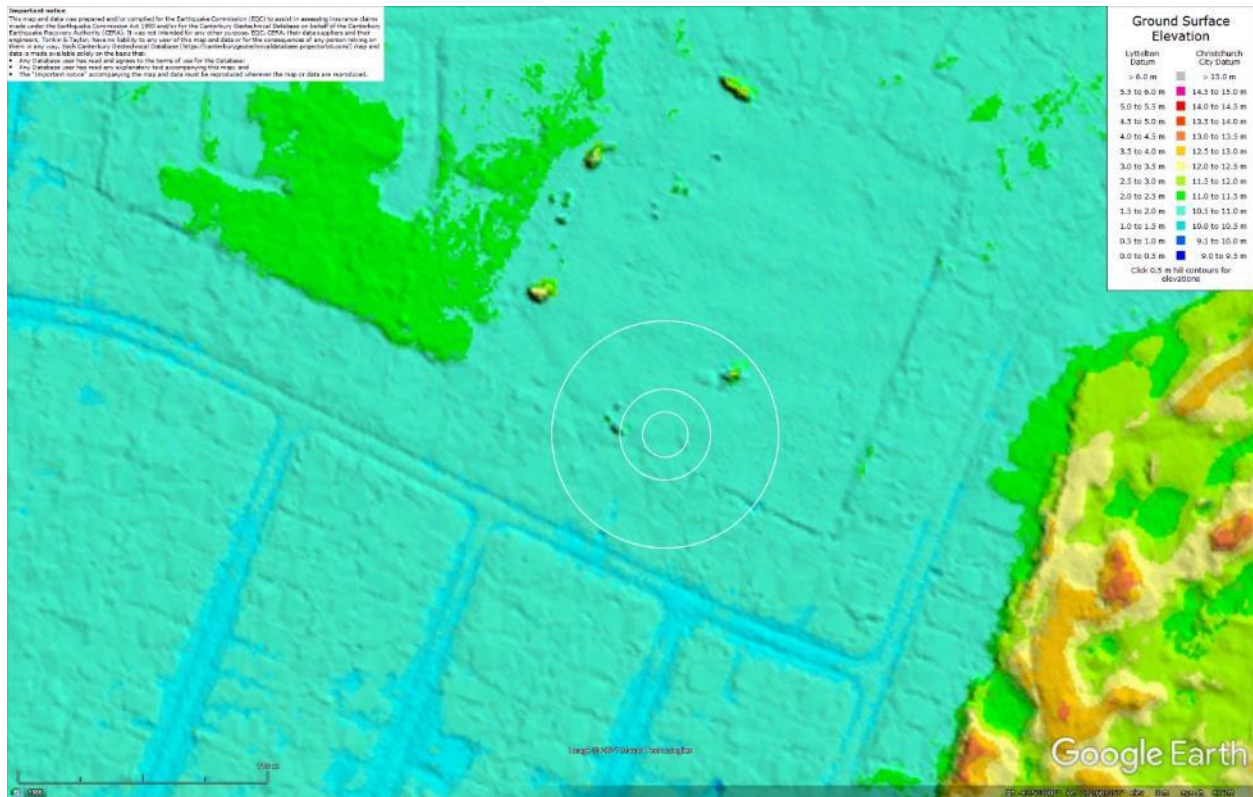
**Figure 48: Ground surface elevation according to the Sep-11 LiDAR survey.**

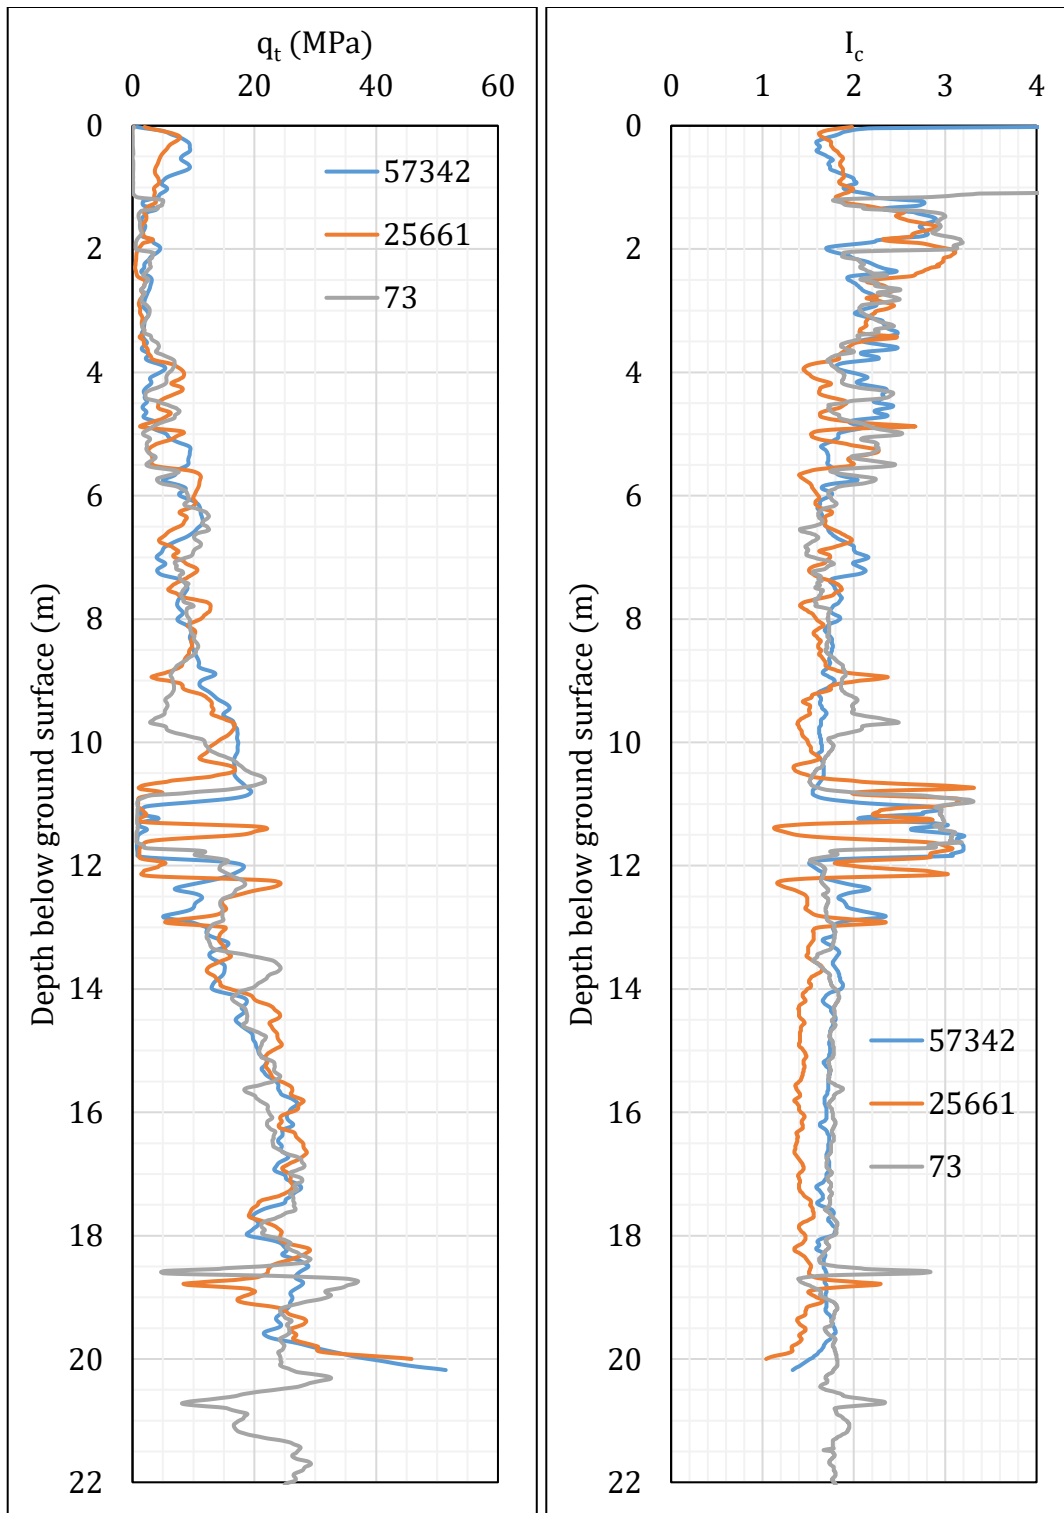
Figure 49:  $q_t$  and  $I_c$  profiles.

**Note 5:** The selection of CPTs for the area considered for settlement assessment (Figure 1) is based on the proximity of the CPTs to the considered areas. In accordance with that, the following table shows CPTs that were used for the volumetric settlement analysis in *Cliq* v.3.0.3.2, a CPT soil liquefaction software developed by GeoLogismiki. (The average volumetric settlements were reported in Table 8.)

EQ Event	Parameter	CPT ID		
		57342	25661	73
Sep-10	$S_{V1D}$ (mm)	41	80	60
	LSN	9	15	11
	LPI	1	2	1
	$LPI_{ish}$	0	0	0
	$D_{FS<1}$ (m)	4.24	2.80	4.89
Feb-11	$S_{V1D}$ (mm)	154	182	174
	LSN	35	33	35
	LPI	17	21	20
	$LPI_{ish}$	4	12	4
	$D_{FS<1}$ (m)	1.88	2.46	2.02
Jun-11	$S_{V1D}$ (mm)	124	164	148
	LSN	31	40	33
	LPI	11	15	15
	$LPI_{ish}$	9	9	11
	$D_{FS<1}$ (m)	1.94	1.08	2.02
Dec-11	$S_{V1D}$ (mm)	122	154	144
	LSN	29	29	30
	LPI	10	13	12
	$LPI_{ish}$	6	8	7
	$D_{FS<1}$ (m)	1.96	2.46	2.02
