Appendix A.34:

Dunarnan St – CPT 24039

**Table 1: Site Description for Dunarnan St (CC LIQ 25 – CPT 24039).**

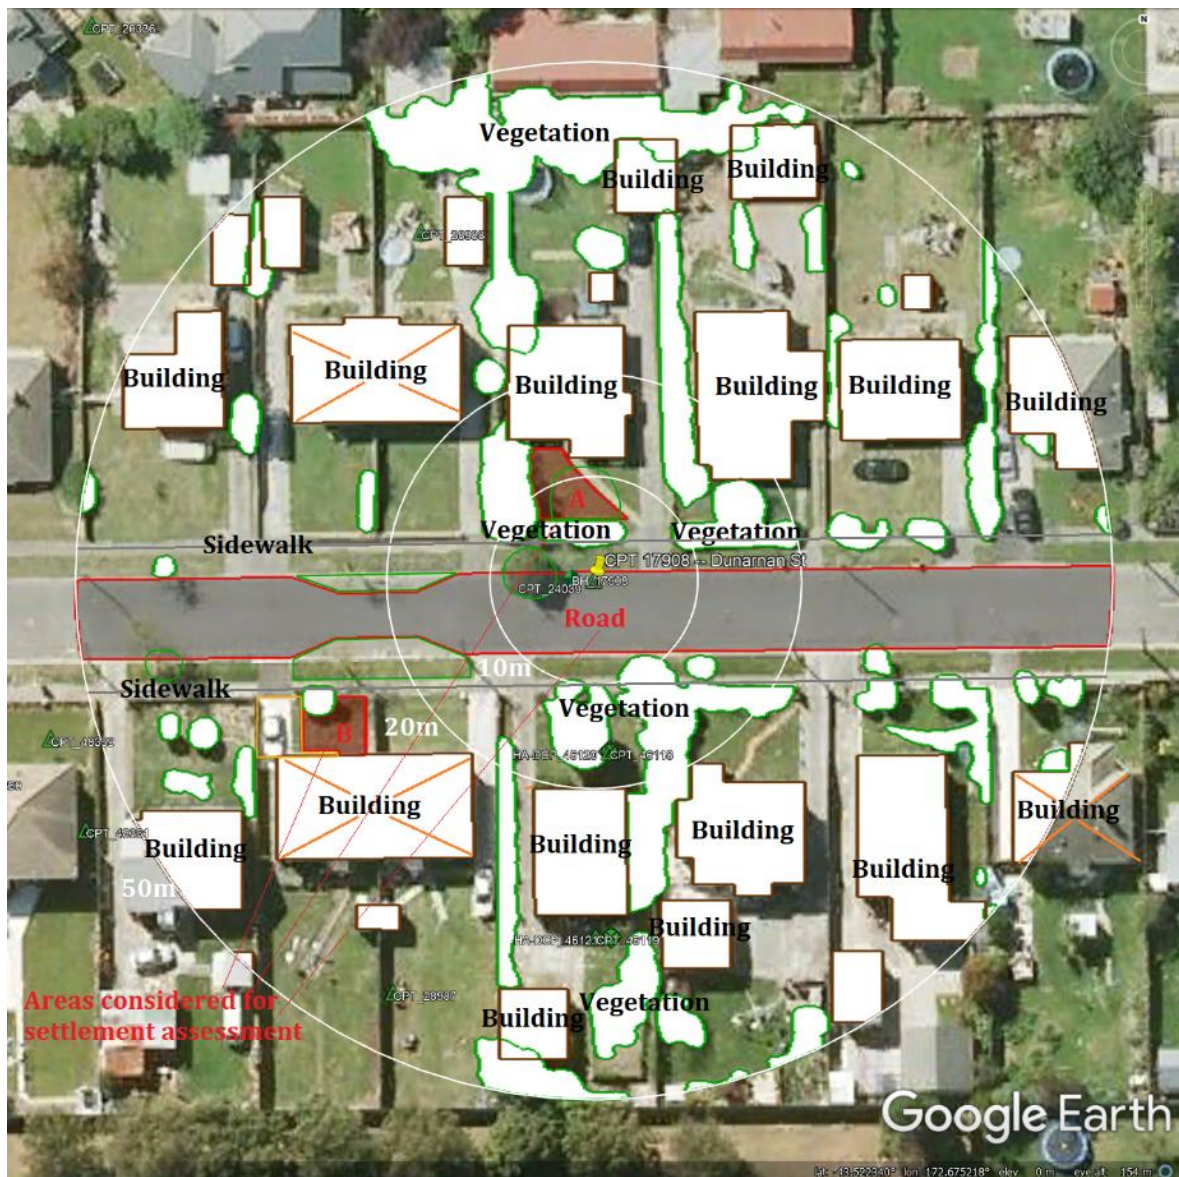
**Figure 1: Site plan with areas where ejecta-induced settlement is considered.**

**Note 1:** Two patches (outlined in red) in the free field were selected for settlement assessment as areas free of vegetation and structures. Other important factors considered in the patch selection process were its proximity to a CPT, a property subjected to addition and/or demolition of a structure, front yard/backyard alterations (e.g., ploughing, rubble, scrap), and aerial distribution of sediment ejecta. In addition, the entire portion of the road within the 50-m buffer was considered for the settlement assessment. Roads as hard, relatively flat surfaces provide many ground-classified points. Finally, the LiDAR-based settlement analyses for the Sep-10 EQ were not conducted due to the evident absence of ejecta from Patches A and B and Road. The Oct 2015 LiDAR survey was not considered for Patch B due to the building removal between Jan 2015 and July 2015.

**Note 7:** The selection of CPTs for the area considered for settlement assessment (Figure 1) is based on the proximity of the CPTs to the considered areas. In accordance with that, the following table shows CPTs that were used for the volumetric settlement analysis in *Cliq v.3.0.3.2*, a CPT soil liquefaction software developed by GeoLogismiki. (The average volumetric settlements were reported in Table 8.)

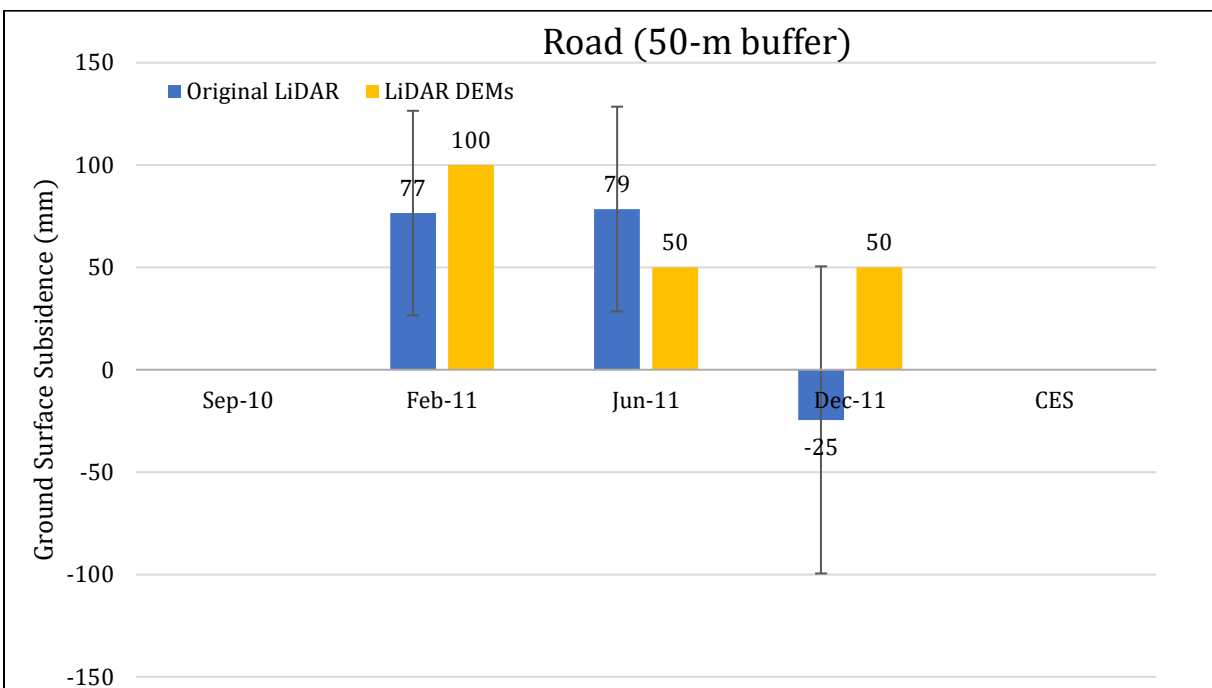
**Figure 6: Comparison between ground surface subsidence determined from original LiDAR survey points and ground surface subsidence (50<sup>th</sup> %ile) estimated using LiDAR DEMs for Road (50-m buffer).**

**Note 2:** The ground surface subsidence values determined from the original LiDAR survey points are similar to the ground surface subsidence values estimated using LiDAR DEMs for all earthquake events.
