Appendix A.41:

Bideford Pl – CPT 17200

Table 1: Site Description for Bideford Pl (CC LIQ 17 – CPT 17200).

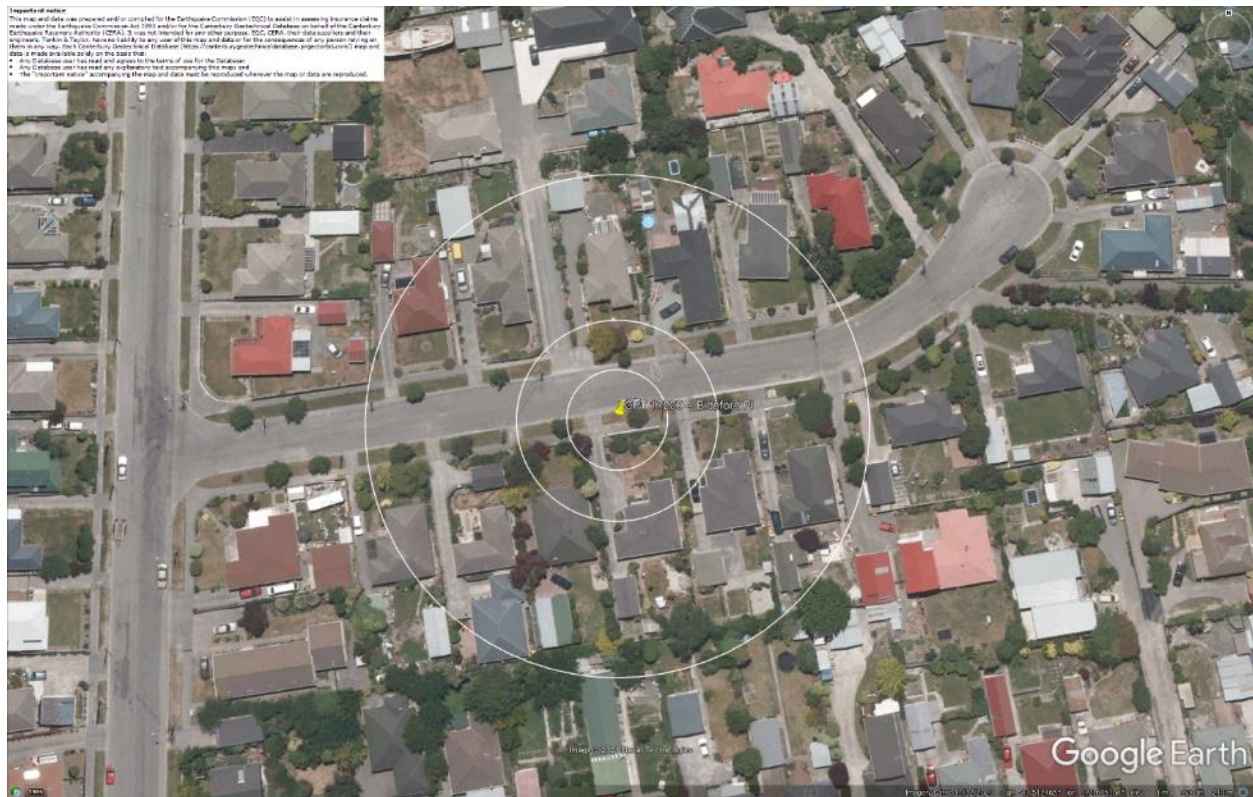
Figure 28: Aerial photograph of the site taken on Dec 24, 2011.

Note 4: The values in Table 9 correspond to the coverage area of ejecta outlined in aerial photographs (Figures 28 and 63-65) and the lower and upper estimates of ejecta height based on geometrical approximations, ground photographs (Figures 67 and 68), and EQC LDAT property inspection reports (e.g., Figure 66). The ejecta-induced settlement using photographs and engineering judgment, $S_{E,p}$, is estimated as

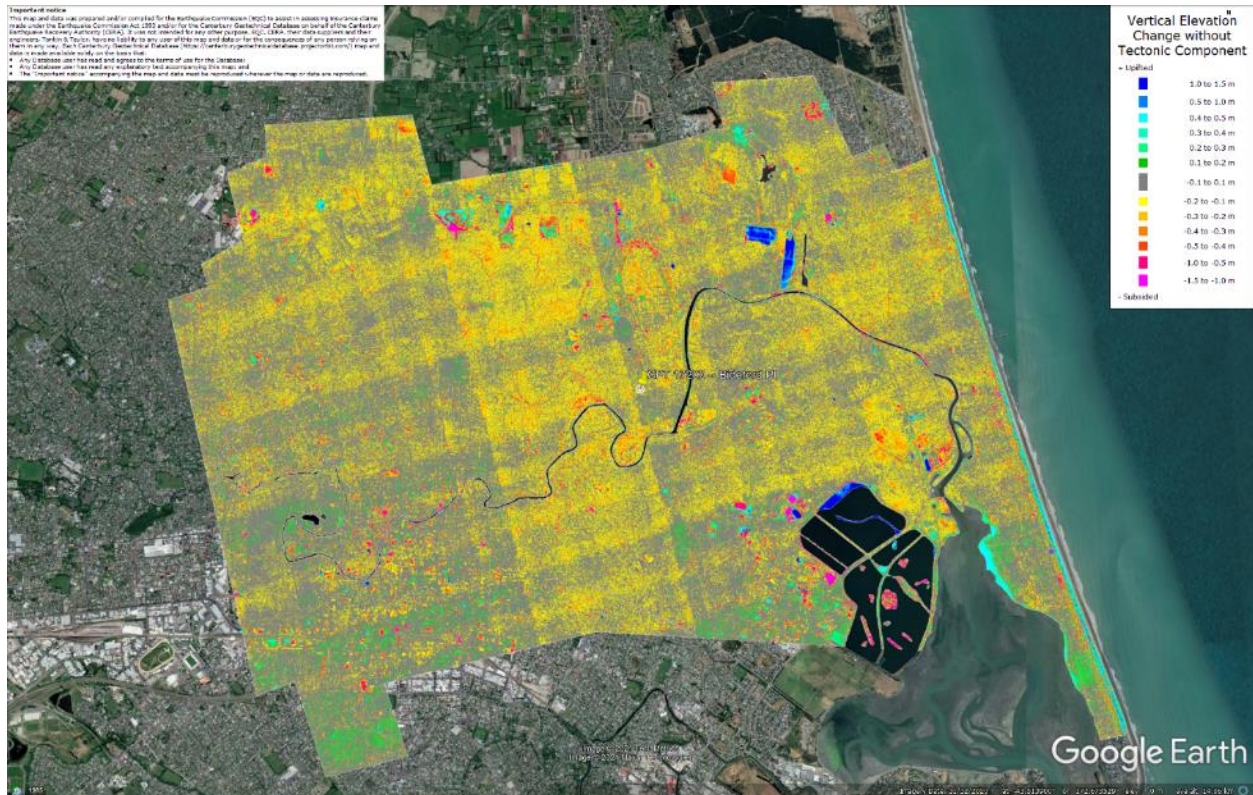
Figure 29: Vertical Ground Movements (Surface – Tectonic) for Sep 2010 Earthquake – the site is in the apparent zone of overestimated ground surface subsidence (i.e., July 2003 LiDAR flight error band).

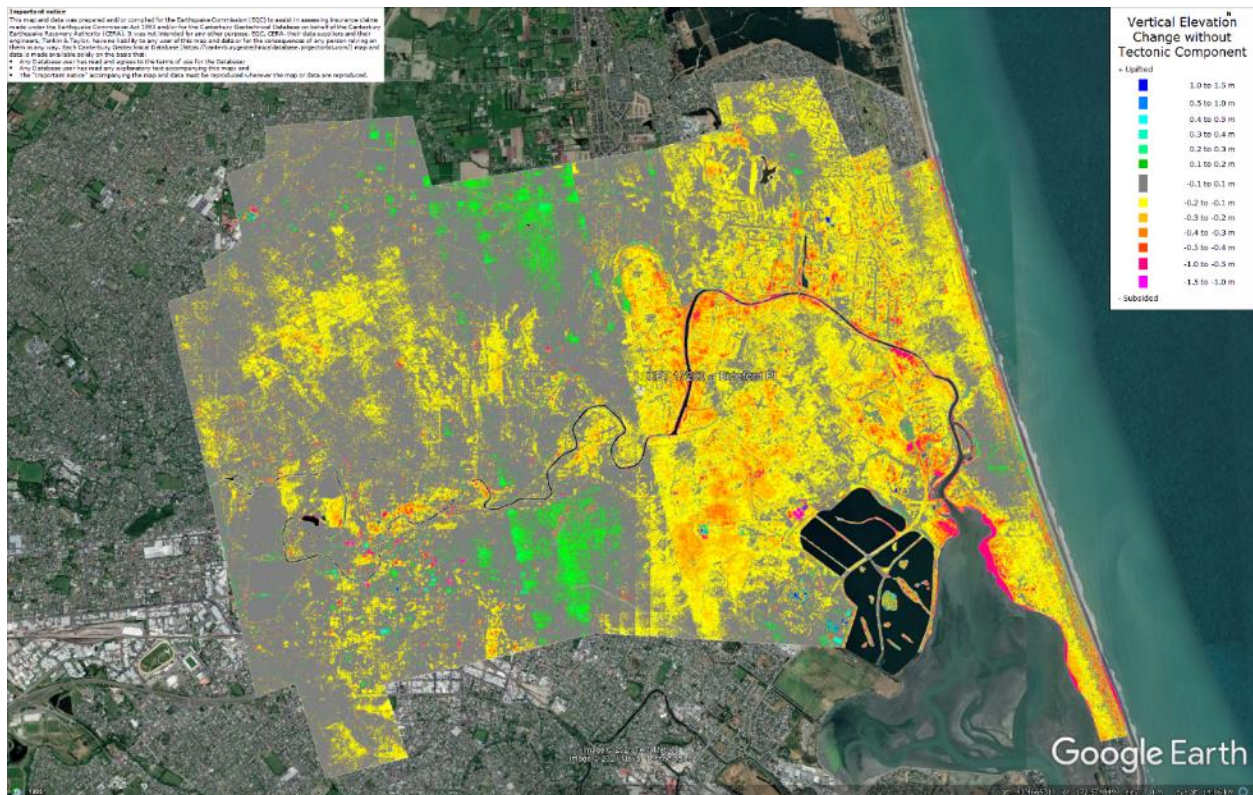
Figure 30: Vertical Ground Movements (Surface – Tectonic) for Feb 2011 Earthquake – the site is not in the apparent zone of underestimated ground surface subsidence.

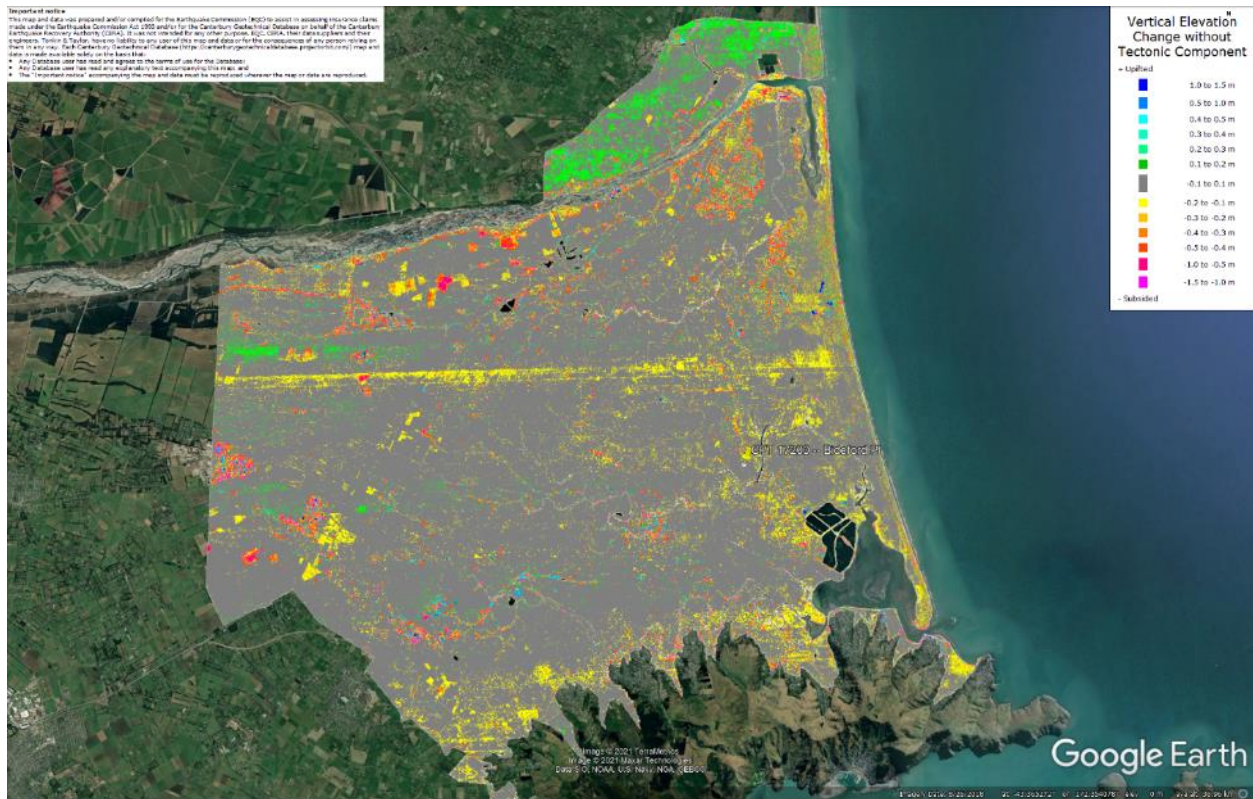
Figure 31: Vertical Ground Movements (Surface – Tectonic) for June 2011 Earthquake – the site is not in the apparent zone of overestimated or underestimated ground surface subsidence.

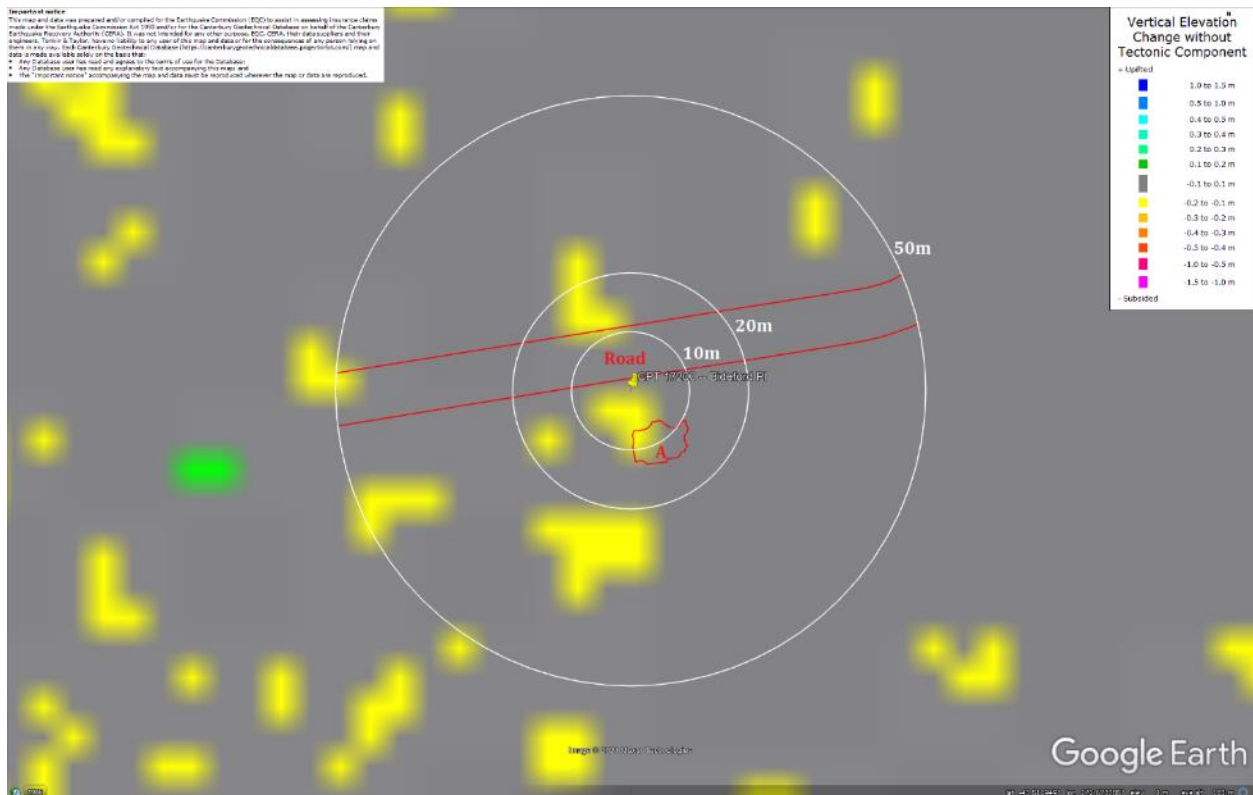
Figure 36: Ground surface subsidence without tectonic component for Dec 2011 Earthquake according to the LiDAR DEM.

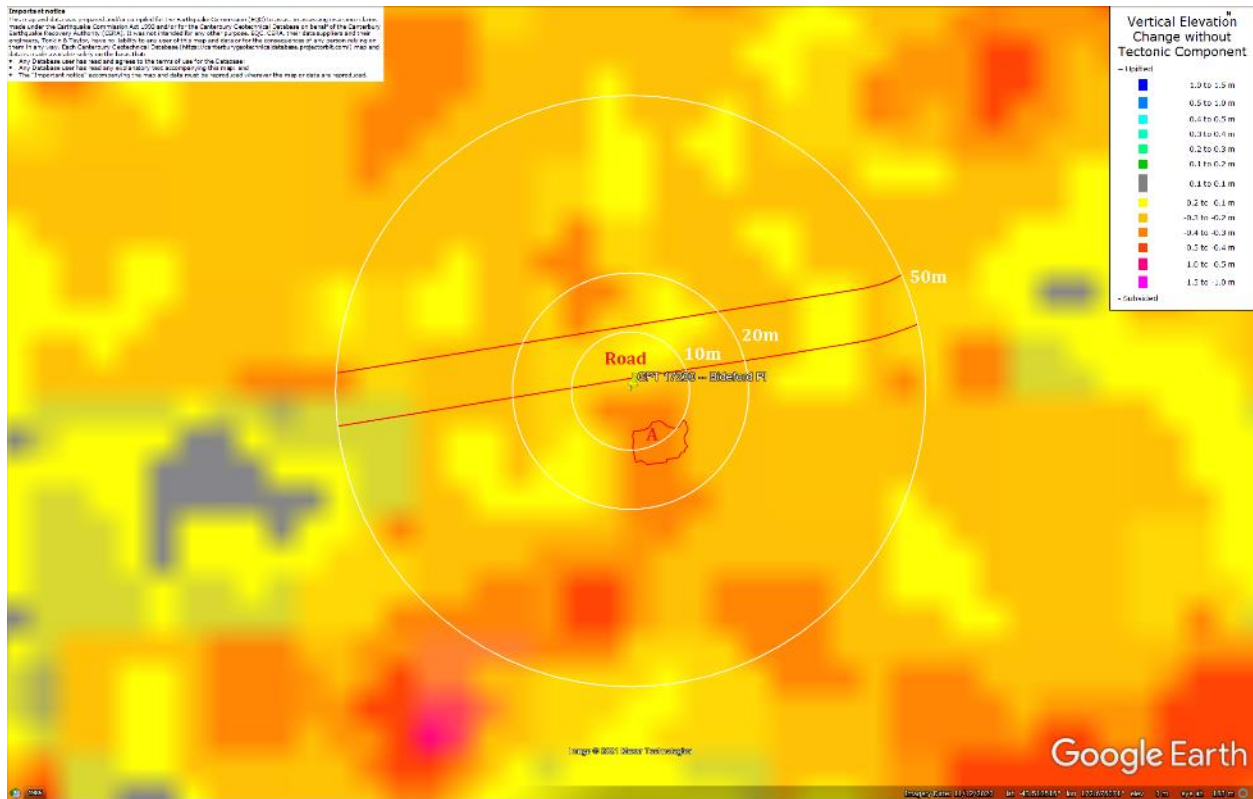
Figure 37: Ground surface subsidence without tectonic component for Canterbury Earthquake Sequence according to the LiDAR DEM.

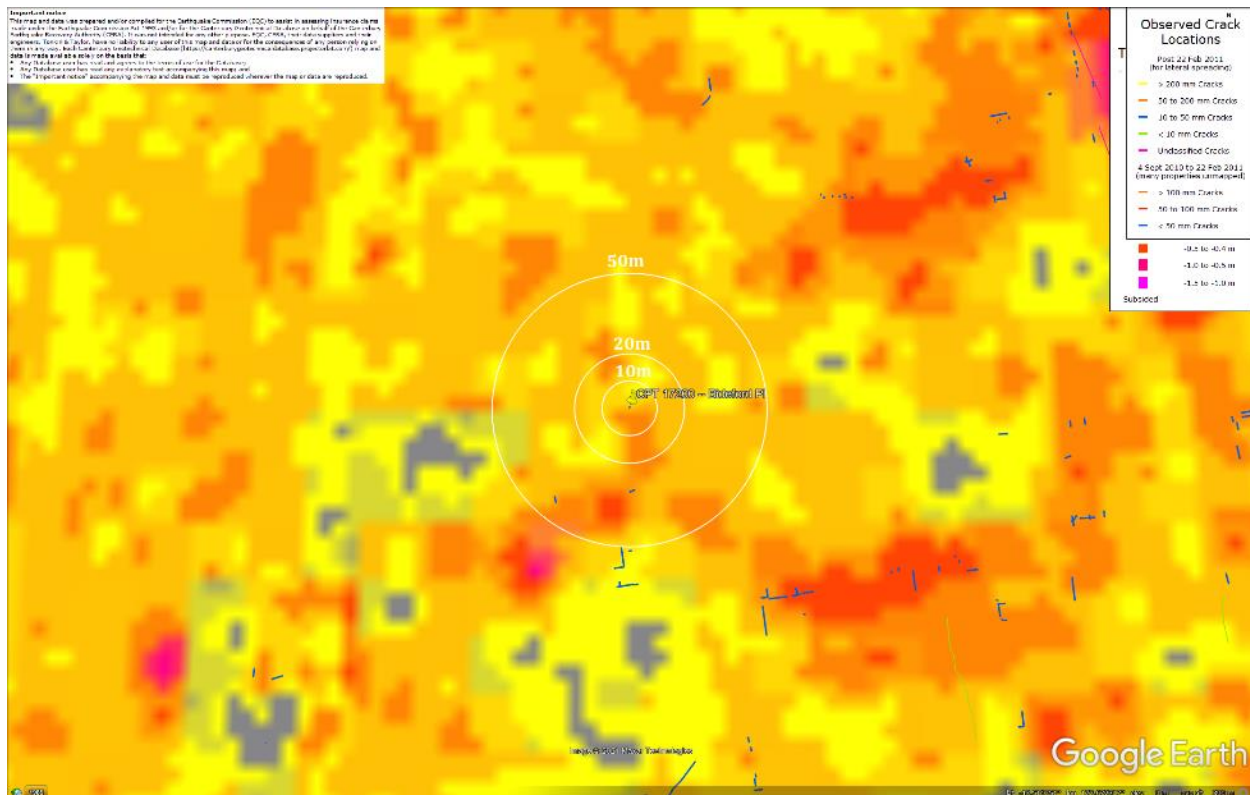
Figure 38: No lateral spreading for Canterbury Earthquake Sequence.

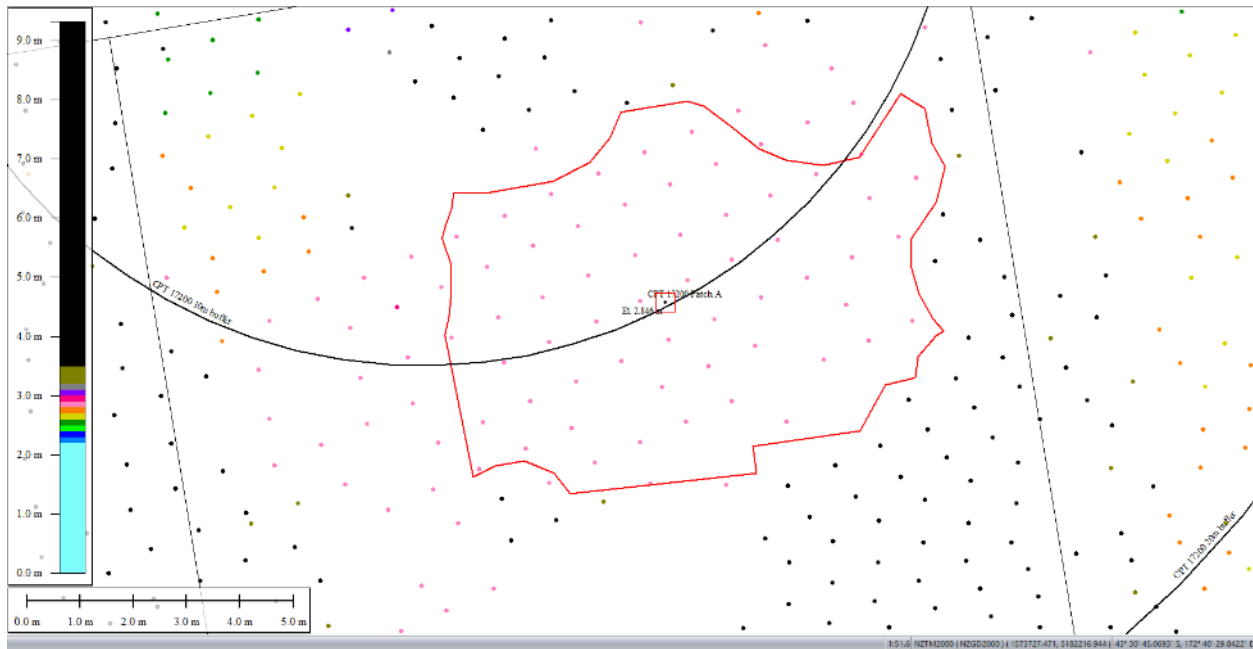
Figure 48: Ground surface elevation averaged over 10-m, 20-m, and 50-m buffers for Patch A for Sep 5, 2010 LiDAR survey.

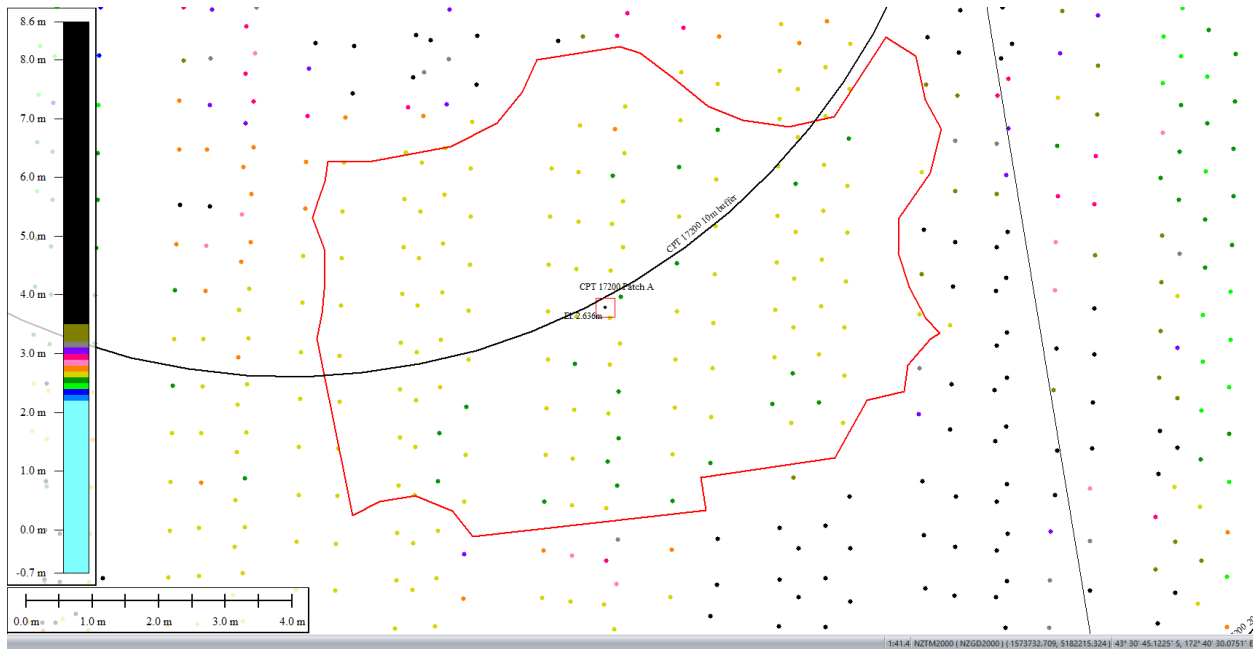
Figure 52: Ground surface elevation averaged over 10-m, 20-m, and 50-m buffers for Patch A for Mar 2011 LiDAR survey.

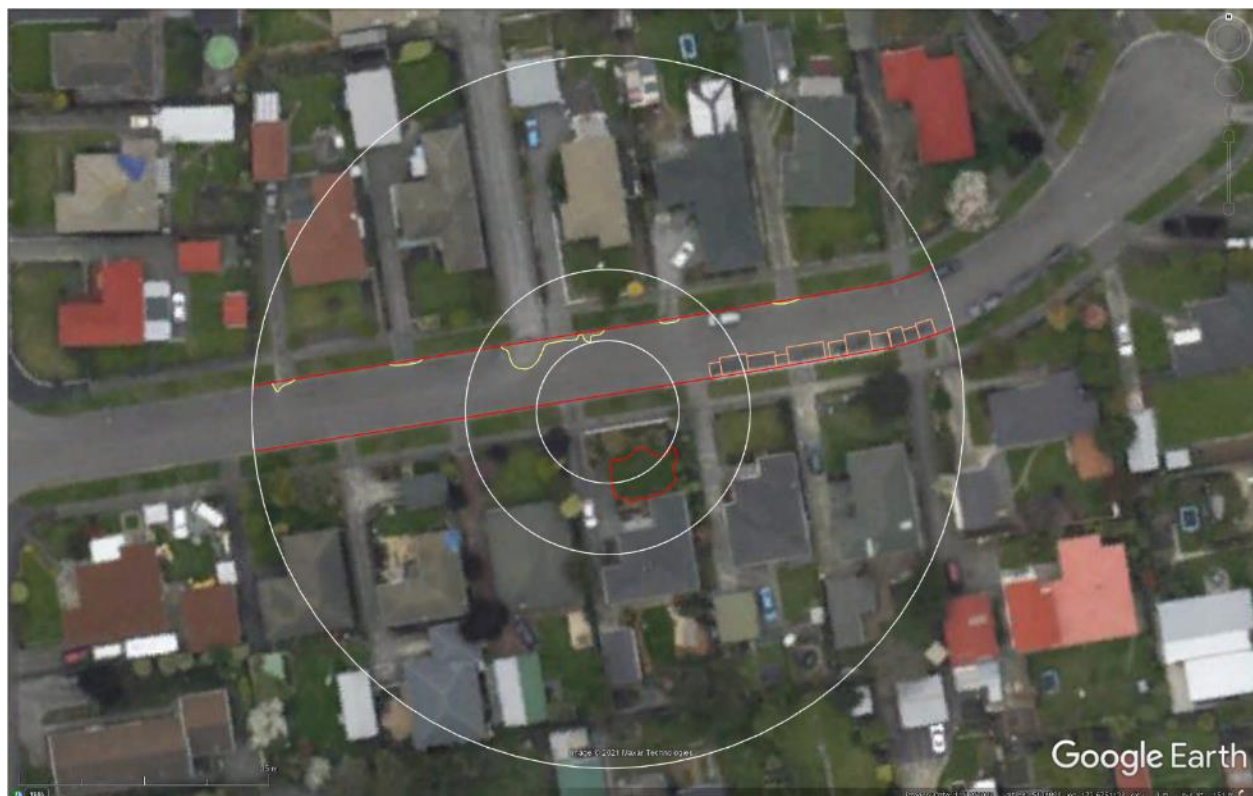
Figure 63: Aerial photograph showing the ejecta outline at the site for Sep-10 EQ.

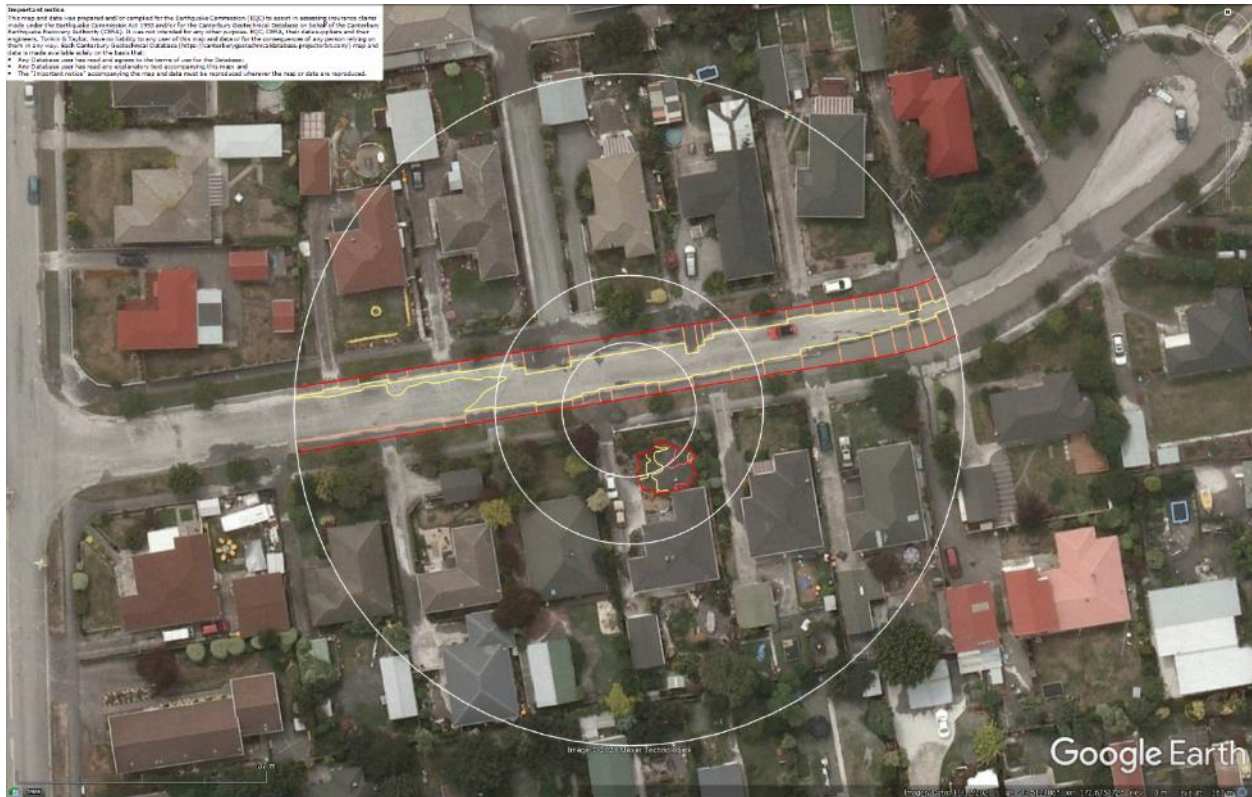
Figure 64: Aerial photograph showing the ejecta outline at the site for Feb-11 EQ.

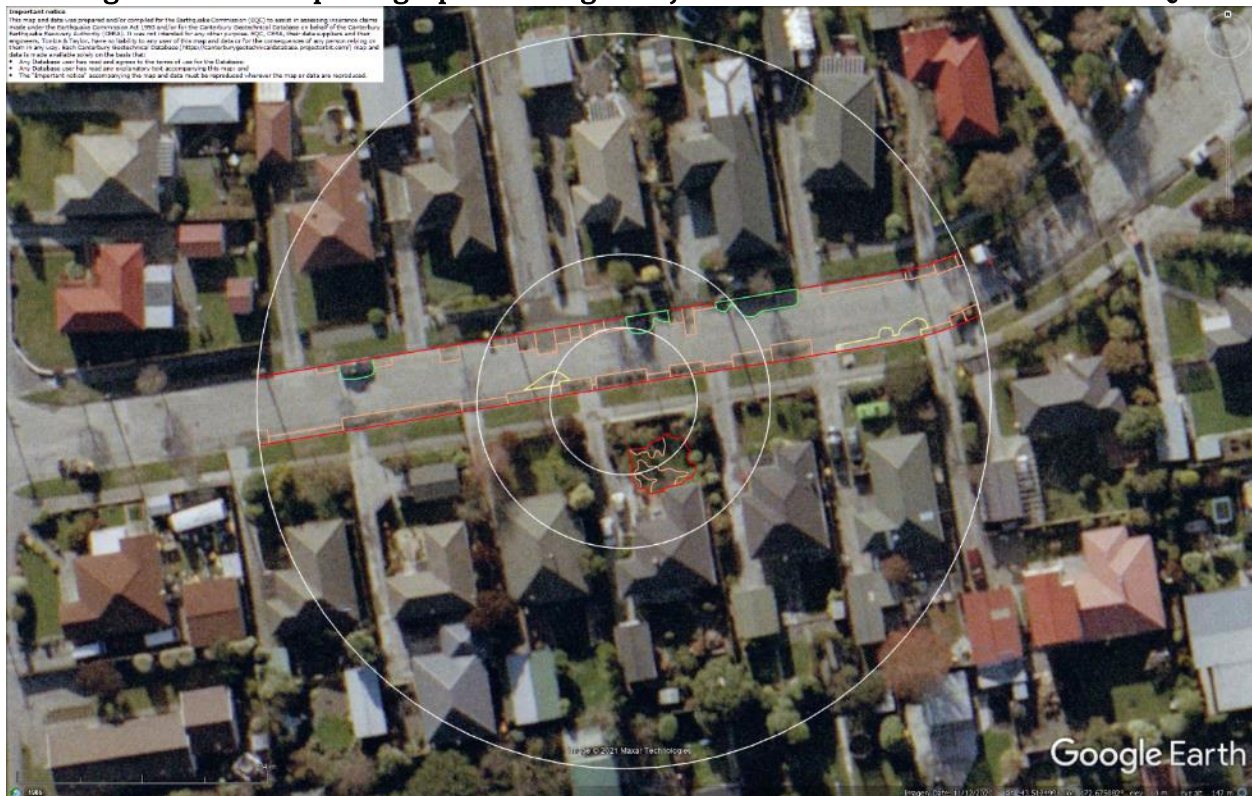
Figure 65: Aerial photograph acquired on 16 Jun 2011 showing the ejecta outline at the site for Jun-11 EQ.

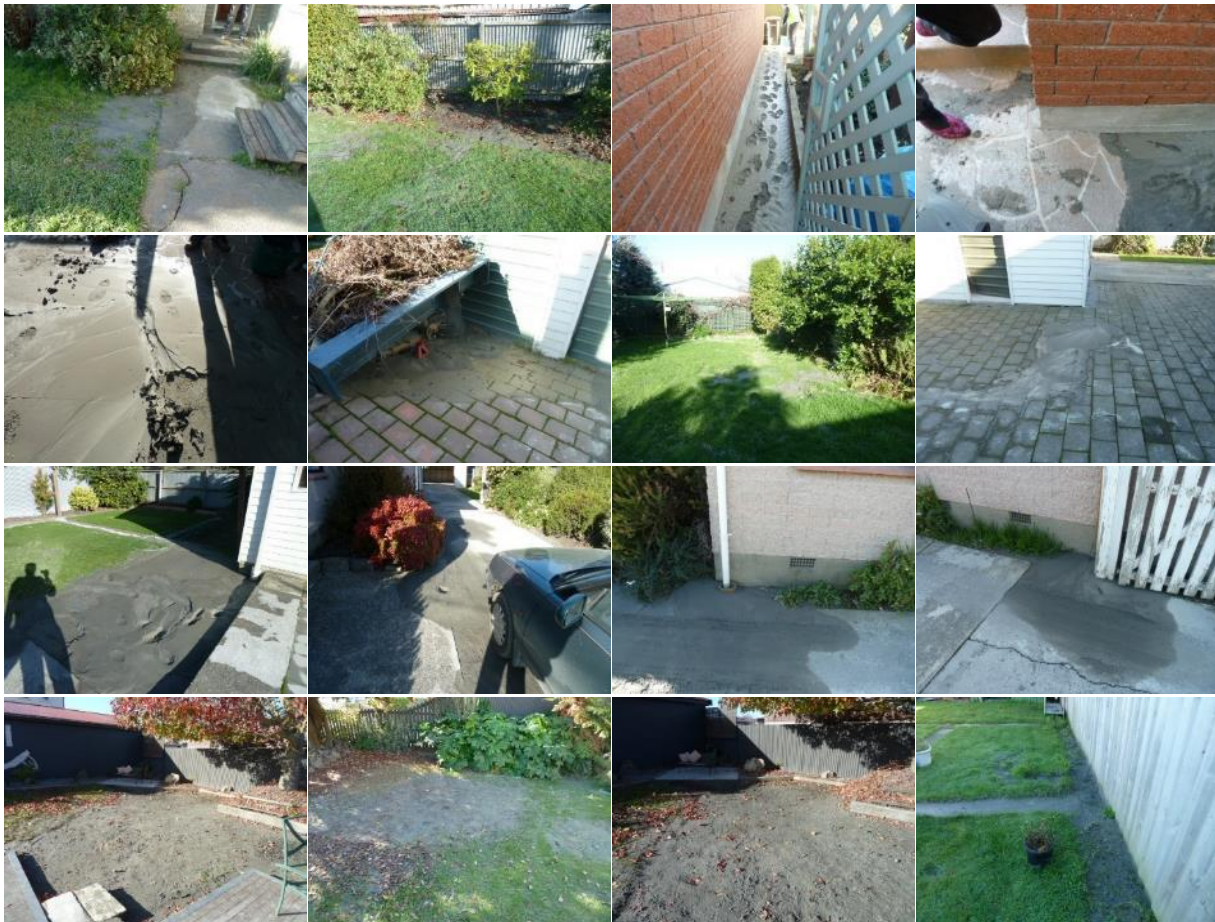
Figure 68: Ground photographs showing ejecta remnants at the properties within the 50-m buffer (photograph date: 16 June 2011).

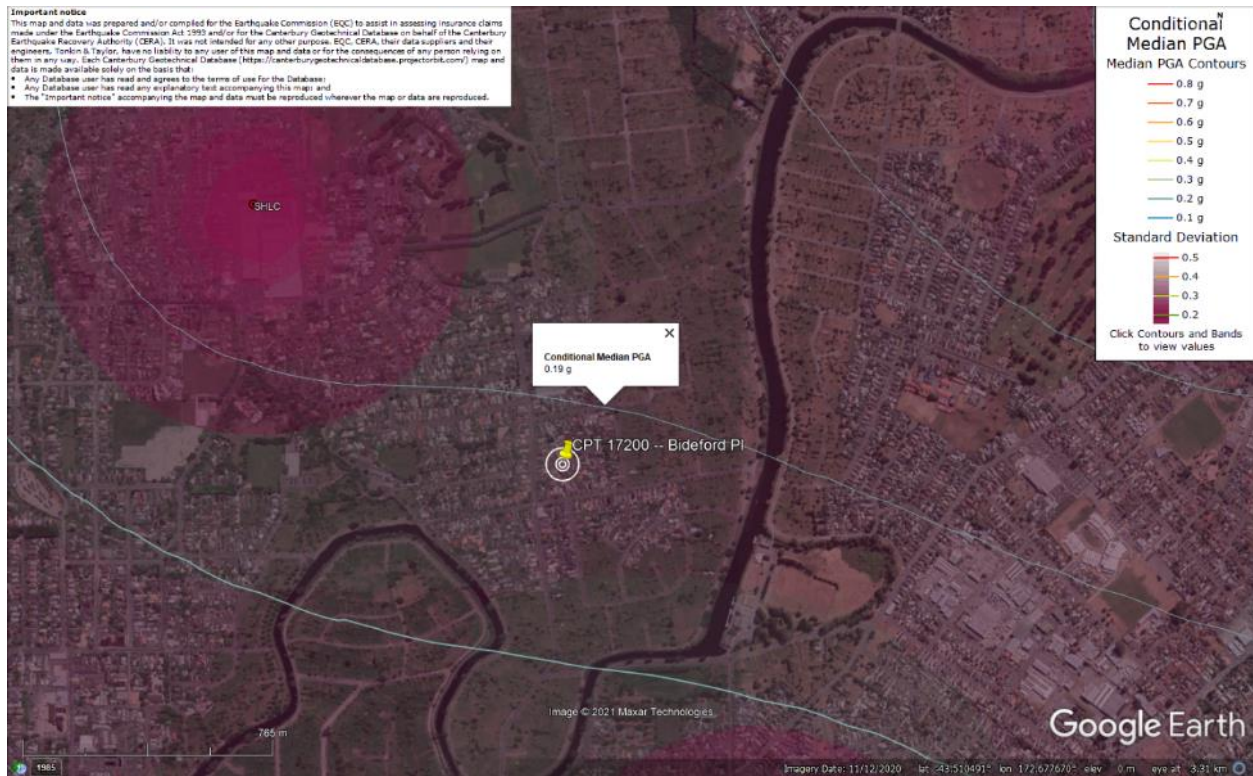
Figure 69: PGA for Sep-10 EQ (st. dev. = 0.275-0.325 ln units).

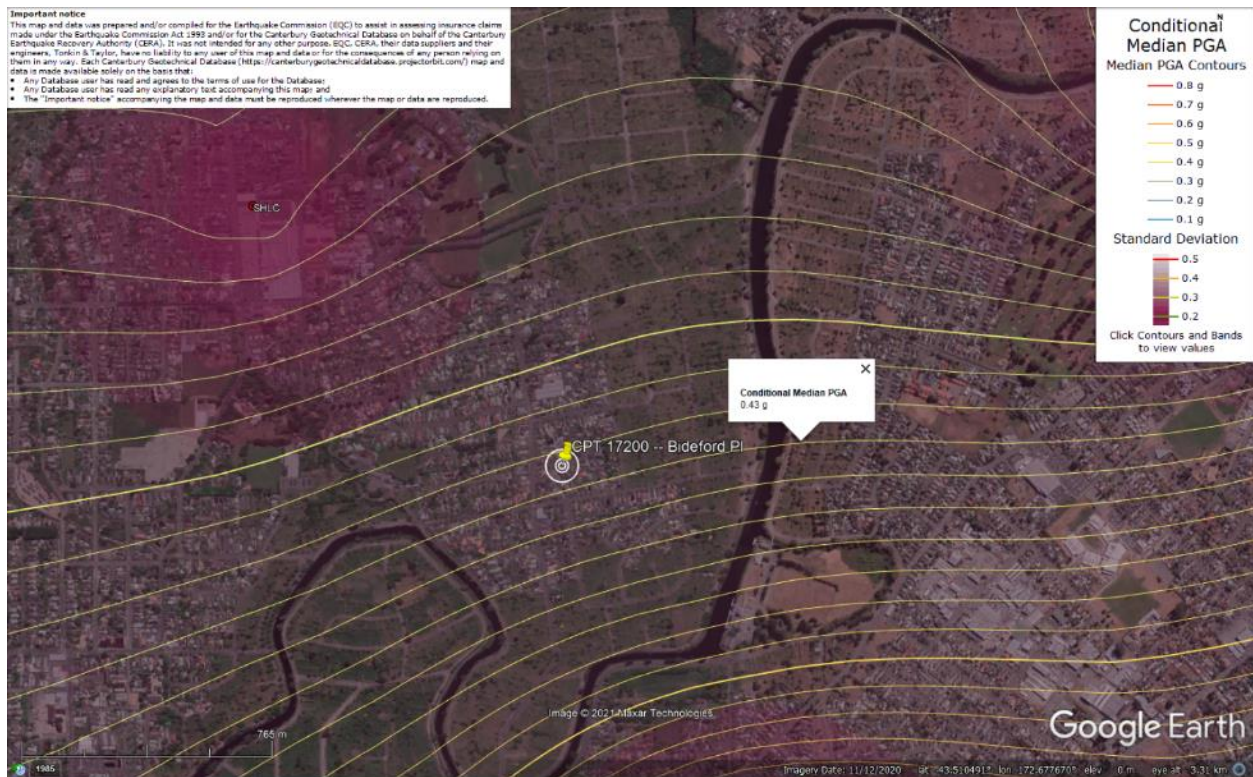
Figure 70: PGA for Feb-11 EQ (st. dev. = 0.300-0.325 ln units).

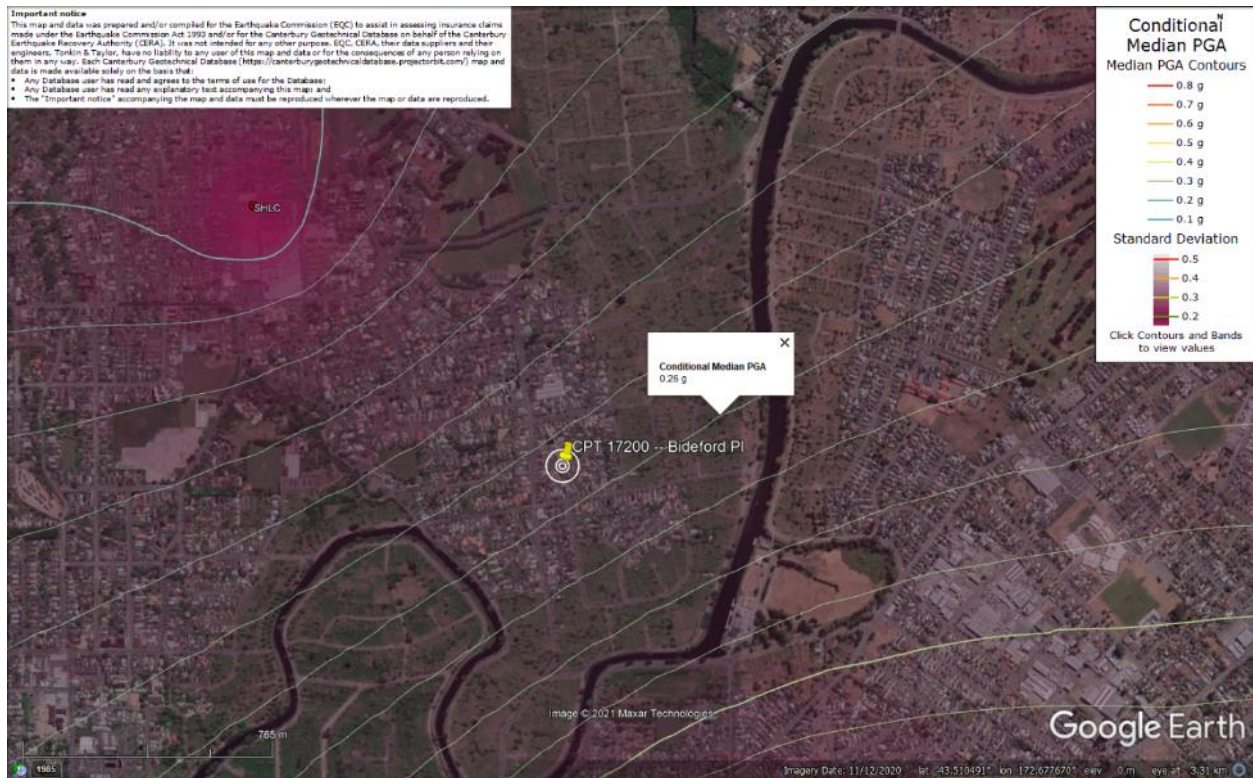
Figure 71: PGA for Jun-11 EQ (st. dev. = 0.325-0.350 ln units).

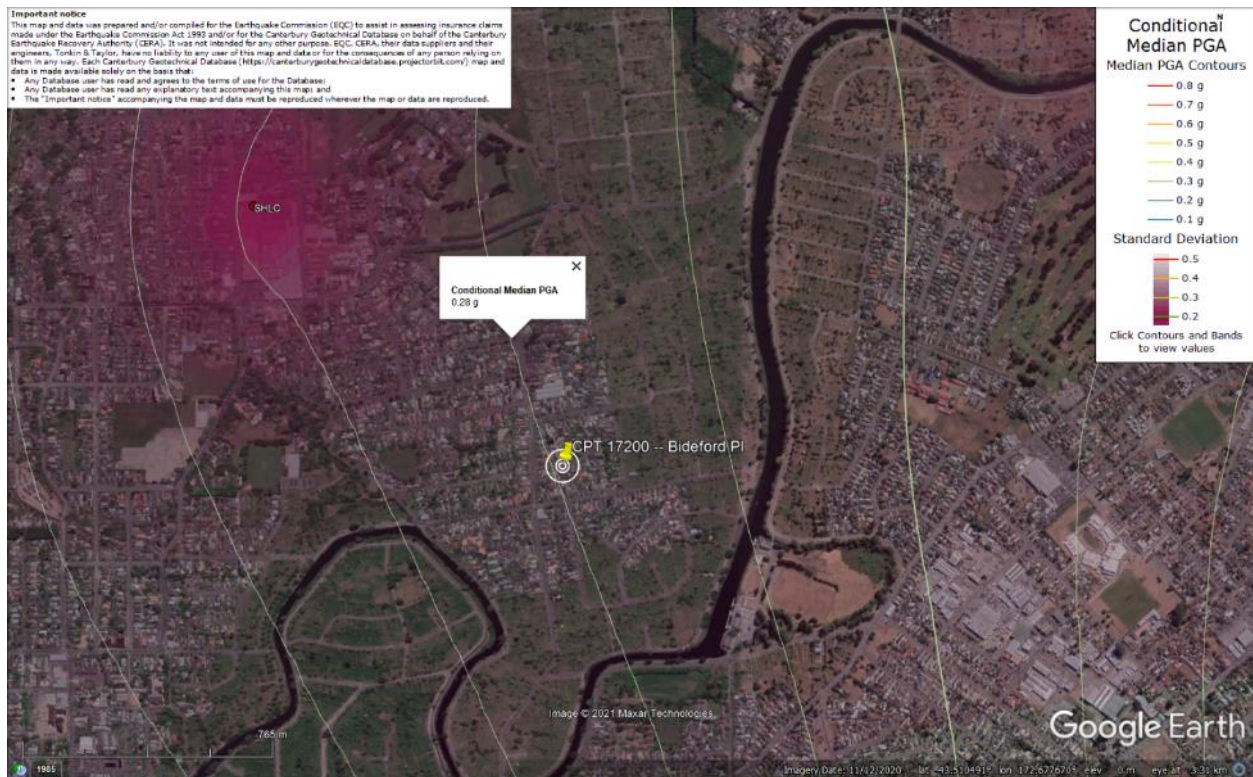
Figure 72: PGA for Dec-11 EQ (st. dev. = 0.350-0.375 ln units).

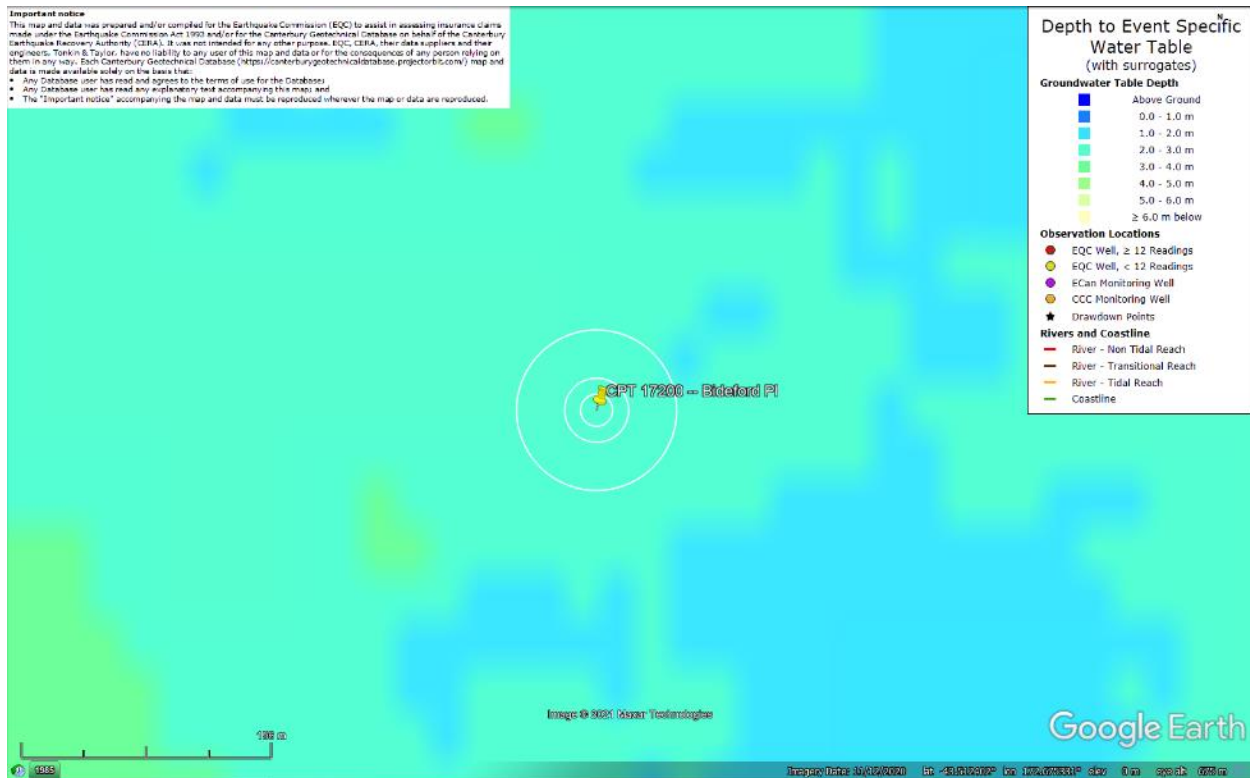
Figure 73: Depth to groundwater table for Sep-10 EQ.

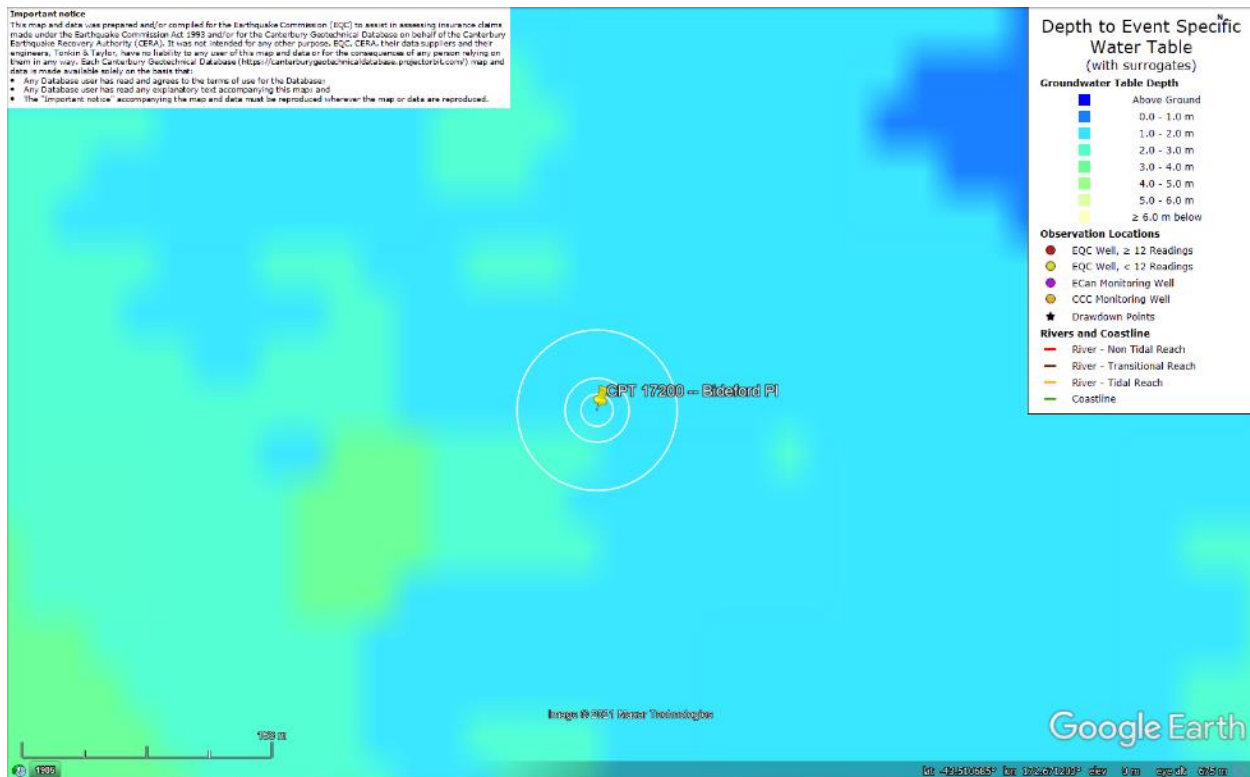
Figure 74: Depth to groundwater table for Feb-11 EQ.

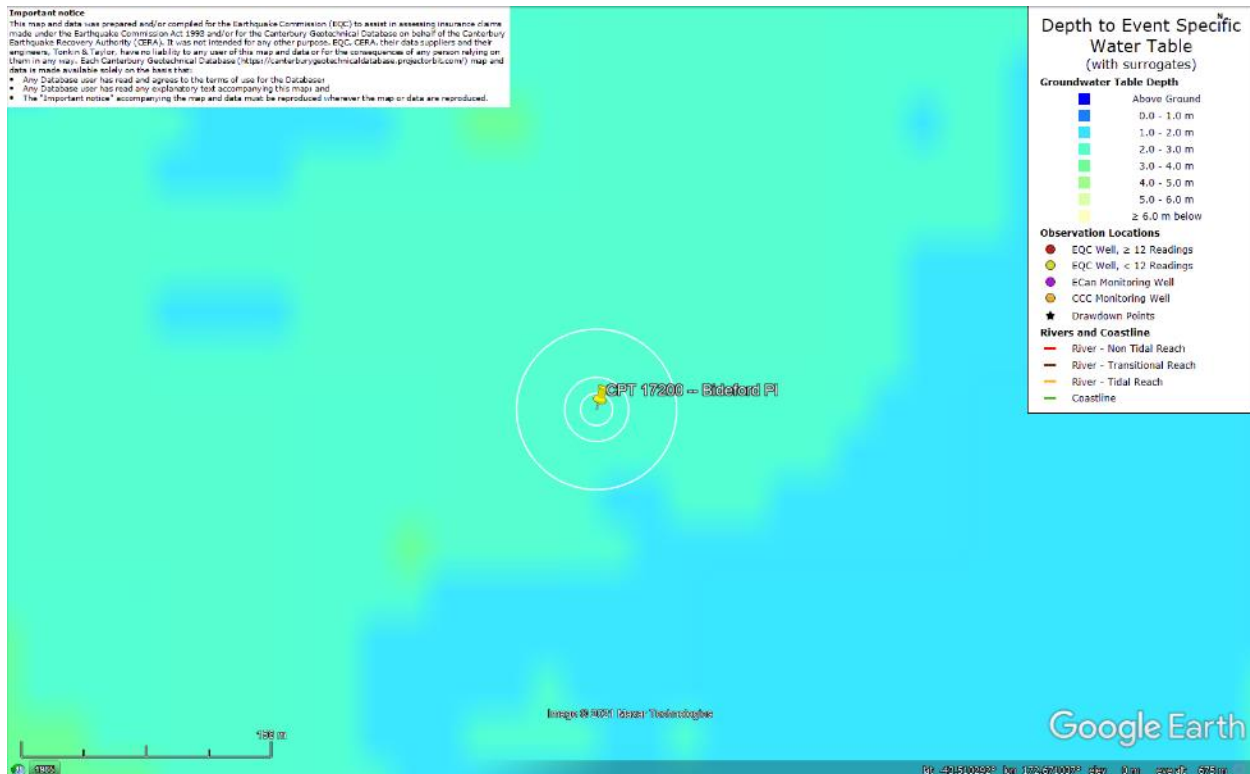
Figure 75: Depth to groundwater table for Jun-11 EQ.

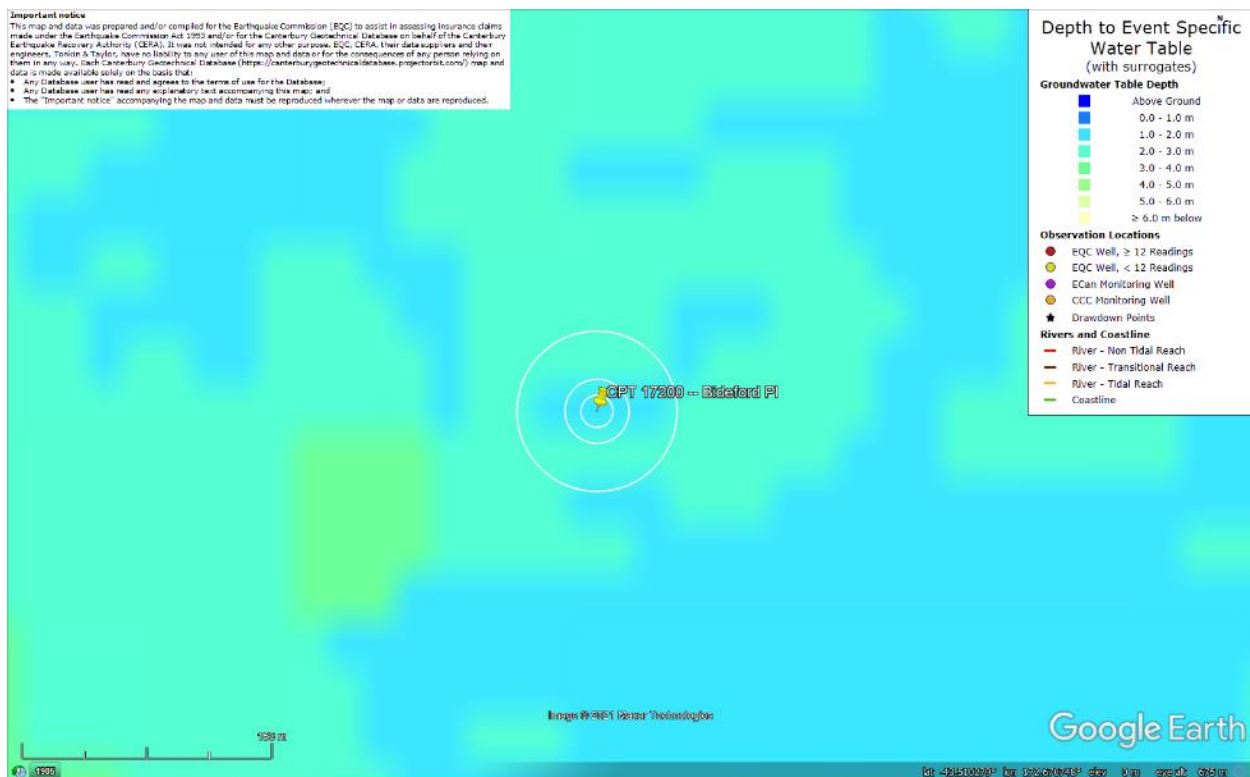
Figure 76: Depth to groundwater table for Dec-11 EQ.

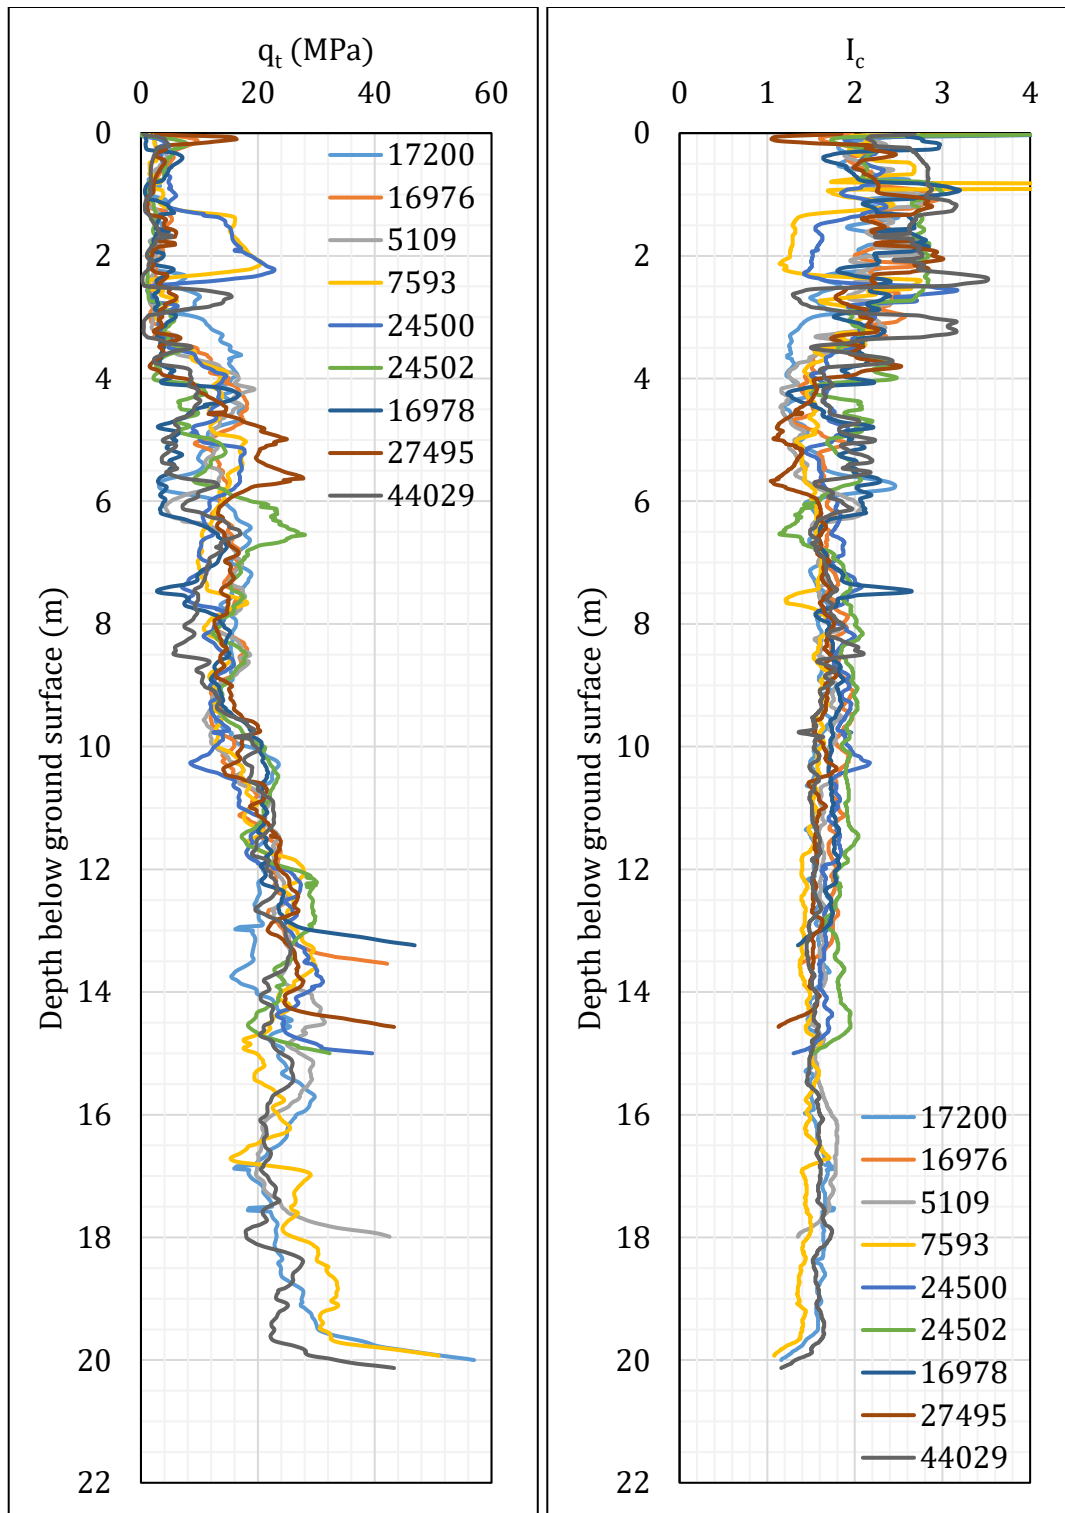
Figure 78: q_t and I_c profiles.

Note 6: The selection of CPTs for the area considered for settlement assessment (Figure 1) is based on the proximity of the CPTs to the considered areas. In accordance with that, the following table shows CPTs that were used for the volumetric settlement analysis in *Cliq v.3.0.3.2*, a CPT soil liquefaction software developed by GeoLogismiki. (The average volumetric settlements were reported in Table 8.)
