Appendix A.43:

Heaton Normal Intermediate School – VsVp 57181

## Liquefaction Ejecta Case Histories for 2010-11 Canterbury Earthquakes

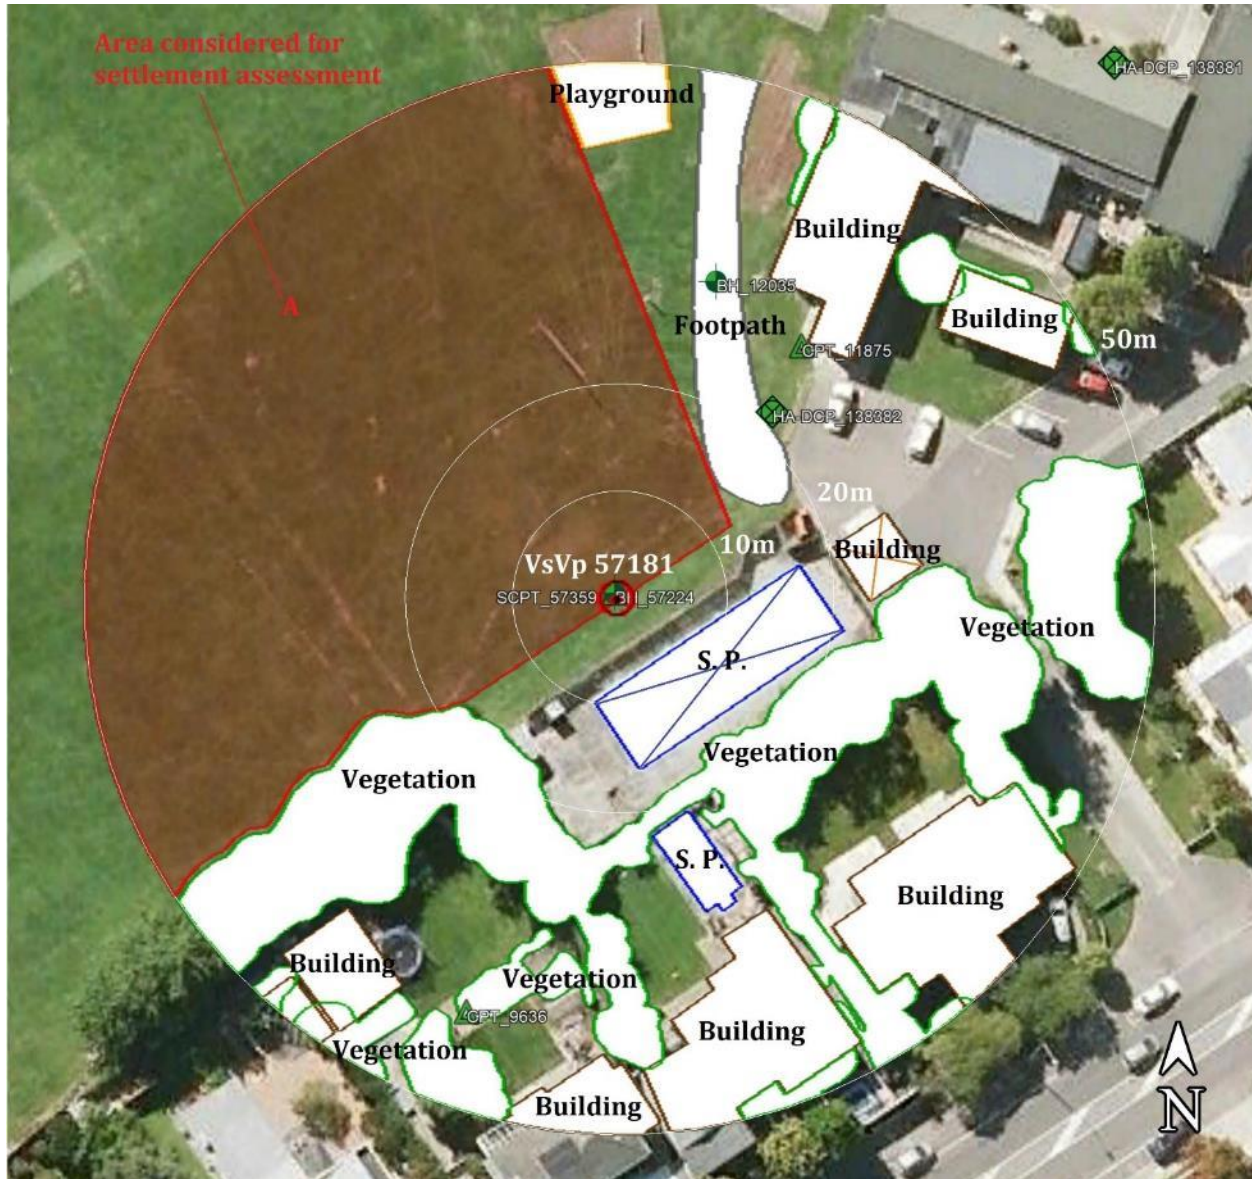
**Figure 1: Site plan with areas where ejecta-induced settlement is considered.**

**Note 1:** Patch A (outlined in red) in the free field was selected for settlement assessment as an area free of vegetation and structures. Other important factors considered for the patch selection were its proximity to a CPT, a property subjected to addition and/or demolition of a structure, front yard/backyard alterations (e.g., ploughing, rubble, scrap), swimming pool, and aerial distribution of sediment ejecta. The LiDAR-based settlement analyses were not performed for any earthquake event because the Sep 2010 LiDAR survey was affected by ejecta from the Sep-10 EQ and the Sep 2011, Feb 2012, and Oct 2015 LiDAR surveys were affected by anthropogenic changes.

- $A_{E,thick,i}$  and  $H_{E,thick,i}$  are the area and the height of a thick ejecta layer, respectively;
- $A_{E,thin,j}$  and  $H_{E,thin,j}$  are the area and the height of a thin ejecta layer, respectively;
- $A_T$  is the total assessment area for a buffer being considered (Figure 1).

**Note 5:** The selection of CPTs for the area considered for settlement assessment (Figure 1) is based on the proximity of the CPTs to the considered areas. In accordance with that, the following table shows CPTs that were used for the volumetric settlement analysis in *Cliq v.3.0.3.2*, a CPT soil liquefaction software developed by GeoLogismiki. (The average volumetric settlements were reported in Table 8.)

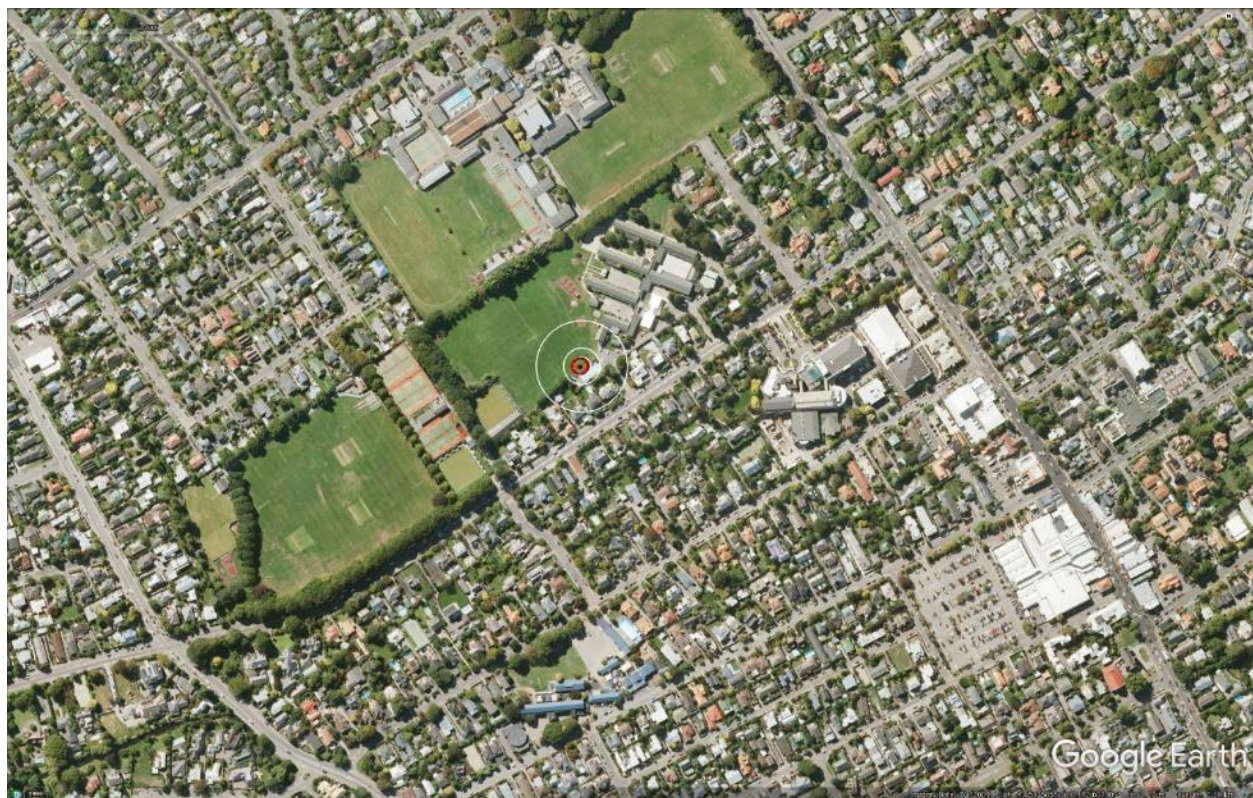
**Figure 3: Position of the site relative to nearby buildings, vegetation, and free-face features.**

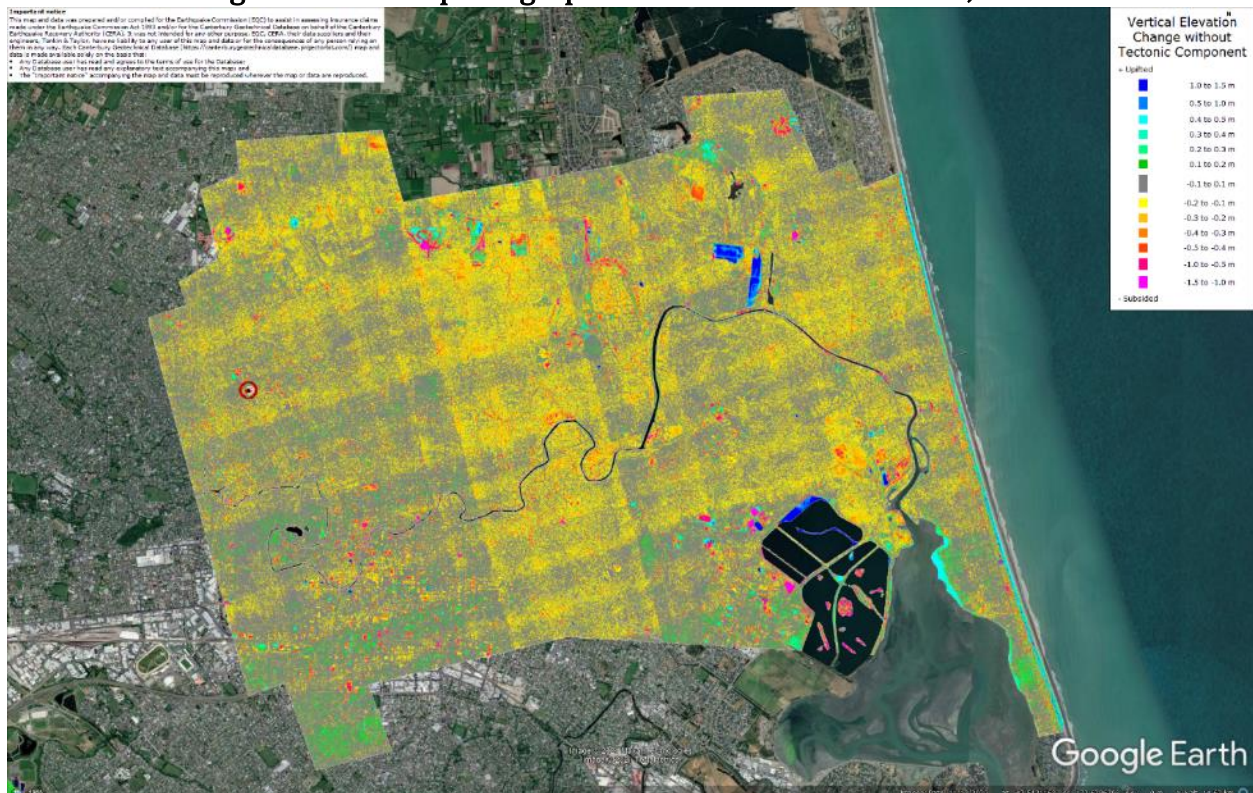
**Figure 27: Vertical Ground Movements (Surface – Tectonic) for Sep 2010 Earthquake – the site is not in the apparent zone of overestimated ground surface subsidence.**

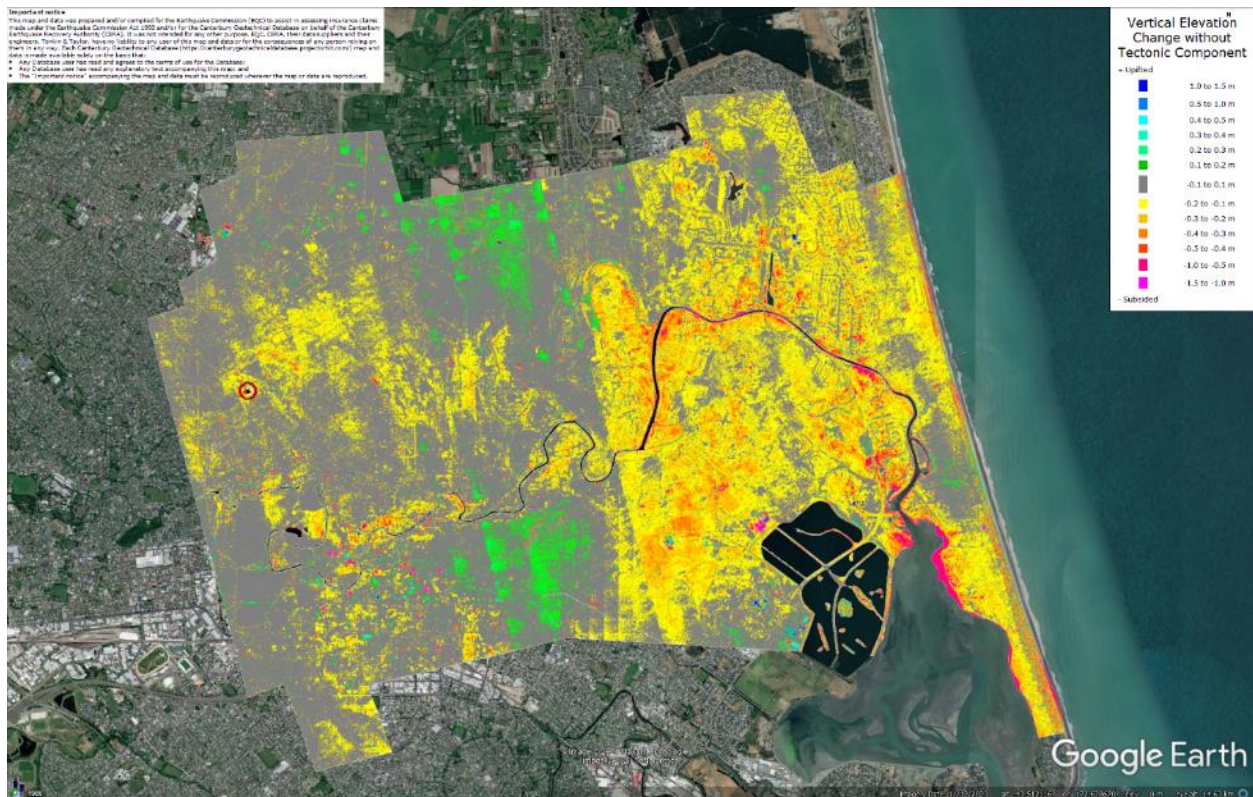
**Figure 28: Vertical Ground Movements (Surface – Tectonic) for Feb 2011 Earthquake – the site is not in the apparent zone of underestimated ground surface subsidence.**

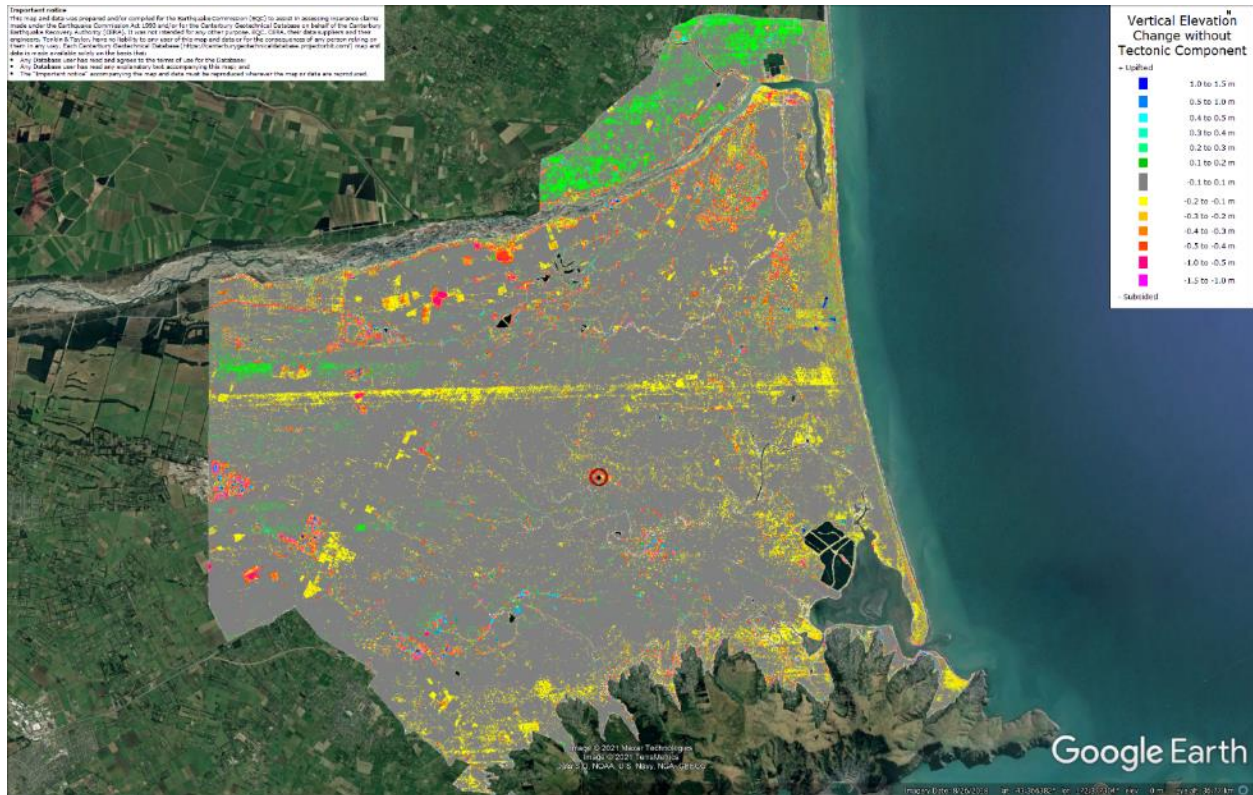
**Figure 29: Vertical Ground Movements (Surface – Tectonic) for June 2011 Earthquake – the site is not in the apparent zone of overestimated/underestimated ground surface subsidence.**

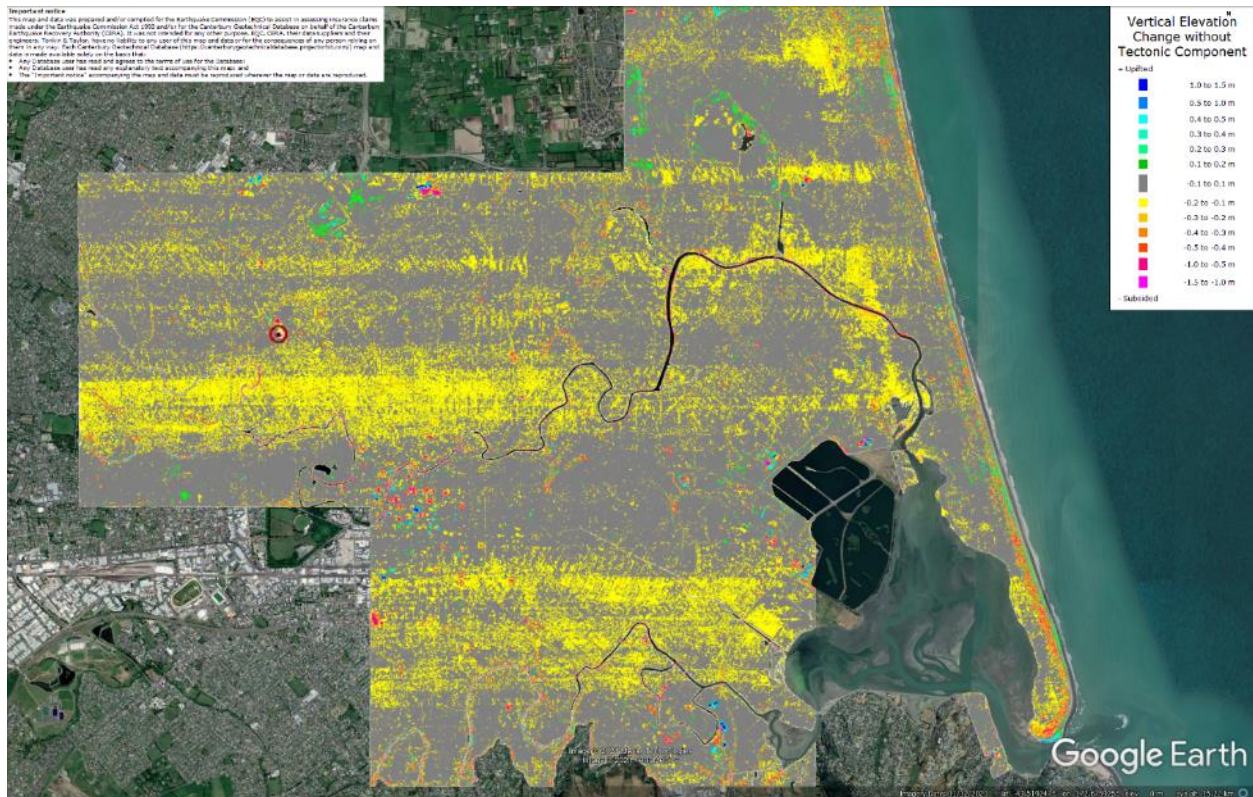
**Figure 30: Vertical Ground Movements (Surface – Tectonic) for Dec 2011 Earthquake – the site is not in the apparent zone of overestimated/underestimated ground surface subsidence.**

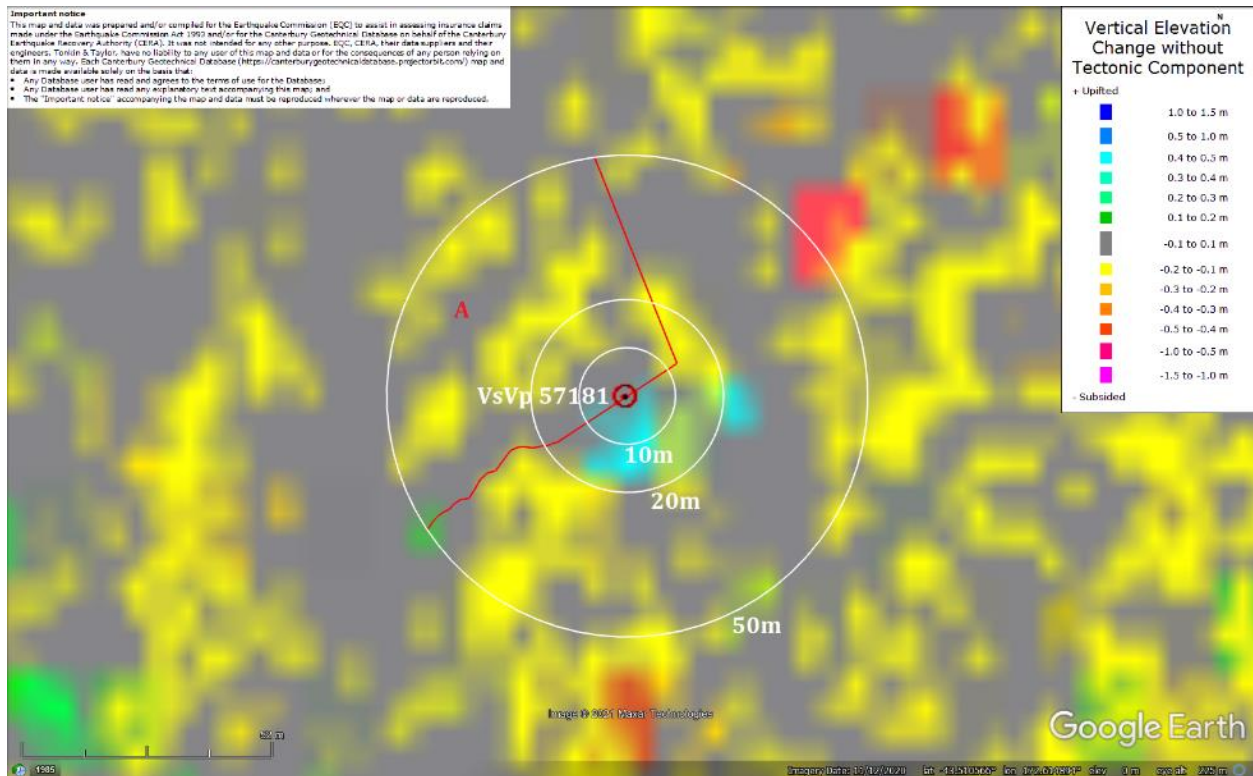
**Figure 31: Ground surface subsidence without tectonic component for Sep 2010 Earthquake according to the LiDAR DEM.**

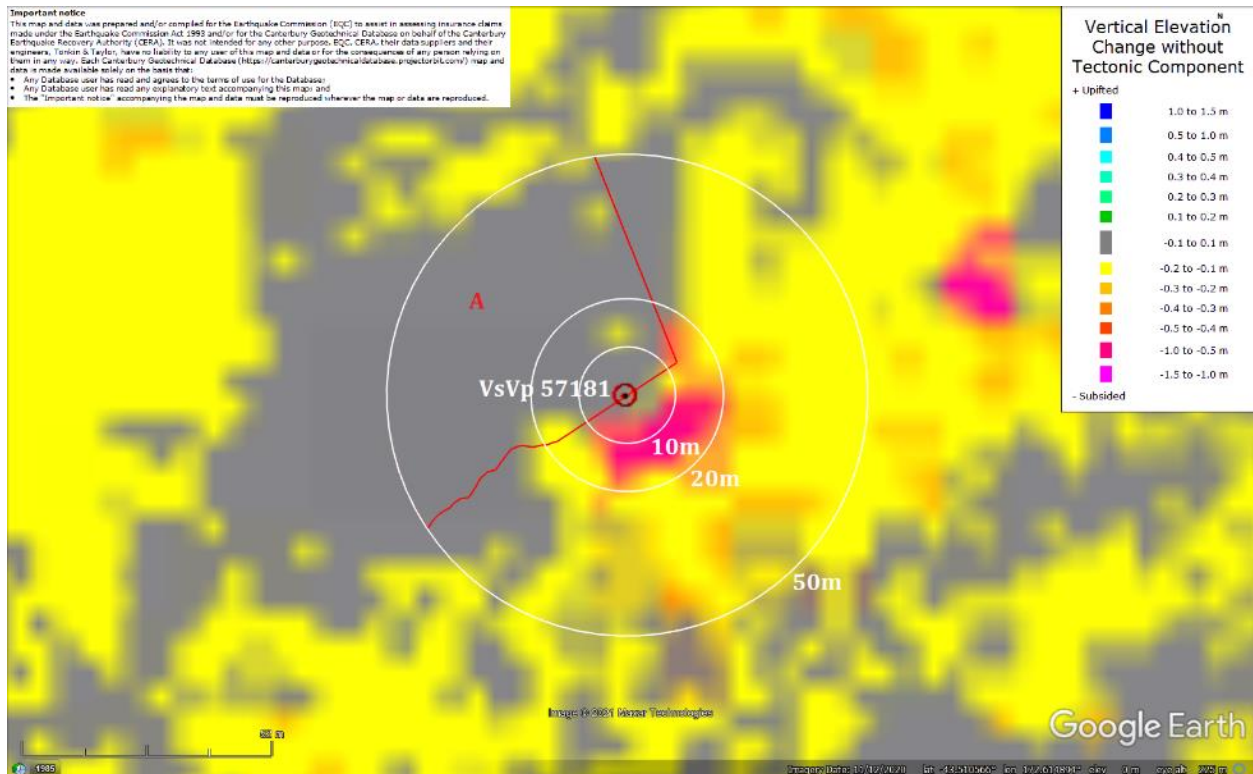
**Figure 32: Ground surface subsidence without tectonic component for Feb 2011 Earthquake according to the LiDAR DEM.**

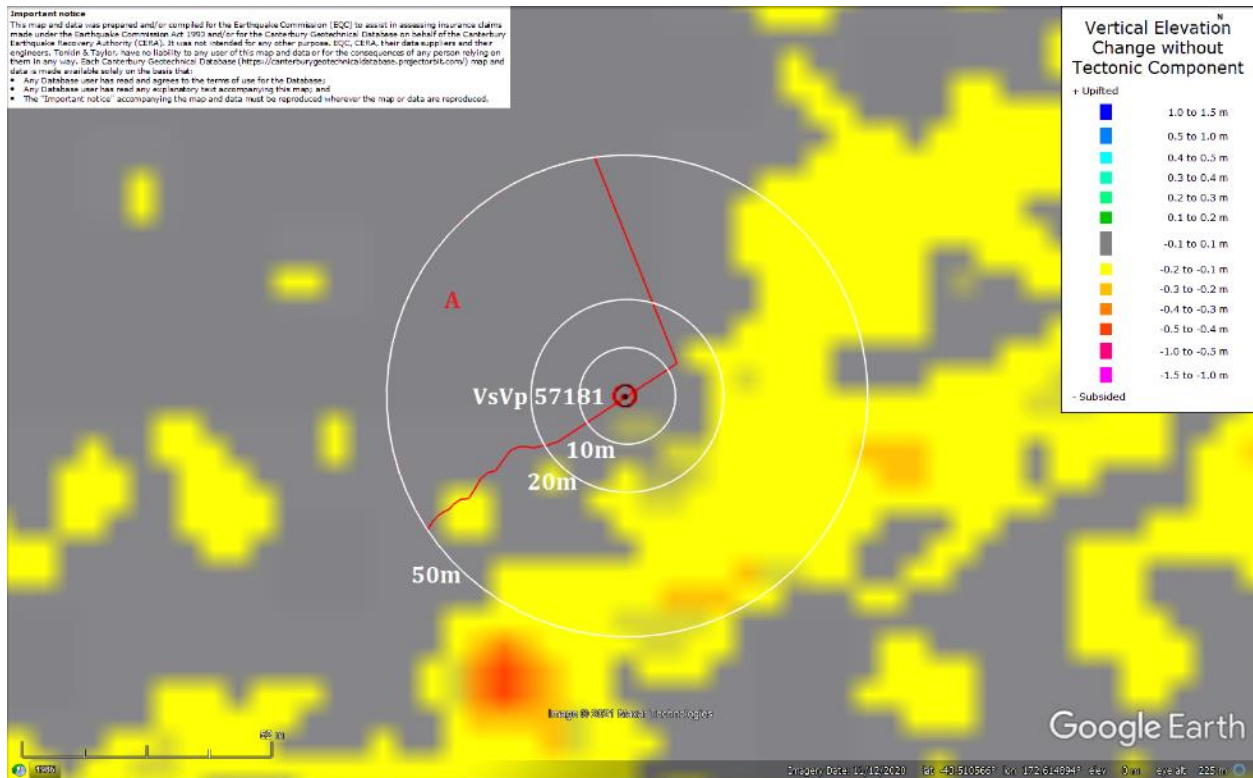
**Figure 33: Ground surface subsidence without tectonic component for June 2011 Earthquake according to the LiDAR DEM.**

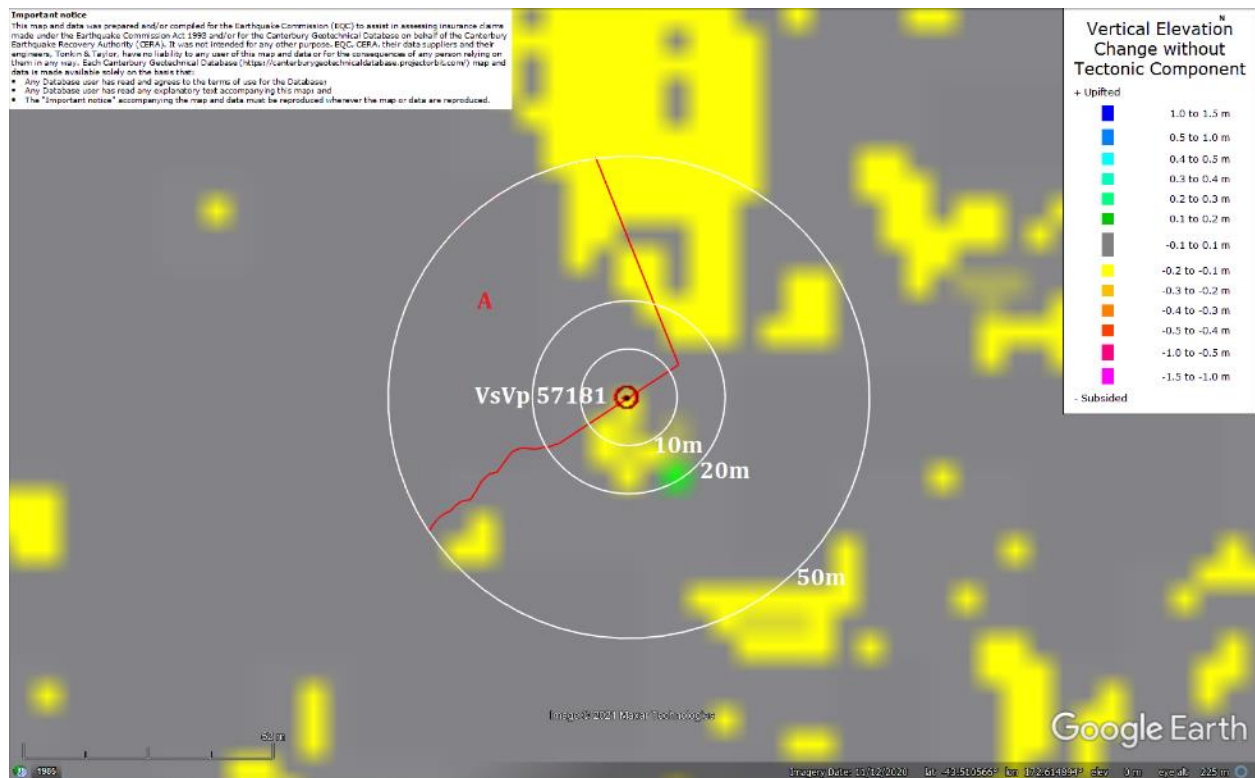
**Figure 34: Ground surface subsidence without tectonic component for Dec 2011 Earthquake according to the LiDAR DEM.**

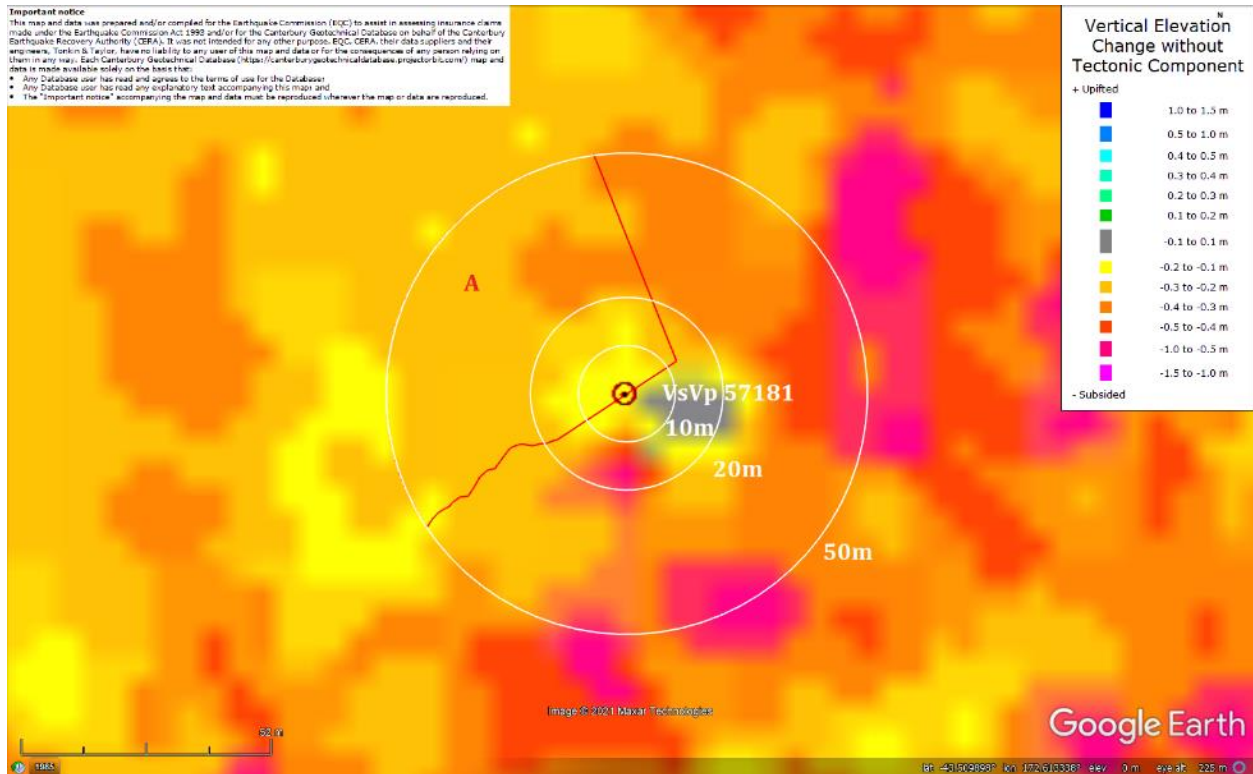
**Figure 35: Ground surface subsidence without tectonic component for Canterbury Earthquake Sequence according to the LiDAR DEM.**

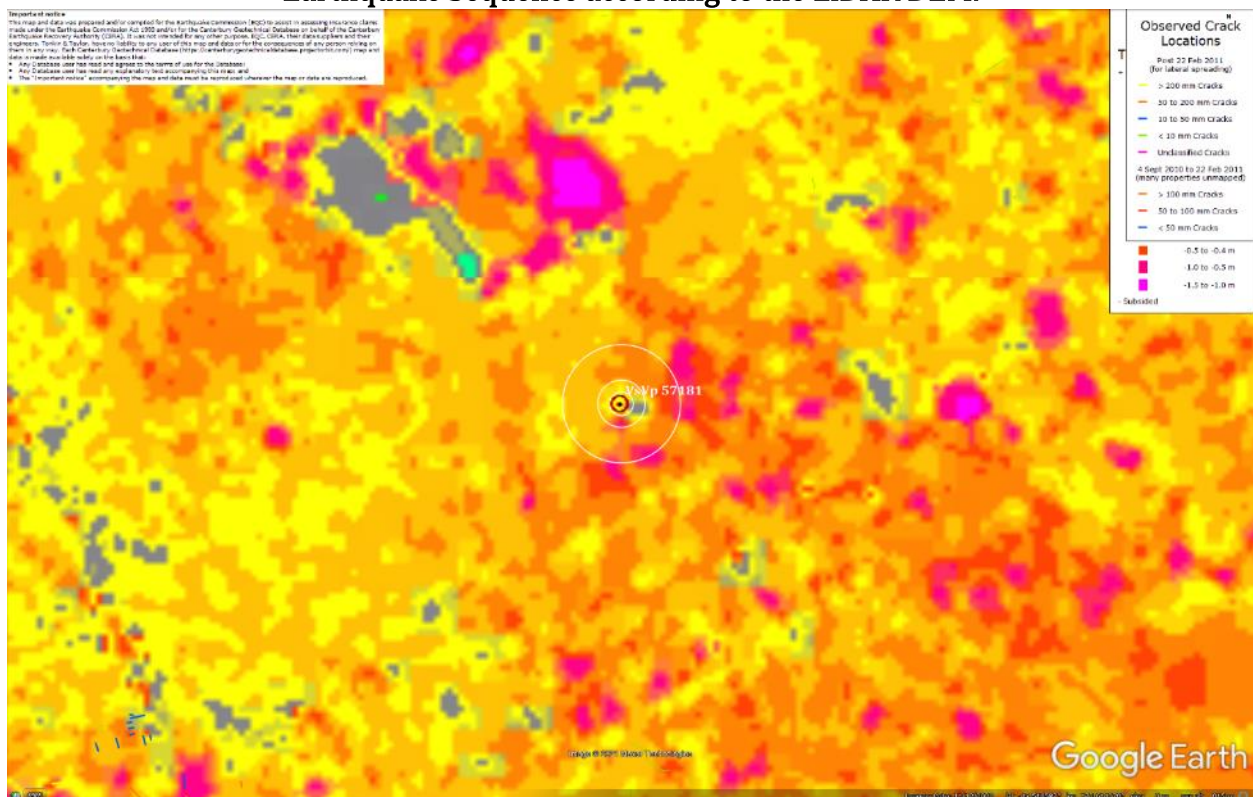
**Figure 36: No lateral spreading for Canterbury Earthquake Sequence.**

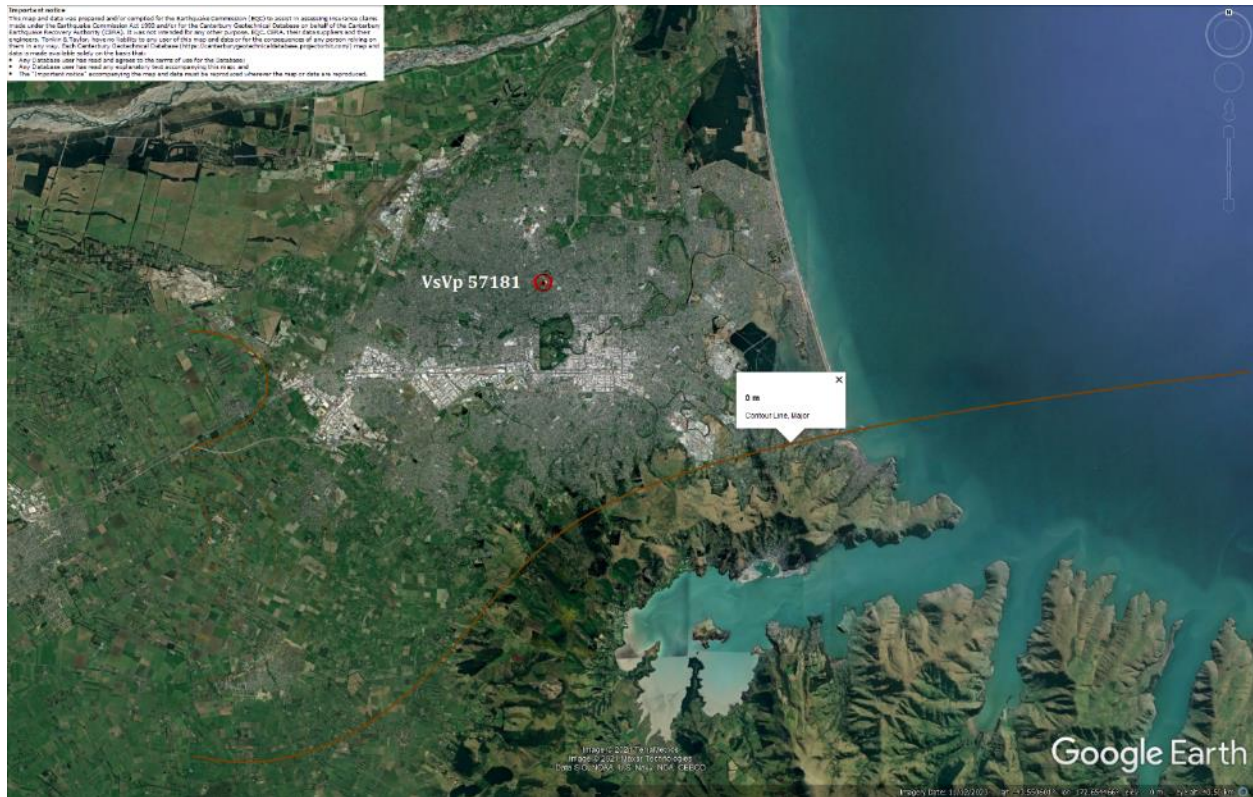
**Figure 37: Vertical tectonic movements for Sep 2010 Earthquake.**

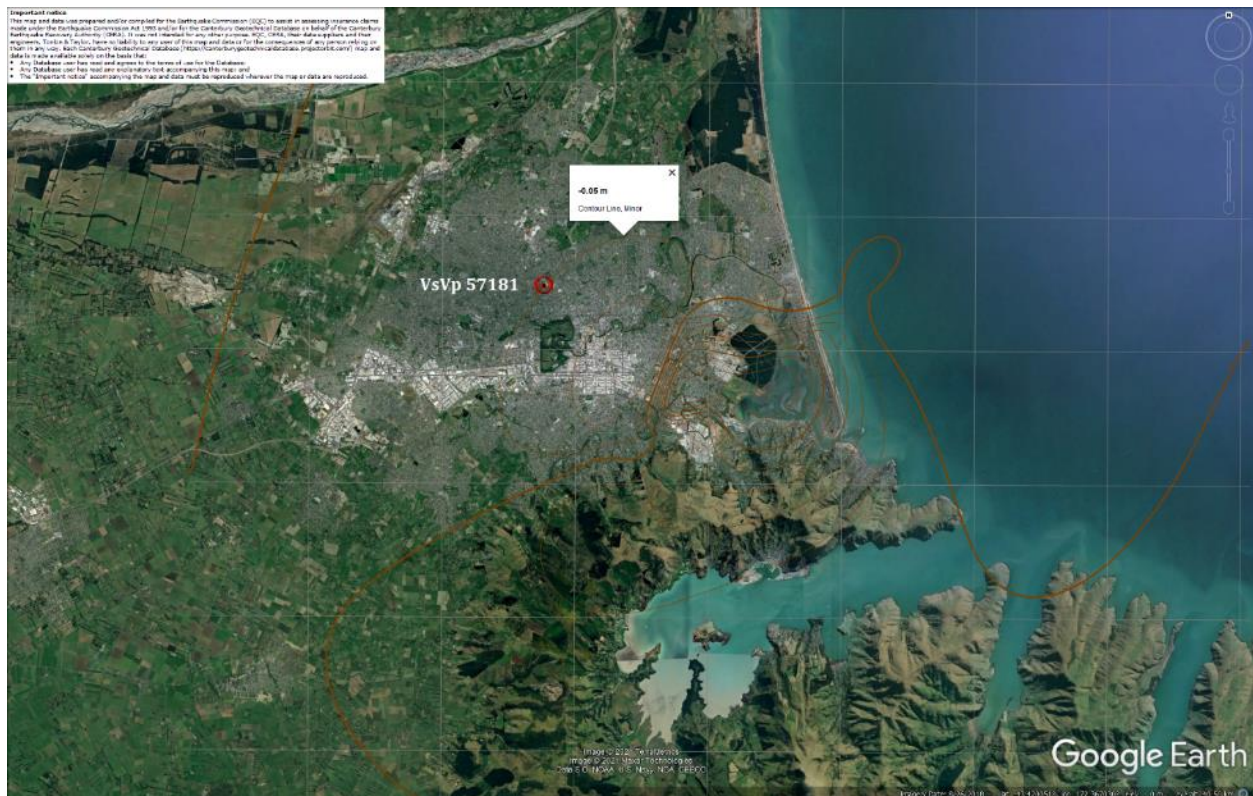
**Figure 38: Vertical tectonic movements for Feb 2011 Earthquake.**

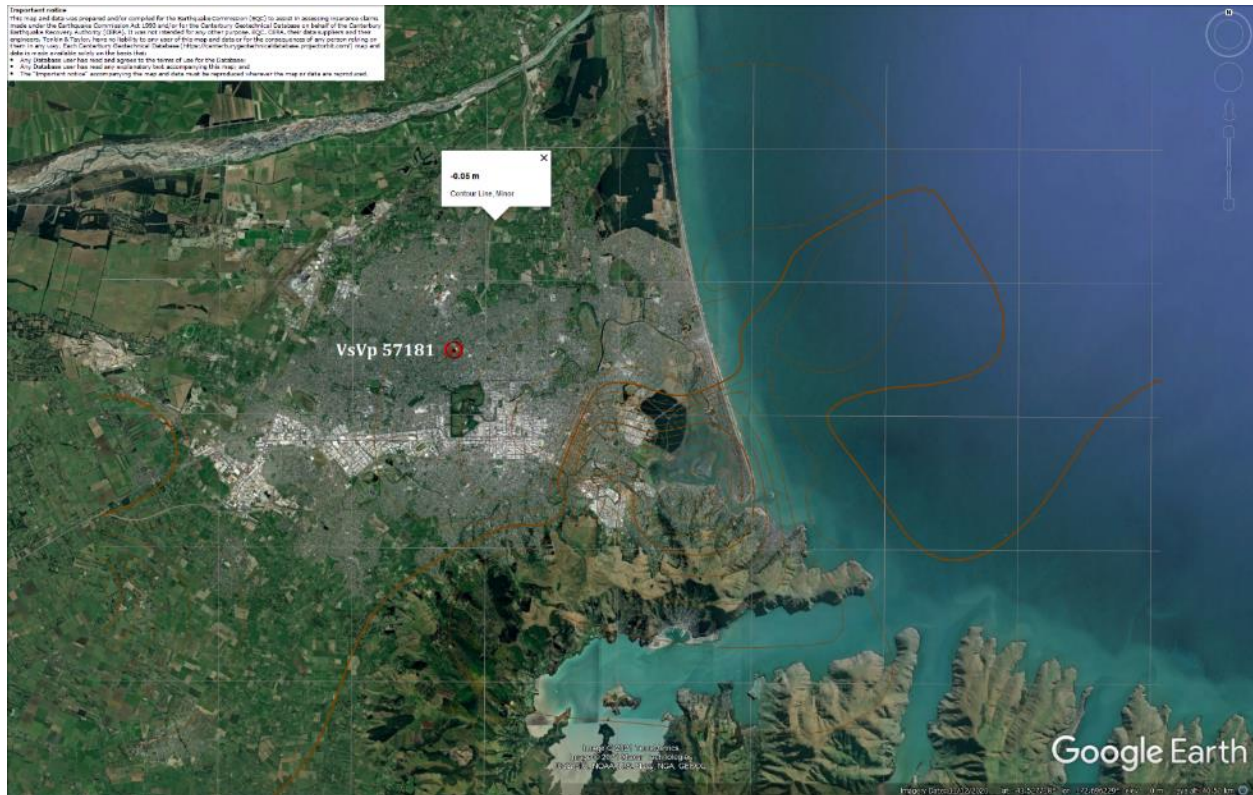
**Figure 41: Vertical tectonic movements for Canterbury Earthquake Sequence.**

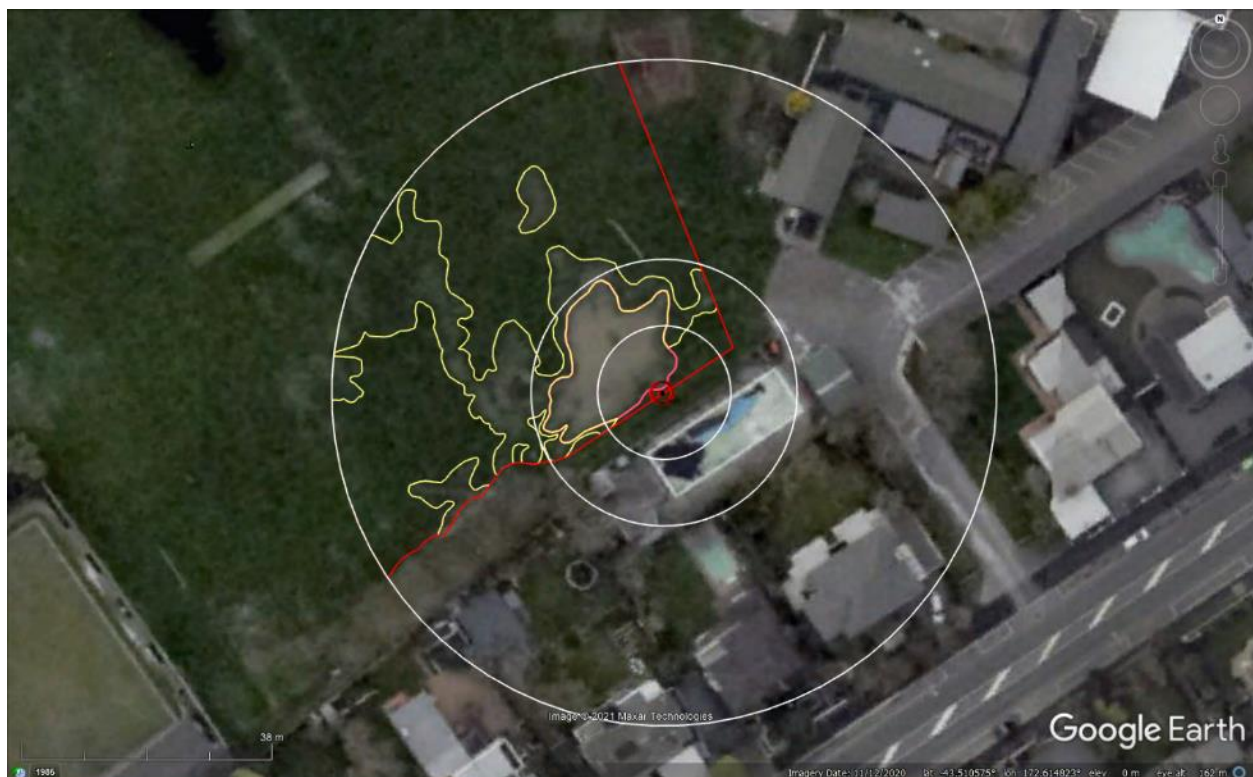
**Figure 42: Aerial photograph showing no ejecta at the site for Sep-10 EQ.**

**Note 3:** The values in Table 9 correspond to the coverage area of ejecta outlined in aerial photographs (Figures 42-45) and the lower and upper estimates of ejecta height based on geometrical approximations and EQC LDAT property inspection reports. The ejecta-induced settlement using photographs and engineering judgment,  $S_{E,P}$ , is estimated as

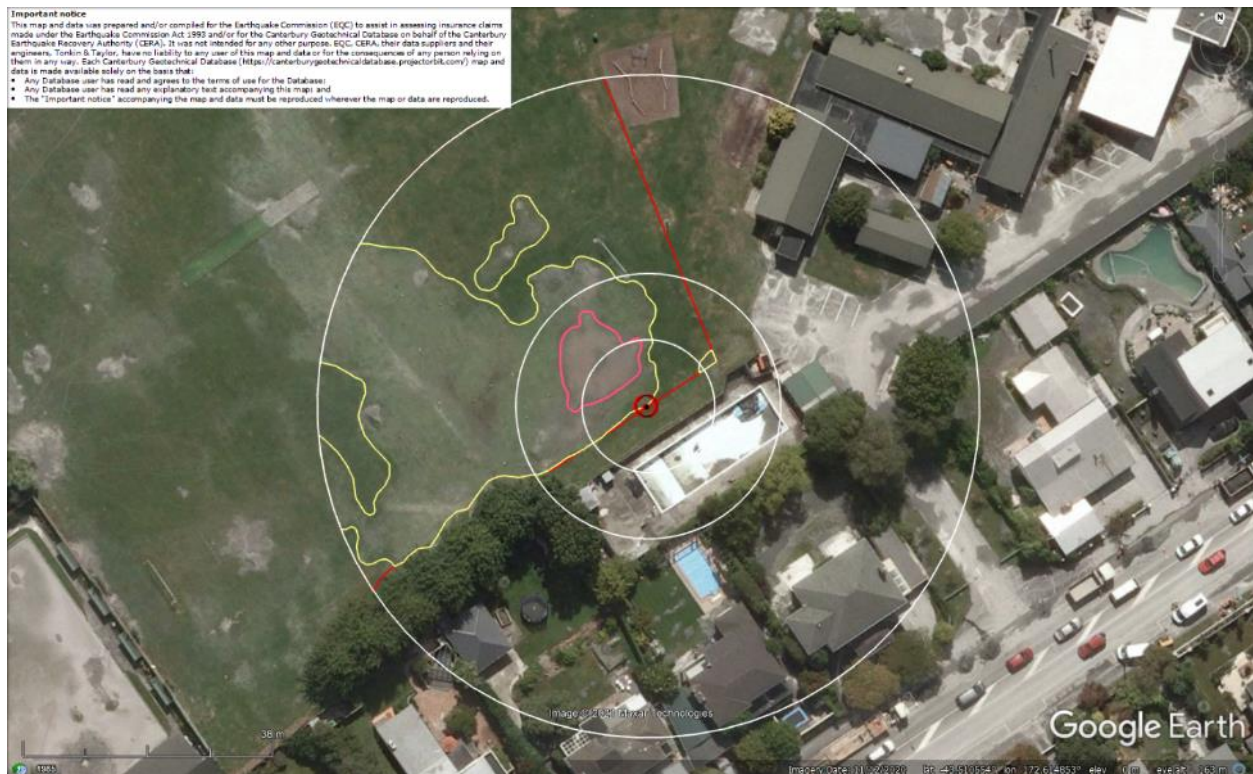
**Figure 43: Aerial photograph showing the ejecta outline at the site for Feb-11 EQ.**

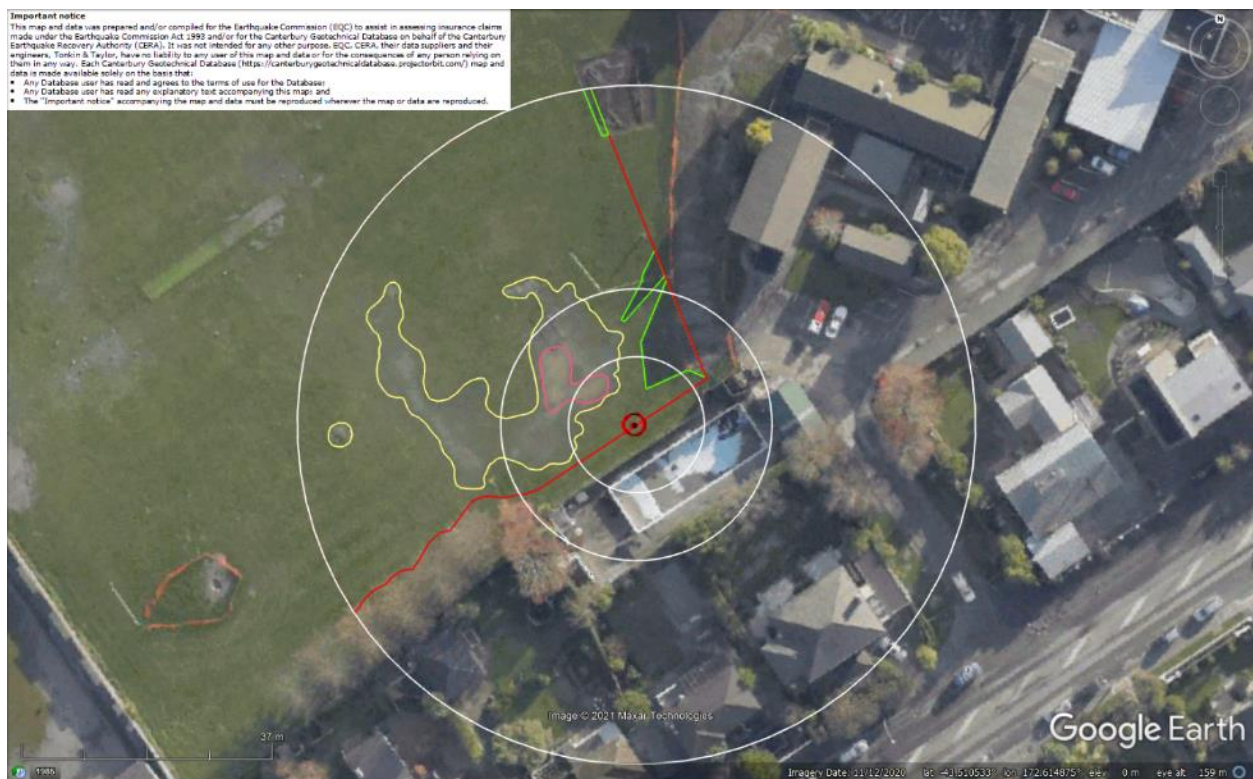
**Figure 44: Aerial photograph acquired on 14-15 Jun 2011 showing the ejecta outline at the site for Jun-11 EQ.**

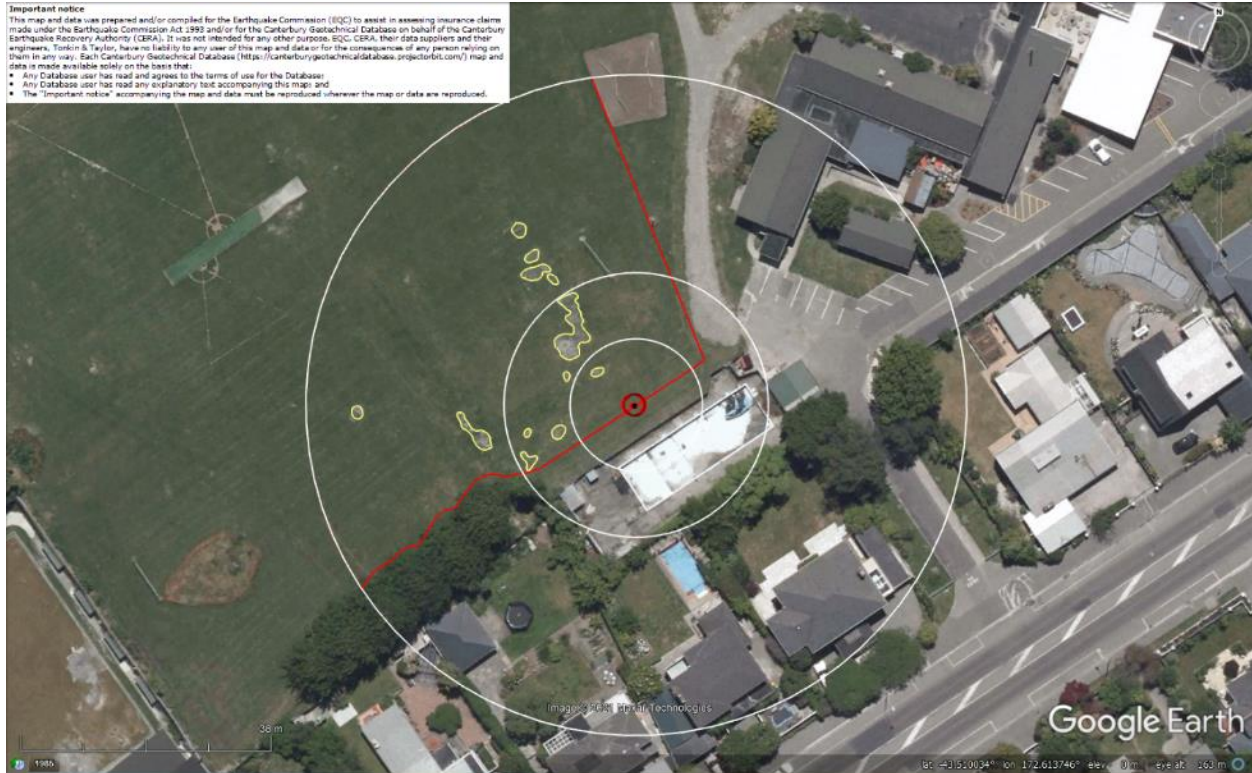
**Figure 45: Aerial photograph showing the ejecta outline at the site for Dec-11 EQ.**

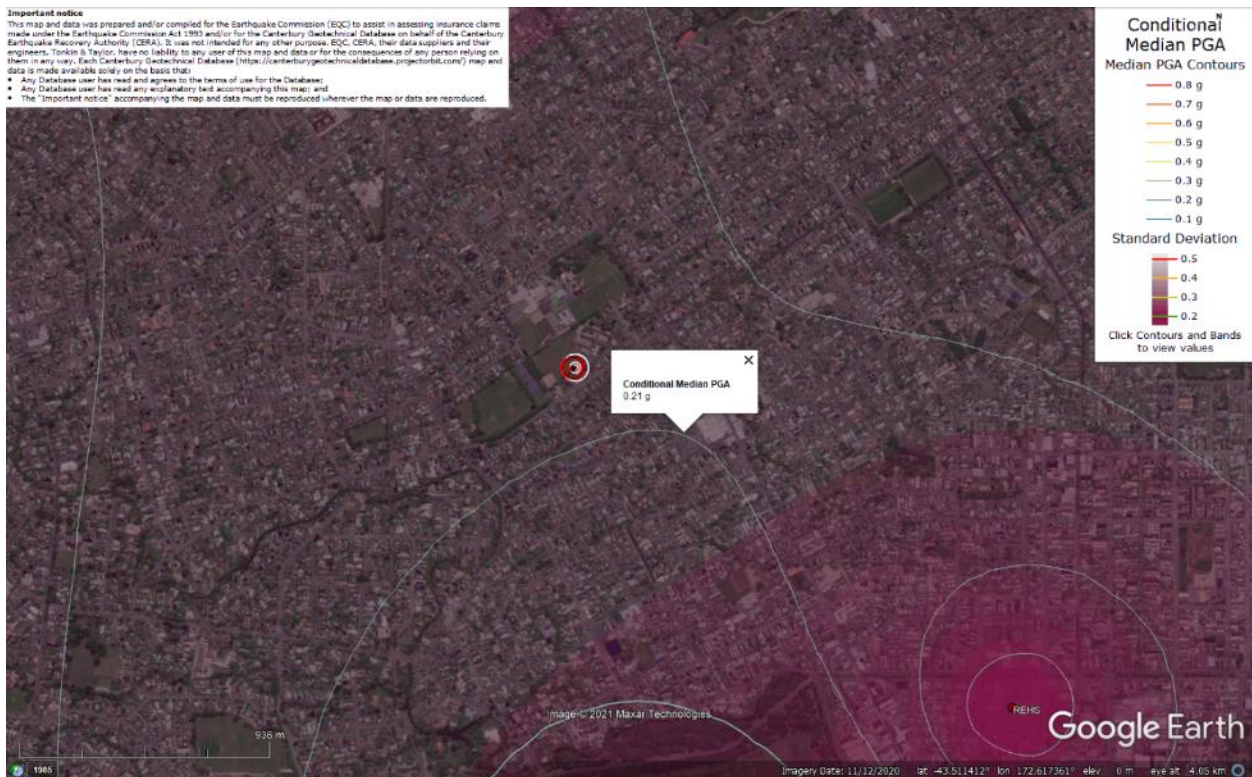
**Figure 46: PGA for Sep-10 EQ (st. dev. = 0.300-0.350 ln units).**

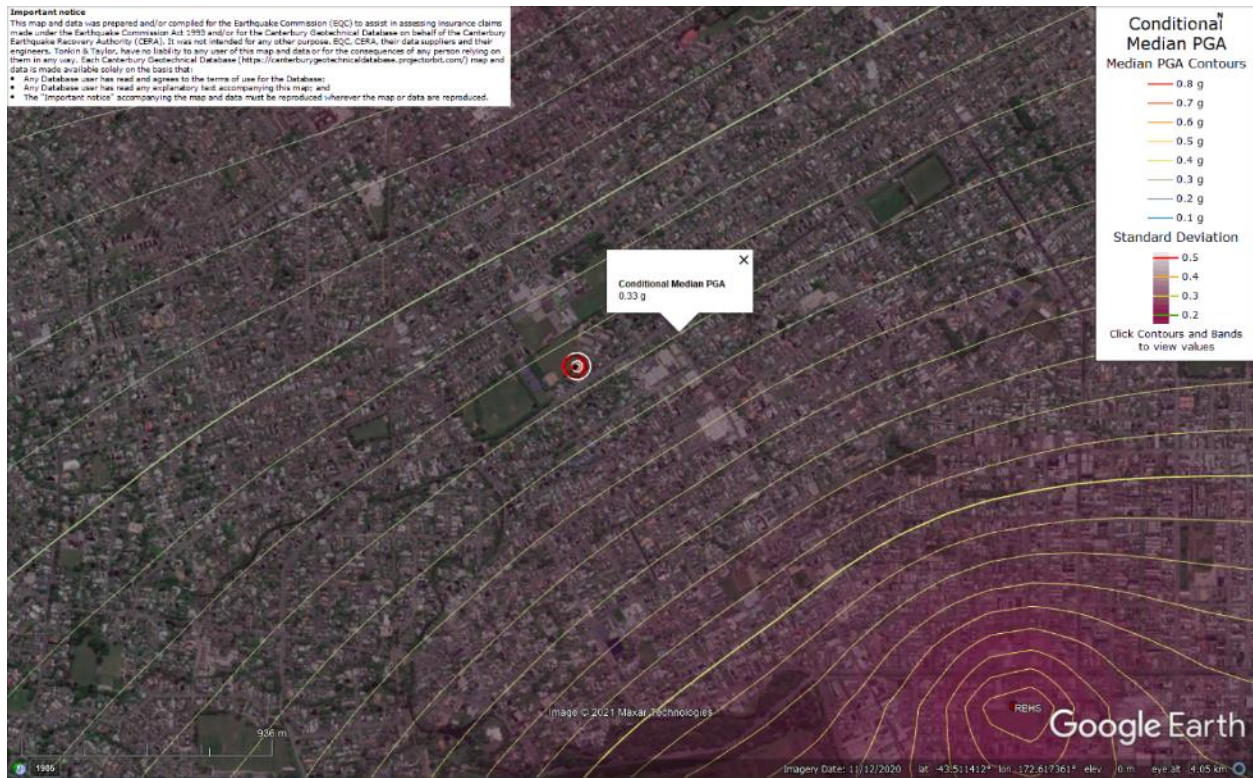
Figure 47: PGA for Feb-11 EQ (st. dev. = 0.350-0.375 ln units).

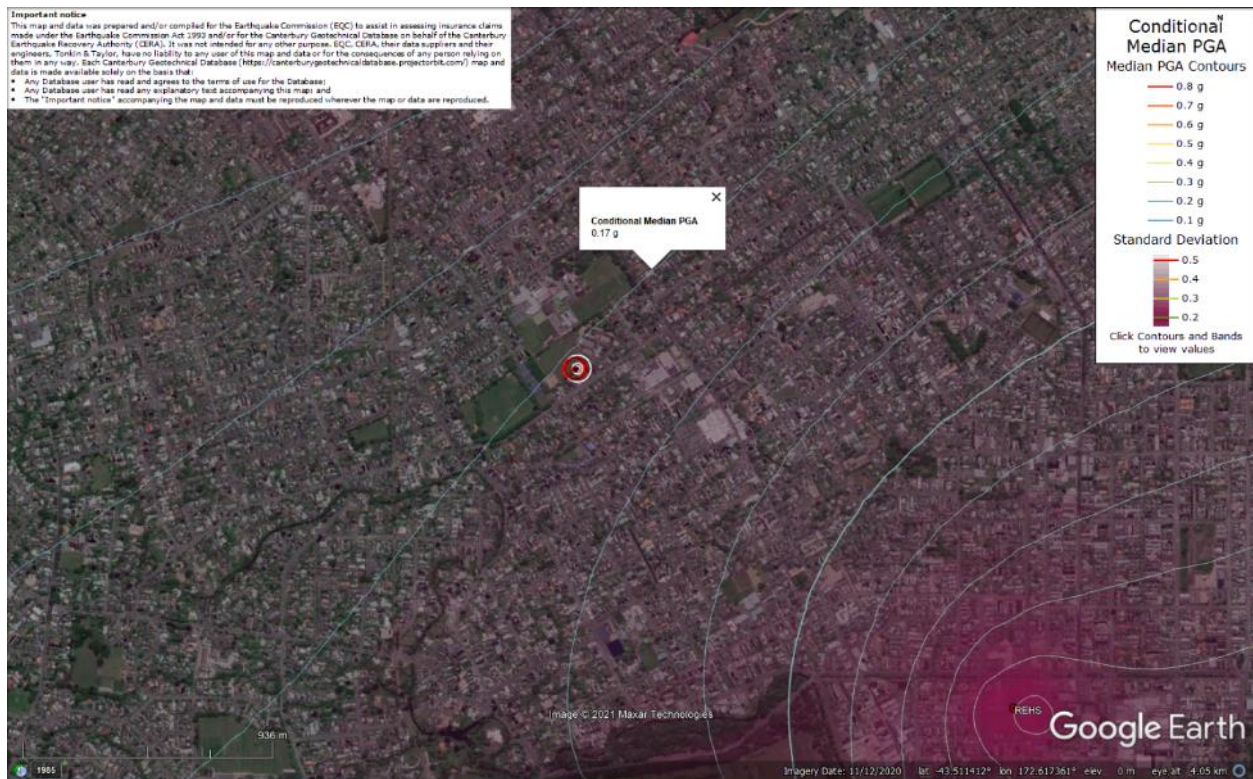
Figure 48: PGA for Jun-11 EQ (st. dev. = 0.350-0.375 ln units).
