Appendix A.43:

Heaton Normal Intermediate School – VsVp 57181

## Liquefaction Ejecta Case Histories for 2010-11 Canterbury Earthquakes

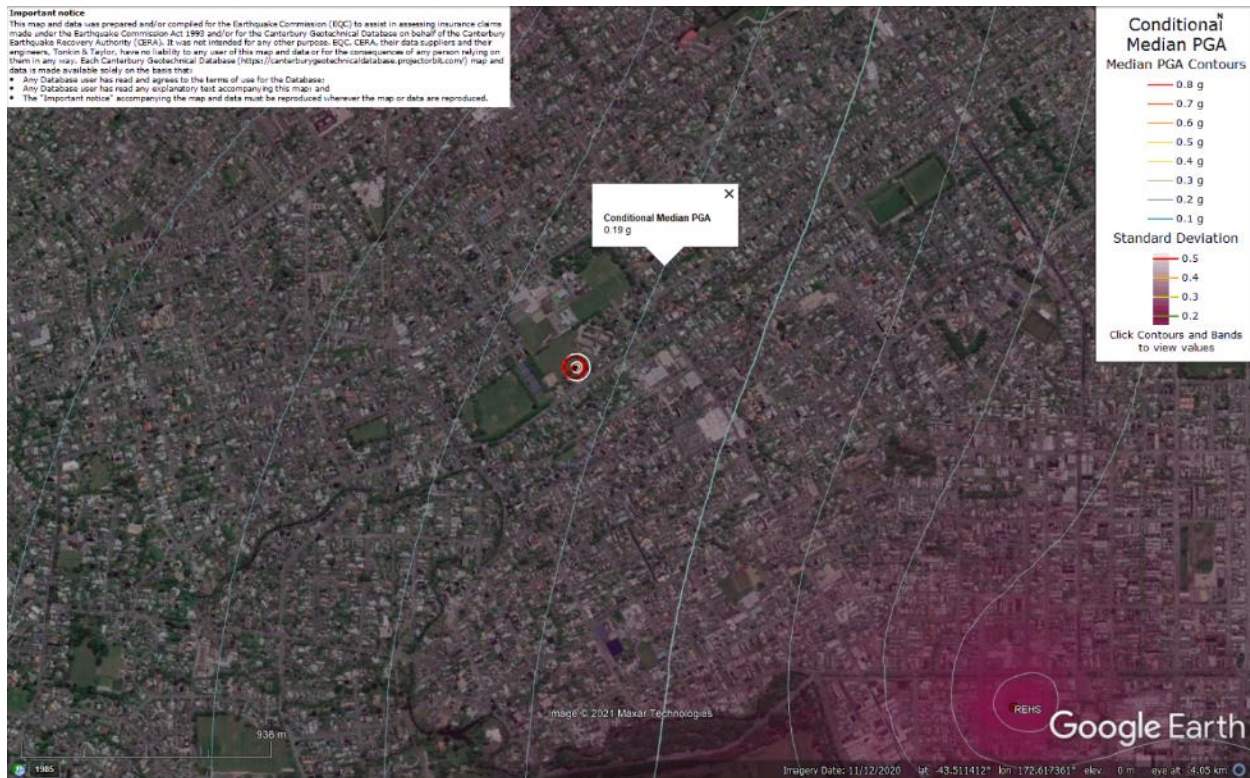
Figure 49: PGA for Dec-11 EQ (st. dev. = 0.375-0.400 ln units).

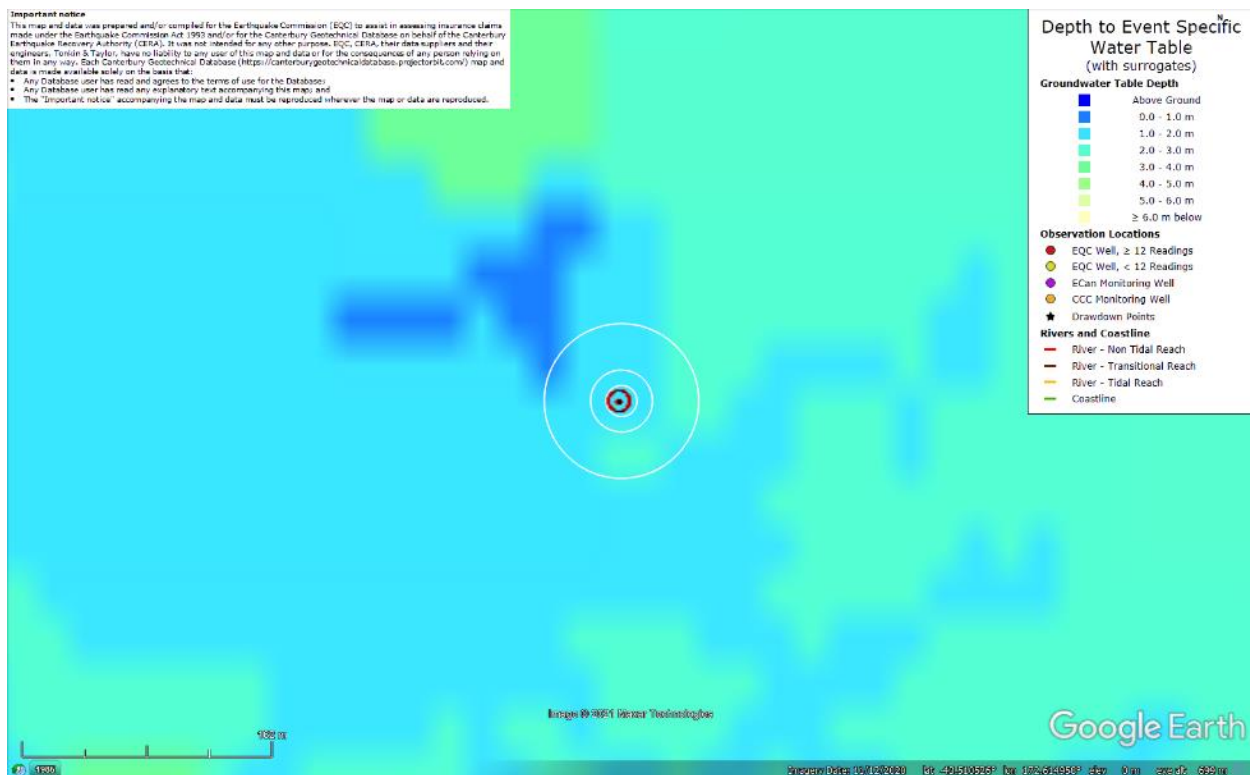
Figure 50: Depth to groundwater table for Sep-10 EQ.

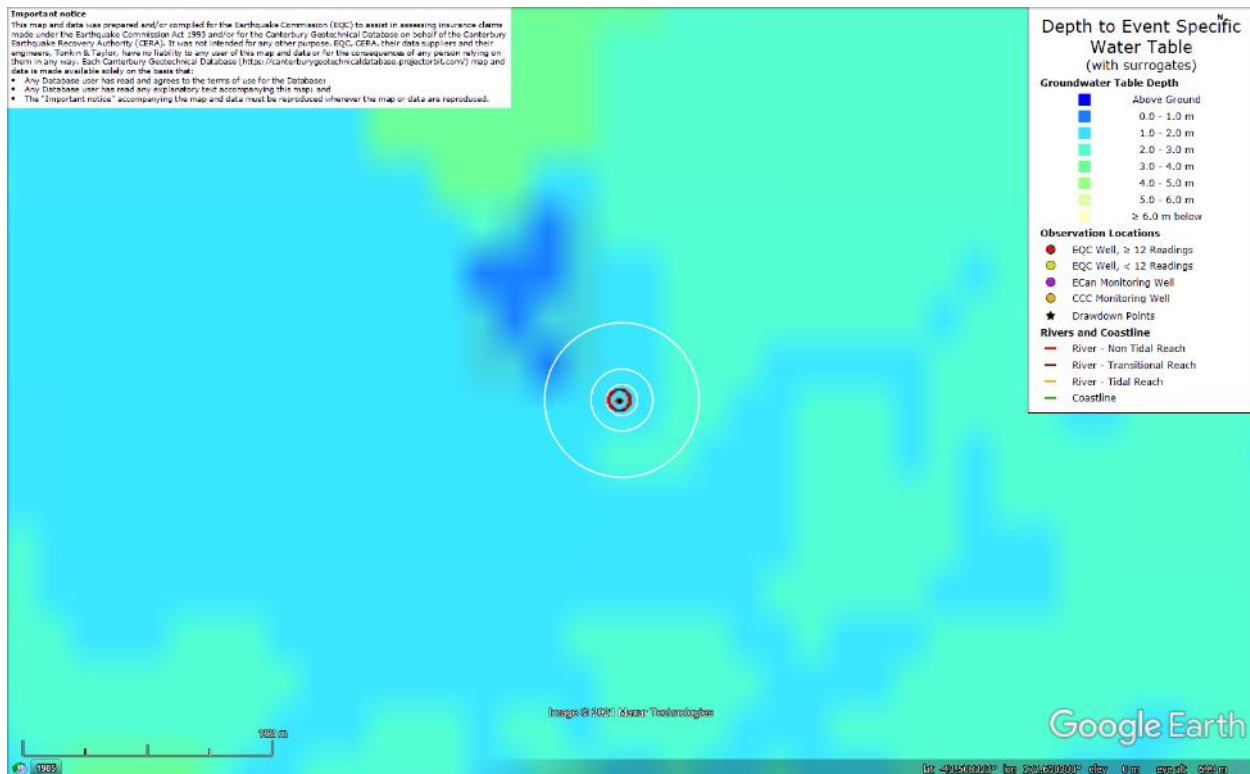
Figure 51: Depth to groundwater table for Feb-11 EQ.

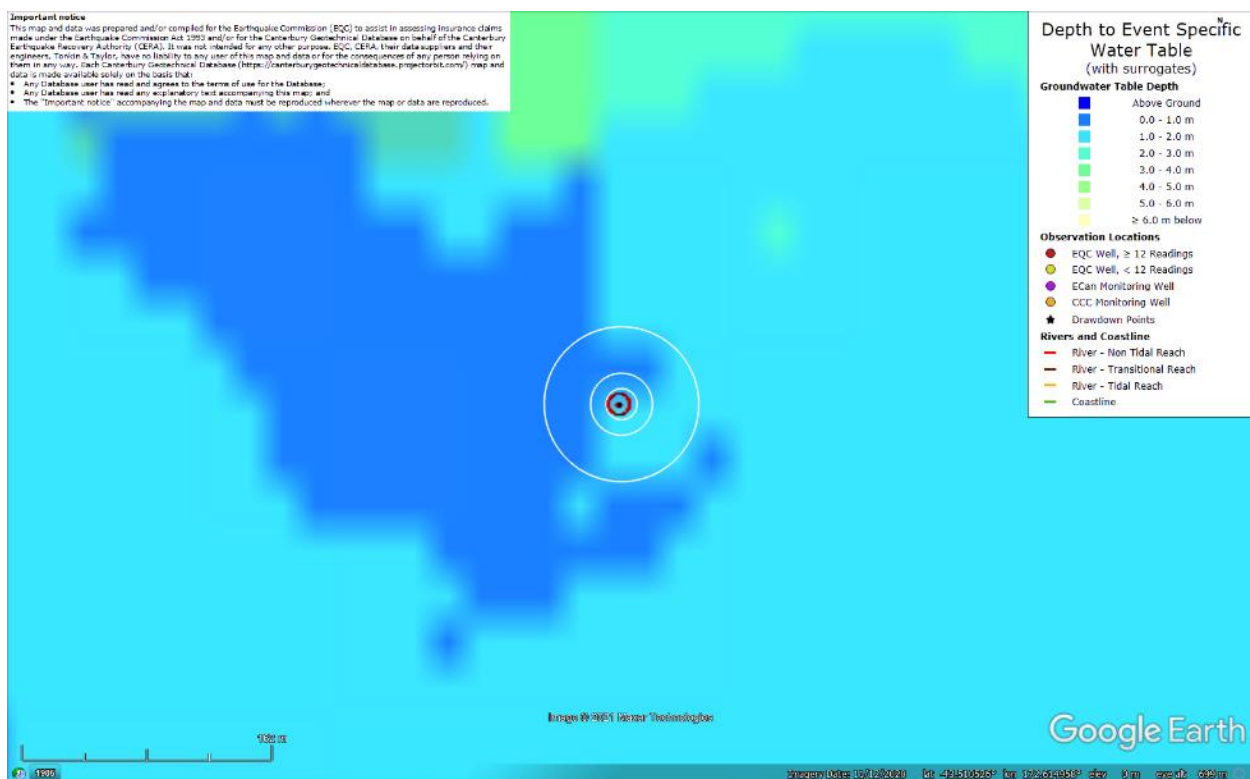
Figure 52: Depth to groundwater table for Jun-11 EQ.

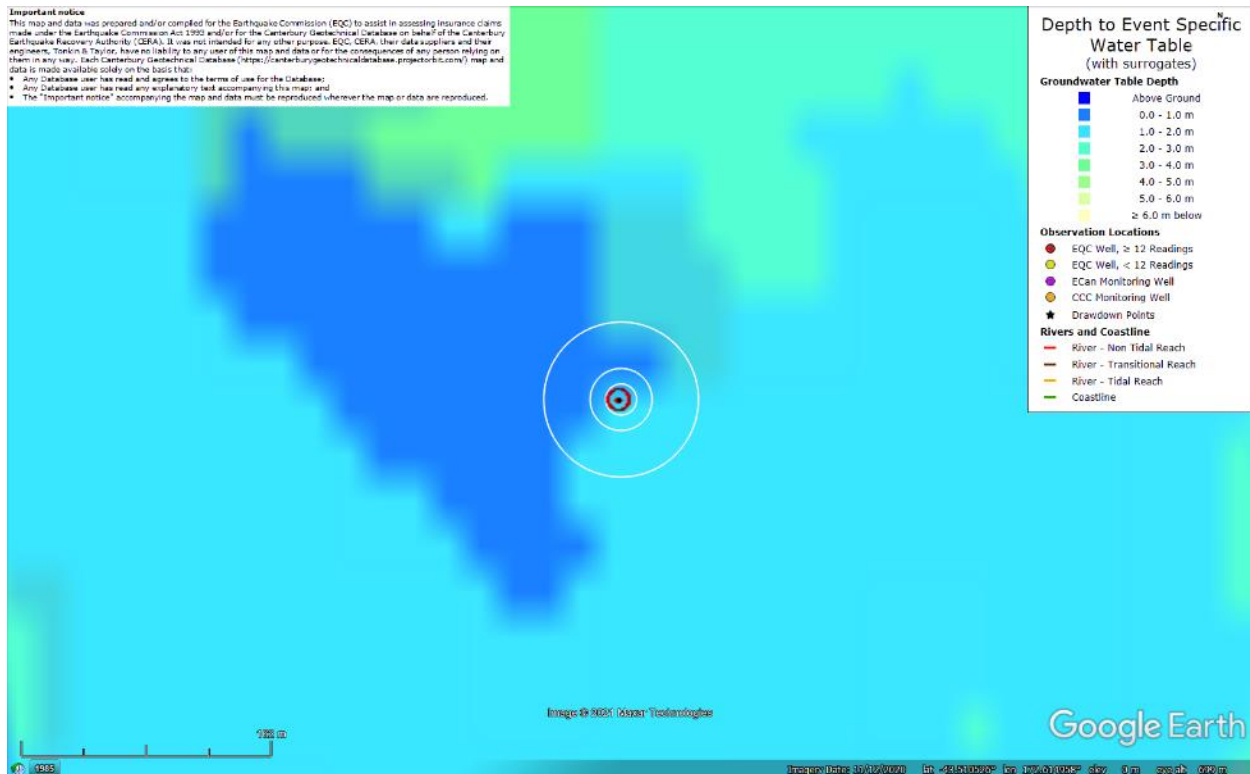
Figure 53: Depth to groundwater table for Dec-11 EQ.

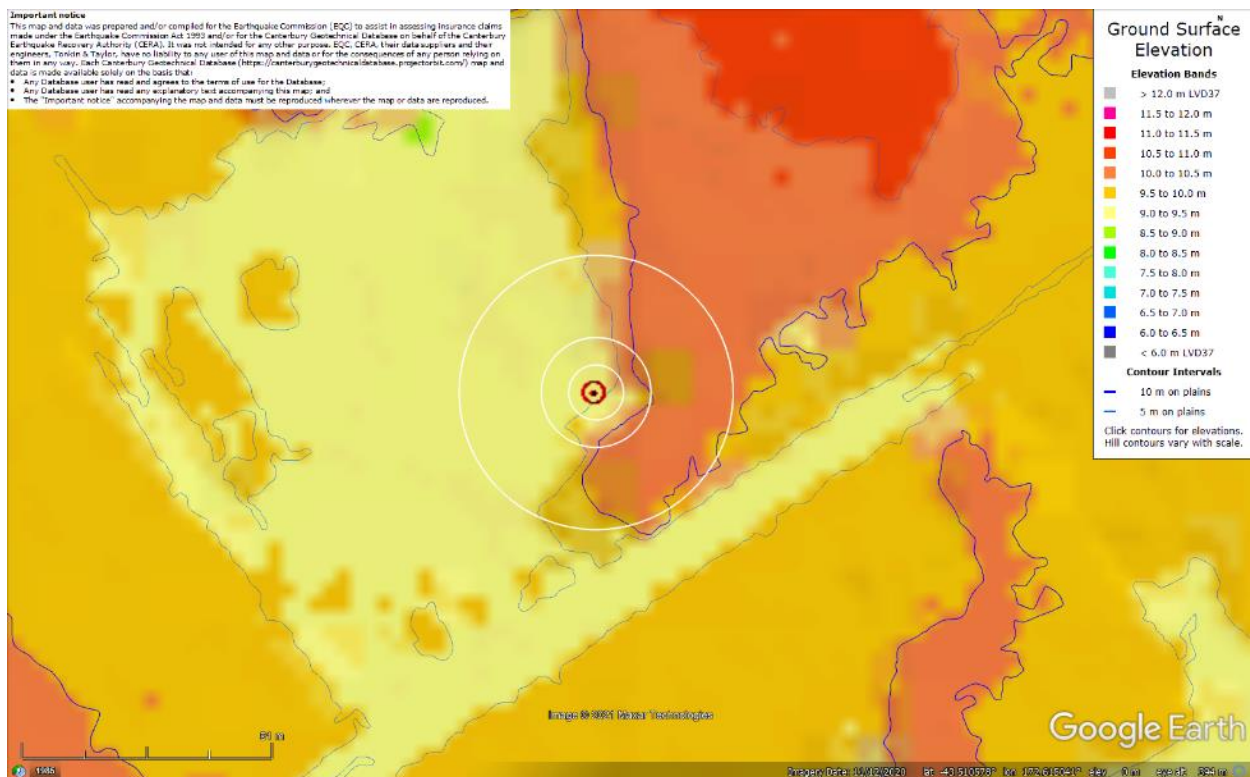
Figure 54: Ground surface elevation according to the Sep-11 LiDAR survey.

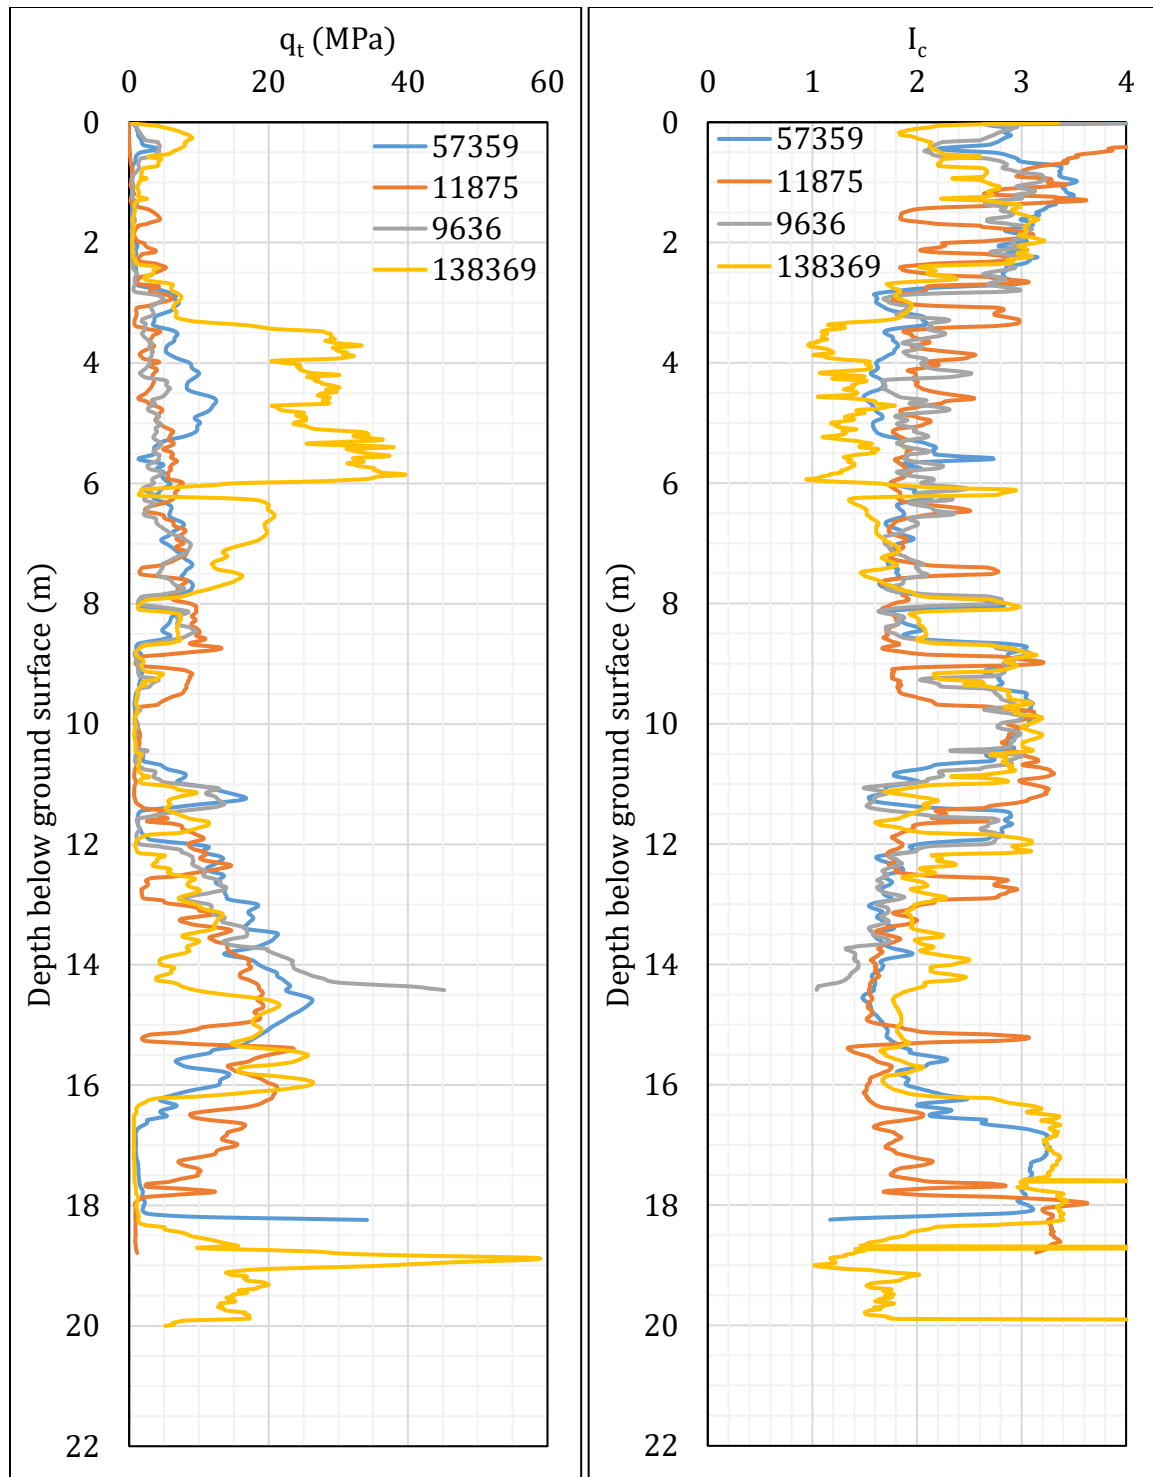
Figure 55:  $q_t$  and  $I_c$  profiles.

**Note 5:** The selection of CPTs for the area considered for settlement assessment (Figure 1) is based on the proximity of the CPTs to the considered areas. In accordance with that, the following table shows CPTs that were used for the volumetric settlement analysis in *Cliq v.3.0.3.2*, a CPT soil liquefaction software developed by GeoLogismiki. (The average volumetric settlements were reported in Table 8.)
