Appendix A.53:

Gainsborough Reserve – VsVp 38176

Liquefaction Ejecta Case Histories for 2010-11 Canterbury Earthquakes

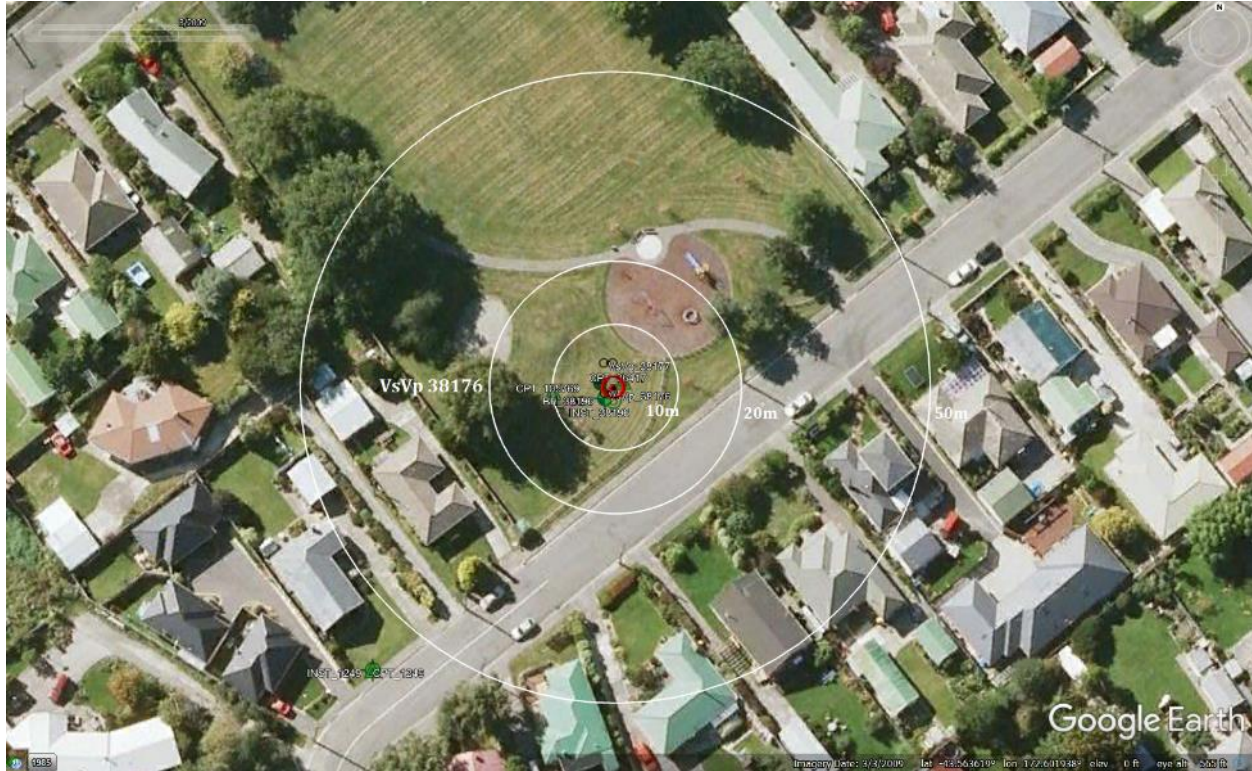
Figure 1: Site plan.

Note: Buffer is the area within a circle of a specified radius with VsVp investigations done at its center (172.601913°, -43.563623°).

Note 4: The selection of CPTs for the area considered for settlement assessment (Figure 1) is based on the proximity of the CPTs to the considered areas. In accordance with that, the following table shows CPTs that were used for the volumetric settlement analysis in *Cliq v.3.0.3.2*, a CPT soil liquefaction software developed by GeoLogismiki. (The average volumetric settlements were reported in Table 8.)

Note 5: Based on the borehole log (BH 38196, Figure 1), the groundwater table is at a depth of 0.4 m below the ground surface. The soil profile consists of (1) topsoil to a depth of 0.1 m, (2) silt, ML, to a depth of 4.7 m, (3) silty fine sand, SM, to a depth of 6.2 m, (4) silt, ML, to a depth of 7.75 m, (5) silty fine sand, SM, to a depth of 9.1 m, and (6) sandy silt, ML, to a depth of 10 m (the end of the borehole). These are the Yaldhurst members of the Springston formation (except the topsoil layer).

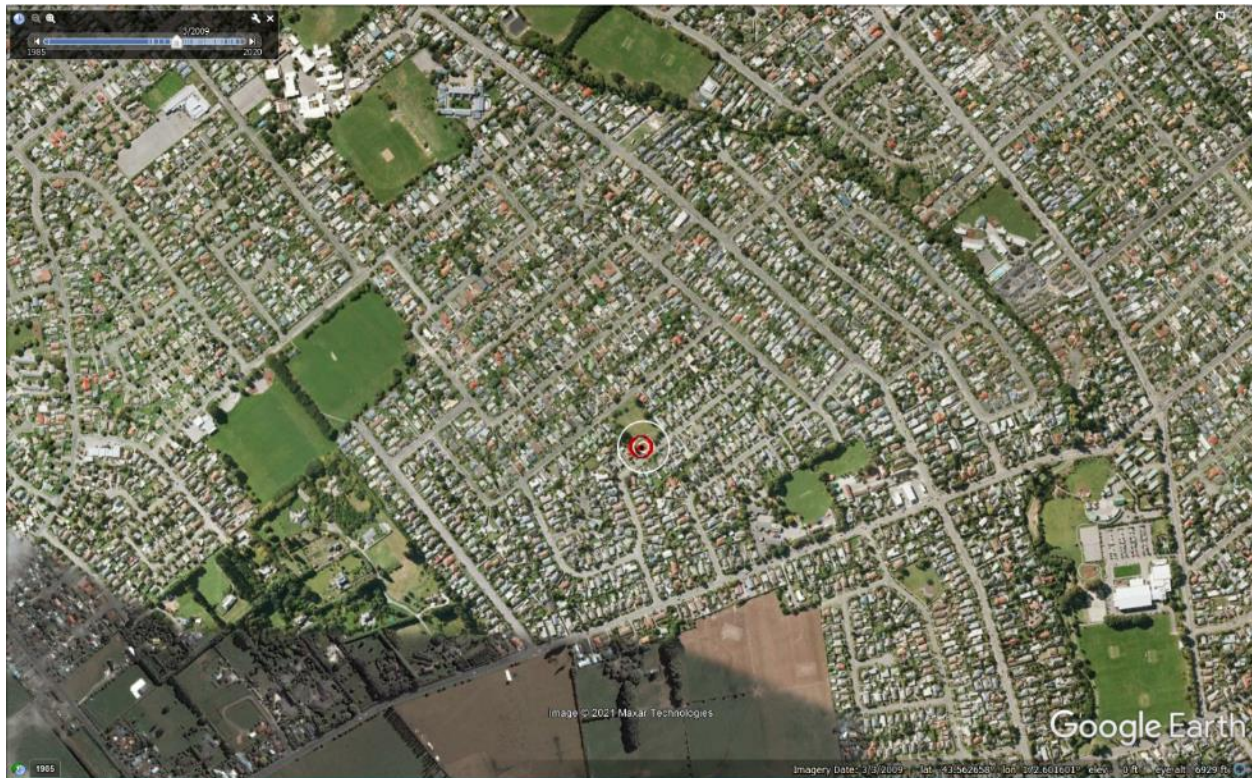
Figure 3: Position of the site relative to nearby buildings, vegetation, and free-face features.

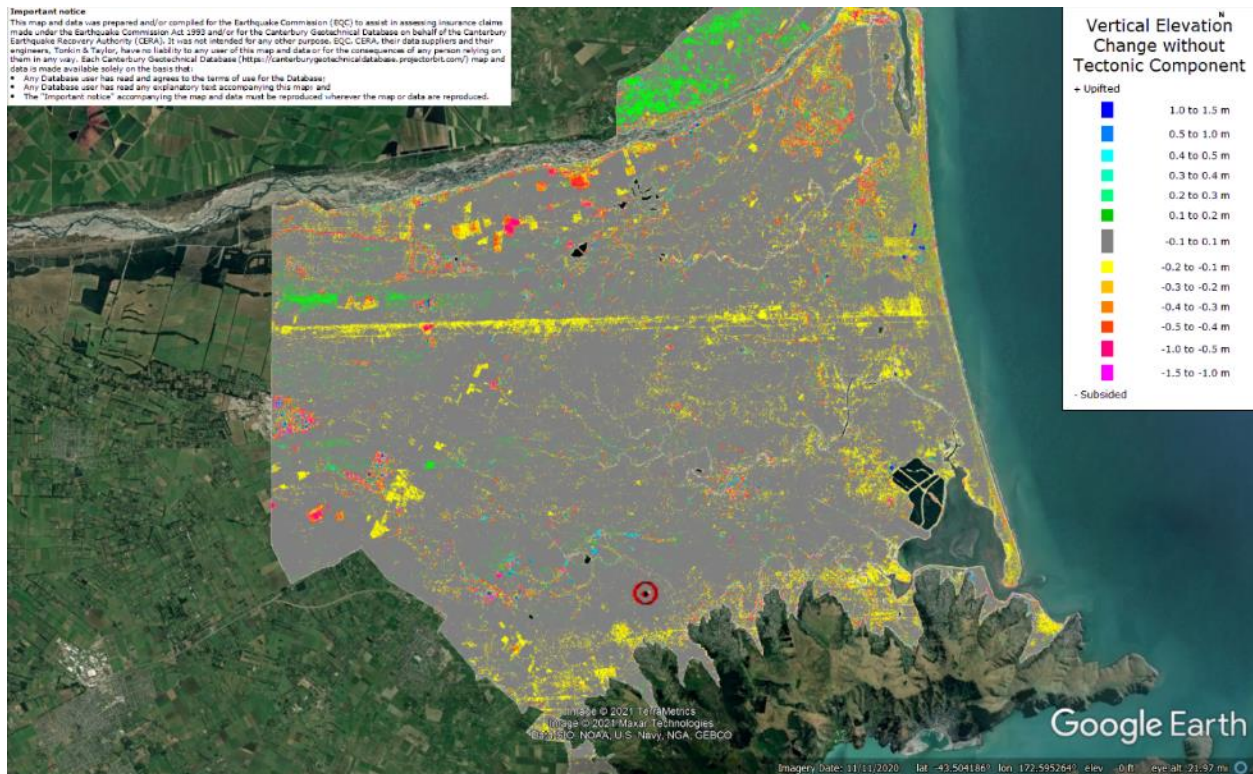
Figure 22: Vertical Ground Movements (Surface – Tectonic) for June 2011 Earthquake – the site is not in the apparent zone of overestimated ground surface subsidence.

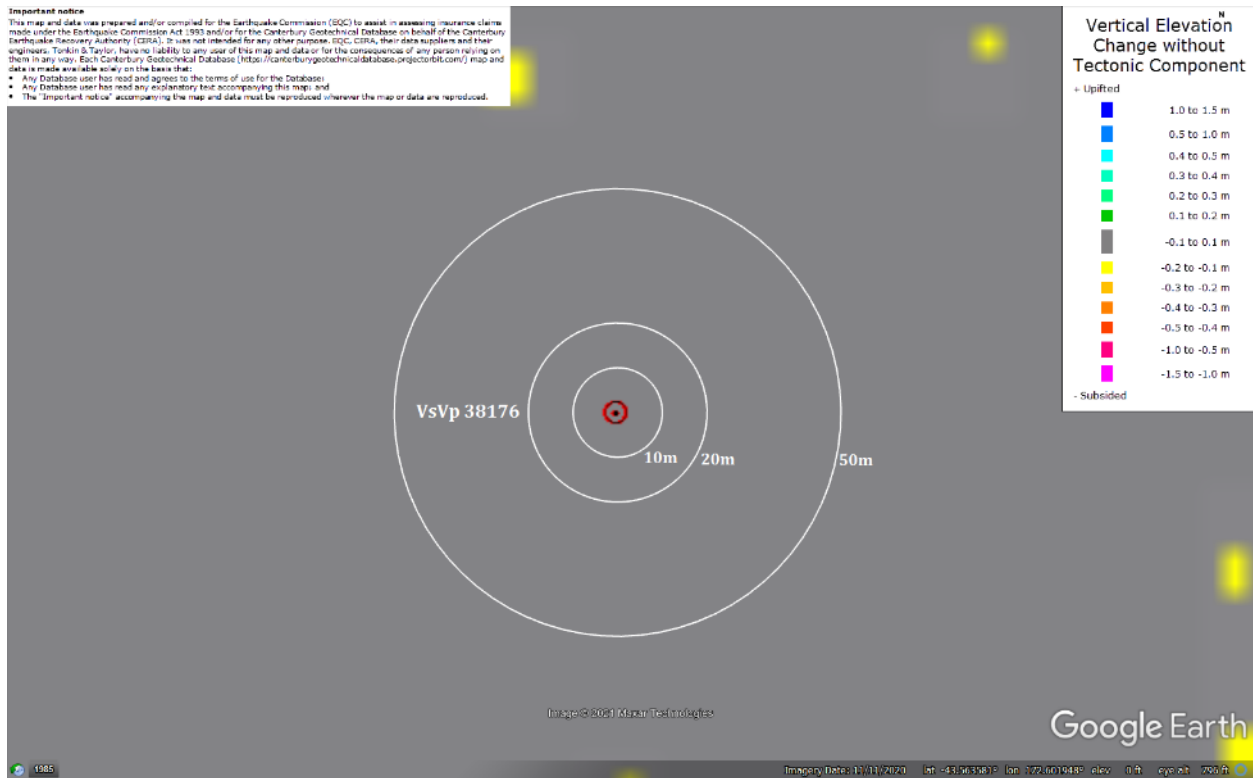
Figure 24: Ground surface subsidence without tectonic component for June 2011 Earthquake according to the LiDAR DEM.

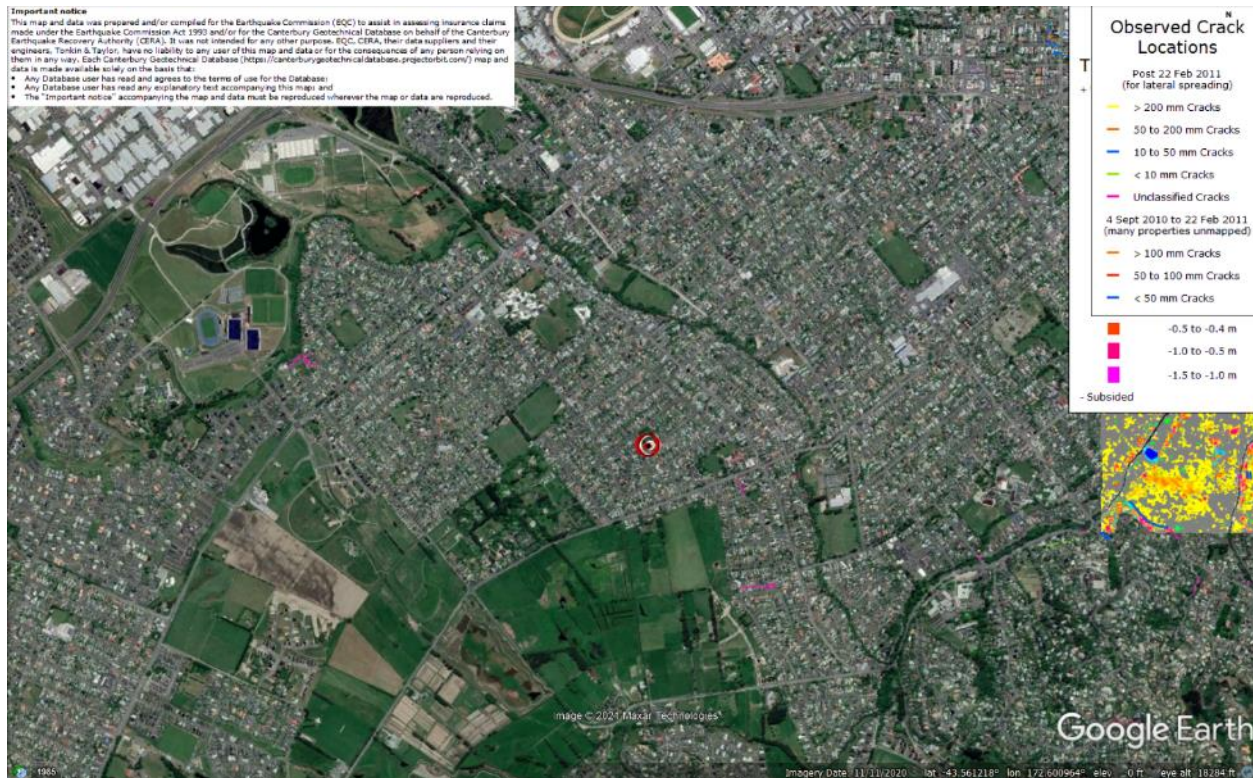
Figure 25: No lateral spreading for Canterbury Earthquake Sequence.

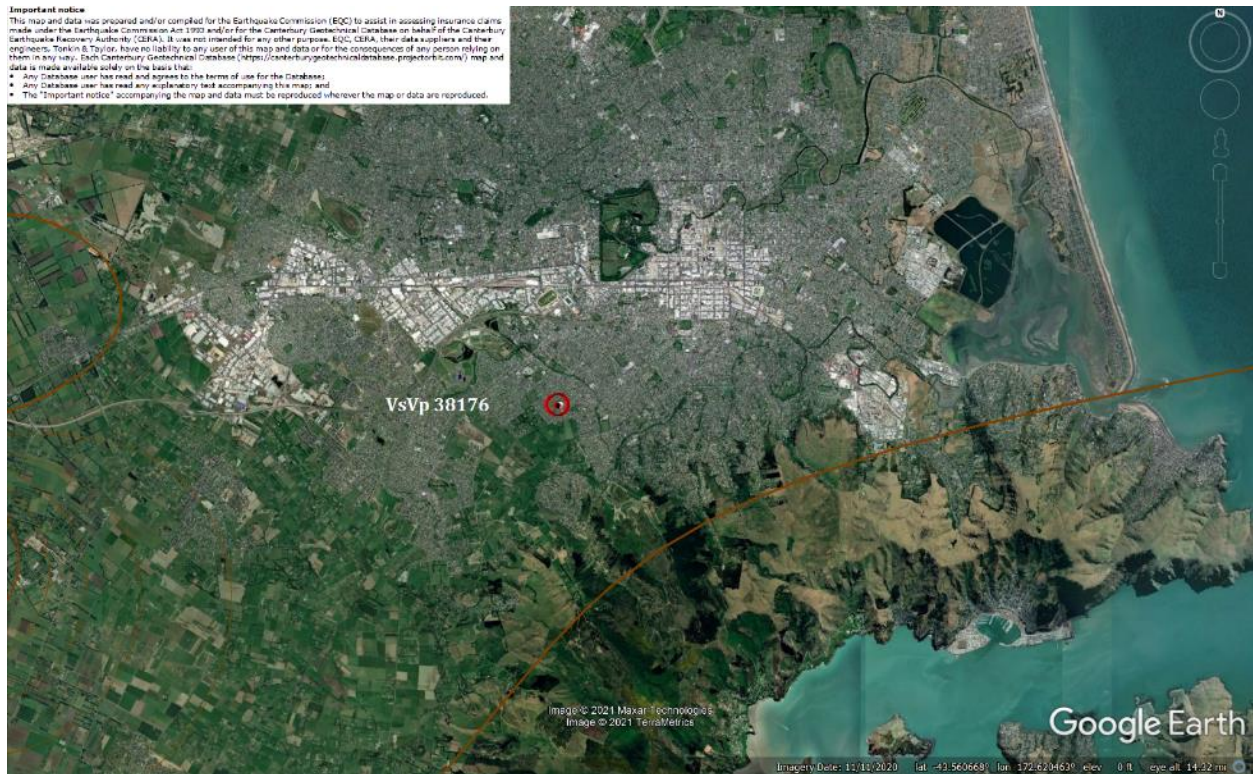
Figure 26: Vertical tectonic movements for Sep 2010 Earthquake.

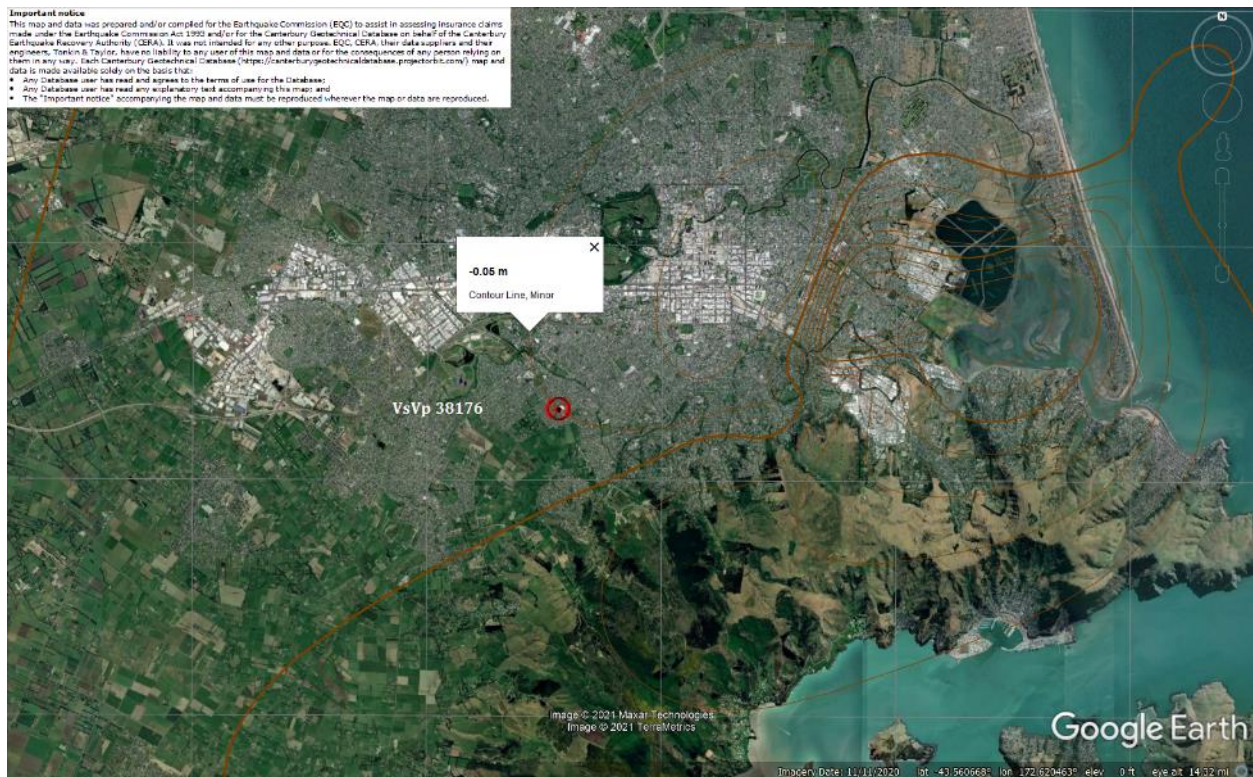
Figure 27: Vertical tectonic movements for Feb 2011 Earthquake.

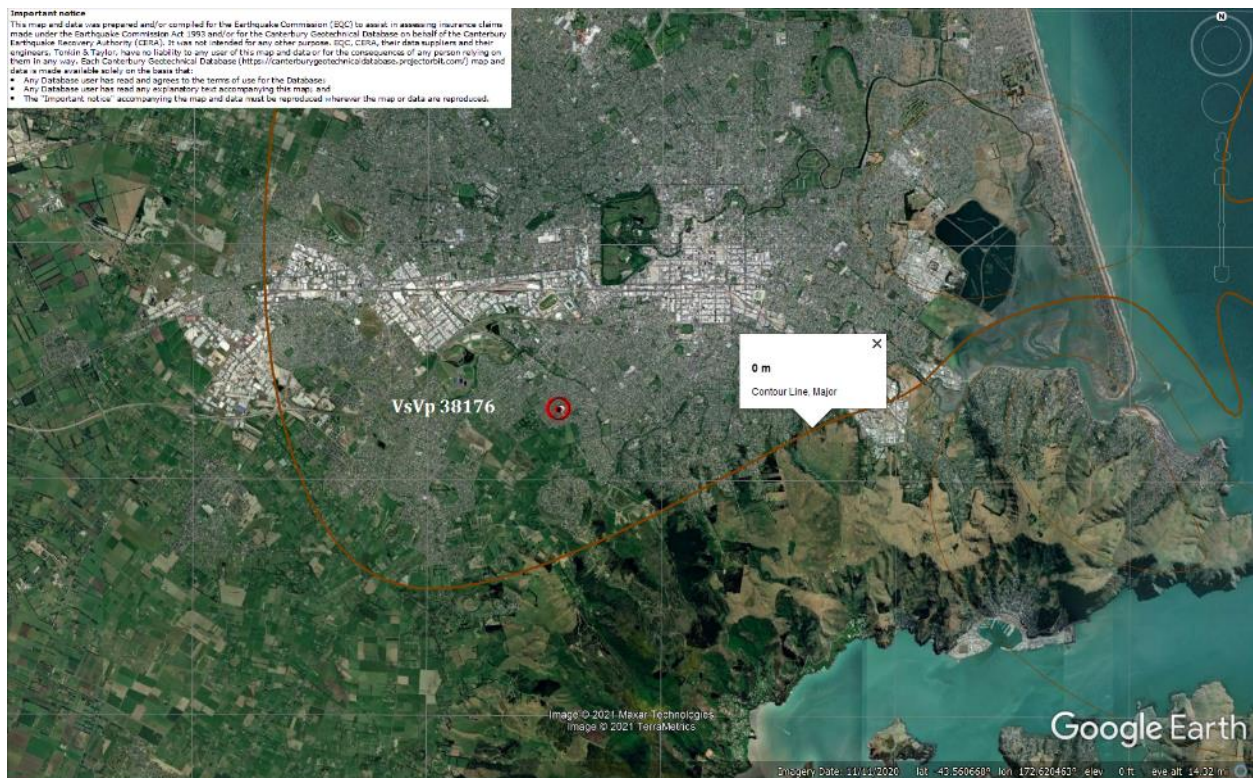
Figure 28: Vertical tectonic movements for June 2011 Earthquake.

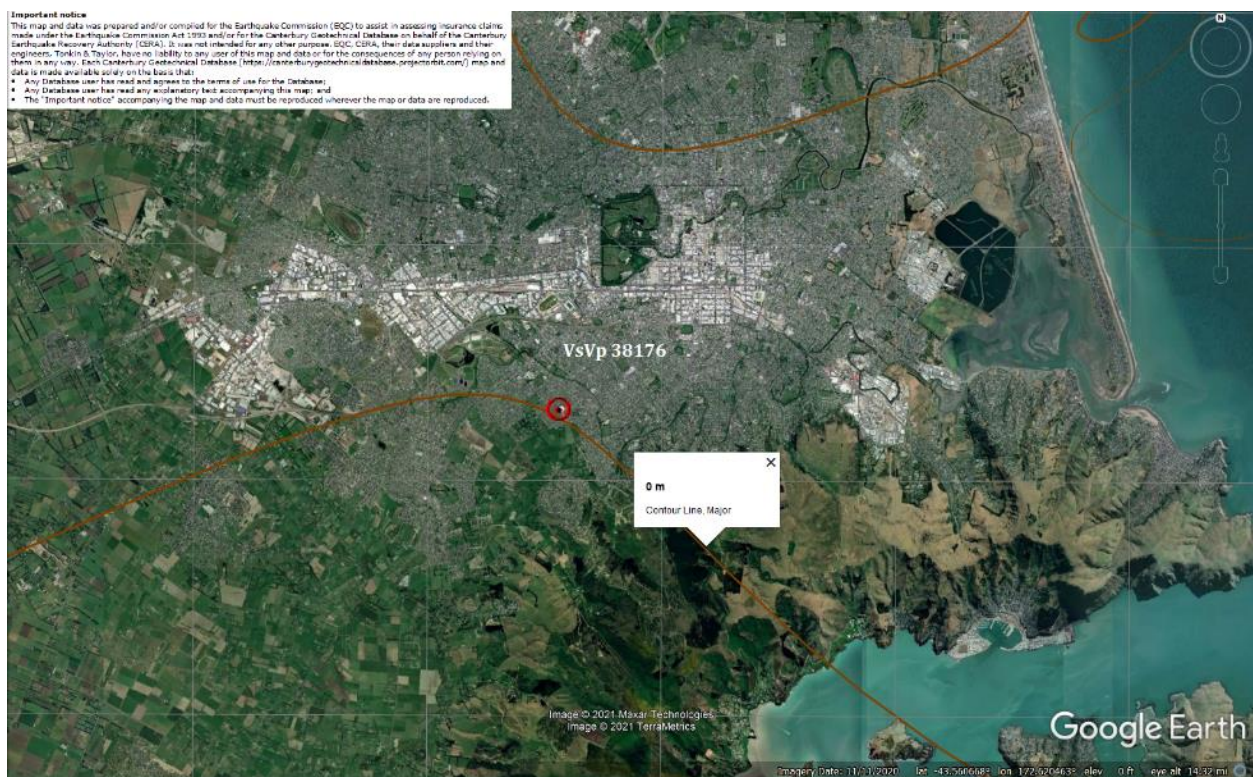
Figure 29: Vertical tectonic movements for Dec 2011 Earthquake.

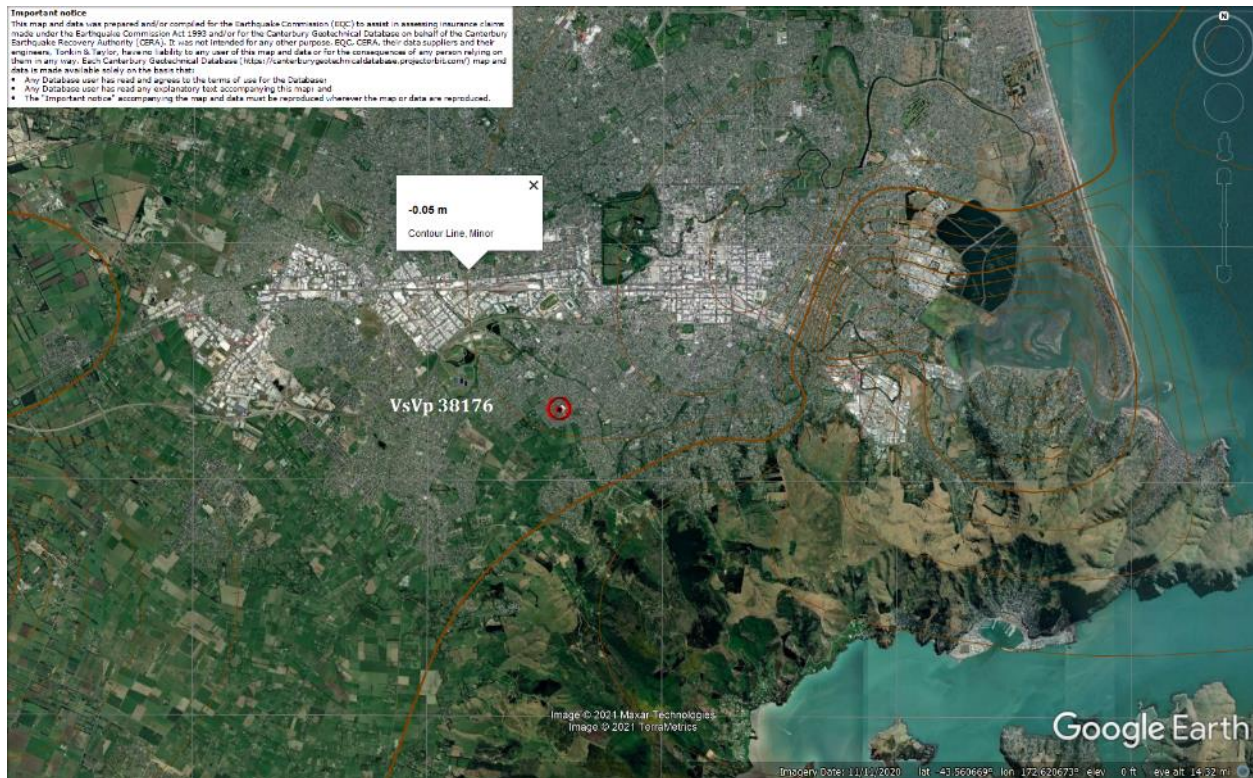
Figure 30: Vertical tectonic movements for Canterbury Earthquake Sequence.

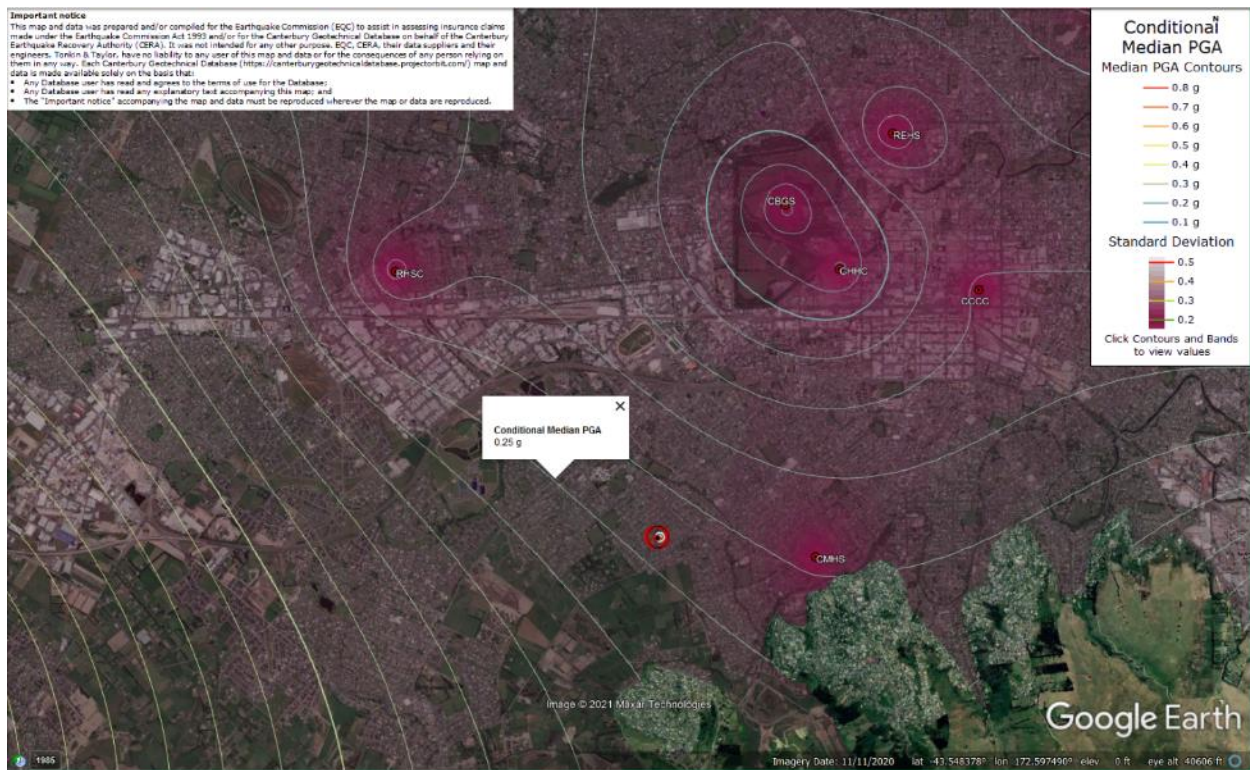
Figure 31: PGA for Sep-10 EQ (st. dev. = 0.325 to 0.350 ln units).

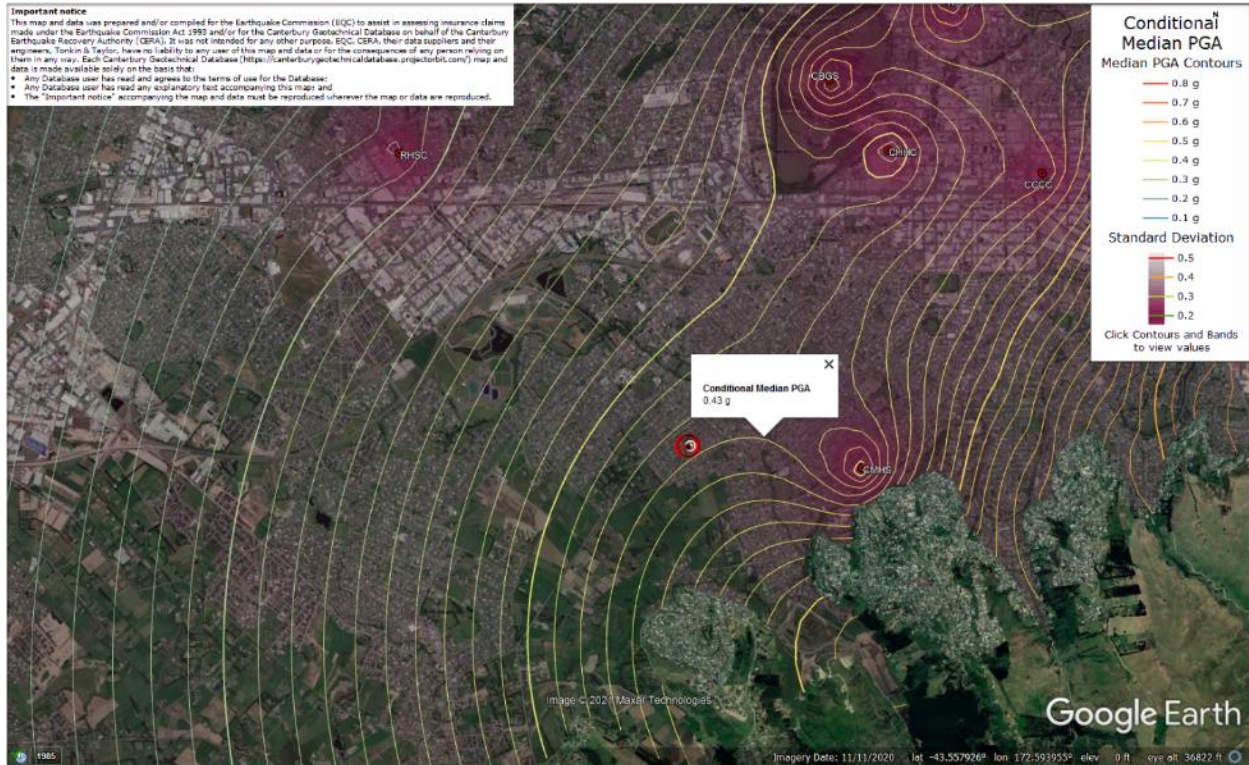
Figure 32: PGA for Feb-11 EQ (st. dev. = 0.375 to 0.400 ln units).

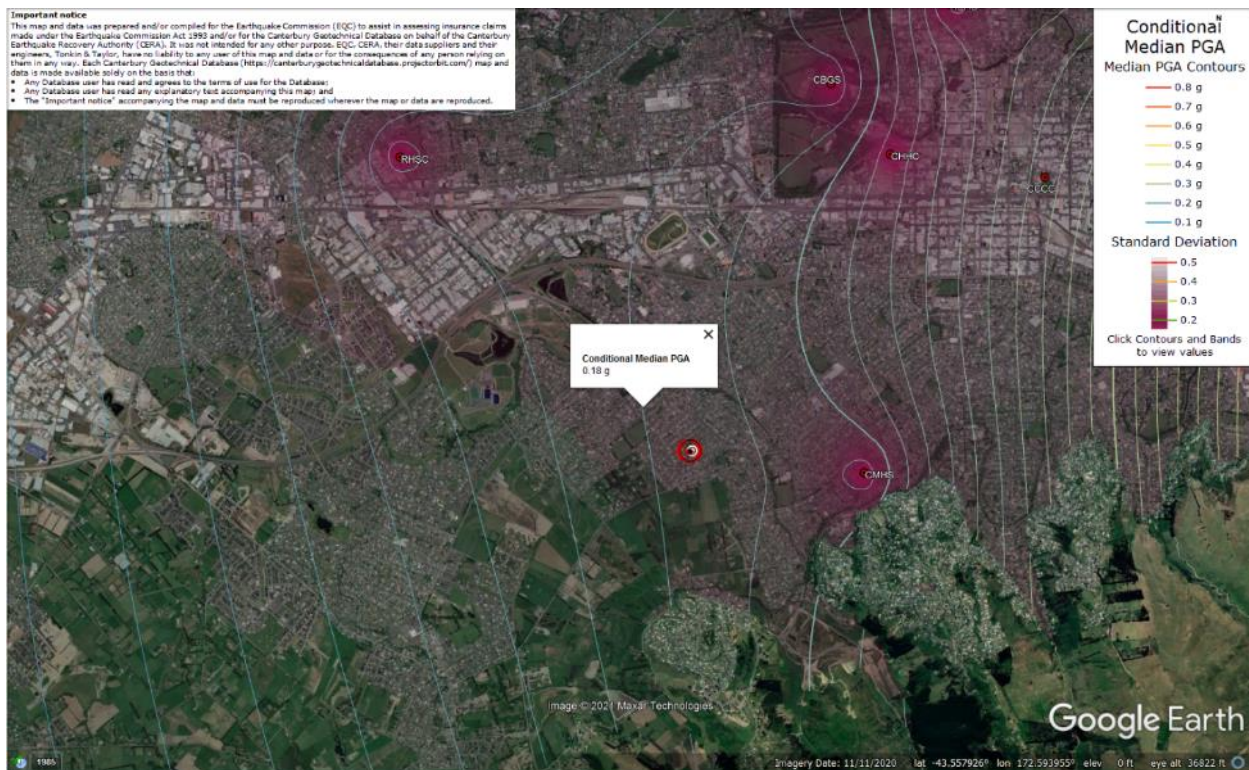
Figure 33: PGA for Jun-11 EQ (st. dev. = 0.400 to 0.425 ln units).

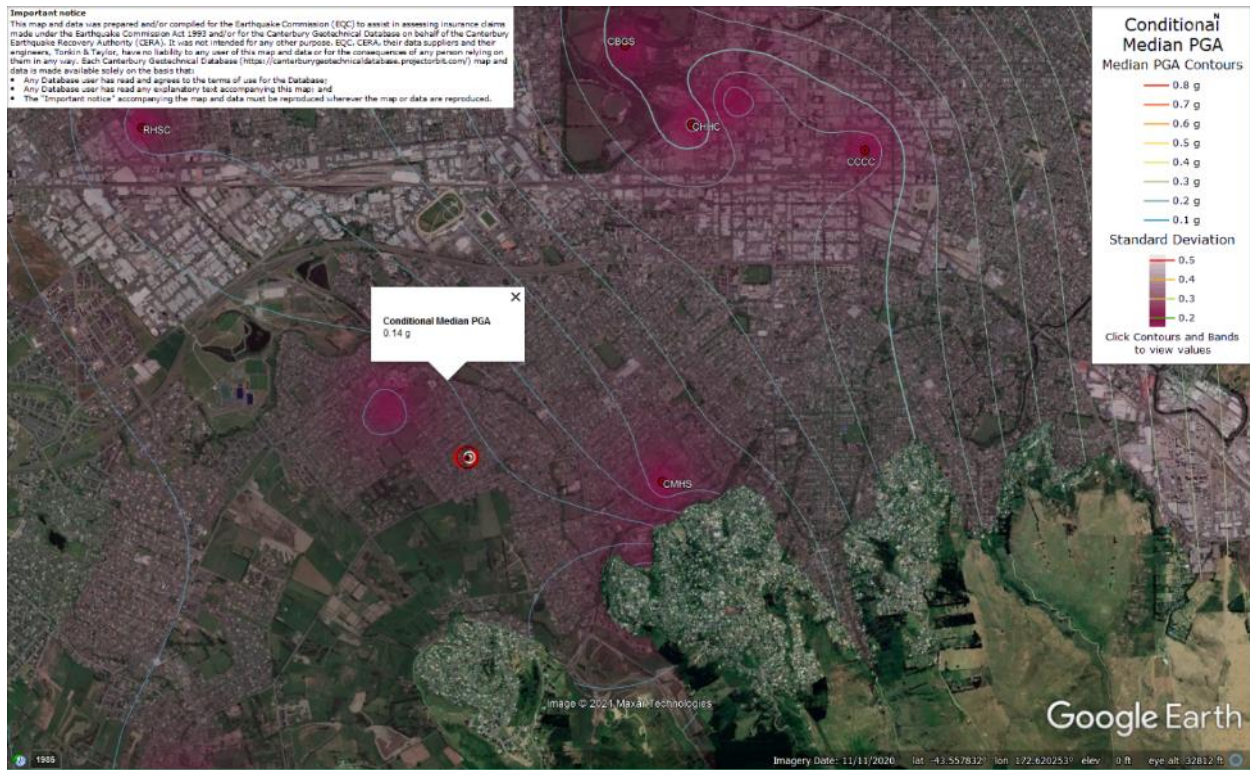
Figure 34: PGA for Dec-11 EQ (st. dev. = 0.325 to 0.350 ln units).

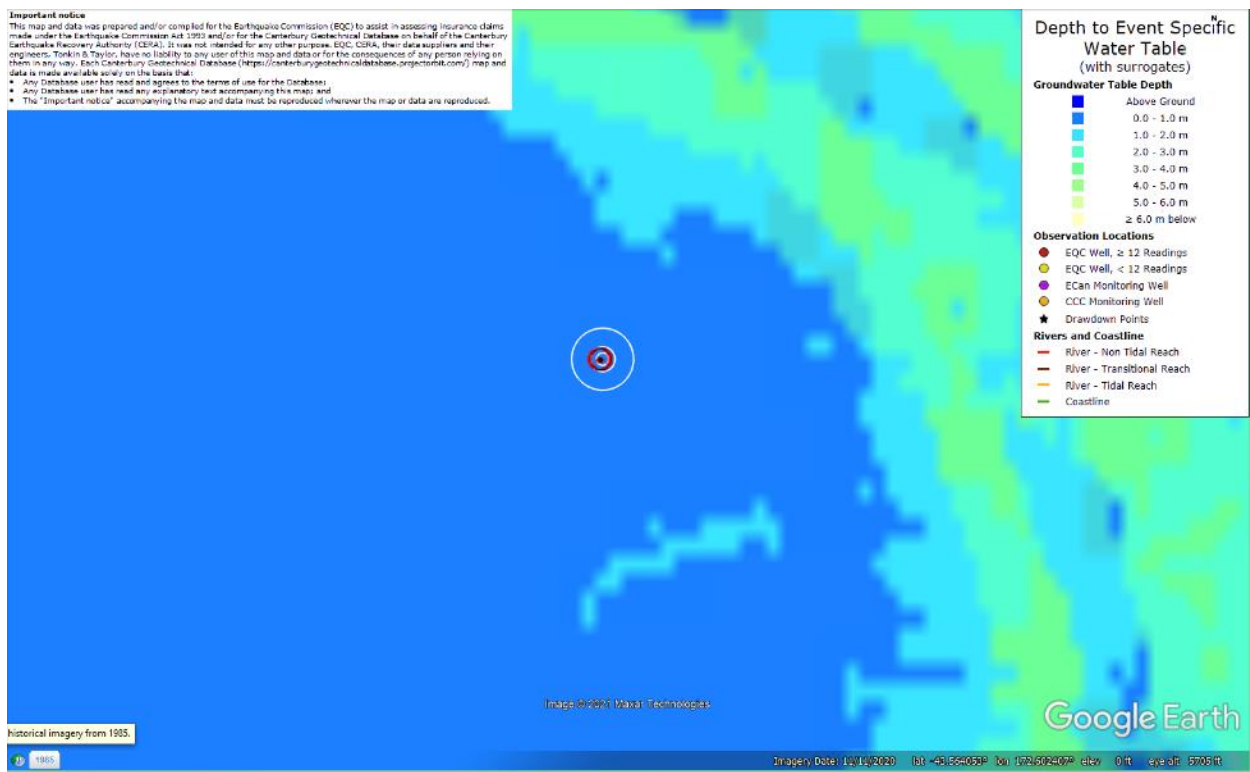
Figure 35: Depth to groundwater table for Sep-10 EQ.

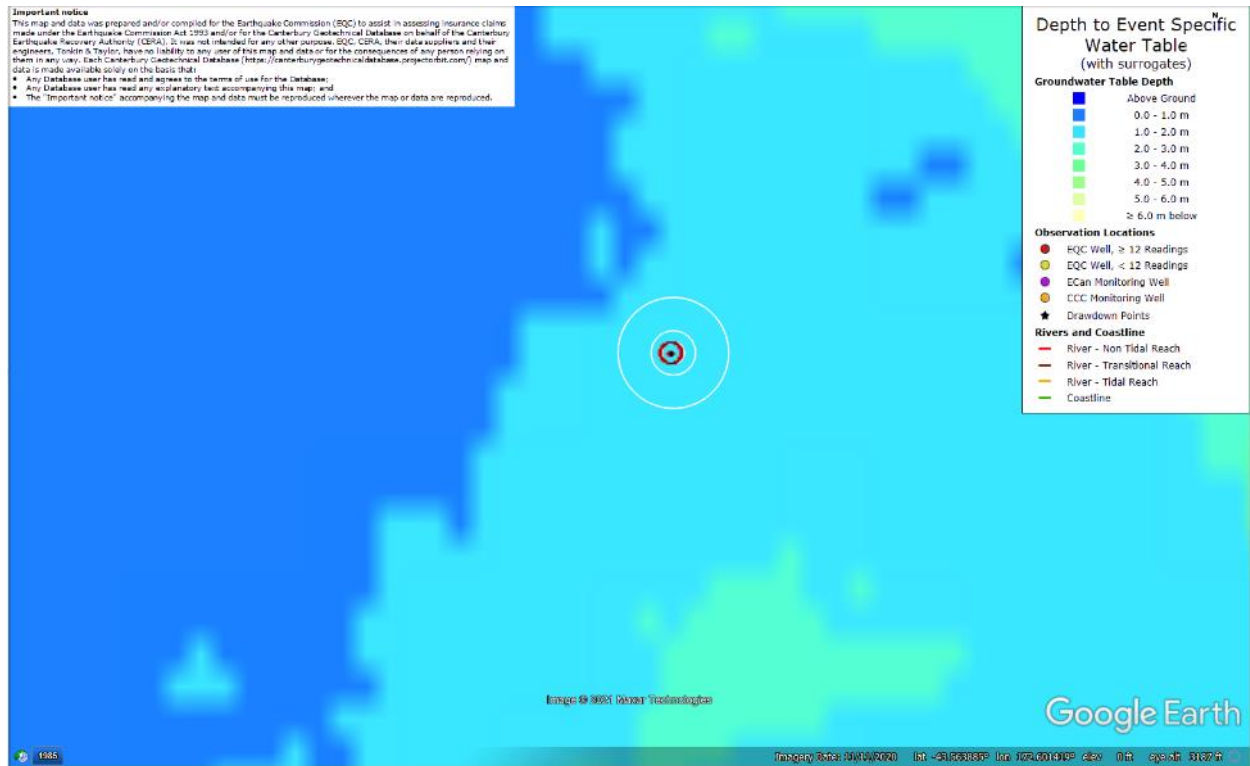
Figure 36: Depth to groundwater table for Feb-11 EQ.

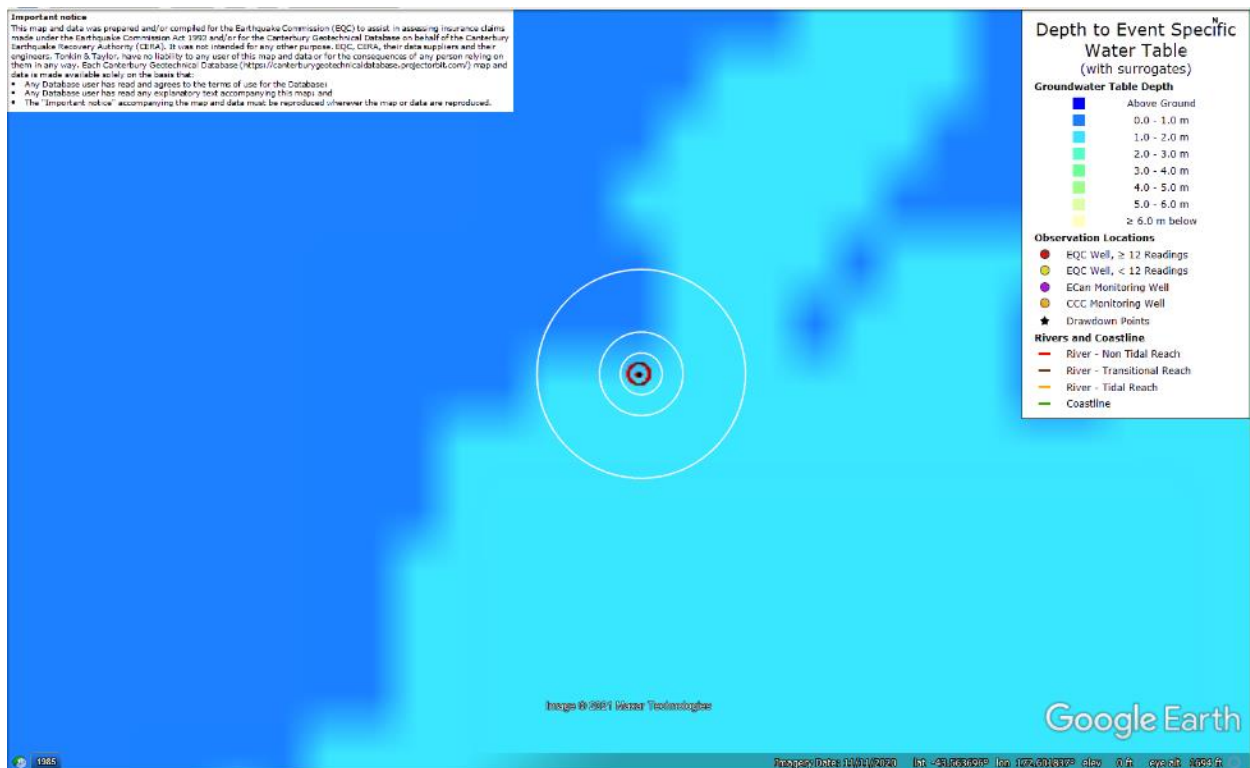
Figure 37: Depth to groundwater table for Jun-11 EQ.

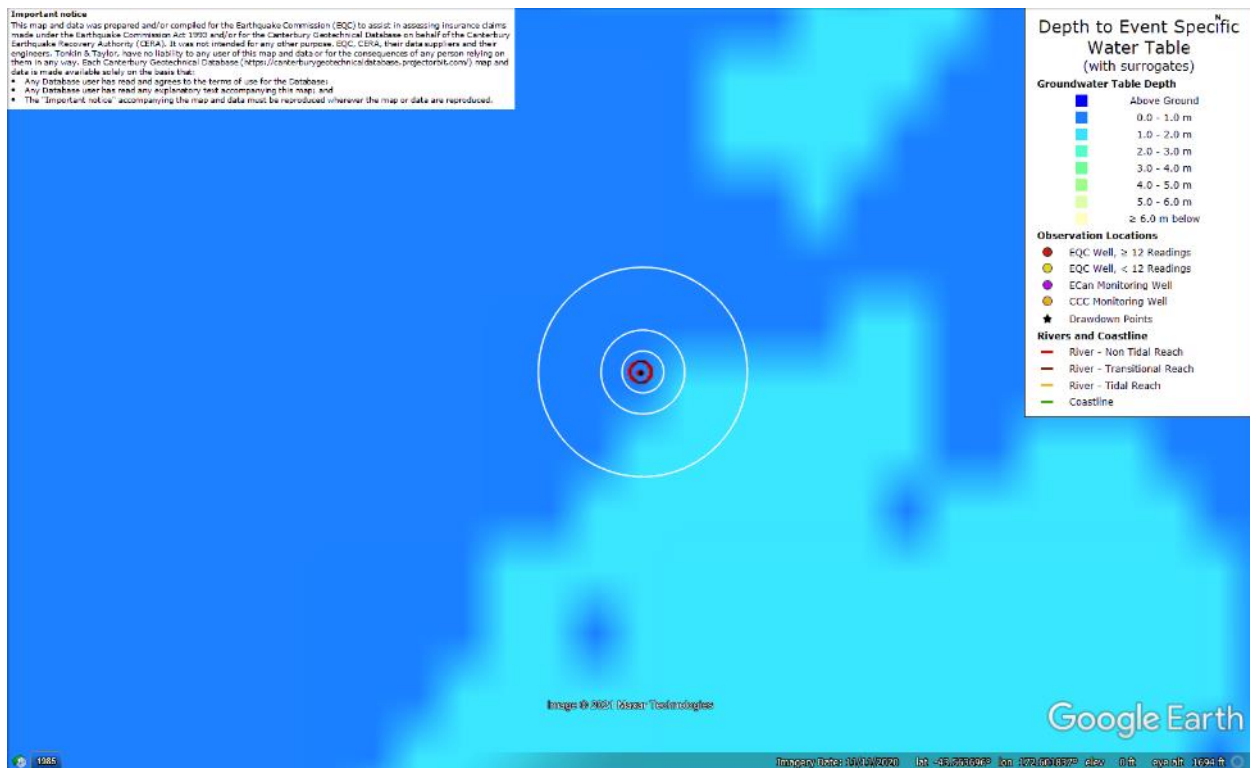
Figure 38: Depth to groundwater table for Dec-11 EQ.

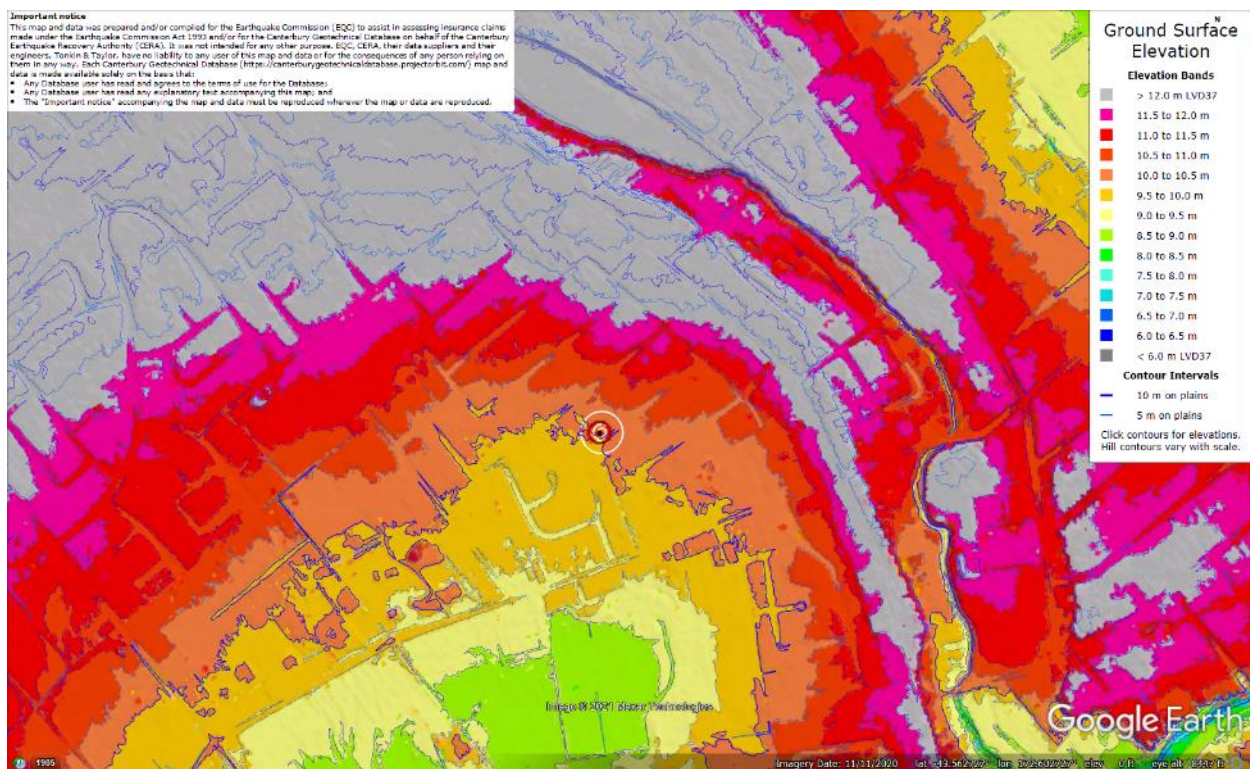
Figure 39: Ground surface elevation according to the Sep-11 LiDAR survey.

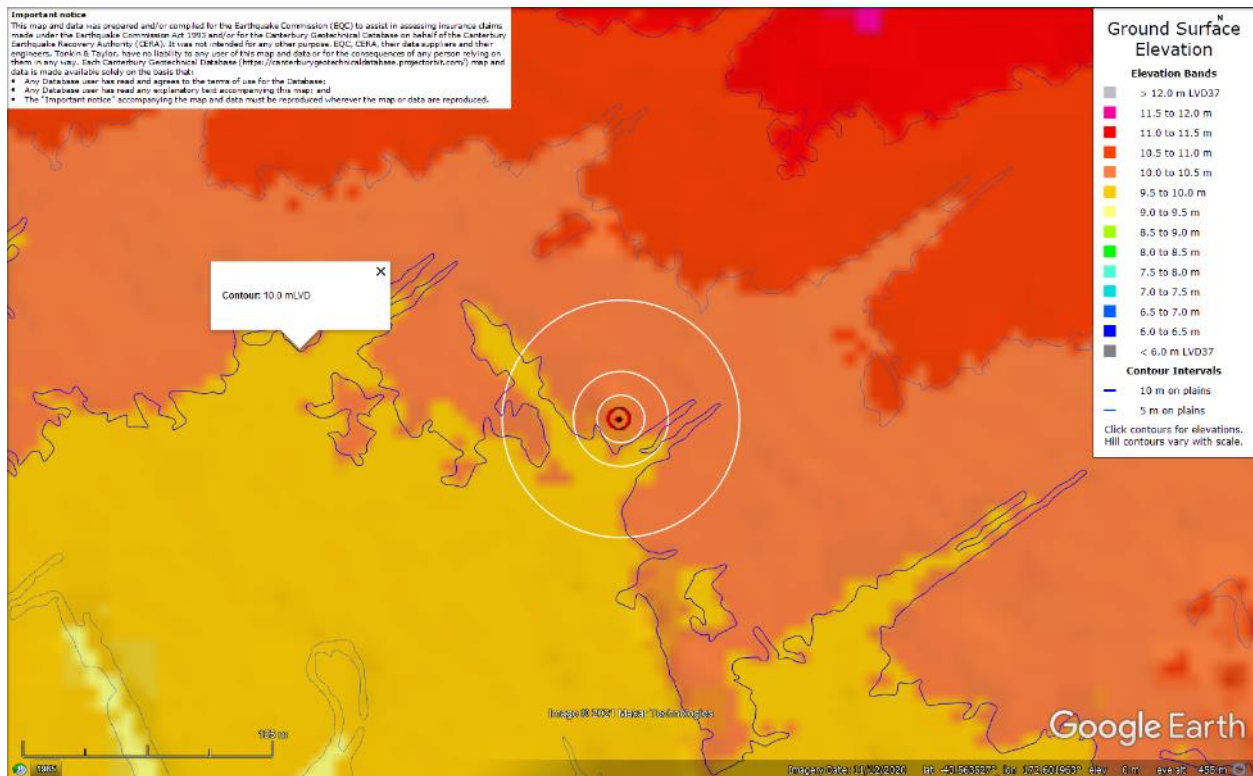
Figure 40: Ground surface elevation according to the Sep-11 LiDAR survey (enlarged).

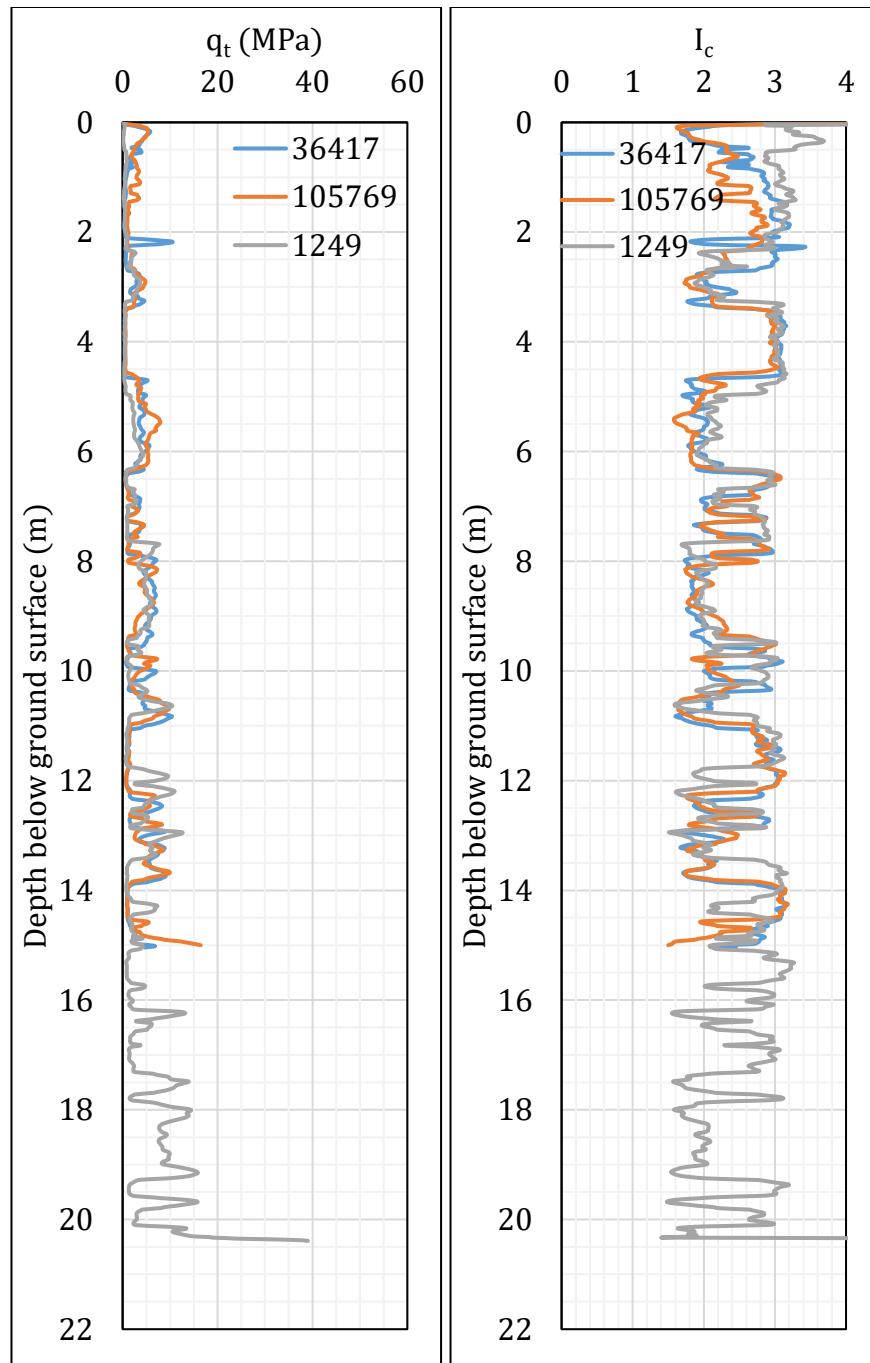
Figure 41: q_t and I_c profiles.
