Appendix A.7:

50 Eureka St – VsVp 57195

Liquefaction Ejecta Case Histories for 2010-11 Canterbury Earthquakes

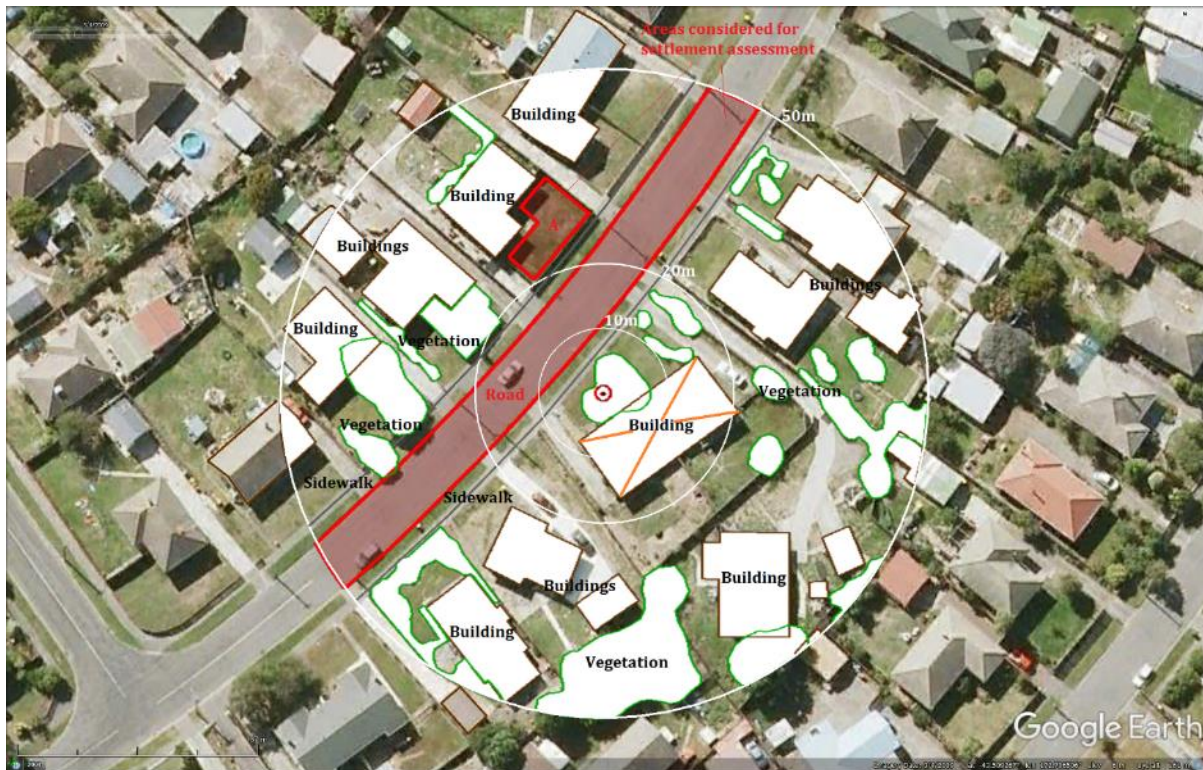
Figure 1: Site plan with areas where LiDAR survey data is considered.

Note 1: The areas selected for settlement assessment (Patch A and Road) are free of vegetation, structures, manmade changes, and other important factors that have the potential to influence LiDAR measurements.

Note: Buffer is the area within a circle of a specified radius with VsVp investigations done at its center (172.706500°, -43.509273°).

where $A_{E,thick,i}$ and $H_{E,thick,i}$ are the area and the height of a thick ejecta layer, respectively, $A_{E,thin,j}$ and $H_{E,thin,j}$ are the area and the height of a thin ejecta layer, respectively, and A_T is the total assessment area for a buffer being considered (Figure 1).

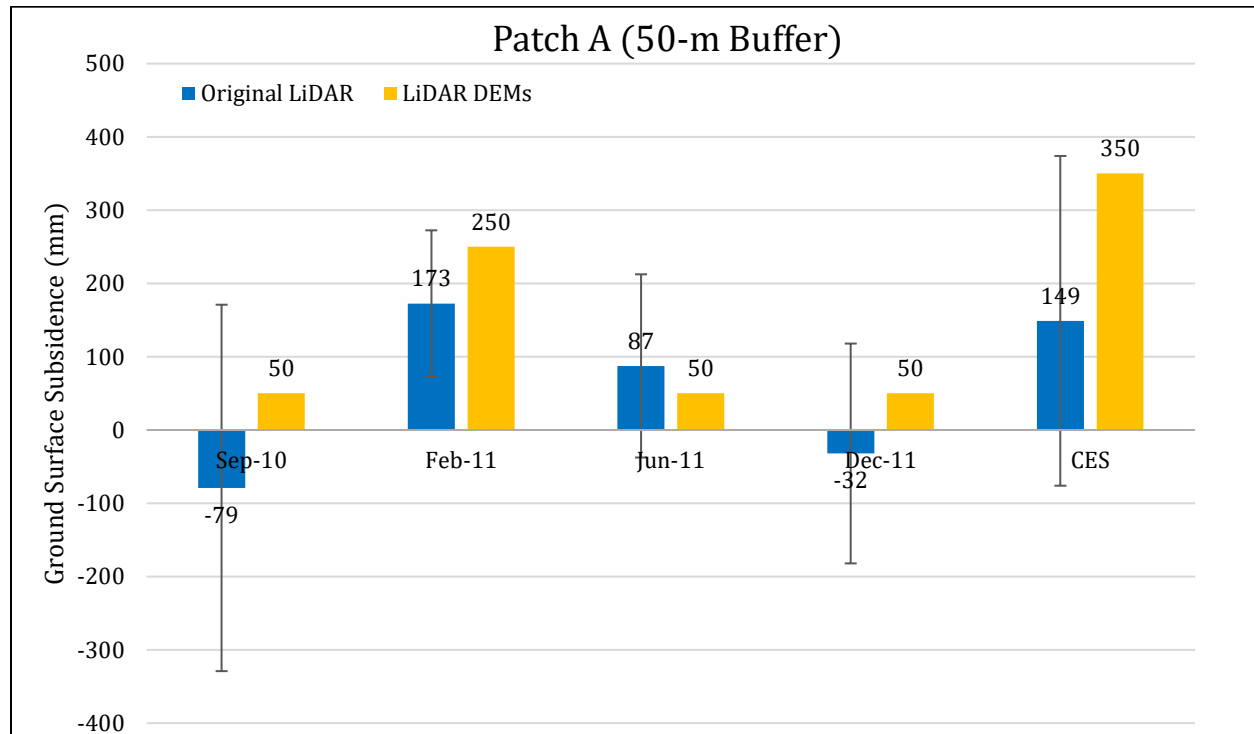
Figure 2: Comparison between ground surface subsidence determined from original LiDAR survey points and ground surface subsidence (50th %ile) estimated using LiDAR DEMs for Patch A within the 50-m buffer.

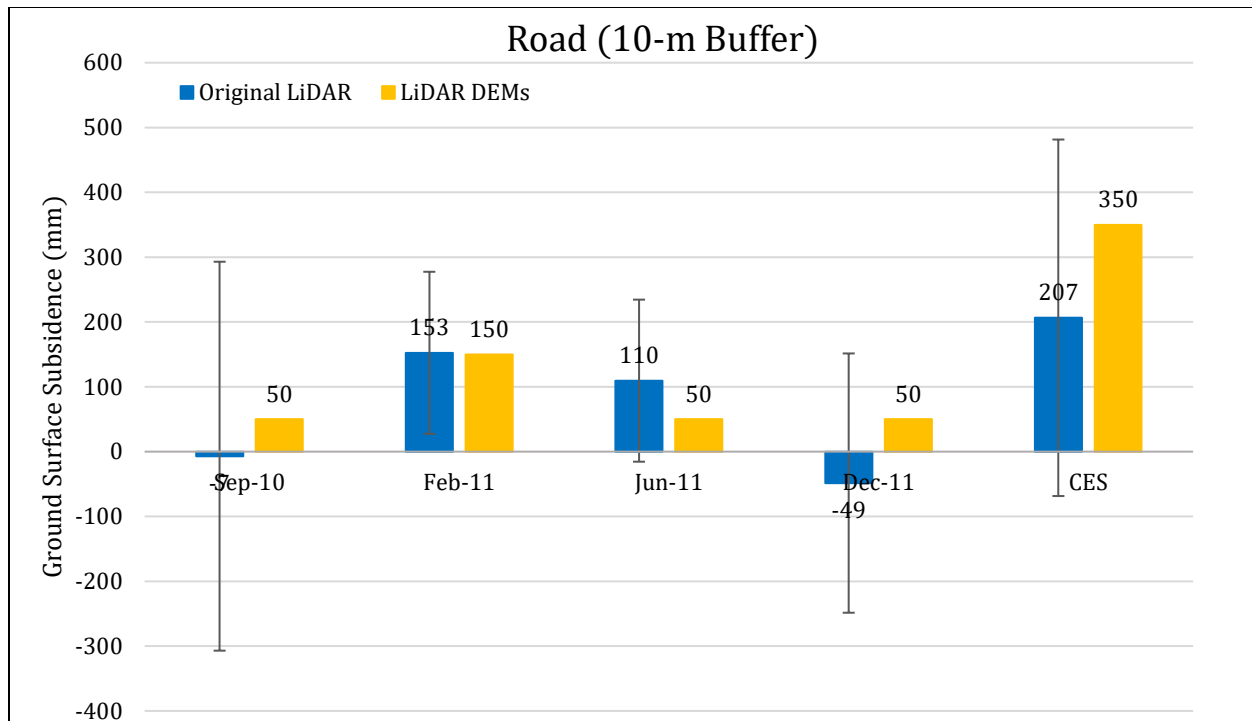
Figure 3: Comparison between ground surface subsidence determined from original LiDAR survey points and ground surface subsidence (50th %ile) estimated using LiDAR DEMs for Road within the 10-m buffer.

Note 2: The ground surface subsidence values determined from original LiDAR survey points for Road are similar to the ground surface subsidence values estimated using LiDAR DEMs for all earthquake events. Some discrepancy between the two methods is observed for Patch A, specifically the Sep-10 EQ and consequently the CES. However, the values determined by the two methods are comparable when the standard deviations are accounted for.

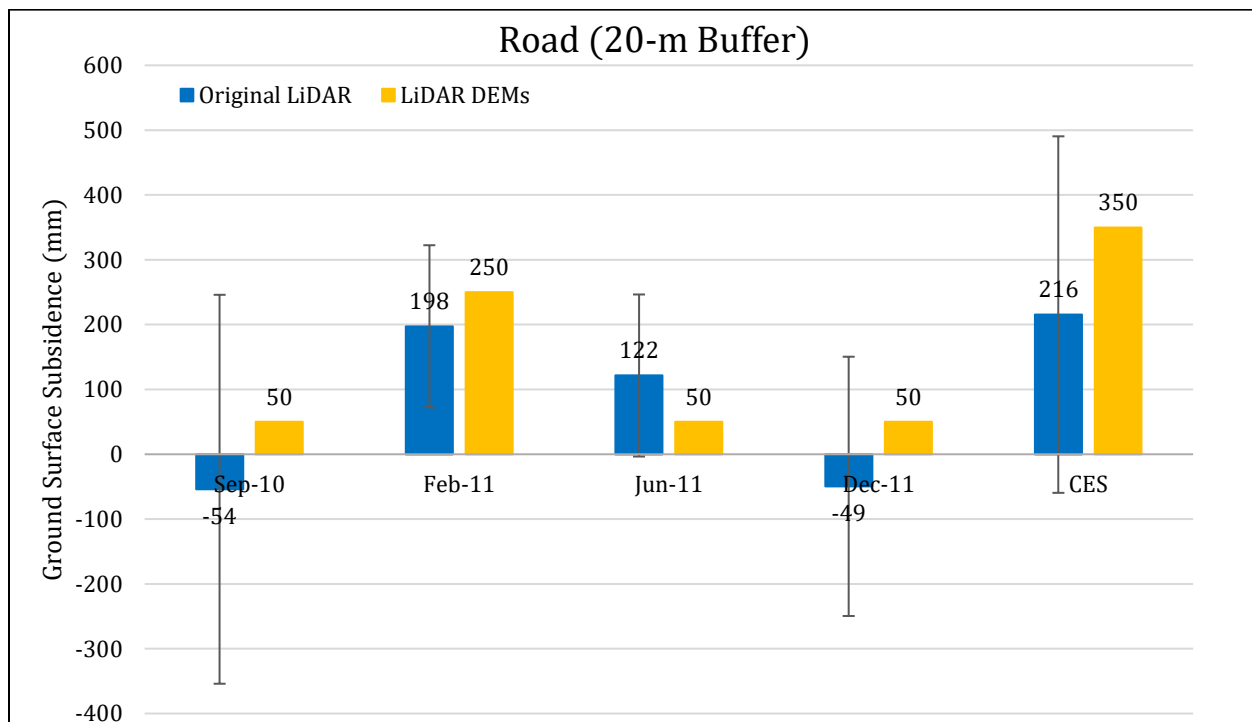
Figure 4: Comparison between ground surface subsidence determined from original LiDAR survey points and ground surface subsidence (50th %ile) estimated using LiDAR DEMs for Road within the 20-m buffer.

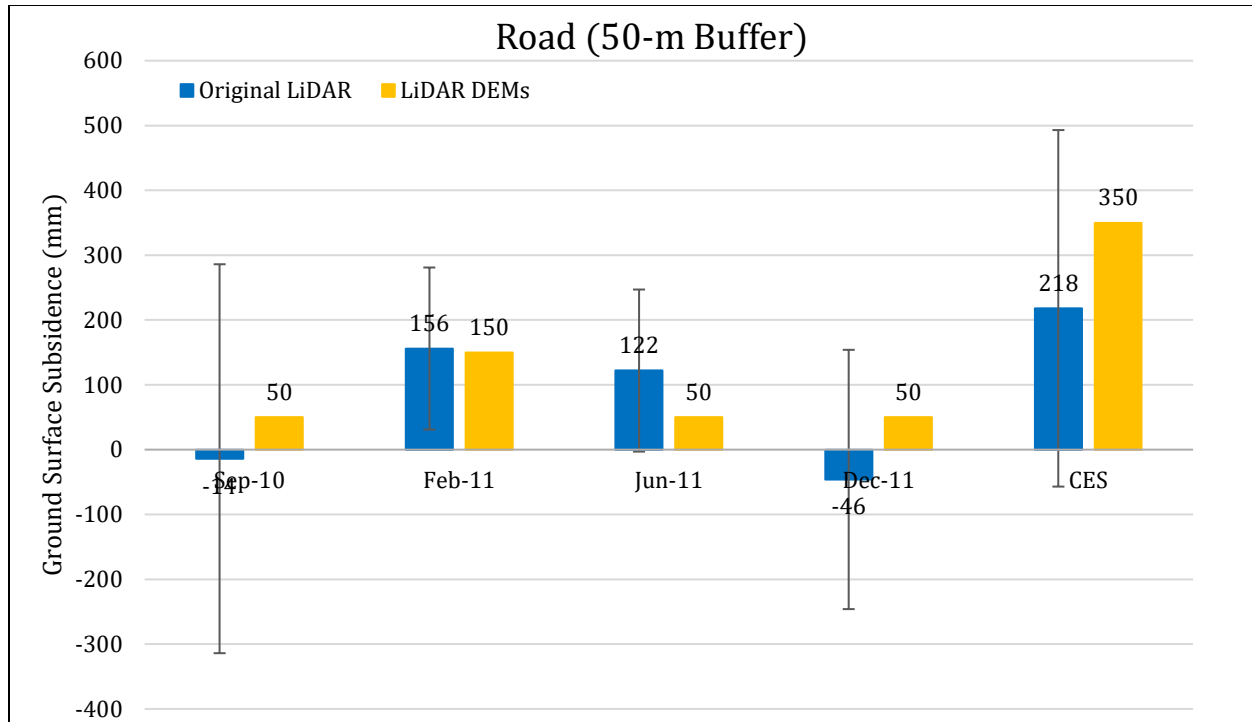
Figure 5: Comparison between ground surface subsidence determined from original LiDAR survey points and ground surface subsidence (50th %ile) estimated using LiDAR DEMs for Road within the 50-m buffer.

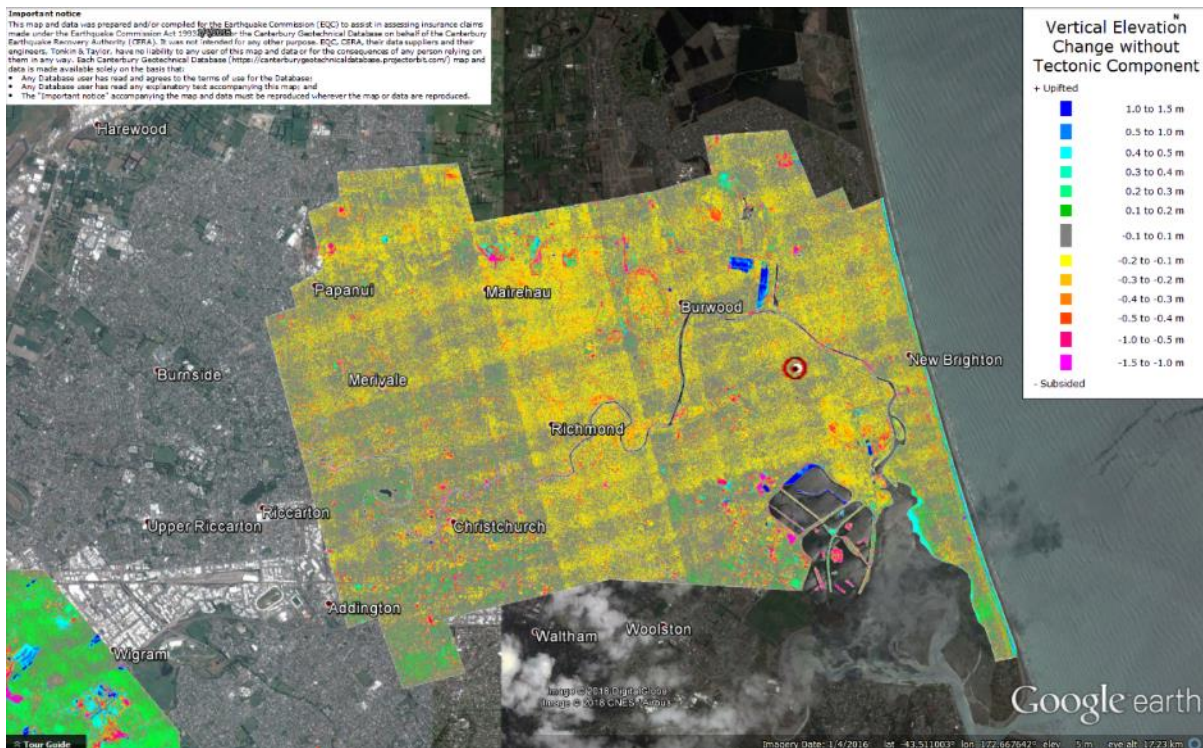
Figure 18: Vertical Ground Movements (Surface – Tectonic) for Sep 2010 Earthquake – the site is not in the apparent zone of overestimated ground surface subsidence.

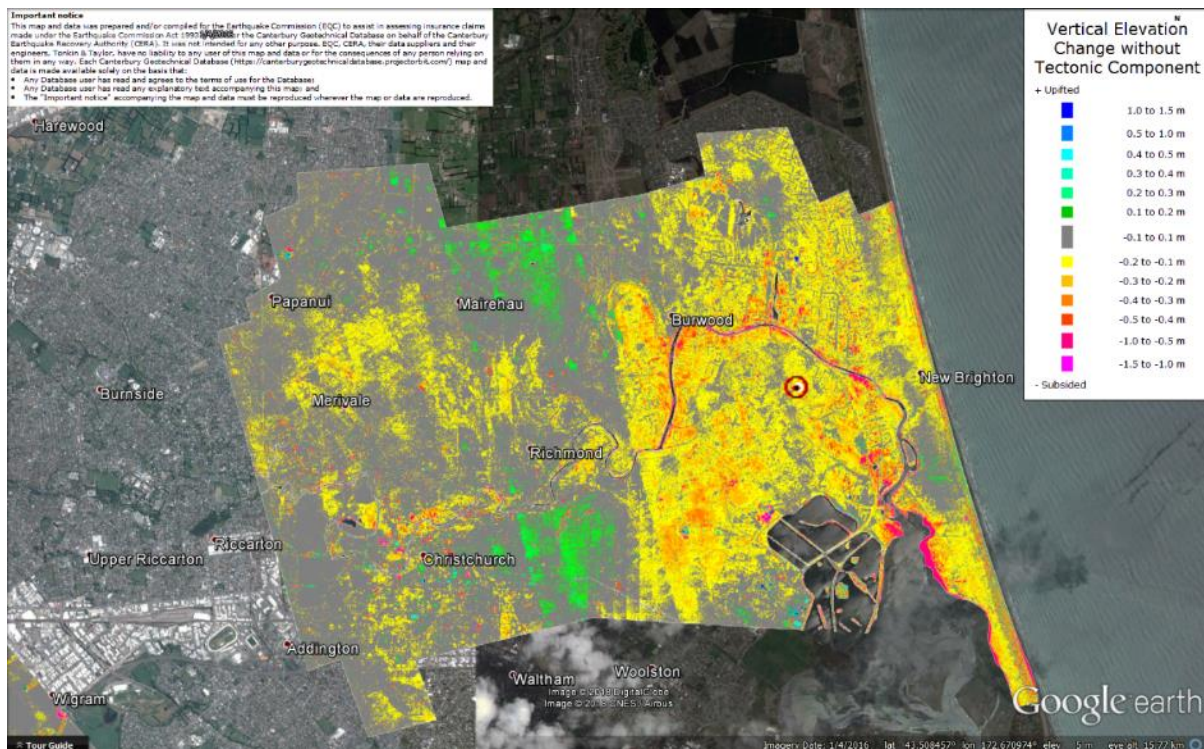
Figure 19: Vertical Ground Movements (Surface – Tectonic) for Feb 2011 Earthquake – the site is not in the apparent zone of underestimated ground surface subsidence.

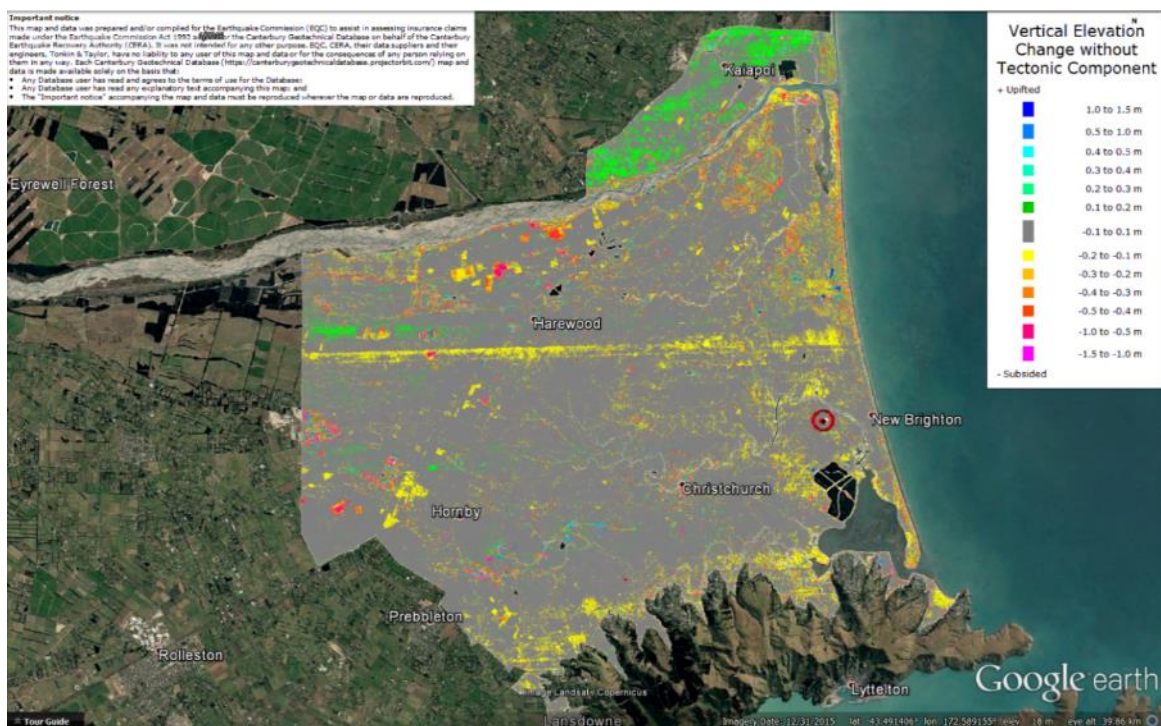
Figure 20: Vertical Ground Movements (Surface – Tectonic) for June 2011 Earthquake – the site is not in the apparent zone of overestimated or underestimated ground surface subsidence.

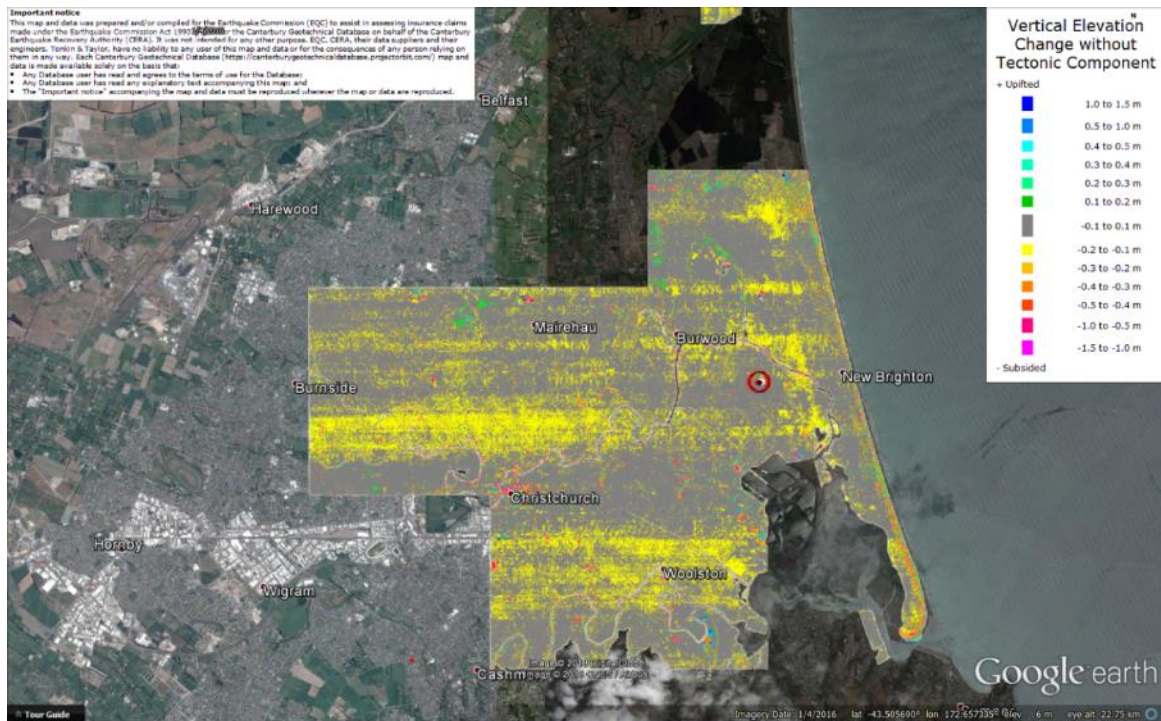
Figure 21: Vertical Ground Movements (Surface – Tectonic) for Dec 2011 Earthquake – the site is not in the apparent zone of overestimated or underestimated ground surface subsidence.

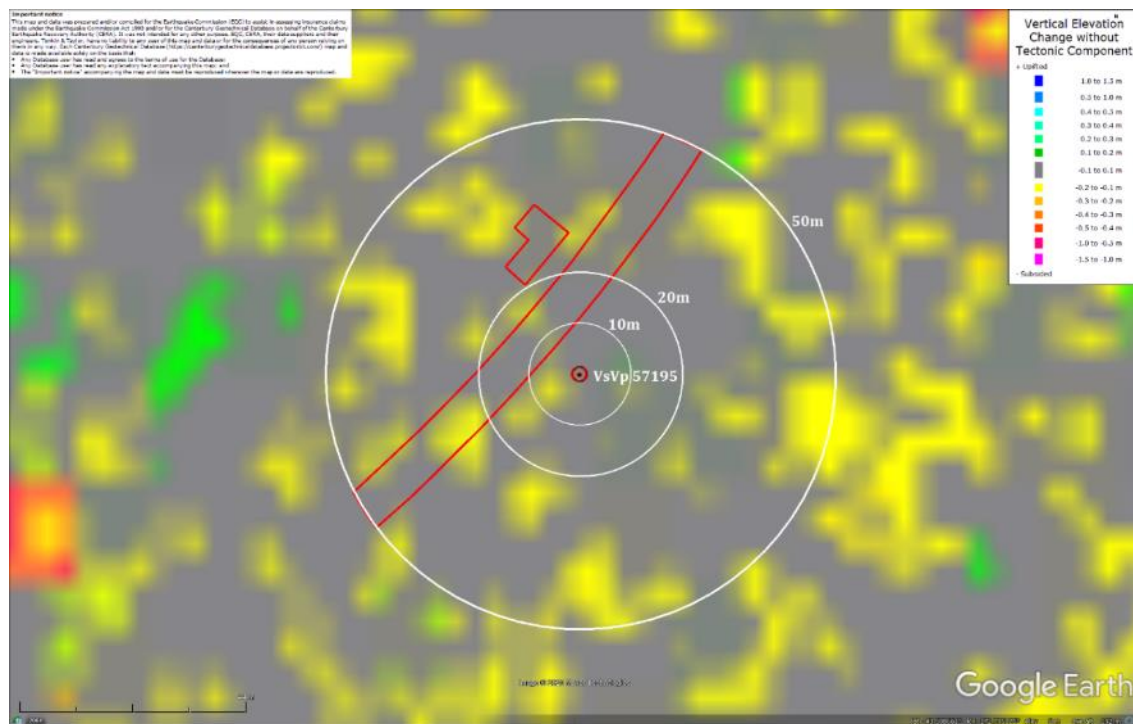
Figure 22: Ground surface subsidence without tectonic component for Sep 2010 Earthquake according to the LiDAR DEM.

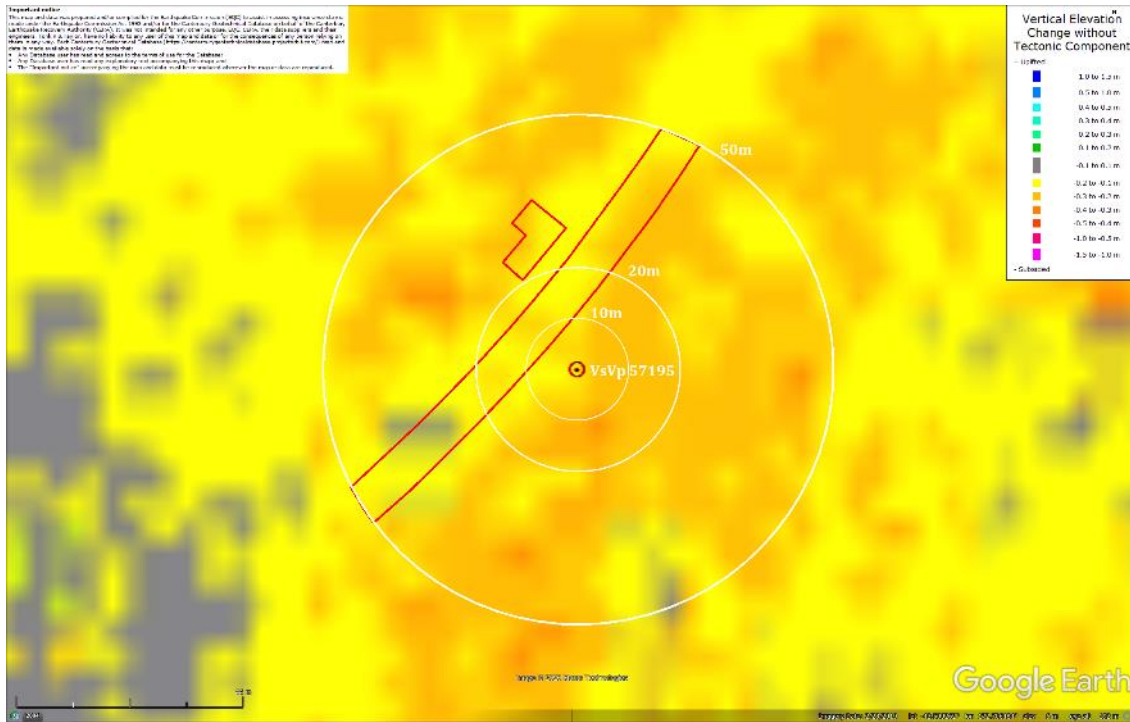
Figure 23: Ground surface subsidence without tectonic component for Feb 2011 Earthquake according to the LiDAR DEM.

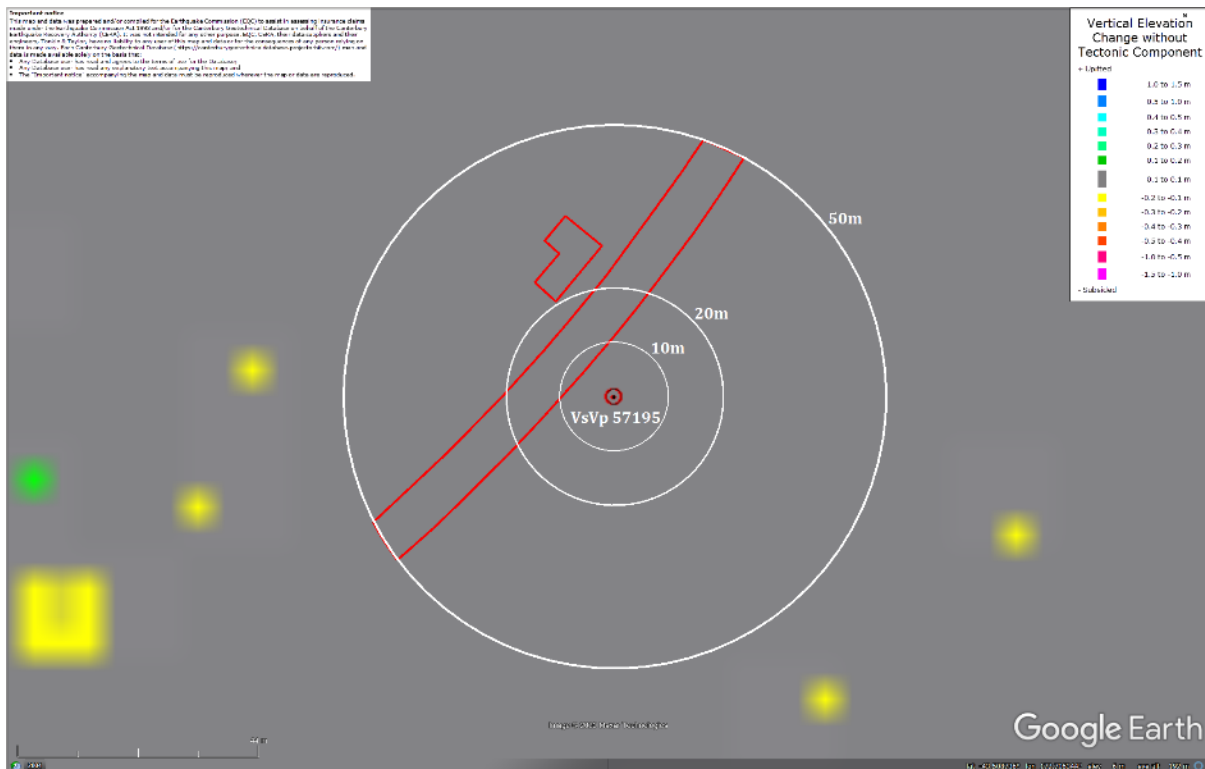
Figure 24: Ground surface subsidence without tectonic component for June 2011 Earthquake according to the LiDAR DEM.

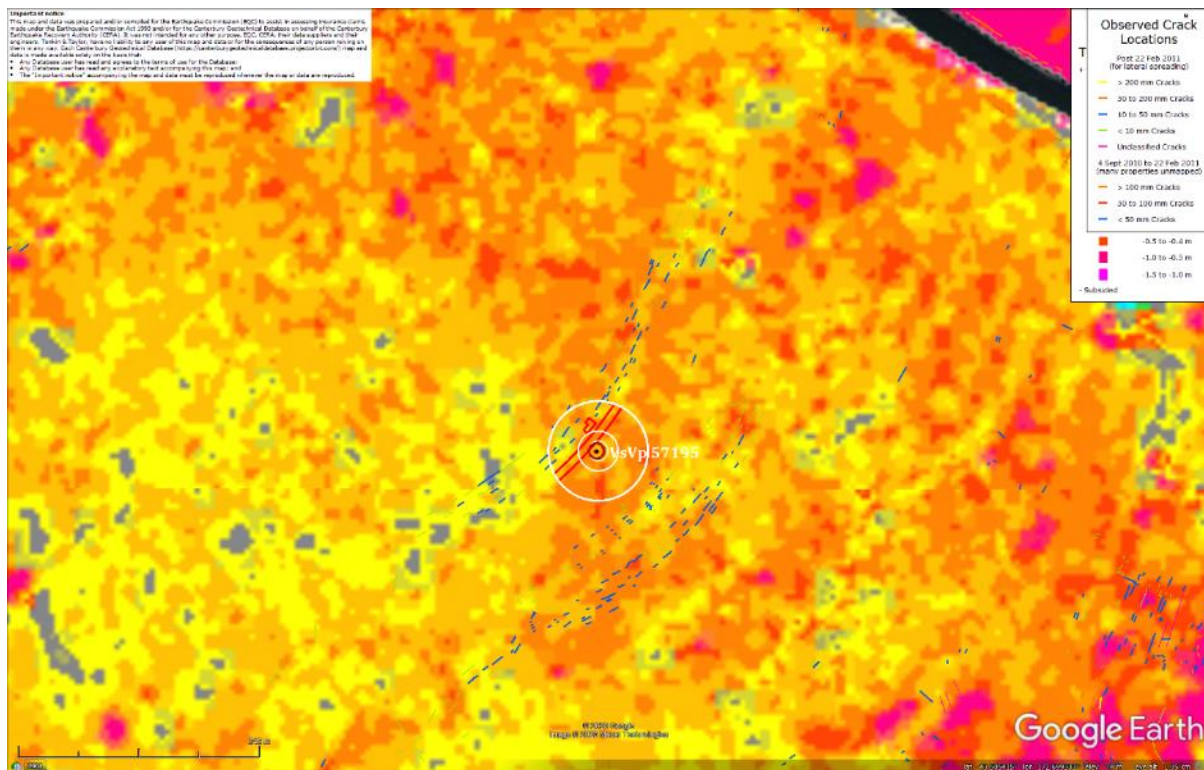
Figure 27: Absence of significant ground cracks indicating no lateral spreading for Canterbury Earthquake Sequence.

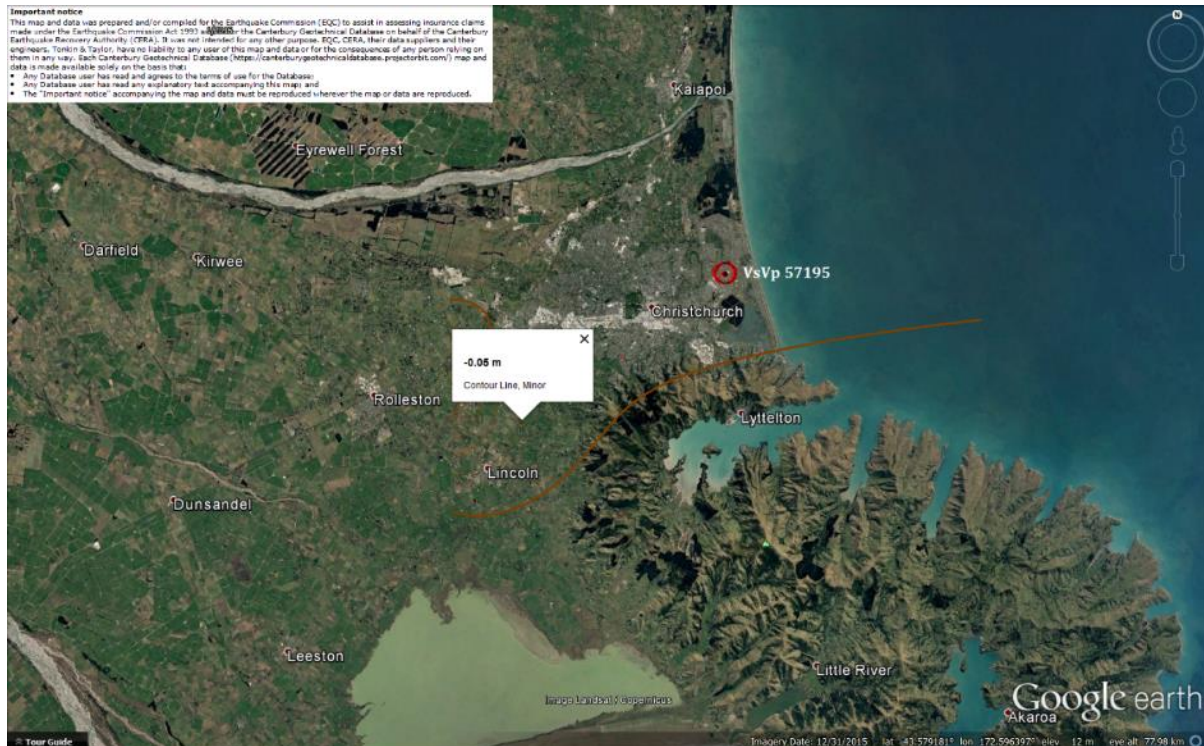
Figure 28: Vertical tectonic movements for Sep 2010 Earthquake.

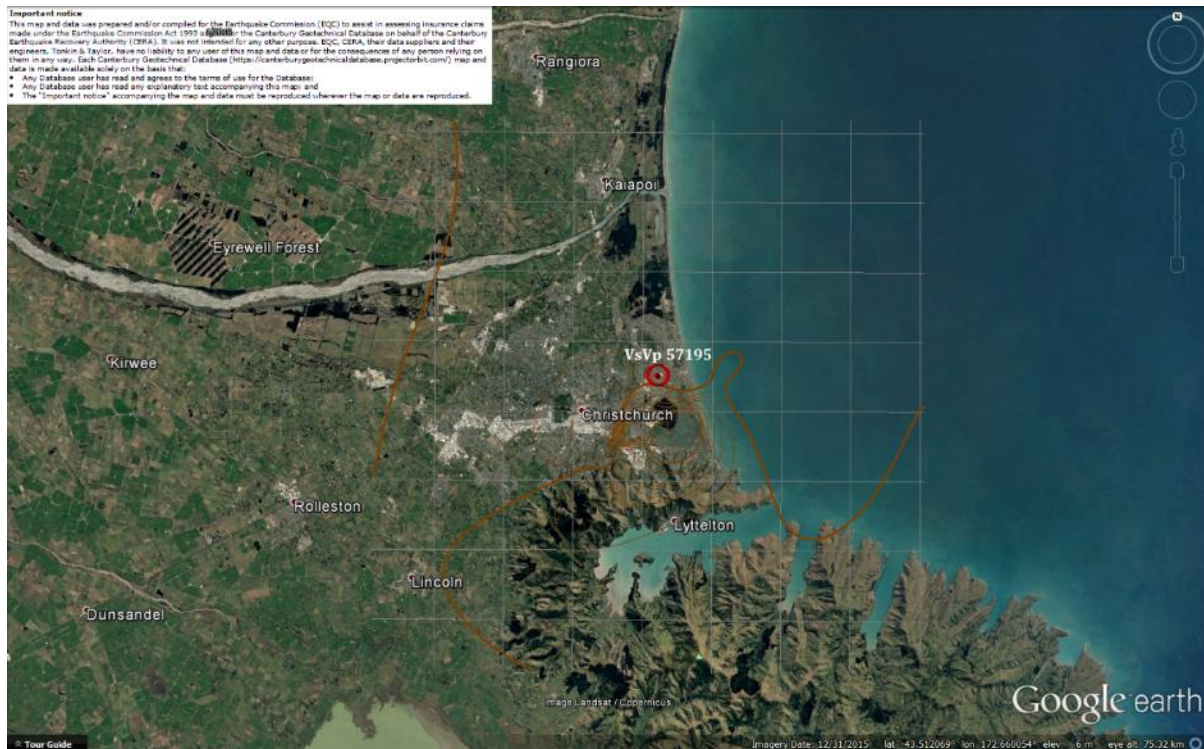
Figure 29: Vertical tectonic movements for Feb 2011 Earthquake.

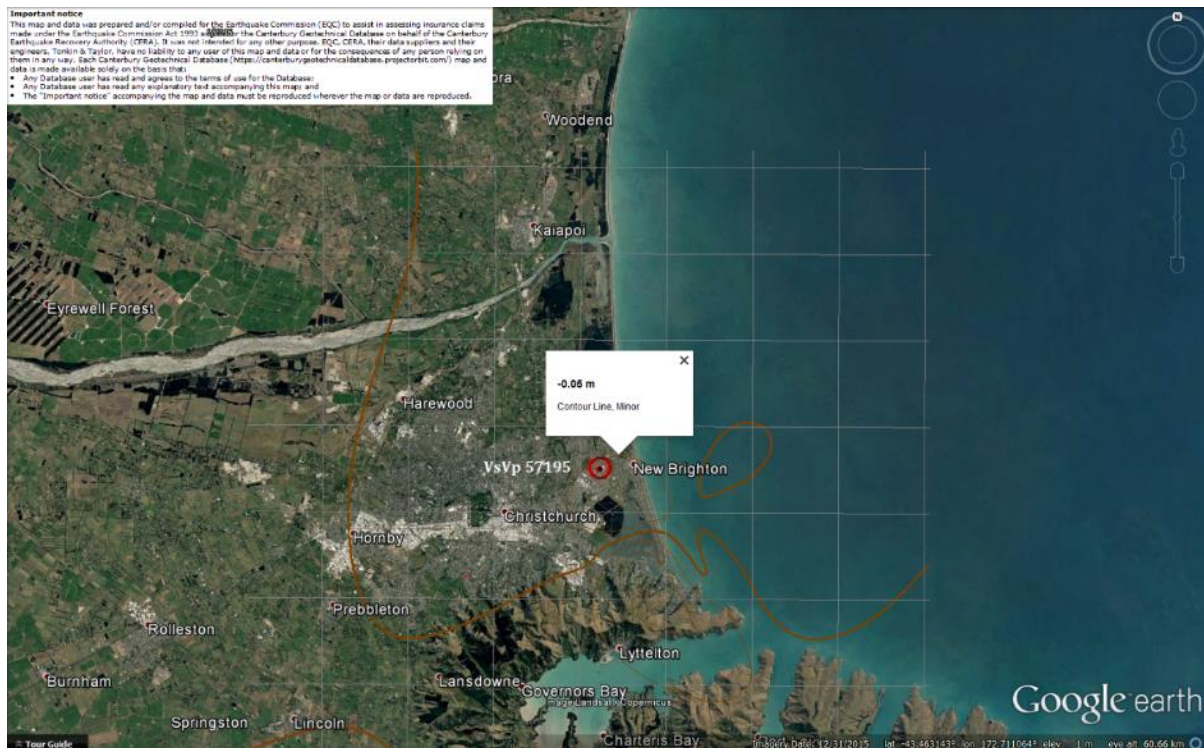
Figure 30: Vertical tectonic movements for June 2011 Earthquake.

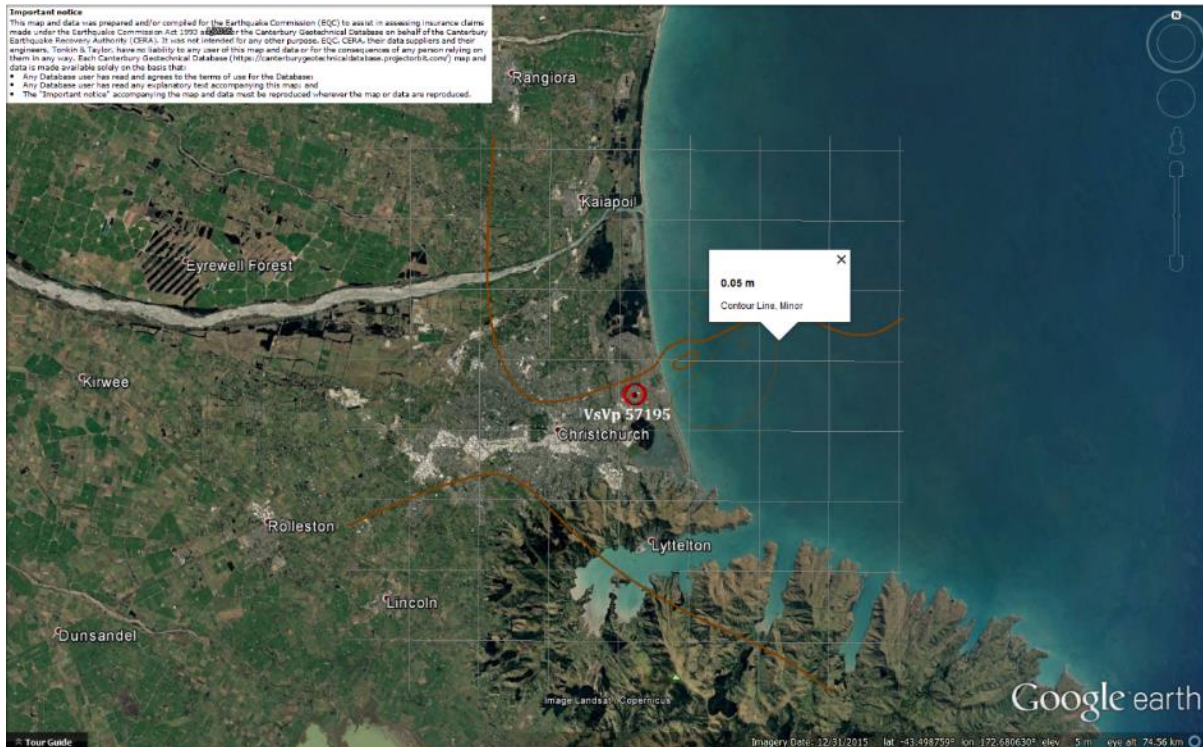
Figure 31: Vertical tectonic movements for Dec 2011 Earthquake.

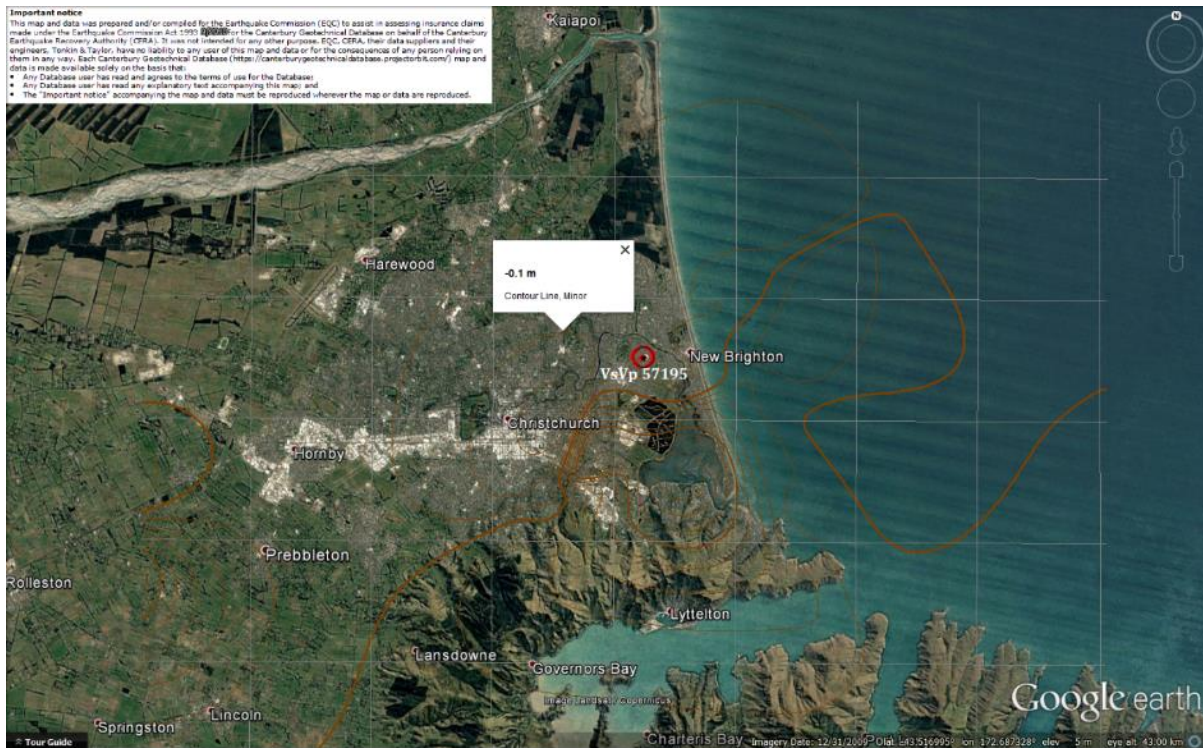
Figure 32: Vertical tectonic movements for Canterbury Earthquake Sequence.

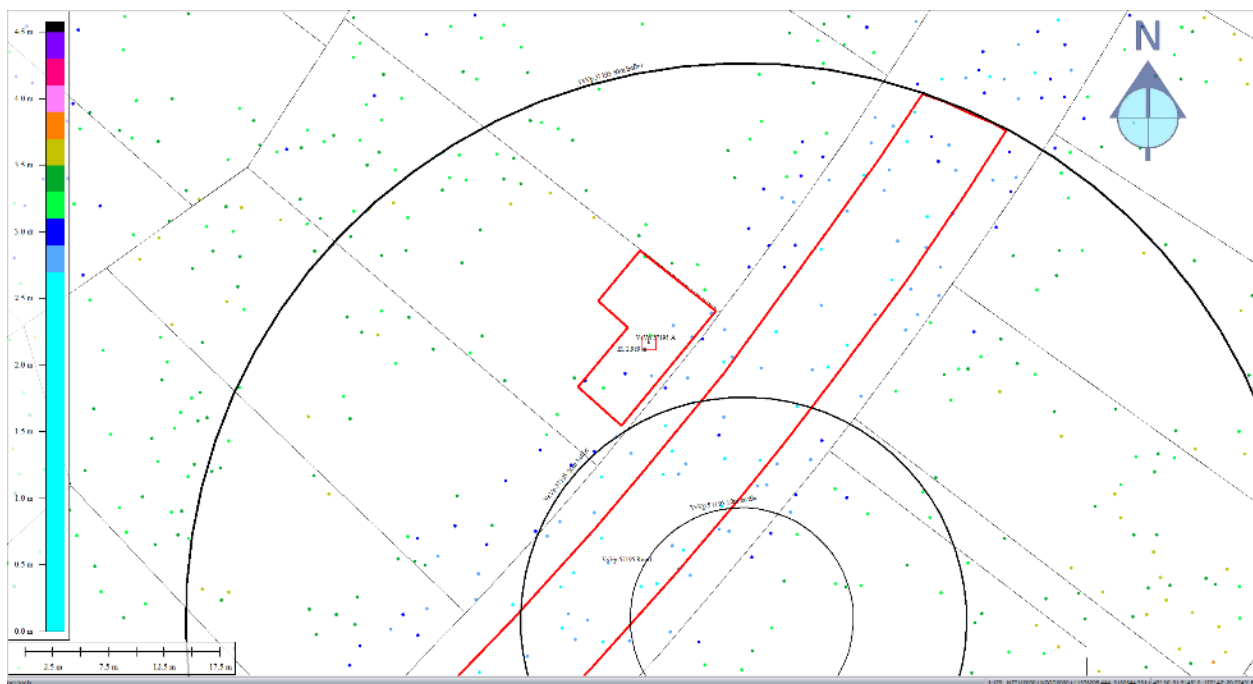
Figure 34: Ground surface elevation averaged over 50-m buffer for Patch A for Jul 2003 LiDAR survey.

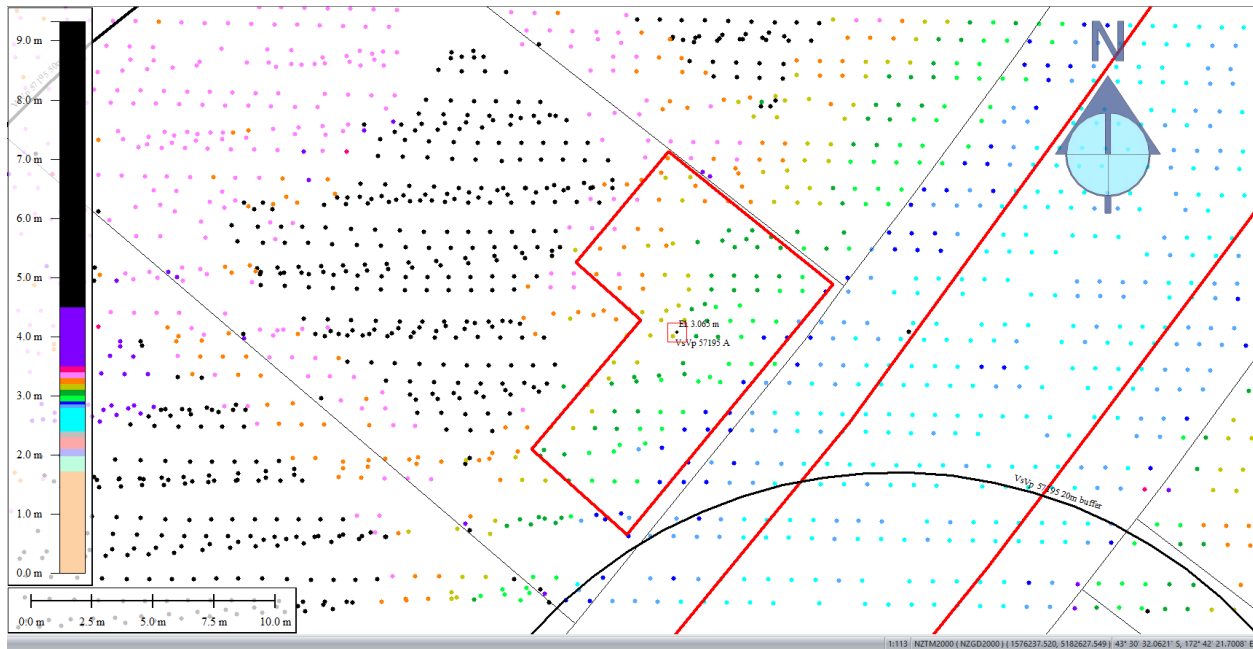
Figure 39: Ground surface elevation averaged over 50-m buffer for Patch A for Sep 5, 2010 LiDAR survey.

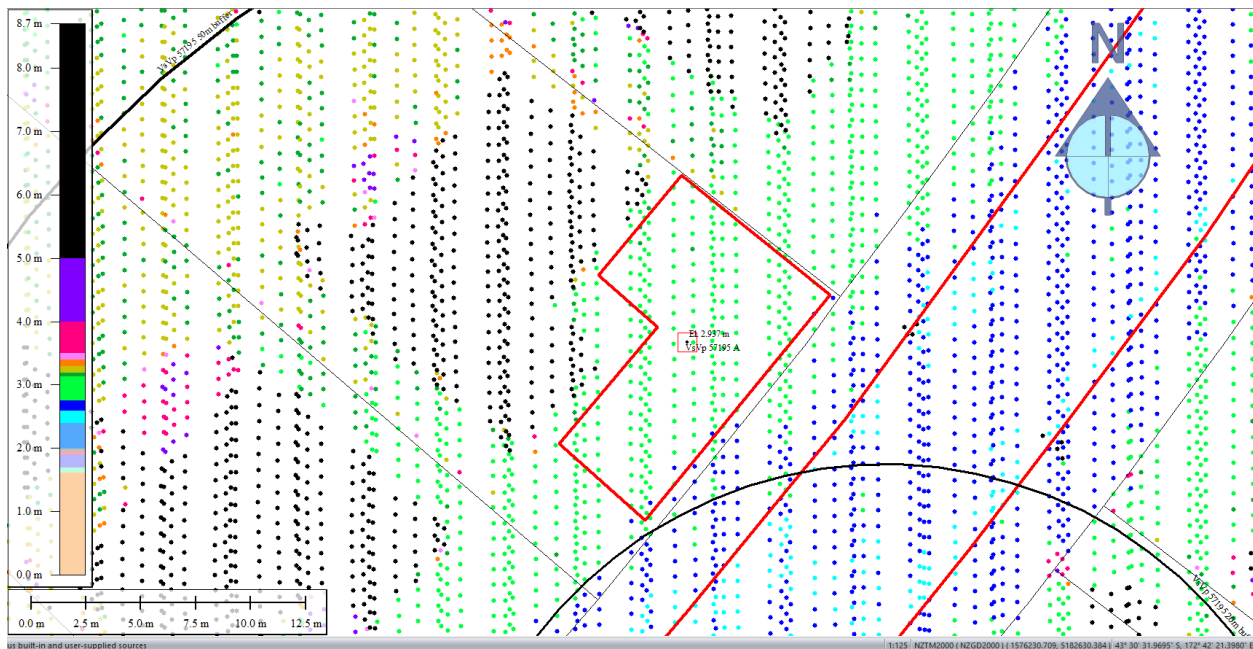
Figure 44: Ground surface elevation averaged over 50-m buffer for Patch A for Mar 2011 LiDAR survey.

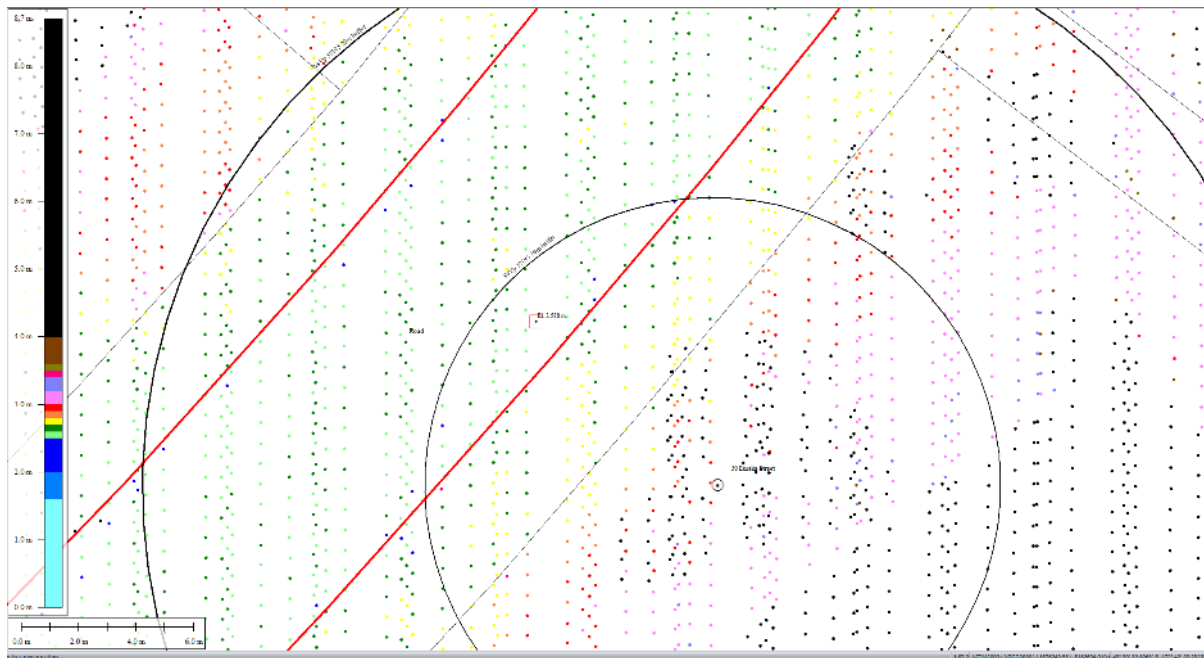
Figure 45: Ground surface elevation averaged over 10-m buffer for Road for Mar 2011 LiDAR survey.

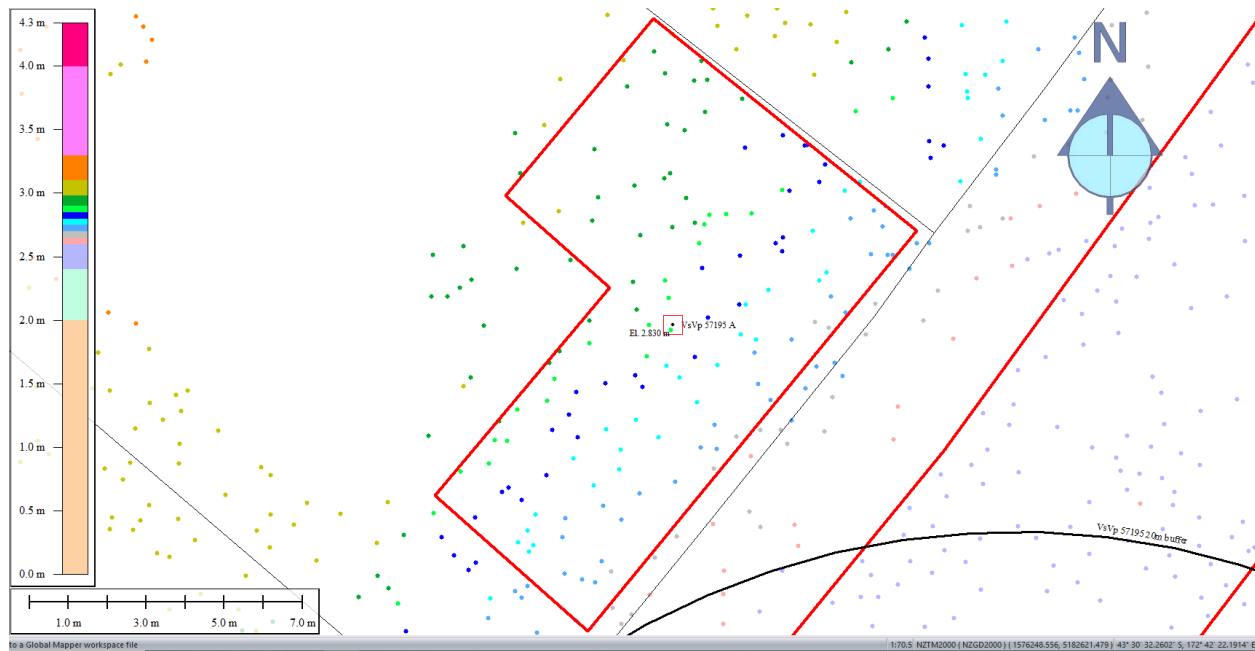
Figure 49: Ground surface elevation averaged over 50-m buffer for Patch A for May 2011 LiDAR survey.

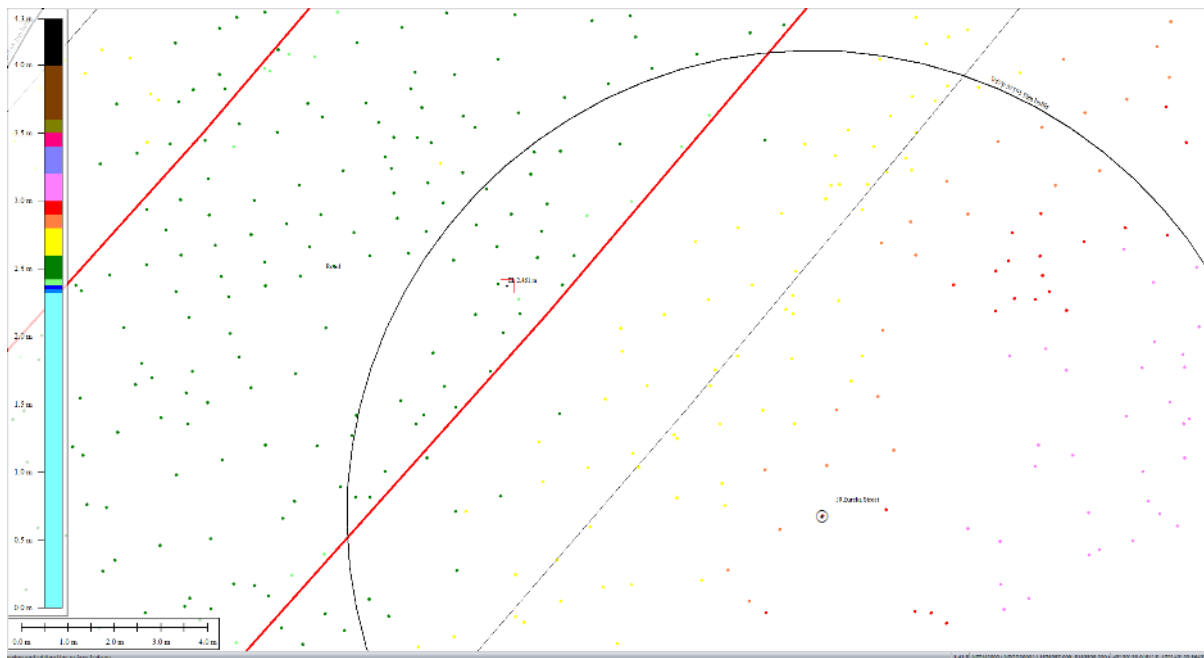
Figure 50: Ground surface elevation averaged over 10-m buffer for Road for May 2011 LiDAR survey.

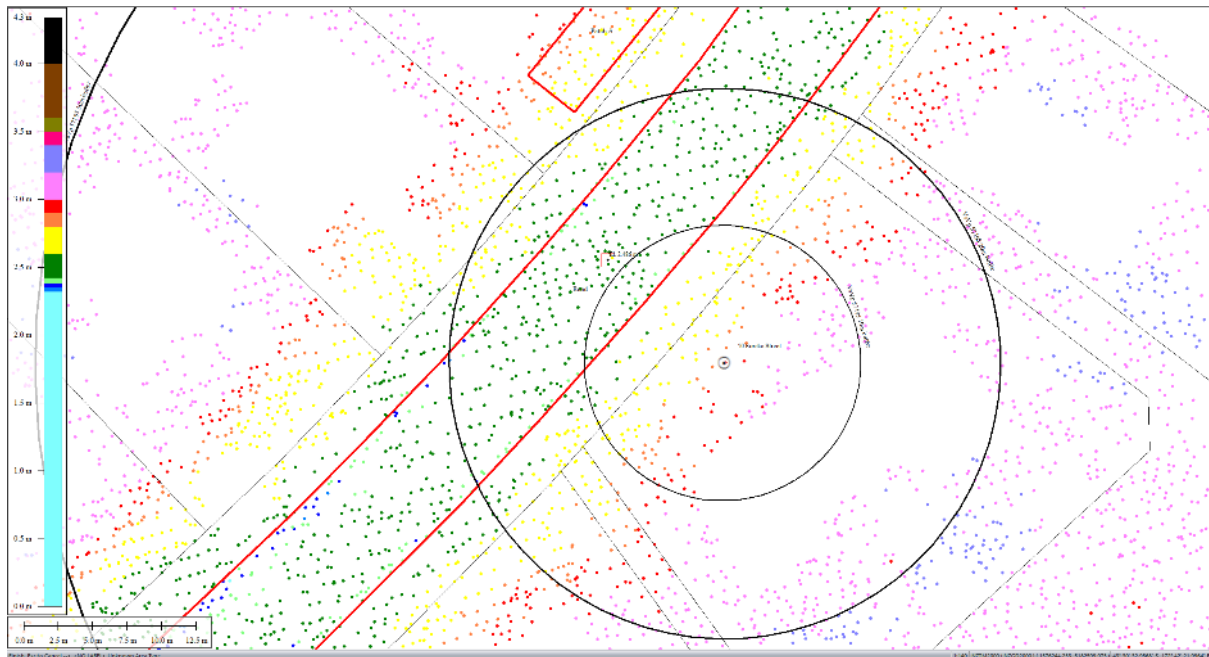
Figure 51: Ground surface elevation averaged over 20-m buffer for Road for May 2011 LiDAR survey.
