Appendix A.7:

50 Eureka St – VsVp 57195

Liquefaction Ejecta Case Histories for 2010-11 Canterbury Earthquakes

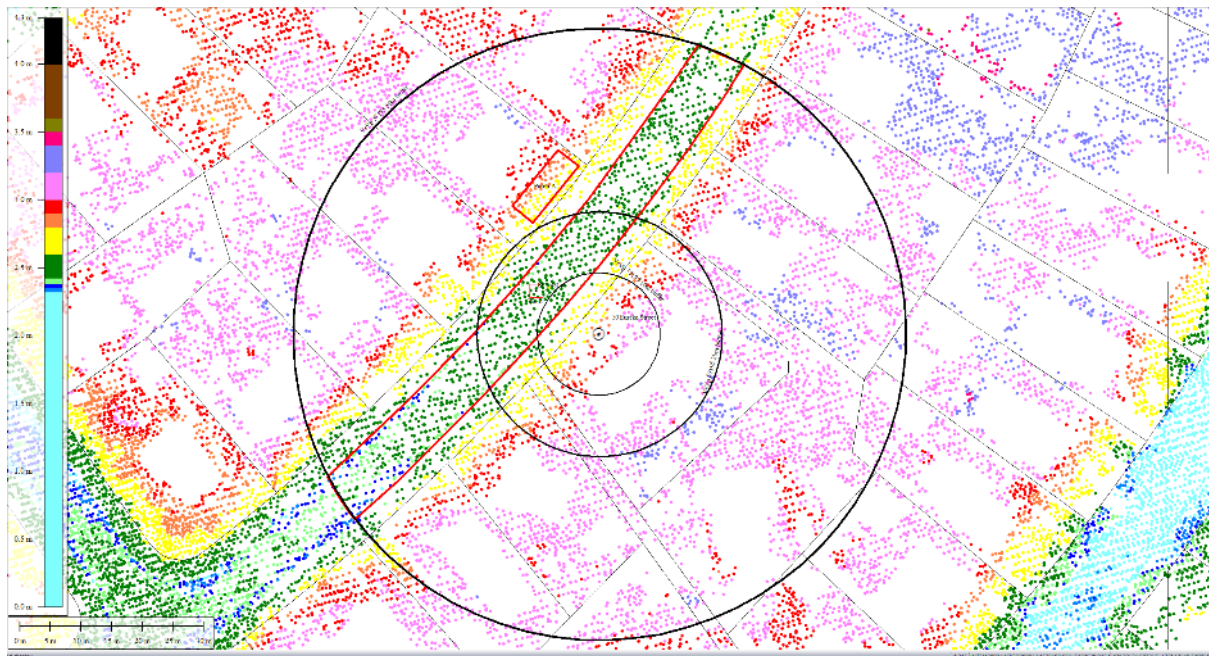
Figure 52: Ground surface elevation averaged over 50-m buffer for Road for May 2011 LiDAR survey.

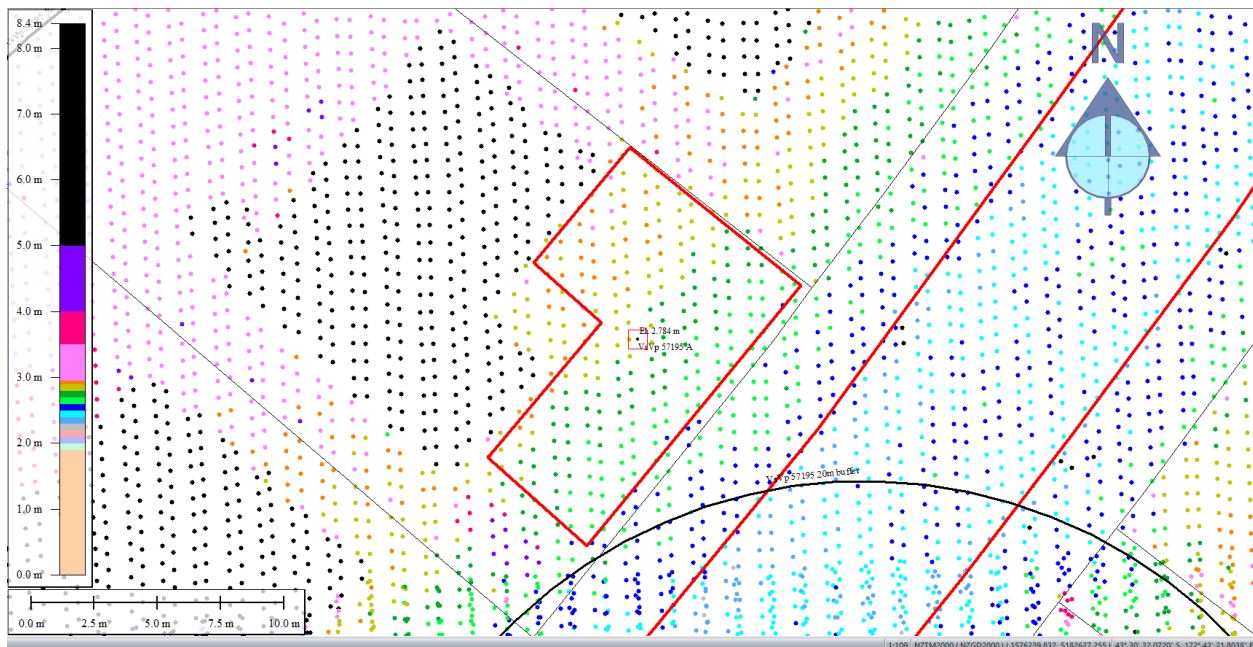
Figure 54: Ground surface elevation averaged over 50-m buffer for Patch A for Sep 2011 LiDAR survey.

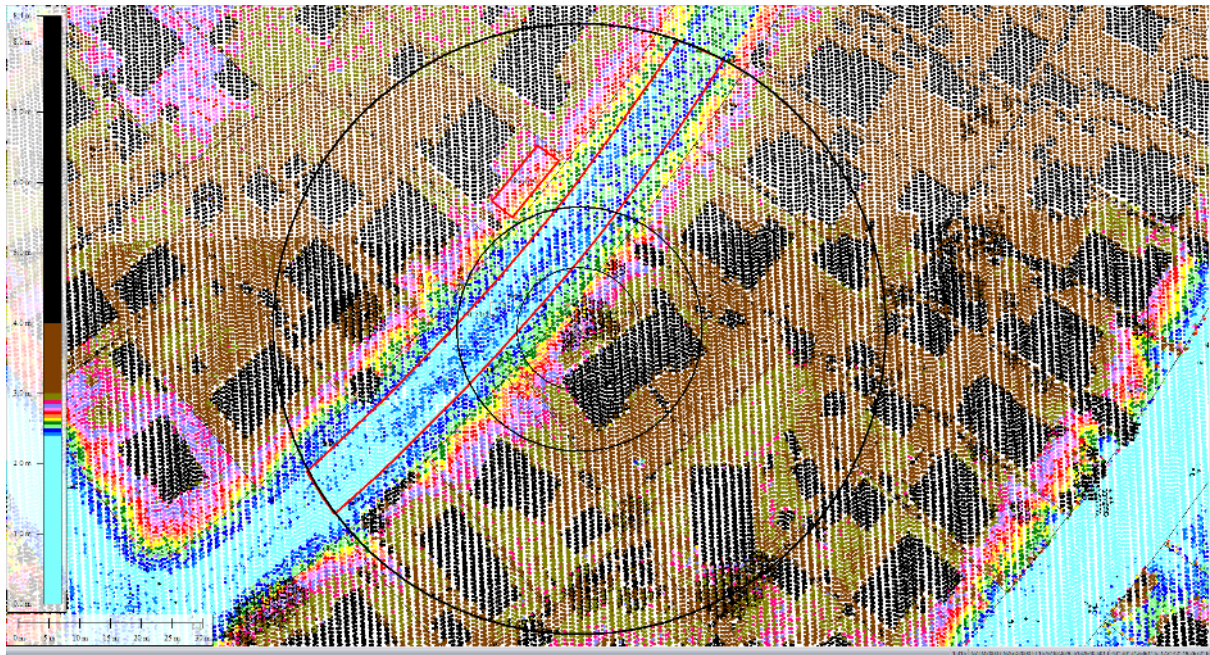
Figure 57: Ground surface elevation averaged over 50-m buffer for Road for Sep 2011 LiDAR survey.

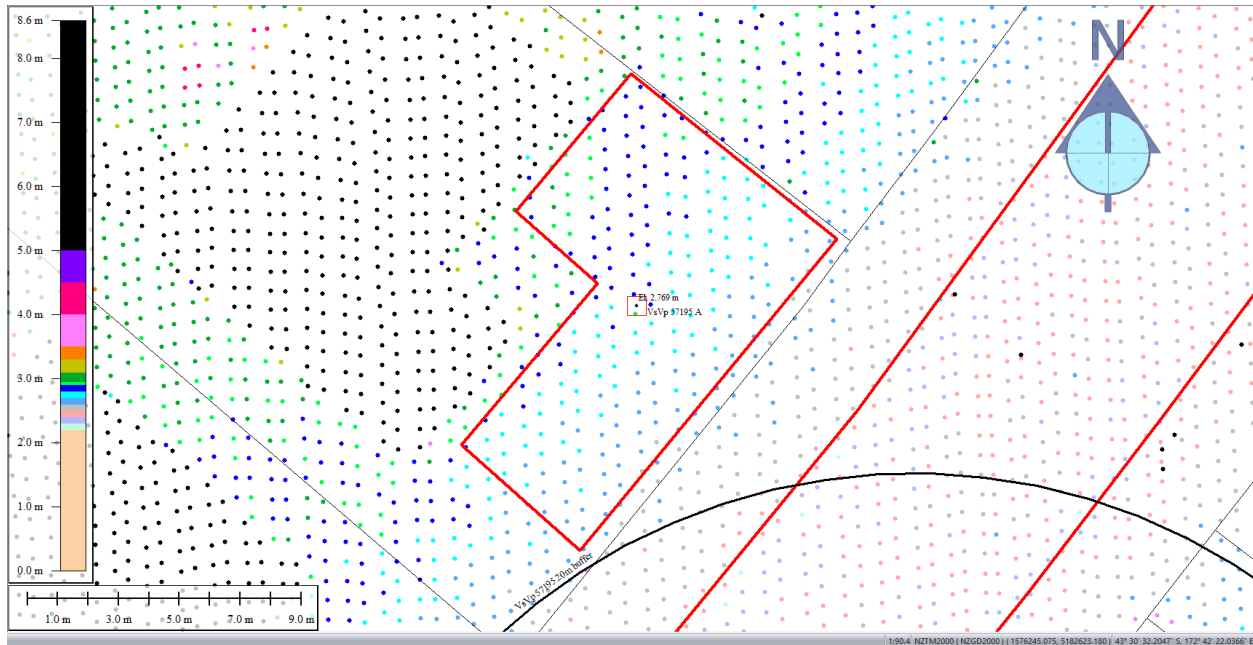
Figure 59: Ground surface elevation averaged over 50-m buffer for Patch A for Feb 2012 LiDAR survey.

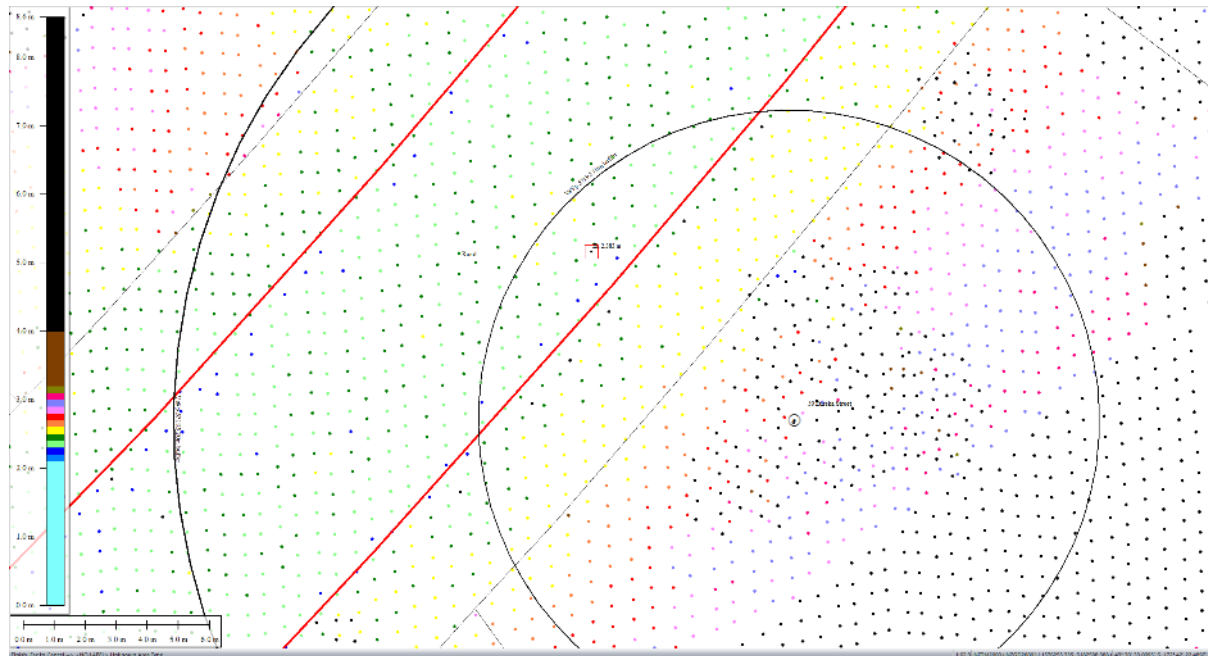
Figure 60: Ground surface elevation averaged over 10-m buffer for Road for Feb 2012 LiDAR survey.

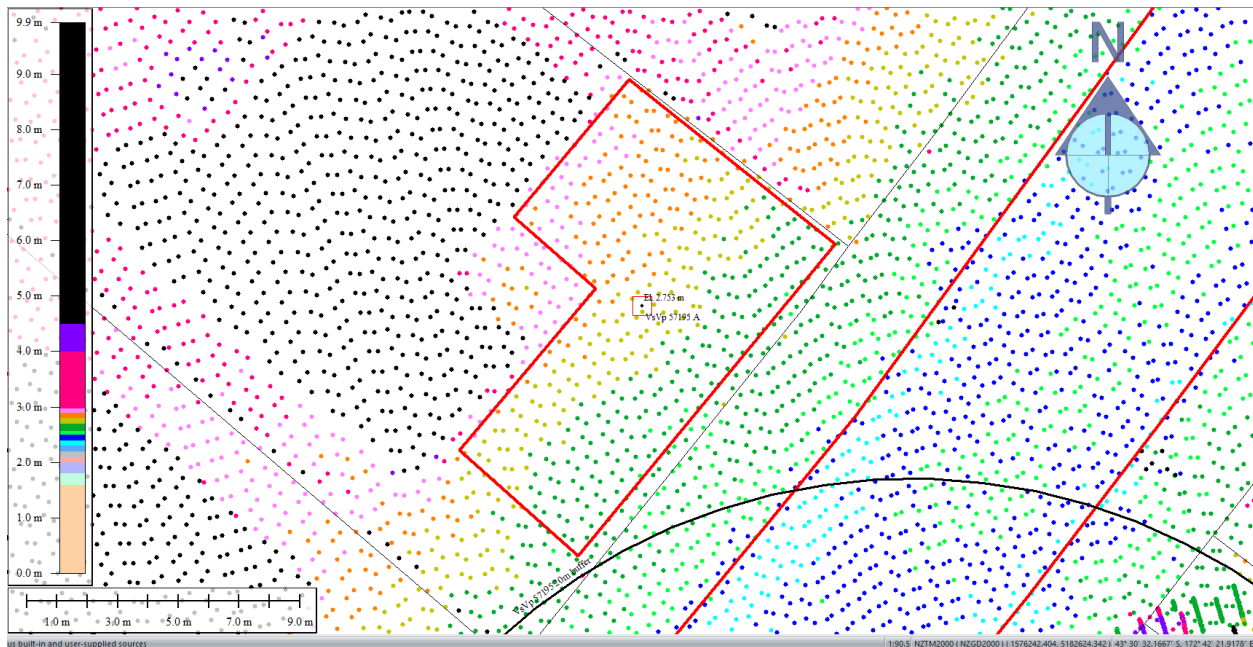
Figure 64: Ground surface elevation averaged over 50-m buffer for Patch A for Oct 2015 LiDAR survey.

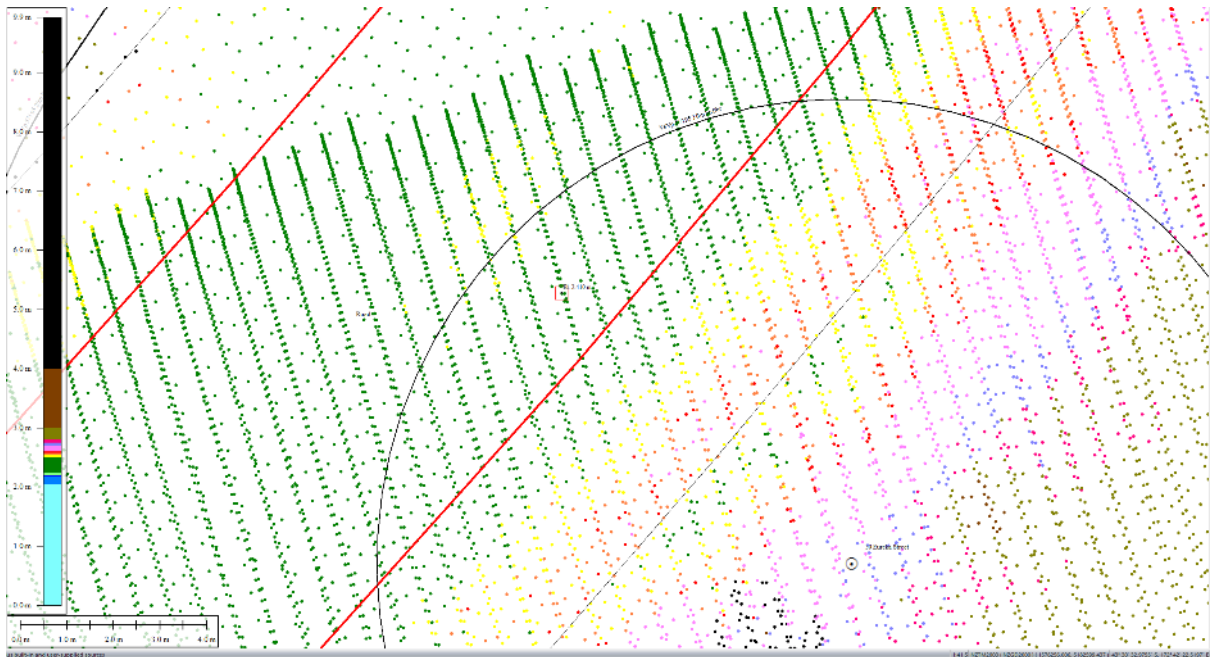
Figure 65: Ground surface elevation averaged over 10-m buffer for Road for Oct 2015 LiDAR survey.

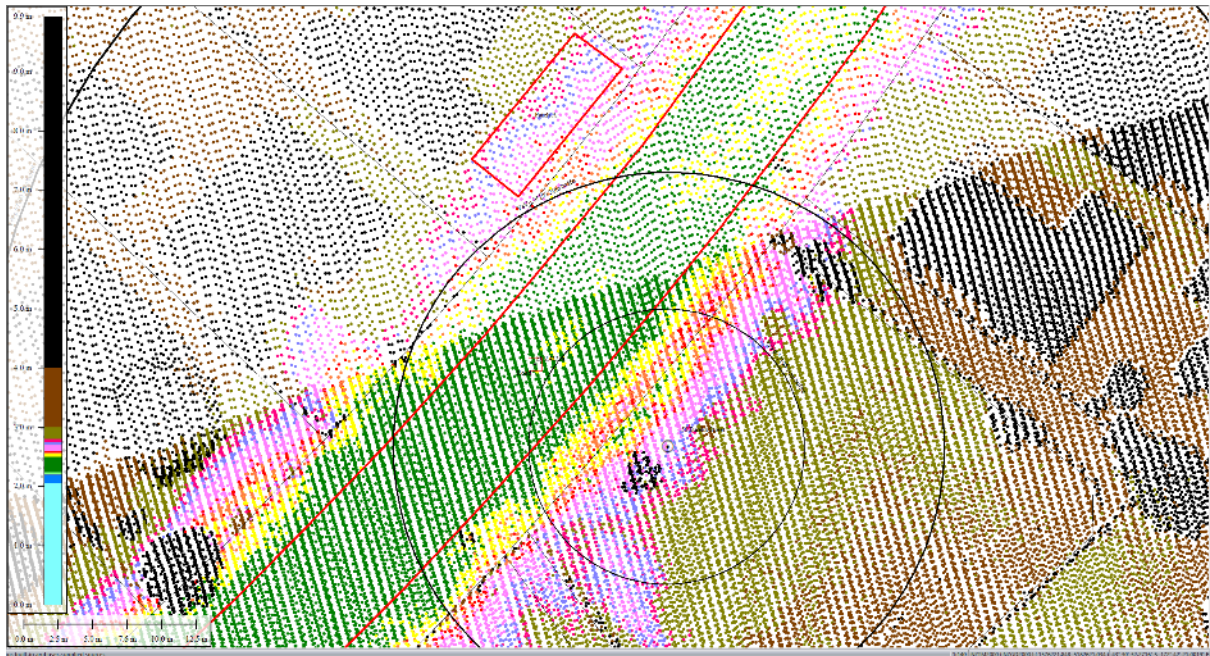
Figure 66: Ground surface elevation averaged over 20-m buffer for Road for Oct 2015 LiDAR survey.

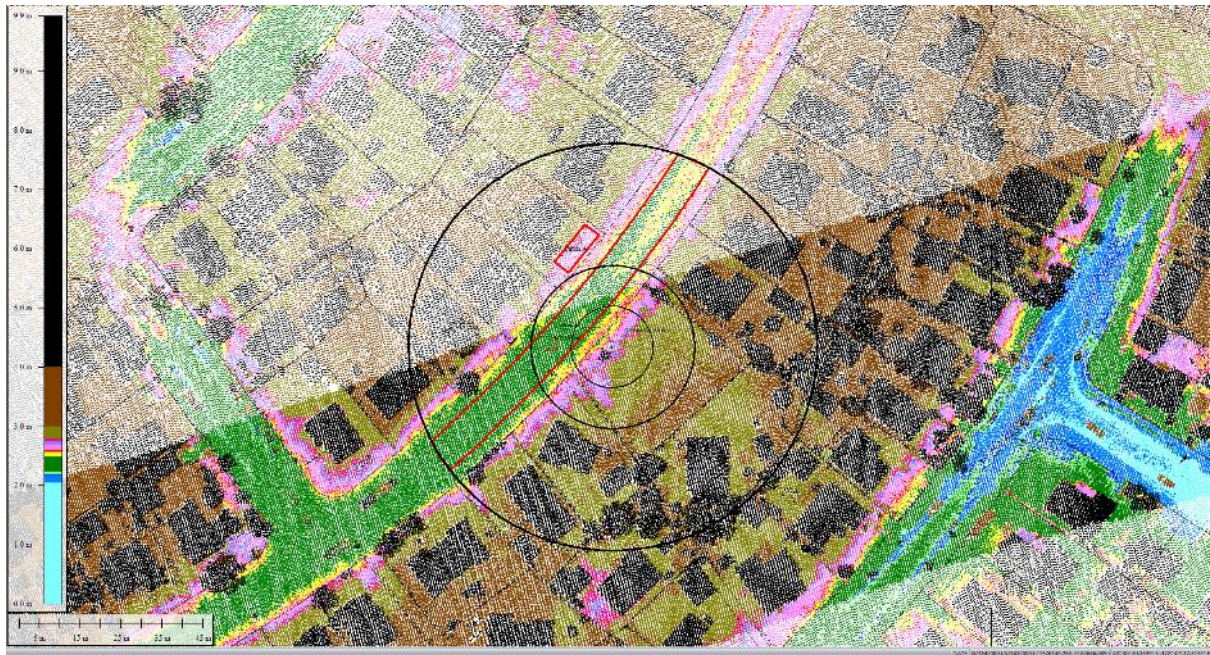
Figure 67: Ground surface elevation averaged over 50-m buffer for Road for Oct 2015 LiDAR survey.

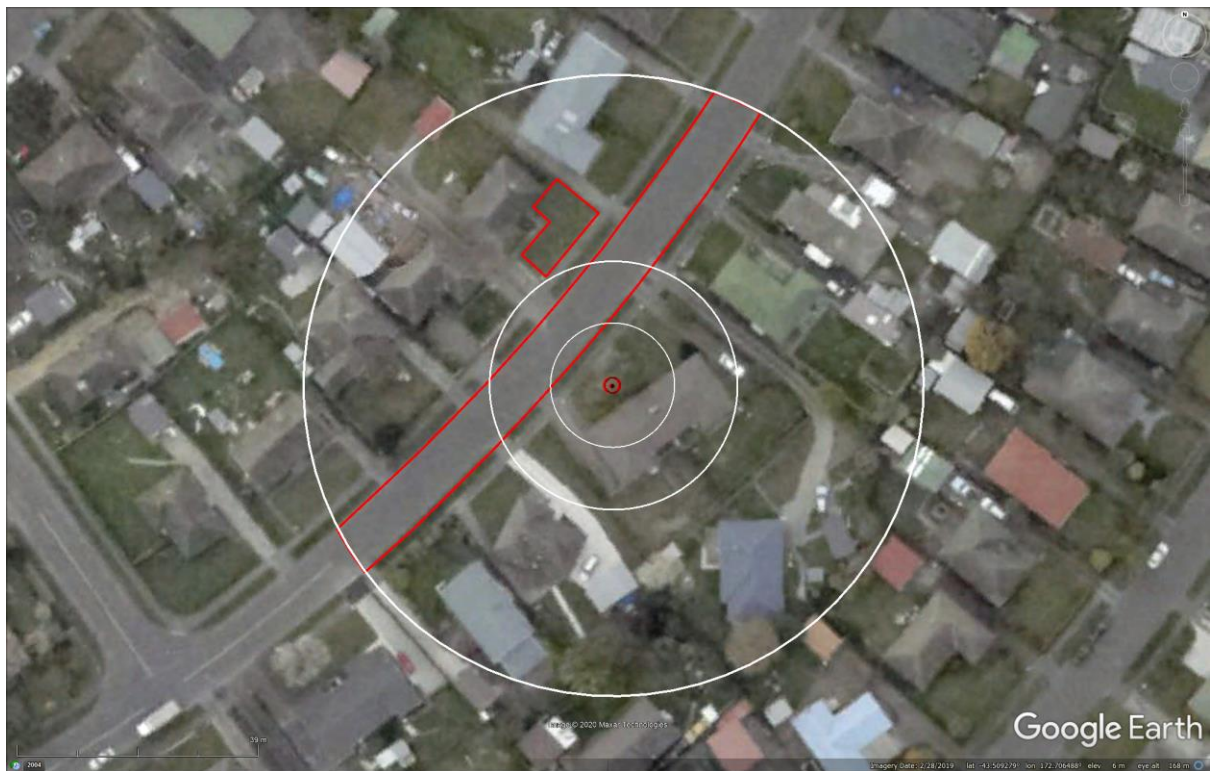
Figure 68: Absence of ejecta at the site for Sep-10 EQ; evidence No. 1.

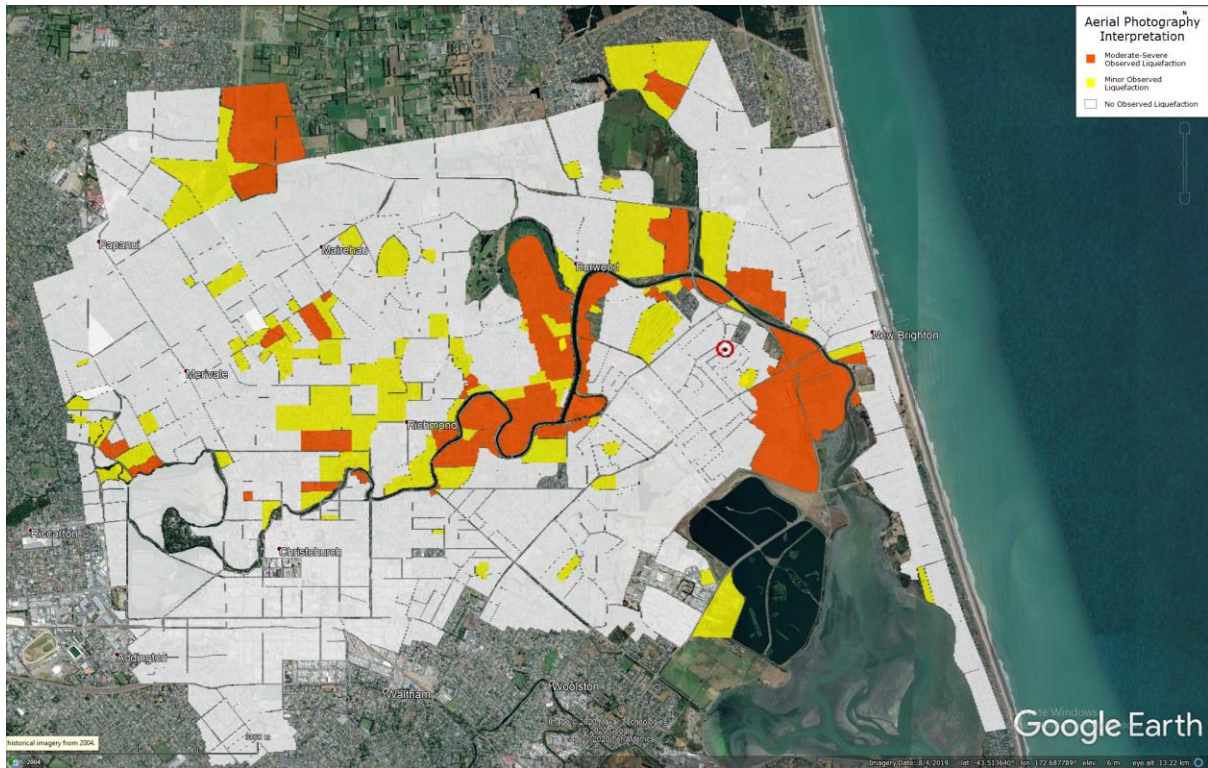
Figure 69: Liquefaction interpreted from aerial photography for Sep-10 EQ as none at the site; evidence No. 2.

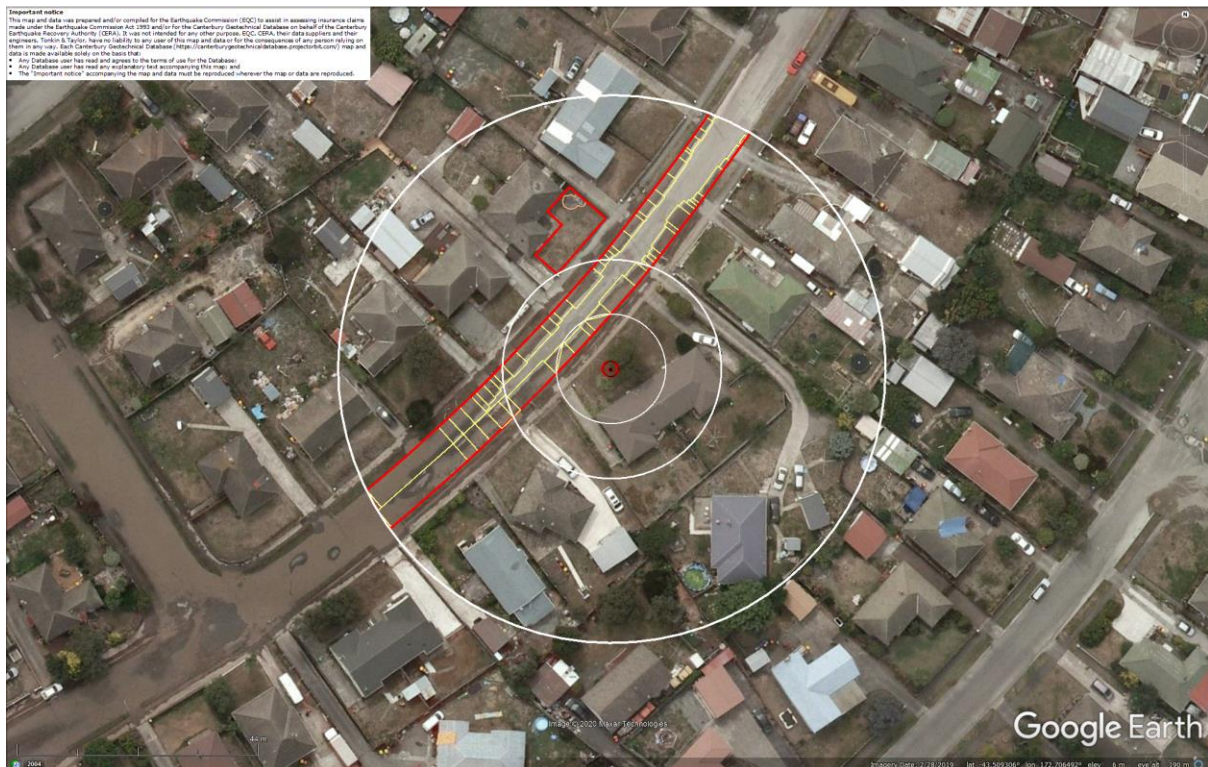
Figure 70: Ejecta outline for Feb-11 EQ.

- The values in Table 9a correspond to the coverage area of ejecta outlined in aerial photographs (Figure 70) and the lower and upper estimates of ejecta height based on ground photographs taken nearby and LDAT property inspection notes (Figure 75). The ejecta-induced settlement using photographs and engineering judgment, $S_{E,P}$, is estimated as

- The values in Tables 9b, c, and d correspond to the coverage area of ejecta outlined in aerial photographs (Figures 70 and 72) and the lower and upper estimates of ejecta height based on typical 2-4% cross slope of normal road crown, EQC LDAT property inspection reports and ground photographs. The ejecta-induced settlement using photographs and engineering judgment, $S_{E,P}$, is estimated as

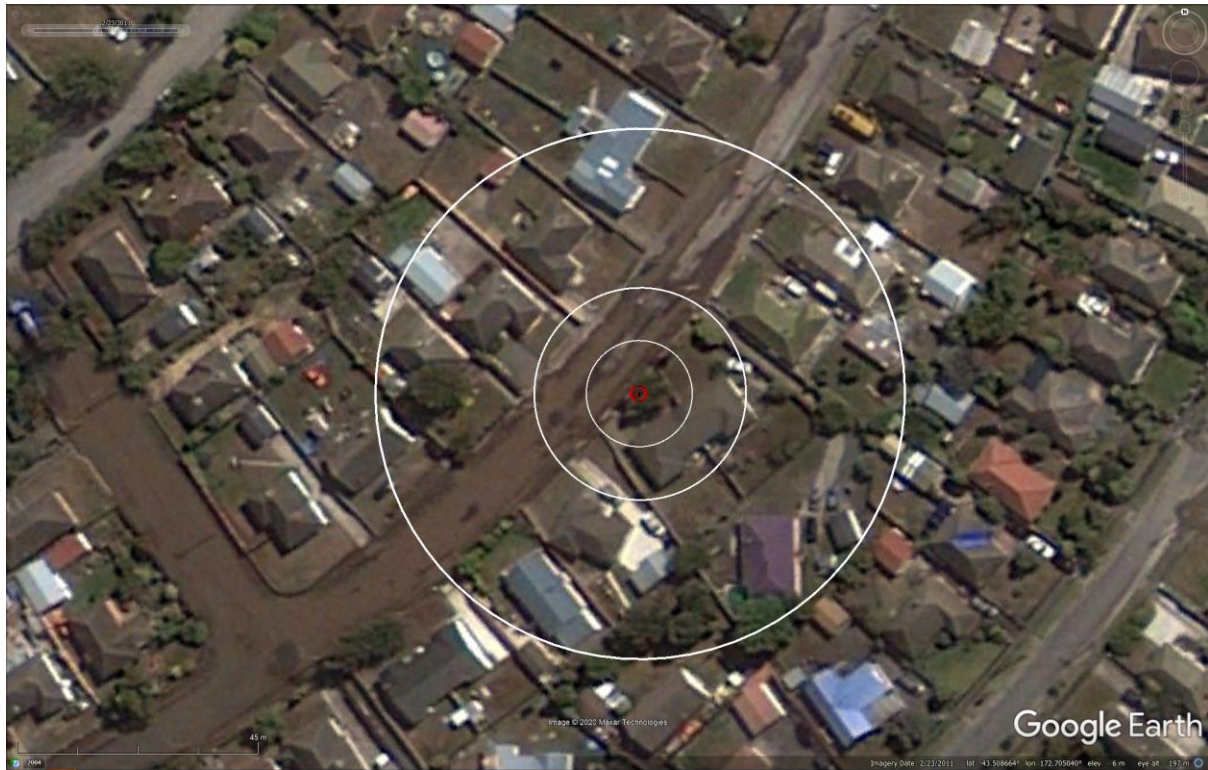
Figure 71: Ejecta at the site for Feb-11 EQ.

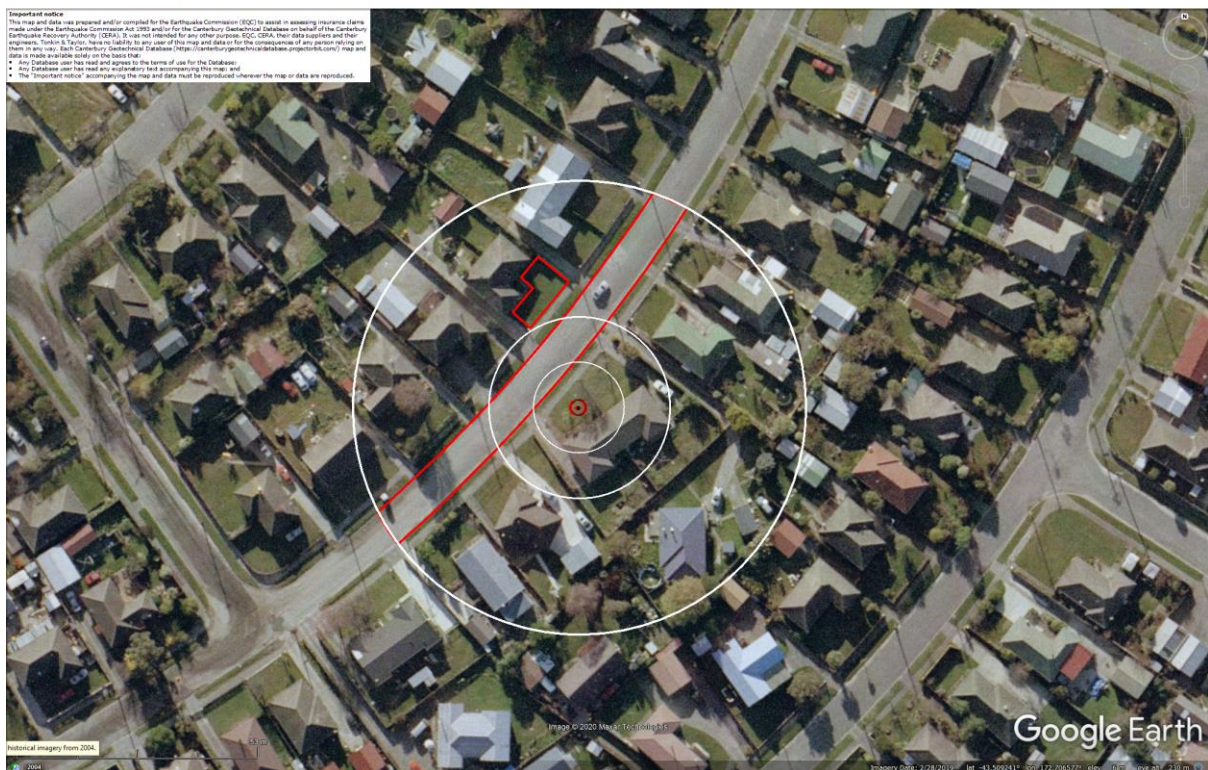
Figure 72: Ejecta outline for Jun-11 EQ.

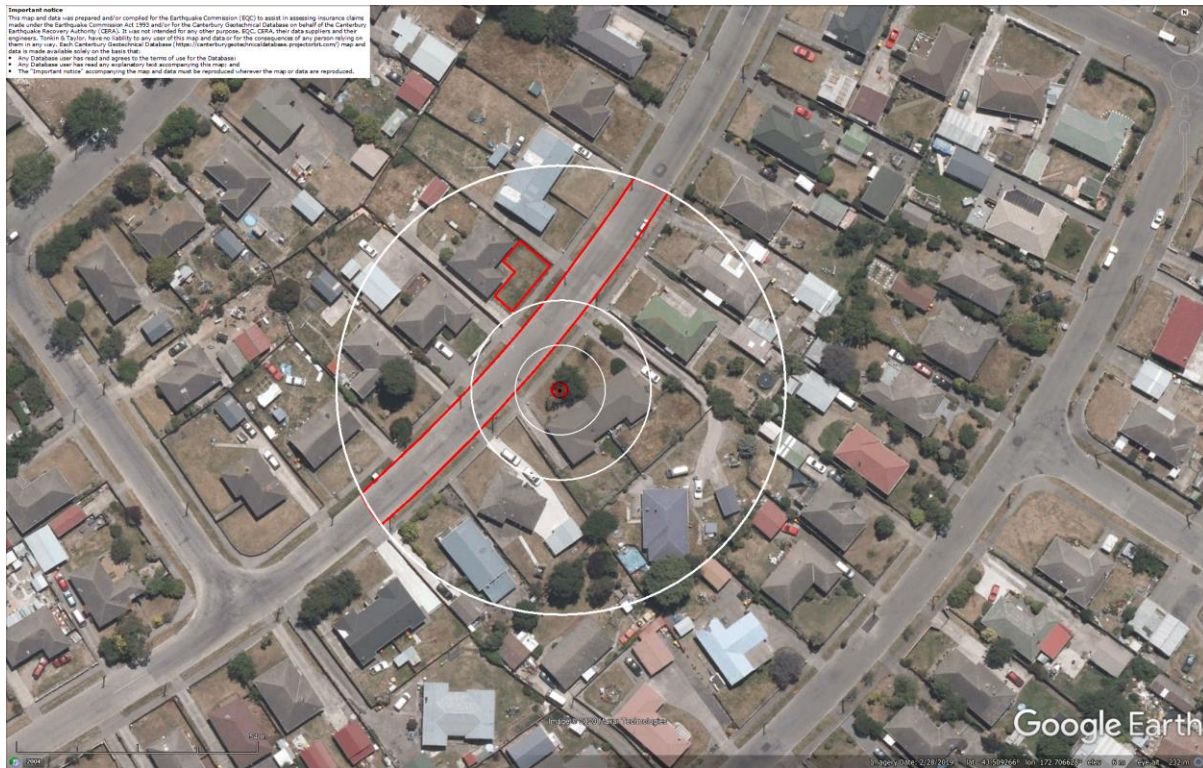
Figure 73: Absence of ejecta for Dec-11 EQ; evidence No. 1.

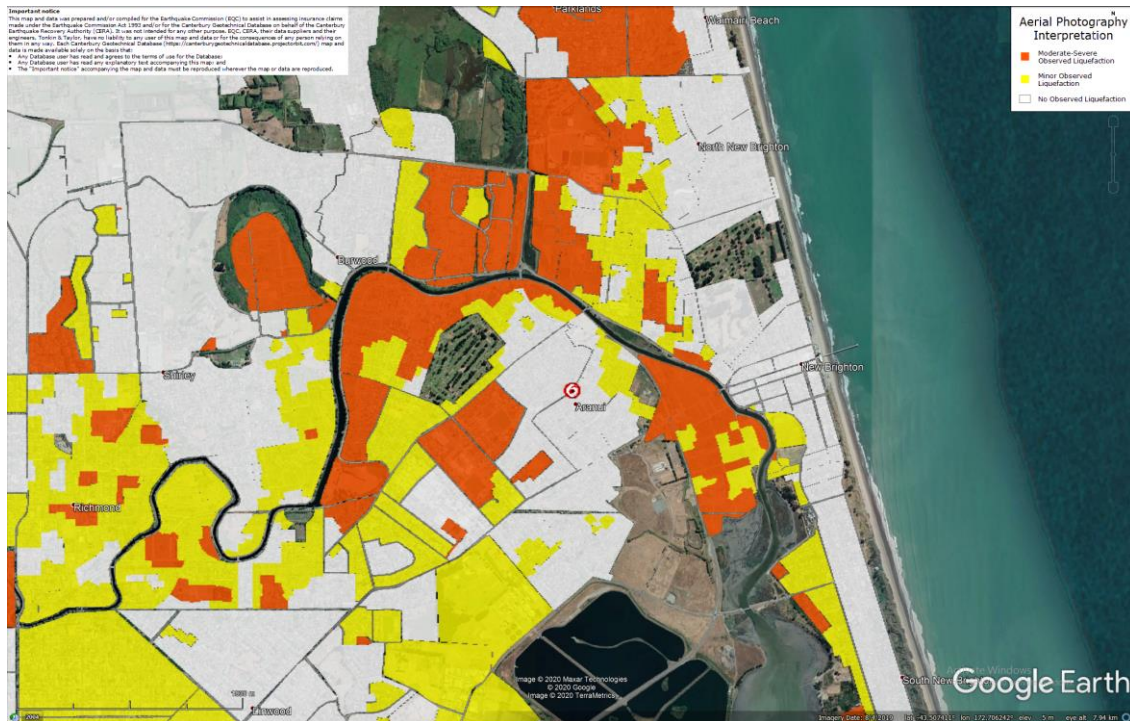
Figure 74: Liquefaction interpreted from aerial photography for Dec-11 EQ; evidence No. 2 supporting absence of ejecta at the site.

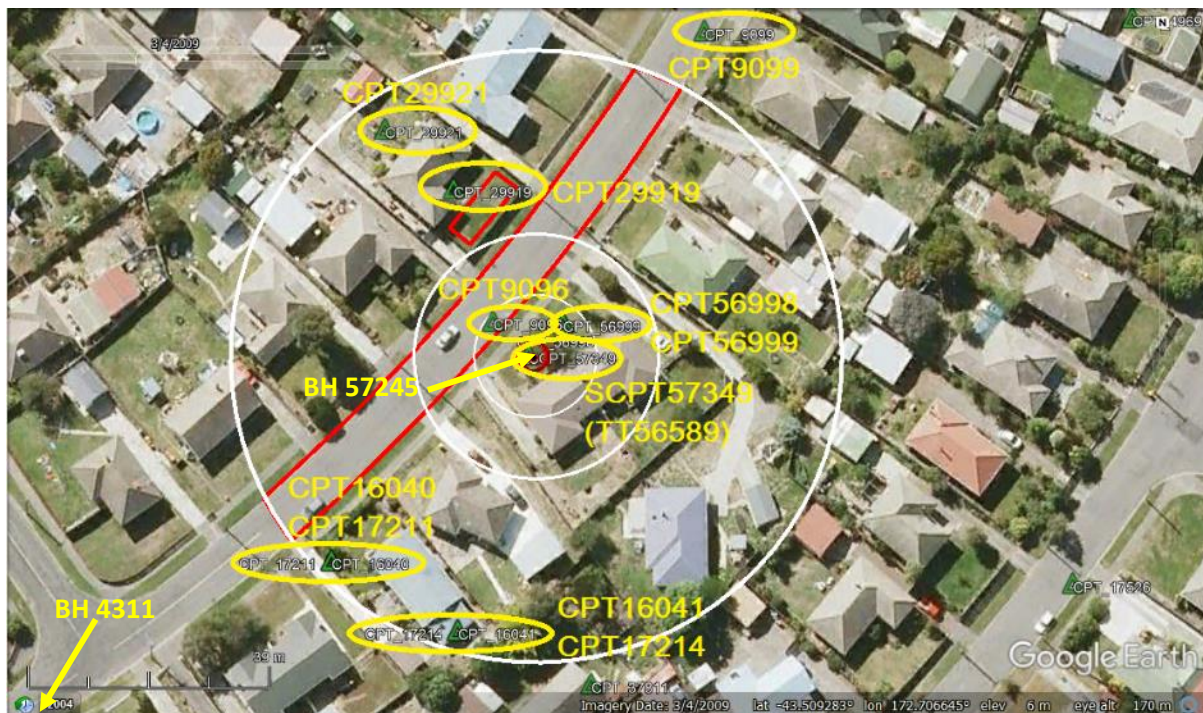
Figure 76: CPT locations at the site.

Note 7: The selection of CPTs for the areas considered for settlement assessment (Figure 1) is based on the proximity of the CPTs to the considered areas. In accordance with that, the following table shows CPTs that were used for the volumetric settlement analysis in *Cliq v.3.0.3.2*, a CPT soil liquefaction software developed by GeoLogismiki. (The average volumetric settlements were reported in Table 8.)

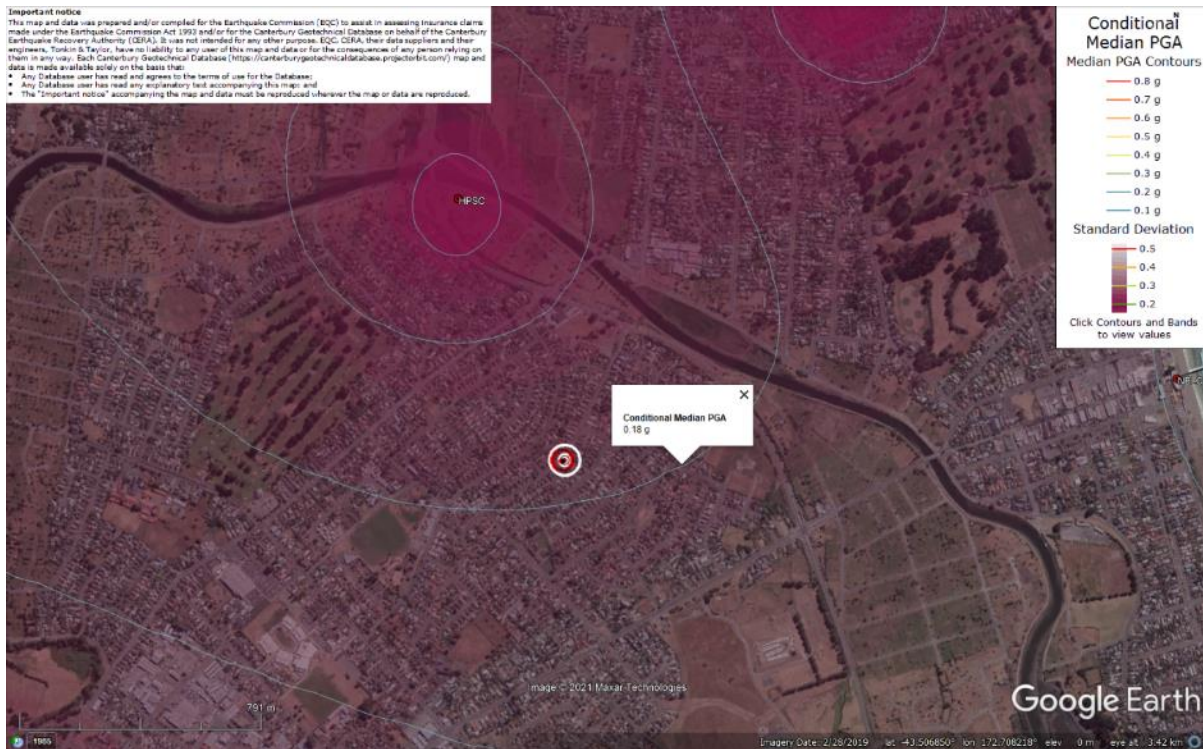
Figure 77: PGA for Sep-10 EQ (st. dev. = 0.275-0.325 ln units).

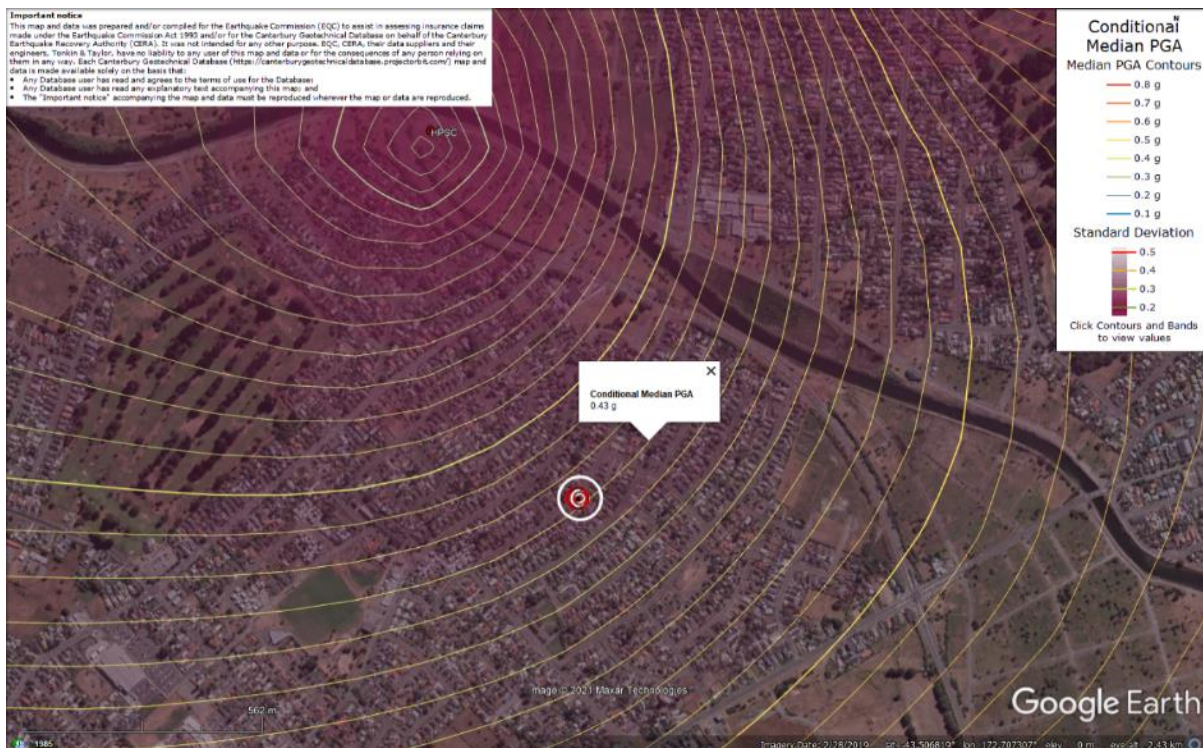
Figure 78: PGA for Feb-11 EQ (st. dev. = 0.300-0.325 ln units).

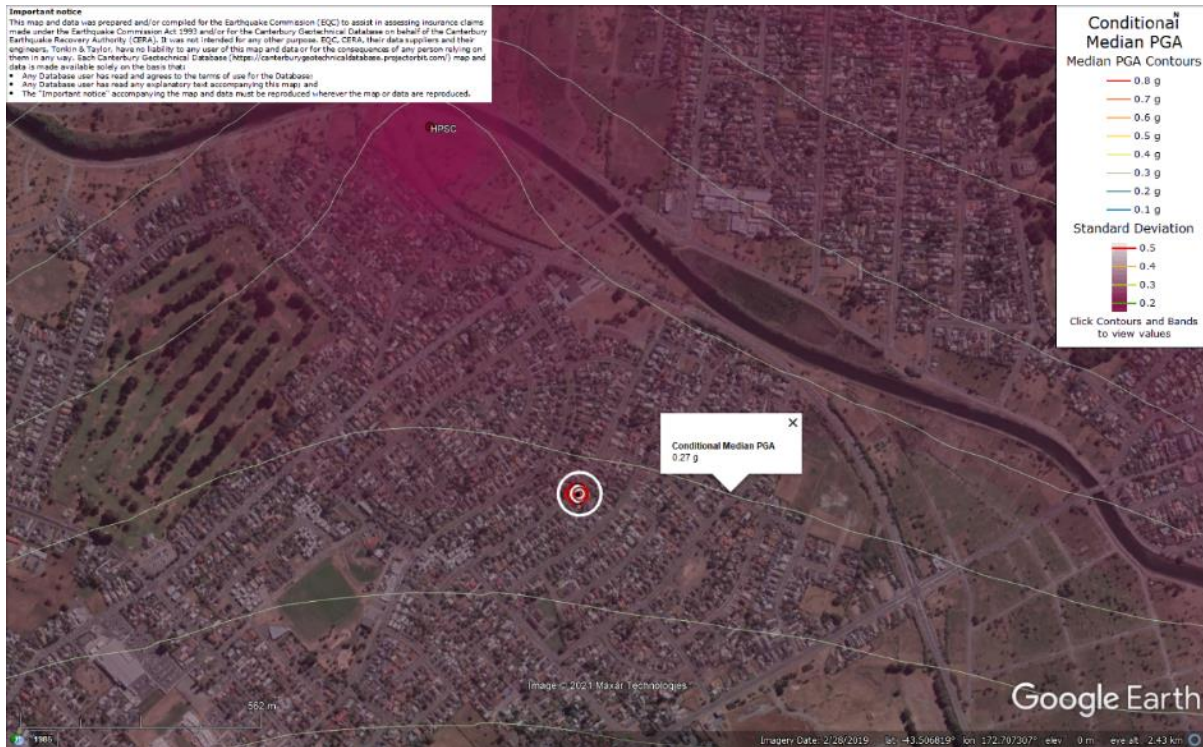
Figure 79: PGA for Jun-11 EQ (st. dev. = 0.300-0.350 ln units).

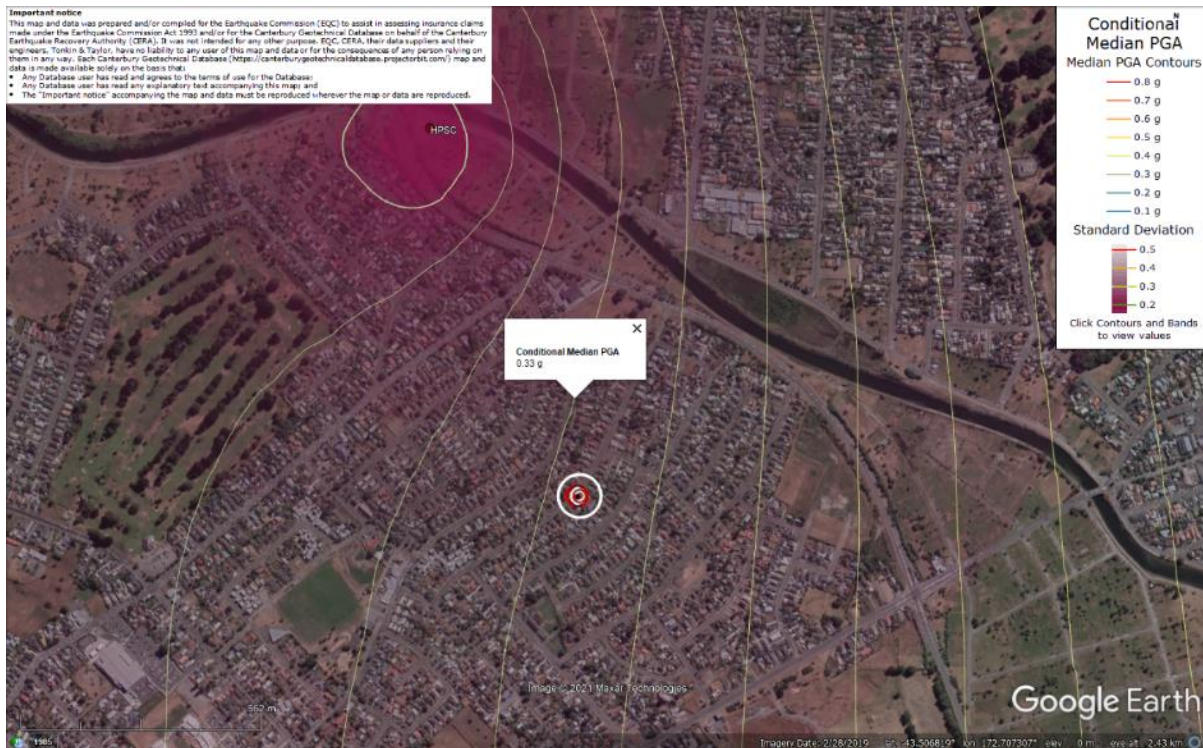
Figure 80: PGA for Dec-11 EQ (st. dev. = 0.350-0.375 ln units).

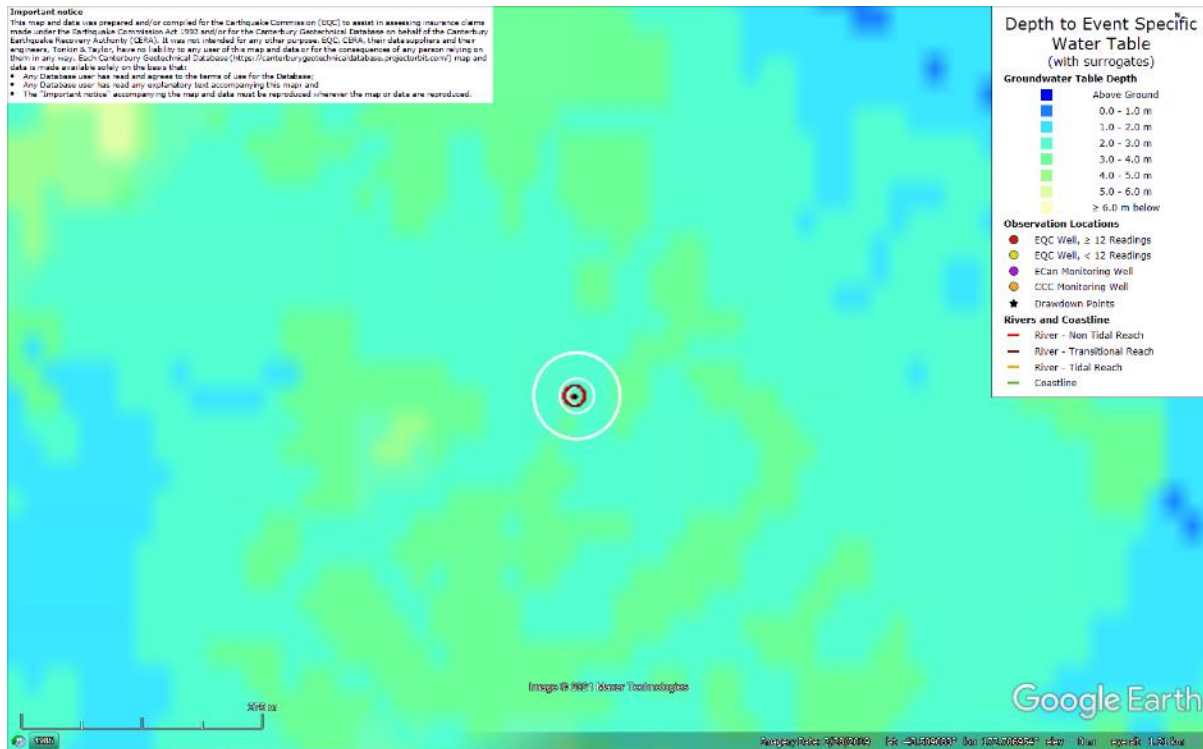
Figure 81: Depth to groundwater table for Sep-10 EQ.

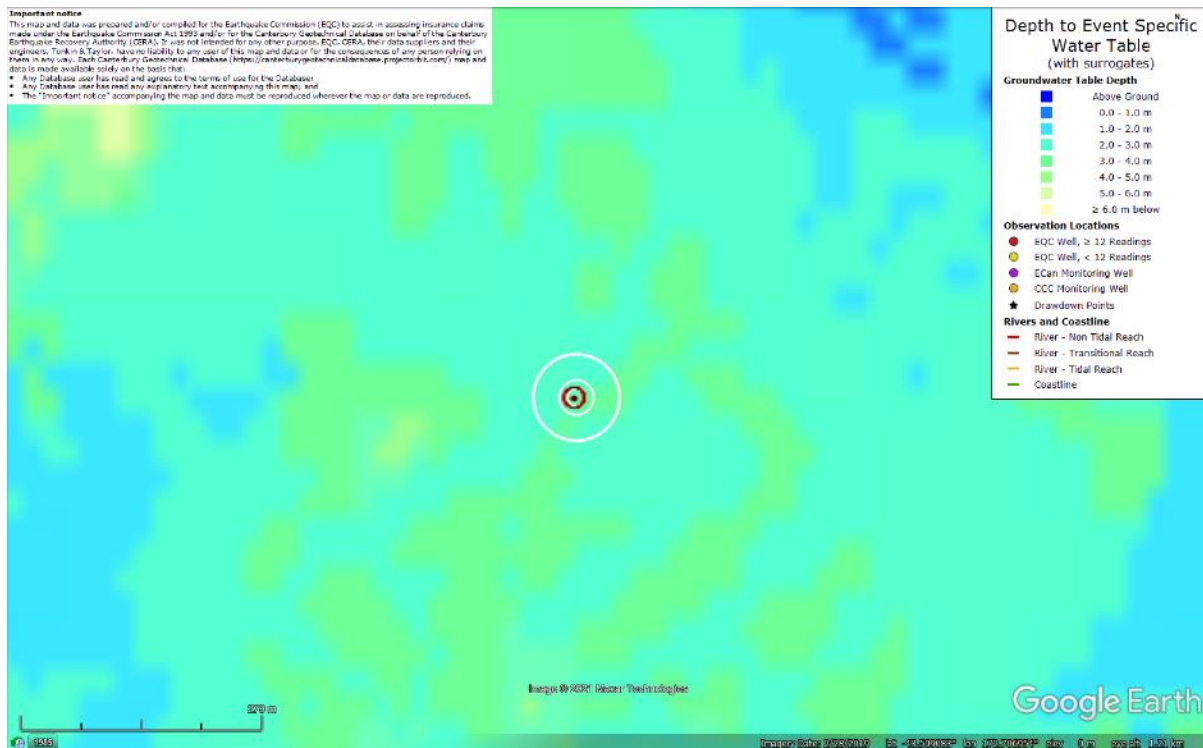
Figure 82: Depth to groundwater table for Feb-11 EQ.

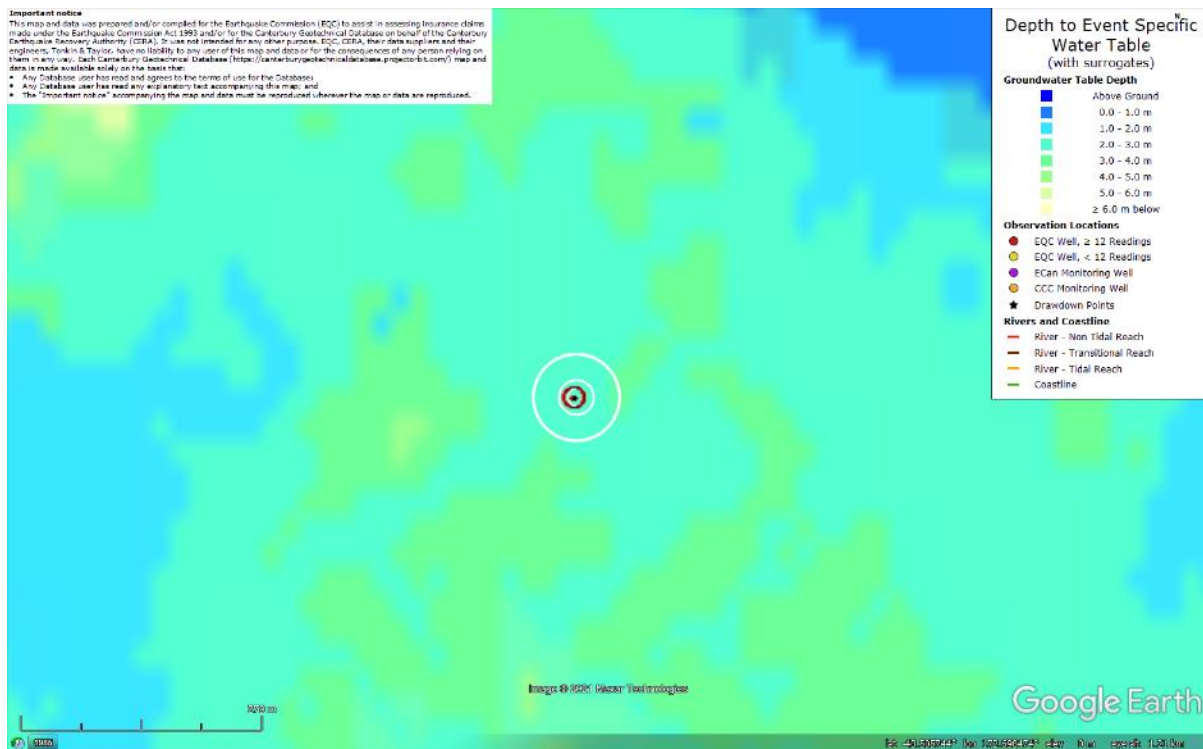
Figure 83: Depth to groundwater table for Jun-11 EQ.

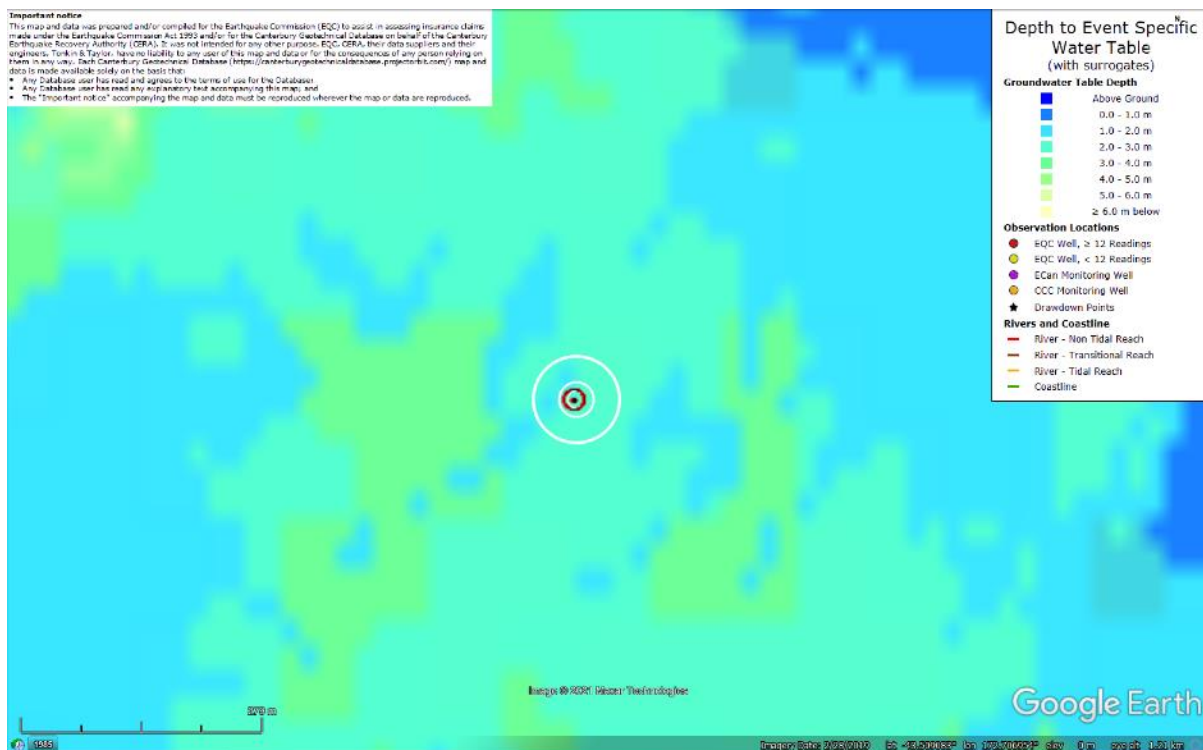
Figure 84: Depth to groundwater table for Dec-11 EQ.
