Appendix A.7:

50 Eureka St – VsVp 57195

Liquefaction Ejecta Case Histories for 2010-11 Canterbury Earthquakes

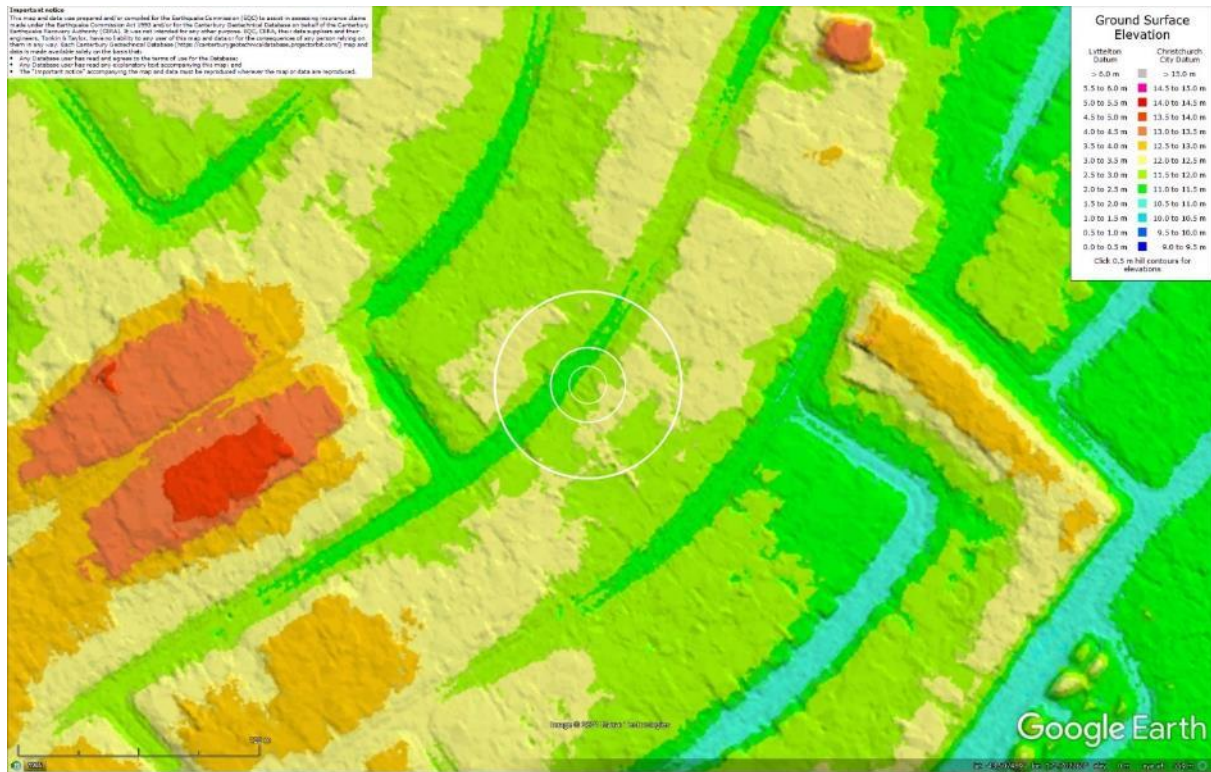
Figure 85: Ground surface elevation according to the Sep-11 LiDAR survey.

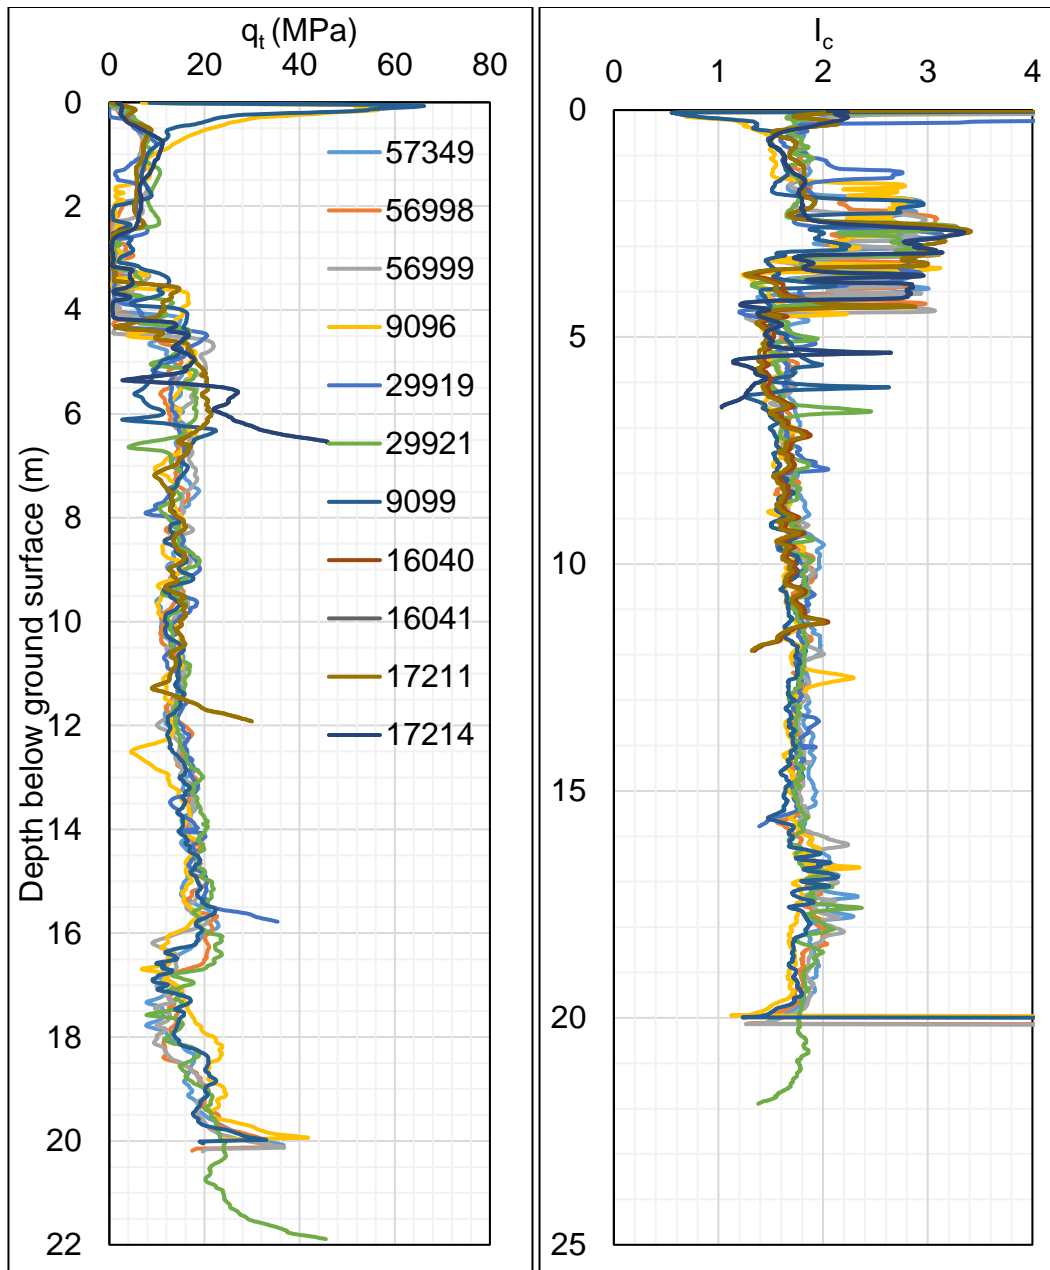
Figure 86: q_t and I_c profiles.

Note 7: The selection of CPTs for the areas considered for settlement assessment (Figure 1) is based on the proximity of the CPTs to the considered areas. In accordance with that, the following table shows CPTs that were used for the volumetric settlement analysis in *Cliq v.3.0.3.2*, a CPT soil liquefaction software developed by GeoLogismiki. (The average volumetric settlements were reported in Table 8.)
