Appendix A.14:

Wattle Dr – CPT 90678

Liquefaction Ejecta Case Histories for 2010-11 Canterbury Earthquakes

CC LIQ 3 – CPT 90678 (172.706167, -43.497325) – Wattle Dr

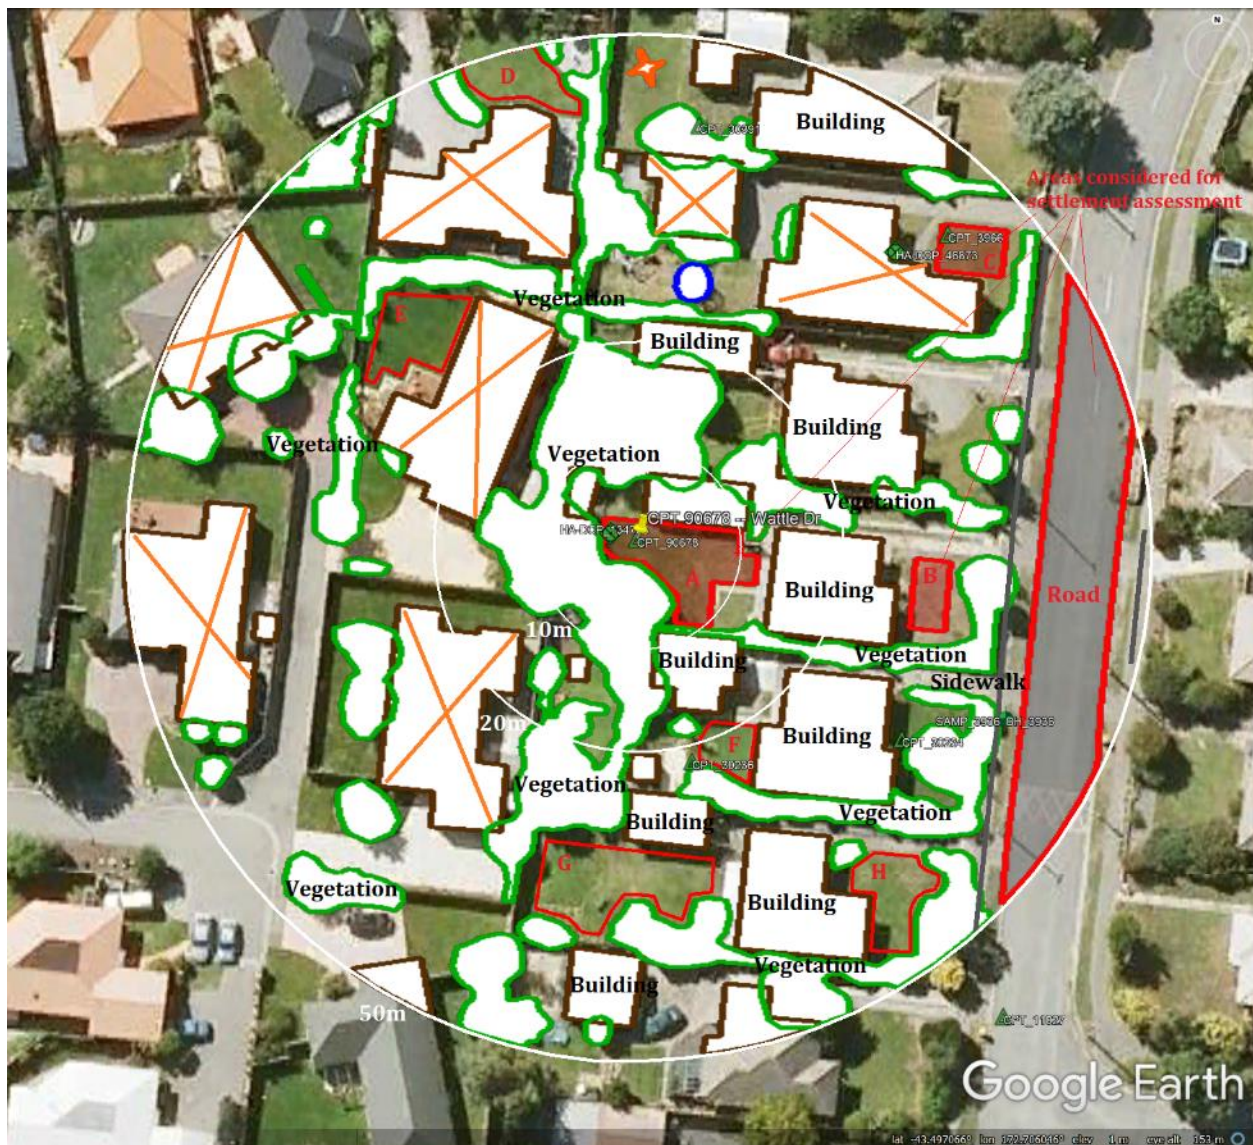
Figure 1: Site plan with areas where LiDAR survey data is considered.

Note 1: Eight patches (outlined in red) in free field were initially selected for settlement assessment as areas free of vegetation and structures. Further analyses such as proximity of a patch to a CPT, proximity of a patch to a property subjected to addition and/or demolition of a structure, front yard/backyard alterations (e.g., ploughing, rubble, scrap), and density of LiDAR points for 2003 resulted in Patches A, B, and C being selected for detailed settlement assessment and other patches being discarded in detailed settlement assessment. In addition, since significant amounts of ejecta were observed on roads in the CES, the entire road and the driveway were considered for settlement assessment. Roads as hard, relatively flat surfaces provide many ground-classified points. Therefore, it is very useful to compare settlement estimates on roads with settlement estimates for the unpaved patches.

Note 8: The selection of CPTs for the area considered for settlement assessment (Figure 1) is based on the proximity of the CPTs to the considered areas. In accordance with that, the following table shows CPTs that were used for the volumetric settlement analysis in *Cliq v.3.0.3.2*, a CPT soil liquefaction software developed by GeoLogismiki. (The average volumetric settlements were reported in Table 8.)

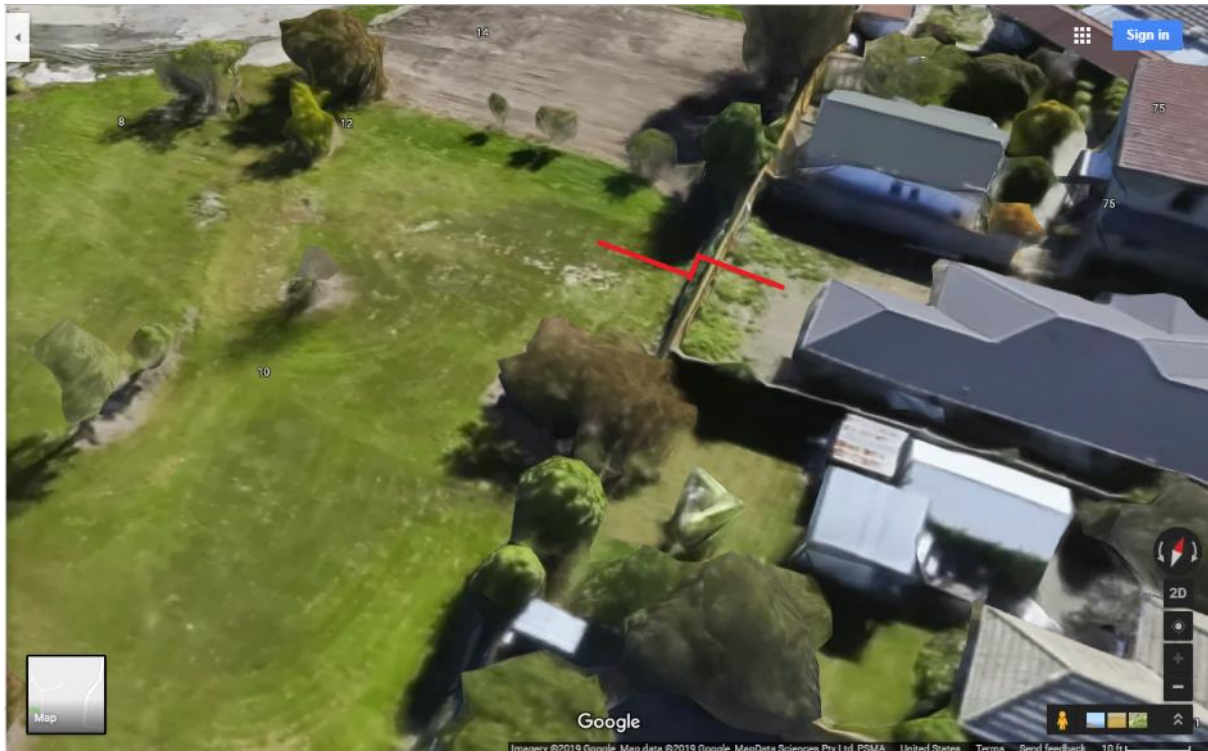
Figure 10: Step change in ground surface elevation supported by retaining wall.

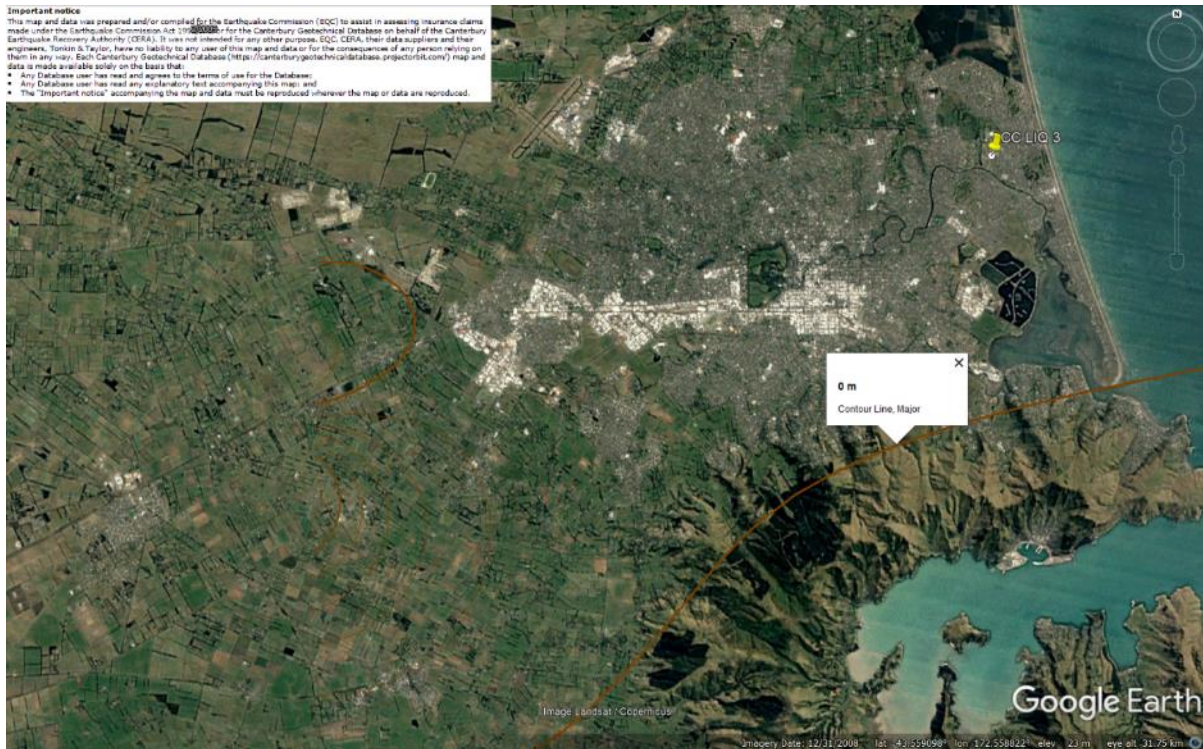
Figure 34: Vertical tectonic movements for Sep 2010 Earthquake.

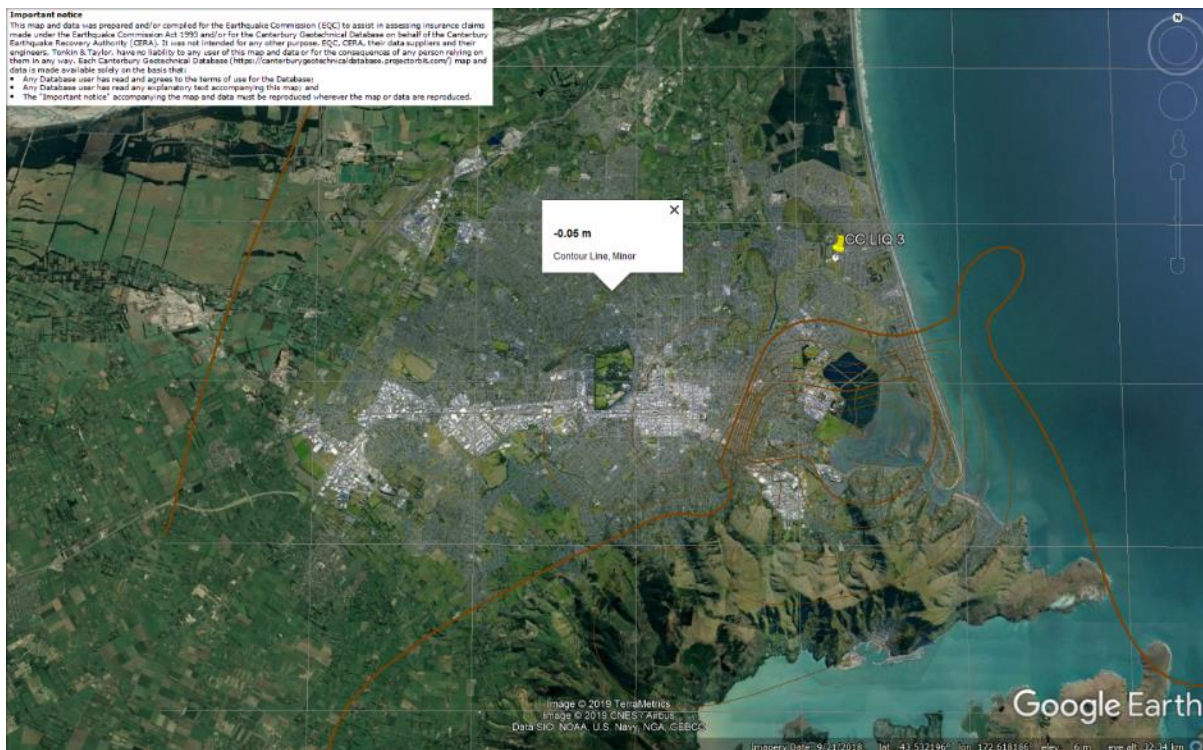
Figure 35: Vertical tectonic movements for Feb 2011 Earthquake.

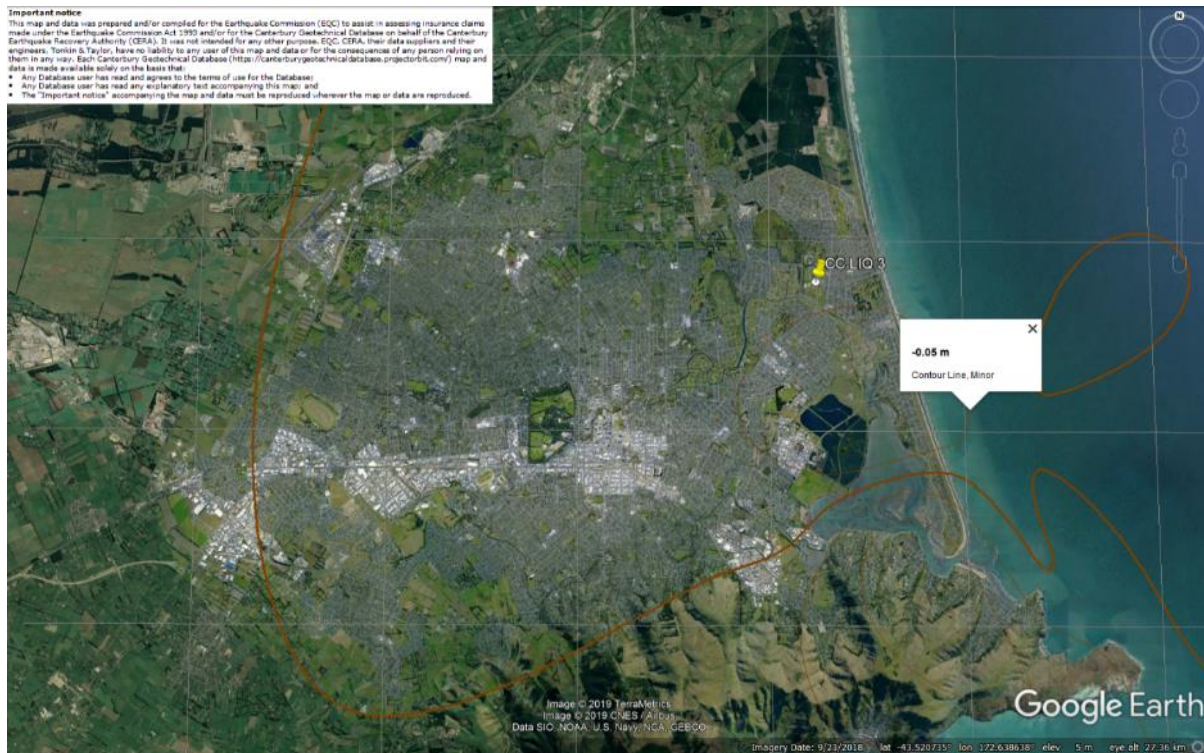
Figure 36: Vertical tectonic movements for June 2011 Earthquake.

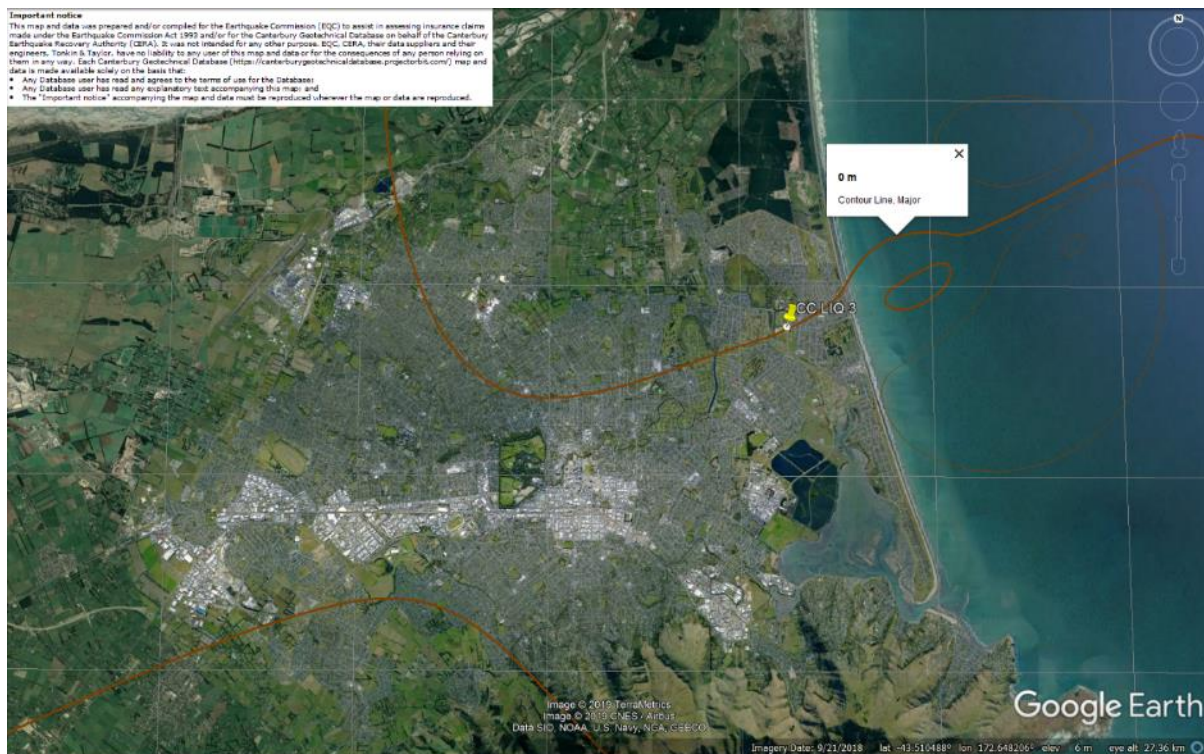
Figure 37: Vertical tectonic movements for Dec 2011 Earthquake.

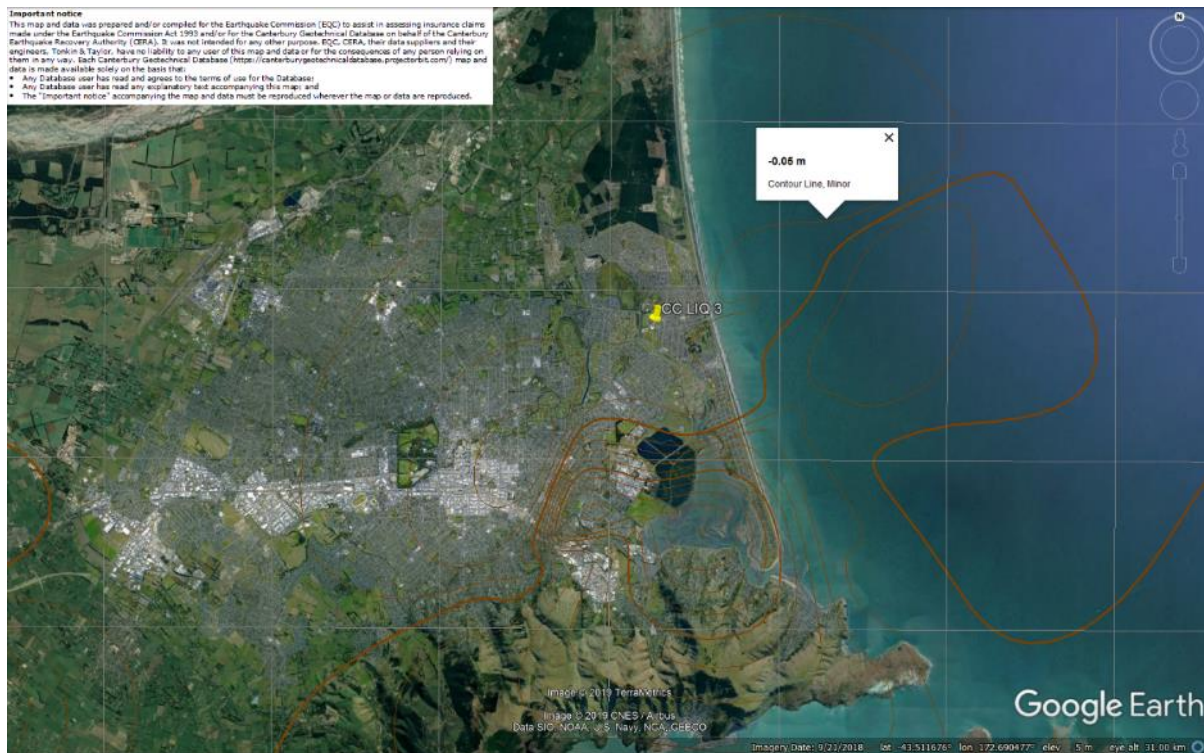
Figure 38: Vertical tectonic movements for Canterbury Earthquake Sequence.

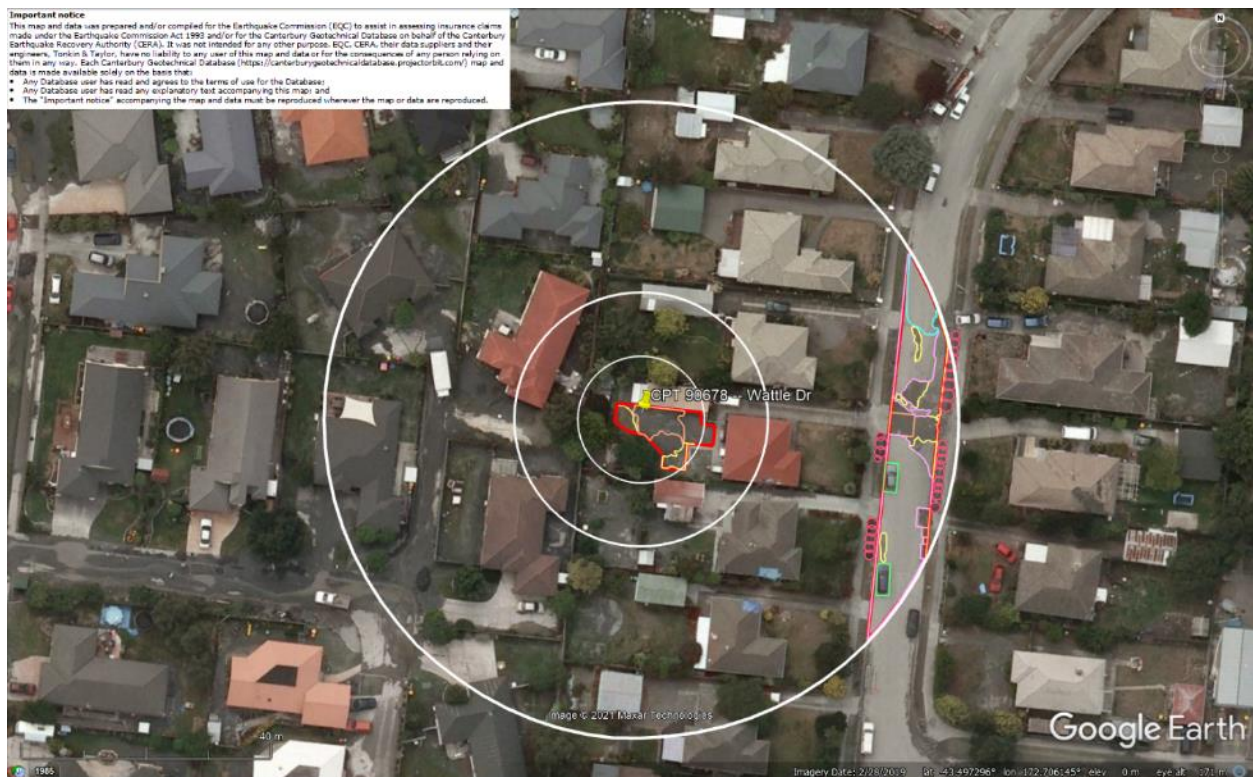
Figure 79: Ejecta outline for Feb-11 EQ.

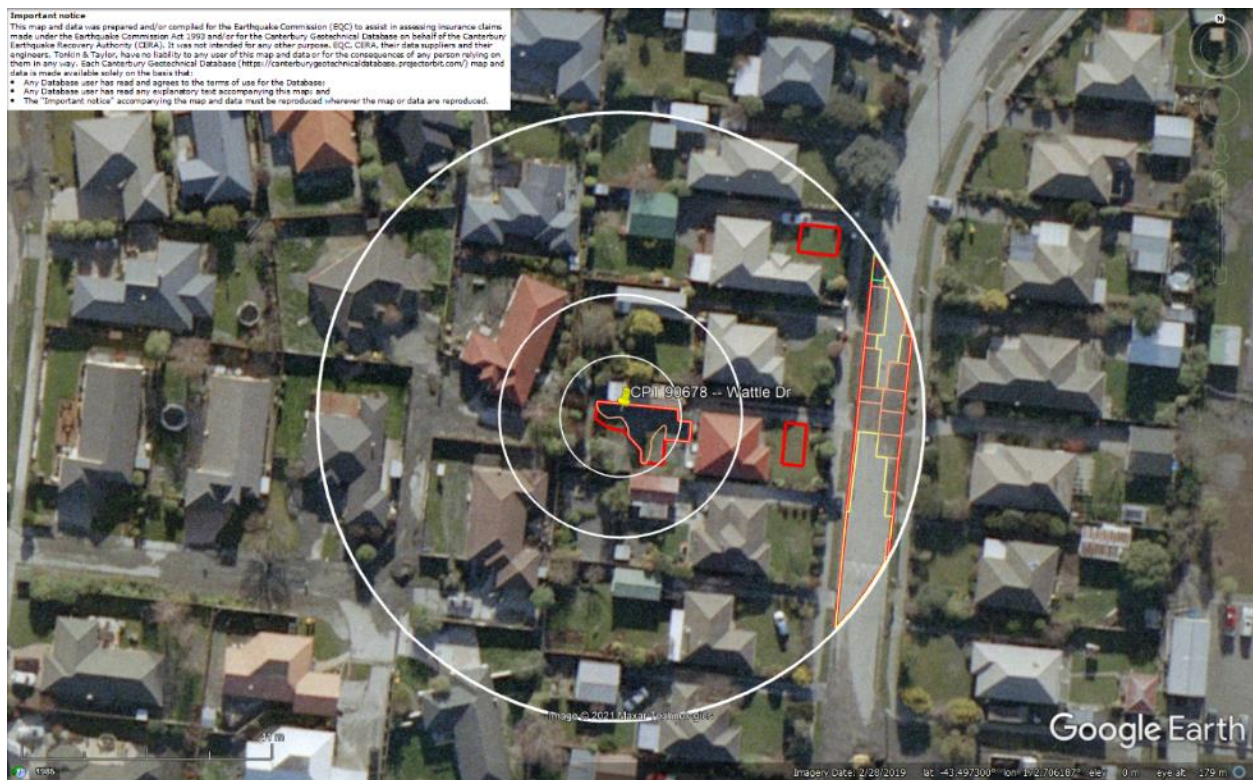
Figure 81: Ejecta outline for Jun-11 EQ.

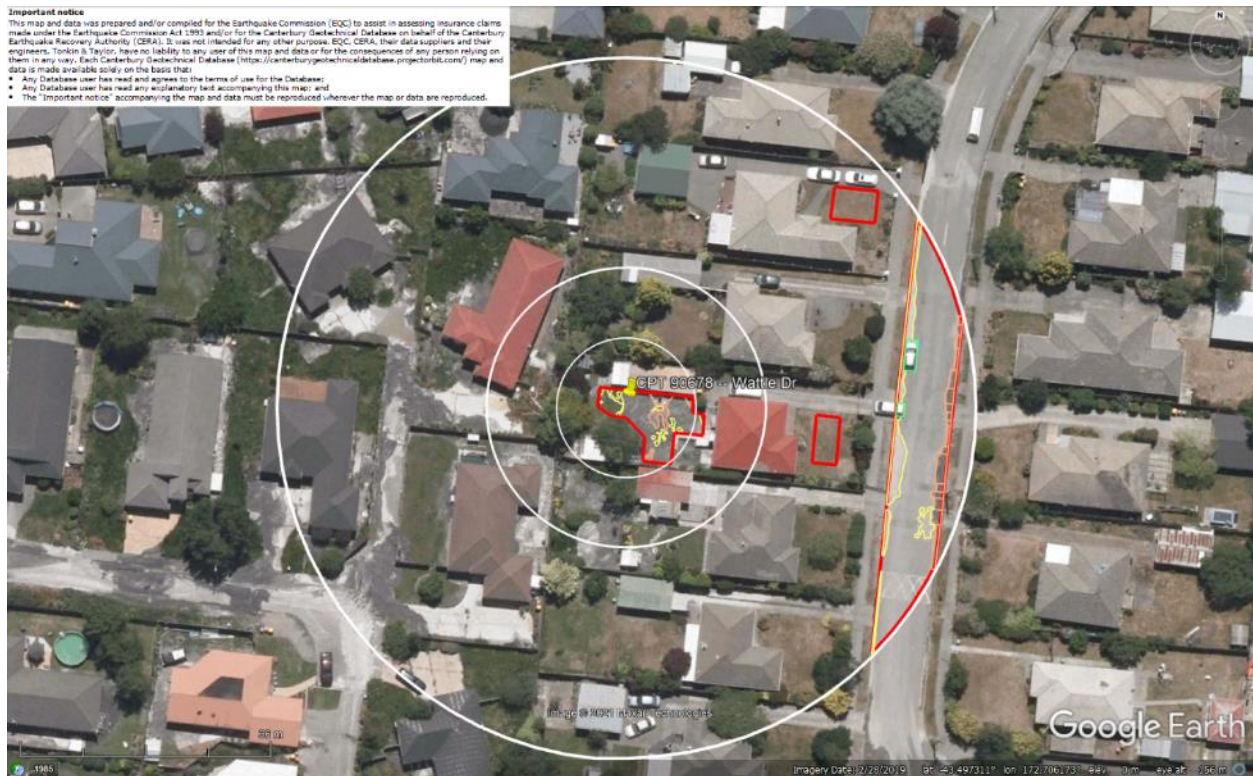
Figure 82: Ejecta outline for Dec-11 EQ.

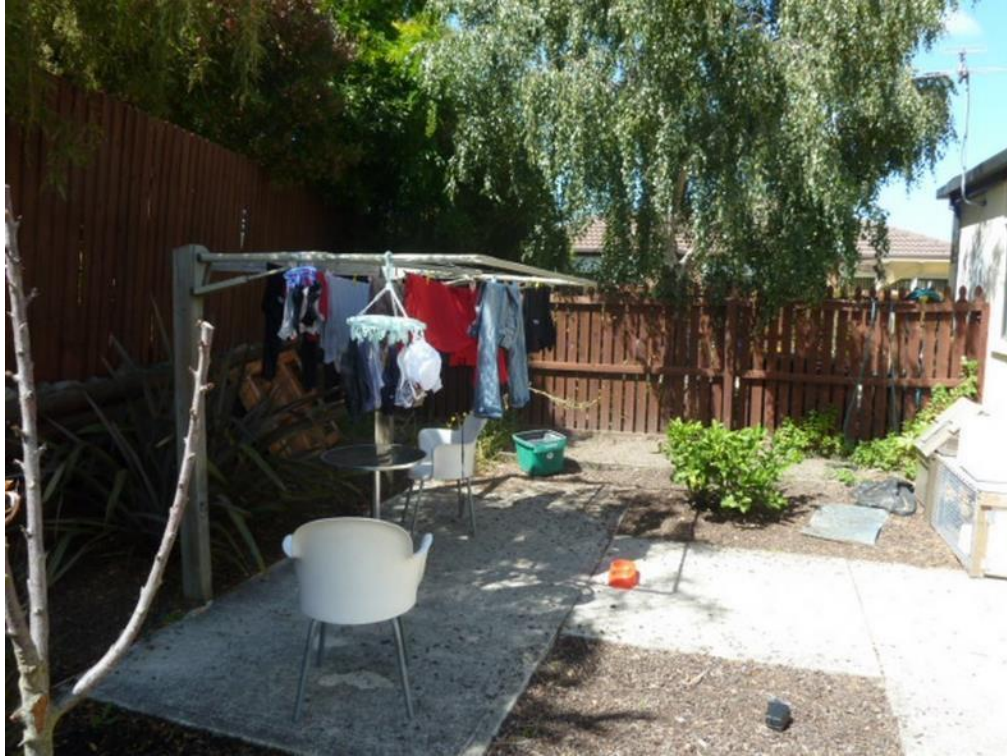
Figure 86: Retaining wall adjacent to the property with Patch A, as seen from 28 Atlantis St.

Note 6: The inspection team did not observe lateral spreading and the retaining wall at the property with Patch A was not damaged as a result of the Feb-11 or Jun-11 earthquake (Figure 86).

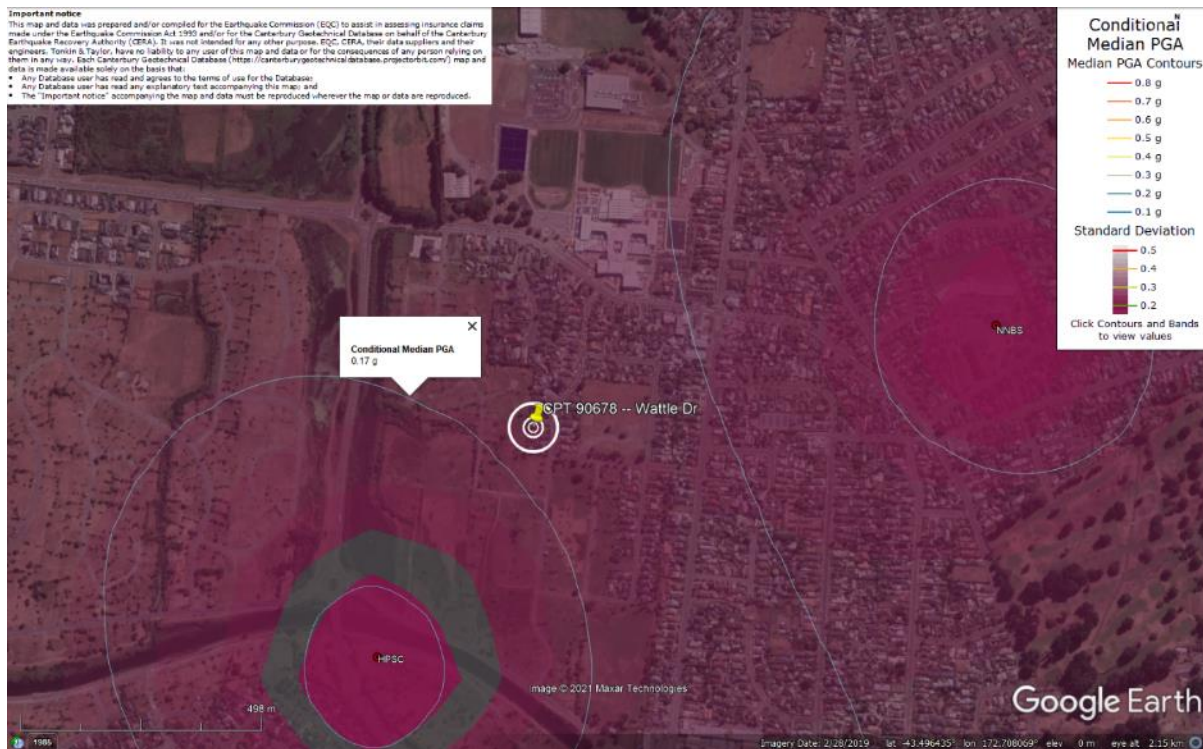
Figure 88: PGA for Sep-10 EQ (st. dev. = 0.225-0.275 ln units).

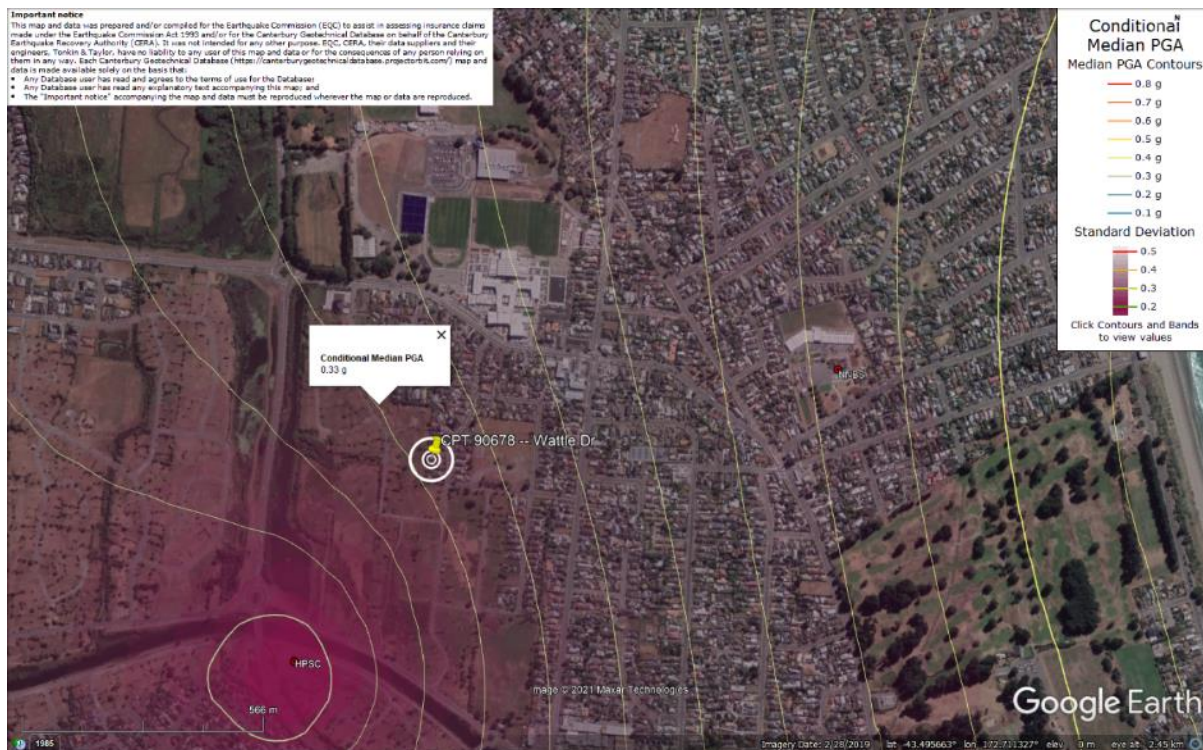
Figure 91: PGA for Dec-11 EQ (st. dev. = 0.300-0.325 ln units).

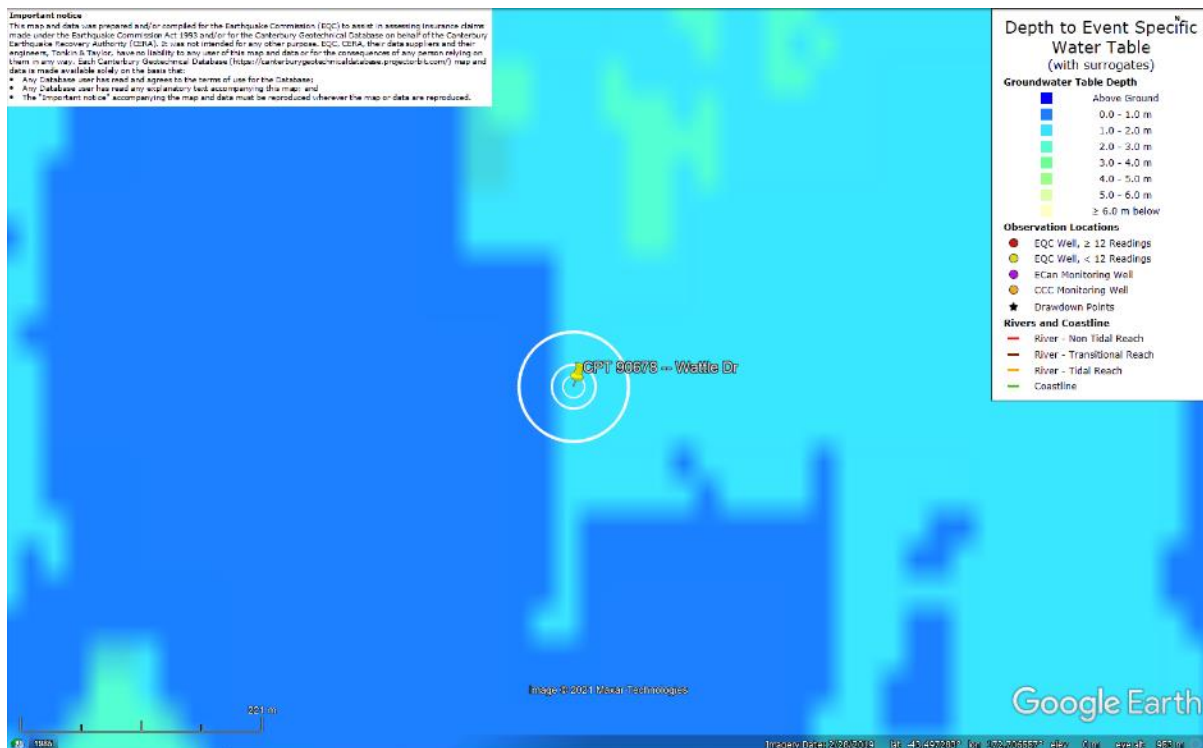
Figure 95: Depth to groundwater table for Dec-11 EQ.
