Appendix A.16:

Hunt Ln – CPT 4674

Liquefaction Ejecta Case Histories for 2010-11 Canterbury Earthquakes

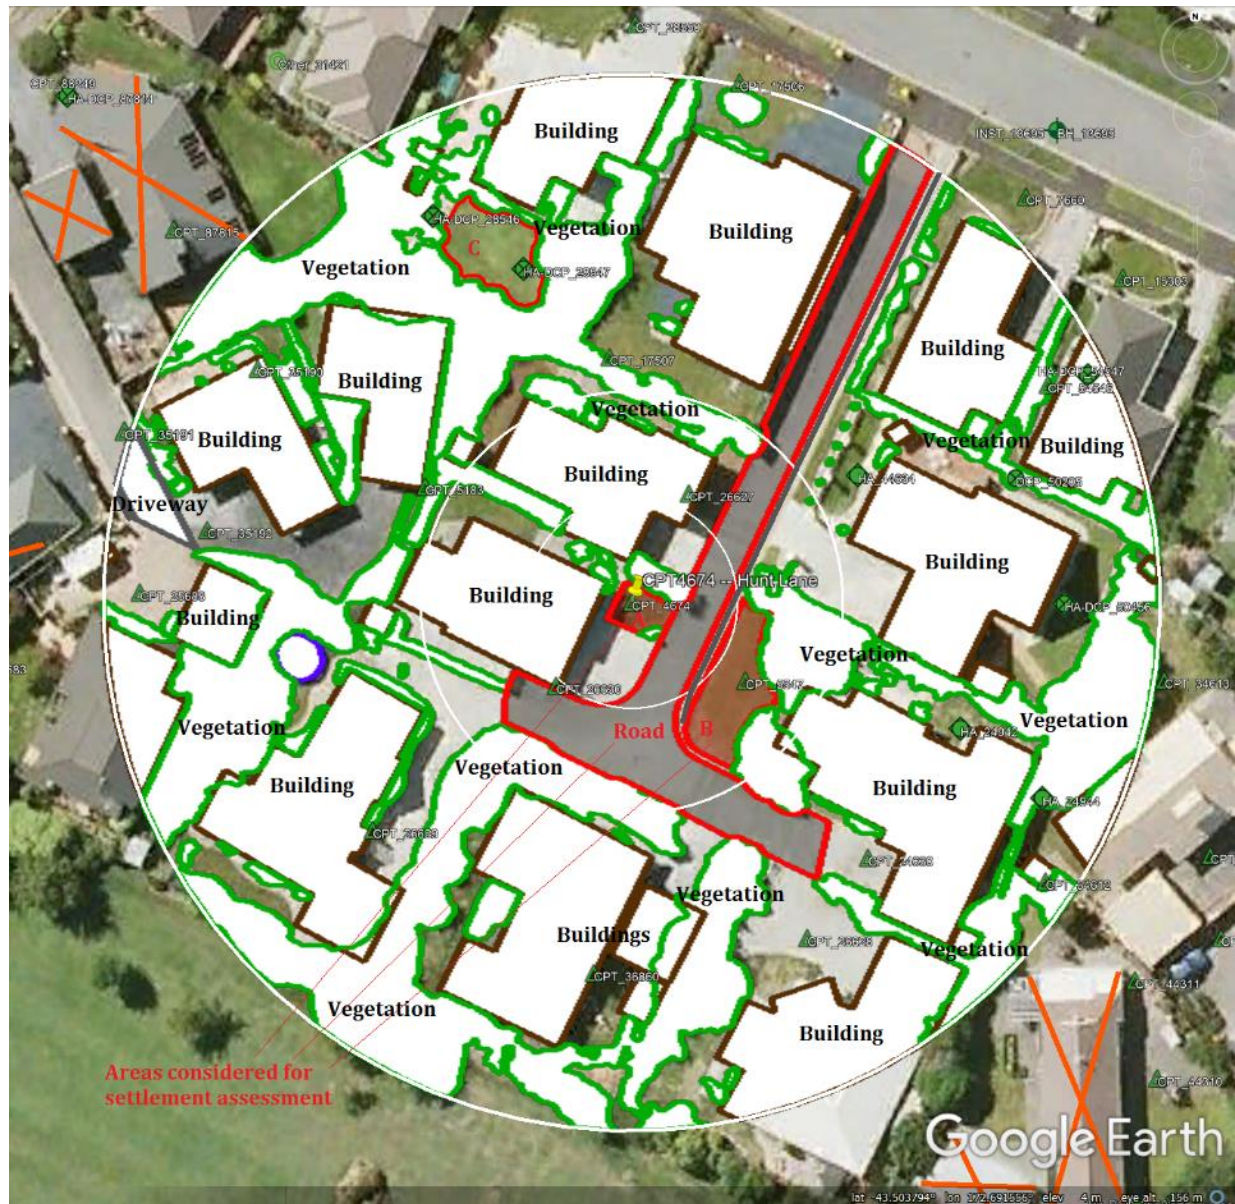
Figure 1: Site plan with areas where LiDAR survey data is considered.

Note 1: Three patches (outlined in red) in the free field were initially selected for settlement assessment as areas free of vegetation and structures. Further analyses such as proximity of a patch to a CPT, proximity of a patch to a property subjected to addition and/or demolition of a structure, front yard/backyard alterations (e.g., ploughing, rubble, scrap), aerial distribution of sediment ejecta, and density of LiDAR points for 2003 resulted in Patches A and B being selected for detailed settlement assessment and the third patch being discarded in detailed settlement assessment. In addition, since significant amounts of ejecta were observed on roads in the CES, the entire portion of the road within the 50-m buffer was considered for settlement assessment. Roads as hard, relatively flat surfaces provide many ground-classified points. Therefore, it is very useful to compare settlement estimates on roads with settlement estimates for the unpaved patches.

Note 7: The selection of CPTs for the area considered for settlement assessment (Figure 1) is based on the proximity of the CPTs to the considered areas. In accordance with that, the following table shows CPTs that were used for the volumetric settlement analysis in *Cliq v.3.0.3.2*, a CPT soil liquefaction software developed by GeoLogismiki. (The average volumetric settlements were reported in Table 8.)

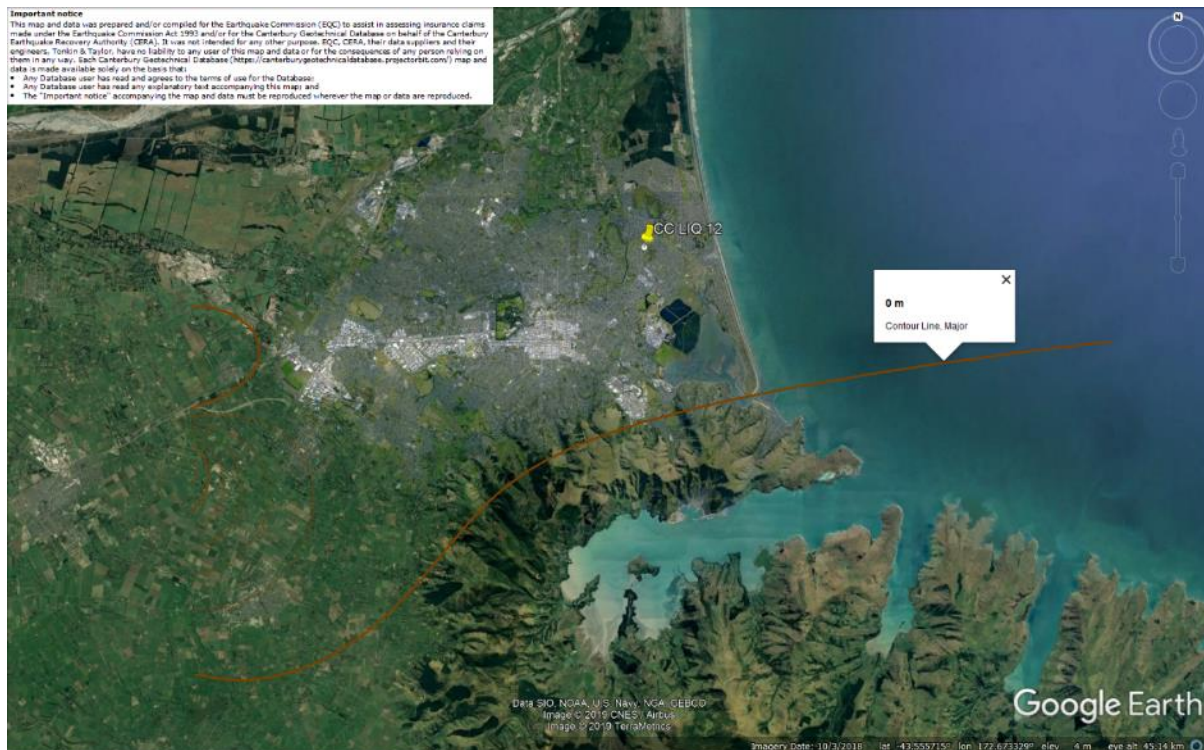
Figure 41: Vertical tectonic movements for Sep 2010 Earthquake.

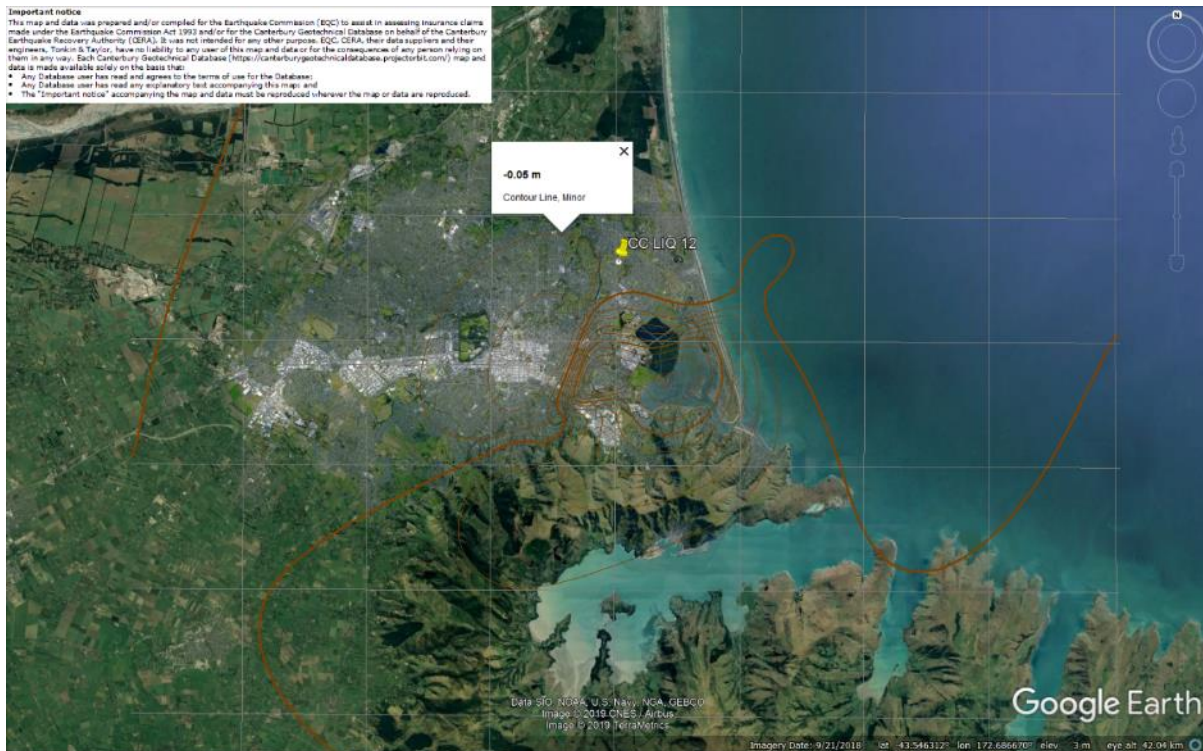
Figure 42: Vertical tectonic movements for Feb 2011 Earthquake.

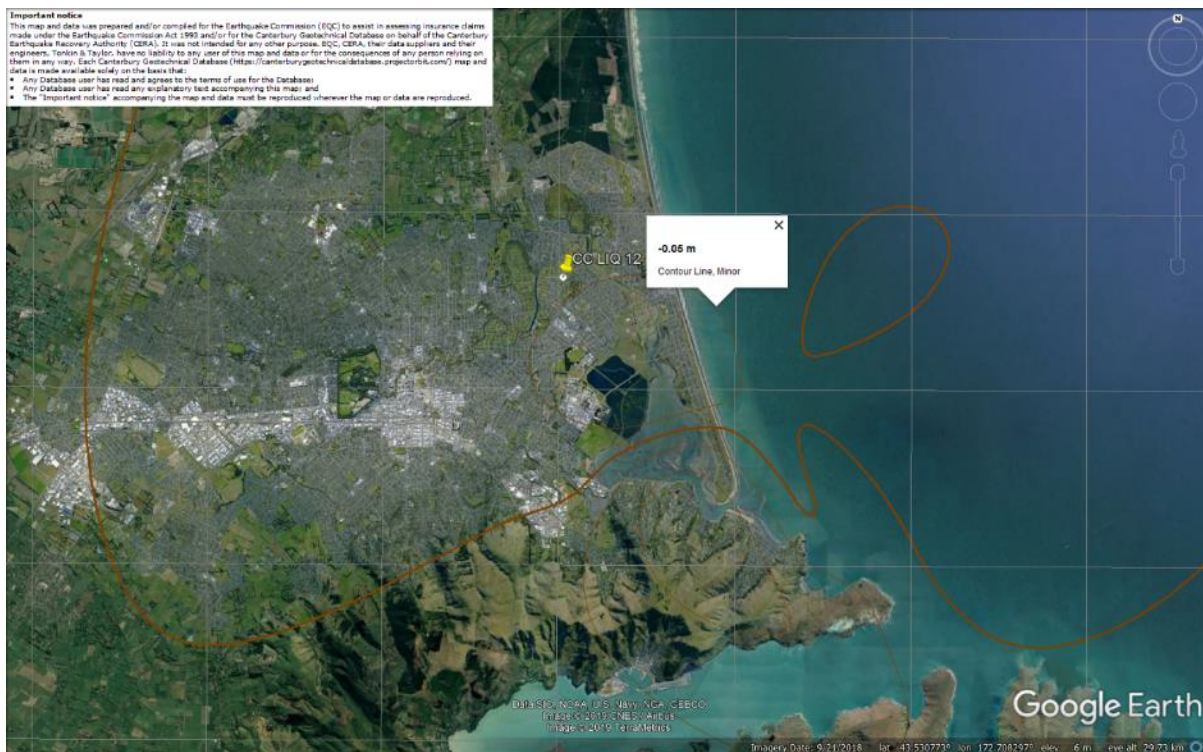
Figure 43: Vertical tectonic movements for June 2011 Earthquake.

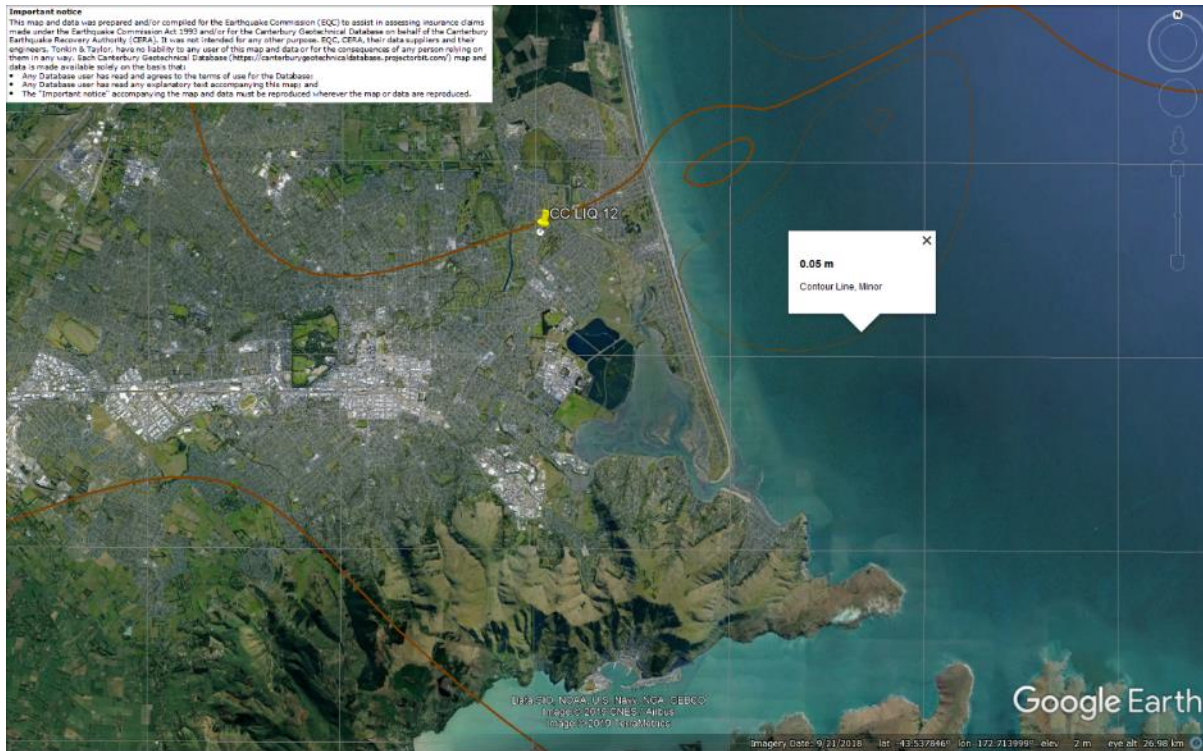
Figure 44: Vertical tectonic movements for Dec 2011 Earthquake.

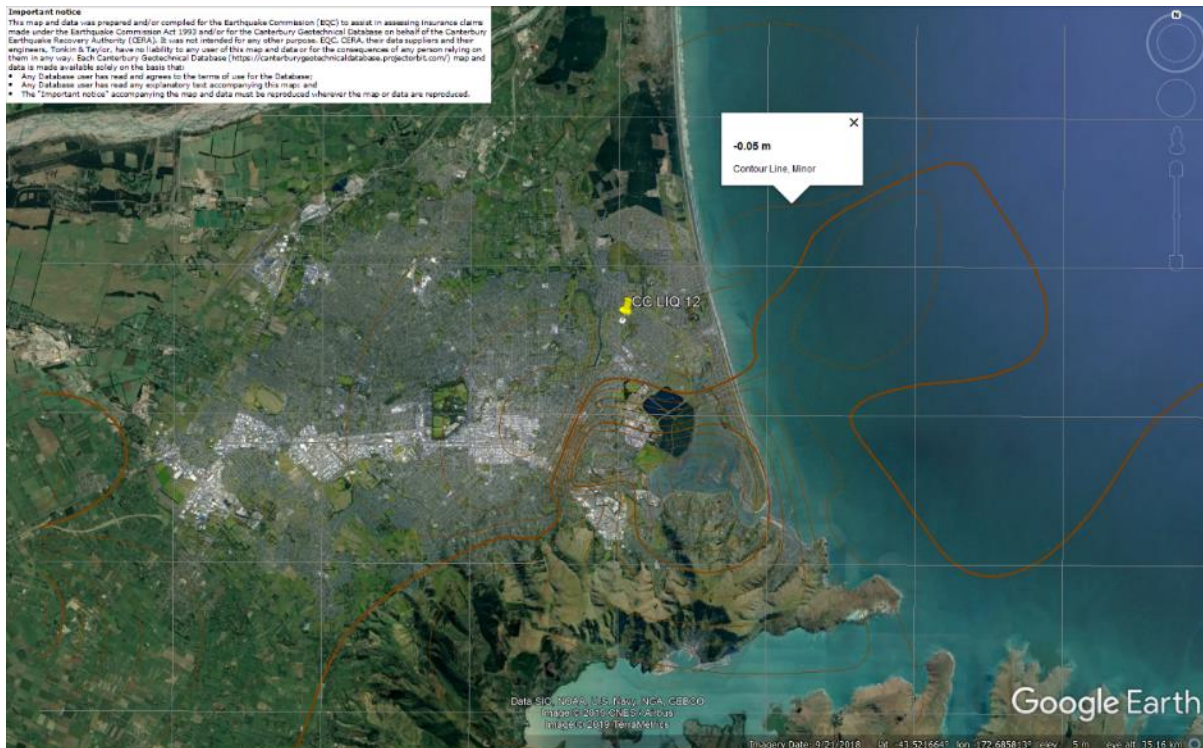
Figure 45: Vertical tectonic movements for Canterbury Earthquake Sequence.

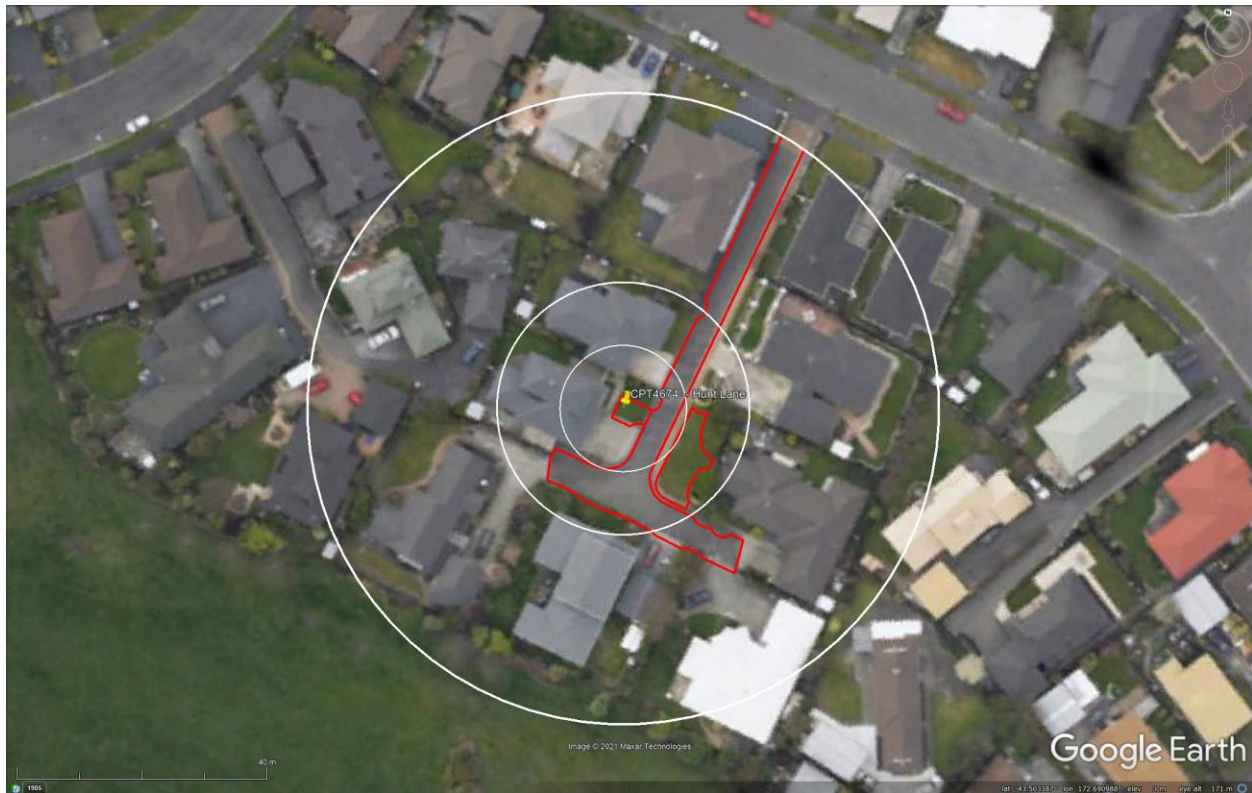
Figure 88: Aerial photograph showing absence of ejecta for Sep-10 EQ.

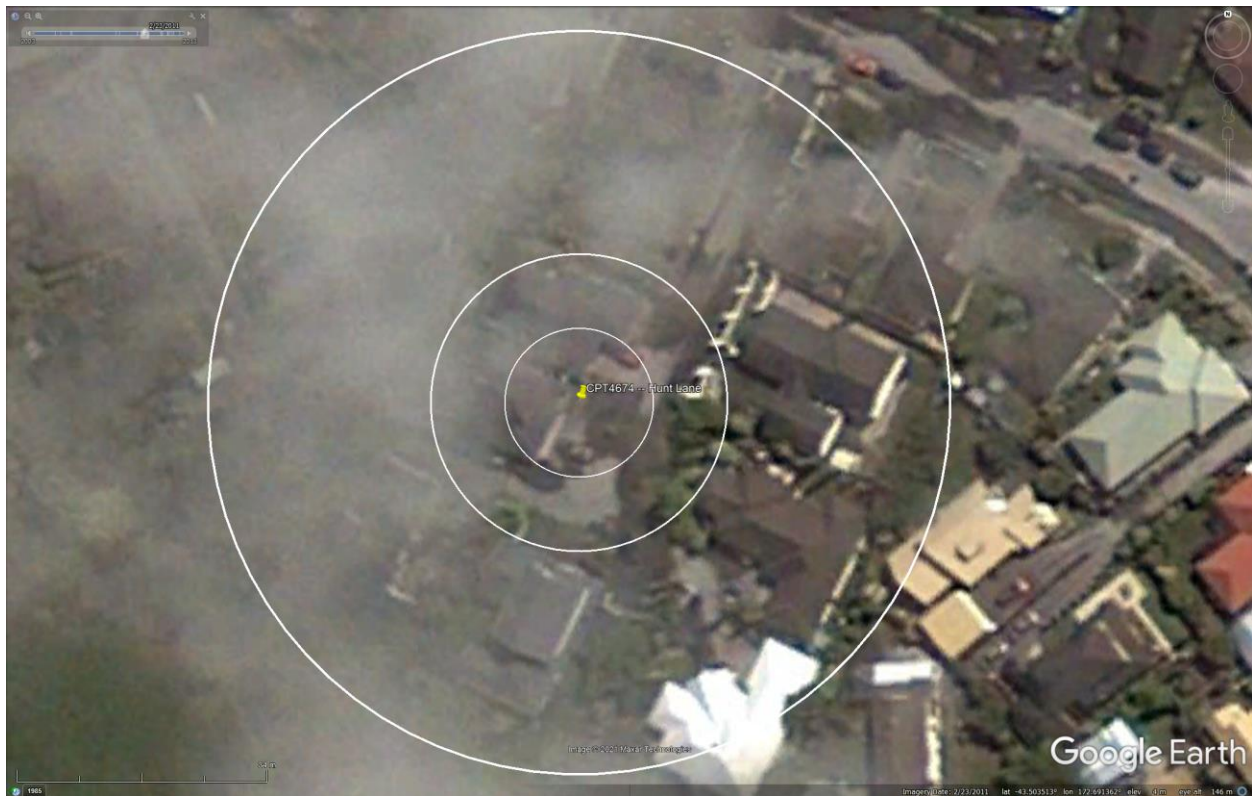
Figure 89: Satellite image from 23 Feb 2011 showing ejecta at the site.

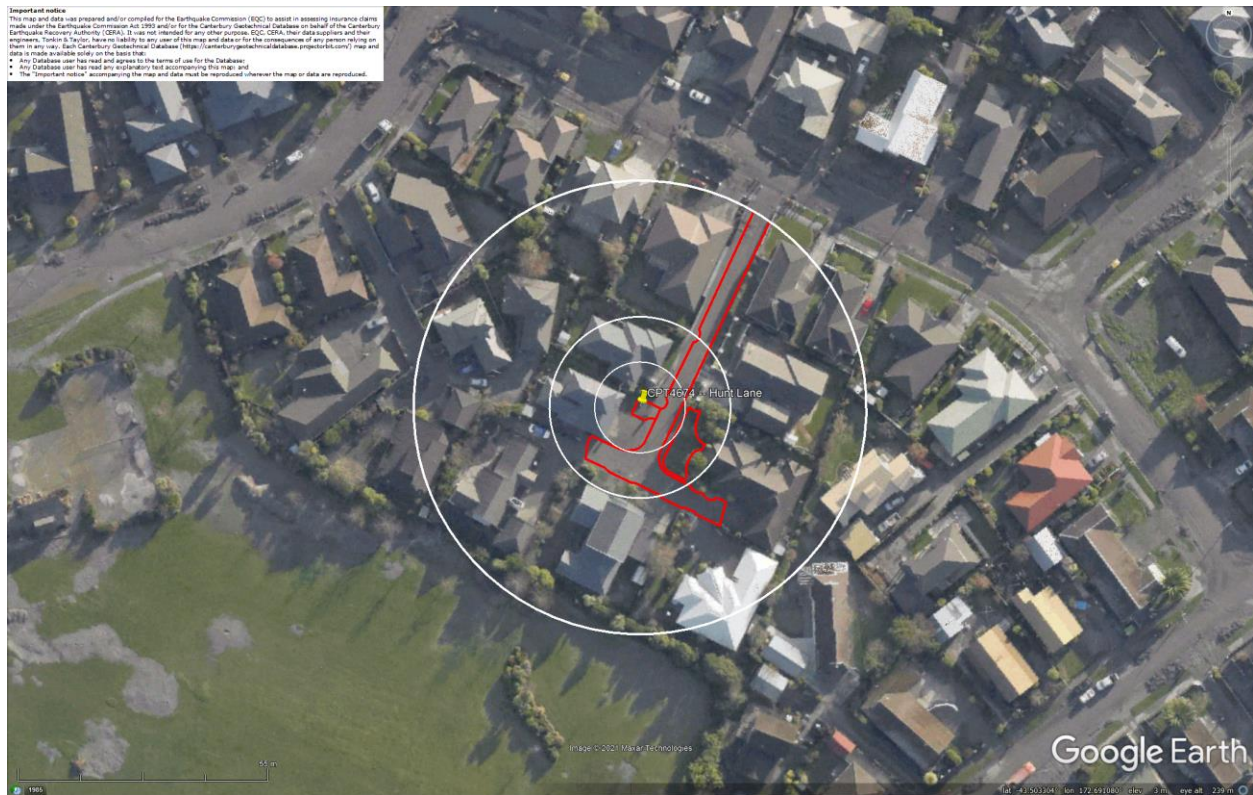
Figure 92: Aerial photograph from 14-15 Jun 2011 showing ejecta at the site.

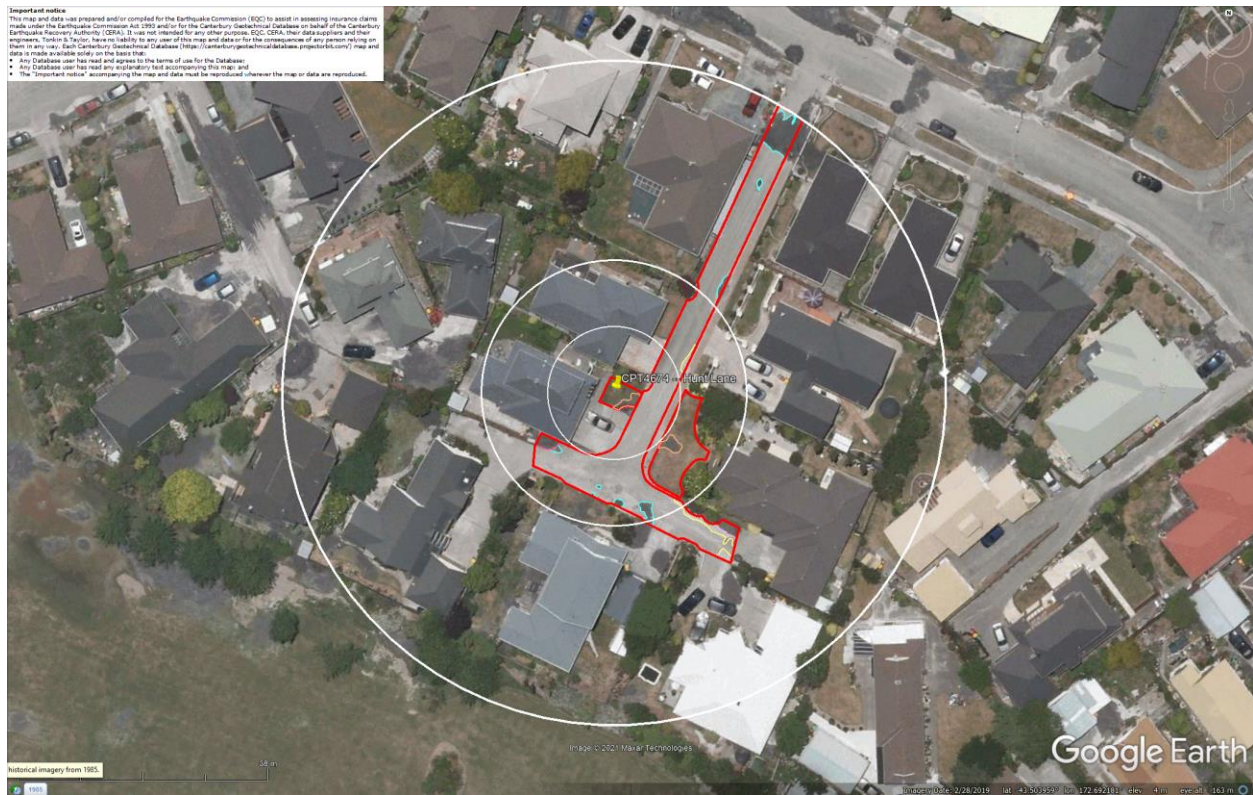
Figure 94: Ejecta outline for Dec-11 EQ.
