Appendix A.19:

Aldershot St – CPT 5261

Table 1: Site Description for Aldershot St (CPT 5261 – CC LIQ 9).

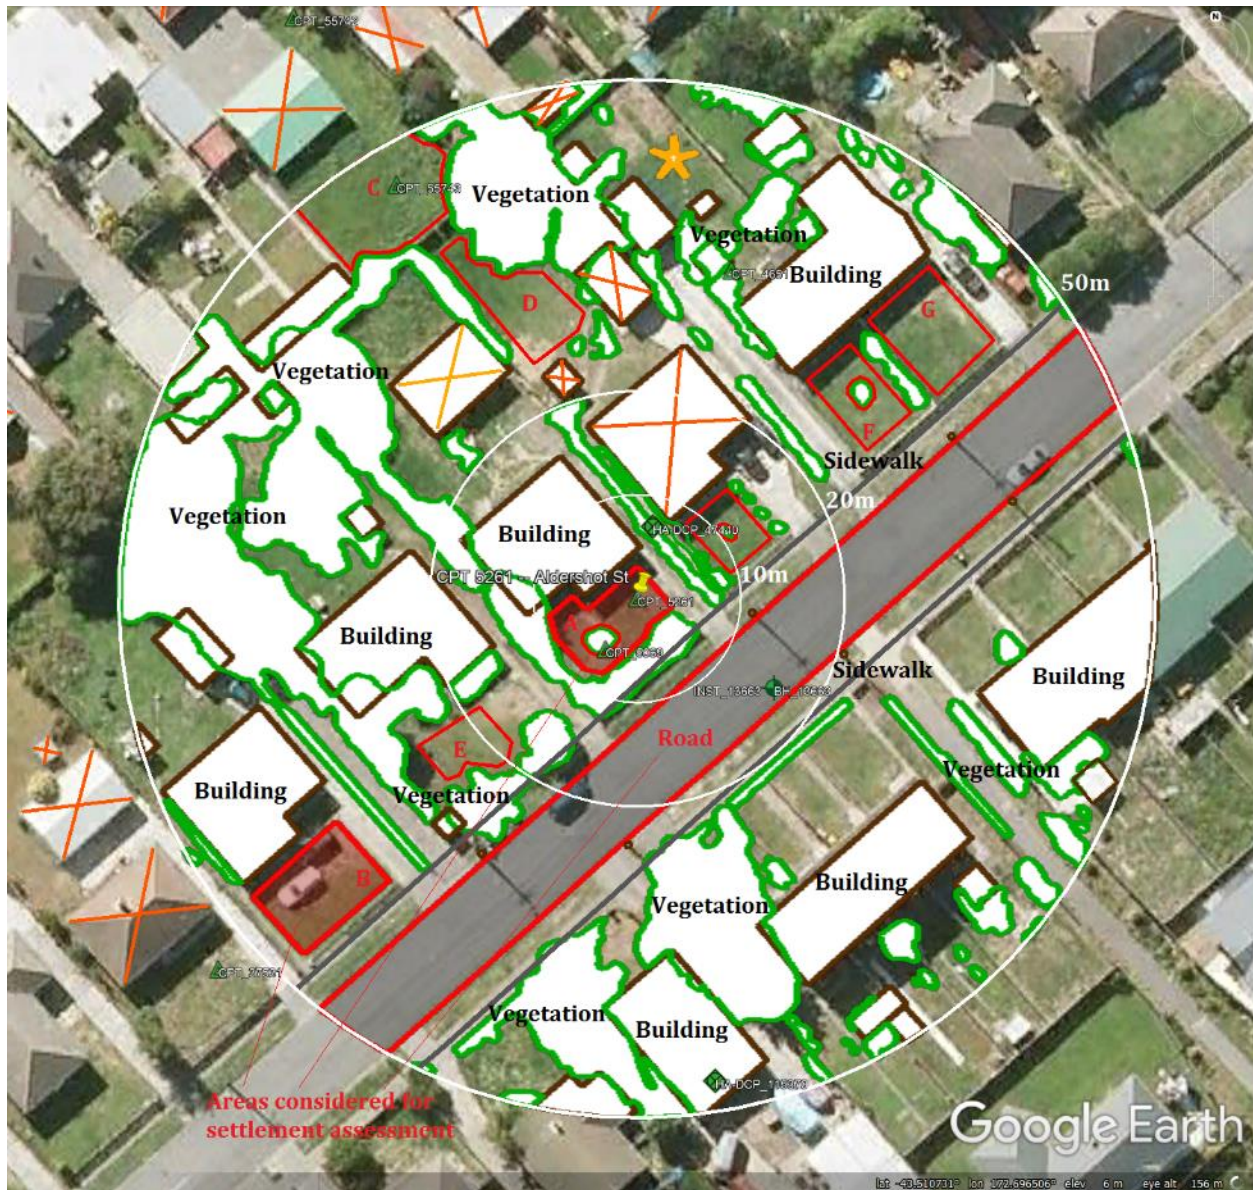
Figure 1: Site plan with areas where LiDAR survey data is considered.

Note 1: Eight patches (outlined in red) in free field were initially selected for settlement assessment as areas free of vegetation and structures. Further analyses such as proximity of a patch to a CPT, proximity of a patch to a property subjected to addition and/or demolition of a structure, front yard/backyard alterations (e.g., ploughing, rubble, scrap), aerial distribution of sediment ejecta, and density of LiDAR points for 2003 resulted in Patches A and B being selected for detailed settlement assessment and other patches being discarded in detailed settlement assessment. In addition, since significant amounts of ejecta were observed on roads in the CES, the entire portion of the road was analyzed for settlement. Roads as hard, relatively flat surfaces provide many ground-classified points. Therefore, it is very useful to compare settlement estimates on roads with settlement estimates for the unpaved patches.

Note 8: The original outline of Patch A was changed to the one shown in Figure 1; however, the original outline still remains in some of the following figures.

Note 9: The selection of CPTs for the area considered for settlement assessment (Figure 1) is based on the proximity of the CPTs to the considered areas. In accordance with that, the following table shows CPTs that were used for the volumetric settlement analysis in *Cliq v.3.0.3.2*, a CPT soil liquefaction software developed by GeoLogismiki. (The average volumetric settlements were reported in Table 8.)

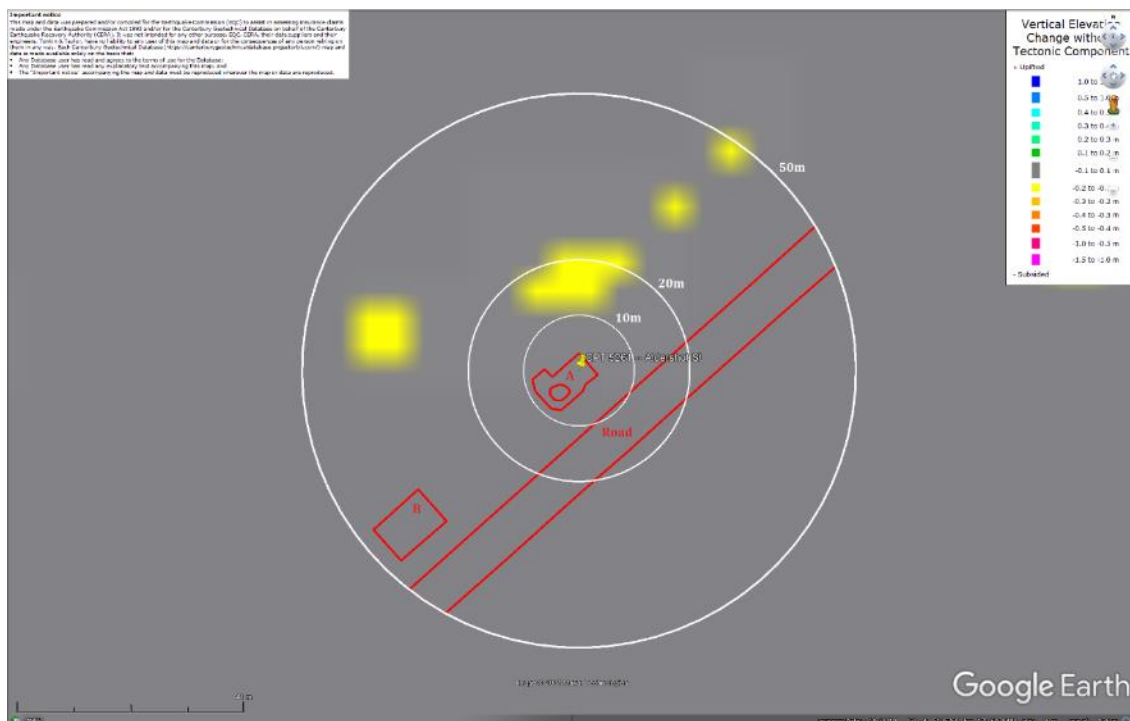
Figure 33: Ground surface subsidence without tectonic component for June 2011 Earthquake according to the LiDAR DEM.

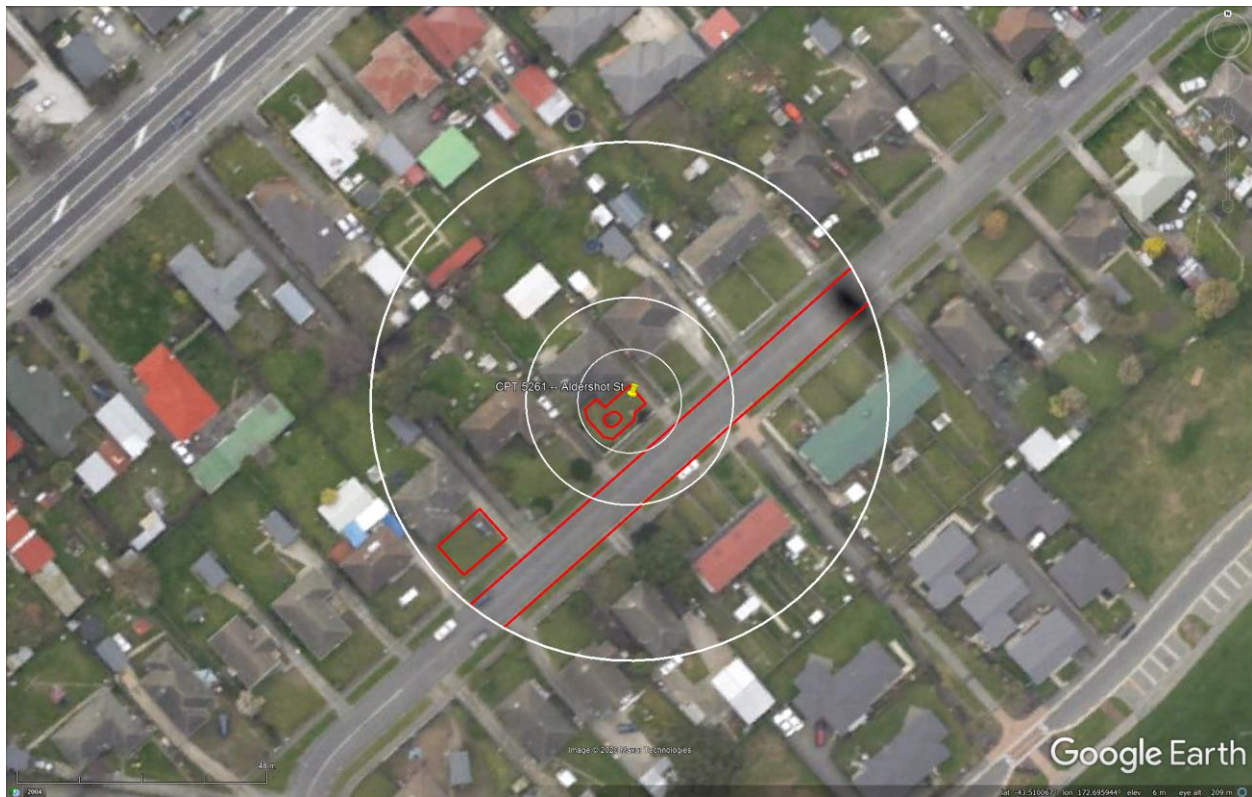
Figure 88: Absence of ejecta at the site for Sep-10 EQ.

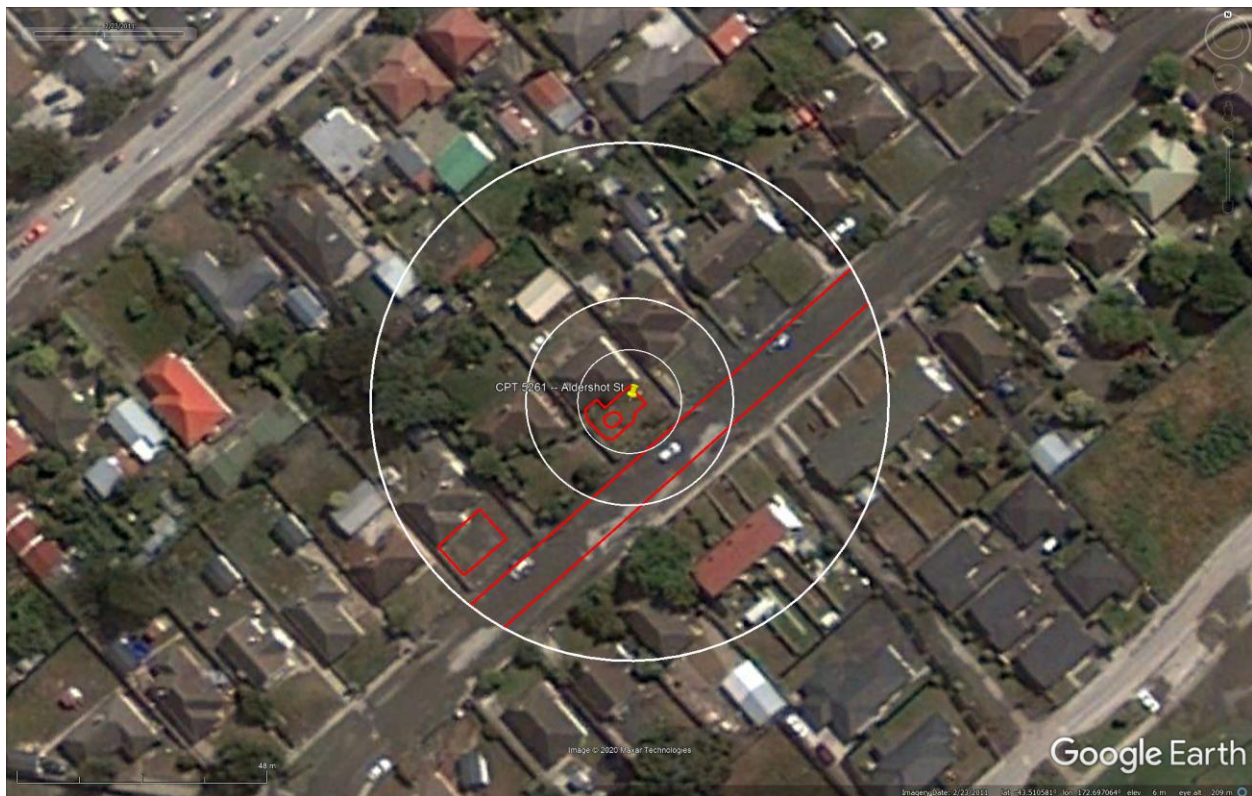
Figure 89: Satellite image showing ejecta at the site for Feb-11 EQ.

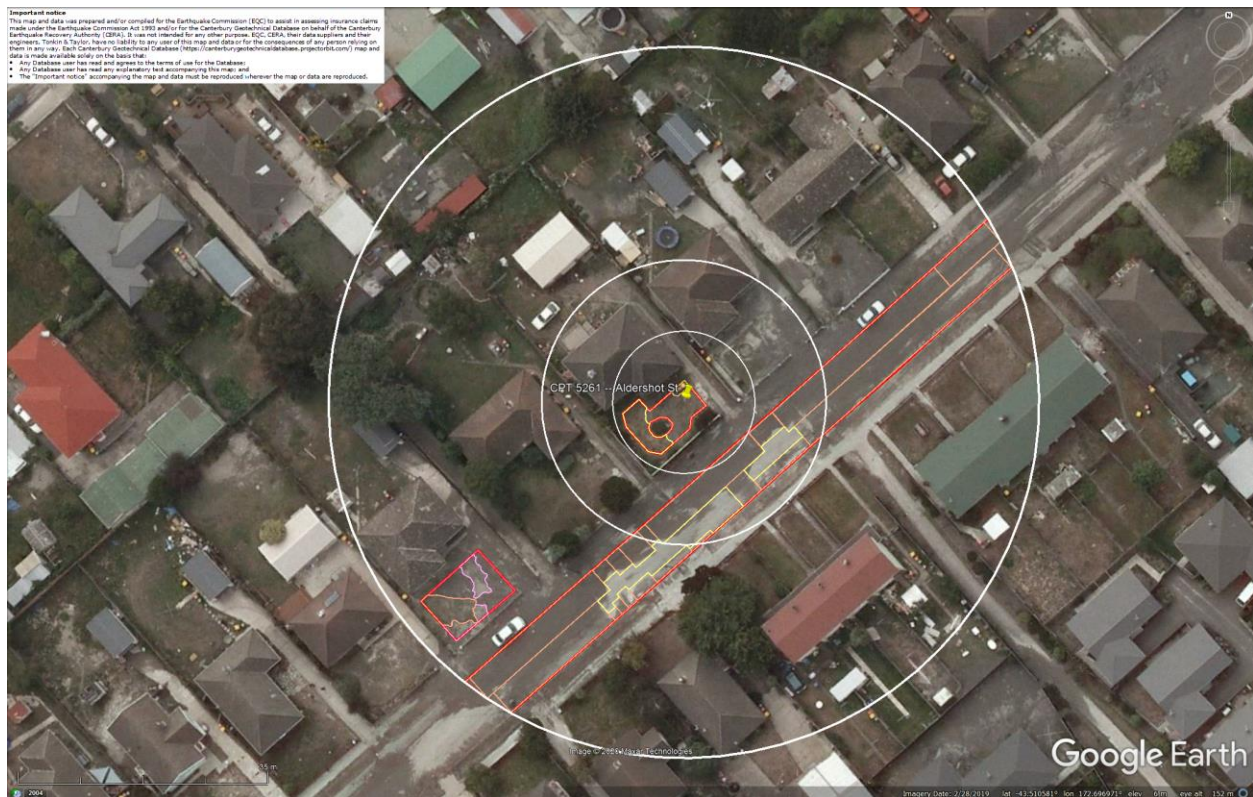
Figure 90: Ejecta outline for Feb-11 EQ.

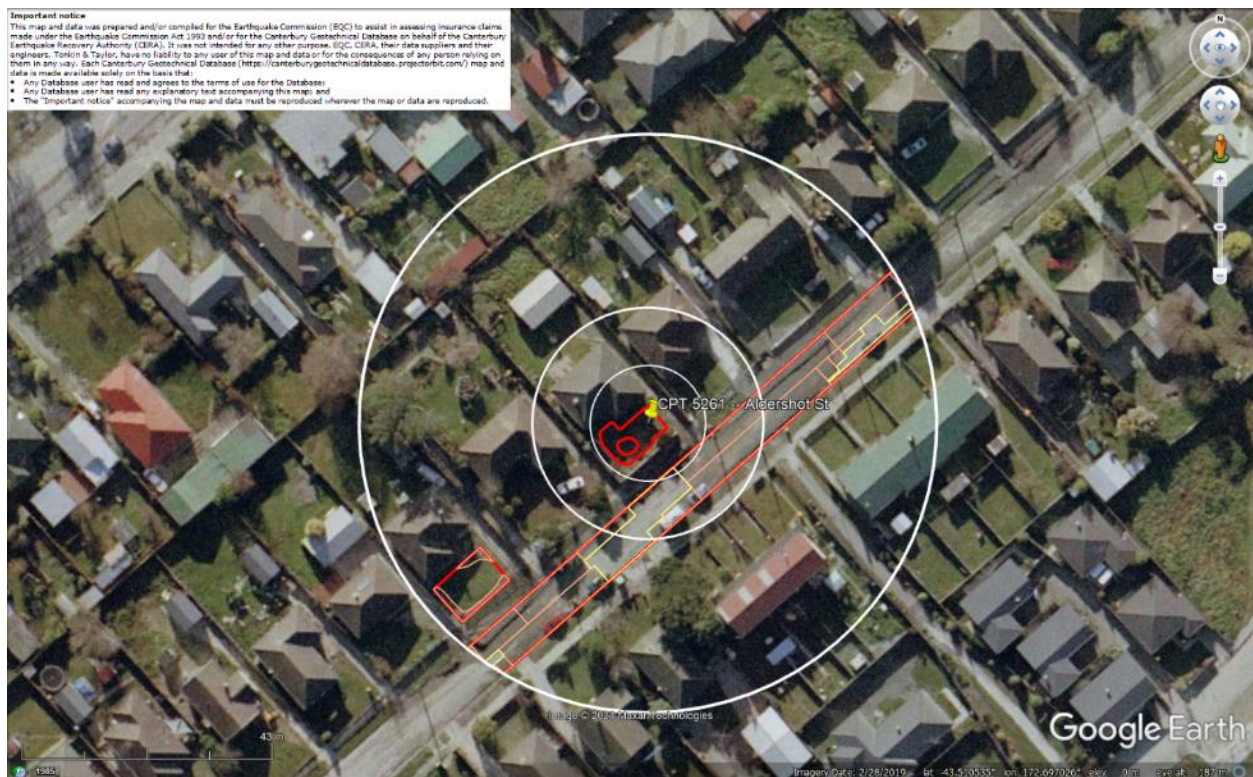
Figure 91: Ejecta outline for Jun-11 EQ.

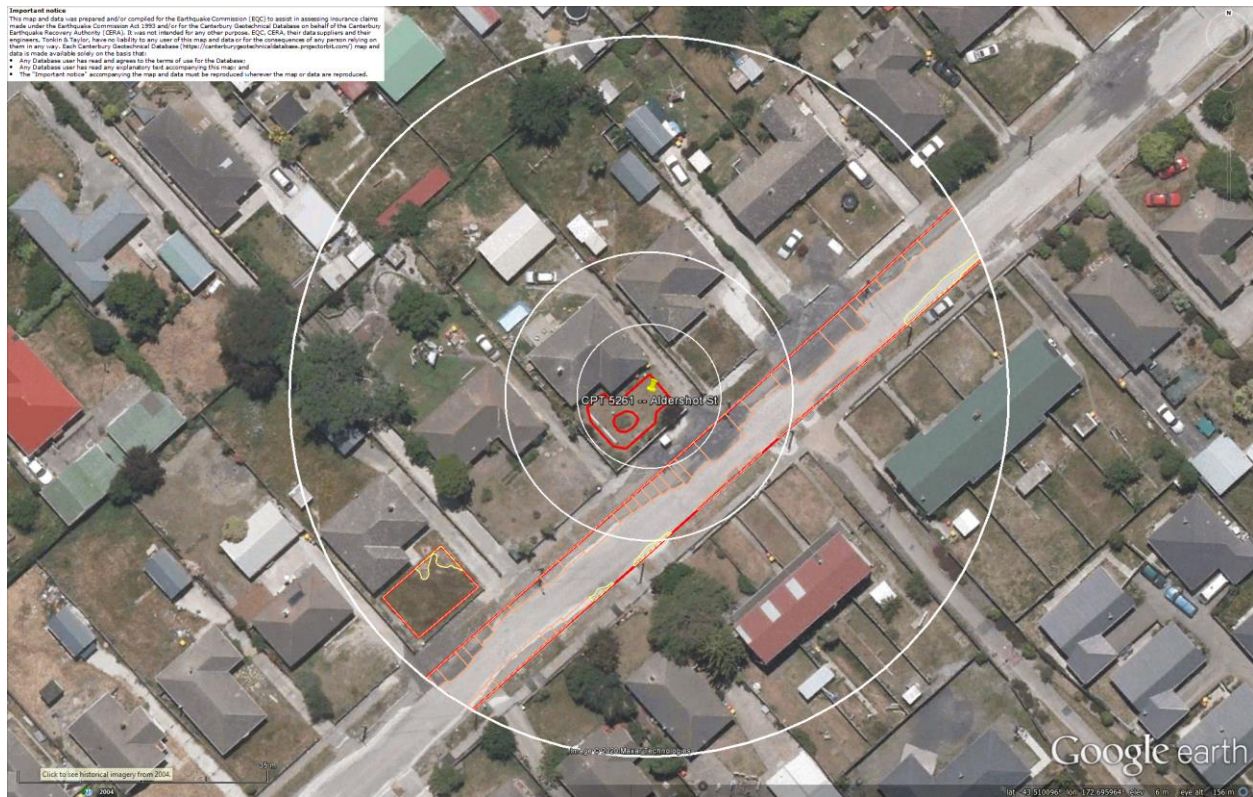
Figure 92: Ejecta outline for Dec-11 EQ.
