Appendix A.1:

Shirley Intermediate School – VsVp 57203

Liquefaction Ejecta Case Histories for 2010-11 Canterbury Earthquakes

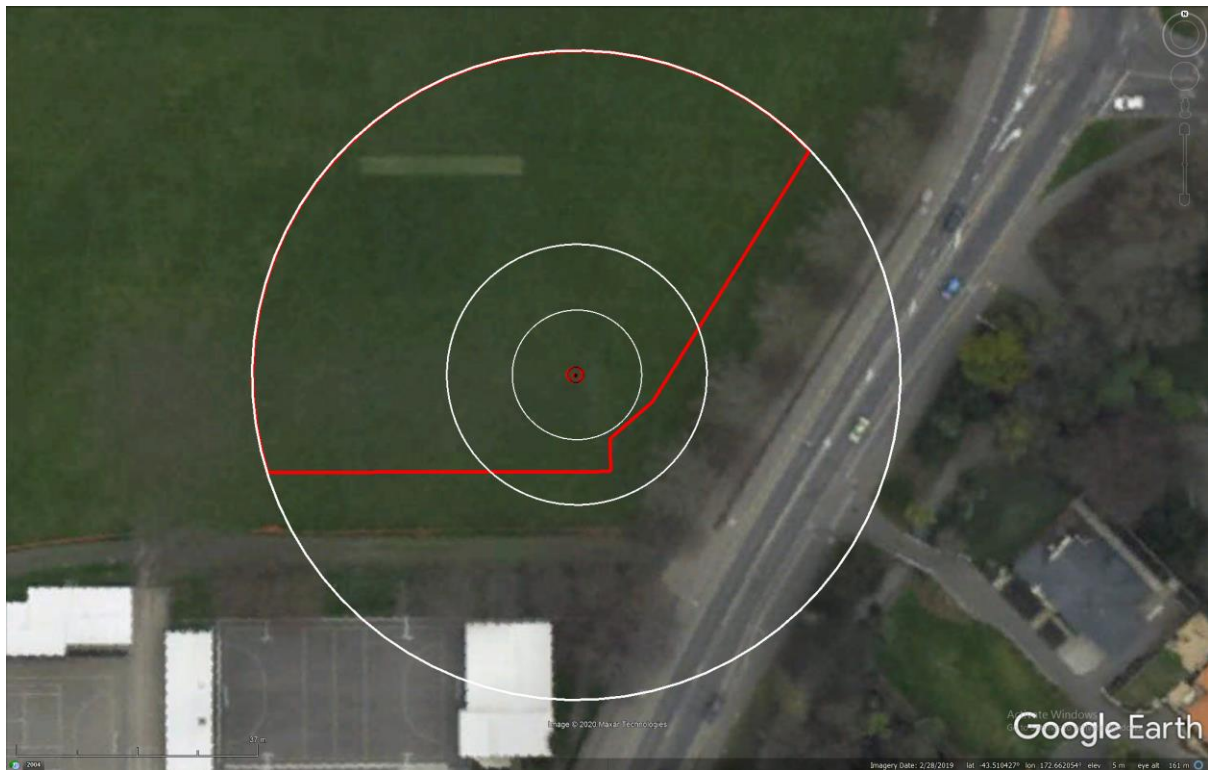
Figure 60: Ejecta outline for Sep-10 EQ.

Note 4: The values in Table 9 correspond to the coverage area of ejecta outlined in aerial photographs (Figures 60 through 63) and the lower and upper estimates of ejecta height based on residents' reports (e.g., <https://www.odt.co.nz/lifestyle/magazine/all-one-one-all>) and ground photographs taken in neighboring areas. The ejecta-induced settlement using photographs and engineering judgment, $S_{E,P}$, is estimated as

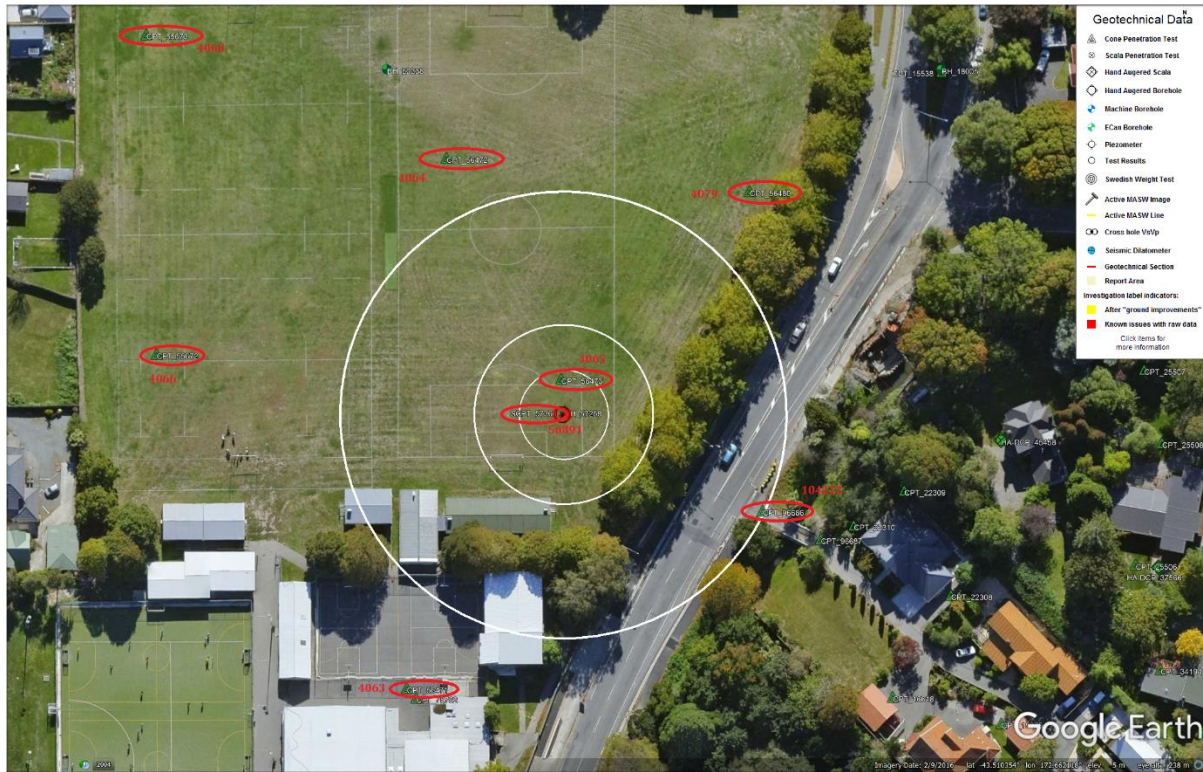
Figure 64. Locations of Cone Penetration Tests (CPTs).

Note 7: Based on the borehole log (BH 57258, Figure 64), the soil profile consists of (1) topsoil to a depth of 0.4 m, (2) interchangeable layers of non-plastic to low plasticity silt and silty sand, ML, the Yaldhurst members of the Springston formation, to a depth of 3.35 m, (3) poorly graded sand, SP, of
