Appendix A.23:

Normans Rd/Papanui Rd – VsVp 57200

Liquefaction Ejecta Case Histories for 2010-11 Canterbury Earthquakes

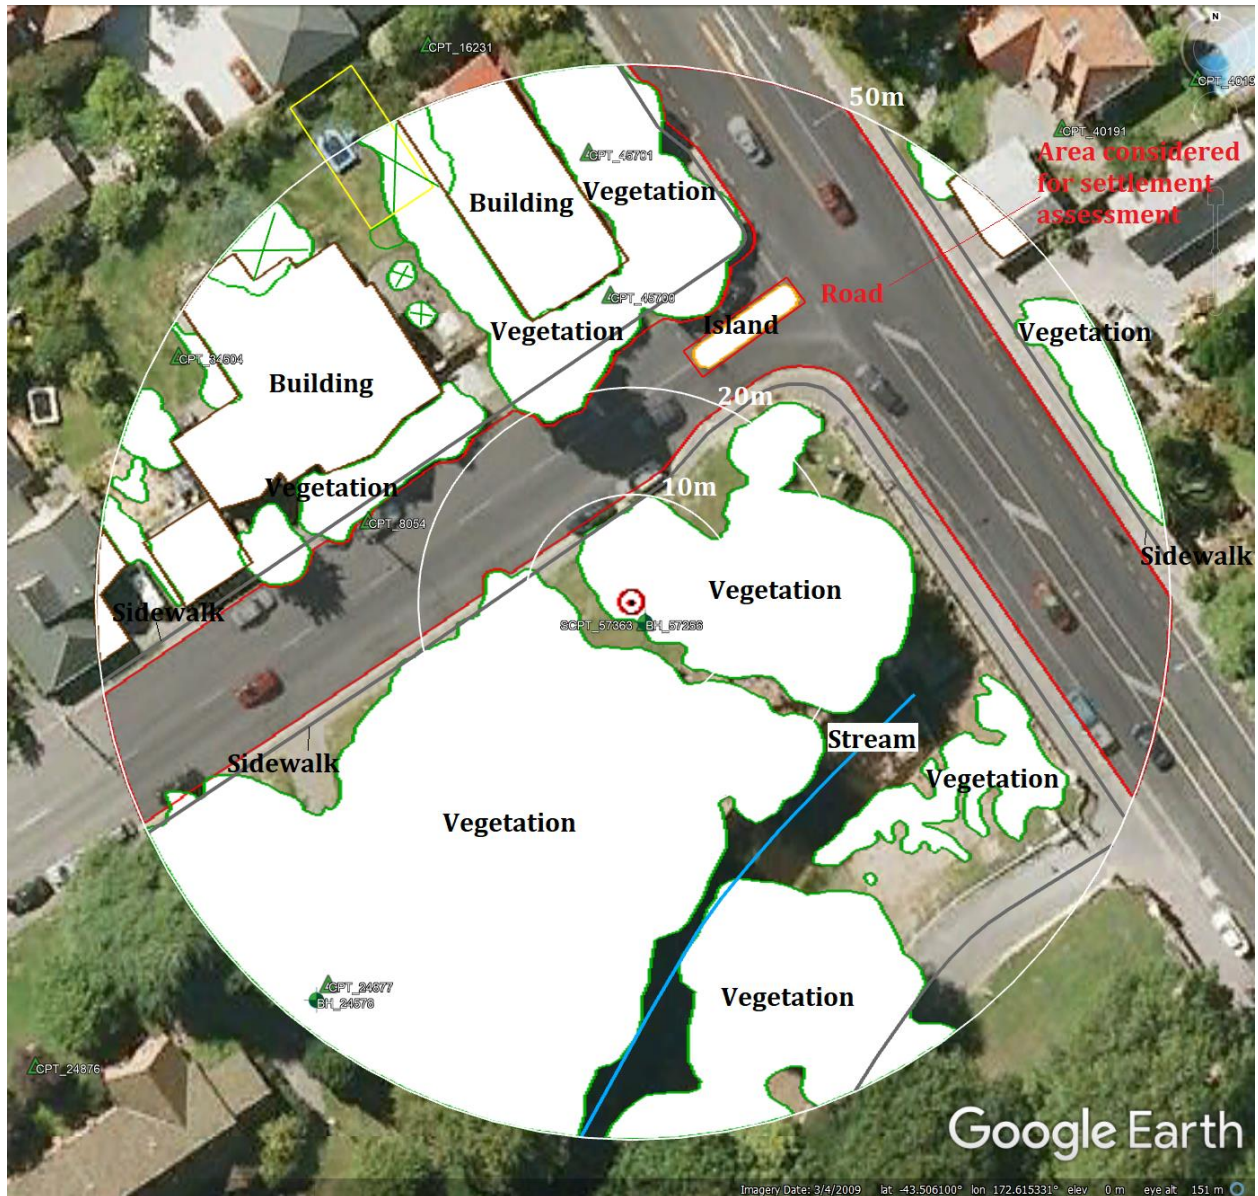
Figure 1: Site plan with areas where ejecta-induced settlement is considered.

Note 1: Road (outlined in red) is the only area selected for detailed settlement assessment because most of the site is covered with vegetation and buildings or was subjected to the addition of a structure and/or front yard/backyard alterations (e.g., addition or removal of vegetation). However, the LiDAR-based settlement analysis was not performed due to the evident absence of ejecta for the Sep-10 EQ. Also, the site was not assessed for the ejecta-induced settlement for the Feb-11, Jun-11, and Dec-11 EQs due to lateral spreading.

- $A_{E,thick,i}$ and $H_{E,thick,i}$ are the area and the height of a thick ejecta layer, respectively;
- $A_{E,thin,j}$ and $H_{E,thin,j}$ are the area and the height of a thin ejecta layer, respectively;
- A_T is the total assessment area for a buffer being considered (Figure 1).

Note 5: The selection of CPTs for the area considered for settlement assessment (Figure 1) is based on the proximity of the CPTs to the considered areas. In accordance with that, the following table shows CPTs that were used for the volumetric settlement analysis in *Cliq v.3.0.3.2*, a CPT soil liquefaction software developed by GeoLogismiki. (The average volumetric settlements were reported in Table 8.)

Note 6: Based on the borehole log (BH 57256, Figure 1), the groundwater table is at a depth of 3.2 m below the ground surface. The soil profile consists of (1) topsoil (organic silt) to a depth of 0.1 m and silty fill to a depth of 0.5 m, (2) silt, ML, to a depth of 4.15 m, (3) silty sand, SM, to a depth of 4.4 m, (4) fine sand, SP, to a depth of 6.35 m, (5) sandy fine to coarse gravel, GW, to a depth of 11.65 m, (6) silt with minor gravel, ML, to a depth of 11.85 m, (7) fine sand, SP, to a depth of 13.15 m, (8) sandy fine to coarse gravel, GW, to a depth of 15.1 m, and (9) fine to coarse sand, SW, to a depth of 15.65 m (the end of the borehole). All soils layers (apart from the topsoil and the fill) are the Yaldhurst members of the Springston formation.

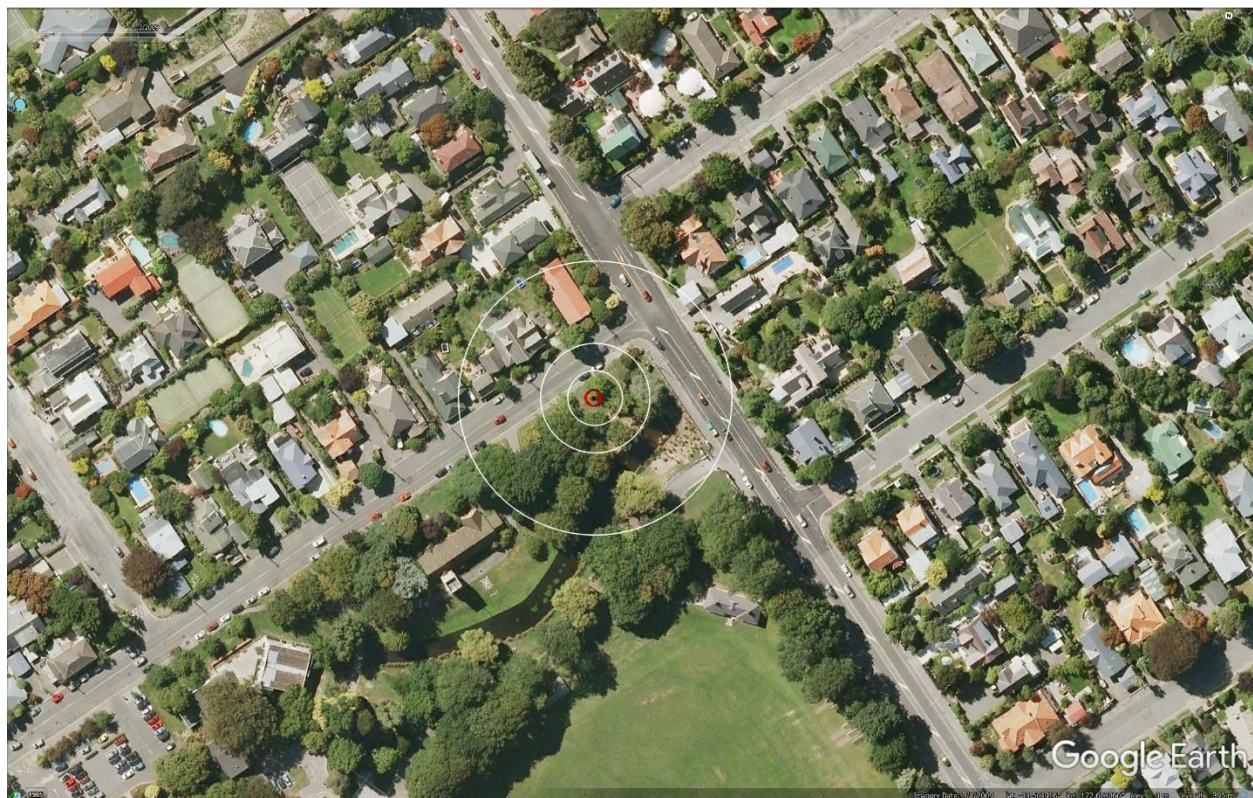
Figure 3: Position of the site relative to nearby buildings, vegetation, and free-face features.

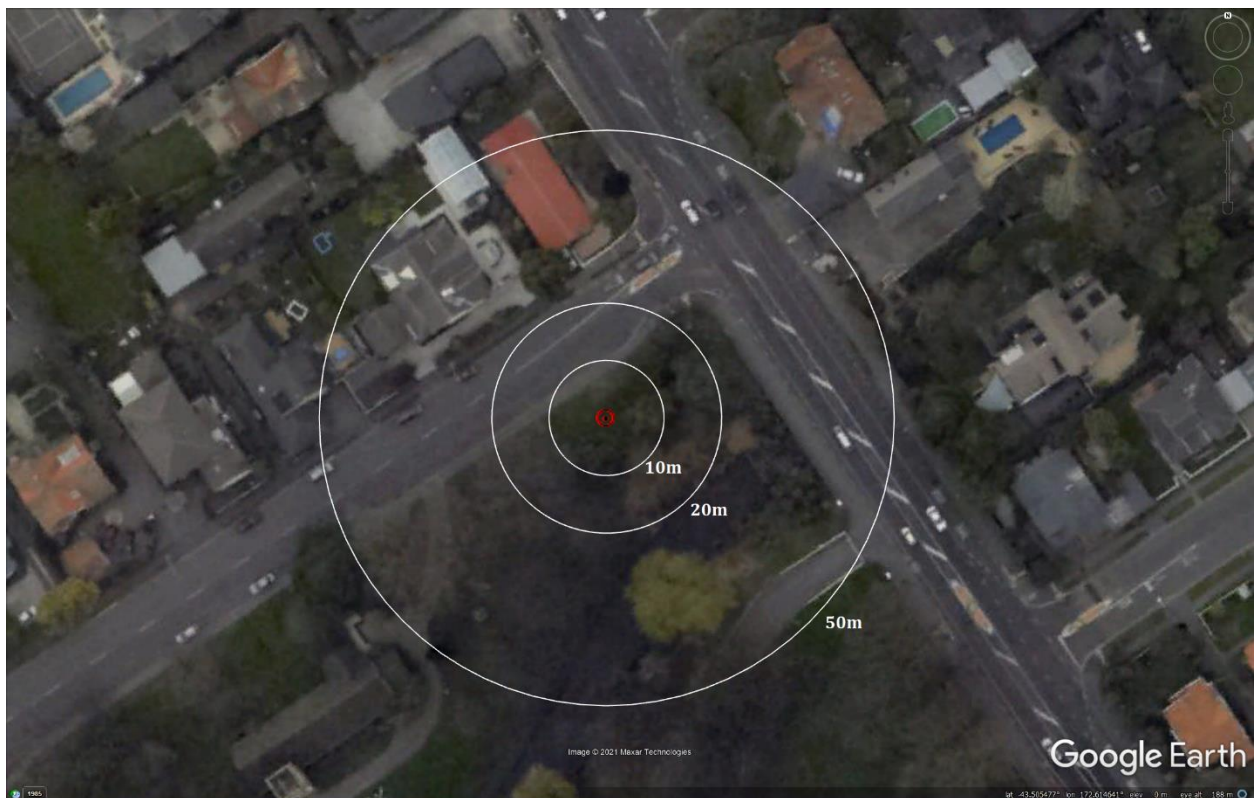
Figure 11: Aerial photograph of the site taken on Sep 4, 2010.

Note 3: The values in Table 9 are based on satellite and aerial photographs (Figures 8, 9, and 11). The ejecta-induced settlement using photographs and engineering judgment, $S_{E,P}$, is estimated as

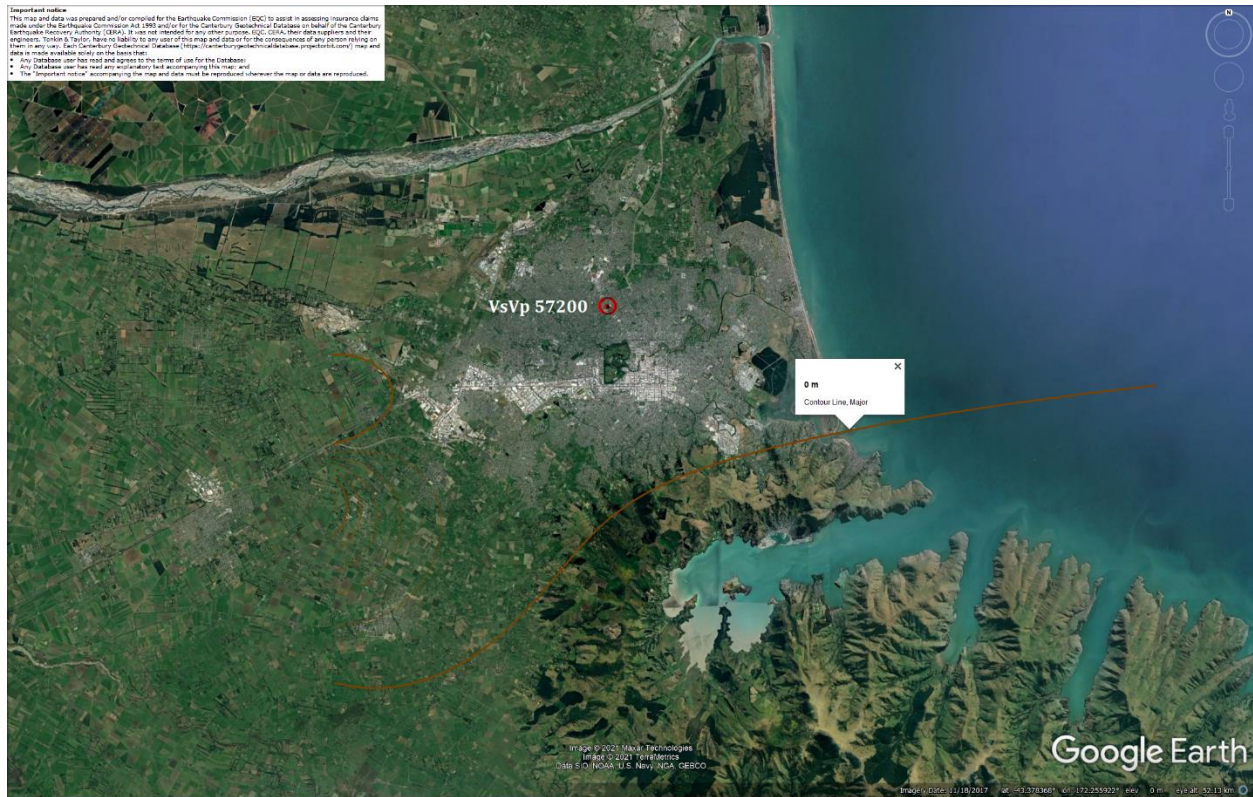
Figure 21: Vertical tectonic movements for Sep 2010 Earthquake.

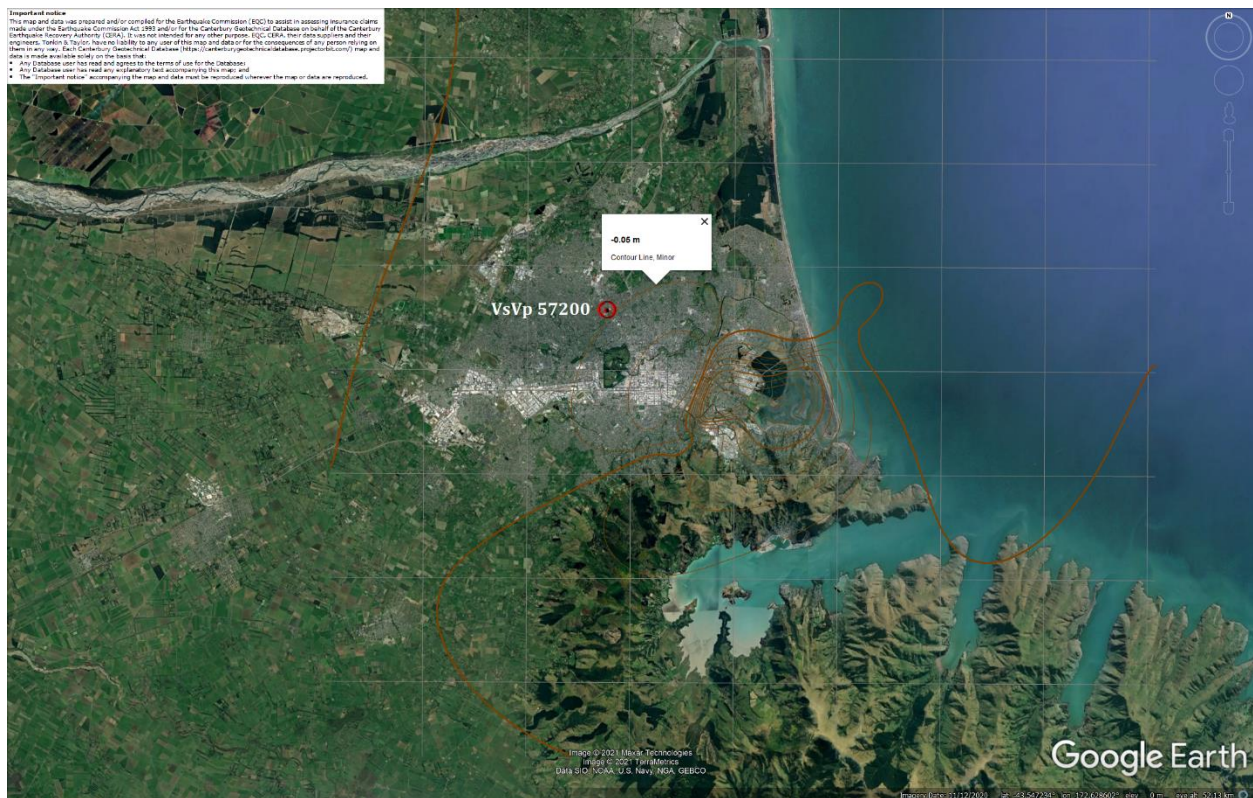
Figure 22: Vertical tectonic movements for Feb 2011 Earthquake.

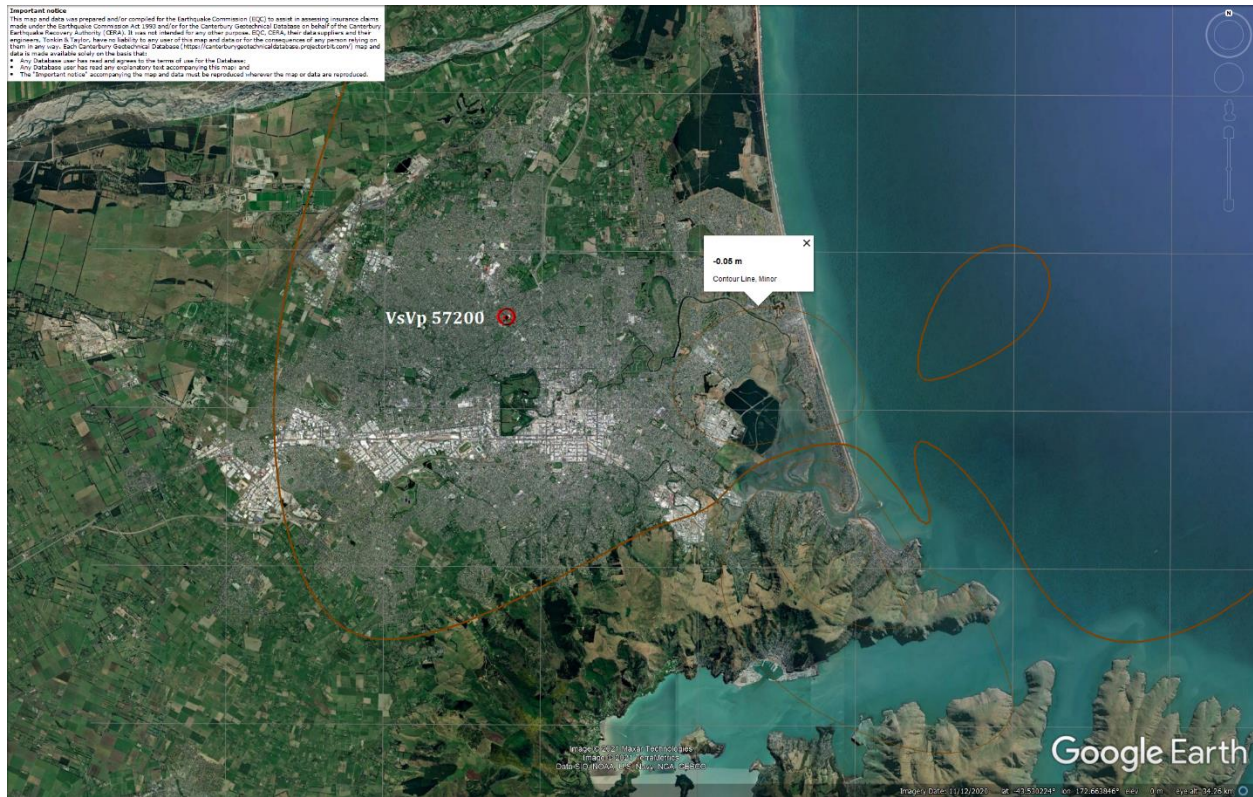
Figure 23: Vertical tectonic movements for June 2011 Earthquake.

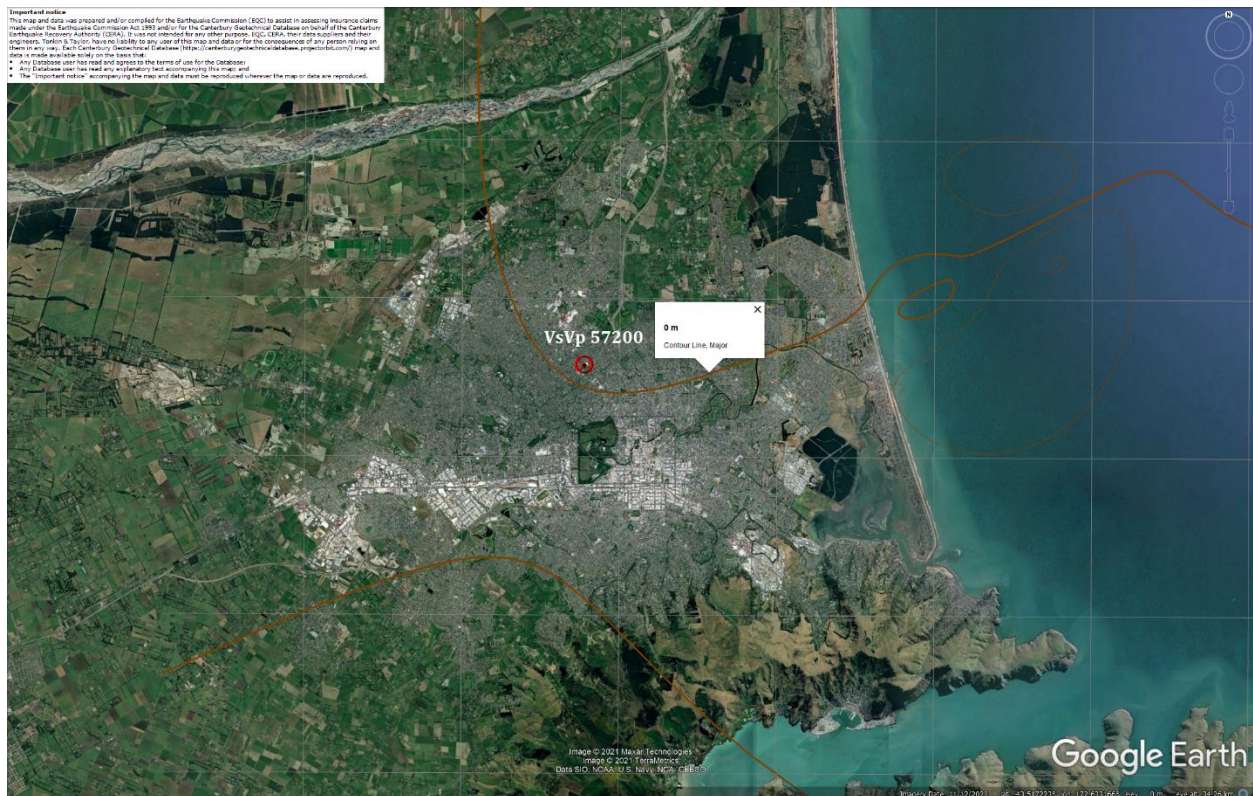
Figure 24: Vertical tectonic movements for Dec 2011 Earthquake.

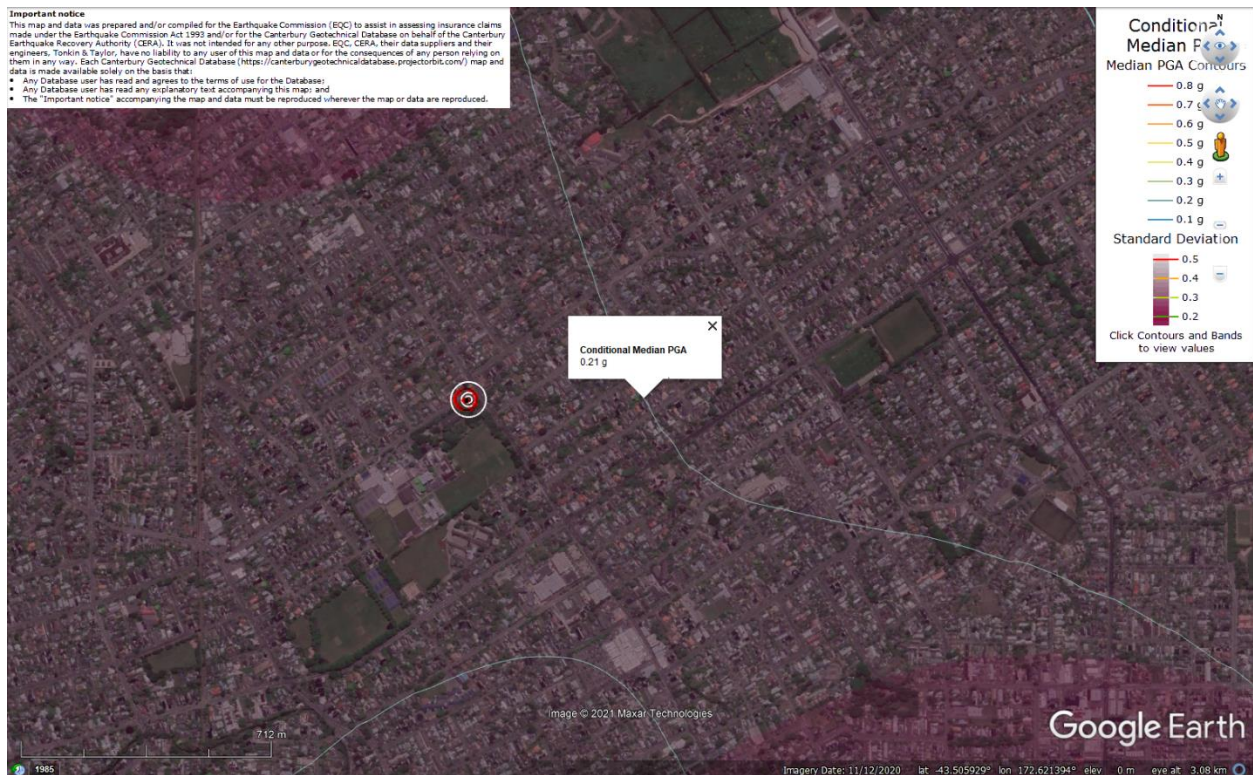
Figure 26: PGA for Sep-10 EQ (st. dev. = 0.300-0.325 ln units).

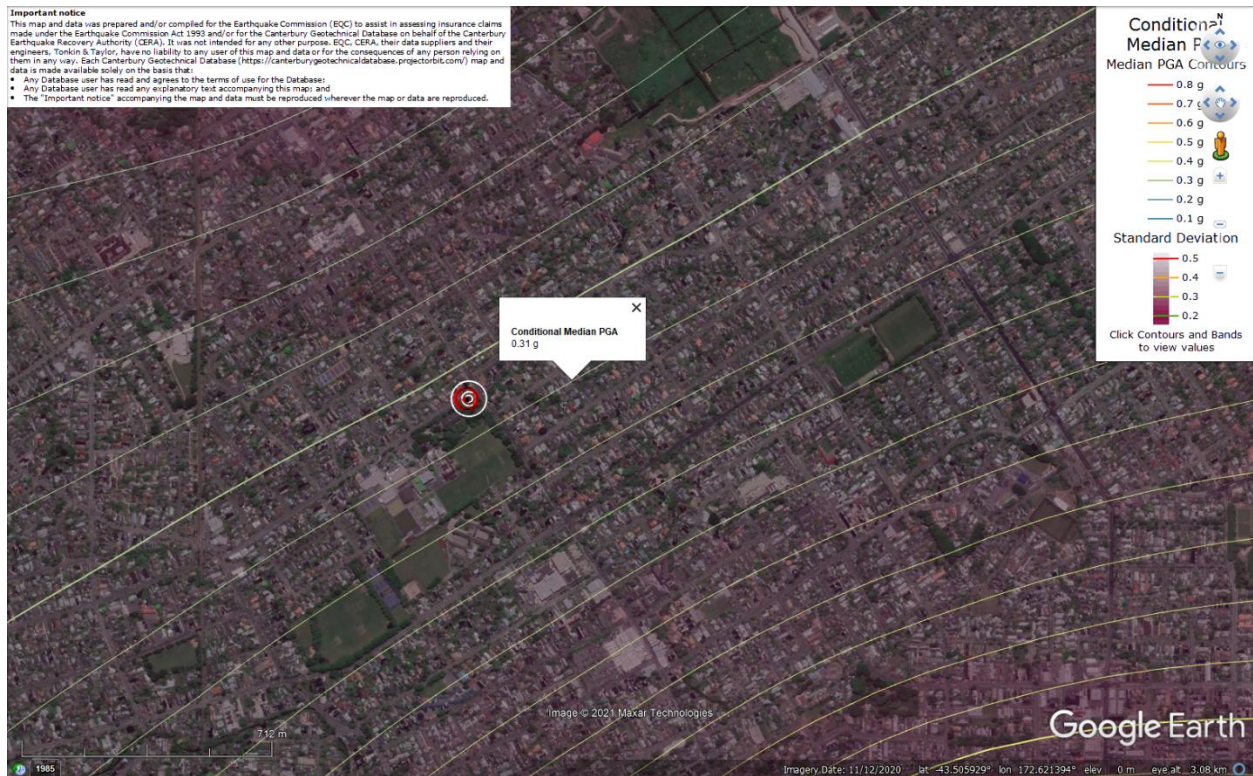
Figure 27: PGA for Feb-11 EQ (st. dev. = 0.350-0.375 ln units).

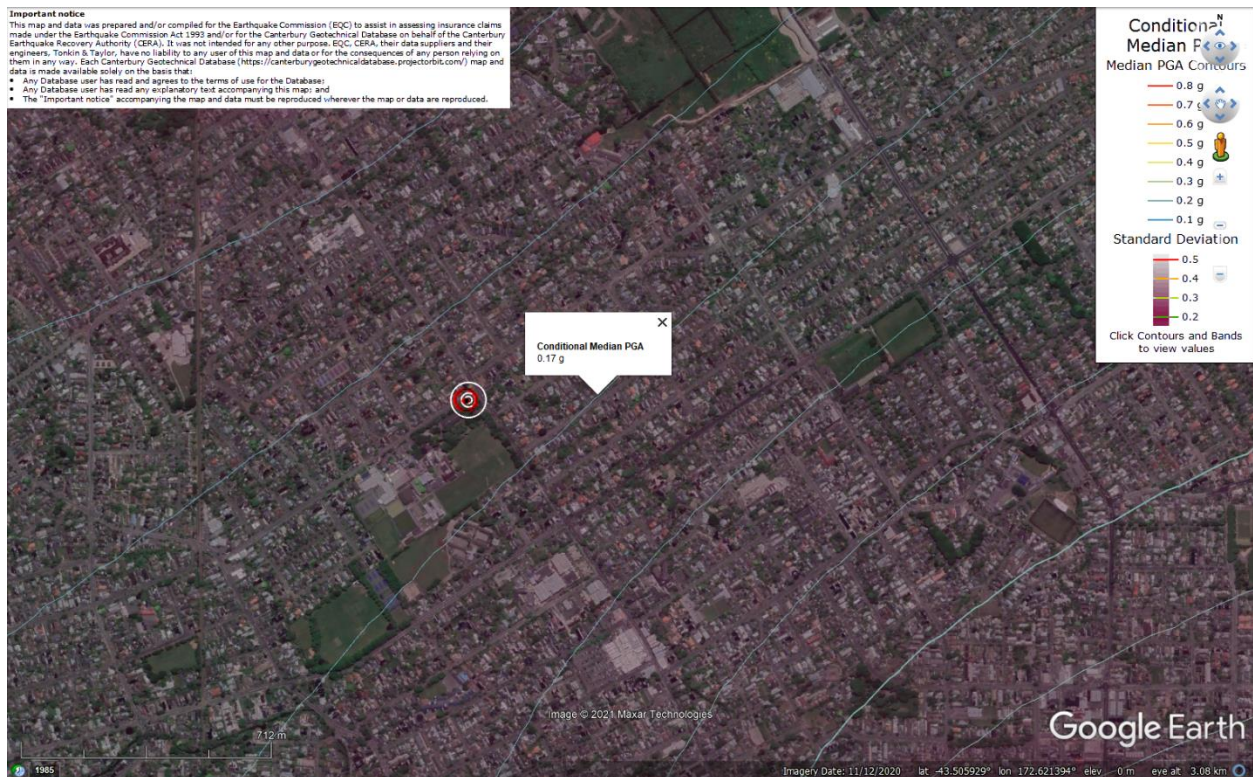
Figure 28: PGA for Jun-11 EQ (st. dev. = 0.350-0.375 ln units).

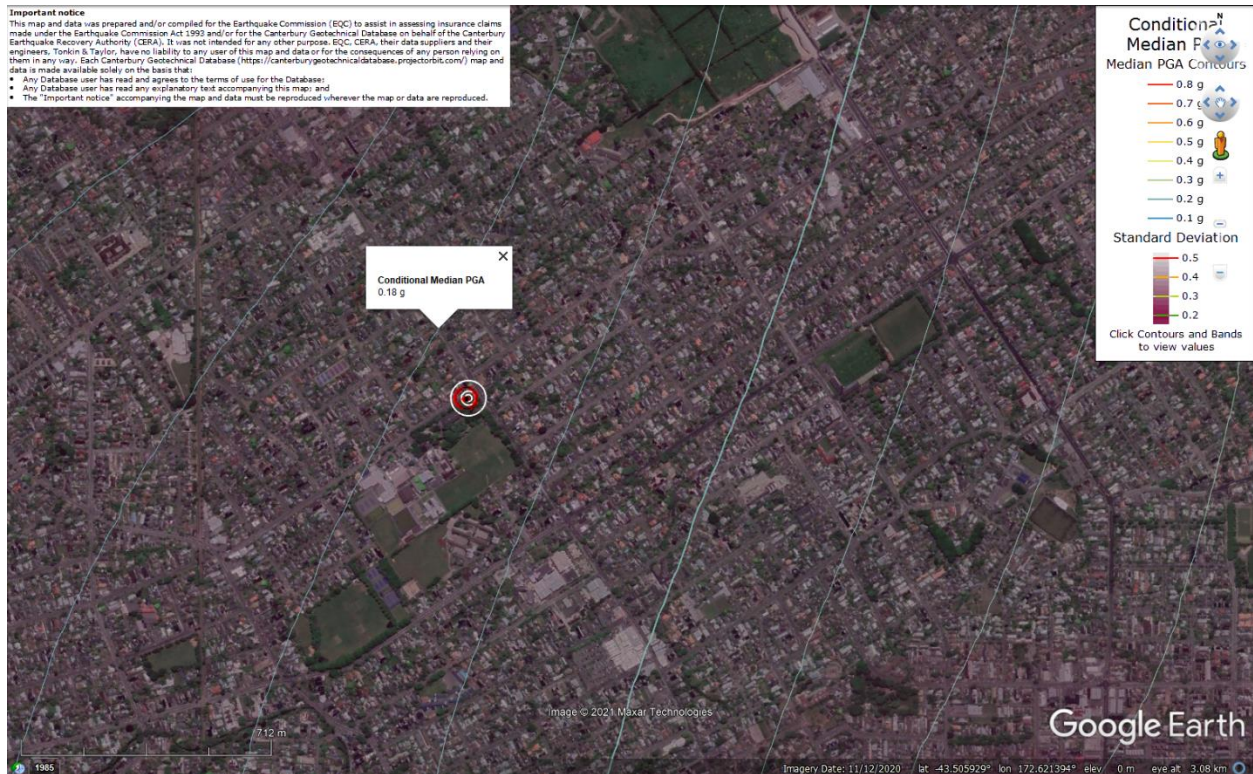
Figure 29: PGA for Dec-11 EQ (st. dev. = 0.375-0.400 ln units).
