Appendix A.2:

Rydal Reserve – VsVp 57190

Liquefaction Ejecta Case Histories for 2010-11 Canterbury Earthquakes

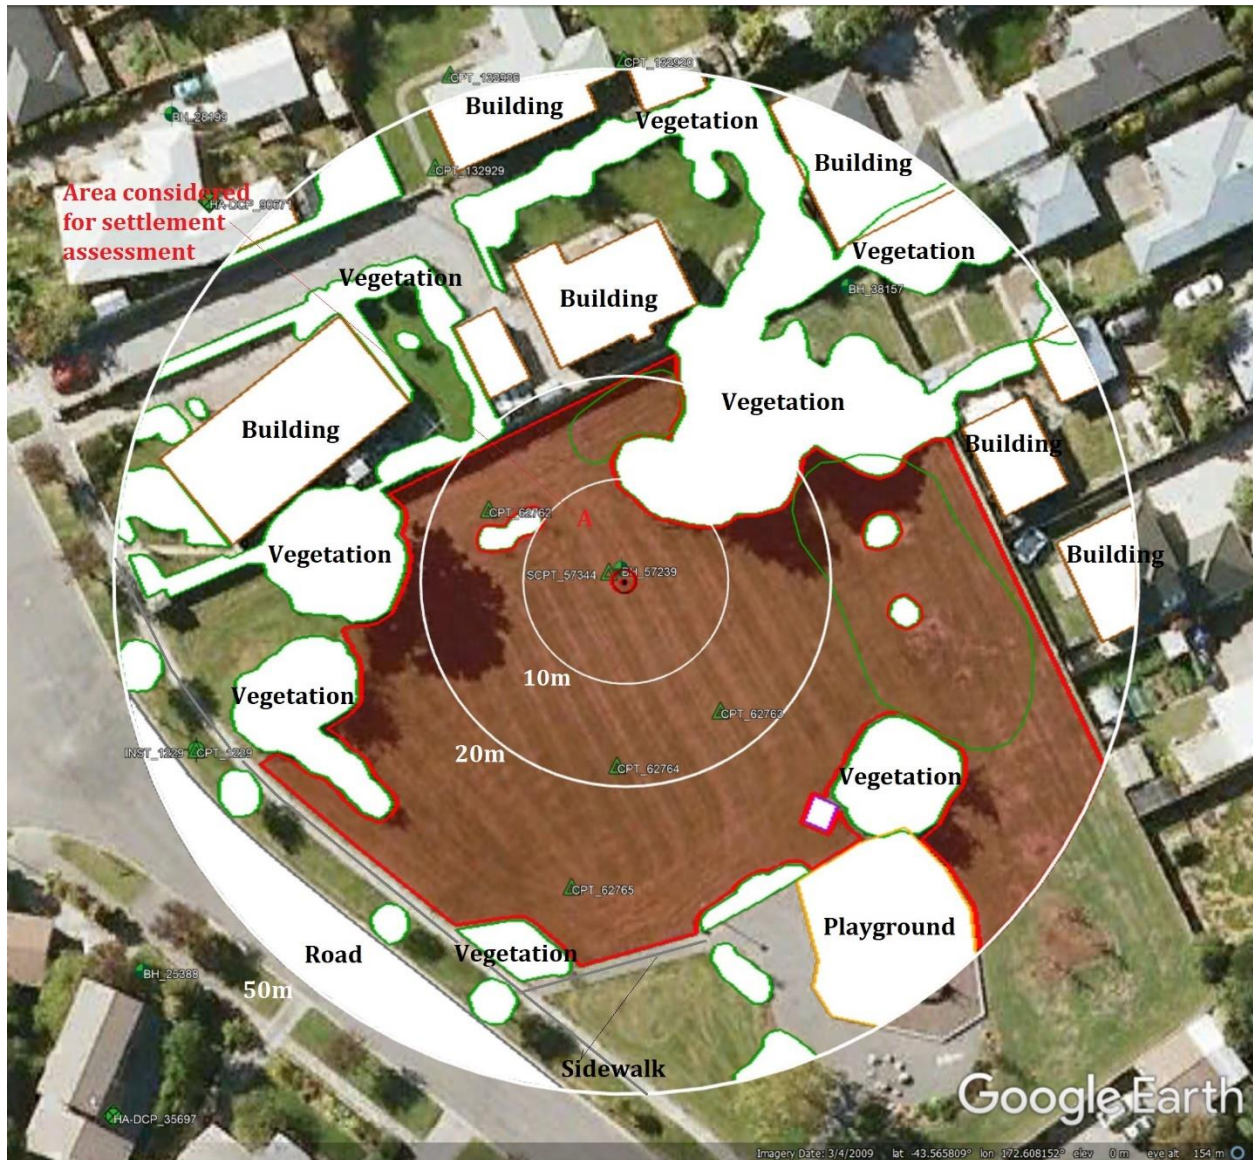
Figure 1: Site plan with the area considered for settlement analysis.

Notes: Buffer is the area within a circle of a specified radius with VsVp investigations done at its center (172.608493, -43.565806).

- A_T is the total assessment area for a buffer being considered (Figure 1).
- It is stated in the LDAT property report that ejecta were not removed at the time of the inspection, on 9 Nov 2011, and that earthwork was required to remediate the entire site. The inspection team reported the undulating land (lawn > 50 mm high). Furthermore, the settlement of LINZ benchmarks near the site due to the Sep-10, Feb-11 and Jun-11 earthquake was evaluated as 58 ± 48 mm, 67 ± 66 mm, and 10 ± 10 mm, respectively. For the Jun-11 EQ, there are no aerial photographs or satellite images of the site. However, liquefaction at nearby sites was interpreted as none from the aerial photograph for the Jun-11 EQ (Figure 35). Thus, it is reasonable to assume no liquefaction ejecta occurred for the Jun-11 EQ. For the Dec-11 EQ, no ejecta are visible in the aerial photograph except for the minor quantum along the curb of the road.

Note 8: The selection of CPTs for the area considered for settlement assessment (Figure 1) is based on the proximity of the CPTs to the considered areas. In accordance with that, the following table shows CPTs that were used for the volumetric settlement analysis in *Cliq v.3.0.3.2*, a CPT soil liquefaction software developed by GeoLogismiki. (The average volumetric settlements were reported in Table 8.)

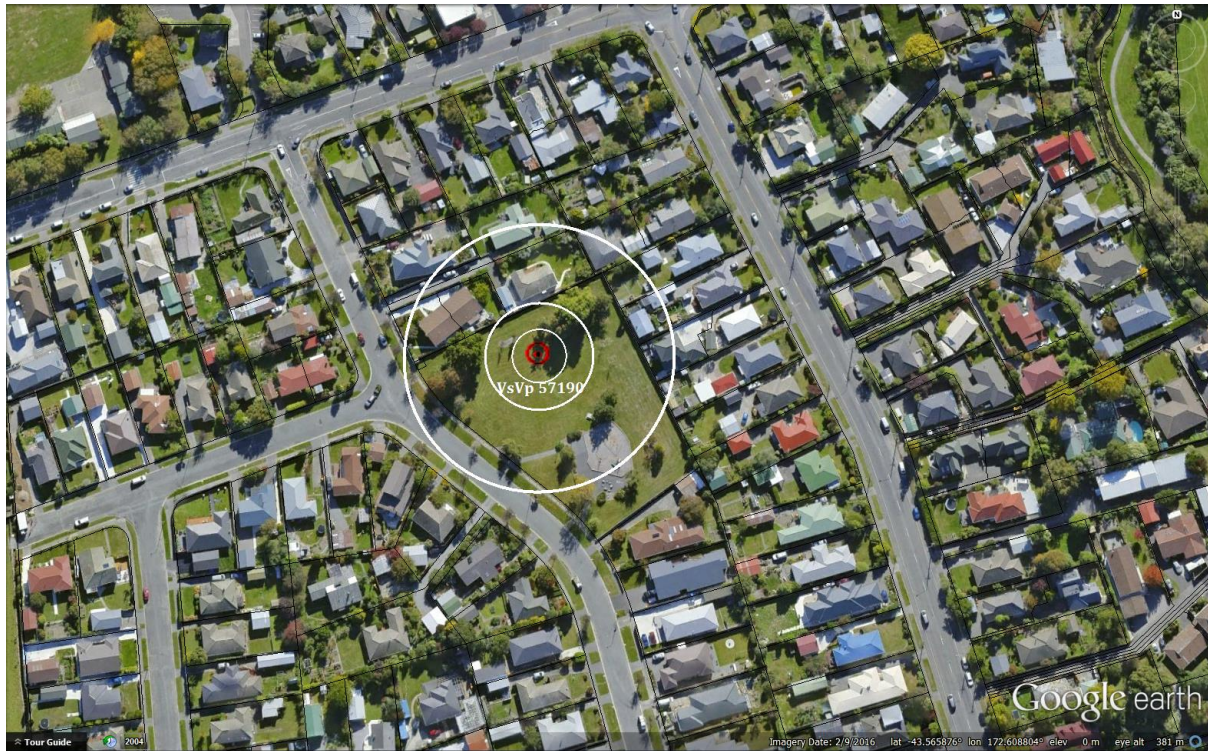
Figure 3: Position of the site relative to nearby buildings, vegetation, and other important features.

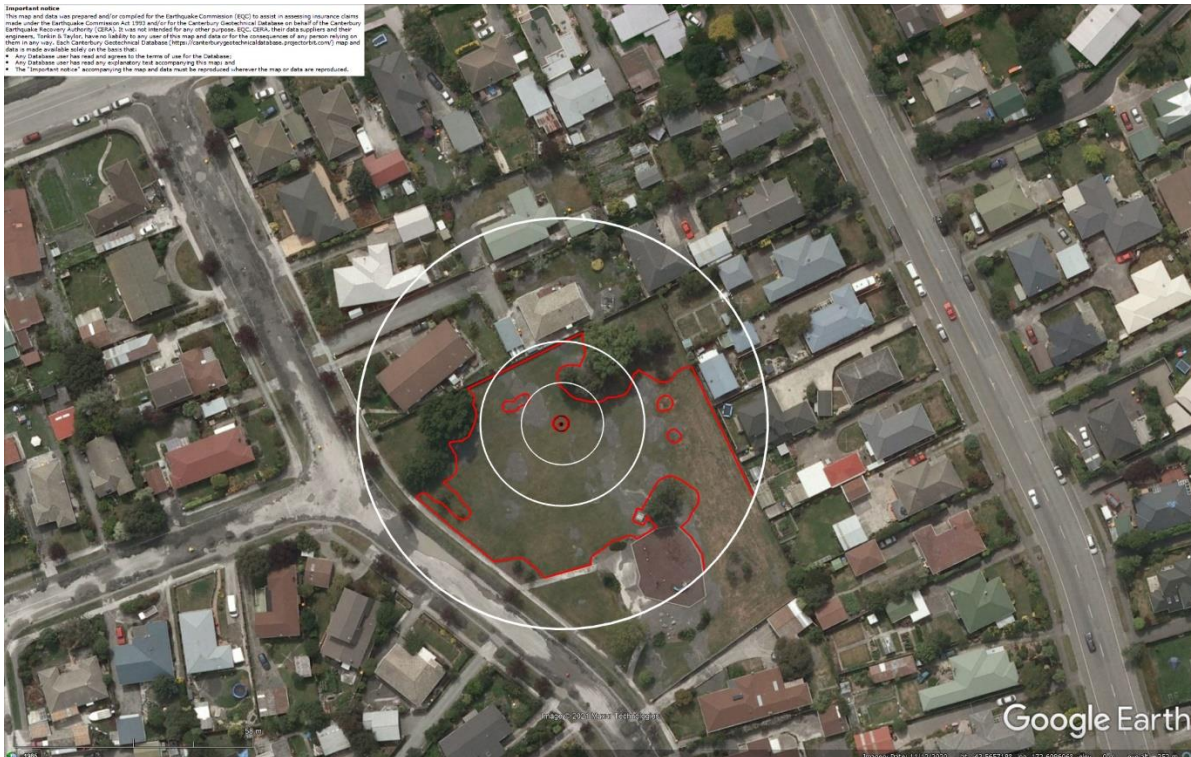
Figure 15: EQC Aerial Photograph of the site taken on Feb 24, 2011.

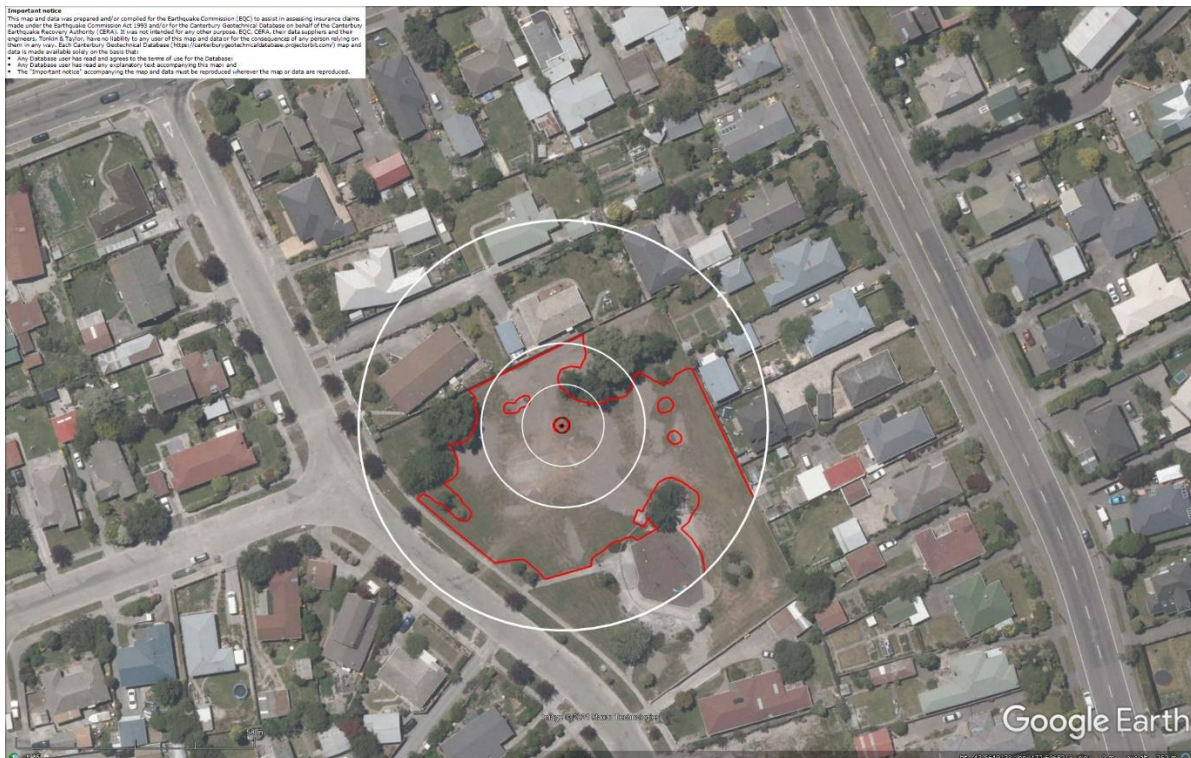
Figure 16: EQC Aerial Photograph of the site taken on Dec 24, 2011.

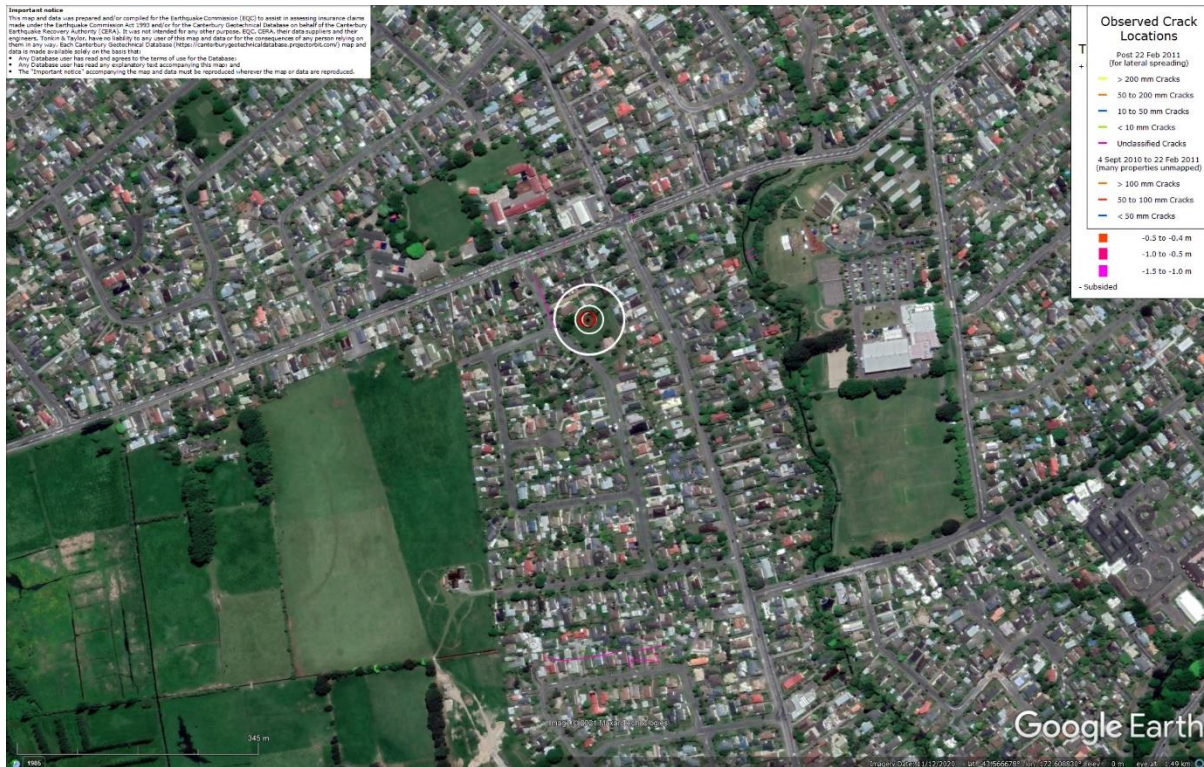
Figure 22: Absence of ground cracks indicating no lateral spreading for Canterbury Earthquake Sequence.

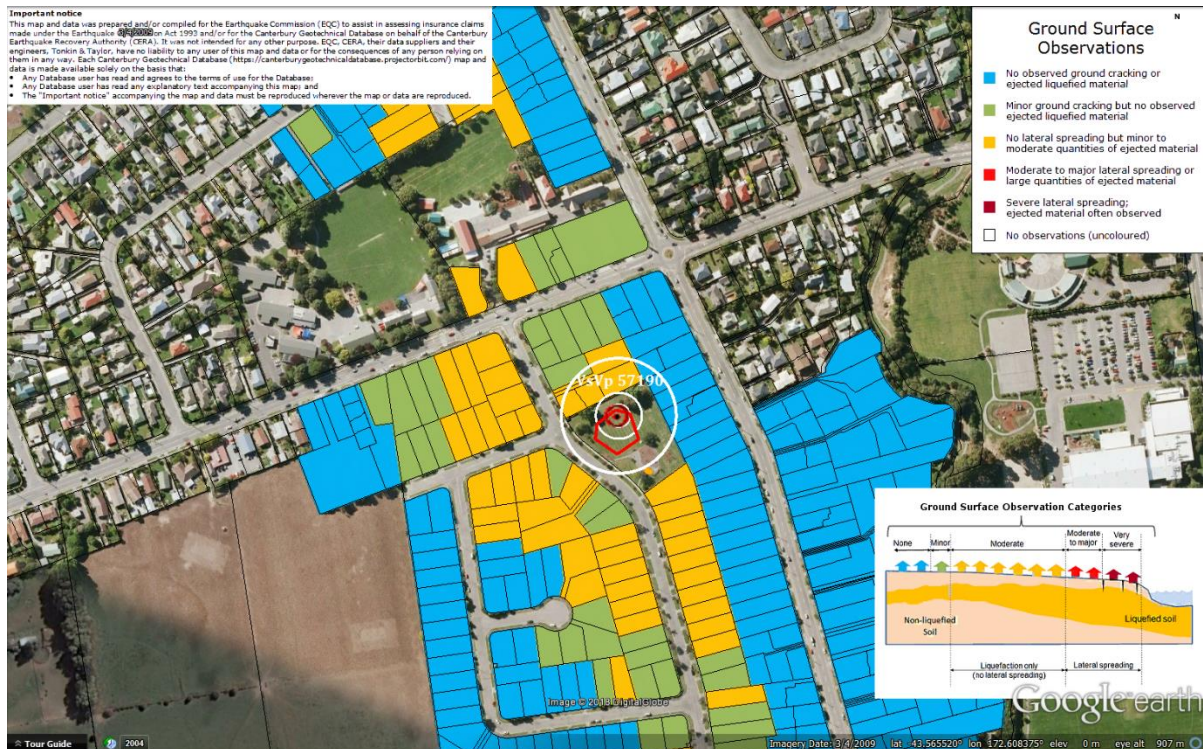
Figure 28: EQC liquefaction and lateral spreading observations for Sep 2010 Earthquake to determine ejecta quantum.

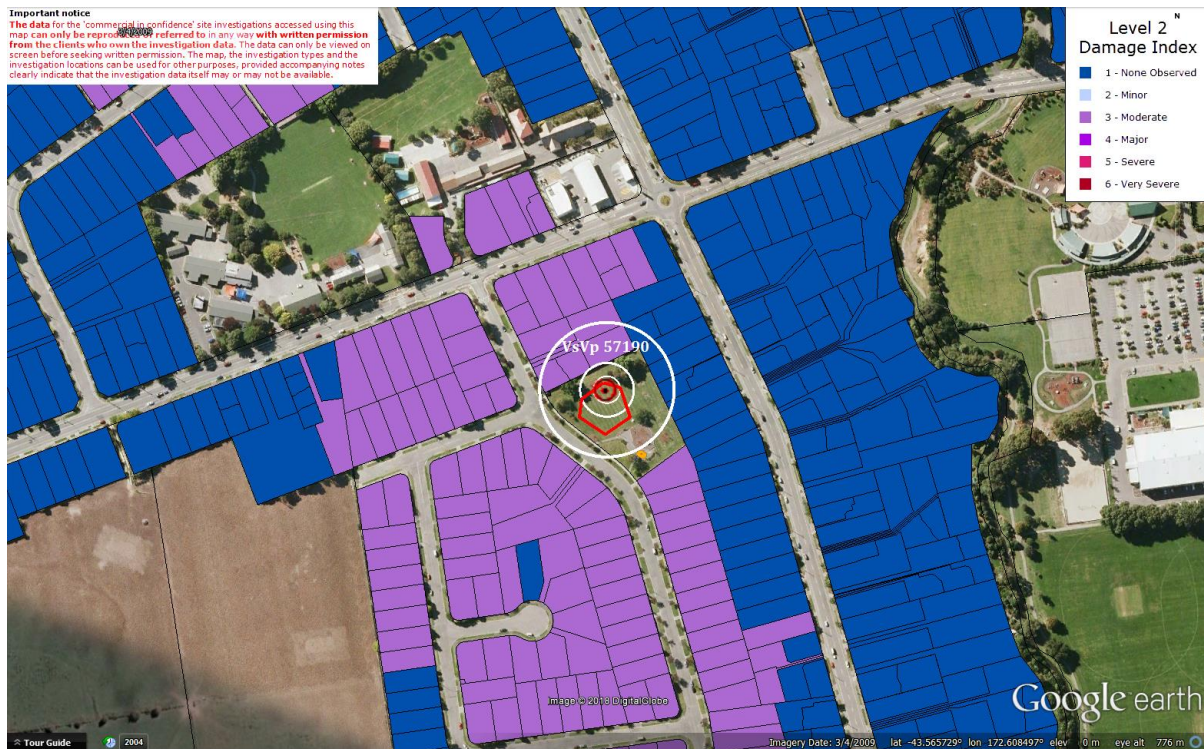
Figure 30: EQC Level 2 Damage Index map for Jun 2011 Earthquake to determine ejecta quantum.

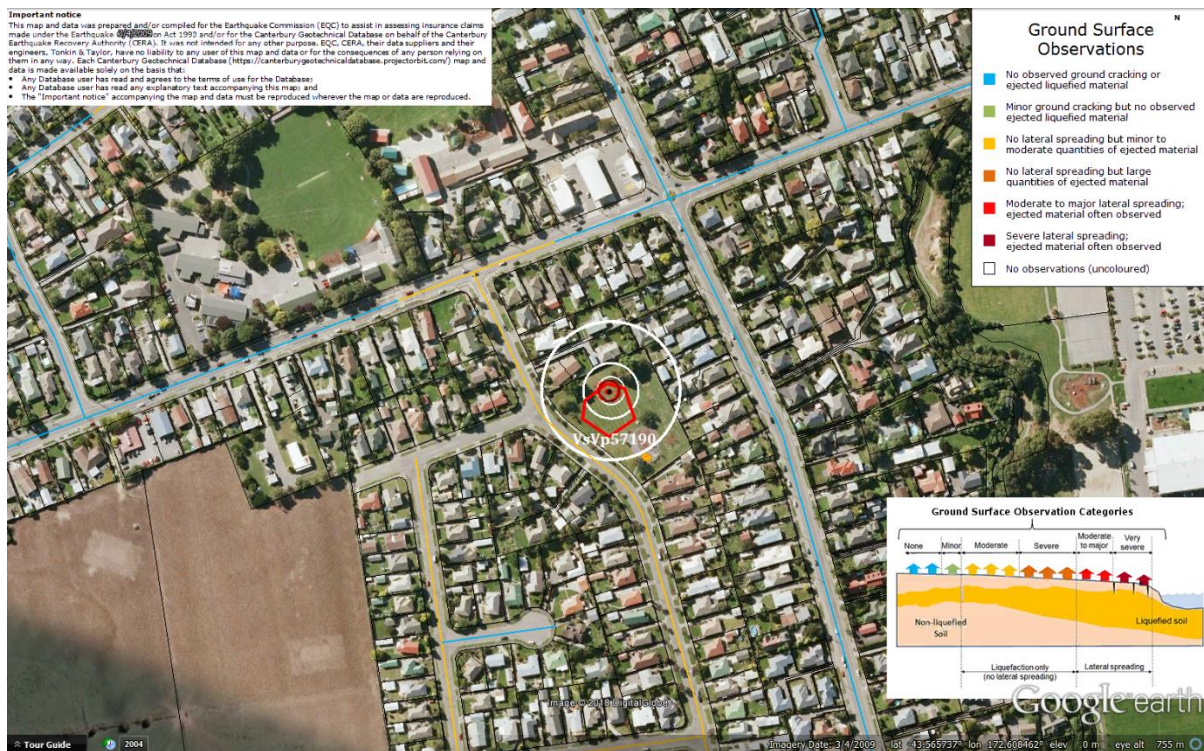
Figure 31: EQC liquefaction and lateral spreading observations for Jun 2011 Earthquake to determine ejecta quantum.

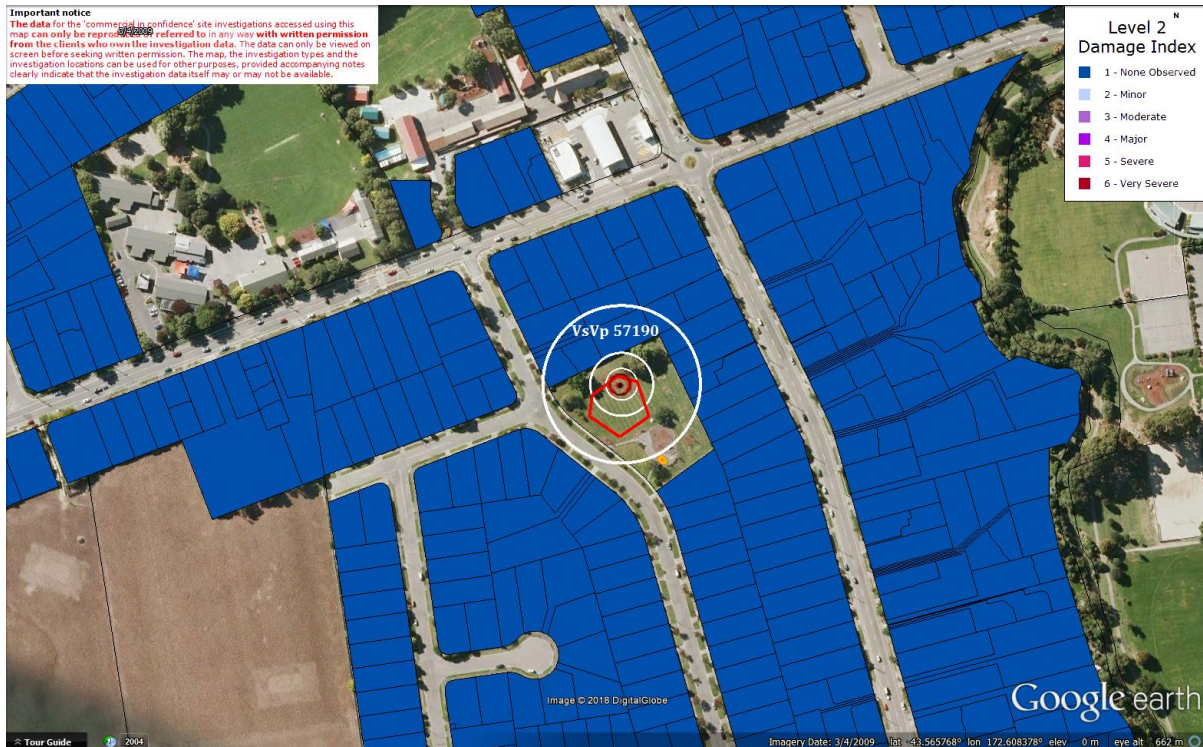
Figure 32: EQC Level 2 Damage Index map for Dec 2011 Earthquake to determine ejecta quantum.

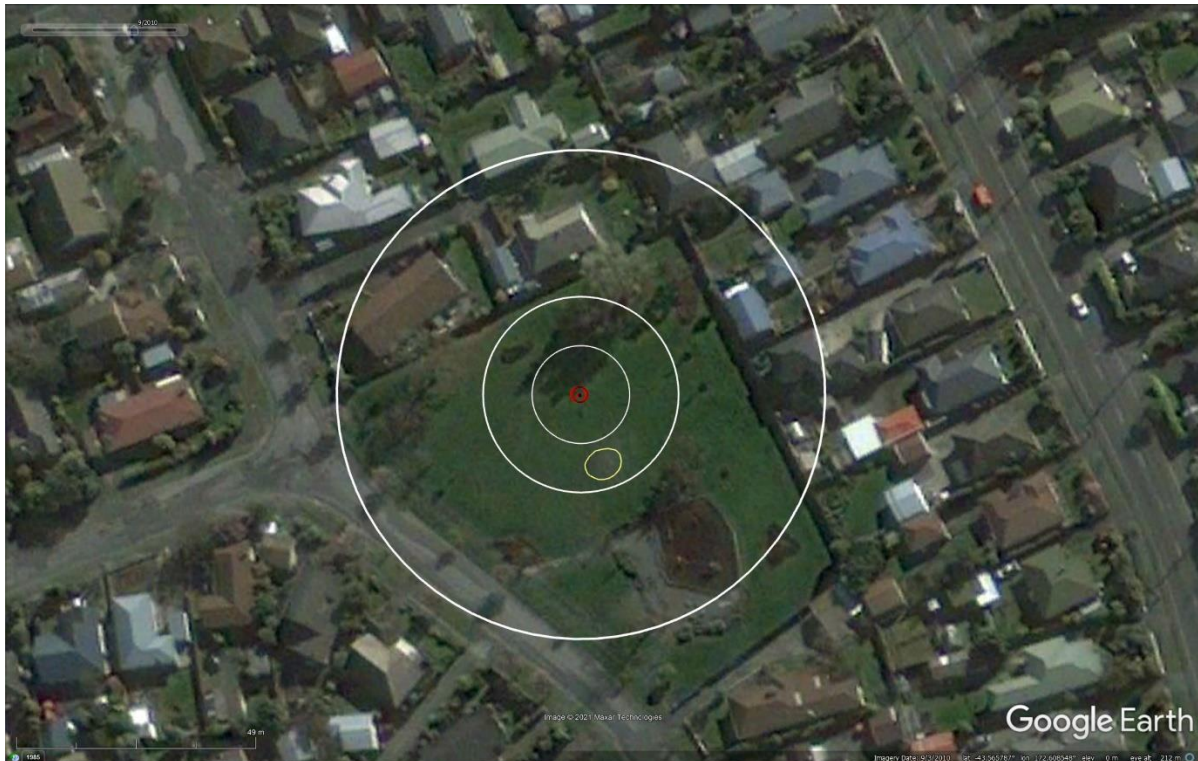
Figure 33: Outline of ejecta for Sep-10 EQ.

- The values in Table 9 correspond to the coverage area of ejecta outlined in aerial photographs (Figures 33, 34, and 36) and the lower and upper estimates of ejecta height based on EQC LDAT property inspection reports and ground photographs (Figure 52). The ejecta-induced settlement using photograph and engineering judgment, $S_{E,P}$, is estimated as

- The high-resolution aerial photograph for the Sep-10 EQ is unavailable and there is uncertainty in estimating the ejecta-induced settlement of the assessment area for the Sep-10 EQ. However, the satellite image reveals the significant quantum of ejecta on the road within the 50-m buffer.

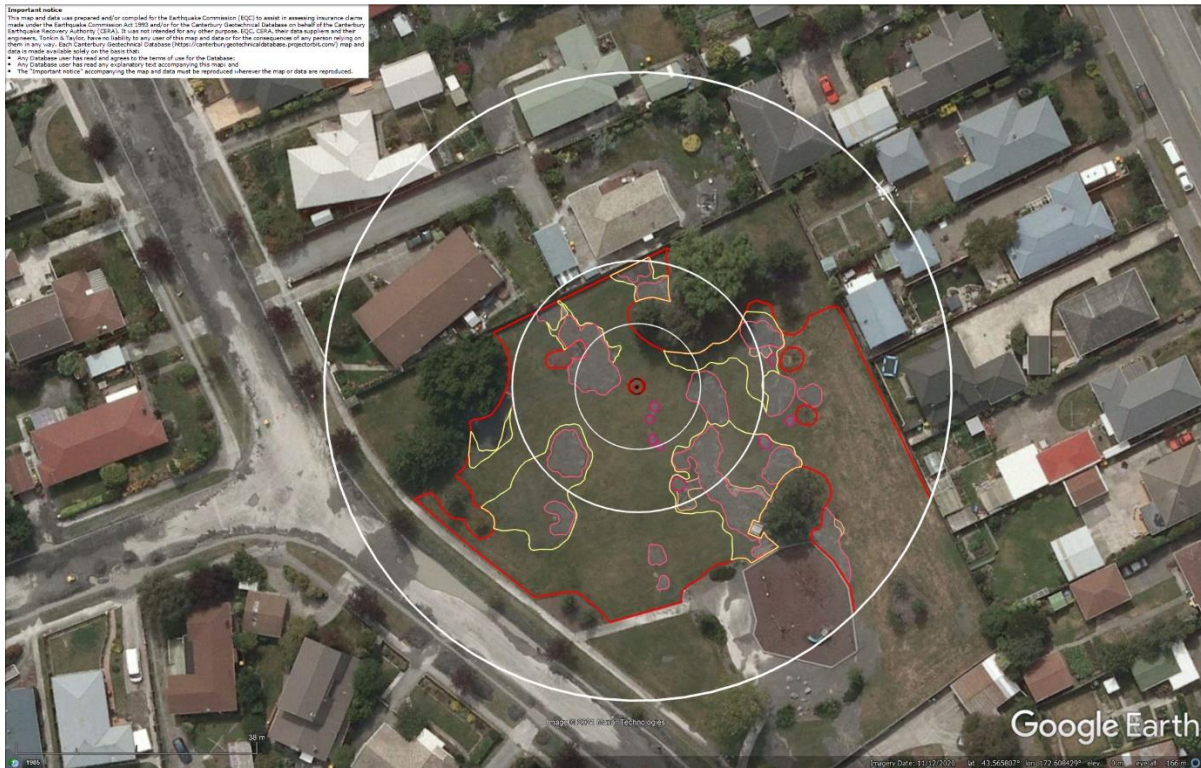
Figure 34: Outline of ejecta for Feb-11 EQ.

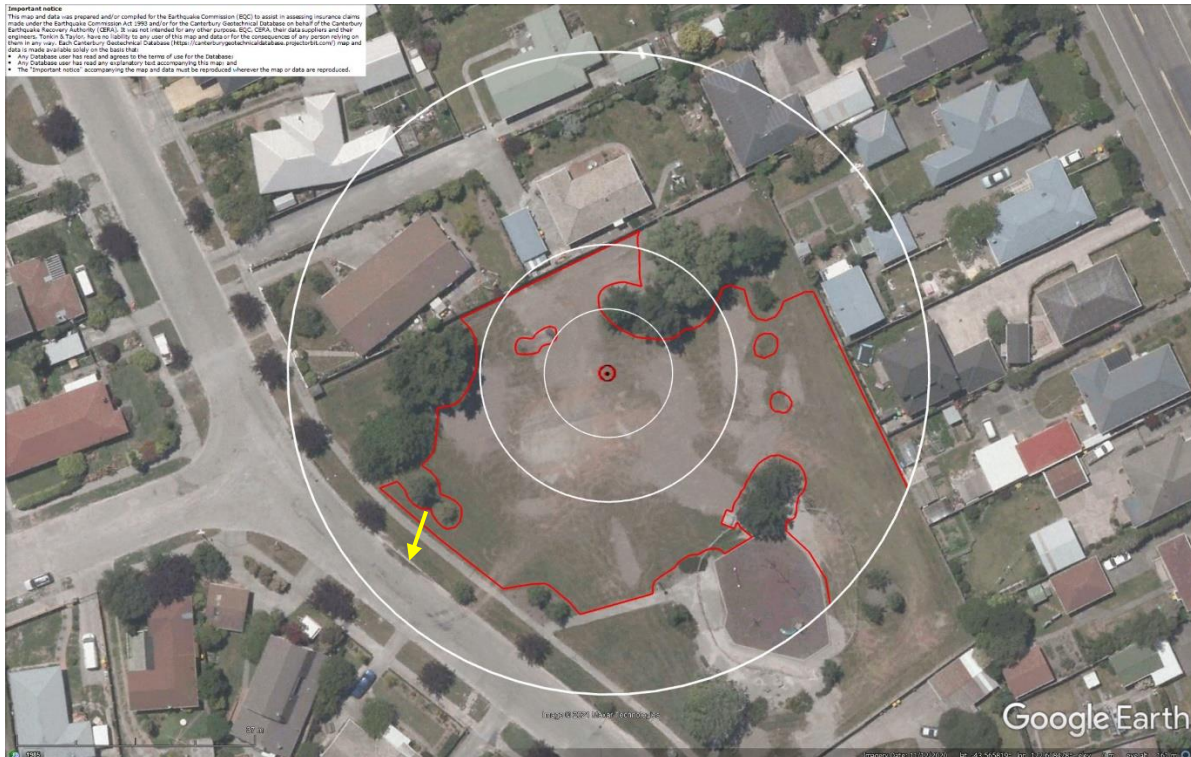
Figure 36: Absence of ejecta at the site for Dec-11 EQ. (The yellow arrow is pointing to the only place with fresh ejecta.)

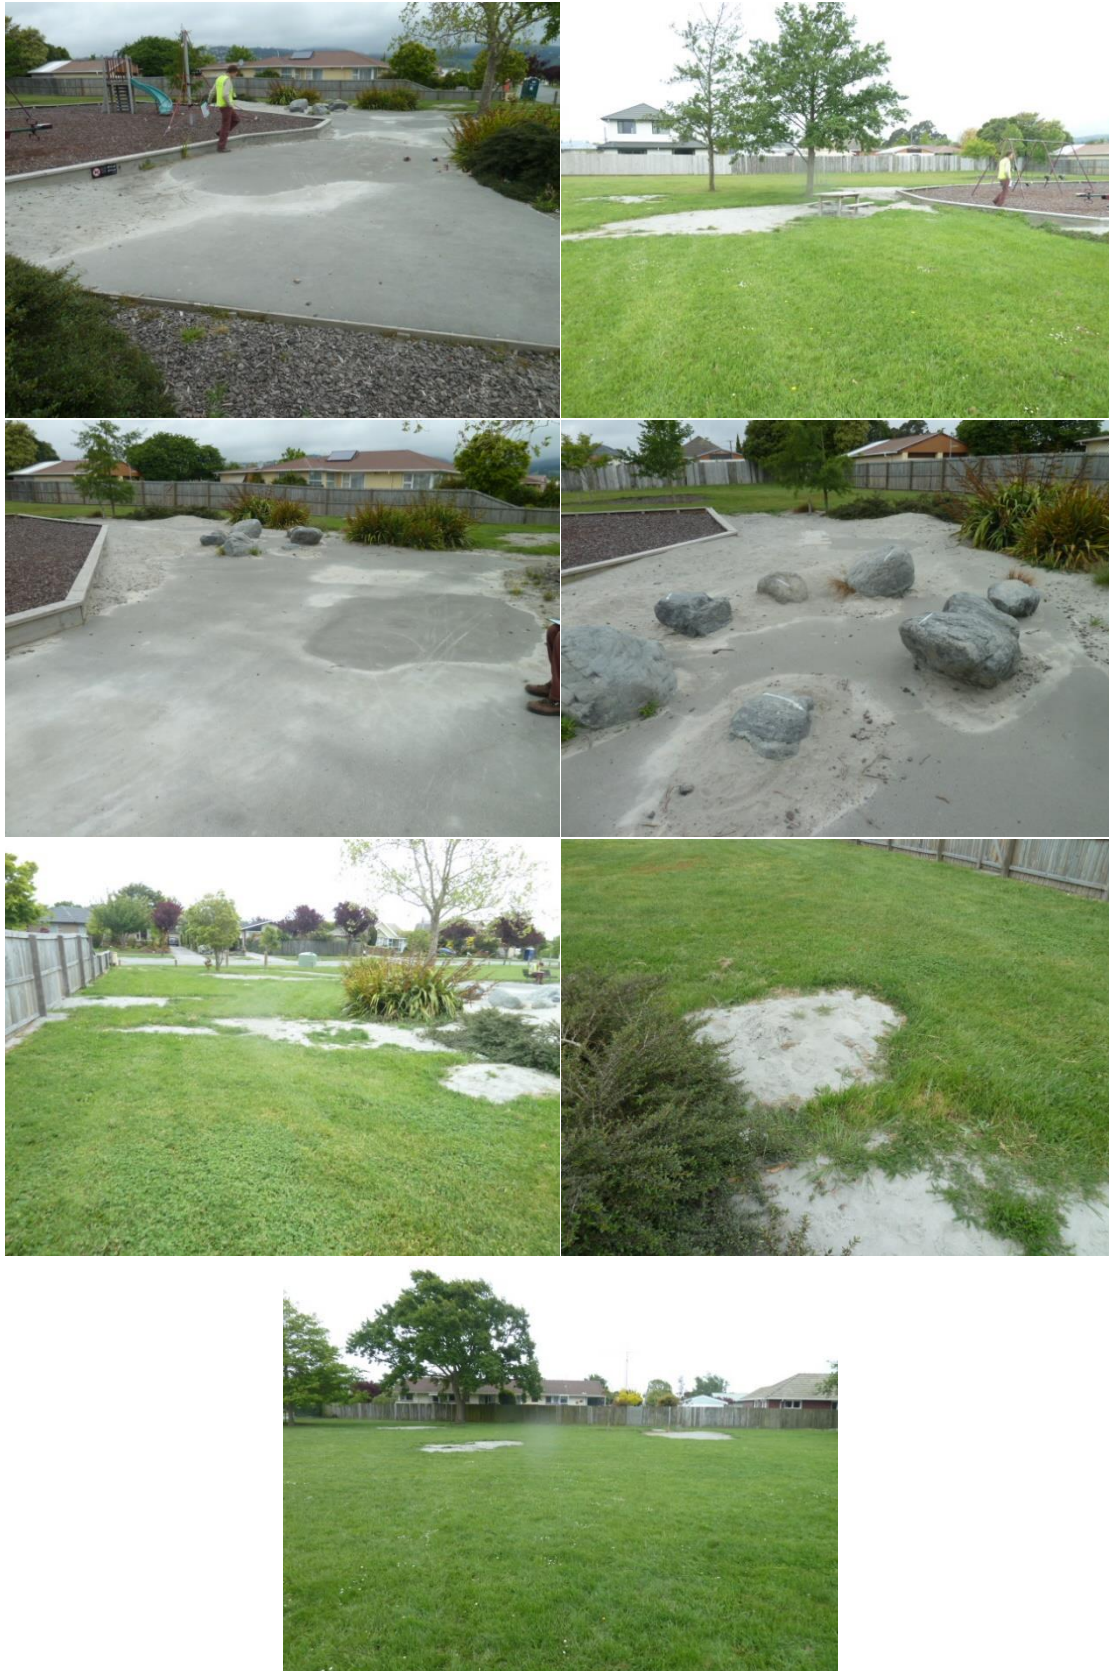
Figure 37: Ground photographs of the site taken on 9 Nov 2011.

*Ejecta from the Feb-11 EQ remained at the site until the period between 9 Nov 2011 and 24 Dec 2011; which affected the Dec-11 EQ; thus, ~20 mm (based on photographs) would need to be subtracted from the ground surface subsidence for the Dec-11 EQ. The presence of ejecta at the site at the time of May 2011 and Sep 2011 LiDAR surveys would not impact the subsidence estimates for the Jun-11 event.

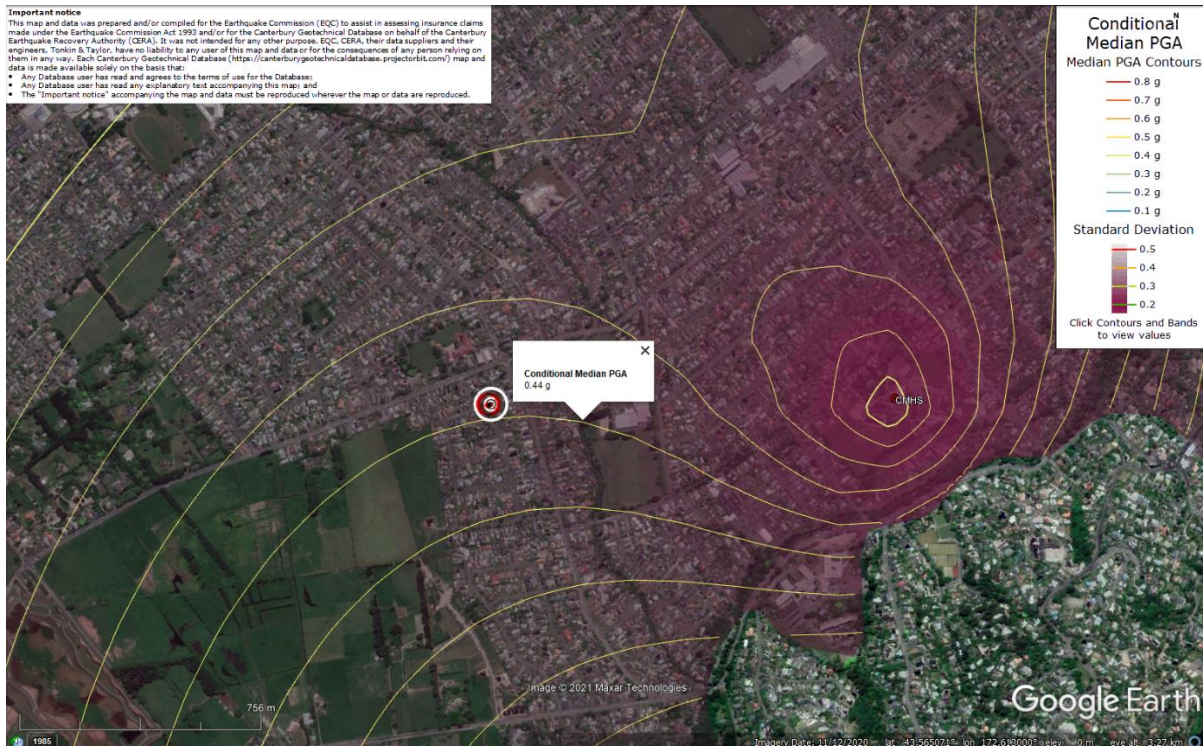
Figure 39: PGA for Feb-11 EQ (st. dev = 0.350-0.375 ln units).

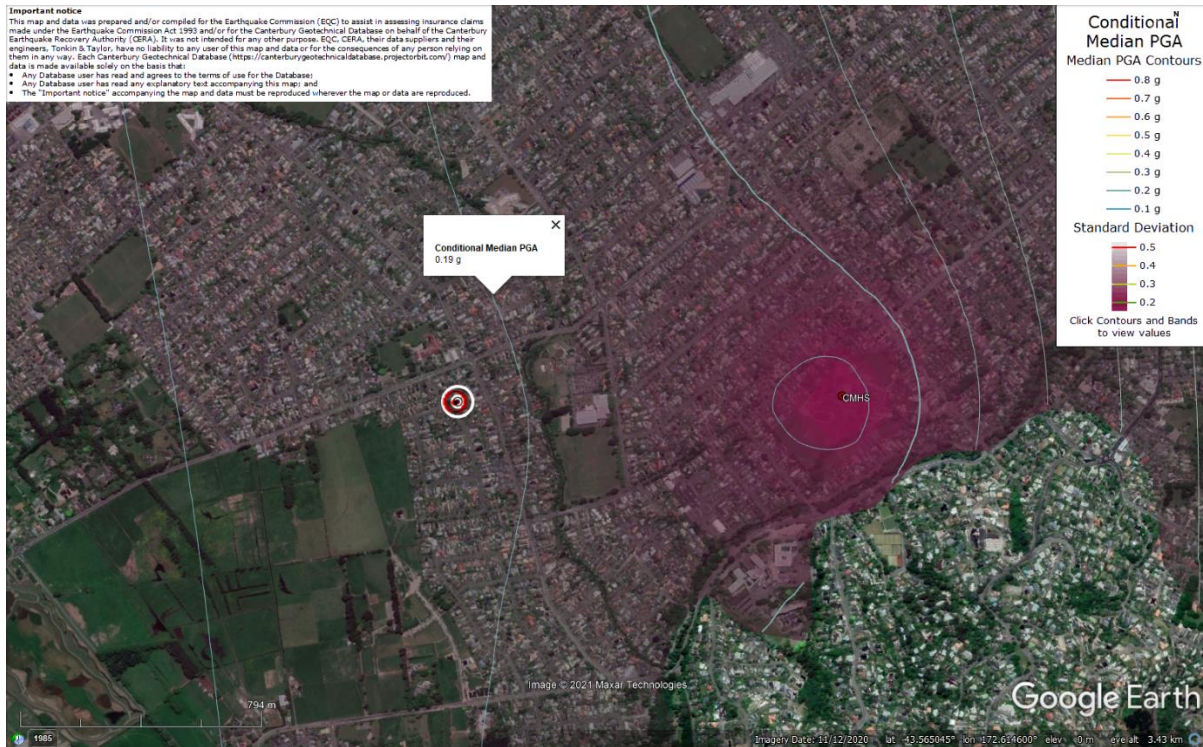
Figure 40: PGA for Jun-11 EQ (st. dev = 0.375-0.400 ln units).
