Appendix A.35:

Baker St – CPT 14070

Liquefaction Ejecta Case Histories for 2010-11 Canterbury Earthquakes

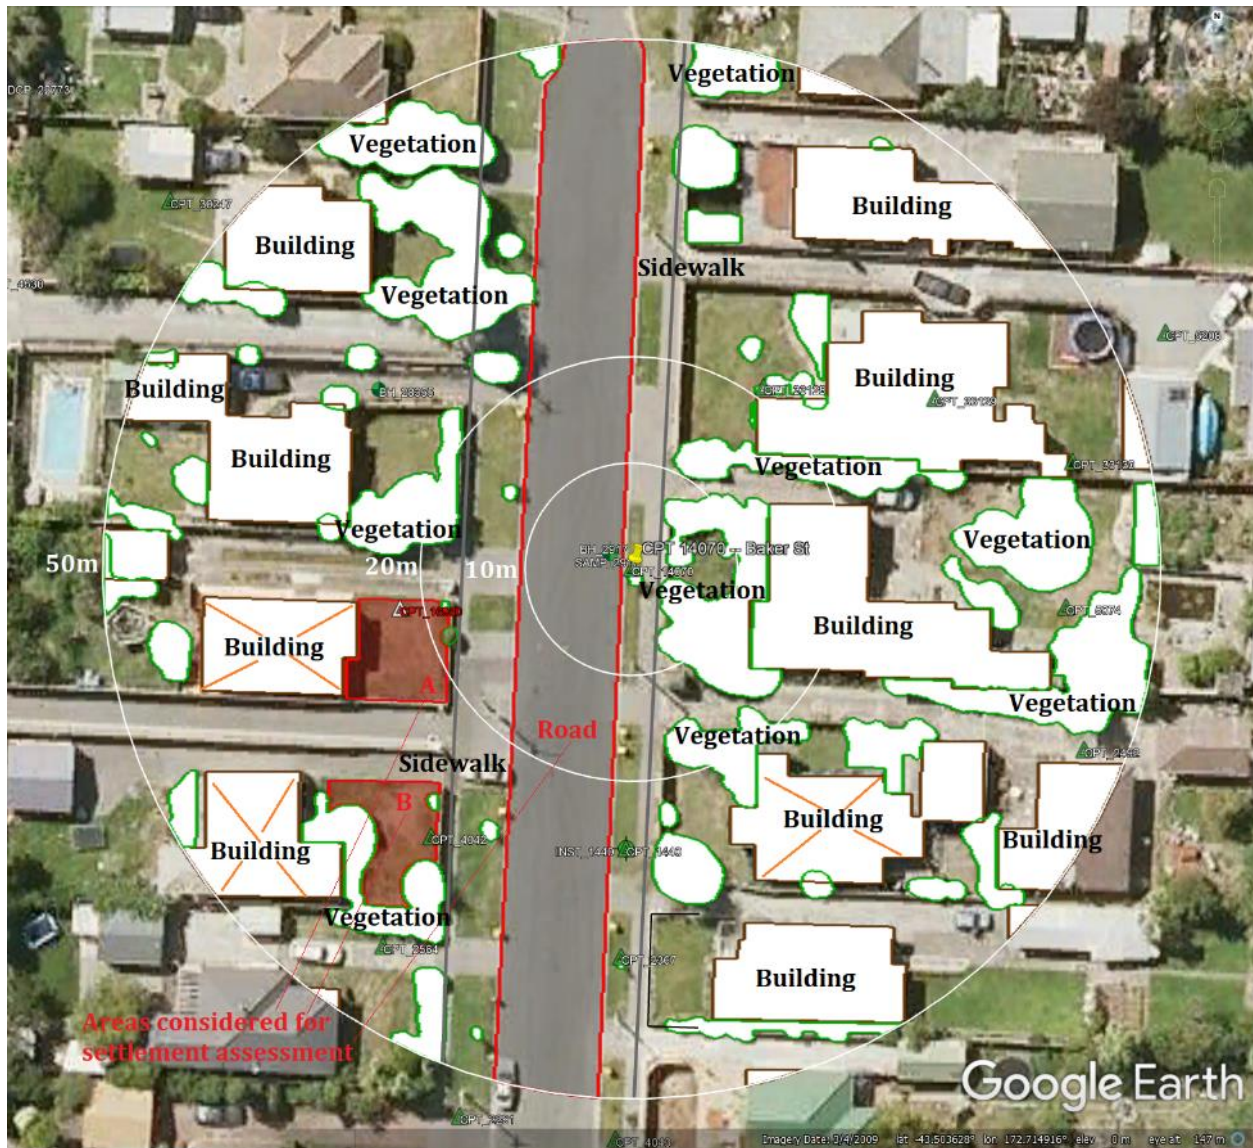
Figure 1: Site plan with areas where ejecta-induced settlement is considered.

Note 1: Two patches (outlined in red) in the free field were selected for settlement assessment as areas free of vegetation and structures. Other important factors considered in the patch selection process were its proximity to a CPT, a property subjected to addition and/or demolition of a structure, front yard/backyard alterations (e.g., ploughing, rubble, scrap), and aerial distribution of sediment ejecta. In addition, the entire portion of the road within the 50-m buffer was considered for the settlement assessment. The LiDAR-based settlement analyses for the Sep-10 EQ were not conducted due to the evident absence of ejecta from Patches A and B and Road. The Oct 2015 LiDAR survey was not considered for Patches A and B due to the anthropogenic changes.

Note 6: The selection of CPTs for the area considered for settlement assessment (Figure 1) is based on the proximity of the CPTs to the considered areas. In accordance with that, the following table shows CPTs that were used for the volumetric settlement analysis in *Cliq v.3.0.3.2*, a CPT soil liquefaction software developed by GeoLogismiki. (The average volumetric settlements were reported in Table 8.)

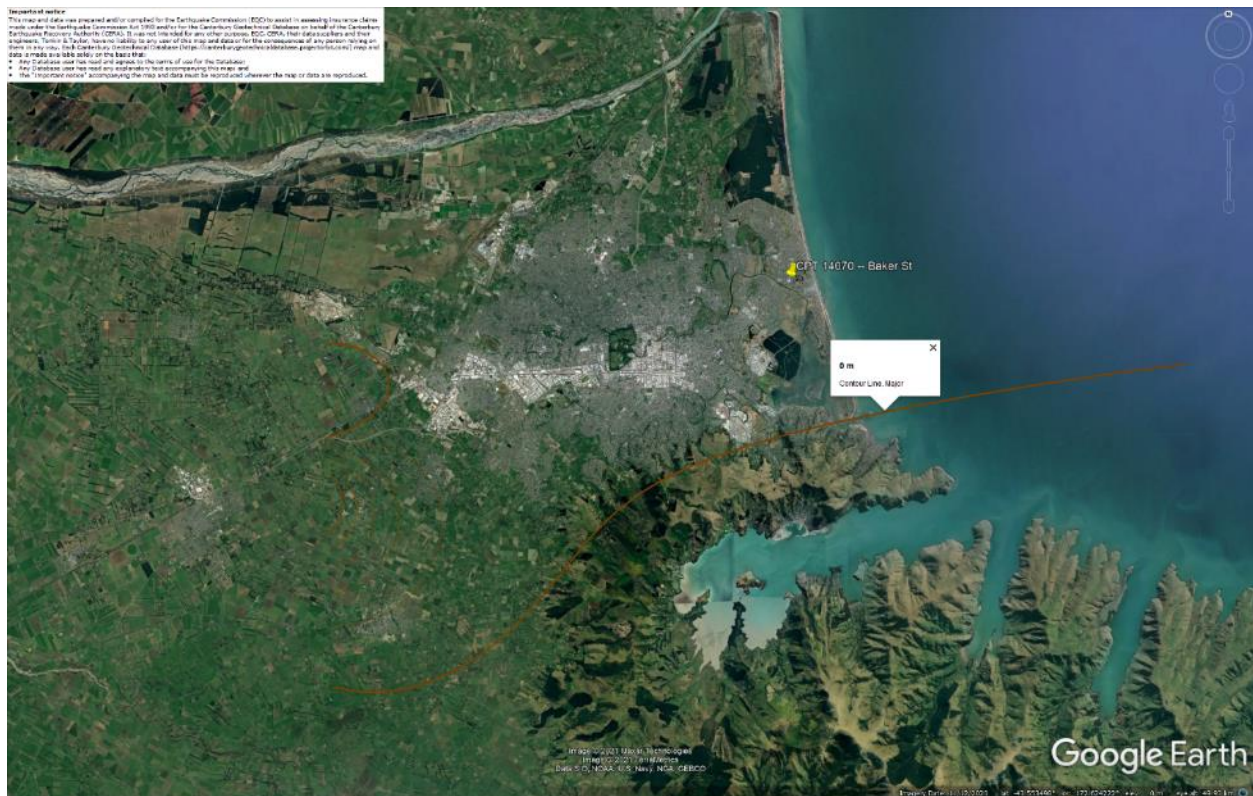
Figure 42: Vertical tectonic movements for Sep 2010 Earthquake.

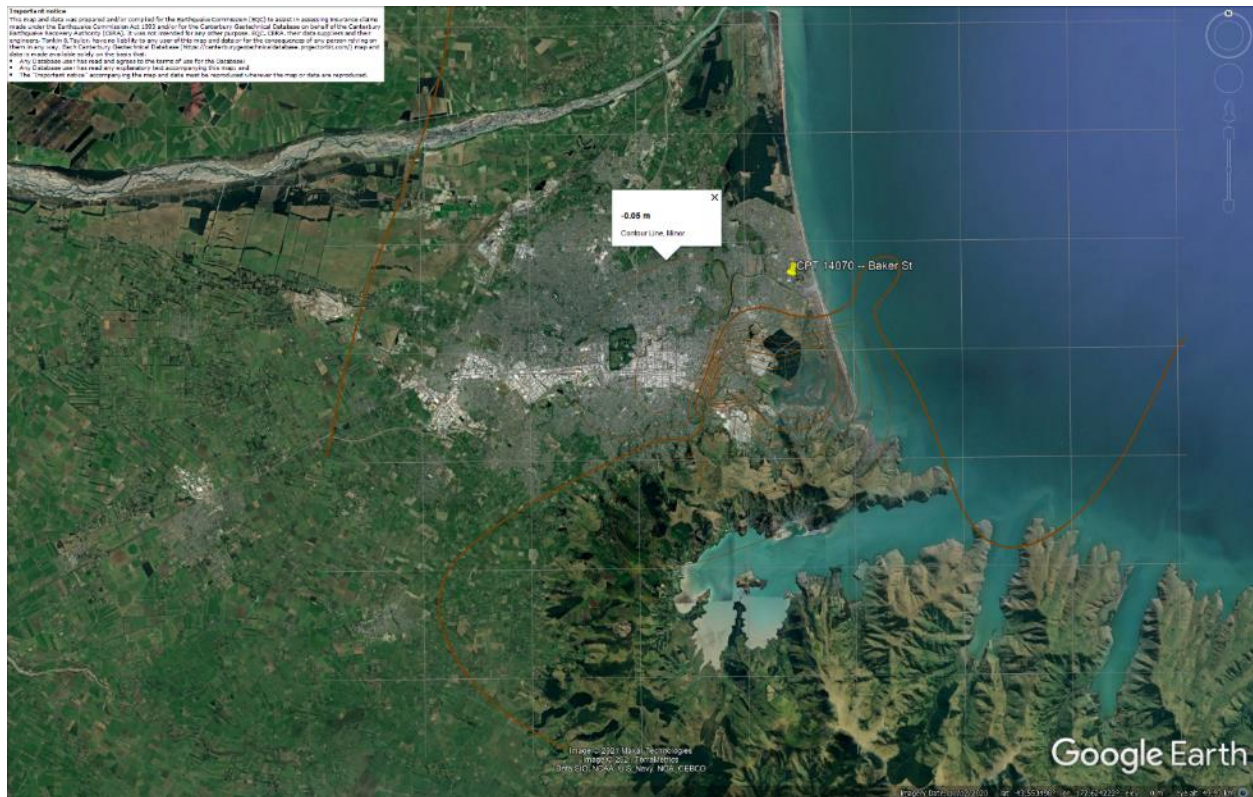
Figure 43: Vertical tectonic movements for Feb 2011 Earthquake.

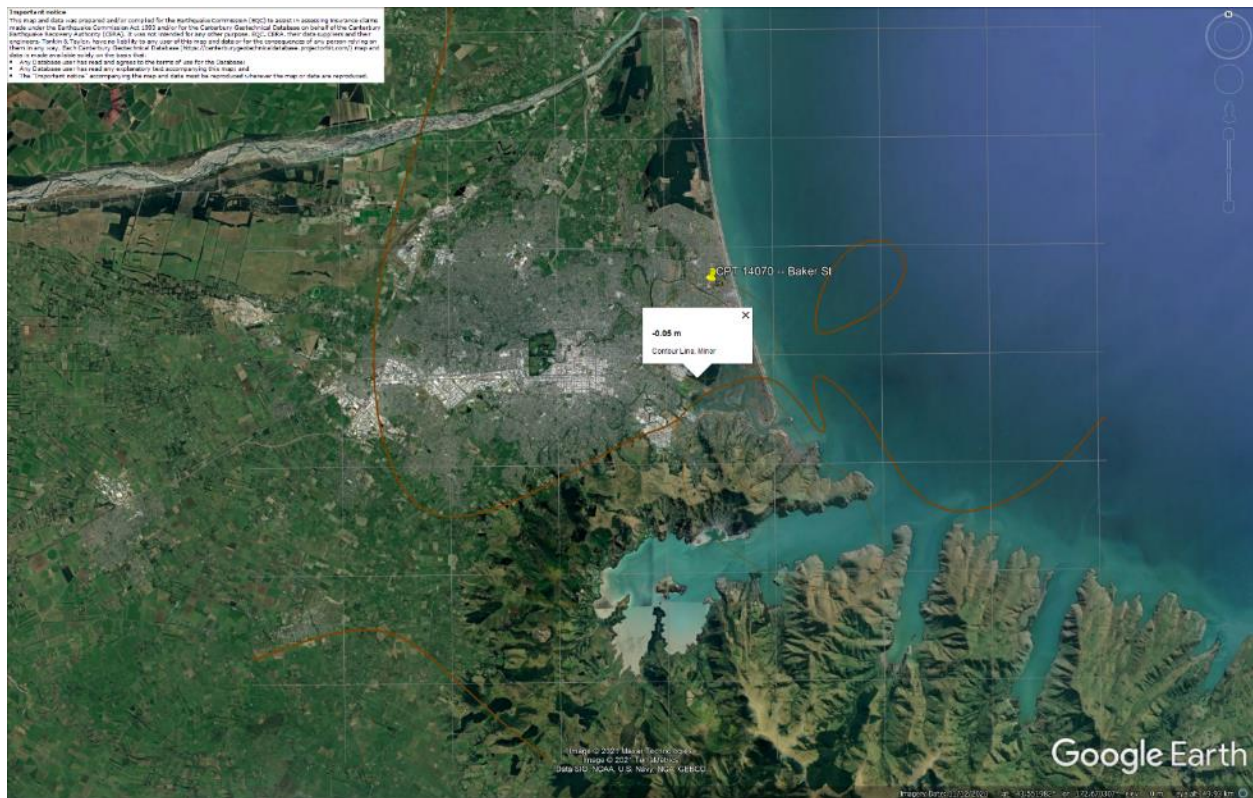
Figure 44: Vertical tectonic movements for June 2011 Earthquake.

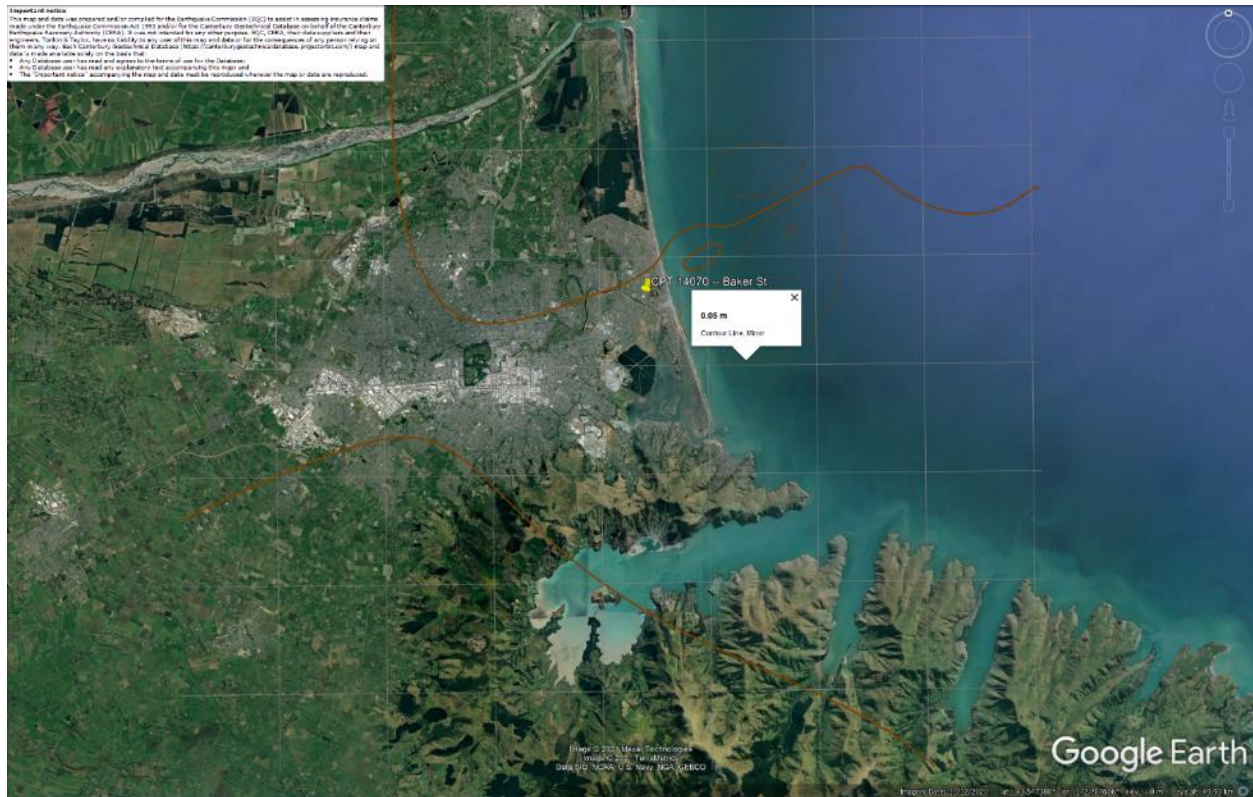
Figure 45: Vertical tectonic movements for Dec 2011 Earthquake.

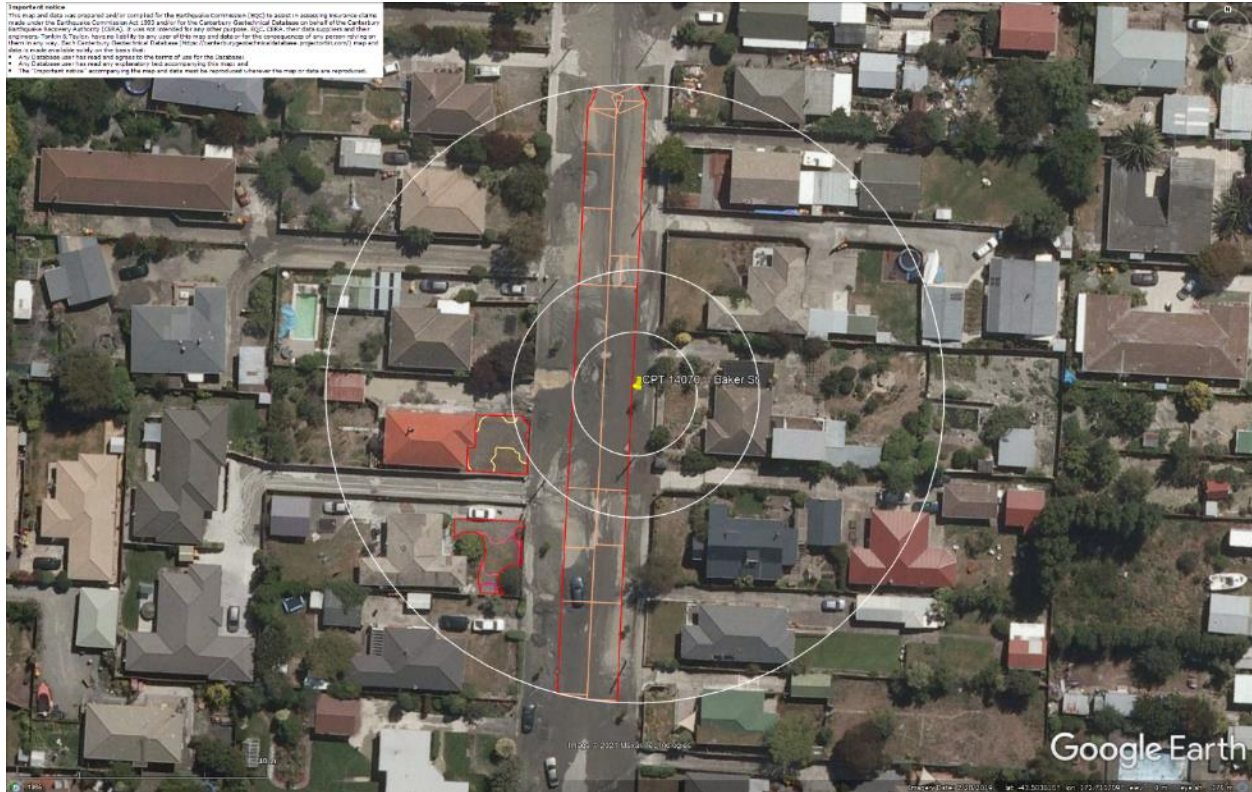
Figure 81: Aerial photograph showing the ejecta outline at the site for Feb-11 EQ.

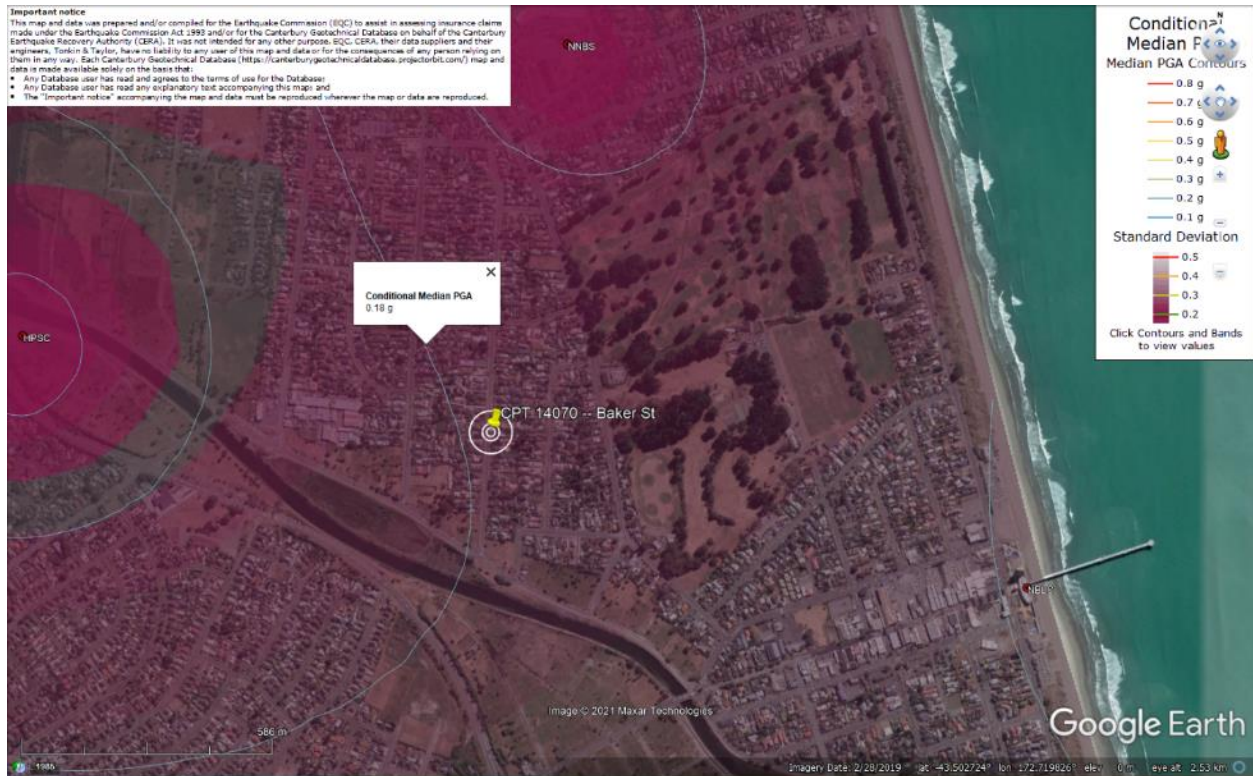
Figure 91: PGA for Sep-10 EQ (st. dev. = 0.275-0.300 ln units).

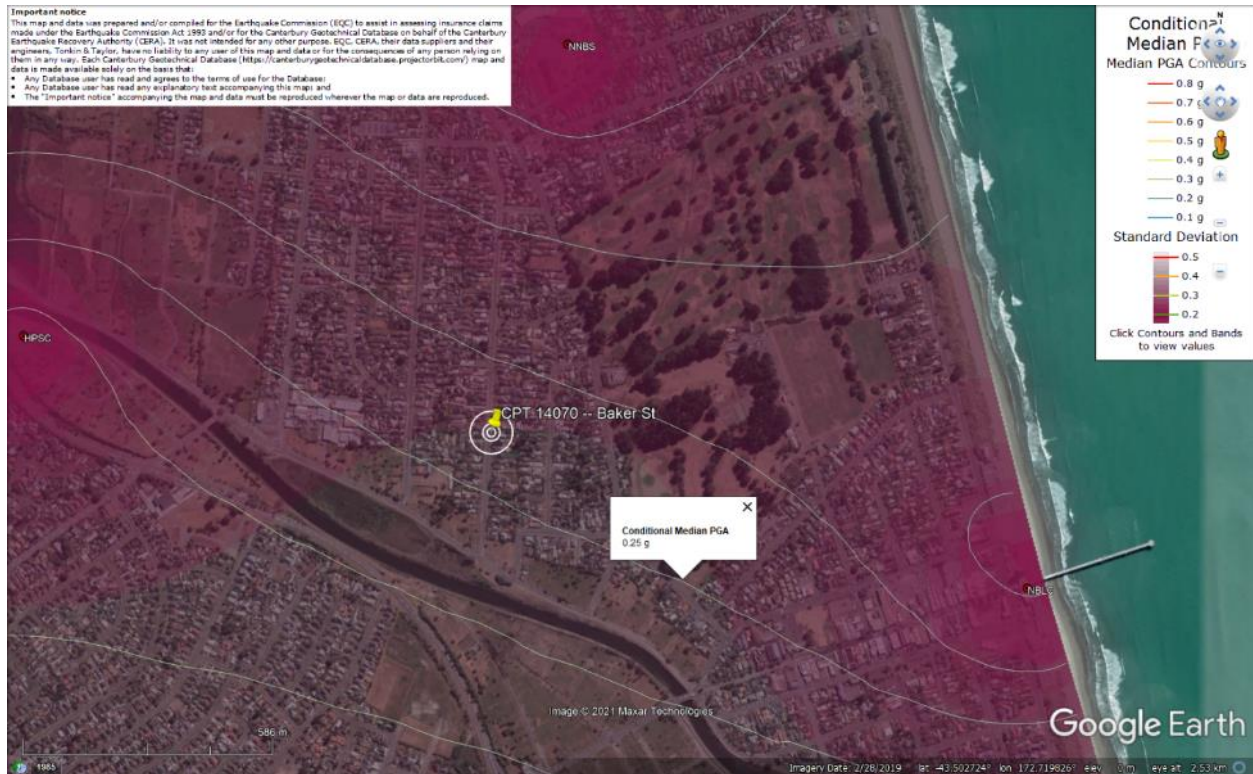
Figure 93: PGA for Jun-11 EQ (st. dev. = 0.275-0.325 ln units).

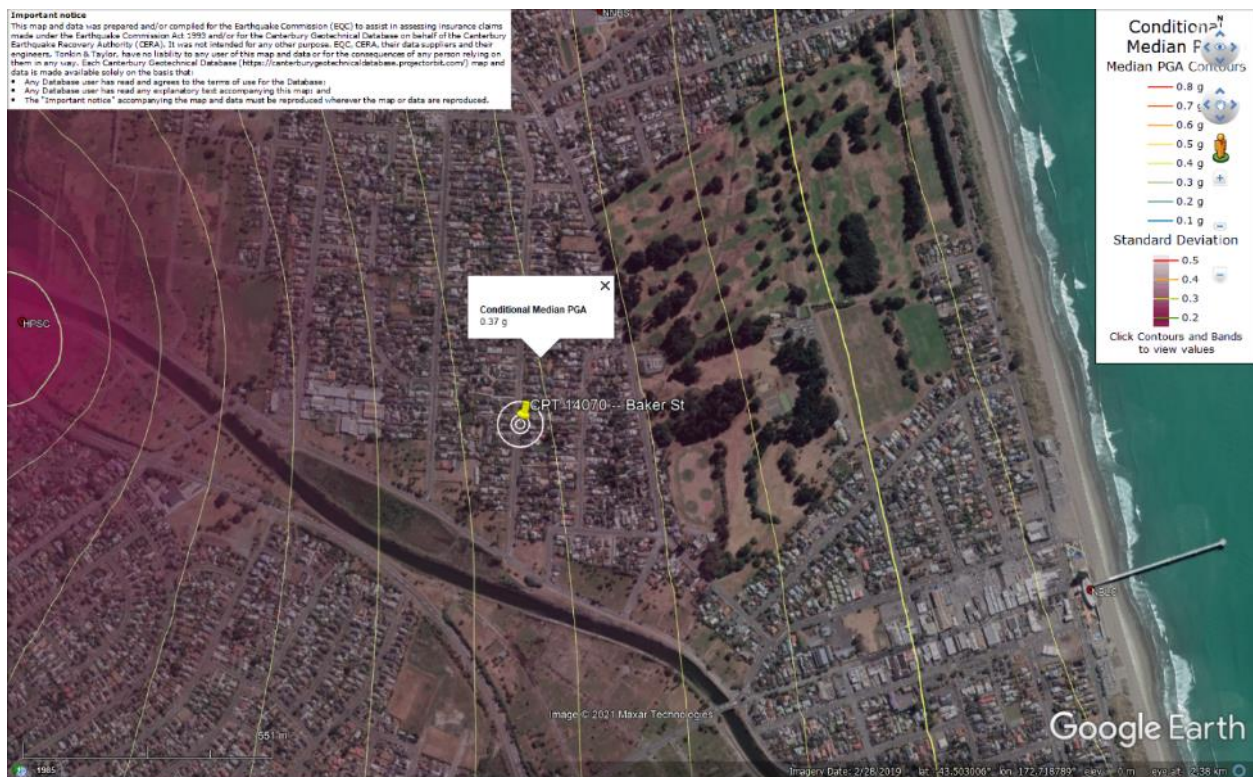
Figure 94: PGA for Dec-11 EQ (st. dev. = 0.350-0.375 ln units).
