Appendix A.37:

Woodham Rd – CPT 25514

Liquefaction Ejecta Case Histories for 2010-11 Canterbury Earthquakes

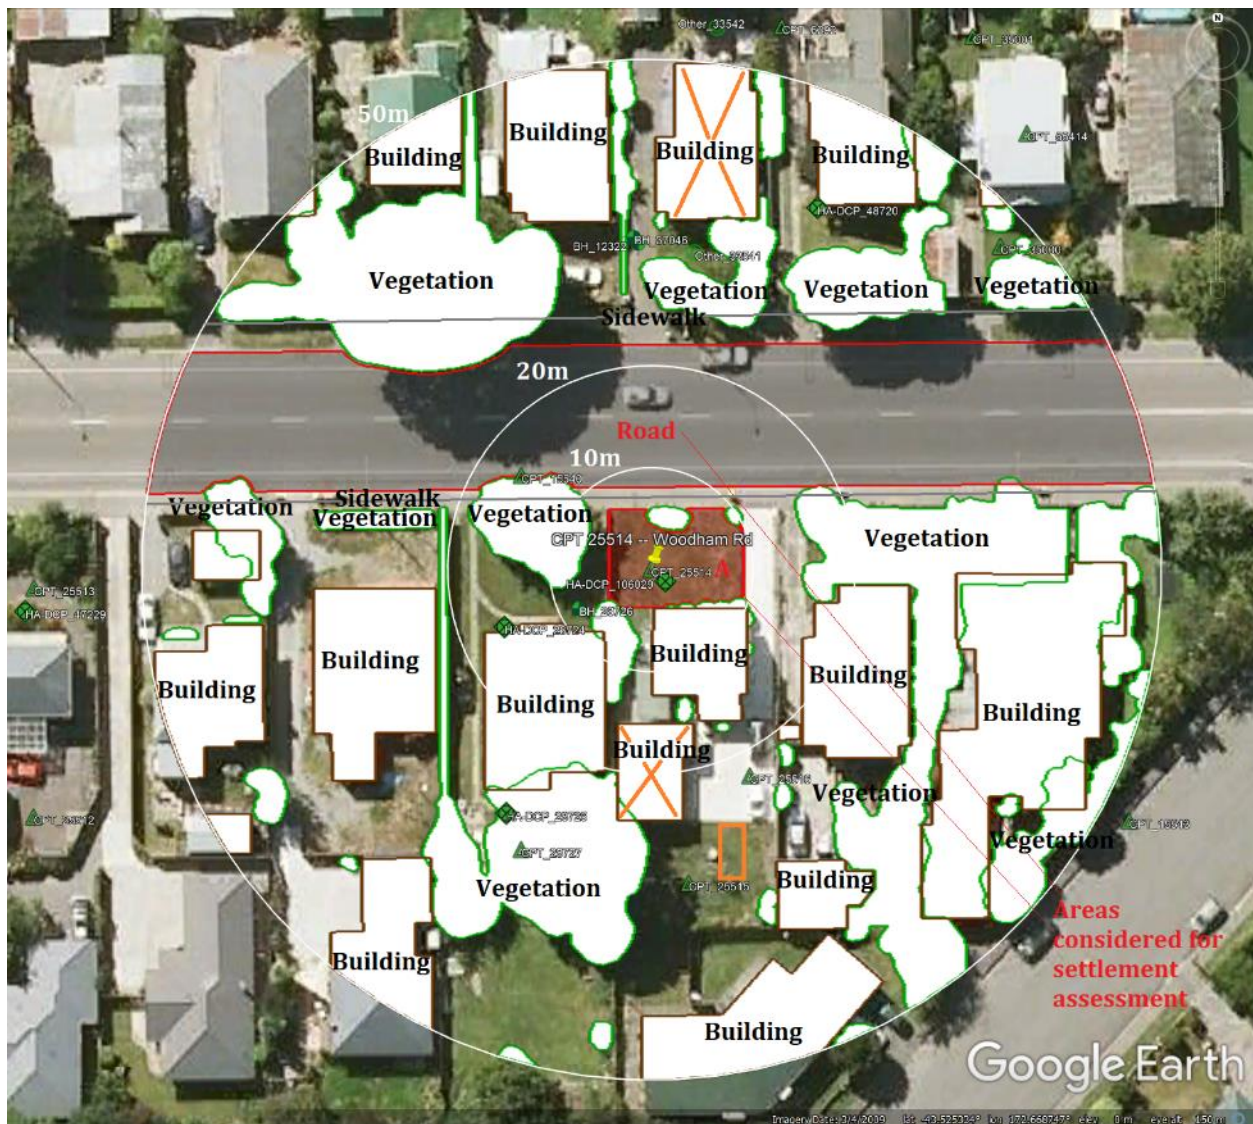
Figure 1: Site plan with patches where LiDAR survey data is considered.

Note 1: Patch A (outlined in red) in the free field was selected for the settlement assessment as an area free of vegetation and structures. Other factors that were considered for the patch selection included its proximity to a CPT, a property subjected to addition and/or demolition of a structure, front yard/backyard alterations (e.g., ploughing, rubble, scrap), and aerial distribution of sediment ejecta. In addition, the entire portion of the road within the 50-m buffer was considered for settlement assessment. Finally, the LiDAR-based settlement analyses for the Sep-10 and Dec-11 EQs were not conducted due to the evident absence of ejecta from Patch A and Road. The LiDAR-based settlement analyses were not considered for the Feb-11 and Jun-11 EQs due to the minor quantum of ejecta and the LiDAR flight error for the Feb-11 EQ.

- $A_{E,thick,i}$ and $H_{E,thick,i}$ are the area and the height of a thick ejecta layer, respectively;
- $A_{E,thin,j}$ and $H_{E,thin,j}$ are the area and the height of a thin ejecta layer, respectively;
- $A_{E,cc,k}$ and $R_{E,cc,k}$ are the area and the radius of an ejecta pile component, respectively, shaped as a cone with the repose angle of 30°;
- $W_{E,prism,n}$ and $L_{E,prism,n}$ are the width and the length of the coverage area of a prismatically shaped ejecta layer, respectively, and $H_{E,prism,n}$ is the height of a prism-like ejecta layer;
- $W_{E,pyr,p}$ and $L_{E,pyr,p}$ are the width and the length of the coverage area of a pyramid-like ejecta layer, respectively, and $H_{E,pyr,p}$ is the height of a pyramid-like ejecta layer;
- A_T is the total assessment area for a buffer being considered (Figure 1).

Note 5: The selection of CPTs for the area considered for settlement assessment (Figure 1) is based on the proximity of the CPTs to the considered areas. In accordance with that, the following table shows CPTs that were used for the volumetric settlement analysis in *Cliq v.3.0.3.2*, a CPT soil liquefaction software developed by GeoLogismiki. (The average volumetric settlements were reported in Table 8.)

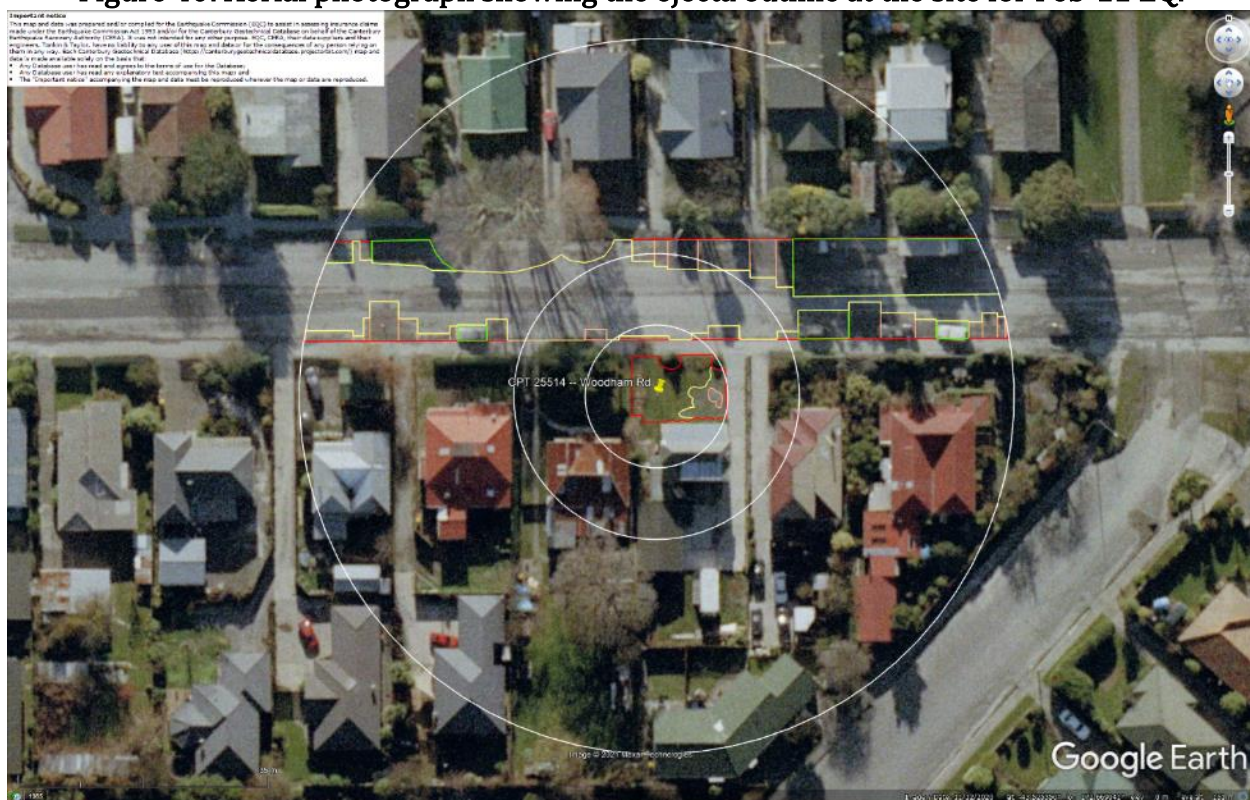
Figure 41: Aerial photograph acquired on 16 Jun 2011 showing the ejecta outline at the site for Jun-11 EQ.

Note 3: The values in Table 9 correspond to the coverage area of ejecta outlined in aerial photographs (Figures 20, 22, 24, 40, and 41) and the lower and upper estimates of ejecta height based on geometrical approximations, ground photographs (Figure 42), and EQC LDAT property inspection reports (Figure 43). The ejecta-induced settlement using photographs and engineering judgment, $S_{E,P}$, is estimated as

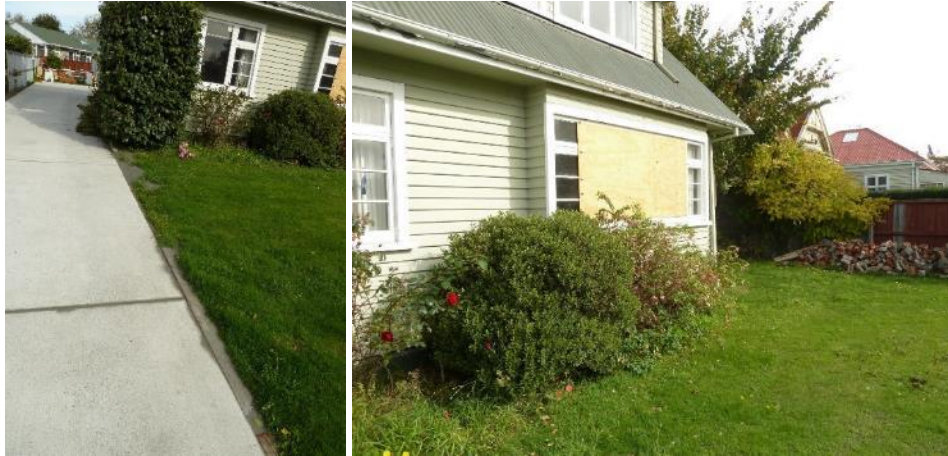
Figure 42: Ground photographs showing ejecta remnants within Patch A (photograph date: Apr 2011).
