Appendix A.45:

St. Albans Catholic School – VsVp 57180

## Liquefaction Ejecta Case Histories for 2010-11 Canterbury Earthquakes

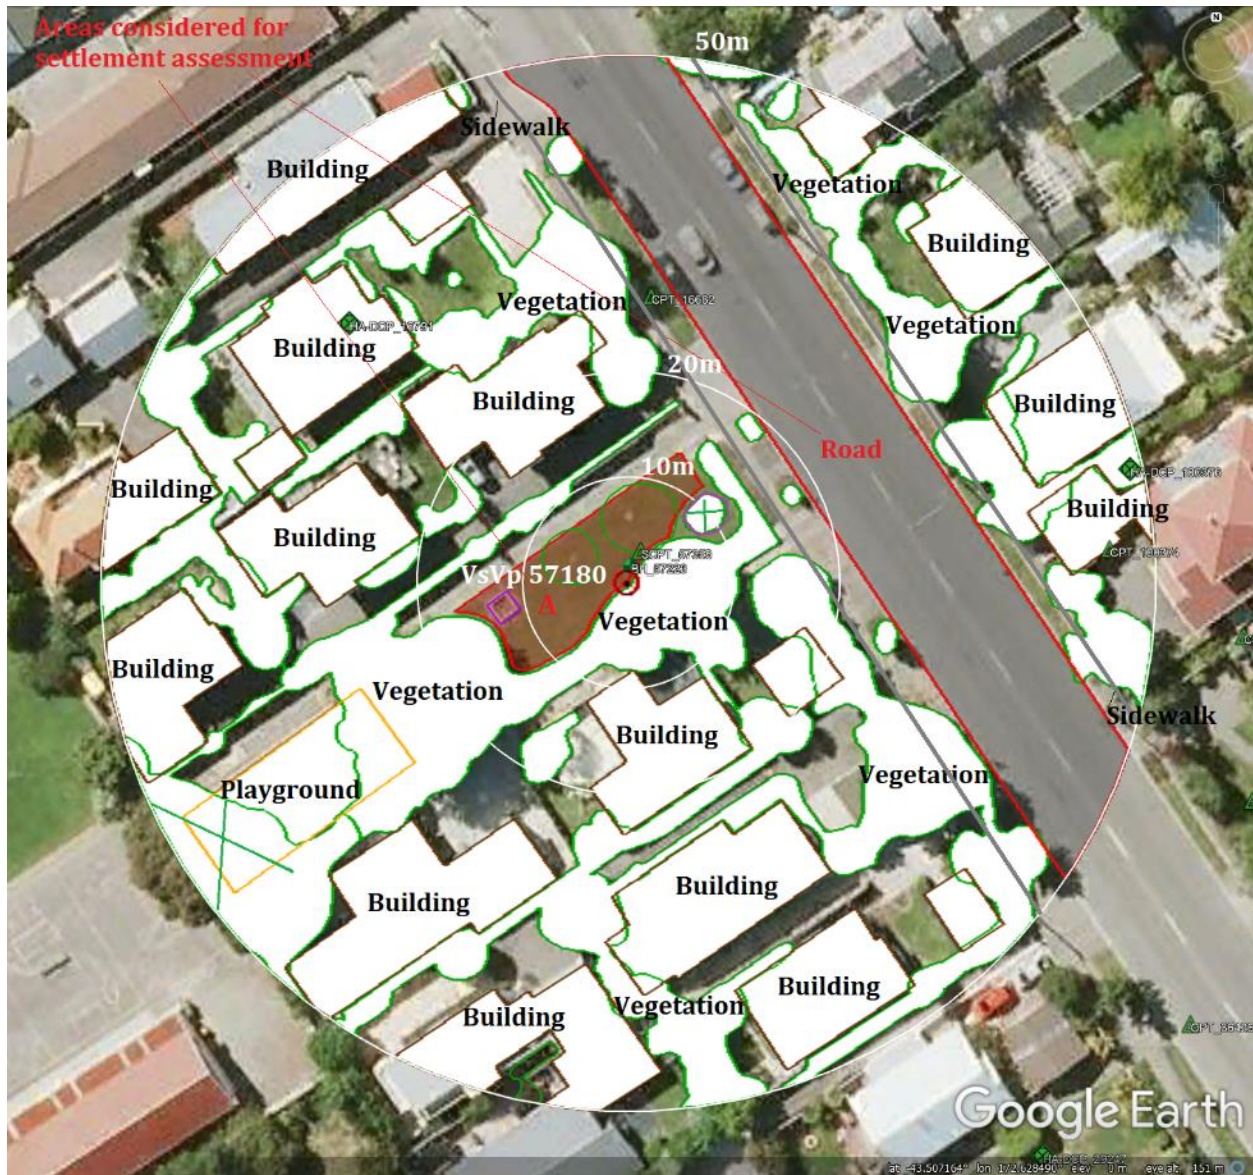
**Figure 1: Site plan with areas where ejecta-induced settlement is considered.**

**Note 1:** Patch A (outlined in red) in the free field was selected for settlement assessment as an area free of vegetation and structures. Other important factors considered for the patch selection were its proximity to a CPT, a property subjected to addition and/or demolition of a structure, front yard/backyard alterations (e.g., ploughing, rubble, scrap), and aerial distribution of sediment ejecta. The entire portion of the road within the 50-m buffer was considered for settlement assessment, too. The LiDAR-based settlement analyses of Patch A and Road were not considered for any earthquake event due to the evident absence of ejecta for the Sep-10 and Dec-11 EQs and minor quantum of ejecta for the Feb-11 and Jun-11 EQs.

Note: Buffer is the area within a circle of a specified radius with CPT investigations done at its center (172.629117°, -43.507198°).

- $A_{E,thick,i}$  and  $H_{E,thick,i}$  are the area and the height of a thick ejecta layer, respectively;
- $A_{E,thin,j}$  and  $H_{E,thin,j}$  are the area and the height of a thin ejecta layer, respectively;
- $A_{E,pile,k}$  and  $R_{E,pile,k}$  are the area and the radius of an ejecta pile component, respectively, shaped as a cone with the repose angle of  $30^\circ$ ;
- $A_{E,cone,m}$  and  $H_{E,cone,m}$  are the area and the height of a conically shaped ejecta, respectively;
- $W_{E,prism,n}$  and  $L_{E,prism,n}$  are the width and the length of the coverage area of a prismatically shaped ejecta layer, respectively, and  $H_{E,prism,n}$  is the height of a prism-like ejecta layer;
- $A_T$  is the total assessment area for a buffer being considered (Figure 1).

**Note 6:** The selection of CPTs for the area considered for settlement assessment (Figure 1) is based on the proximity of the CPTs to the considered areas. In accordance with that, the following table shows CPTs that were used for the volumetric settlement analysis in *Cliq v.3.0.3.2*, a CPT soil liquefaction software developed by GeoLogismiki. (The average volumetric settlements were reported in Table 8.)

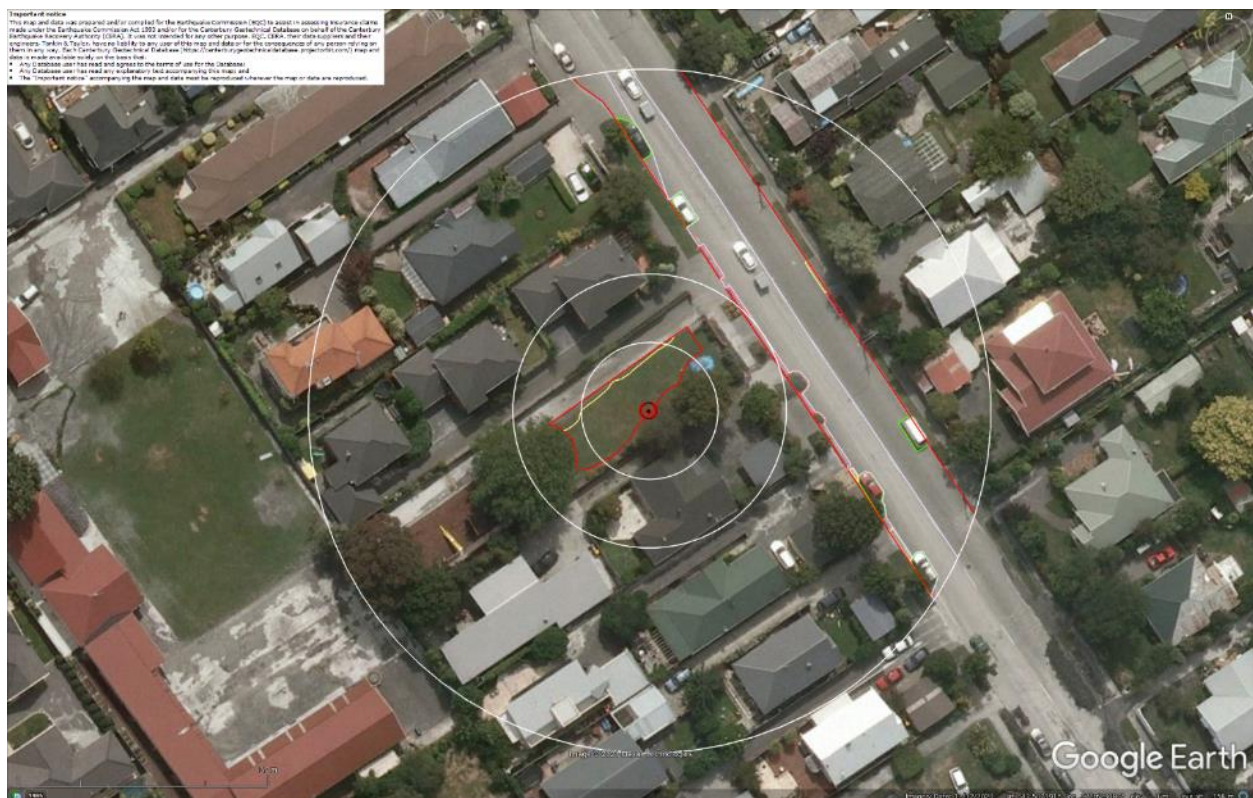
**Figure 38: Aerial photograph showing the ejecta outline at the site for Feb-11 EQ.**

**Note 3:** The values in Table 9 correspond to the coverage area of ejecta outlined in aerial photographs (Figures 38 and 39) and the lower and upper estimates of ejecta height based on geometrical approximations and EQC LDAT property inspection reports. The ejecta-induced settlement using photographs and engineering judgment,  $S_{E,P}$ , is estimated as

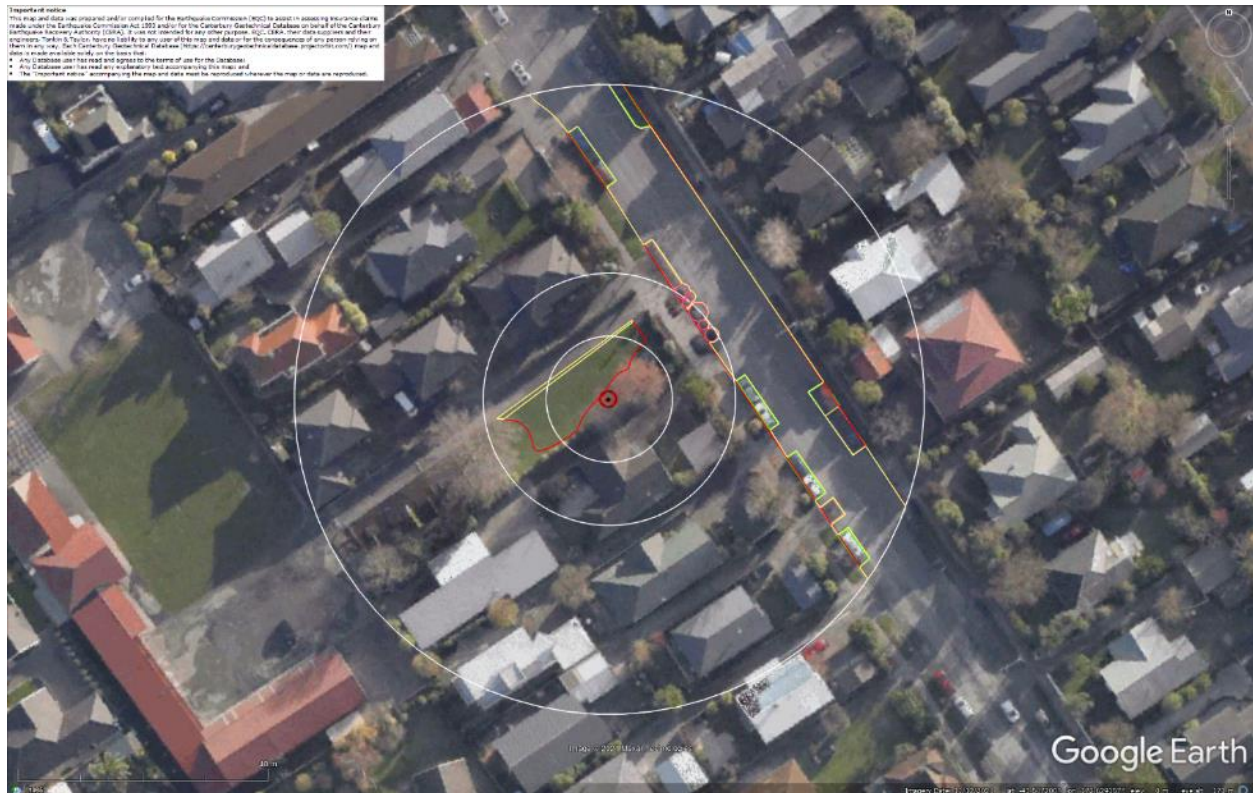
**Figure 39: Aerial photograph acquired on 14-15 Jun 2011 showing the ejecta outline at the site for Jun-11 EQ.**

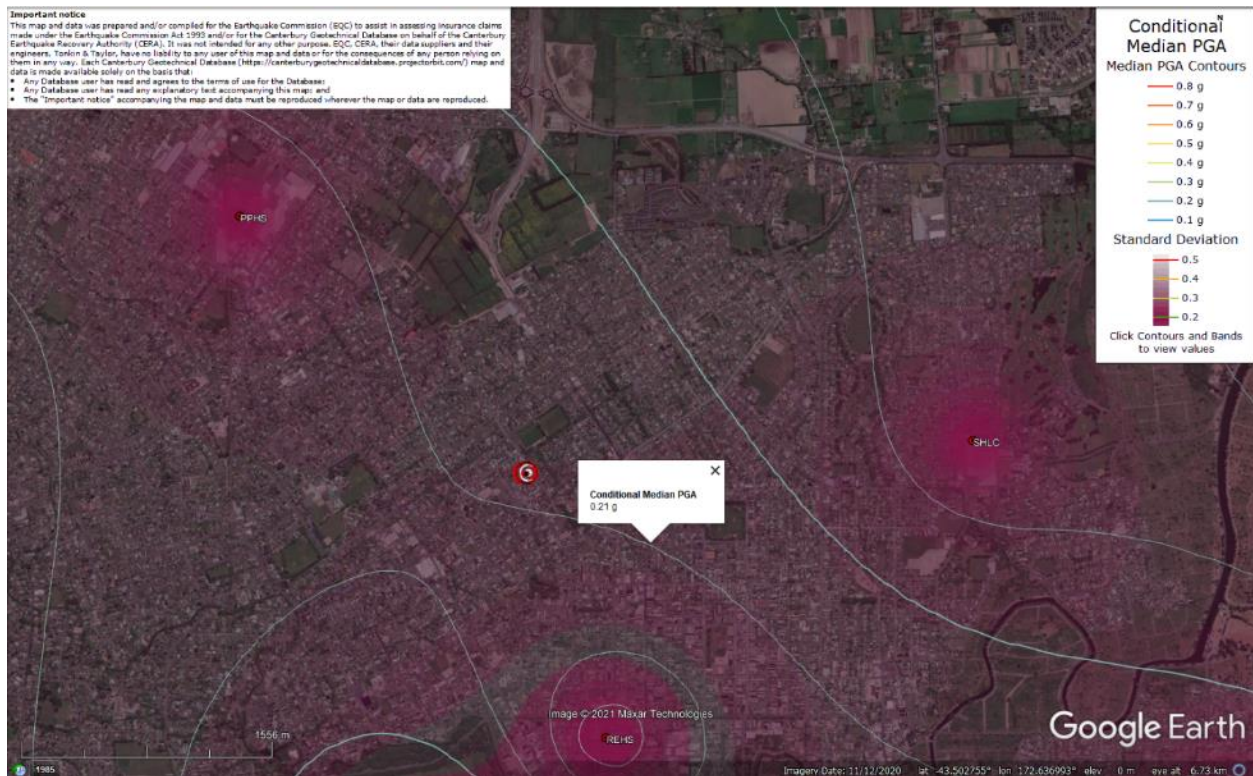
**Figure 40: PGA for Sep-10 EQ (st. dev. = 0.300-0.325 ln units).**

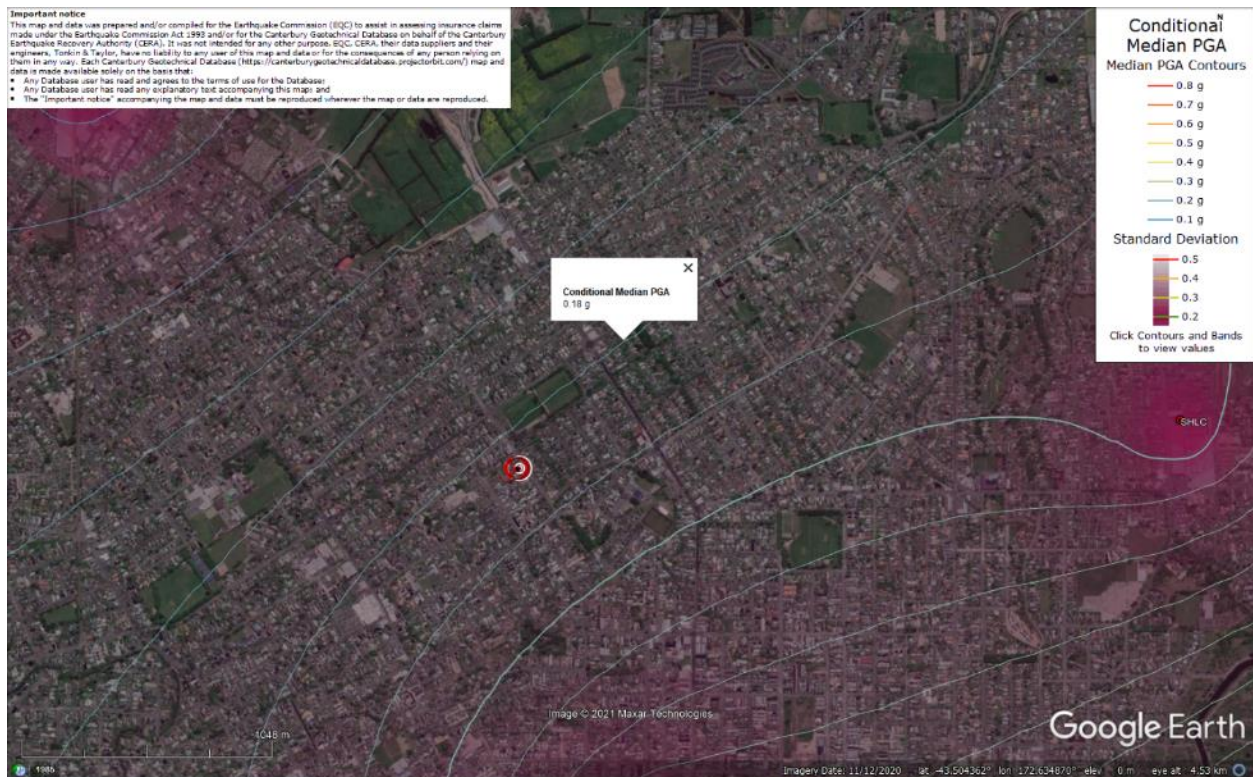
Figure 42: PGA for Jun-11 EQ (st. dev. = 0.350-0.375 ln units).
