Appendix A.47:

Hurst Pl – CPT 25981

Liquefaction Ejecta Case Histories for 2010-11 Canterbury Earthquakes

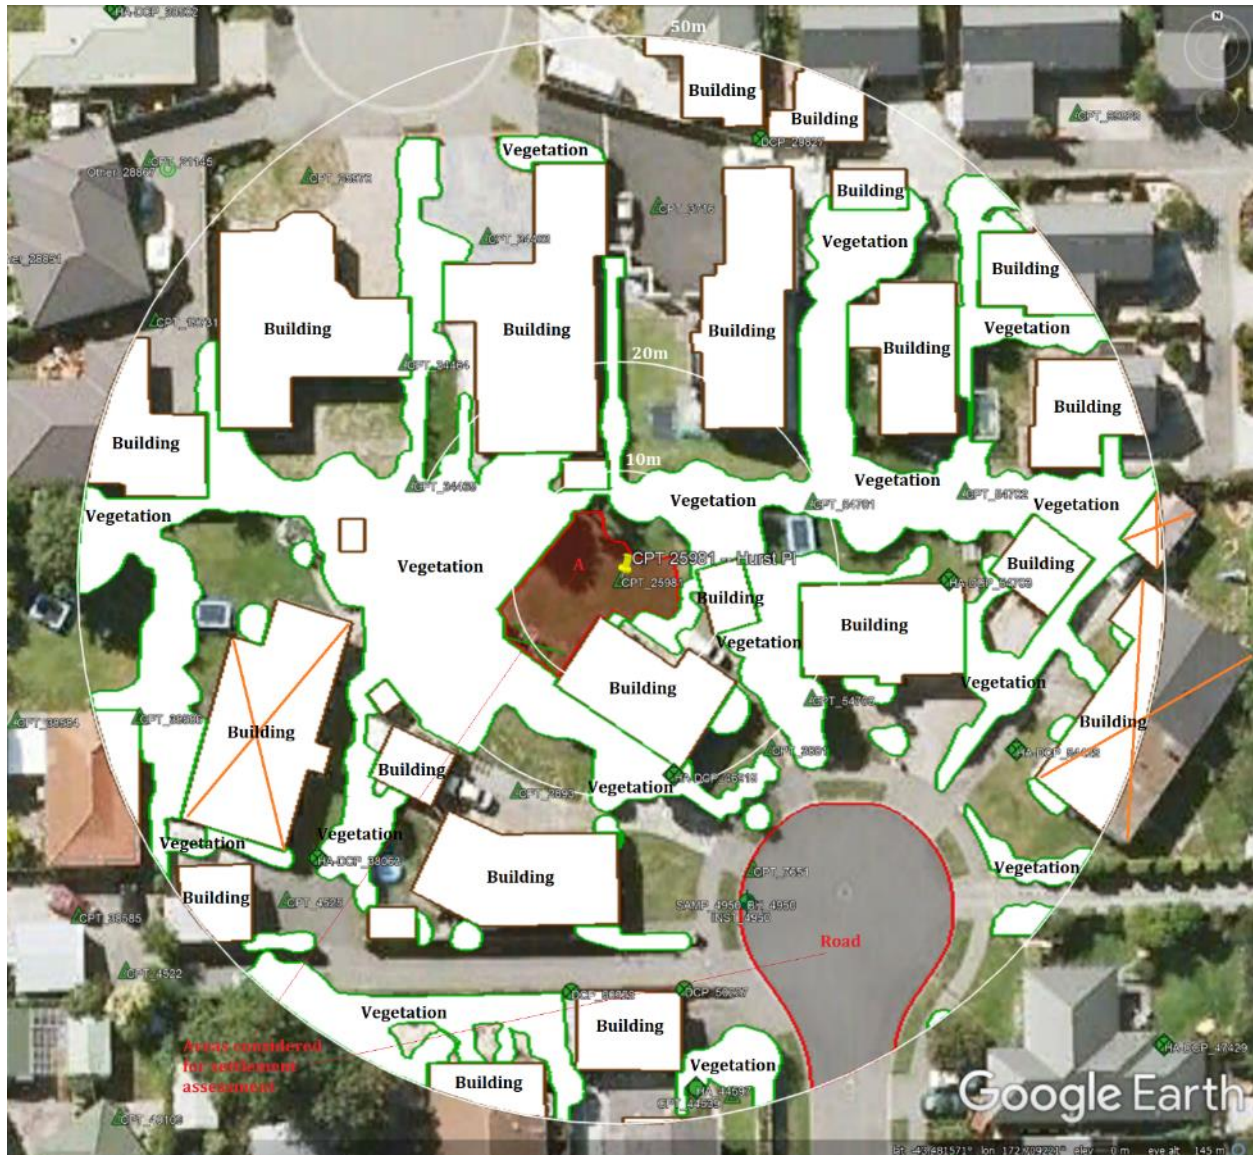
Figure 1: Site plan with areas where ejecta-induced settlement is considered.

Note 1: Patch A in the free field was selected for settlement assessment as an area free of vegetation and structures. Other important factors considered in the patch selection process were its proximity to a CPT, a property subjected to addition and/or demolition of a structure, front yard/backyard alterations (e.g., ploughing, rubble, scrap), aerial distribution of sediment ejecta, and the availability of LDAT property inspection notes. In addition, the entire portion of the road within the 50-m buffer was considered for the settlement assessment. The LiDAR-based settlement analyses were not conducted for this site due to the unavailability of the Sep-10 LiDAR survey used to compute the ground surface subsidence for the Sep-10 and Feb-11 EQs and the uncertainties associated with LiDAR measurements for the Jun-11 and Dec-11 EQs (Table 2).

- A_T is the total assessment area for a buffer being considered (Figure 1).

Note 5: The selection of CPTs for the area considered for settlement assessment (Figure 1) is based on the proximity of the CPTs to the considered areas. In accordance with that, the following table shows CPTs that were used for the volumetric settlement analysis in *Cliq v.3.0.3.2*, a CPT soil liquefaction software developed by GeoLogismiki. (The average volumetric settlements were reported in Table 8.)

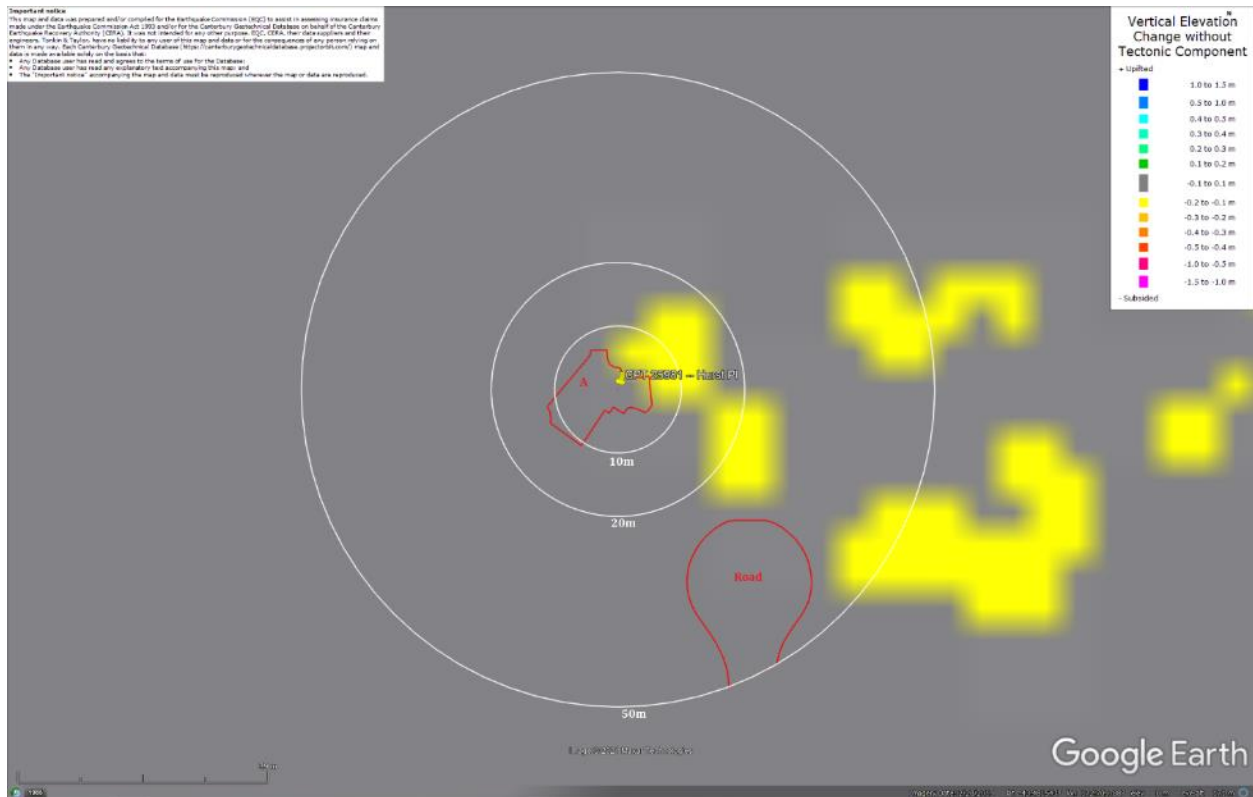
Figure 31: Ground surface subsidence without tectonic component for Dec 2011 Earthquake according to the LiDAR DEM.

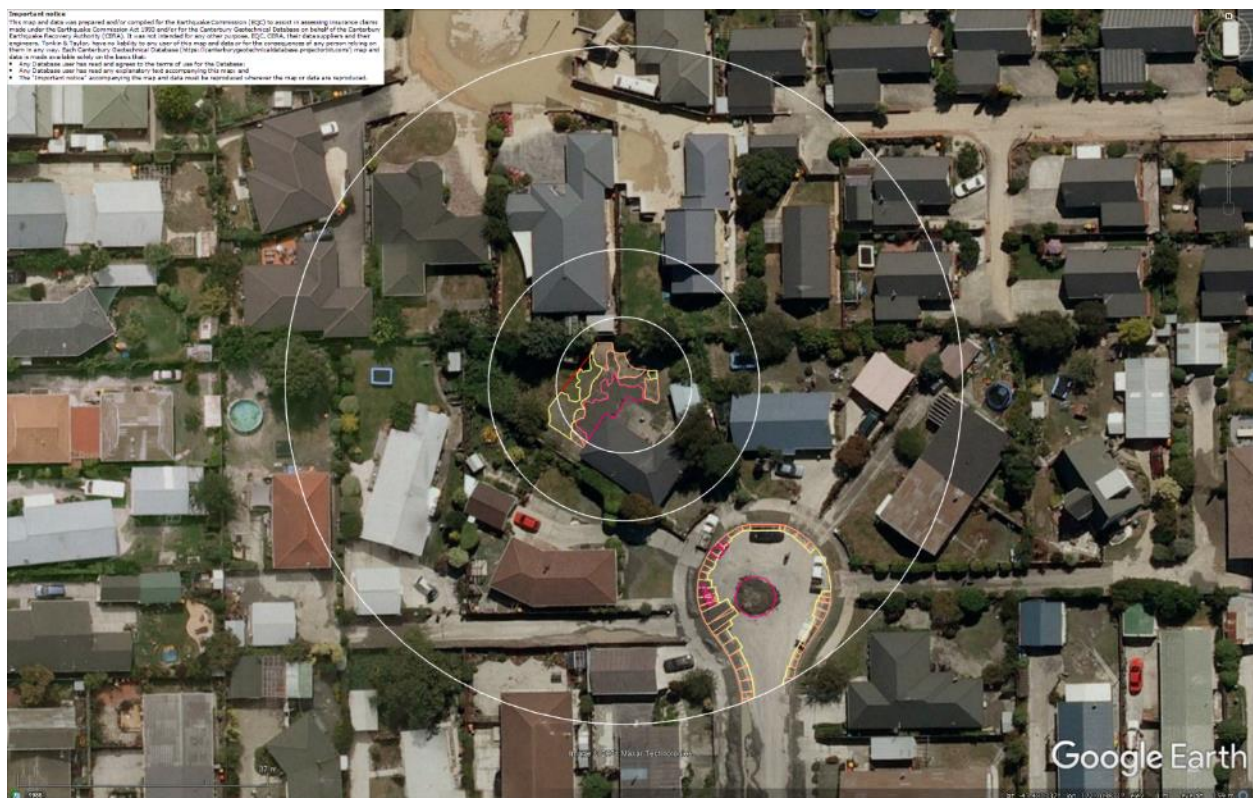
Figure 39: Aerial photograph showing the ejecta outline at the site for Feb-11 EQ.

Note 3: The values in Table 9 correspond to the coverage area of ejecta outlined in aerial photographs (Figures 9, 10, and 39-41) and the lower and upper estimates of ejecta height based on geometrical approximations, ground photographs (Figures 43 and 44), and EQC LDAT property inspection reports (e.g., Figure 42). The ejecta-induced settlement using photographs and engineering judgment, $S_{E,P}$, is estimated as

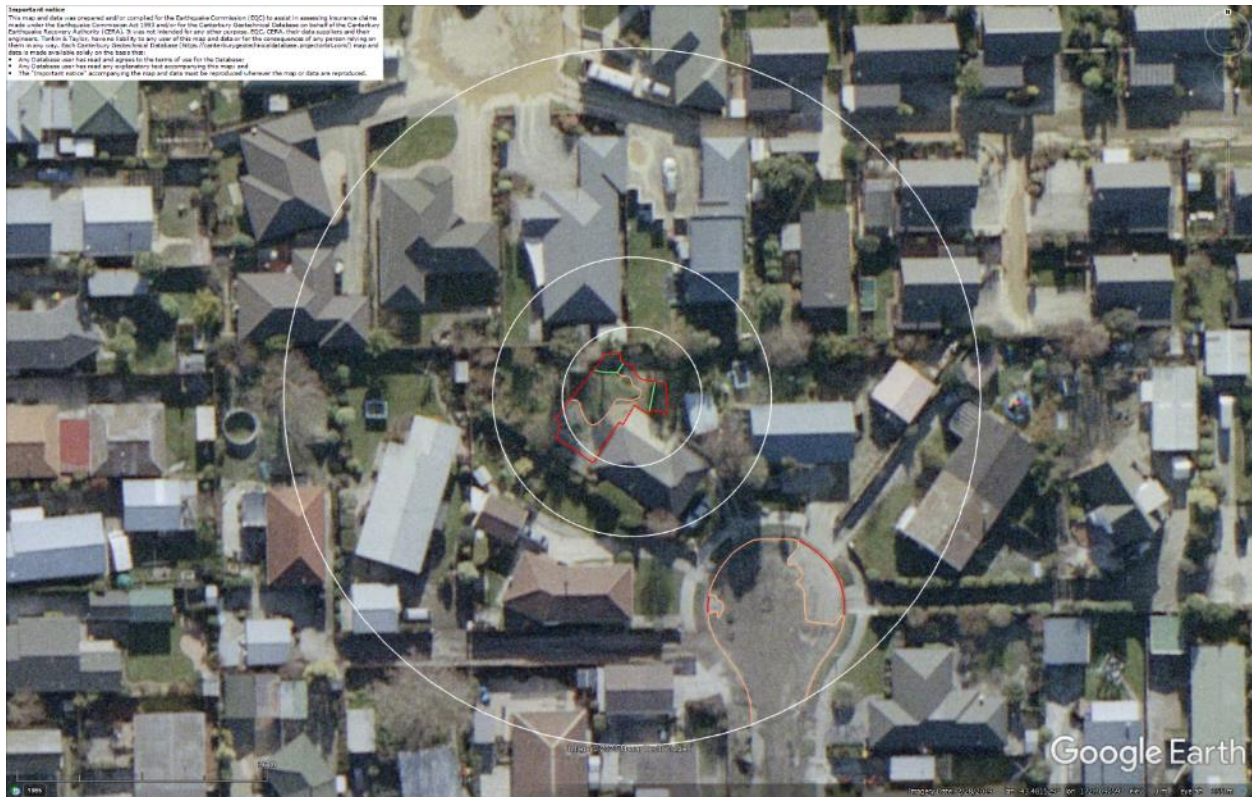
Figure 40: Aerial photograph acquired on 16 Jun 2011 showing the ejecta outline at the site for Jun-11 EQ.

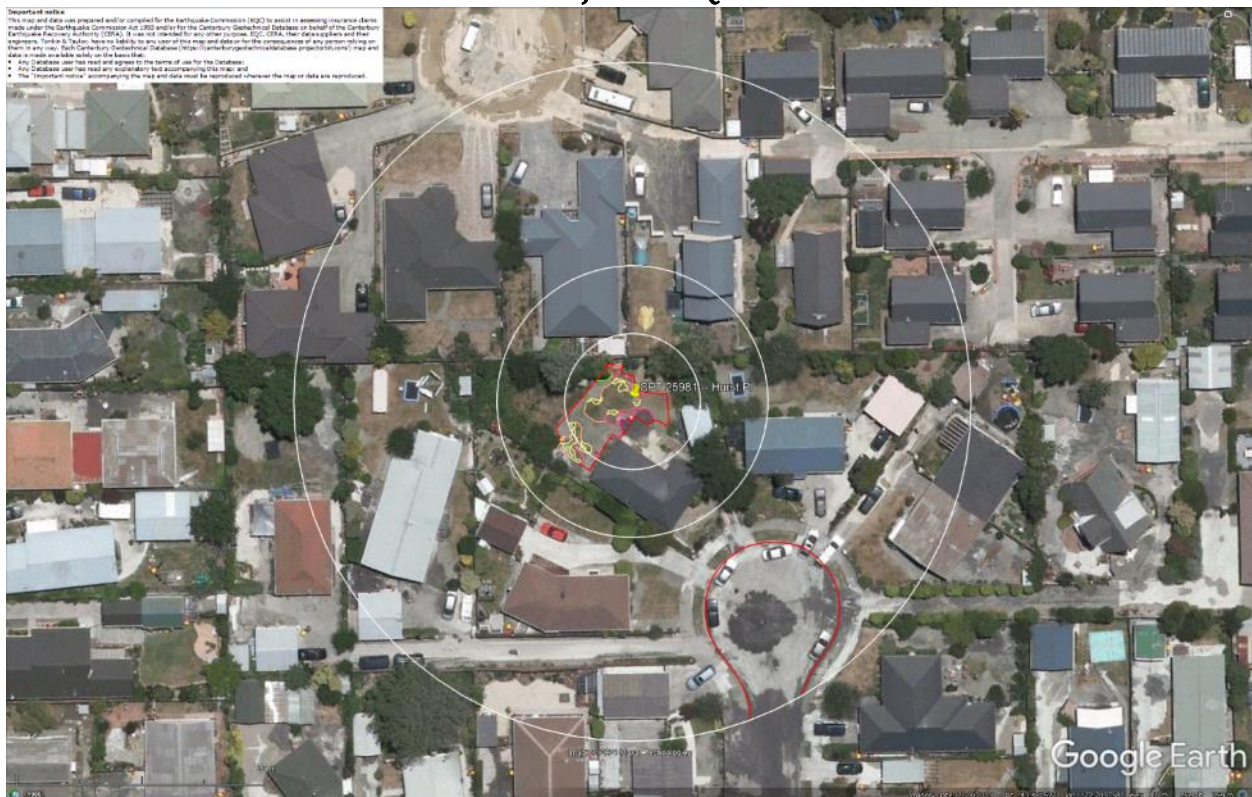
Figure 41: Aerial photograph showing the ejecta outline at the site for Dec-11 EQ.

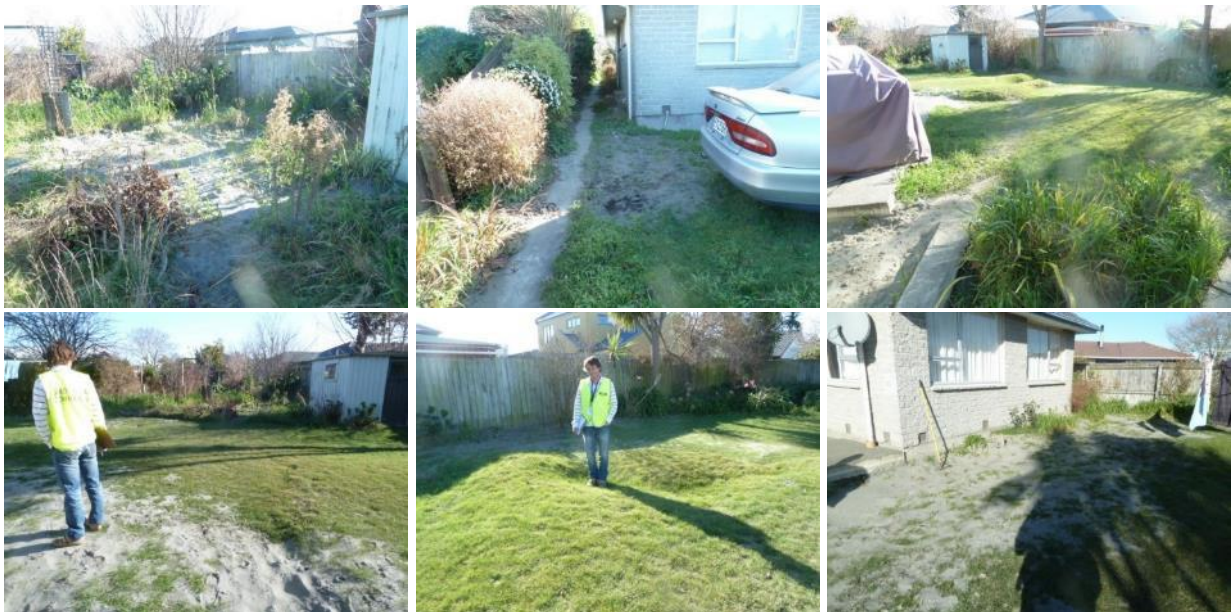
Figure 43: Ground photographs showing ejecta remnants at the property with Patch A (photograph date: July 2011).

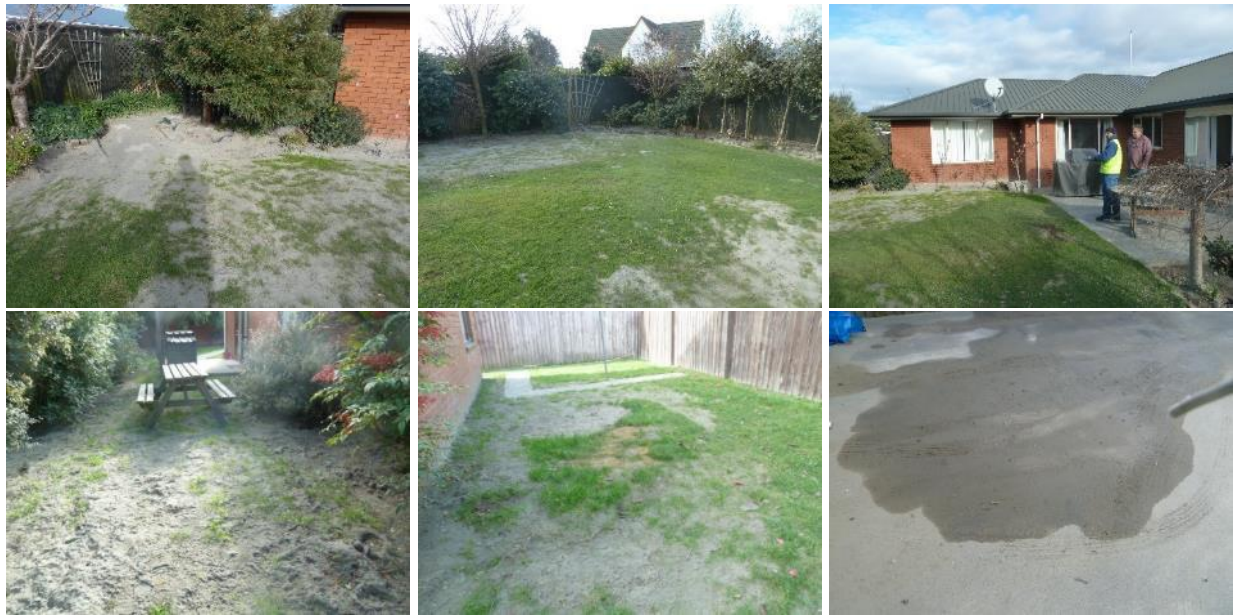
Figure 44: Ground photographs showing ejecta remnants at the properties within the 50-m buffer (photograph date: July 2011).

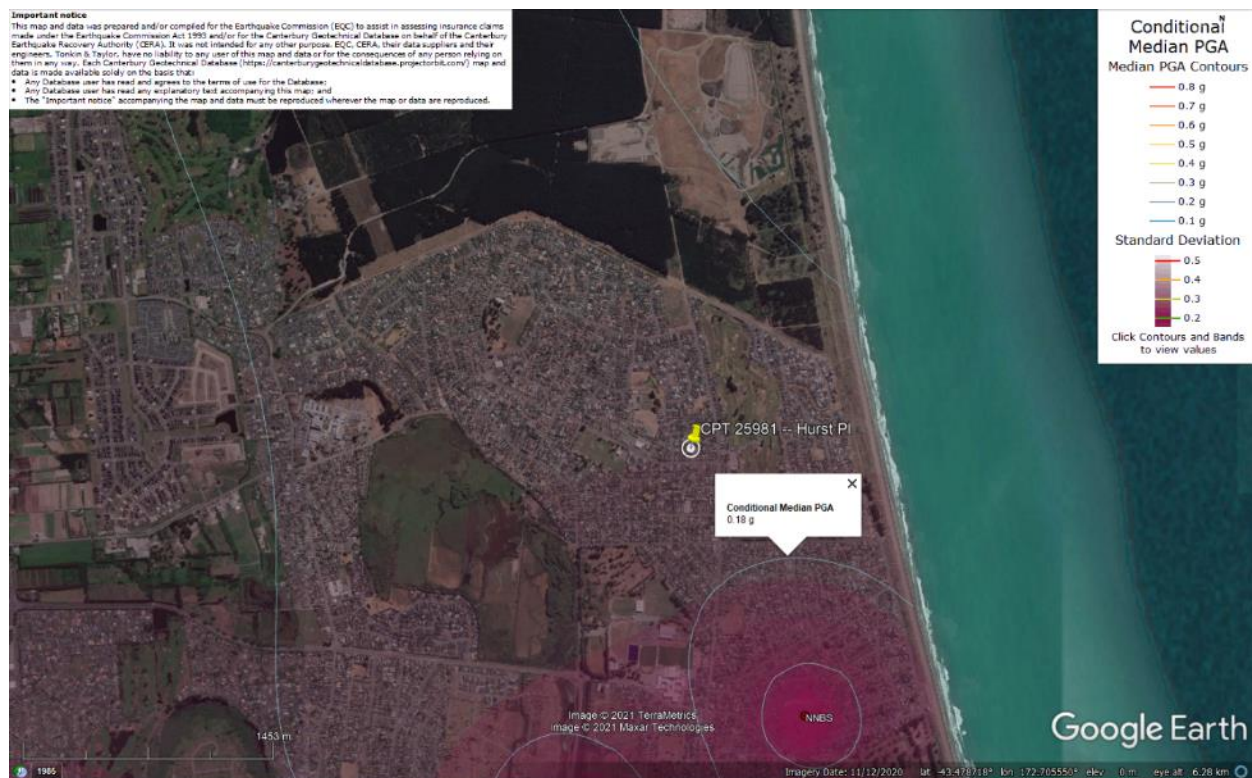
Figure 45: PGA for Sep-10 EQ (st. dev. = 0.325-0.375 ln units).

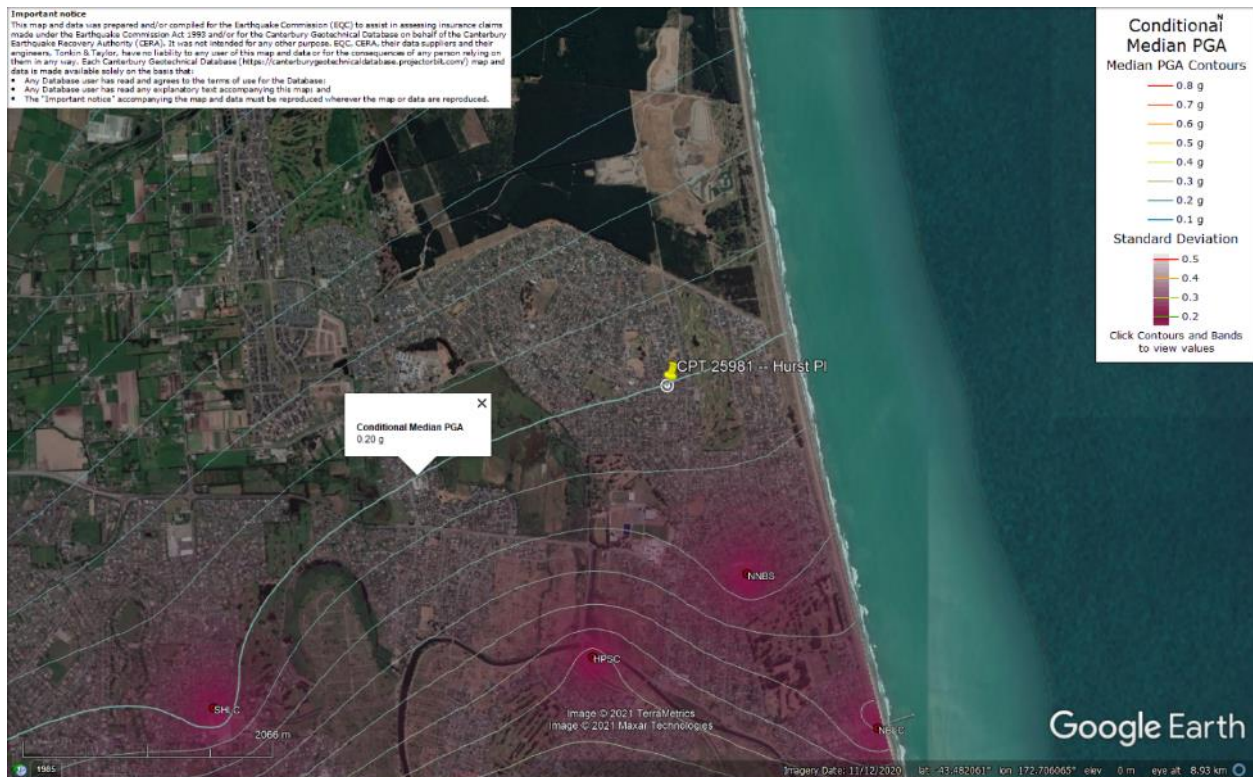
Figure 47: PGA for Jun-11 EQ (st. dev. = 0.375-0.400 ln units).

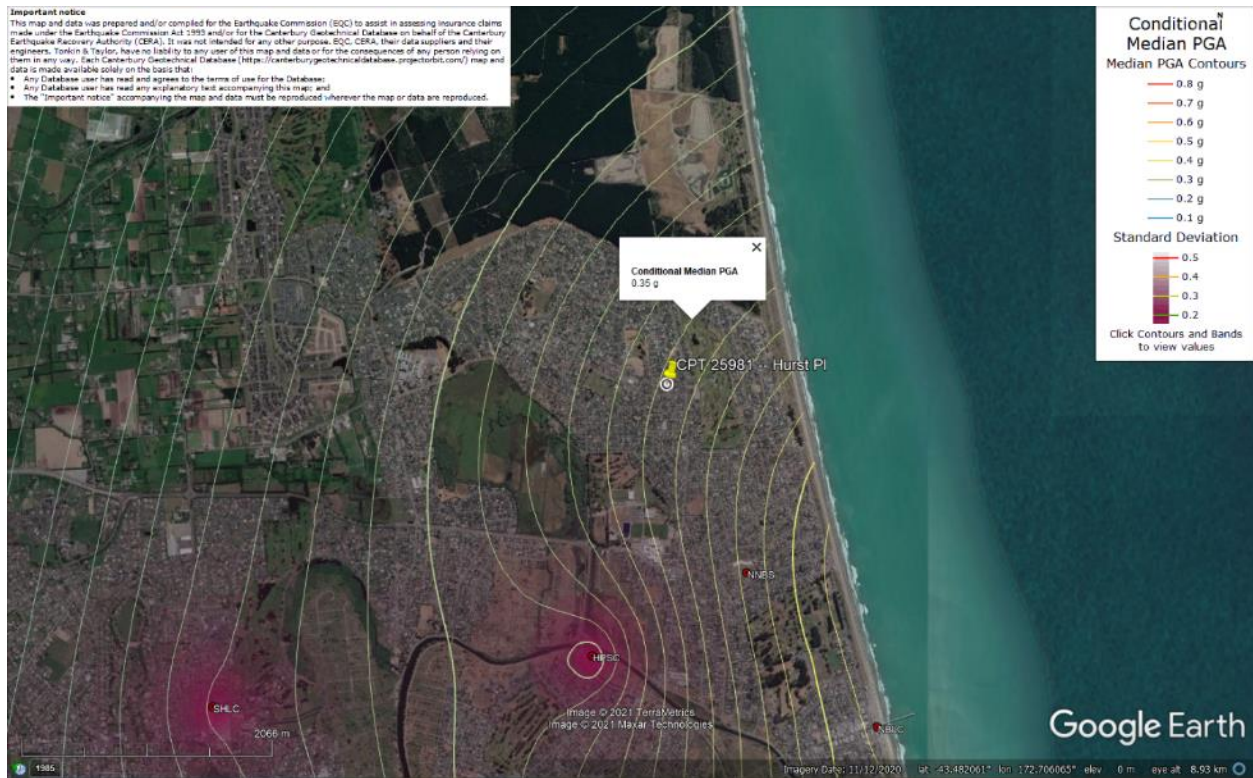
Figure 48: PGA for Dec-11 EQ (st. dev. = 0.400-0.425 ln units).
