Appendix A.49:

Bracken St – CPT 59661

Liquefaction Ejecta Case Histories for 2010-11 Canterbury Earthquakes

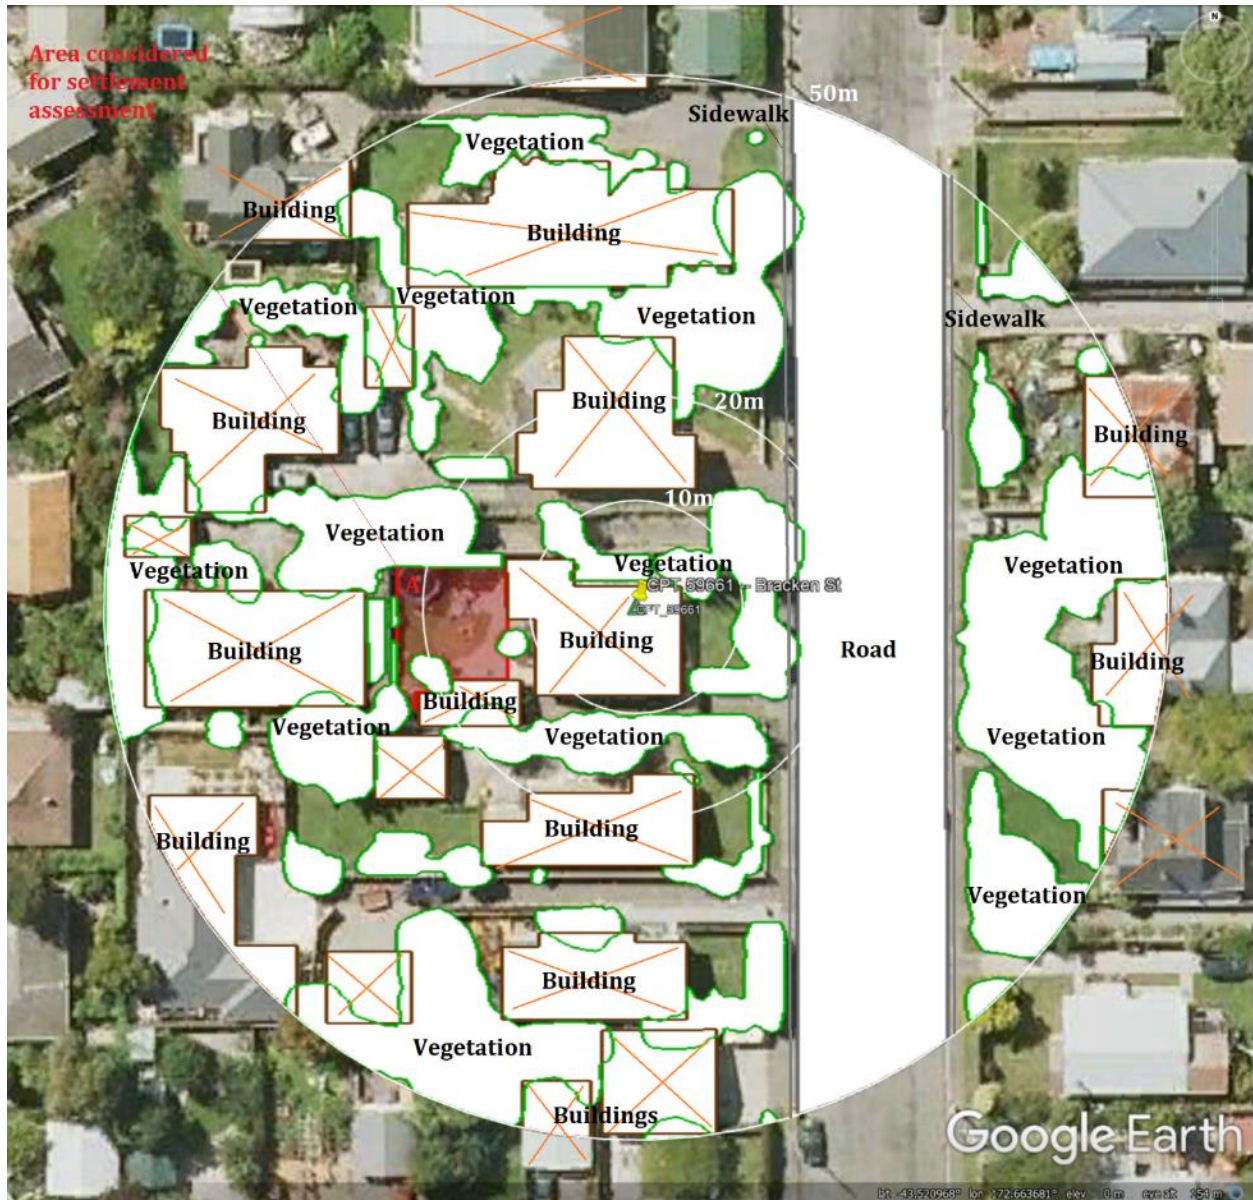
Figure 1: Site plan with areas where ejecta-induced settlement is considered.

Note 1: Patch A (outlined in red) in the free field was selected for settlement assessment as an area free of vegetation and structures. Other important factors considered in the patch selection process were its proximity to a CPT, a property subjected to addition and/or demolition of a structure, front yard/backyard alterations (e.g., ploughing, rubble, scrap), and aerial distribution of sediment ejecta. The LiDAR-based settlement analyses were not performed for any earthquake event due to the uncertainties explained in Table 2.

- $A_{E,thick,i}$ and $H_{E,thick,i}$ are the area and the height of a thick ejecta layer, respectively;
- $A_{E,thin,j}$ and $H_{E,thin,j}$ are the area and the height of a thin ejecta layer, respectively;
- A_T is the total assessment area for a buffer being considered (Figure 1).

Note 6: The selection of CPTs for the area considered for settlement assessment (Figure 1) is based on the proximity of the CPTs to the considered areas. In accordance with that, the following table shows CPTs that were used for the volumetric settlement analysis in *Cliq v.3.0.3.2*, a CPT soil liquefaction software developed by GeoLogismiki. (The average volumetric settlements were reported in Table 8.)

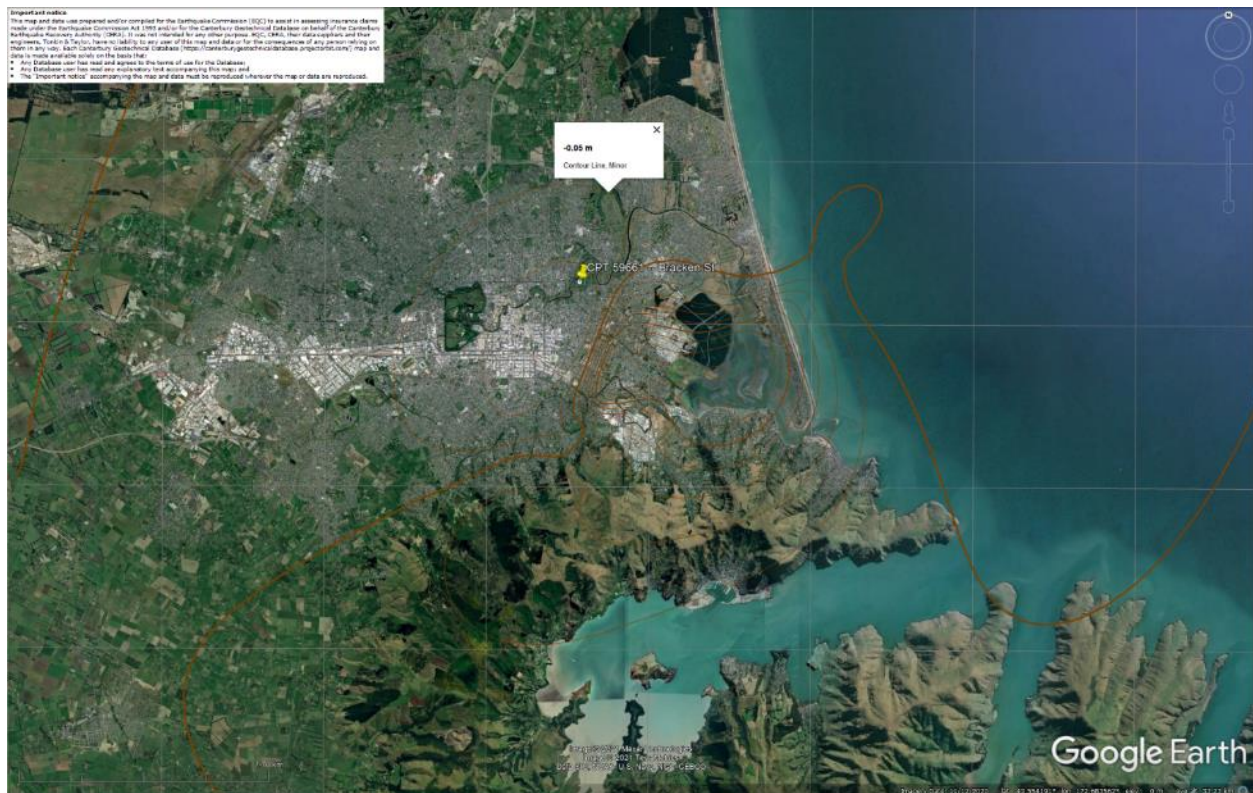
Figure 33: Vertical tectonic movements for Feb 2011 Earthquake.

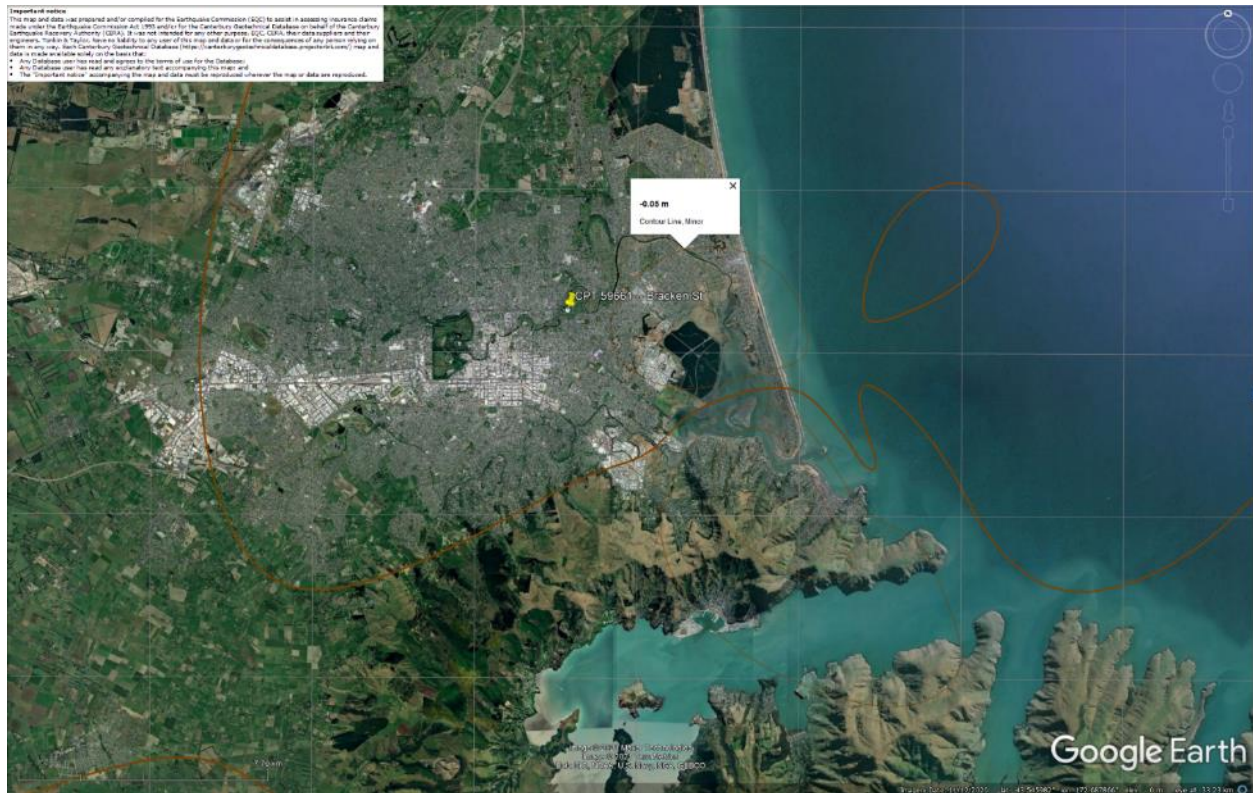
Figure 34: Vertical tectonic movements for June 2011 Earthquake.

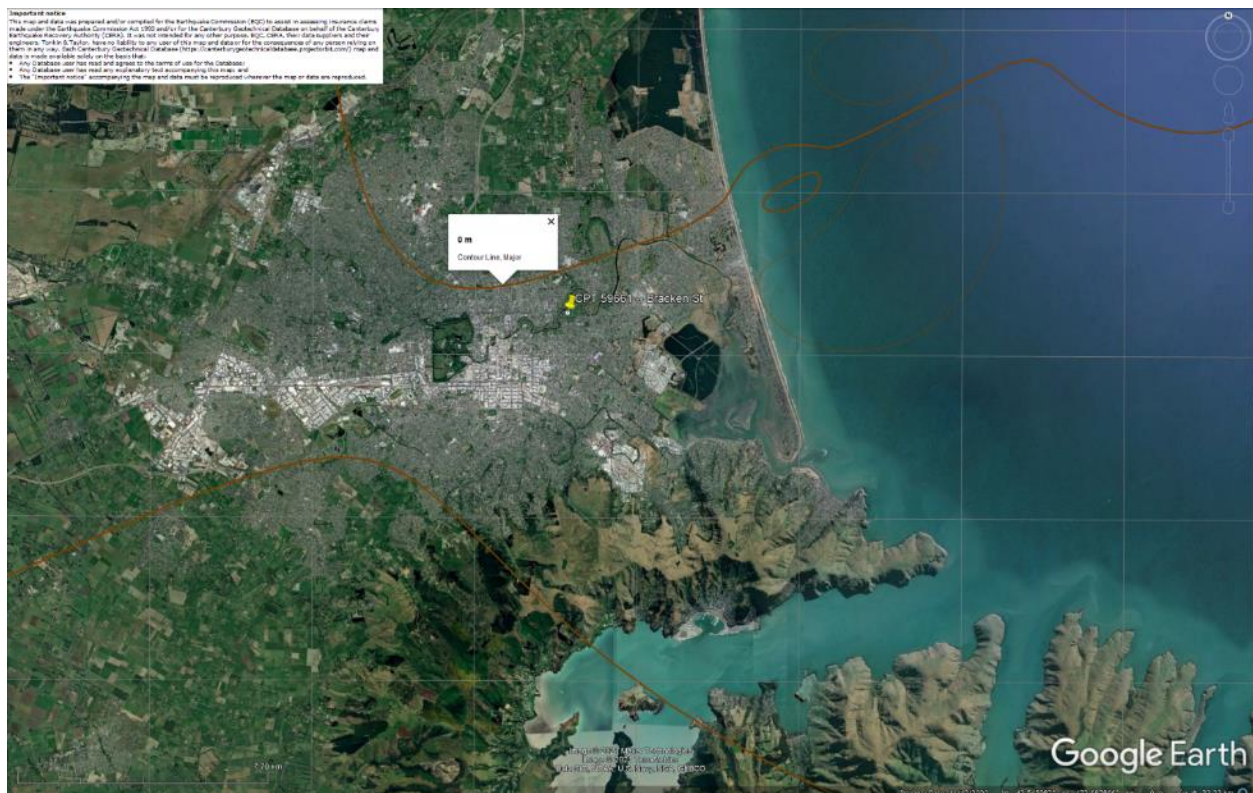
Figure 35: Vertical tectonic movements for Dec 2011 Earthquake.

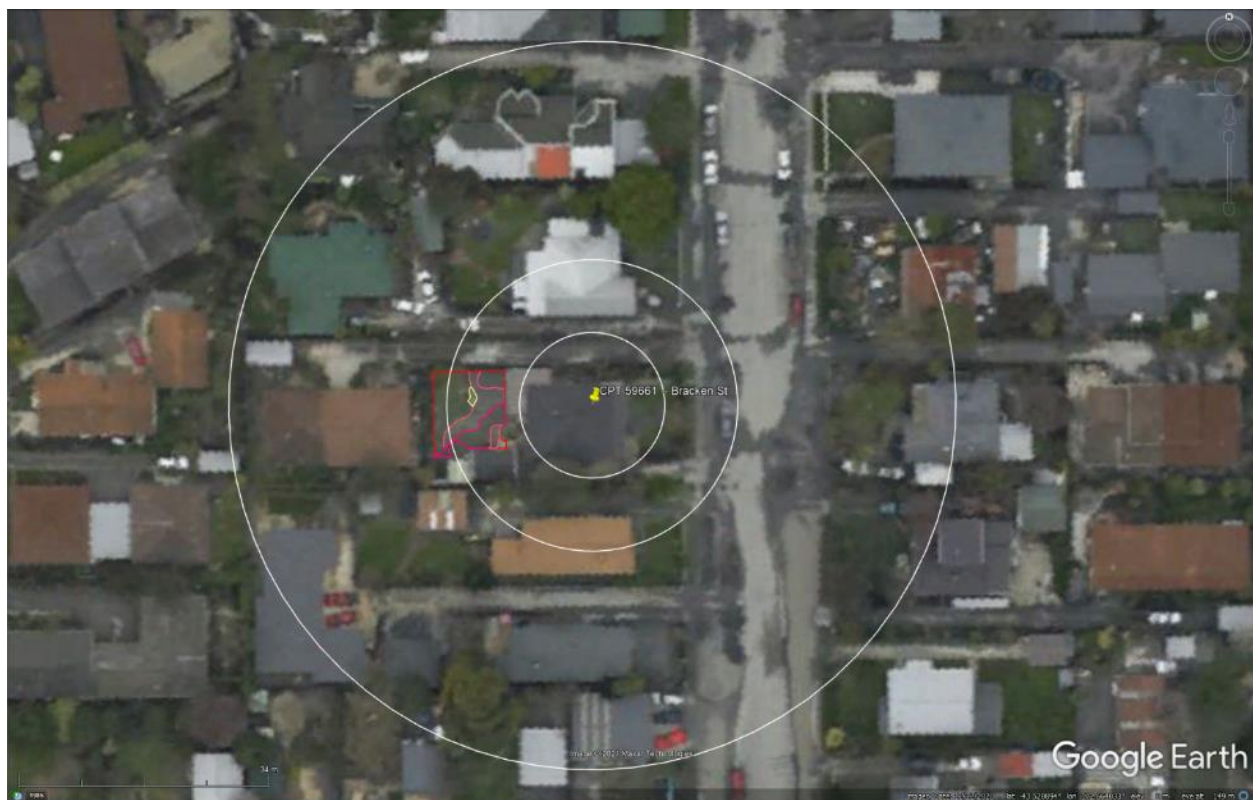
Figure 37: Aerial photograph showing the ejecta outline at the site for Sep-10 EQ.

Note 3: The values in Table 9 correspond to the coverage area of ejecta outlined in aerial photographs (Figures 37-40) and the lower and upper estimates of ejecta height based on geometrical approximations (Figures 41 and 42), ground photographs, and EQC LDAT property inspection reports (e.g., Figures 43 and 44). The ejecta-induced settlement using photographs and engineering judgment, $S_{E,P}$, is estimated as

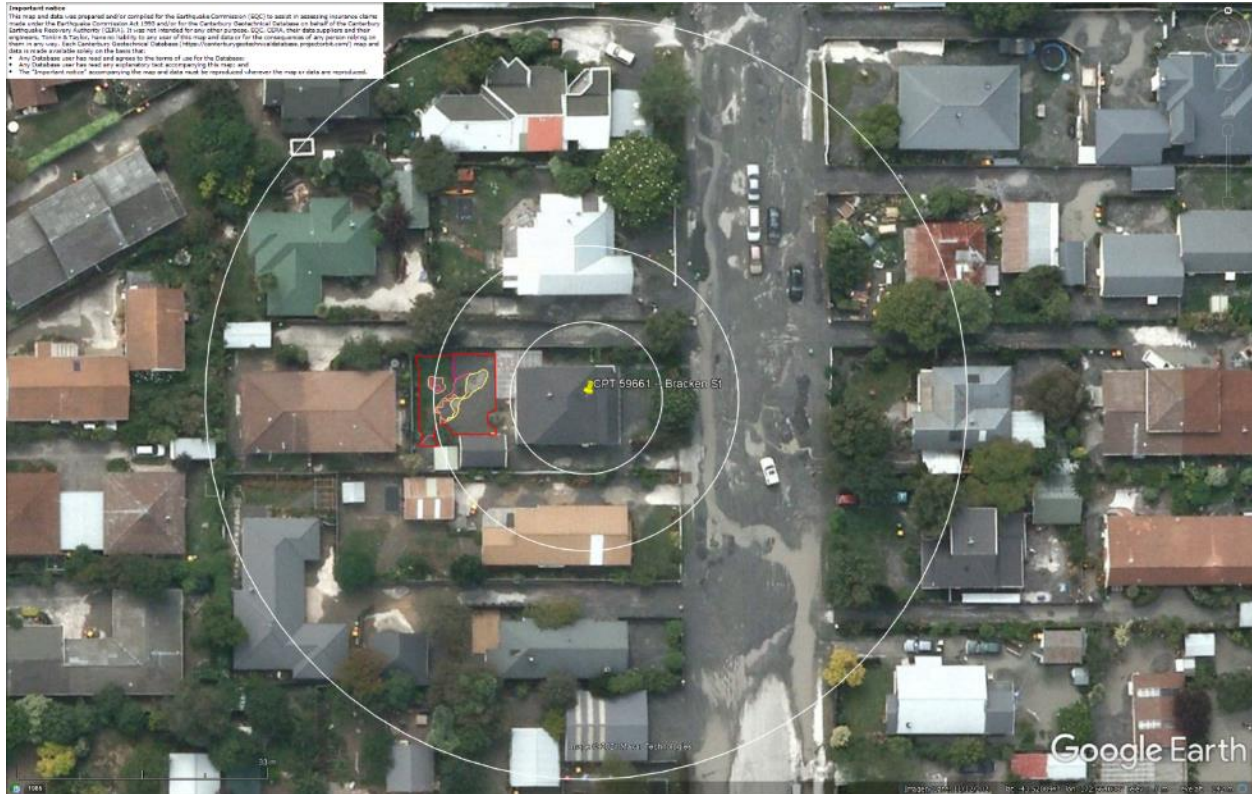
Figure 38: Aerial photograph showing the ejecta outline at the site for Feb-11 EQ.

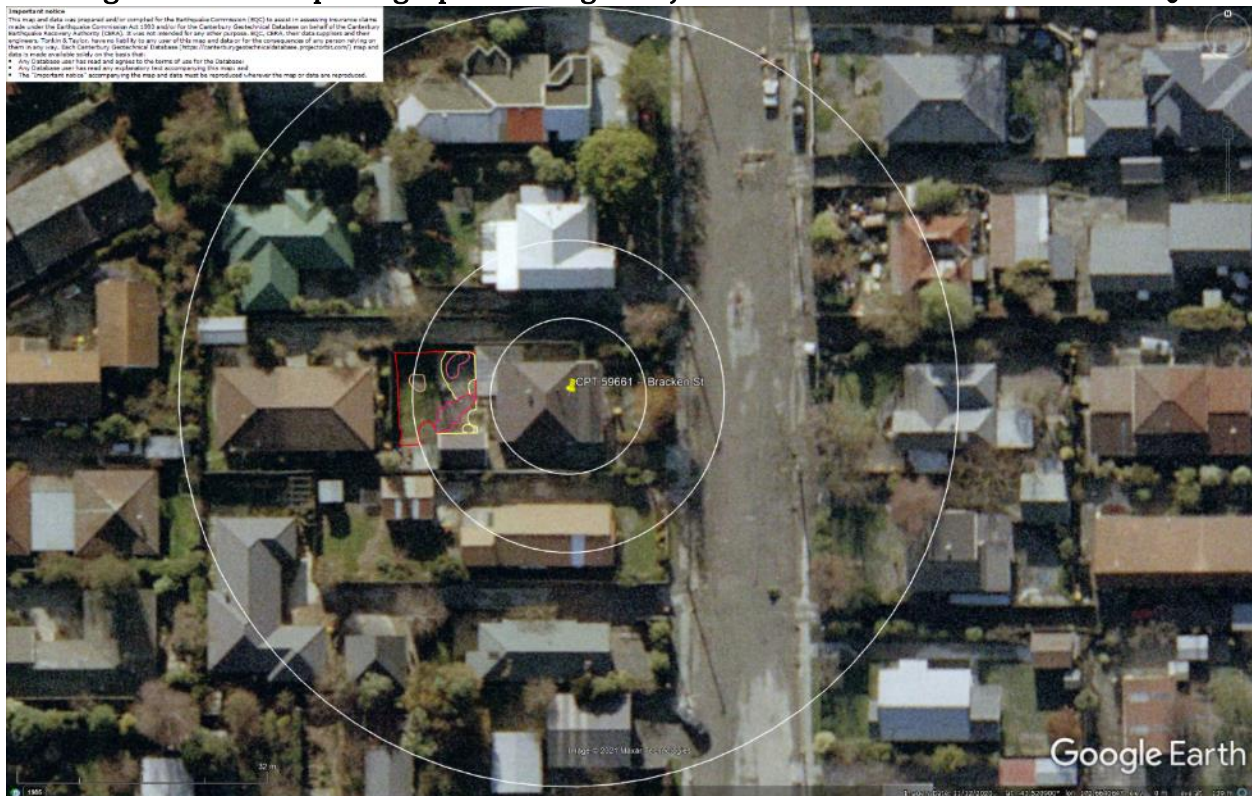
Figure 39: Aerial photograph acquired on 16 Jun 2011 showing the ejecta outline at the site for Jun-11 EQ.

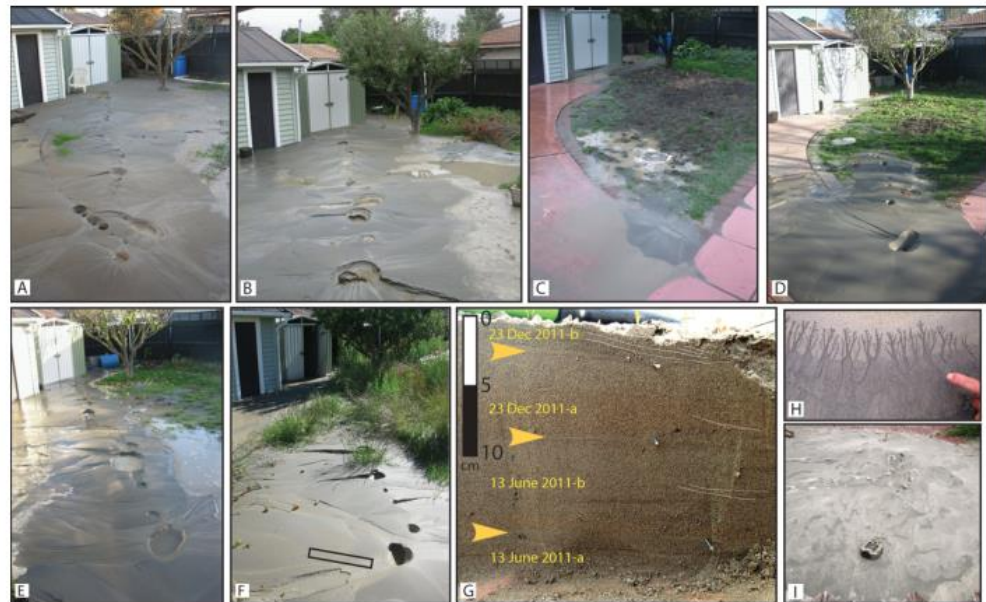
Figure 2. A-F: Field photographs (looking south-west) of sand blows at study site following the (A) Darfield M_L 7.1 earthquake, (B) 22 February 2011 M_L 6.3, 5.8, and 5.9 earthquakes, (C) 16 April 2011 M_L 5.5 earthquake, (D) 13 June 2011-a M_L 5.6 earthquake, (E) 13 June 2011-b M_L 6.4 earthquake, and (F) 23 December 2011 M_L 5.8 and 6.0 earthquakes. All photos were taken from same location within 3 h of last inducing earthquake. G: Distinct liquefaction ejecta units in sand blow stratigraphy. Arrows and nails denote silt drapes. Cross-bedding as sketched in F. H: Microrill development in silt drape at edge of a sand blow. I: Post-depositional erosion of sand blow and silt drape to form parabolic microdunes and ripples only 2 mo after formation.

Figure 41: Figure 2 from Quigley et al. (2013) showing ejecta within Patch A for CES.

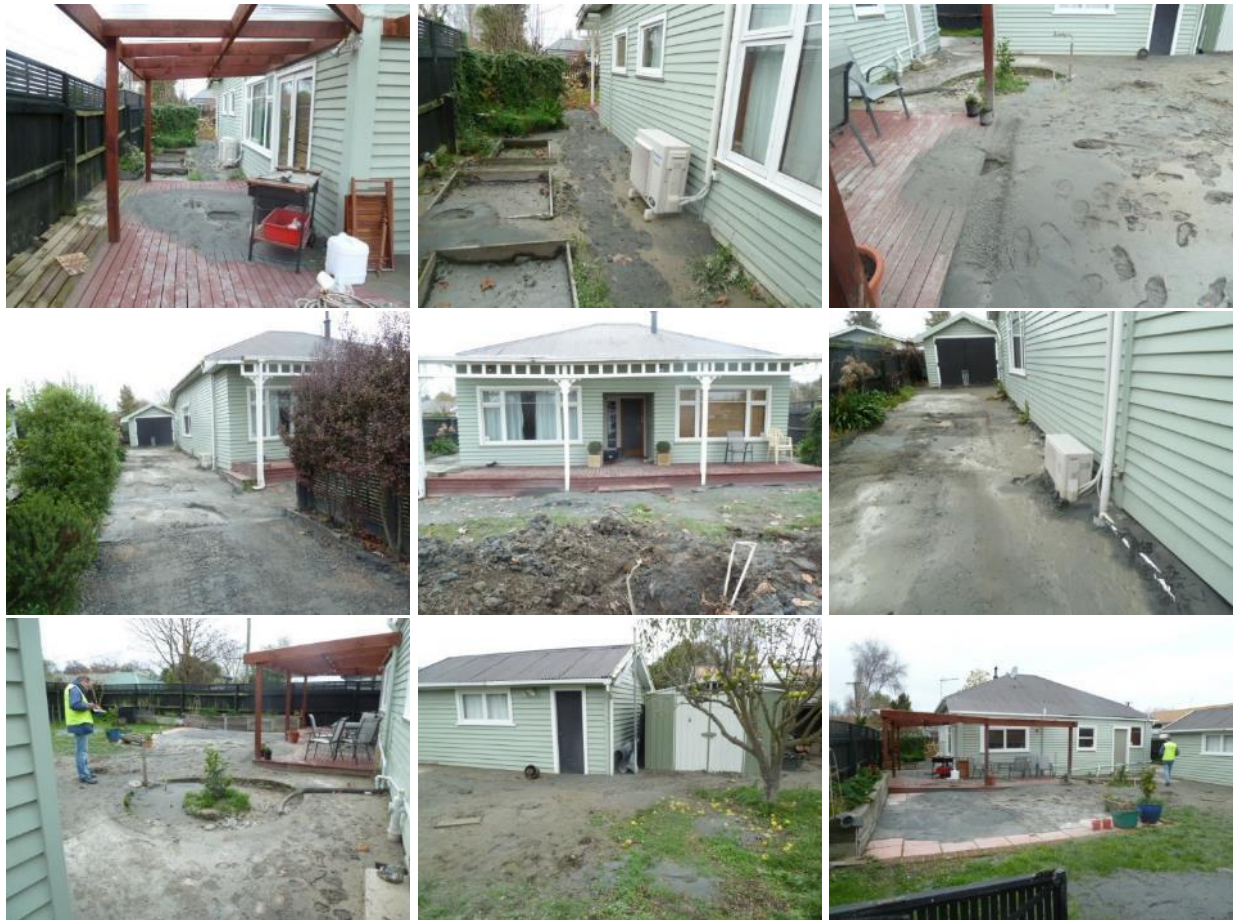
Figure 42: Ground photographs showing ejecta at the property with Patch A (photograph date: 22 June 2011).

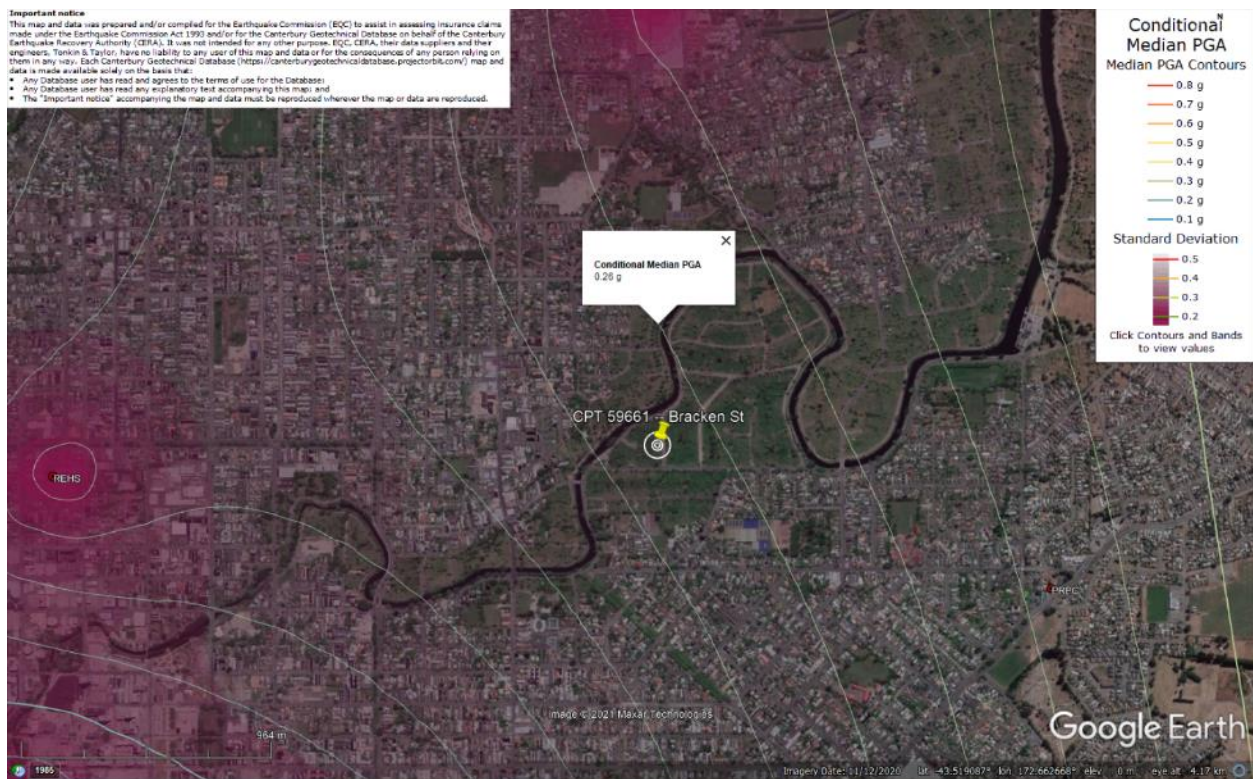
Figure 48: PGA for Dec-11 EQ (st. dev. = 0.350-0.375 ln units).
