Appendix A.54:

455 Papanui Rd – VsVp 57189

Table 1: Site Description for 455 Papanui Road (VsVp 57189).

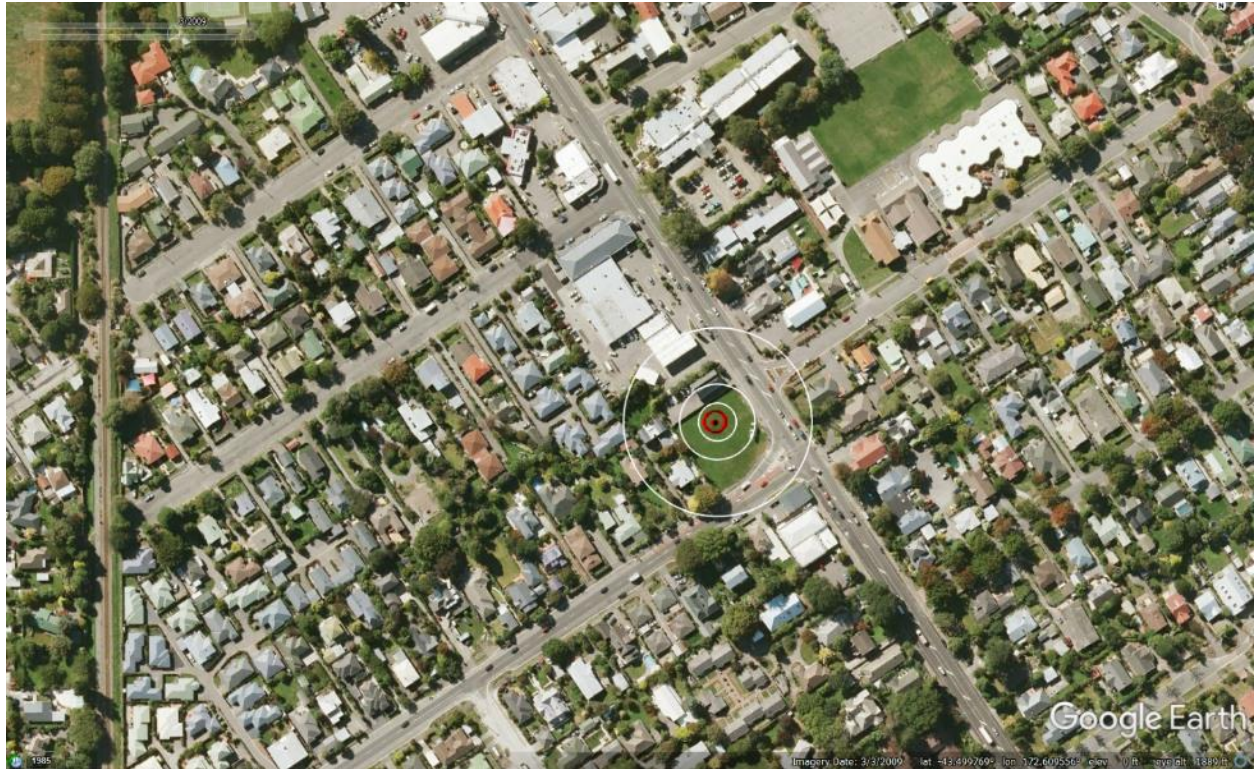
Figure 3: Position of the site relative to nearby buildings, vegetation, and free-face features.

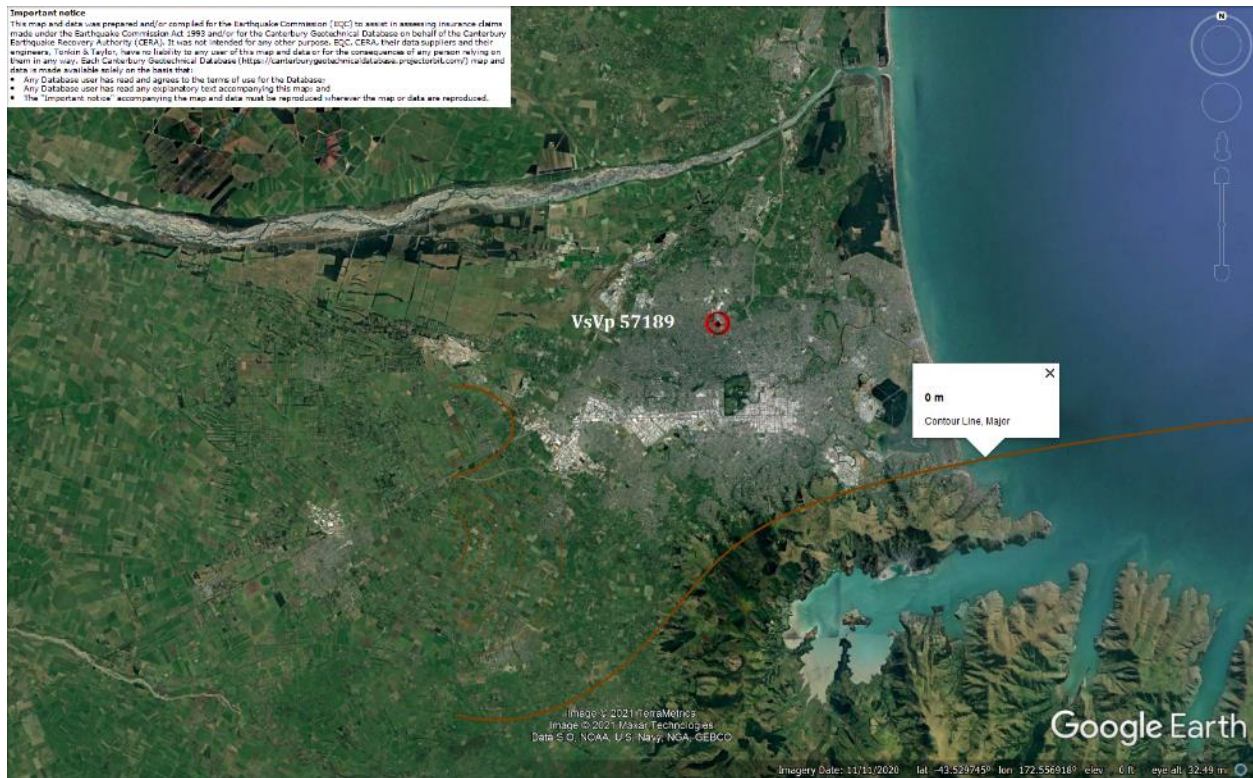
Figure 30: Vertical tectonic movements for Sep 2010 Earthquake.

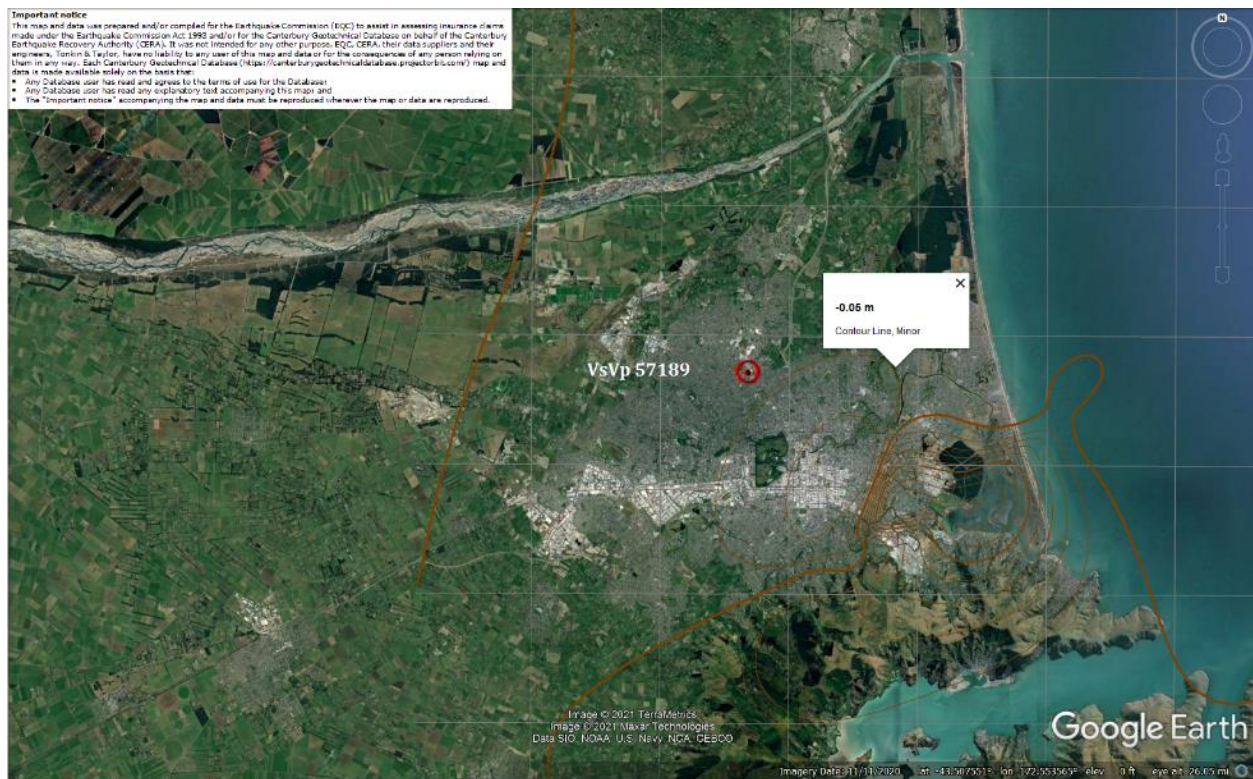
Figure 31: Vertical tectonic movements for Feb 2011 Earthquake.

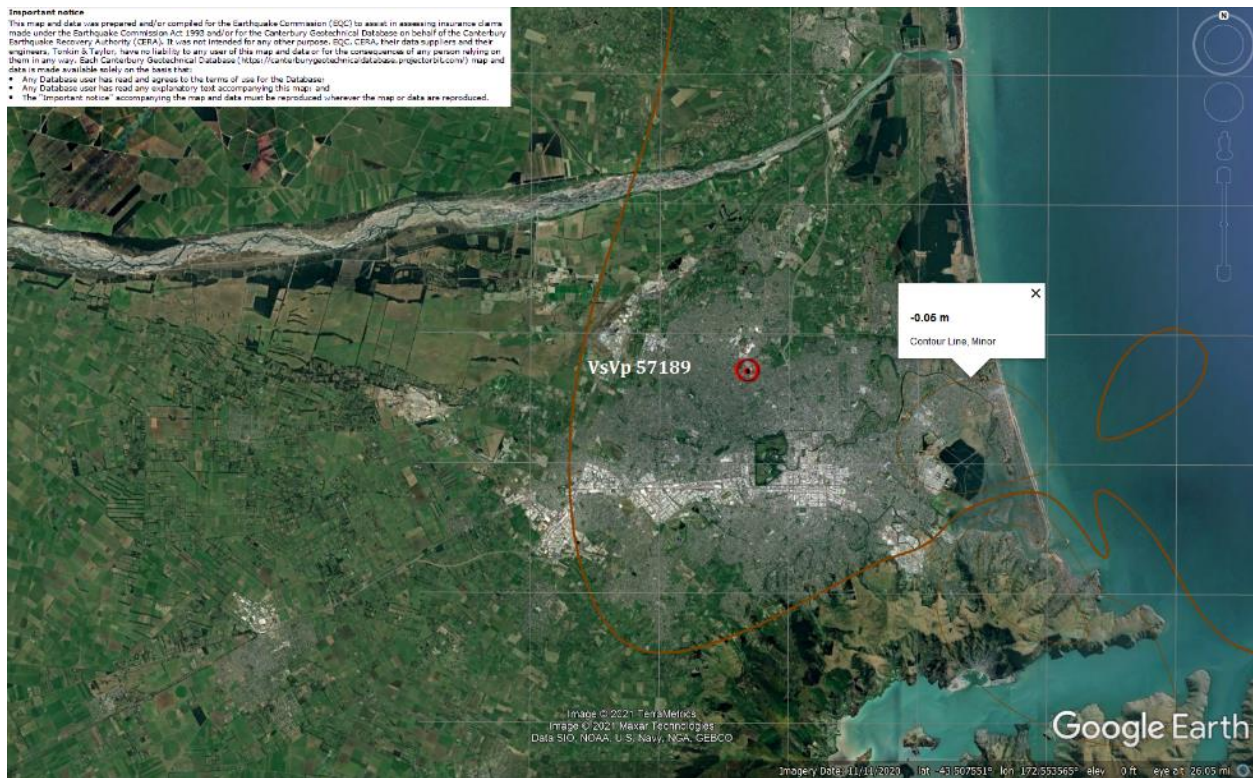
Figure 32: Vertical tectonic movements for June 2011 Earthquake.

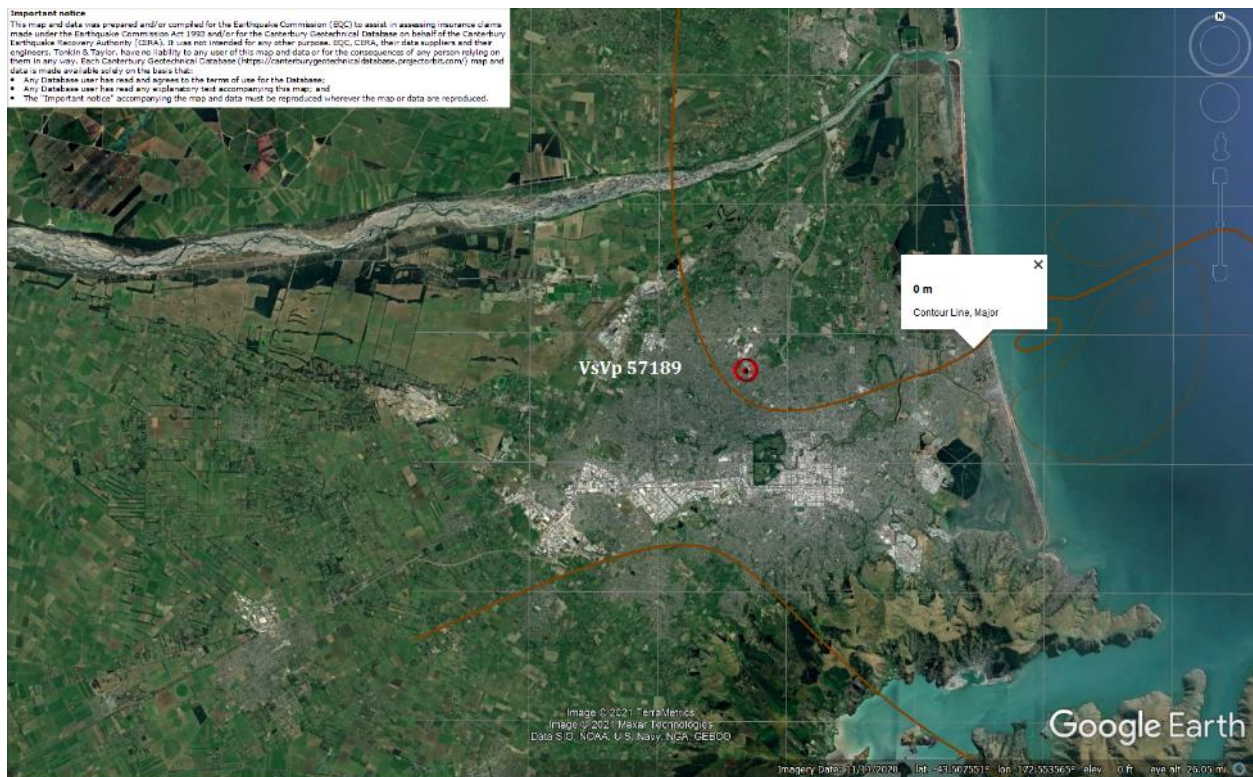
Figure 33: Vertical tectonic movements for Dec 2011 Earthquake.

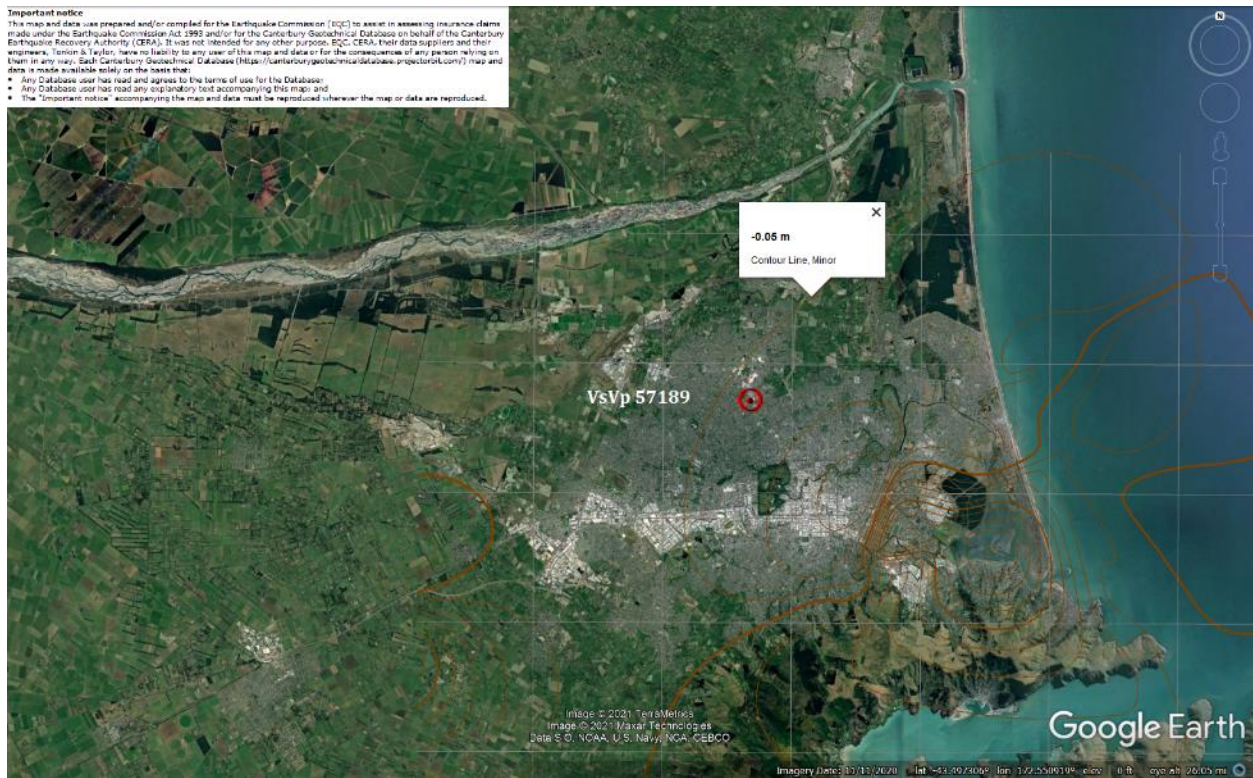
Figure 34: Vertical tectonic movements for Canterbury Earthquake Sequence.

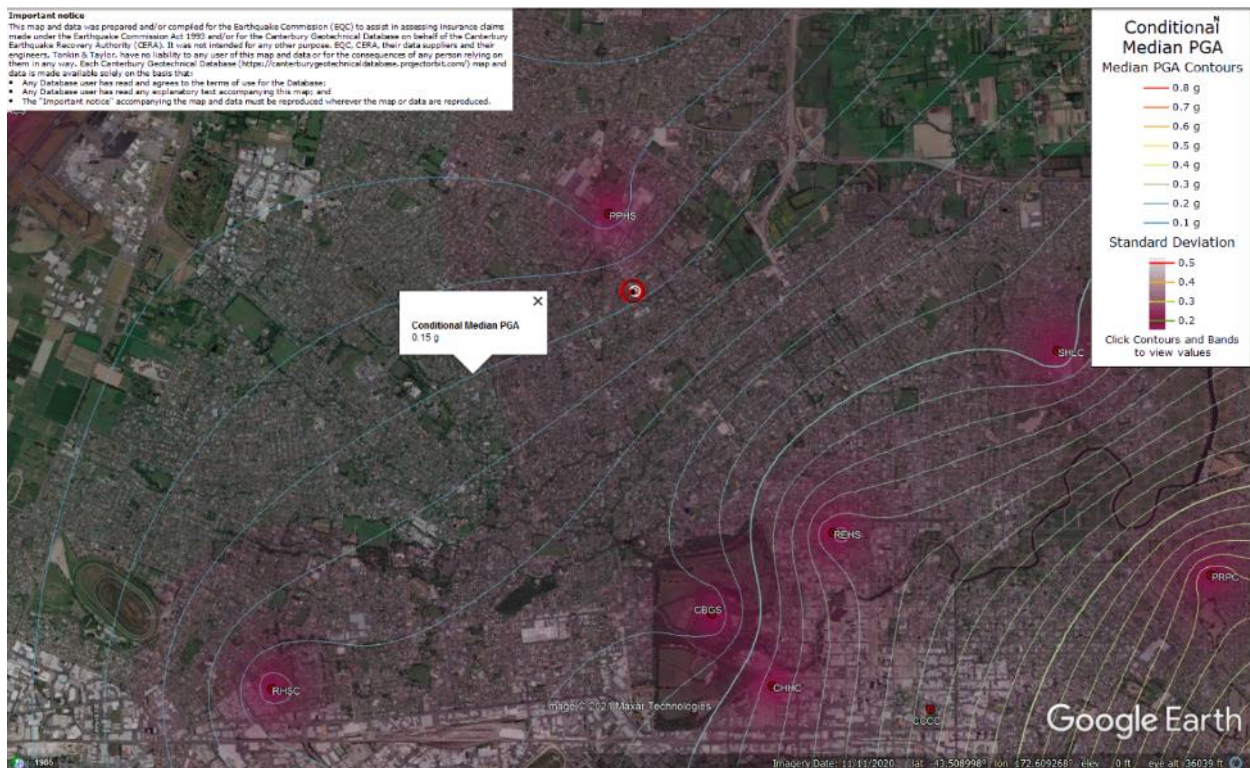
Figure 37: PGA for Jun-11 EQ (st. dev. = 0.325 to 0.350 ln units).
