Appendix A.6:

Vivian St – CPT 5586

Liquefaction Ejecta Case Histories for 2010-11 Canterbury Earthquakes

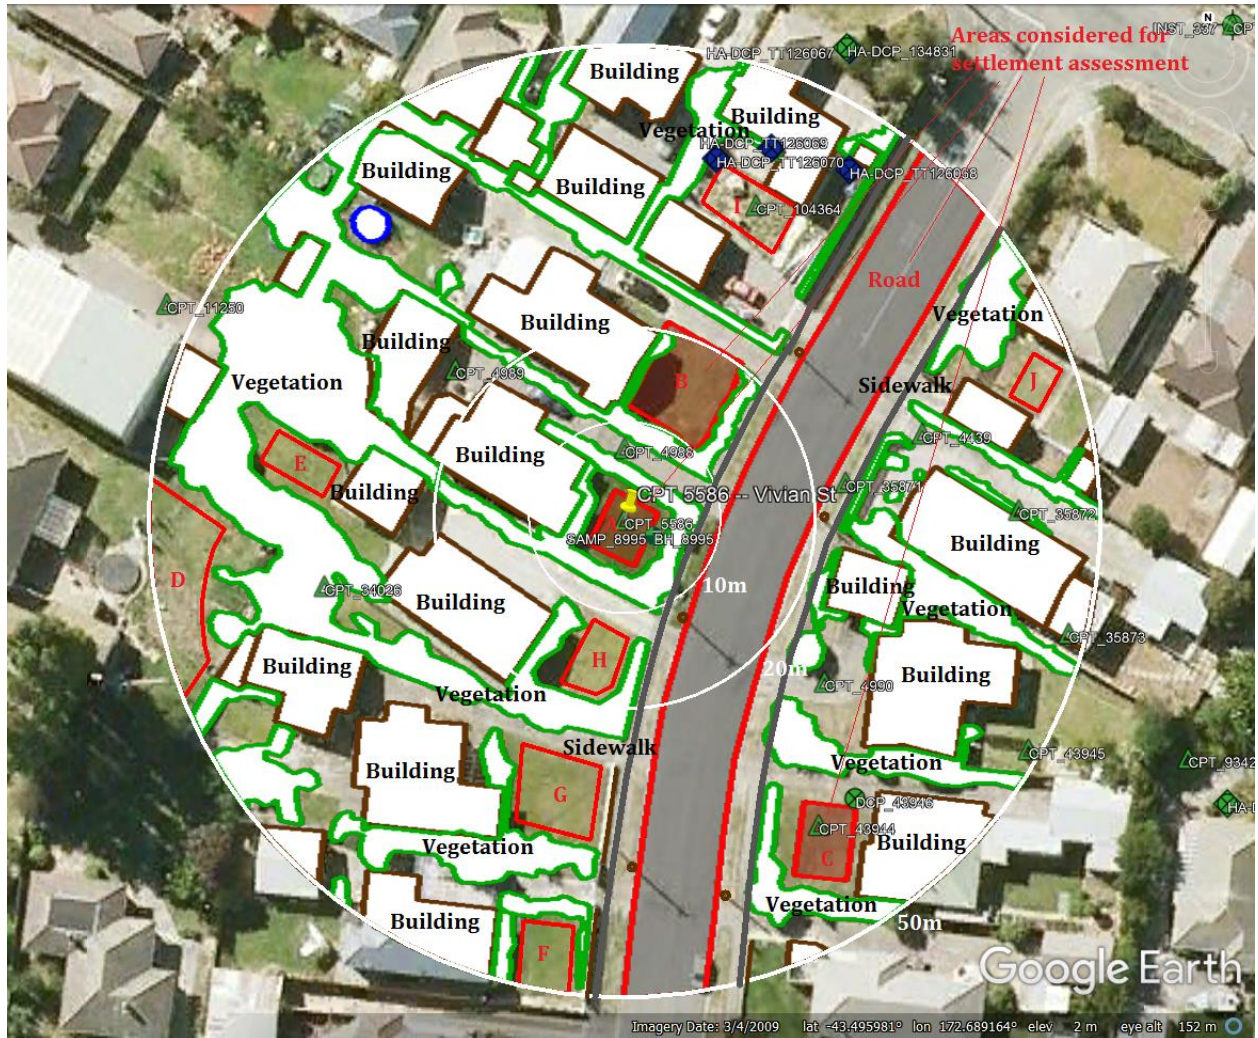
Figure 1: Site plan with patches where LiDAR survey data is considered.

Note 1: Ten patches (outlined in red) in free field were initially selected for settlement assessment as areas free of vegetation and structures. Further analyses such as proximity of a patch to a CPT, proximity of a patch to a property subjected to addition and/or demolition of a structure, front yard/backyard alterations (e.g., ploughing, rubble, scrap), aerial distribution of sediment ejecta, and density of LiDAR points for 2003 resulted in Patches A, B, and C being selected for detailed settlement assessment and other patches being discarded in detailed settlement assessment. In addition, since significant amounts of ejecta were observed on roads in the CES, the entire portion of the road within the 50-m buffer was considered for settlement assessment. Roads as hard, relatively flat surfaces provide many ground-classified points. Therefore, it is very useful to compare settlement estimates on roads with settlement estimates for the selected patches.

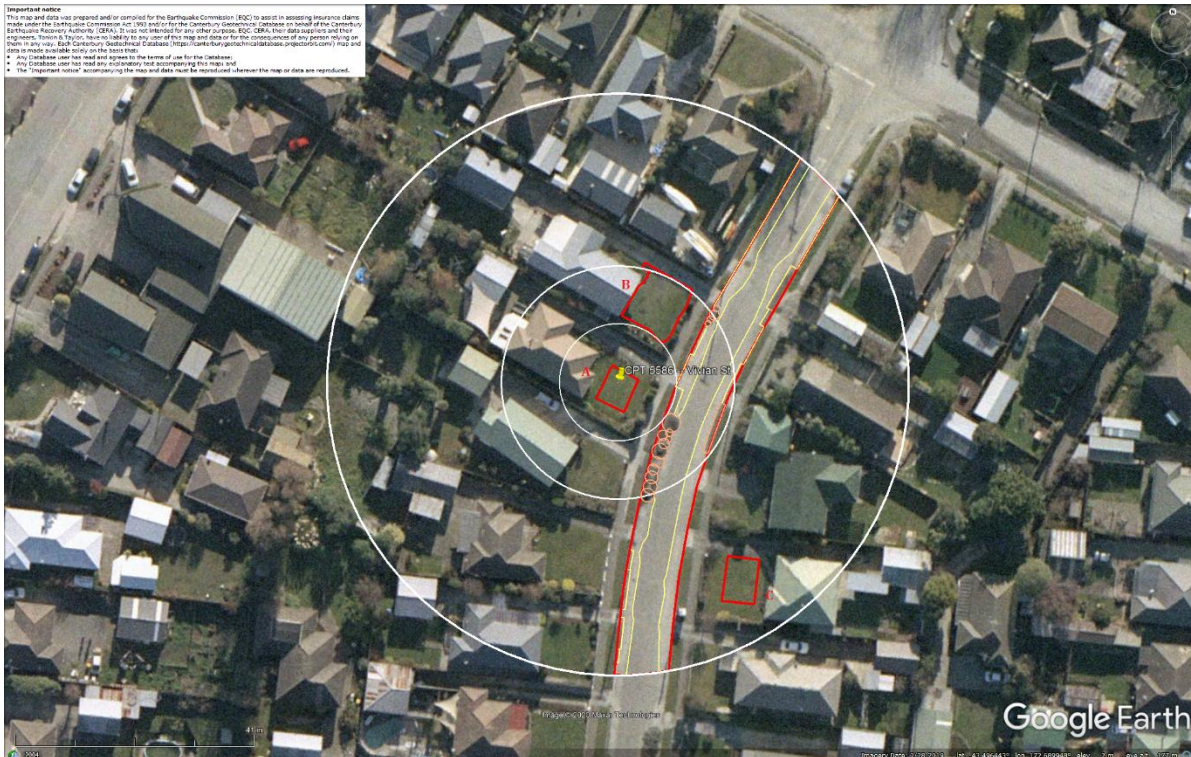
Figure 83: Aerial photograph acquired on 16 Jun 2011 showing the ejecta outline at the site for Jun-11 EQ.

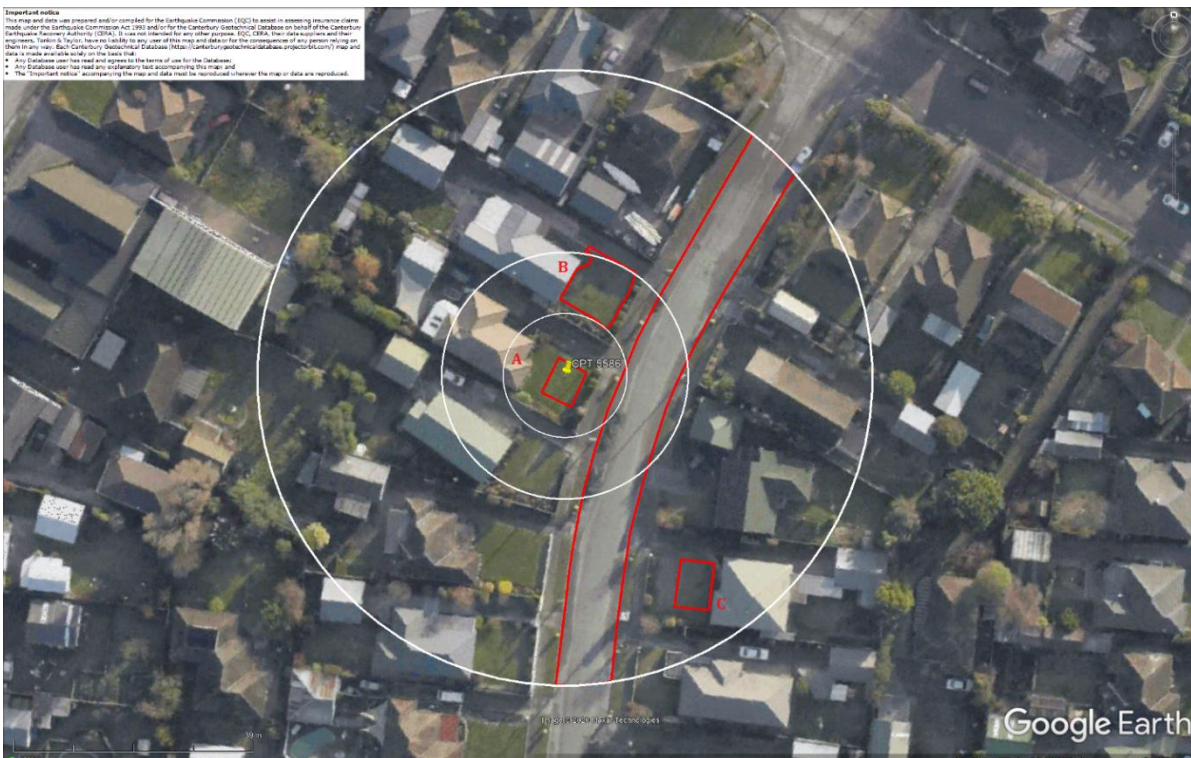
Figure 84: Aerial photograph acquired on 14-15 Jun 2011 showing ejecta at the site for Jun-11 EQ.

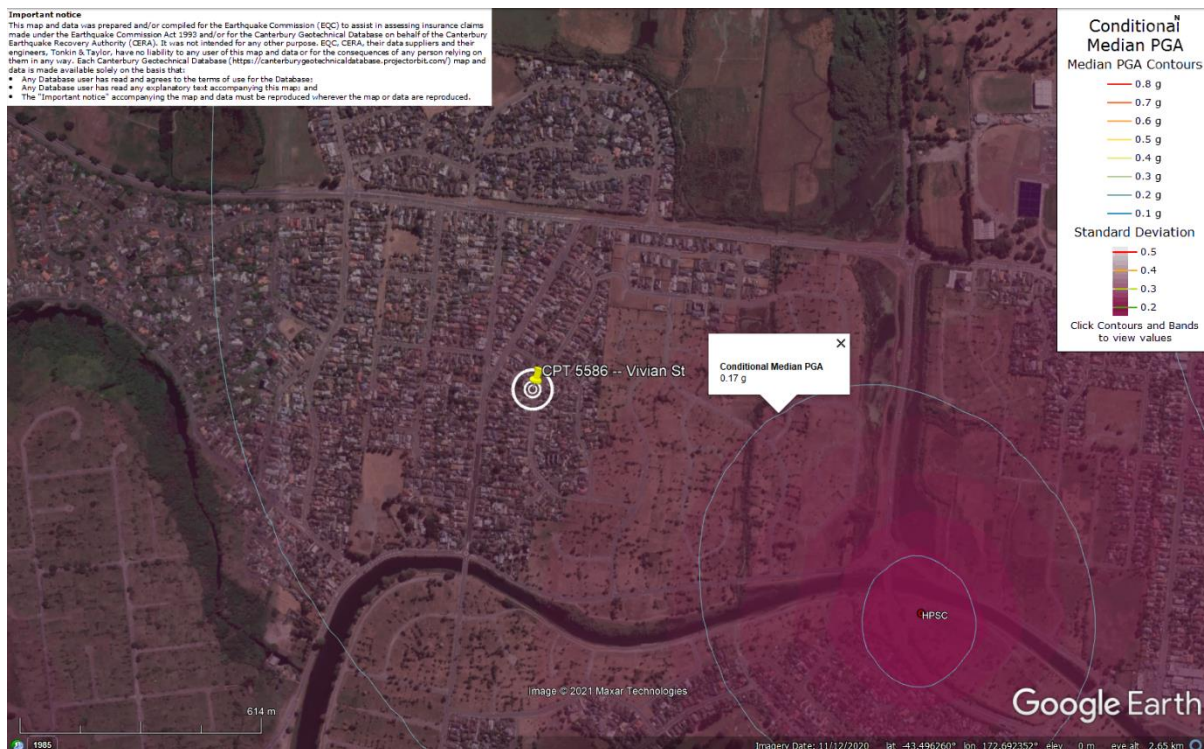
Figure 86: PGA for Sep-10 EQ (st. dev. = 0.300-0.325 ln units).
