Appendix A.10:

Pinewood Ave – CPT 61991

Liquefaction Ejecta Case Histories for 2010-11 Canterbury Earthquakes

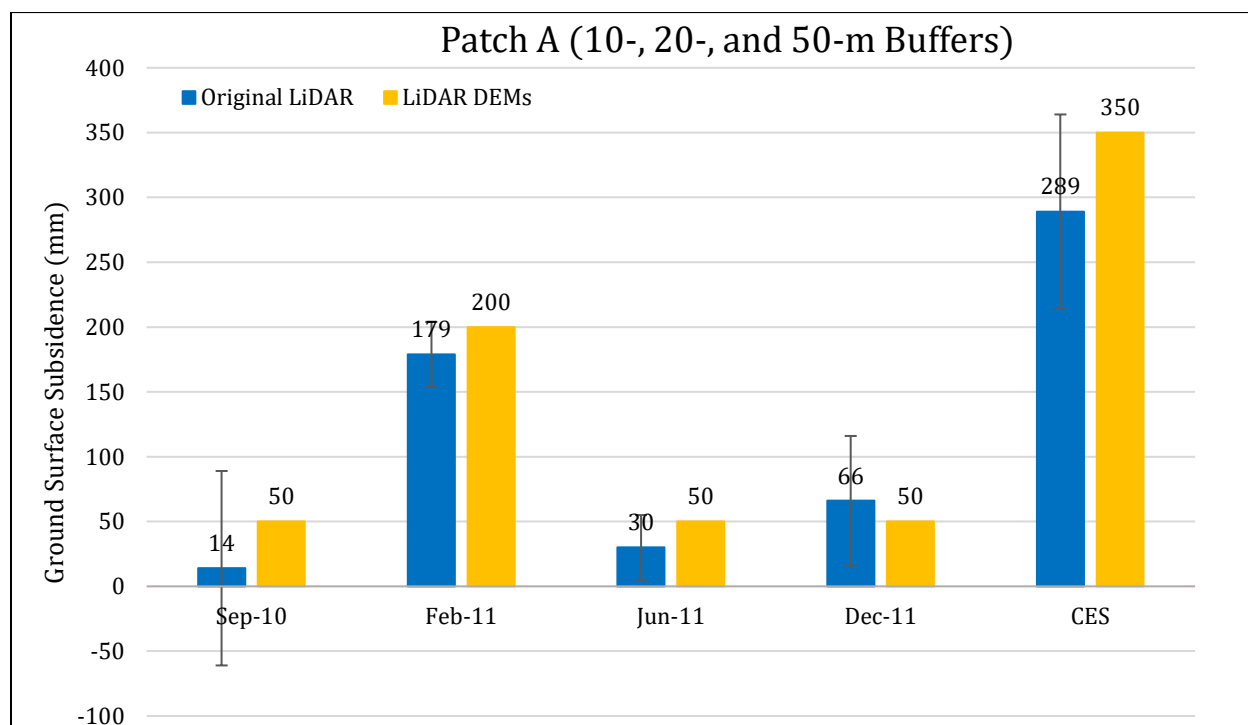
Figure 2: Comparison between ground surface subsidence determined from original LiDAR survey points and ground surface subsidence (50th %ile) estimated using LiDAR DEMs for Patch A.

Note 2: The ground surface subsidence values determined from original LiDAR survey points are similar to the ground surface subsidence values estimated using LiDAR DEMs for all earthquake events.

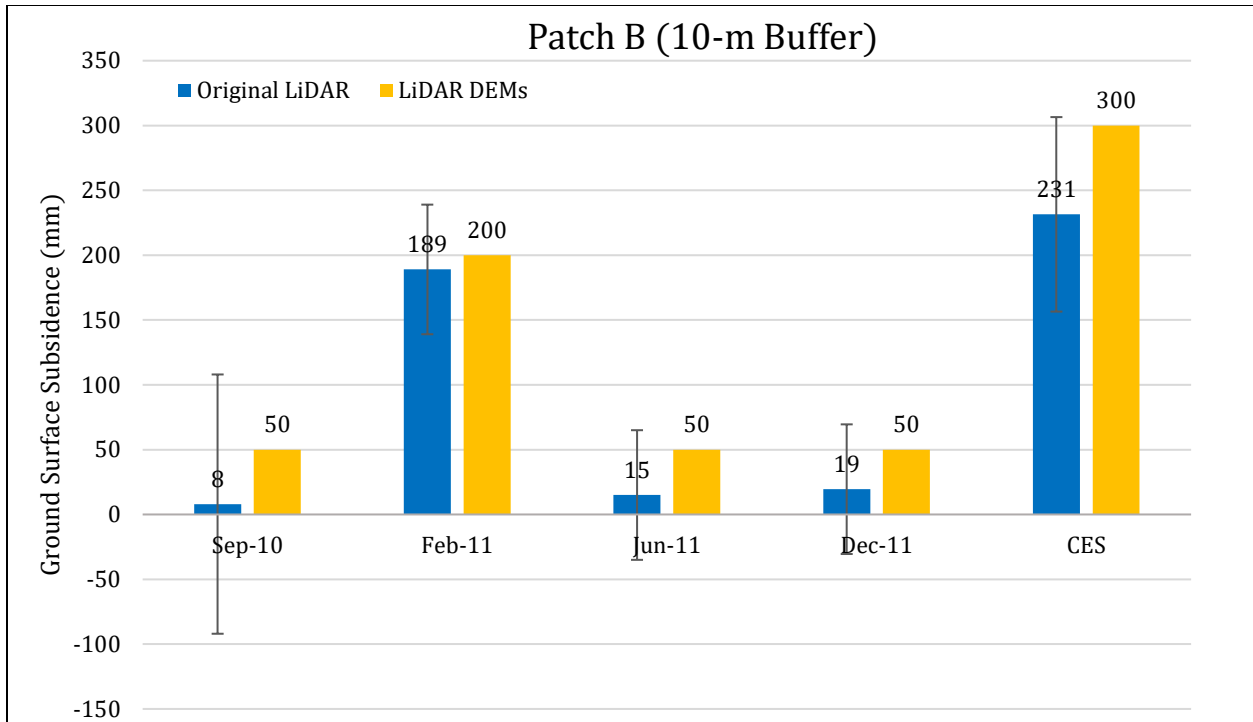
Figure 3: Comparison between ground surface subsidence determined from original LiDAR survey points and ground surface subsidence (50th %ile) estimated using LiDAR DEMs for Patch B for the 10-m buffer.

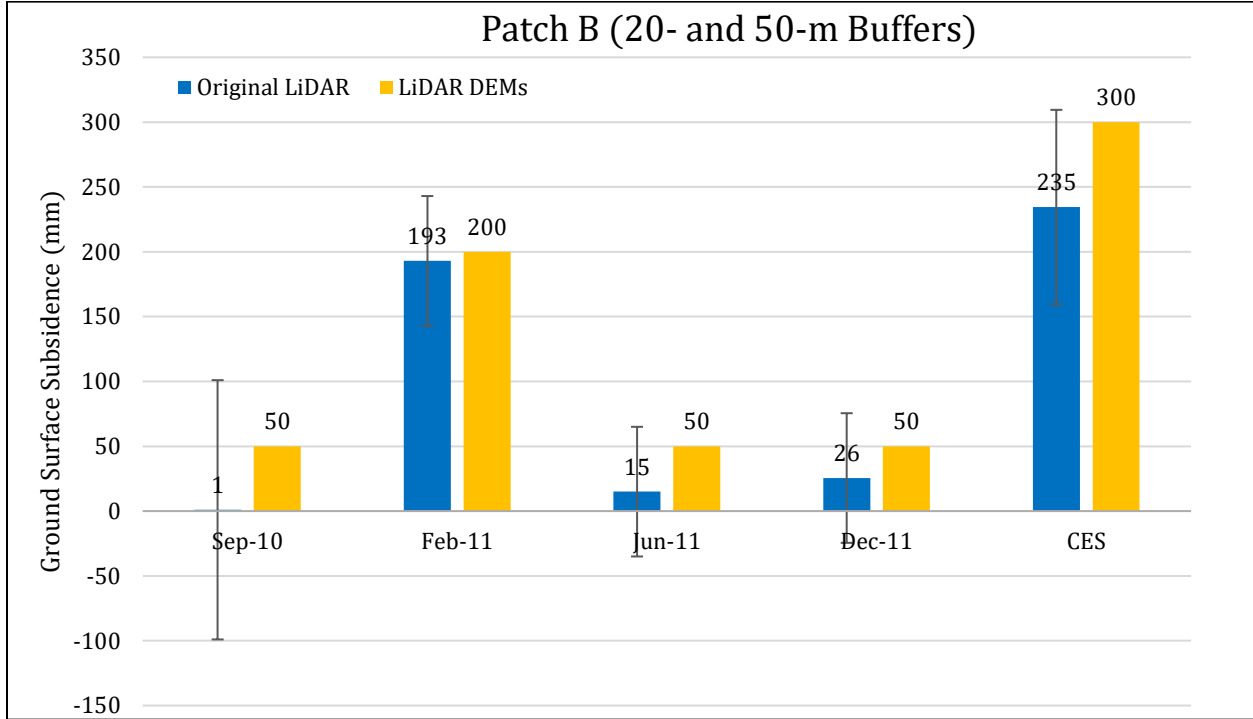
Figure 4: Comparison between ground surface subsidence determined from original LiDAR survey points and ground surface subsidence (50th %ile) estimated using LiDAR DEMs for Patch B for the 20-m and 50-m buffers.

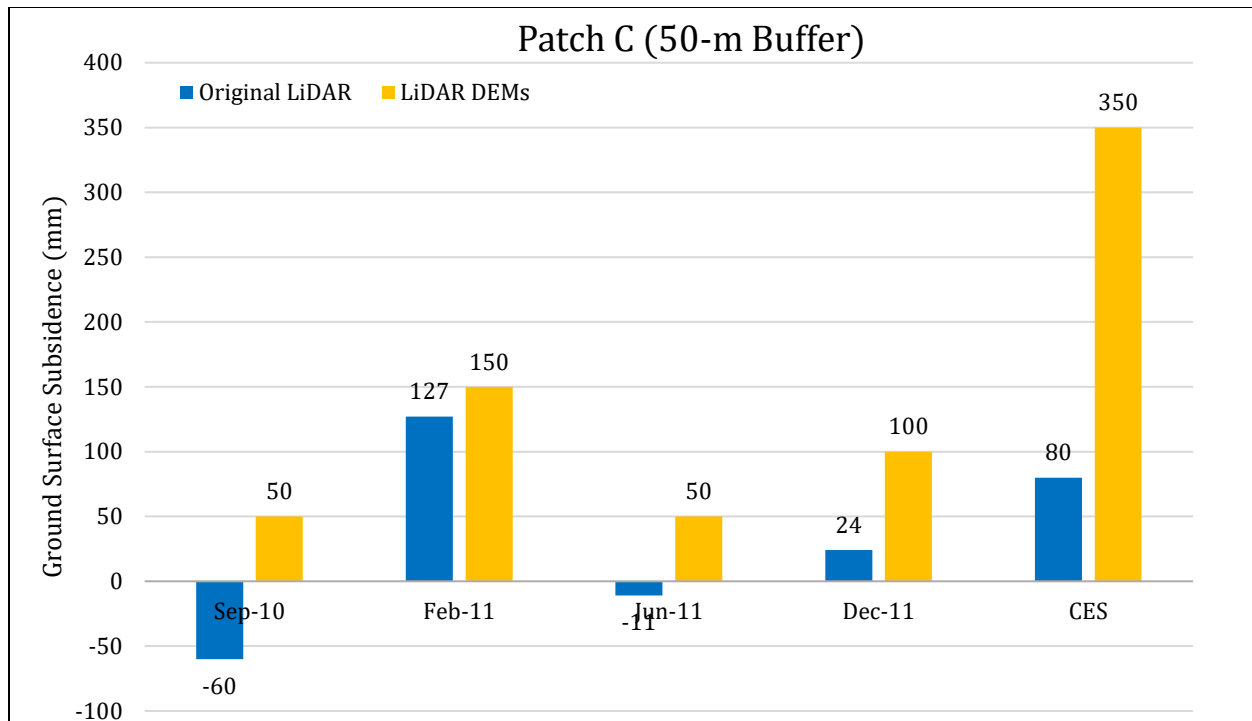
Figure 5: Comparison between ground surface subsidence determined from original LiDAR survey points and ground surface subsidence (50th %ile) estimated using LiDAR DEMs for Patch C for the 50-m buffer.

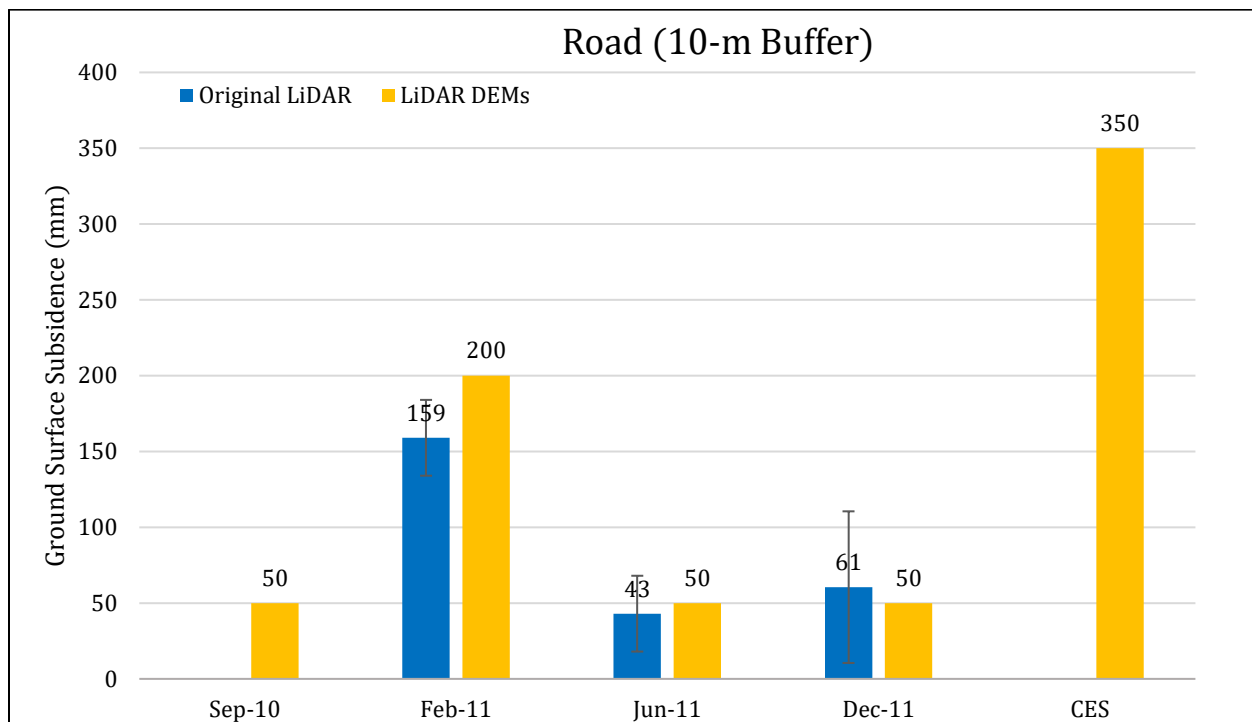
Figure 6: Comparison between ground surface subsidence determined from original LiDAR survey points and ground surface subsidence (50th %ile) estimated using LiDAR DEMs for Road for the 10-m buffer.

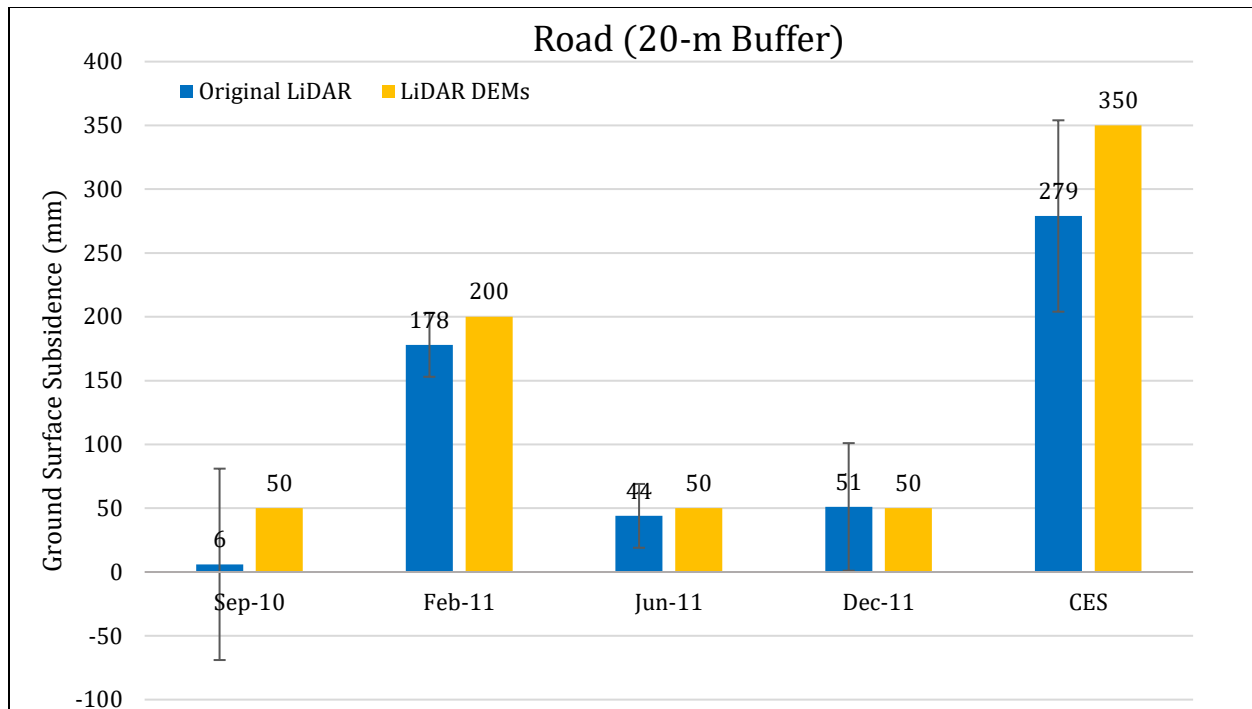
Figure 7: Comparison between ground surface subsidence determined from original LiDAR survey points and ground surface subsidence (50th %ile) estimated using LiDAR DEMs for Road for the 20-m buffer.

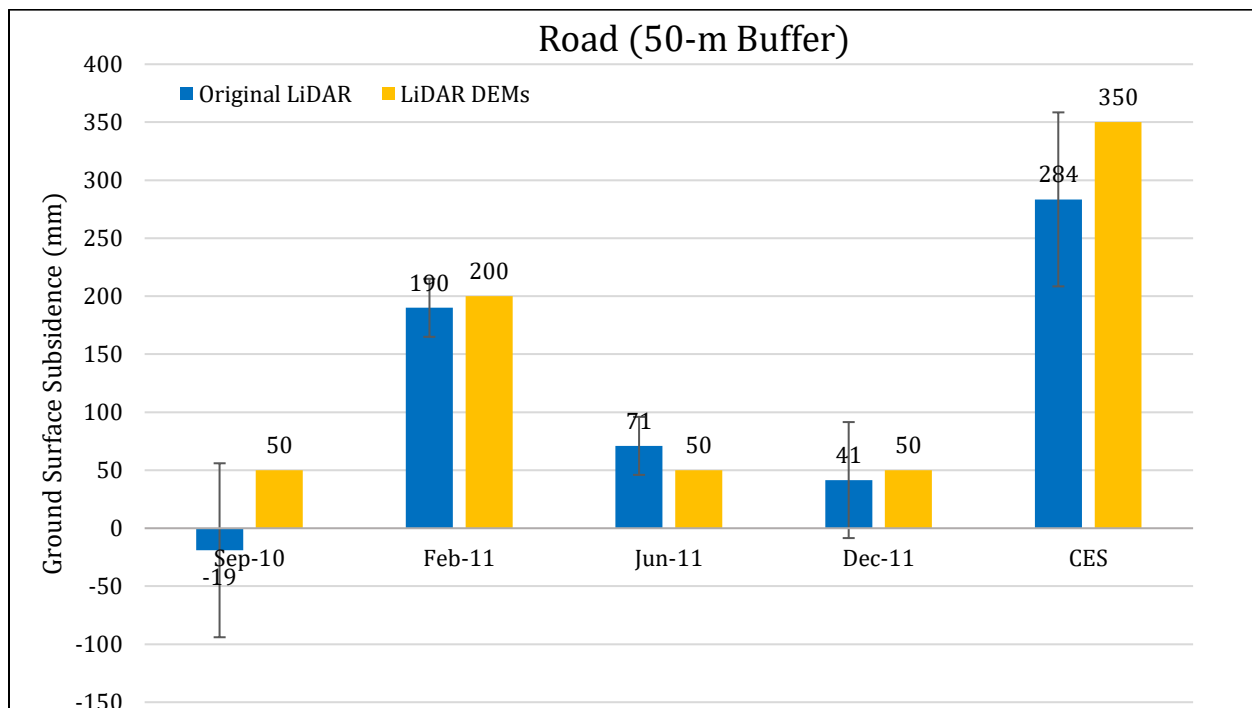
Figure 8: Comparison between ground surface subsidence determined from original LiDAR survey points and ground surface subsidence (50th %ile) estimated using LiDAR DEMs for Road for the 50-m buffer.

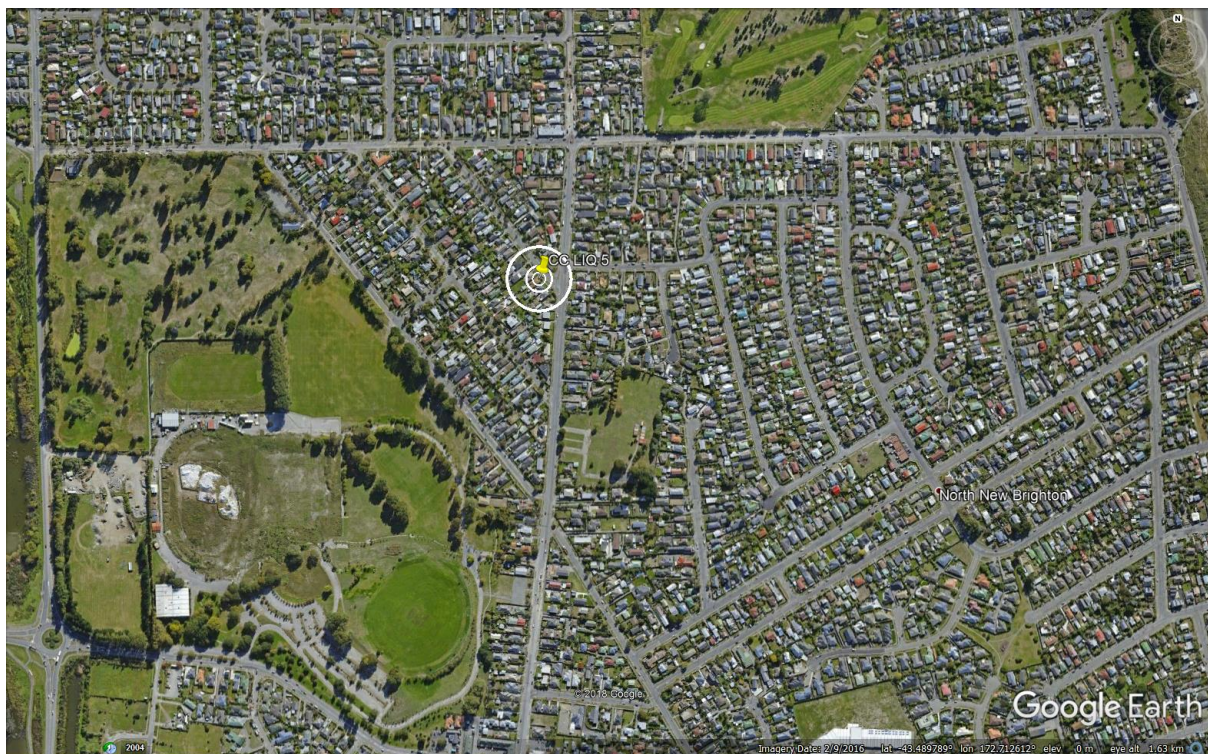
Figure 10: Position of the site relative to nearby buildings, vegetation, and free-face features.

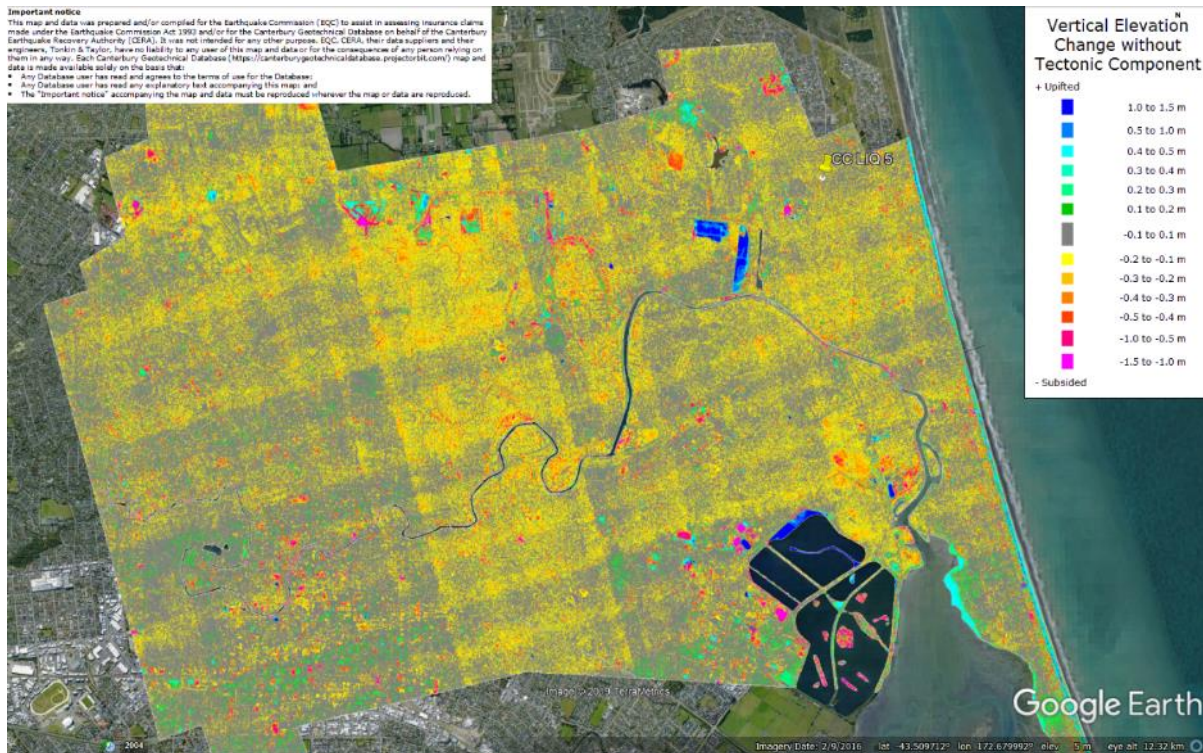
Figure 25: Vertical Ground Movements (Surface – Tectonic) for Sep 2010 Earthquake – the site is in the apparent zone of overestimated ground surface subsidence (i.e., Sep 2010 flight band error).

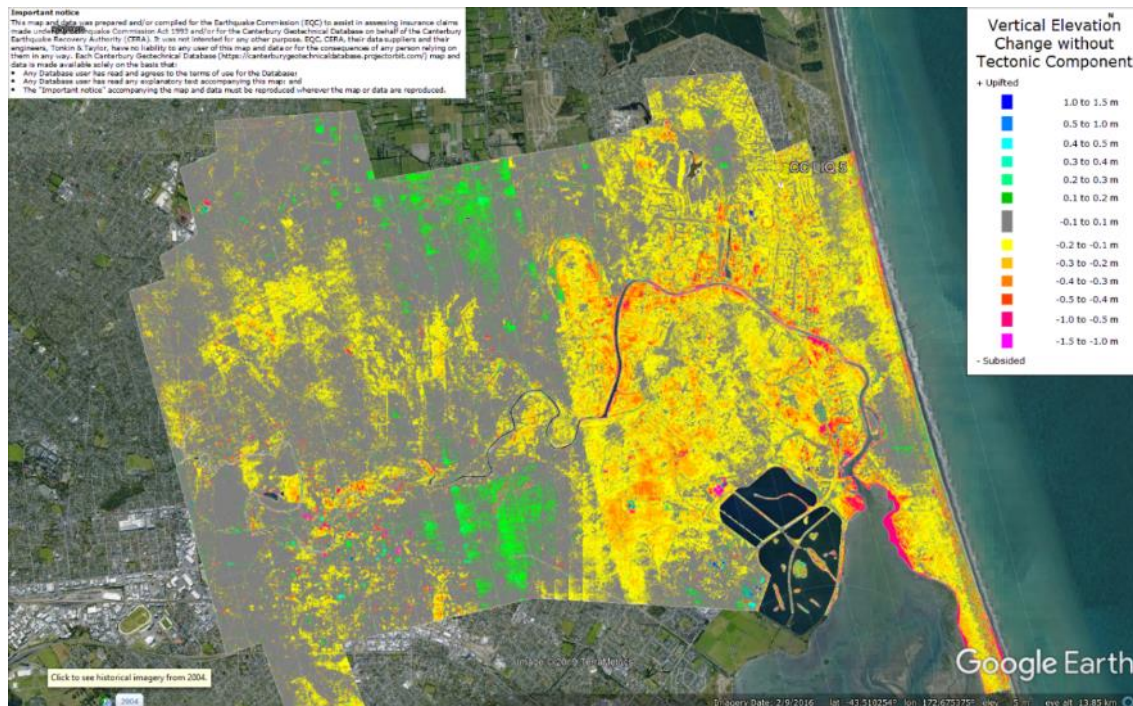
Figure 26: Vertical Ground Movements (Surface – Tectonic) for Feb 2011 Earthquake – the site is in the apparent zone of underestimated ground surface subsidence (i.e., Sep 2010 flight band error).

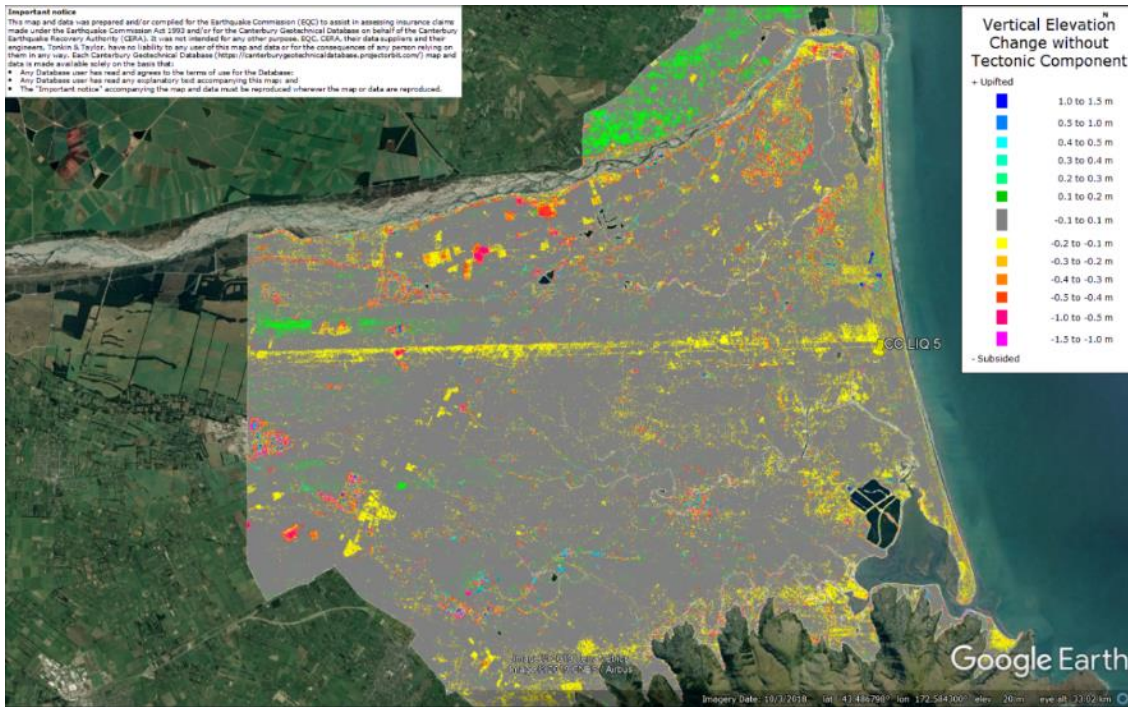
Figure 27: Vertical Ground Movements (Surface – Tectonic) for June 2011 Earthquake – the site is not in the apparent zone of overestimated or underestimated ground surface subsidence.

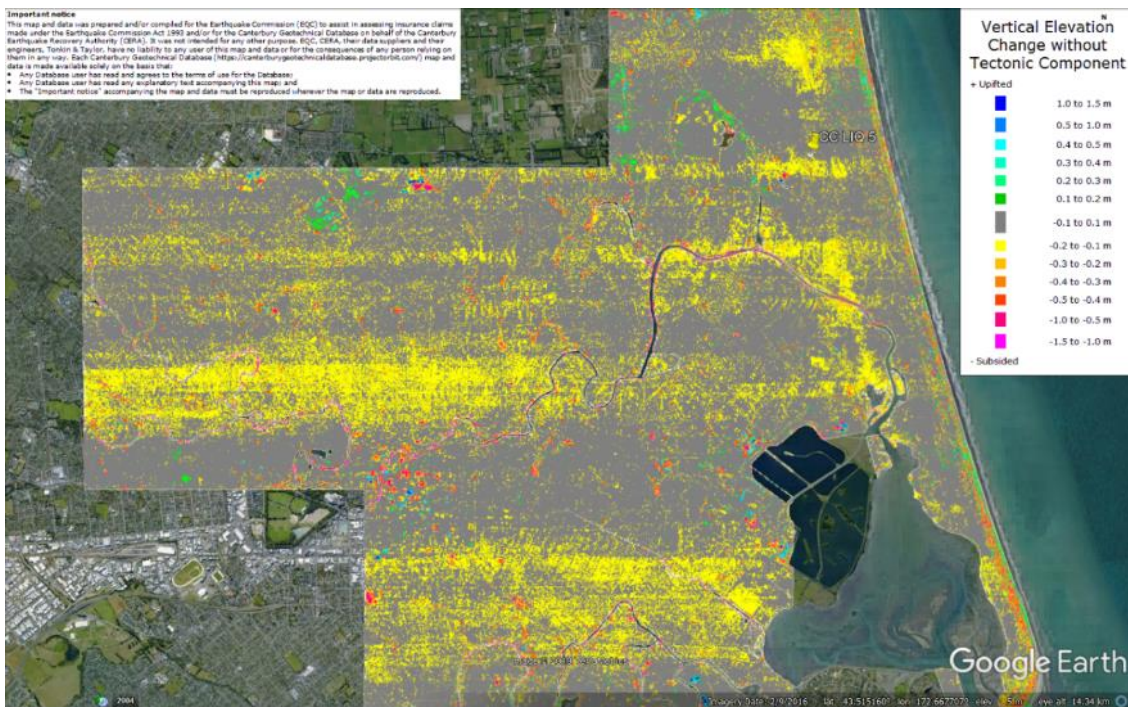
Figure 28: Vertical Ground Movements (Surface – Tectonic) for Dec 2011 Earthquake – the site is not in the apparent zone of overestimated or underestimated ground surface subsidence.

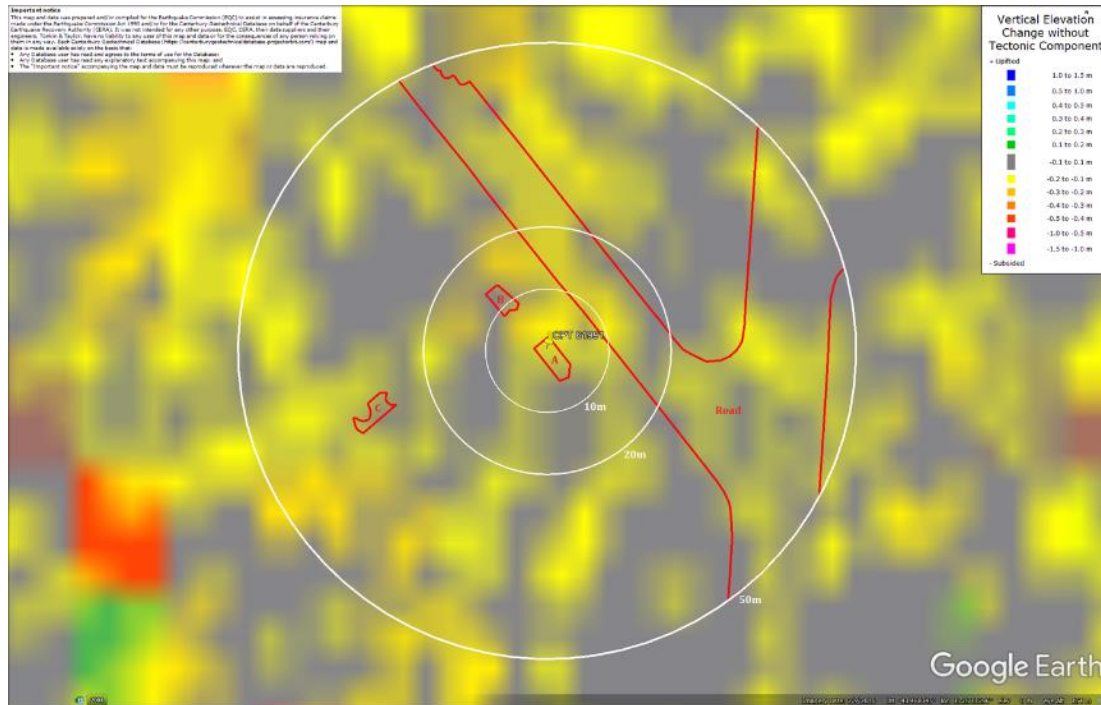
Figure 29: Ground surface subsidence without tectonic component for Sep 2010 Earthquake according to the LiDAR DEM.

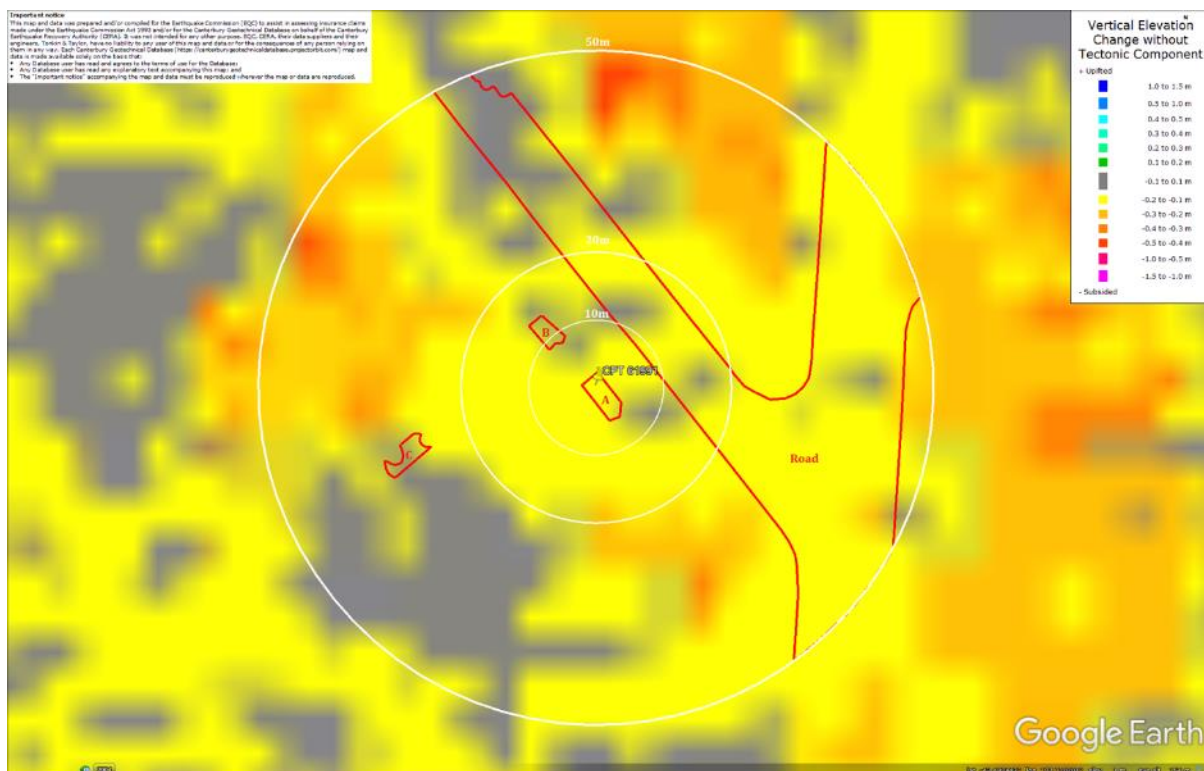
Figure 30: Ground surface subsidence without tectonic component for Feb 2011 Earthquake according to the LiDAR DEM.

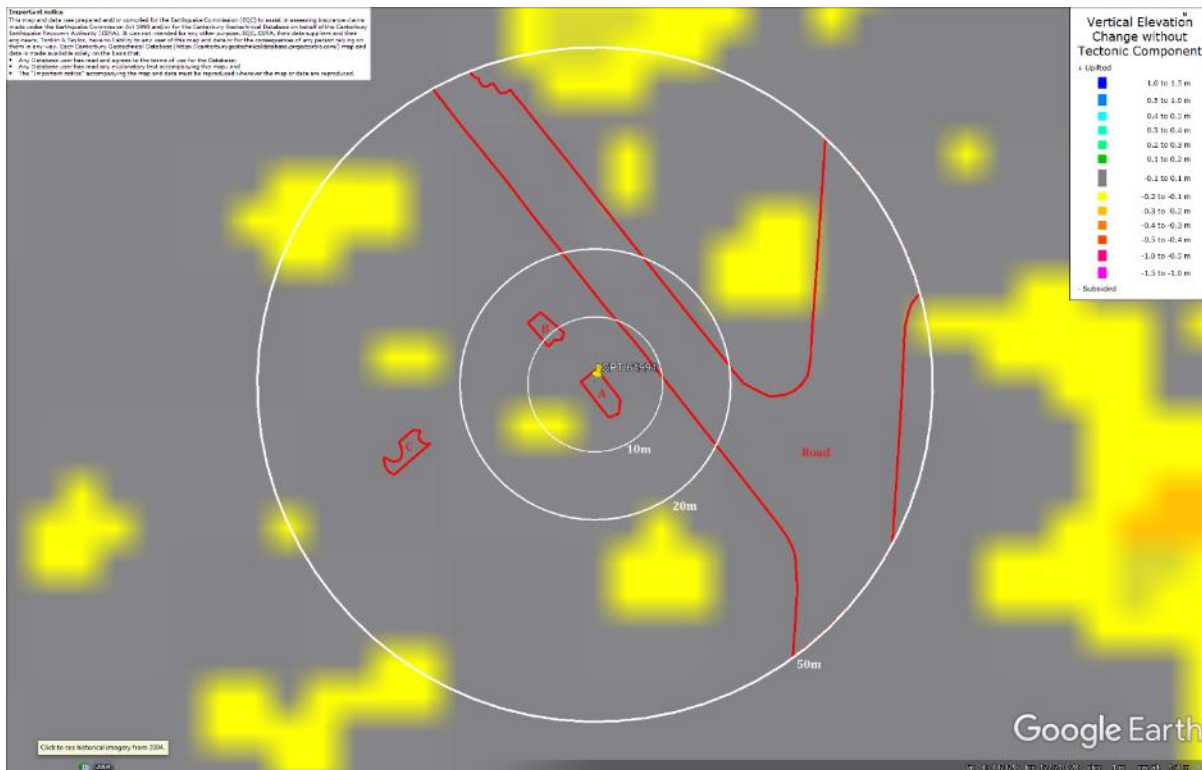
Figure 31: Ground surface subsidence without tectonic component for Jun 2011 Earthquake according to the LiDAR DEM.

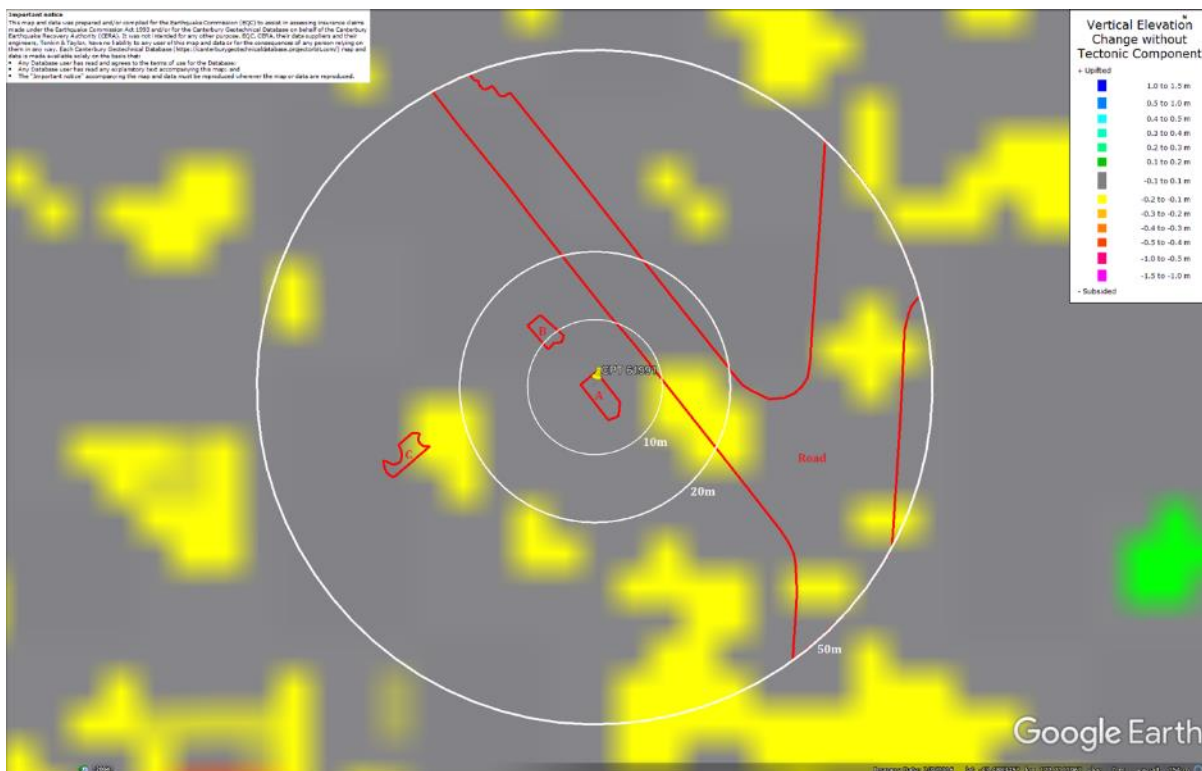
Figure 32: Ground surface subsidence without tectonic component for Dec 2011 Earthquake according to the LiDAR DEM.

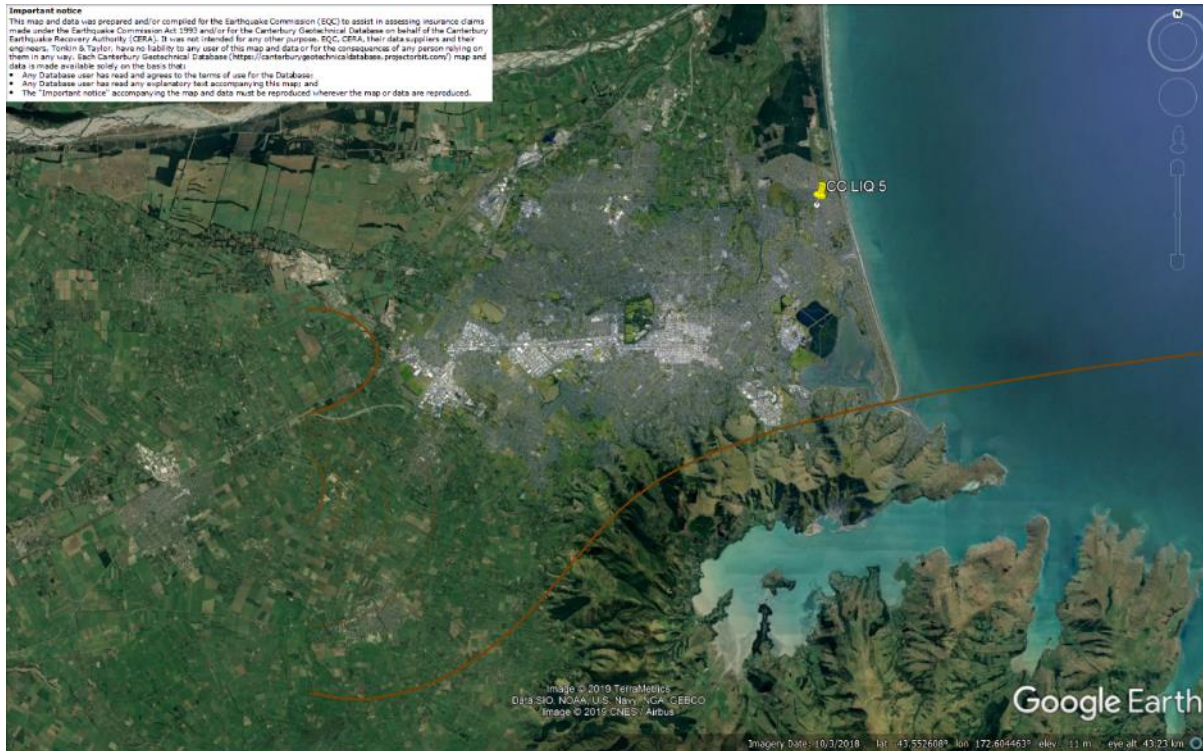
Figure 35: Vertical tectonic movements for Sep 2010 Earthquake.

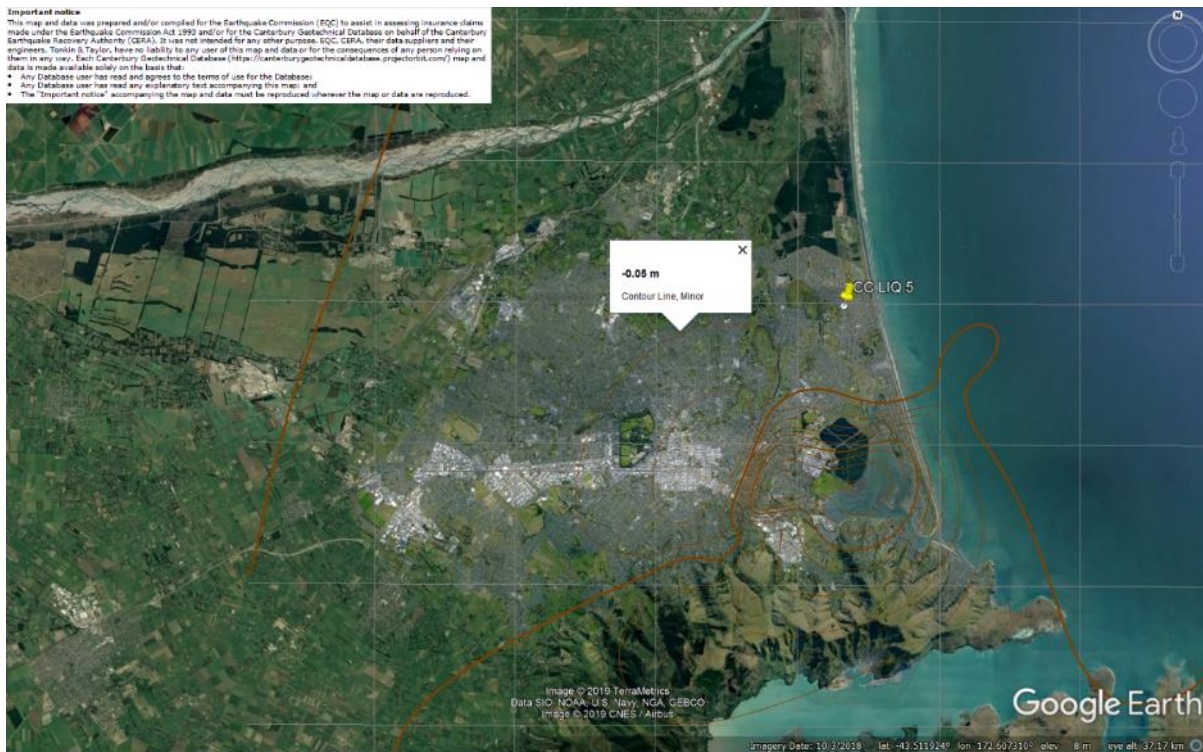
Figure 36: Vertical tectonic movements for Feb 2011 Earthquake.

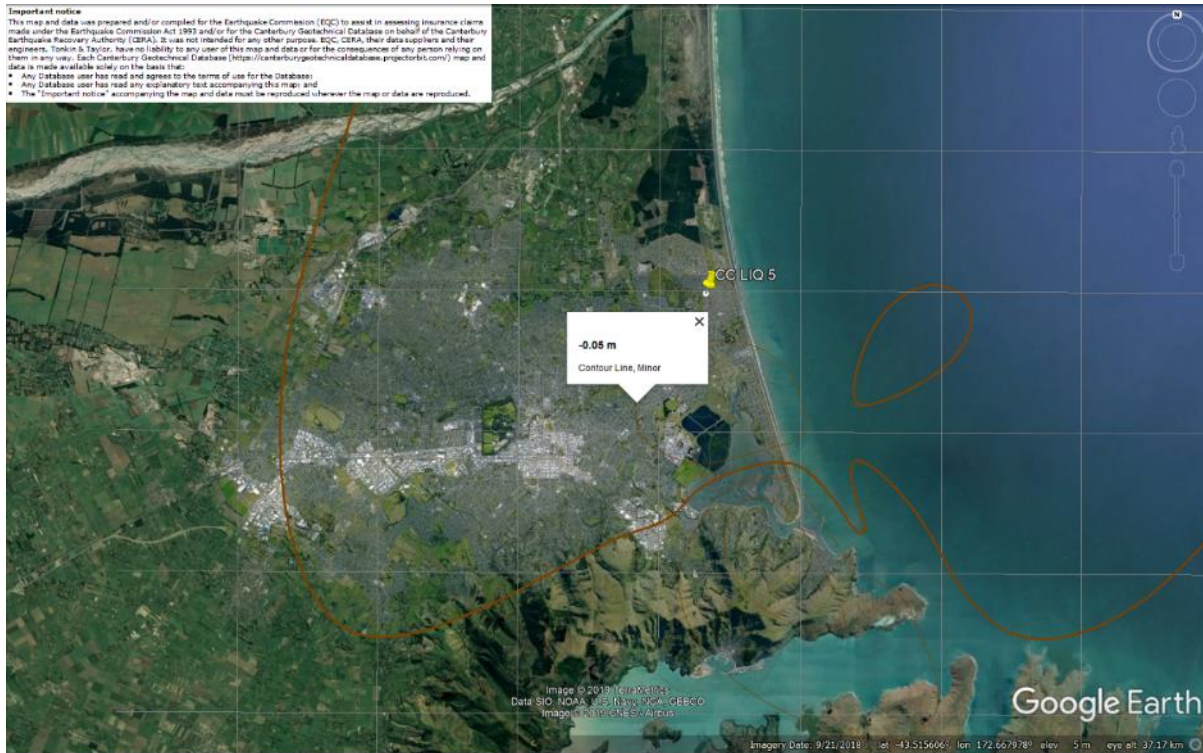
Figure 37: Vertical tectonic movements for June 2011 Earthquake.

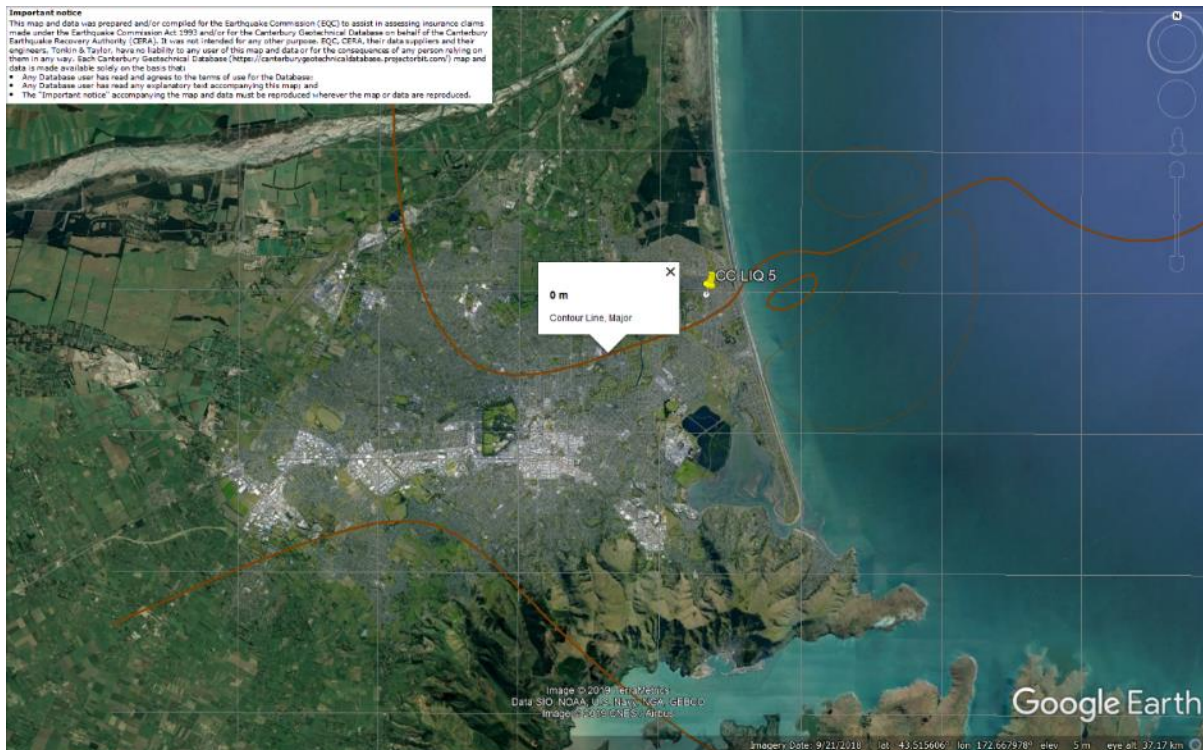
Figure 38: Vertical tectonic movements for Dec 2011 Earthquake.

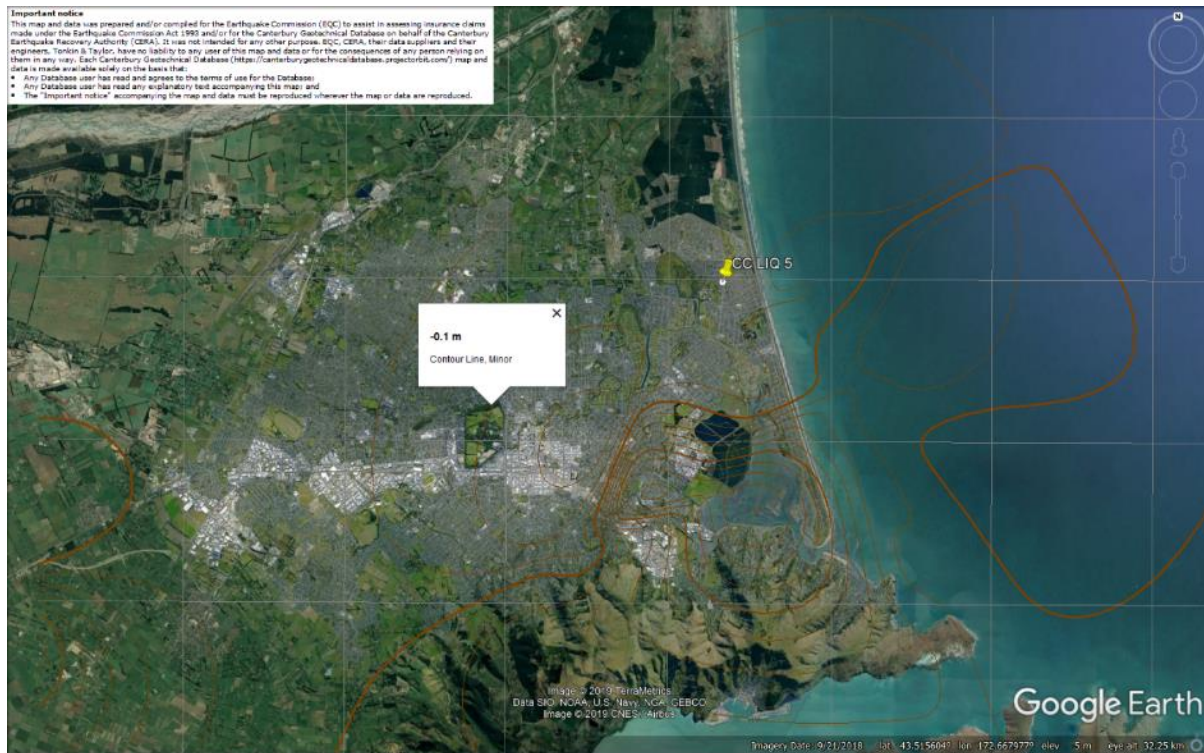
Figure 39: Vertical tectonic movements for Canterbury Earthquake Sequence.

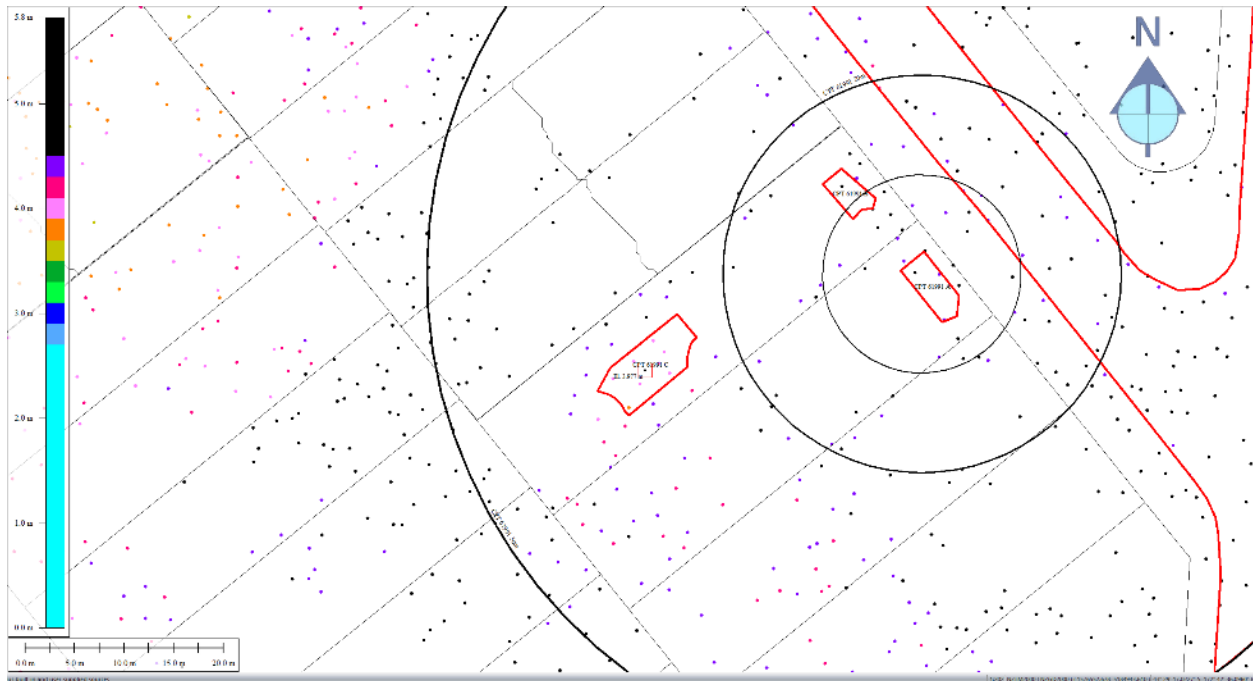
Figure 43: Ground surface elevation for Patch C for Jul 2003 LiDAR survey.

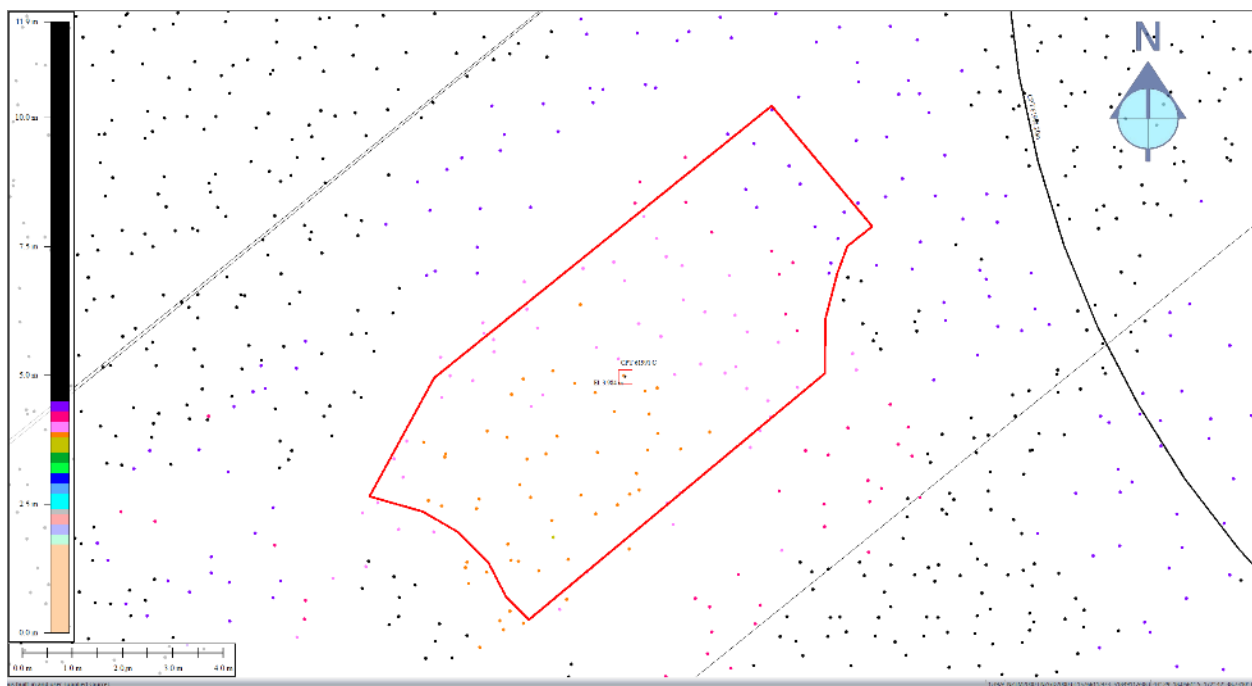
Figure 50: Ground surface elevation for Patch C for Sep 5, 2010 LiDAR survey.

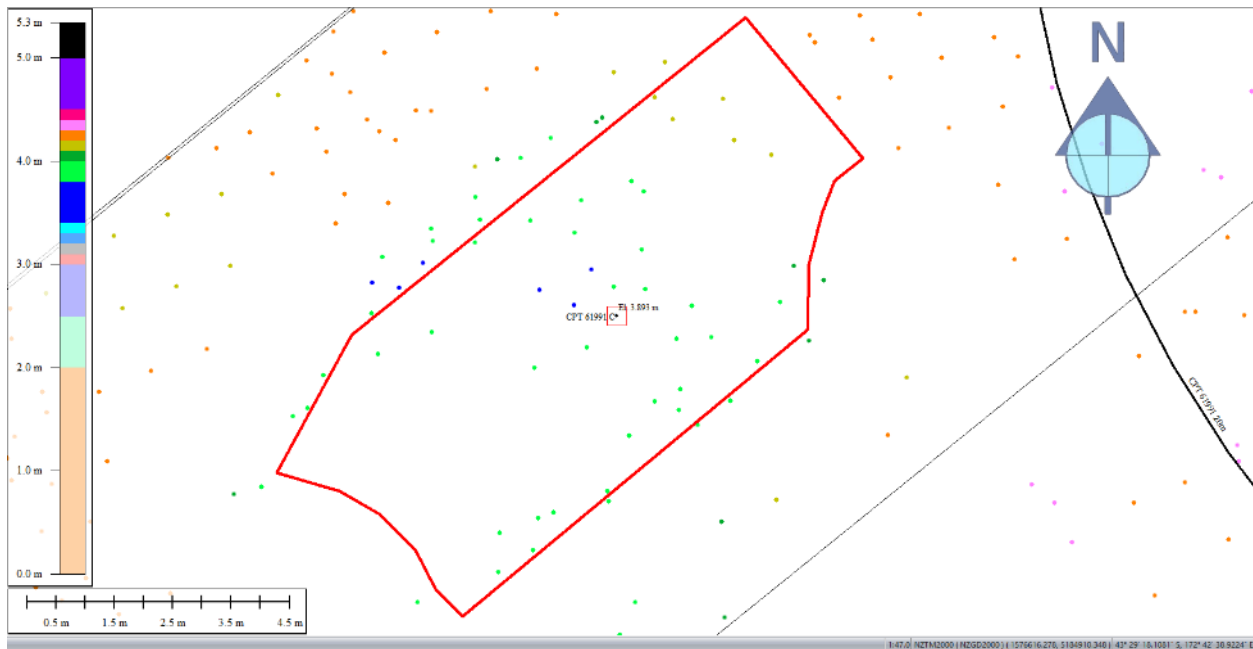
Figure 58: Ground surface elevation for Patch C for May 2011 LiDAR survey.

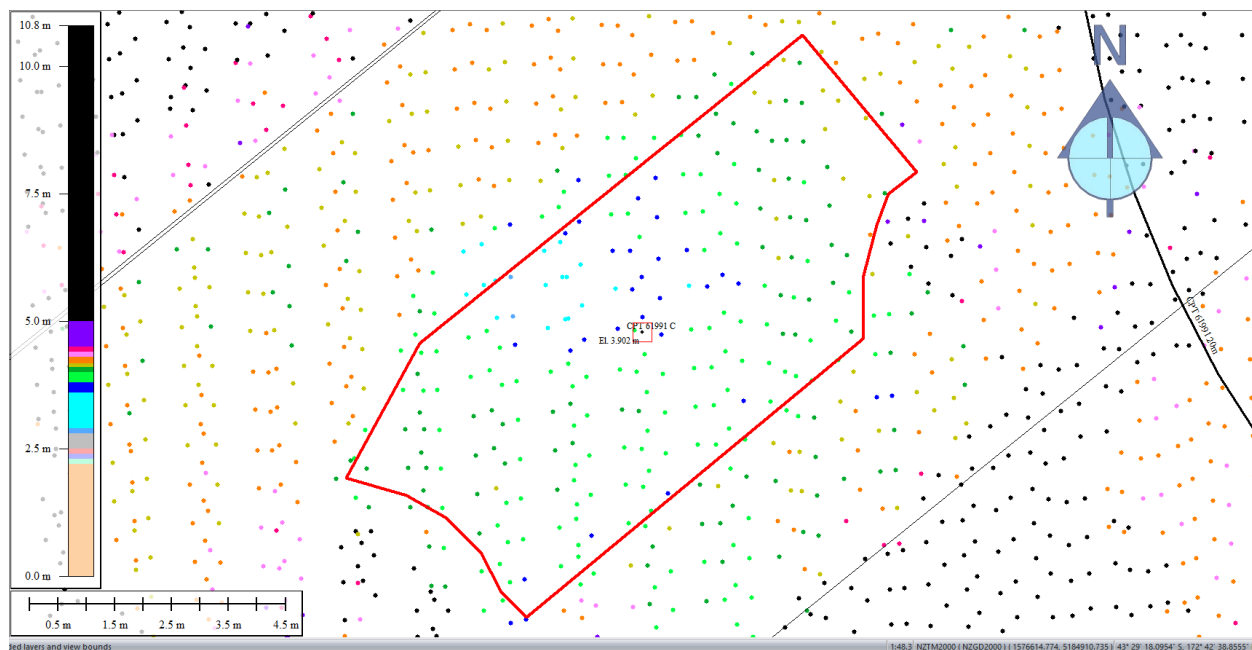
Figure 66: Ground surface elevation for Patch C for Sep 2011 LiDAR survey.
