Appendix A.10:

Pinewood Ave – CPT 61991

Liquefaction Ejecta Case Histories for 2010-11 Canterbury Earthquakes

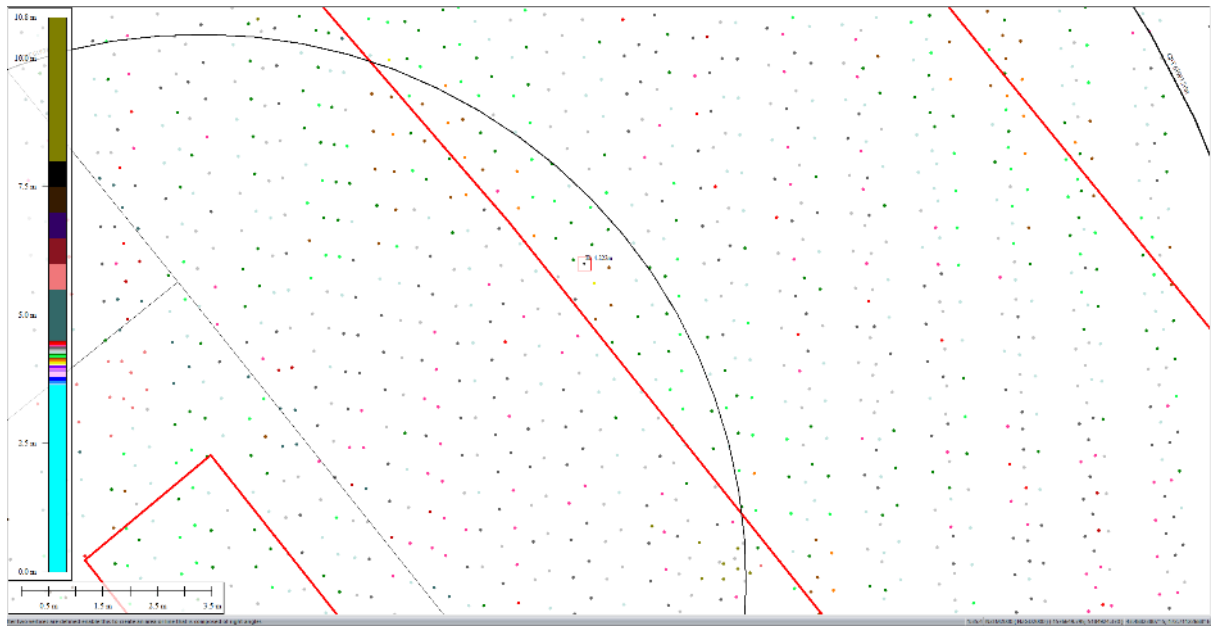
Figure 67: Ground surface elevation for Road averaged over the 10-m buffer for Sep 2011 LiDAR survey.

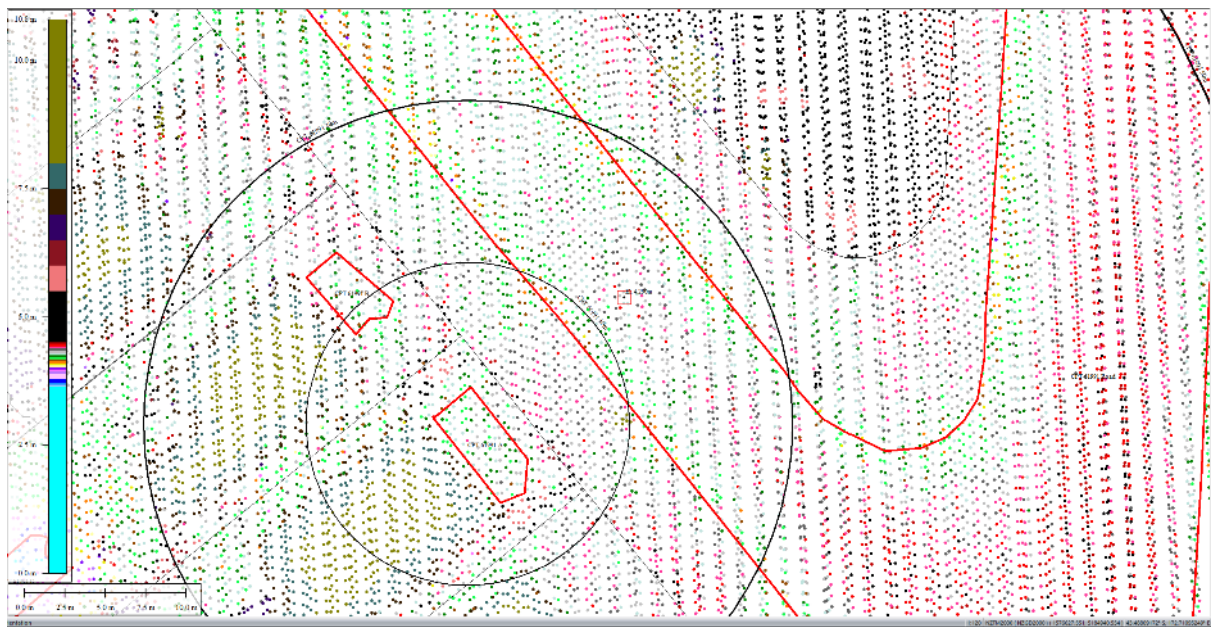
Figure 68: Ground surface elevation for Road averaged over the 20-m buffer for Sep 2011 LiDAR survey.

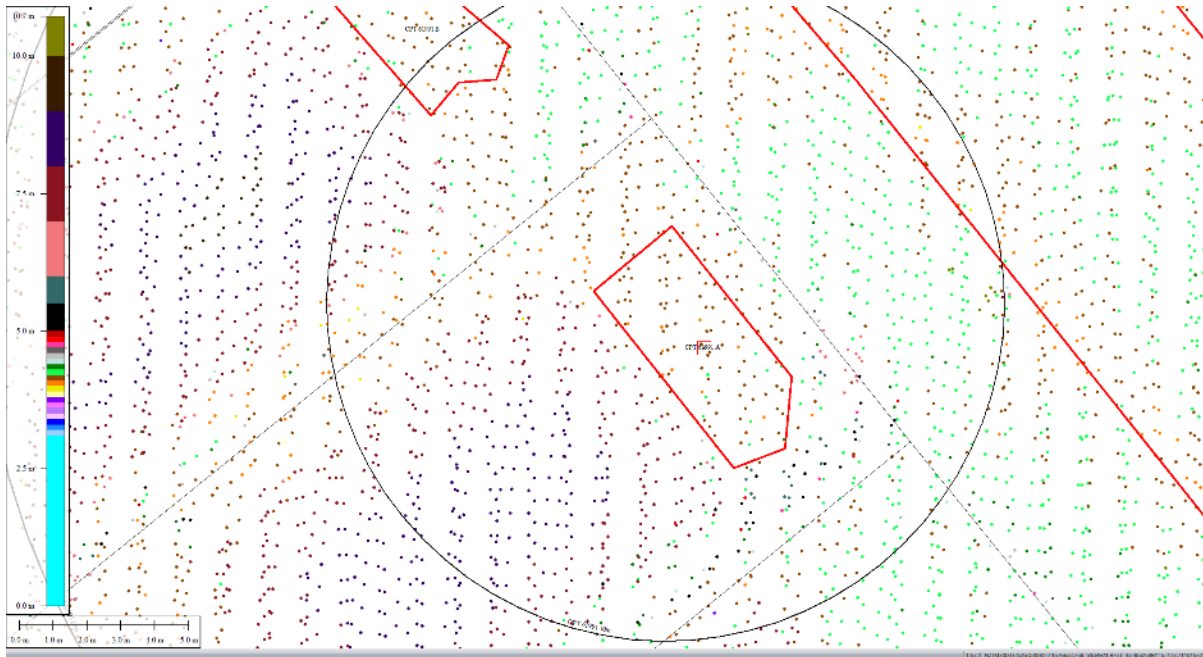
Figure 71: Ground surface elevation for Patch A for Feb 2012 LiDAR survey.

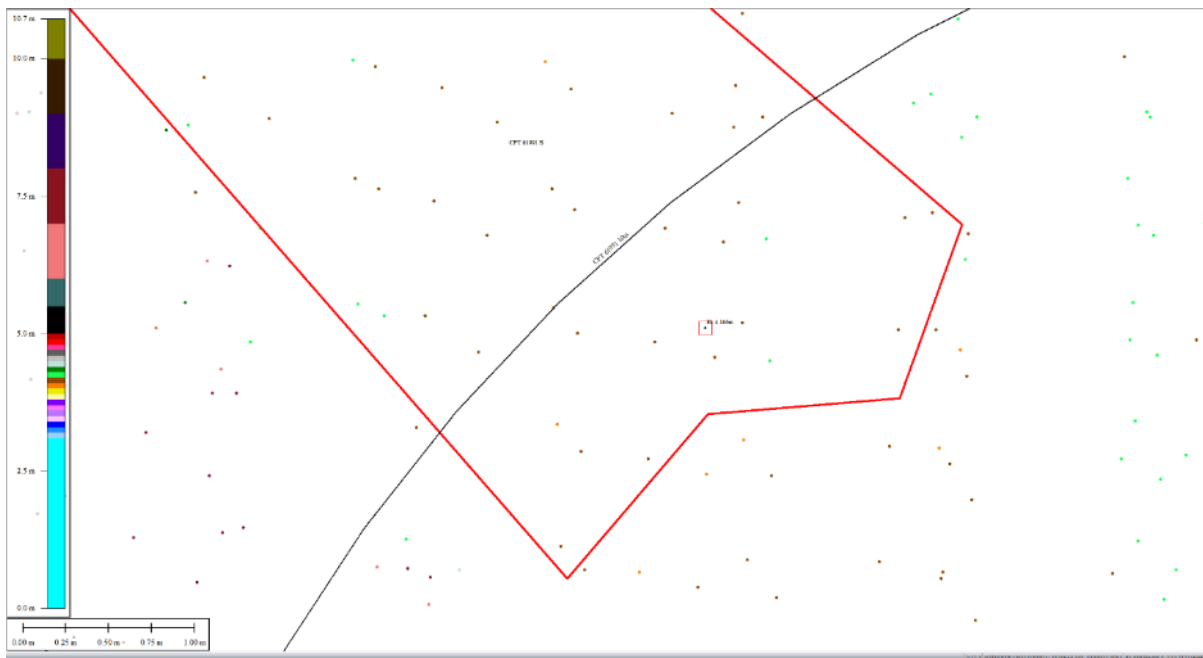
Figure 72: Ground surface elevation for Patch B averaged over the 10-m buffer for Feb 2012 LiDAR survey.

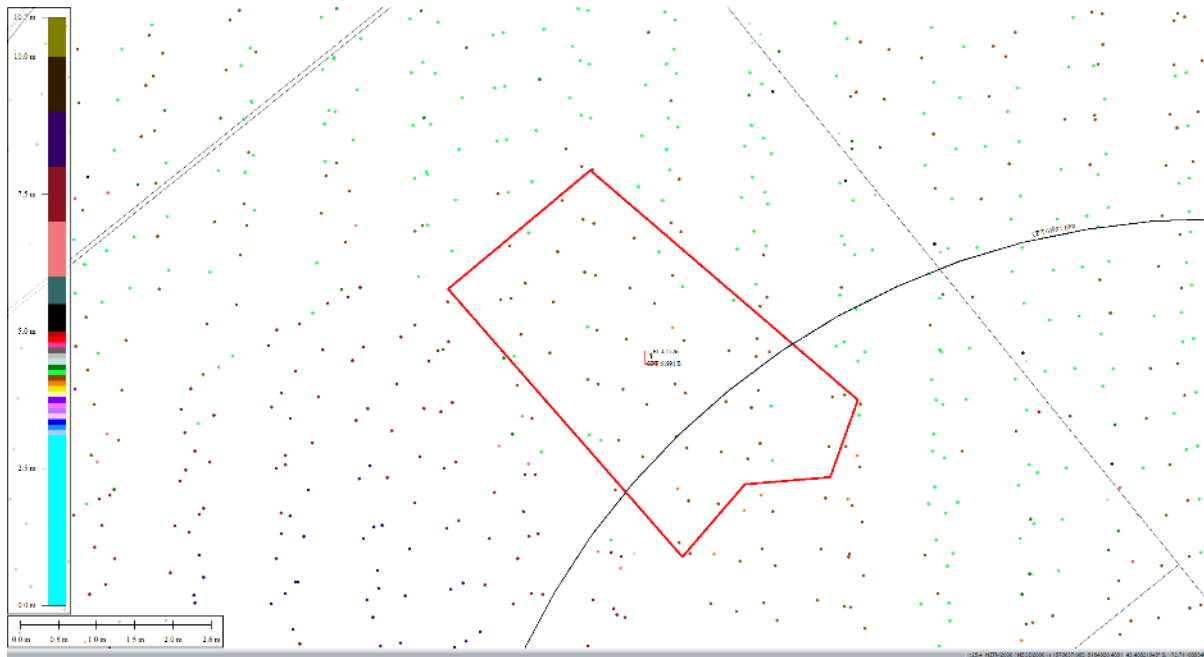
Figure 73: Ground surface elevation for Patch B averaged over the 20-m buffer for Feb 2012 LiDAR survey.

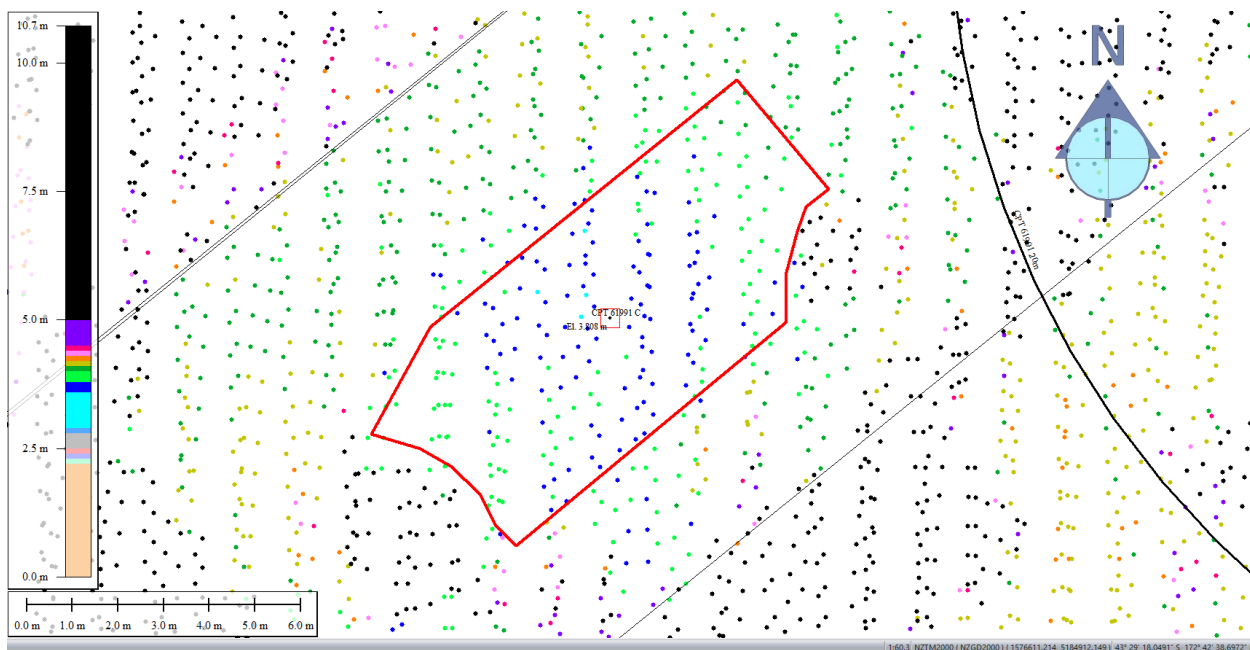
Figure 74: Ground surface elevation for Patch C for Feb 2012 LiDAR survey.

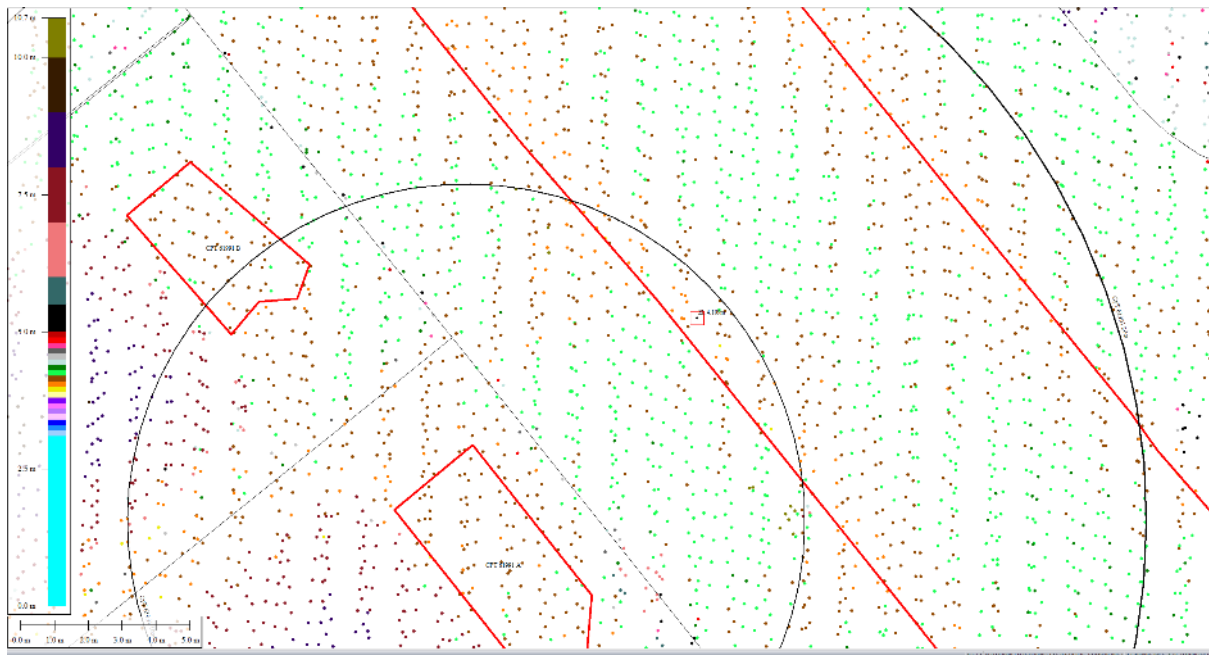
Figure 75: Ground surface elevation for Road averaged over the 10-m buffer for Feb 2012 LiDAR survey.

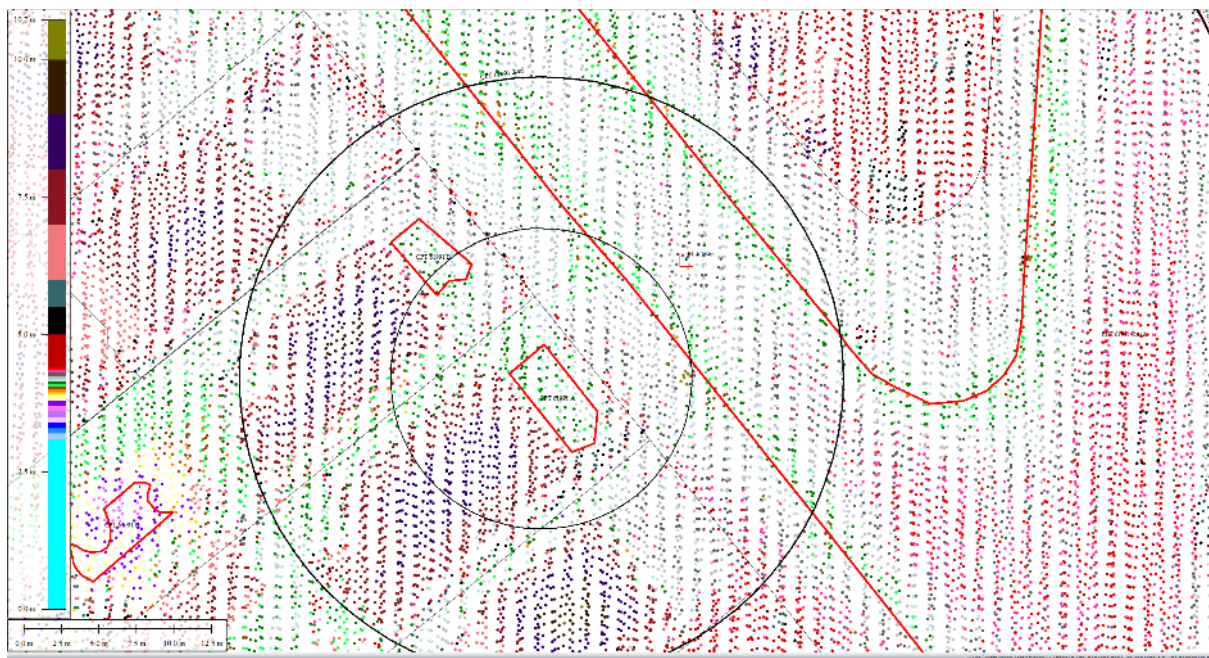
Figure 76: Ground surface elevation for Road averaged over the 20-m buffer for Feb 2012 LiDAR survey.

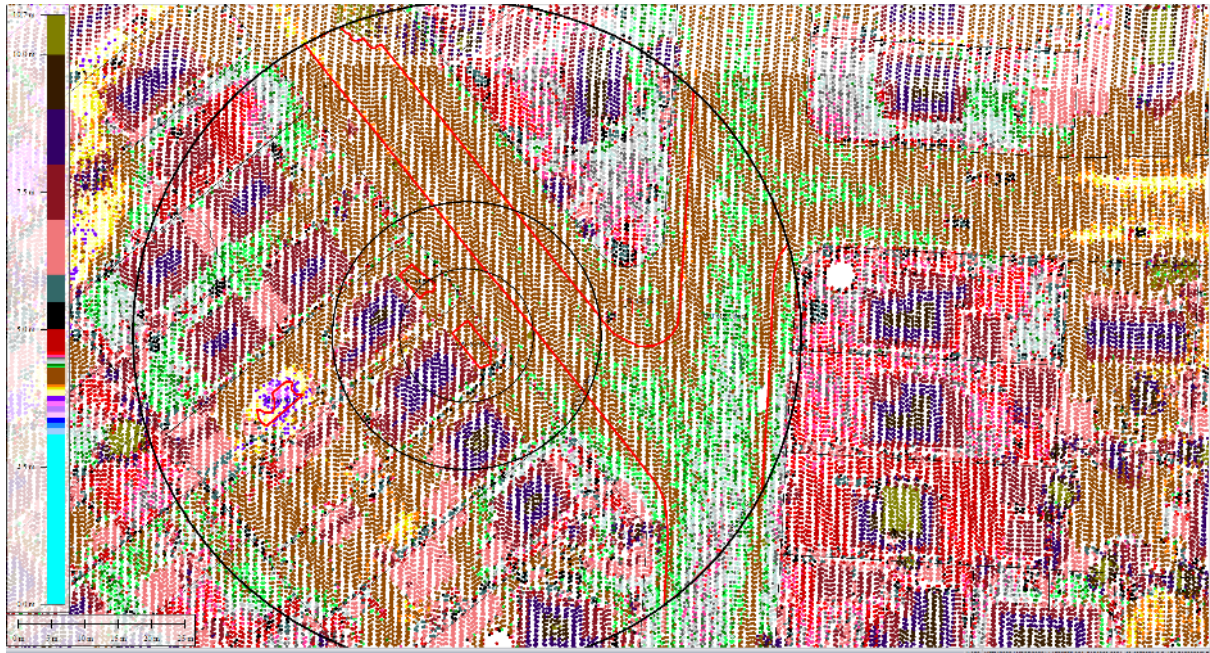
Figure 77: Ground surface elevation for Road averaged over the 50-m buffer for Feb 2012 LiDAR survey.

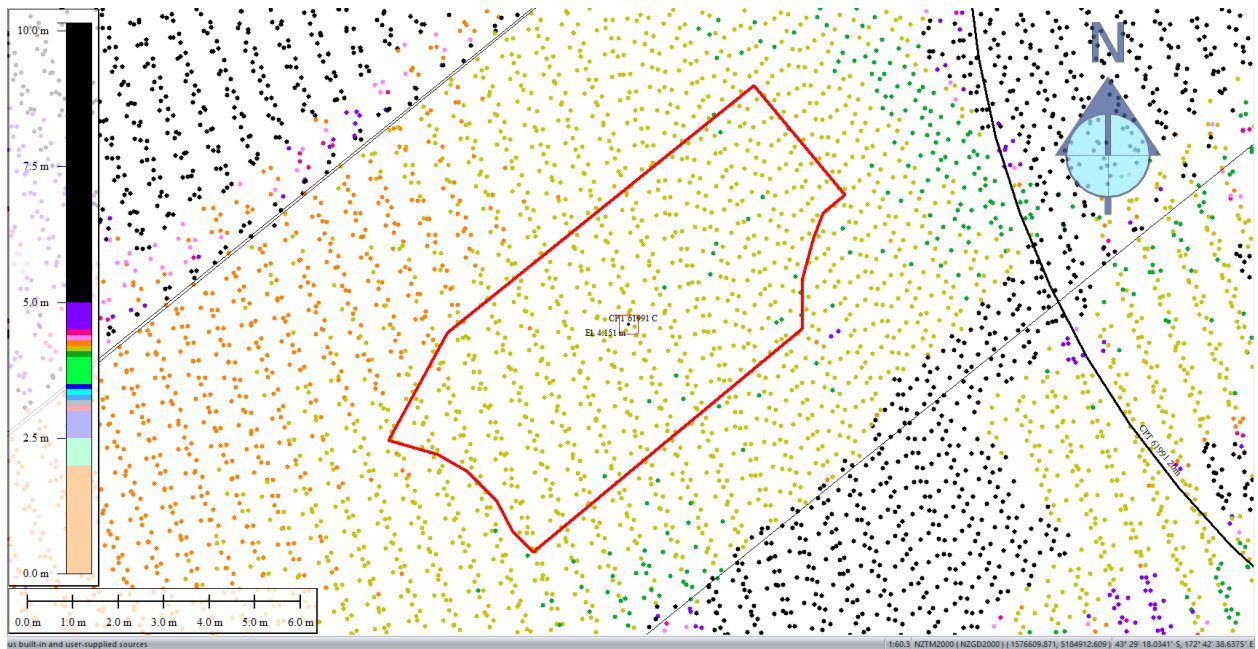
Figure 82: Ground surface elevation for Patch C for Oct 2015 LiDAR survey.

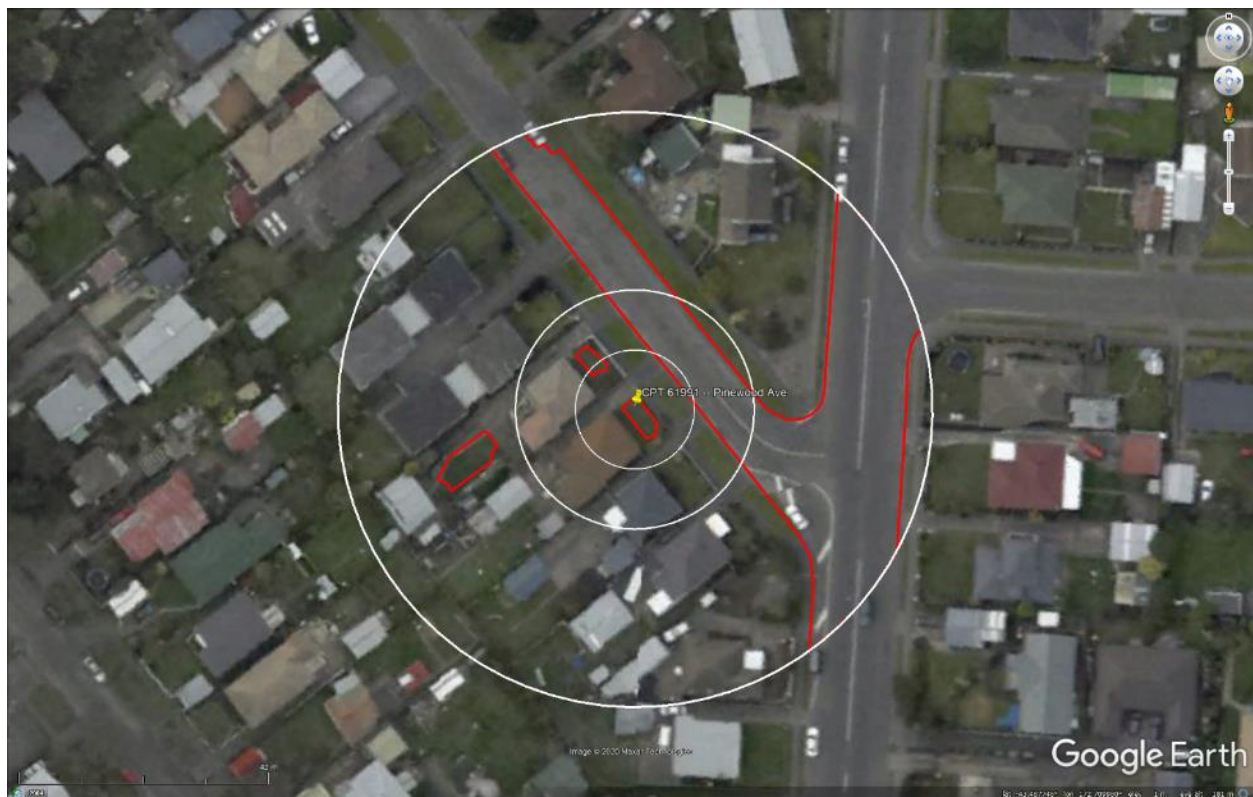
Figure 86: Absence of ejecta at the site for Sep-10 EQ.

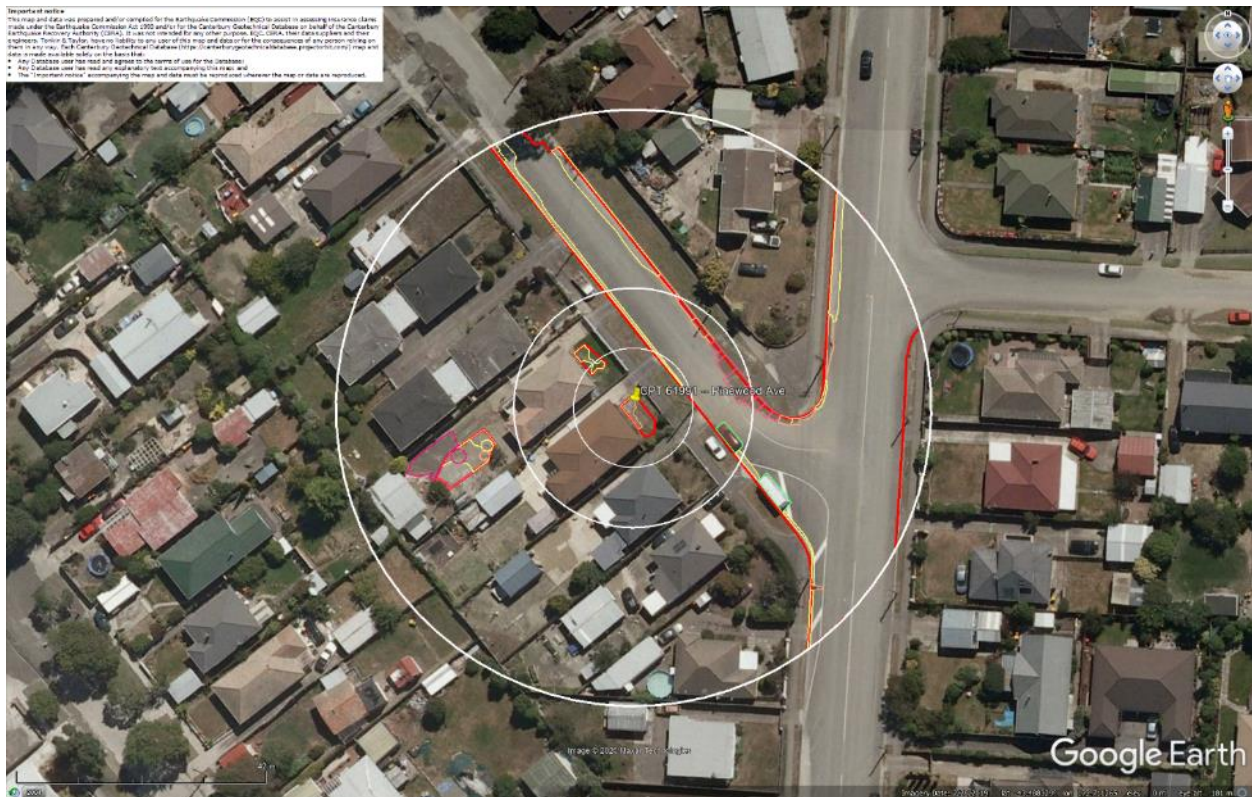
Figure 87: Ejecta outline for Feb-11 EQ.

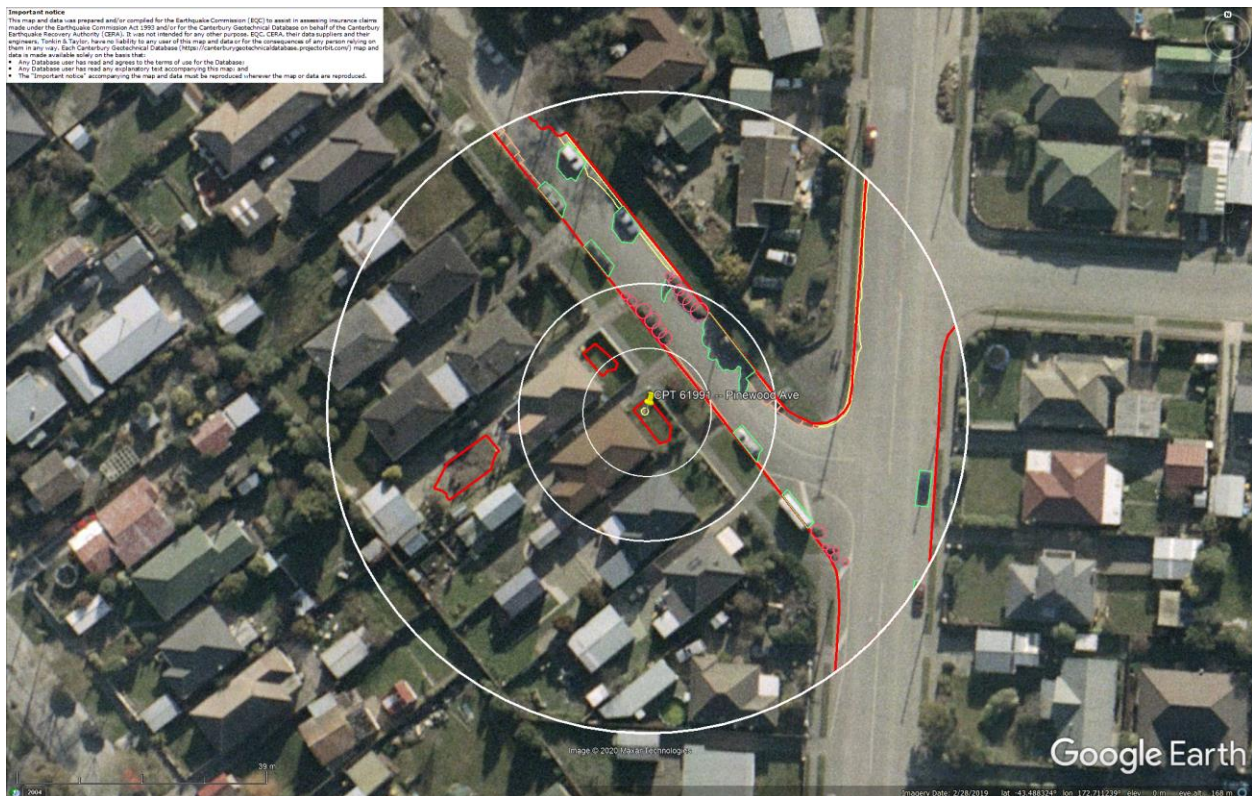
Figure 88: Ejecta outline for Jun-11 EQ.

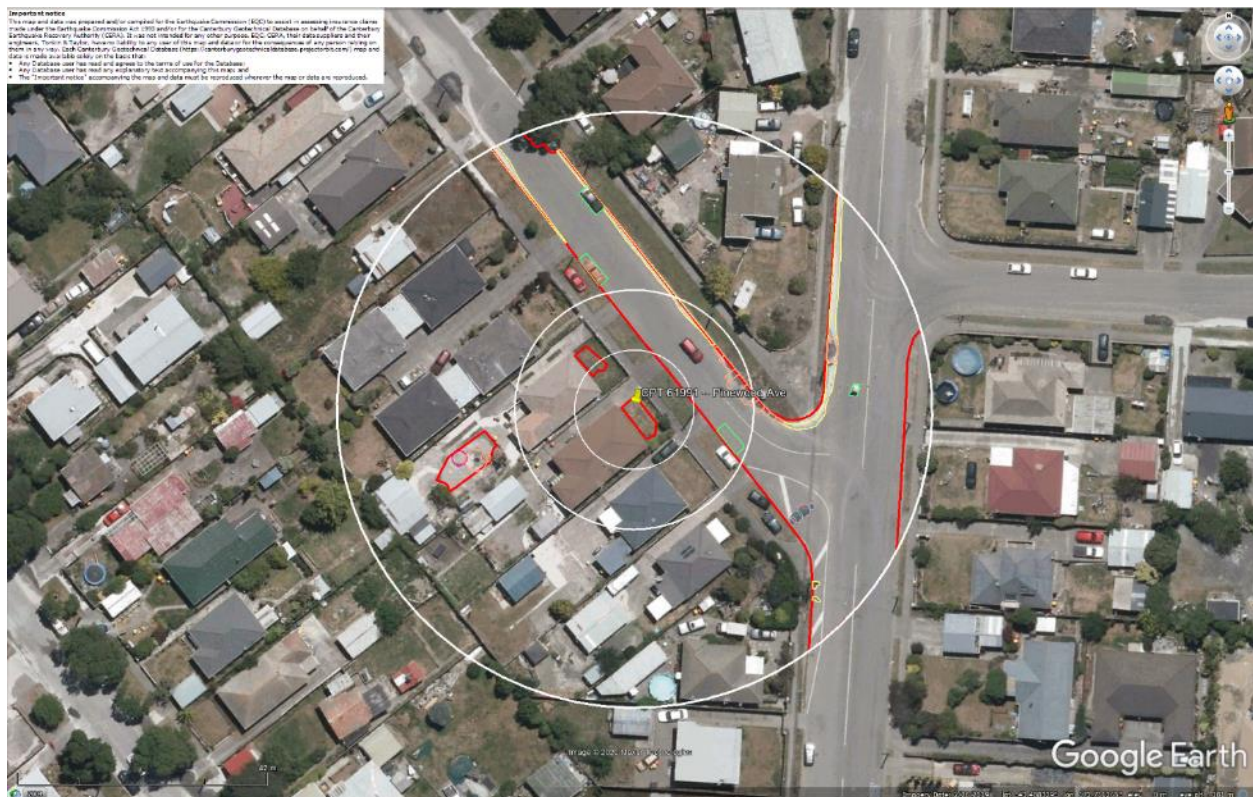
Figure 89: Ejecta outline for Dec-11 EQ.

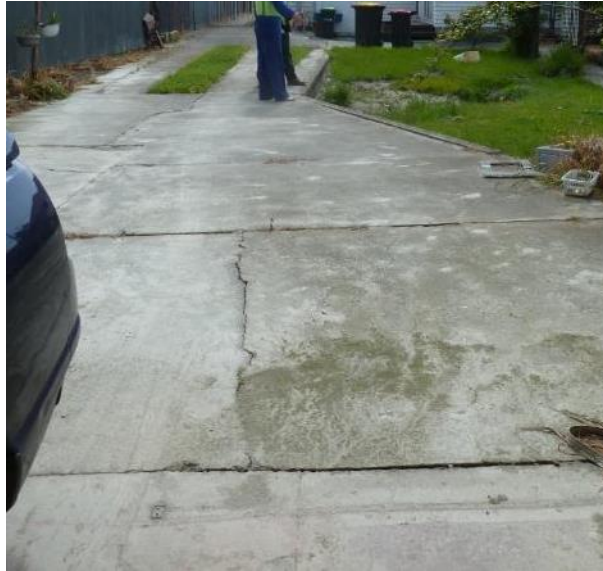
Figure 96: Cracks in the driveway next to Patch C.

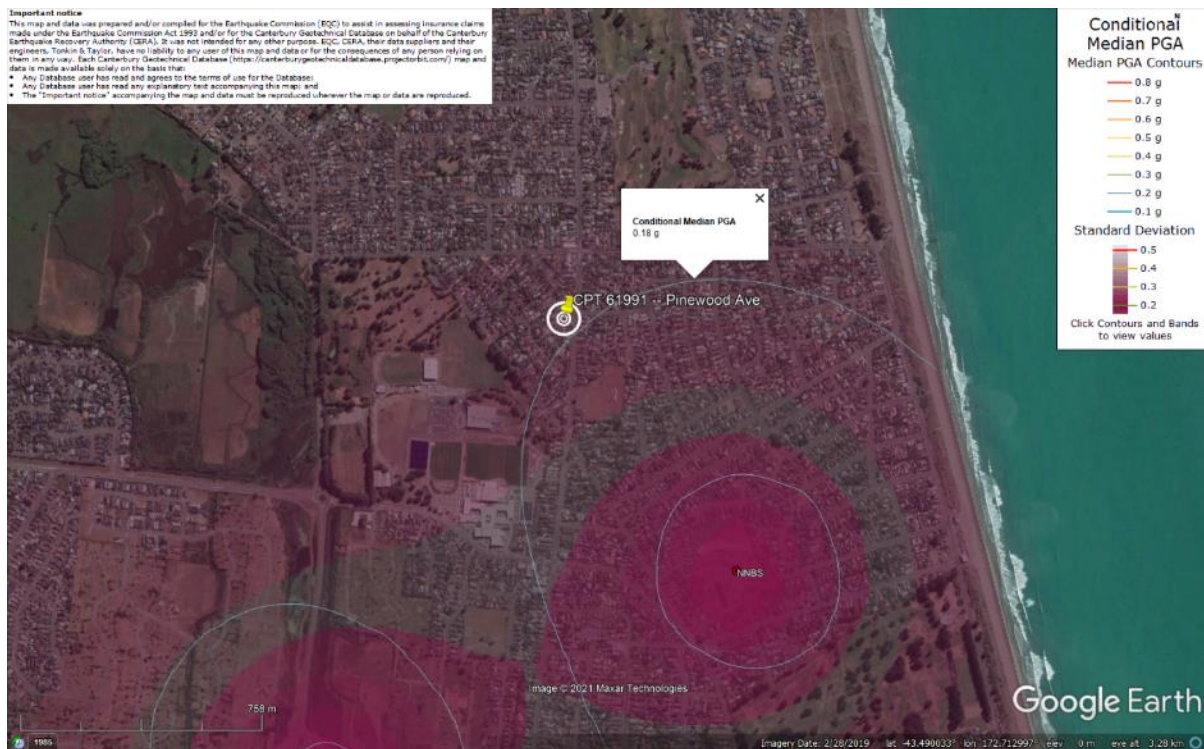
Figure 97: PGA for Sep-10 EQ (st. dev. = 0.300-0.325 ln units).

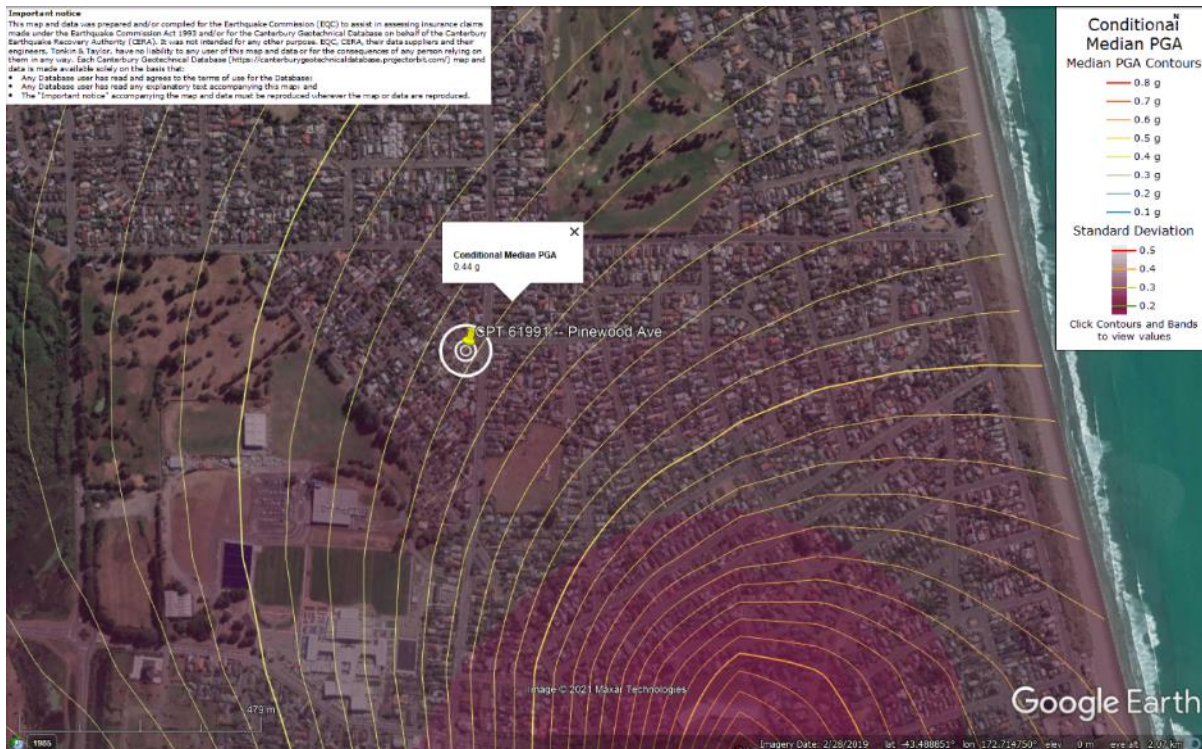
Figure 98: PGA for Feb-11 EQ (st. dev. = 0.325-0.350 ln units).

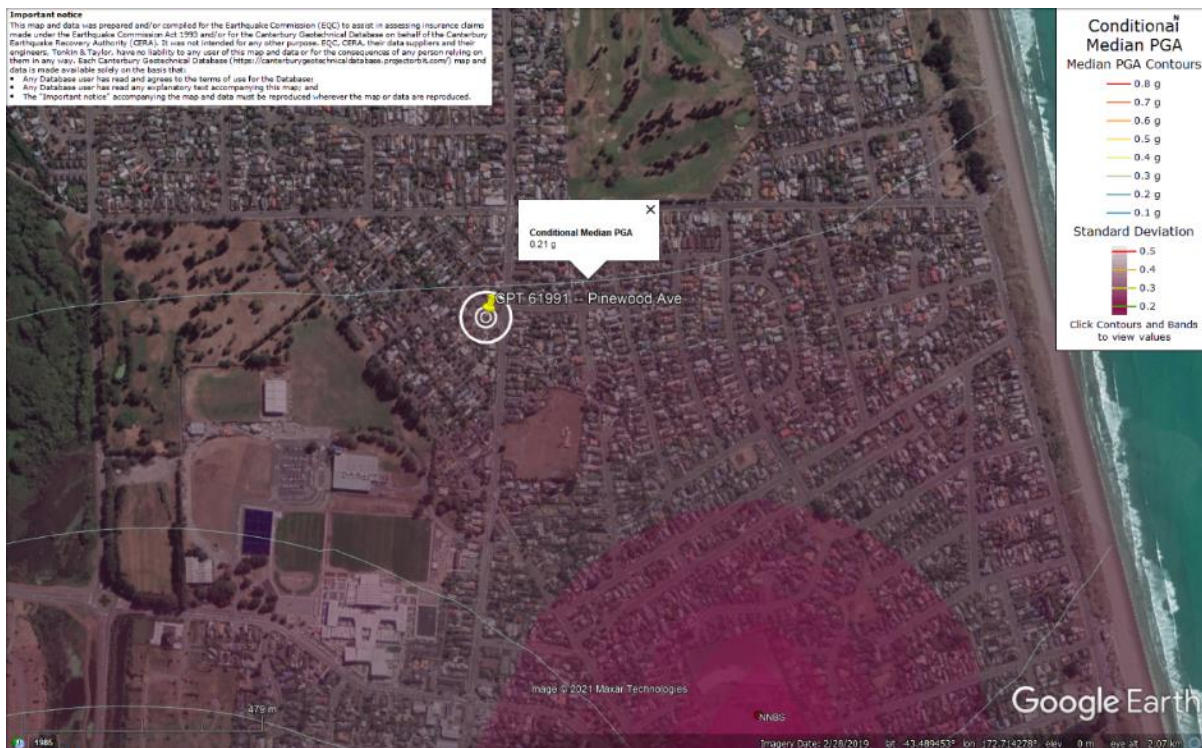
Figure 99: PGA for Jun-11 EQ (st. dev. = 0.325-0.350 ln units).

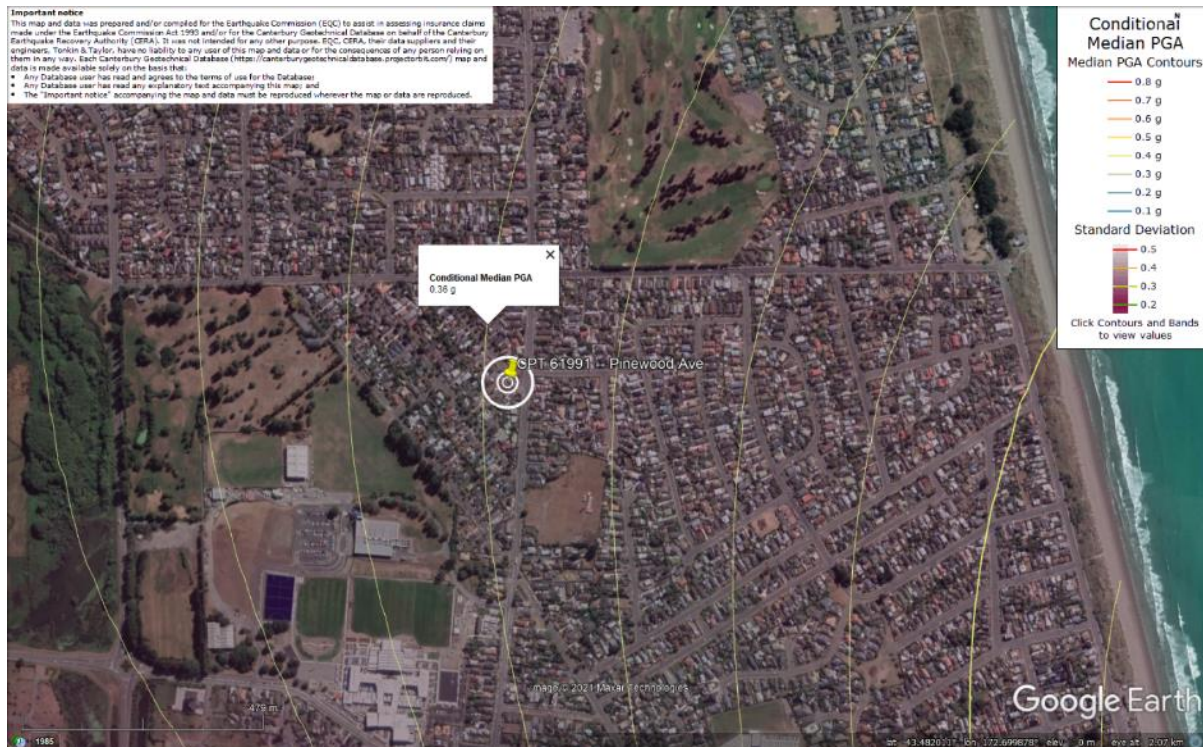
Figure 100: PGA for Dec-11 EQ (st. dev. = 0.375-0.425 ln units).

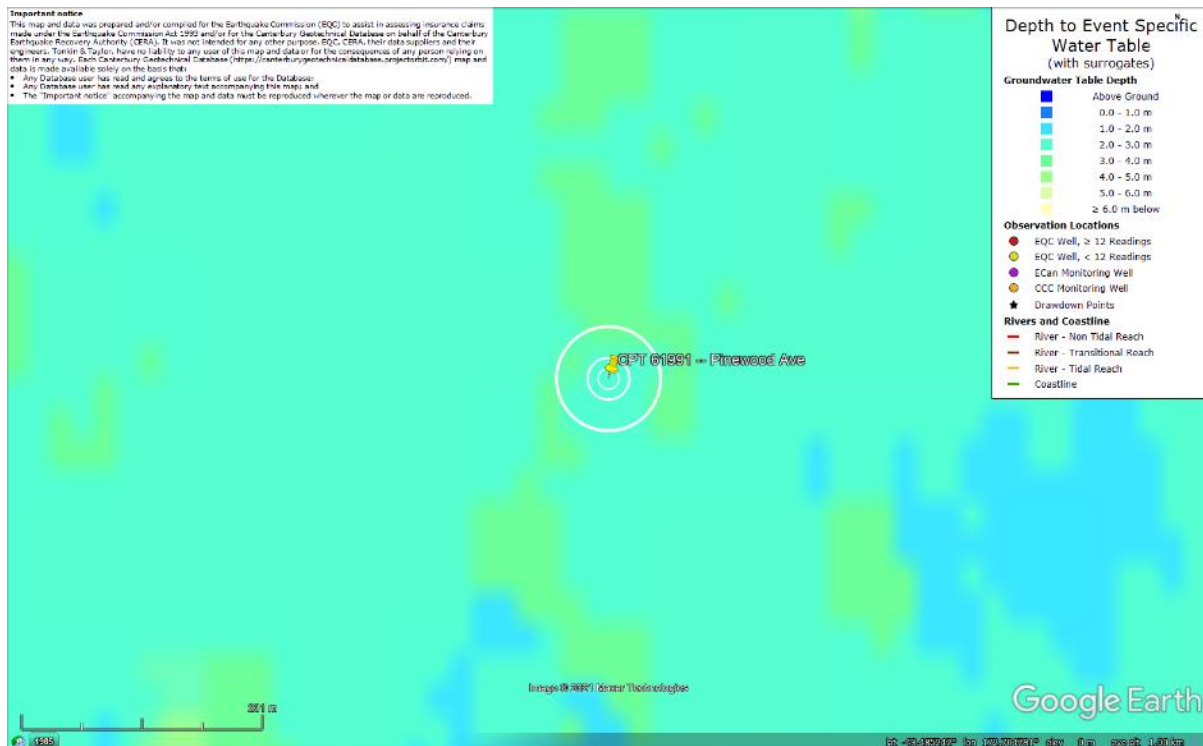
Figure 101: Depth to groundwater table for Sep-10 EQ.

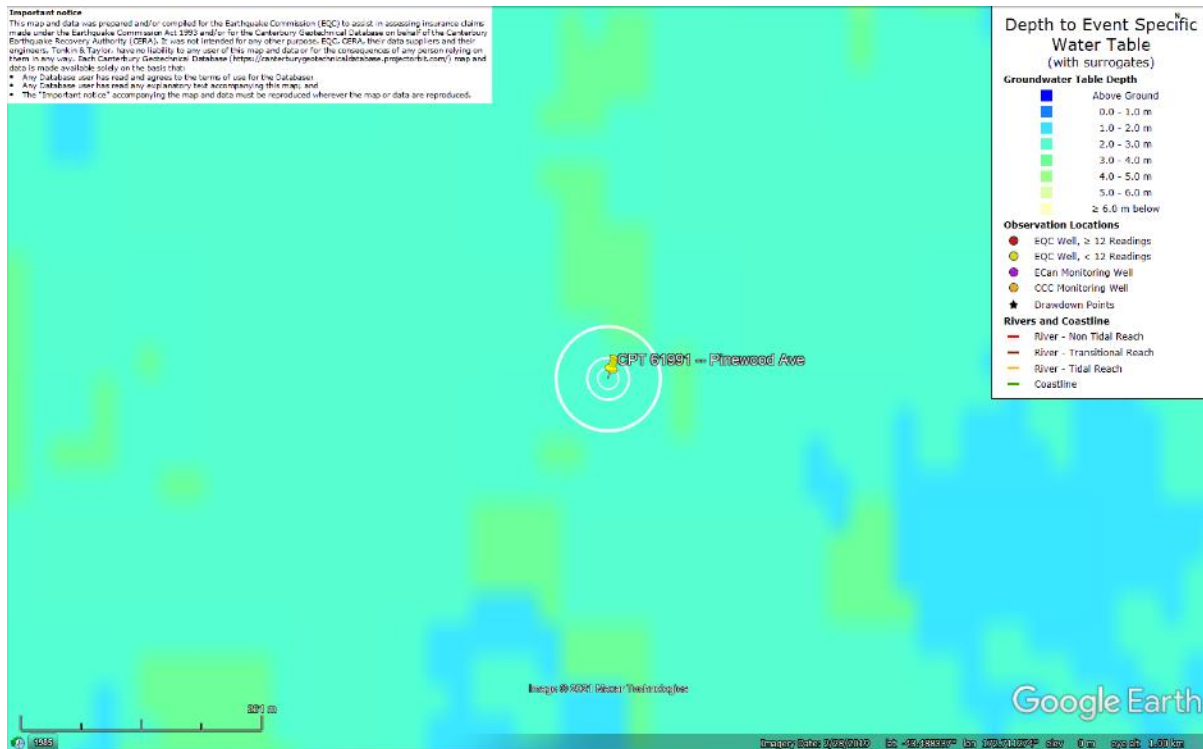
Figure 102: Depth to groundwater table for Feb-11 EQ.

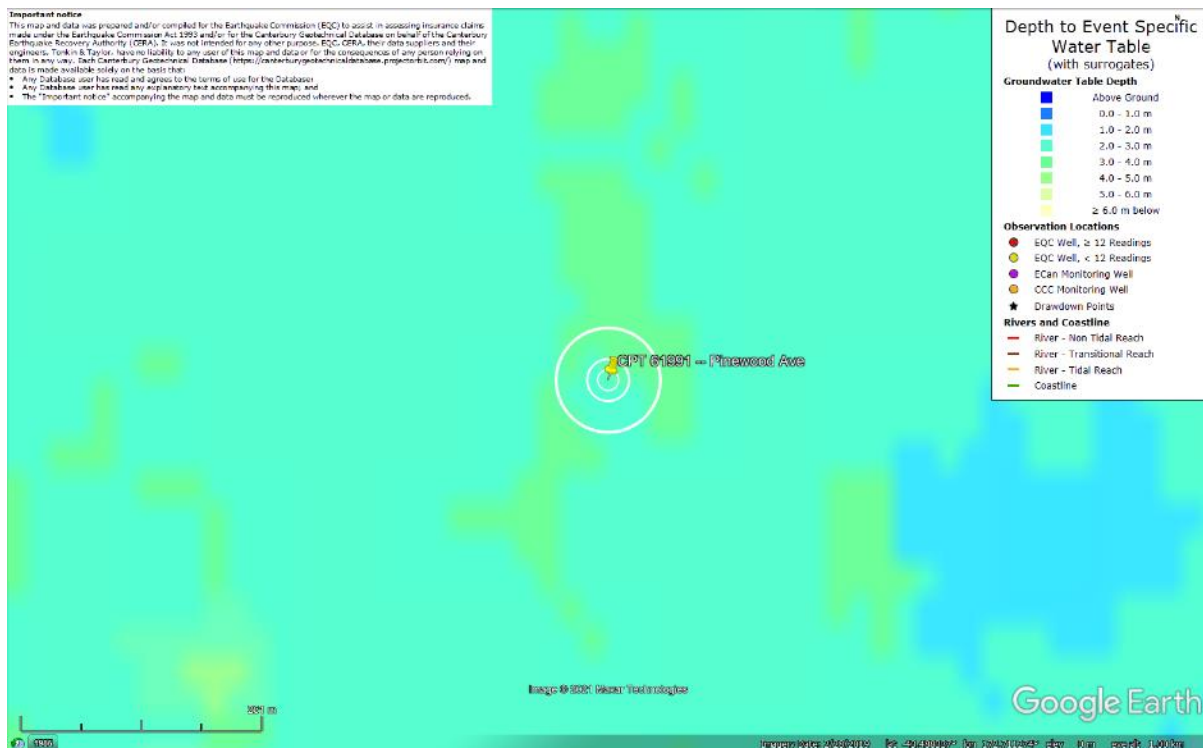
Figure 103: Depth to groundwater table for Jun-11 EQ.

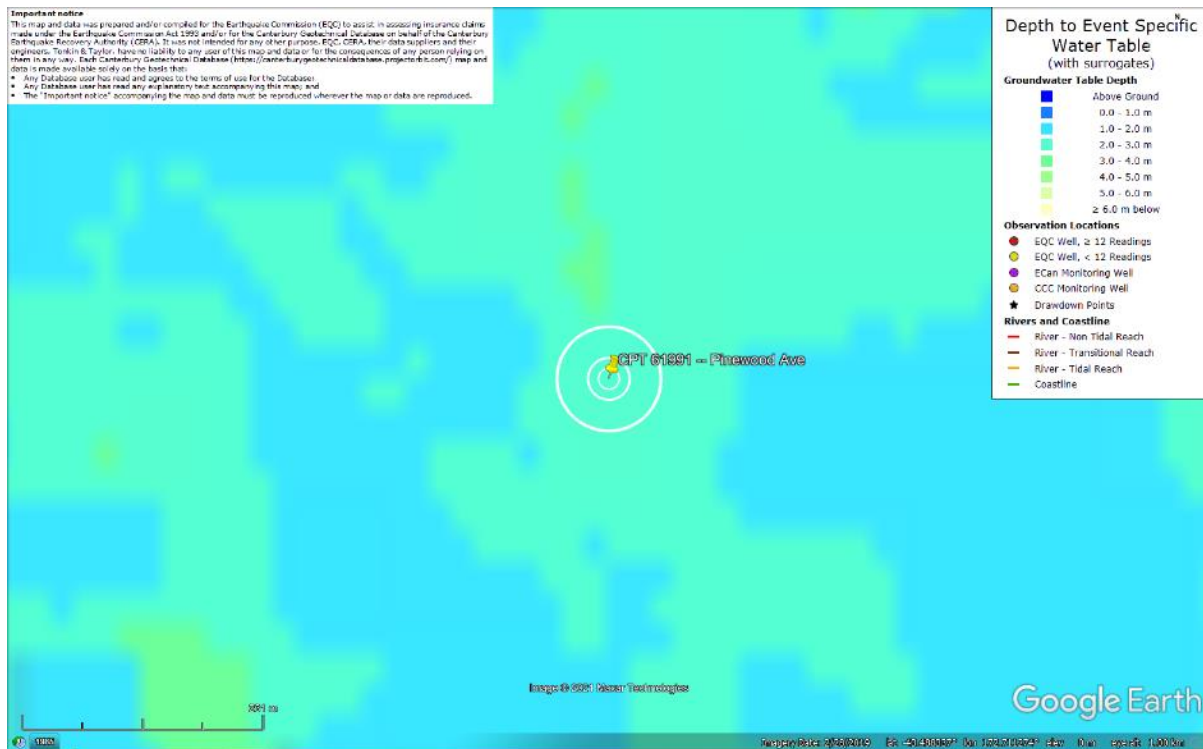
Figure 104: Depth to groundwater table for Dec-11 EQ.

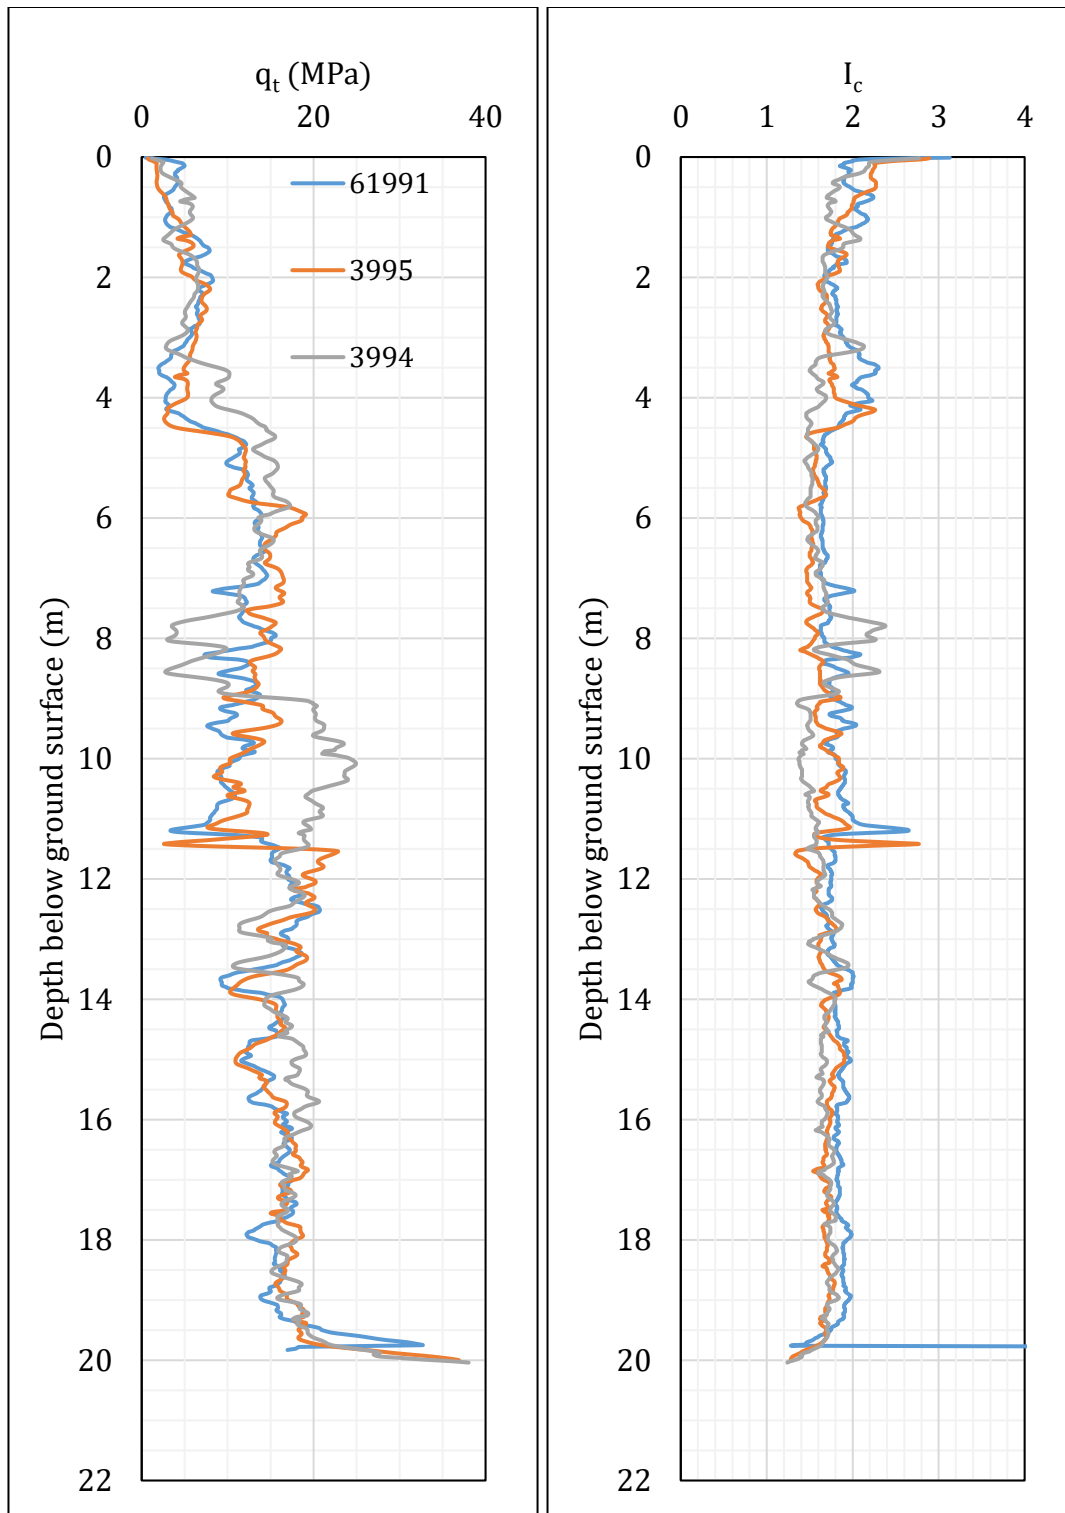
Figure 106: q_t and I_c profiles.

Note 8: The selection of CPTs for the area considered for settlement assessment (Figure 1) is based on the proximity of the CPTs to the considered areas. In accordance with that, the following table shows CPTs that were used for the volumetric settlement analysis in *Cliq v.3.0.3.2*, a CPT soil liquefaction software developed by GeoLogismiki. (The average volumetric settlements were reported in Table 8.)
