Appendix A.11:

Carisbrooke Playground – VsVp 57193

Liquefaction Ejecta Case Histories for 2010-11 Canterbury Earthquakes

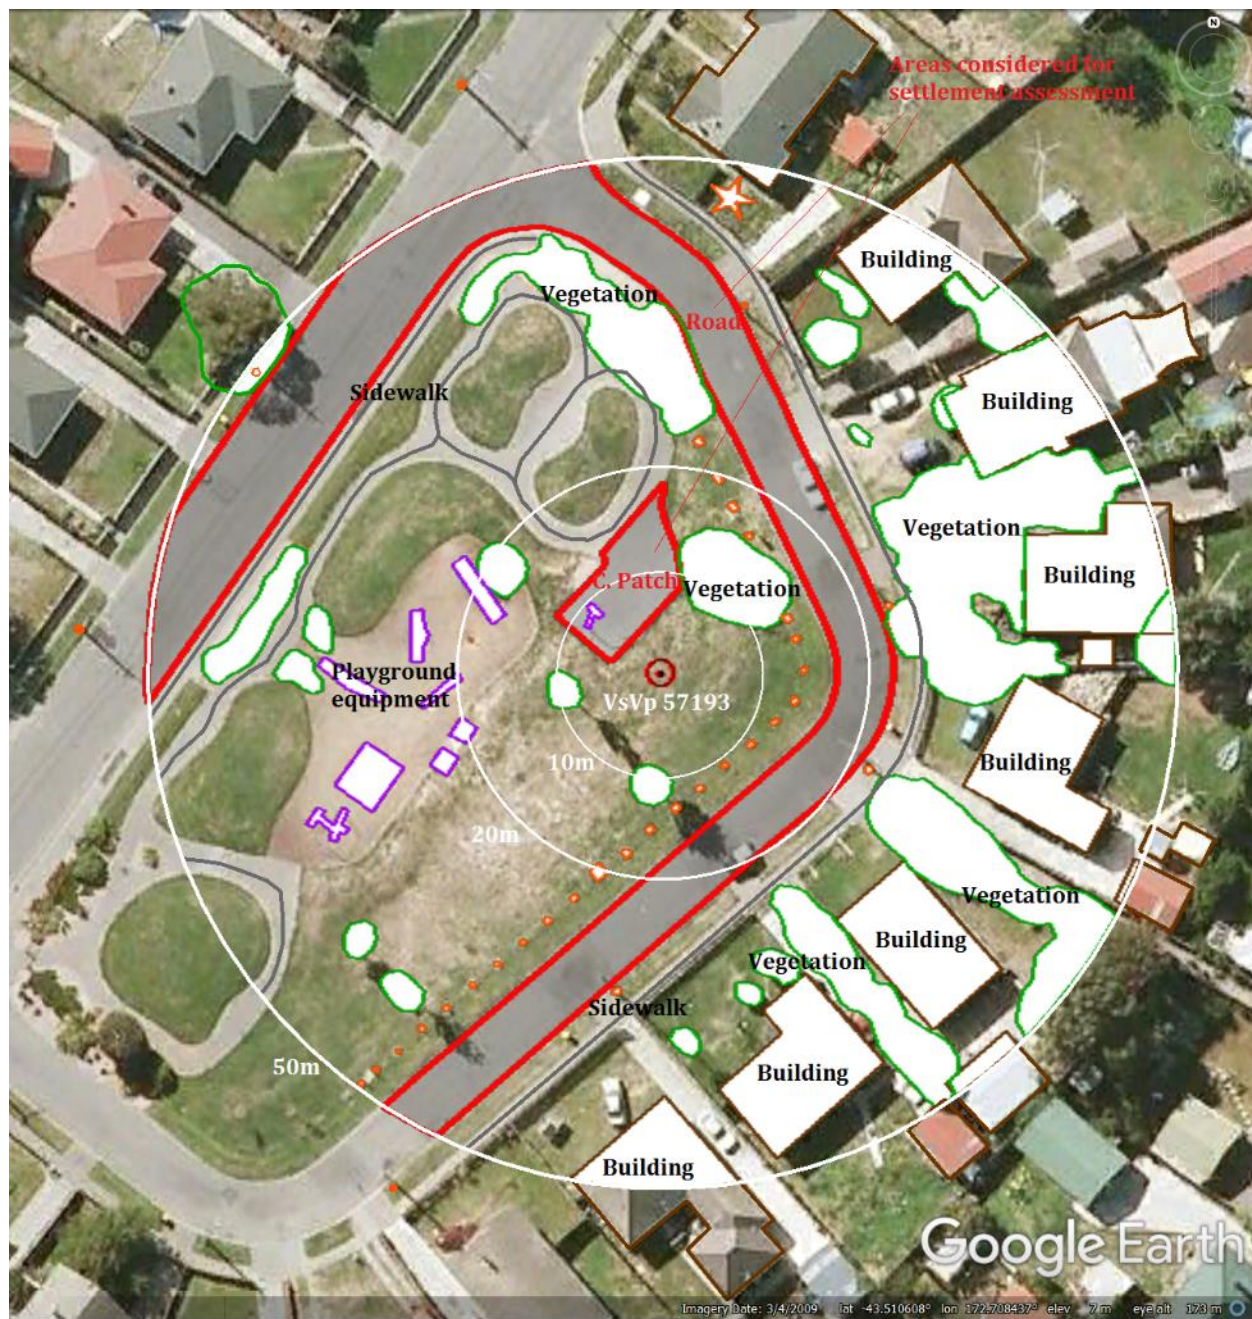
Figure 1: Site plan with areas where LiDAR survey data is considered.

Note 1: The selected patch in the free field is level, free of vegetation, and structures, all of which have the potential to influence LiDAR surveys. The entire portion of the road within the 50-m buffer was considered for settlement assessment.

- $A_{E,thick,i}$ and $H_{E,thick,i}$ are the area and the height of a thick ejecta layer, respectively;
- $A_{E,thin,j}$ and $H_{E,thin,j}$ are the area and the height of a thin ejecta layer, respectively;
- $W_{E,prism,n}$ and $L_{E,prism,n}$ are the width and the length of the coverage area of an ejecta layer shaped as a right triangular prism, respectively, and $H_{E,prism,n}$ is the height of a right triangular prism-like ejecta layer;
- $W_{E,pyr,p}$ and $L_{E,pyr,p}$ are the width and the length of the coverage area of a pyramid-like ejecta layer, respectively, and $H_{E,pyr,p}$ is the height of a pyramid-like ejecta layer;
- A_T is the total assessment area for a buffer being considered (Figure 1).

Note 8: The selection of CPTs for the area considered for settlement assessment (Figure 1) is based on the proximity of the CPTs to the considered areas. In accordance with that, the following table shows CPTs that were used for the volumetric settlement analysis in *Cliq v.3.0.3.2*, a CPT soil liquefaction software developed by GeoLogismiki. (The average volumetric settlements were reported in Table 8.)

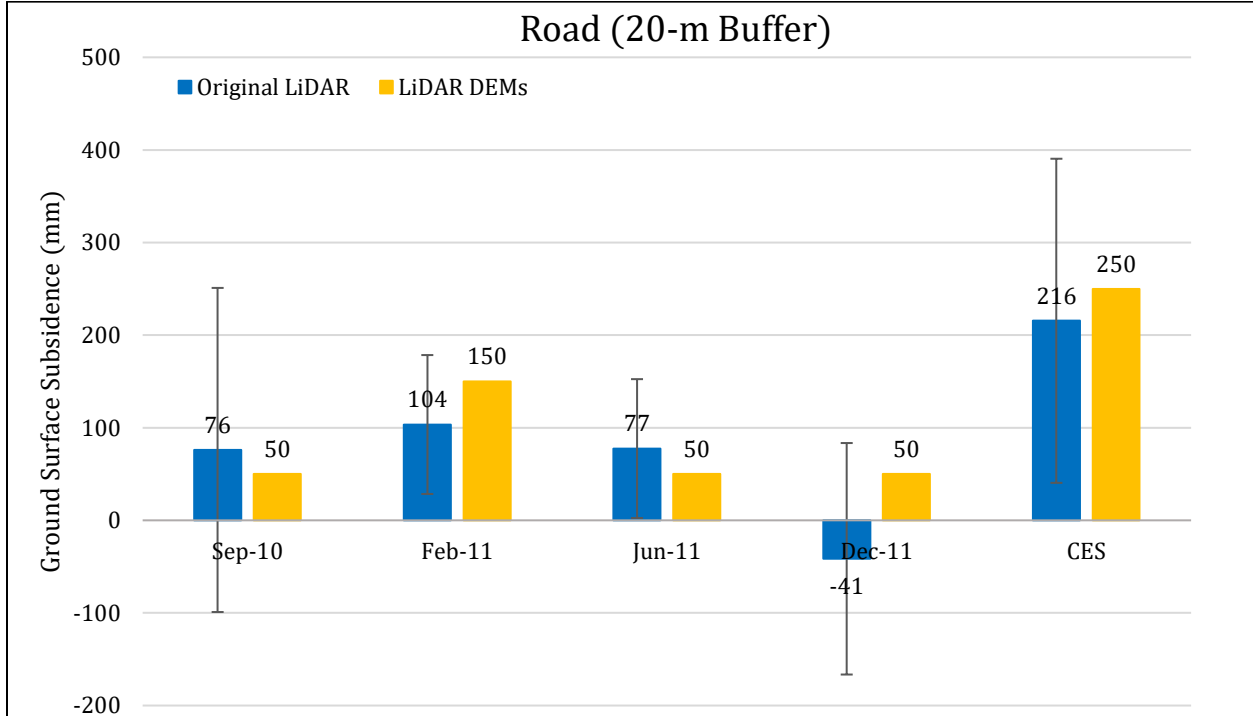
Figure 3: Comparison between ground surface subsidence determined from original LiDAR survey points and ground surface subsidence (50th %ile) estimated using LiDAR DEMs for Road within the 20-m buffer.

Note 2: The ground surface subsidence values determined from original LiDAR survey points are generally similar to the ground surface subsidence values estimated using LiDAR DEMs for all earthquake events.

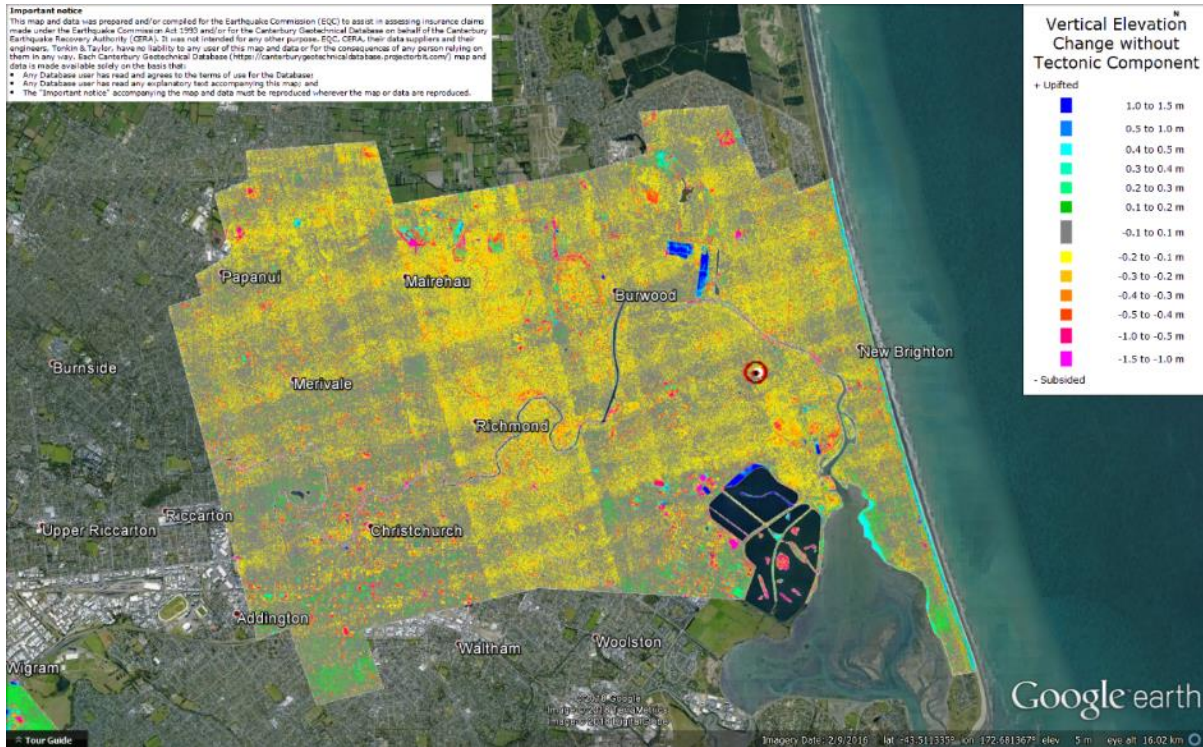
Figure 19: Vertical Ground Movements (Surface – Tectonic) for Sep 2010 Earthquake – the site is not in the apparent zone of overestimated ground surface subsidence.

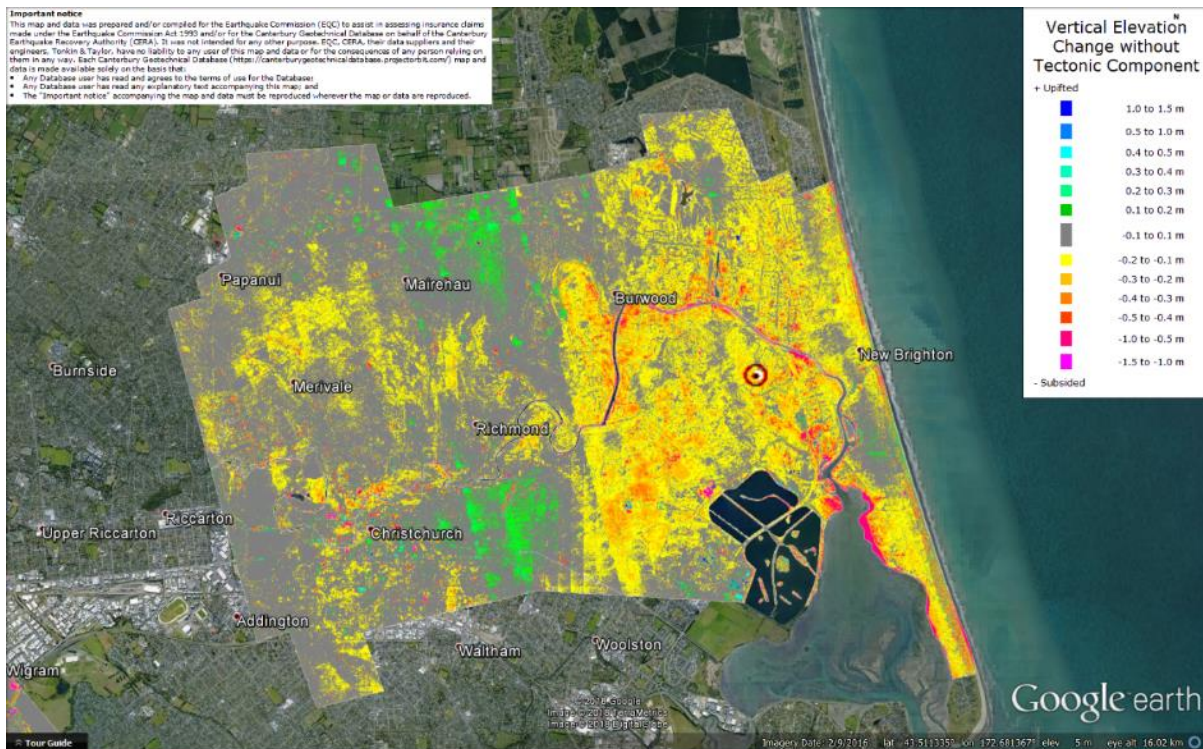
Figure 20: Vertical Ground Movements (Surface – Tectonic) for Feb 2011 Earthquake – the site is not in the apparent zone of underestimated ground surface subsidence.

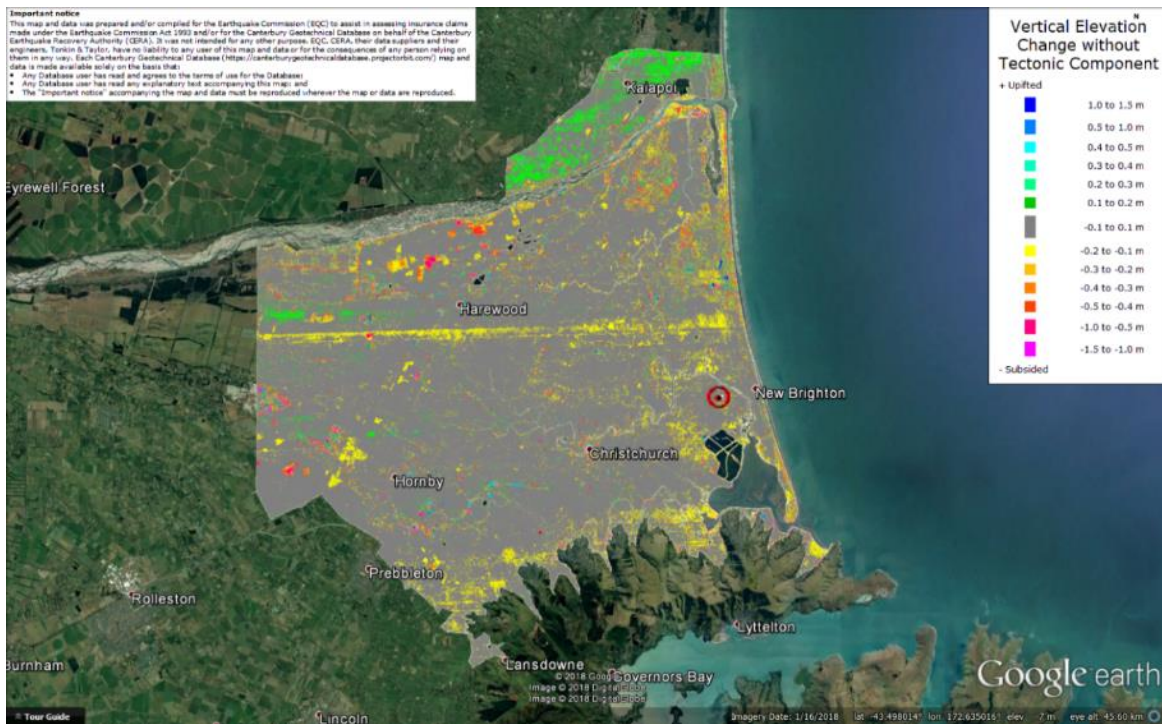
Figure 21: Vertical Ground Movements (Surface – Tectonic) for June 2011 Earthquake – the site is not in the apparent zone of overestimated or underestimated ground surface subsidence.

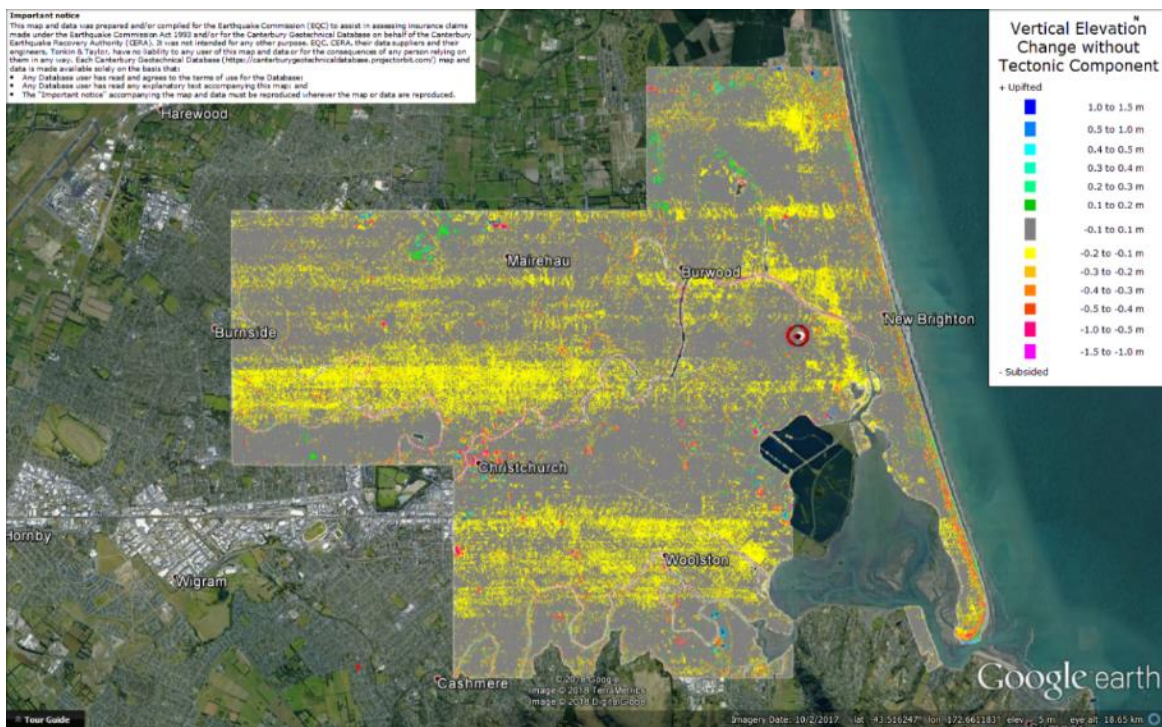
Figure 22: Vertical Ground Movements (Surface – Tectonic) for Dec 2011 Earthquake – the site is not in the apparent zone of overestimated or underestimated ground surface subsidence.

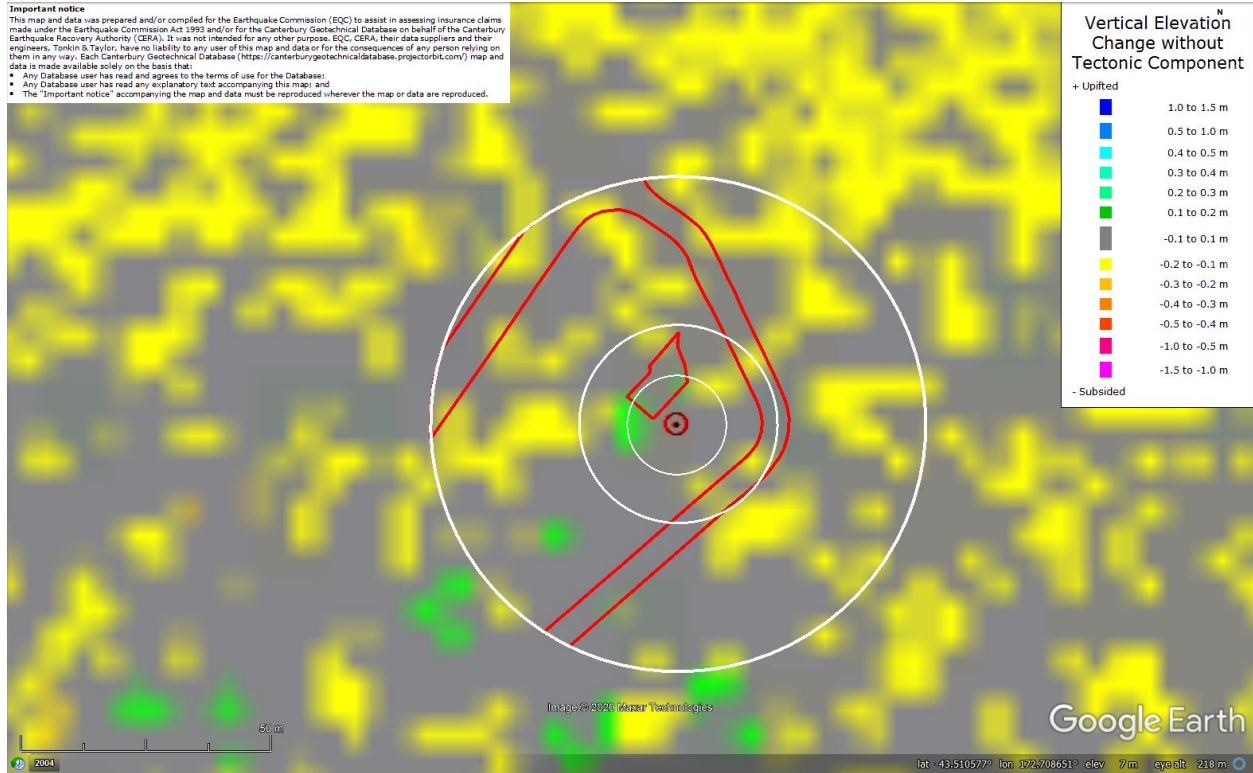
Figure 23: Ground surface subsidence without tectonic component for Sep 2010 Earthquake according to the LiDAR DEM.

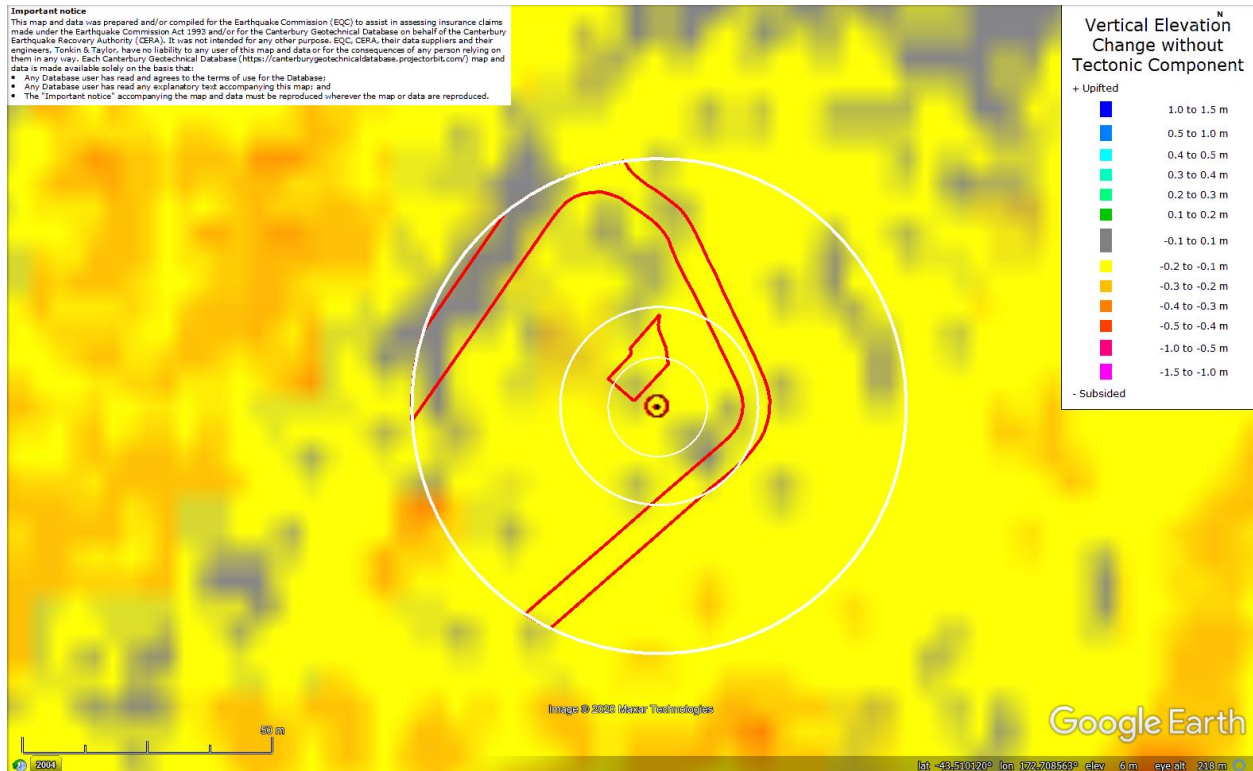
Figure 24: Ground surface subsidence without tectonic component for Feb 2011 Earthquake according to the LiDAR DEM.

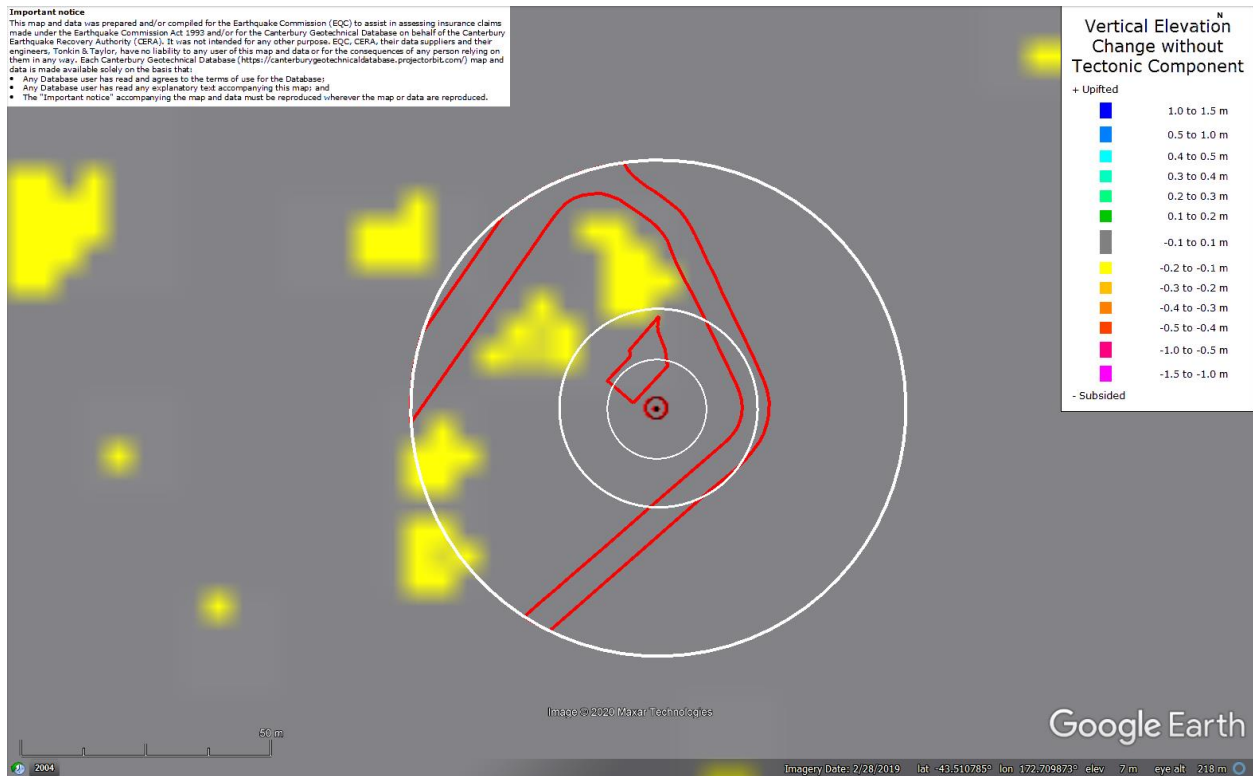
Figure 25: Ground surface subsidence without tectonic component for June 2011 Earthquake according to the LiDAR DEM.

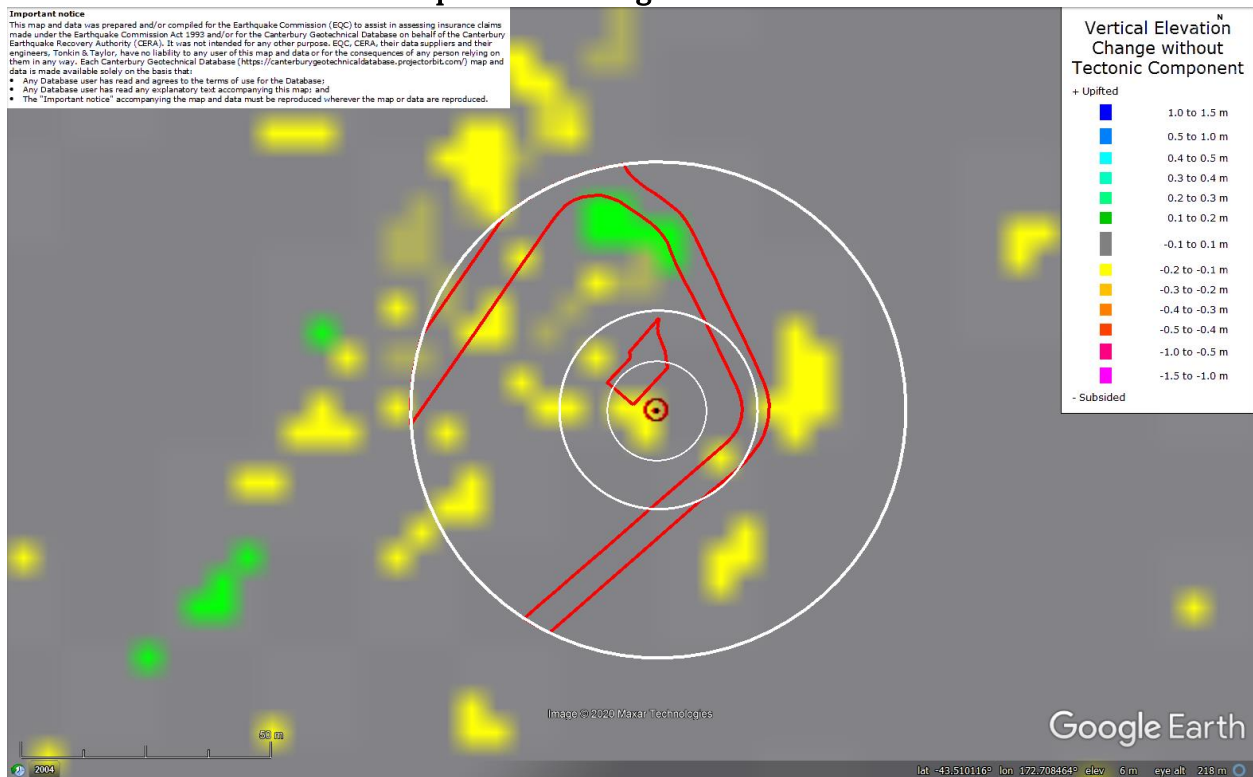
Figure 26: Ground surface subsidence without tectonic component for Dec 2011 Earthquake according to the LiDAR DEM.

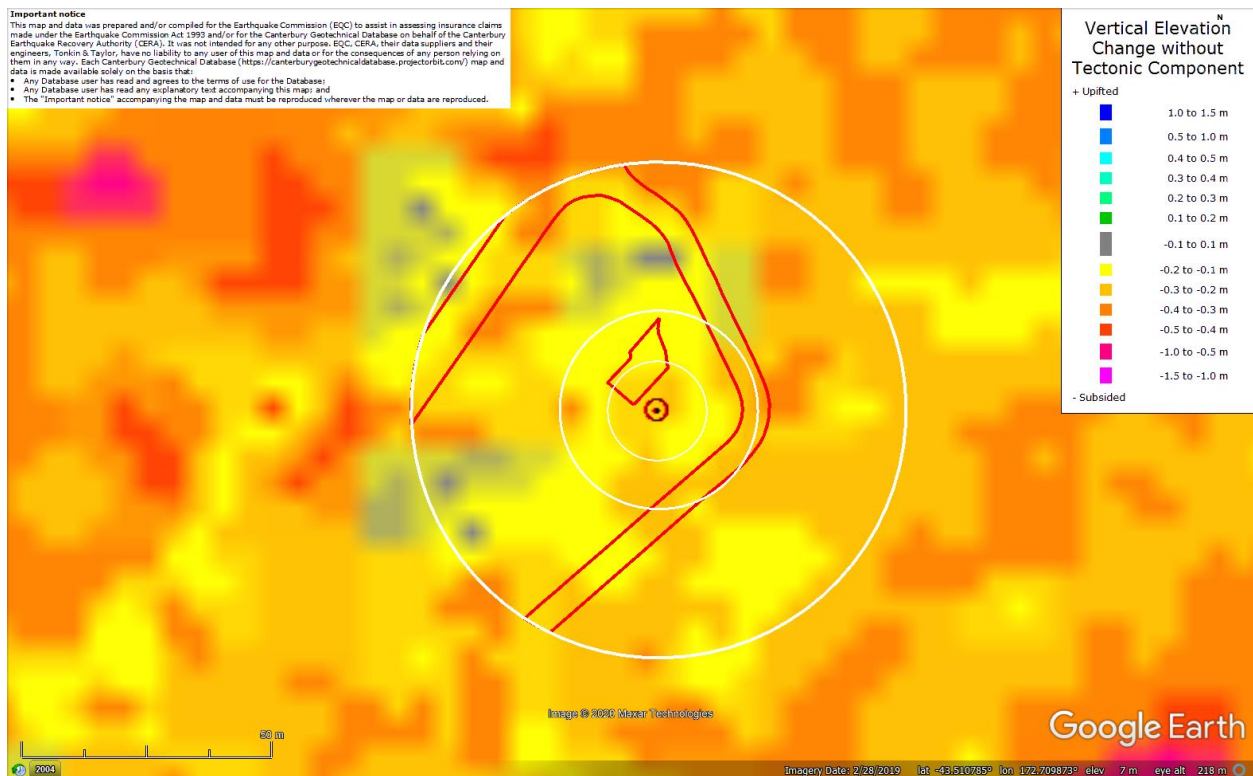
Figure 27: Ground surface subsidence without tectonic component for Canterbury Earthquake Sequence according to the LiDAR DEM.

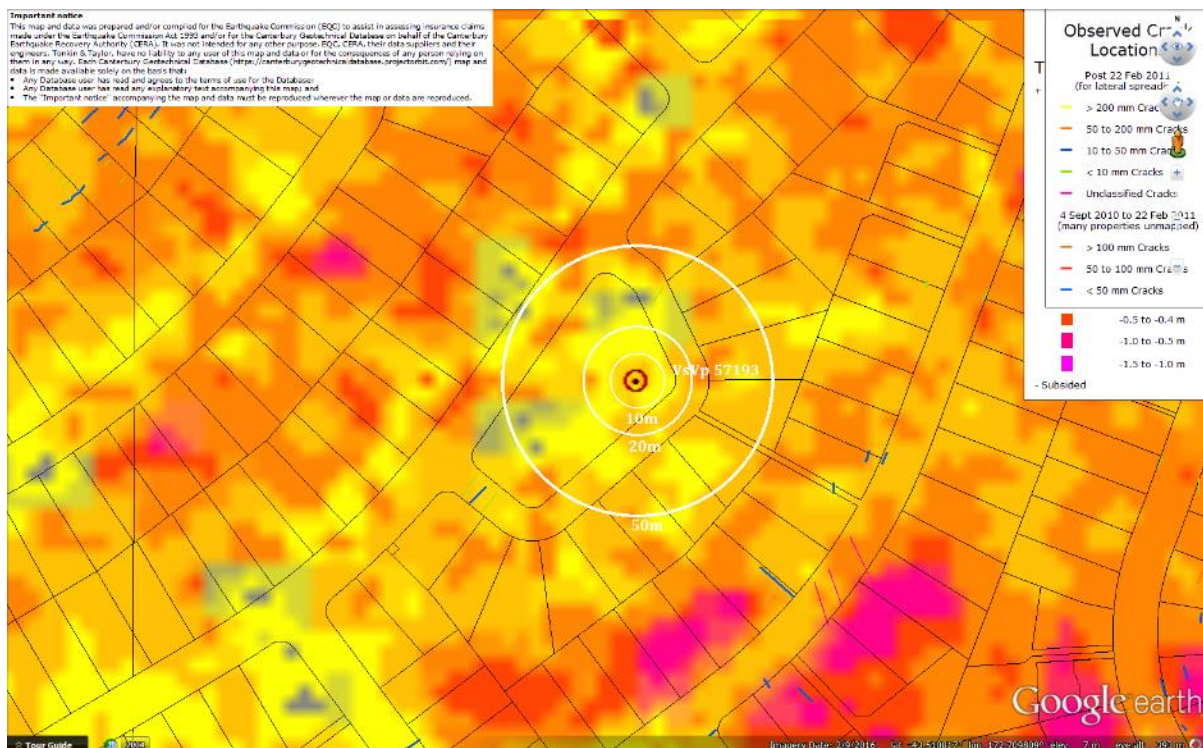
Figure 28: Absence of significant ground cracks indicating no lateral spreading for Canterbury Earthquake Sequence.

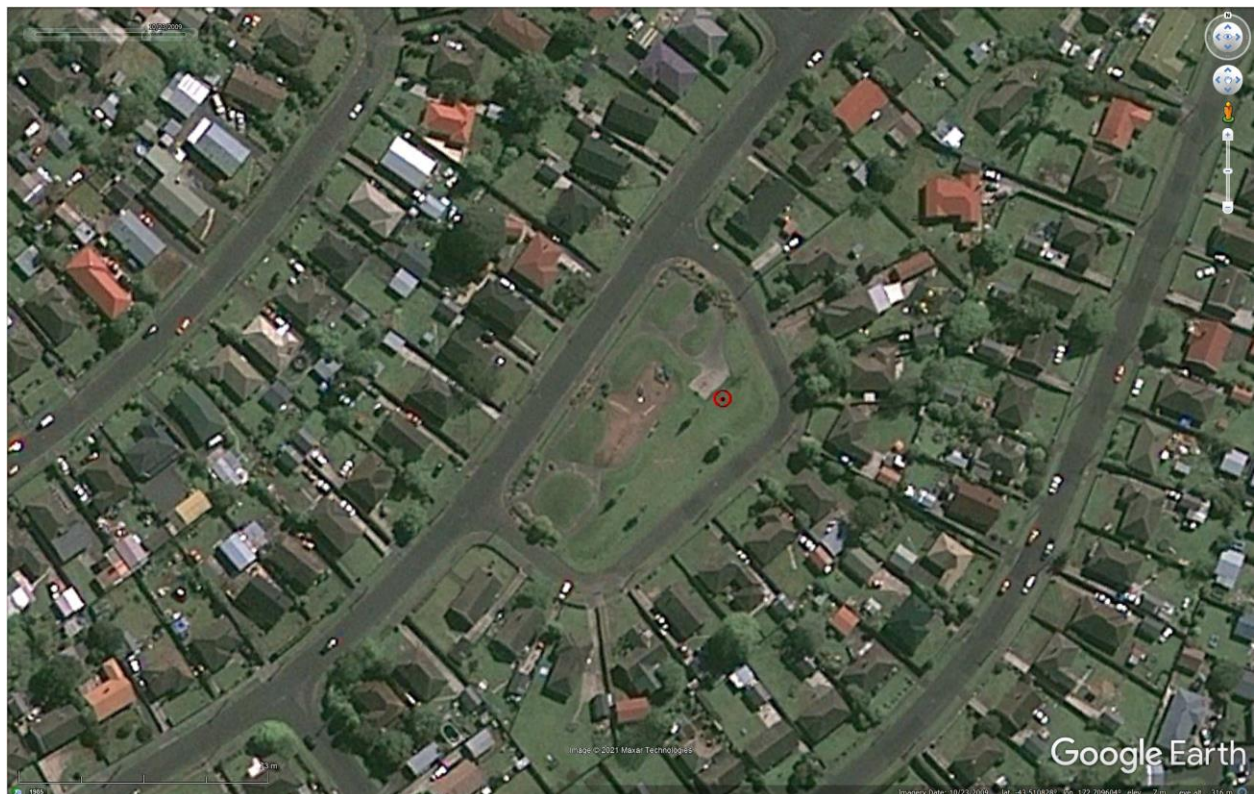
Figure 62: Satellite image of the site from Oct 2009 showing the basketball court inundated with soil sediments.

Figure 63: Satellite image for Sep-10 EQ (the pooled water on the basketball court is likely from showers of rain on 3 Sep 2010 and the sediments were likely present prior to the Sep-10 EQ as shown in Figure 62).

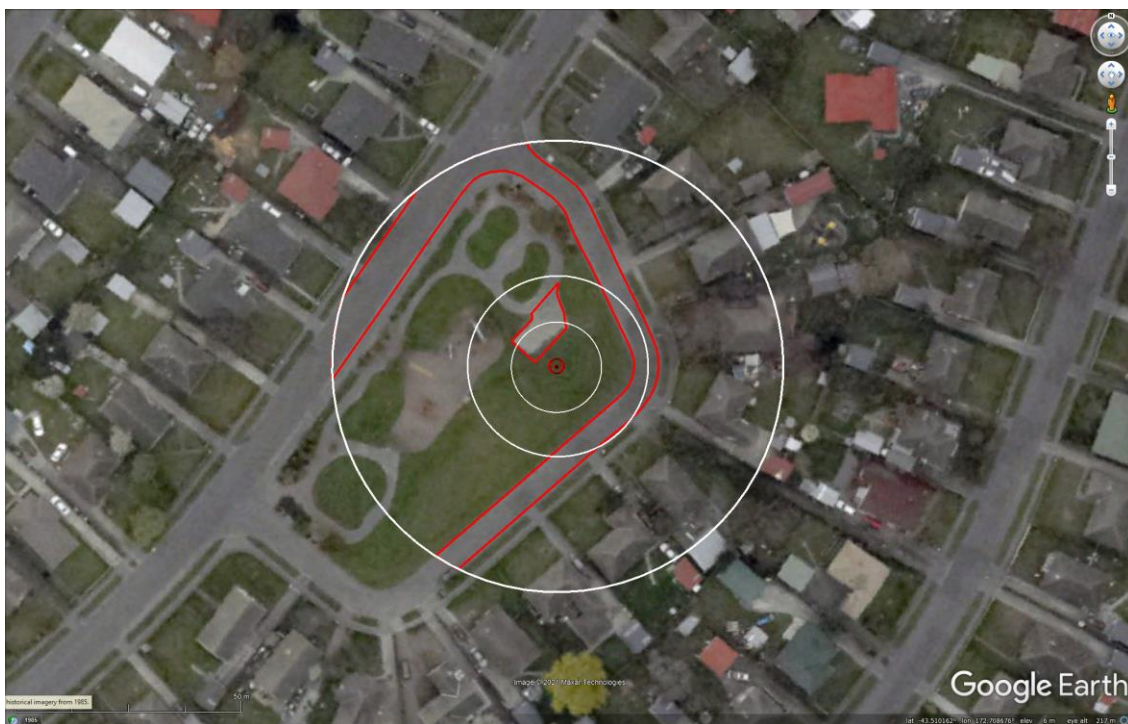
Figure 64: Ejecta outline for Sep-10 EQ.

Note 4: The values in Table 9 correspond to the coverage area of ejecta outlined in aerial photographs (Figures 64 through 67) and the lower and upper estimates of ejecta height based on geometry and ground photographs (Figure 68). Figure 62 shows the presence of sediments within Paved Patch prior to the earthquake events (Oct 2009), while the water pooled on Paved Patch is likely a result of rain showers from 3 Sep 2010 (Figure 63). The ejecta-induced settlement using the photographs and engineering judgment, $S_{E,P}$, is estimated as

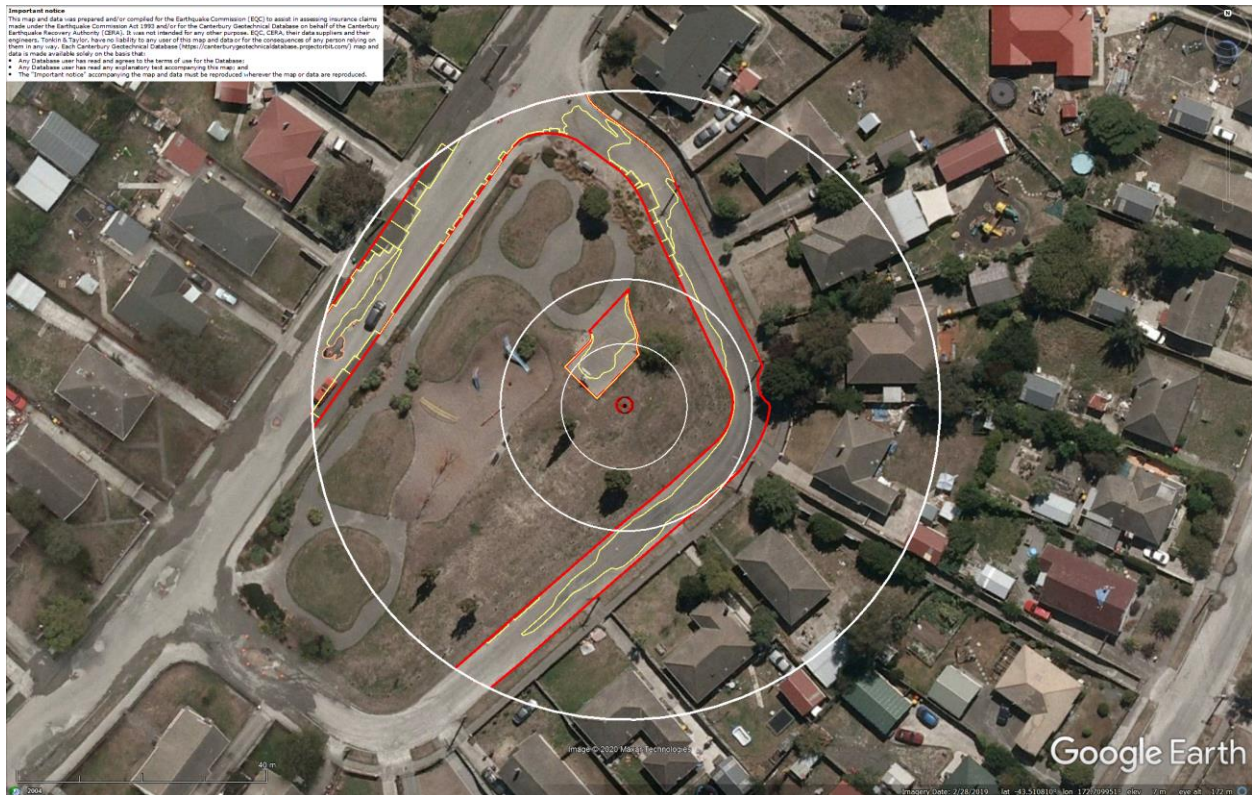
Figure 65: Ejecta outline for Feb-11 EQ.

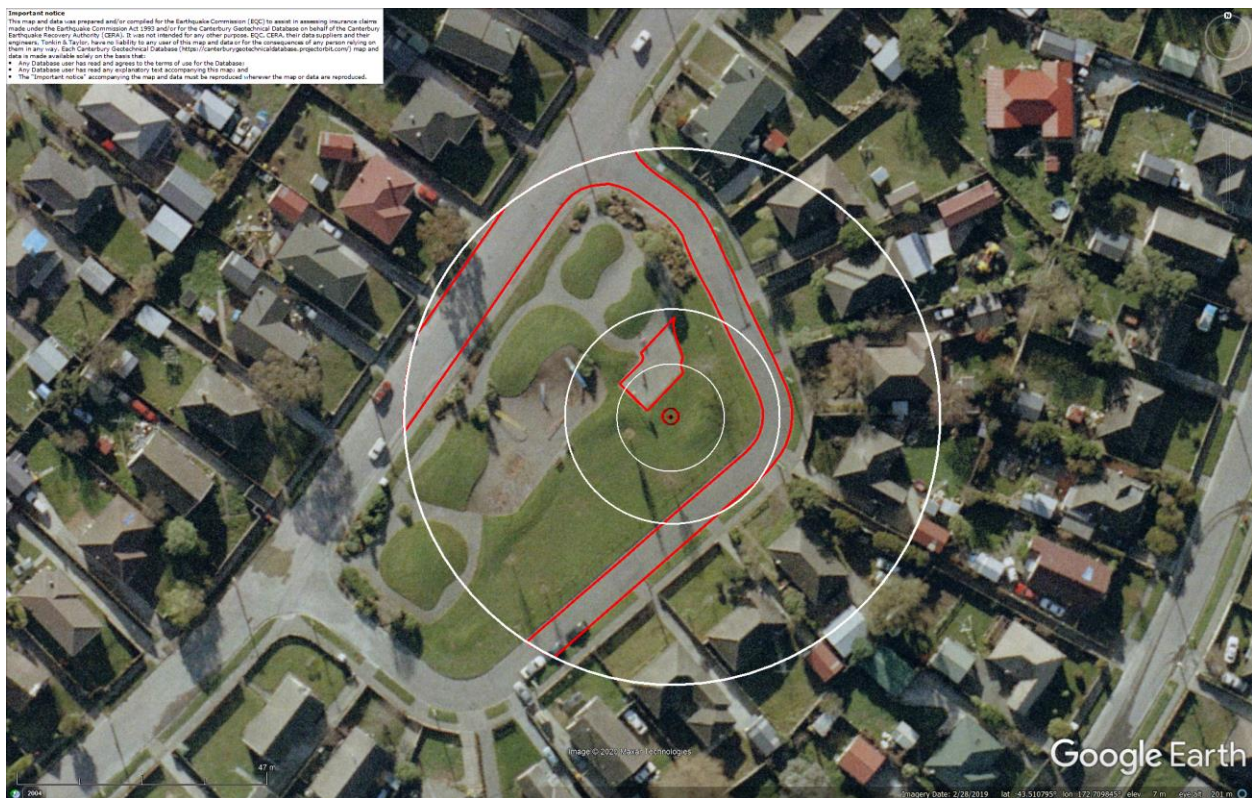
Figure 66: Aerial photograph from 16-06-2011 showing no ejecta at the site for Jun-11 EQ.

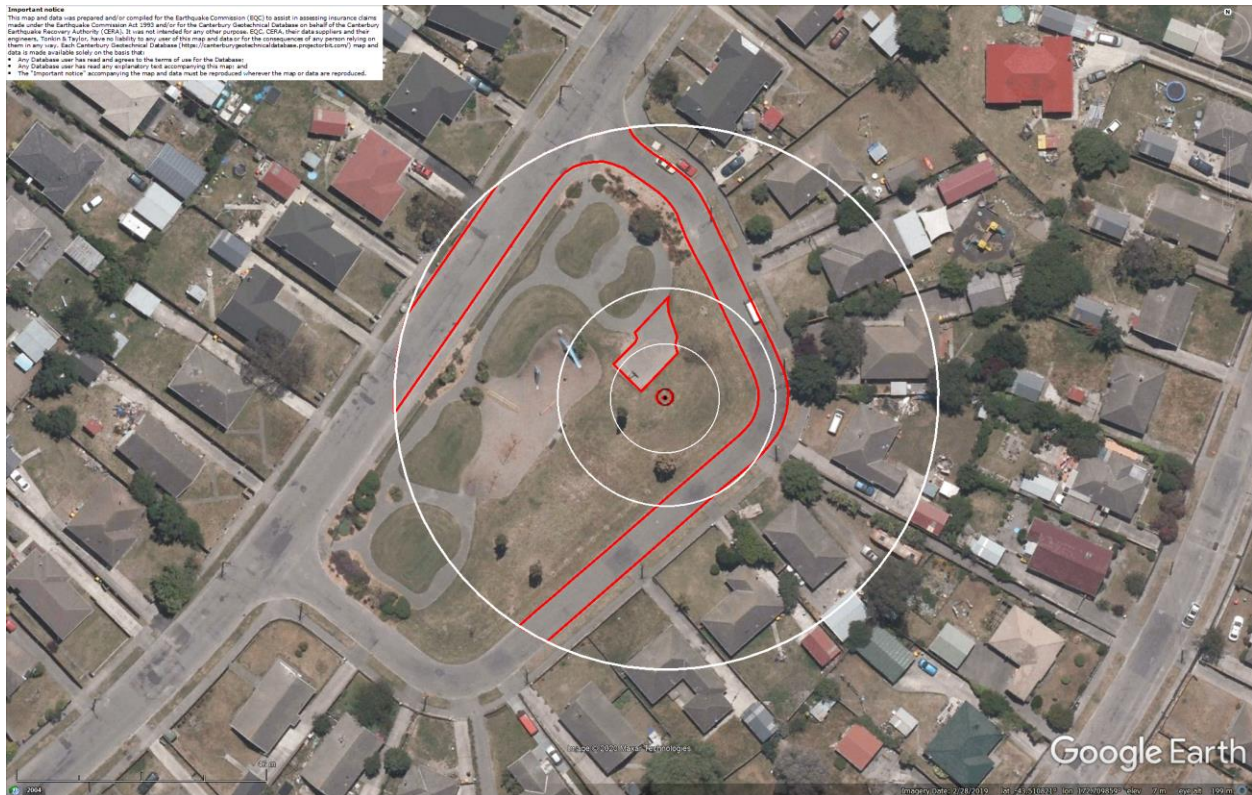
Figure 67: Aerial photograph showing no ejecta for Dec-11 EQ.

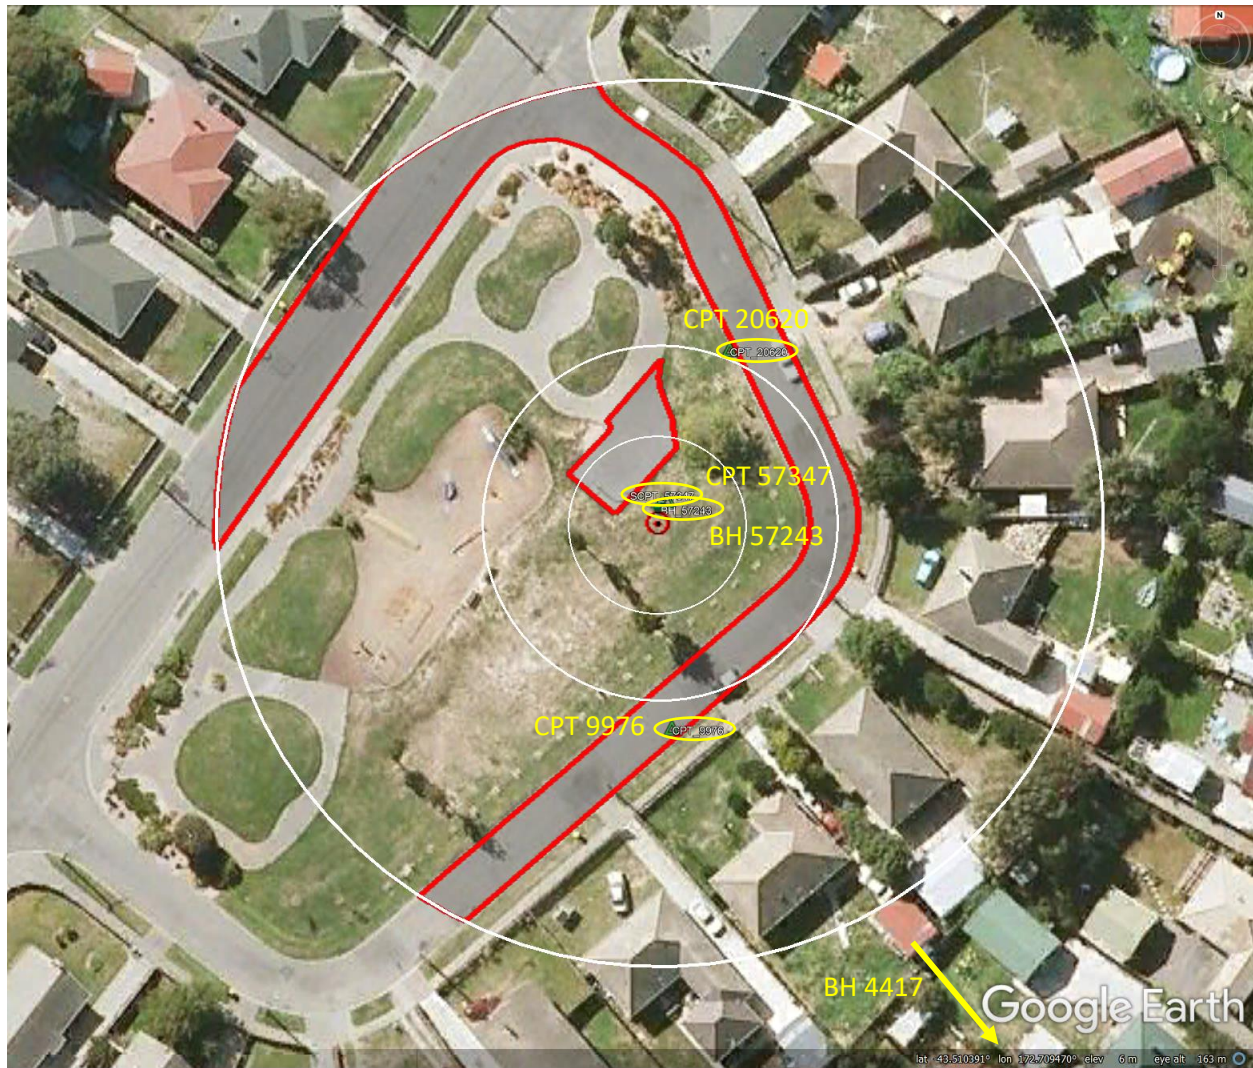
Figure 79: CPT and borehole locations.

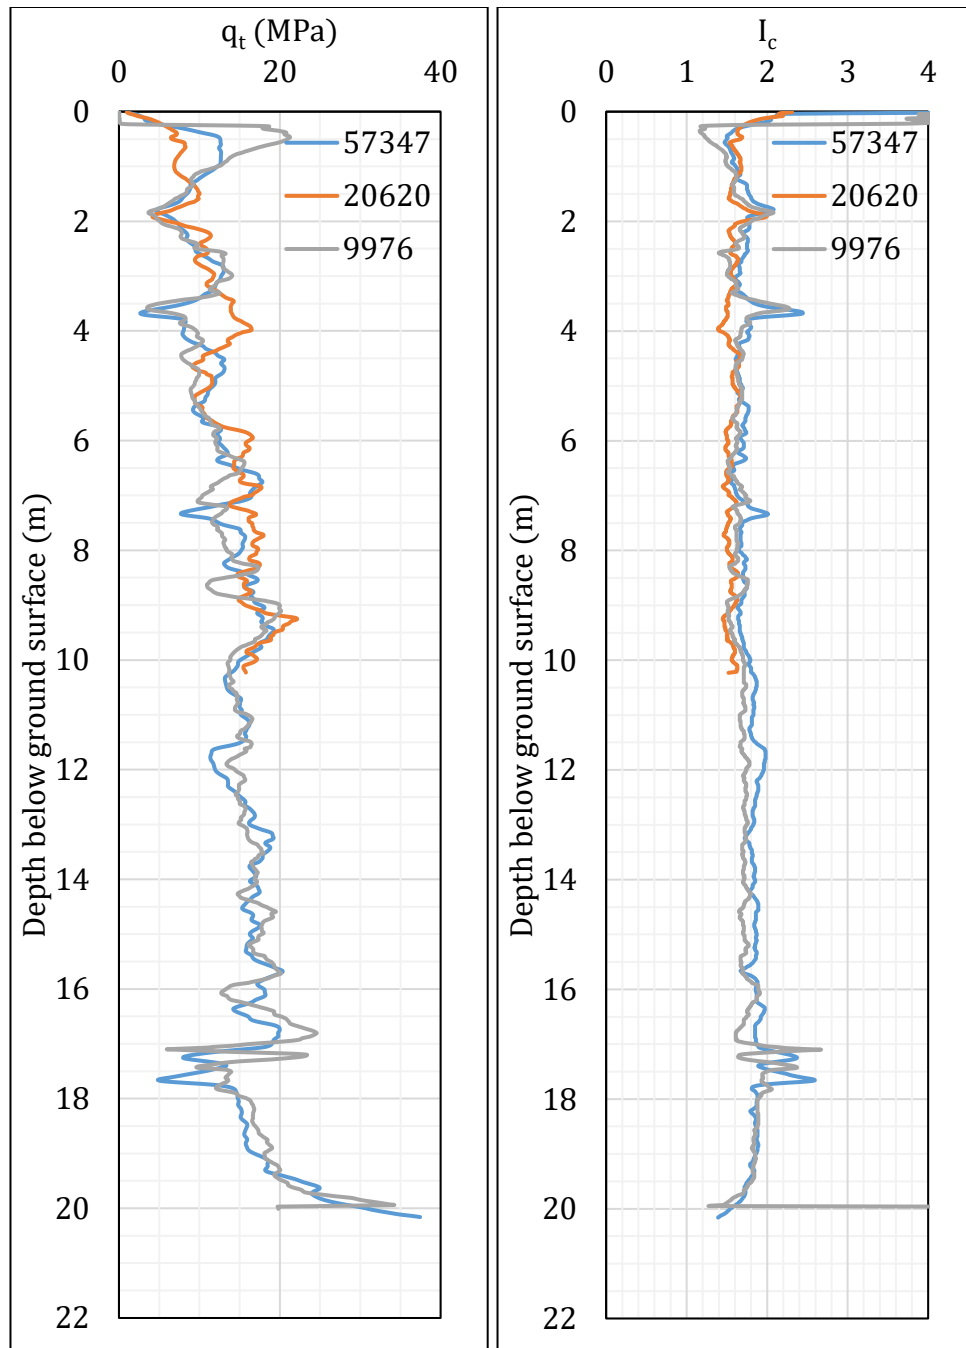
Figure 80: q_t and I_c profiles.
