Appendix A.15:

Warrington St – CPT 44959

Liquefaction Ejecta Case Histories for 2010-11 Canterbury Earthquakes

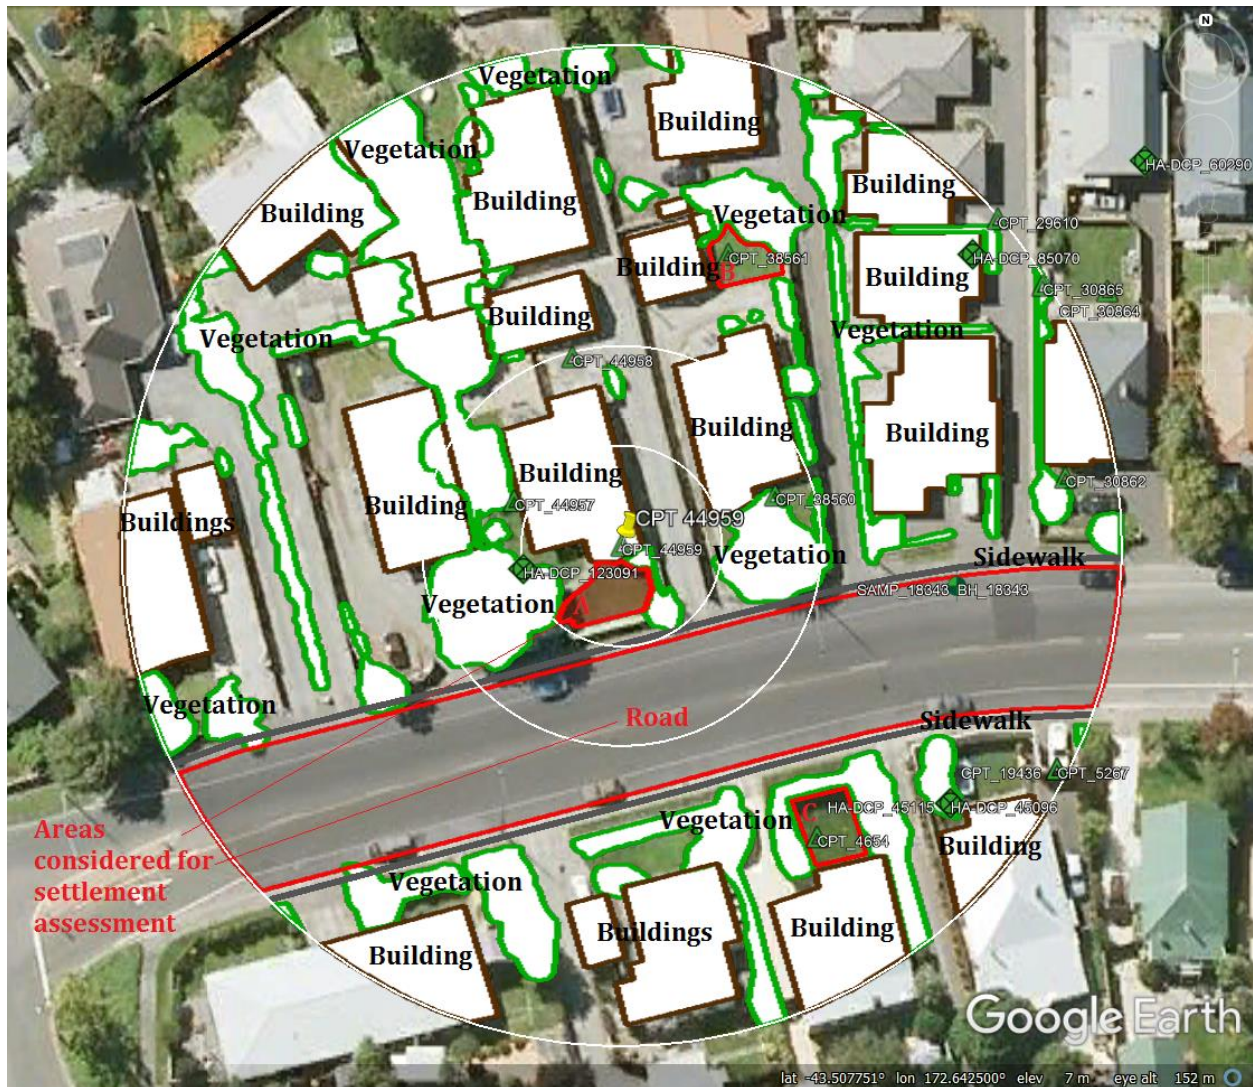
Figure 1: Site plan with areas where LiDAR survey data is considered.

Note 1: Two patches (outlined in red) in the free field were initially selected for settlement assessment as areas free of vegetation and structures. Further analyses such as proximity of a patch to a CPT, proximity of a patch to a property subjected to addition and/or demolition of a structure, front yard/backyard alterations (e.g., ploughing, rubble, scrap), spatial distribution of sediment ejecta, and density of LiDAR points for 2003 resulted in Patch A being selected for detailed settlement assessment and other patch being discarded in detailed settlement assessment. In addition, since significant amounts of ejecta were observed on roads in the CES, the entire portion of the road within the 50-m buffer was considered for settlement assessment. Roads as hard, relatively flat surfaces provide many ground-classified points. Therefore, it is very useful to compare settlement estimates on roads with settlement estimates for the unpaved patch.

- $A_{E,thick,i}$ and $H_{E,thick,i}$ are the area and the height of a thick ejecta layer, respectively;
- $A_{E,thin,j}$ and $H_{E,thin,j}$ are the area and the height of a thin ejecta layer, respectively;
- $W_{E,prism,n}$ and $L_{E,prism,n}$ are the width and the length of the coverage area of a prismatically shaped ejecta layer, respectively, and $H_{E,prism,n}$ is the height of a prism-like ejecta layer;
- $A_{E,pile,k}$ and $R_{E,pile,k}$ are the area and the radius of an ejecta pile component, respectively, shaped as a cone with the repose angle of 30° ;
- A_T is the total assessment area for a buffer being considered (Figure 1).

Note 7: The selection of CPTs for the area considered for settlement assessment (Figure 1) is based on the proximity of the CPTs to the considered areas. In accordance with that, the following table shows CPTs that were used for the volumetric settlement analysis in *Cliq v.3.0.3.2*, a CPT soil liquefaction software developed by GeoLogismiki. (The average volumetric settlements were reported in Table 8.)

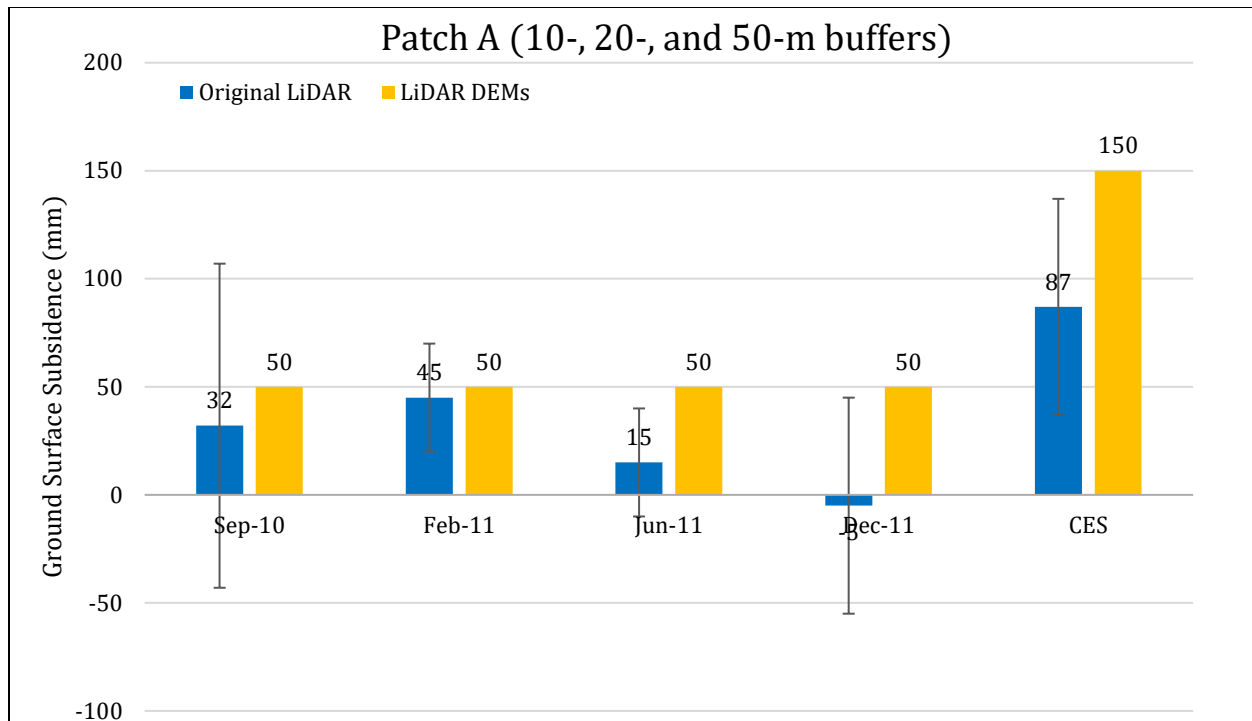
Figure 2: Comparison between ground surface subsidence determined from original LiDAR survey points and ground surface subsidence (50th %ile) estimated using LiDAR DEMs for the 20-m buffer.

Note 2: The ground surface subsidence values determined from original LiDAR survey points are generally similar to the ground surface subsidence values estimated using LiDAR DEMs for all earthquake events.
