Appendix A.17:

Sandown Cres – CPT 15498

Liquefaction Ejecta Case Histories for 2010-11 Canterbury Earthquakes

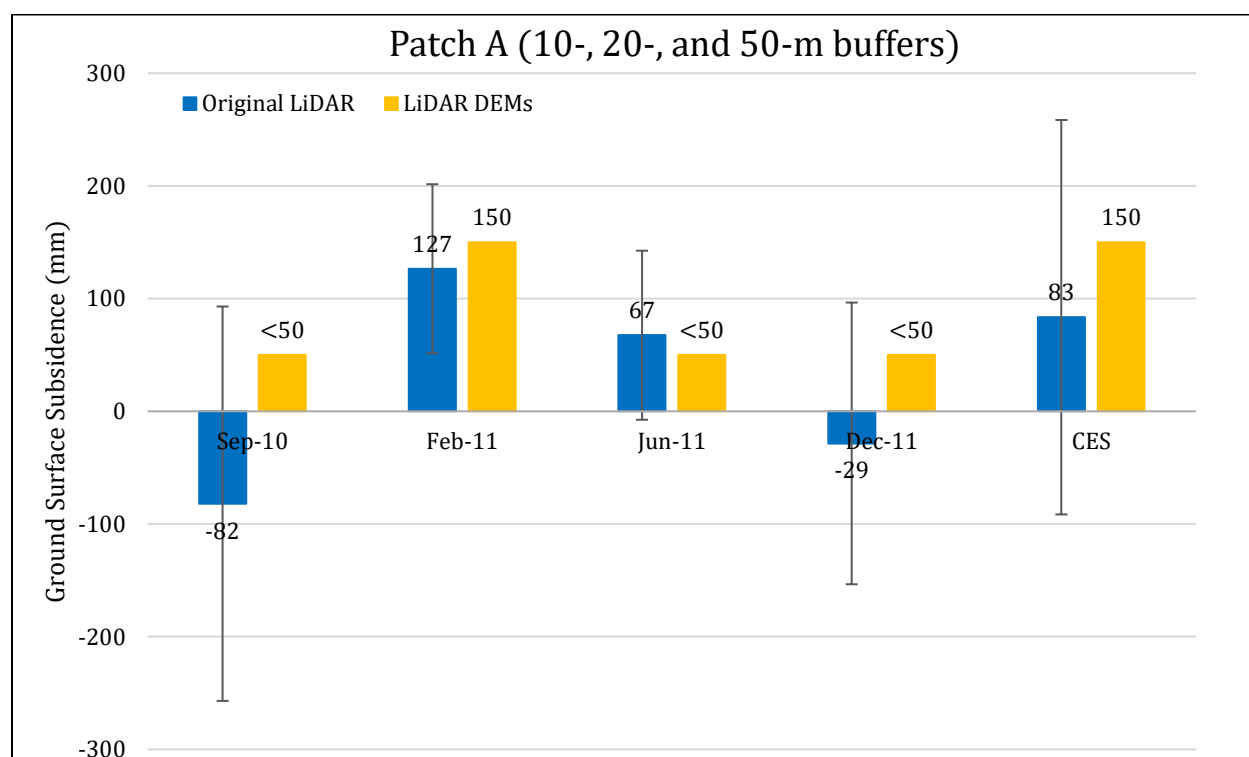
Figure 2: Comparison between ground surface subsidence determined from original LiDAR survey points and ground surface subsidence (50th %ile) estimated using LiDAR DEMs for Patch A.

Note 2: The ground surface subsidence values determined from original LiDAR survey points are similar to the ground surface subsidence values estimated using LiDAR DEMs for all earthquake events.

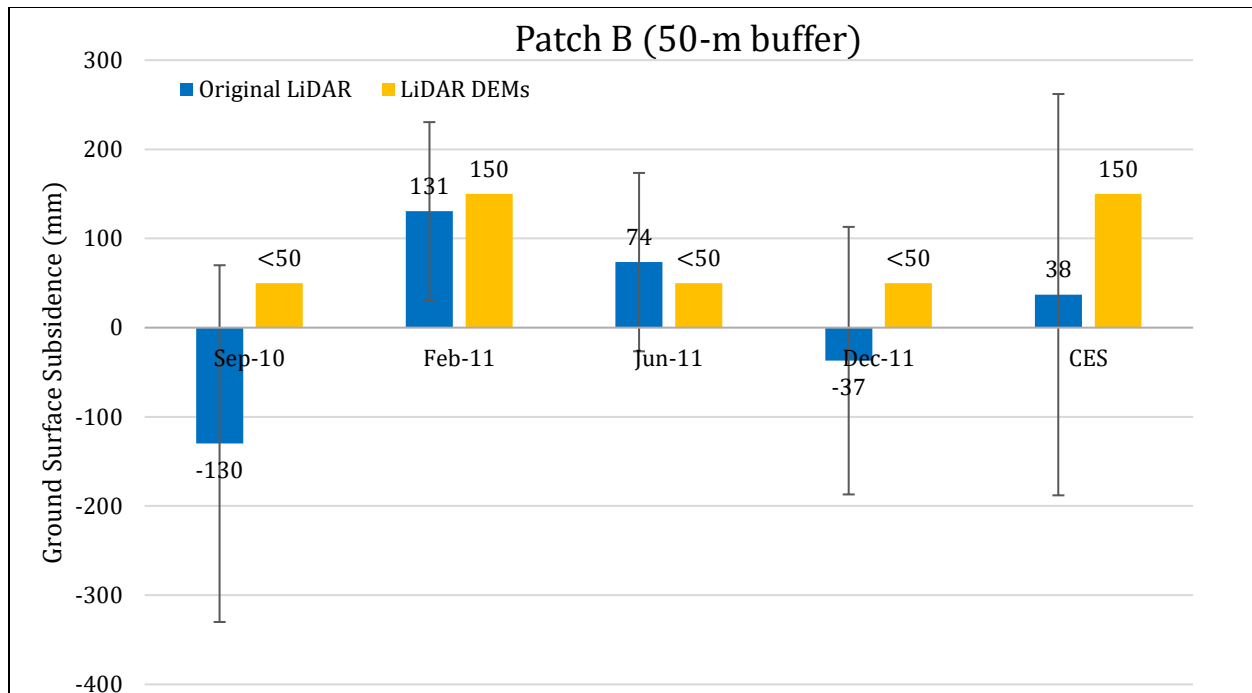
Figure 3: Comparison between ground surface subsidence determined from original LiDAR survey points and ground surface subsidence (50th %ile) estimated using LiDAR DEMs for Patch B.

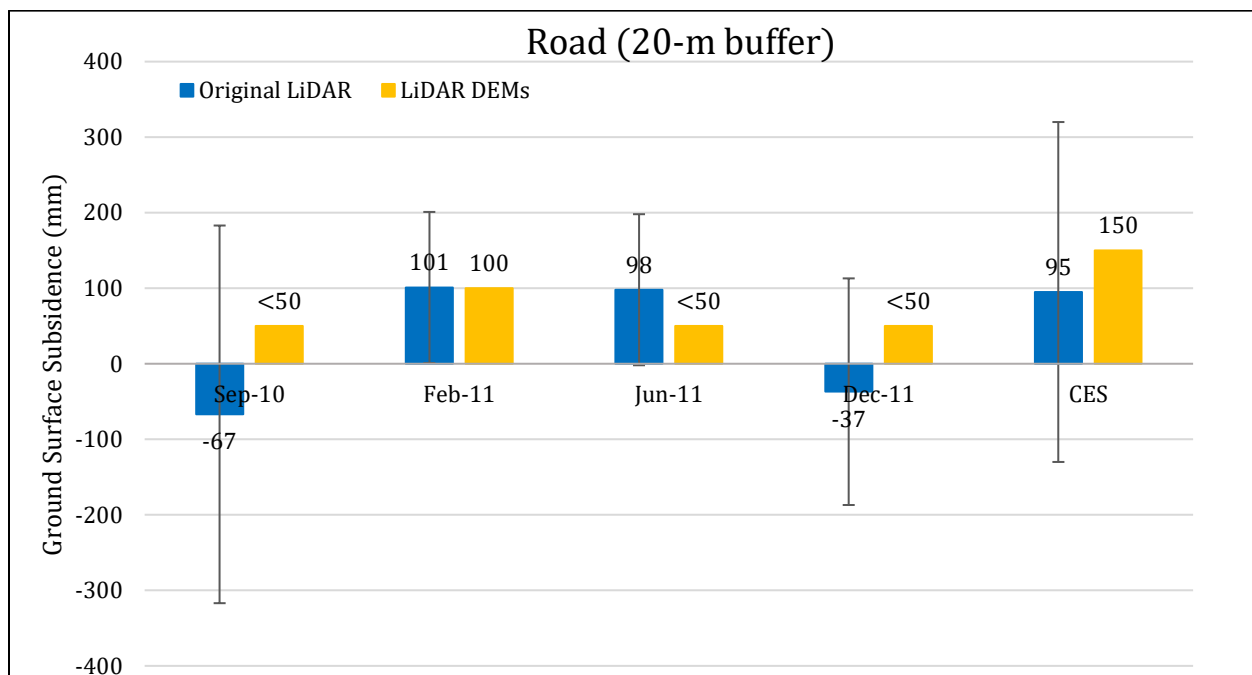
Figure 4: Comparison between ground surface subsidence determined from original LiDAR survey points and ground surface subsidence (50th %ile) estimated using LiDAR DEMs for Road for the 20-m buffer.

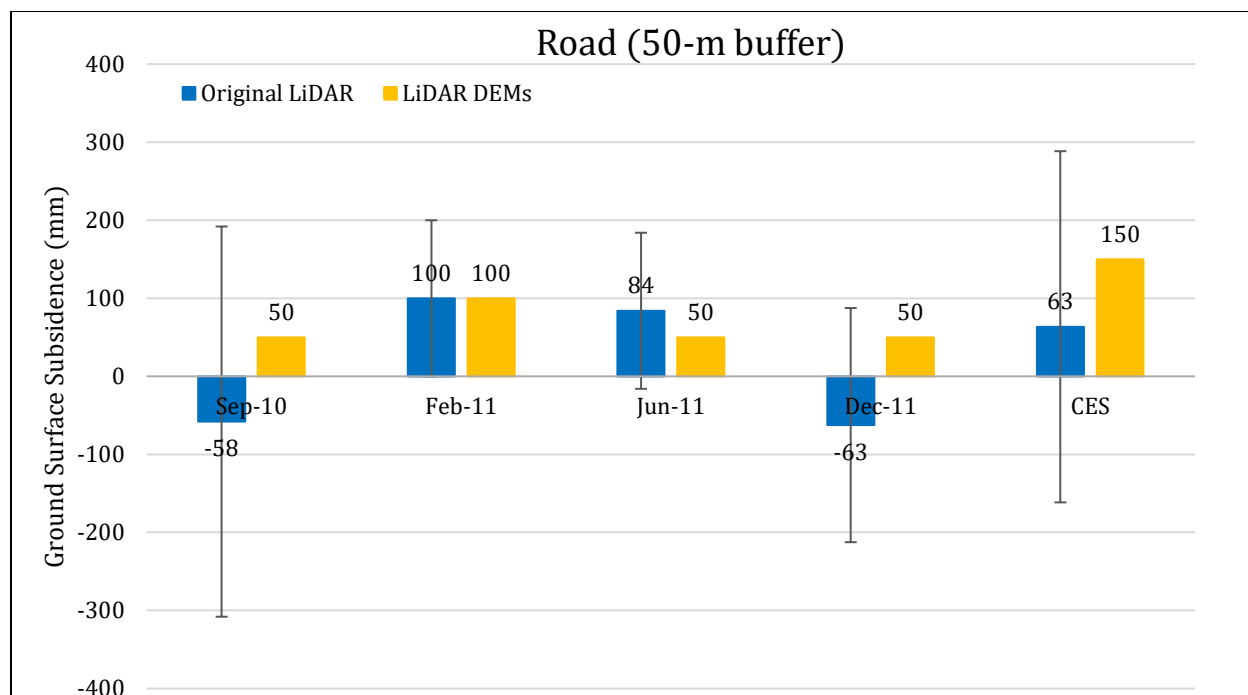
Figure 5: Comparison between ground surface subsidence determined from original LiDAR survey points and ground surface subsidence (50th %ile) estimated using LiDAR DEMs for Road for the 50-m buffer.

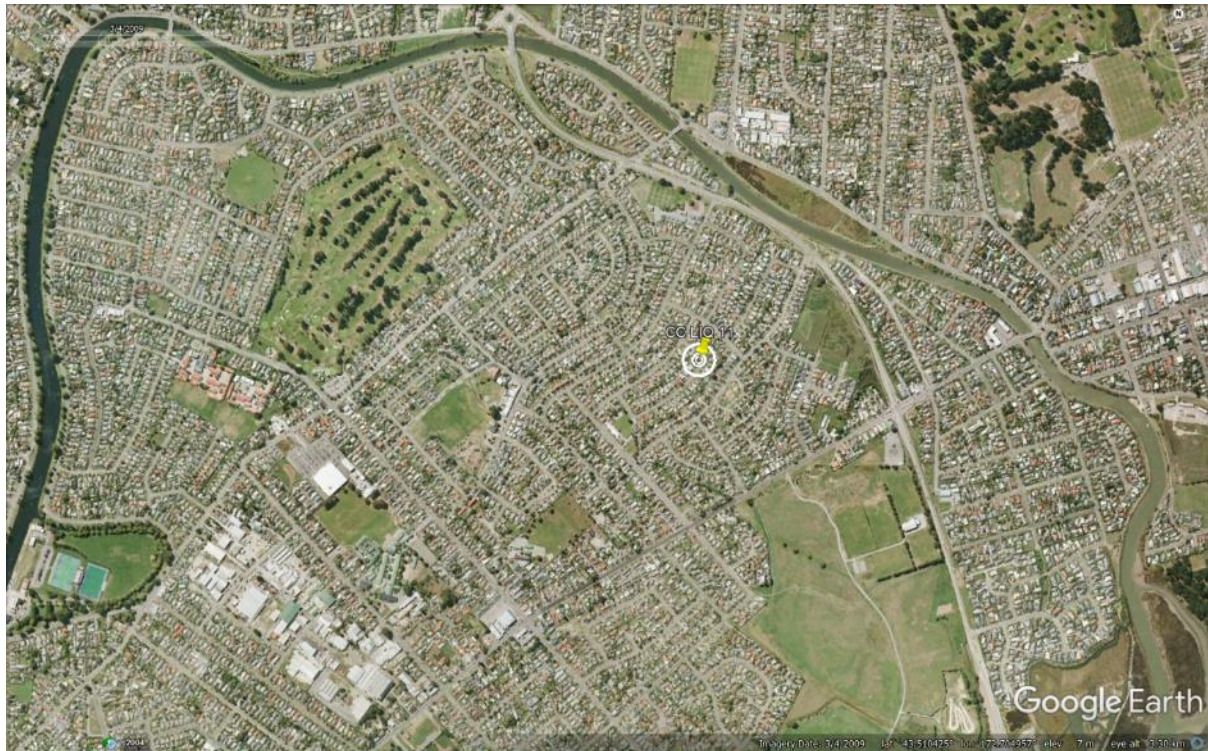
Figure 7: Position of the site relative to nearby buildings, vegetation, and free-face features.

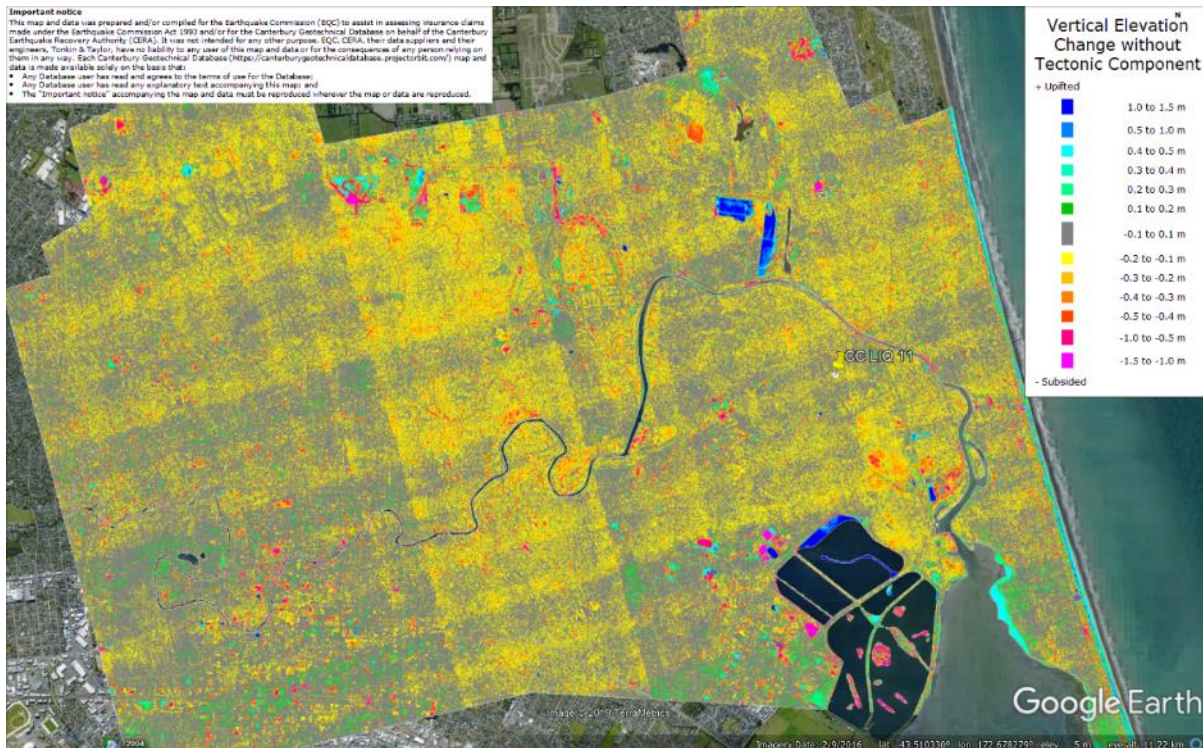
Figure 20: Vertical Ground Movements (Surface – Tectonic) for Sep 2010 Earthquake – the site is in the apparent zone of overestimated ground surface subsidence (e.g., July 2003 LIDAR flight error band).

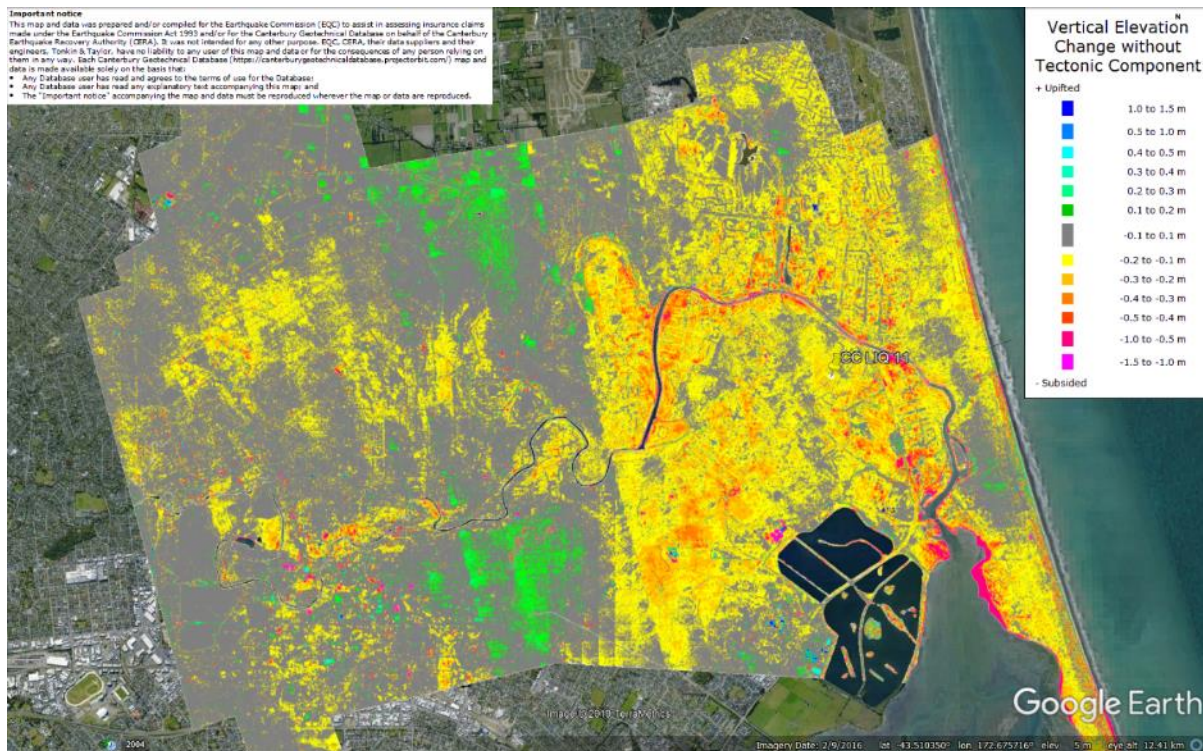
Figure 21: Vertical Ground Movements (Surface – Tectonic) for Feb 2011 Earthquake – the site is not in the apparent zone of underestimated ground surface subsidence.

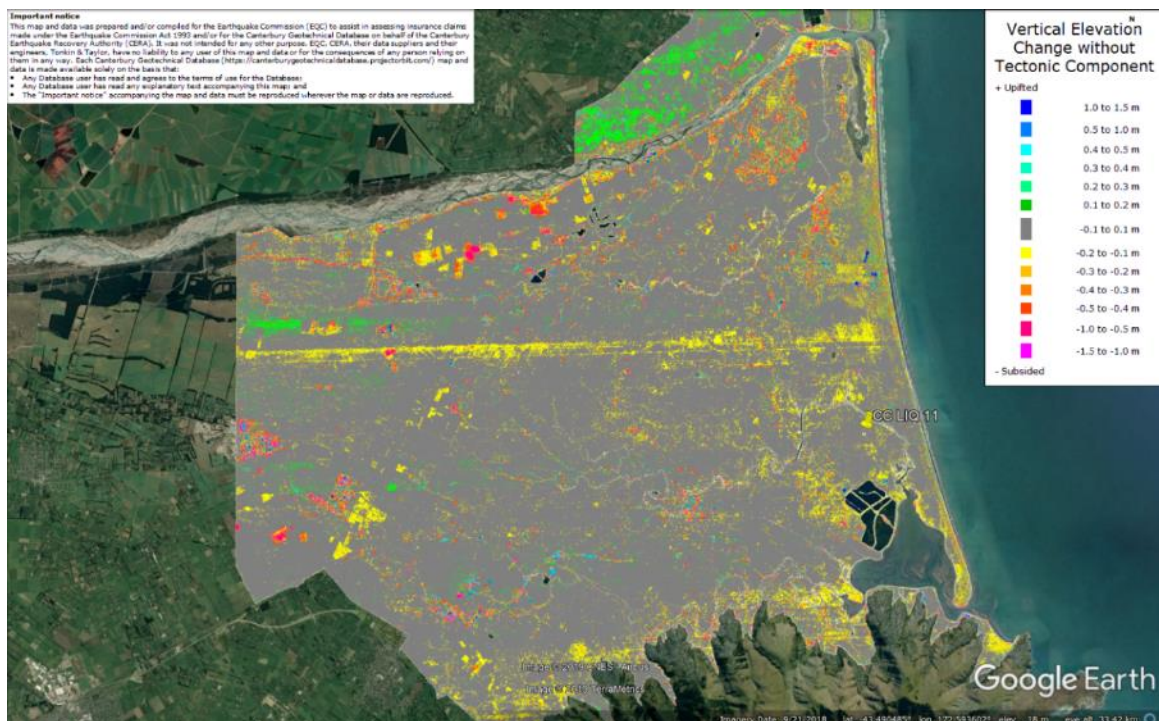
Figure 22: Vertical Ground Movements (Surface – Tectonic) for June 2011 Earthquake – the site is not in the apparent zone of overestimated or underestimated ground surface subsidence.

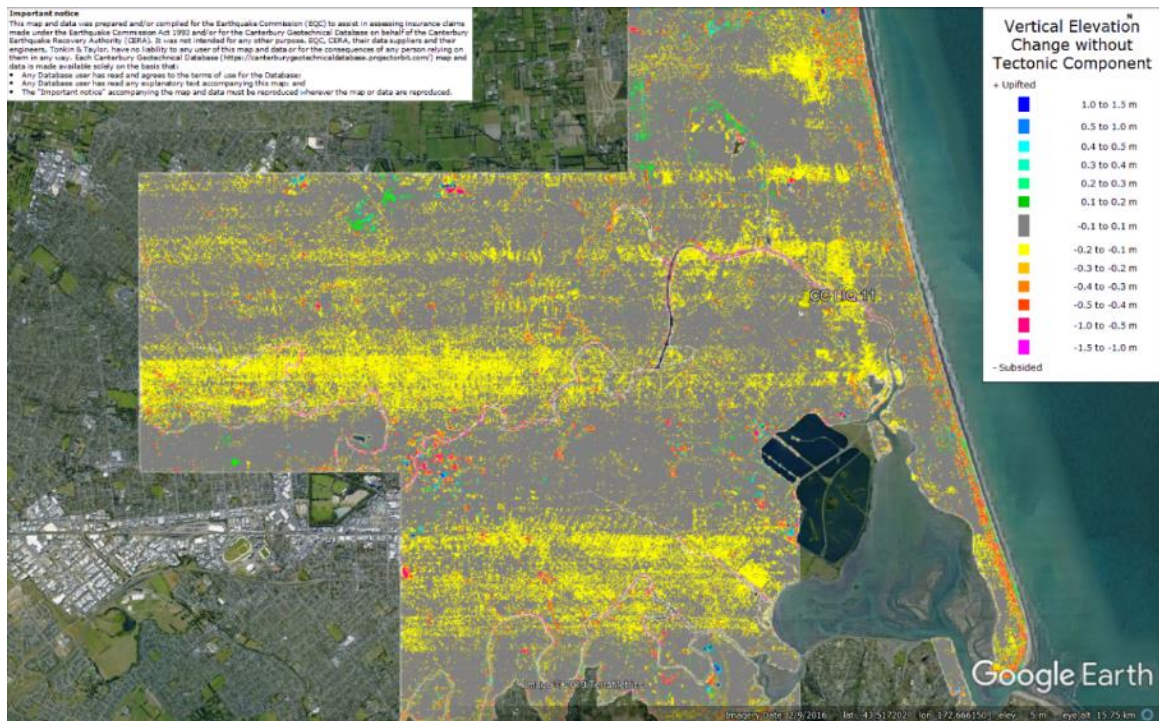
Figure 23: Vertical Ground Movements (Surface – Tectonic) for Dec 2011 Earthquake – the site is not in the apparent zone of overestimated or underestimated ground surface subsidence.

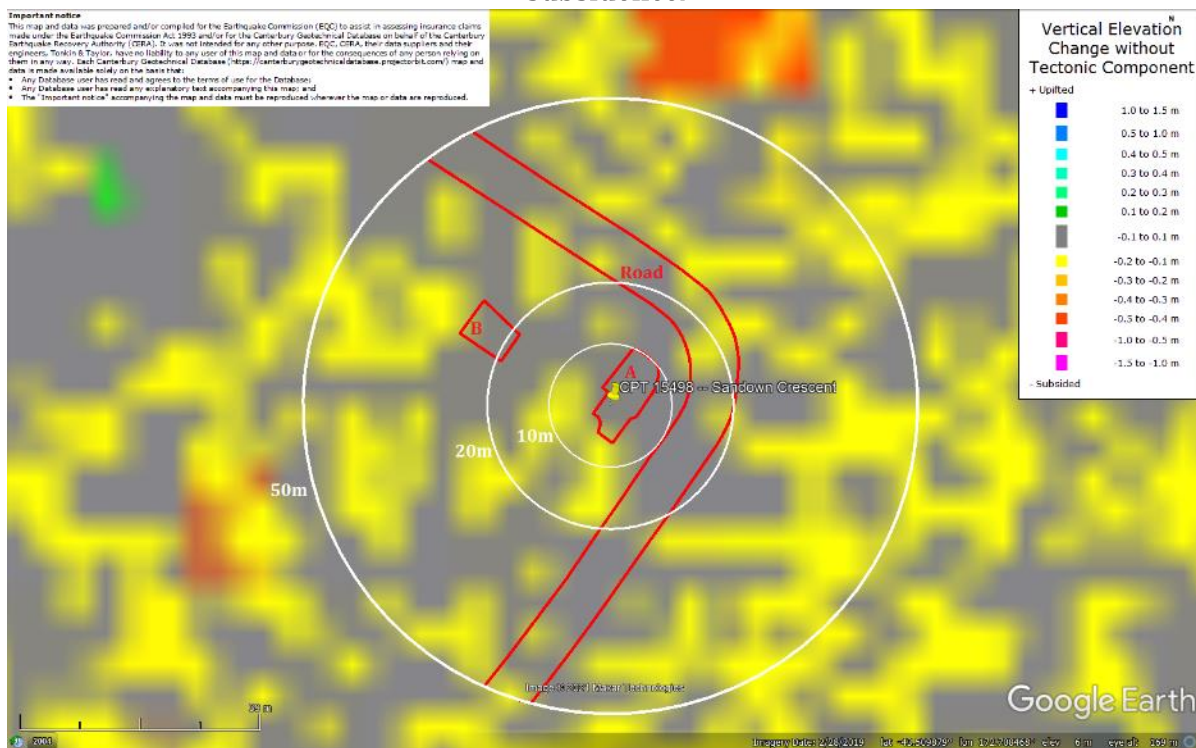
Figure 24: Ground surface subsidence without tectonic component for Sep 2010 Earthquake according to the LiDAR DEM.

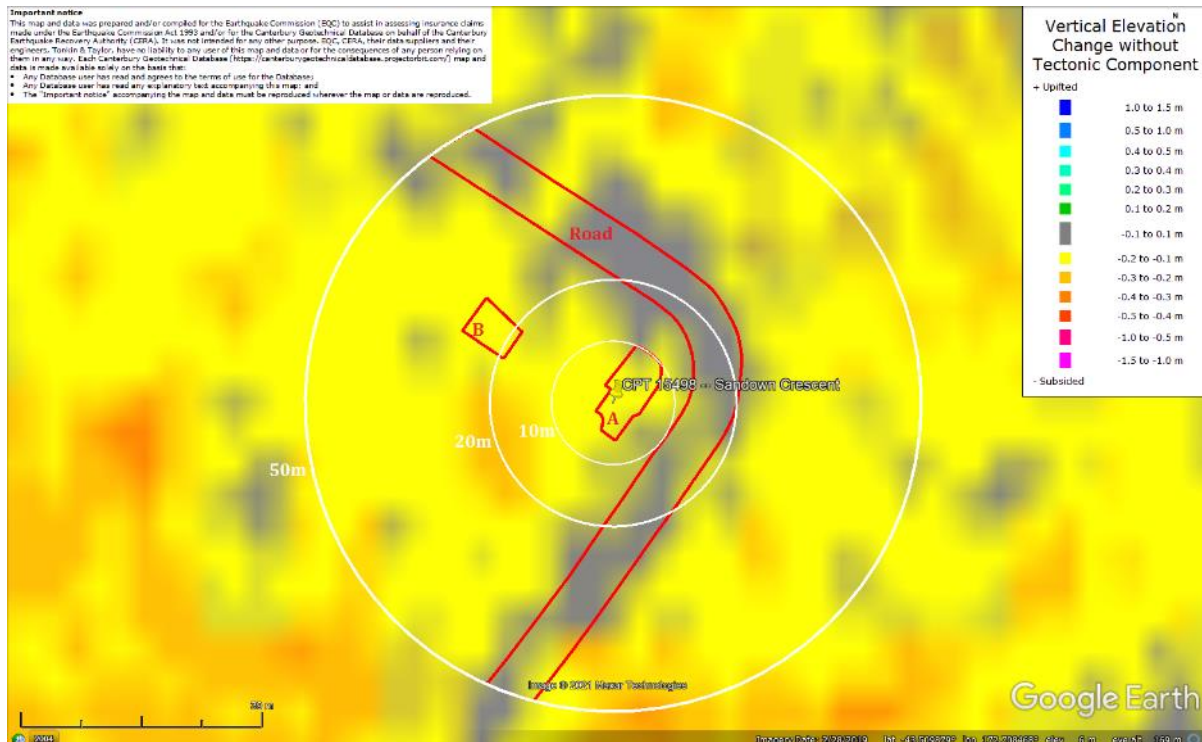
Figure 25: Ground surface subsidence without tectonic component for Feb 2011 Earthquake according to the LiDAR DEM.

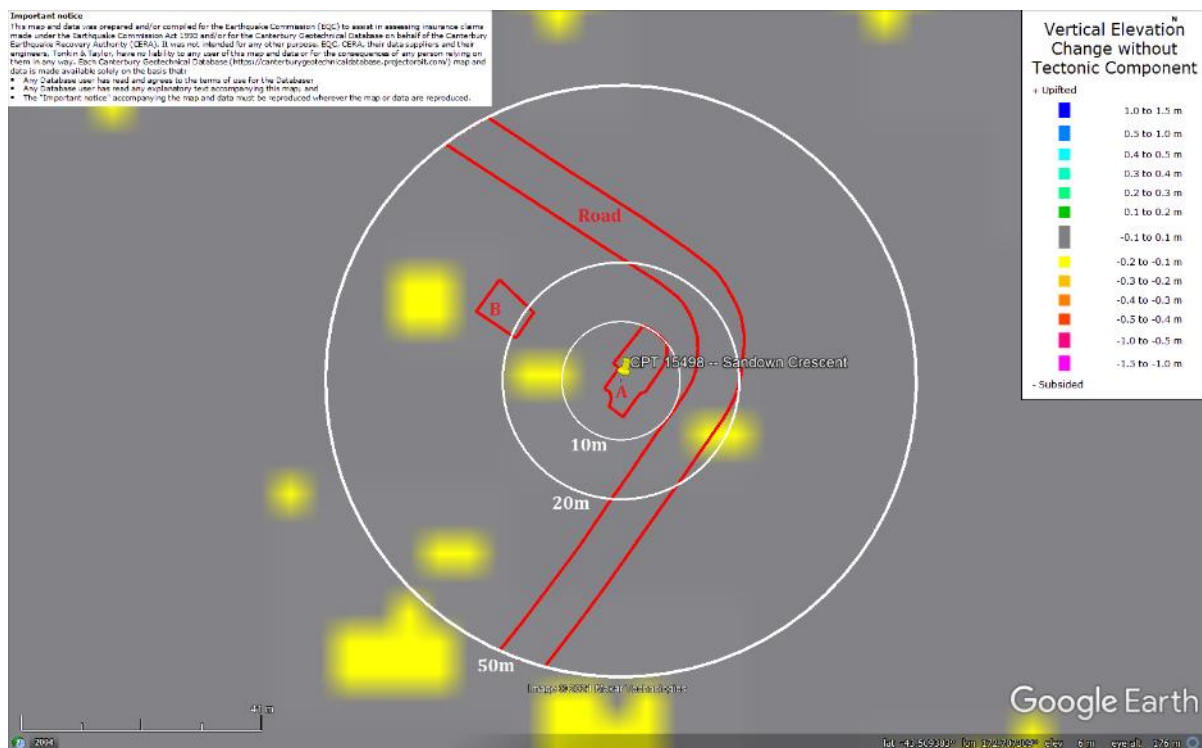
Figure 26: Ground surface subsidence without tectonic component for Jun 2011 Earthquake according to the LiDAR DEM.

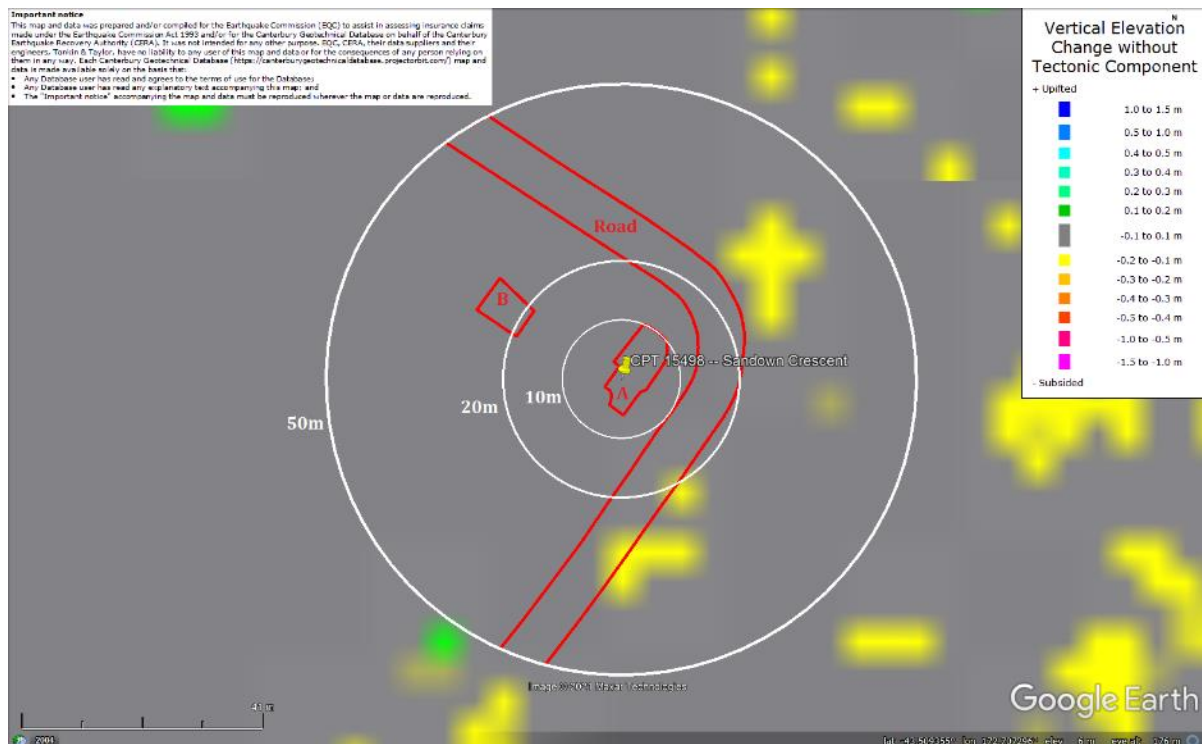
Figure 27: Ground surface subsidence without tectonic component for Dec 2011 Earthquake according to the LiDAR DEM.

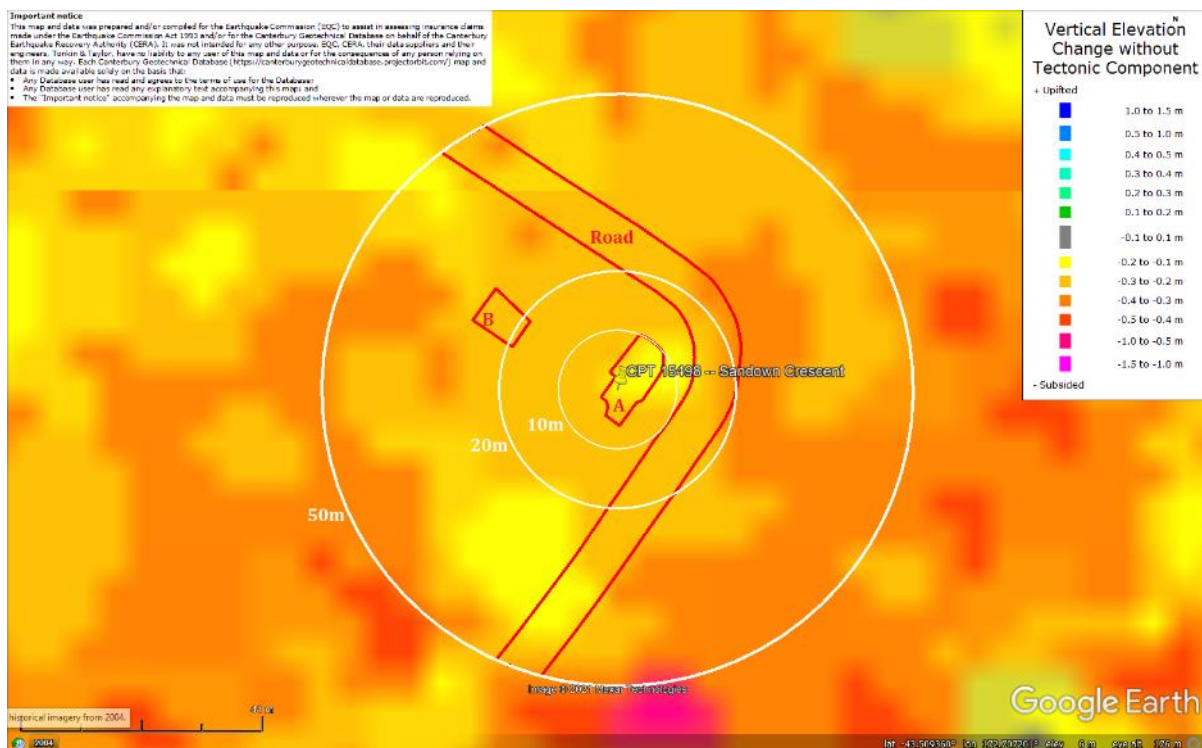
Figure 28: Ground surface subsidence without tectonic component for Canterbury Earthquake Sequence according to the LiDAR DEM.

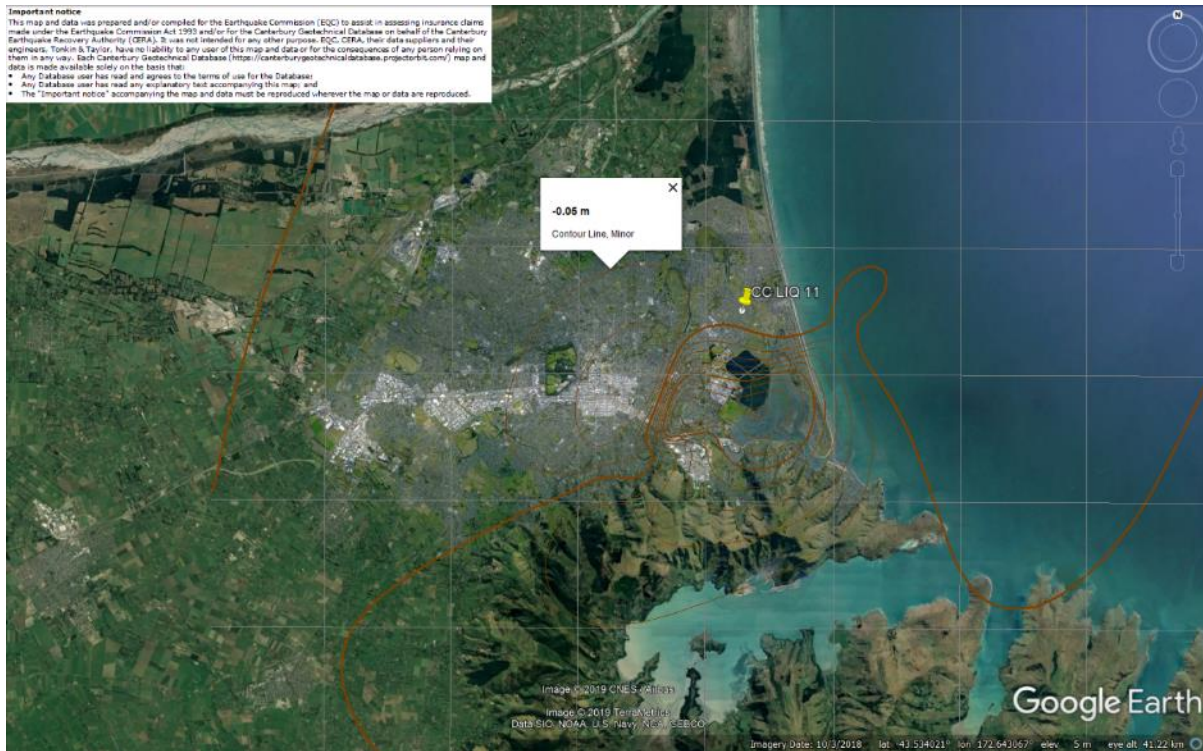
Figure 31: Vertical tectonic movements for Feb 2011 Earthquake.

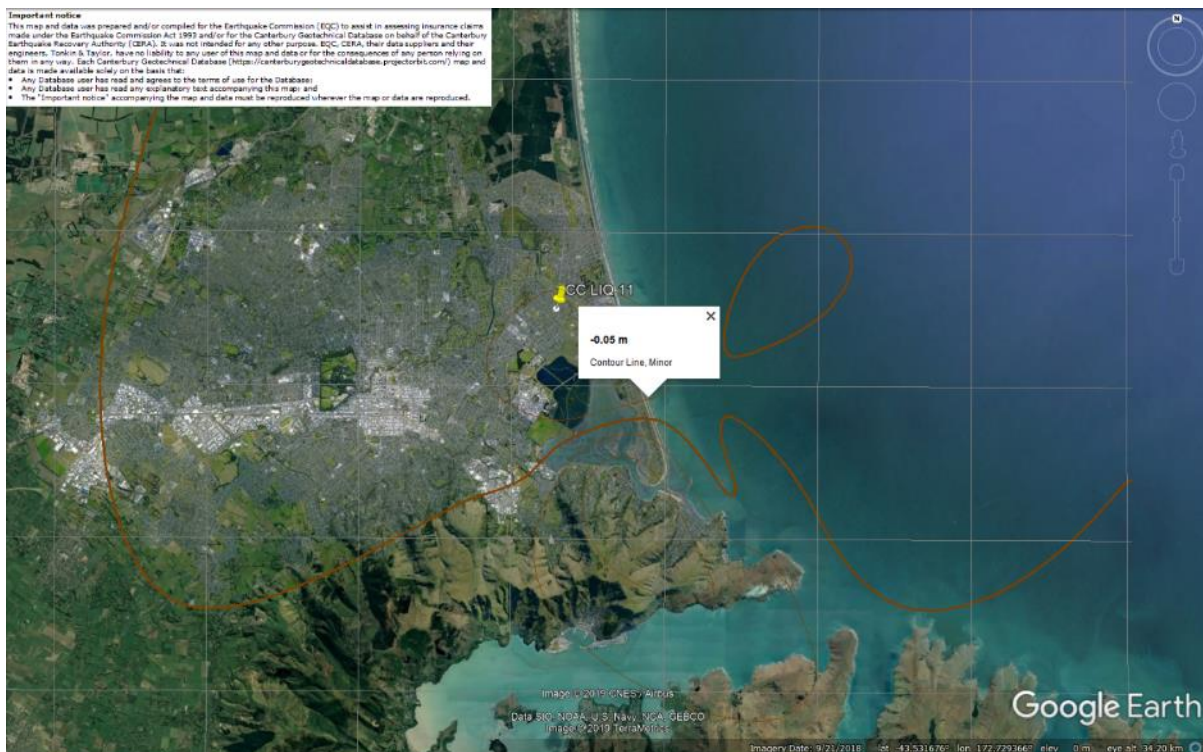
Figure 32: Vertical tectonic movements for June 2011 Earthquake.

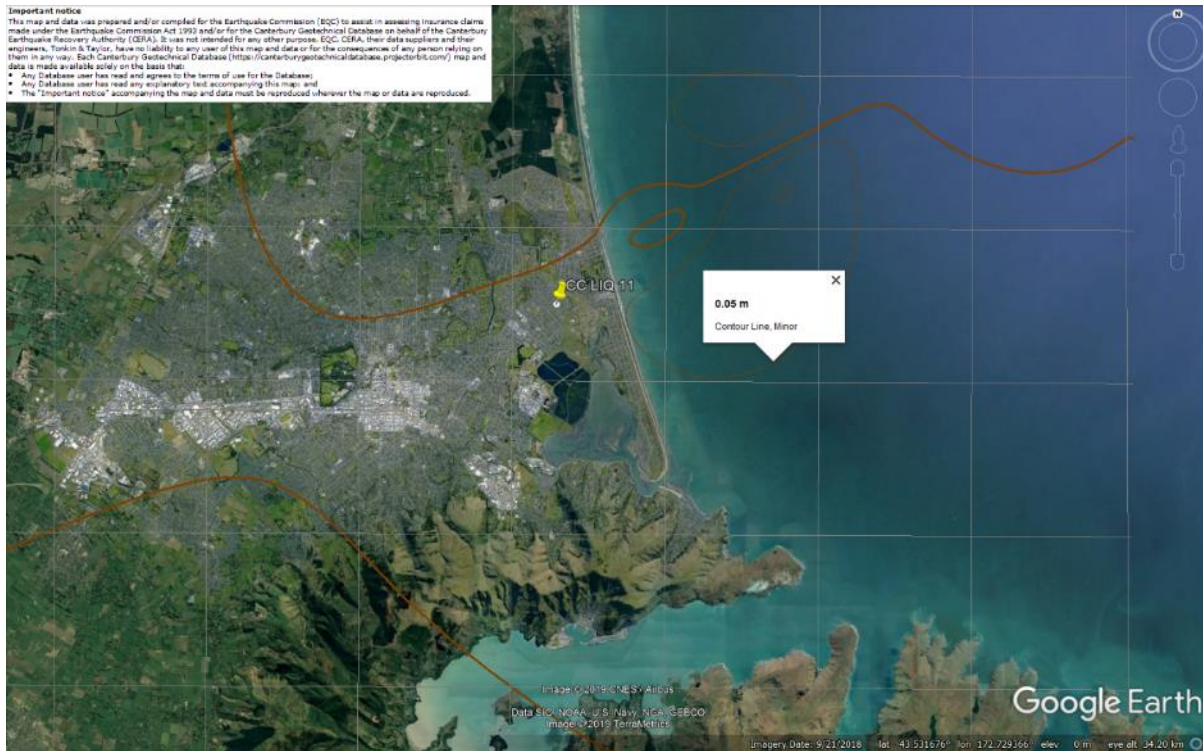
Figure 33: Vertical tectonic movements for Dec 2011 Earthquake.

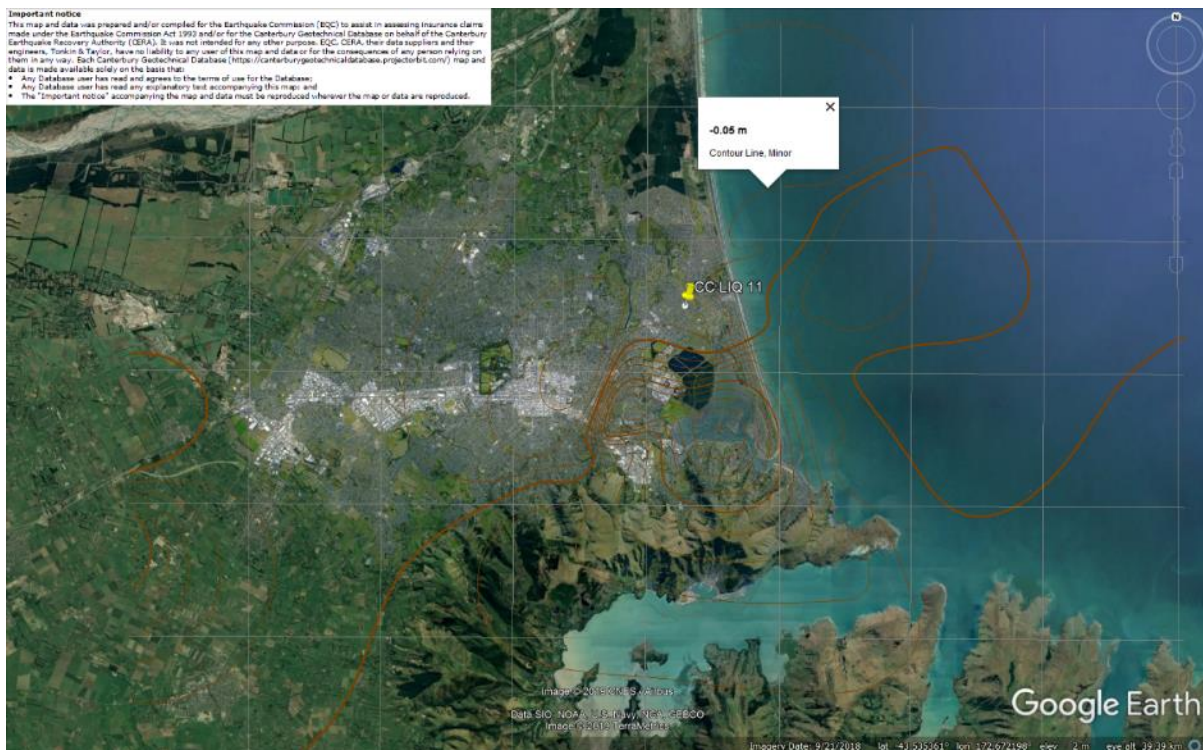
Figure 34: Vertical tectonic movements for Canterbury Earthquake Sequence.

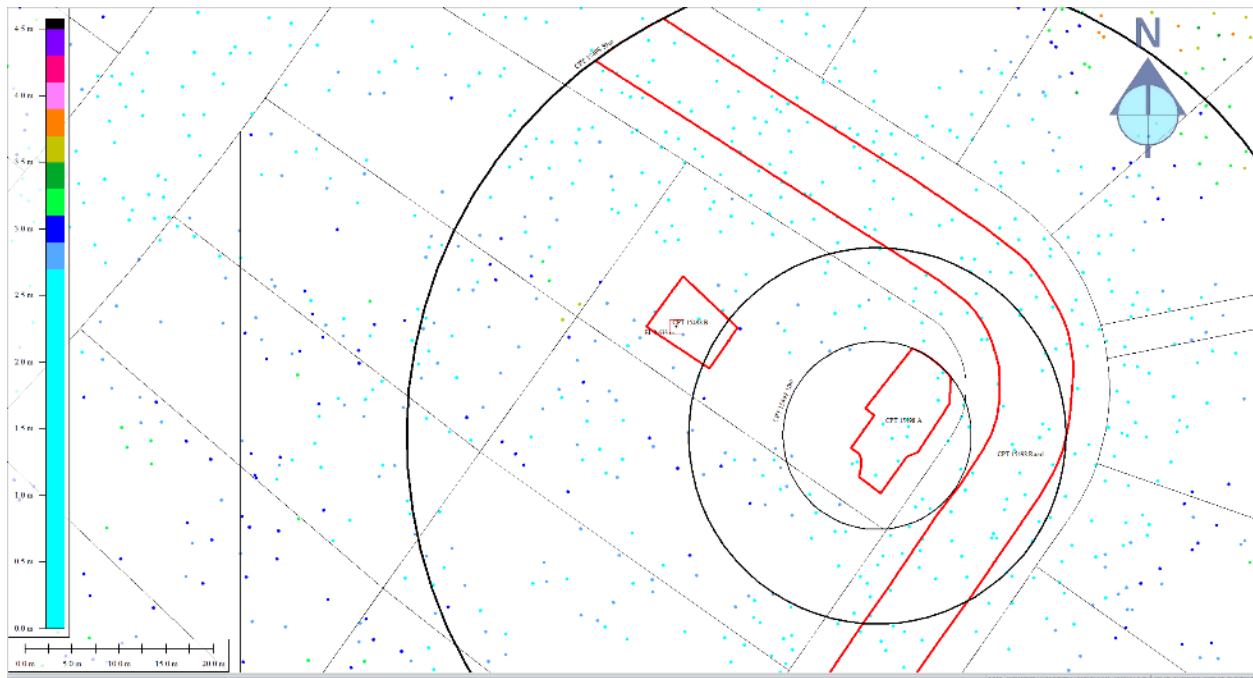
Figure 37: Ground surface elevation for Patch B for Jul 2003 LiDAR survey.

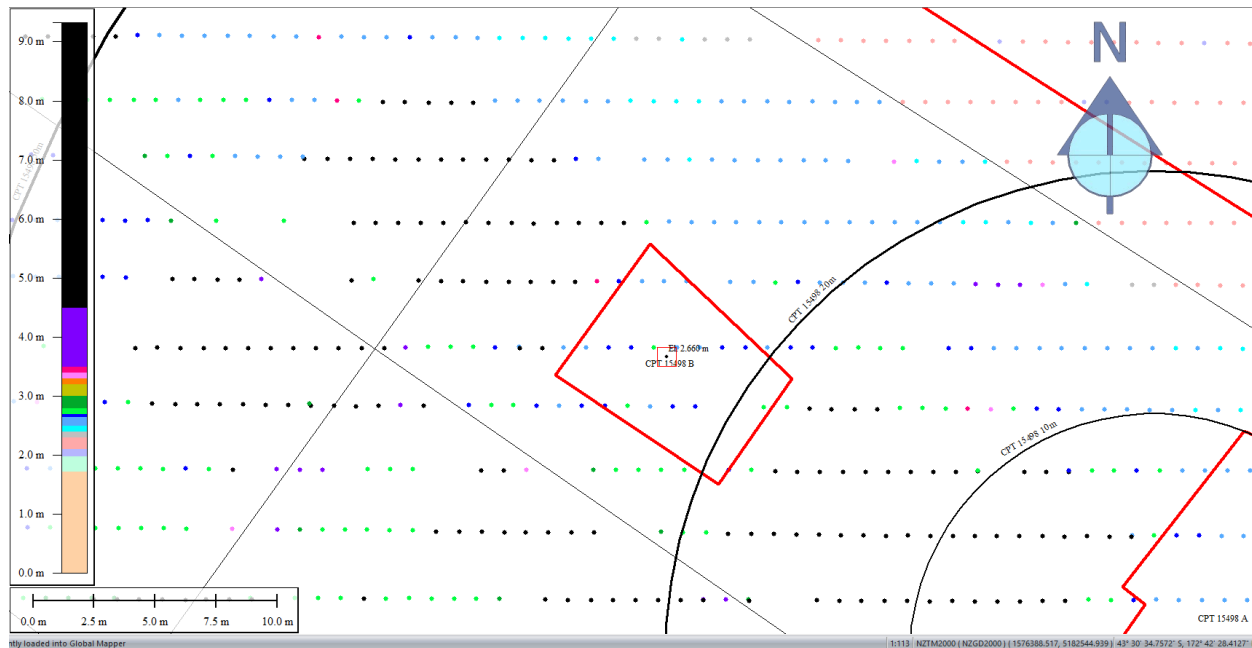
Figure 42: Ground surface elevation for Patch B for Sep 5, 2010 LiDAR survey.

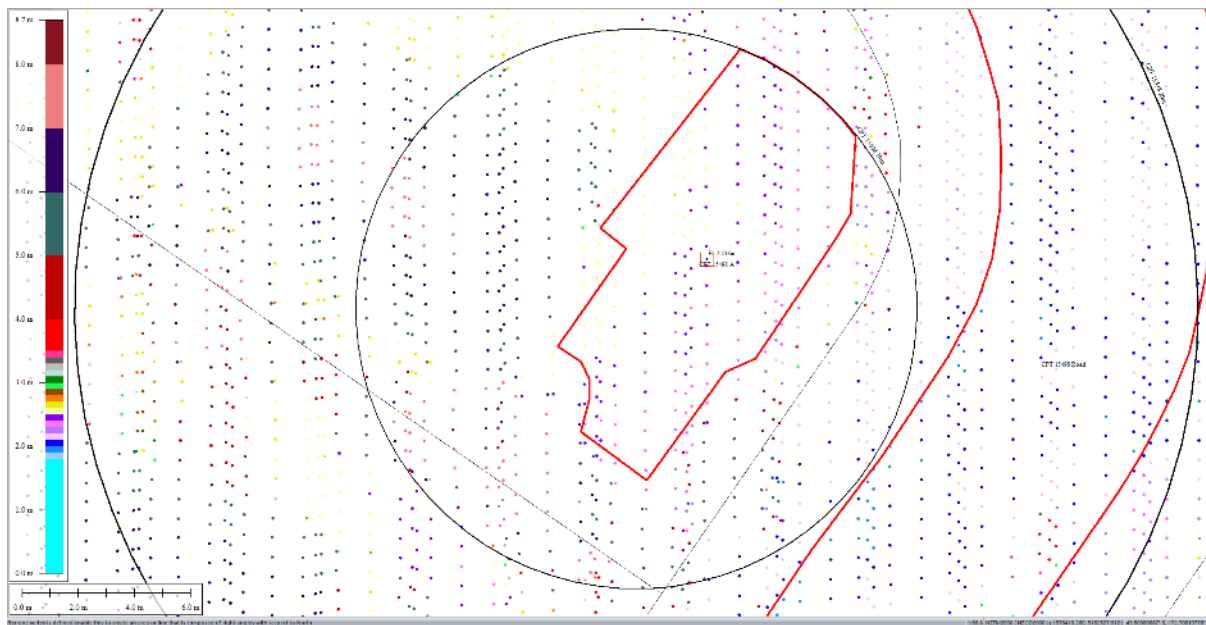
Figure 46: Ground surface elevation for Patch A for Mar 2011 LiDAR survey.

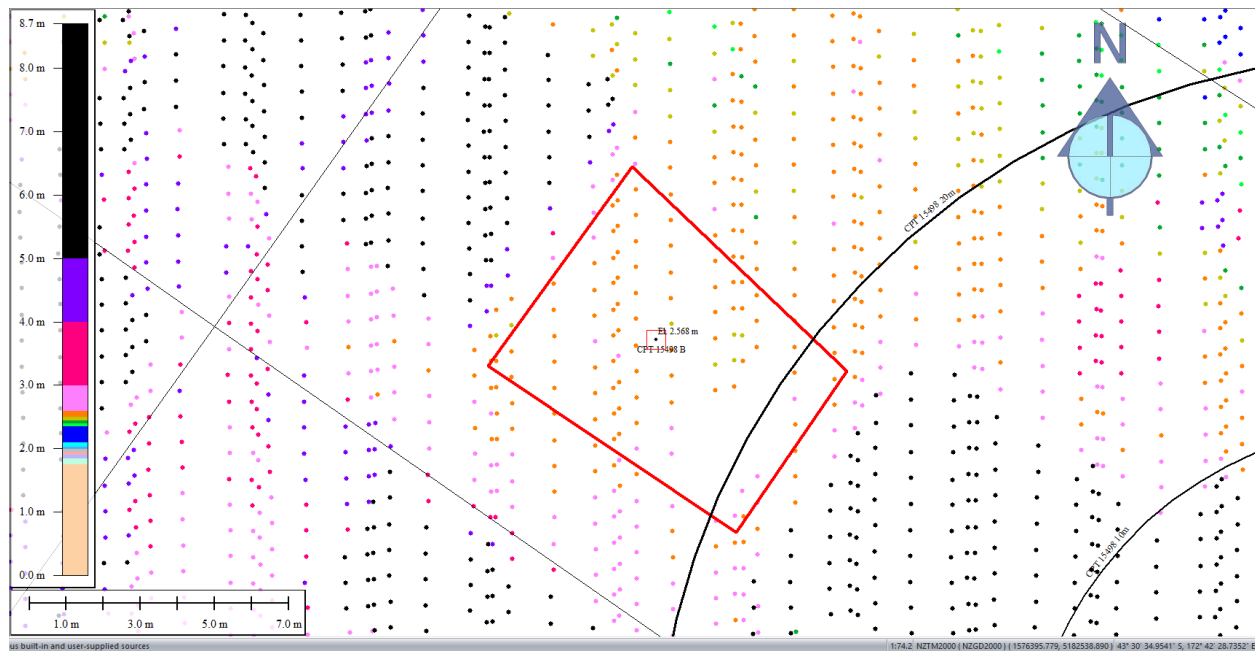
Figure 47: Ground surface elevation for Patch A for Mar 2011 LiDAR survey.

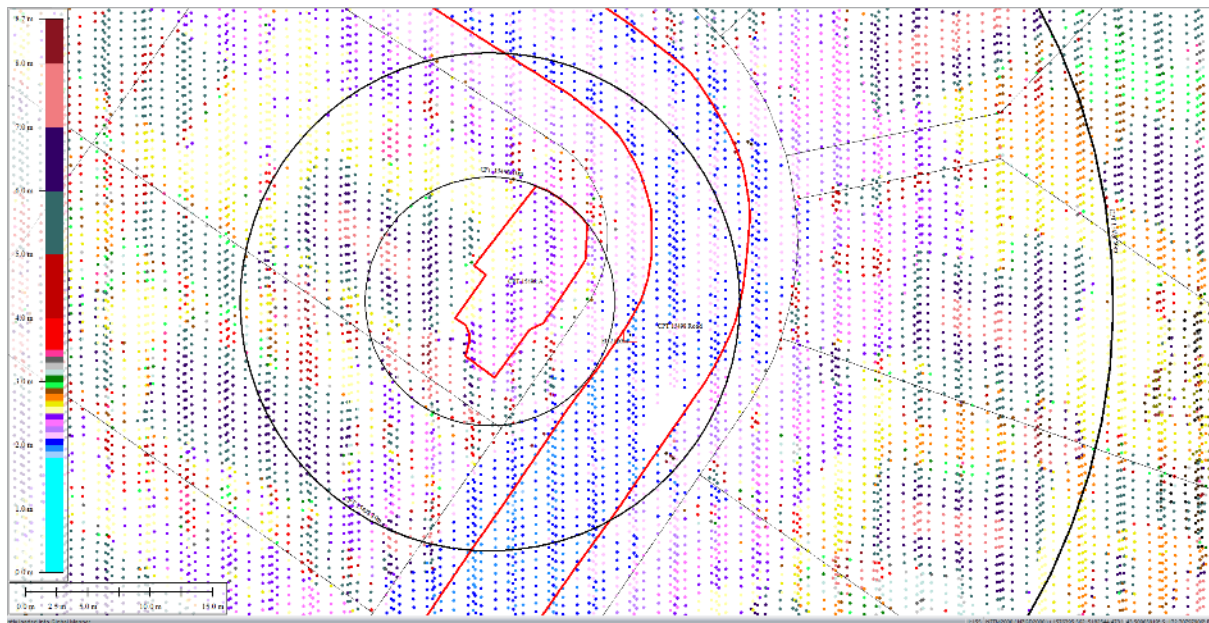
Figure 48: Ground surface elevation averaged over the 20-m buffer for Road for Mar 2011 LiDAR survey.

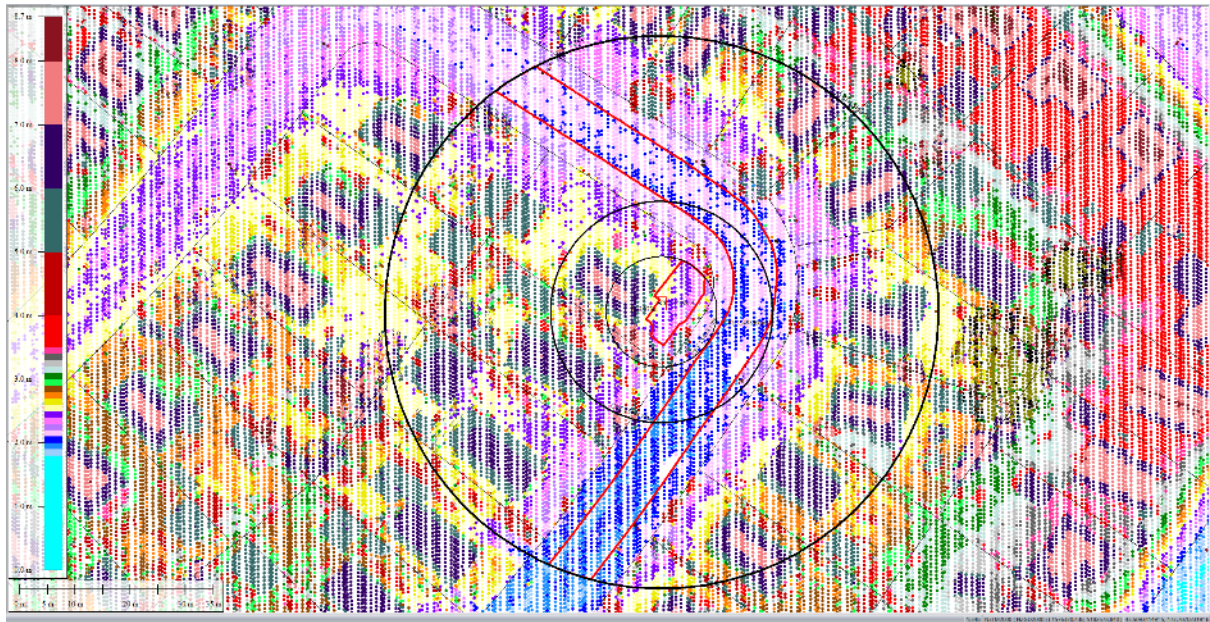
Figure 49: Ground surface elevation averaged over the 20-m buffer for Road for Mar 2011 LiDAR survey.

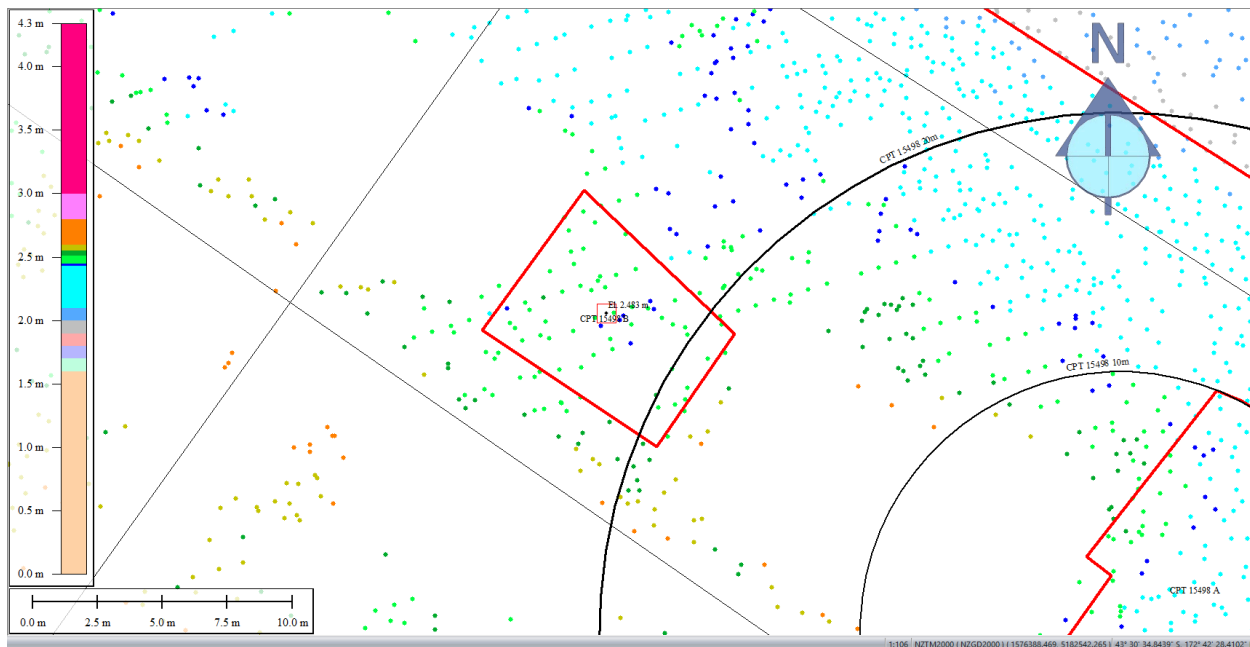
Figure 52: Ground surface elevation for Patch B for May 2011 LiDAR survey.

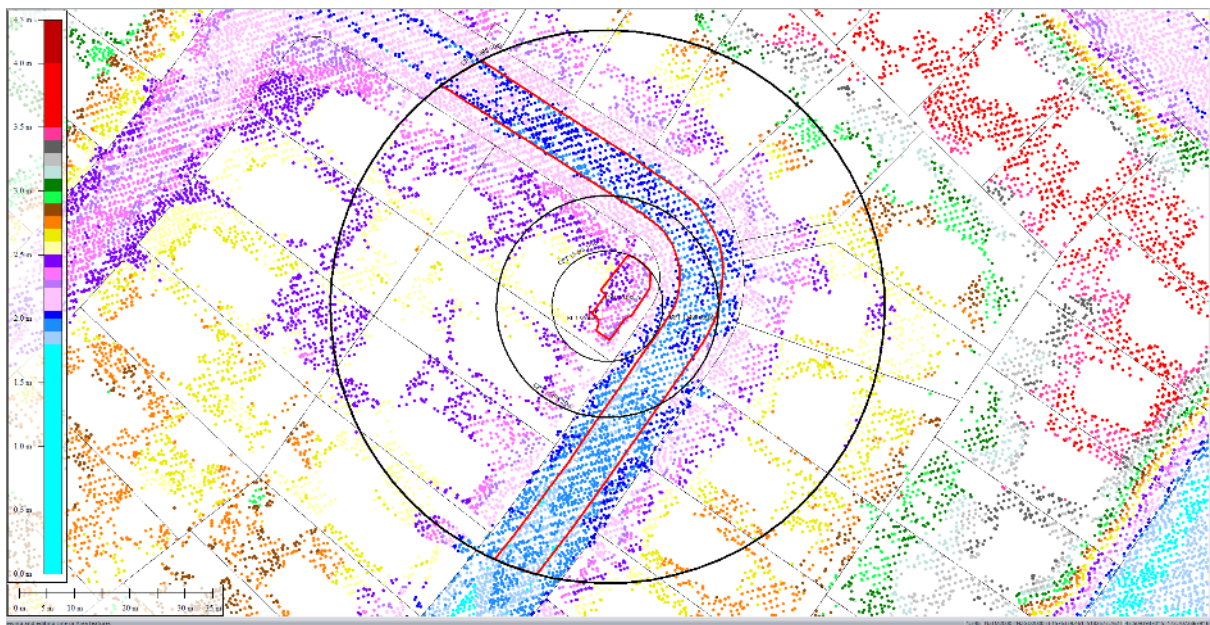
Figure 54: Ground surface elevation averaged over the 50-m buffer for Road for May 2011 LiDAR survey.
