Appendix A.17:

Sandown Cres – CPT 15498

Liquefaction Ejecta Case Histories for 2010-11 Canterbury Earthquakes

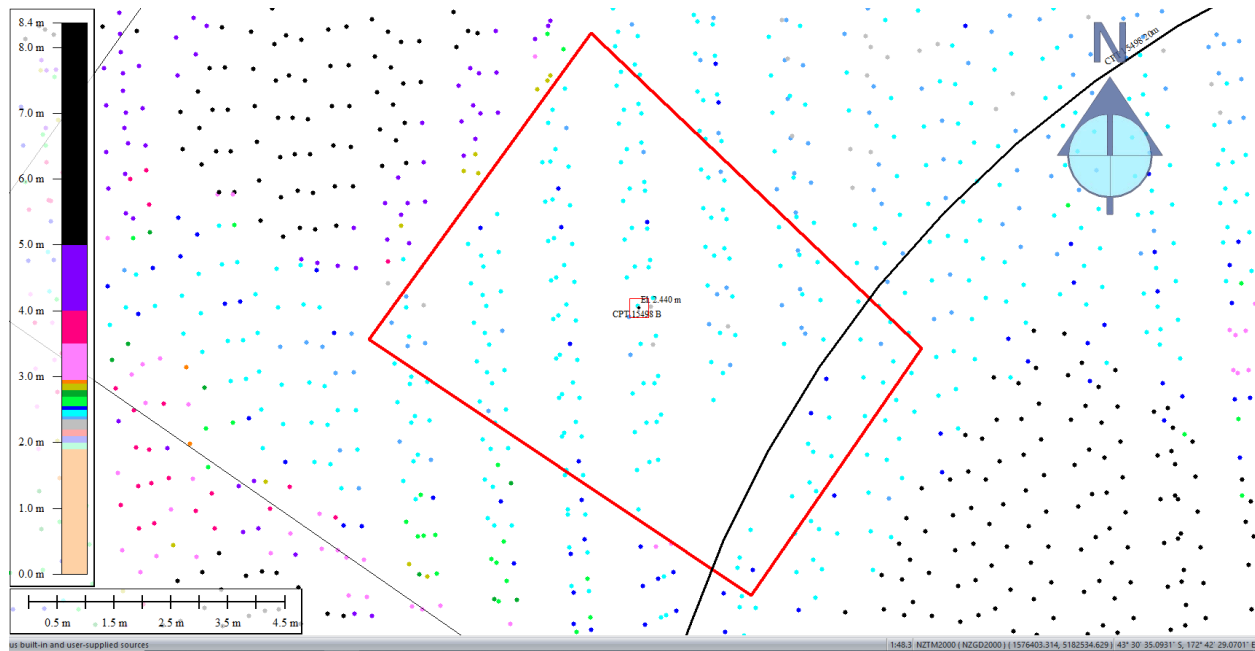
Figure 57: Ground surface elevation for Patch B for Sep 2011 LiDAR survey.

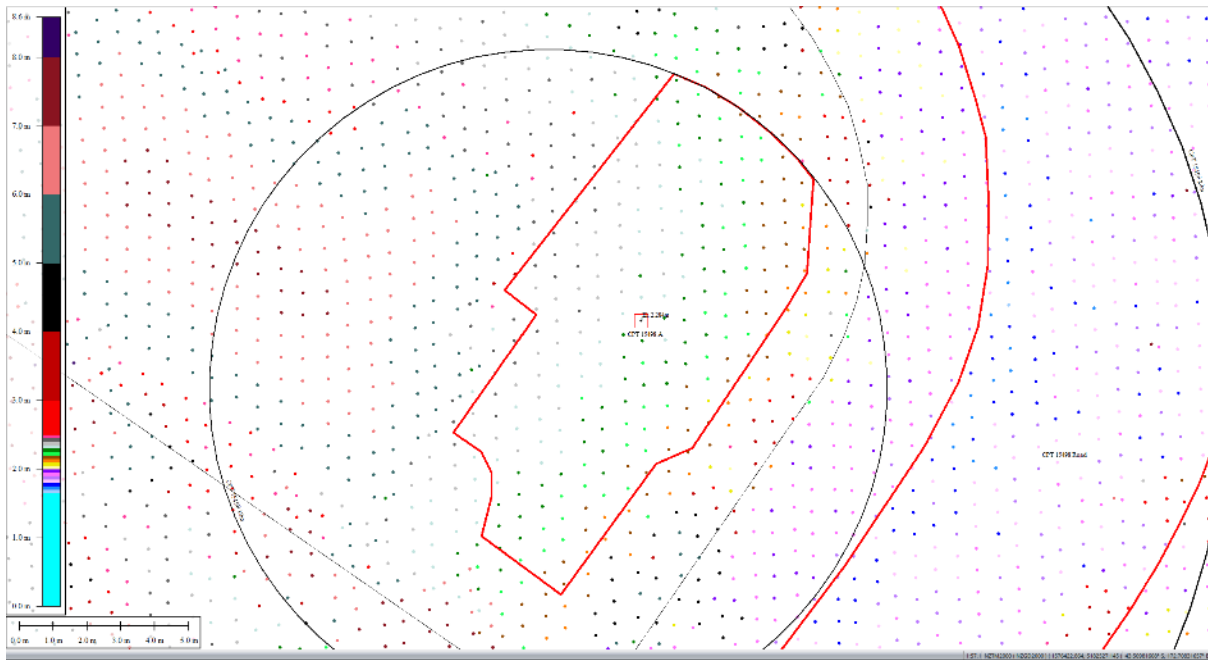
Figure 61: Ground surface elevation for Patch A for Feb 2012 LiDAR survey.

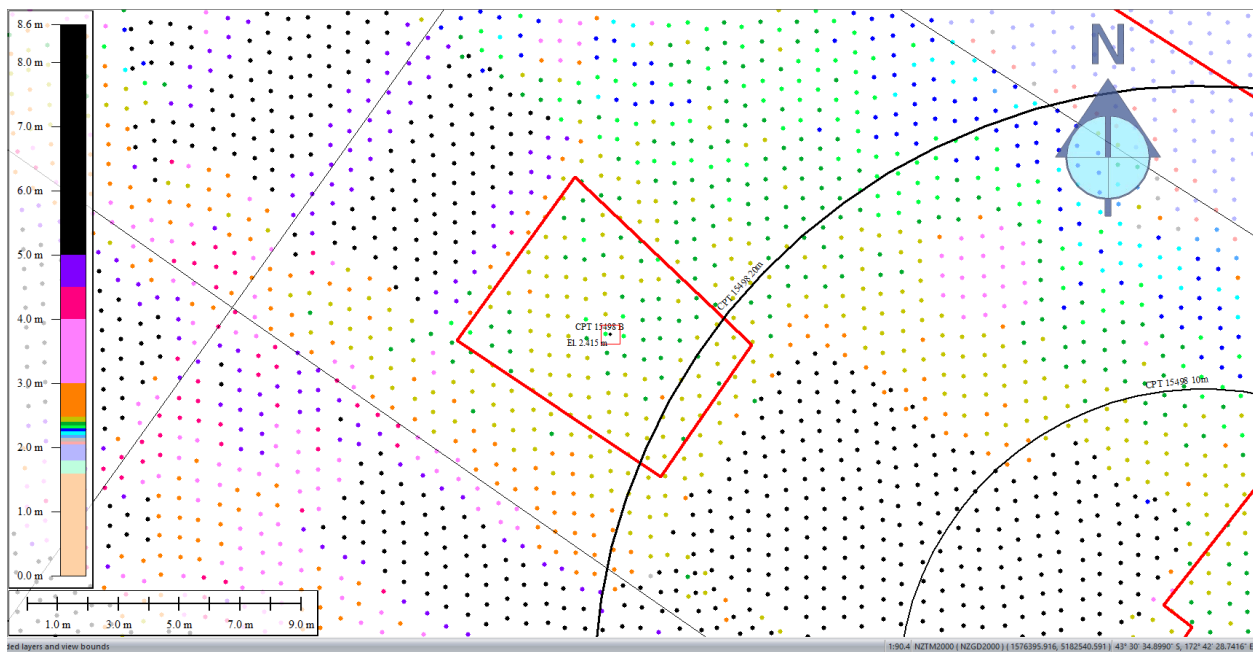
Figure 62: Ground surface elevation for Patch B for Feb 2012 LiDAR survey.

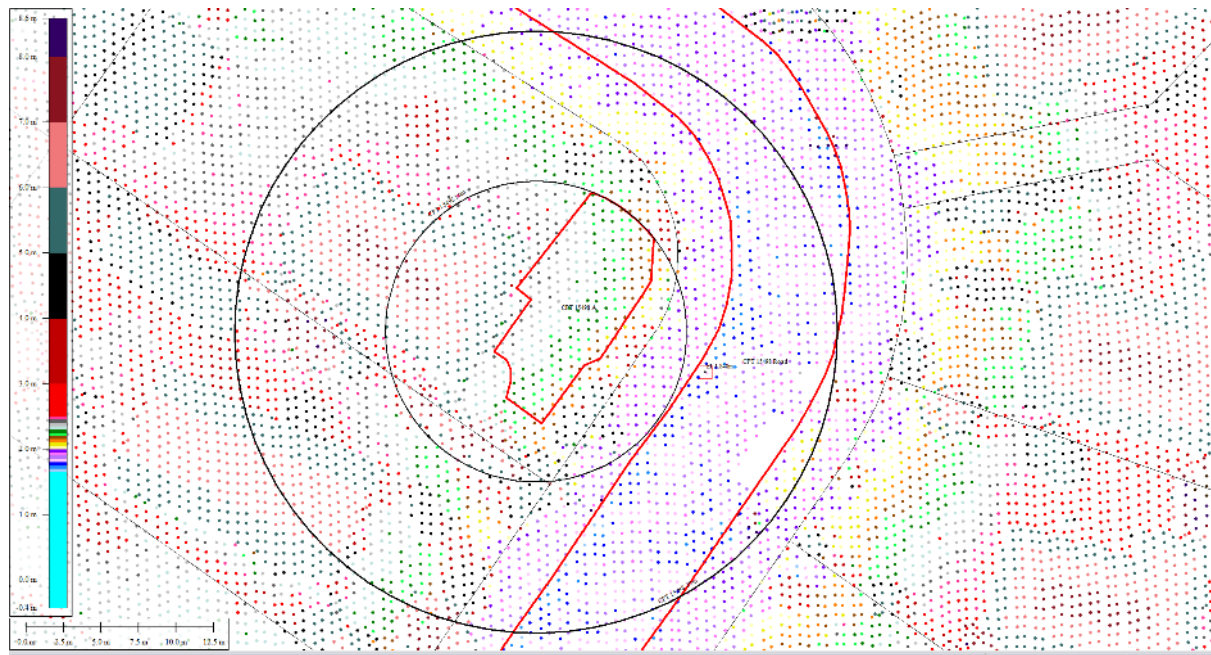
Figure 63: Ground surface elevation averaged over the 20-m buffer for Road for Feb 2012 LiDAR survey.

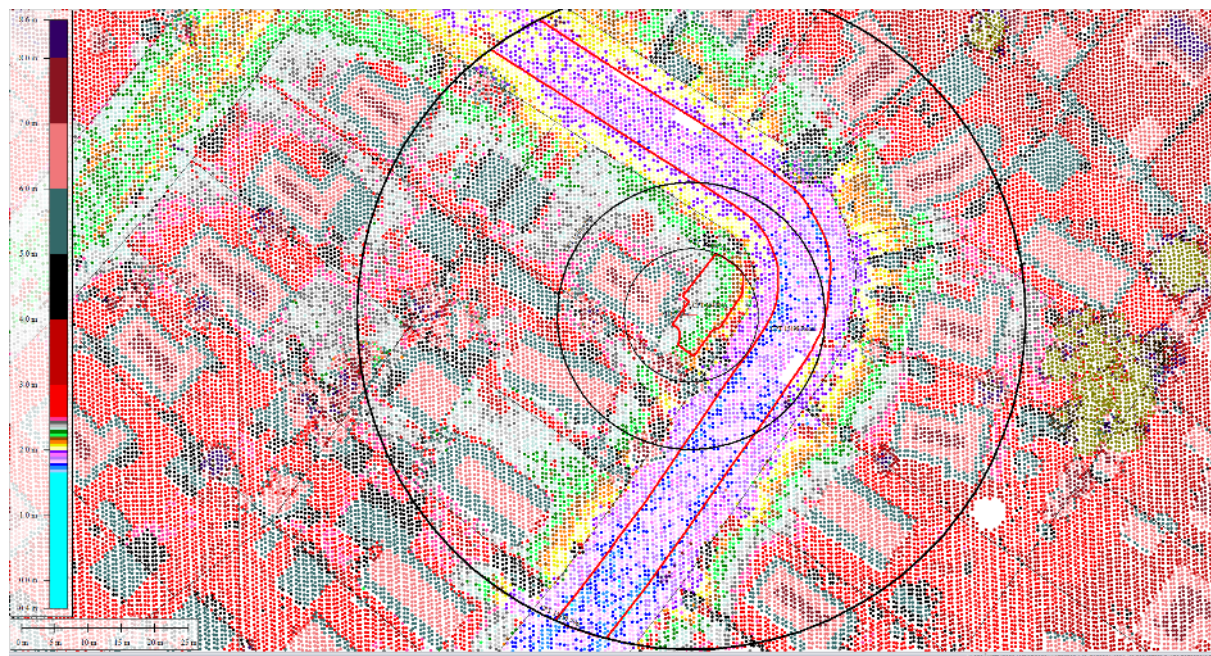
Figure 64: Ground surface elevation averaged over the 50-m buffer for Road for Feb 2012 LiDAR survey.

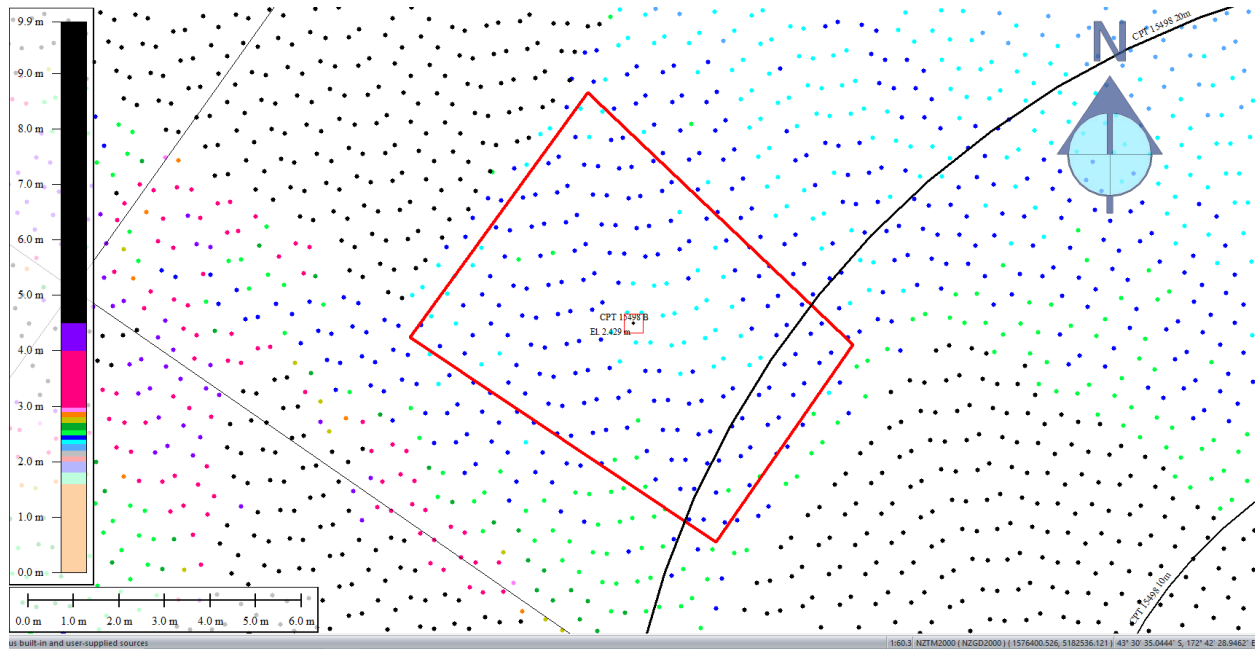
Figure 67: Ground surface elevation for Patch B for Oct 2015 LiDAR survey.

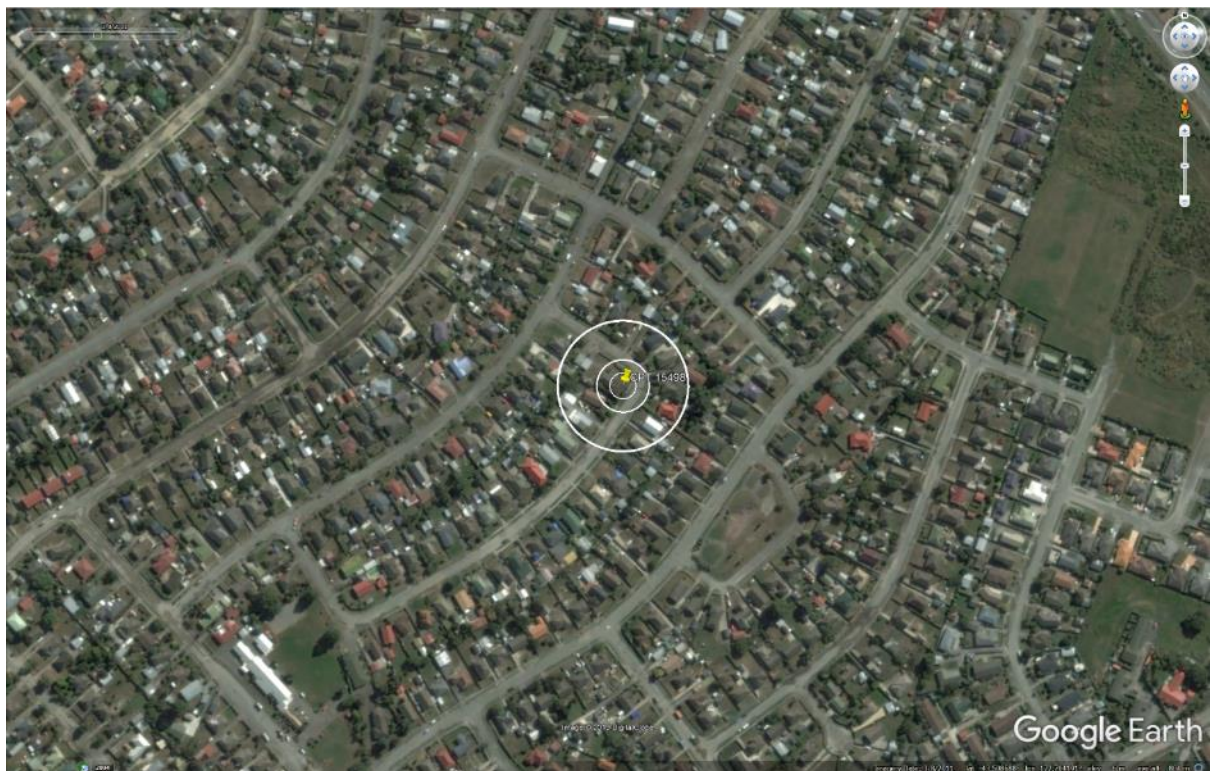
Figure 70: Satellite image taken on Mar 8, 2011 showing evidence of ejecta.

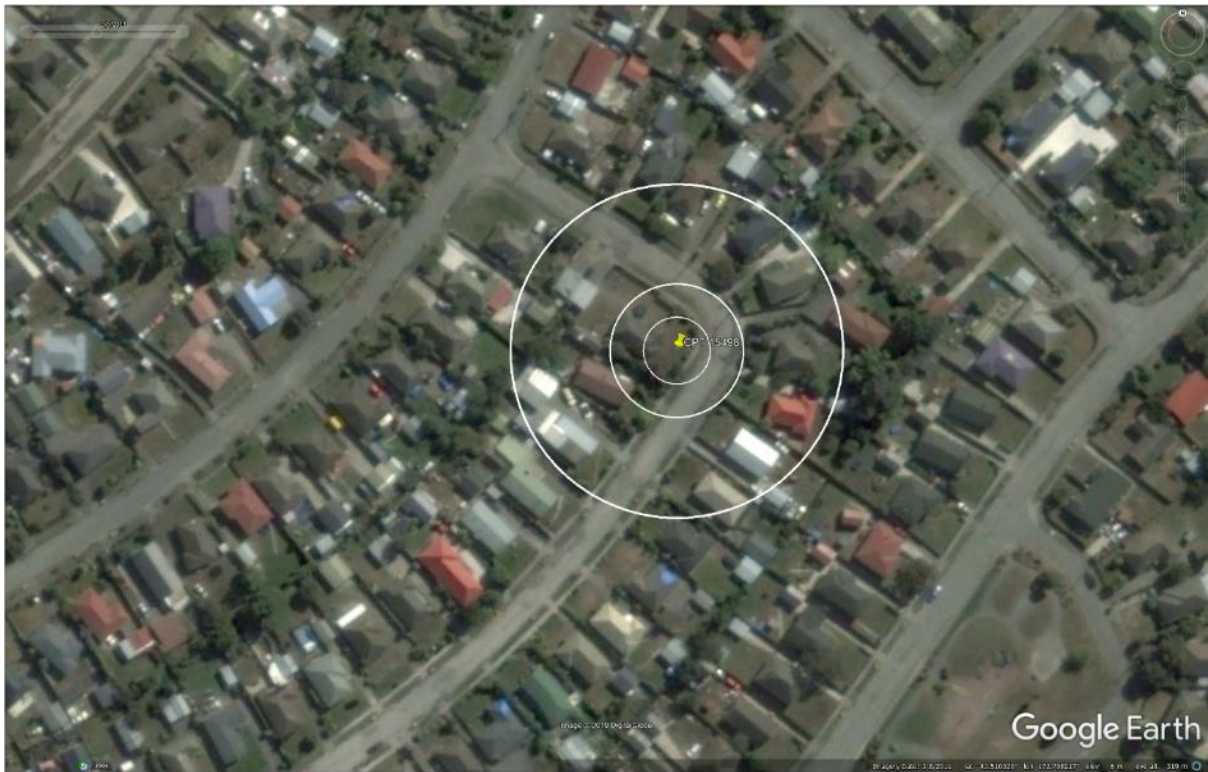
Figure 71: Satellite image taken on Mar 8, 2011 showing evidence of some ejecta remaining on the road at the time of the Mar 2011 LiDAR survey.

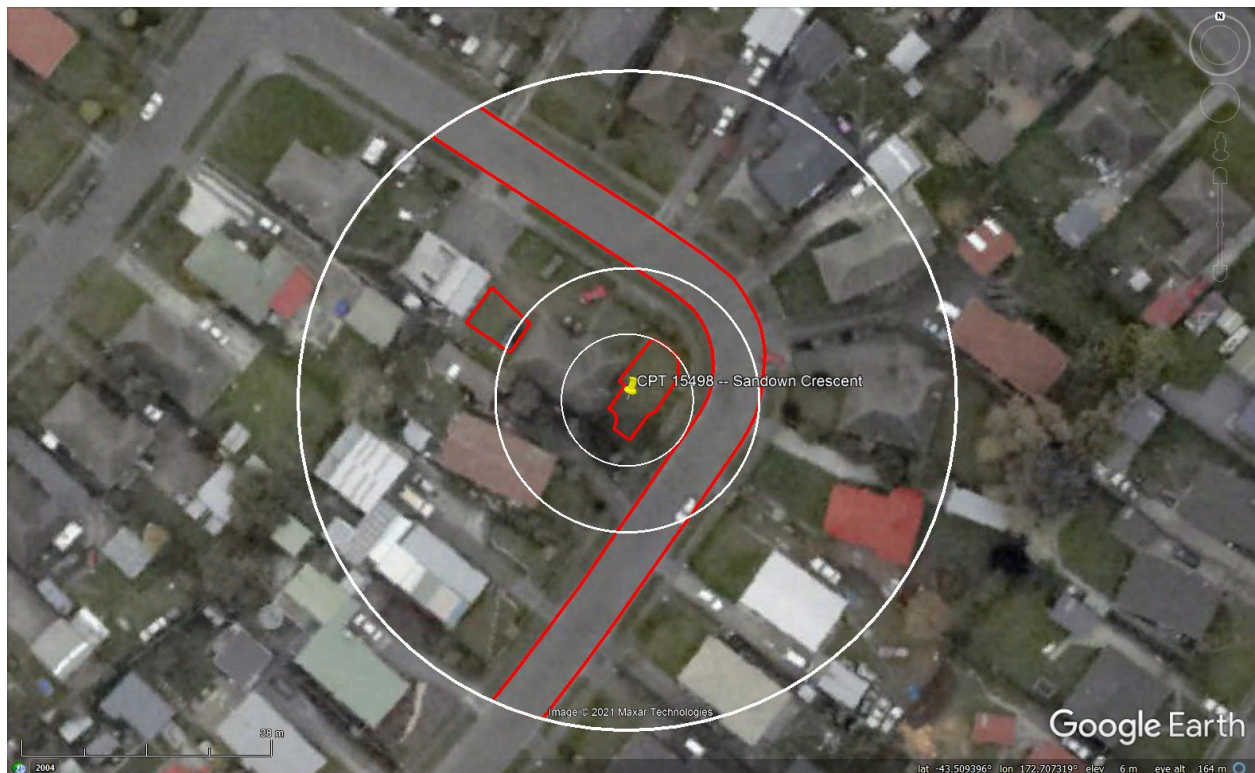
Figure 72: Aerial photograph showing absence of ejecta at the site for Sep-10 EQ.

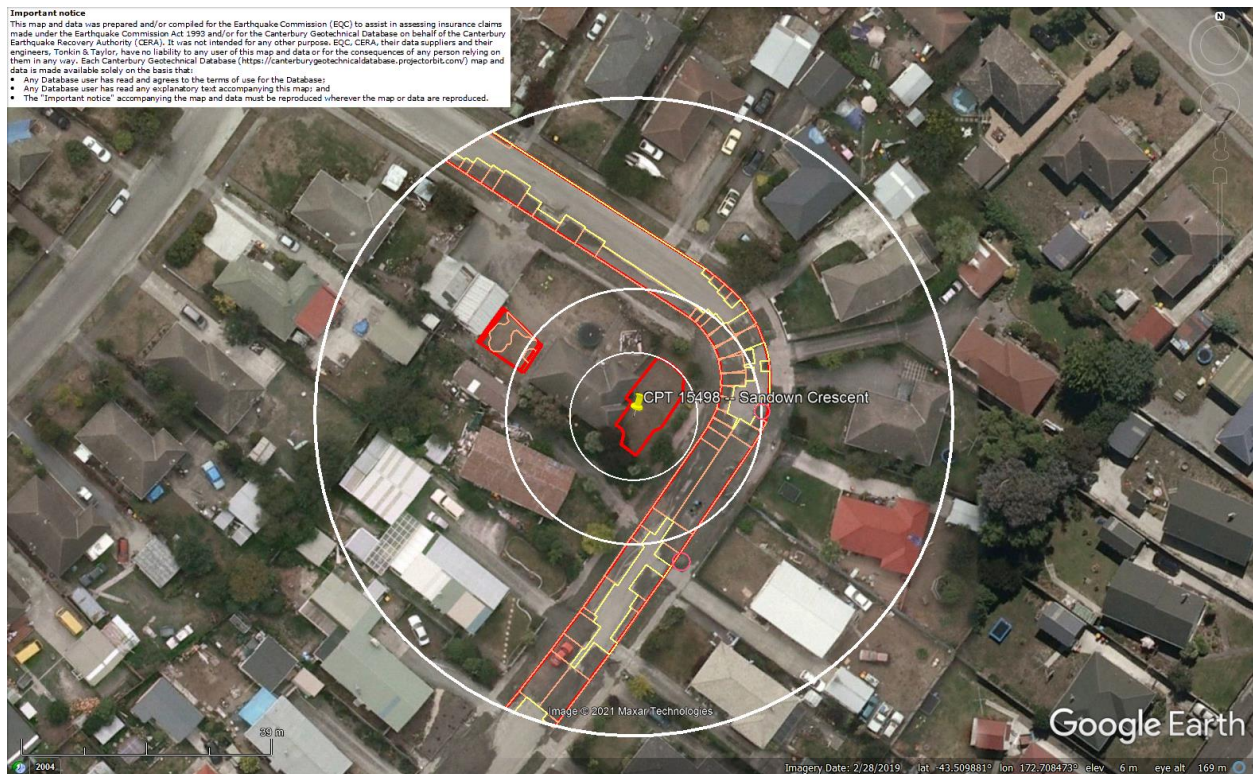
Figure 73: Ejecta outline for Feb-11 EQ.

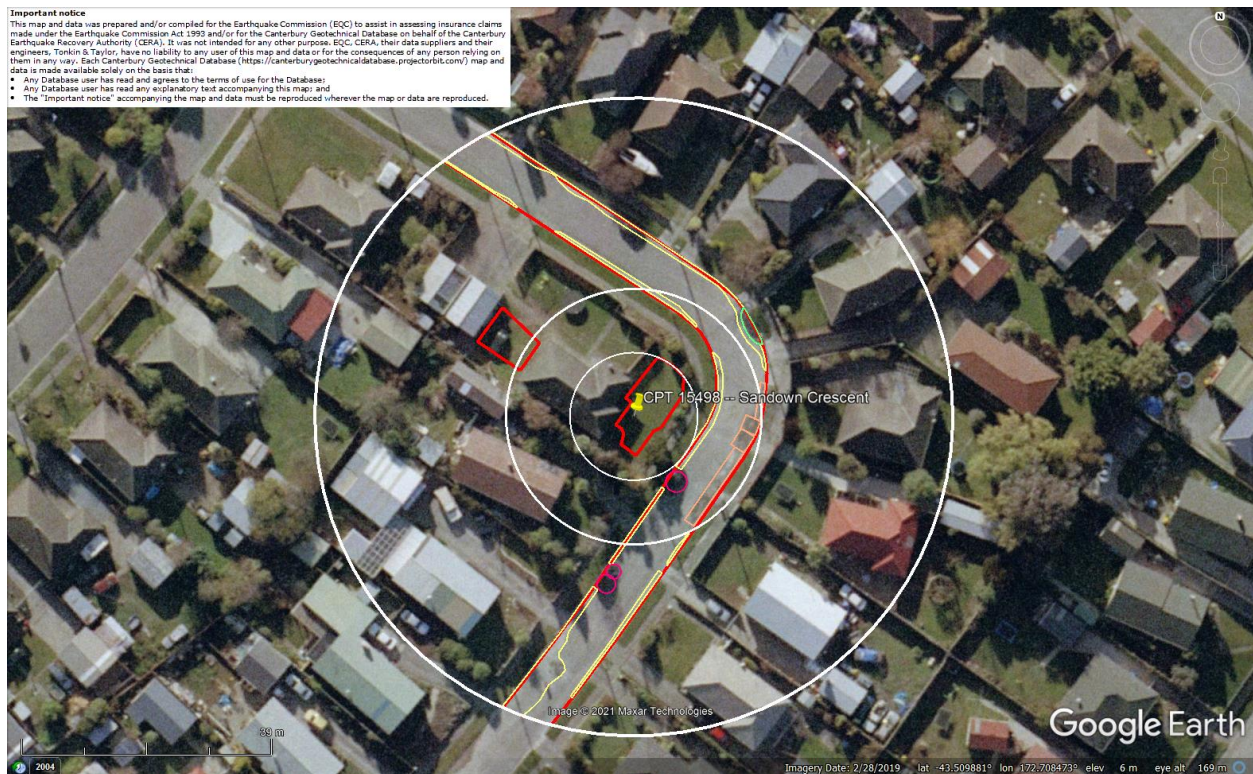
Figure 75: Ejecta outline for Jun-11 EQ.

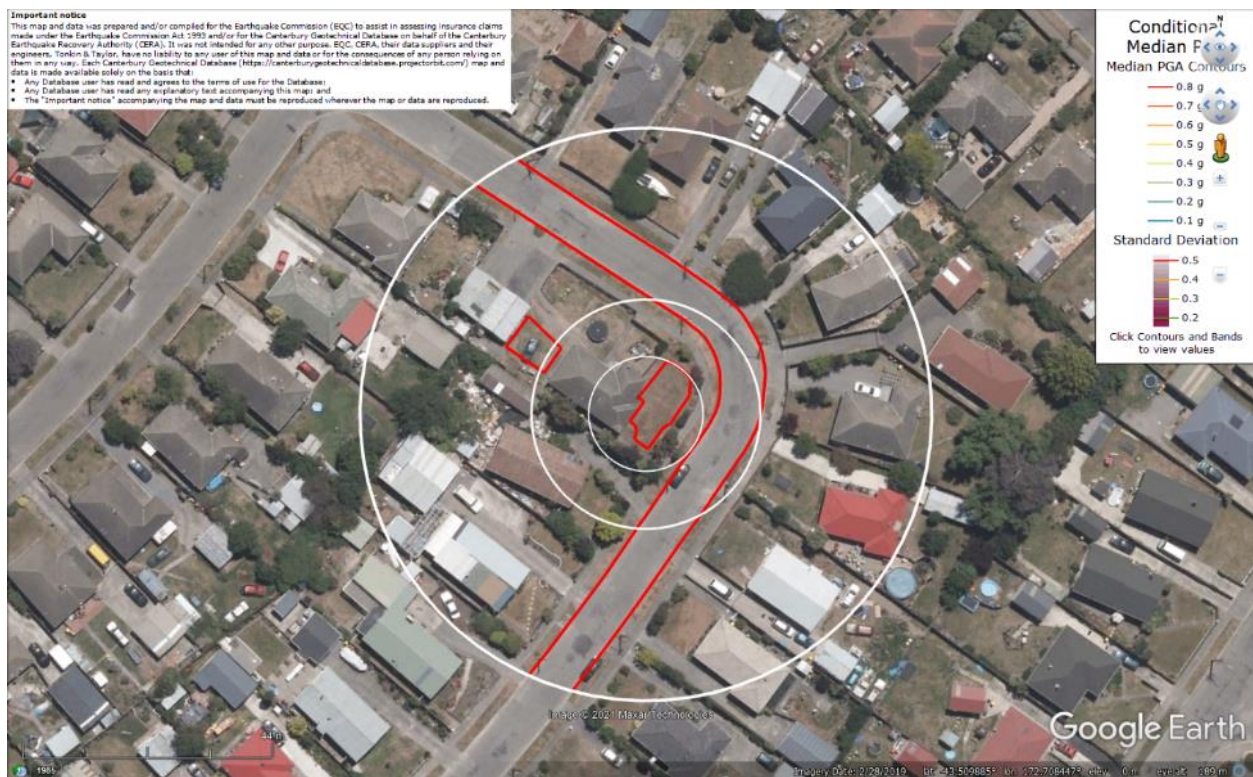
Figure 76: No ejecta for Dec-11 EQ.

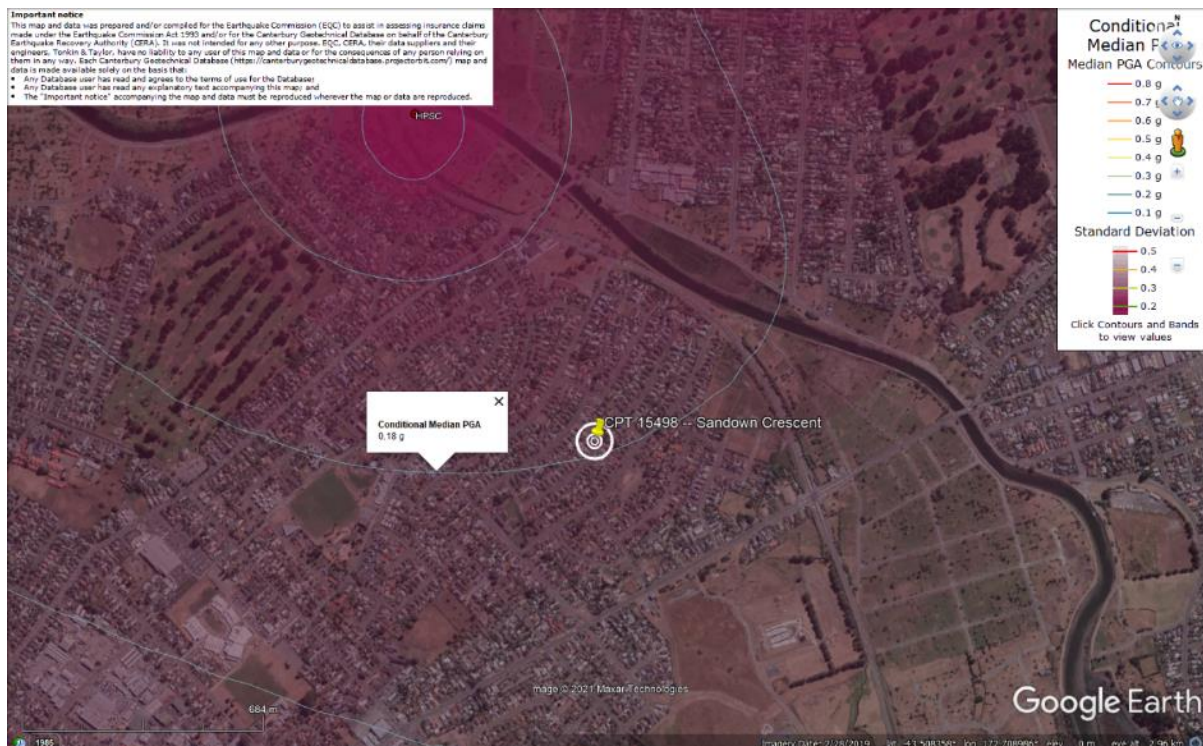
Figure 80: PGA for Sep-10 EQ (st. dev. = 0.300-0.325 ln units).

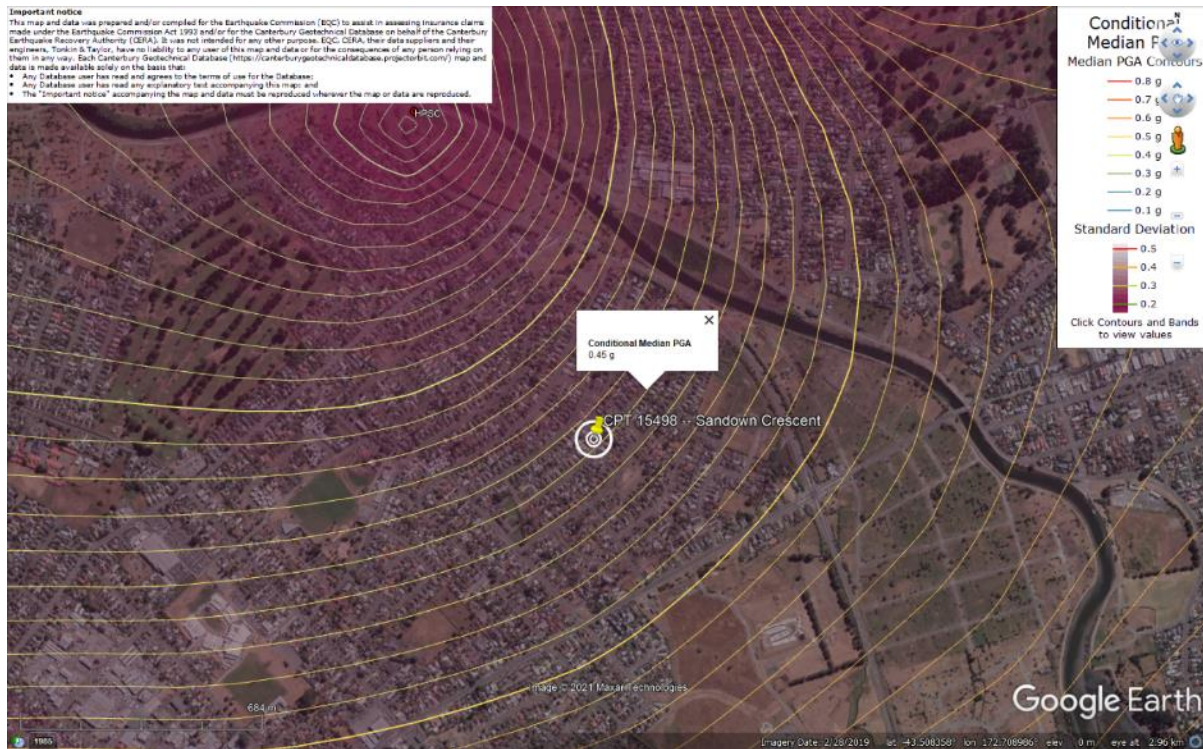
Figure 81: PGA for Feb-11 EQ (st. dev. = 0.325-0.350 ln units).

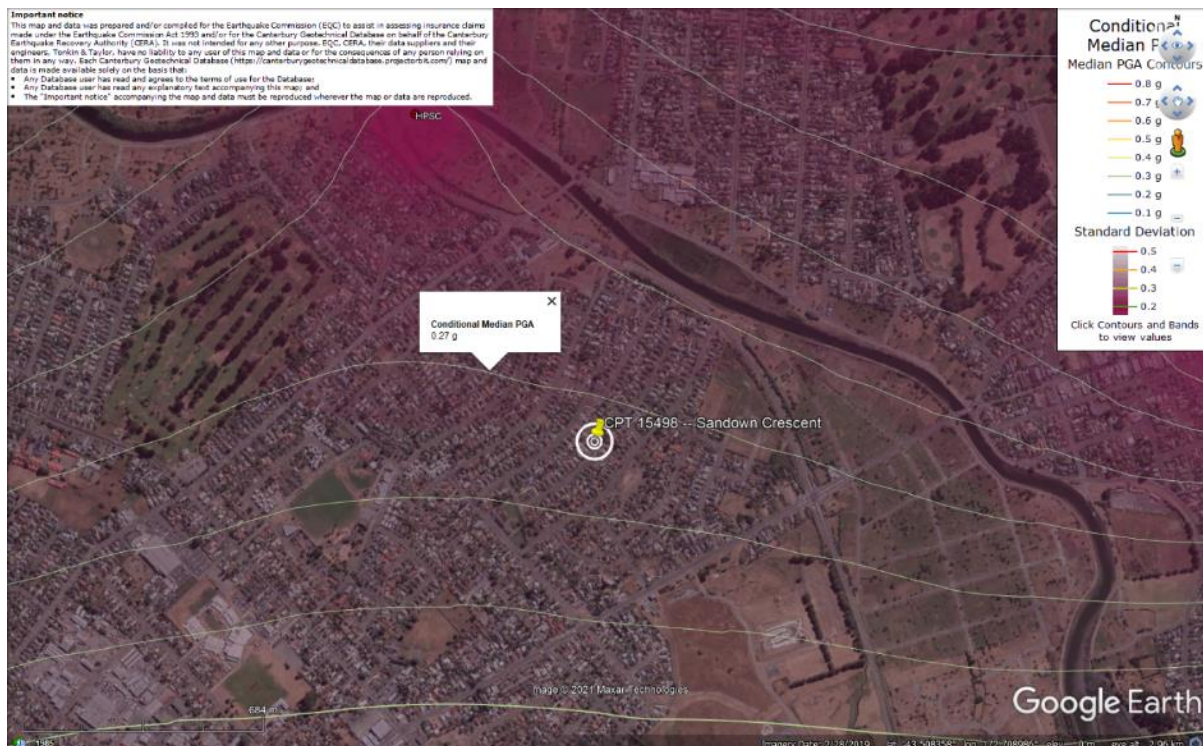
Figure 82: PGA for Jun-11 EQ (st. dev. = 0.325-0.350 ln units).

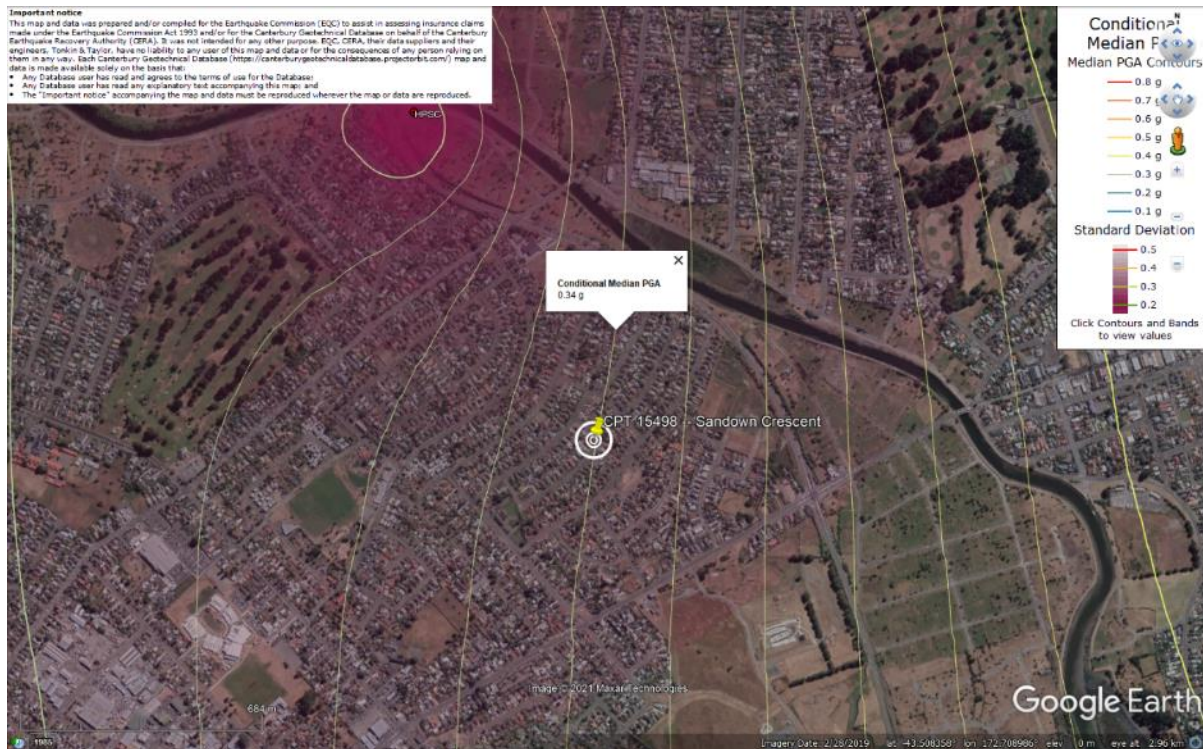
Figure 83: PGA for Dec-11 EQ (st. dev. = 0.350-0.375 ln units).

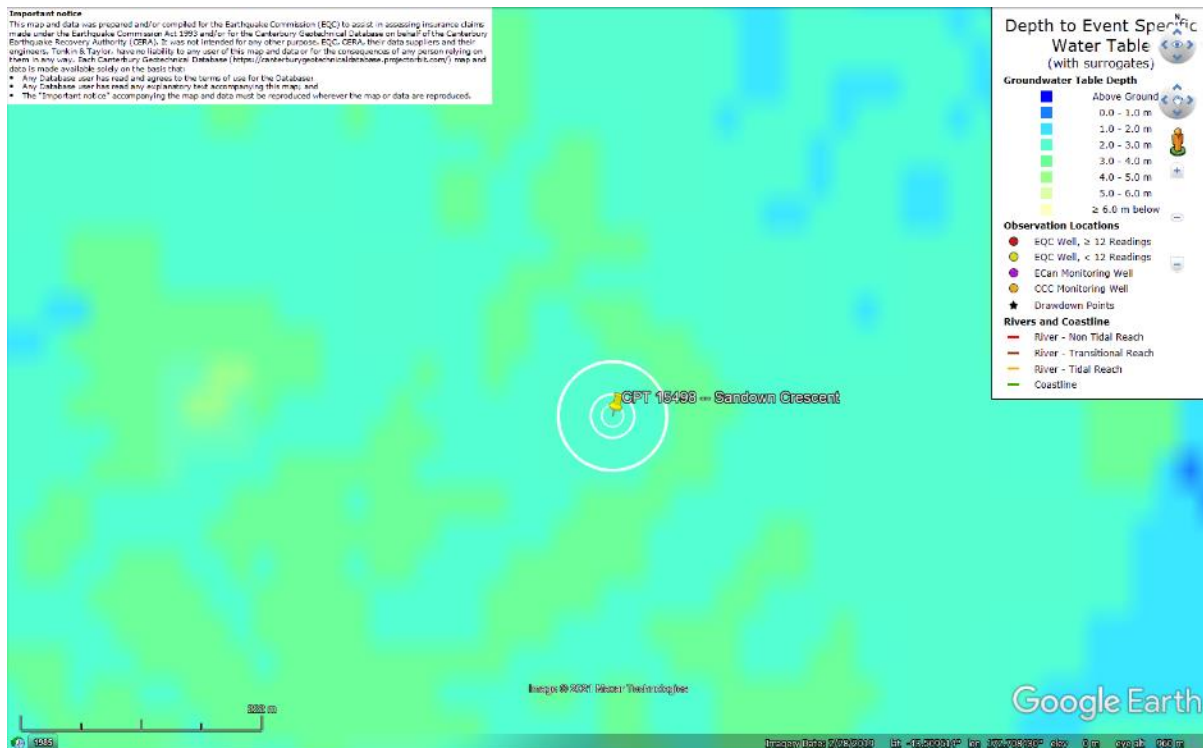
Figure 84: Depth to groundwater table for Sep-10 EQ.

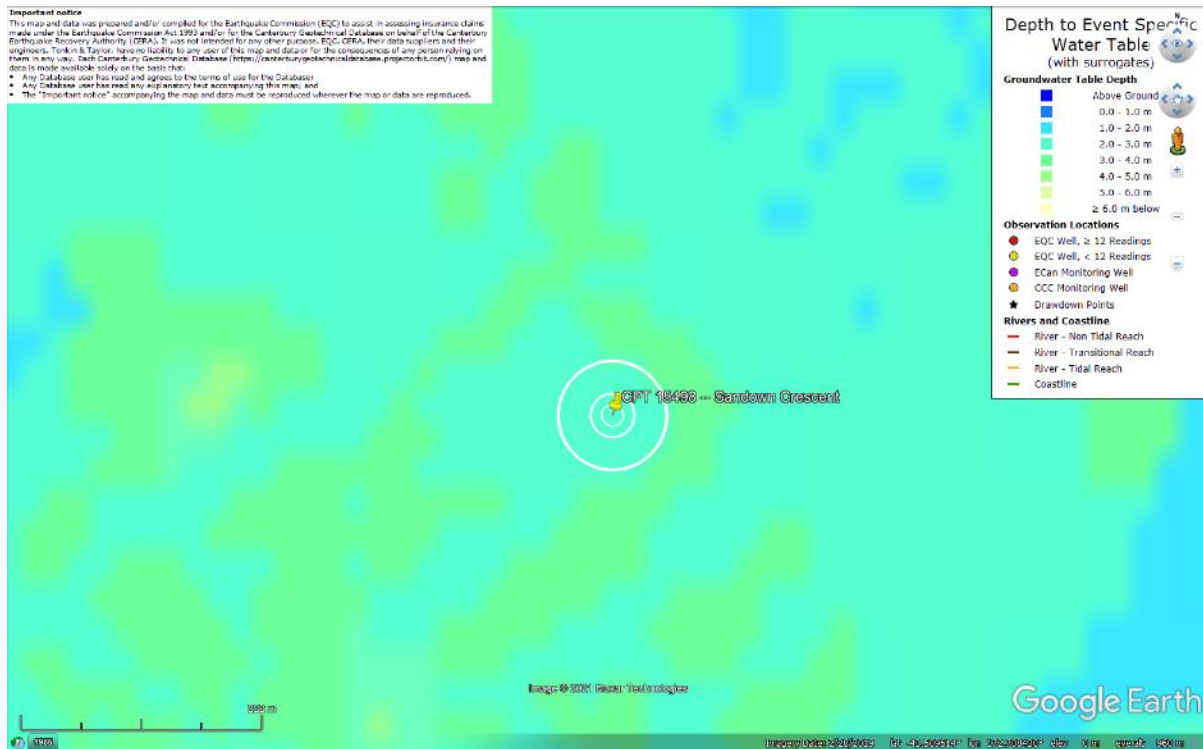
Figure 85: Depth to groundwater table for Feb-11 EQ.

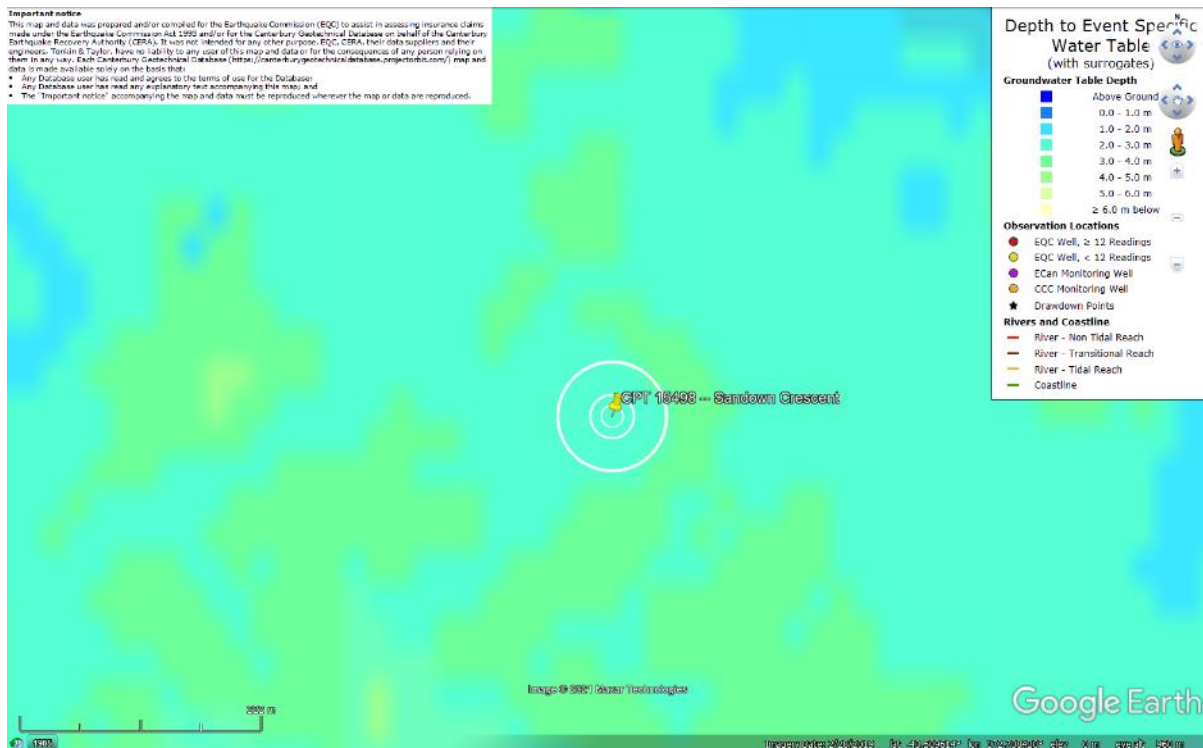
Figure 86: Depth to groundwater table for Jun-11 EQ.

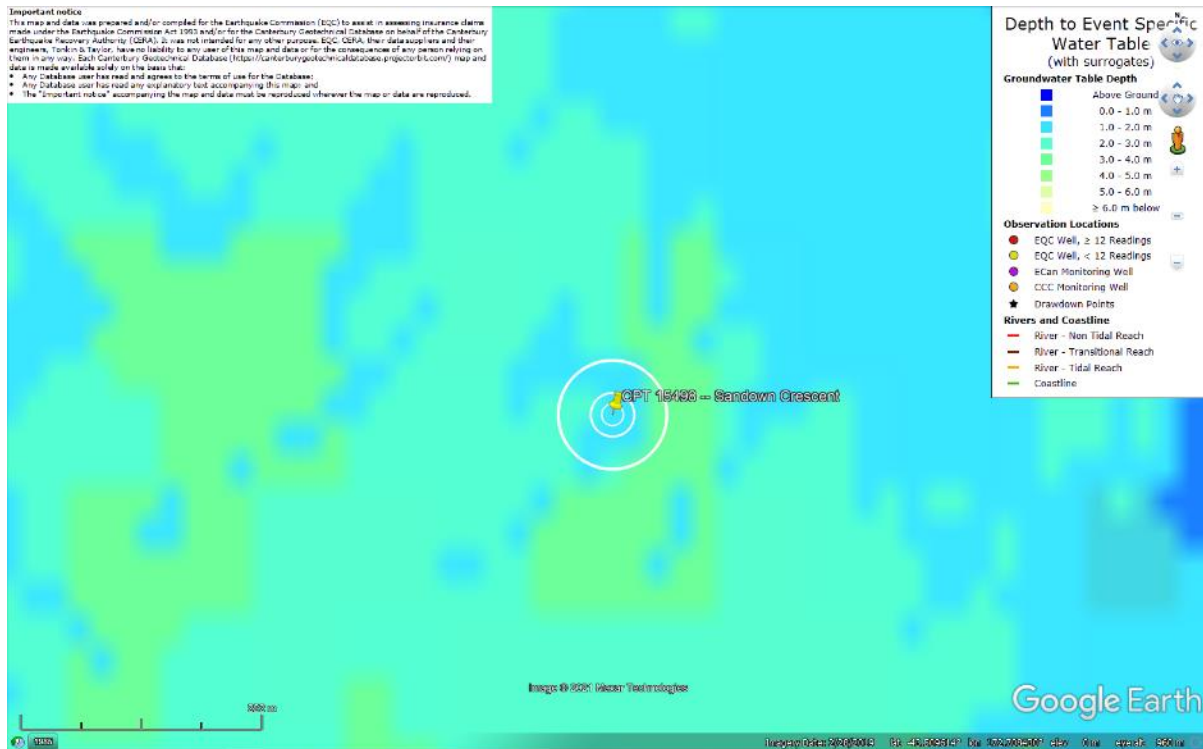
Figure 87: Depth to groundwater table for Dec-11 EQ.

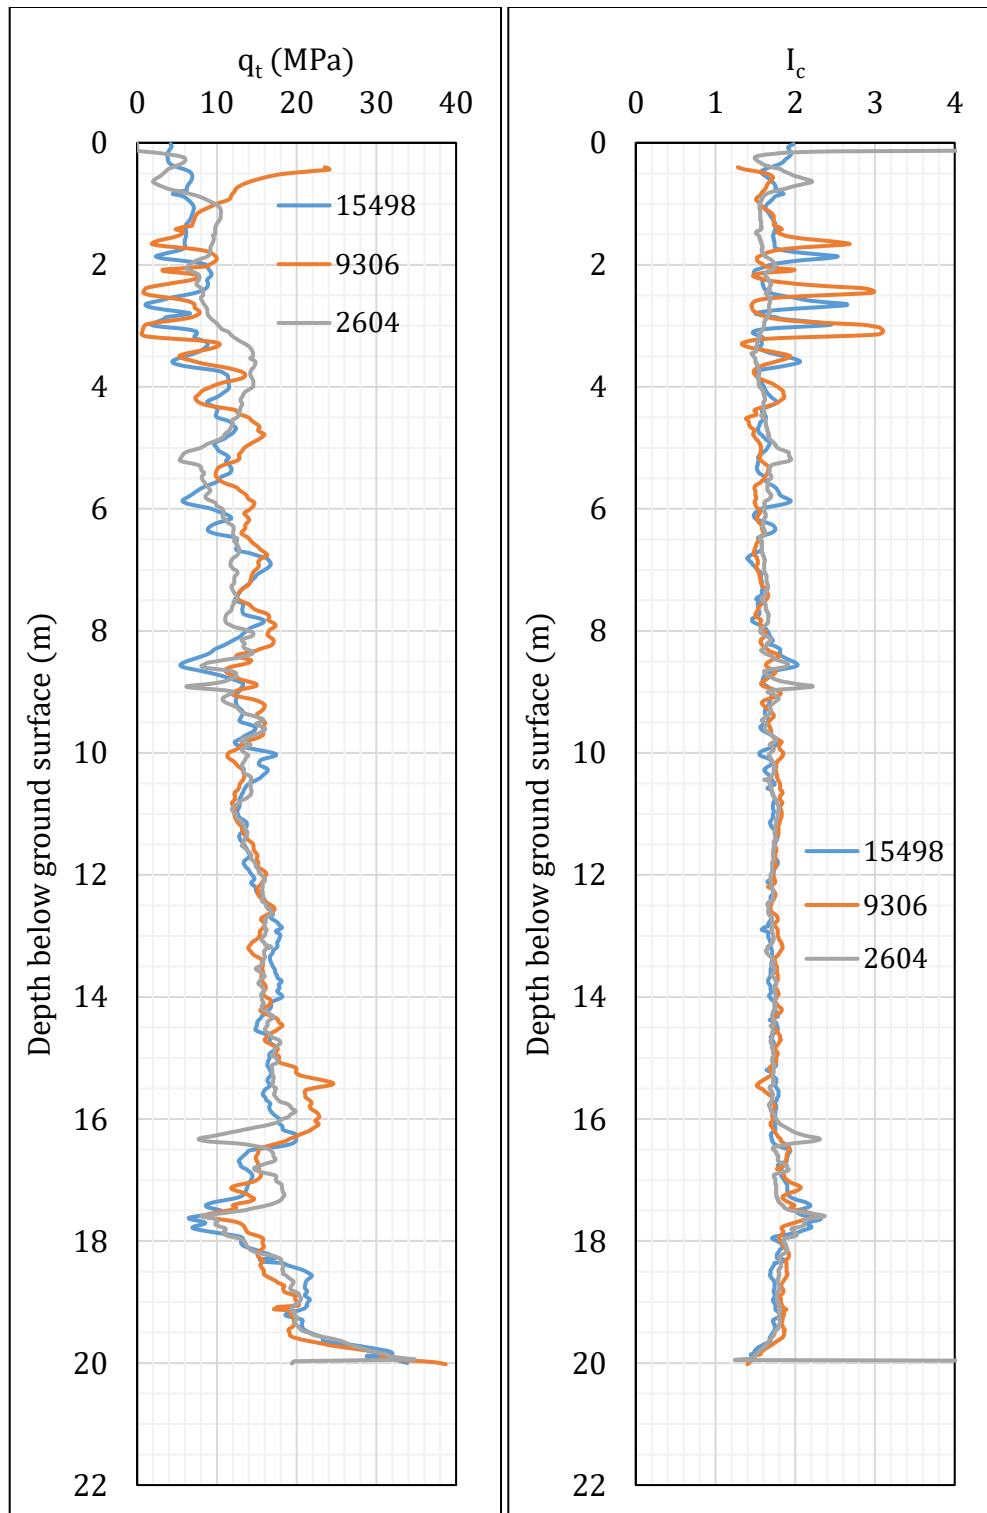
Figure 89: q_t and I_c profiles.

Note 9: The selection of CPTs for the area considered for settlement assessment (Figure 1) is based on the proximity of the CPTs to the considered areas. In accordance with that, the following table shows CPTs that were used for the volumetric settlement analysis in *Cliq v.3.0.3.2*, a CPT soil liquefaction software developed by GeoLogismiki. (The average volumetric settlements were reported in Table 8.)
