Appendix A.22:

31 Landy St – CPT 44439 (VsVp 57203)

Liquefaction Ejecta Case Histories for 2010-11 Canterbury Earthquakes

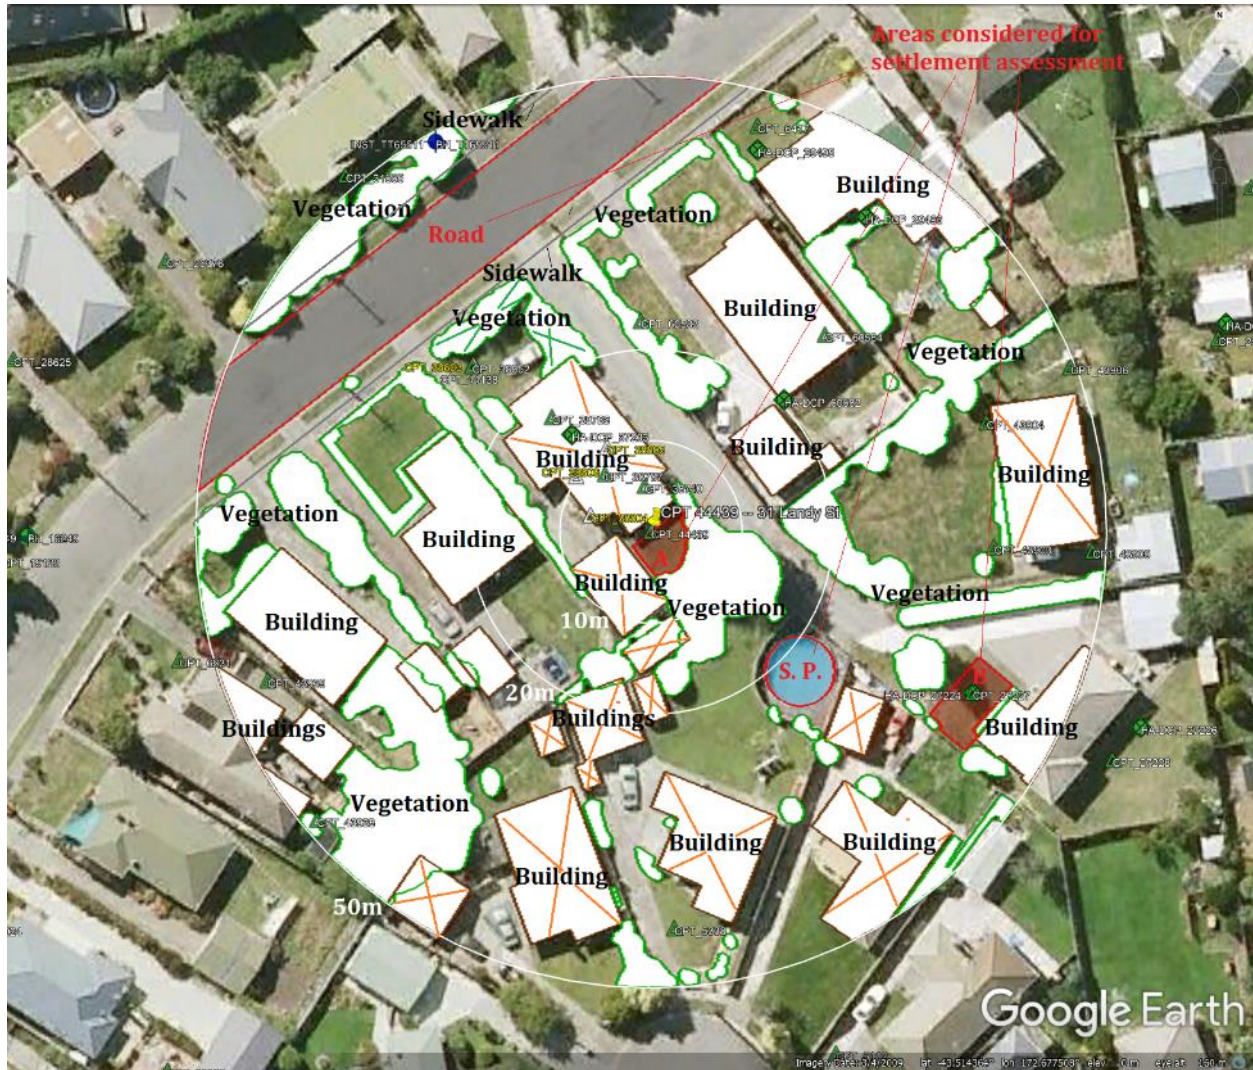
Figure 1: Site plan with areas where ejecta-induced settlement is considered.

Note 1: Two patches (outlined in red) in the free field were selected for settlement assessment as areas free of vegetation and structures. Other important factors considered for the patch selection were its proximity to a CPT, a property subjected to addition and/or demolition of a structure, front yard/backyard alterations (e.g., ploughing, rubble, scrap), and aerial distribution of sediment ejecta. In addition, the entire portion of the road within the 50-m buffer was considered for settlement assessment. Roads as hard, relatively flat surfaces provide many ground-classified points. The LiDAR-based settlement analyses of Patch A were not conducted for any earthquake event due to the evident absence of ejecta. The Oct 2015 LiDAR was not used in the settlement analysis of the Road due to the anthropogenic changes after Apr 2012. The ejecta inside the swimming pool was estimated for the Feb-11 EQ using the physical evidence only.

- A_T is the total assessment area for a buffer being considered (Figure 1).

Note 6: The selection of CPTs for the area considered for settlement assessment (Figure 1) is based on the proximity of the CPTs to the considered areas. In accordance with that, the following table shows CPTs that were used for the volumetric settlement analysis in *Cliq v.3.0.3.2*, a CPT soil liquefaction software developed by GeoLogismiki. (The average volumetric settlements were reported in Table 8.)

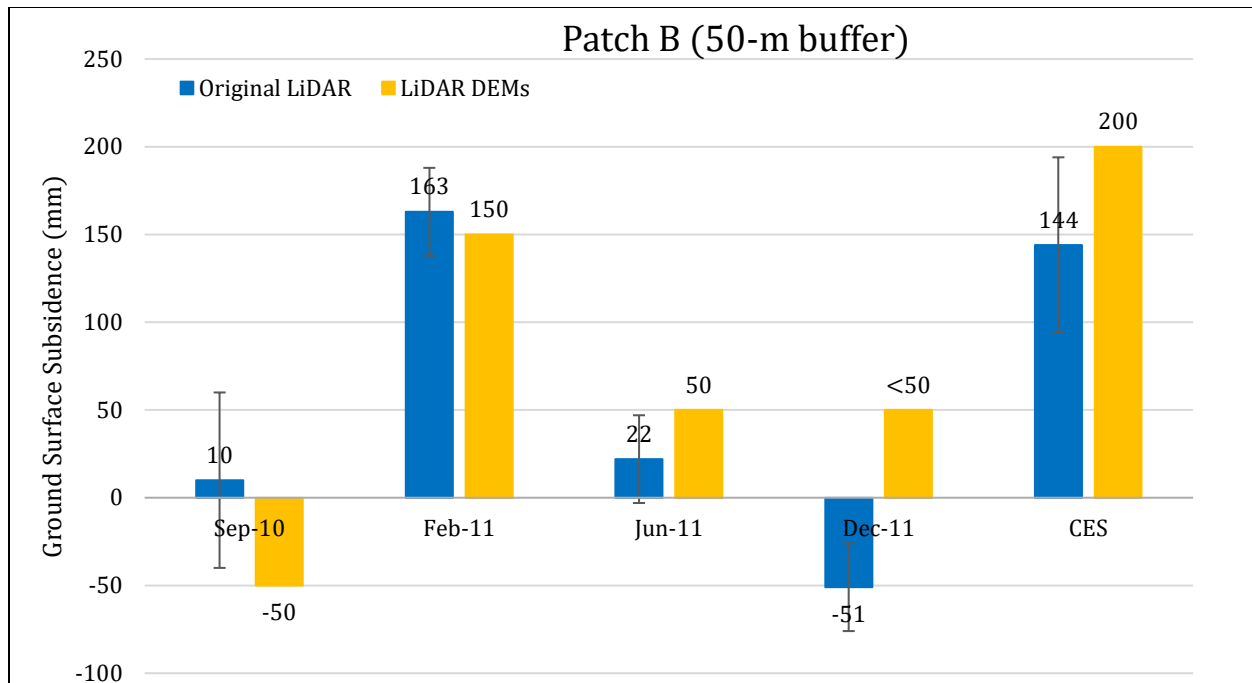
Figure 2: Comparison between ground surface subsidence determined from original LiDAR survey points and ground surface subsidence (50th %ile) estimated using LiDAR DEMs for Patch B.

Note 2: The ground surface subsidence values determined from the original LiDAR survey points are generally consistent with the ground surface subsidence values estimated using the LiDAR DEMs for all earthquake events. The ground surface uplift observed for Patch B (LiDAR DEM) for the Sep-10 EQ may be due to the limited number of the July 2003 elevation points and the DEM cell interpolation.

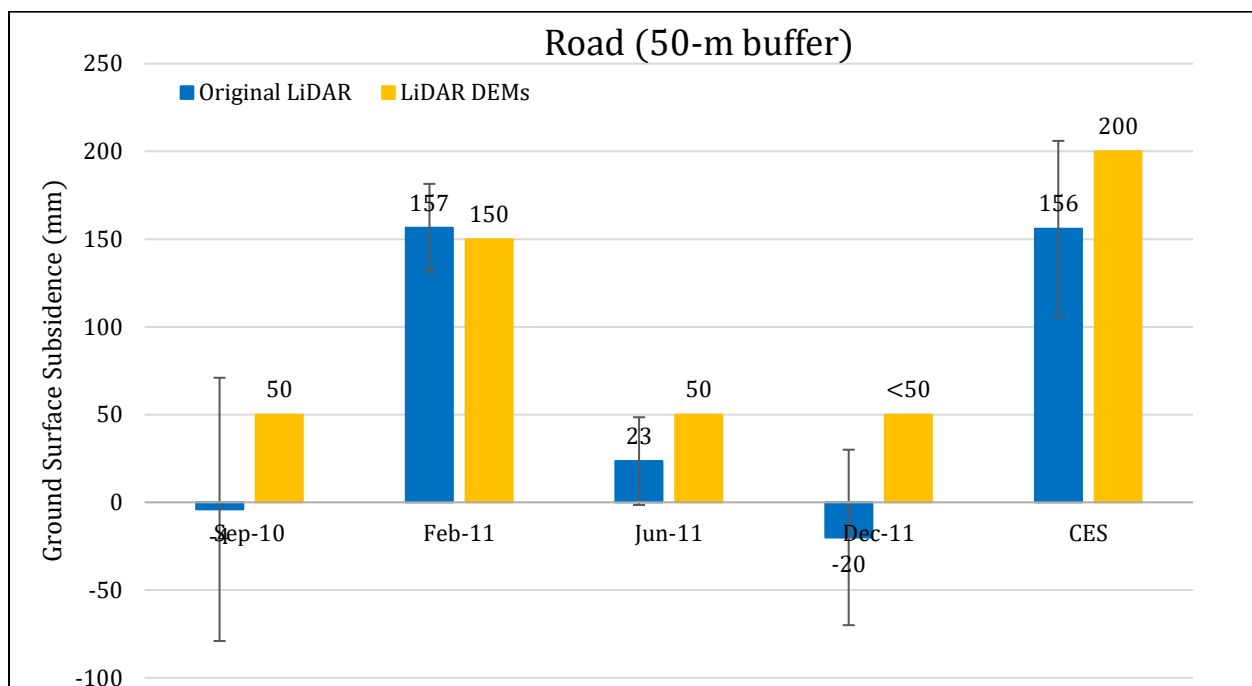
Figure 3: Comparison between ground surface subsidence determined from original LiDAR survey points and ground surface subsidence (50th %ile) estimated using LiDAR DEMs for Road (50-m buffer).

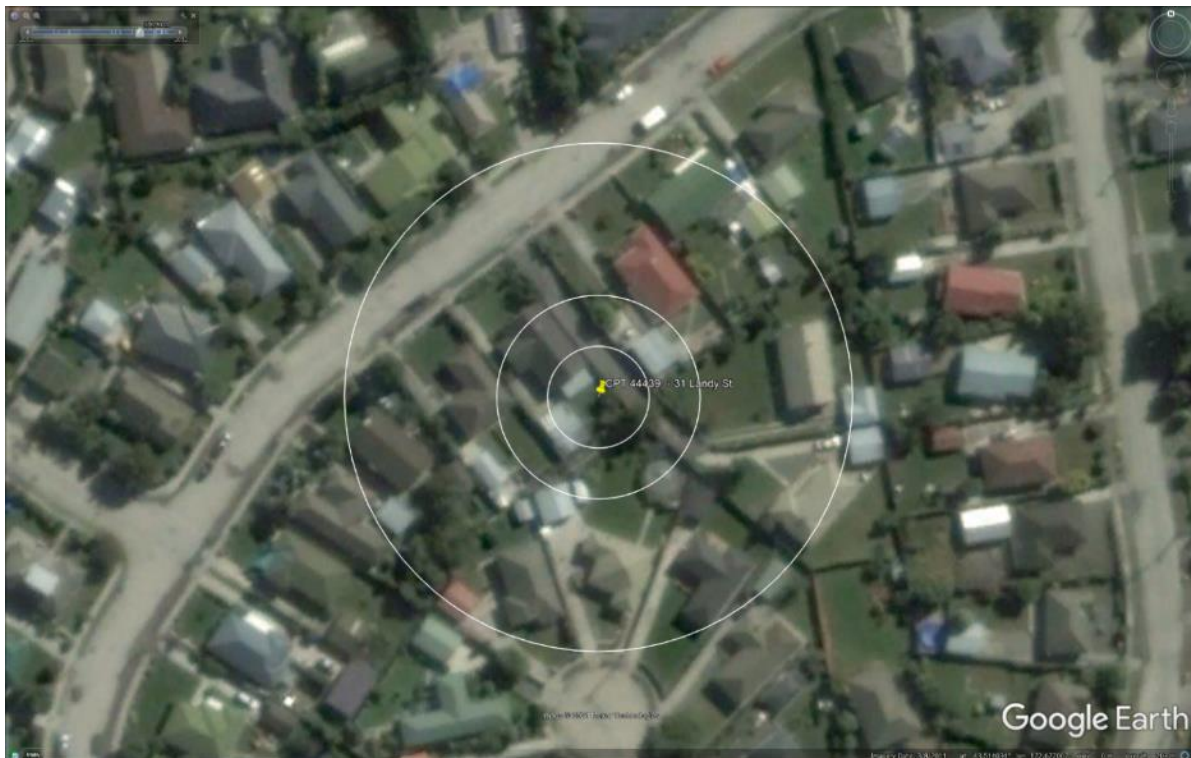
Figure 14: Satellite image of the site taken on Mar 8, 2011. It appears that some ejecta from the Feb-11 EQ remained at the site.

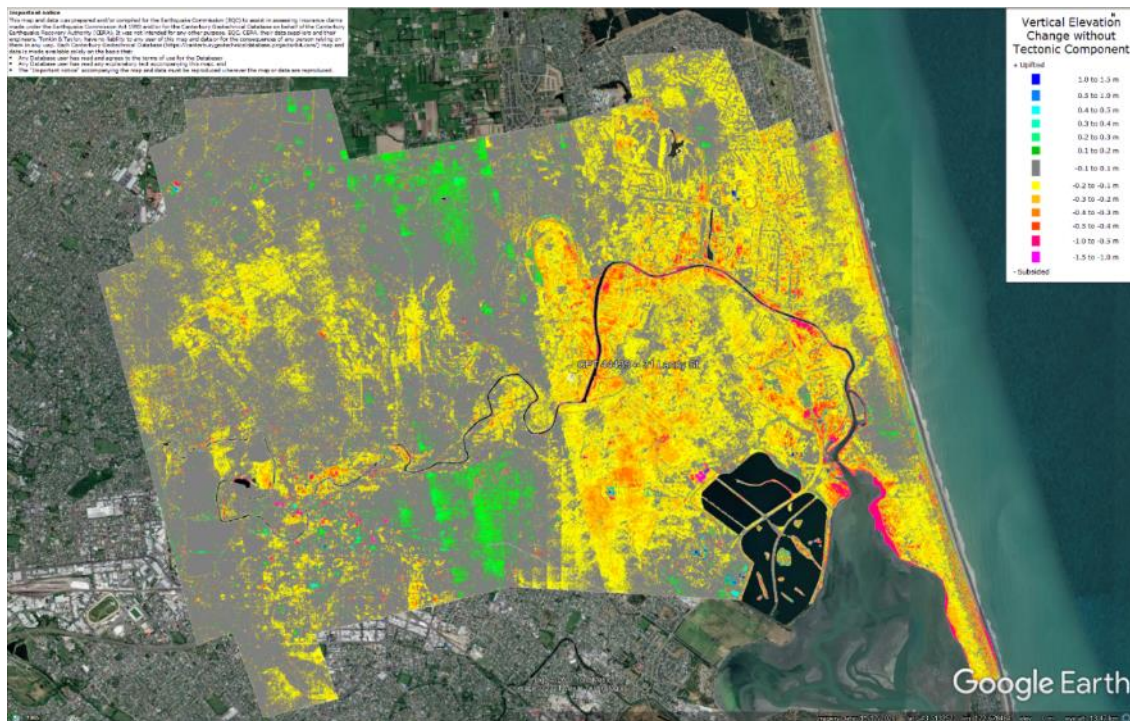
Figure 33: Vertical Ground Movements (Surface – Tectonic) for Feb 2011 Earthquake – the site is not in the apparent zone of underestimated ground surface subsidence.

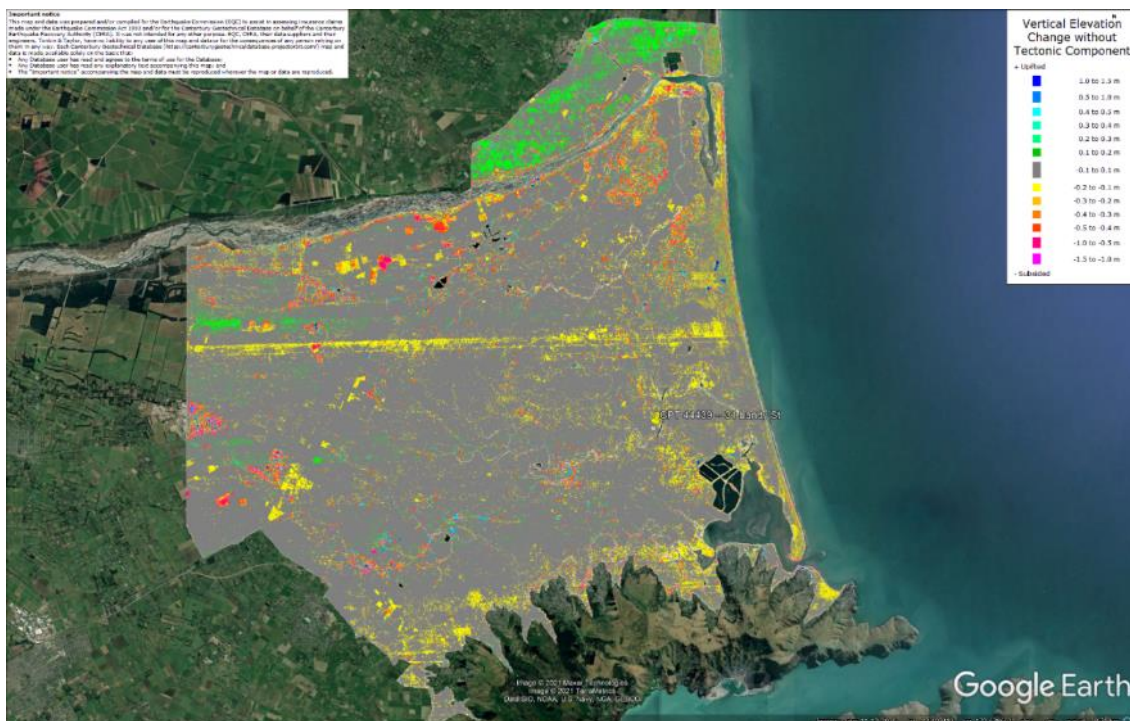
Figure 34: Vertical Ground Movements (Surface – Tectonic) for June 2011 Earthquake – the site is not in the apparent zone of overestimated/underestimated ground surface subsidence.

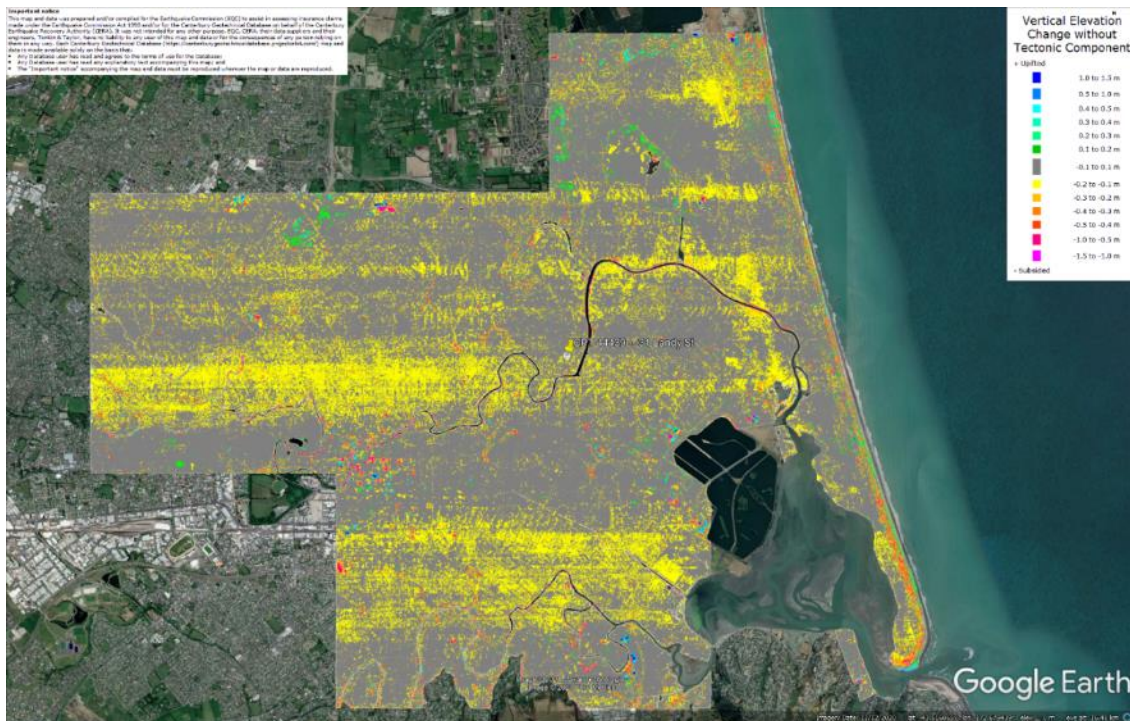
Figure 35: Vertical Ground Movements (Surface – Tectonic) for Dec 2011 Earthquake – the site is not in the apparent zone of overestimated/underestimated ground surface subsidence.

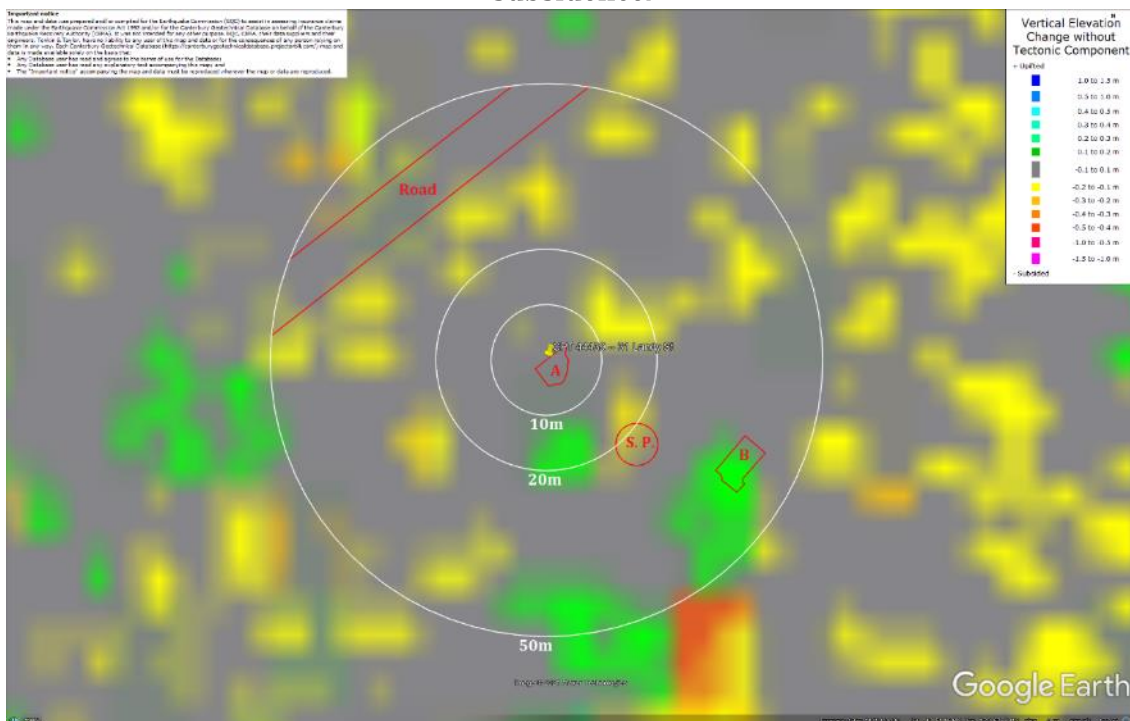
Figure 36: Ground surface subsidence without tectonic component for Sep 2010 Earthquake according to the LiDAR DEM.

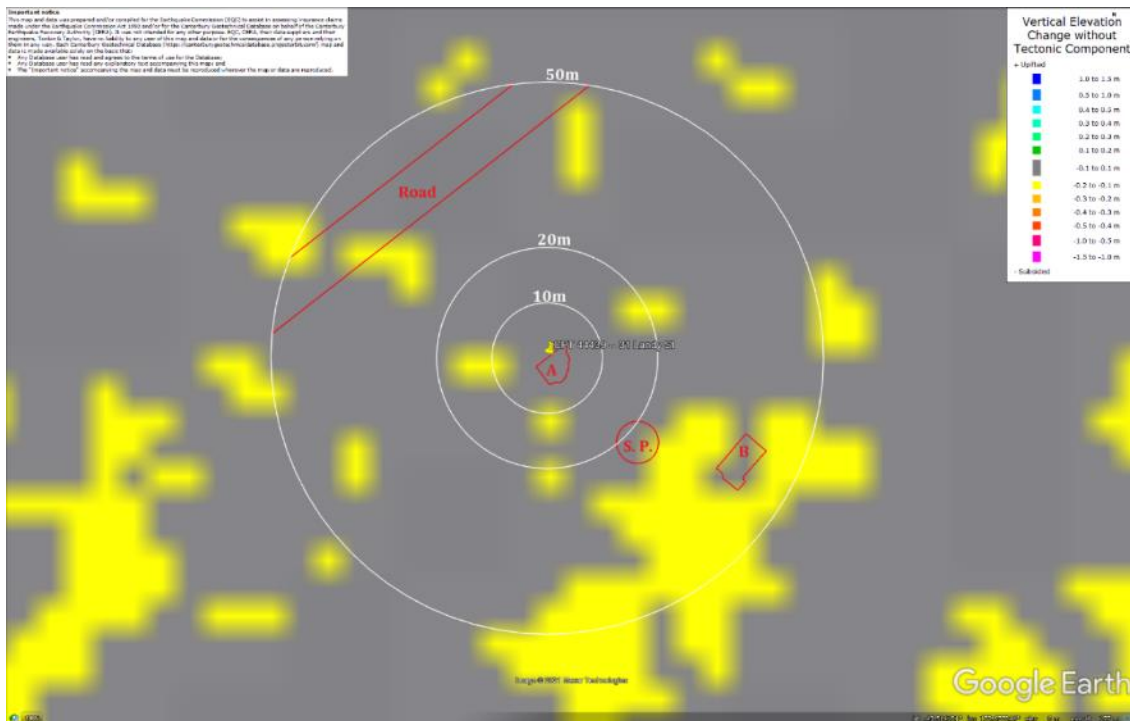
Figure 39: Ground surface subsidence without tectonic component for Dec 2011 Earthquake according to the LiDAR DEM.

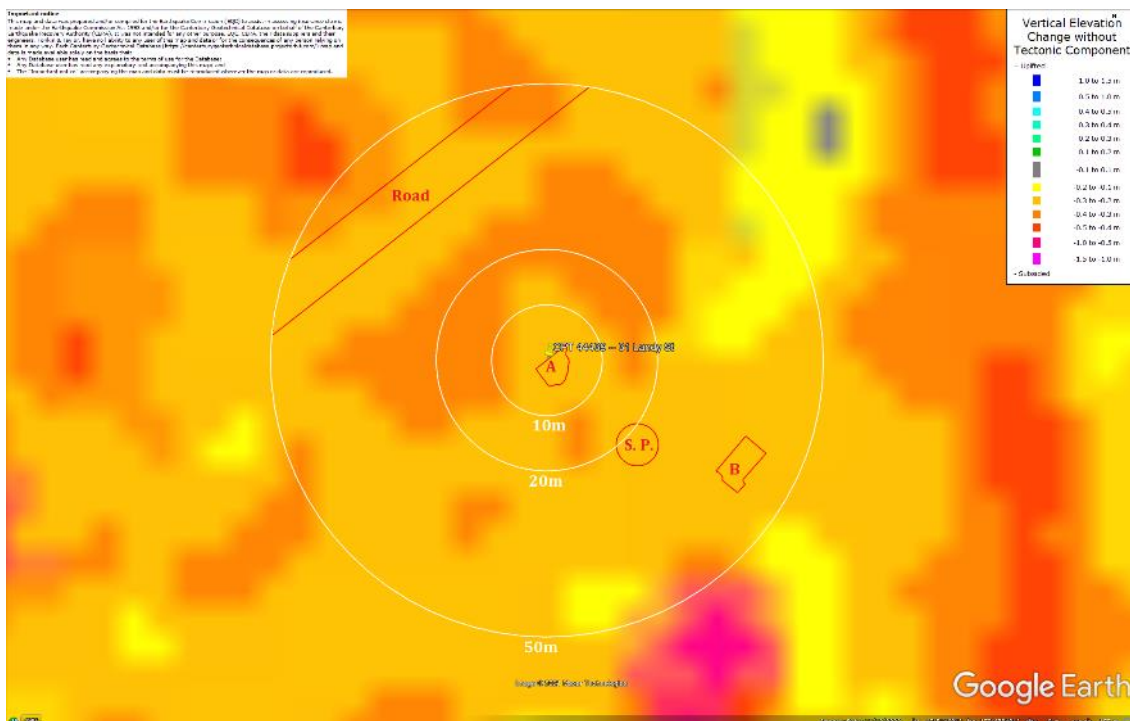
Figure 40: Ground surface subsidence without tectonic component for Canterbury Earthquake Sequence according to the LiDAR DEM.

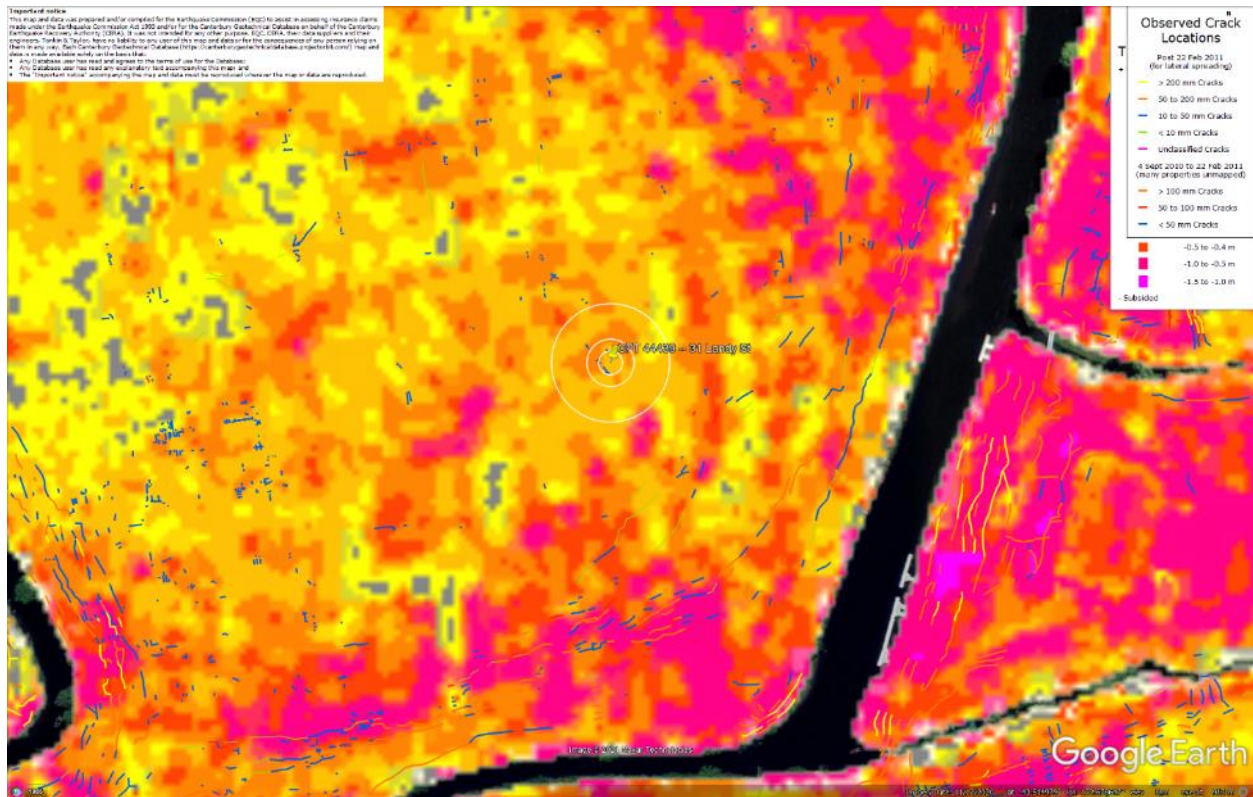
Figure 41: No lateral spreading for Canterbury Earthquake Sequence.

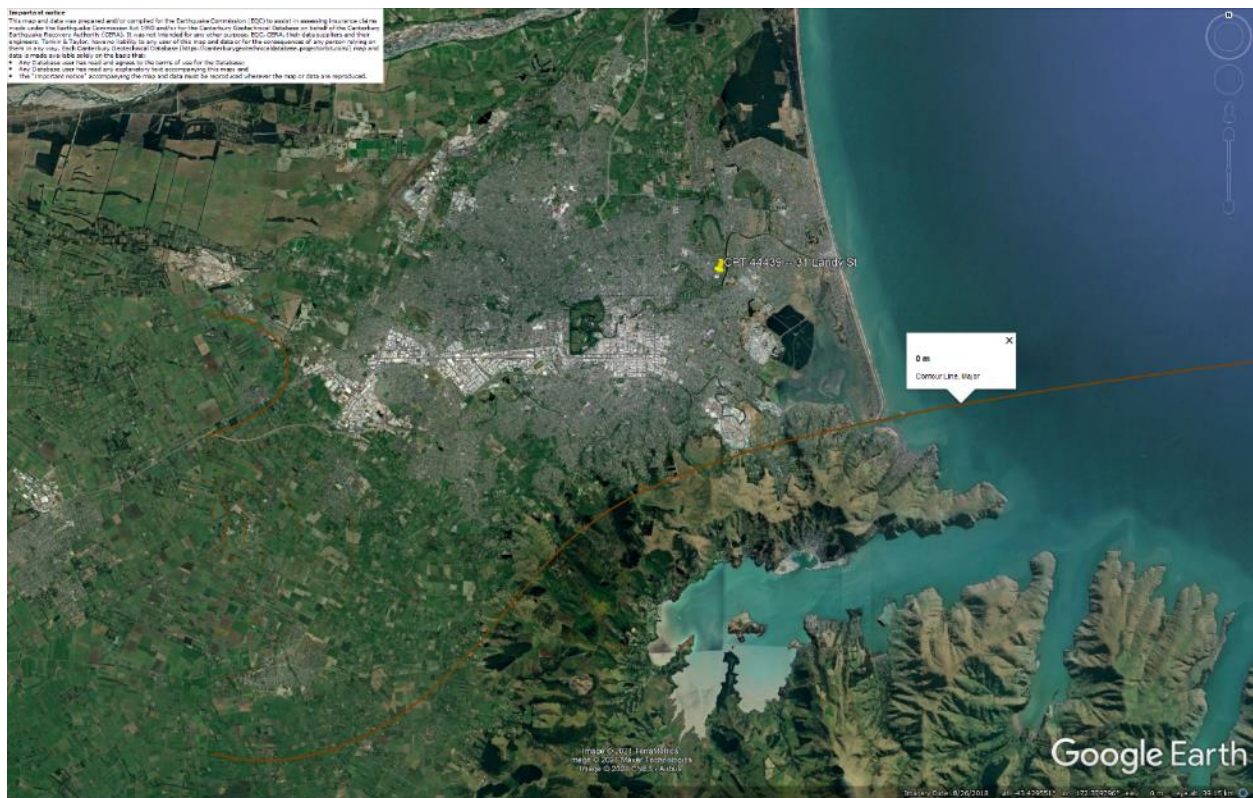
Figure 42: Vertical tectonic movements for Sep 2010 Earthquake.

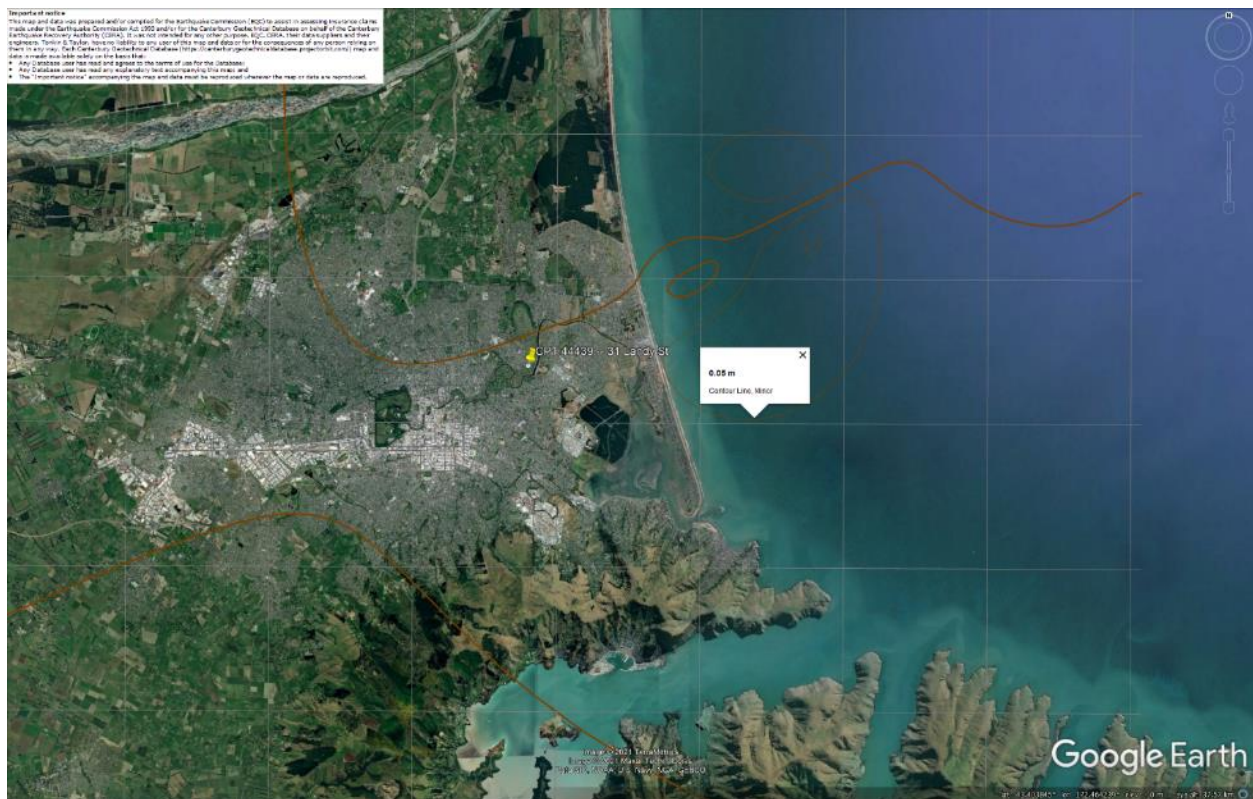
Figure 45: Vertical tectonic movements for Dec 2011 Earthquake.

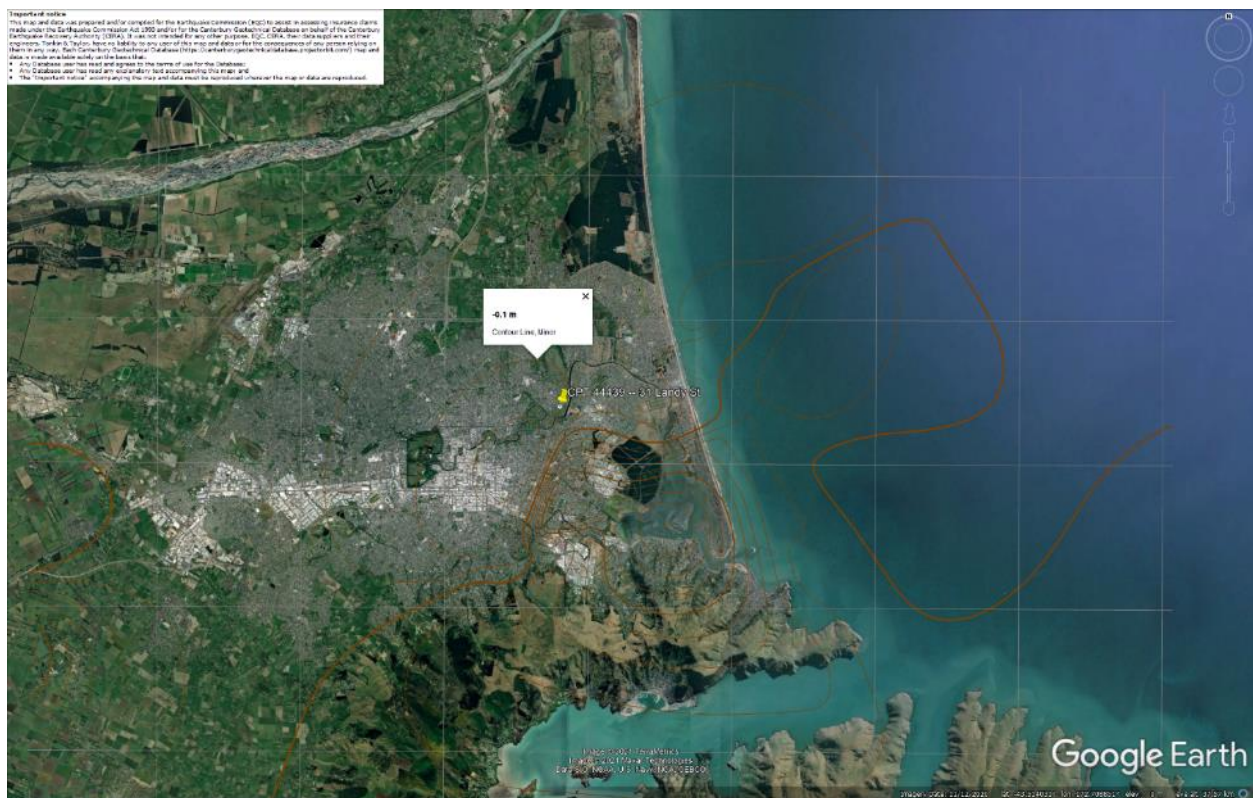
Figure 46: Vertical tectonic movements for Canterbury Earthquake Sequence.

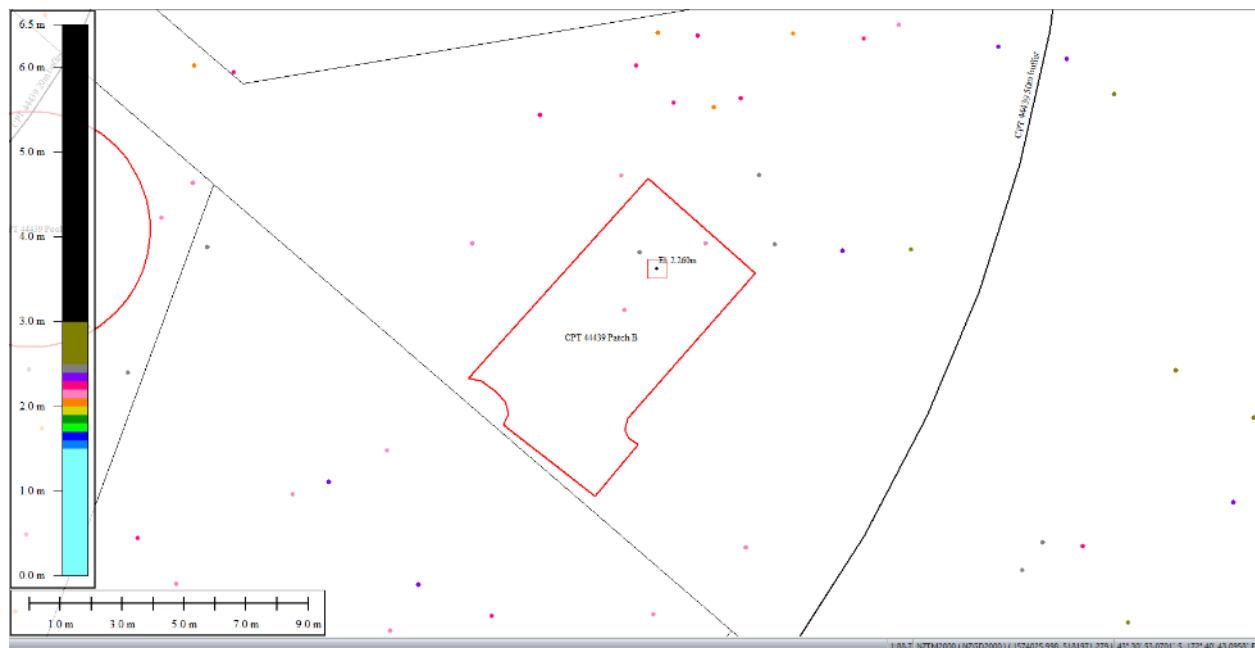
Figure 48: Ground surface elevation averaged over 50-m buffer for Patch B for Jul 2003 LiDAR survey.

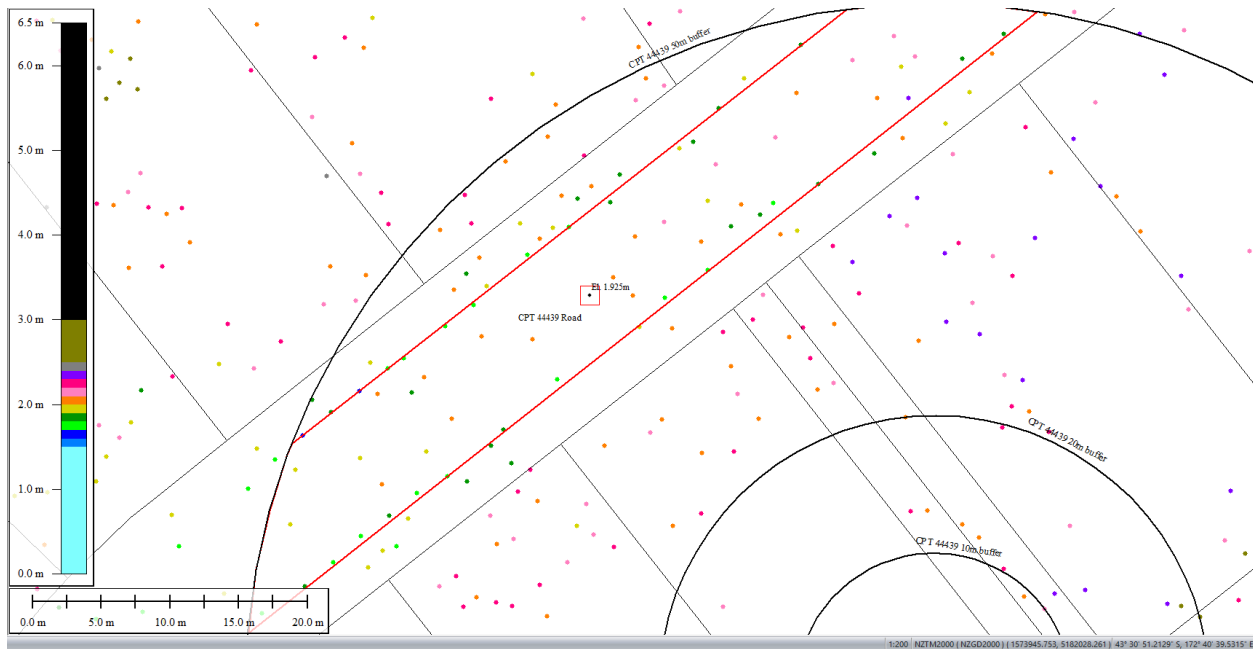
Figure 49: Ground surface elevation averaged over 50-m buffer for Road for Jul 2003 LiDAR survey.

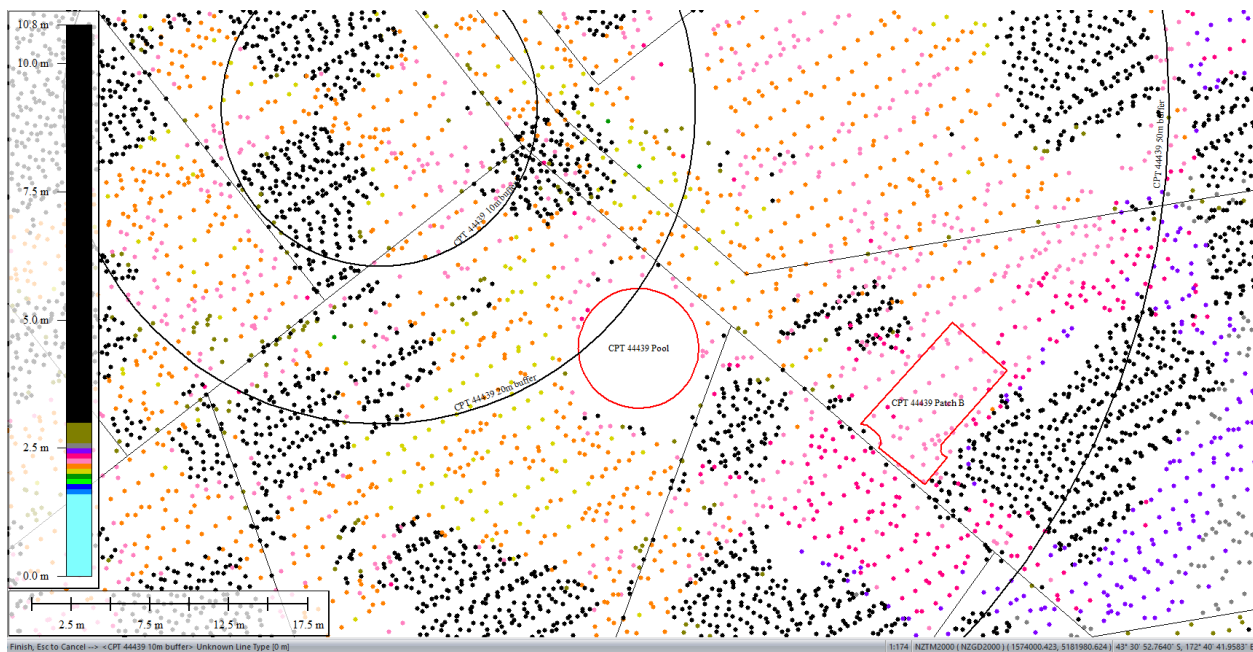
Figure 52: Ground surface elevation averaged over 50-m buffer for Swimming Pool for Sep 5, 2010, LiDAR survey.

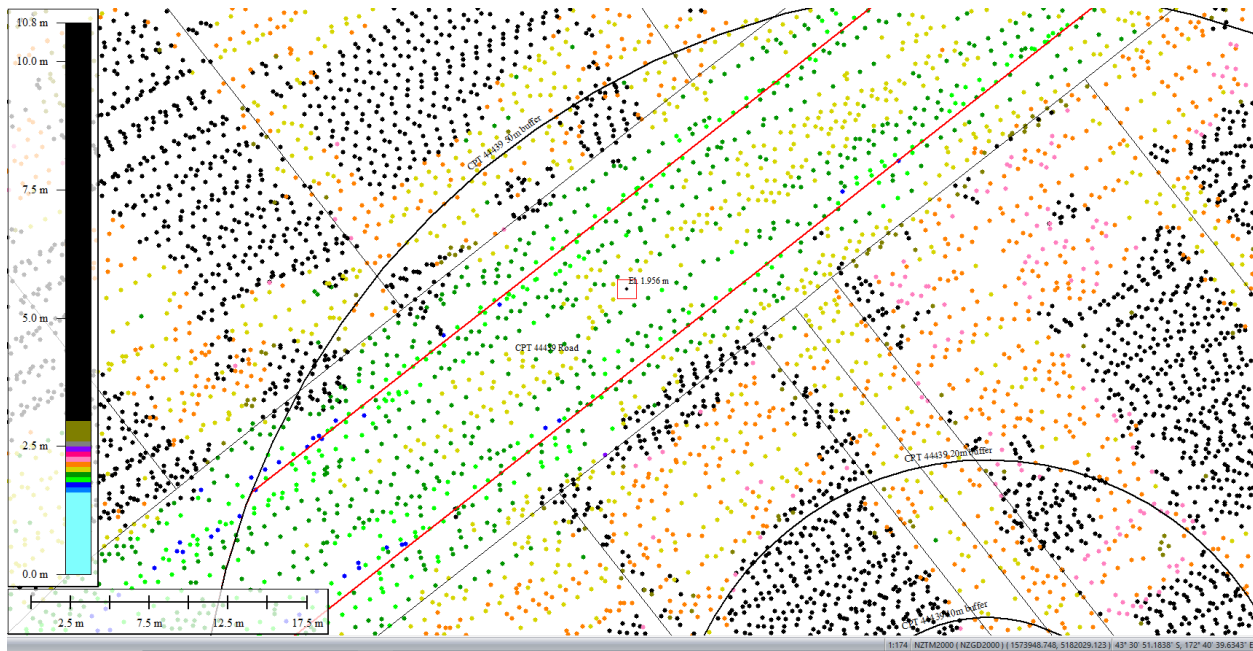
Figure 53: Ground surface elevation averaged over 50-m buffer for Road for Sep 5, 2010, LiDAR survey.

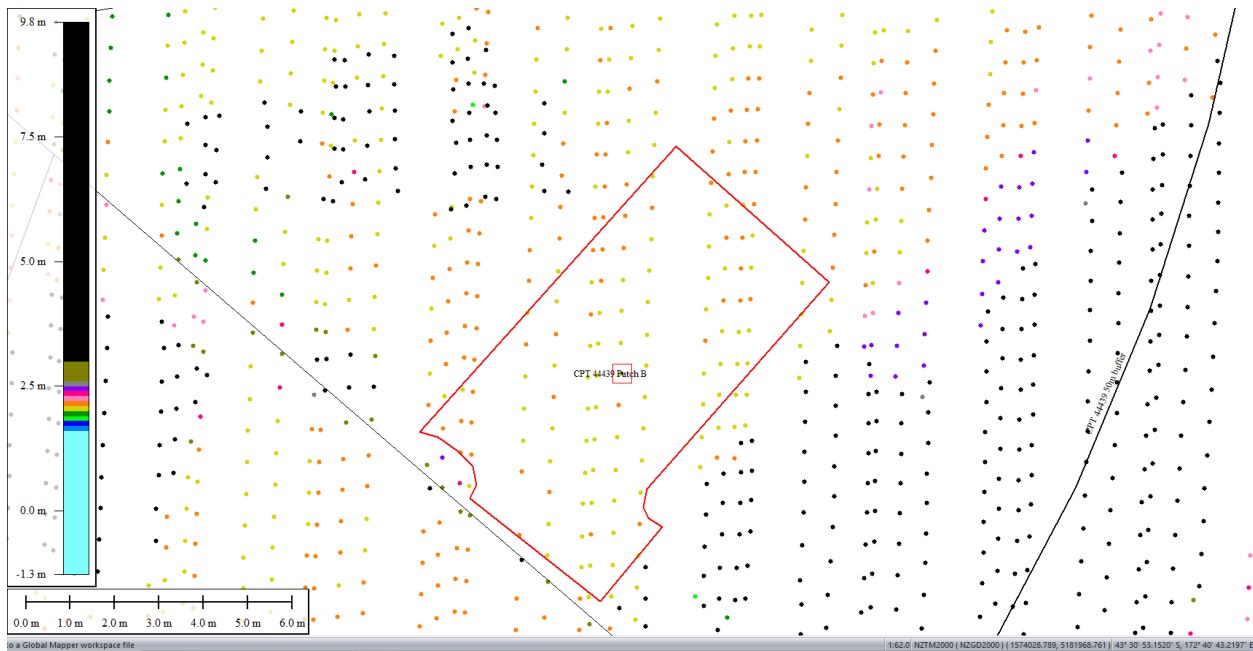
Figure 55: Ground surface elevation averaged over 50-m buffer for Patch B for Mar 2011 LiDAR survey (el. 2.091m).

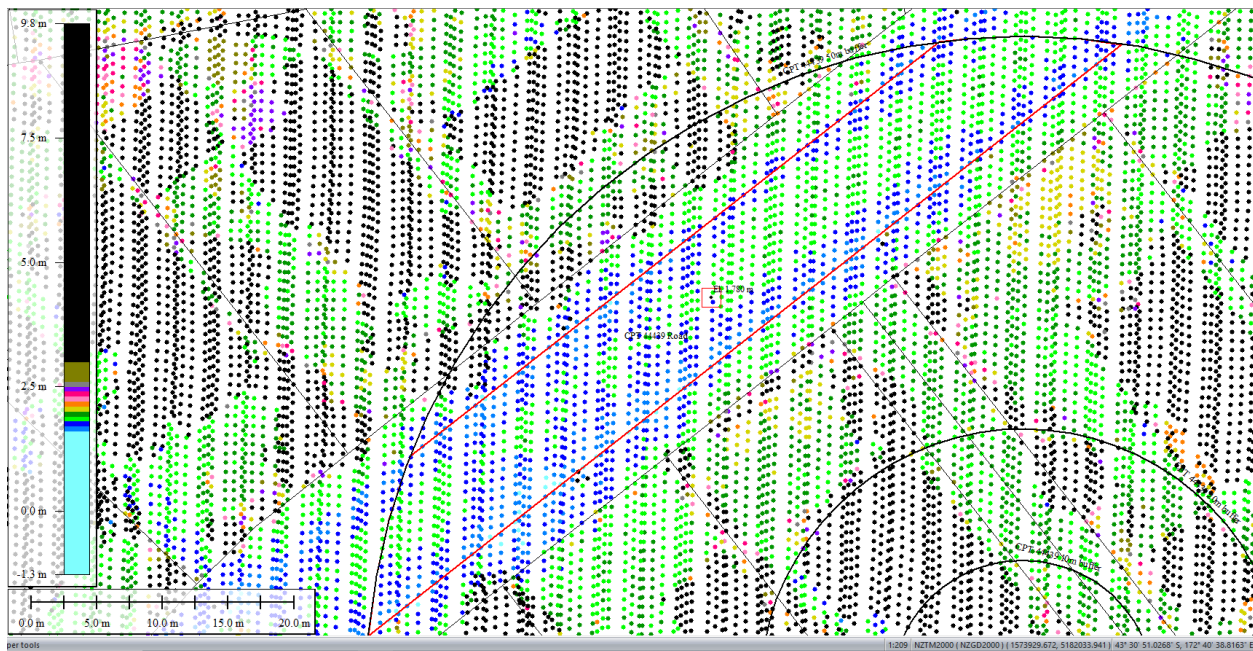
Figure 56: Ground surface elevation averaged over 50-m buffer for Road for Mar 2011 LiDAR survey.

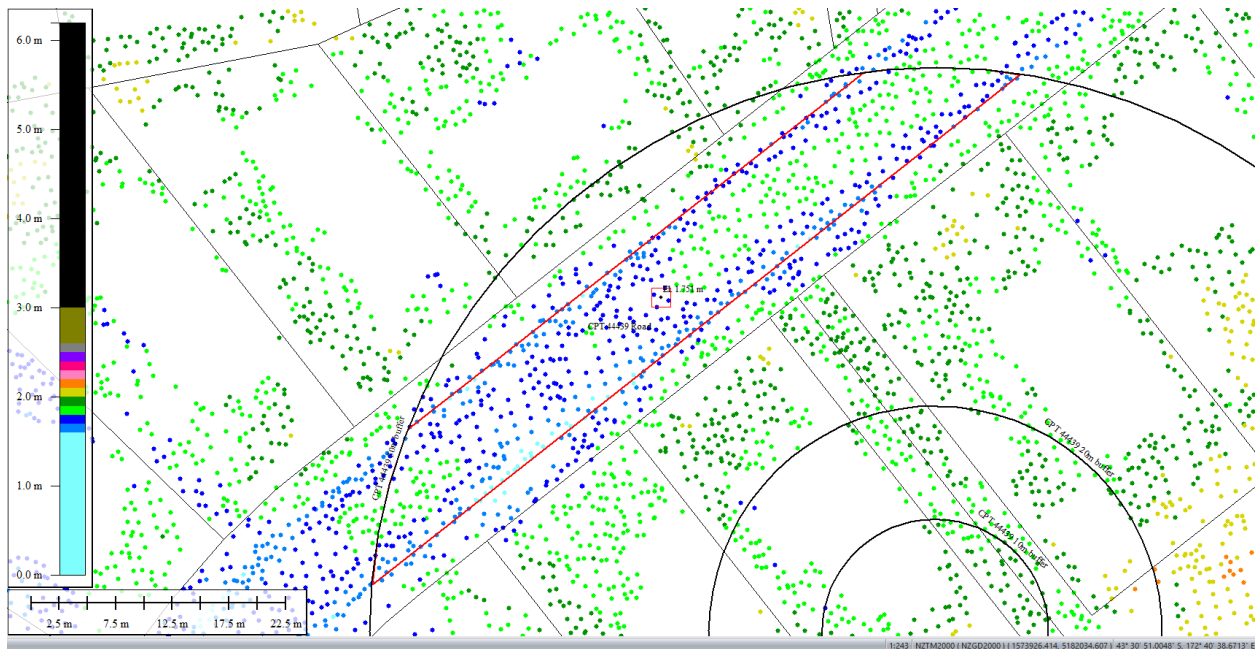
Figure 59: Ground surface elevation averaged over 50-m buffer for Road for May 2011 LiDAR survey.

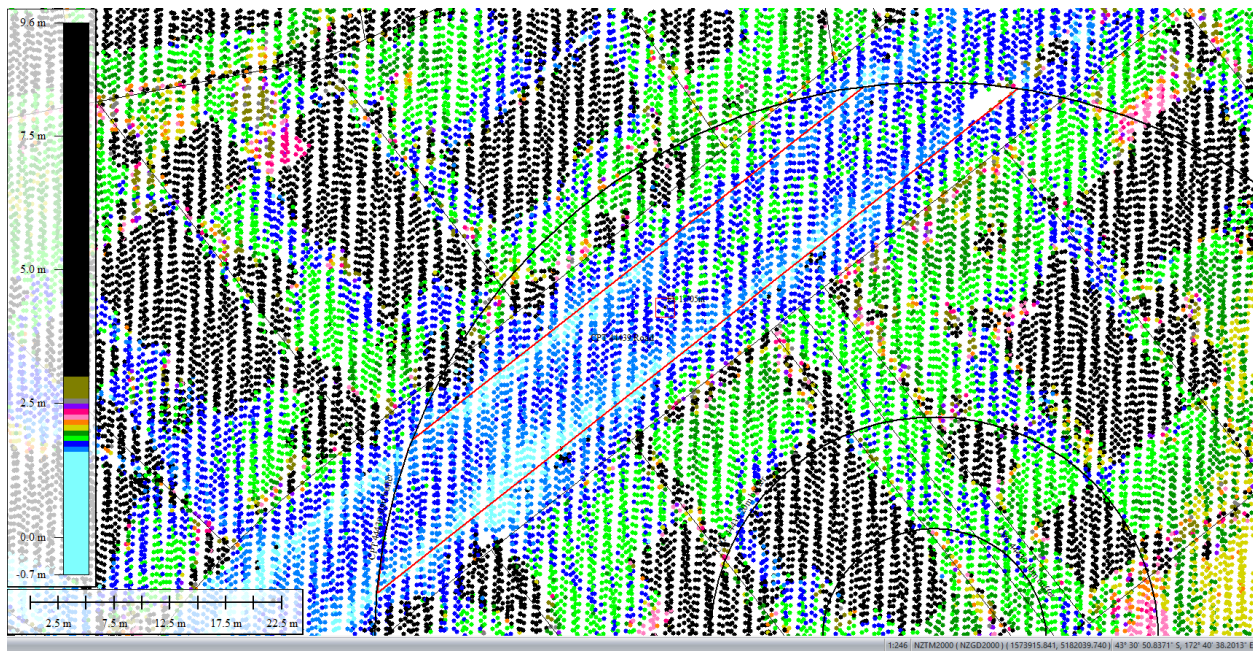
Figure 62: Ground surface elevation averaged over 50-m buffer for Road for Sep 2011 LiDAR survey.

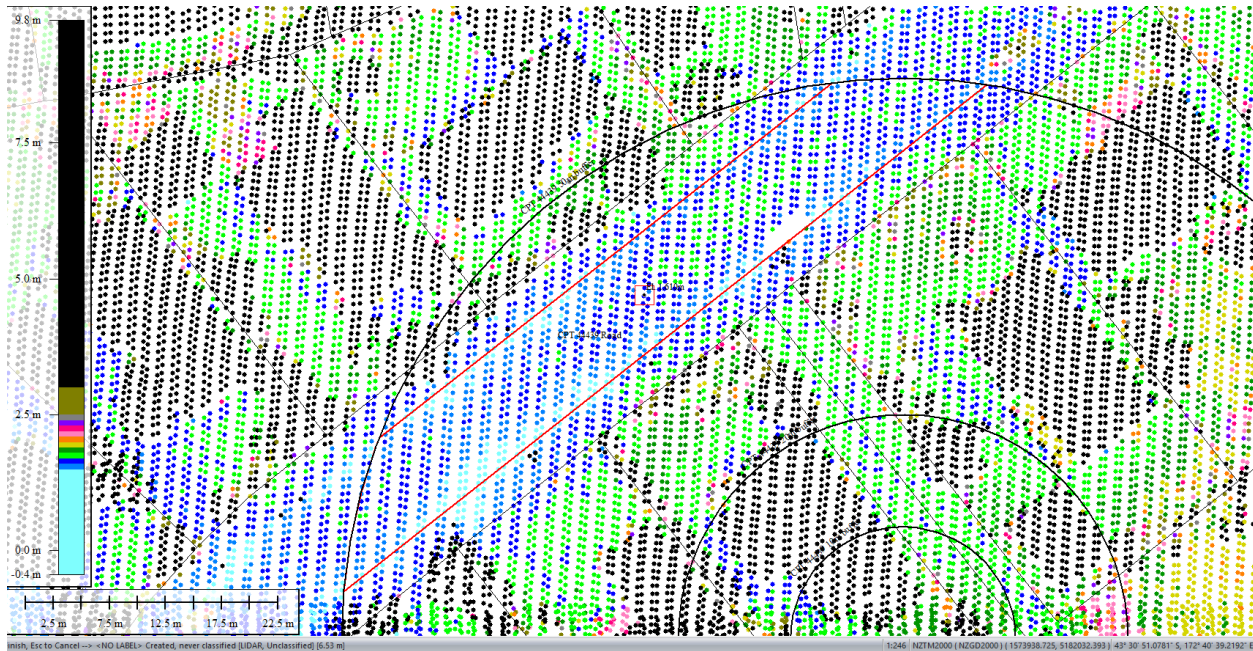
Figure 65: Ground surface elevation averaged over 50-m buffer for Road for Feb 2012 LiDAR survey.

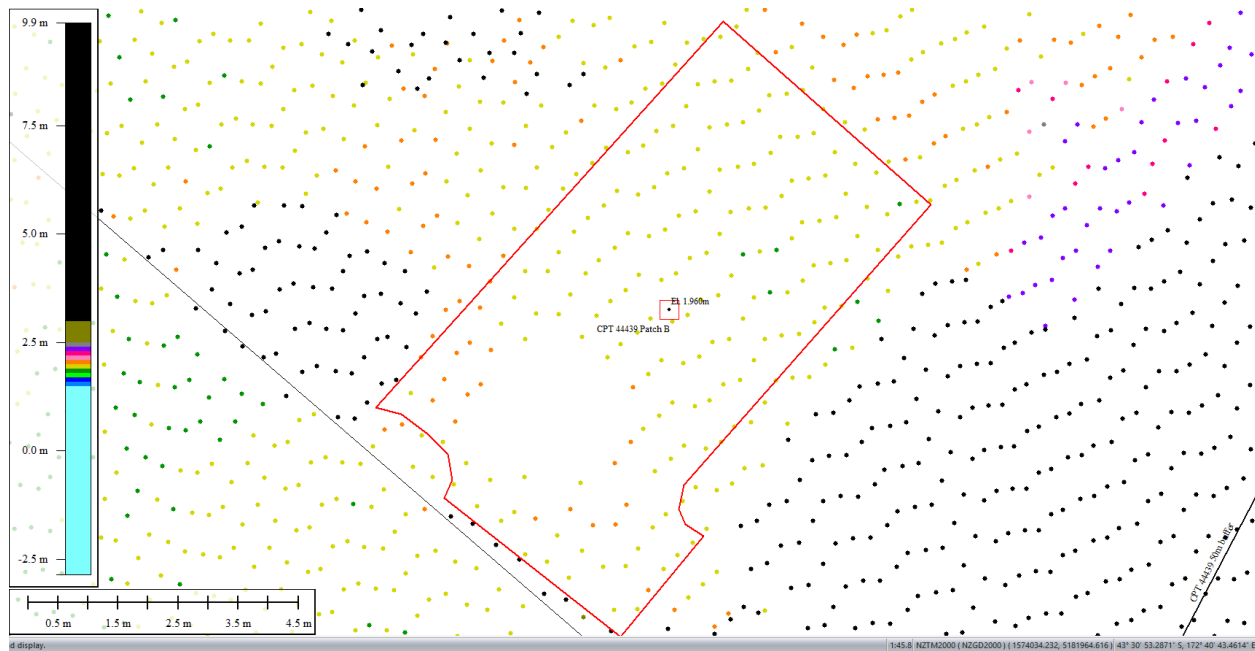
Figure 67: Ground surface elevation averaged over 50-m buffer for Patch B for Oct 2015 LiDAR survey.
