Appendix A.22:

31 Landy St – CPT 44439 (VsVp 57203)

Liquefaction Ejecta Case Histories for 2010-11 Canterbury Earthquakes

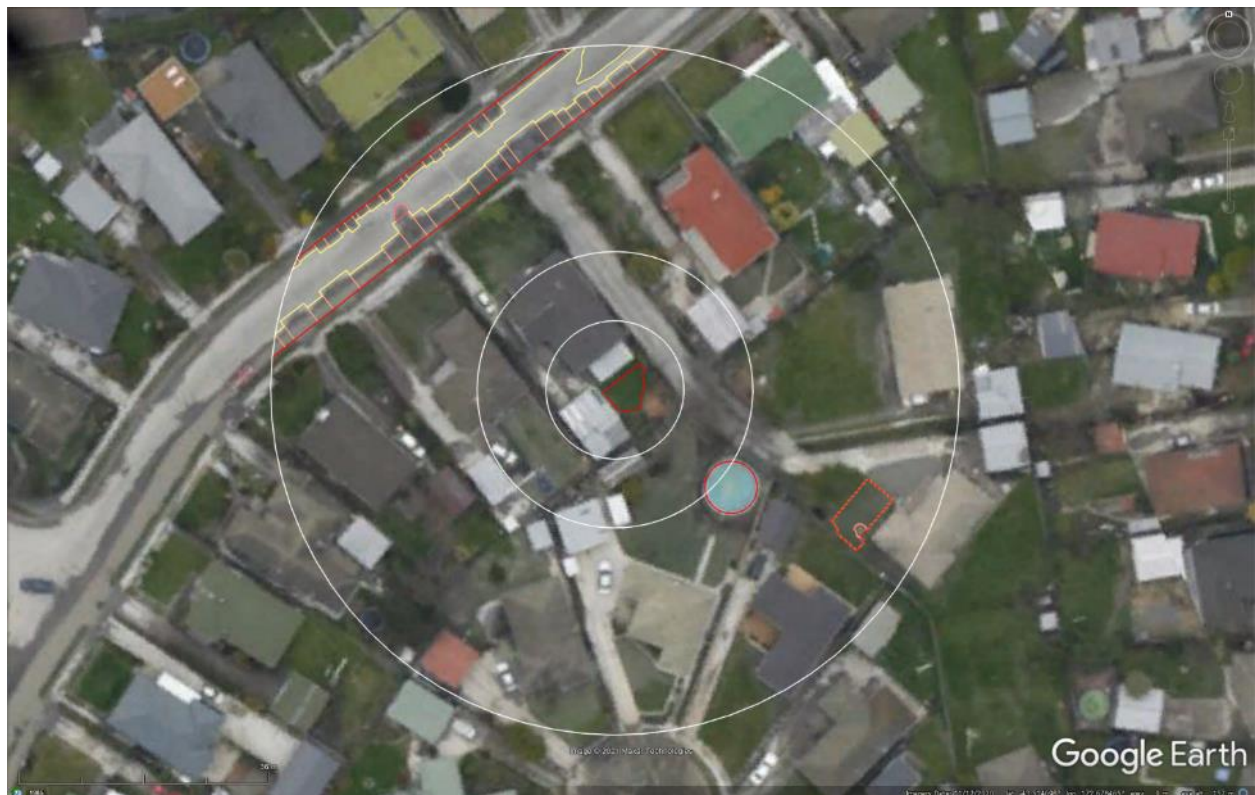
Figure 68: Aerial photograph showing the ejecta outline at the site for the Sep-10 EQ.

Note 4: The values in Table 9 correspond to the coverage area of ejecta outlined in aerial photographs (Figures 68-71) and the lower and upper estimates of ejecta height based on geometrical approximations, ground photographs (Figures 74, 77, 78, 81, and 82), and EQC LDAT property inspection reports (e.g., Figures 72, 73, 75, 76, 79, and 80). The ejecta-induced settlement using photographs and engineering judgment, $S_{E,P}$, is estimated as

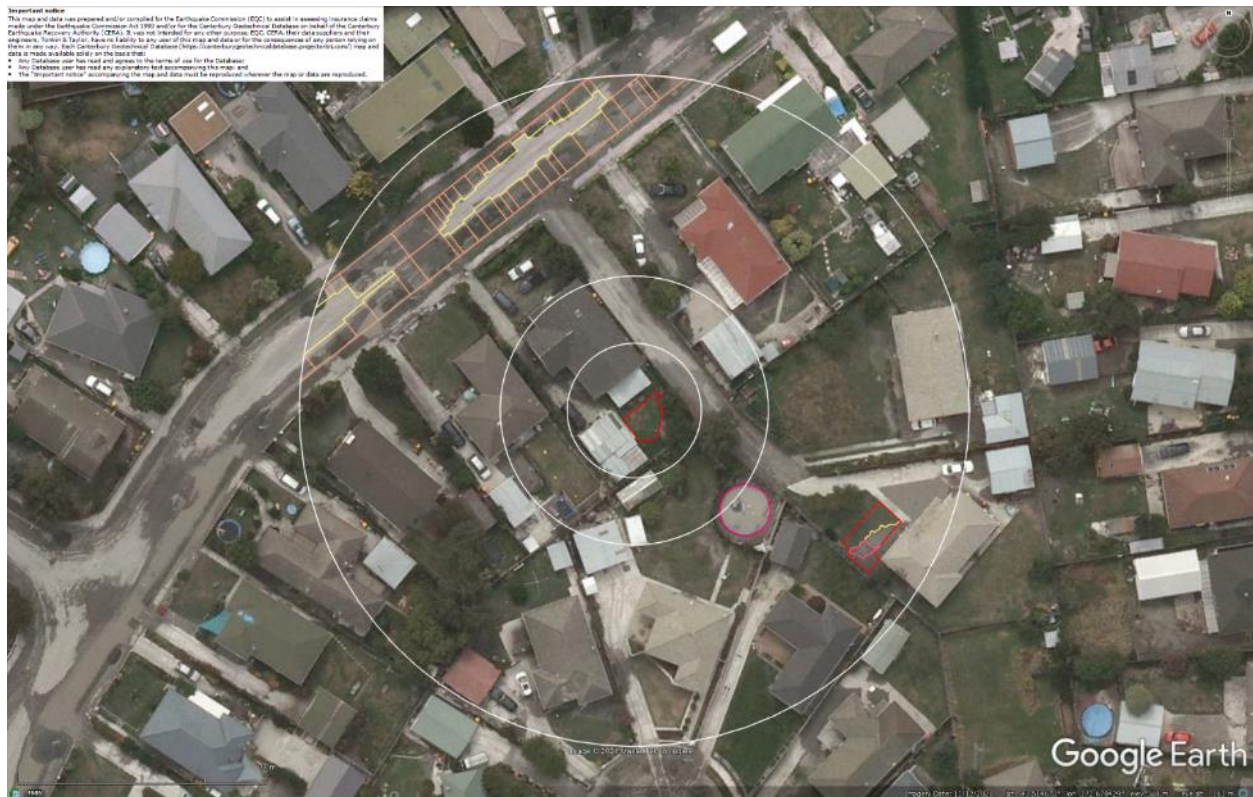
Figure 69: Aerial photograph showing the ejecta outline at the site for the Feb-11 EQ.

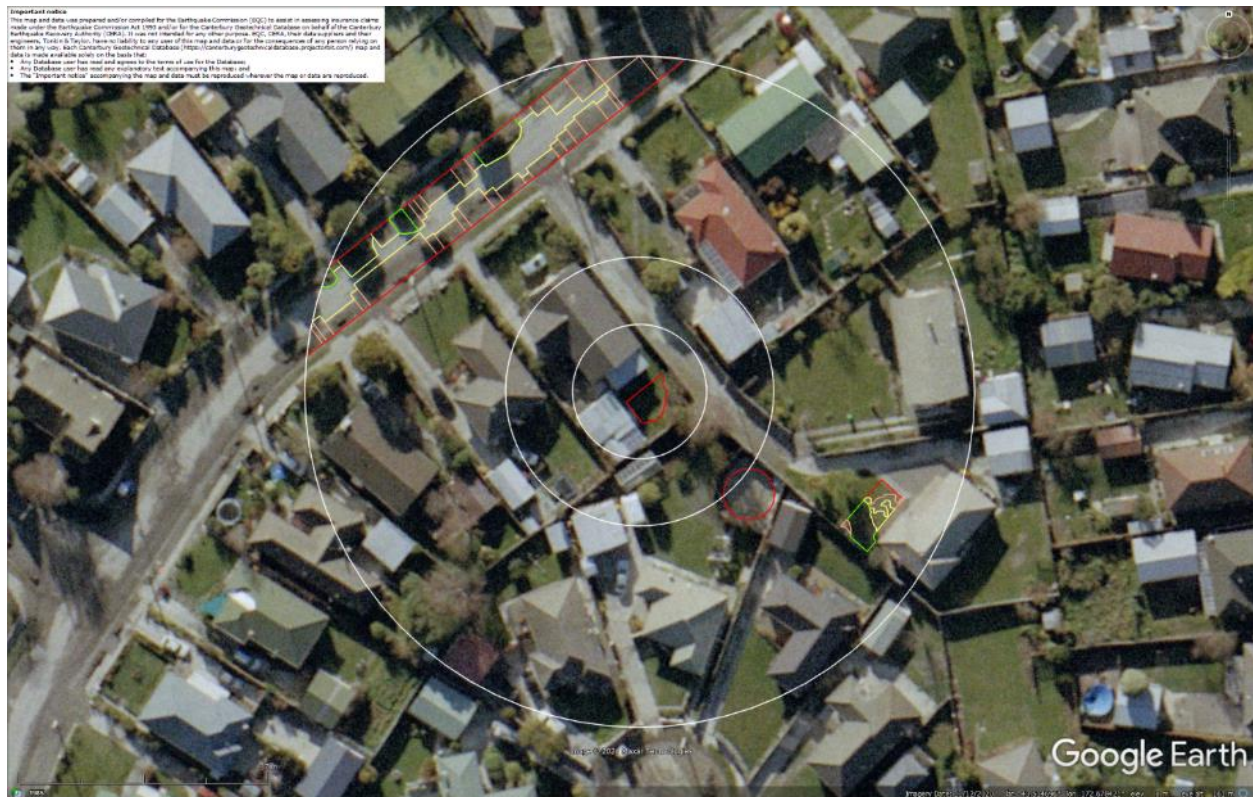
Figure 70: Aerial photograph acquired on 16 Jun 2011 showing the ejecta outline at the site for the Jun-11 EQ.

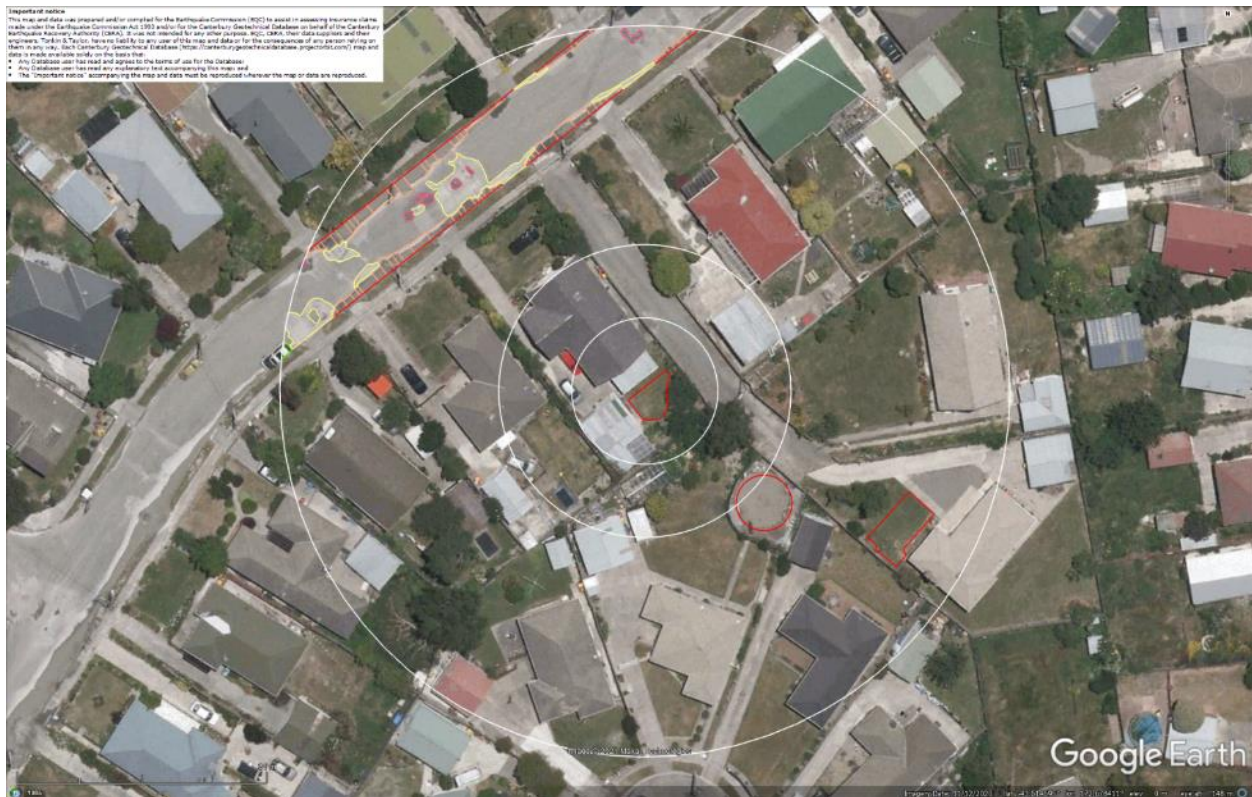
Figure 71: Aerial photograph showing the ejecta outline at the site for the Dec-11 EQ.

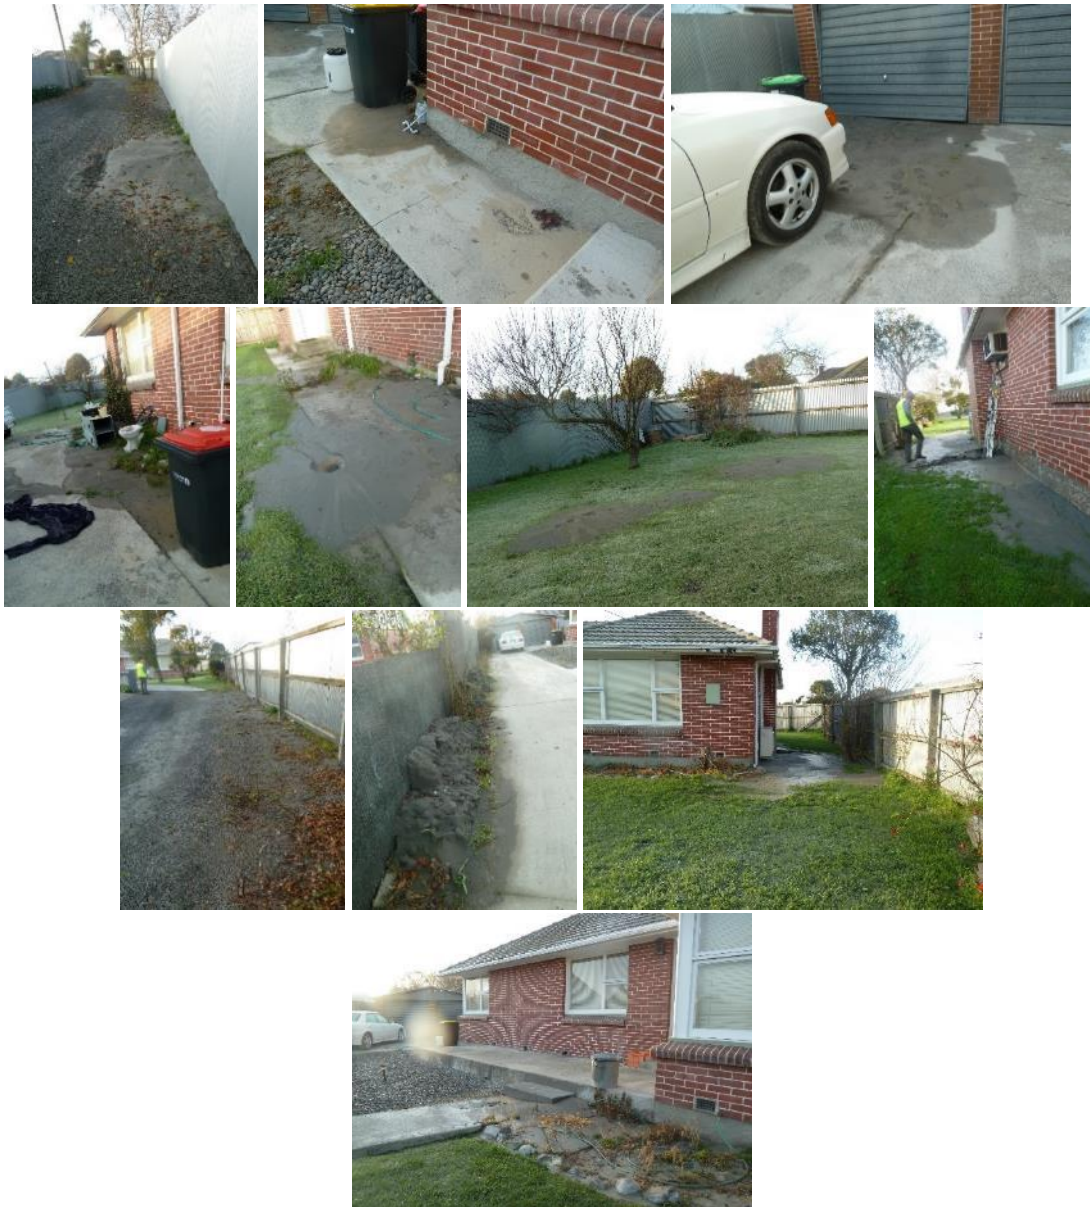
Figure 78: Ground photographs showing ejecta at the property with Patch B (photograph date: 17 June 2011).

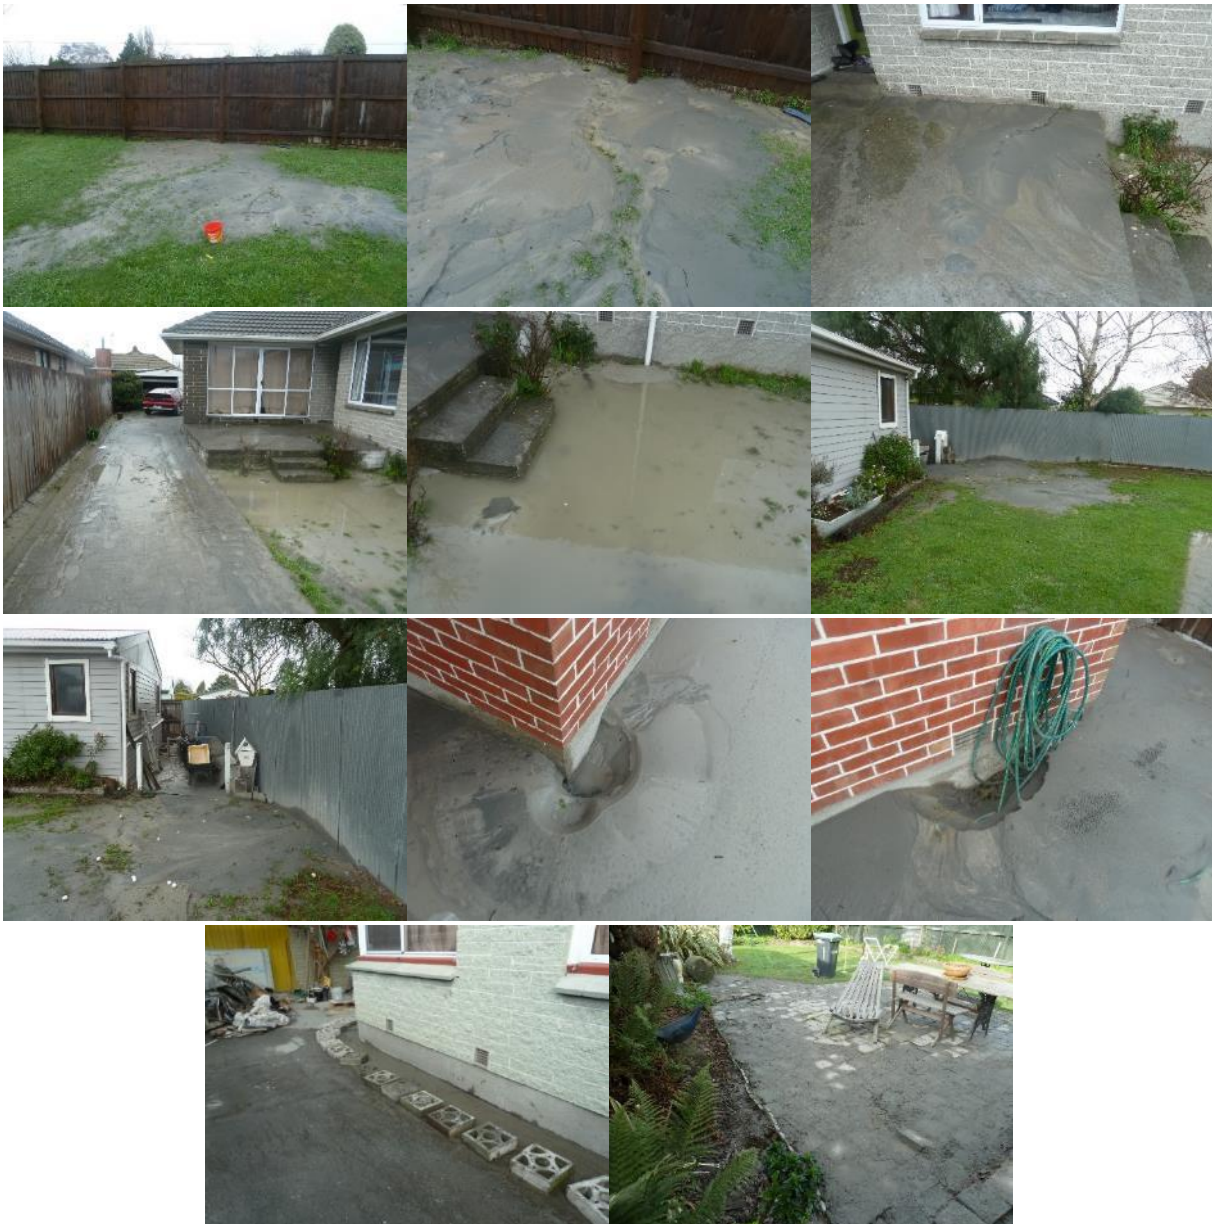
Figure 82: Ground photographs showing ejecta at some properties within the 50-m buffer (photograph date: 17 June 2011).

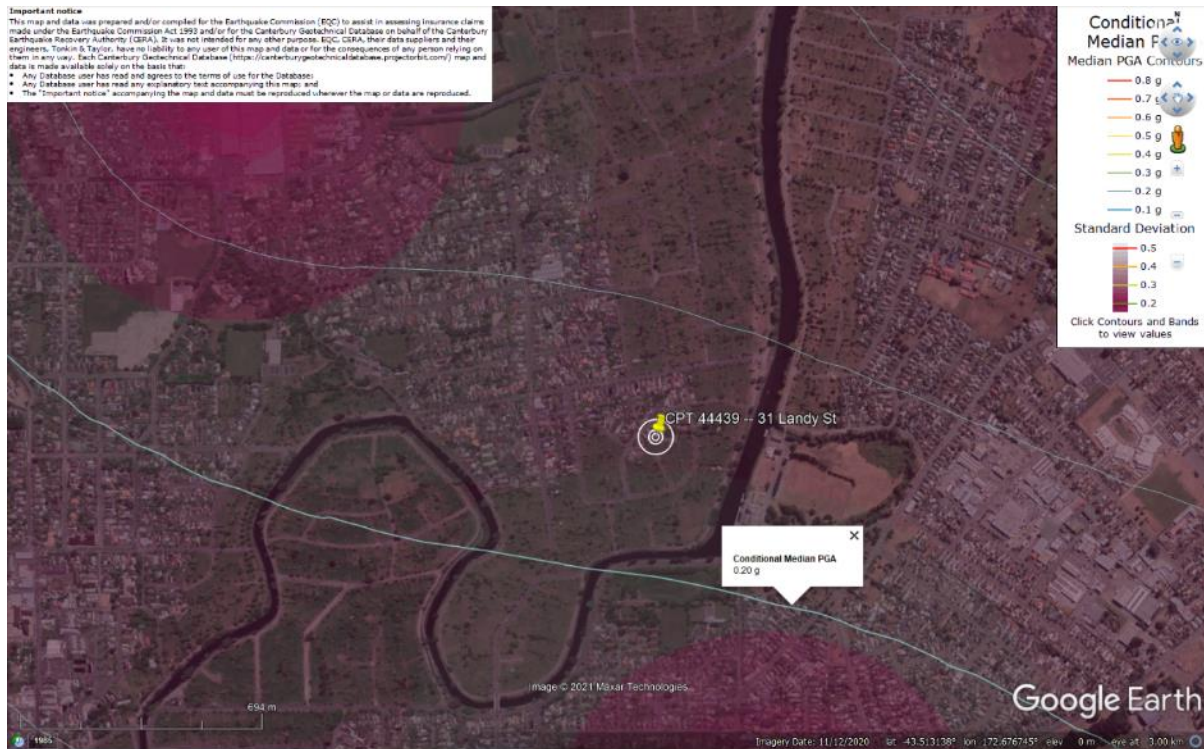
Figure 83: PGA for Sep-10 EQ (st. dev. = 0.300-0.325 ln units).

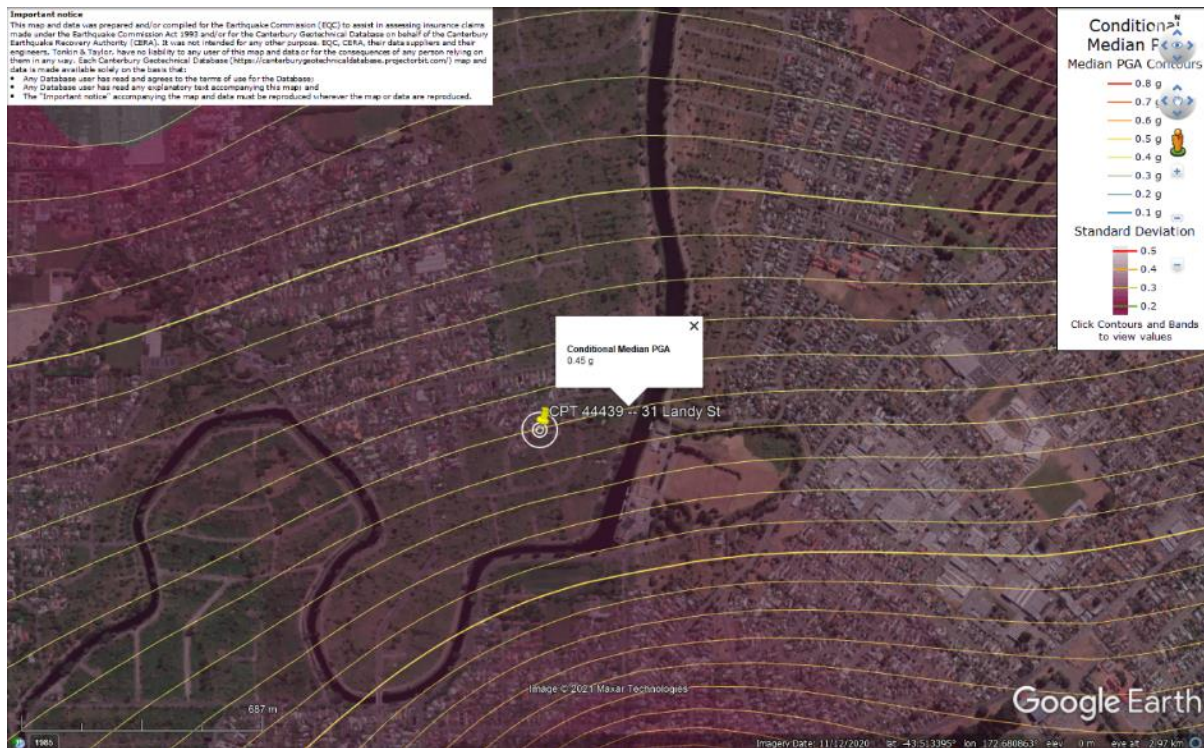
Figure 84: PGA for Feb-11 EQ (st. dev. = 0.300-0.325 ln units).

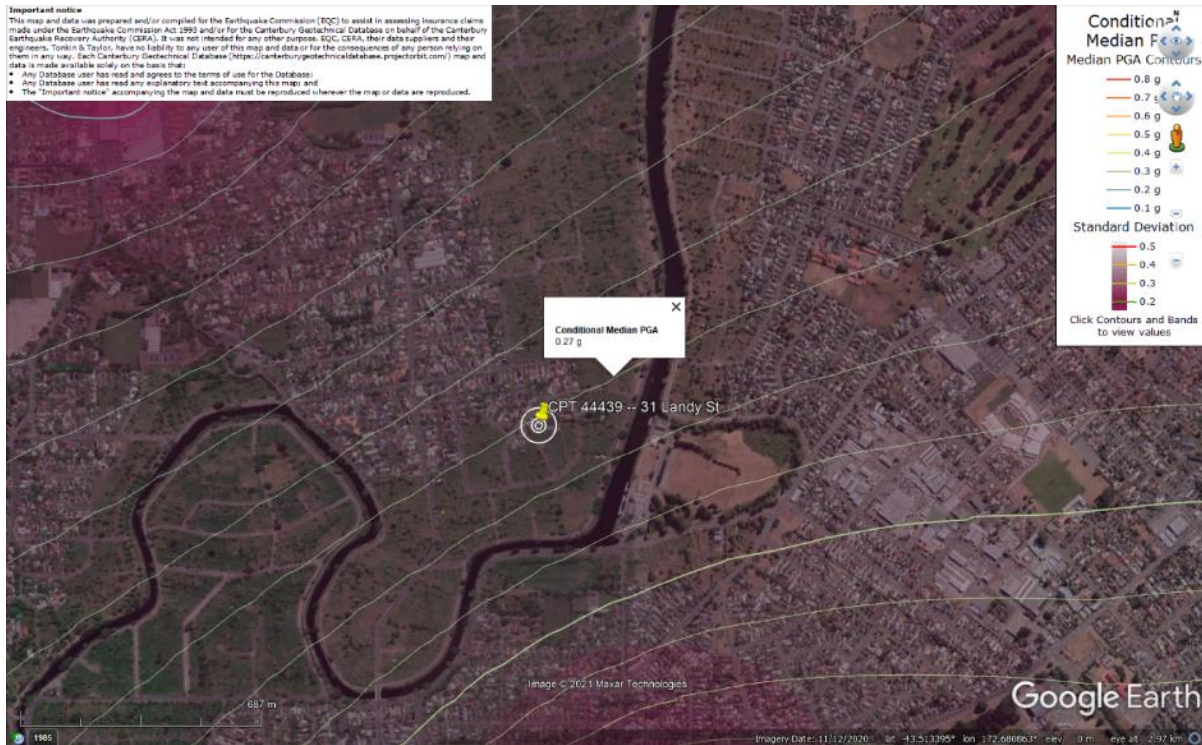
Figure 85: PGA for Jun-11 EQ (st. dev. = 0.325-0.350 ln units).

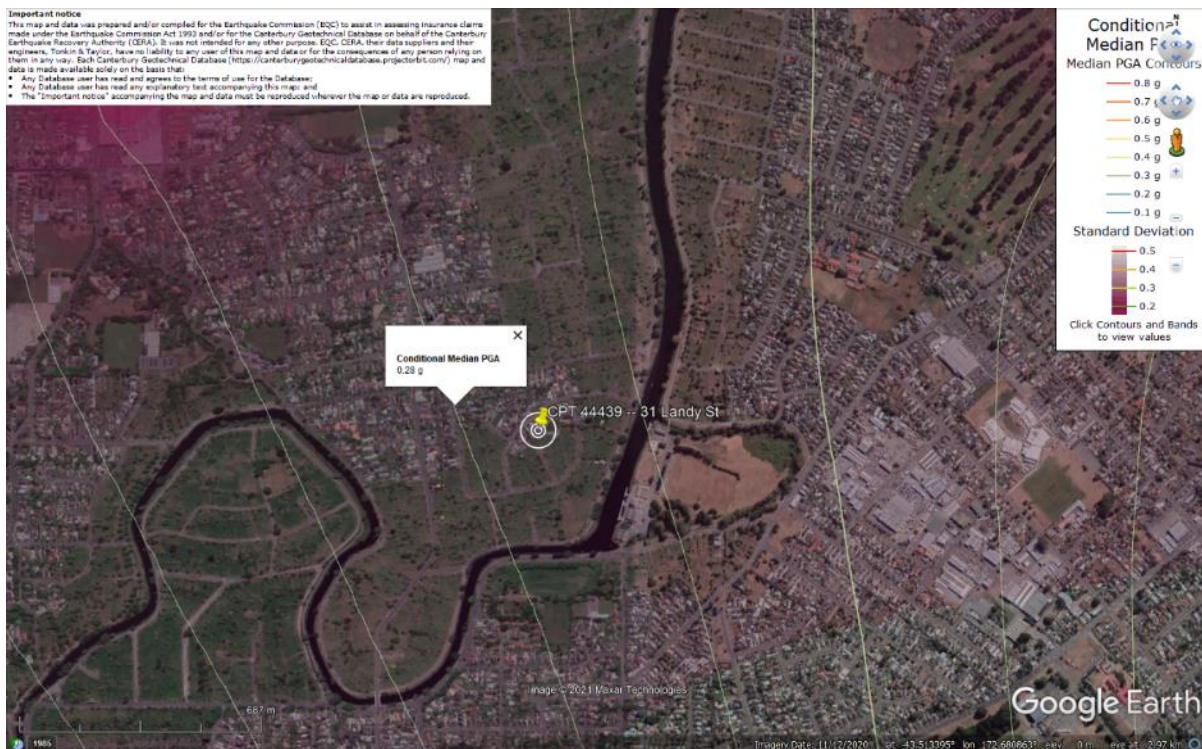
Figure 86: PGA for Dec-11 EQ (st. dev. = 0.375-0.400 ln units).

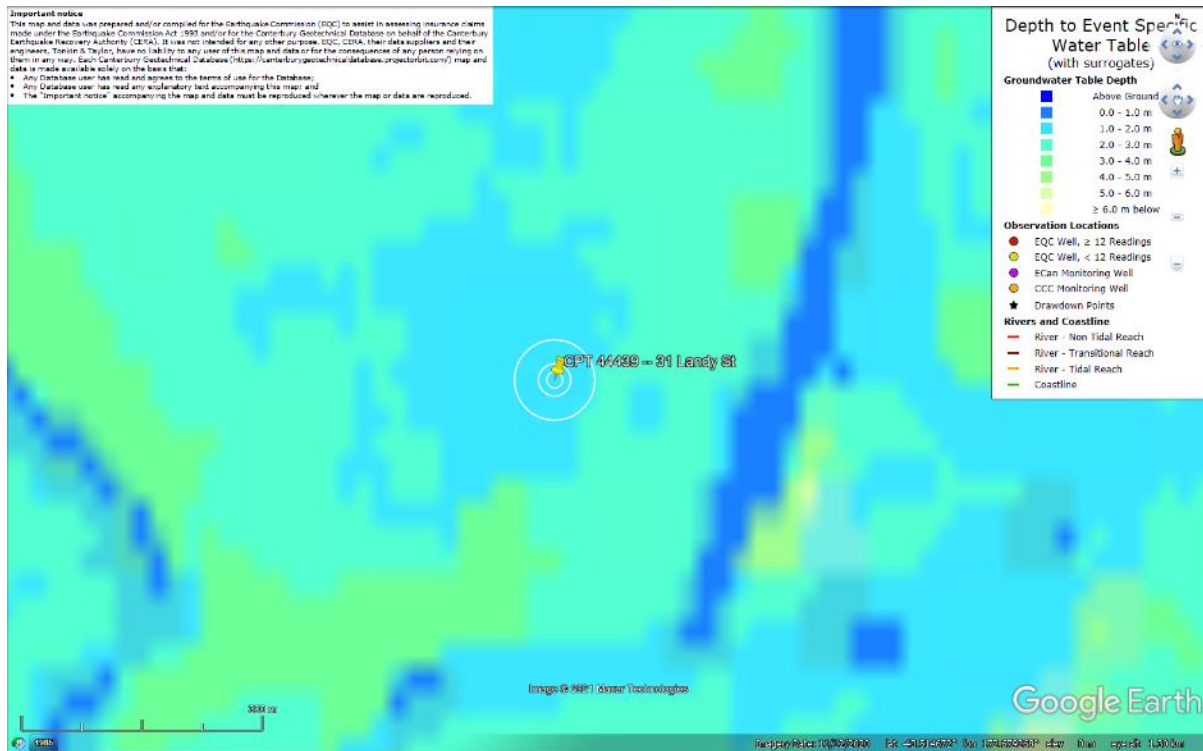
Figure 87: Depth to groundwater table for Sep-10 EQ.

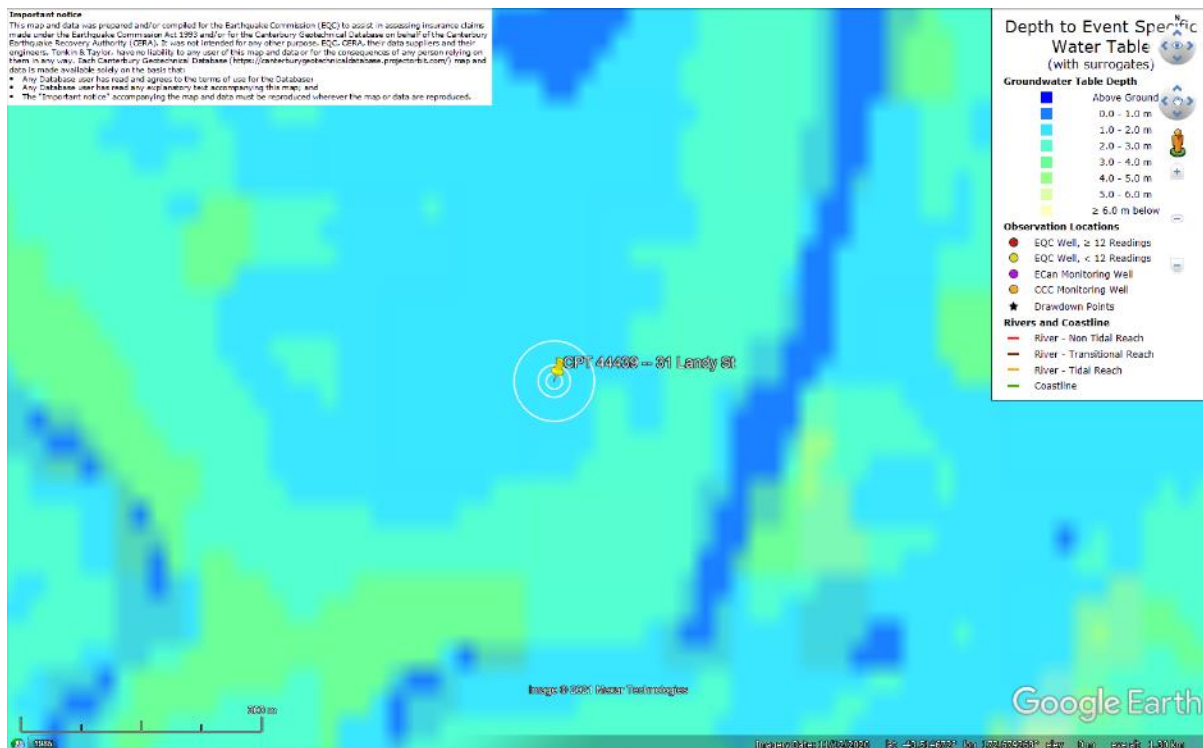
Figure 88: Depth to groundwater table for Feb-11 EQ.

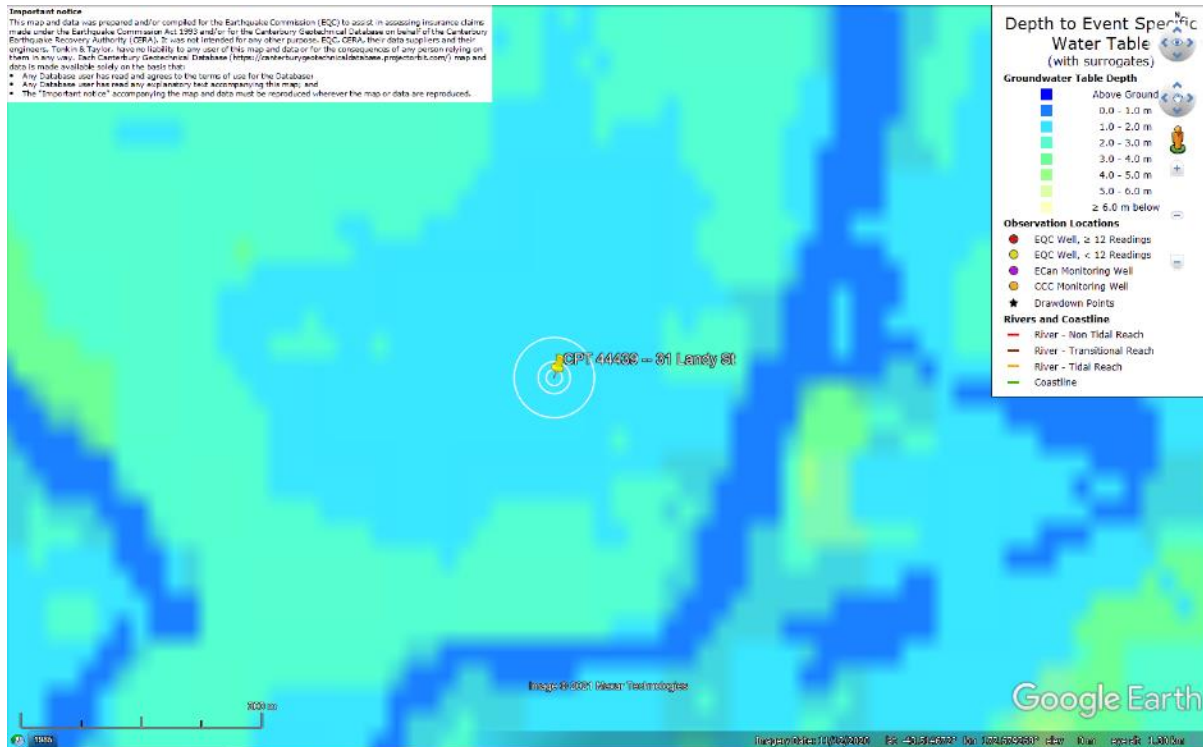
Figure 89: Depth to groundwater table for Jun-11 EQ.

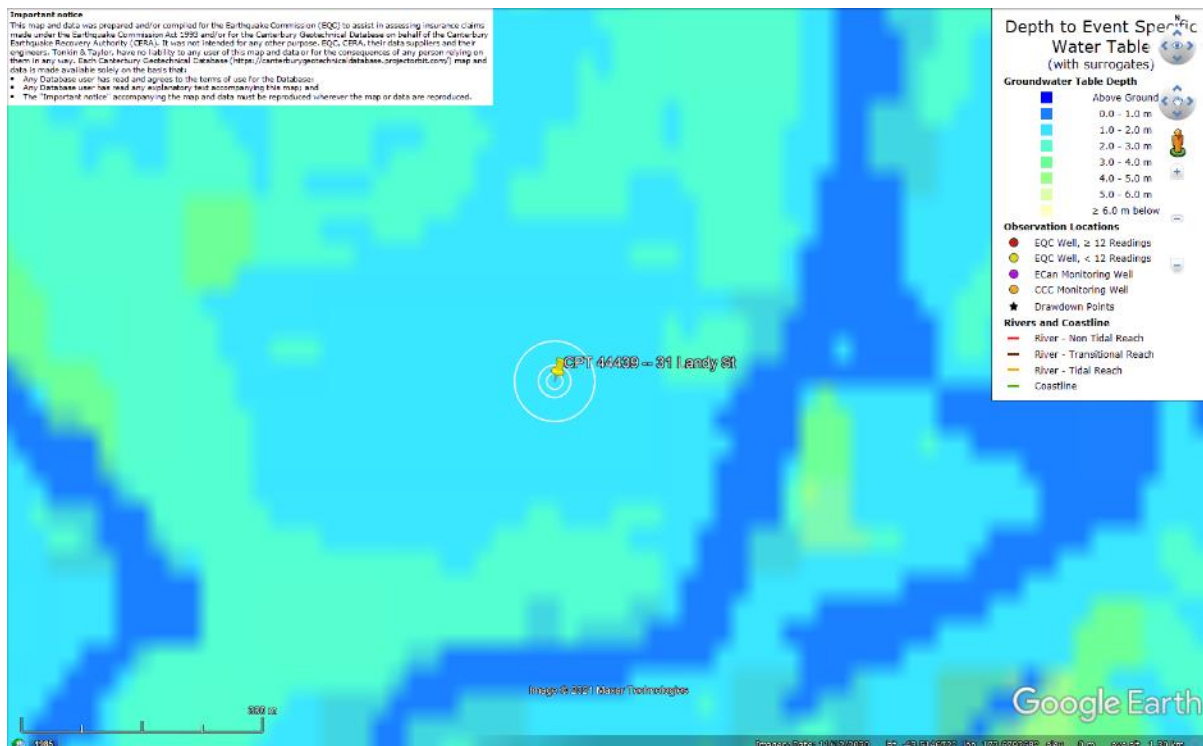
Figure 90: Depth to groundwater table for Dec-11 EQ.

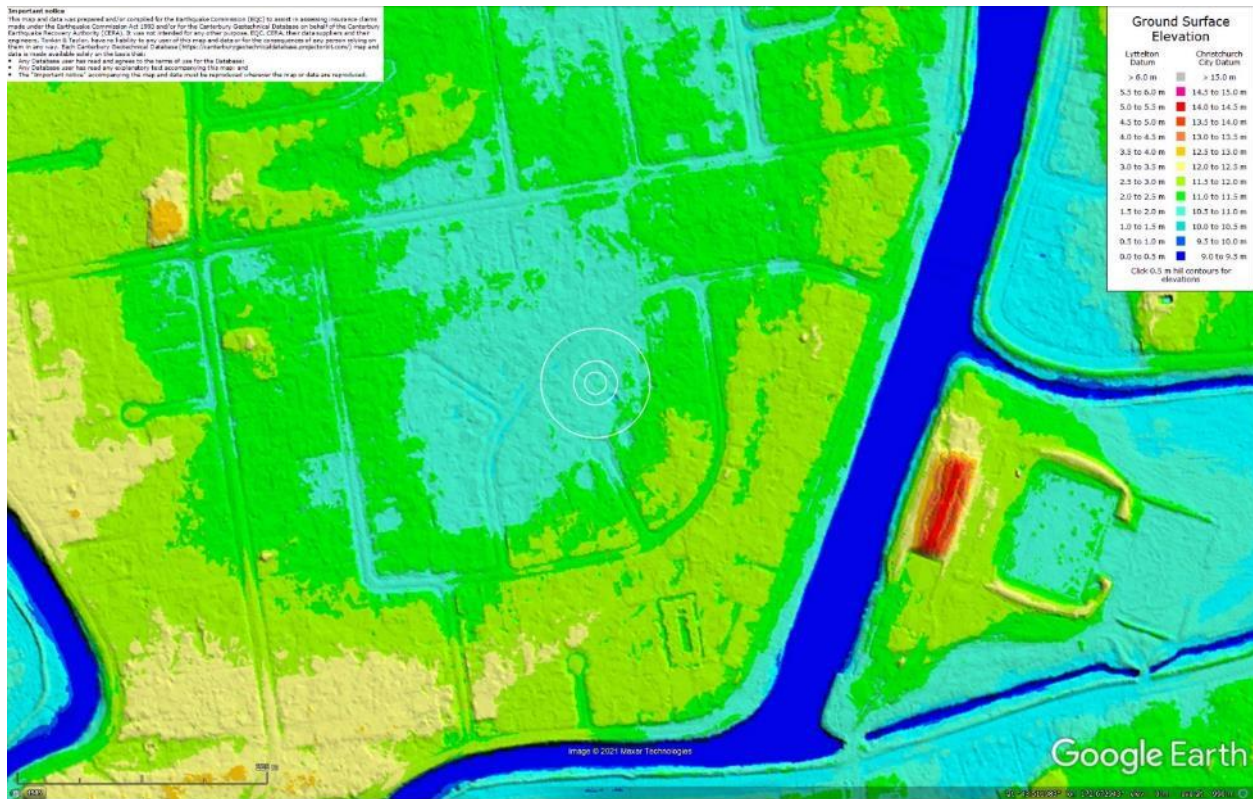
Figure 91: Ground surface elevation according to the Sep-11 LiDAR survey.

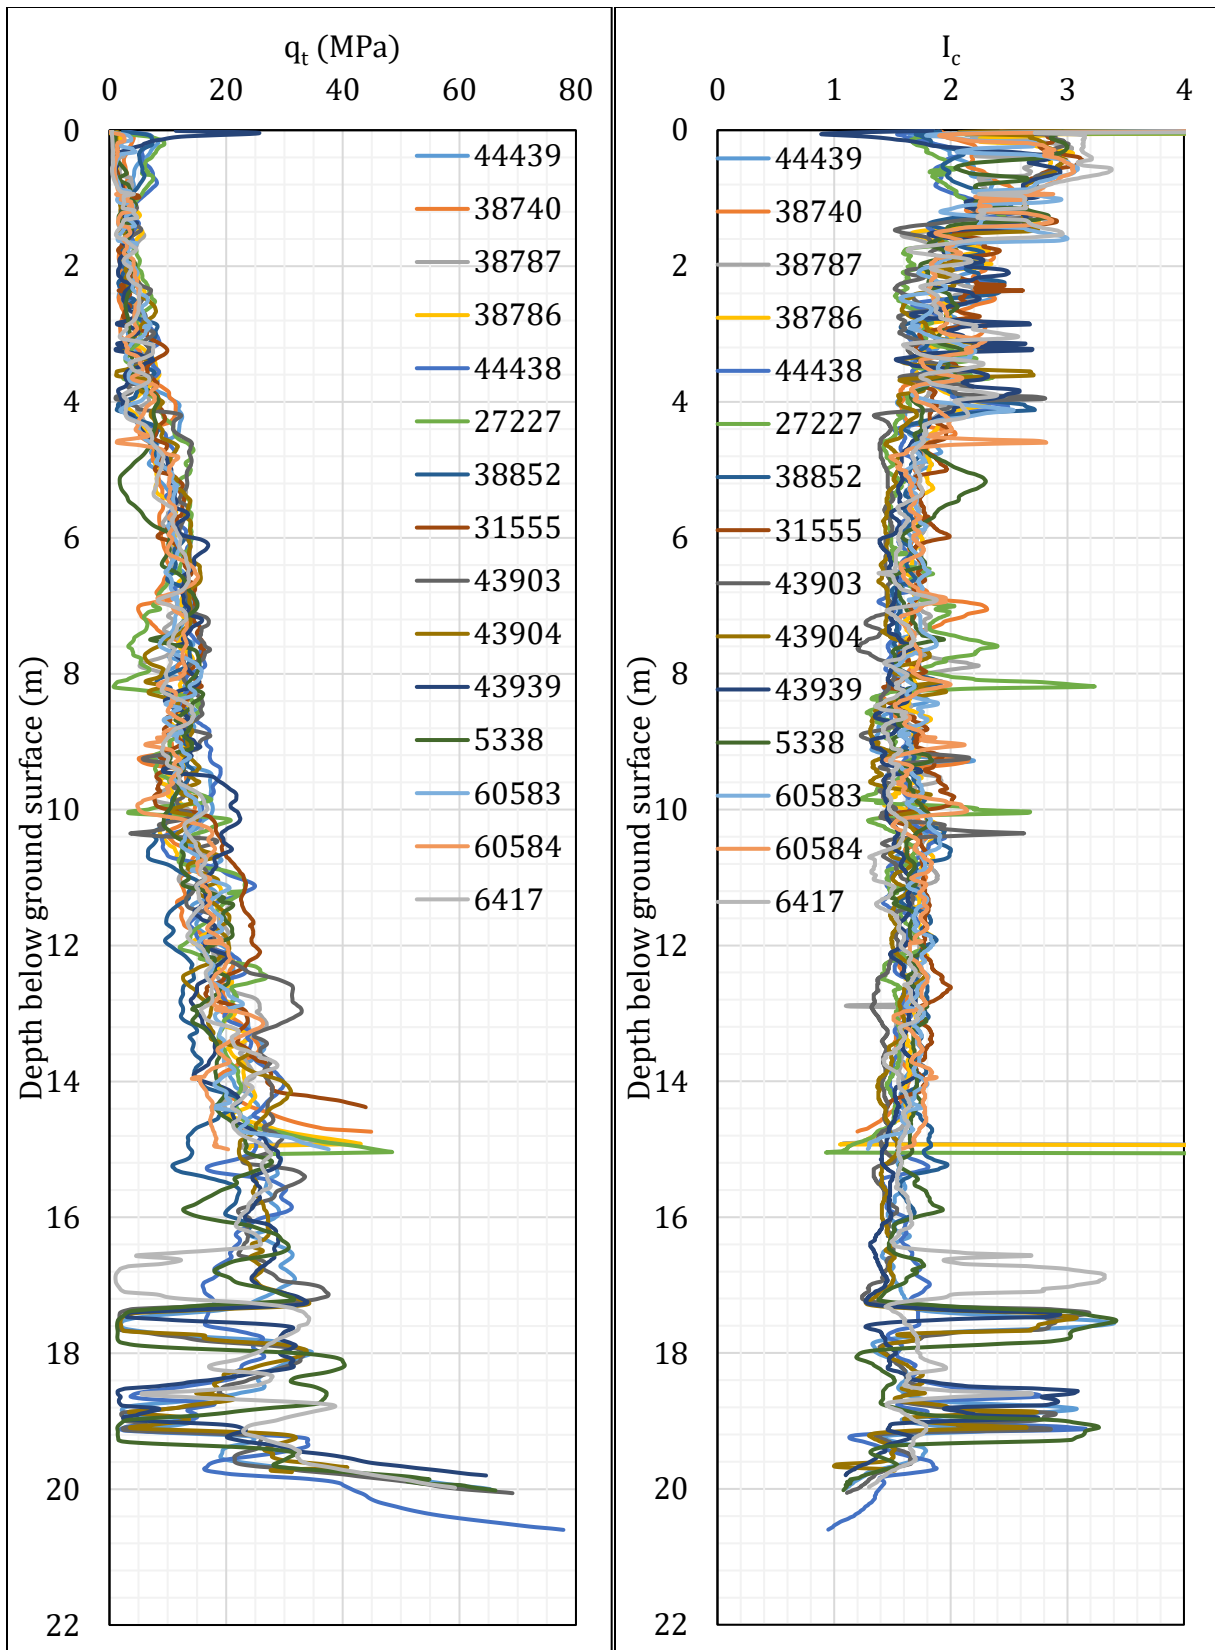
Figure 92: q_t and I_c profiles.

Note 6: The selection of CPTs for the area considered for settlement assessment (Figure 1) is based on the proximity of the CPTs to the considered areas. In accordance with that, the following table shows CPTs that were used for the volumetric settlement analysis in *Cliq v.3.0.3.2*, a CPT soil liquefaction software developed by GeoLogismiki. (The average volumetric settlements were reported in Table 8.)
