Appendix A.26:

Ti Rakau Reserve – VsVp 57186

Liquefaction Ejecta Case Histories for 2010-11 Canterbury Earthquakes

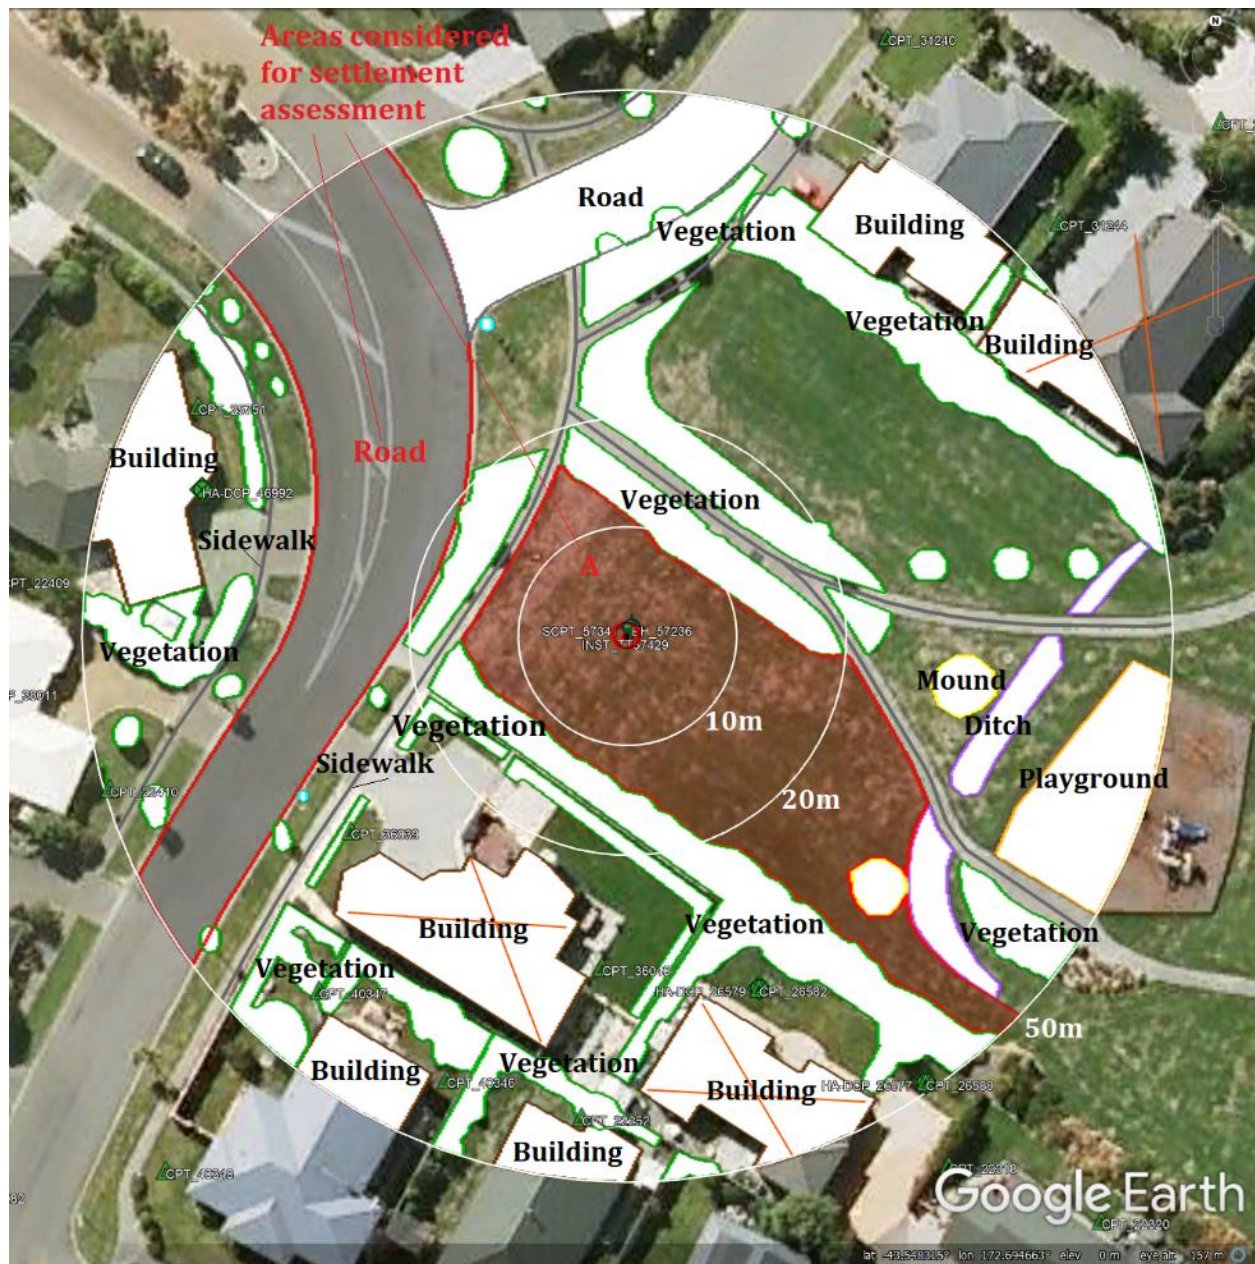
Figure 1: Site plan with areas where ejecta-induced settlement data is considered.

Note 1: Patch A (outlined in red) in the free field was selected for settlement assessment as an area free of vegetation and structures. Other important factors considered in the patch selection process were its proximity to a CPT, a property subjected to addition and/or demolition of a structure, front yard/backyard alterations (e.g., ploughing, rubble, scrap), and aerial distribution of sediment ejecta. In addition, since significant amounts of ejecta were observed on roads in the CES, the entire portion of the road within the 50-m buffer was considered for settlement assessment. The LiDAR surveys were available for the Jun-11 and Dec-11 EQs only; however, they were not used to estimate the ejecta-induced settlement.

- A_T is the total assessment area for a buffer being considered (Figure 1).

Note 6: The selection of CPTs for the area considered for settlement assessment (Figure 1) is based on the proximity of the CPTs to the considered areas. In accordance with that, the following table shows CPTs that were used for the volumetric settlement analysis in *Cliq v.3.0.3.2*, a CPT soil liquefaction software developed by GeoLogismiki. (The average volumetric settlements were reported in Table 8.)
