Appendix A.30:

Shortland St – CPT 6551

Table 1: Site Description for Shortland St (CC LIQ 13 – CPT 6551).

Liquefaction Ejecta Case Histories for 2010-11 Canterbury Earthquakes

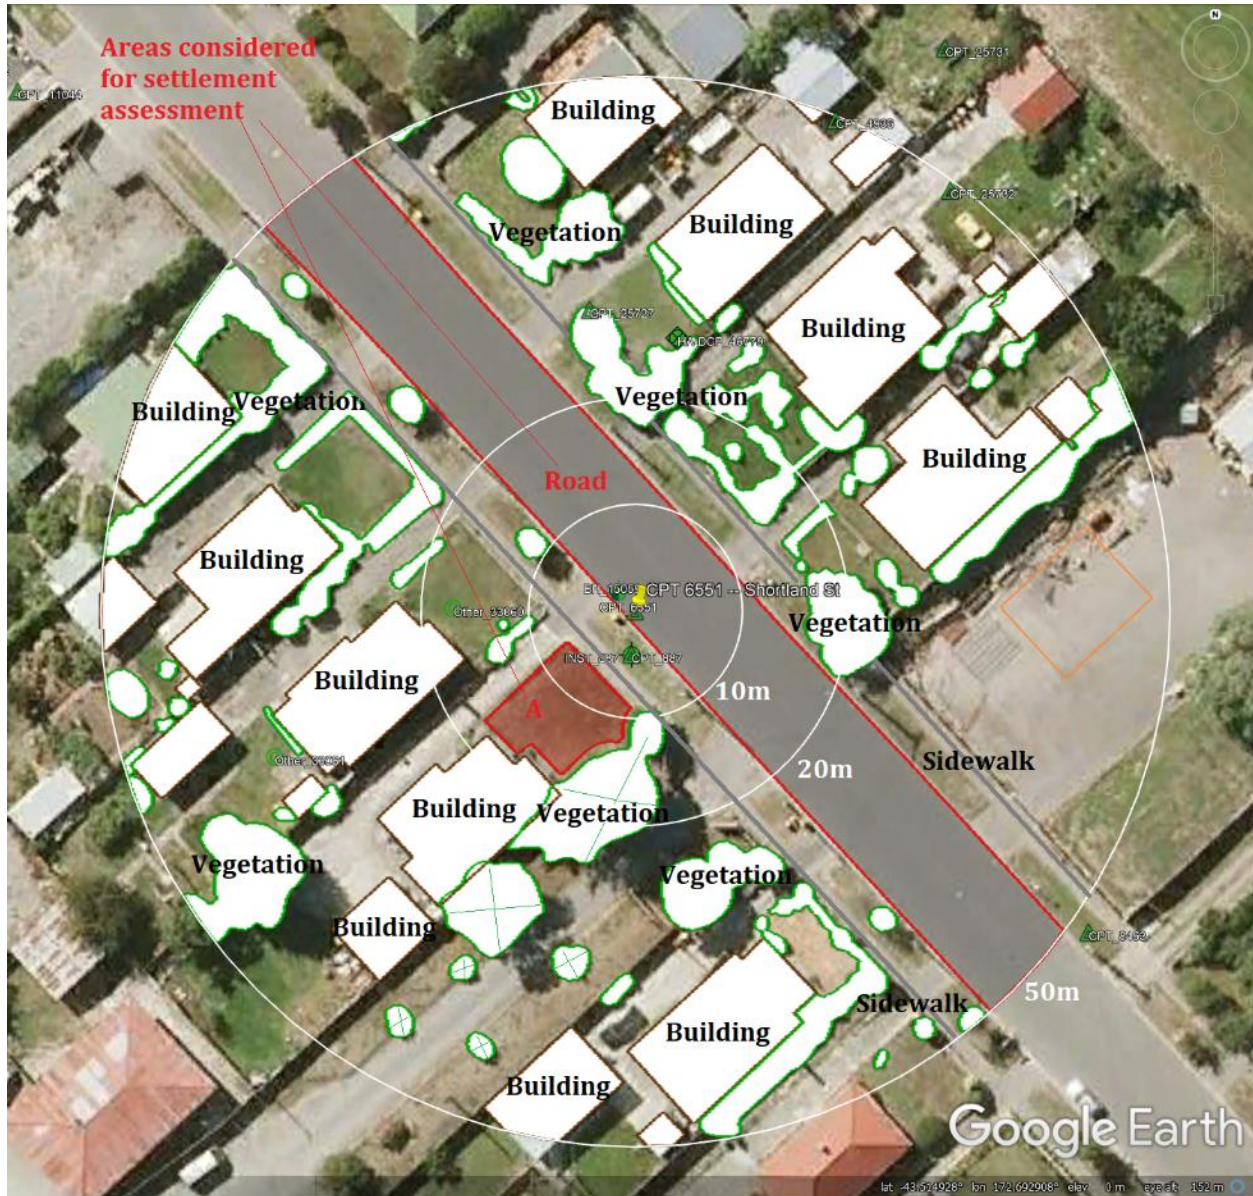
Figure 1: Site plan with areas where ejecta-induced settlement is considered.

Note 1: Patch A (outlined in red) in free field was selected for settlement assessment as an area free of vegetation and structures. Other factors considered in the patch selection were its proximity to a CPT, a property subjected to addition and/or demolition of a structure, front yard/backyard alterations (e.g., ploughing, rubble, scrap), and aerial distribution of sediment ejecta. In addition, the entire portion of the road within the 50-m buffer was considered for settlement assessment. Roads as hard, relatively flat surfaces provide many ground-classified points. The LiDAR-based settlement analyses of Patch A were not conducted for any EQ event due to the evident absence of ejecta. Likewise, the LiDAR-based settlement analyses of the Road were not performed for the Sep-10 and Dec-11 EQs due to the evident absence of ejecta.

- $A_{E,thin,j}$ and $H_{E,thin,j}$ are the area and the height of a thin ejecta layer, respectively;
- $W_{E,prism,n}$ and $L_{E,prism,n}$ are the width and the length of the coverage area of a prismatically shaped ejecta layer, respectively, and $H_{E,prism,n}$ is the height of a prism-like ejecta layer;
- $W_{E,pyr,p}$ and $L_{E,pyr,p}$ are the width and the length of the coverage area of a pyramid-like ejecta layer, respectively, and $H_{E,pyr,p}$ is the height of a pyramid-like ejecta layer;
- A_T is the total assessment area for a buffer being considered (Figure 1).

Note 6: The selection of CPTs for the area considered for settlement assessment (Figure 1) is based on the proximity of the CPTs to the considered areas. In accordance with that, the following table shows CPTs that were used for the volumetric settlement analysis in *Cliq v.3.0.3.2*, a CPT soil liquefaction software developed by GeoLogismiki. (The average volumetric settlements were reported in Table 8.)

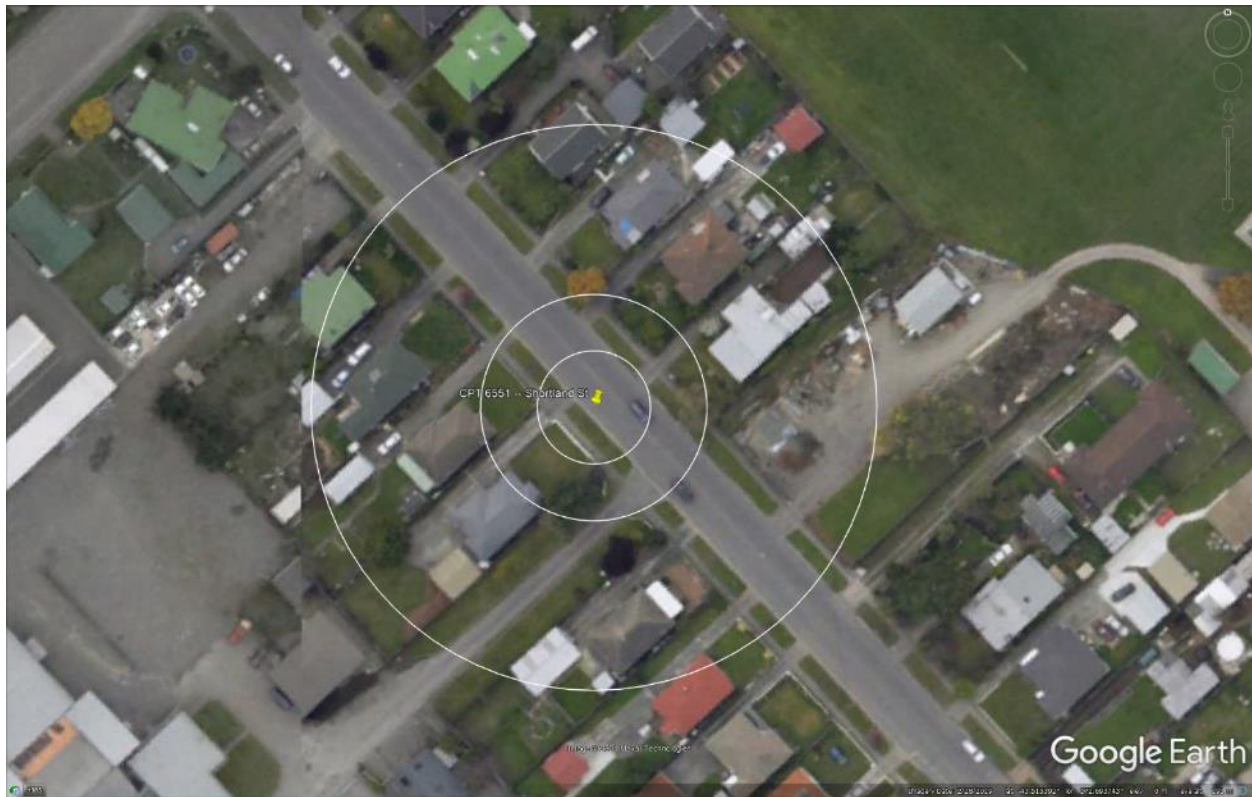
Figure 29: Aerial photograph of the site taken on Sep 4, 2010.

Note 4: The values in Table 9 correspond to the coverage area of ejecta outlined in aerial photographs (Figures 29, 33, 65, and 66) and the lower and upper estimates of ejecta height based on geometrical approximations, ground photographs (Figure 67), and EQC LDAT property inspection reports. The ejecta-induced settlement using photographs and engineering judgment, $S_{E,P}$, is estimated as

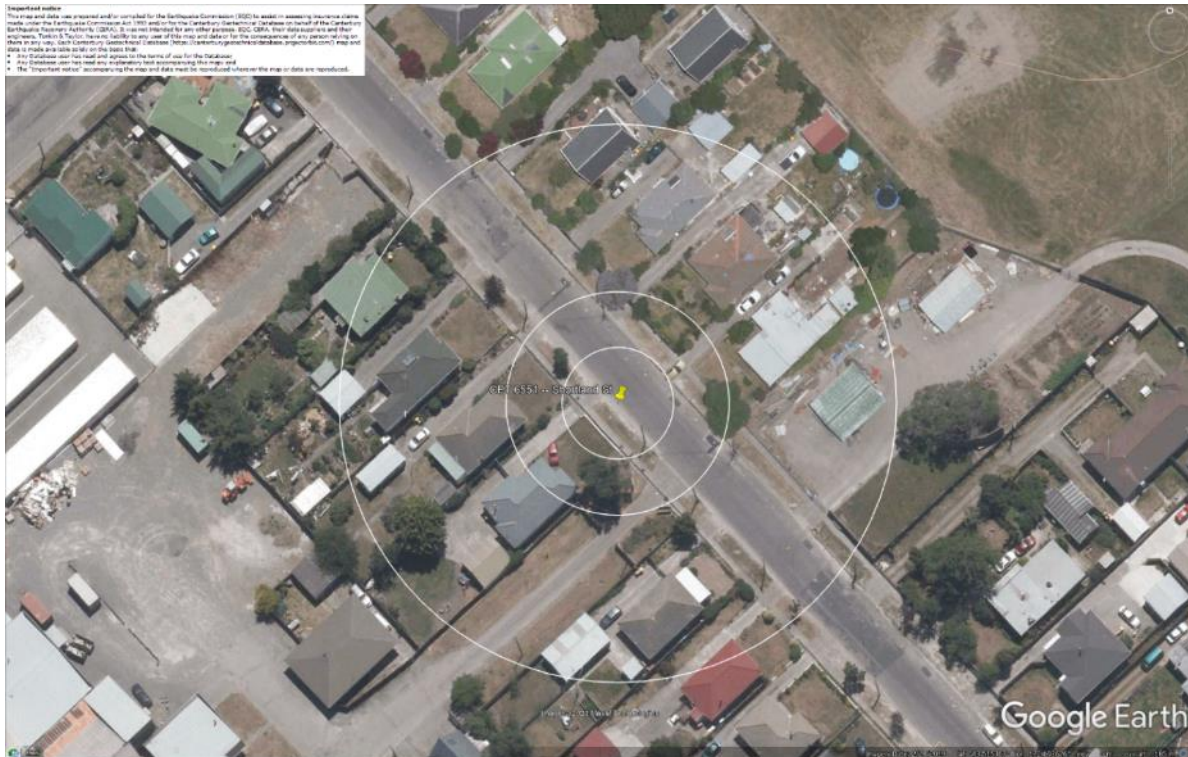
Figure 33: Aerial photograph of the site taken on Dec 24, 2011.

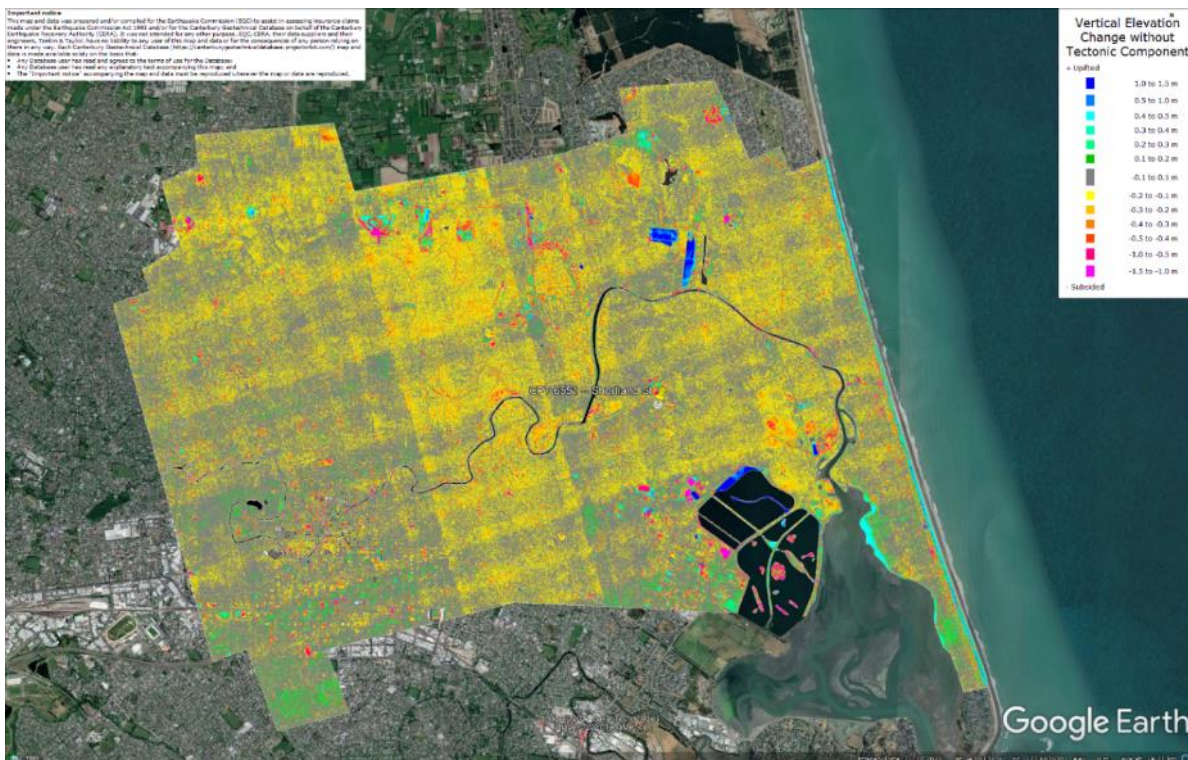
Figure 34: Vertical Ground Movements (Surface – Tectonic) for Sep 2010 Earthquake – the site is not in the apparent zone of overestimated or underestimated ground surface subsidence.

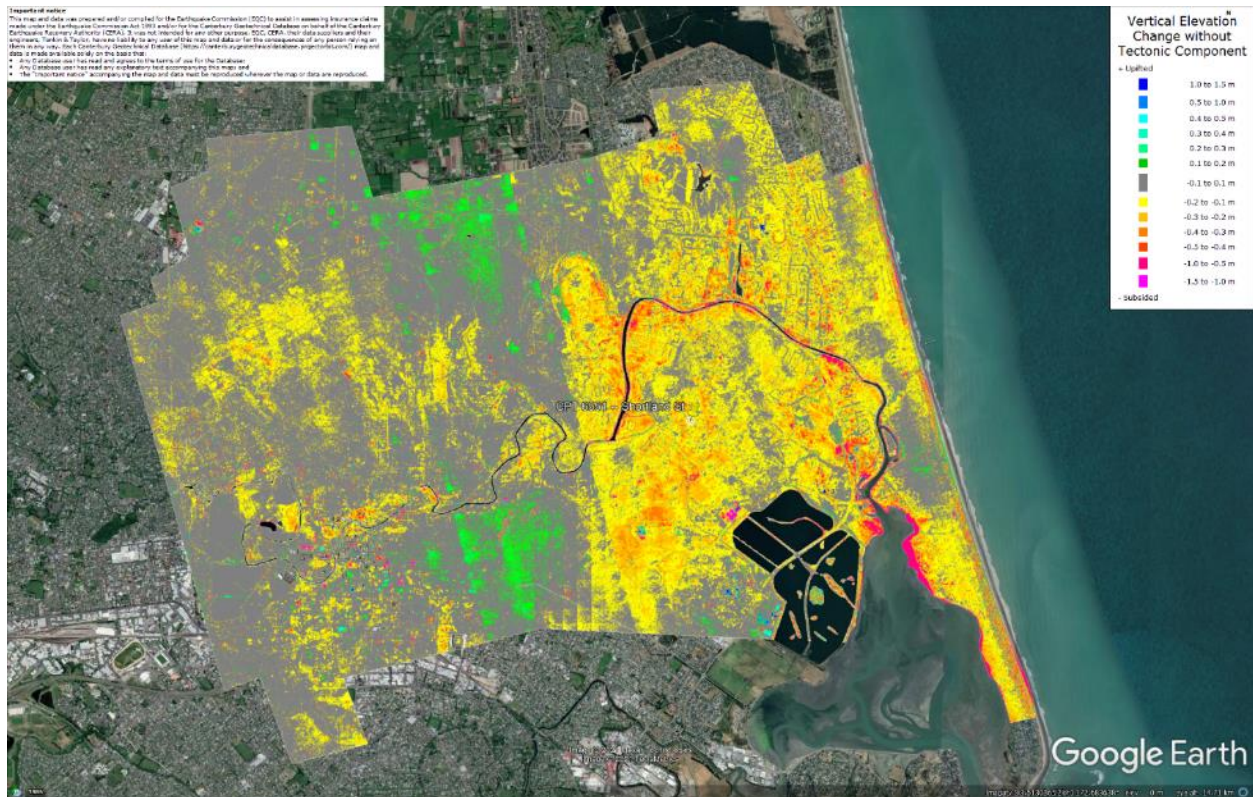
Figure 35: Vertical Ground Movements (Surface – Tectonic) for Feb 2011 Earthquake – the site is not in the apparent zone of overestimated or underestimated ground surface subsidence.

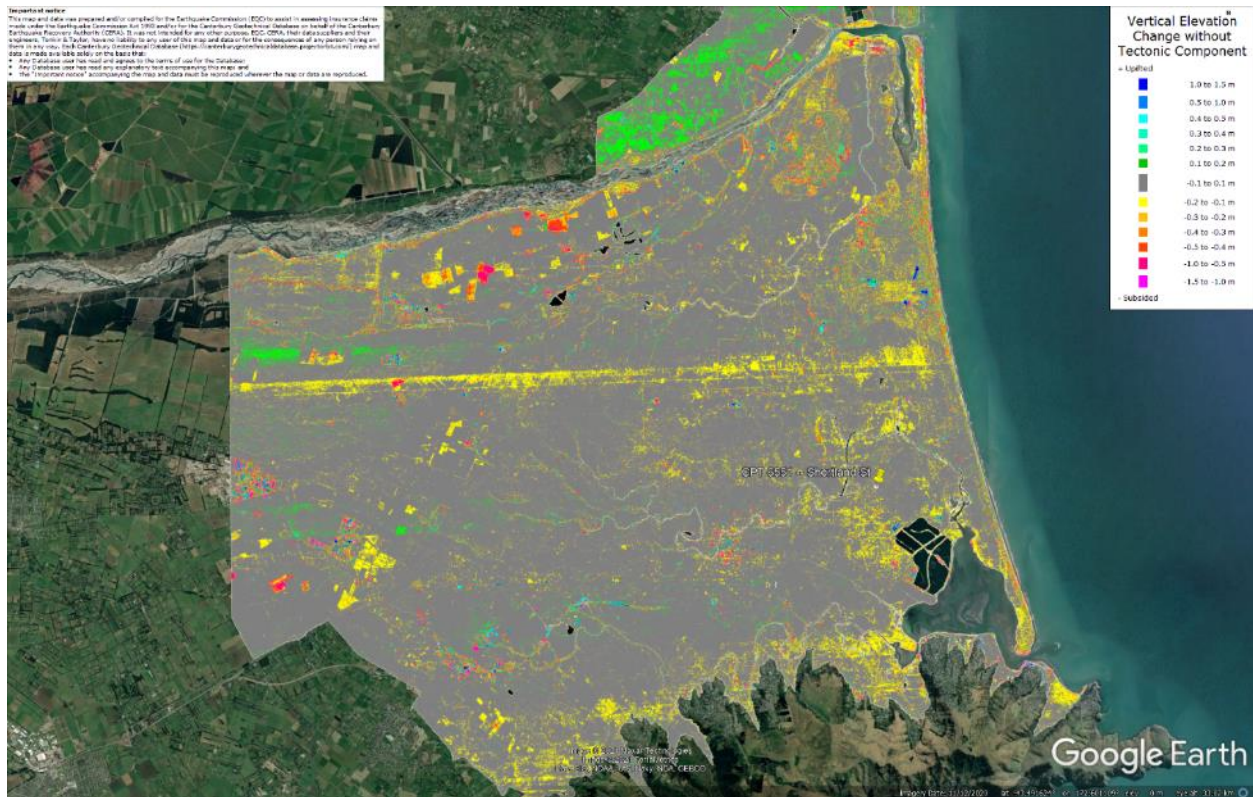
Figure 36: Vertical Ground Movements (Surface – Tectonic) for June 2011 Earthquake – the site is not in the apparent zone of overestimated or underestimated ground surface subsidence.

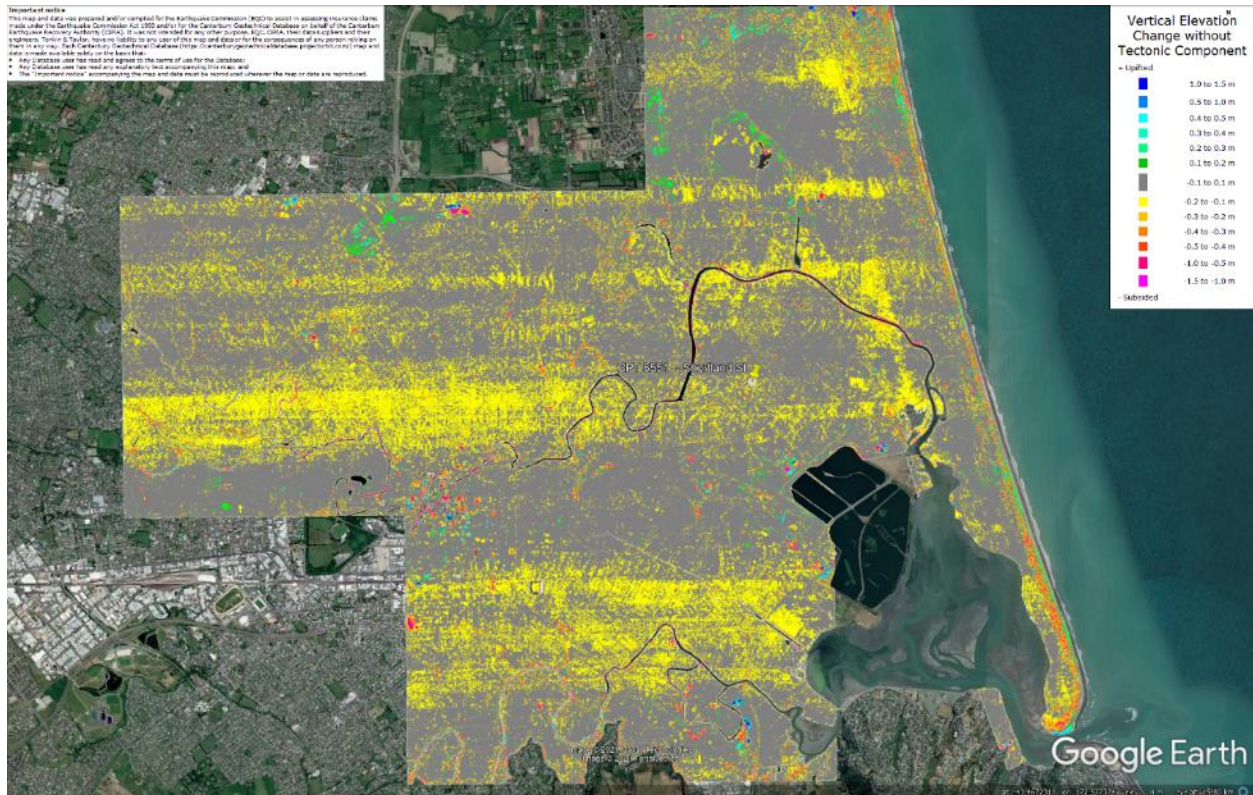
Figure 37: Vertical Ground Movements (Surface – Tectonic) for Dec 2011 Earthquake – the site is not in the apparent zone of overestimated ground surface subsidence (i.e., flight path error for Feb 2012 survey).

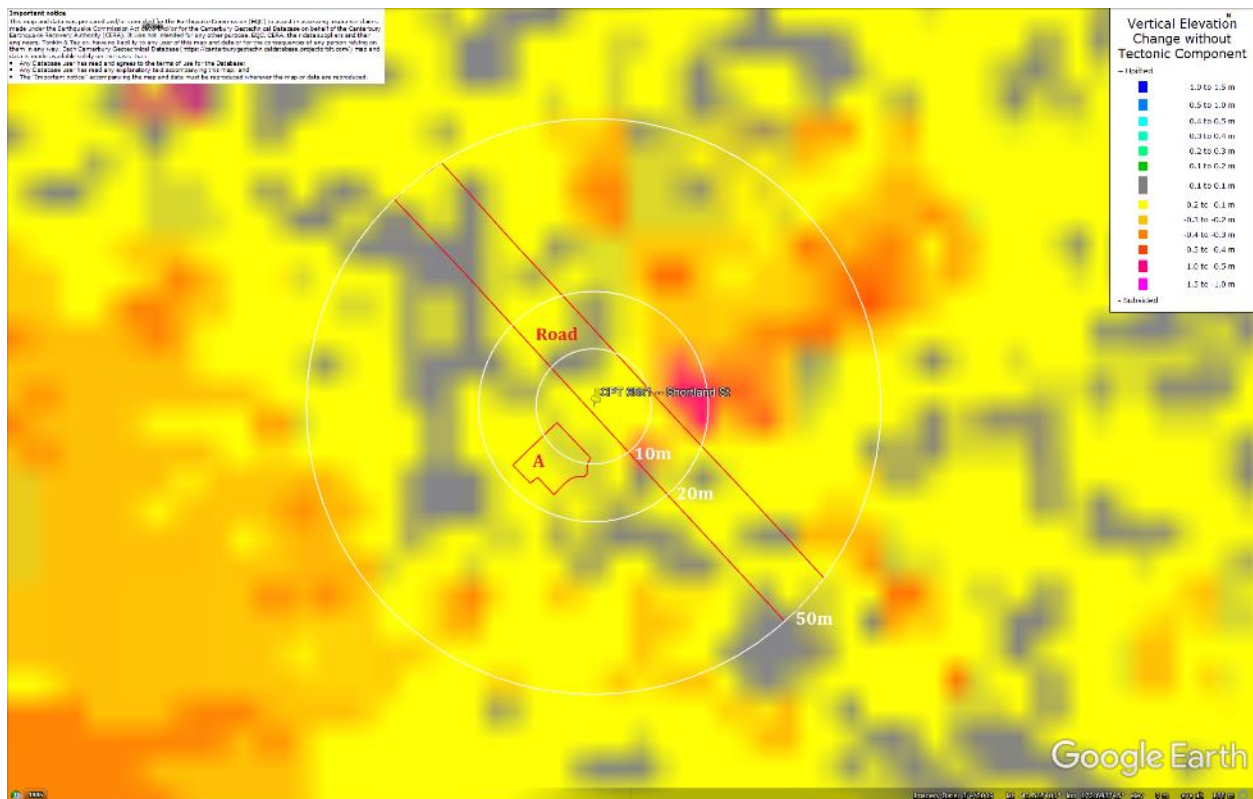
Figure 39: Ground surface subsidence without tectonic component for Feb 2011 Earthquake according to the LiDAR DEM.

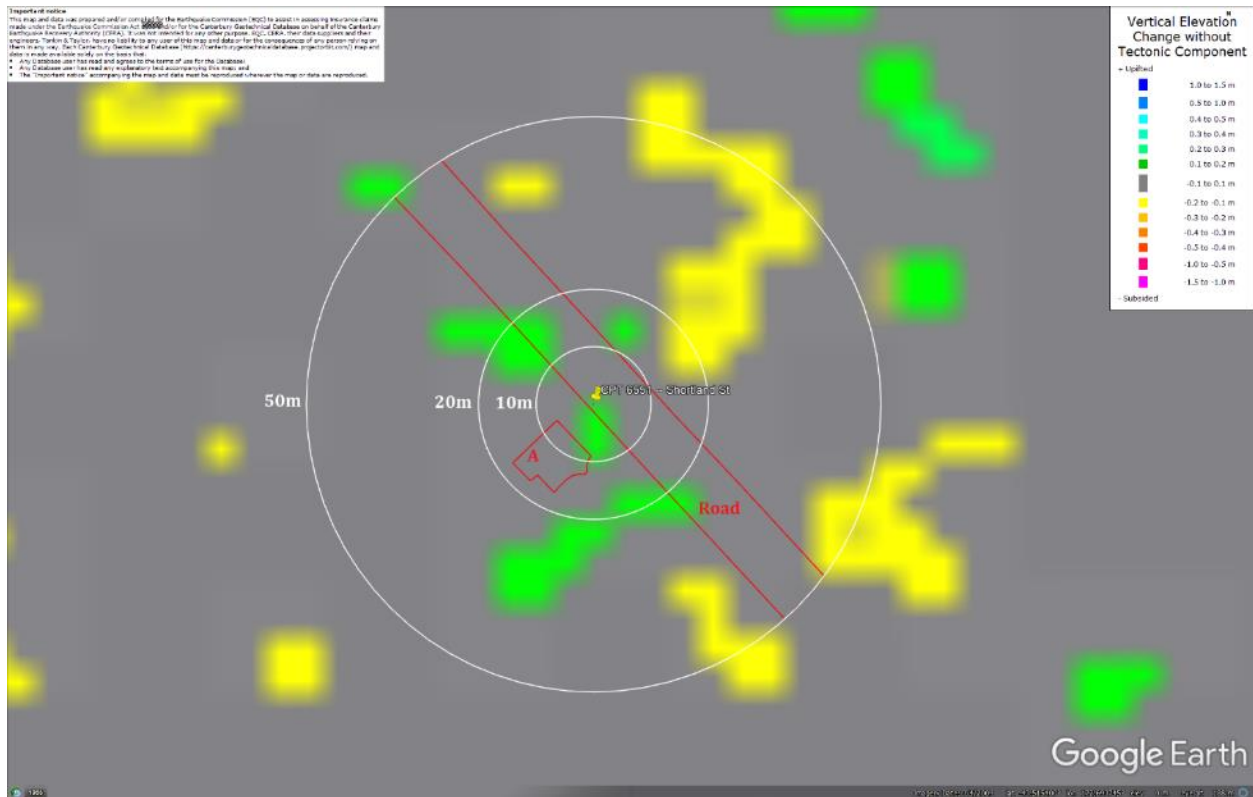
Figure 40: Ground surface subsidence without tectonic component for June 2011 Earthquake according to the LiDAR DEM.

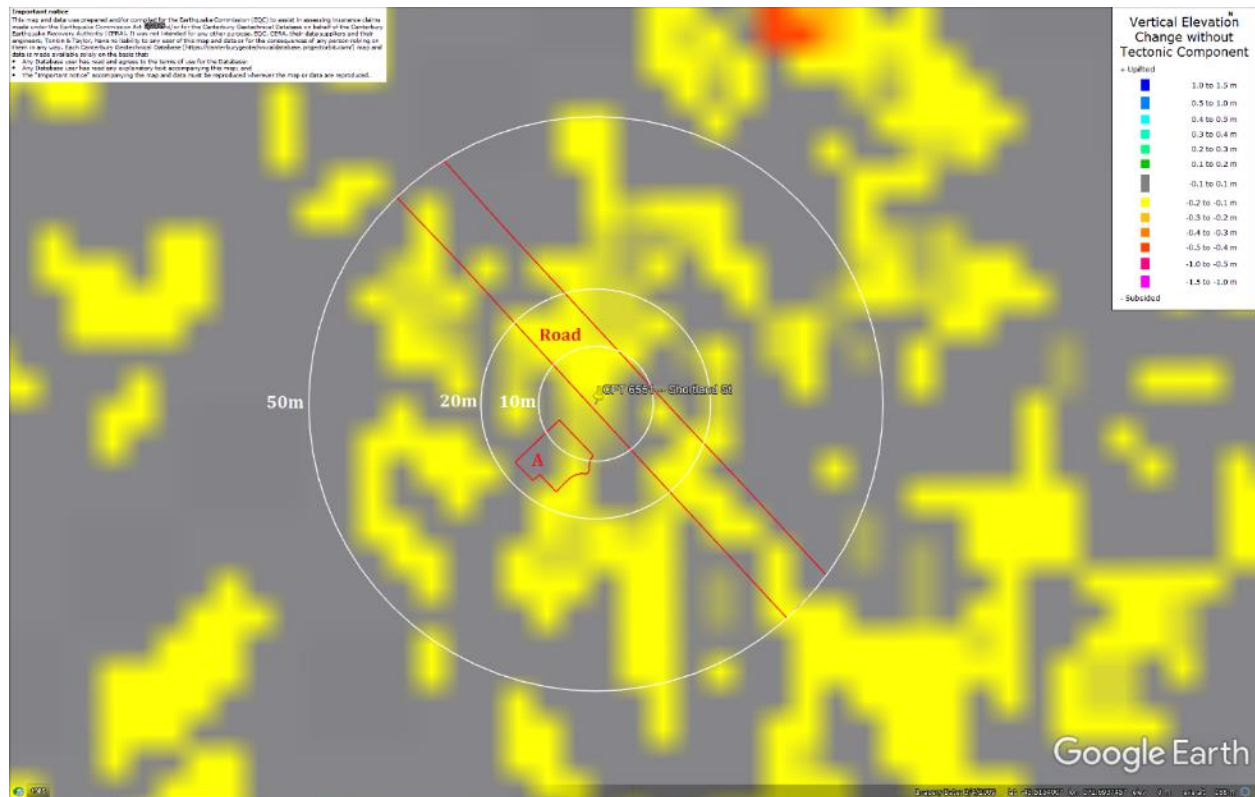
Figure 41: Ground surface subsidence without tectonic component for Dec 2011 Earthquake according to the LiDAR DEM.

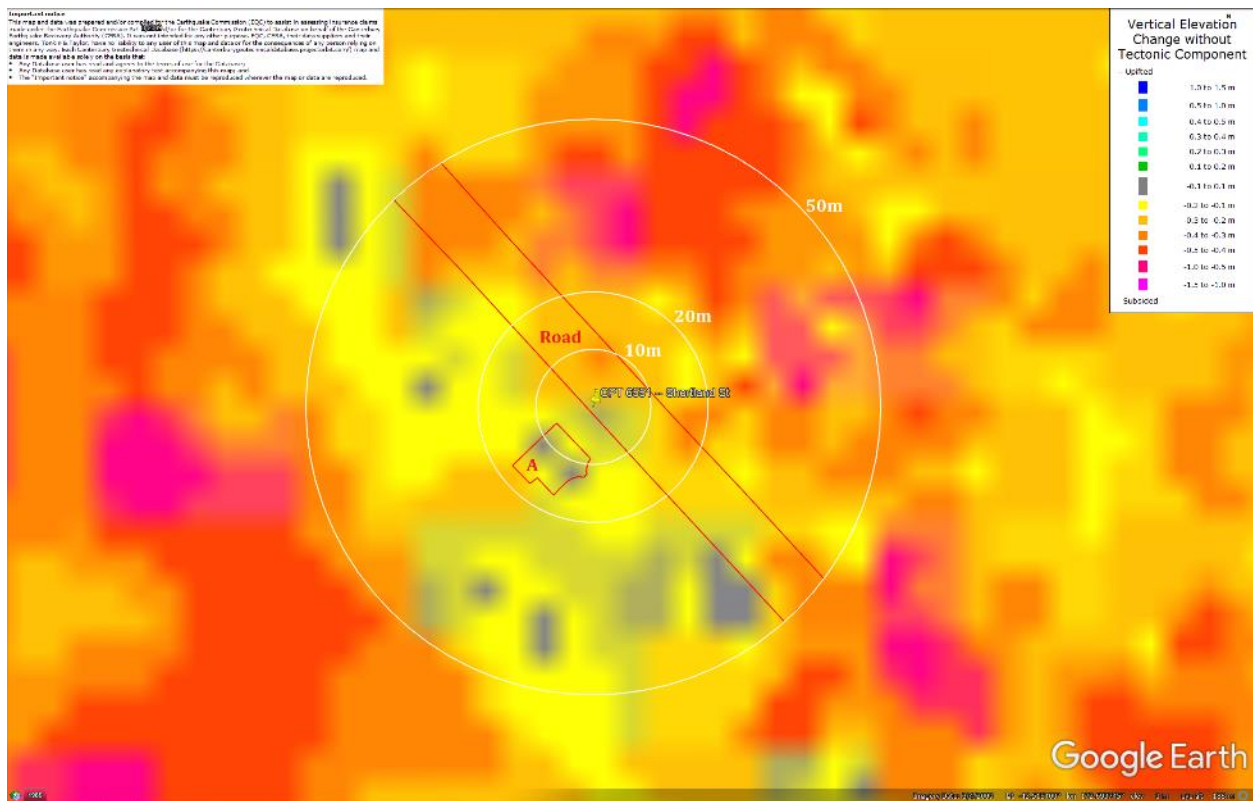
Figure 42: Ground surface subsidence without tectonic component for Canterbury Earthquake Sequence according to the LiDAR DEM.

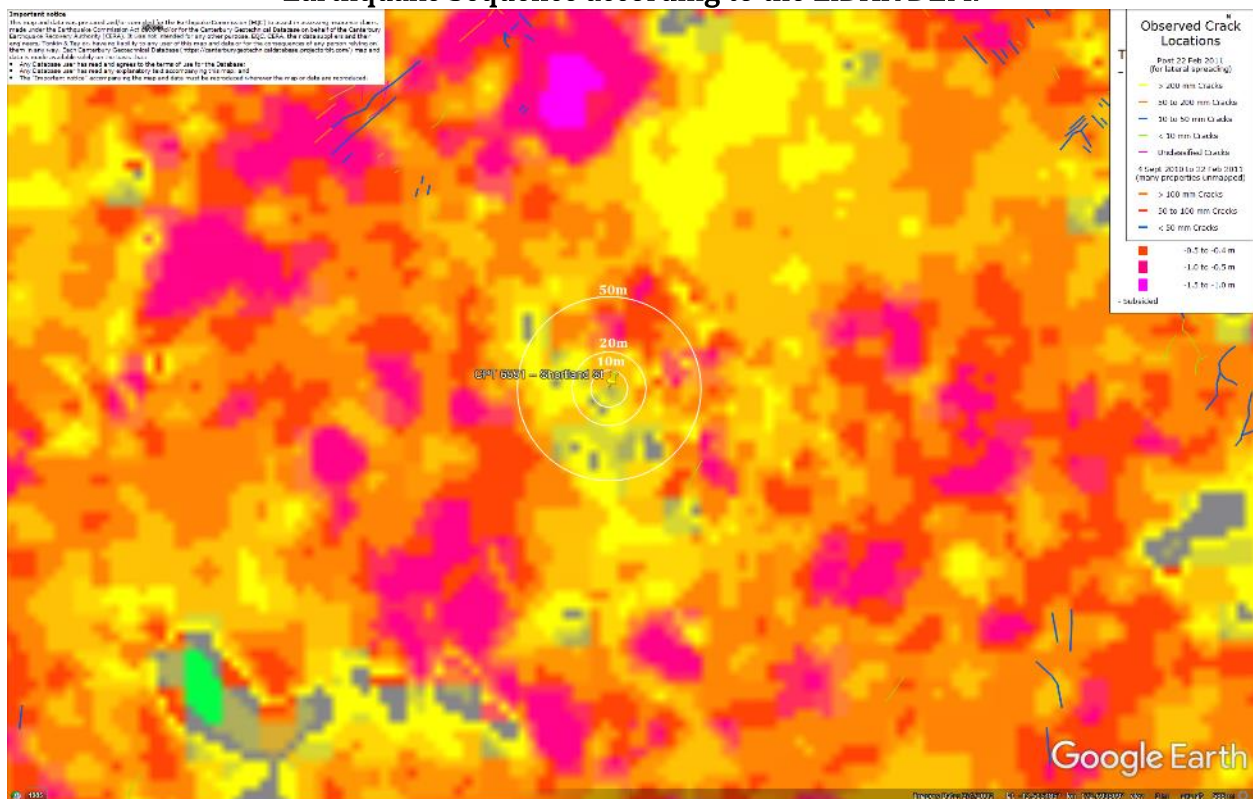
Figure 43: No lateral spreading for Canterbury Earthquake Sequence.

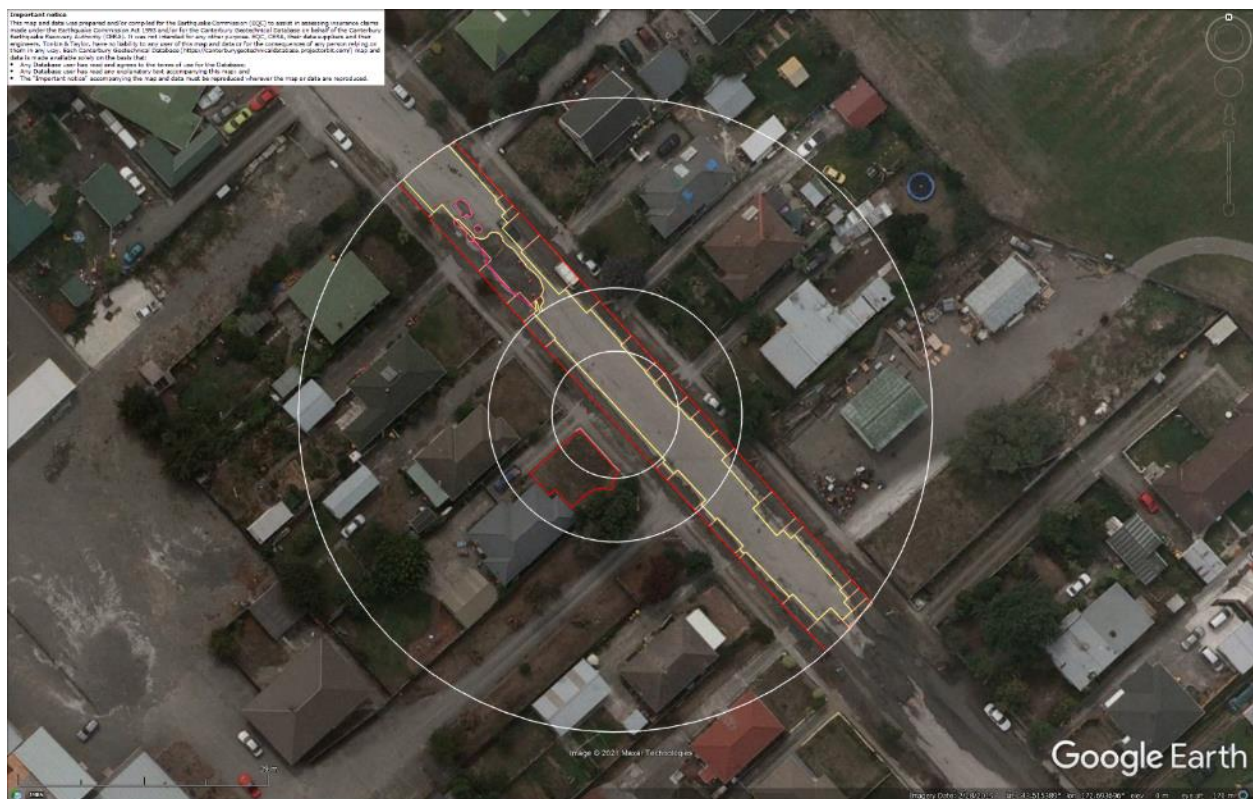
Figure 65: Aerial photograph showing the ejecta outline at the site for Feb-11 EQ.

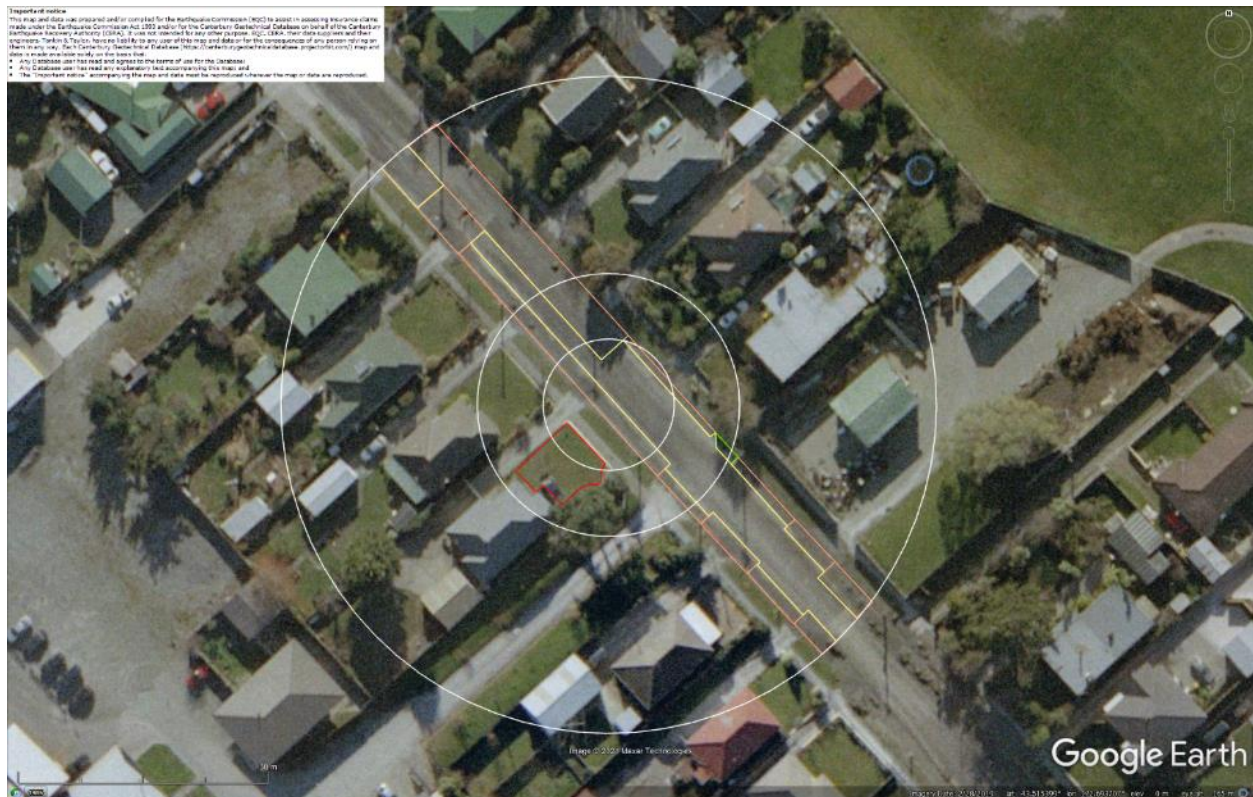
Figure 66: Aerial photograph acquired on 16 Jun 2011 showing the ejecta outline at the site for Jun-11 EQ.

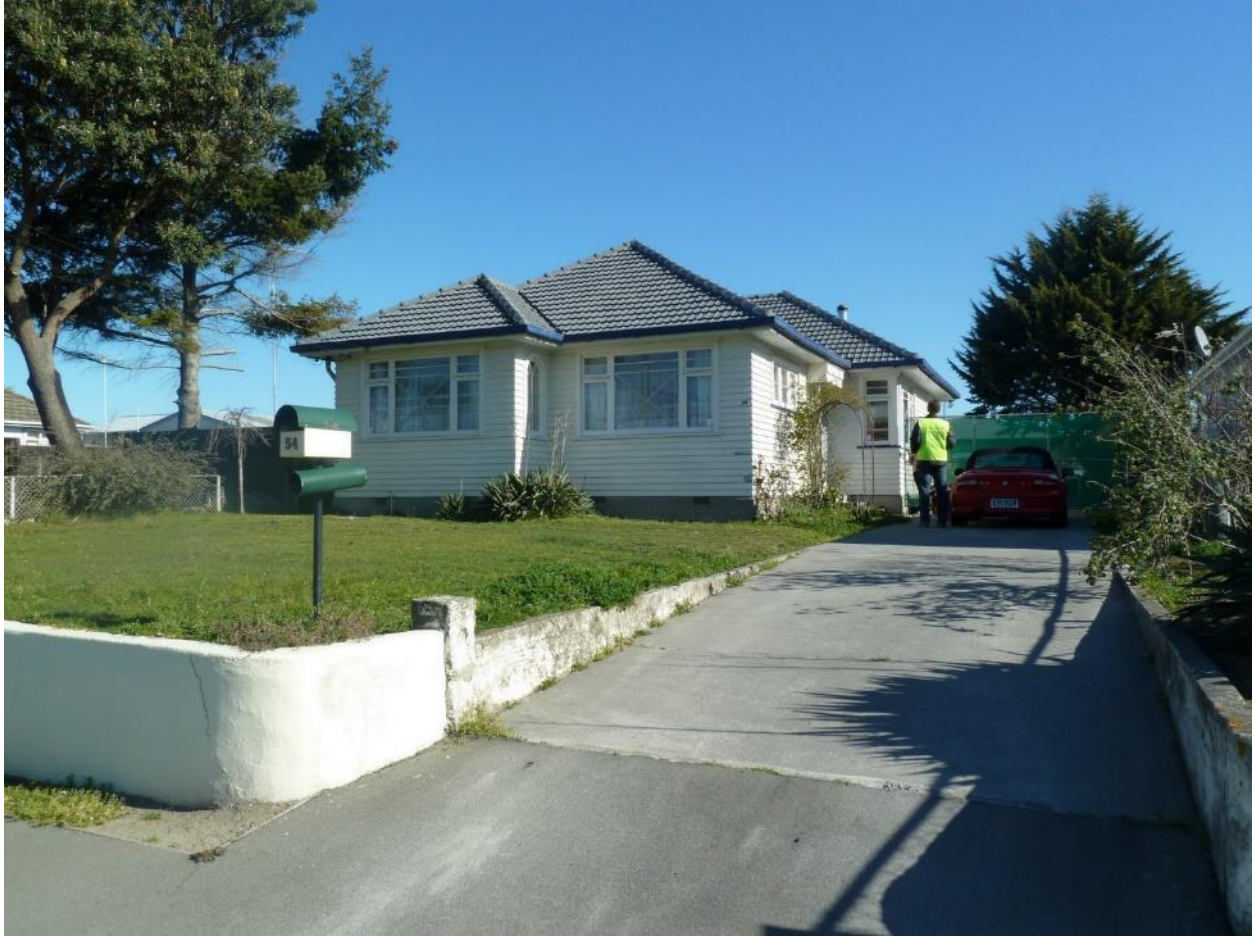
Figure 67: Ground photograph showing absence of ejecta within Patch A (photograph date: Sep 2011).

- Patch A: $S_{E,final}$ is based solely on $S_{E,P}$ for all earthquake events due to the evident absence of ejecta (also confirmed by the LDAT property inspection report).

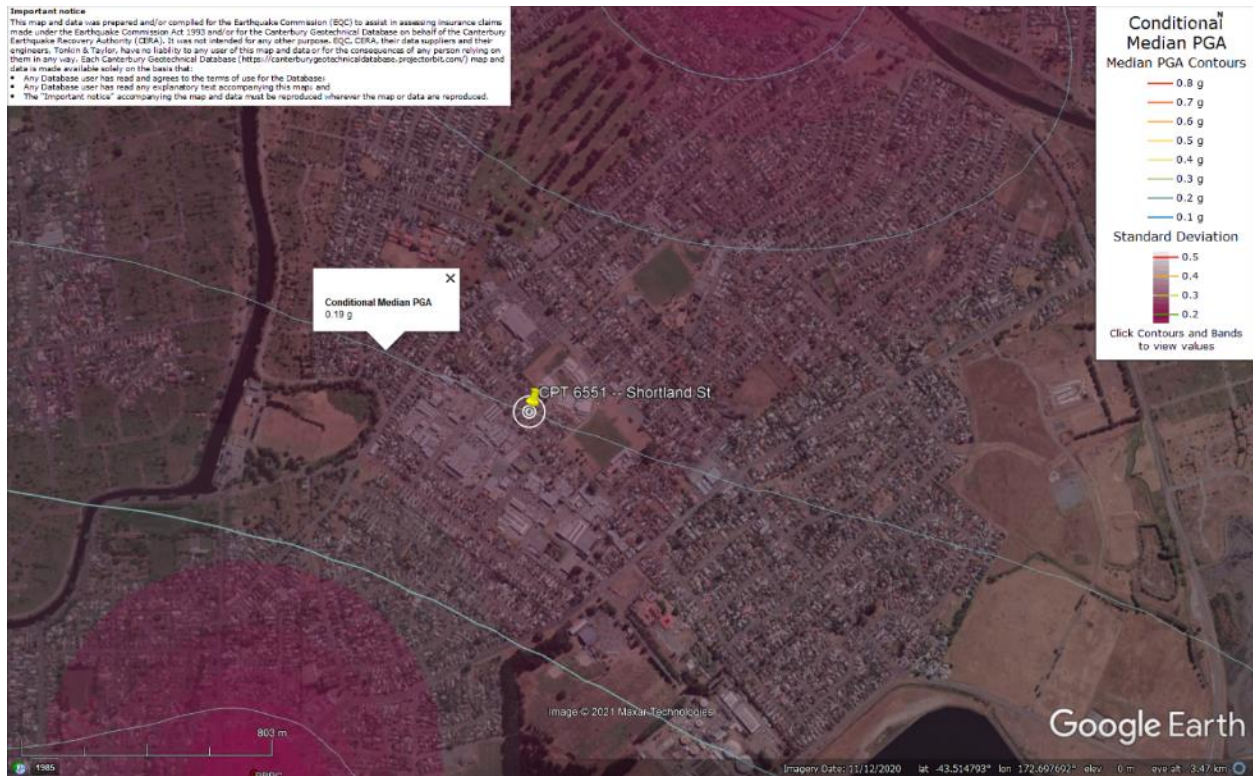
Figure 68: PGA for Sep-10 EQ (st. dev. = 0.300-0.325 ln units).

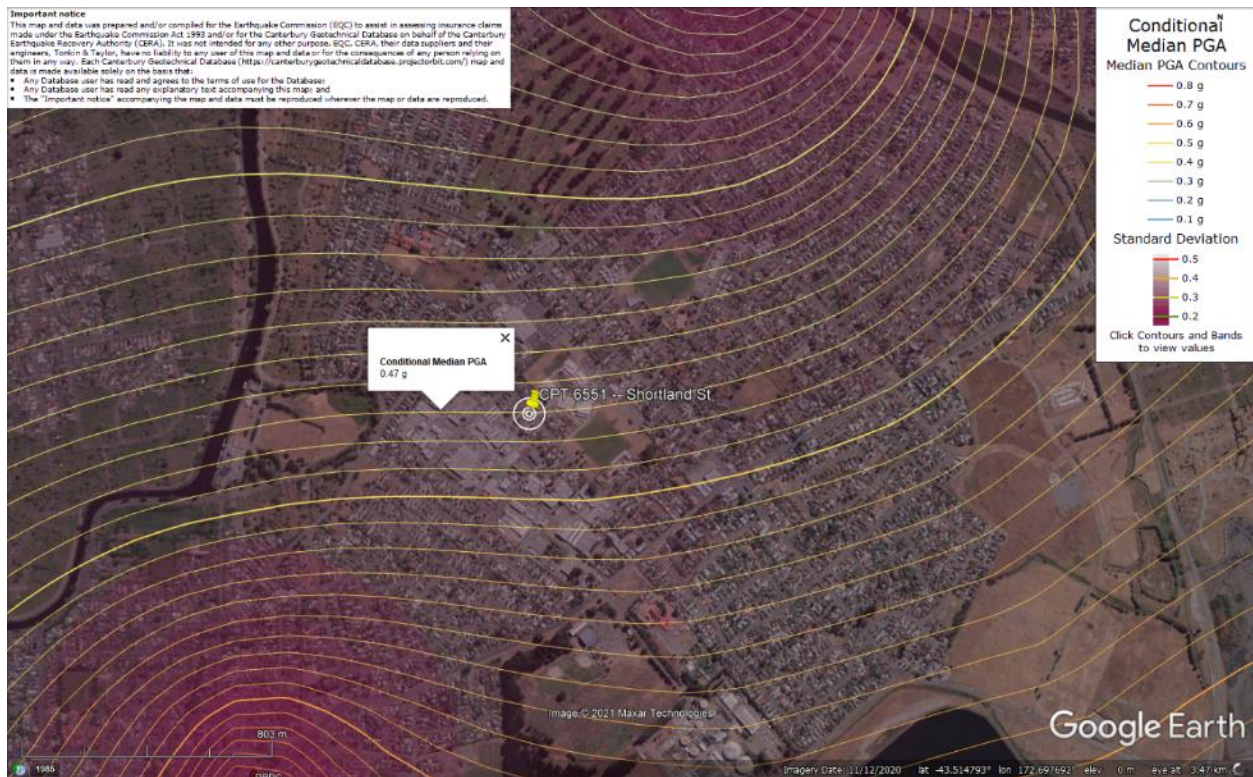
Figure 69: PGA for Feb-11 EQ (st. dev. = 0.325-0.350 ln units).

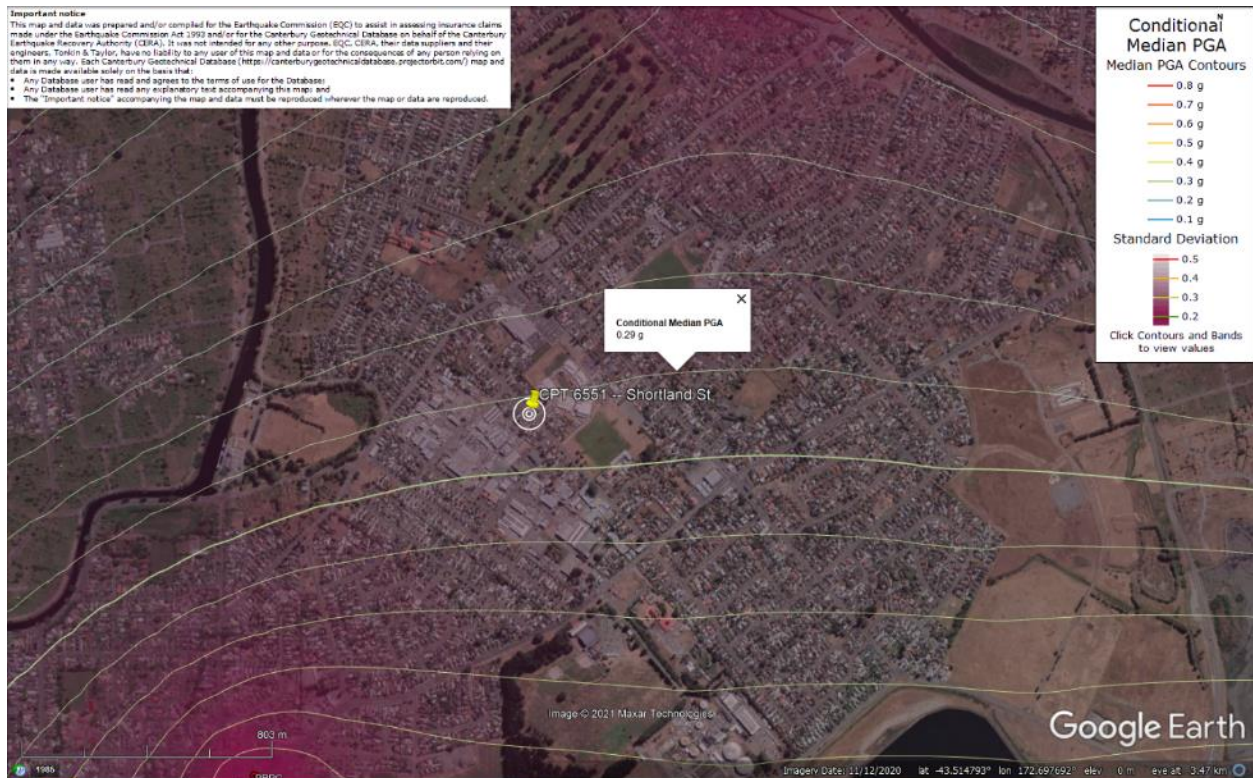
Figure 70: PGA for Jun-11 EQ (st. dev. = 0.325-0.350 ln units).

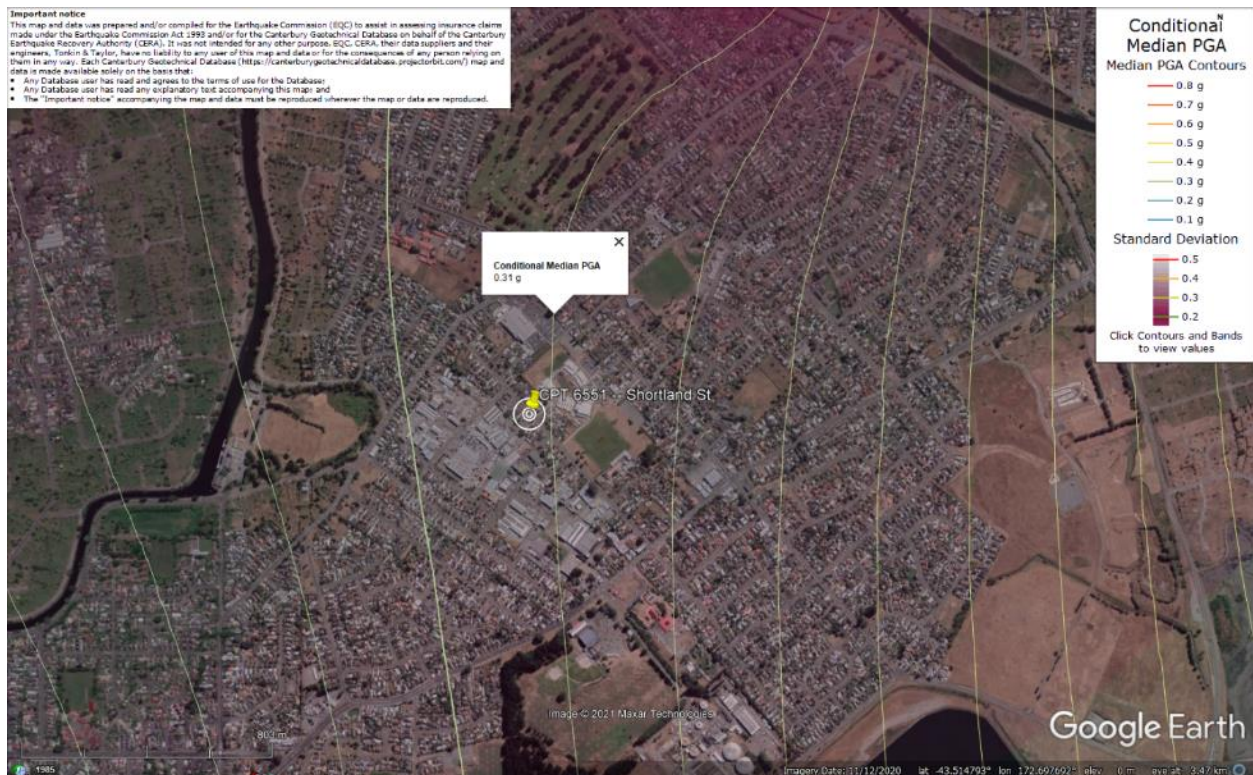
Figure 71: PGA for Dec-11 EQ (st. dev. = 0.375-0.400 ln units).

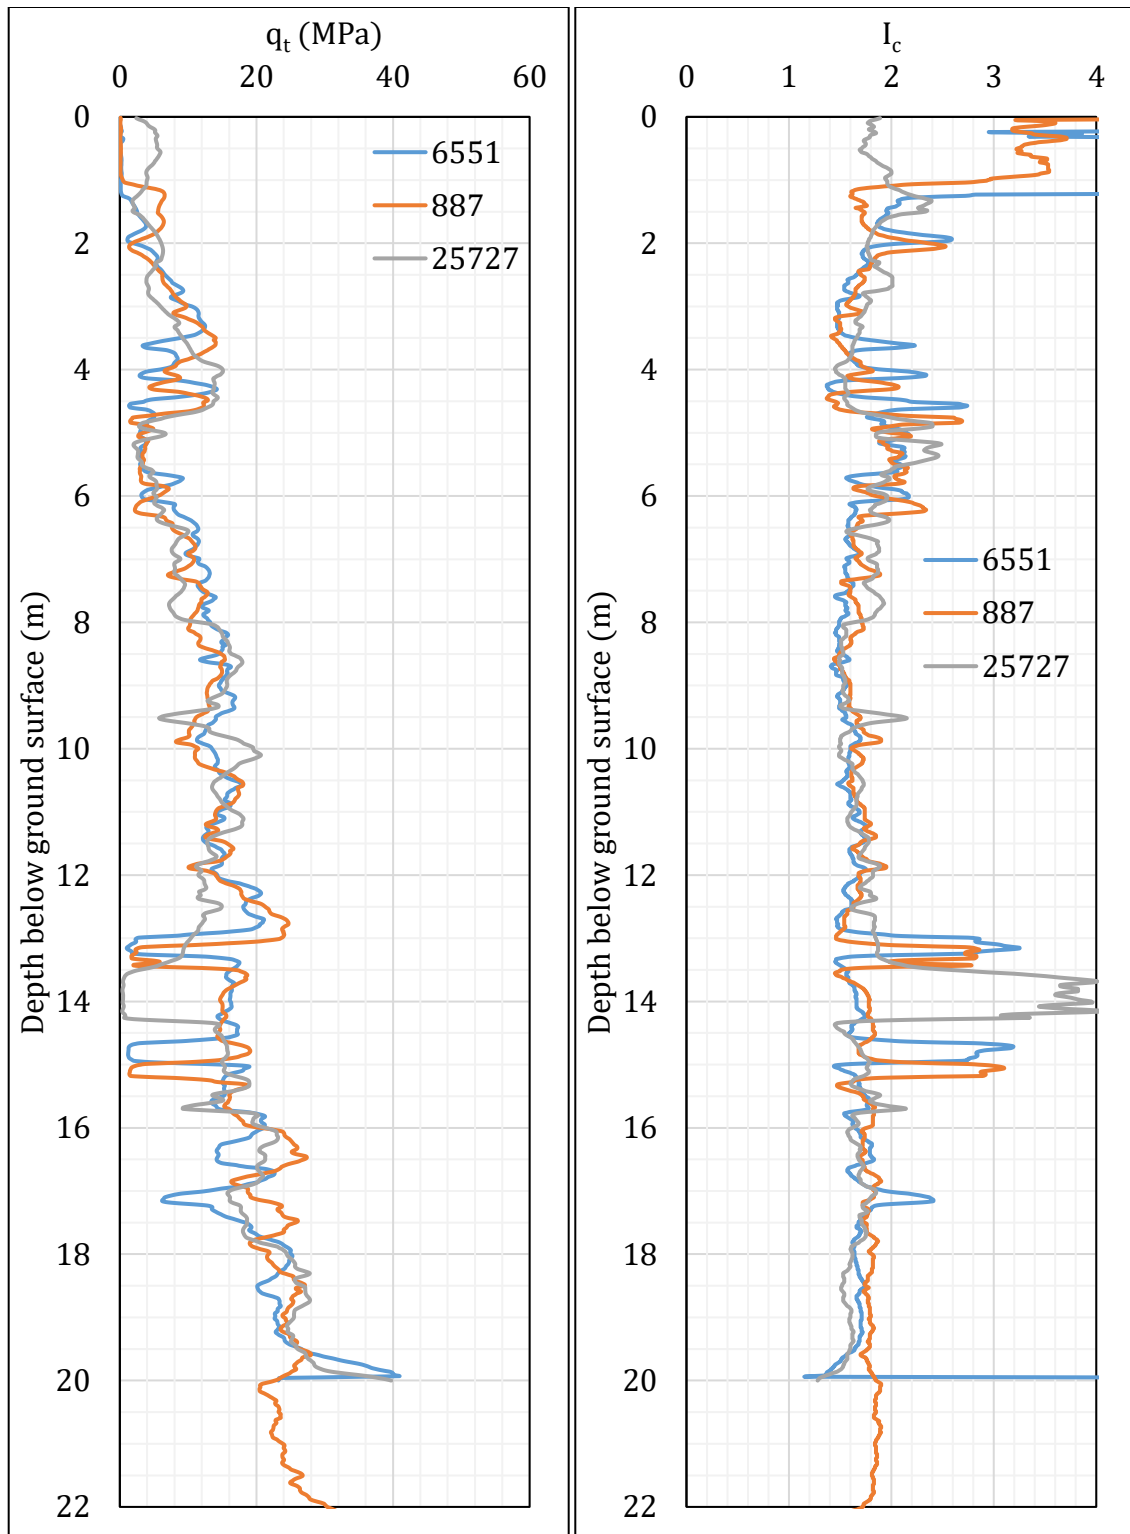
Figure 77: q_t and I_c profiles.

Note 7: Based on the borehole log (BH 15059, Figure 1), the groundwater table is at a depth of 1.5 m below the ground surface. The soil profile consists of (1) fine to medium sand, SP, of the Christchurch formation to a depth of 3.95 m, (2) silty fine to medium sand, SM, of the Christchurch formation to a depth of 4.4 m, (3) silt, ML, of the Christchurch formation to a depth of 5.45 m, and (4) fine to medium sand, SP, of the Christchurch formation to a depth of 20 m.
