Appendix A.36:

Randolph St – CPT 44440

Liquefaction Ejecta Case Histories for 2010-11 Canterbury Earthquakes

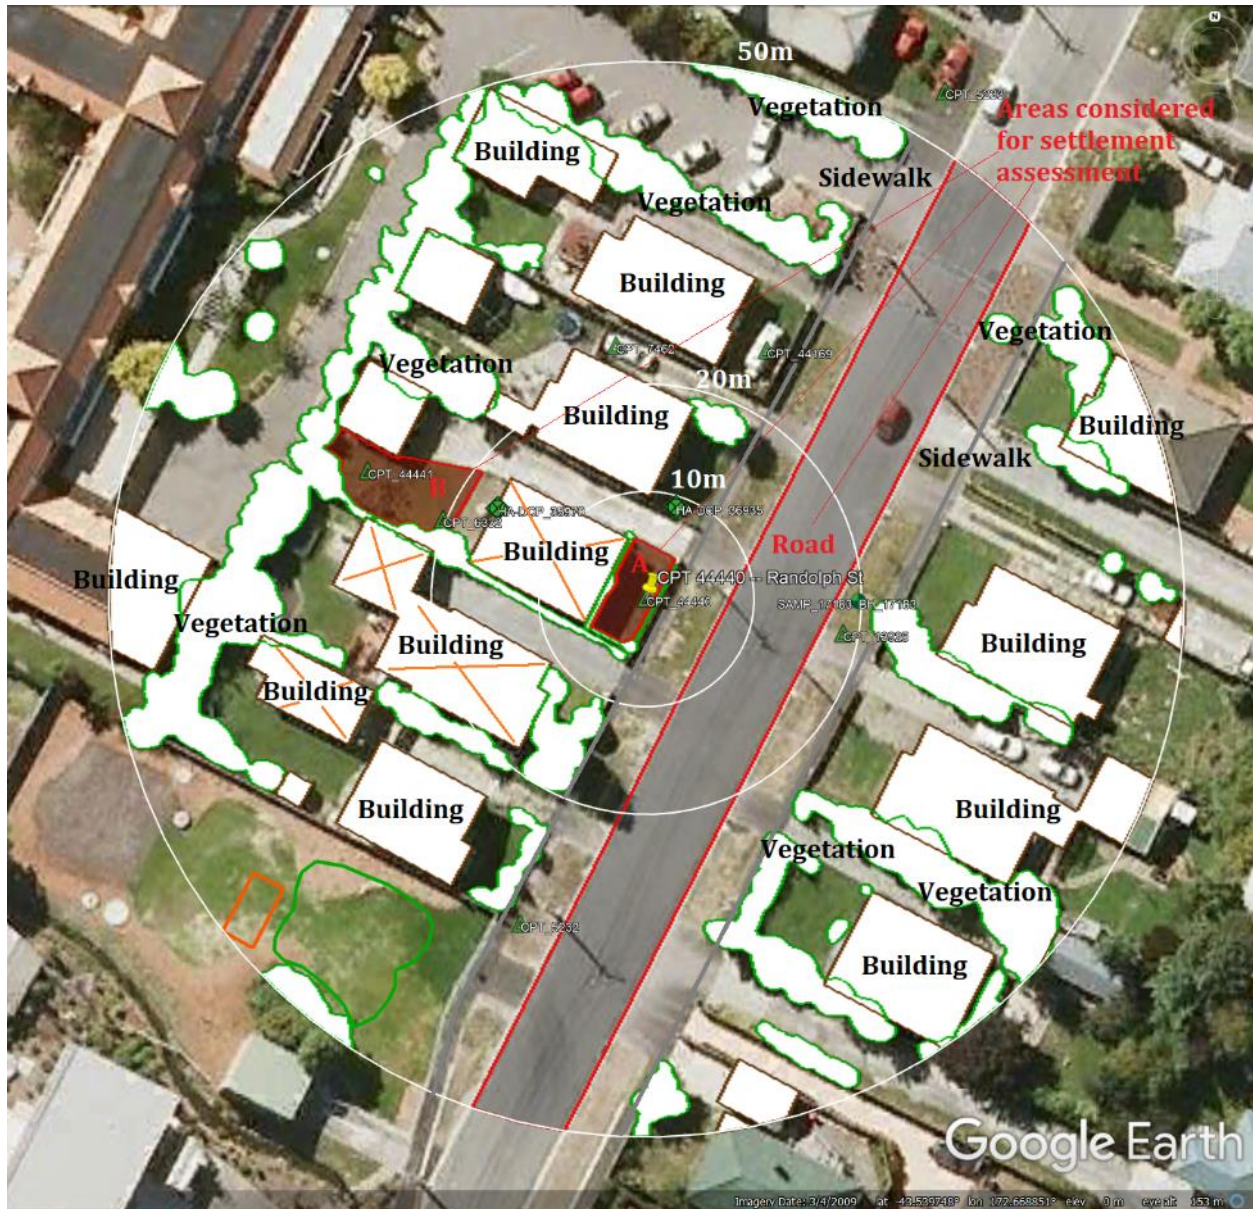
Figure 1: Site plan with areas where ejecta-induced settlement is considered.

Note 1: Two patches (outlined in red) in the free field were selected for the settlement assessment as areas free of vegetation and structures. Other important factors considered in the selection process were the proximity of a patch to a CPT, a property subjected to addition and/or demolition of a structure, and front yard/backyard alterations (e.g., ploughing, rubble, scrap), and aerial distribution of sediment ejecta. In addition, the entire portion of the road within the 50-m buffer was considered for settlement assessment. Roads as hard, relatively flat surfaces provide many ground-classified points. The Sep-10 and Dec-11 LiDAR-based settlement analyses were not conducted due to the evident absence of ejecta from Patches A and B and Road. The LiDAR-based settlement analyses of the Road were not performed for the Feb-11 EQ due to the anthropogenic changes that had the potential to affect the Sep 2010 LiDAR survey.

Note 6: The selection of CPTs for the area considered for settlement assessment (Figure 1) is based on the proximity of the CPTs to the considered areas. In accordance with that, the following table shows CPTs that were used for the volumetric settlement analysis in *Cliq v.3.0.3.2*, a CPT soil liquefaction software developed by GeoLogismiki. (The average volumetric settlements were reported in Table 8.)

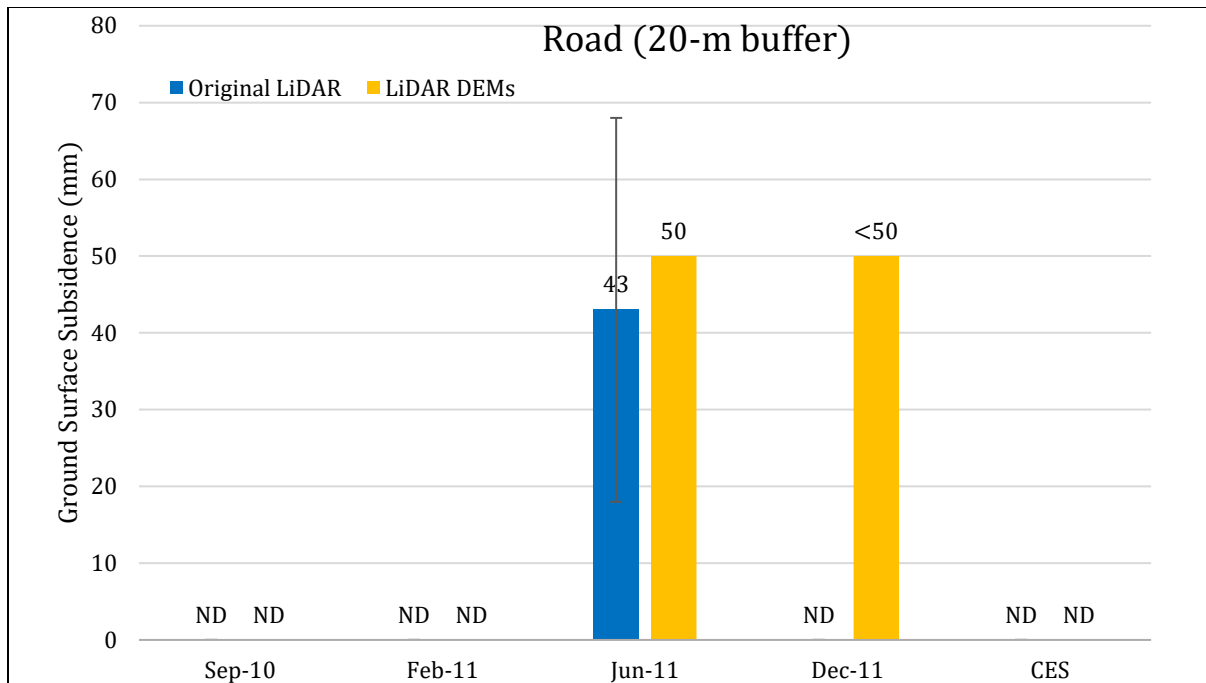
Figure 5: Comparison between ground surface subsidence determined from original LiDAR survey points and ground surface subsidence (50th %ile) estimated using LiDAR DEMs for Road (20-m buffer).

Note 2: The ground surface subsidence values determined from original LiDAR survey points are generally consistent with the ground surface subsidence values estimated using LiDAR DEMs for all earthquake events. The exception to this trend occurs for the Feb-11 earthquake for Patch A as the ground surface subsidence computed using the original LiDAR survey points is three times lower than the ground surface subsidence estimated using the LiDAR DEM (30 mm versus 100 mm, respectively).

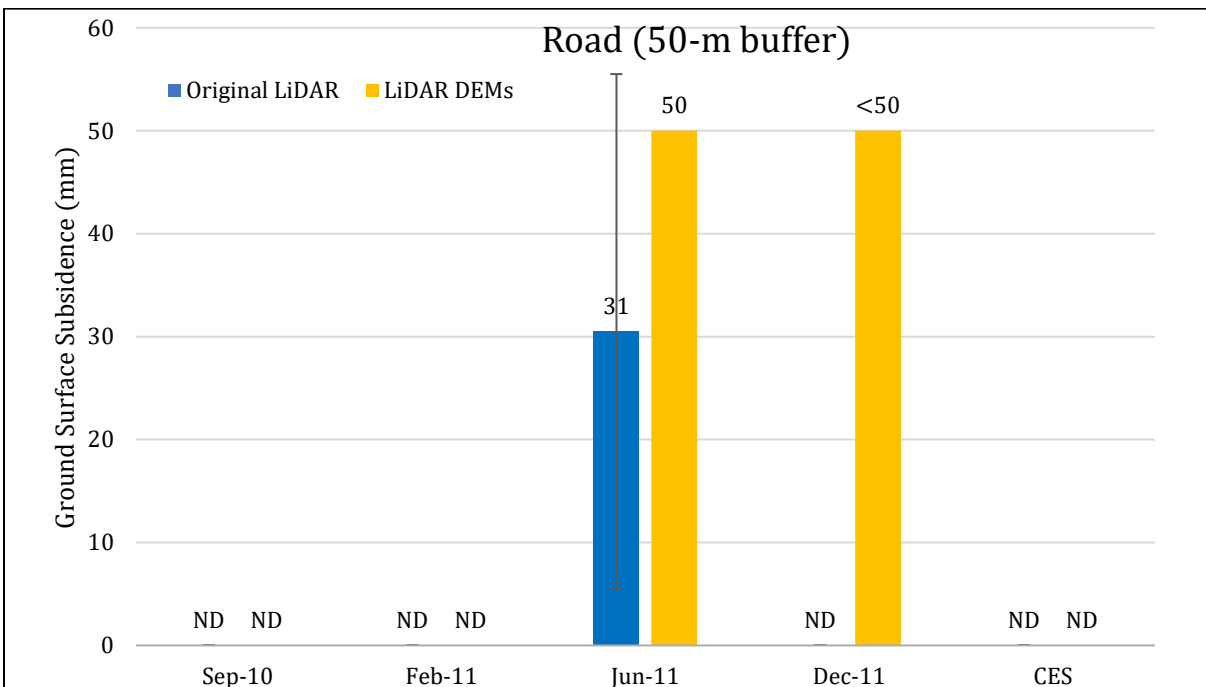
Figure 6: Comparison between ground surface subsidence determined from original LiDAR survey points and ground surface subsidence (50th %ile) estimated using LiDAR DEMs for Road (50-m buffer).

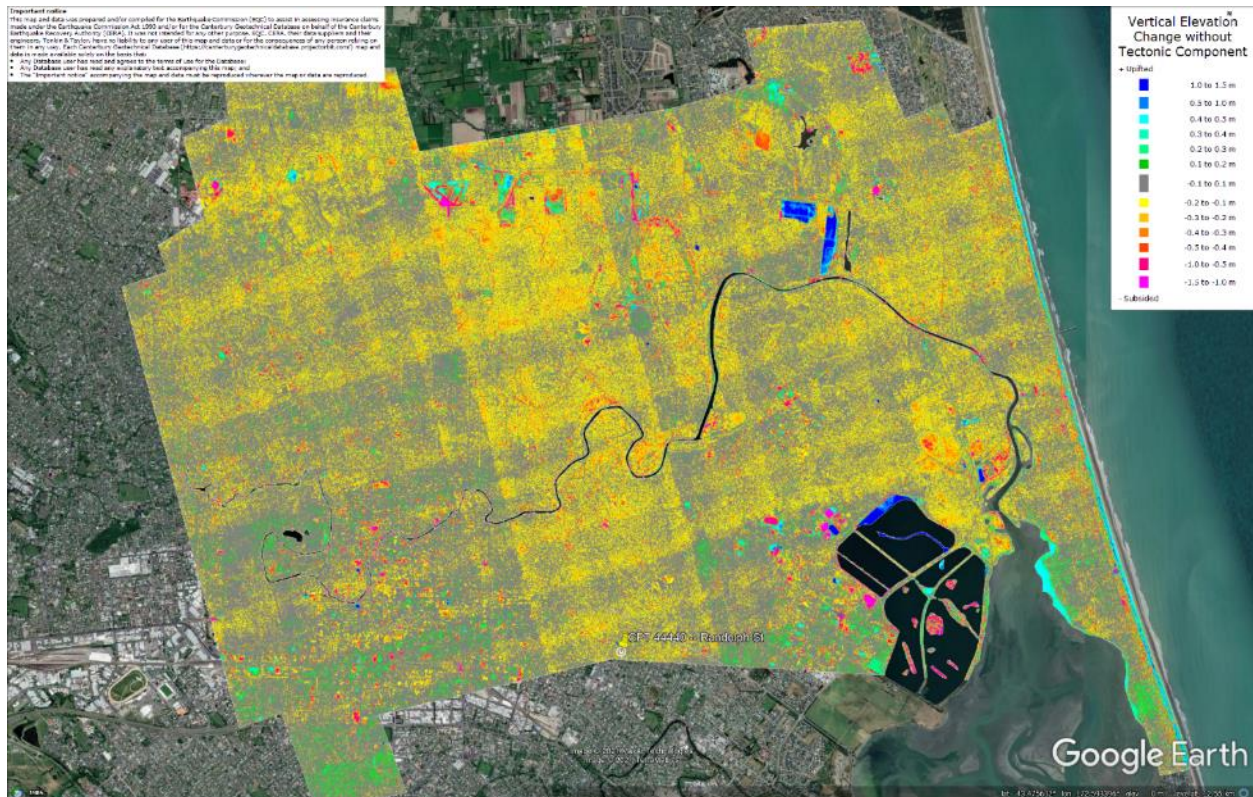
Figure 35: Vertical Ground Movements (Surface – Tectonic) for Sep 2010 Earthquake – the site is in the apparent zone of overestimated ground surface subsidence (i.e., Sep 2010 LiDAR flight error).

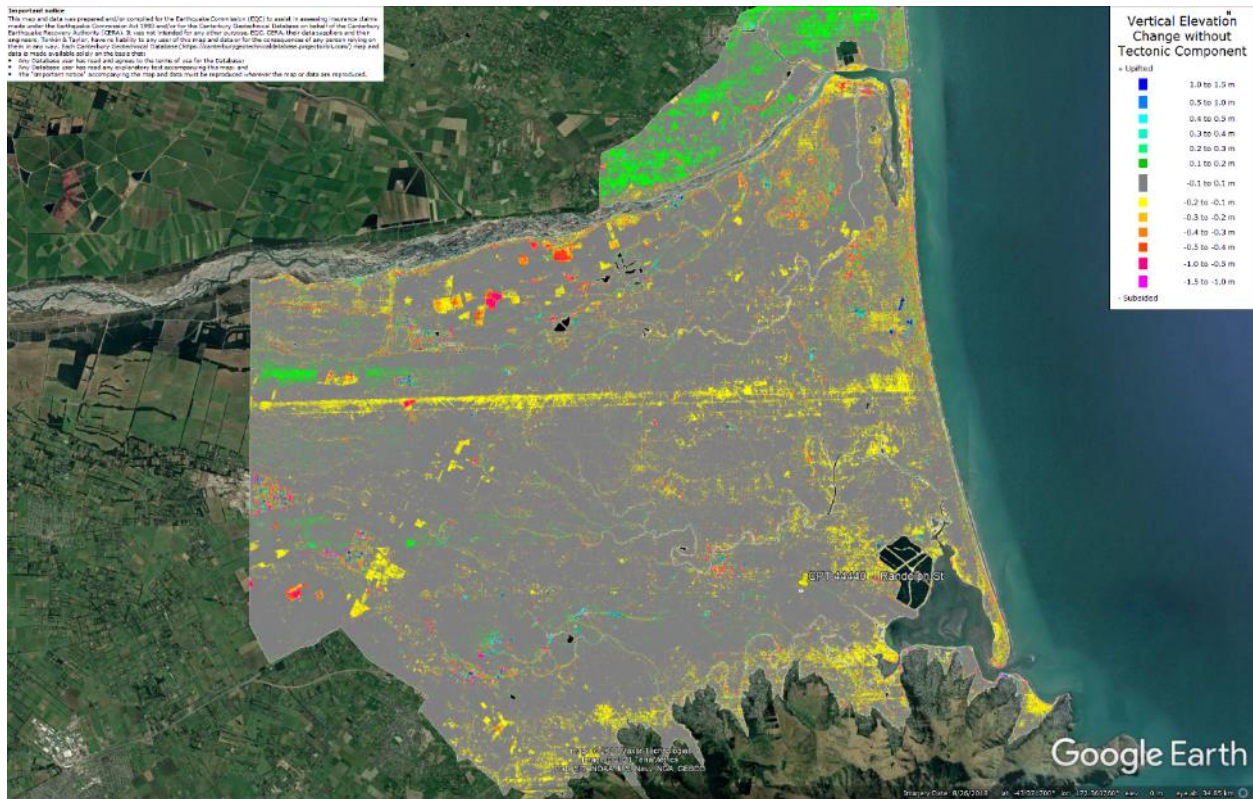
Figure 37: Vertical Ground Movements (Surface – Tectonic) for June 2011 Earthquake – the site is not in the apparent zone of overestimated/underestimated ground surface subsidence.

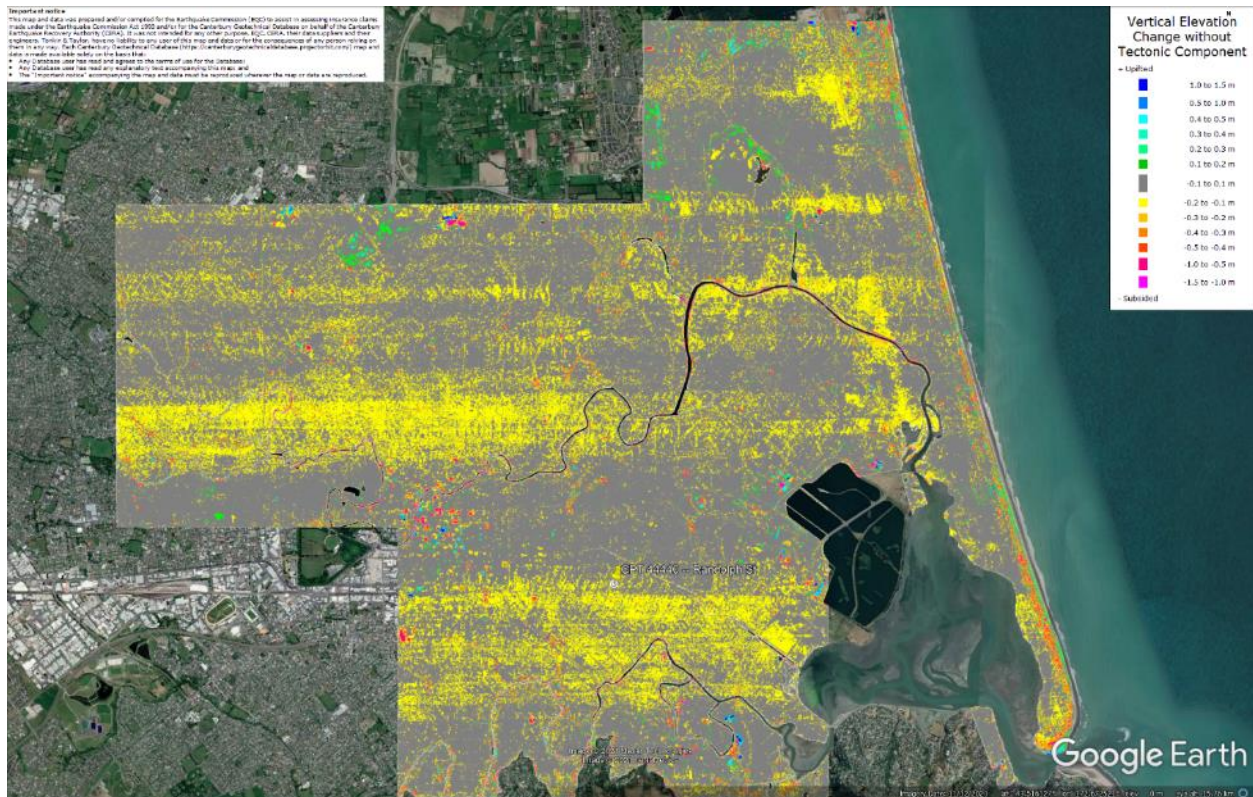
Figure 38: Vertical Ground Movements (Surface – Tectonic) for Dec 2011 Earthquake – the site is in the apparent zone of overestimated ground surface subsidence(i.e., Feb 2012 LiDAR flight error band).

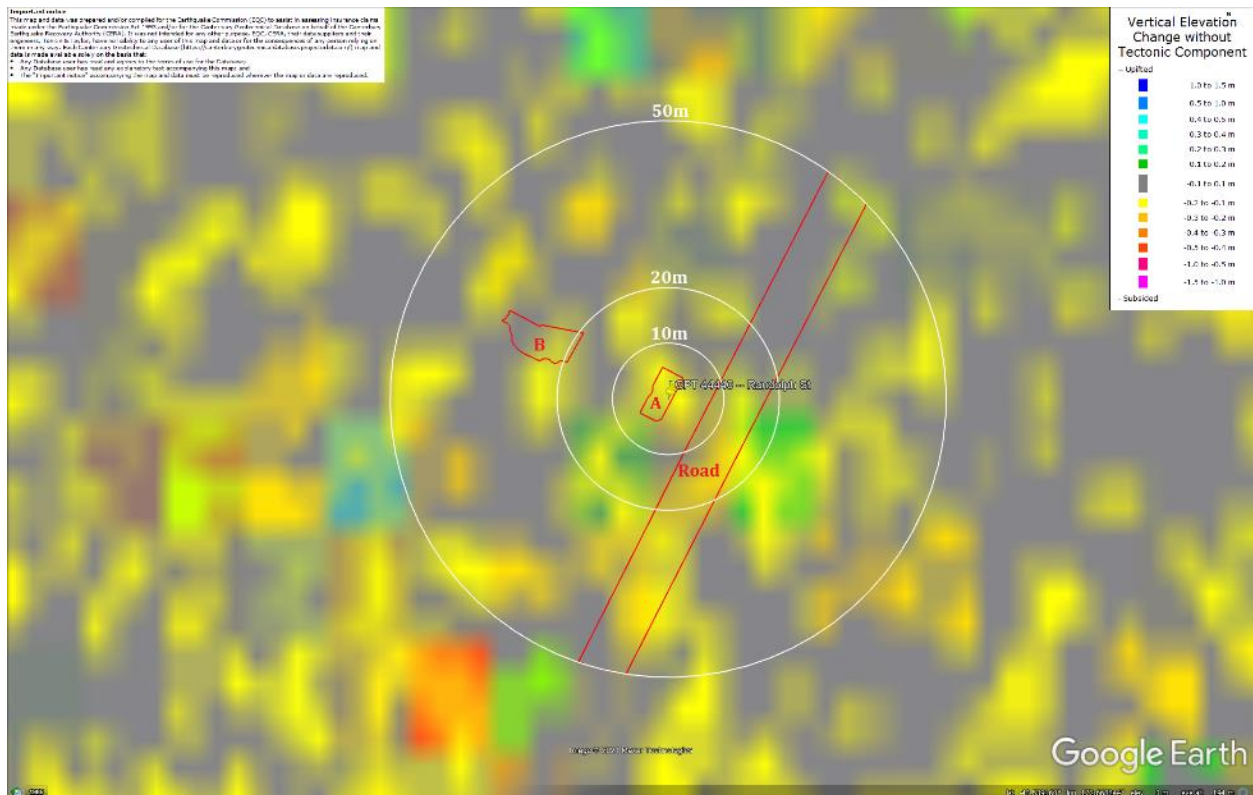
Figure 39: Ground surface subsidence without tectonic component for Sep 2010 Earthquake according to the LiDAR DEM.

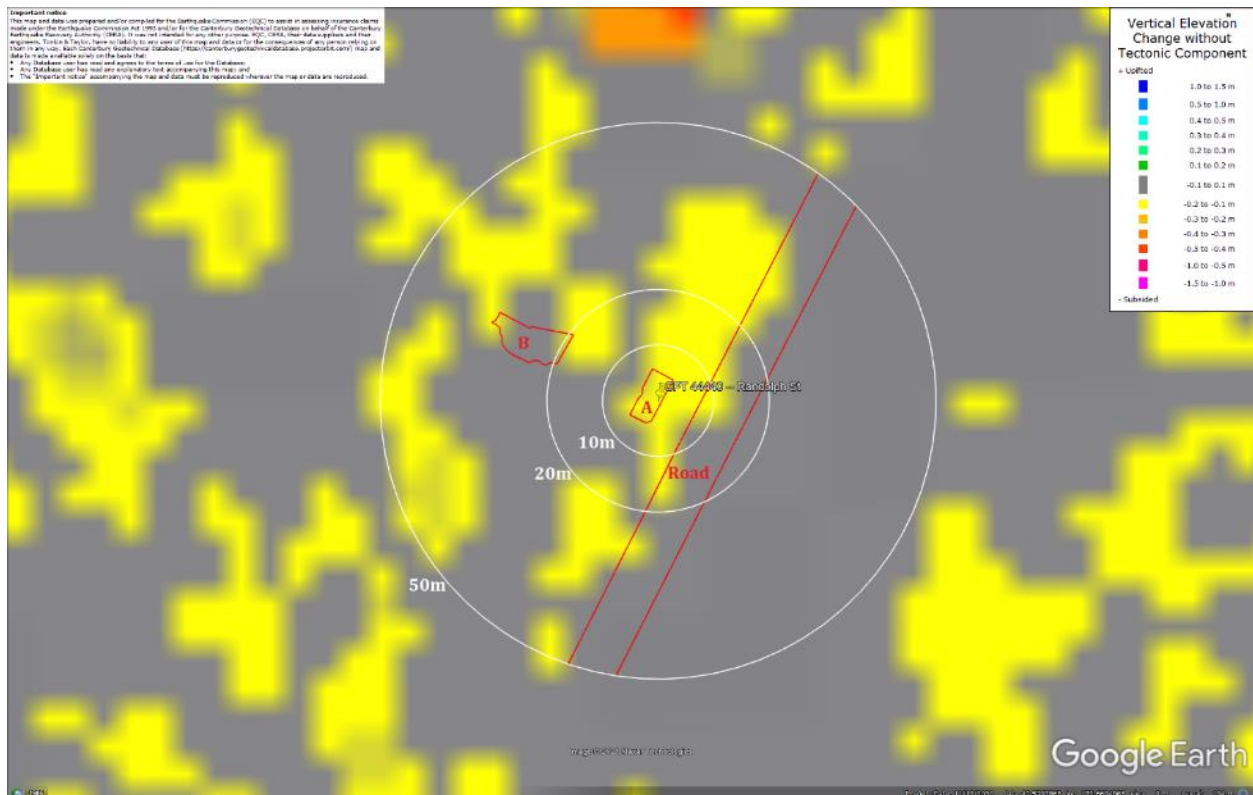
Figure 42: Ground surface subsidence without tectonic component for Dec 2011 Earthquake according to the LiDAR DEM.

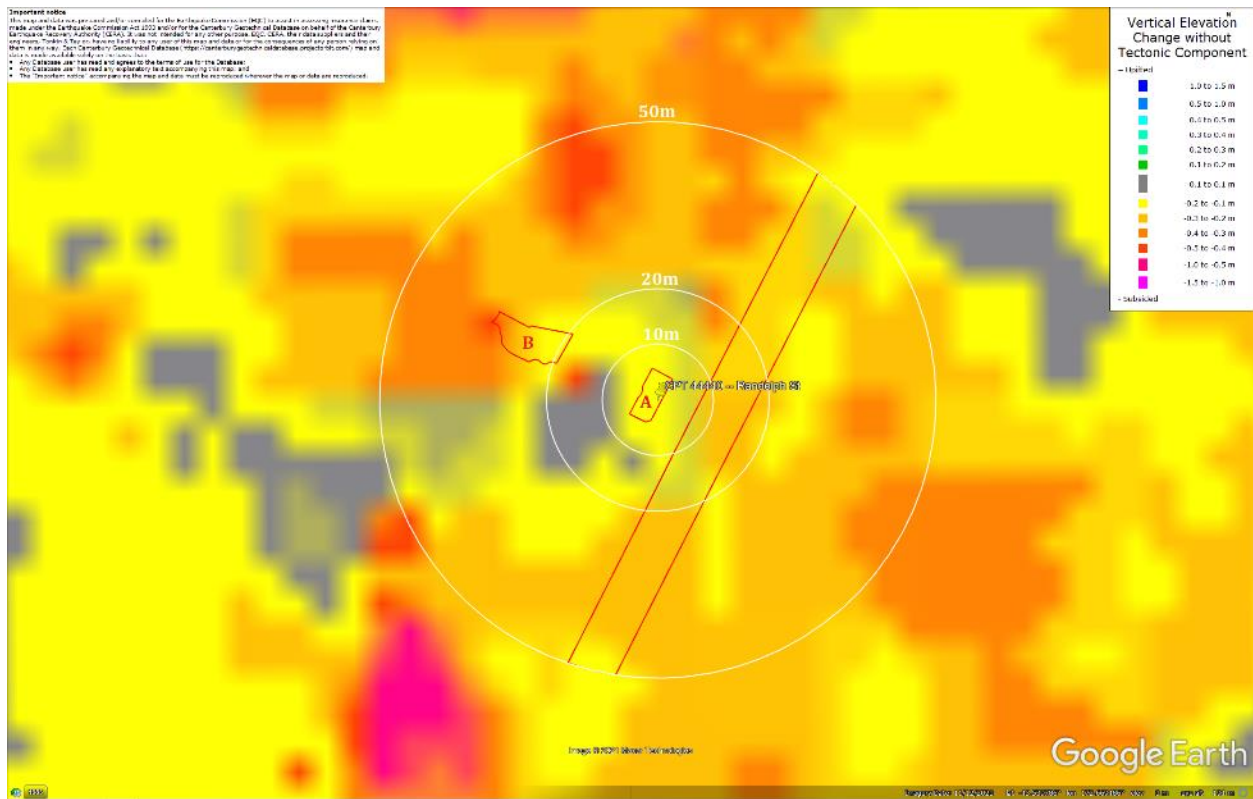
Figure 43: Ground surface subsidence without tectonic component for Canterbury Earthquake Sequence according to the LiDAR DEM.

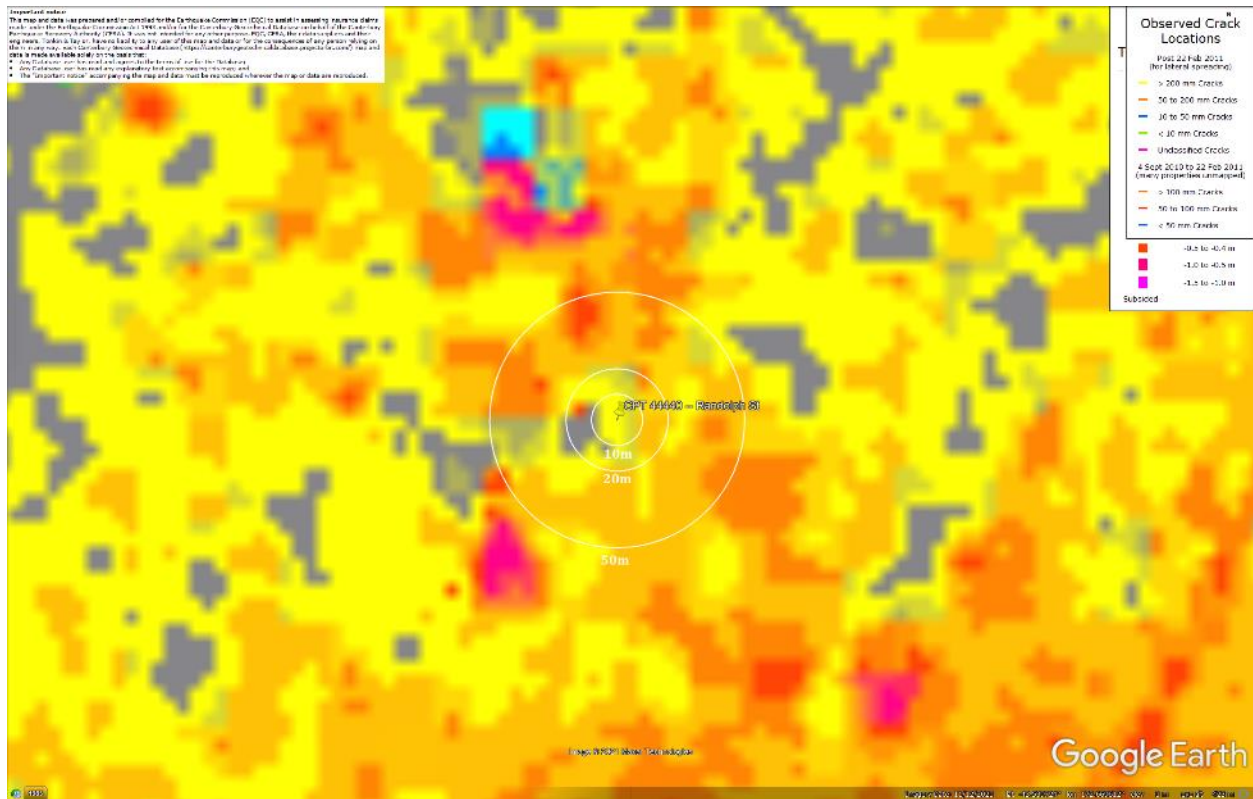
Figure 44: No lateral spreading for Canterbury Earthquake Sequence.

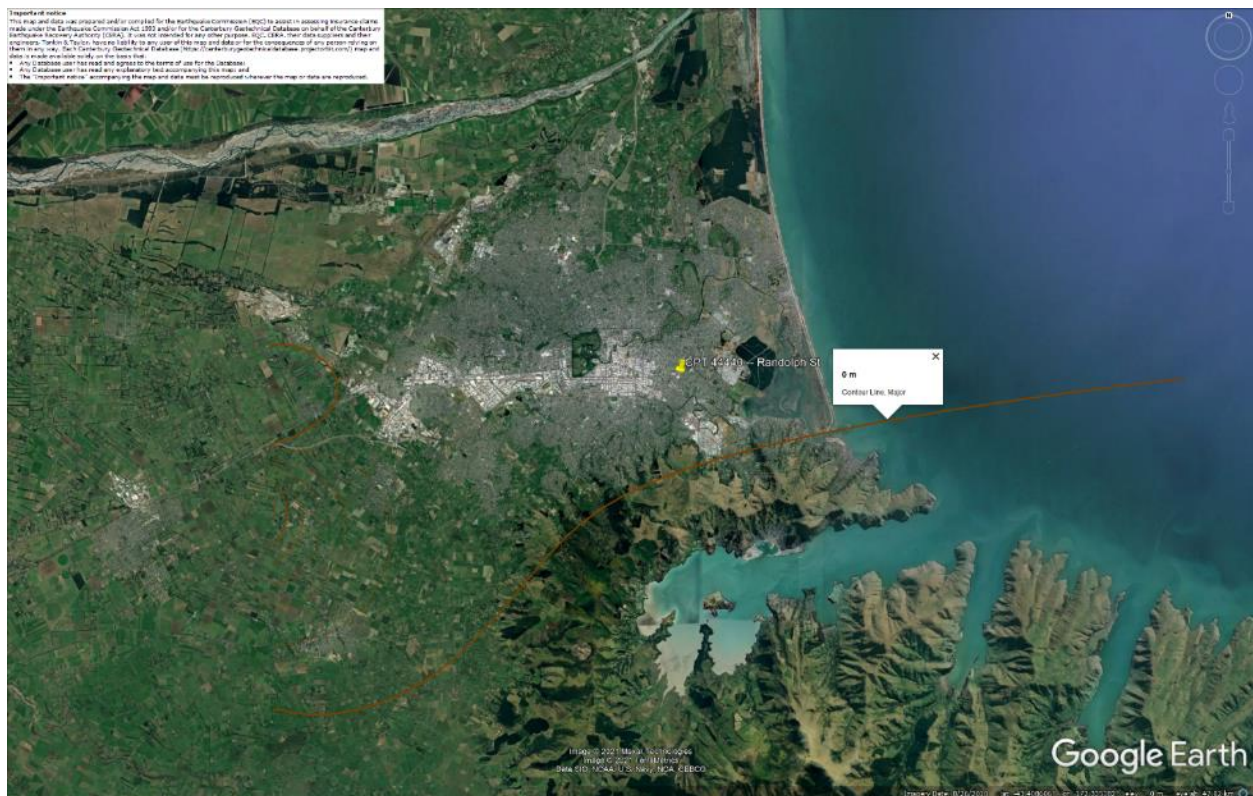
Figure 45: Vertical tectonic movements for Sep 2010 Earthquake.

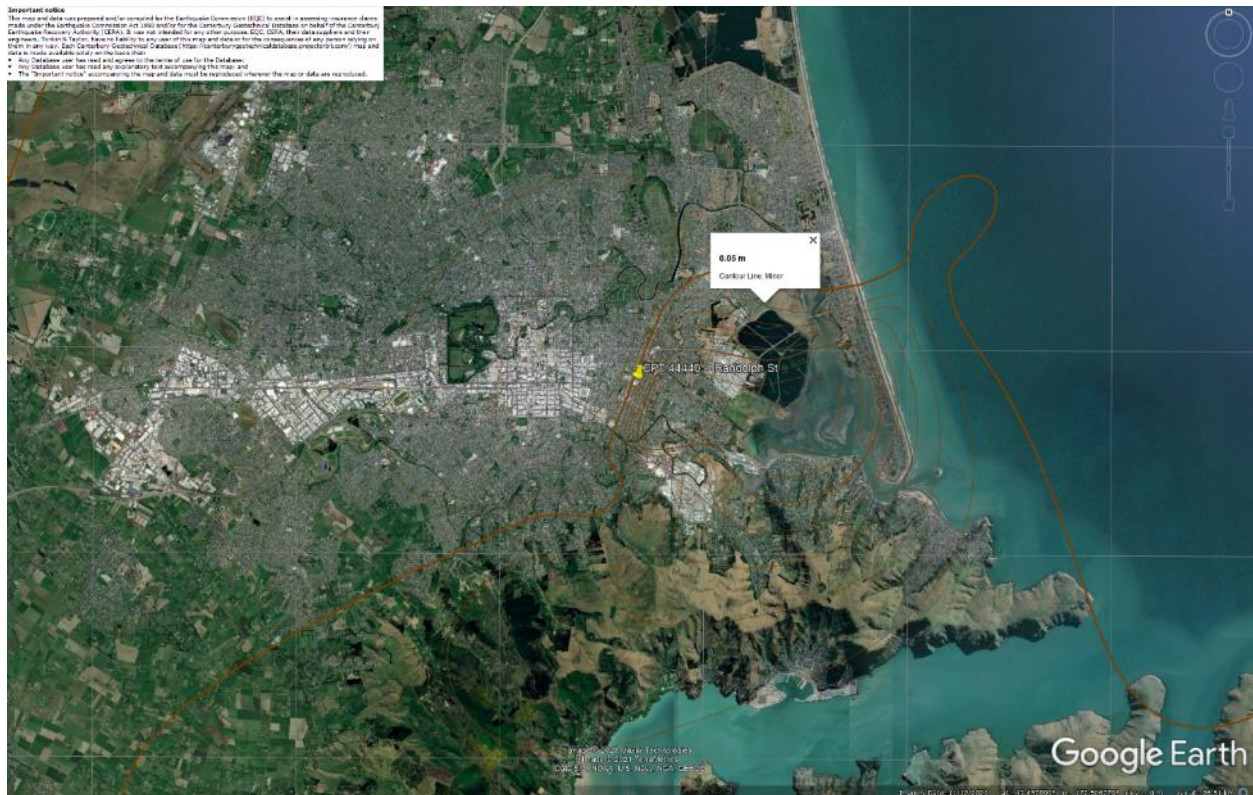
Figure 46: Vertical tectonic movements for Feb 2011 Earthquake.

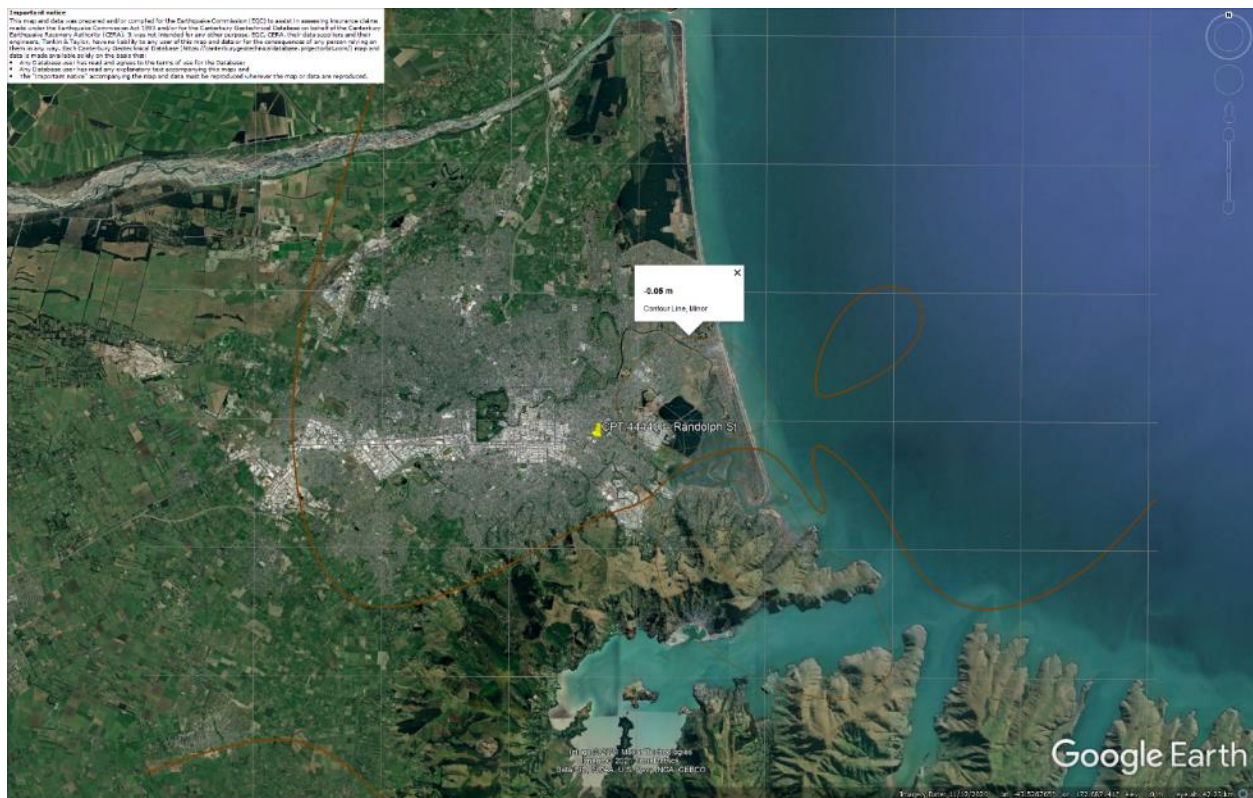
Figure 47: Vertical tectonic movements for June 2011 Earthquake.

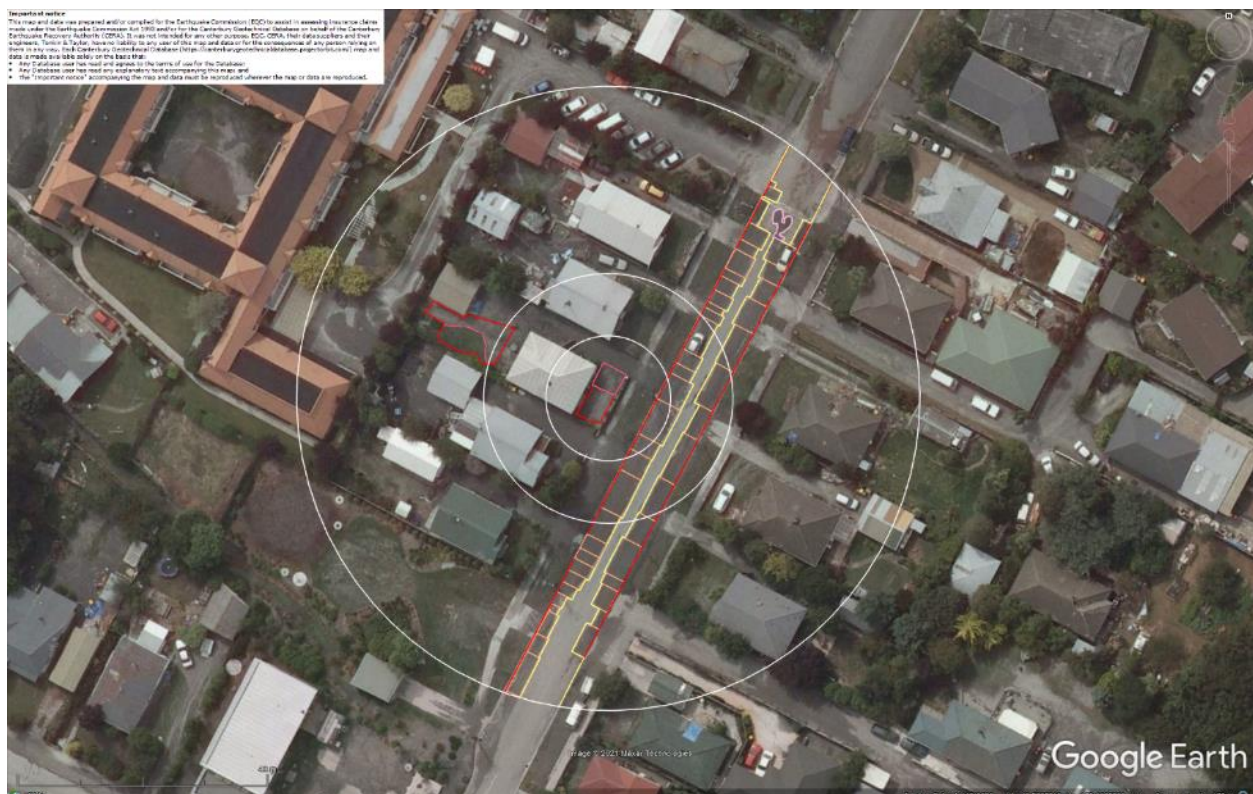
Figure 71: Aerial photograph showing the ejecta outline at the site for Feb-11 EQ.

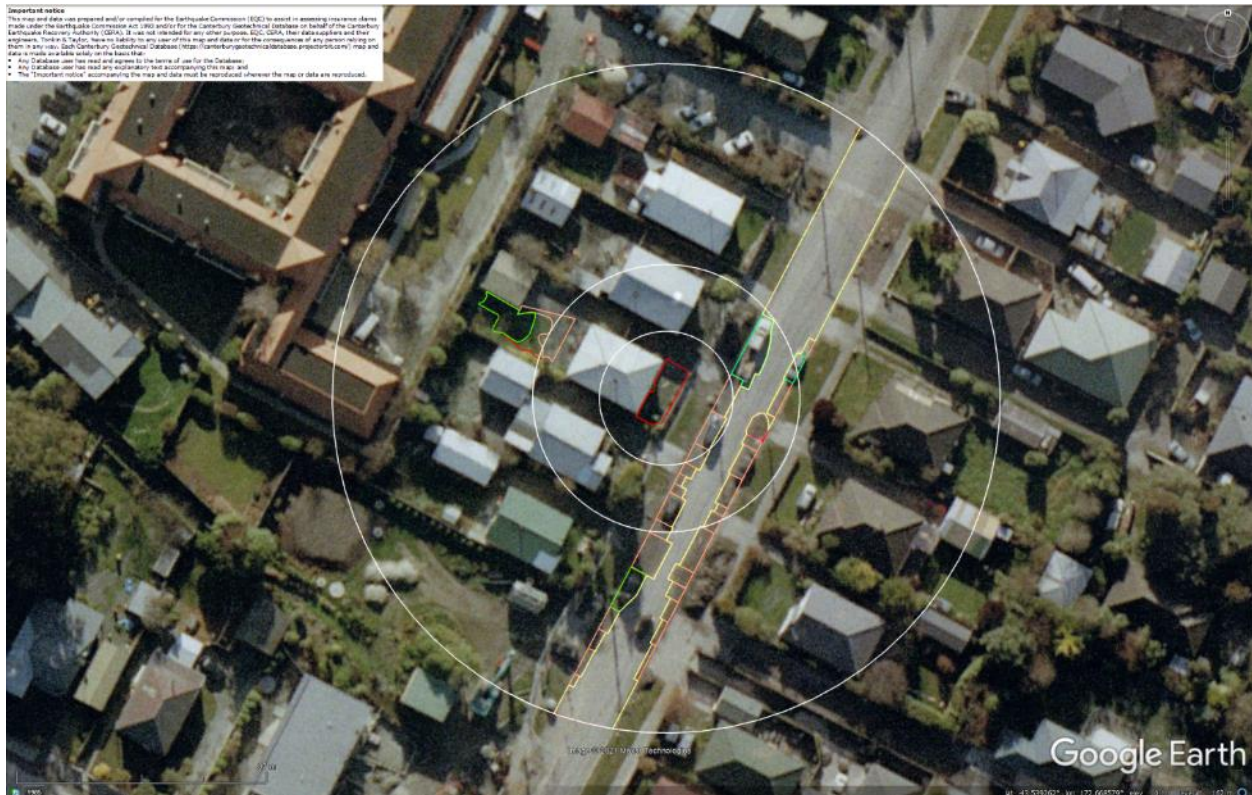
Figure 72: Aerial photograph acquired on 16 Jun 2011 showing the ejecta outline at the site for Jun-11 EQ.

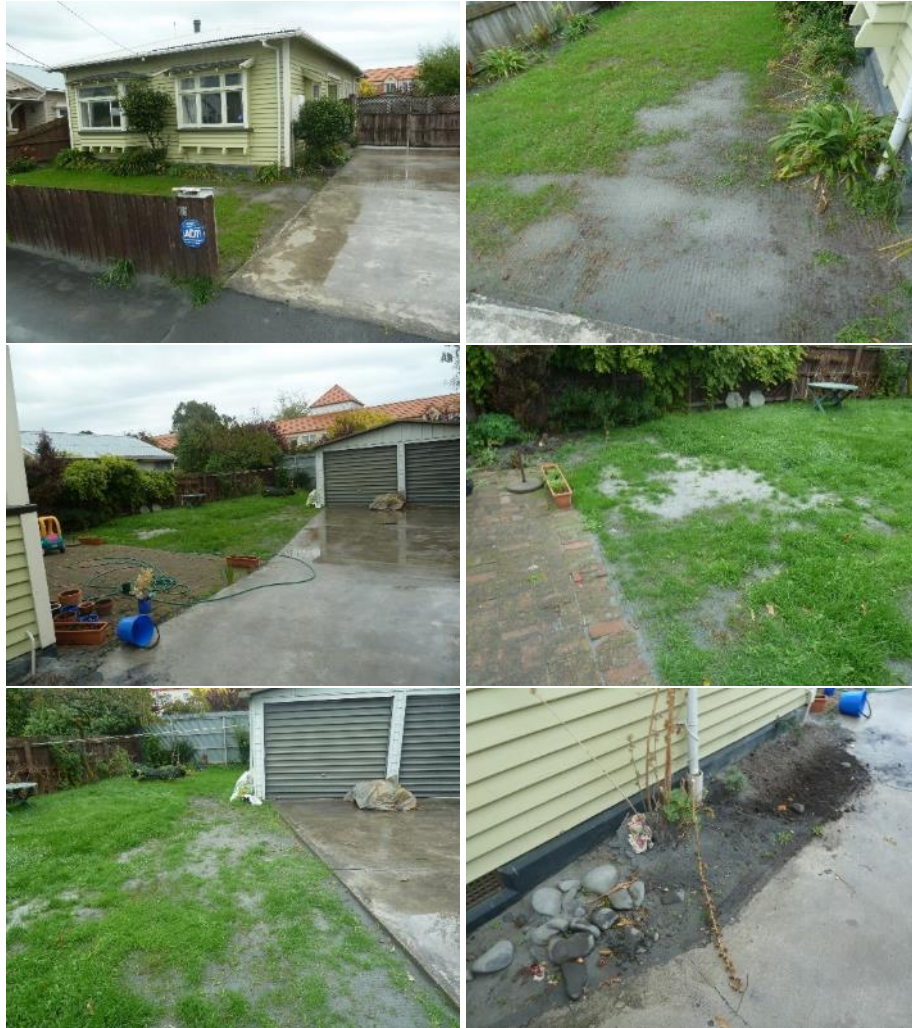
Figure 74: Ground photographs showing ejecta remnants at the property with Patches A and B (photograph date: Apr 2011).

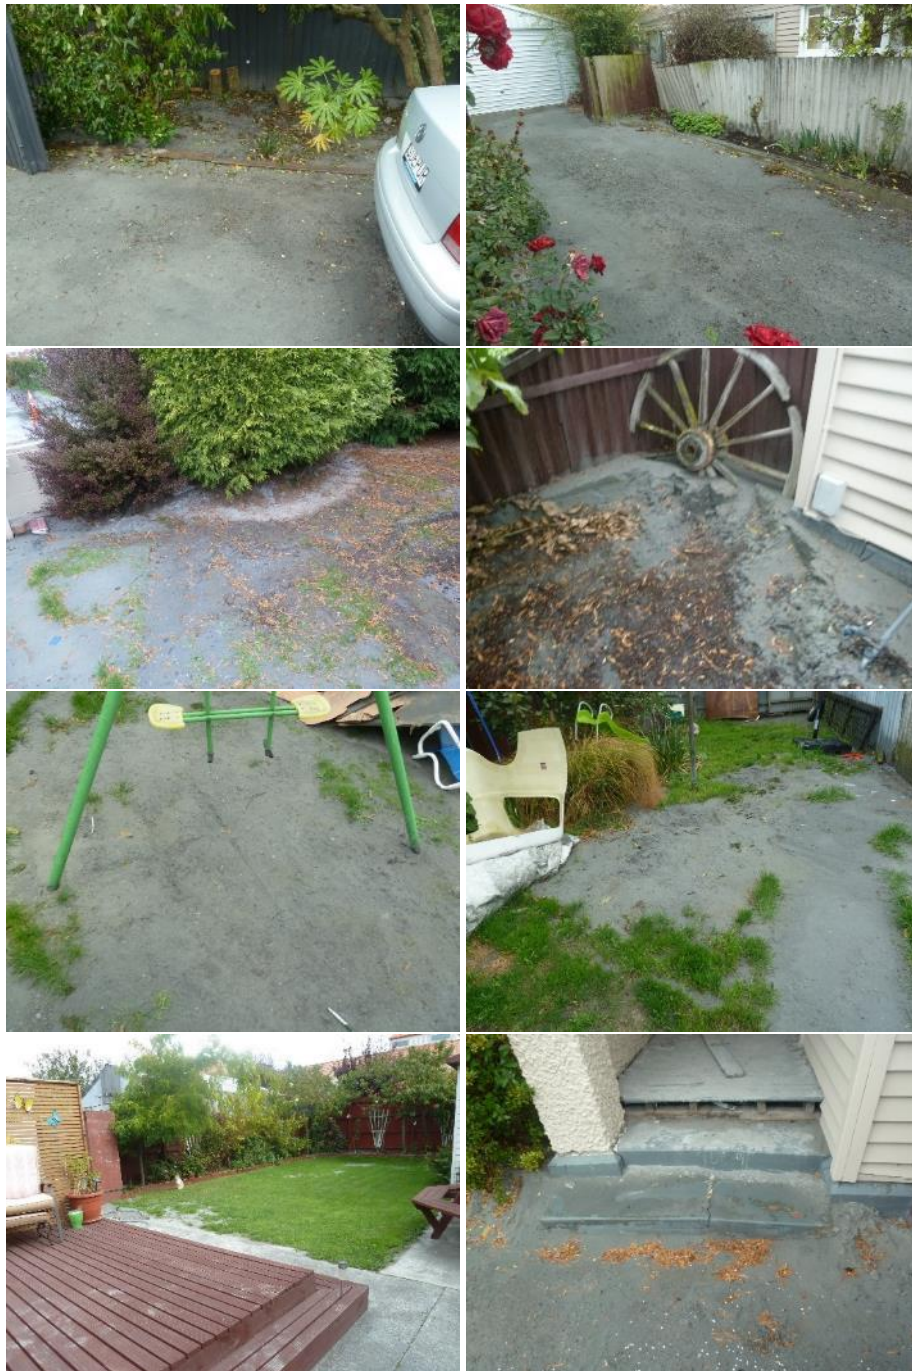
Figure 75: Ground photographs showing ejecta remnants at properties within the 50-m buffer (photograph date: Apr 2011).

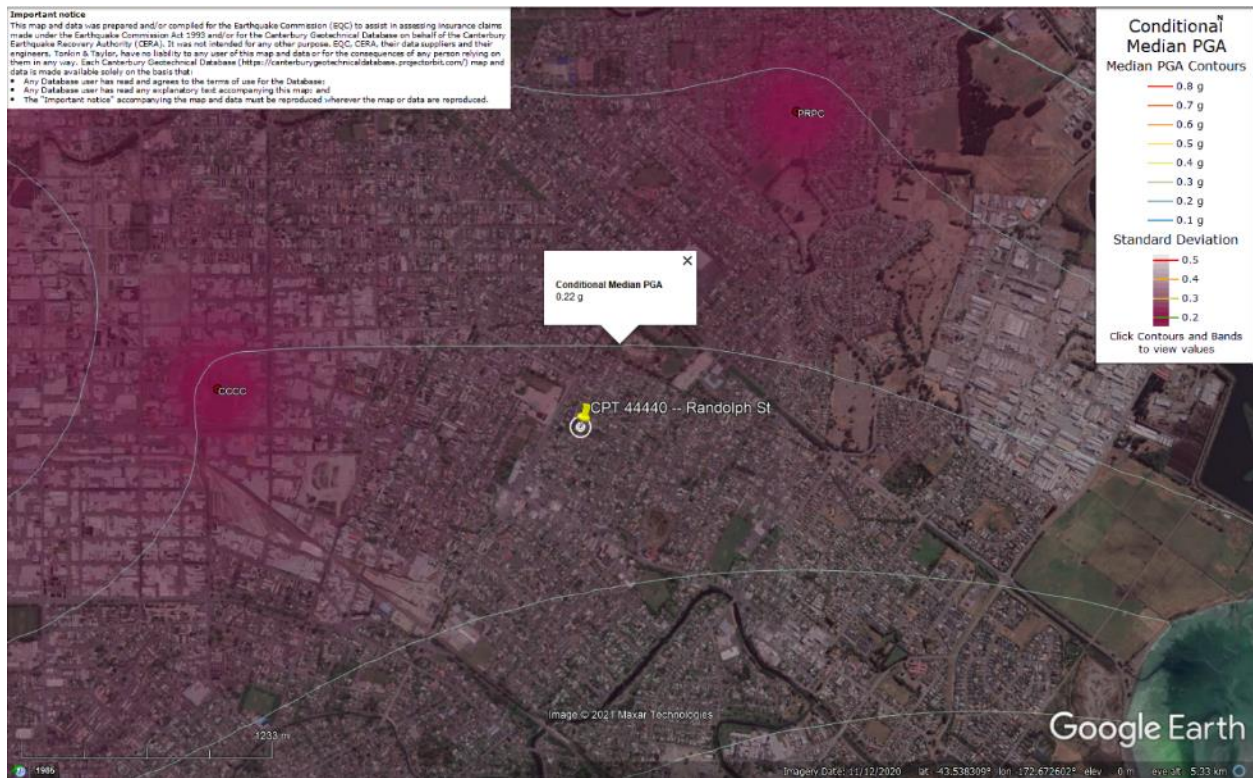
Figure 76: PGA for Sep-10 EQ (st. dev. = 0.325-0.350 ln units).

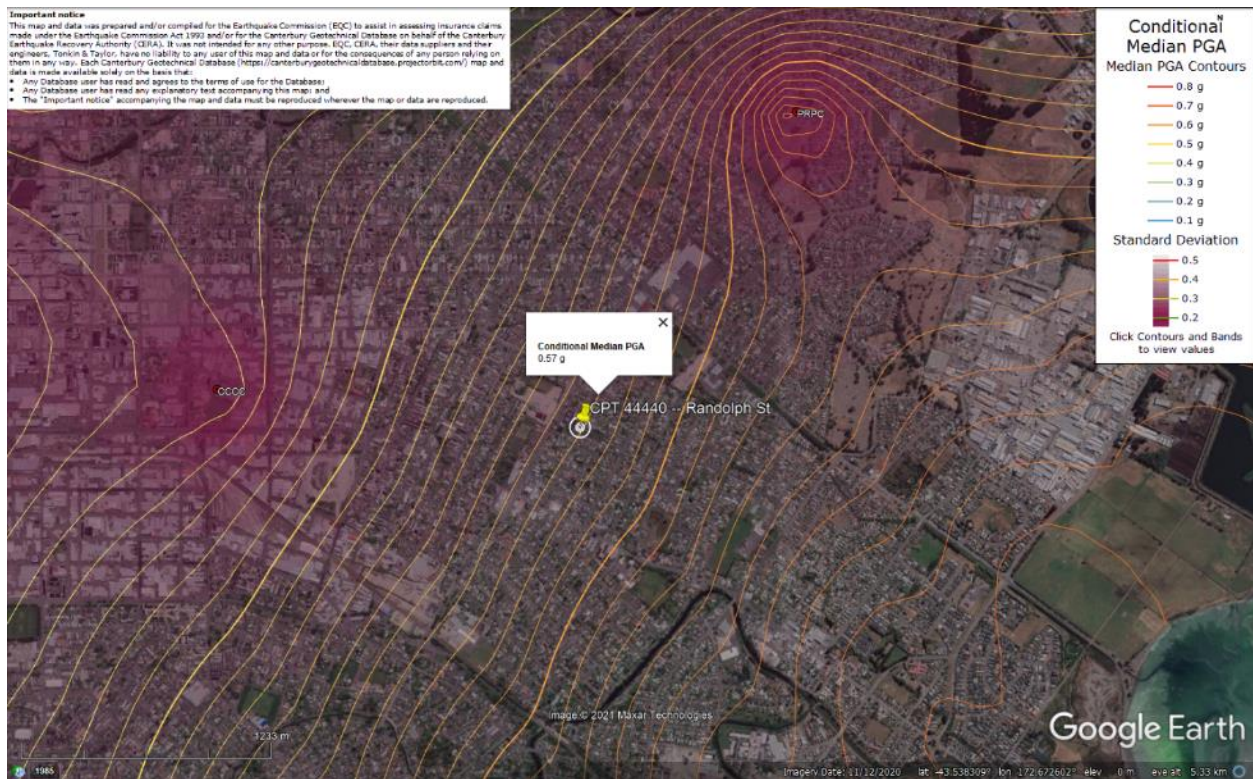
Figure 77: PGA for Feb-11 EQ (st. dev. = 0.350-0.375 ln units).

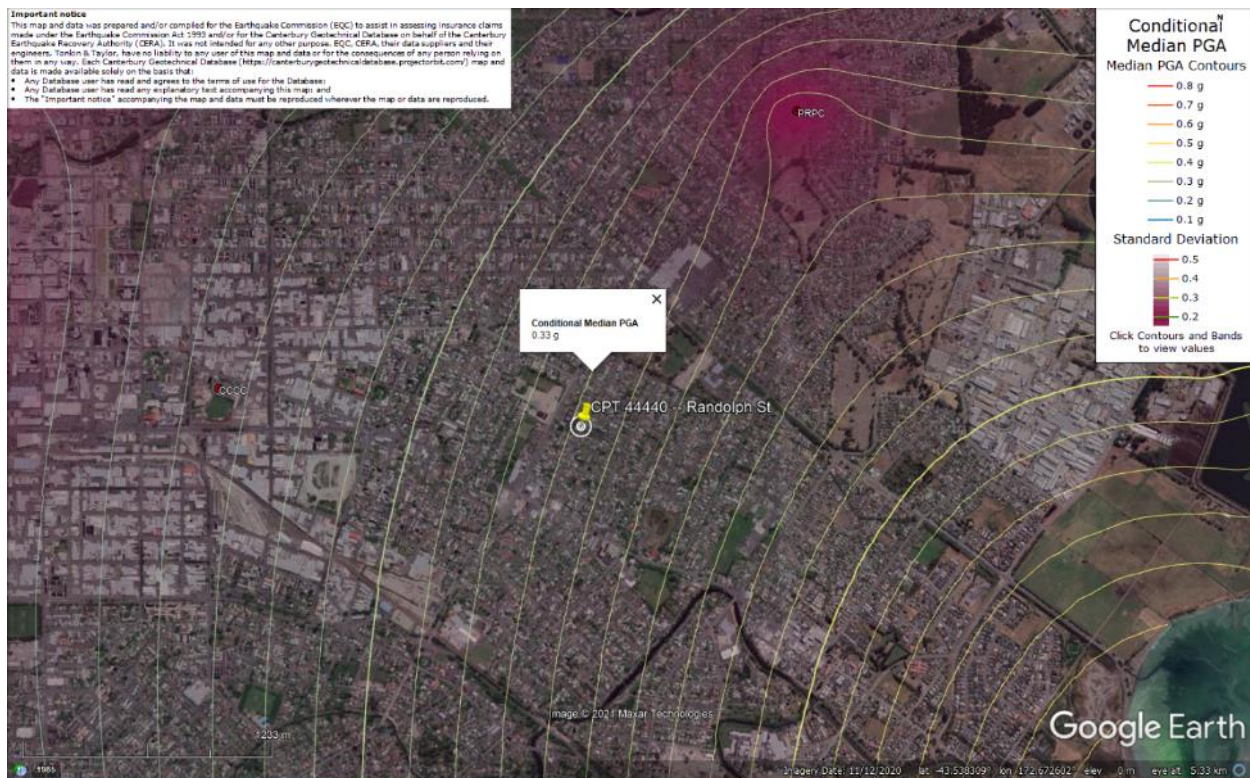
Figure 78: PGA for Jun-11 EQ (st. dev. = 0.375-0.400 ln units).

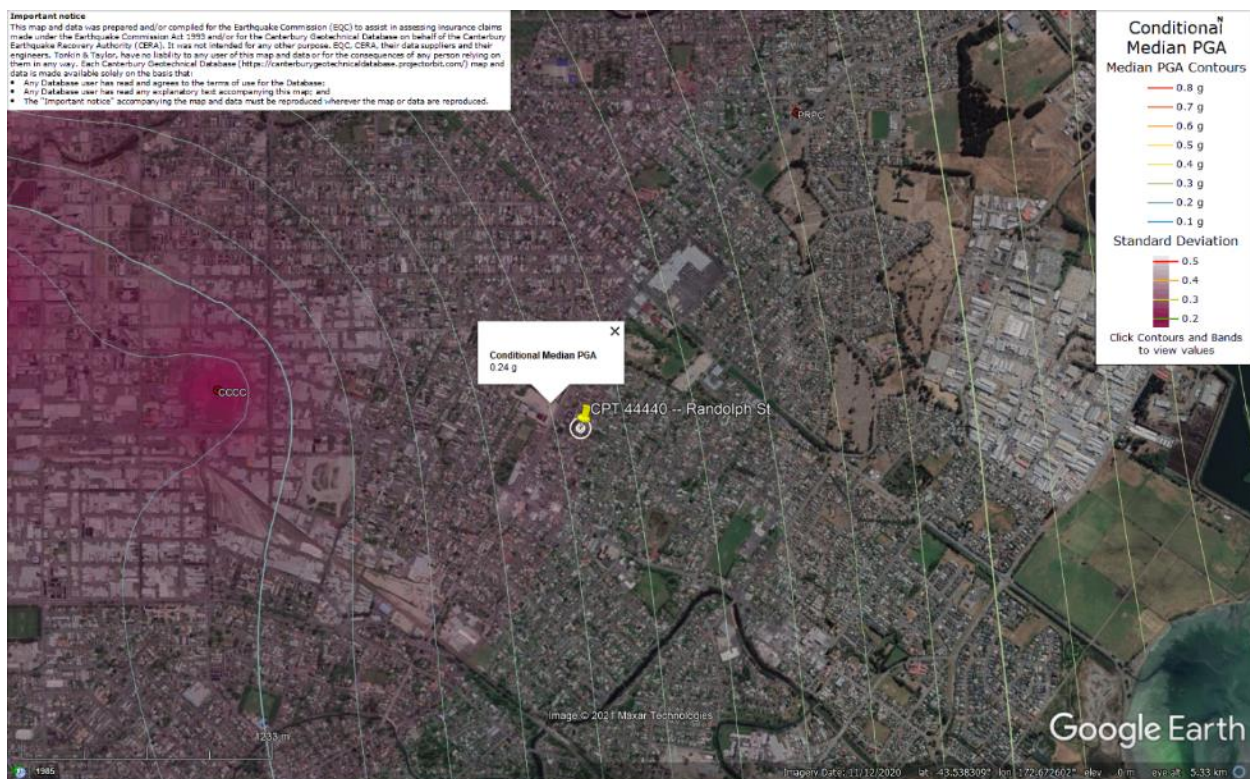
Figure 79: PGA for Dec-11 EQ (st. dev. = 0.375-0.400 ln units).
