Appendix A.36:

Randolph St – CPT 44440

Liquefaction Ejecta Case Histories for 2010-11 Canterbury Earthquakes

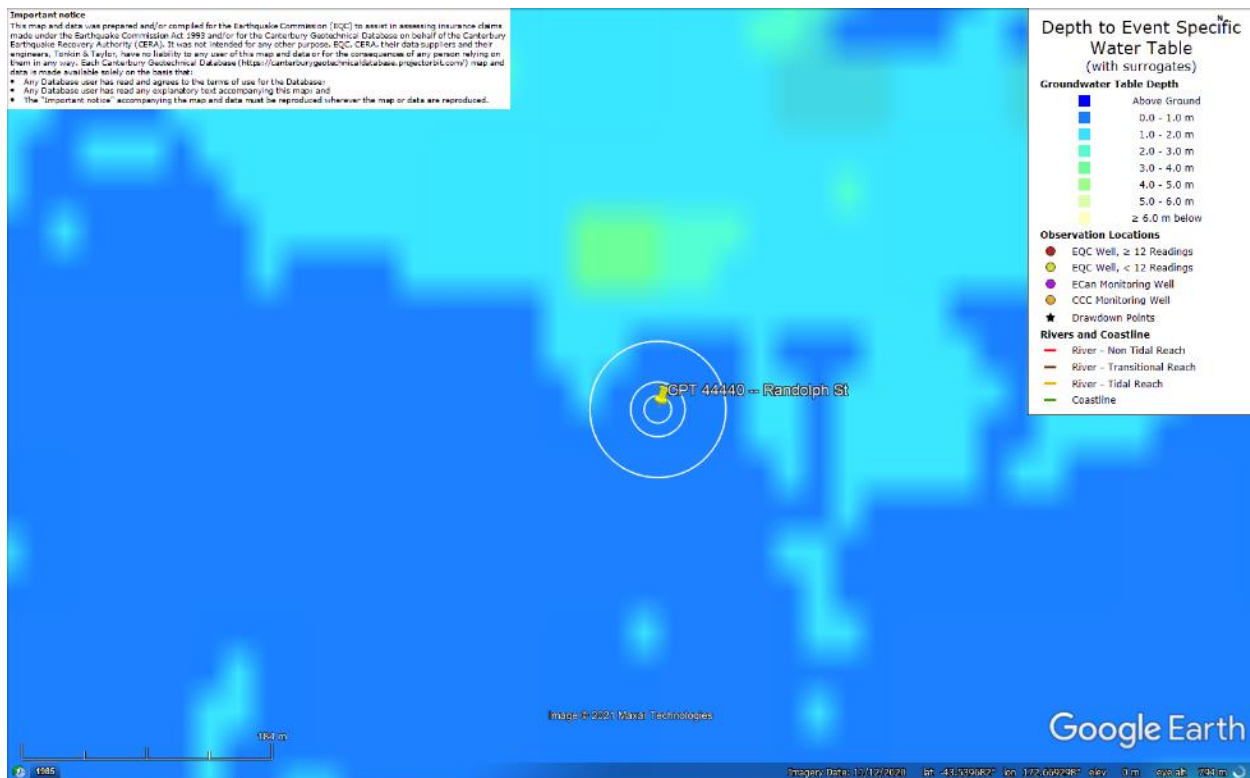
Figure 80: Depth to groundwater table for Sep-10 EQ.

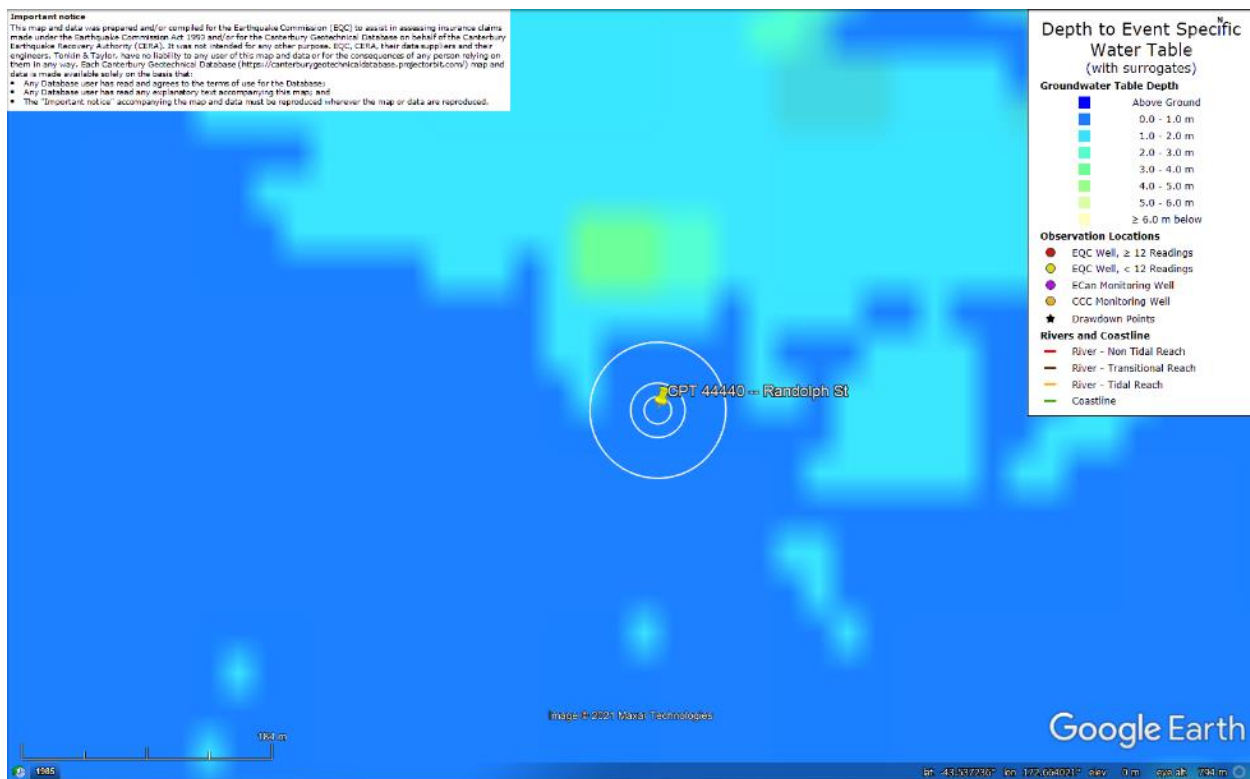
Figure 81: Depth to groundwater table for Feb-11 EQ.

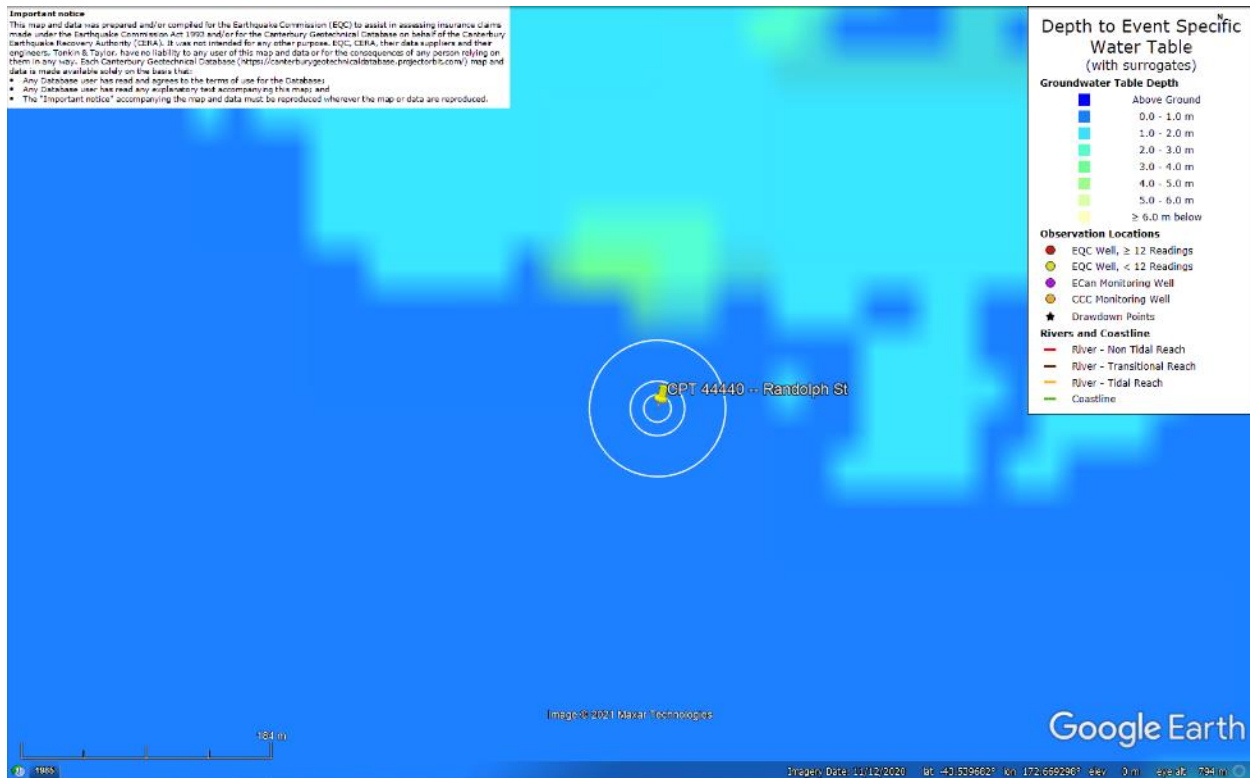
Figure 82: Depth to groundwater table for Jun-11 EQ.

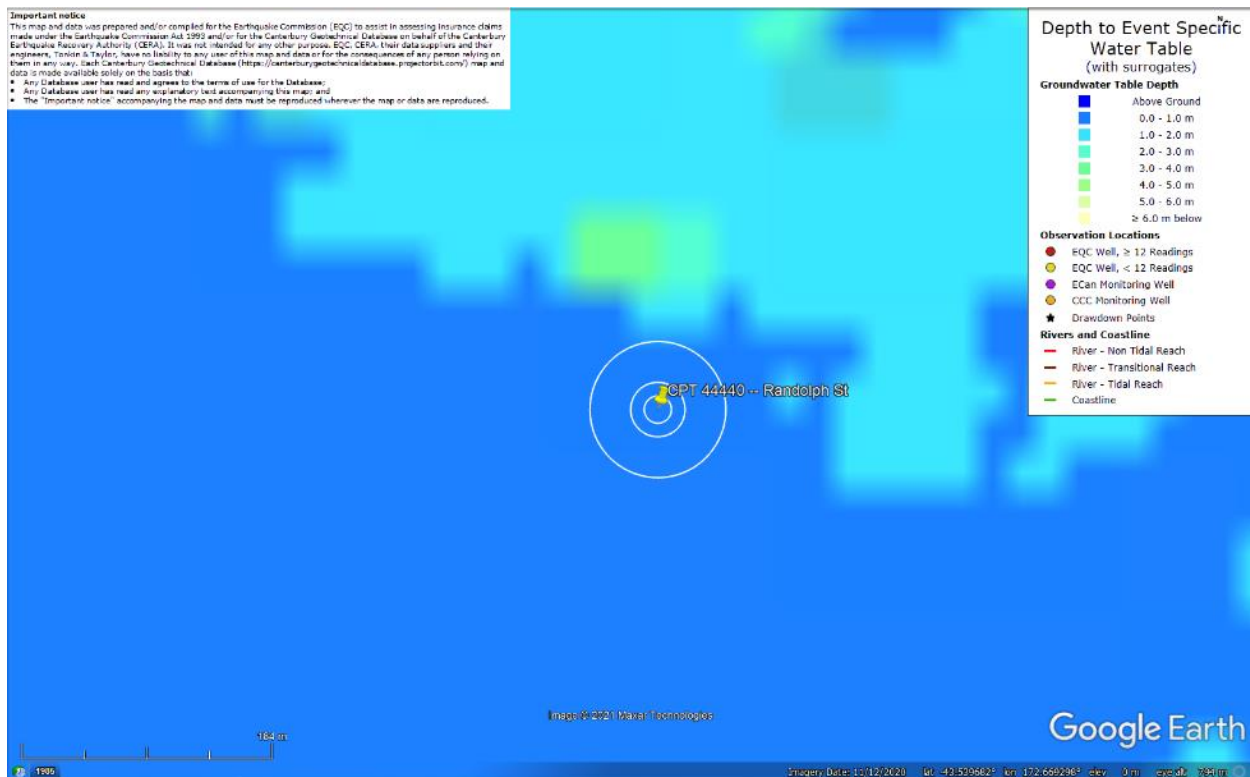
Figure 83: Depth to groundwater table for Dec-11 EQ.

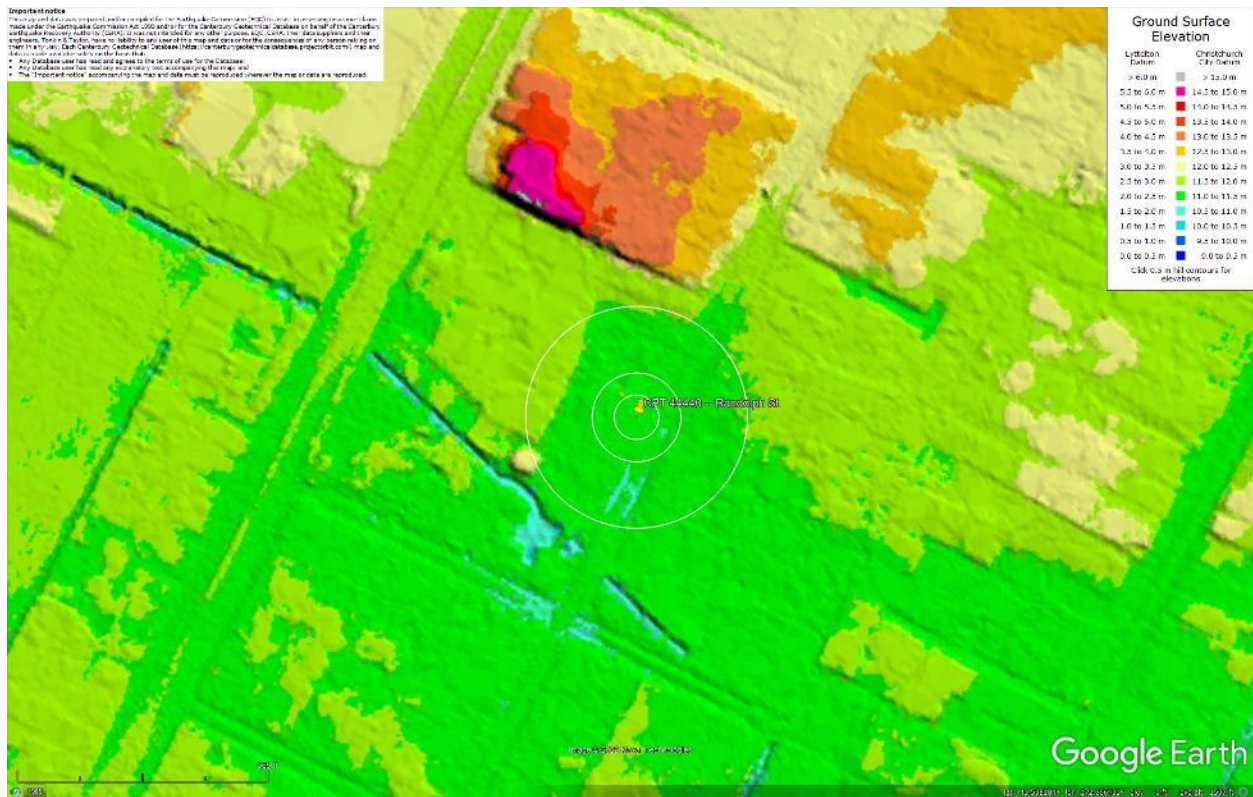
Figure 84: Ground surface elevation (Sep-11 LiDAR survey).

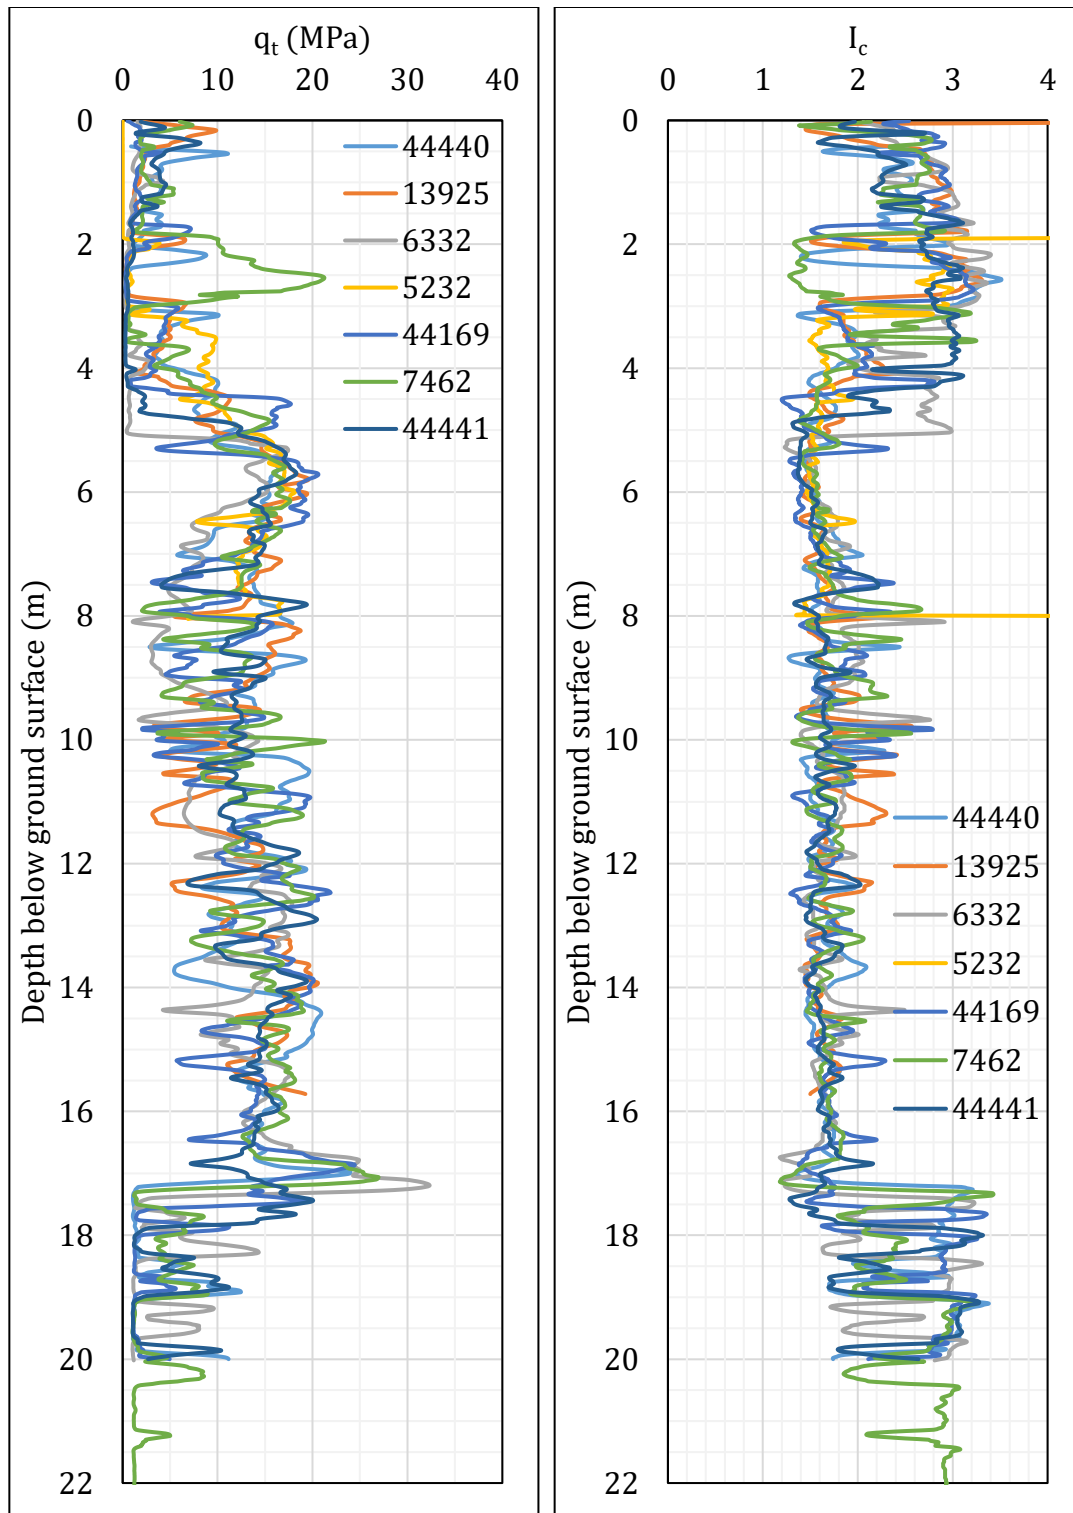
Figure 85: q_t and I_c profiles.

Note 6: The selection of CPTs for the area considered for settlement assessment (Figure 1) is based on the proximity of the CPTs to the considered areas. In accordance with that, the following table shows CPTs that were used for the volumetric settlement analysis in *Cliq v.3.0.3.2*, a CPT soil liquefaction software developed by GeoLogismiki. (The average volumetric settlements were reported in Table 8.)
