Appendix A.39:

Palmers Rd – CPT 27040

## Liquefaction Ejecta Case Histories for 2010-11 Canterbury Earthquakes

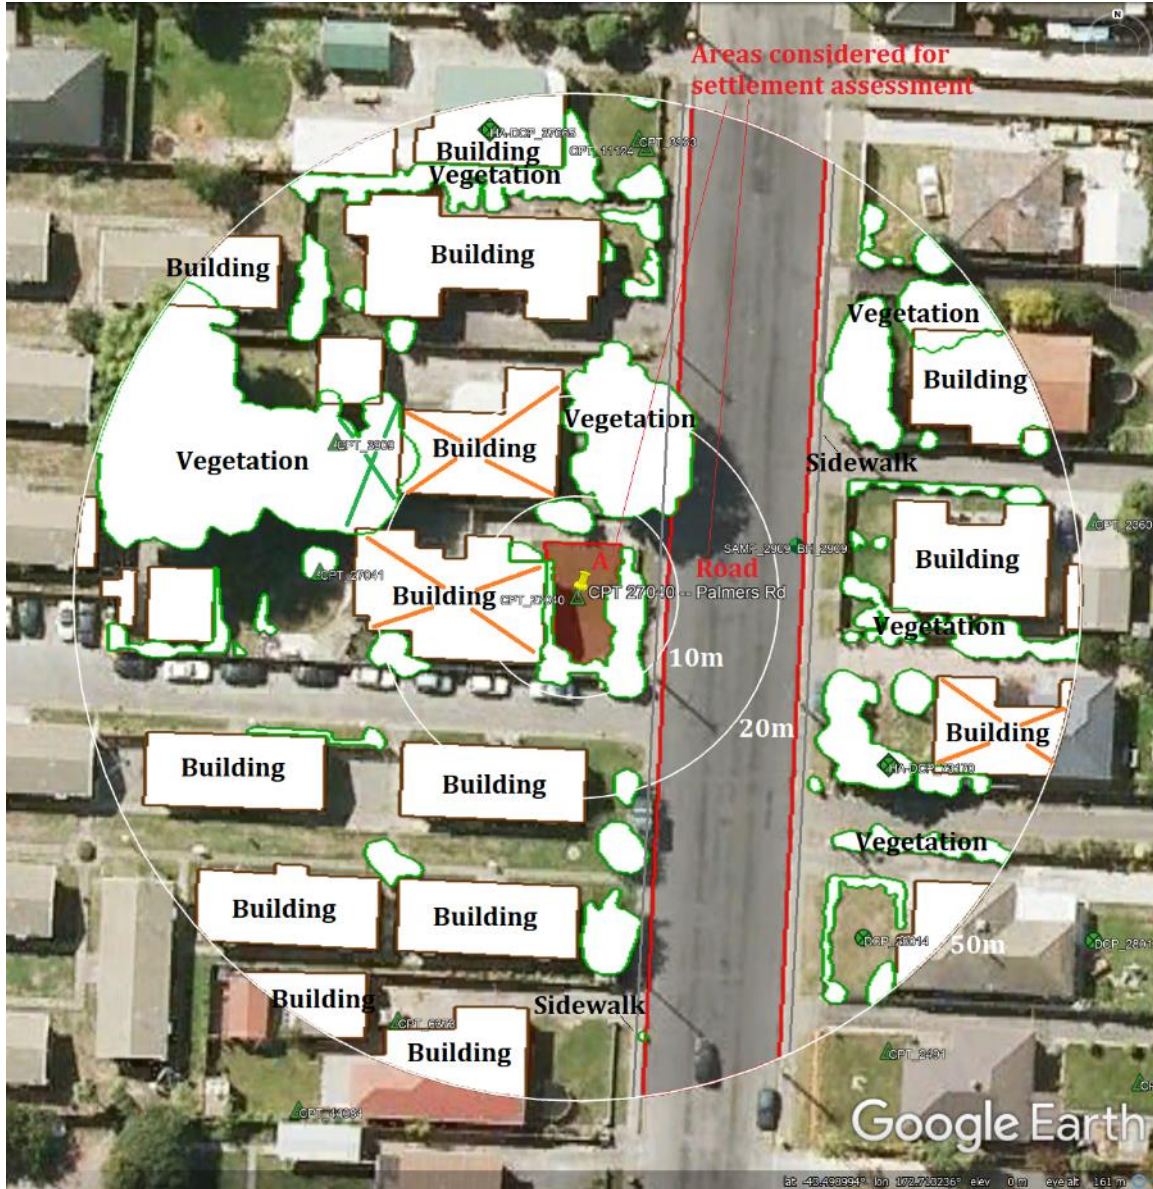
Figure 1: Site plan with areas where ejecta-induced settlement is considered.

**Note 1:** The patch (outlined in red) in the free field was selected for settlement assessment as an area free of vegetation and structures. Other important factors considered in the patch selection process were its proximity to a CPT, a property subjected to addition and/or demolition of a structure, front yard/backyard alterations (e.g., ploughing, rubble, scrap), and aerial distribution of sediment ejecta. In addition, the entire portion of the road within the 50-m buffer was considered for settlement assessment. Roads as hard, relatively flat surfaces provide many ground-classified points. Finally, the LiDAR-based settlement analyses were not conducted for the Sep-10 EQ due to the evident absence of ejecta from Patch A and Road. The Oct 2015 LiDAR survey was not considered for the settlement analysis of Patch A due to the anthropogenic changes.

**Note 6:** The selection of CPTs for the area considered for settlement assessment (Figure 1) is based on the proximity of the CPTs to the considered areas. In accordance with that, the following table shows CPTs that were used for the volumetric settlement analysis in *Cliq v.3.0.3.2*, a CPT soil liquefaction software developed by GeoLogismiki. (The average volumetric settlements were reported in Table 8.)

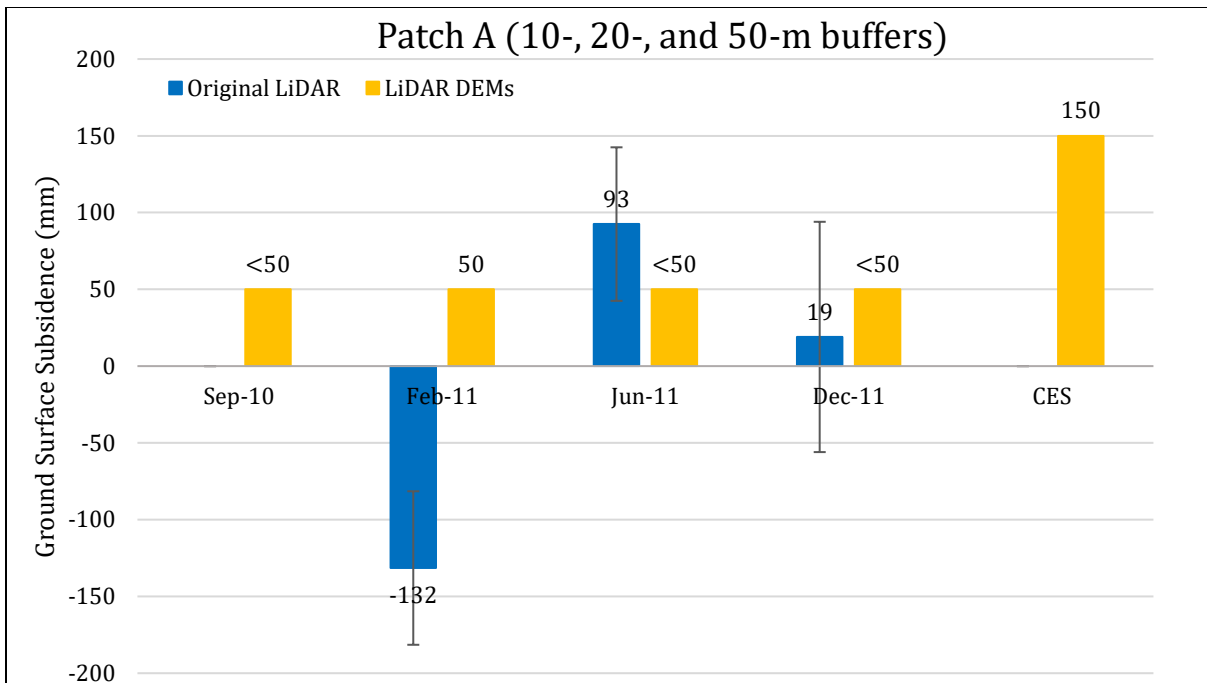
**Figure 2: Comparison between ground surface subsidence determined from original LiDAR survey points and ground surface subsidence (50<sup>th</sup> %ile) estimated using LiDAR DEMs for Patch A.**

**Note 2:** The ground surface subsidence values determined from the original LiDAR survey points are similar to the ground surface subsidence values estimated using the LiDAR DEMs. The exception to this trend occurs for the Feb-11 EQ for Patch A as the ground surface subsidence computed using the original LiDAR survey points is -132 mm compared to 50 mm determined using the LiDAR DEM. One of the potential reasons for this discrepancy can be anthropogenic changes (e.g., land resurfacing) that might have occurred between the July 2003 and Sep 2010 LIDAR surveys but could not be seen in the available satellite images.

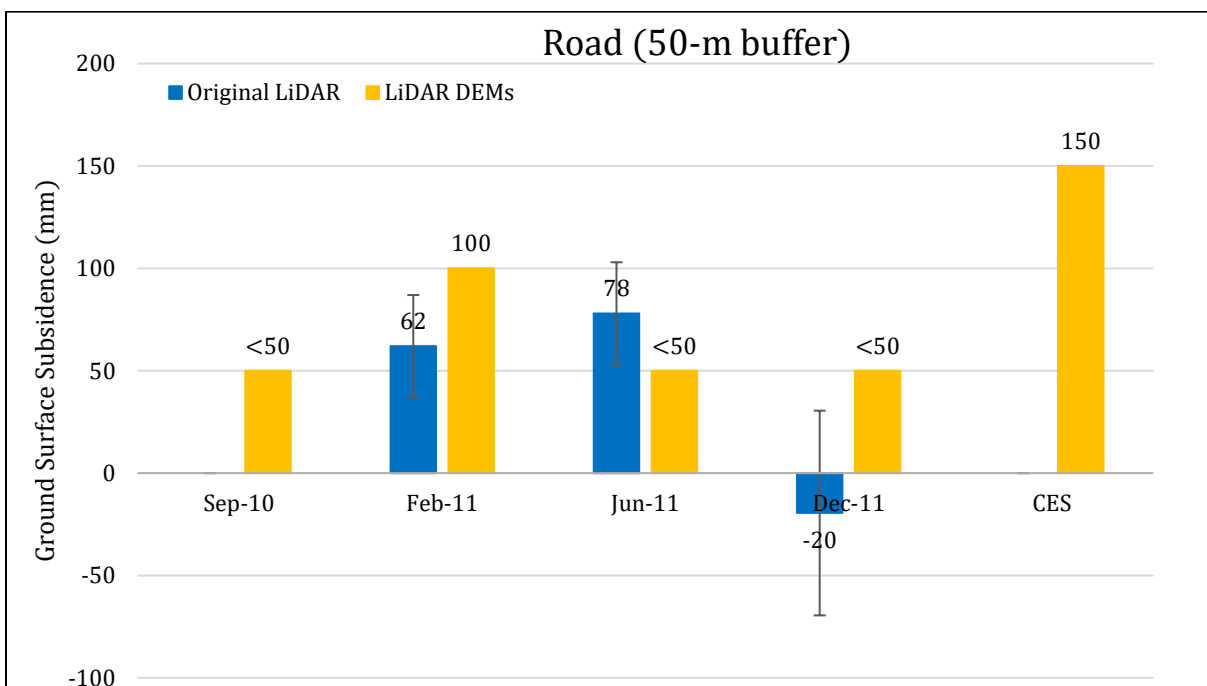
**Figure 3: Comparison between ground surface subsidence determined from original LiDAR survey points and ground surface subsidence (50<sup>th</sup> %ile) estimated using LiDAR DEMs for Road (50-m buffer).**

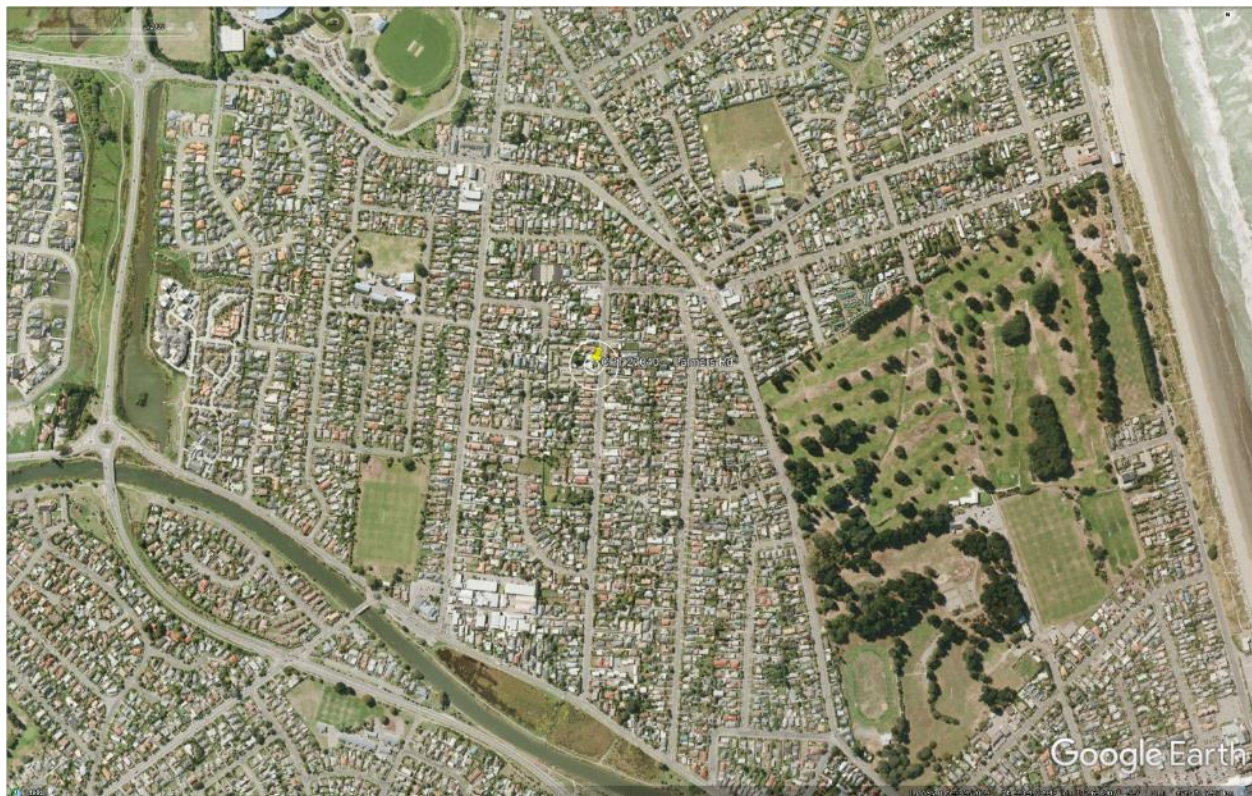
**Figure 5: Position of the site relative to nearby free-face features.**

| Attribute | Yes/No | | | Description/Date | Symbol in Figure 1 |
|--|---|---|---|--|--|
| Near a body of surface water or other free face features? | No | No | No | The center of the site is ~680 m to the NE from the Avon River (the free-face height is ~2m) and ~1180 m to the W from Pegasus Bay. | NA |

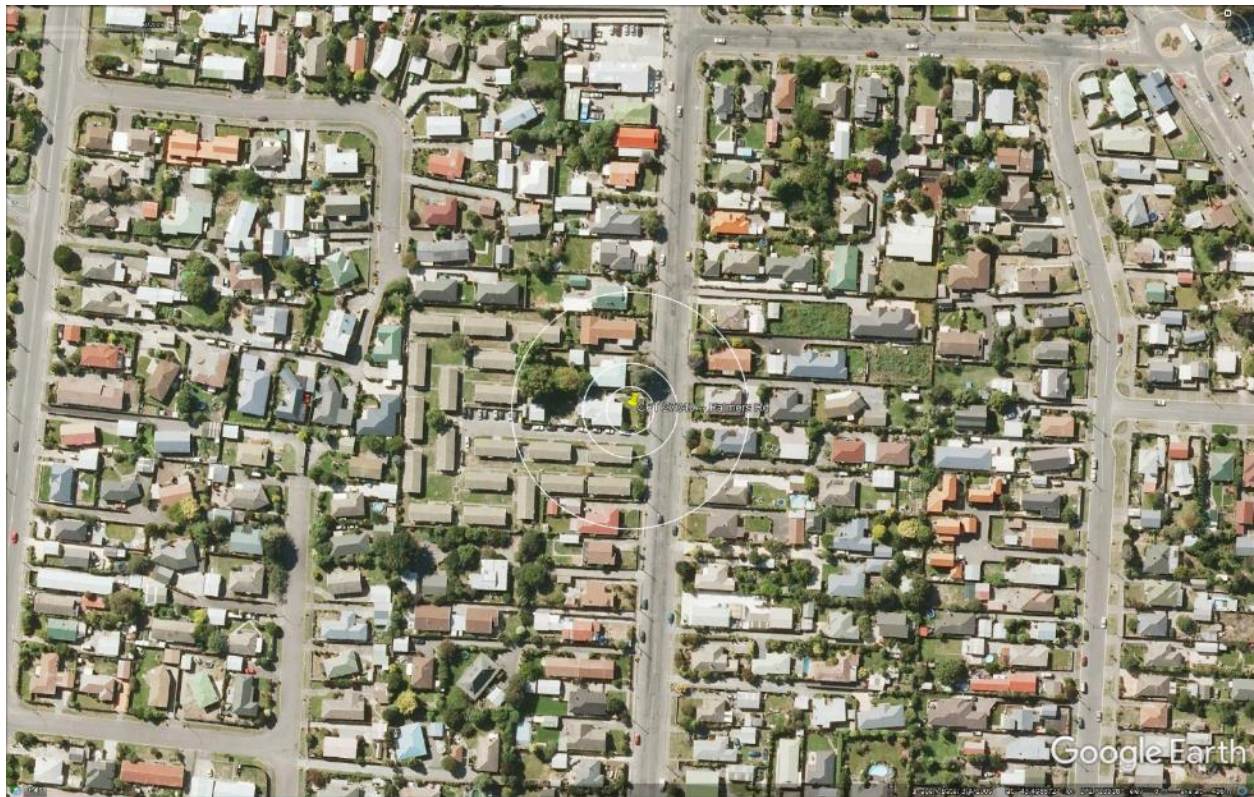
**Figure 6: Position of the site relative to nearby buildings and vegetation.**

| Attribute | Yes/No | | | Description/Date | Symbol in Figure 1 |
|--|---|---|---|--|--|
| Nearby buildings or structures? | Yes | Yes | Yes | Building coverage of the 10-m, 20-m, and 50-m buffers is 21%, 26%, and 25%, respectively. The buildings are in the NW and SW quadrants of the 10-m buffer, the NW, SW, and SE quadrants of the 20-m buffers, and all quadrants of the 50-m buffer. | White Fill + Brown Outline |
| Vegetation? | Yes | Yes | Yes | Trees and bushes cover 26, 17, and 18% of the 10-, 20-, and 50-m buffers, respectively. They are in all quadrants of all buffers. | White Fill + Green Outline |

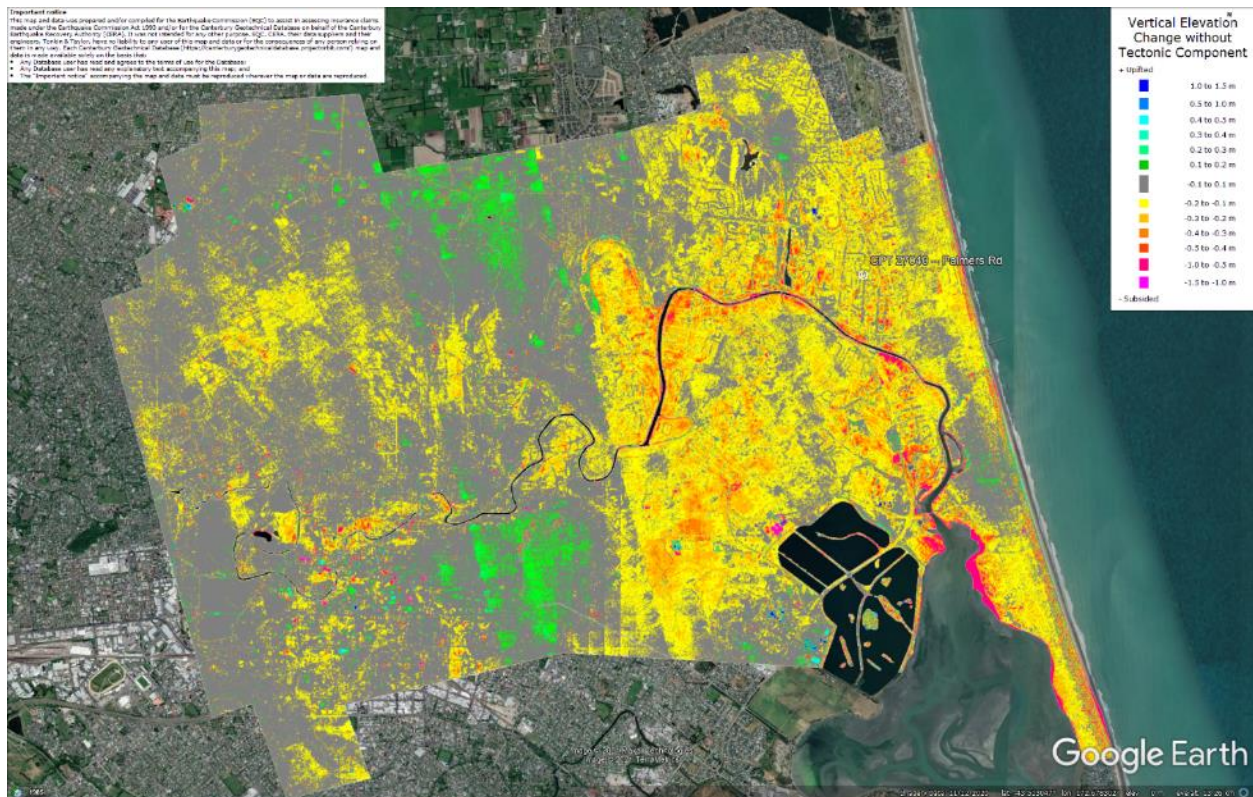
**Figure 32: Vertical Ground Movements (Surface – Tectonic) for Feb 2011 Earthquake – the site is in the apparent zone of underestimated ground surface subsidence (e.g., Sep 2010 LiDAR flight error band).**

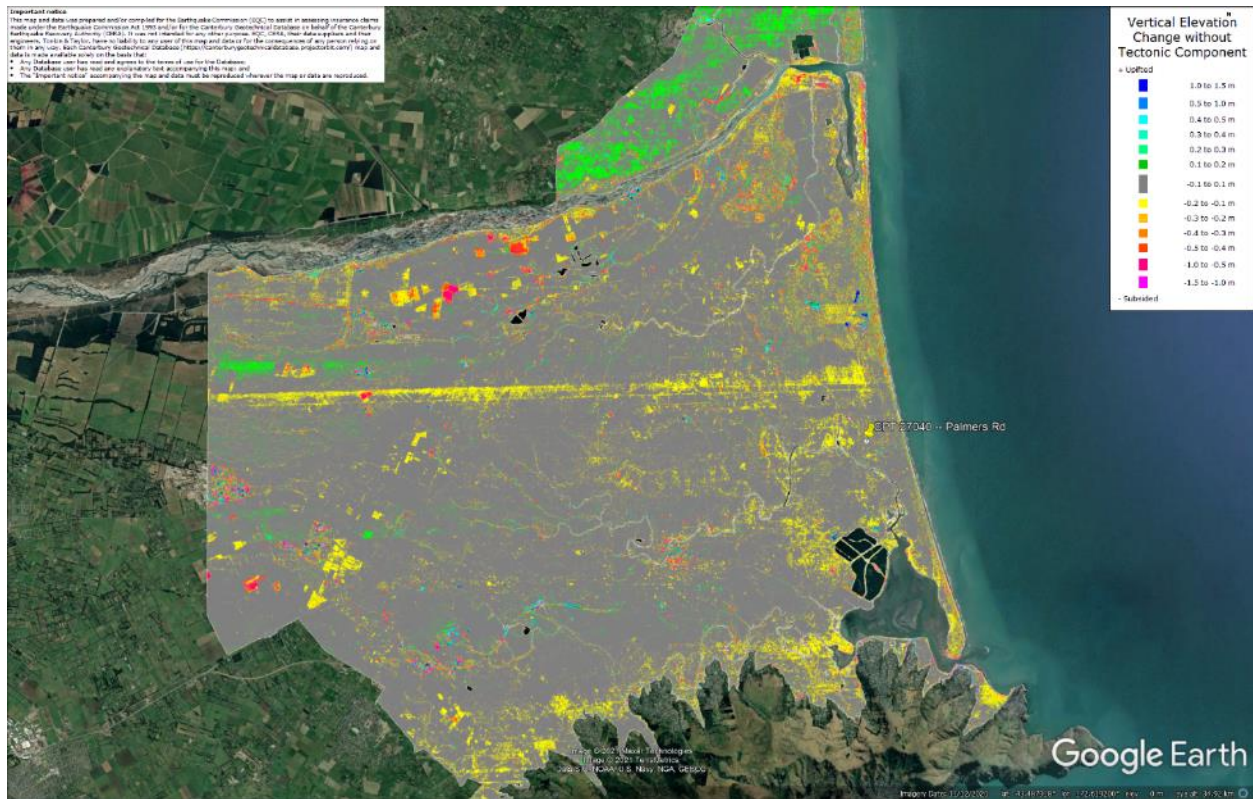
**Figure 33: Vertical Ground Movements (Surface – Tectonic) for June 2011 Earthquake – the site is not in the apparent zone of overestimated or underestimated ground surface subsidence.**

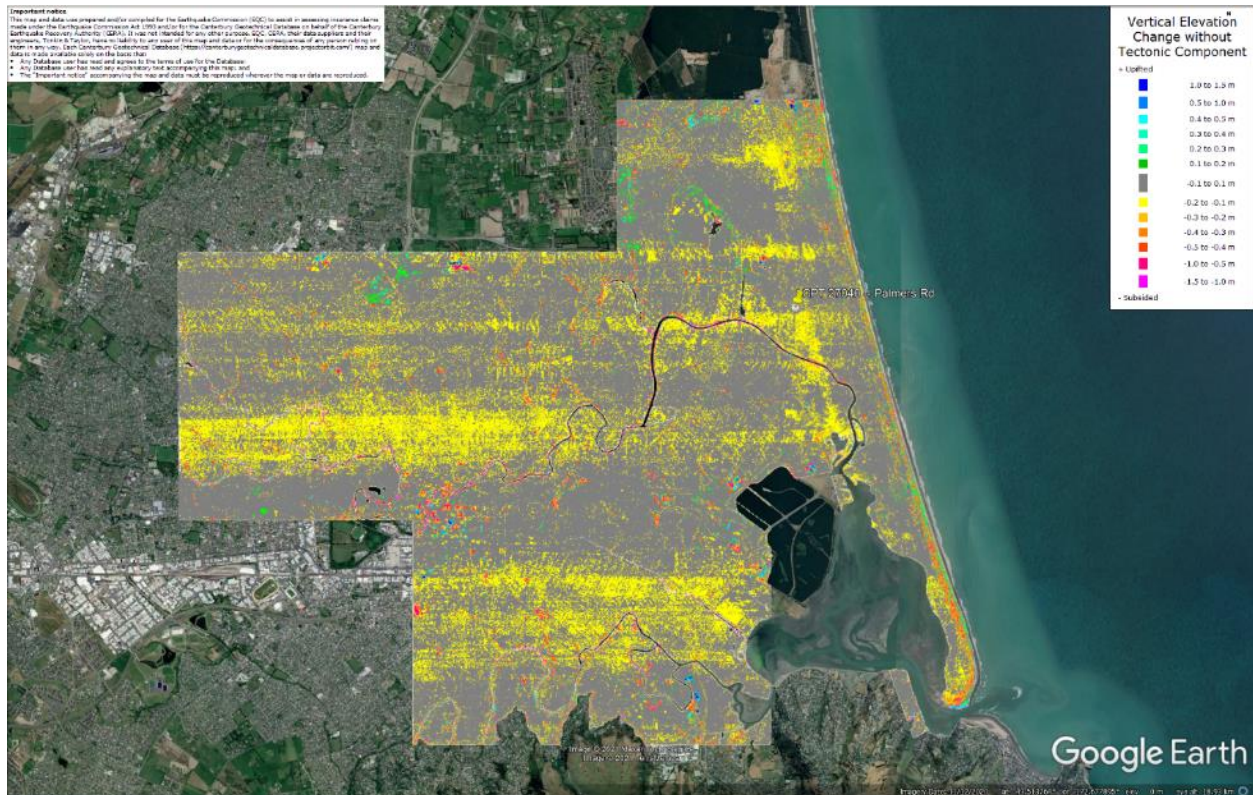
**Figure 34: Vertical Ground Movements (Surface – Tectonic) for Dec 2011 Earthquake – the site is not in the apparent zone of overestimated or underestimated ground surface subsidence.**

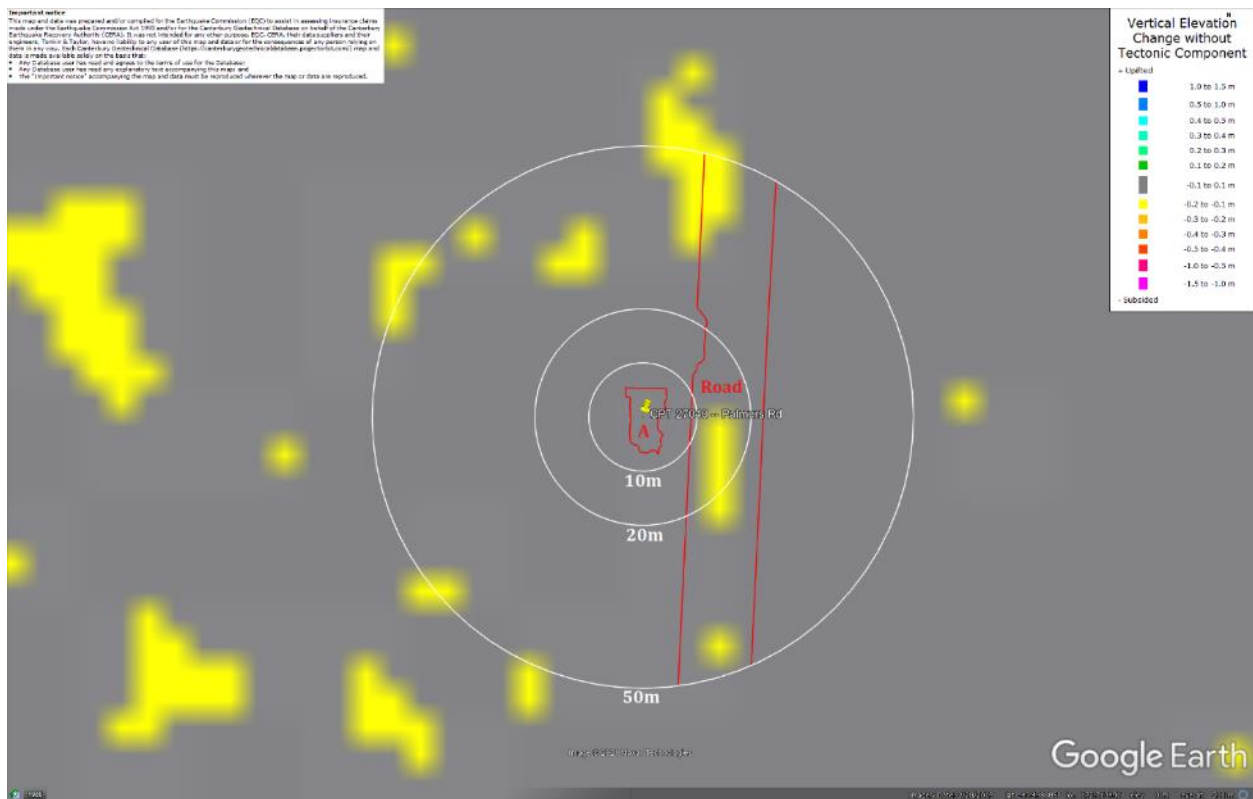
**Figure 37: Ground surface subsidence without tectonic component for June 2011 Earthquake according to the LiDAR DEM.**

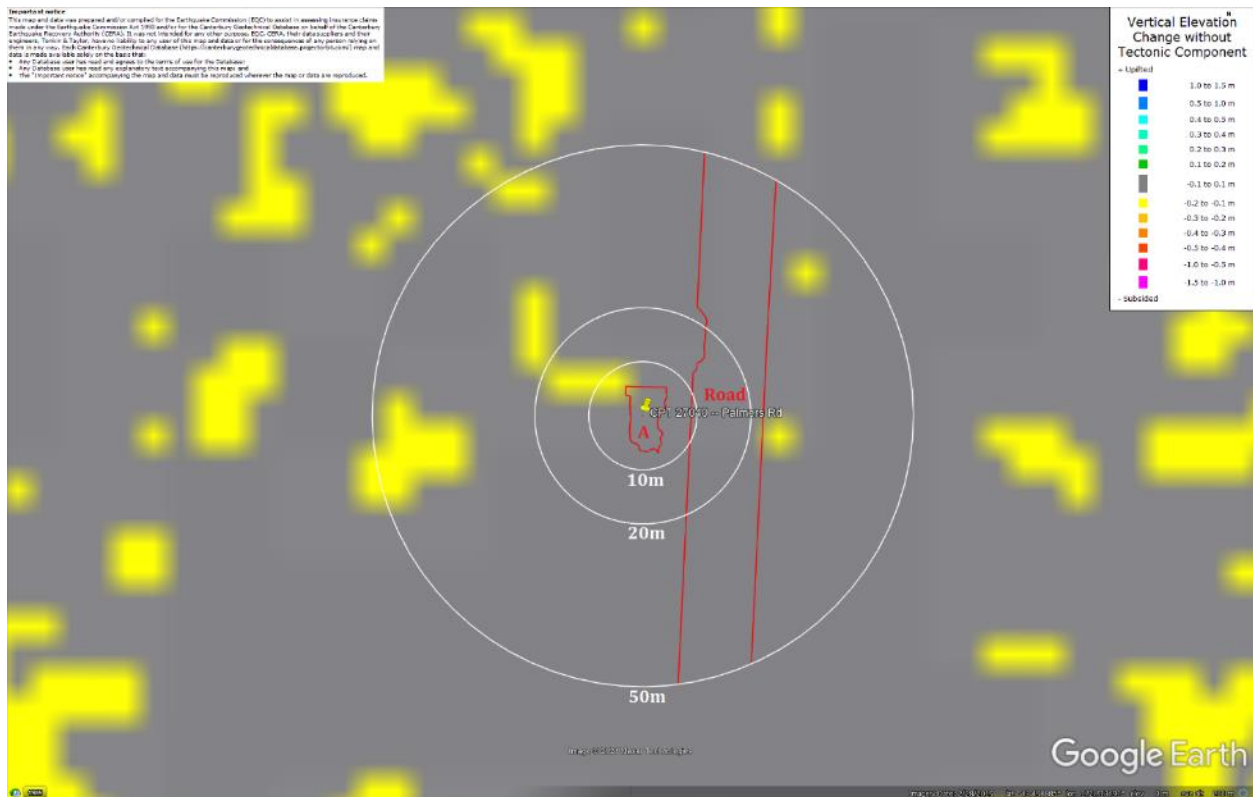
**Figure 38: Ground surface subsidence without tectonic component for Dec 2011 Earthquake according to the LiDAR DEM.**

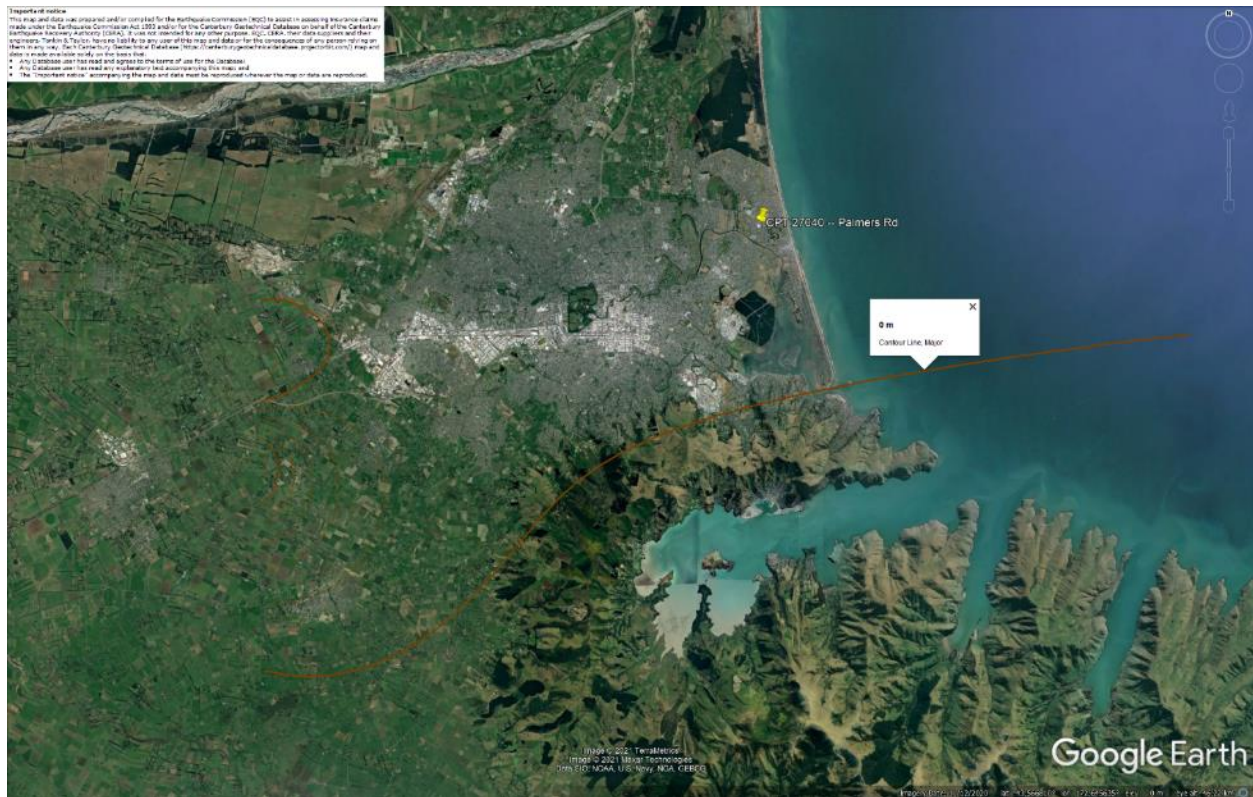
**Figure 41: Vertical tectonic movements for Sep 2010 Earthquake.**

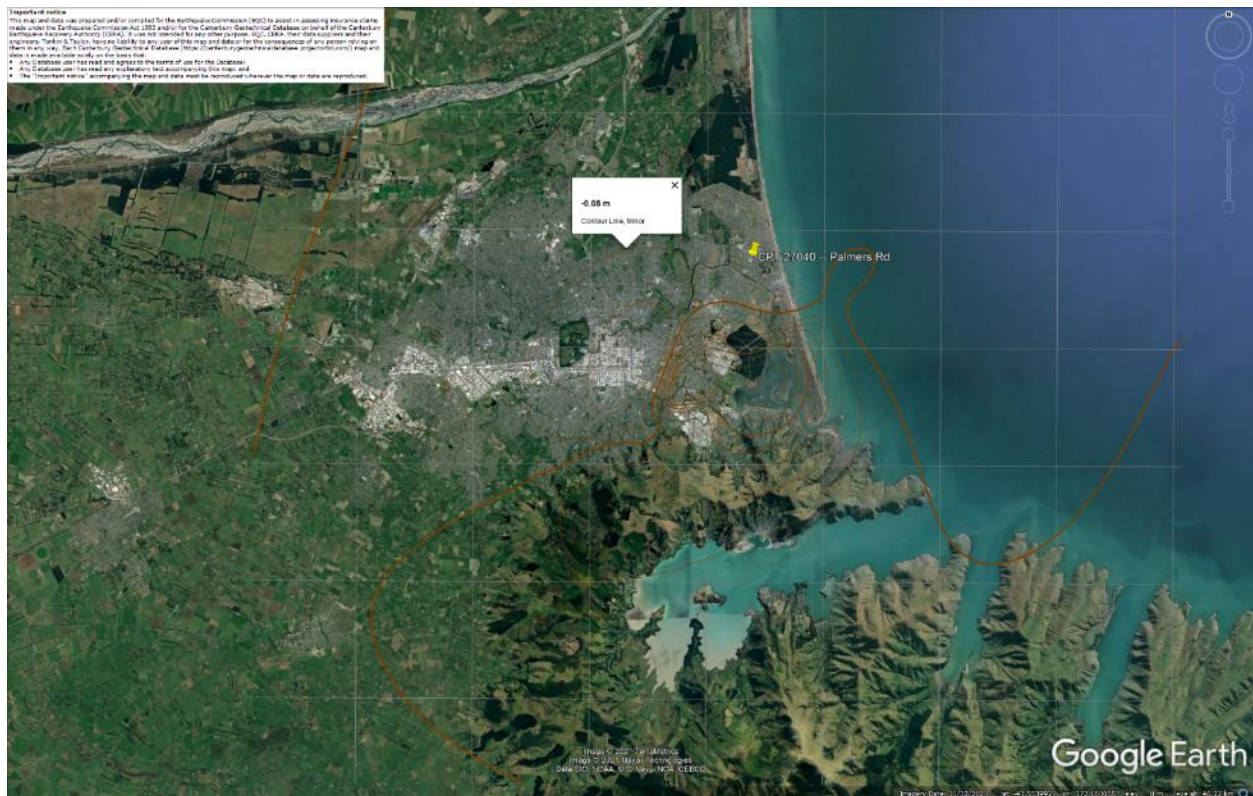
**Figure 42: Vertical tectonic movements for Feb 2011 Earthquake.**

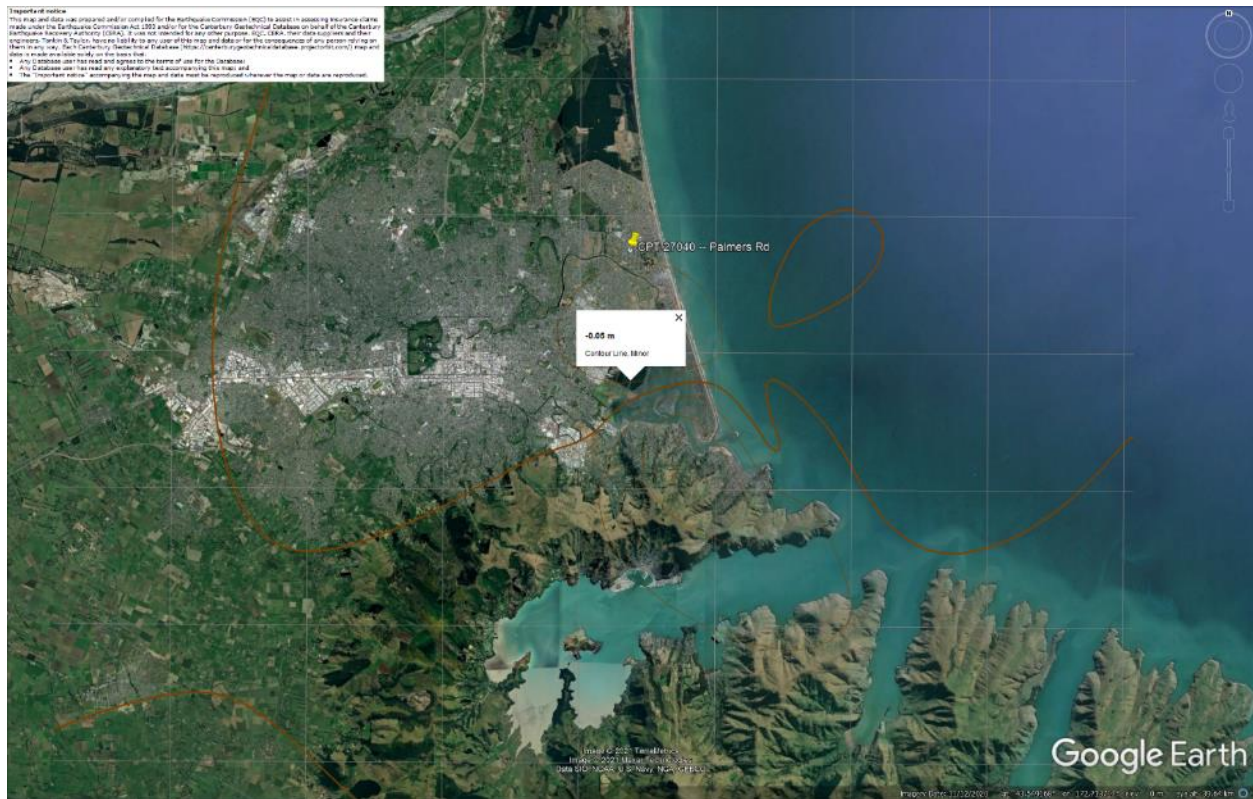
**Figure 43: Vertical tectonic movements for June 2011 Earthquake.**

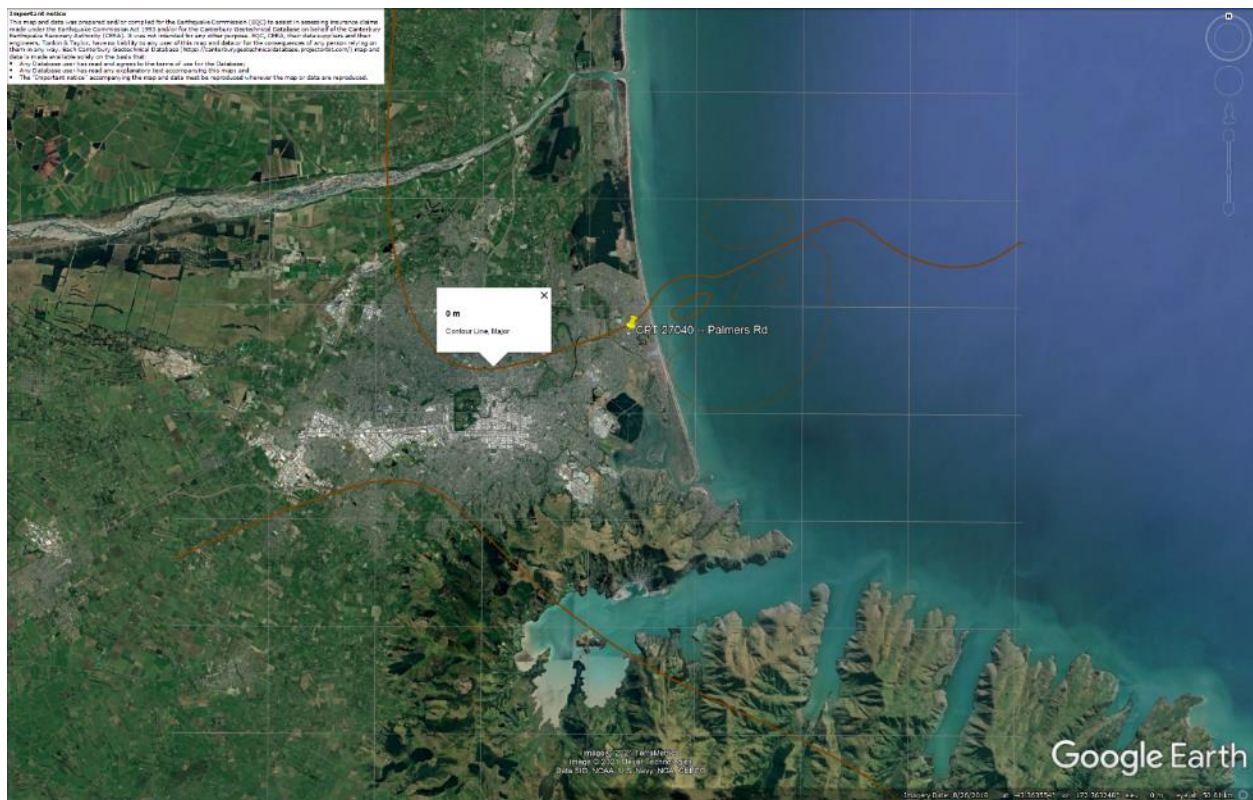
**Figure 44: Vertical tectonic movements for Dec 2011 Earthquake.**

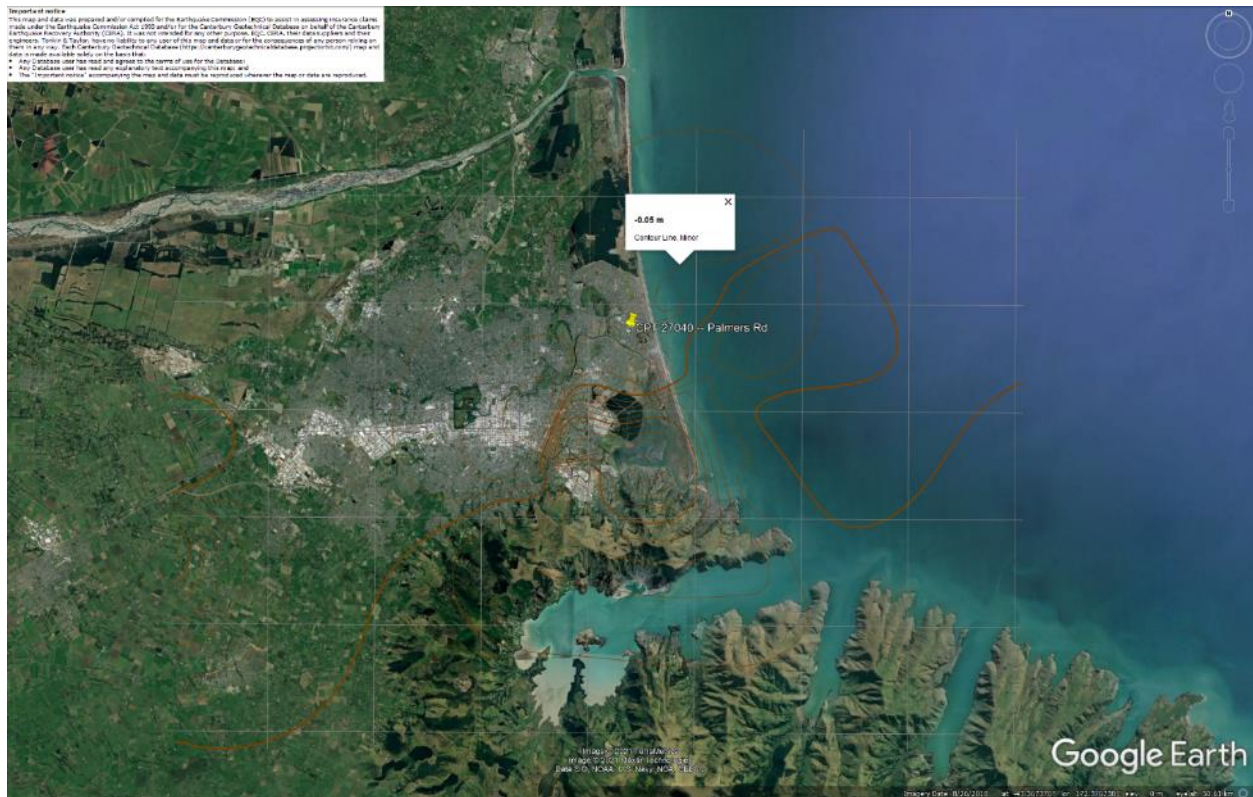
**Figure 45: Vertical tectonic movements for Canterbury Earthquake Sequence.**

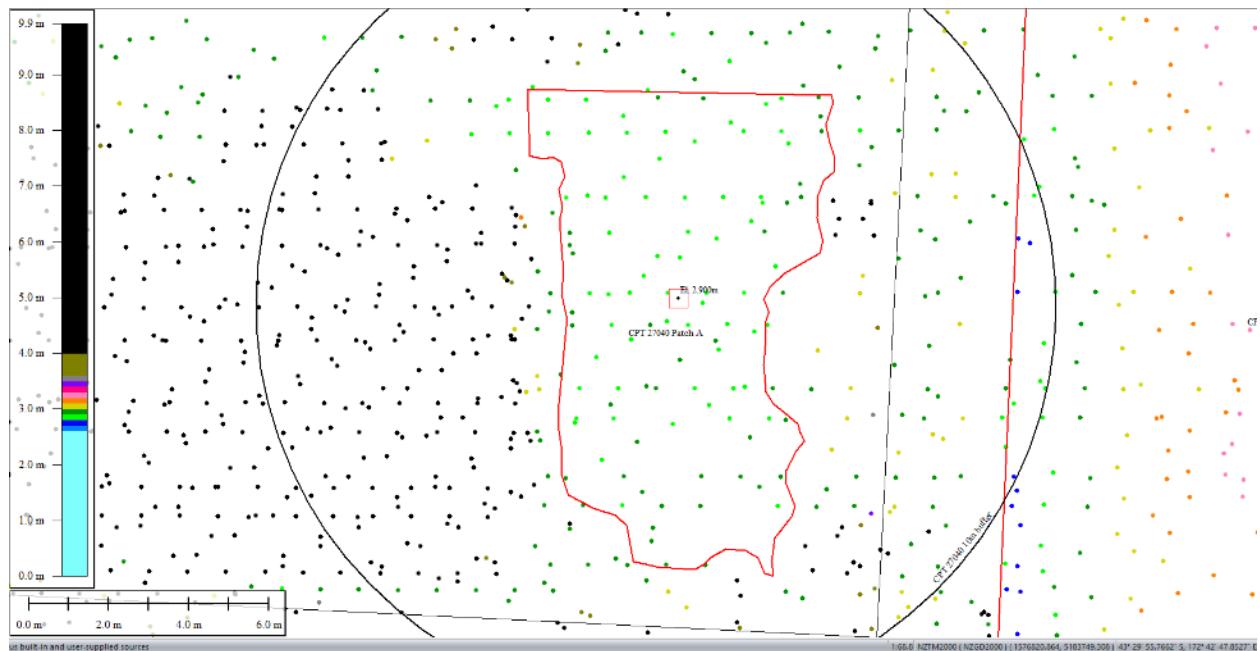
**Figure 47: Ground surface elevation averaged over 10-m, 20-m, and 50-m buffers for Patch A for Sep 5, 2010 LiDAR survey.**

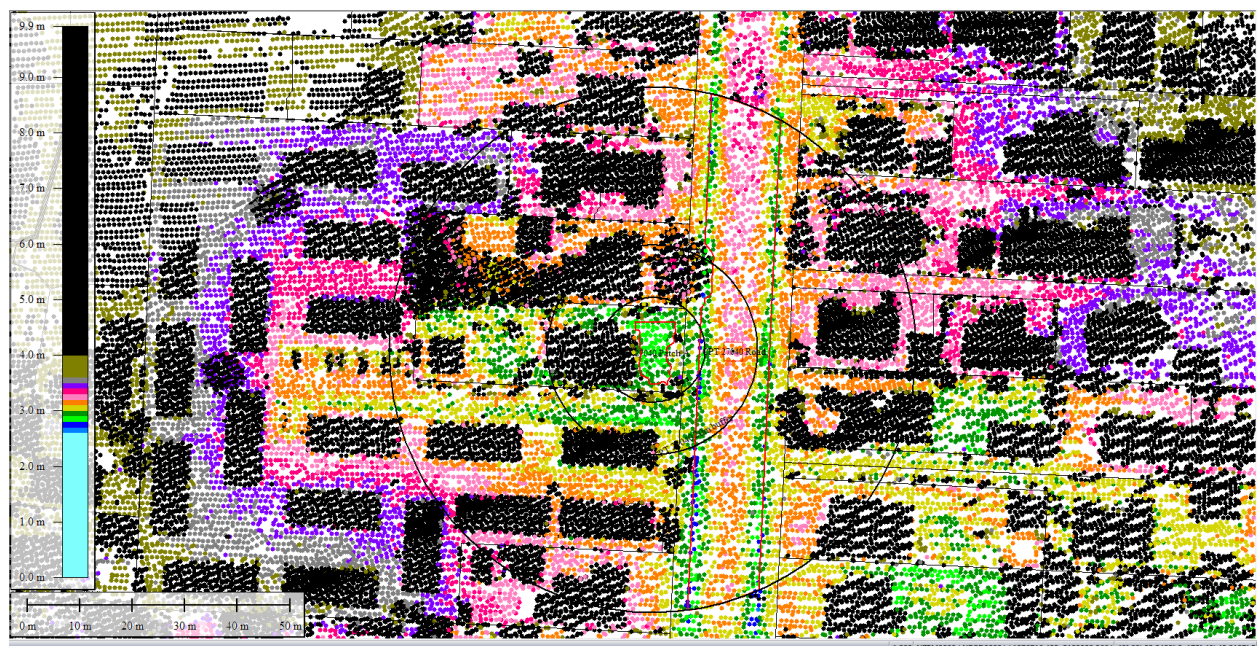
**Figure 48: Ground surface elevation averaged over 50-m buffer for Road for Sep 5, 2010 LiDAR survey.**

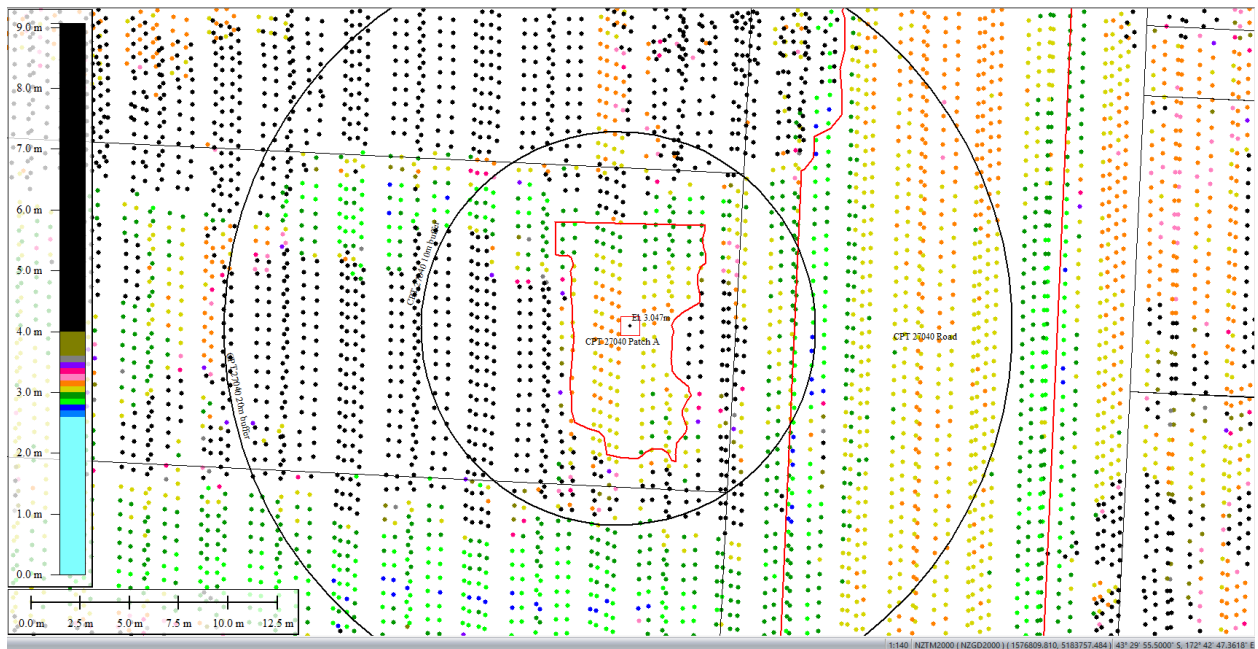
Figure 50: Ground surface elevation averaged over 10-m, 20-m, and 50-m buffers for Patch A for Mar 2011 LiDAR survey.

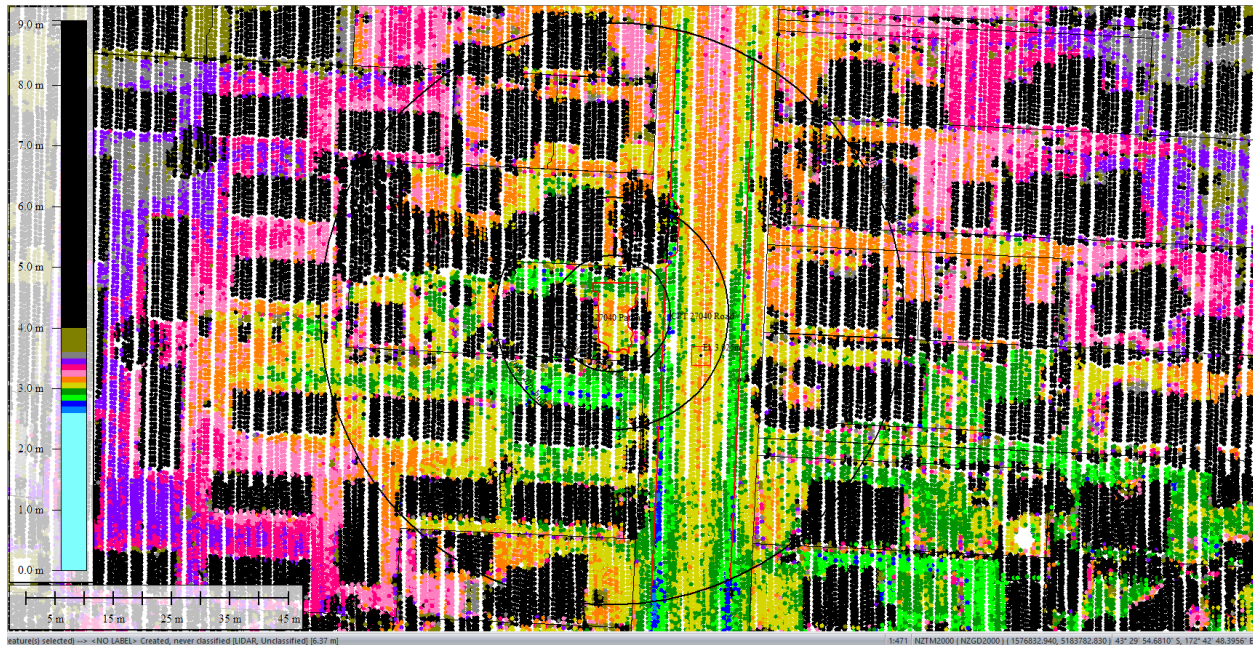
Figure 51: Ground surface elevation averaged over 50-m buffer for Road for Mar 2011 LiDAR survey.

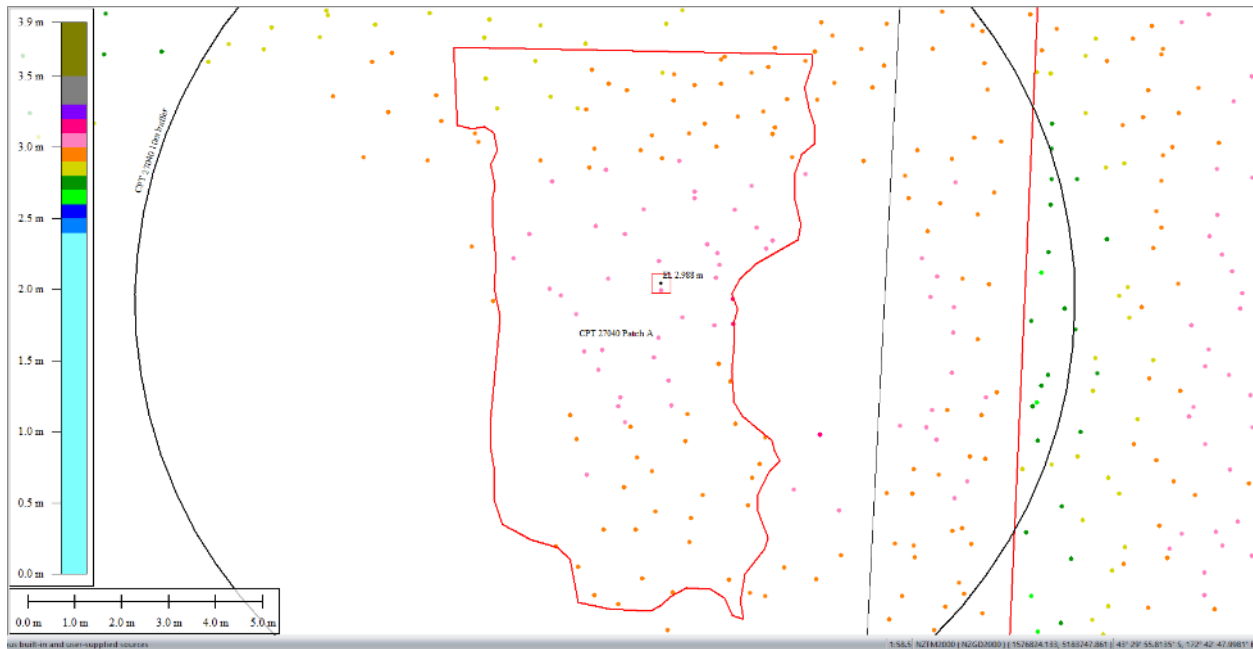
**Figure 53: Ground surface elevation averaged over 10-m, 20-m, and 50-m buffers for Patch A for May 2011 LiDAR survey.**

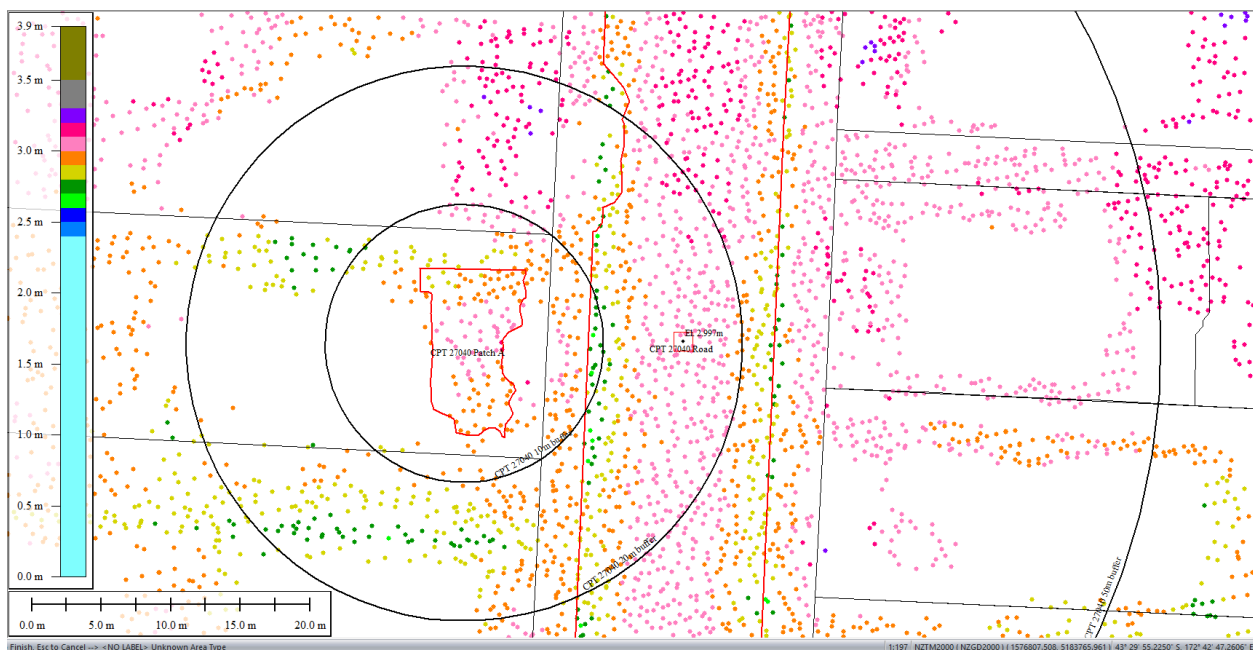
**Figure 54: Ground surface elevation averaged over 50-m buffer for Road for May 2011 LiDAR survey.**

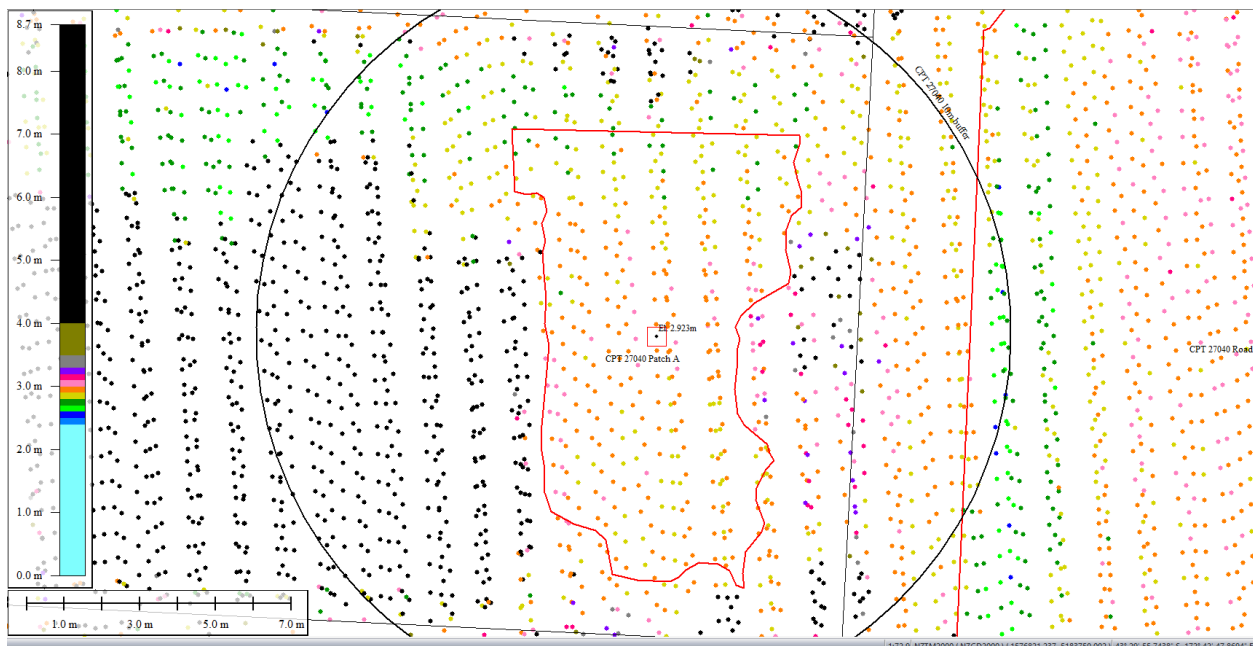
Figure 56: Ground surface elevation averaged over 10-m, 20-m, and 50-m buffers for Patch A for Sep 2011 LiDAR survey.

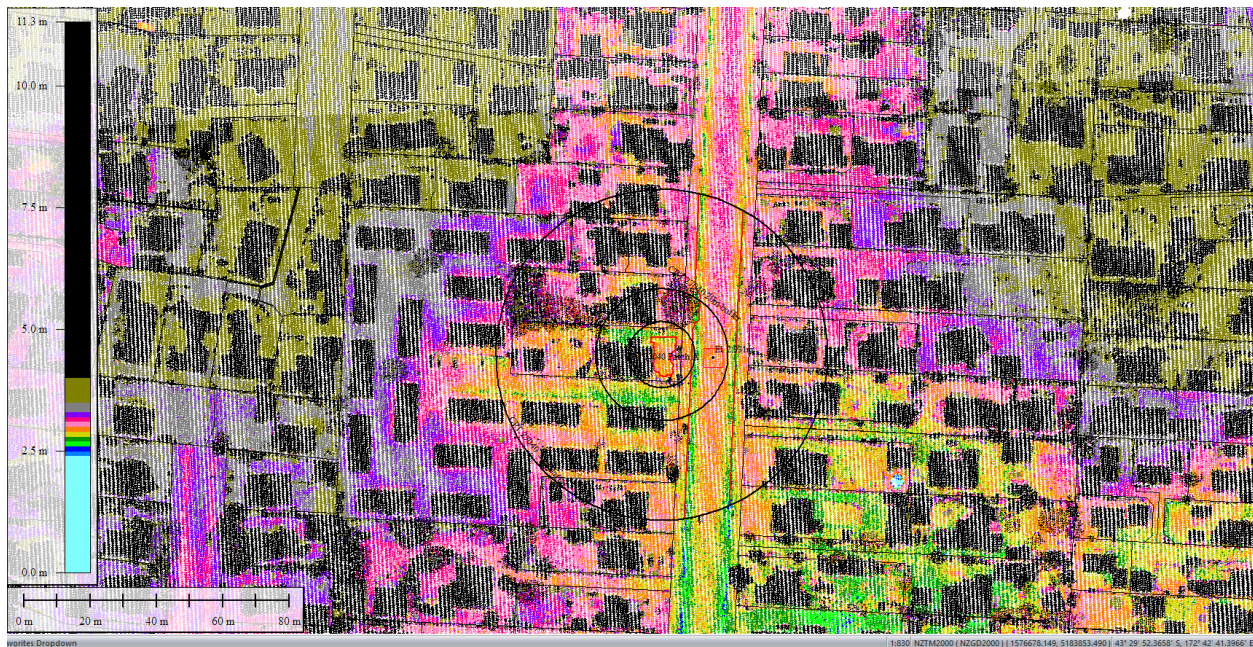
**Figure 57: Ground surface elevation averaged over 50-m buffer for Road for Sep 2011 LiDAR survey.**
