Appendix A.39:

Palmers Rd – CPT 27040

## Liquefaction Ejecta Case Histories for 2010-11 Canterbury Earthquakes

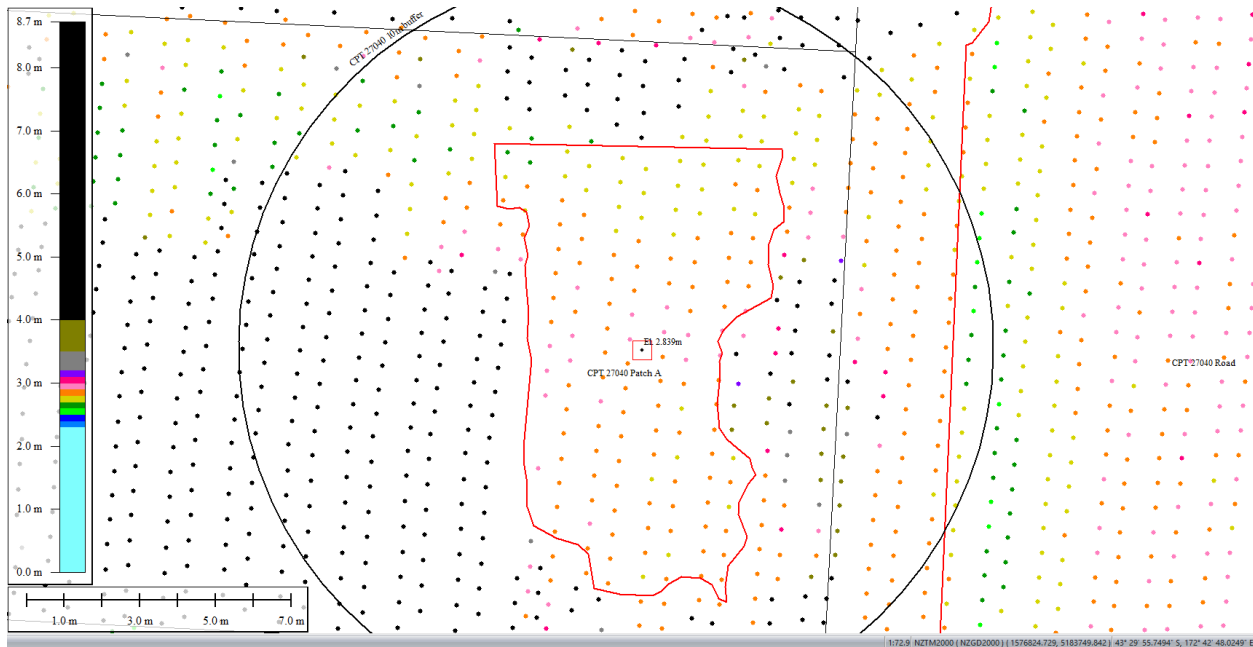
**Figure 59: Ground surface elevation averaged over 10-m, 20-m, and 50-m buffers for Patch A for Feb 2012 LiDAR survey.**

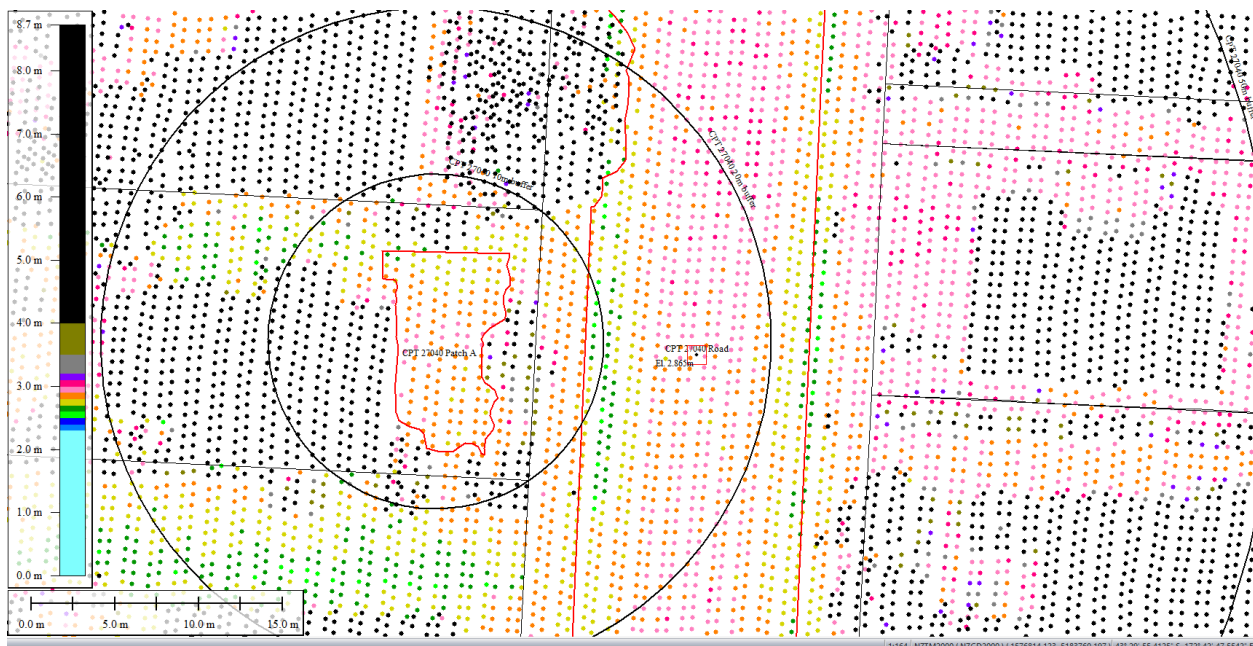
**Figure 60: Ground surface elevation averaged over 50-m buffer for Road for Feb 2012 LiDAR survey.**

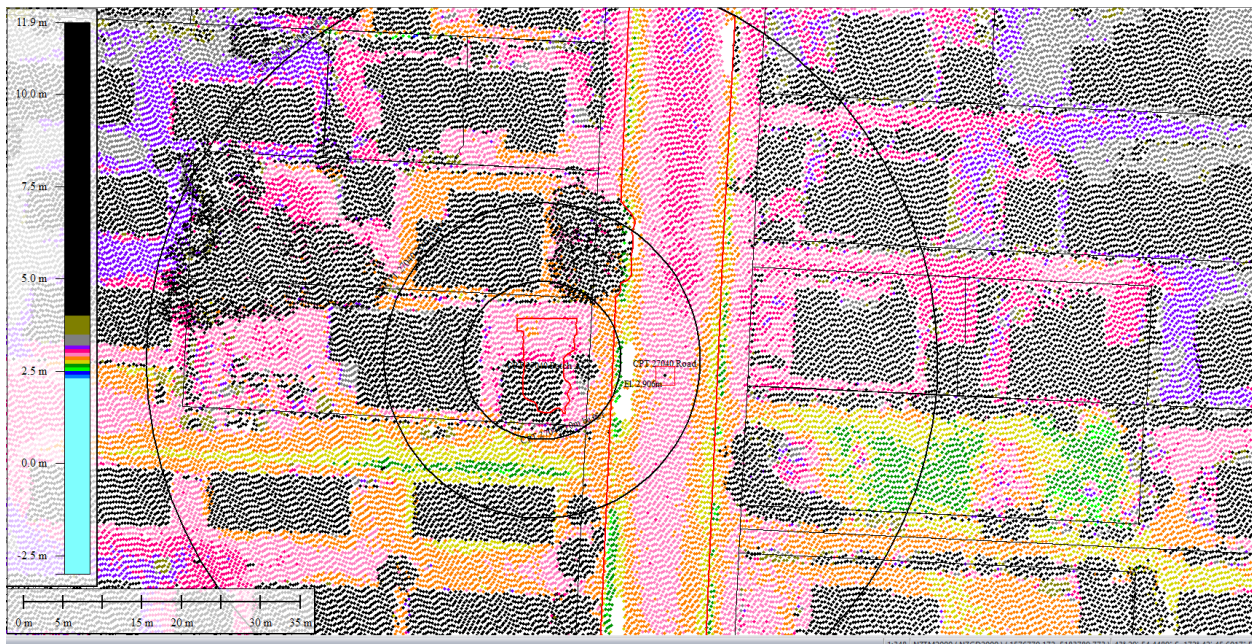
Figure 62: Ground surface elevation averaged over 50-m buffer for Road for Oct 2015 LiDAR survey (el. 2.906m).

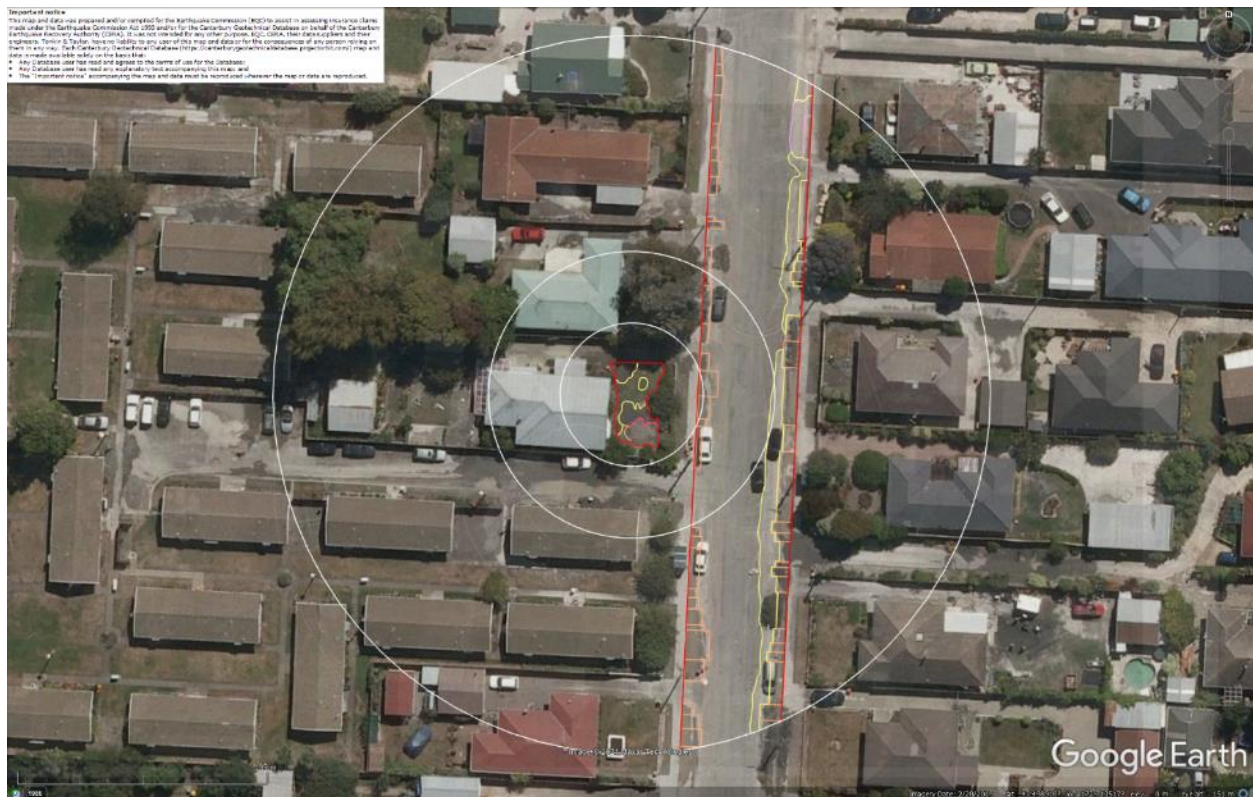
**Figure 63: Aerial photograph showing the ejecta outline at the site for Feb-11 EQ.**

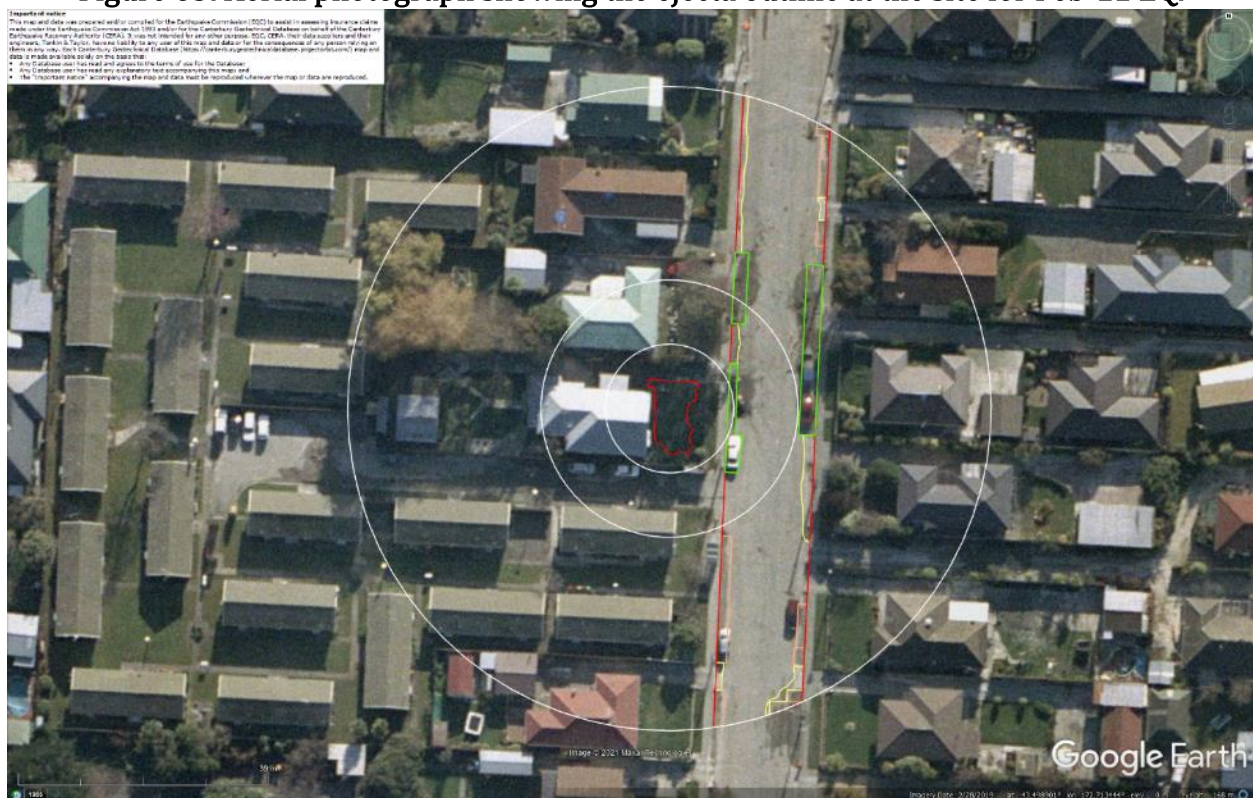
**Figure 64: Aerial photograph acquired on 16 Jun 2011 showing the ejecta outline at the site for Jun-11 EQ.**

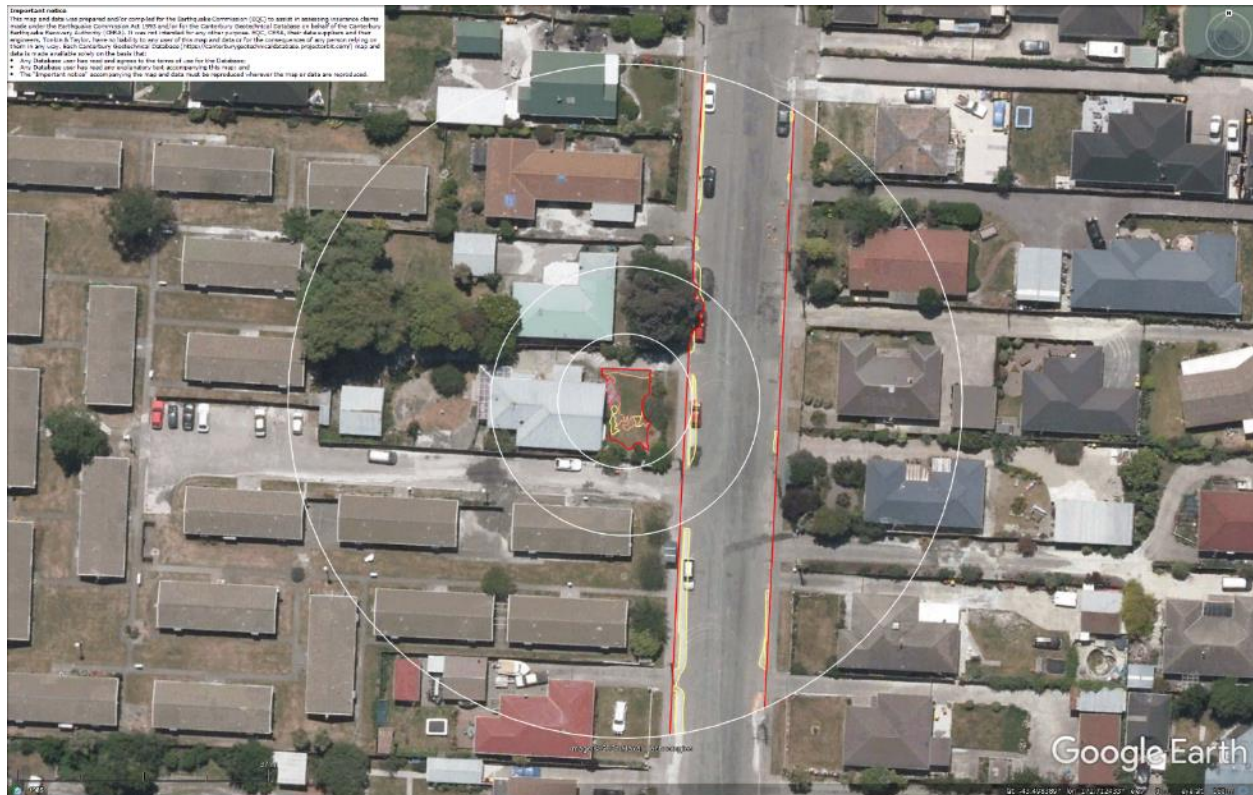
Figure 65: Aerial photograph showing the ejecta outline at the site for Dec-11 EQ.

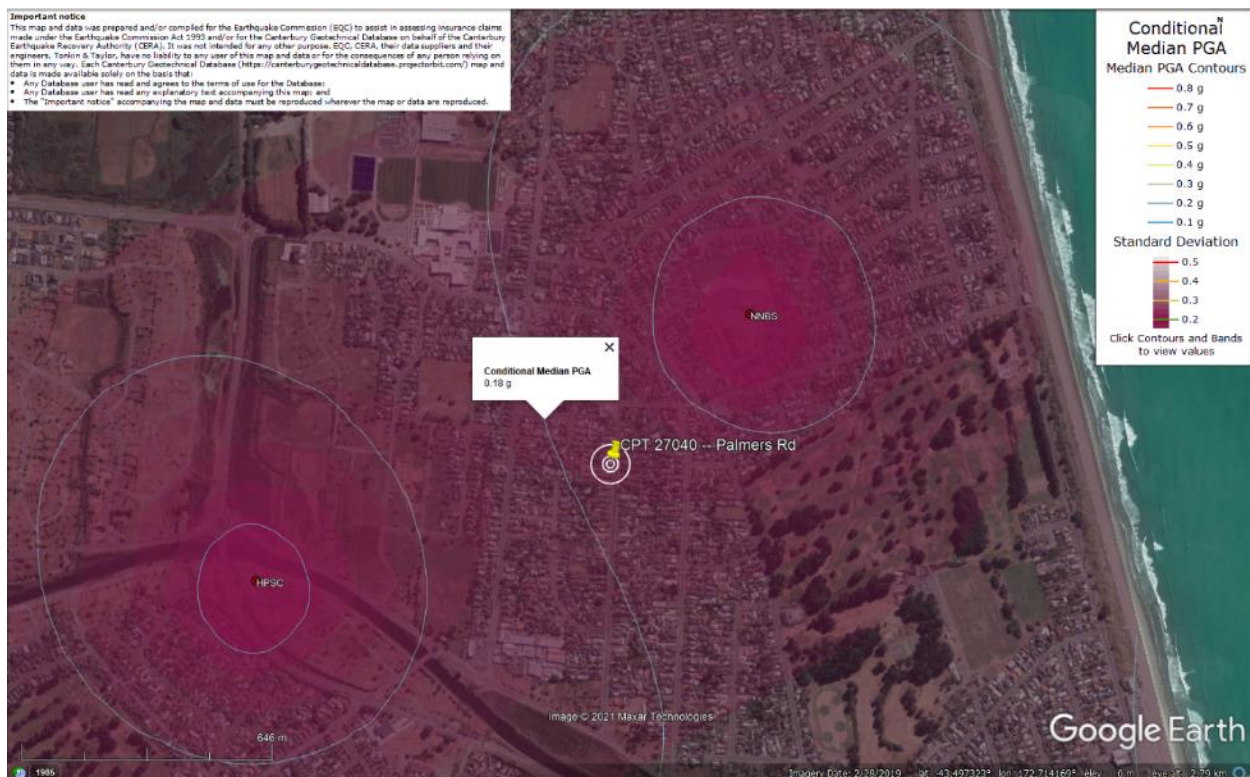
**Figure 69: PGA for Sep-10 EQ (st. dev. = 0.225-0.250 ln units).**

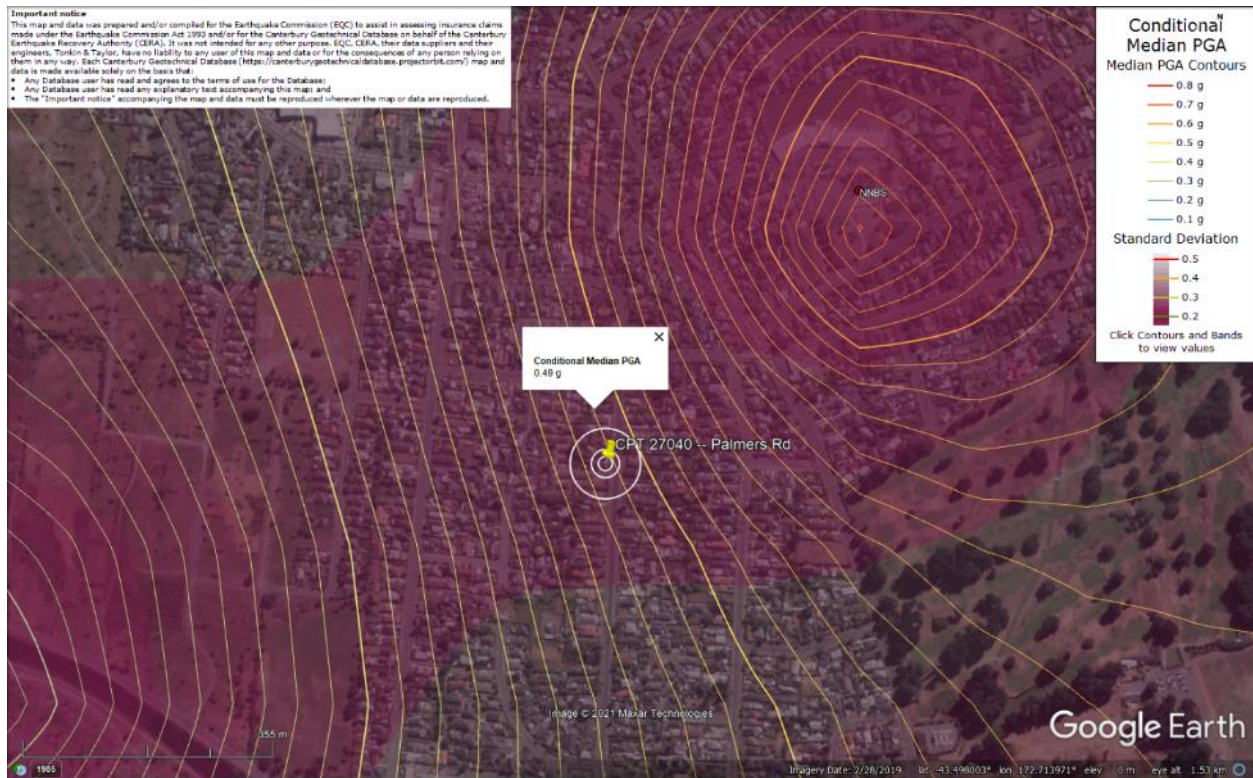
Figure 70: PGA for Feb-11 EQ (st. dev. = 0.250-0.275 ln units).

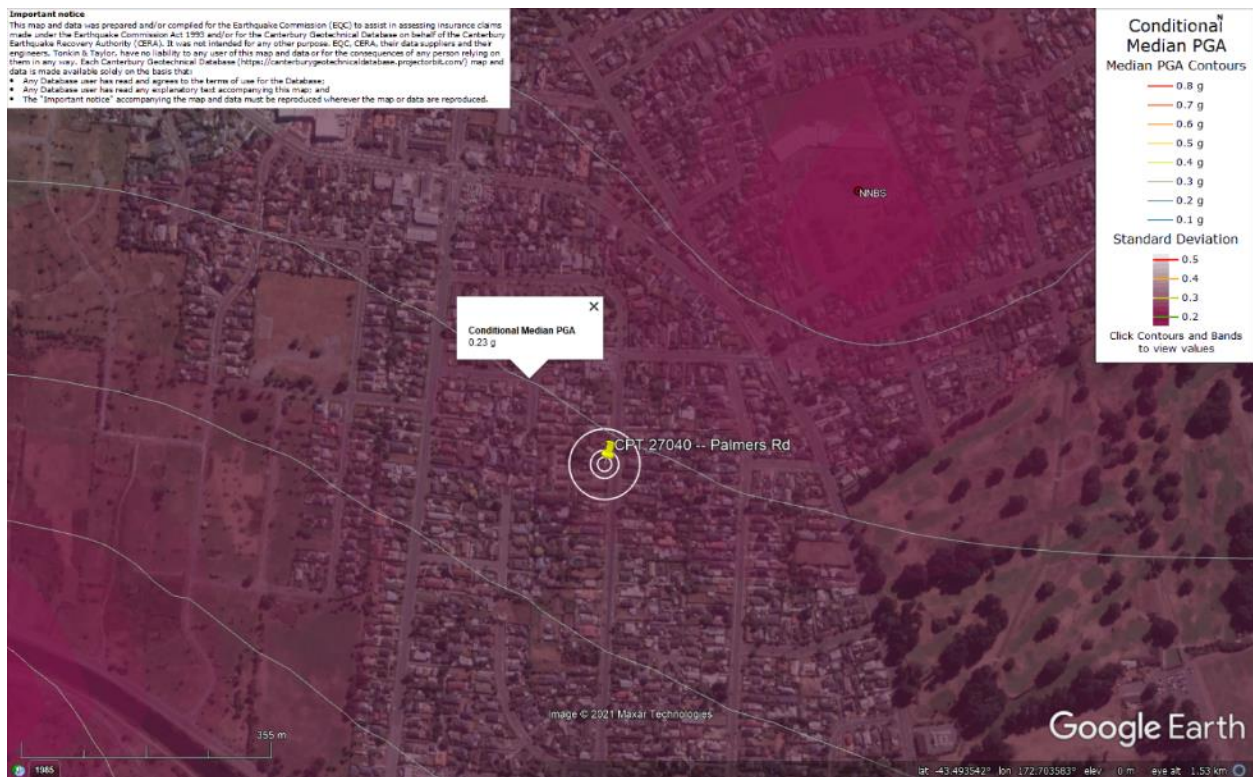
Figure 71: PGA for Jun-11 EQ (st. dev. = 0.250-0.275 ln units).

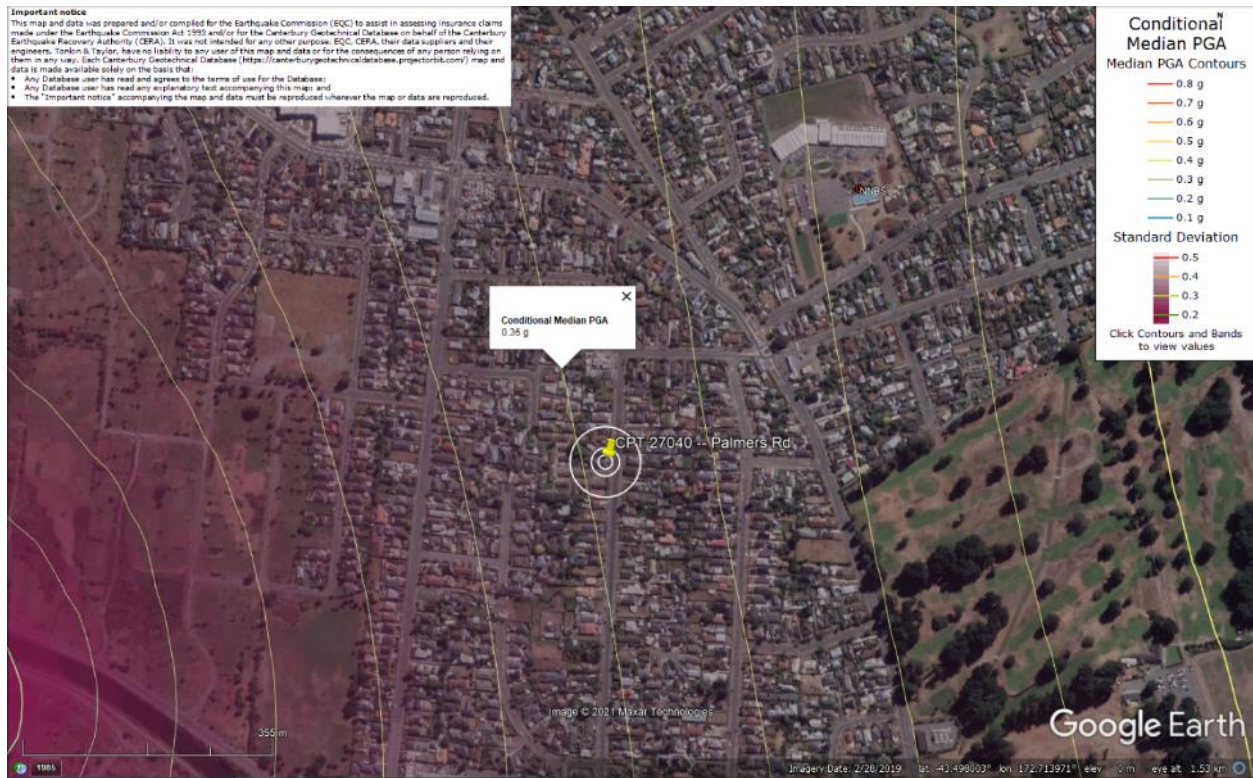
Figure 72: PGA for Dec-11 EQ (st. dev. = 0.350-0.375 ln units).

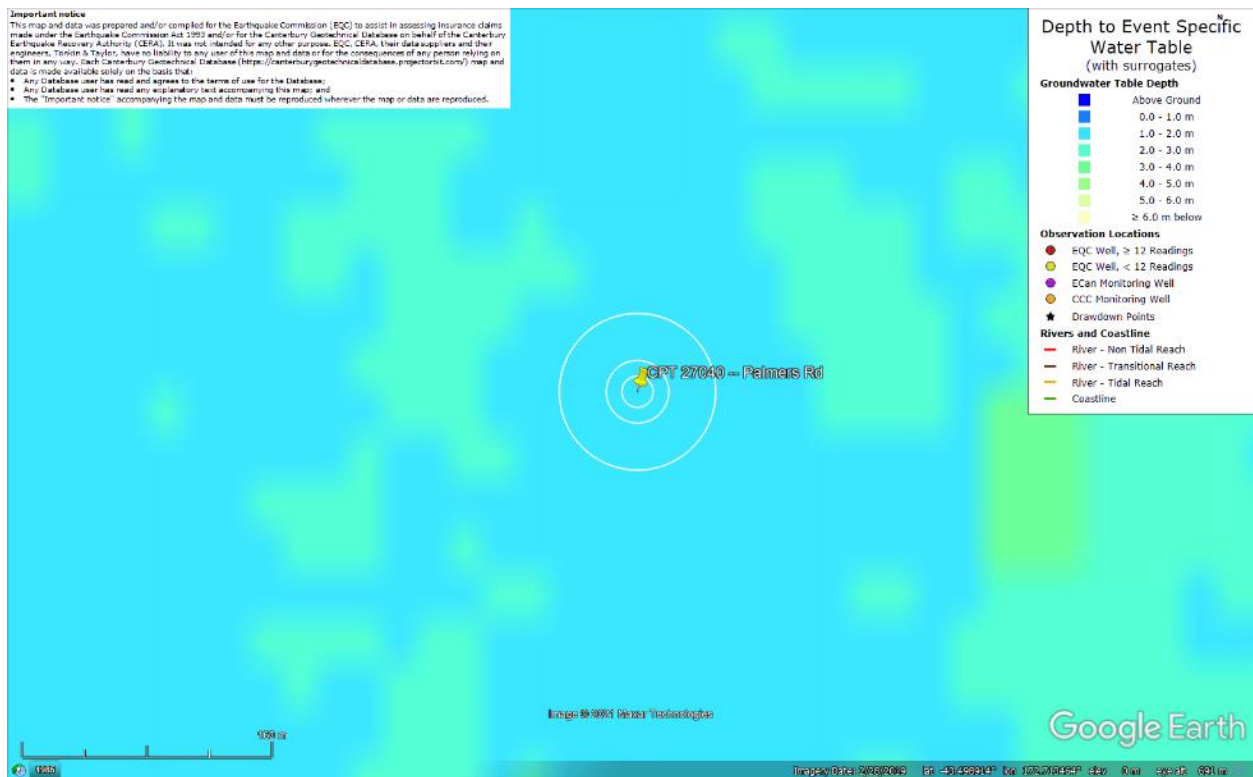
Figure 73: Depth to groundwater table for Sep-10 EQ.

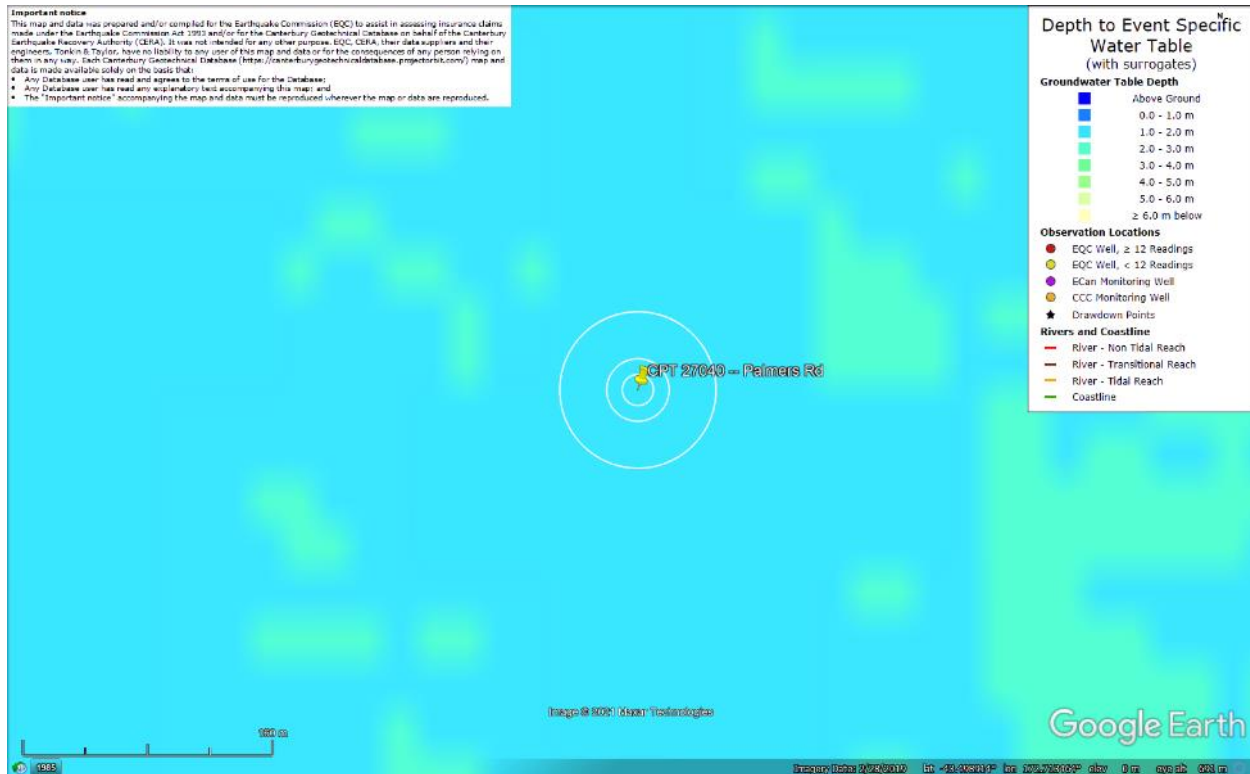
Figure 74: Depth to groundwater table for Feb-11 EQ.

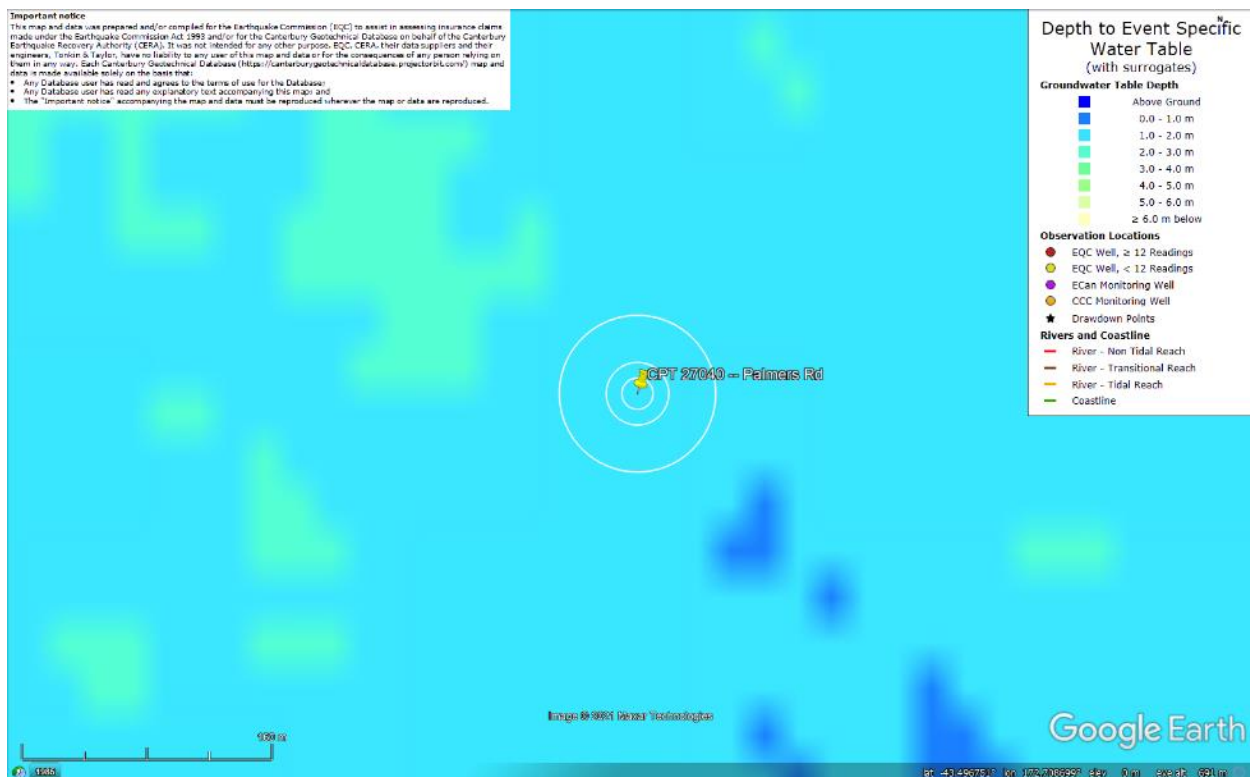
Figure 75: Depth to groundwater table for Jun-11 EQ.

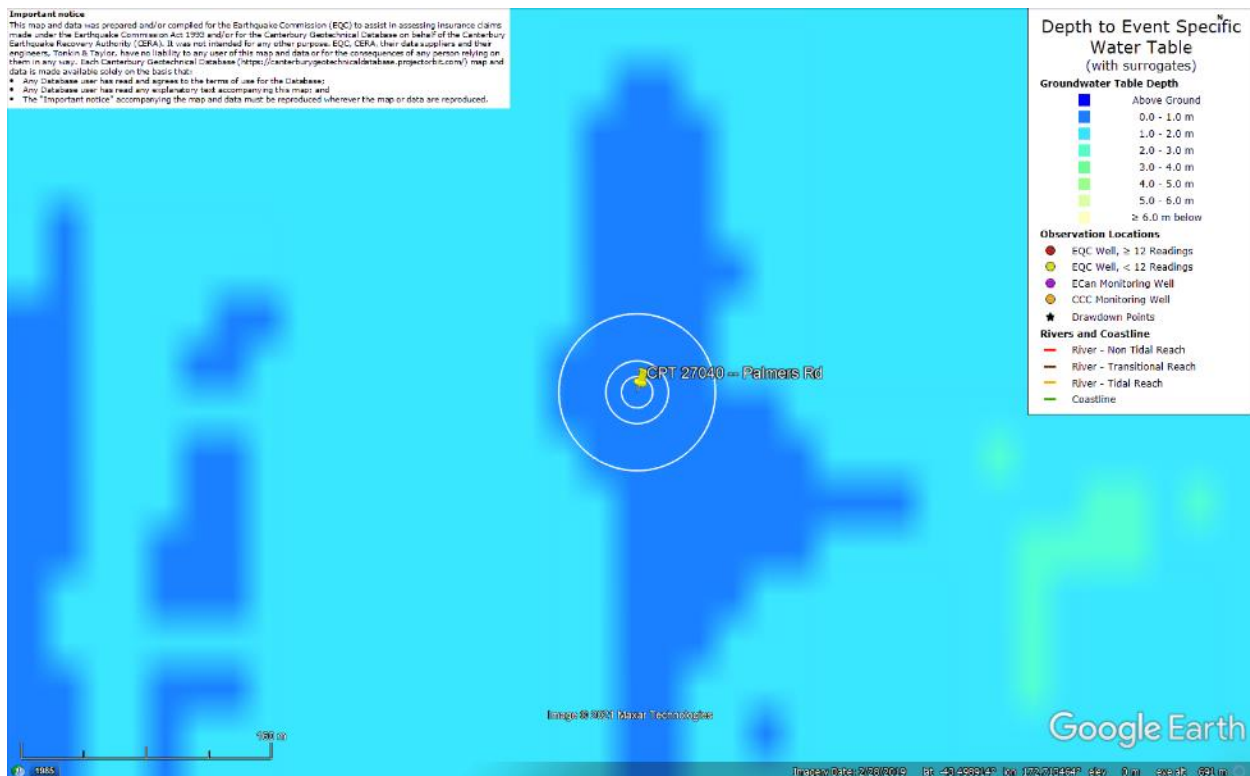
Figure 76: Depth to groundwater table for Dec-11 EQ.

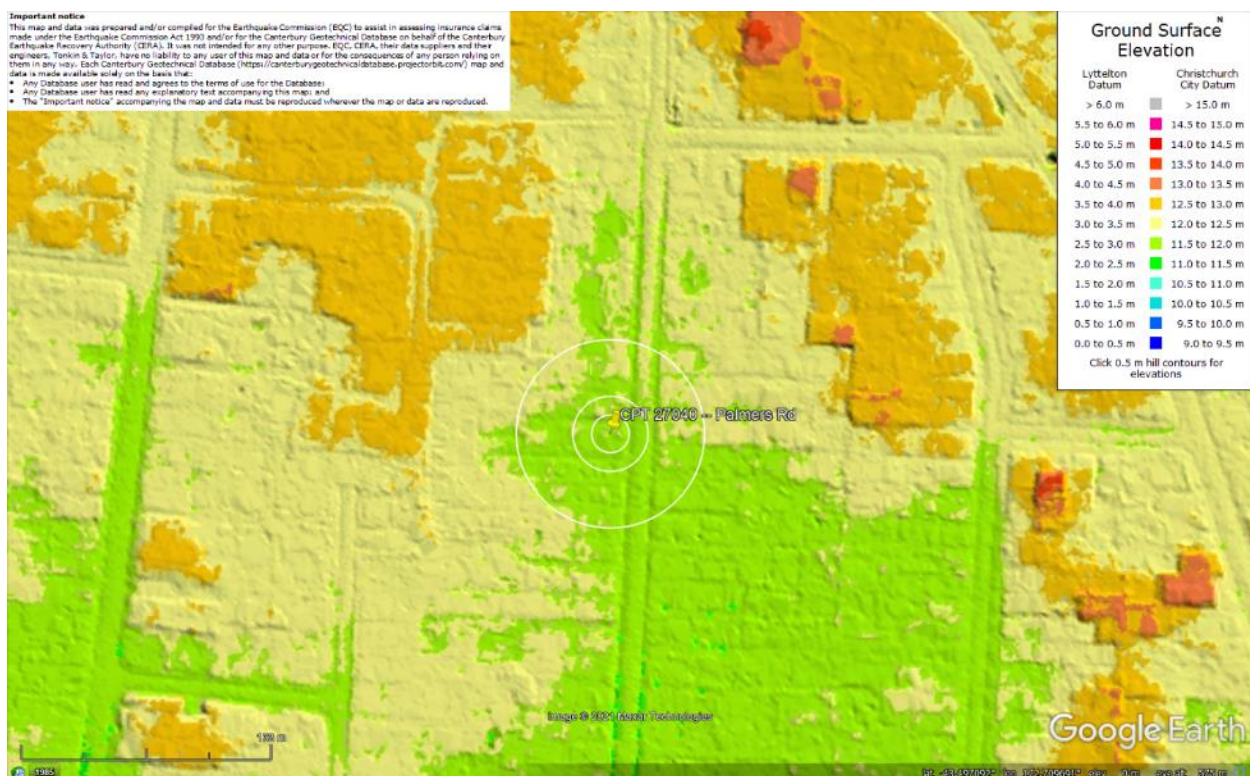
Figure 77: Ground surface elevation according to the Sep-11 LiDAR survey.

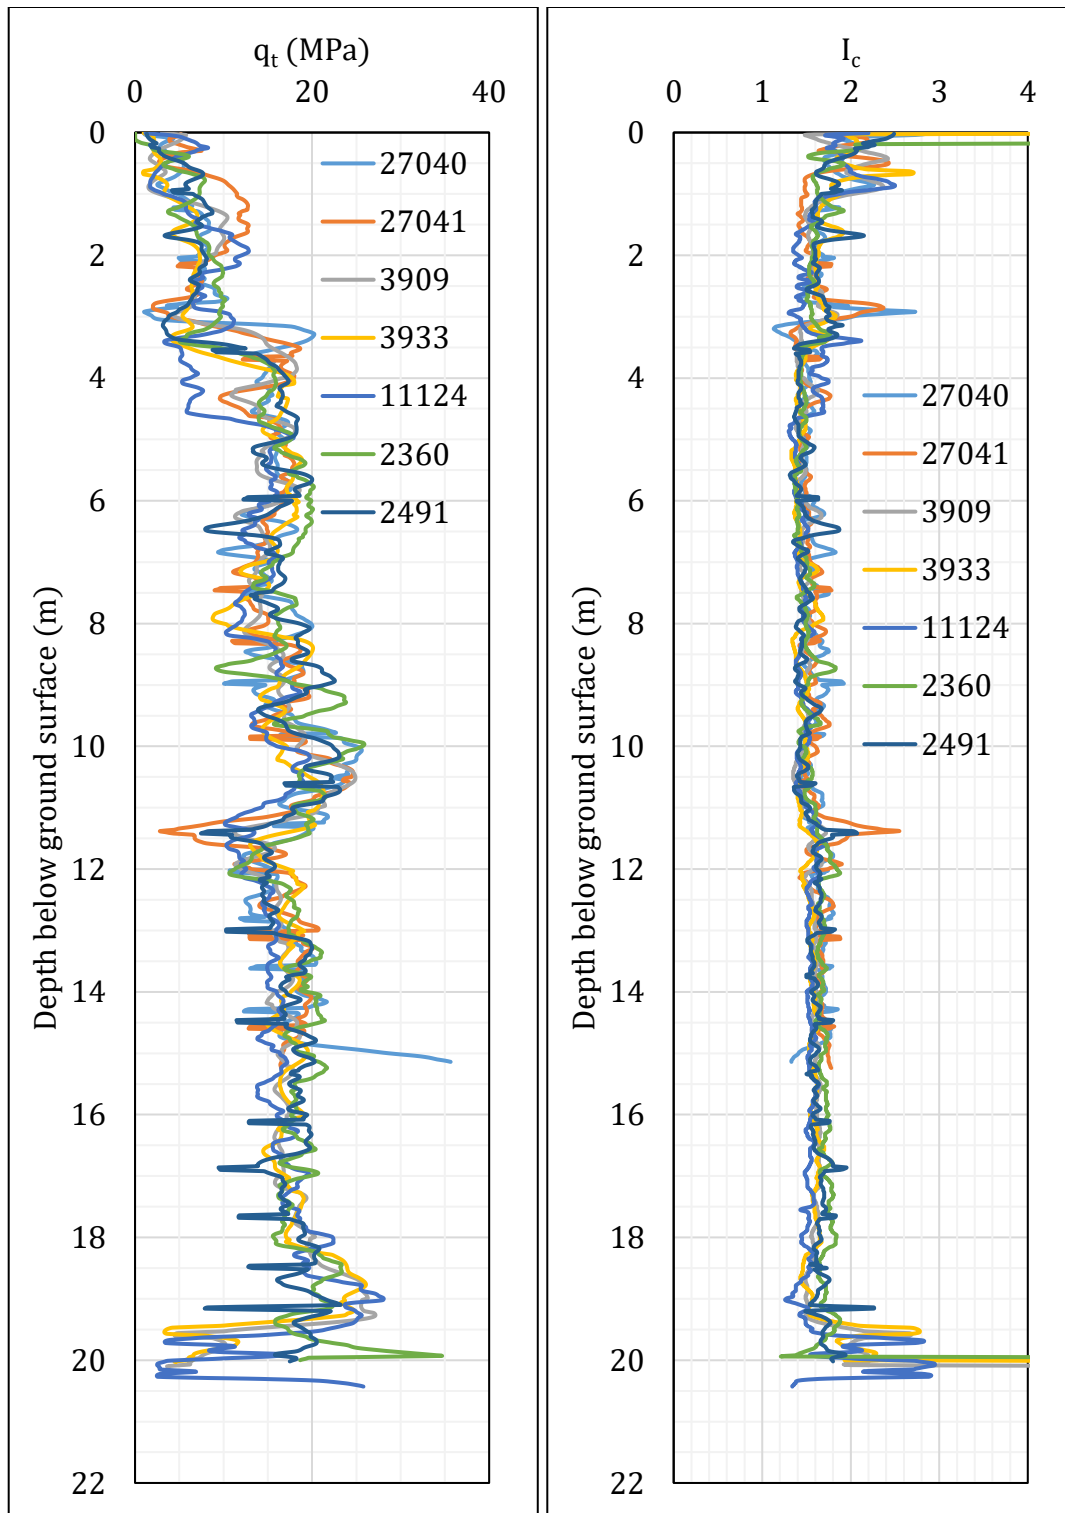
Figure 78:  $q_t$  and  $I_c$  profiles.

**Note 6:** The selection of CPTs for the area considered for settlement assessment (Figure 1) is based on the proximity of the CPTs to the considered areas. In accordance with that, the following table shows CPTs that were used for the volumetric settlement analysis in *Cliq v.3.0.3.2*, a CPT soil liquefaction software developed by GeoLogismiki. (The average volumetric settlements were reported in Table 8.)
