Appendix A.3:

Rawhiti Domain – VsVp 57188

Liquefaction Ejecta Case Histories for 2010-11 Canterbury Earthquakes

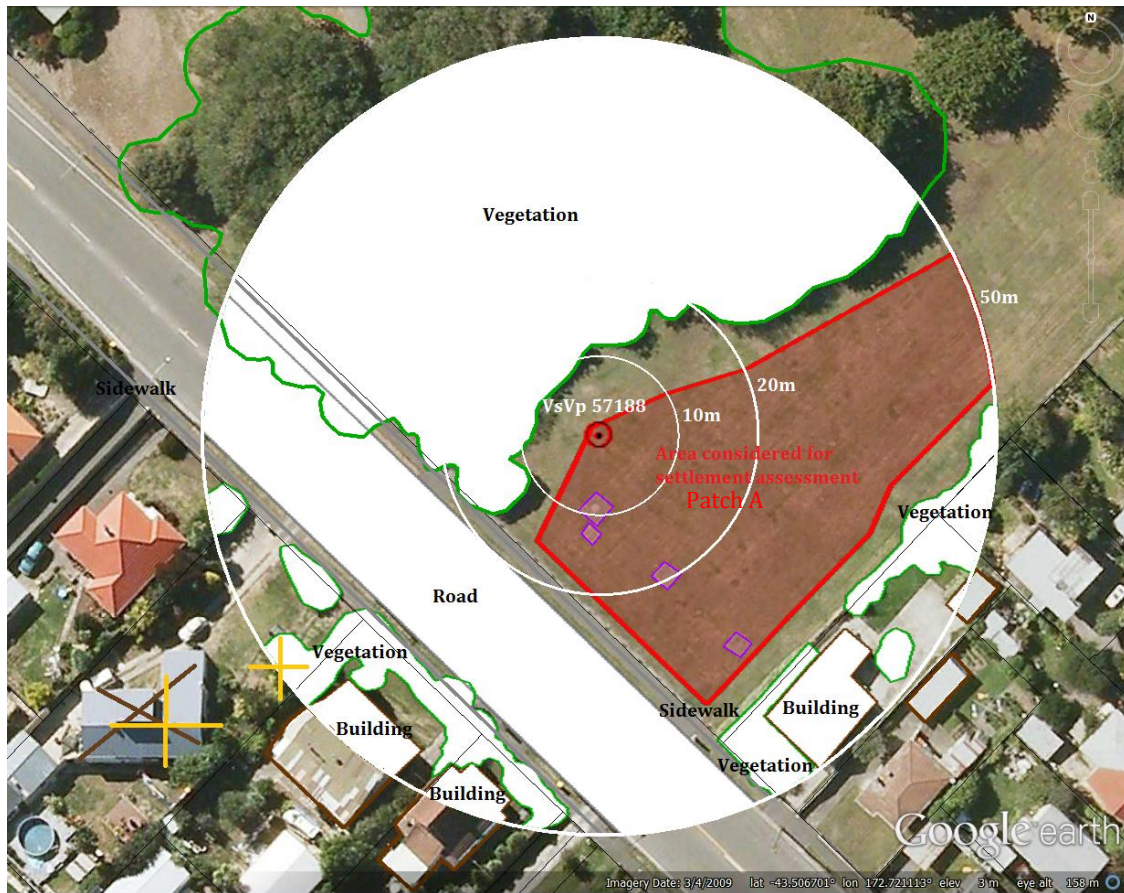
Figure 1: Site plan with areas where LiDAR survey data is considered.

Note 1: The area selected for settlement assessment (Patch A) is free of vegetation, structures, anthropogenic changes, and other important factors that have the potential to influence LiDAR measurements.

Attribute	Yes/No			Description/Date	Symbol in Figure 1
	10-m Buffer	20-m Buffer	50-m Buffer		
Near a body of surface water or other free-face features?	No	No	No	The center of the site is approximately 190 meters away from the Avon River. The direction of the free face is roughly NW-SE, while its height is 1-2 meters.	NA
Lateral spreading observed during the CES?	No	No	No	Ground cracks indicating lateral spreading were not observed by the mapping team. ¹	NA
Nearby buildings or structures?	No	No	Yes	Several residential buildings are situated in the S portion of the 50-m buffer and cover 3% of its area.	White Fill + Brown Outline
Sloping land?	No	No	No	NA	NA
Step changes in the ground surface?	No	No	No	NA	NA
Retaining walls?	No	No	No	NA	NA
Vegetation?	Yes	Yes	Yes	Trees cover 6% of the 10-m buffer, 30% of the 20-m buffer, and 45% of the 50-m buffer. They are located in the NW quadrant of the 10-m buffer, the SW, NW, and NE portions of the 20-m buffer, and the N portion and near the SW and SE rims of the 50-m buffer.	White Fill + Green Outline

Anthropogenic changes to the site between the LiDAR surveys?	No	No	Yes	Removal of a dwelling close to the SW quadrant of the 50-m buffer between Sep 2014 and Jan 2015 and addition of two new structures on the same property between Jan 2015 and June 2015.	Removed Dwelling: Brown X Sign; Added Structures: Yellow + Sign
Other important factors?	No	Yes	Yes	Four concrete patches (covering a total area of 25 m ²) are located within the three buffers. Busy two-way road occupies 15% of the 50-m buffer and stretches throughout the NW, SW, and SE quadrants.	Concrete Patches: Purple Outline Road: White Fill + Gray Outline

Note 6: The selection of CPTs for the area considered for settlement assessment (Figure 1) is based on the proximity of the CPTs to the considered areas. In accordance with that, the following table shows CPTs that were used for the volumetric settlement analysis in *Cliq v.3.0.3.2*, a CPT soil liquefaction software developed by GeoLogismiki. (The average volumetric settlements were reported in Table 8.)

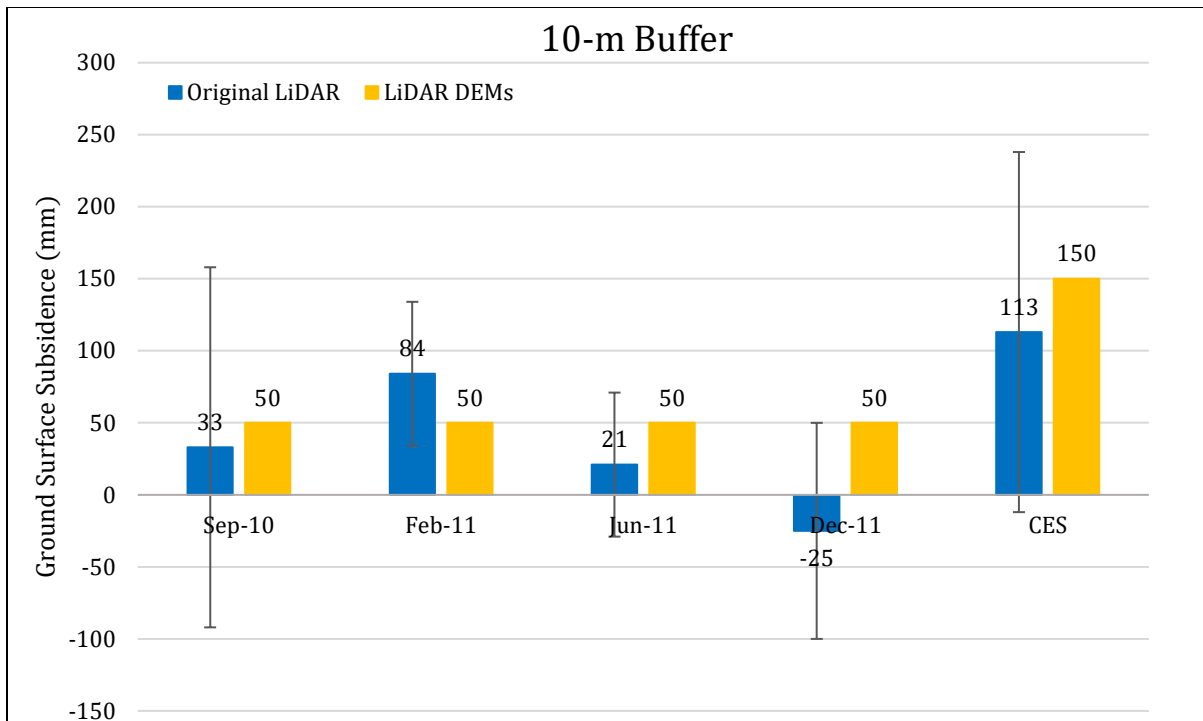
Figure 2: Comparison between ground surface subsidence determined from original LiDAR survey points and ground surface subsidence (50th %ile) estimated using LiDAR DEMs for the 10-m buffer.

Note 2: The ground surface subsidence values determined from original LiDAR survey points are similar to the ground surface subsidence values estimated using LiDAR DEMs for all earthquake events.

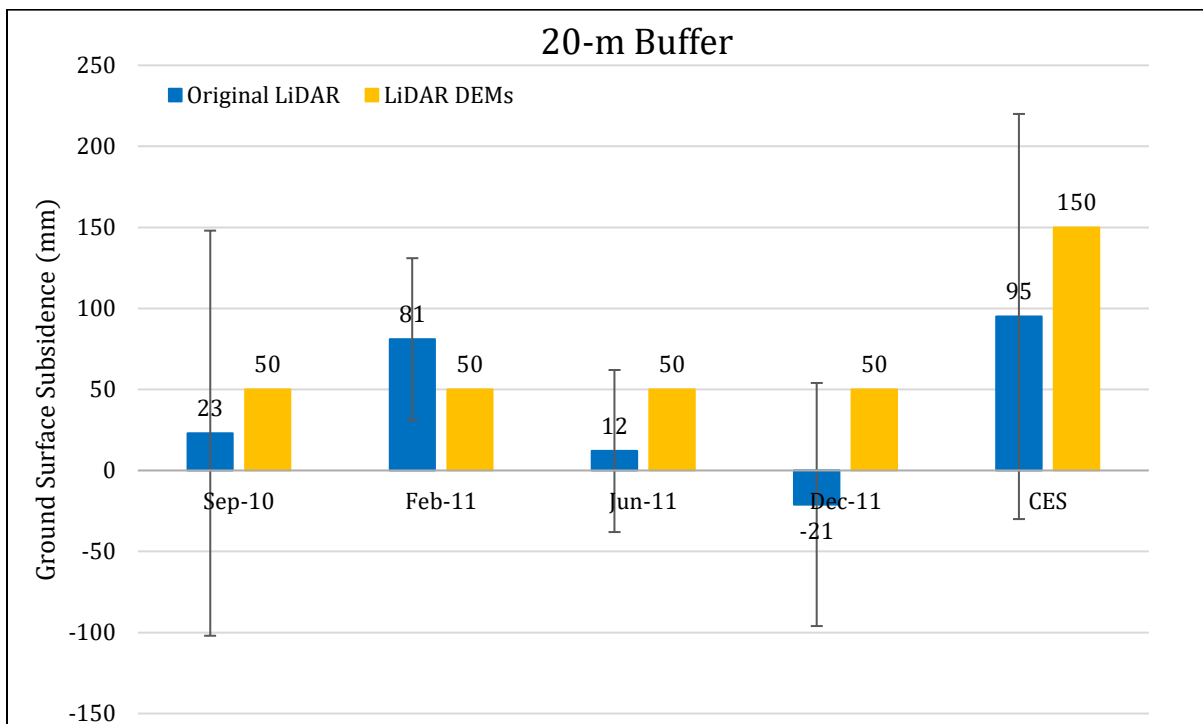
Figure 3: Comparison between ground surface subsidence determined from original LiDAR survey points and ground surface subsidence (50th %ile) estimated using LiDAR DEMs for the 20-m buffer.

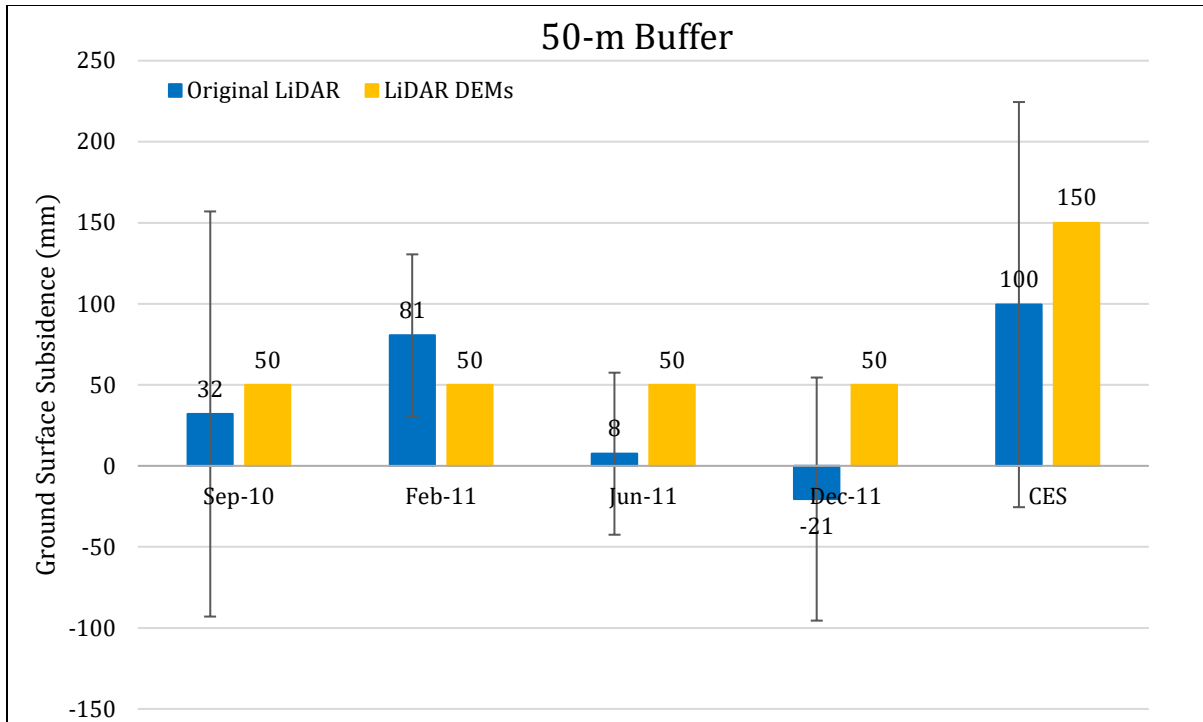
Figure 4: Comparison between ground surface subsidence determined from original LiDAR survey points and ground surface subsidence (50th %ile) estimated using LiDAR DEMs for the 50-m buffer.

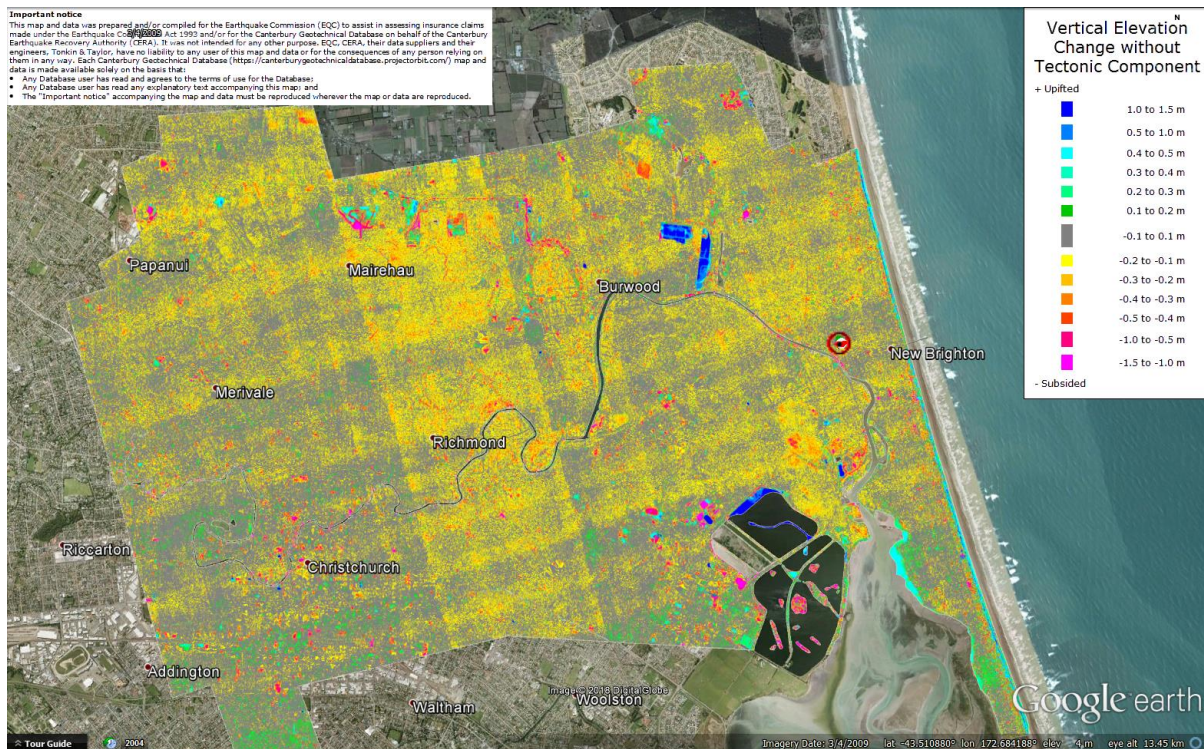
Figure 21: Vertical Ground Movements (Surface – Tectonic) for Sep 2010 Earthquake – the site is not in the apparent zone of overestimated ground surface subsidence.

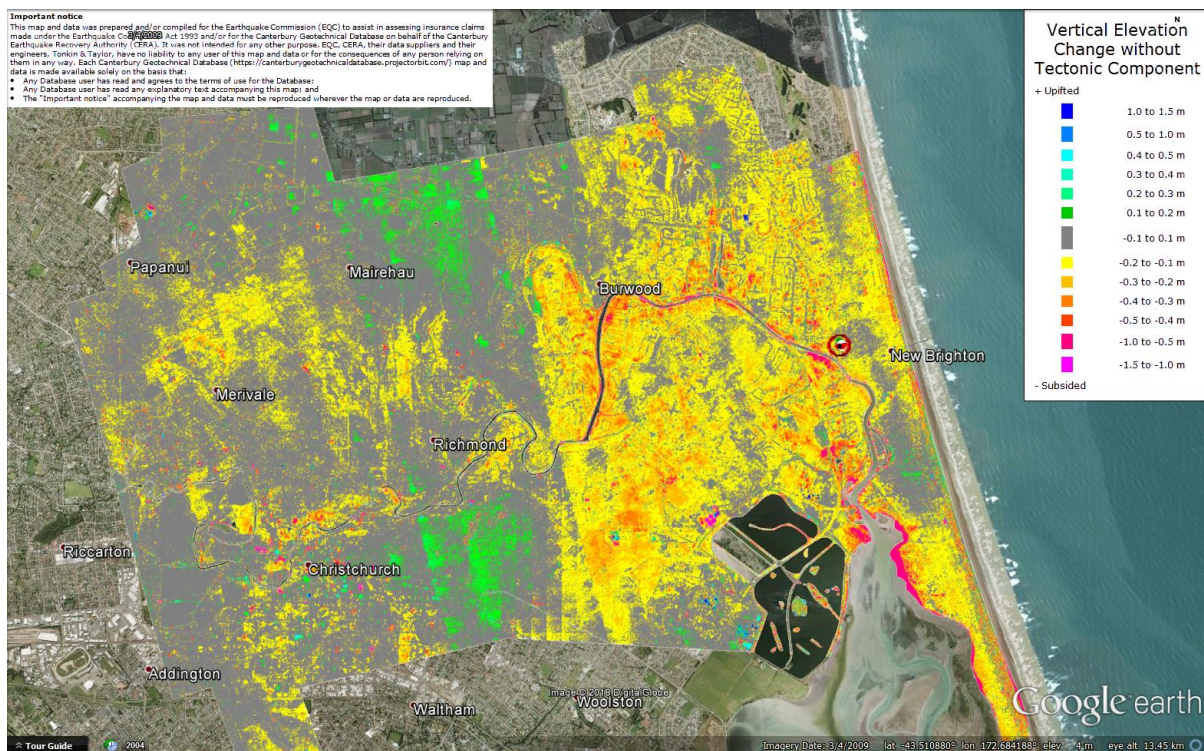
Figure 22: Vertical Ground Movements (Surface – Tectonic) for Feb 2011 Earthquake – the site is not in the apparent zone of underestimated ground surface subsidence.

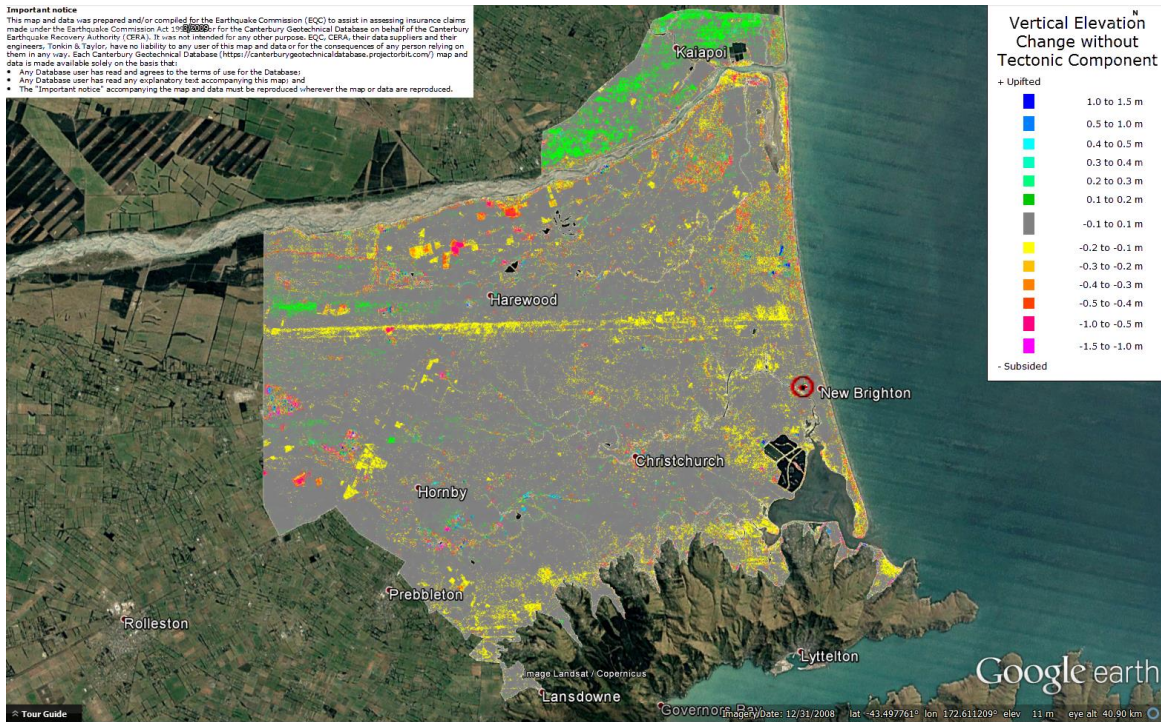
Figure 23: Vertical Ground Movements (Surface – Tectonic) for June 2011 Earthquake – the site is not in the apparent zone of overestimated or underestimated ground surface subsidence.

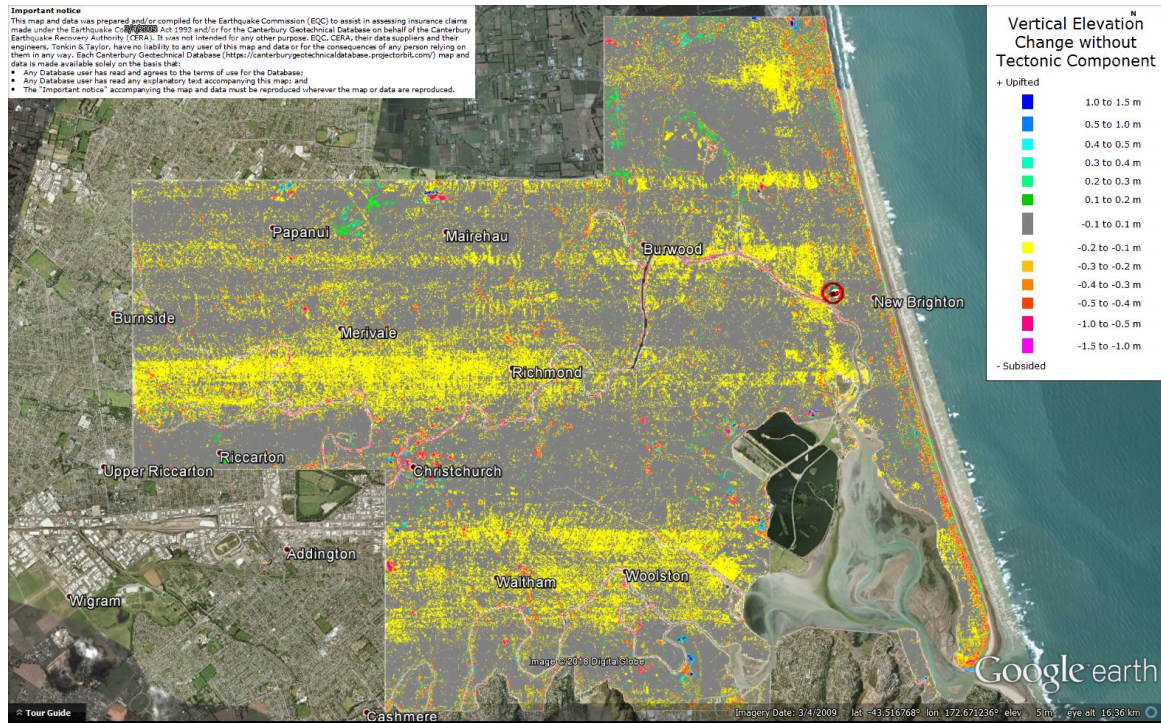
Figure 24: Vertical Ground Movements (Surface – Tectonic) for Dec 2011 Earthquake – the site is not in the apparent zone of overestimated or underestimated ground surface subsidence.

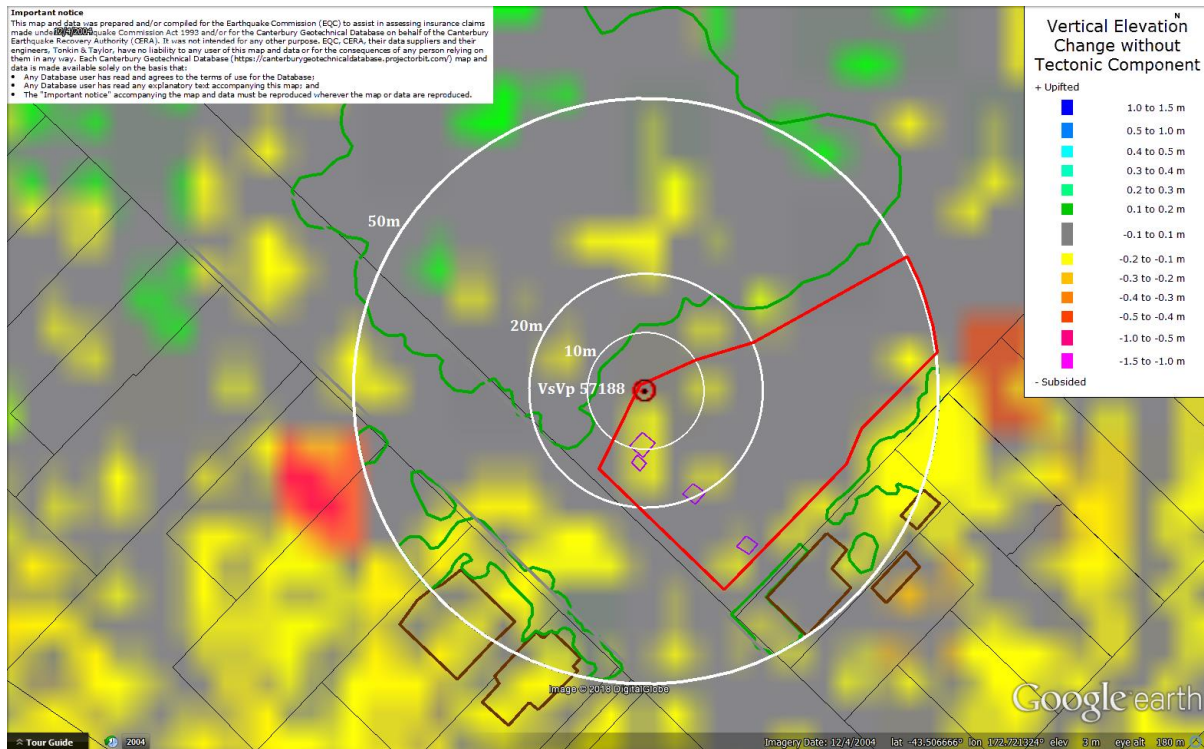
Figure 25: Ground surface subsidence without tectonic component for Sep 2010 Earthquake according to the LiDAR DEM.

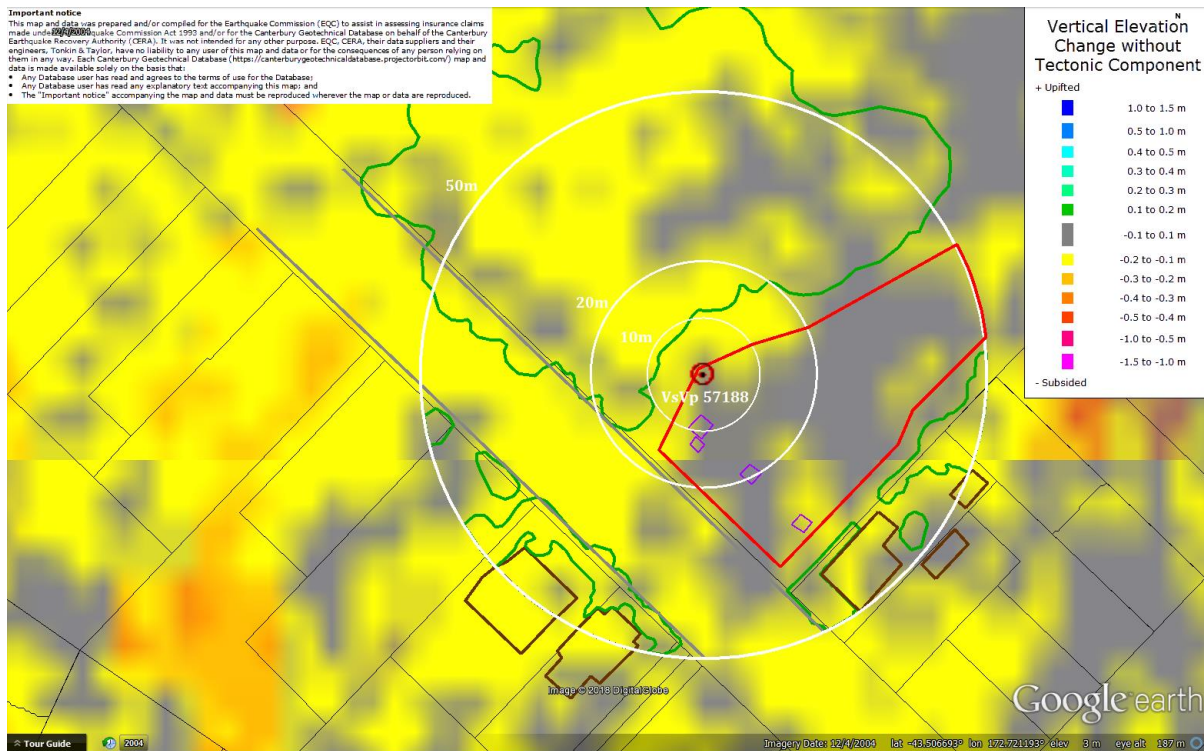
Figure 26: Ground surface subsidence without tectonic component for Feb 2011 Earthquake according to the LiDAR DEM.

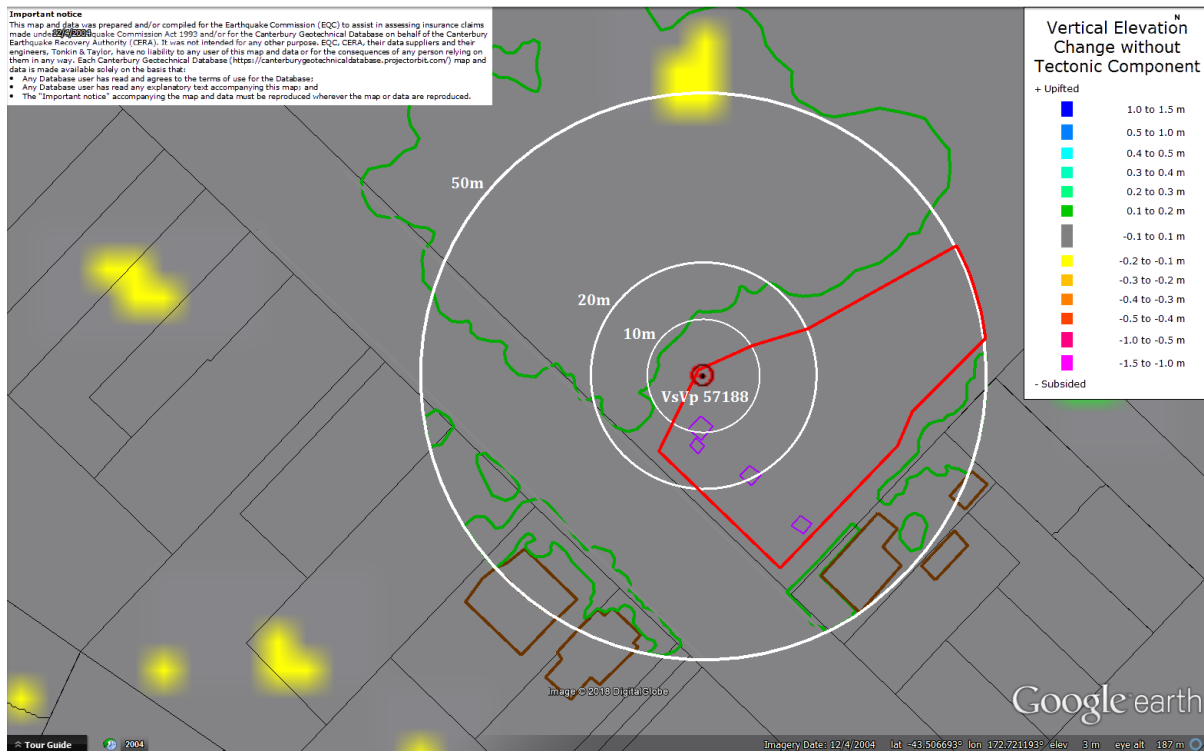
Figure 27: Ground surface subsidence without tectonic component for Jun 2011 Earthquake according to the LiDAR DEM.

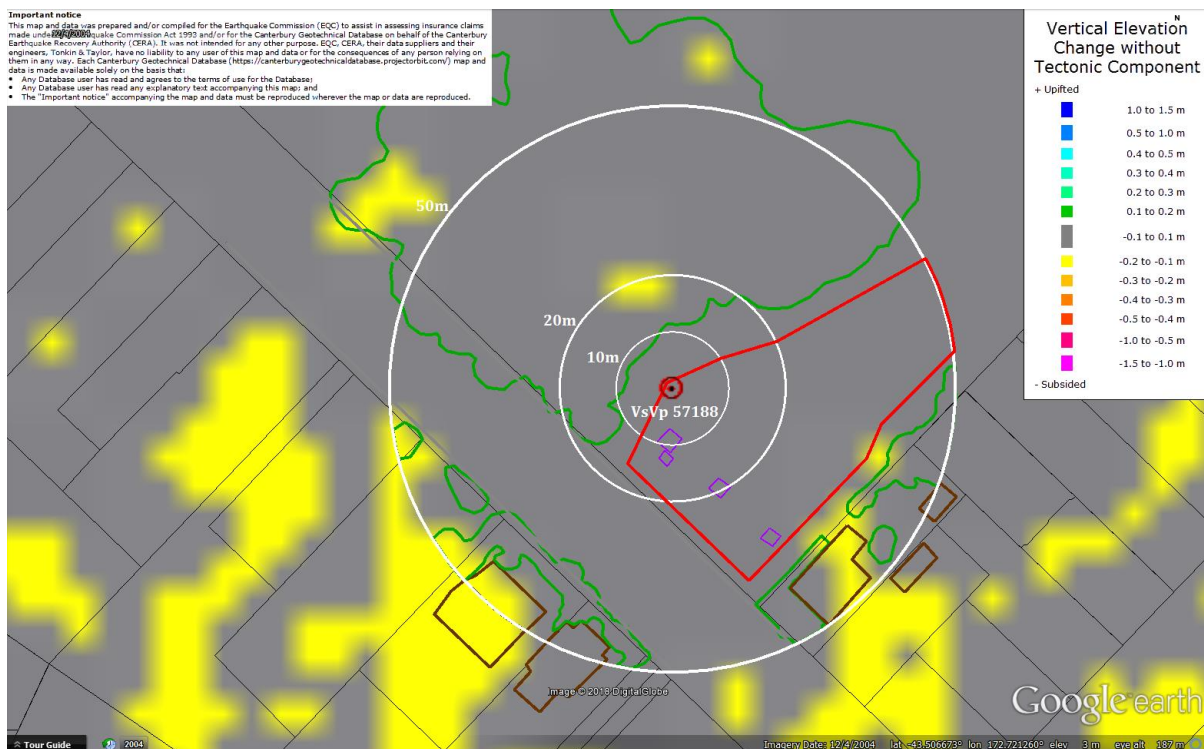
Figure 28: Ground surface subsidence without tectonic component for Dec 2011 Earthquake according to the LiDAR DEM.

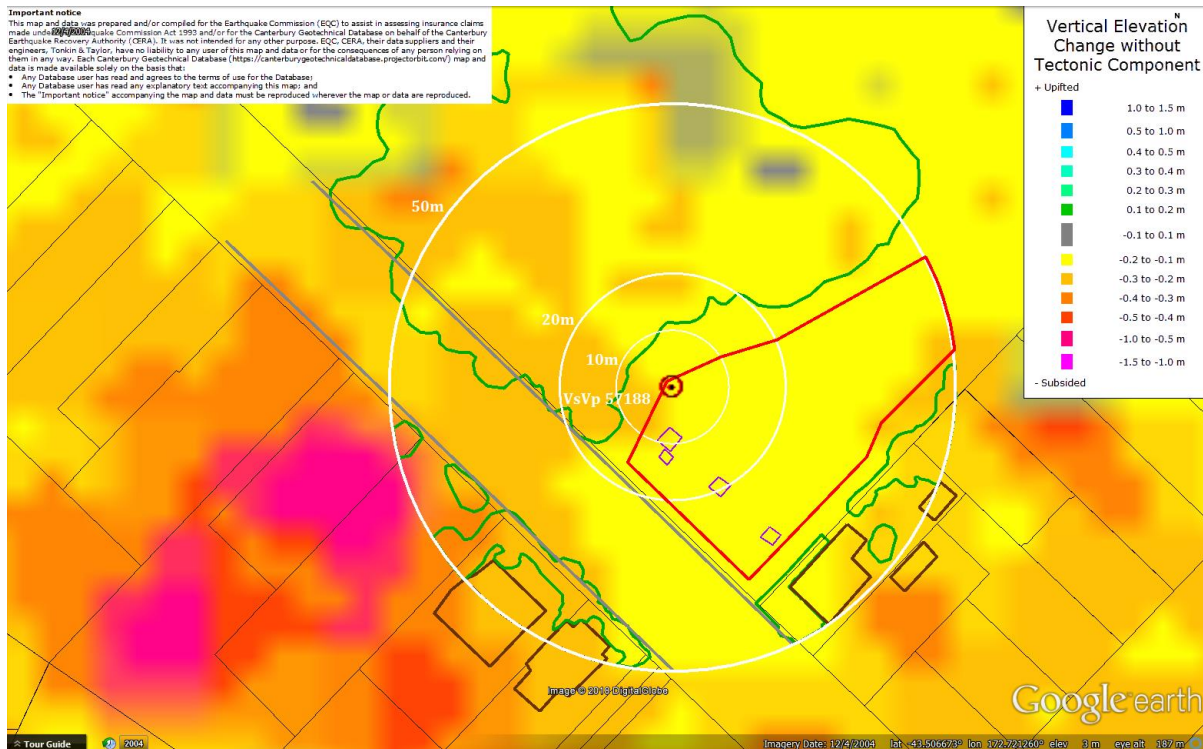
Figure 29: Ground surface subsidence without tectonic component for Canterbury Earthquake Sequence according to the LiDAR DEM.

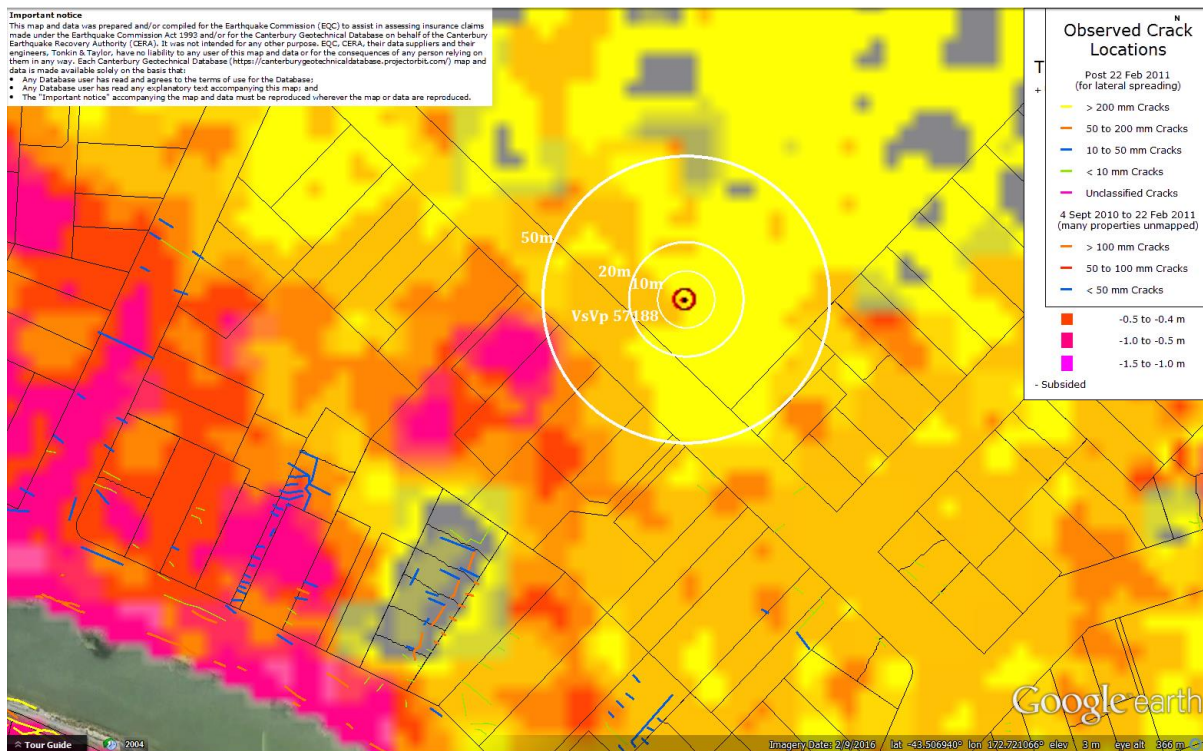
Figure 30: Absence of ground cracks indicating no lateral spreading for Canterbury Earthquake Sequence.

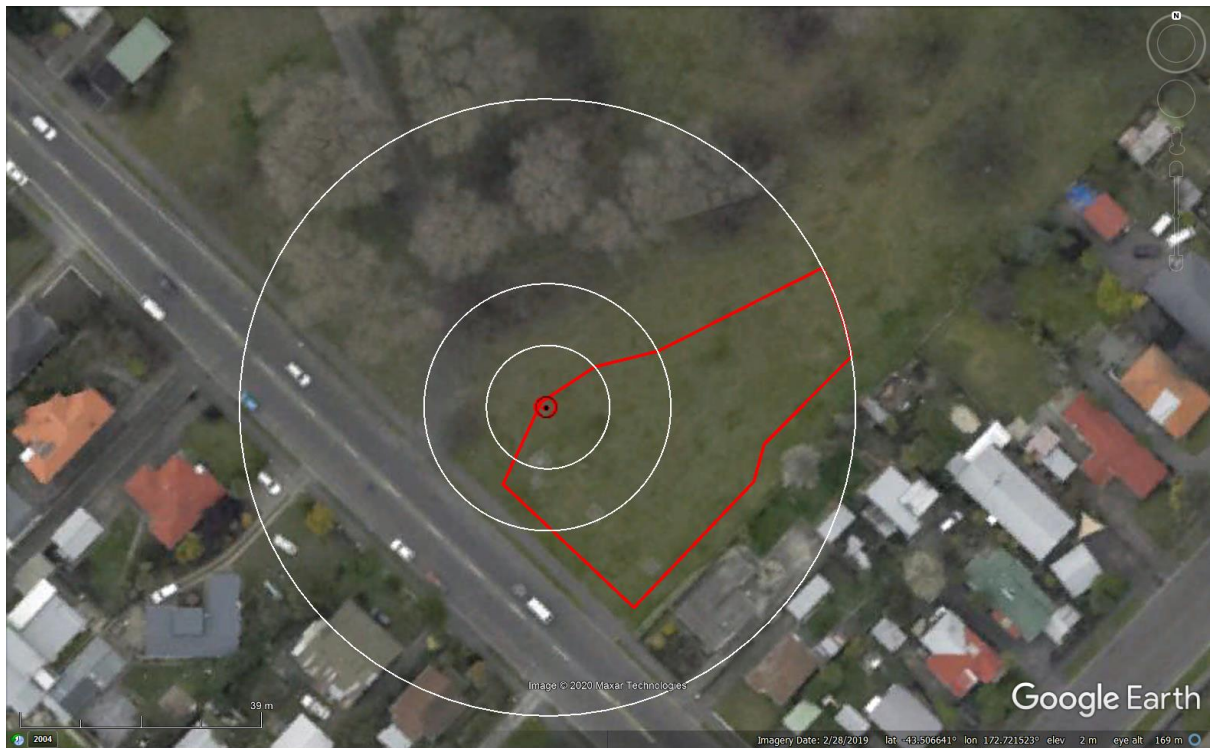
Figure 64: Aerial photograph showing no ejecta at the site for Sep-10 EQ.

Note 4: The values in Table 9 are based on the high-resolution aerial photographs of the site (Figures 64 through 67). The ejecta is not visible at the site within the assessment area for any earthquake event.

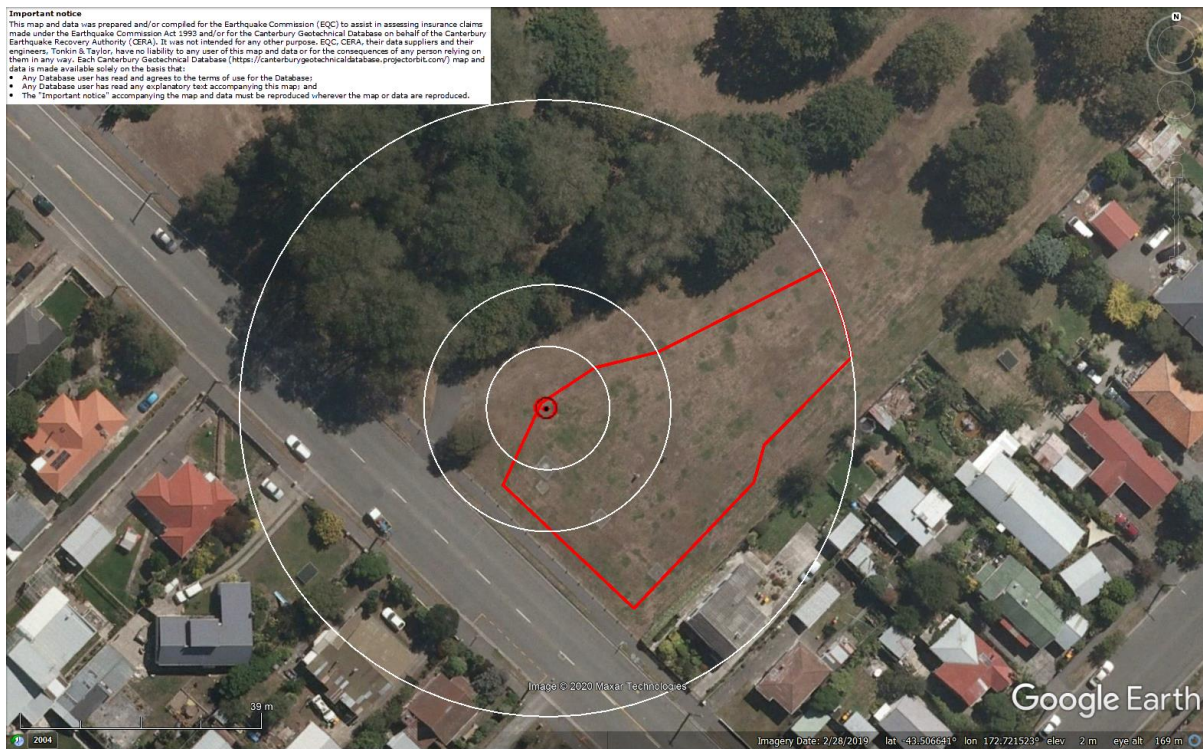
Figure 65: Aerial photograph showing no ejecta at the site for Feb-11 EQ.

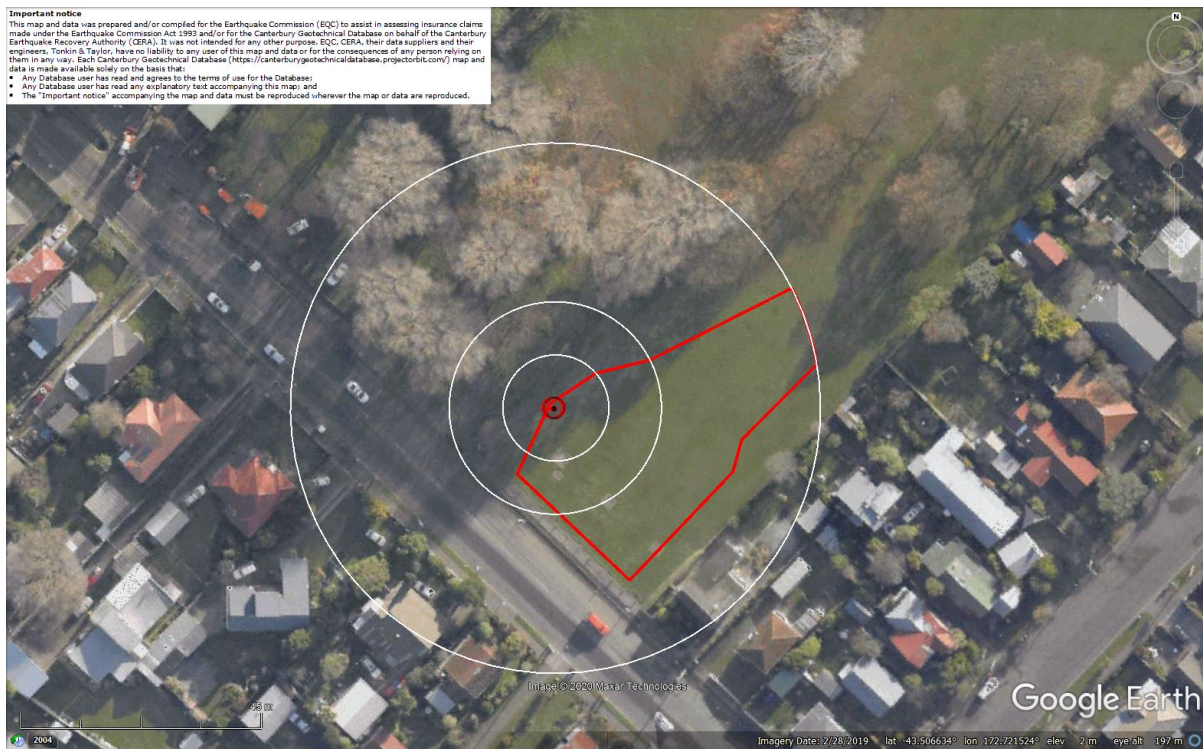
Figure 66: Aerial photograph showing no ejecta at the site for Jun-11 EQ.

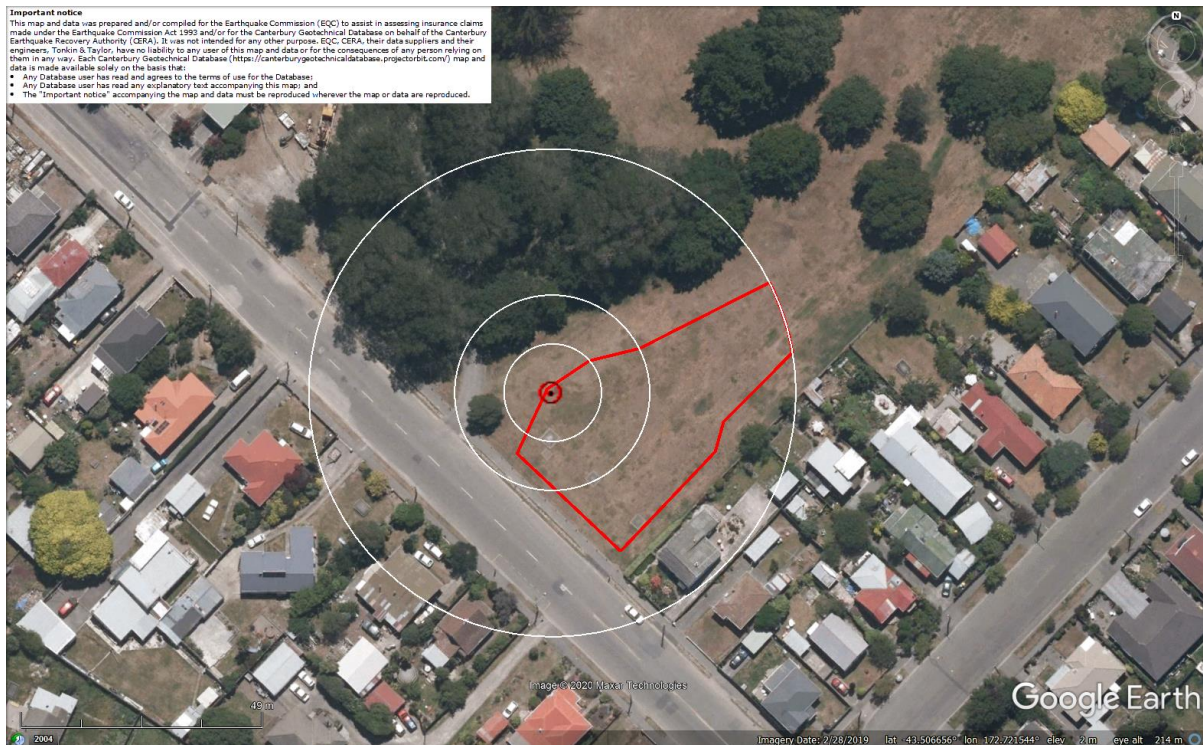
Figure 67: Aerial photograph showing no ejecta within the settlement assessment area for Dec-11 EQ. There are negligible ejecta on the road within the 50-m buffer.

- $S_{E,final}$ is based solely on $S_{E,P}$ due to the availability of the high-resolution aerial photographs for all earthquake events that show no liquefaction ejecta at the site within the assessment area (Patch A). The aerial photograph for the Dec-11 earthquake shows negligible ejecta (<5 mm) on the road, within the 50-m buffer. As a side note, the site is not in the apparent zone of higher/lower ground surface subsidence compared to the adjacent areas for any earthquake event and the LiDAR surveys are not affected by ejecta. The Rawhiti Domain site is in the zone of accurate LPI prediction of liquefaction severity for the Sep-11 and Feb-11 earthquakes (Maurer et al. 2014³).
- There were minor ejecta on the road (<5 mm) for the Dec-11 EQ.

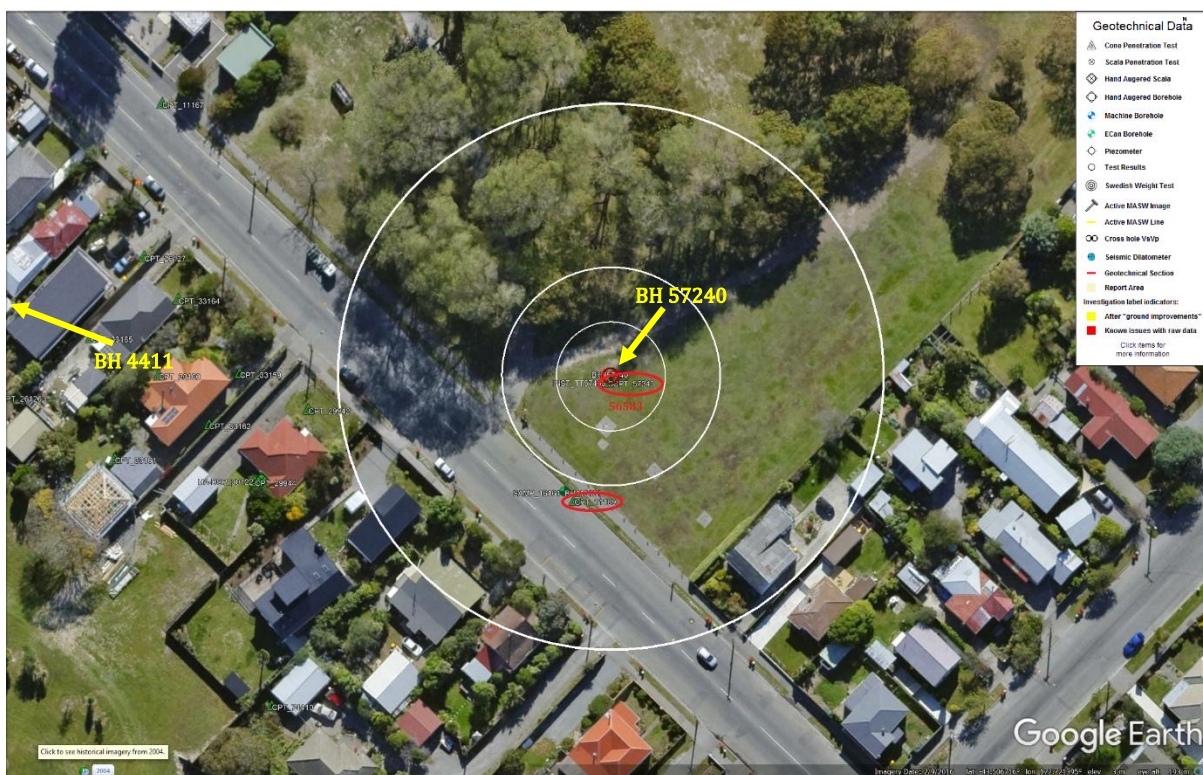
Figure 68: CPT locations.

Note 7: Based on the borehole log (BH 57240, Figure 68), the groundwater table is at a depth of 1.1 m below the ground surface. The soil profile consists of poorly graded sand, SP, of the Christchurch formation to a depth of 11.05 m (the end of the borehole). The nearby borehole (BH 4411, ~190 m away from the centre of the site) suggests the SP layer extends to a depth of 20 m. Trace angular, fine gravel is found from a depth of 0.2 m to a depth of 0.8 m.

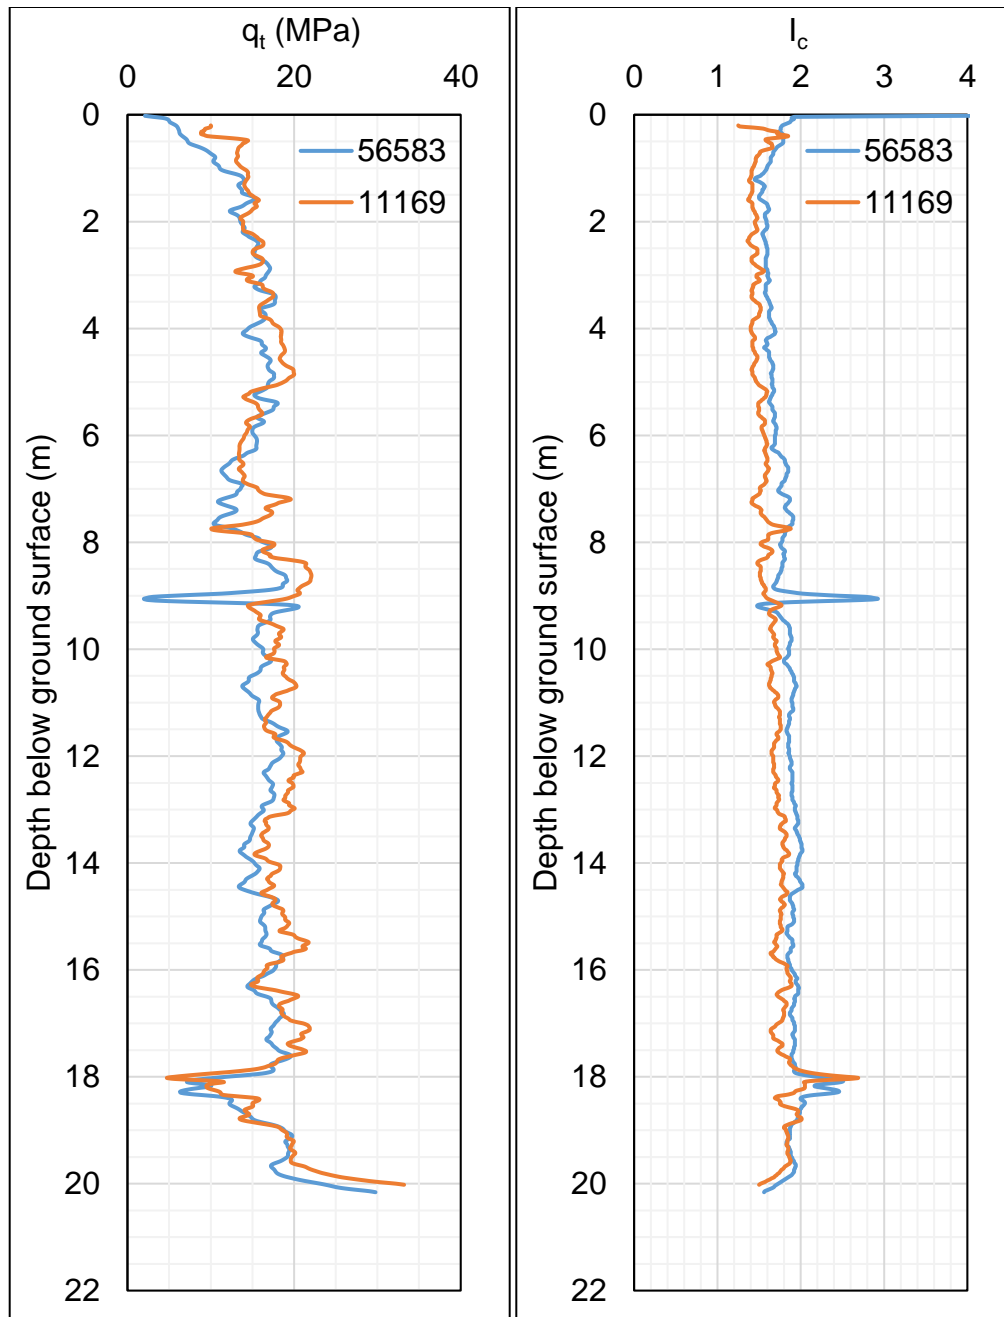
Figure 78: q_t and I_c profiles.
