Appendix A.4:

Caulfield Ave – VsVp 38175

Liquefaction Ejecta Case Histories for 2010-11 Canterbury Earthquakes

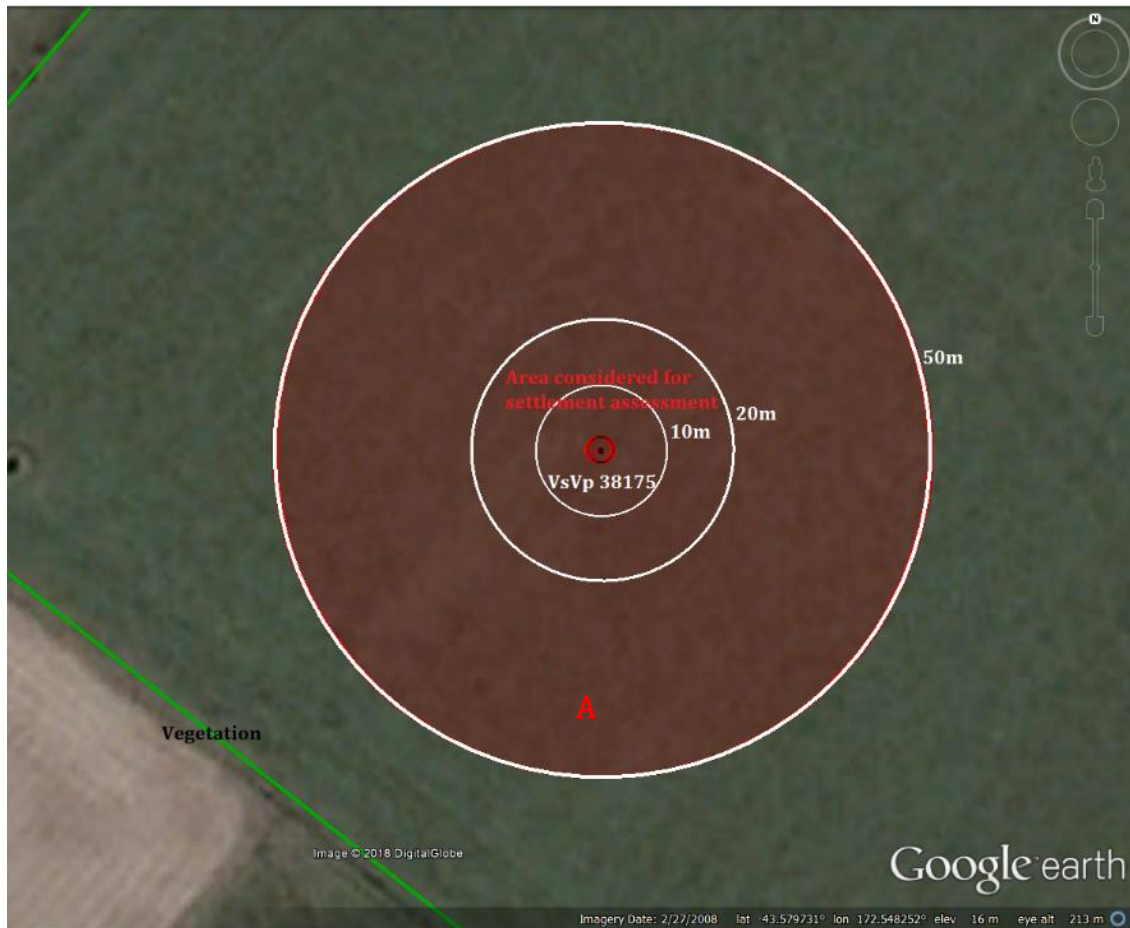
Figure 1: Site plan with areas where LiDAR survey data is considered.

Note 1: The area selected for settlement assessment (Patch A) is free of vegetation, structures, manmade changes, and other important factors that have the potential to influence LiDAR measurements.

Notes: Buffer is the area within a circle of a specified radius with VsVp investigations done at its center (172.548658, -43.579706); Oct 2015 LiDAR survey is excluded from the settlement analysis due to the anthropogenic changes.

Note 9: The selection of CPTs for the area considered for settlement assessment (Figure 1) is based on the proximity of the CPTs to the considered areas. In accordance with that, the following table shows CPTs that were used for the volumetric settlement analysis in *Cliq v.3.0.3.2*, a CPT soil liquefaction software developed by GeoLogismiki. (The average volumetric settlements were reported in Table 8.)

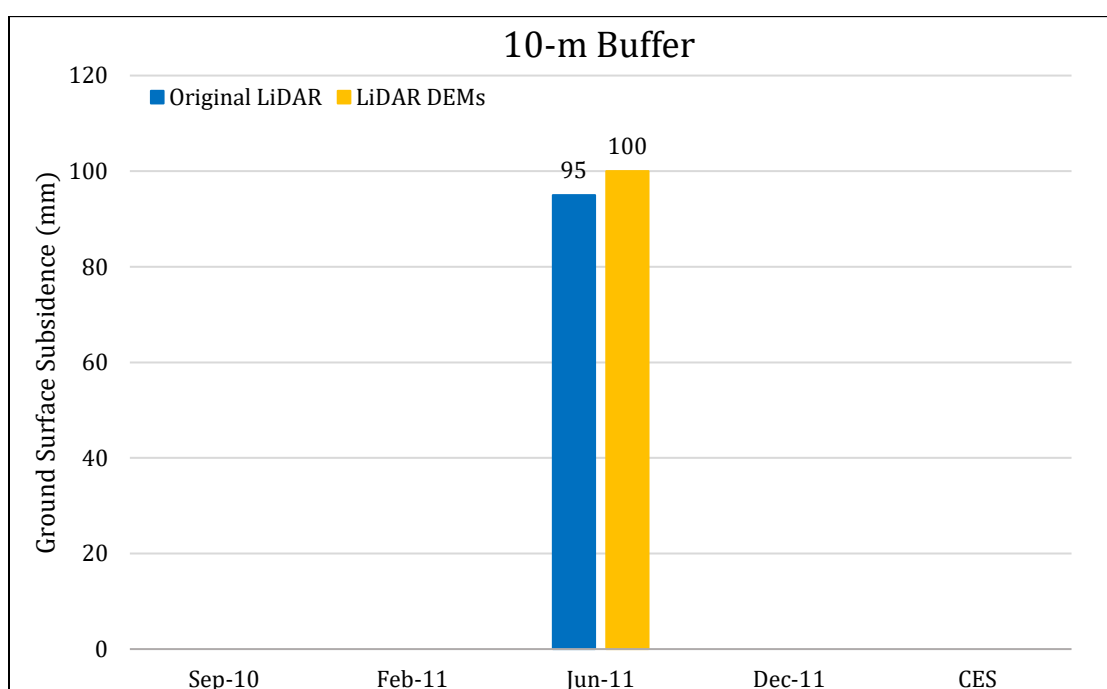
Figure 2: Comparison between ground surface subsidence determined from original LiDAR survey points and ground surface subsidence (50th %ile) estimated using LiDAR DEMs for the 10-m buffer.

Note 2: The ground surface subsidence values determined from original LiDAR survey points are similar to the ground surface subsidence values estimated using LiDAR DEMs for Jun-11 Earthquake.

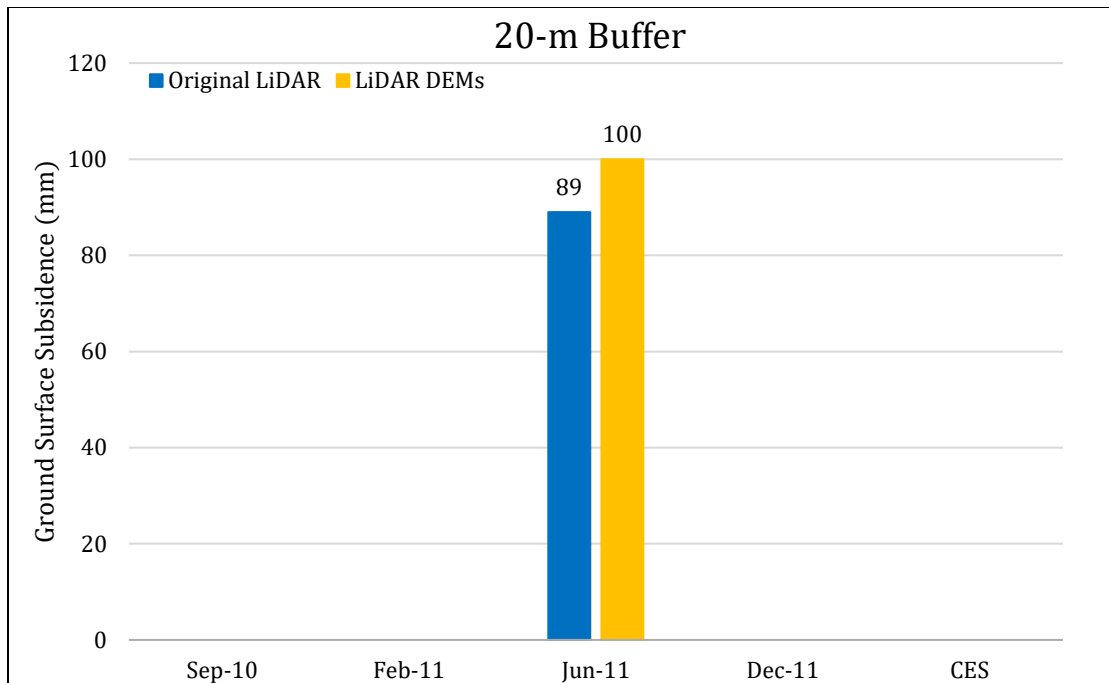
Figure 3: Comparison between ground surface subsidence determined from original LiDAR survey points and ground surface subsidence (50th %ile) estimated using LiDAR DEMs for the 20-m buffer.

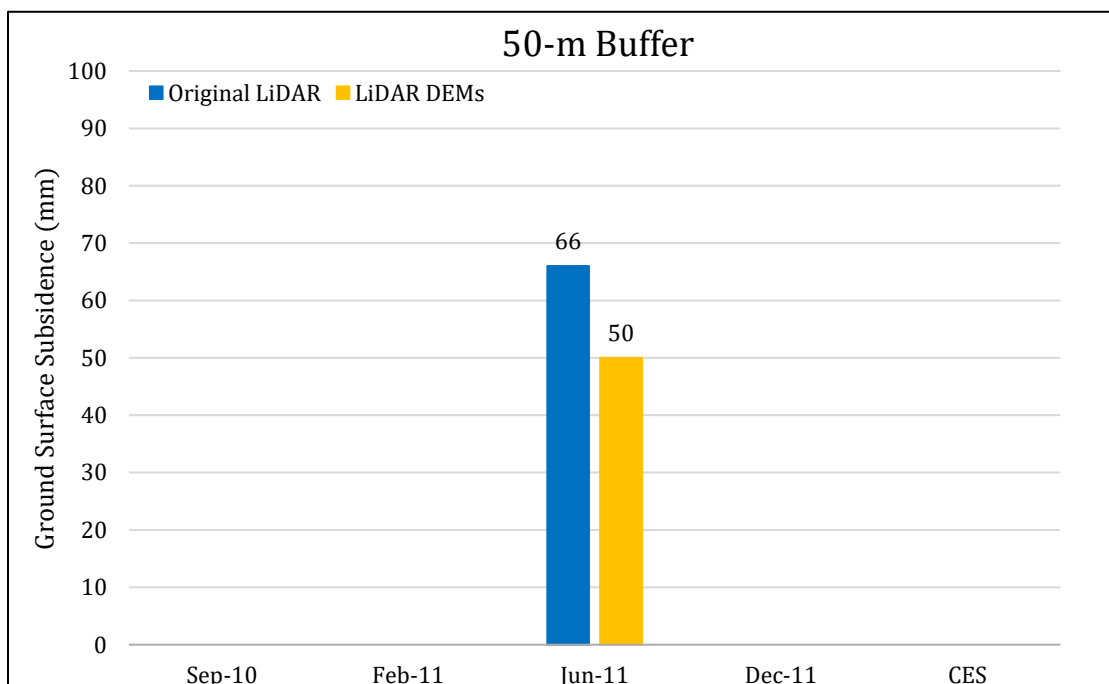
Figure 4: Comparison between ground surface subsidence determined from original LiDAR survey points and ground surface subsidence (50th %ile) estimated using LiDAR DEMs for the 50-m buffer.

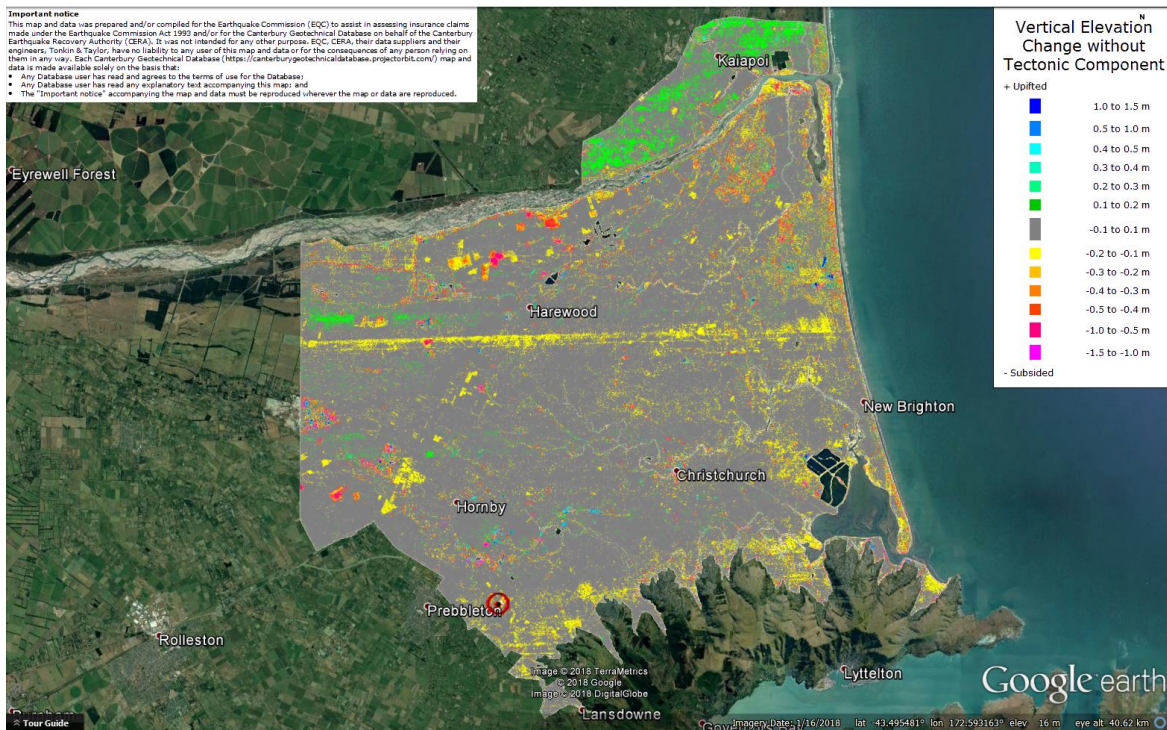
Figure 22: Vertical Ground Movements (Surface – Tectonic) for June 2011 Earthquake – the site is not in the apparent zone of overestimated or underestimated ground surface subsidence.

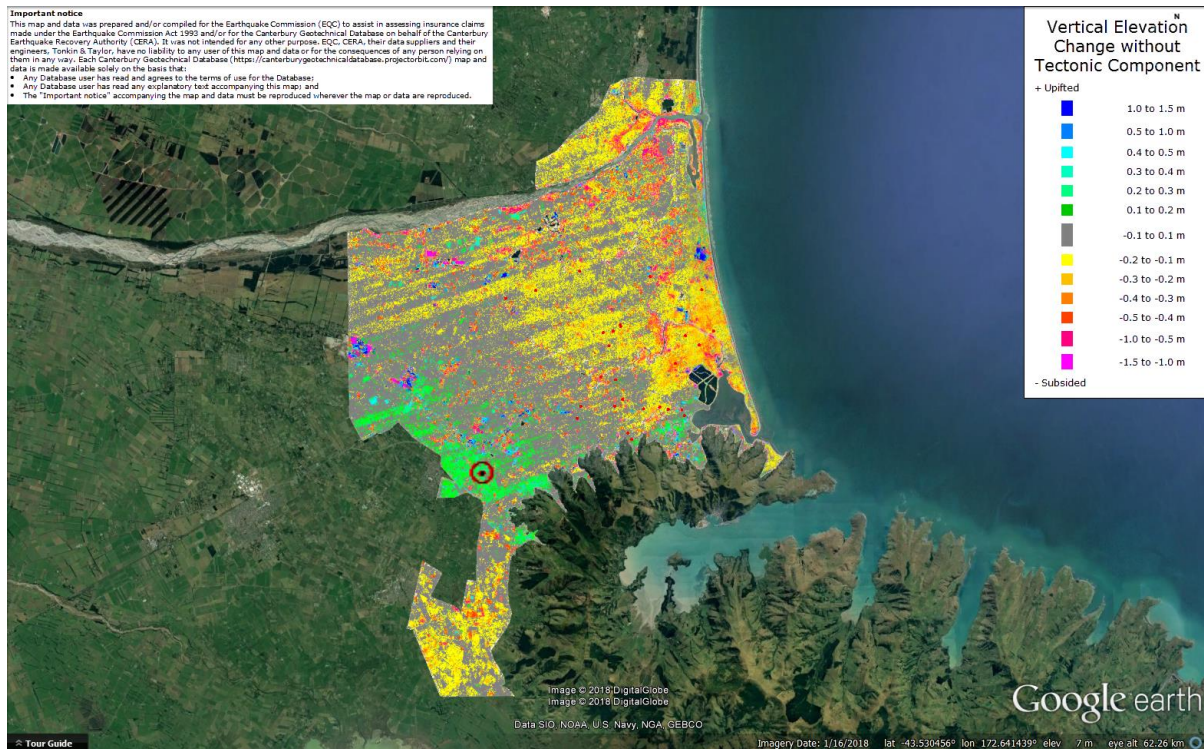
Figure 24: Vertical Ground Movements (Surface – Tectonic) for Sep 2010 and Feb 2011 Earthquakes -- the site is in the apparent zone of ground surface uplift.

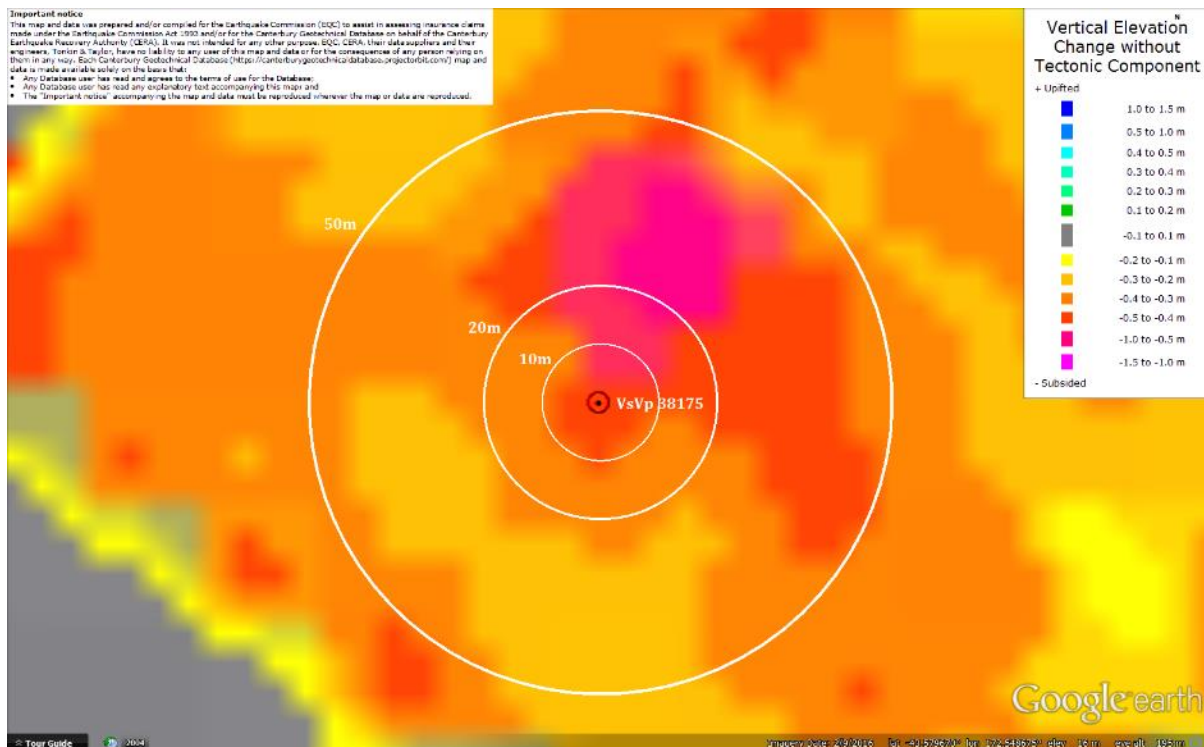
Figure 25: LiDAR DEM-based ground surface subsidence without tectonic component for Jun 2011 Earthquake.

Note 7: LiDAR DEM-based ground surface subsidence without tectonic component is not available for Sep 2010, Feb 2011, and Dec 2011 Earthquakes and Canterbury Earthquake Sequence. The only available LiDAR surveys for this site are dated to Jun 2003, May 2011, and Sep 2011.

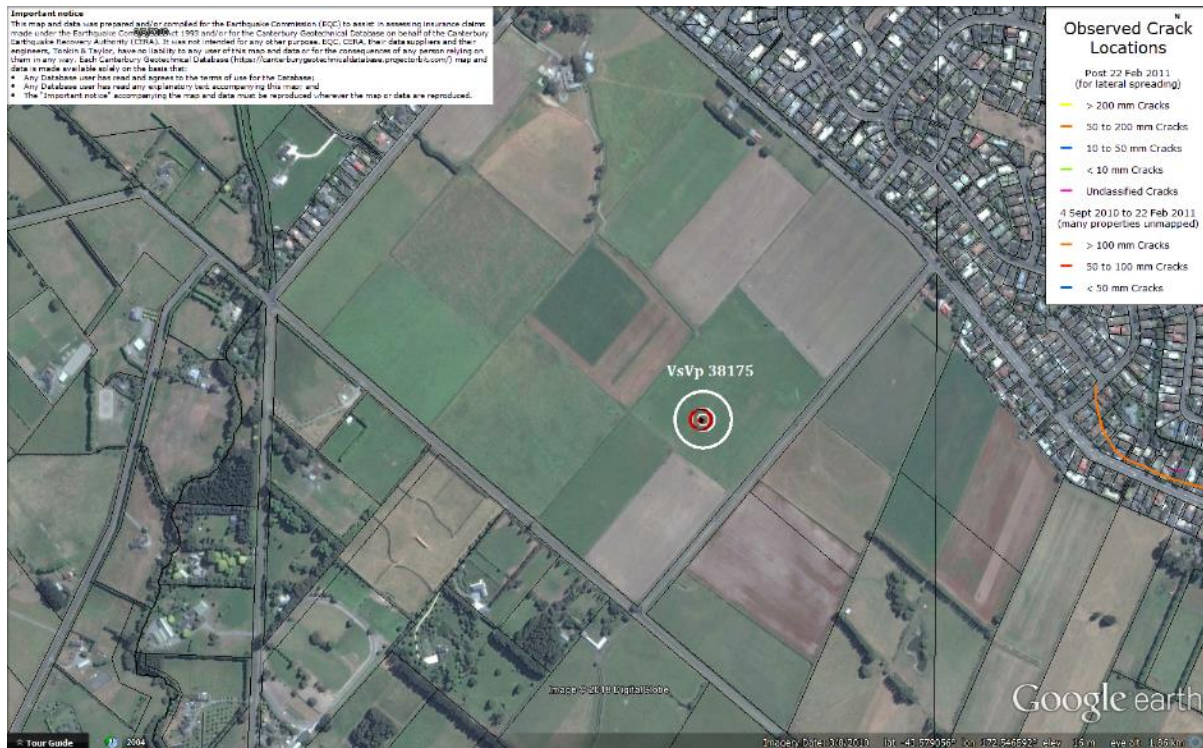
Figure 26: Absence of ground cracks indicating no lateral spreading for Canterbury Earthquake Sequence.

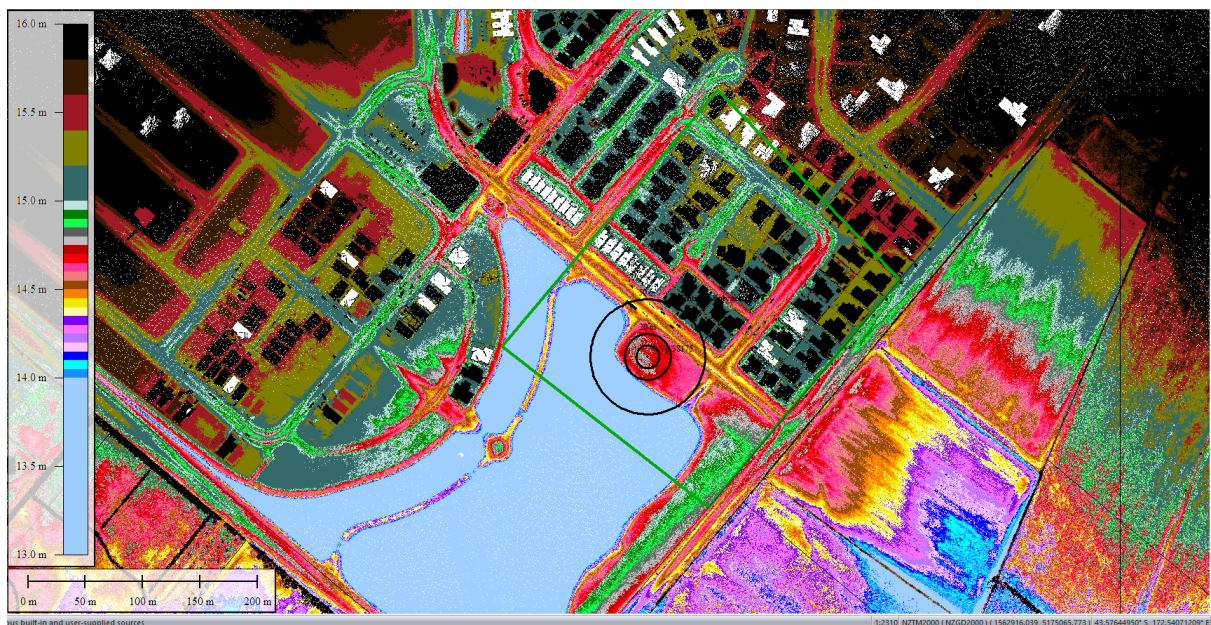
Figure 44: Oct 2015 LiDAR survey (note the change in ground surface elevation due to construction).

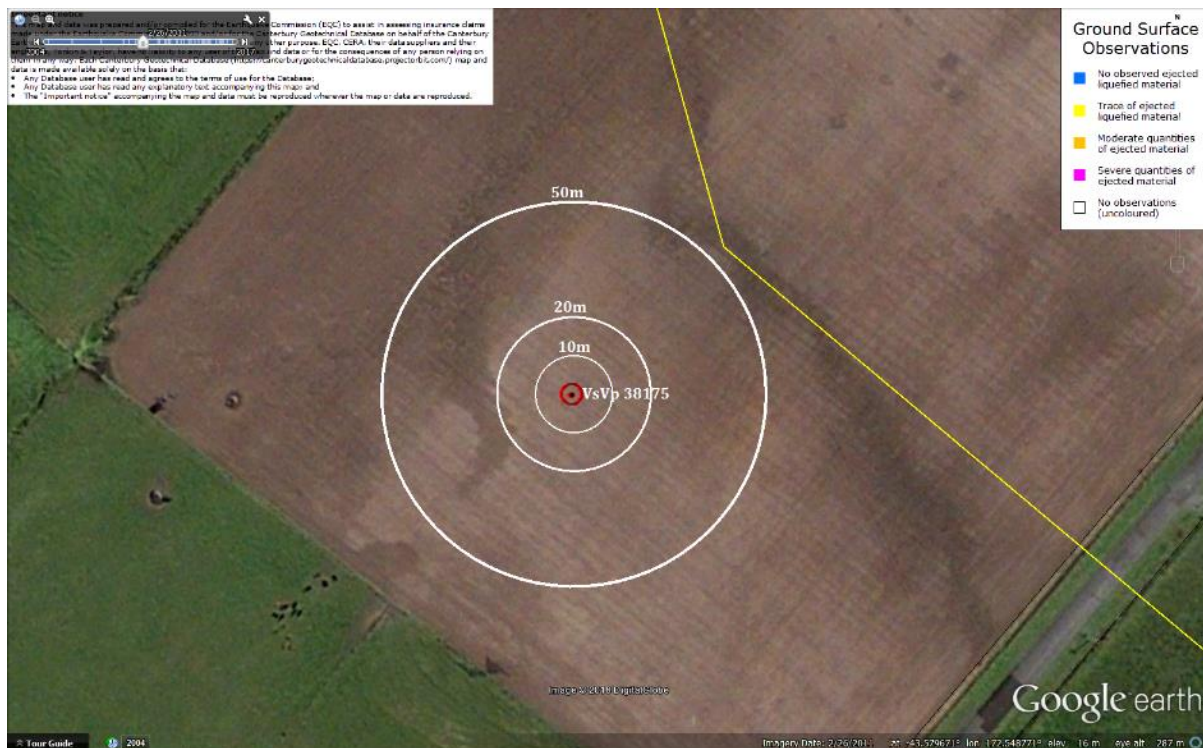
Figure 48: Aerial photograph of the site taken on Feb 26, 2011, showing traces of ejecta.

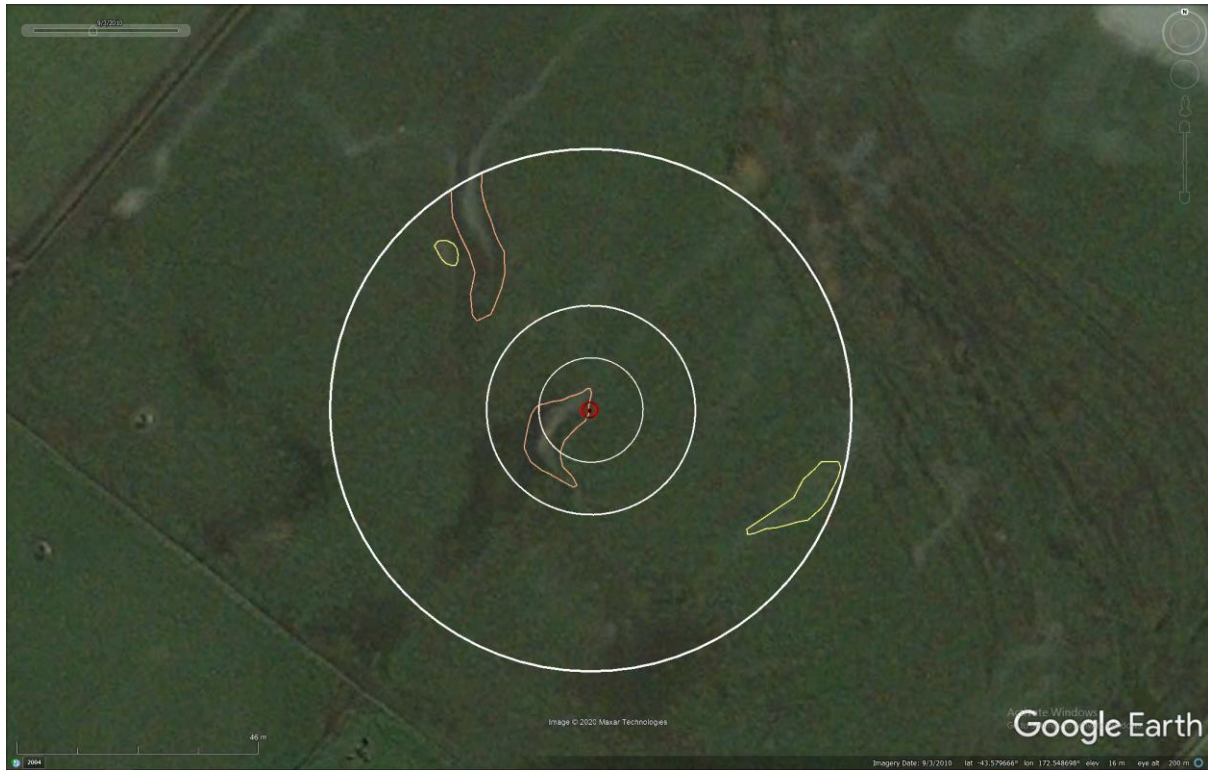
Fig. 53. Ejecta outline for Sep-10 EQ.

Note 4: The values in Table 9 correspond to the coverage area of ejecta outlined in aerial photograph (Figures 53, 55, and 56) and the lower and upper estimates of the ejecta height based on ground photographs taken in neighboring areas (Figure 54). The ejecta-induced settlement using photographs and engineering judgment, $S_{E,P}$, is estimated as

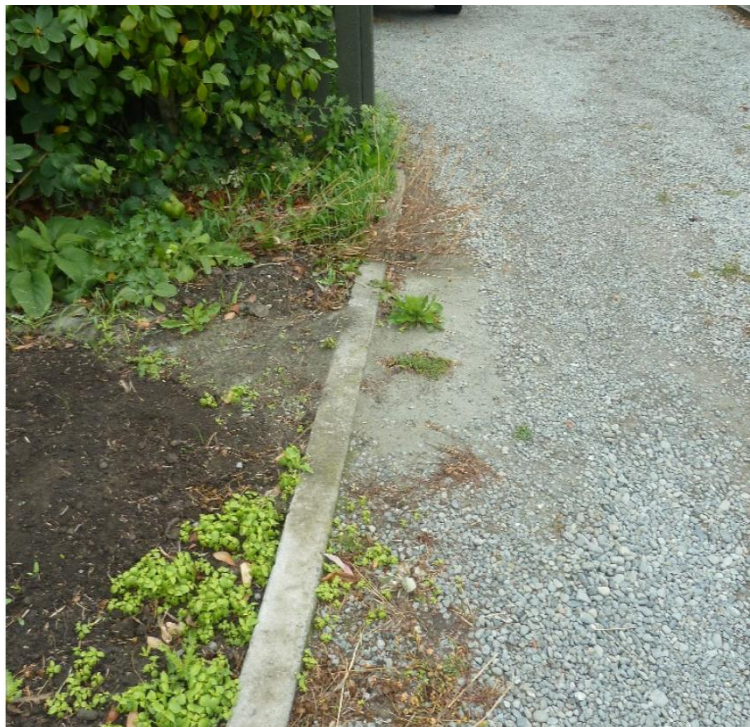
Fig. 54. Ejecta 800 m away from the center of the site for Sep-10 EQ (taken on 18 Feb 2011).

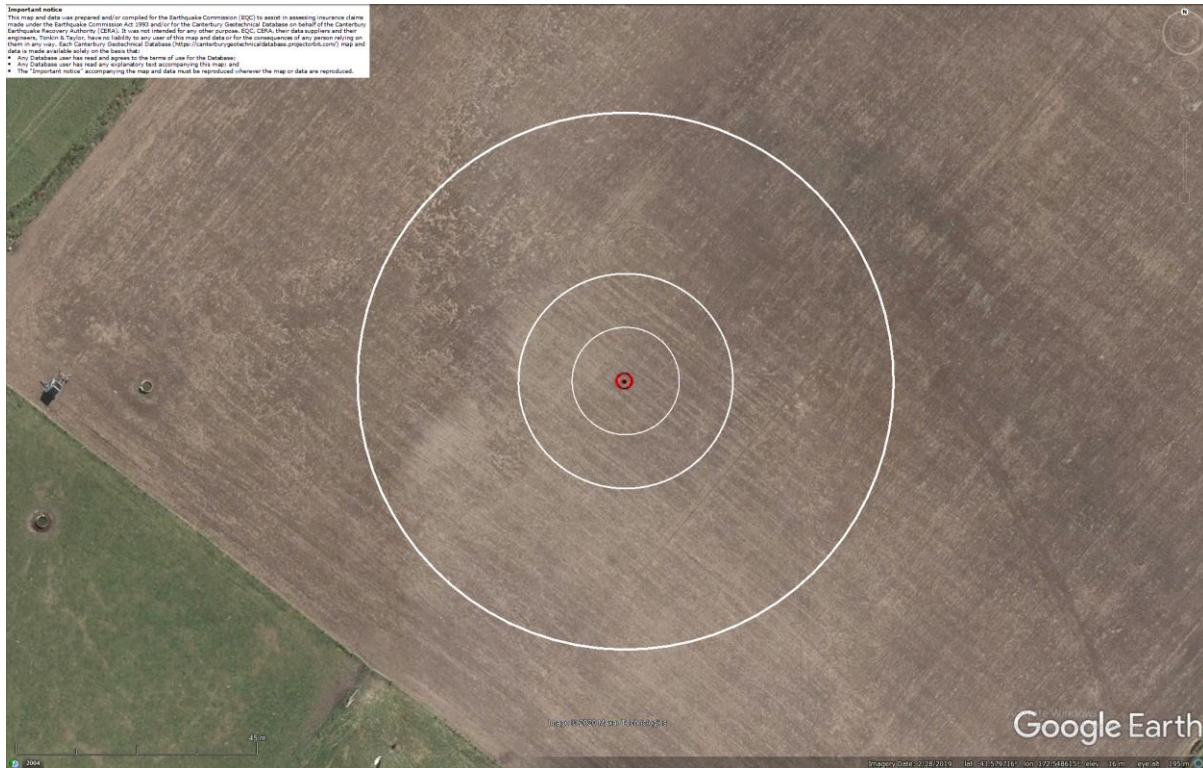
Fig. 55. Absence of ejecta for Feb-11 EQ.

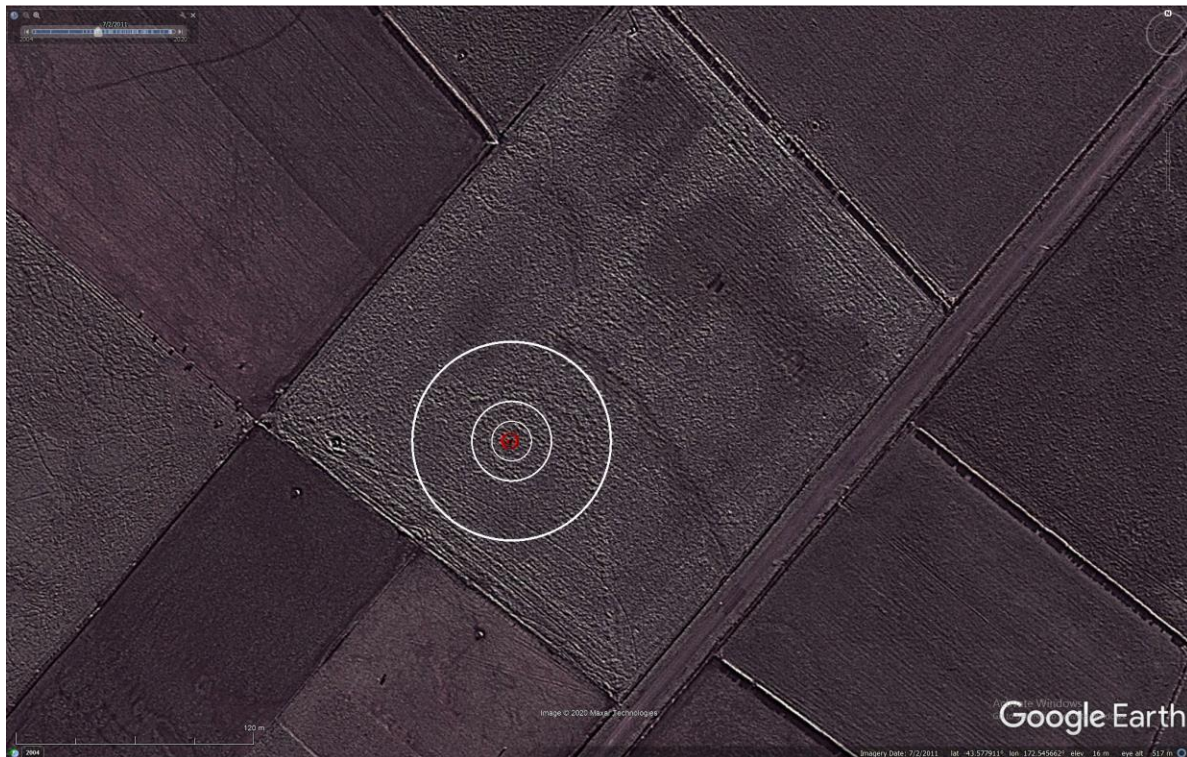
Fig. 56. Absence of ejecta for Jun-11 EQ (the photograph was acquired a month after the event).

Note 5: $S_{E,final}$ for the Sep-10 and Feb-11 earthquakes is based solely on $S_{E,P}$ due to the unavailability of $S_{E,L}$. For the Jun-11 earthquake, there is no aerial or ground photograph, only a satellite image acquired a month after the event showing no visible traces of ejecta at the site. (There are several insurance claims \approx 500 m NE of the site with reports of ejecta and property damage. However, ejecta was also observed for the Feb-11 earthquake away from the site toward NE but not at the site.) The LiDAR-based results suggest ejecta at the site for the Jun-11 earthquake, but there is large uncertainty associated with May 2011 and Sep 2011 LiDAR measurements due to plowing of the paddock. For the Dec-11 earthquake, Figure 57 shows “liquefaction interpreted from aerial photography” as none for the nearby area, but there is no photograph or LDAT property inspection report at the site to report absence of ejecta with confidence. Also, the Caulfield Ave site is in the zone of moderate LPI overprediction for the Sep-10 earthquake and slight to moderate LPI overprediction for the Feb-11 earthquake (Maurer et al. 2014³).

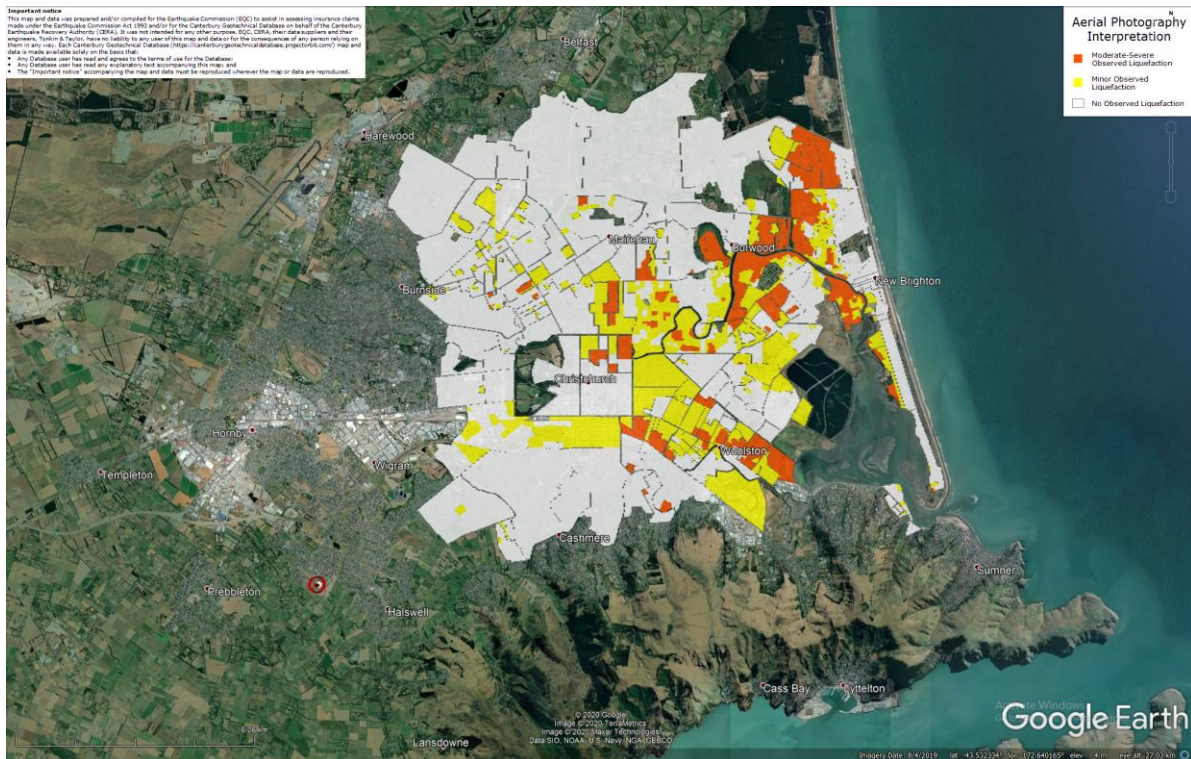
Fig. 57. Liquefaction interpreted from aerial photography for Dec-2011 EQ (low confidence in ejecta estimate due to extrapolation of the interpretation for the site).

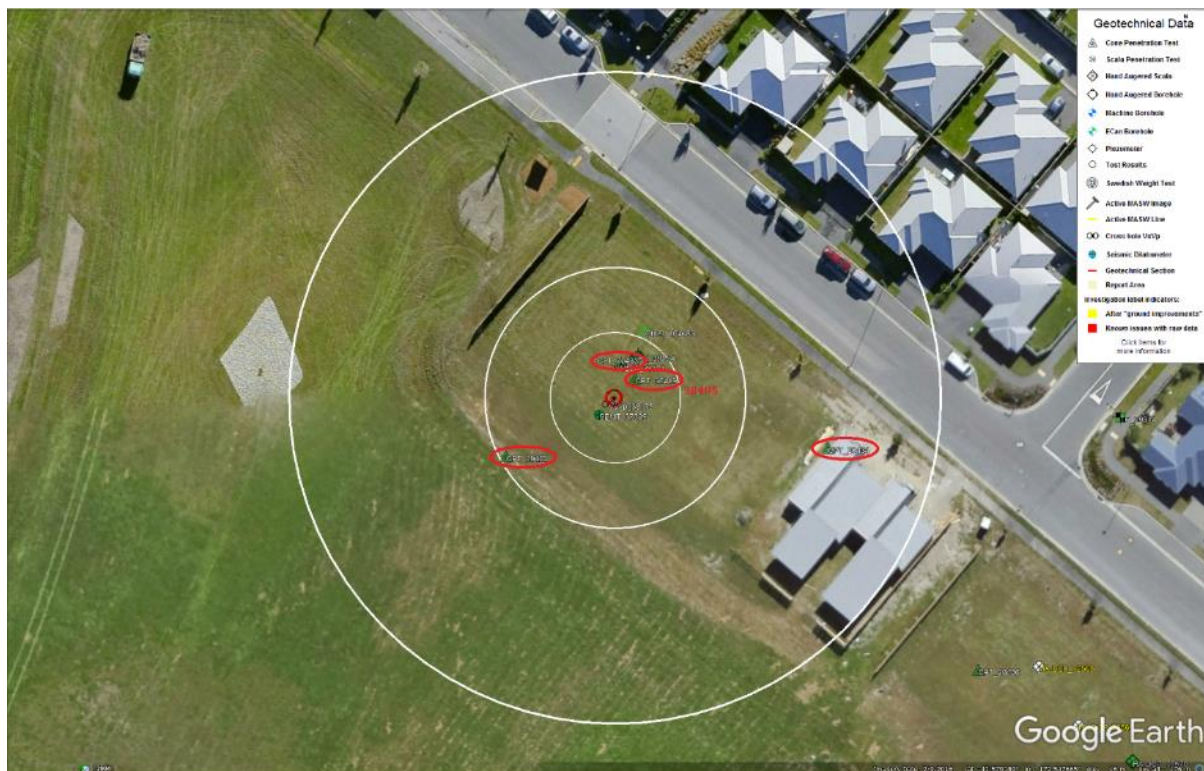
Figure 58: CPT locations.

Note 10: Based on the borehole log (BH 38194, Figure 58), the groundwater table is at a depth of 0.95 m below the ground surface. The soil profile consists of (1) topsoil to a depth of 0.25 m, (2) interchanging layers of silty fine sand, SM, and non-plastic to low-plasticity silt, ML, to a depth of 5.3 m, and (3) fine to coarse gravel, GW, to a depth of 10.0 m (the end of the borehole). The SM, ML, and GW are the Yaldhurst members of the Springston formation. Based on the nearby borehole logs and CPT interpretations, it is inferred that gravel extends to a depth of 20 m.

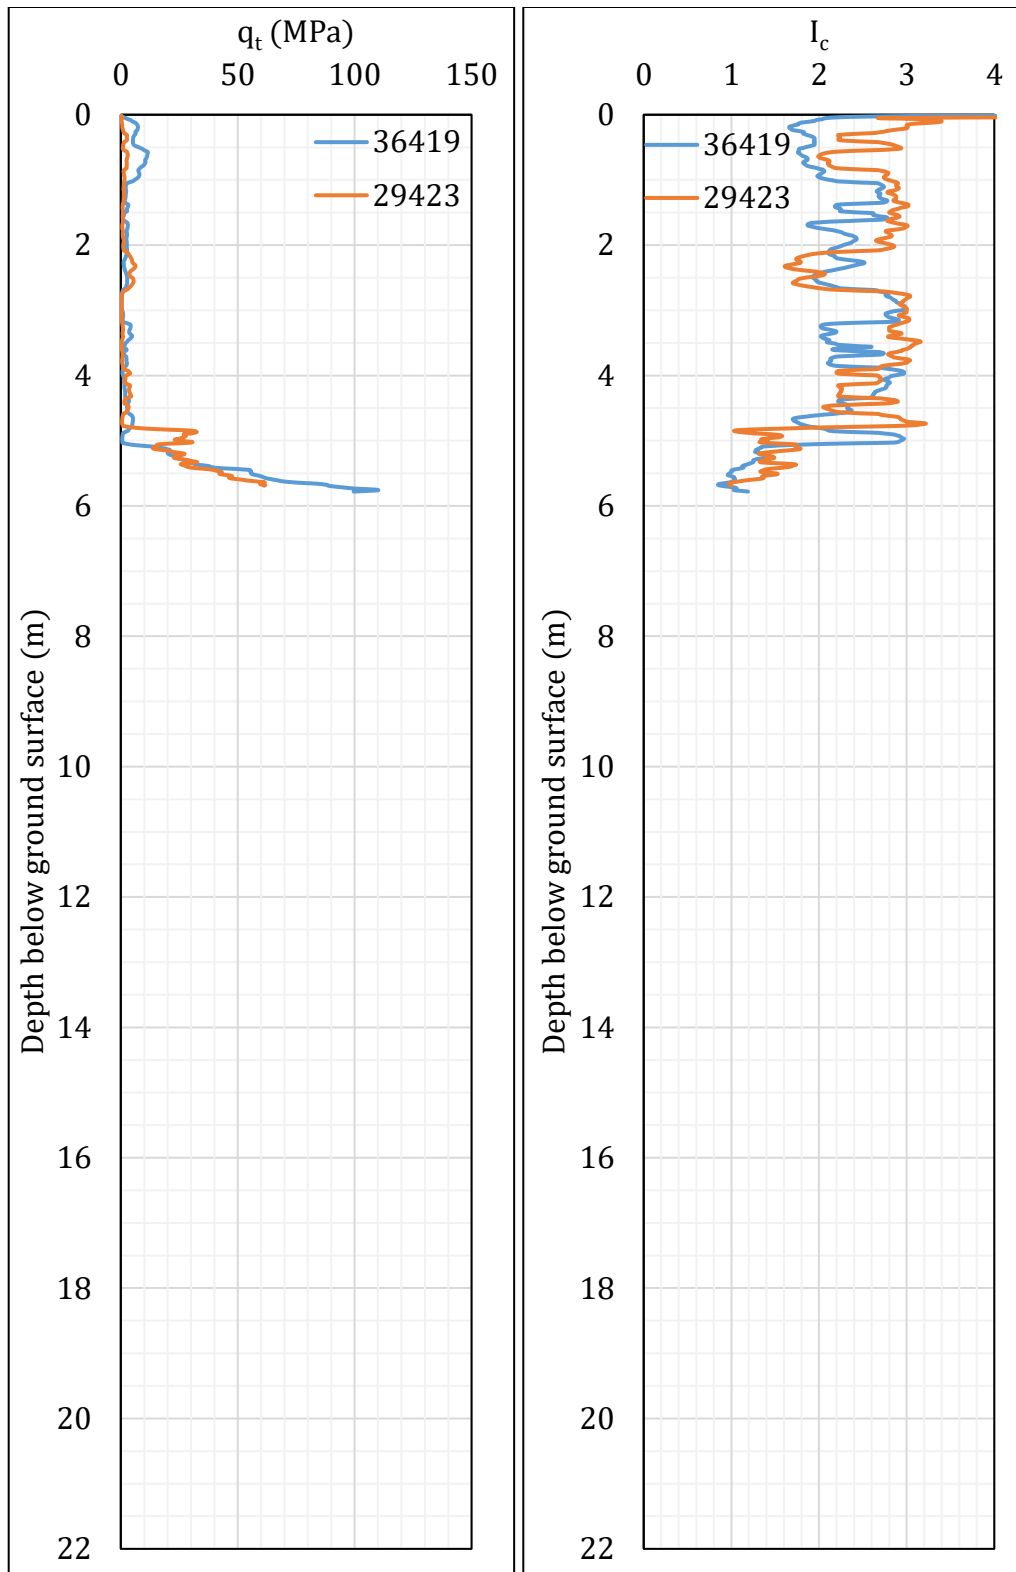
Figure 68: q_t and I_c profiles.
