Appendix A.50:

Palinurus Rd 1 – VsVp 57185

**Table 1: Site Description for Palinurus Rd 1 (VsVp 57185).**

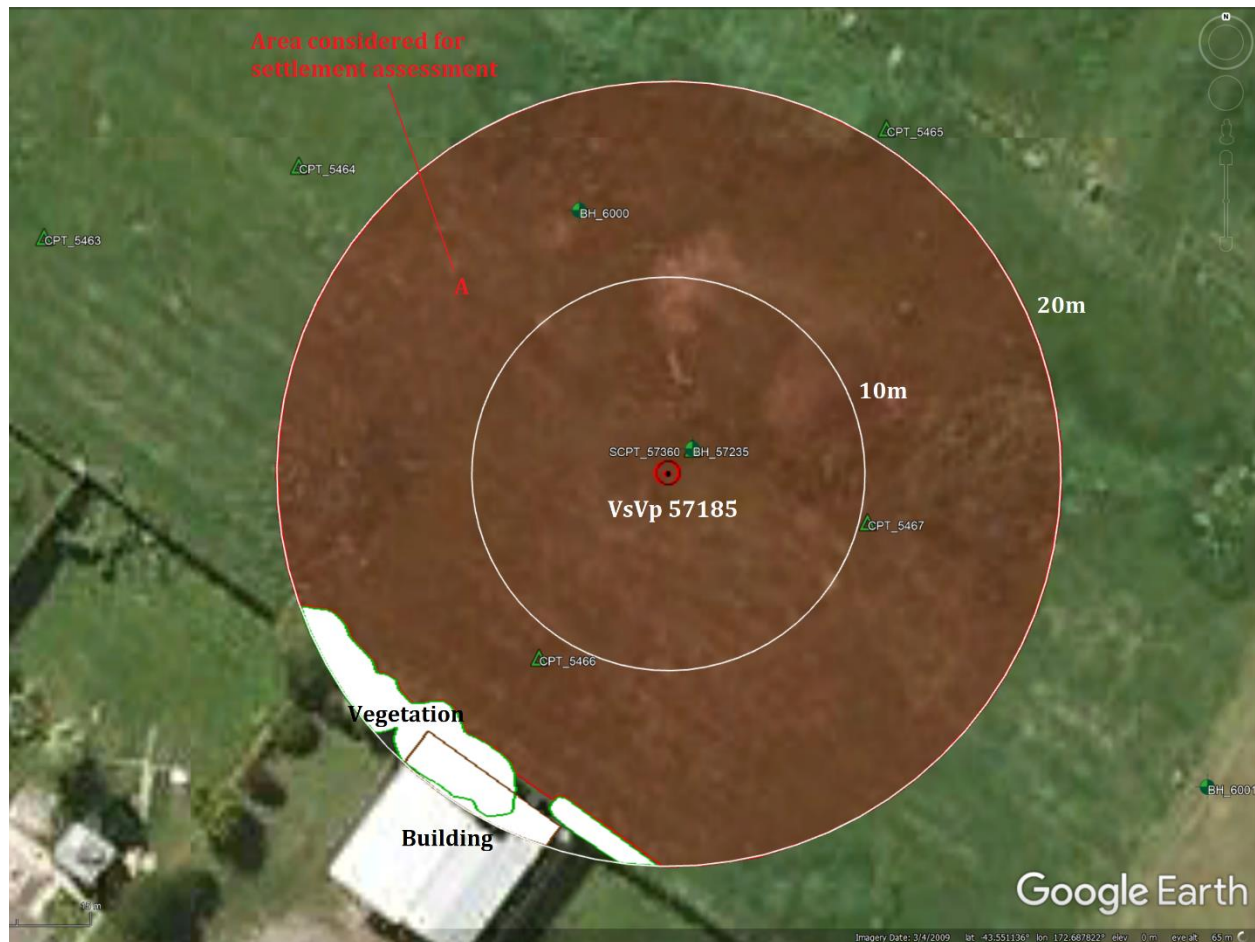
**Figure 1: Site plan with areas where ejecta-induced settlement is considered.**

**Note 1:** Patch A in the free field was selected for settlement assessment as an area free of vegetation and structures. Other important factors considered in the patch selection were its proximity to a CPT, a property subjected to addition and/or demolition of a structure, front yard/backyard alterations (e.g., ploughing, rubble, scrap), and aerial distribution of sediment ejecta. The LiDAR-based ejecta-induced settlement was not estimated for any earthquake event due to the evident absence of ejecta.

- $A_{E,thick,i}$  and  $H_{E,thick,i}$  are the area and the height of a thick ejecta layer, respectively;
- $A_{E,thin,j}$  and  $H_{E,thin,j}$  are the area and the height of a thin ejecta layer, respectively;
- $A_T$  is the total assessment area for a buffer being considered (Figure 1).

**Note 5:** The selection of CPTs for the area considered for settlement assessment (Figure 1) is based on the proximity of the CPTs to the considered areas. In accordance with that, the following table shows CPTs that were used for the volumetric settlement analysis in *Cliq v.3.0.3.2*, a CPT soil liquefaction software developed by GeoLogismiki. (The average volumetric settlements were reported in Table 8.)

**Note 6:** Based on the borehole log (BH 57235, Figure 1), the groundwater table is at a depth of 1.2 m below the ground surface. The soil profile consists of (1) organic silty, OL, topsoil to a depth of 0.45 m, (2) silt, ML, the Yaldhurst member of the Springston formation, to a depth of 1.45 m, (3) organic silt, OL, the Yaldhurst member of the Springston formation to a depth of 1.65 m, (4) sandy silt, ML, the Yaldhurst member of the Springston formation, to a depth of 2.3 m, (5) fine sand, SP, the Yaldhurst member of the Springston formation, to a depth of 2.7 m, (6) silt, ML, the Yaldhurst member of the Springston formation, to a depth of 3.05 m, (7) fine sand, SP, of the Christchurch formation, to a depth of 6.95 m, (8) silt, ML, of the Christchurch formation, to a depth of 8.3 m, and (9) fine to medium sand, SP, of the Christchurch formation, to a depth of 15.65 m (the end of the borehole). According to BHs 6000 and 6001 (Figure 1), the SP layer extends to a depth of 16.5 m and is succeeded by (10) sandy silt, ML, of the Christchurch formation, to a depth of 17.9 m, (11) fine to medium sand, SP, of the Christchurch formation, to a depth of 19.5 m, and (12) silty fine sand, SM, of the Christchurch formation, to a depth of 20 m. The Yaldhurst members of the Springston formation contain trace organics.

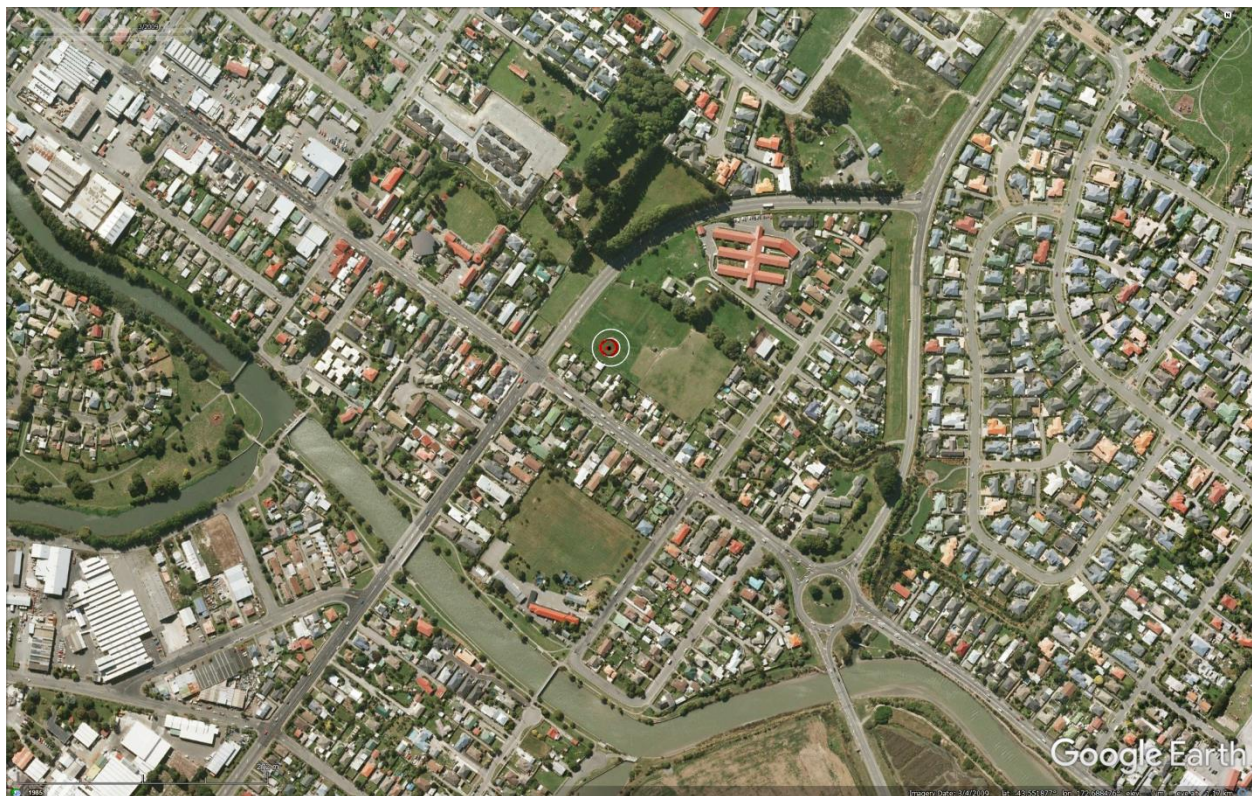
**Figure 3: Position of the site relative to nearby buildings, vegetation, and free-face features.**

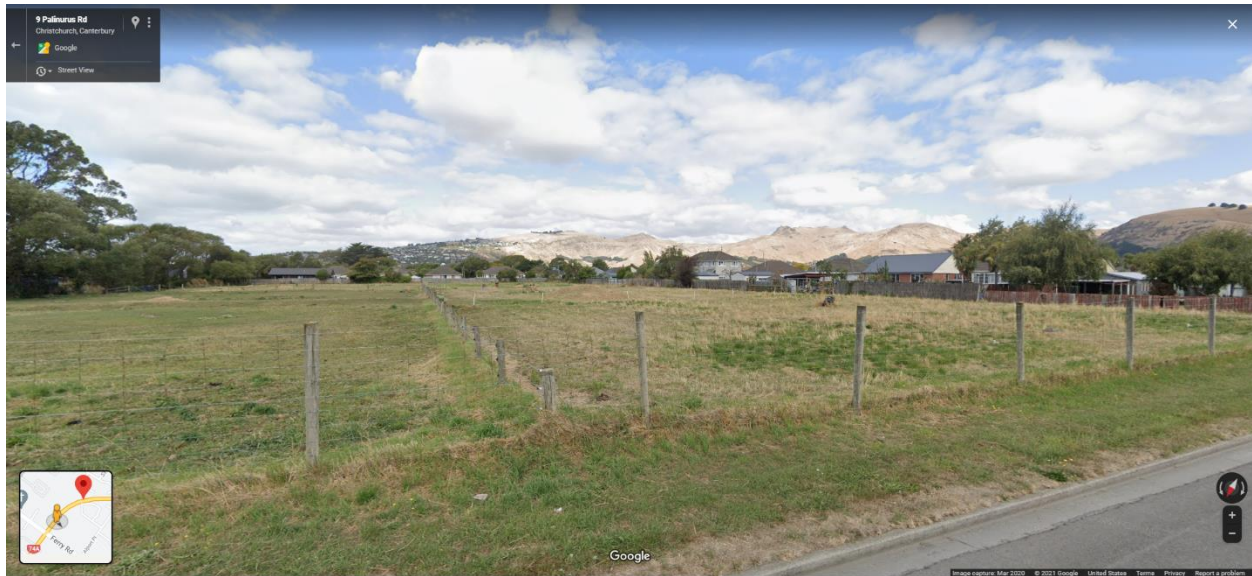
**Figure 4: Street view of the level site with uneven ground surface; note the presence of ground mounds and other topographic features.**

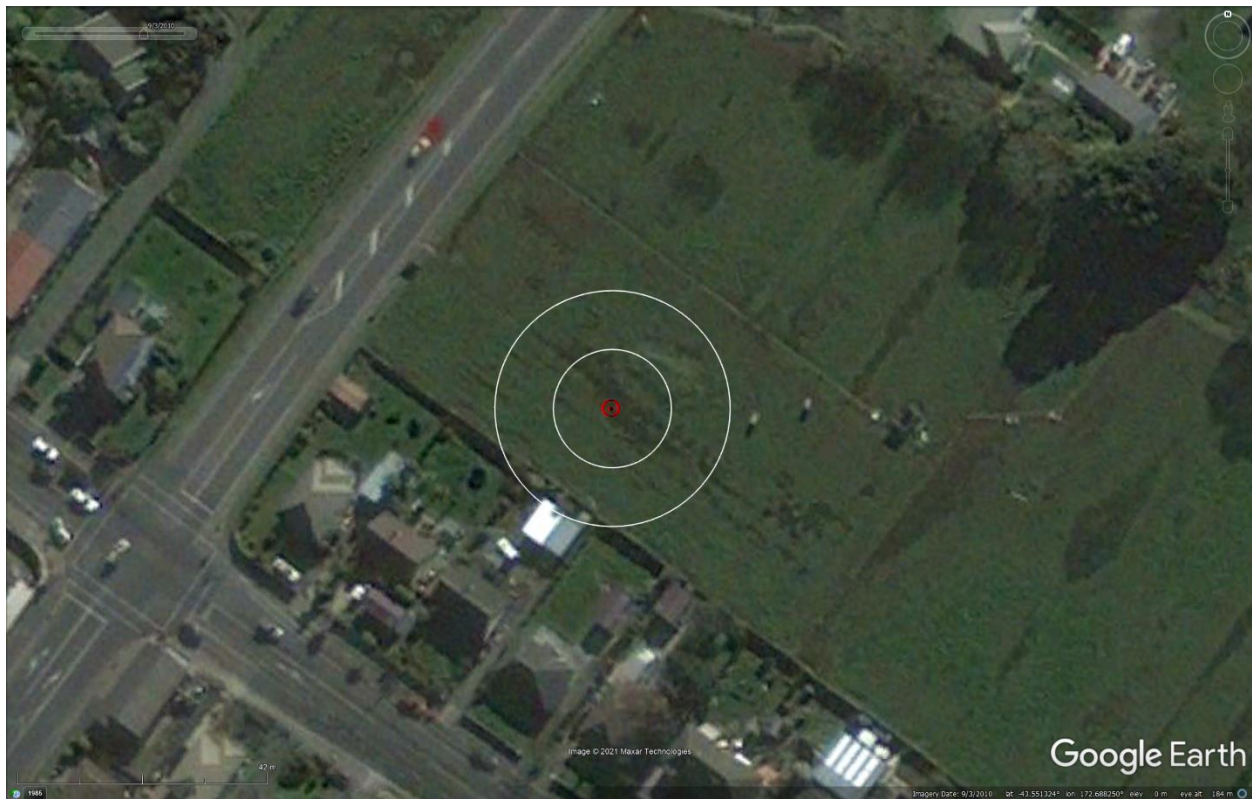
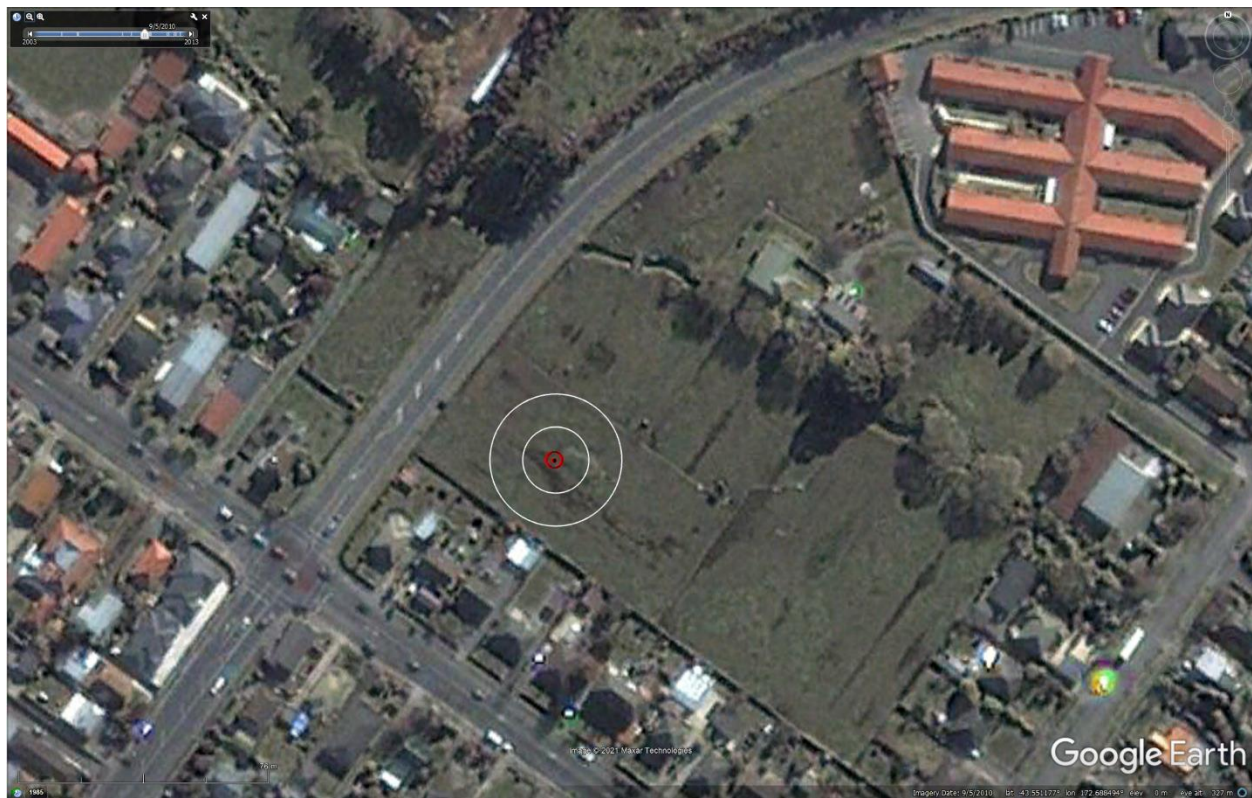
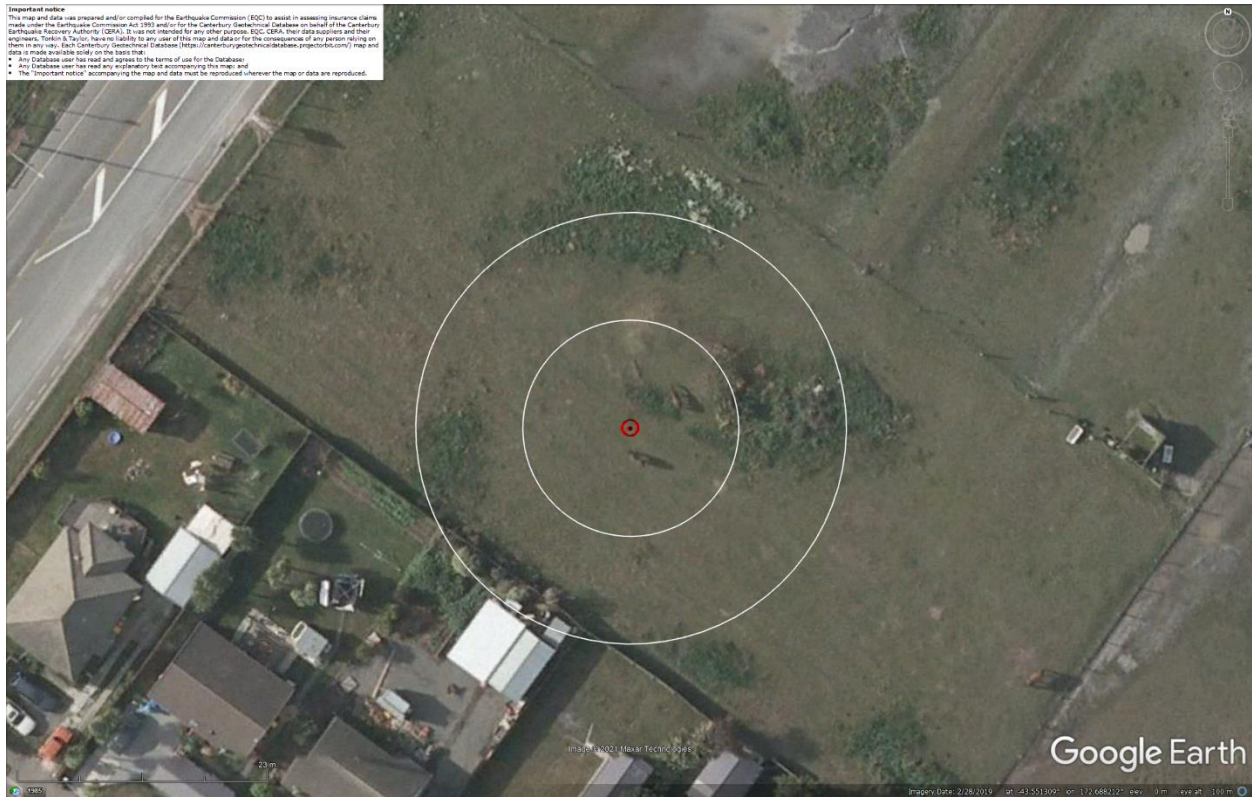
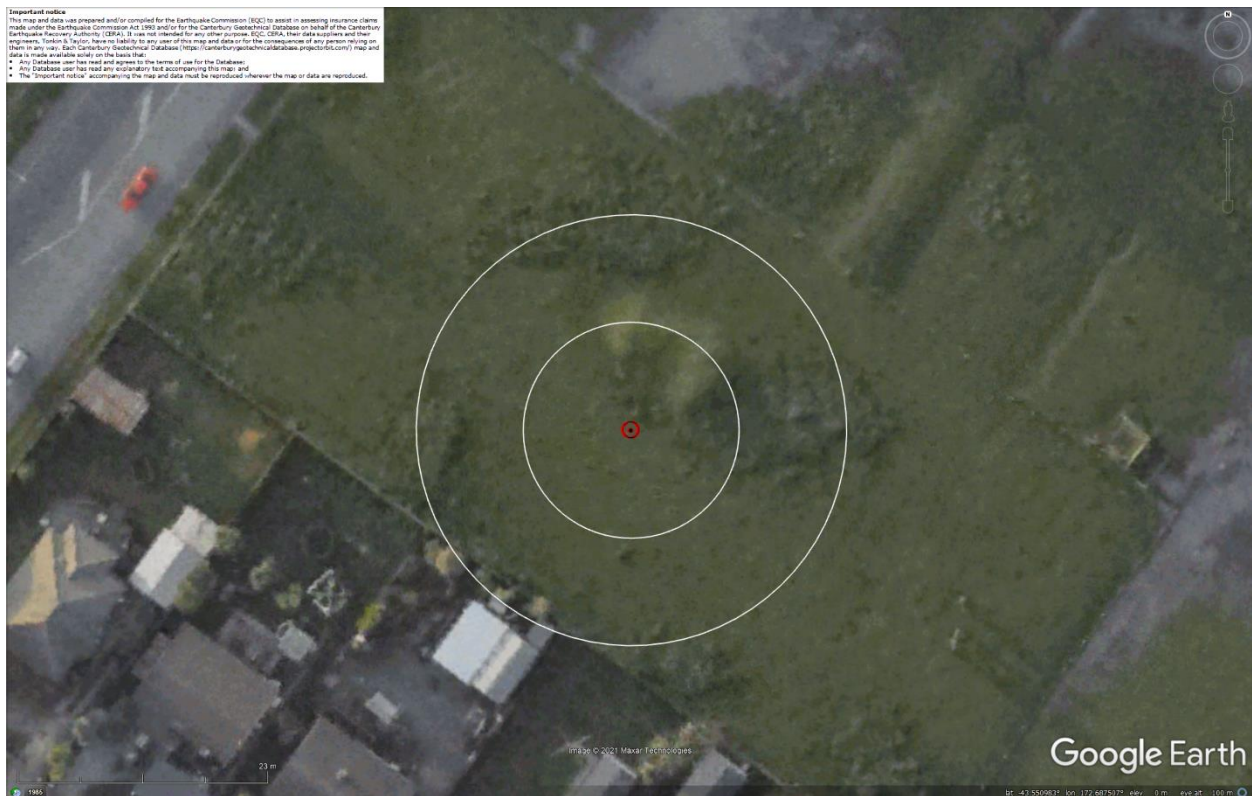
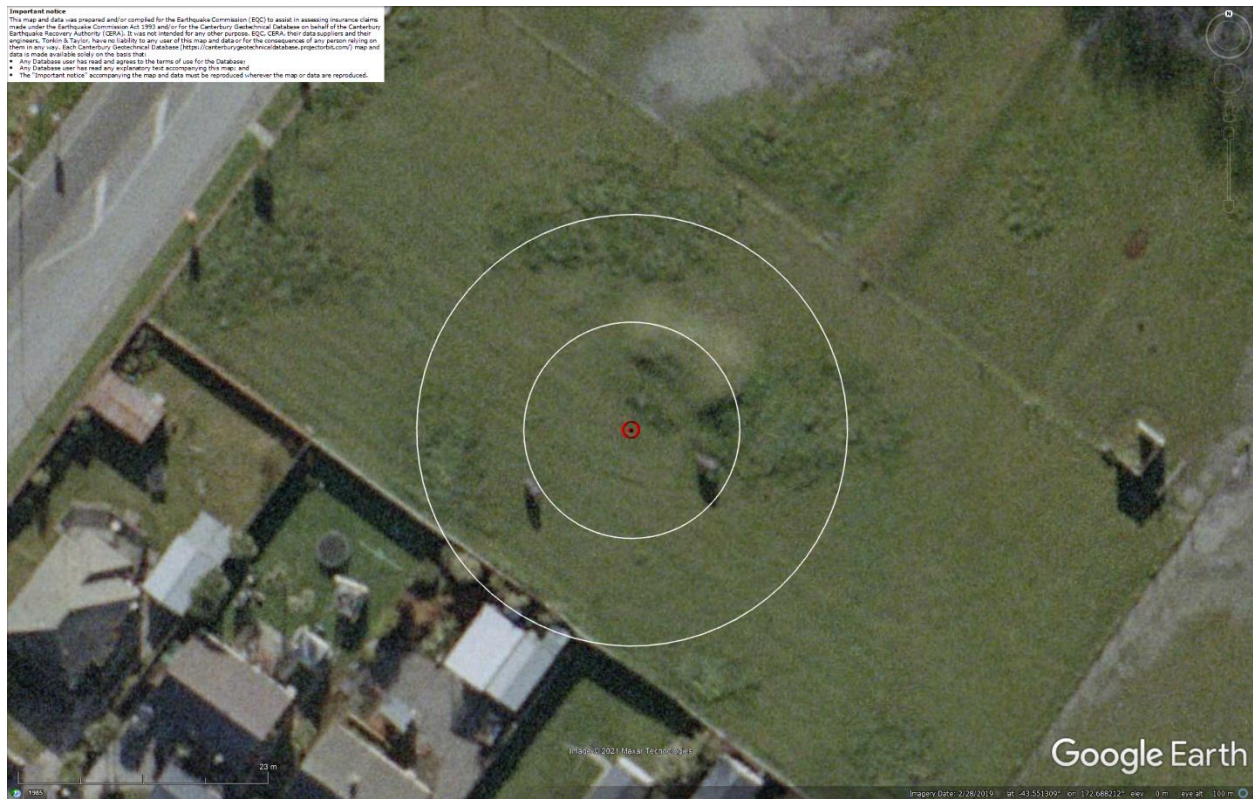
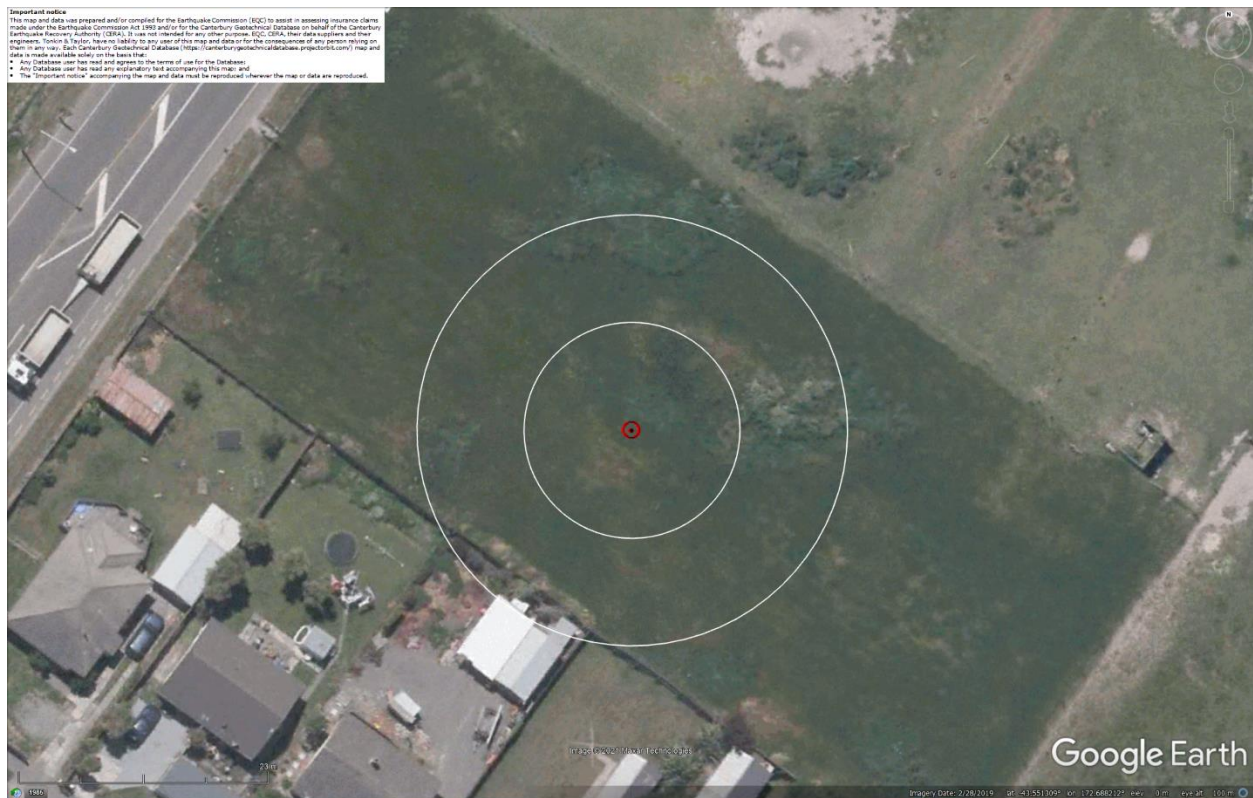
**Note 3:** The values in Table 9 are based on satellite images and aerial photographs (Figures 8, 9, and 18-21). The ejecta-induced settlement using photographs and engineering judgment,  $S_{E,P}$ , is estimated as

Notes:  $A_{E,thick/thin}$  = Coverage area of thick/thin ejecta layers;  $H_{E,thick/thin}$  = Lower-upper estimate of height of thick/thin ejecta layers;  $A_T$  = Total assessment area of a buffer being considered; Thin and thick layers correspond to light gray and dark gray colors of ejecta observed in aerial photographs.

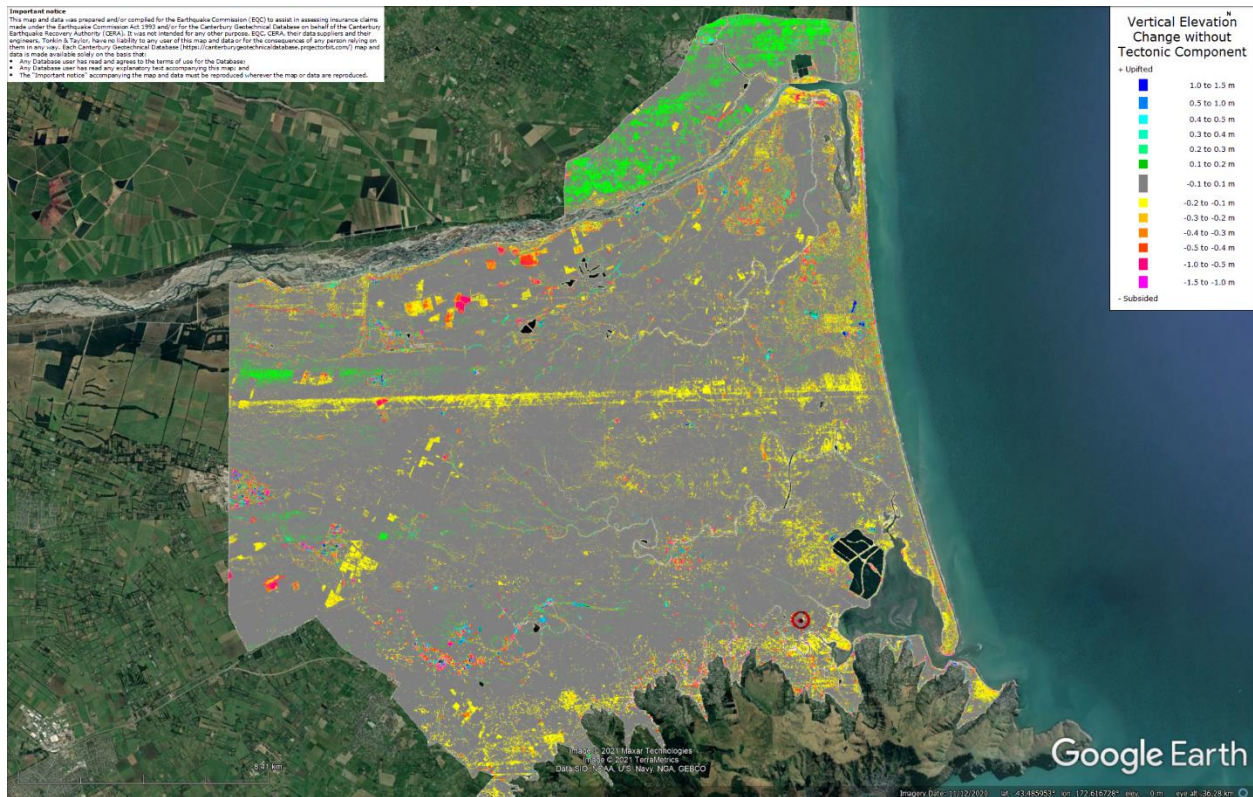
**Figure 24: Vertical Ground Movements (Surface – Tectonic) for June 2011 Earthquake – the site is not in the apparent zone of overestimated ground surface subsidence.**

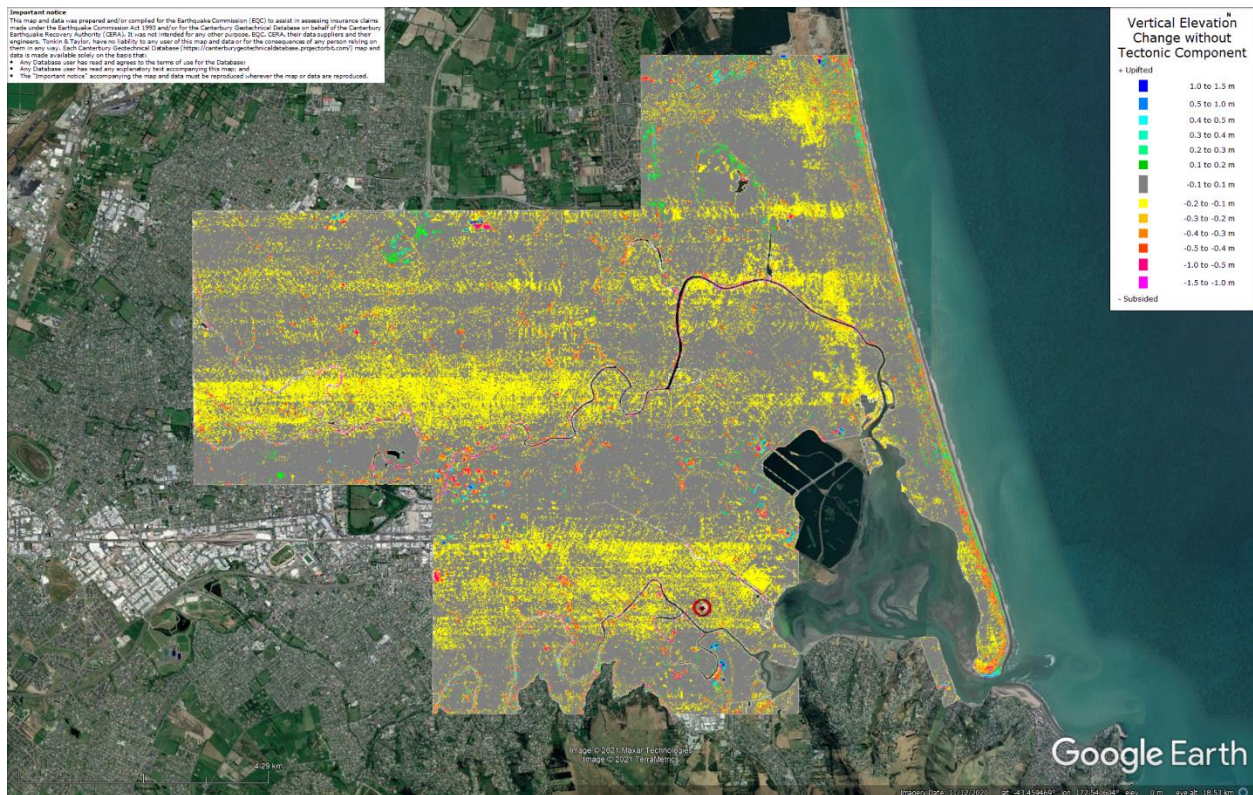
**Figure 25: Vertical Ground Movements (Surface – Tectonic) for Dec 2011 Earthquake – the site is in the apparent zone of overestimated ground surface subsidence (i.e., Feb 2012 LiDAR flight error).**

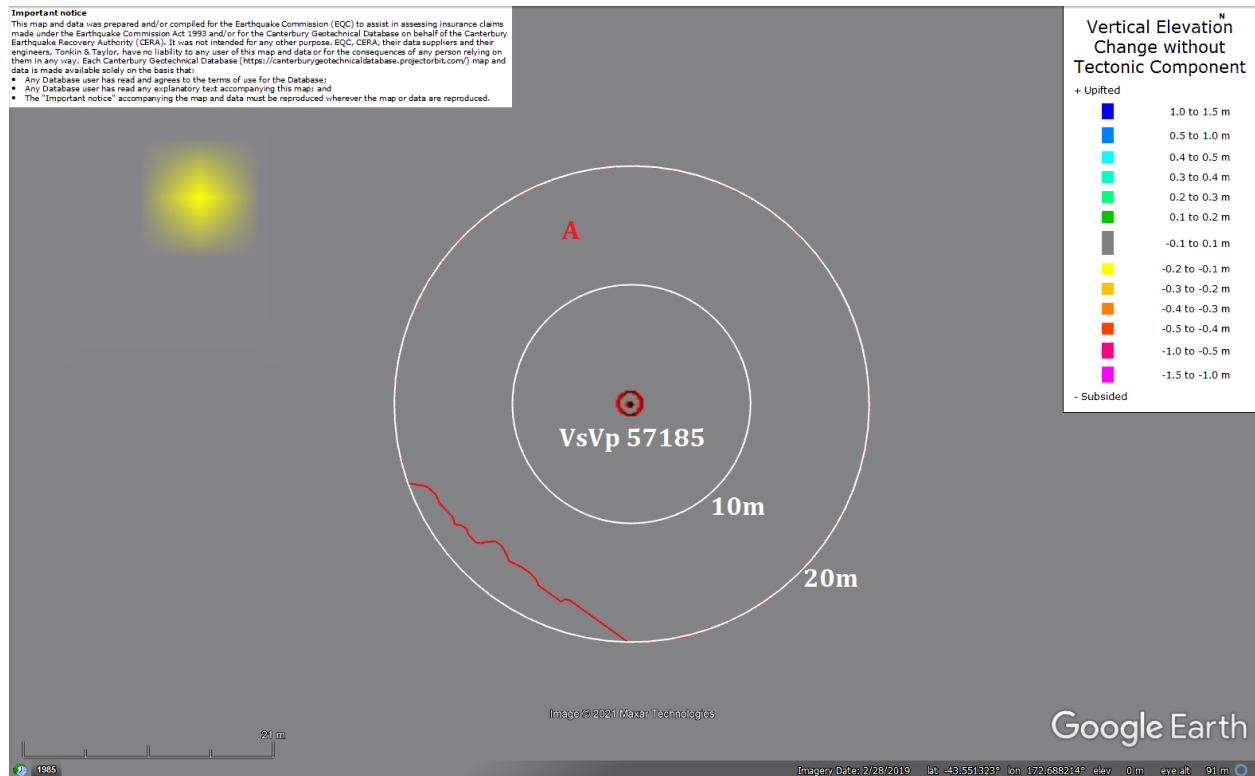
**Figure 26: Ground surface subsidence without tectonic component for June 2011 Earthquake according to the LiDAR DEM.**

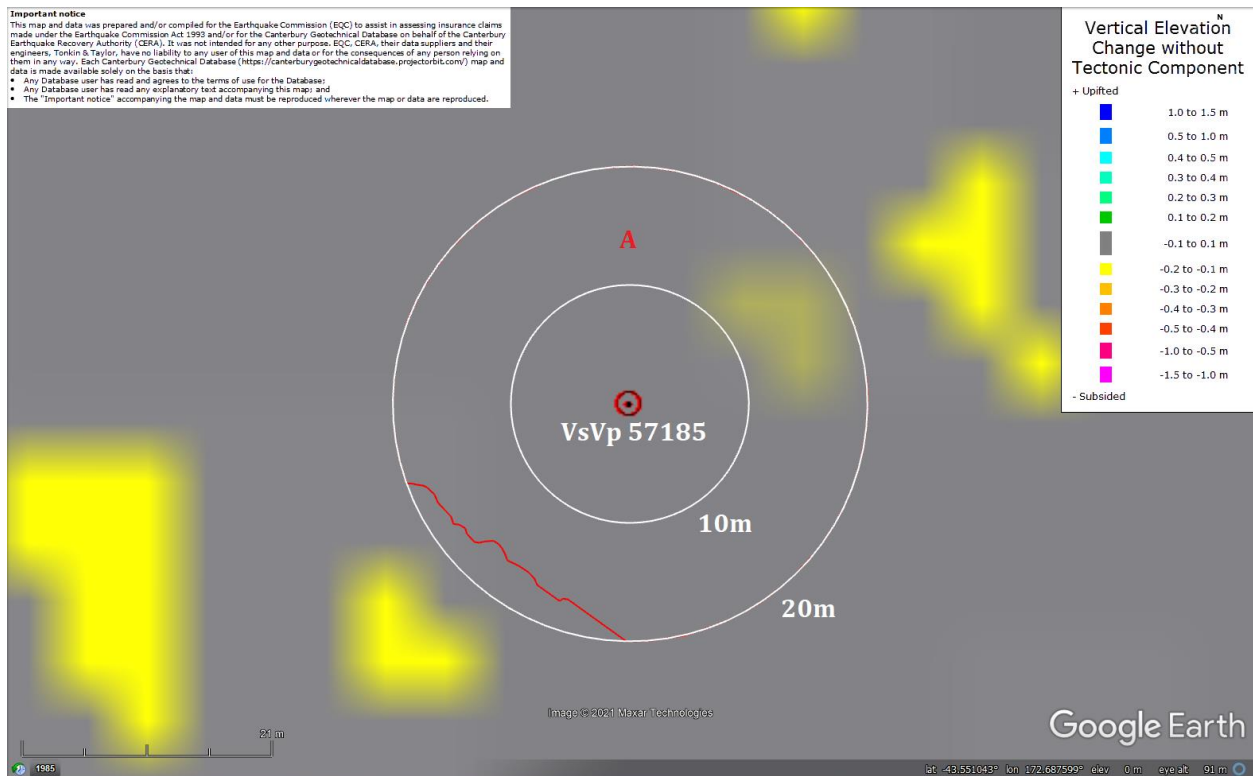
**Figure 27: Ground surface subsidence without tectonic component for Dec 2011 Earthquake according to the LiDAR DEM.**

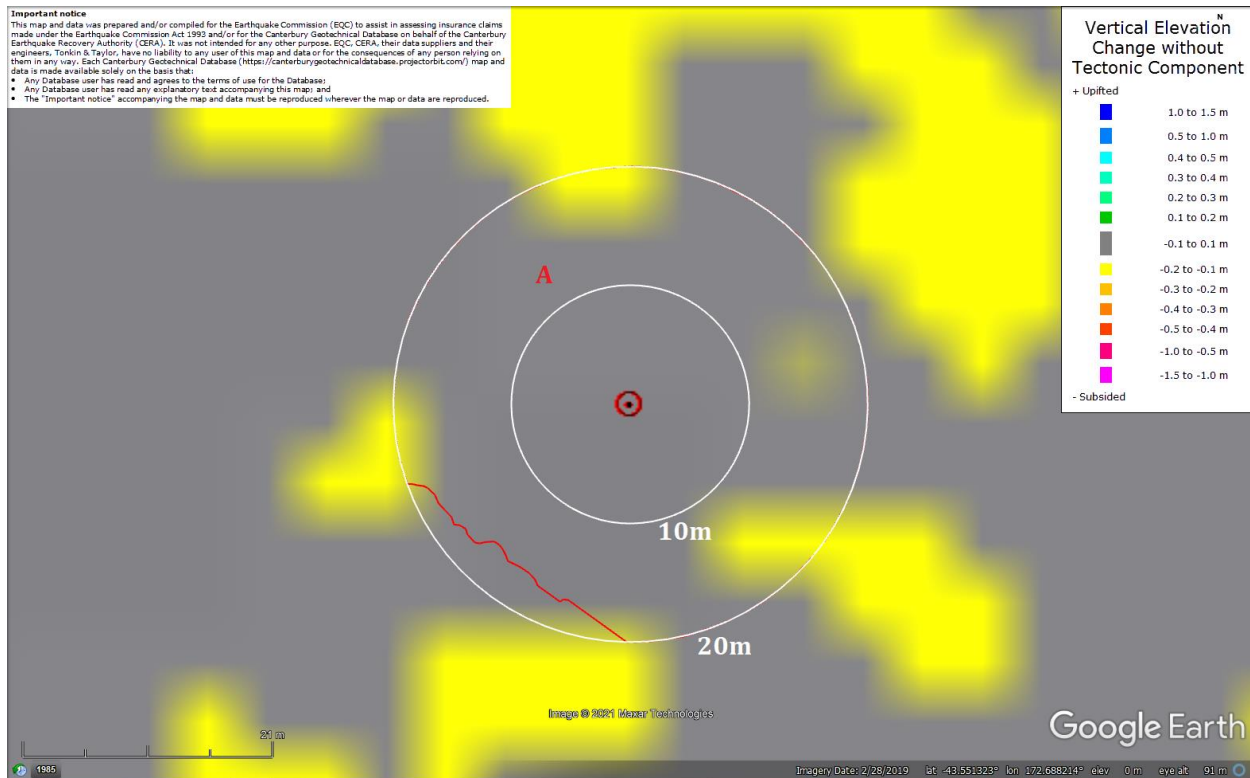
**Figure 28: Ground surface subsidence without tectonic component for Canterbury Earthquake Sequence according to the LiDAR DEM.**

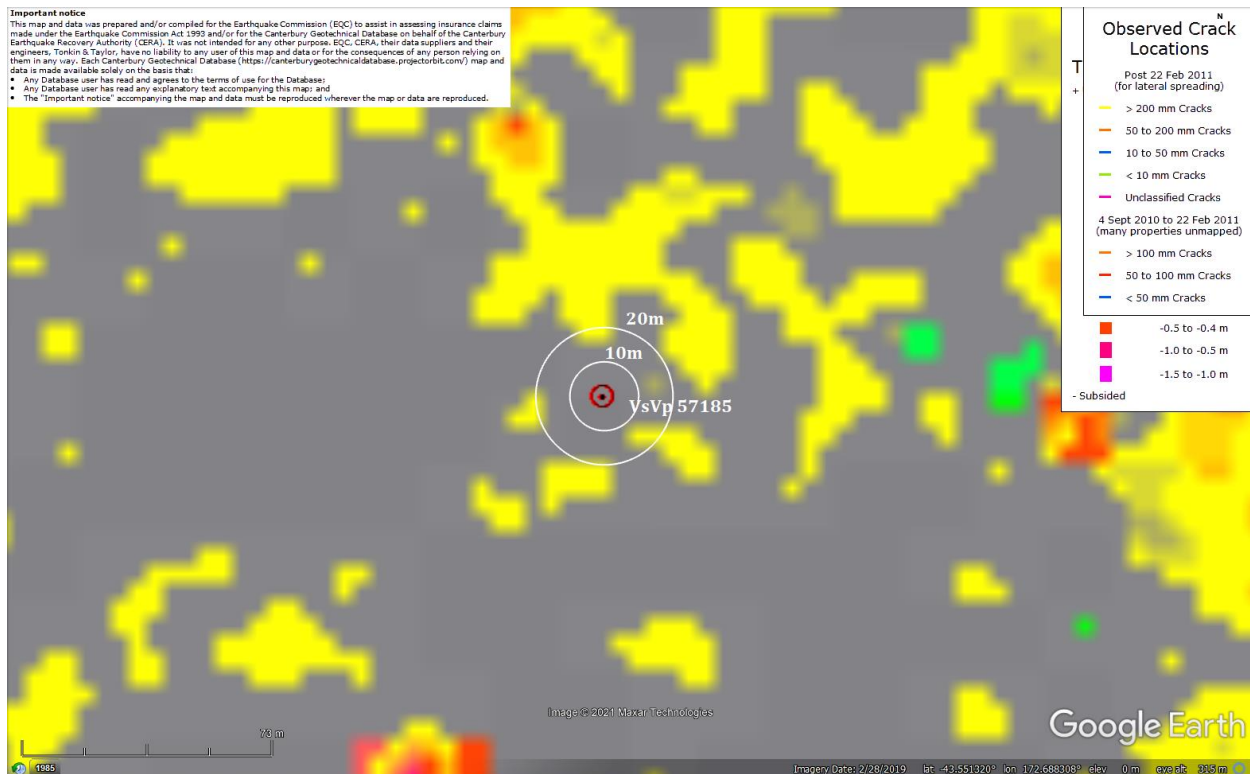
**Figure 29: No lateral spreading for Canterbury Earthquake Sequence.**

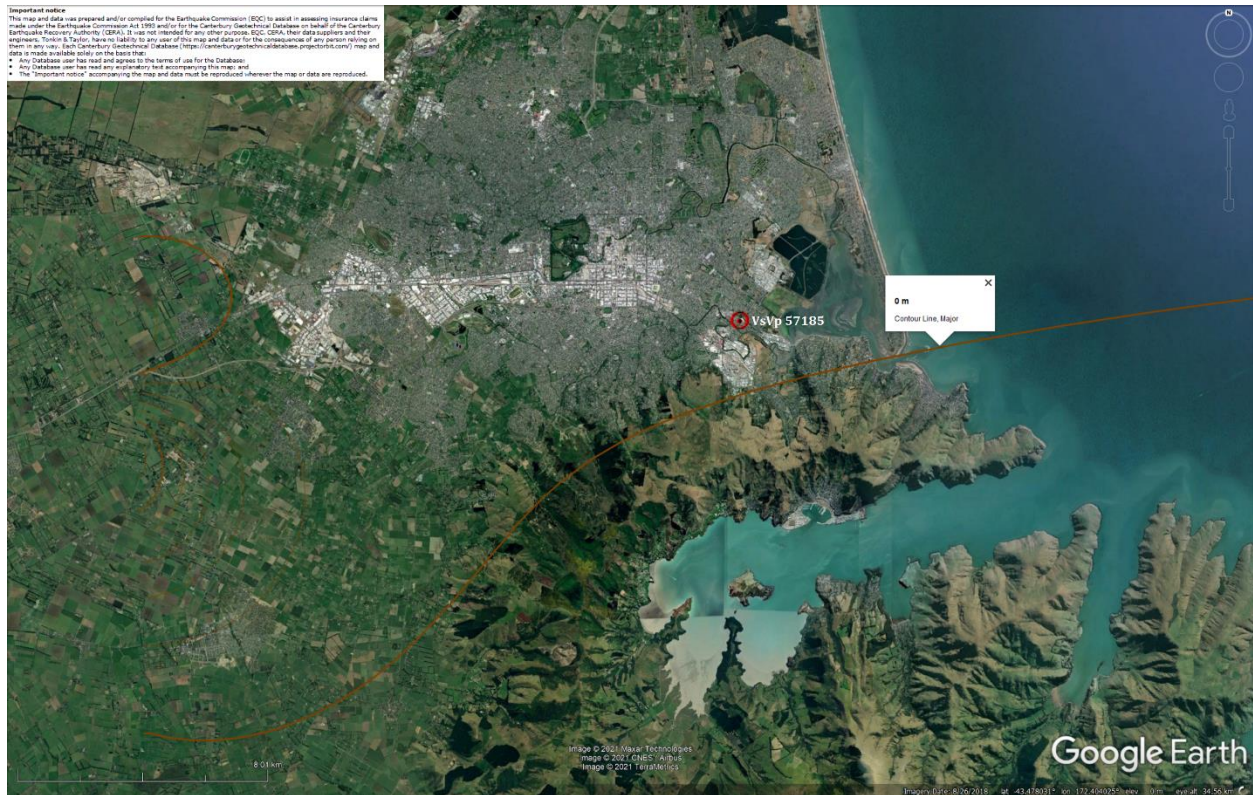
**Figure 30: Vertical tectonic movements for Sep 2010 Earthquake.**

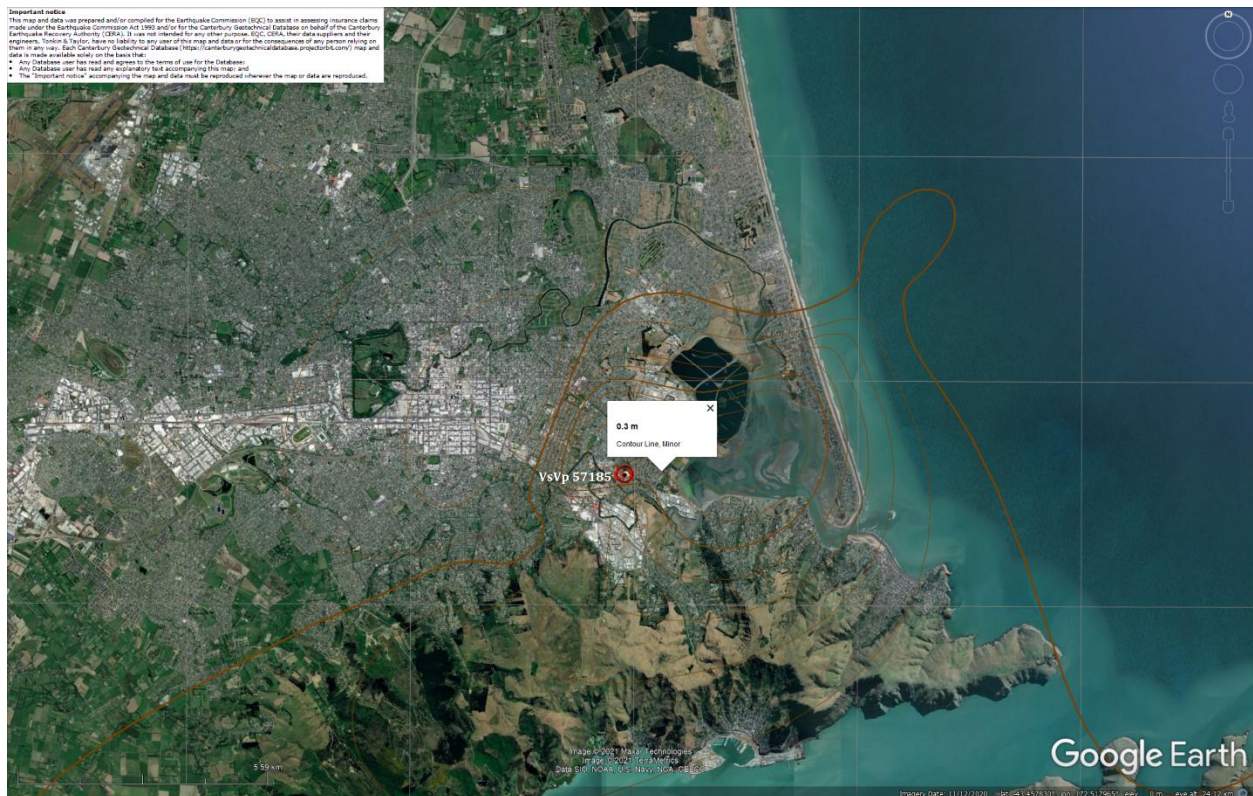
**Figure 31: Vertical tectonic movements for Feb 2011 Earthquake.**

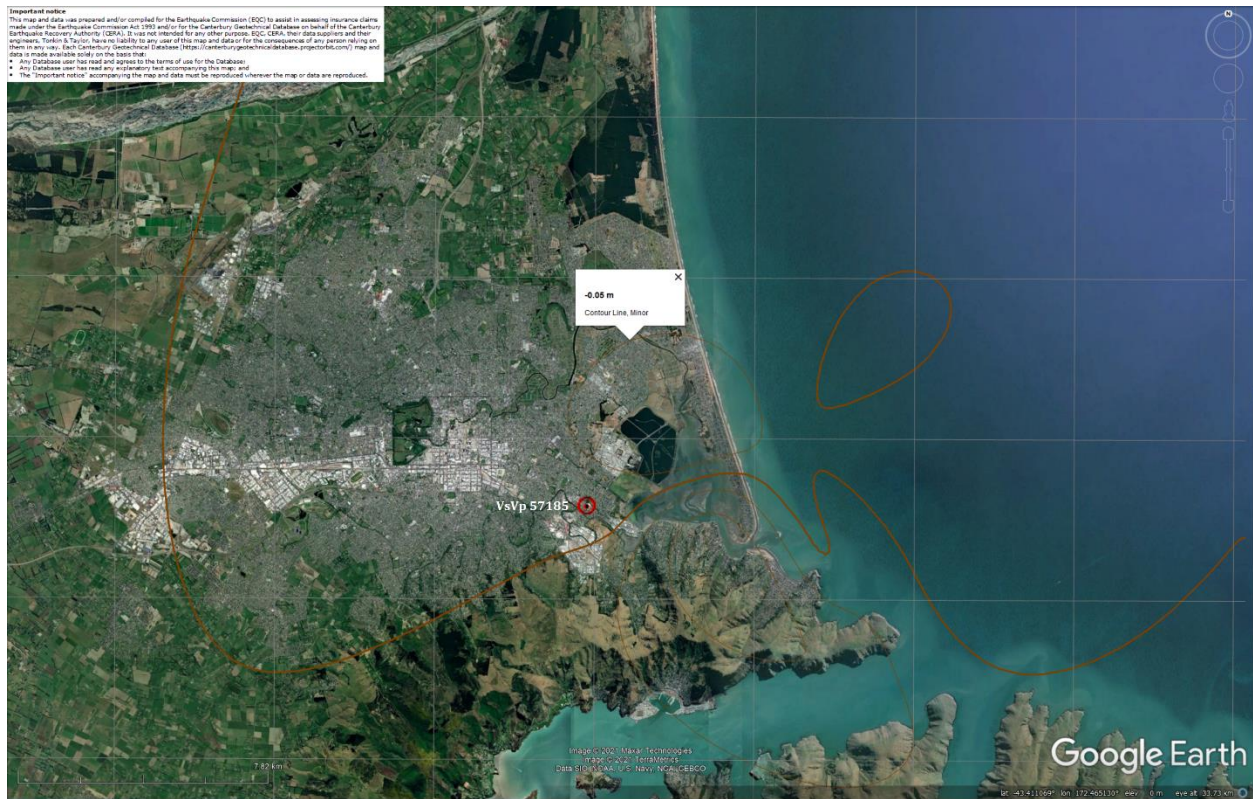
**Figure 32: Vertical tectonic movements for June 2011 Earthquake.**

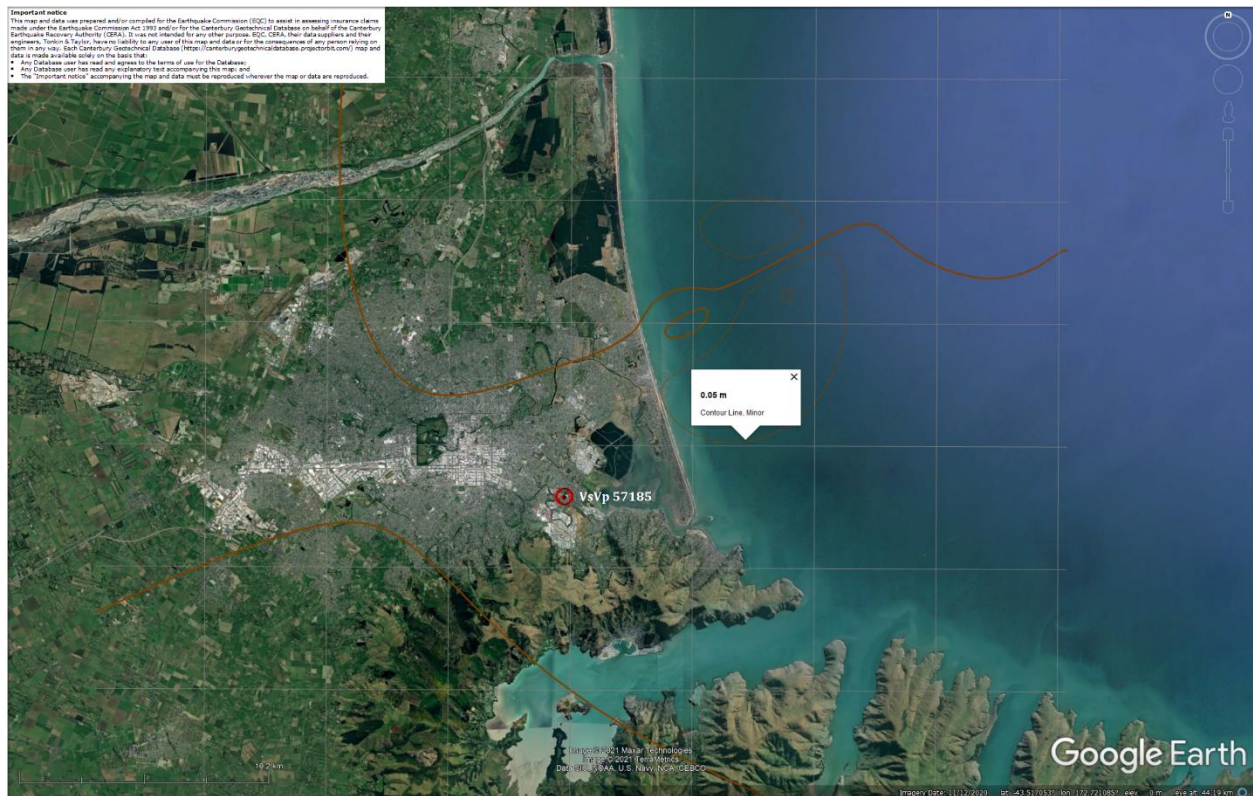
**Figure 33: Vertical tectonic movements for Dec 2011 Earthquake.**

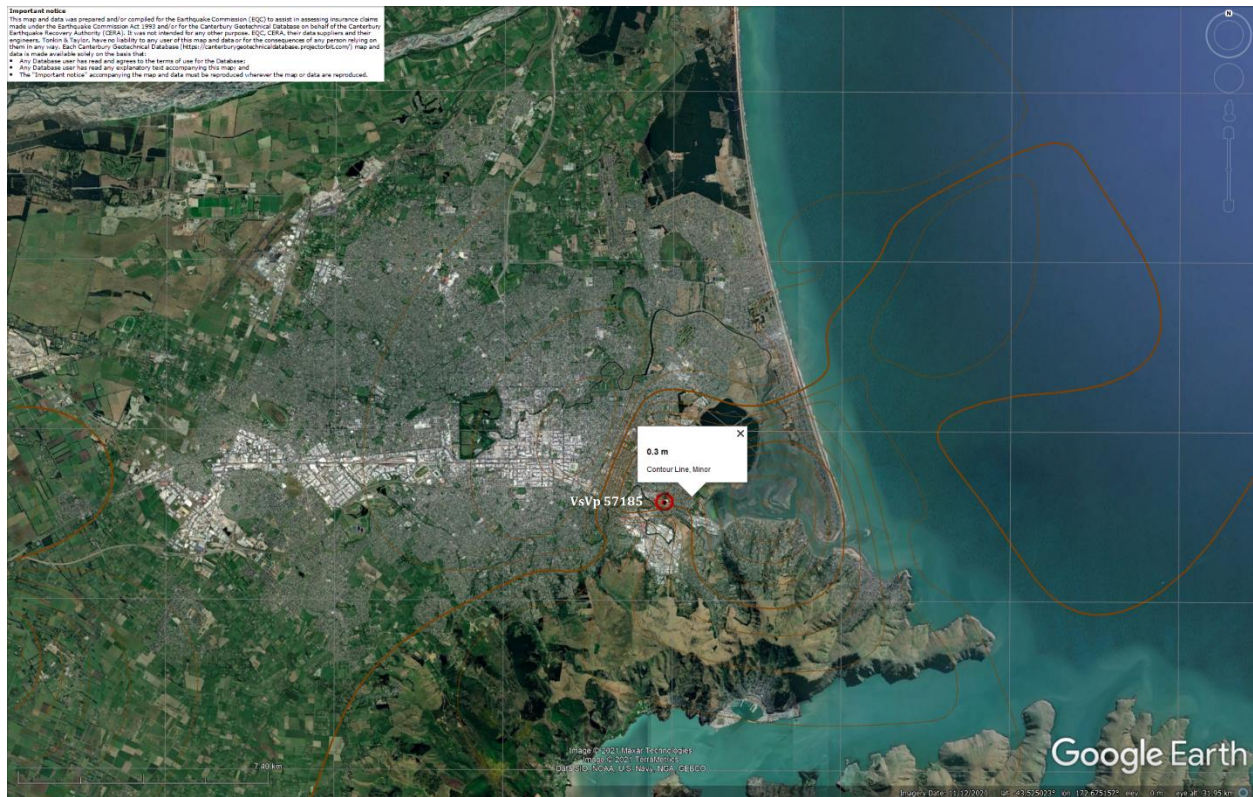
**Figure 34: Vertical tectonic movements for Canterbury Earthquake Sequence.**

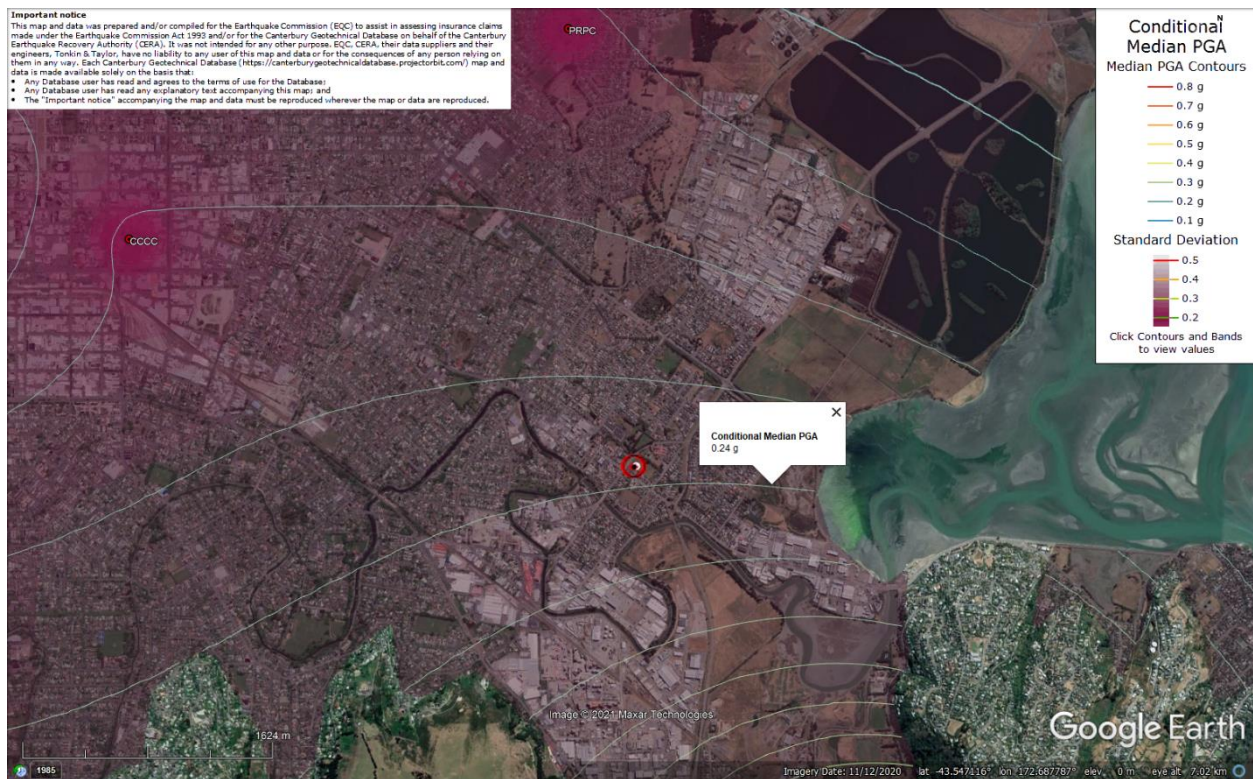
**Figure 35: PGA for Sep-10 EQ (st. dev. = 0.350-0.375 ln units).**

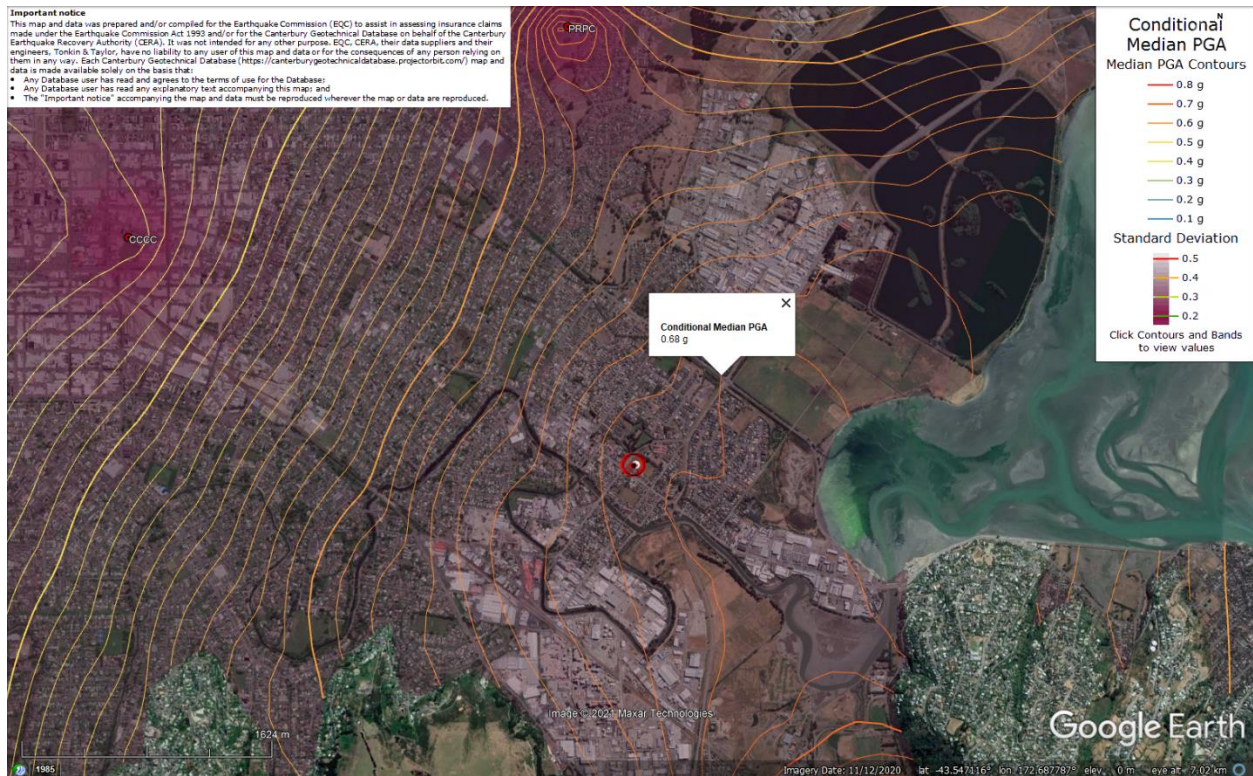
Figure 36: PGA for Feb-11 EQ (st. dev. = 0.375-0.400 ln units).
