Appendix A.50:

Palinurus Rd 1 – VsVp 57185

**Table 1: Site Description for Palinurus Rd 1 (VsVp 57185).**

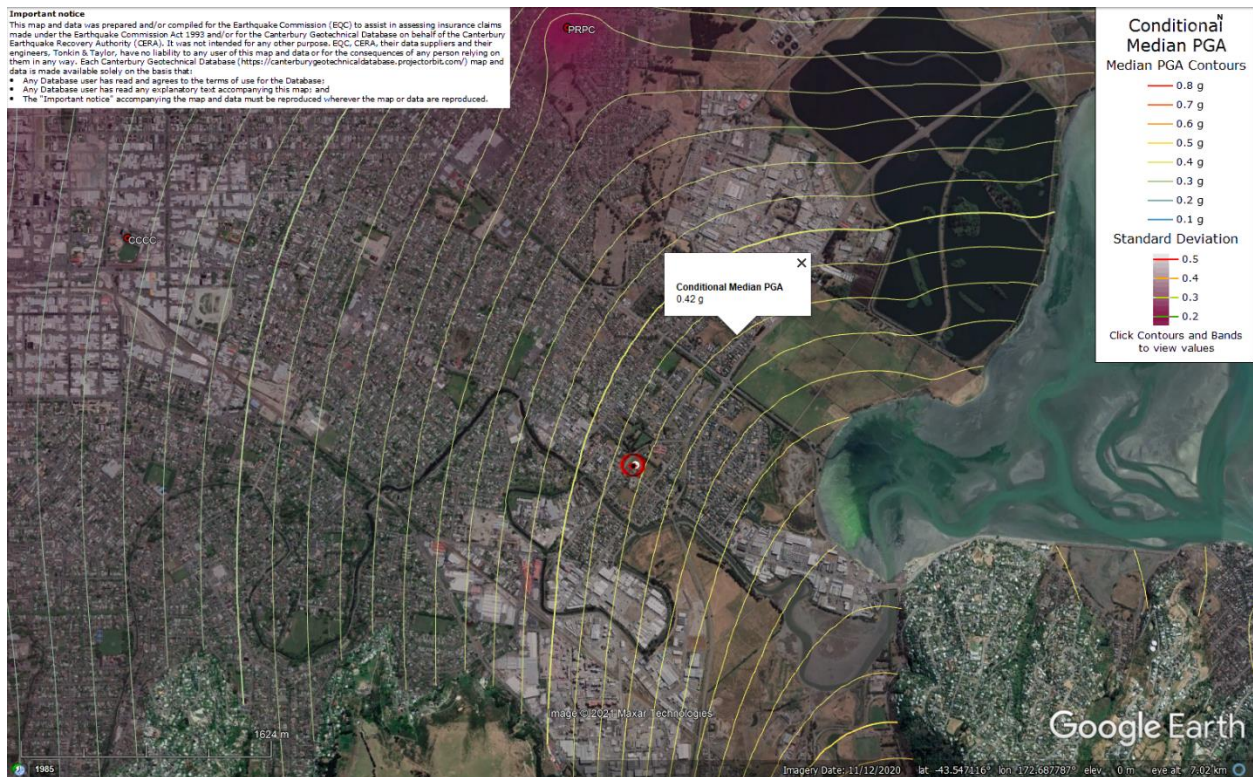
Figure 37: PGA for Jun-11 EQ (st. dev. = 0.400-0.425 ln units).

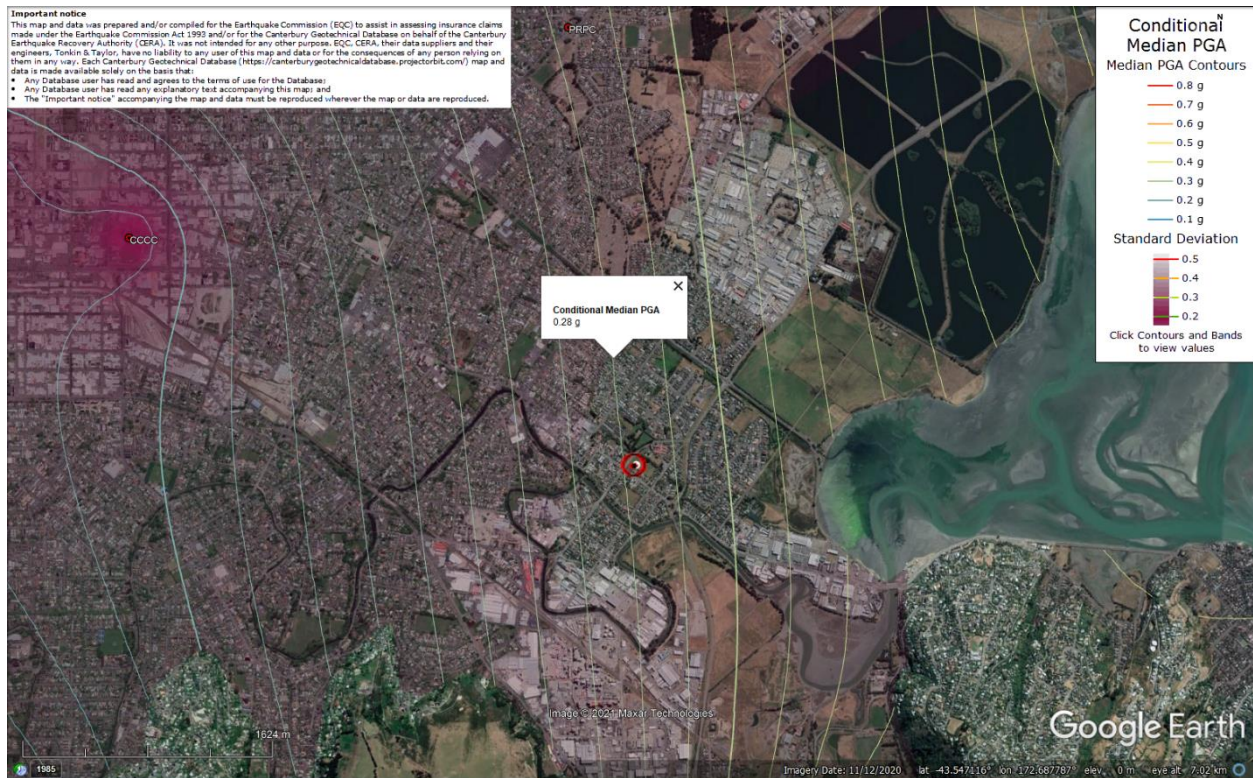
Figure 38: PGA for Dec-11 EQ (st. dev. = 0.425-0.450 ln units).

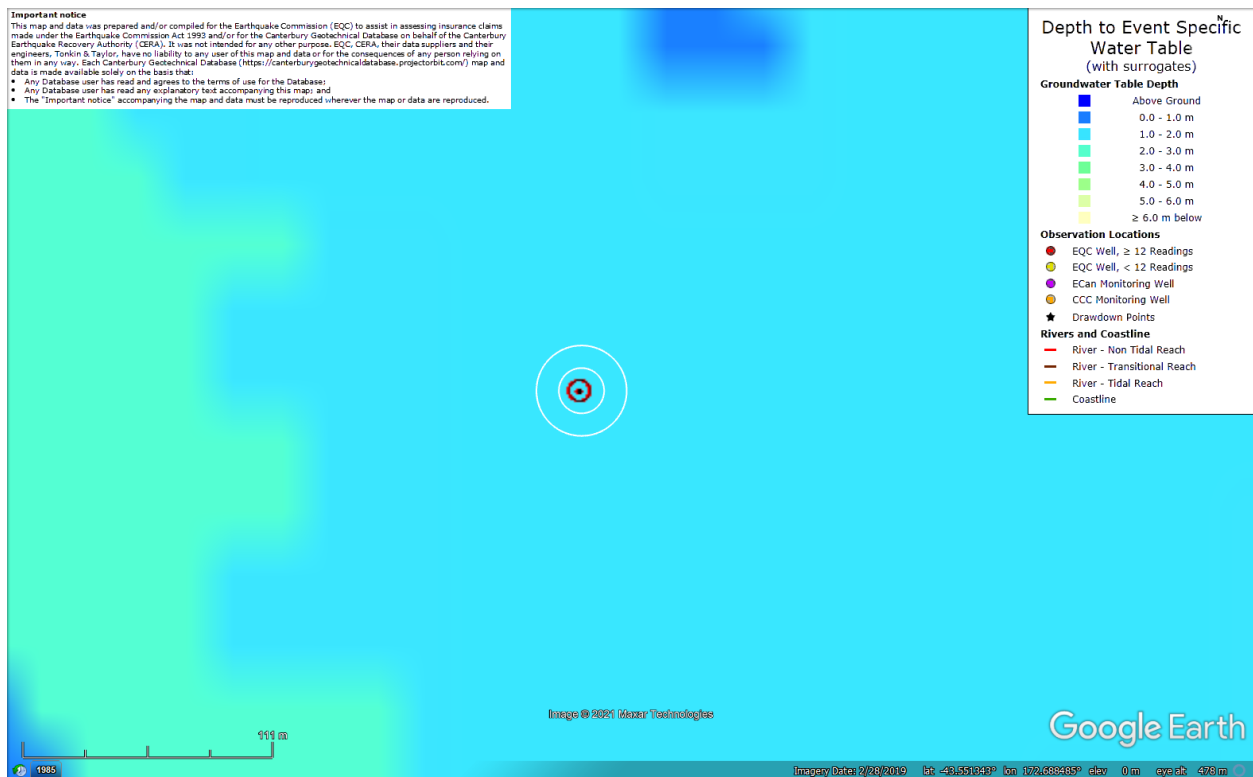
Figure 39: Depth to groundwater table for Sep-10 EQ.

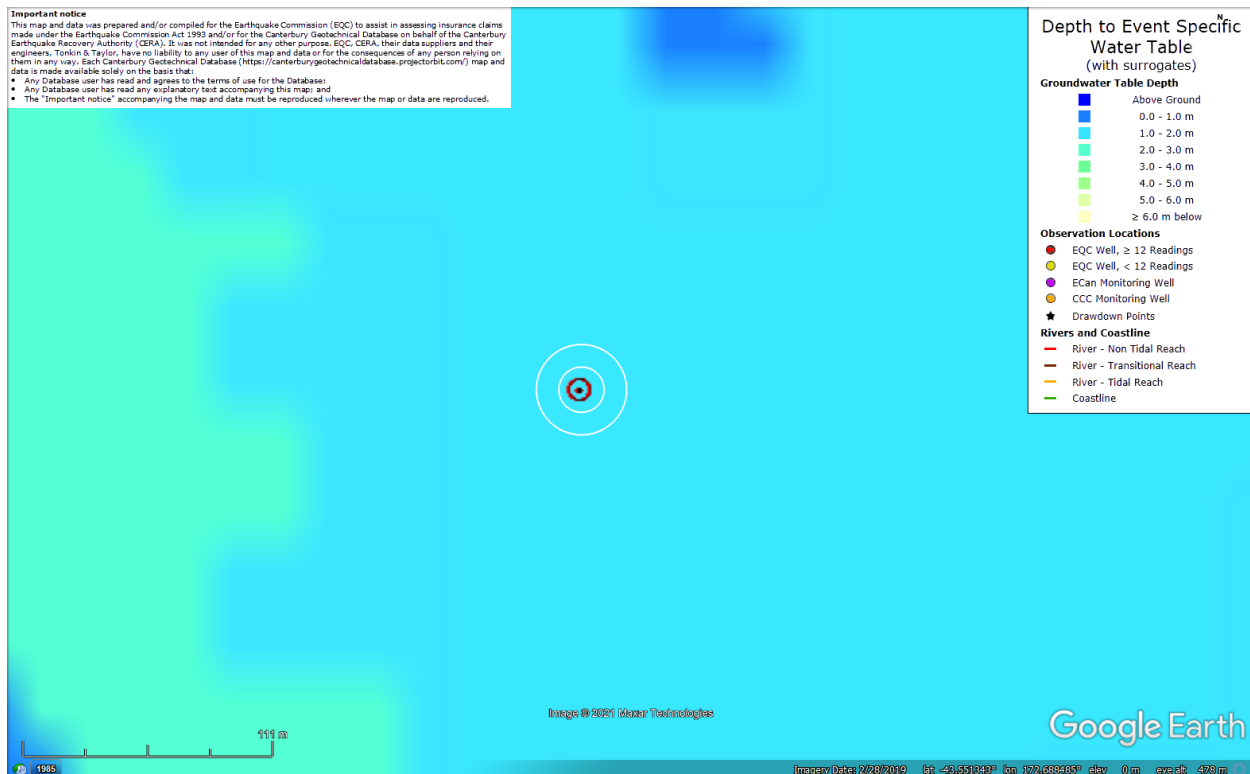
Figure 42: Depth to groundwater table for Dec-11 EQ.

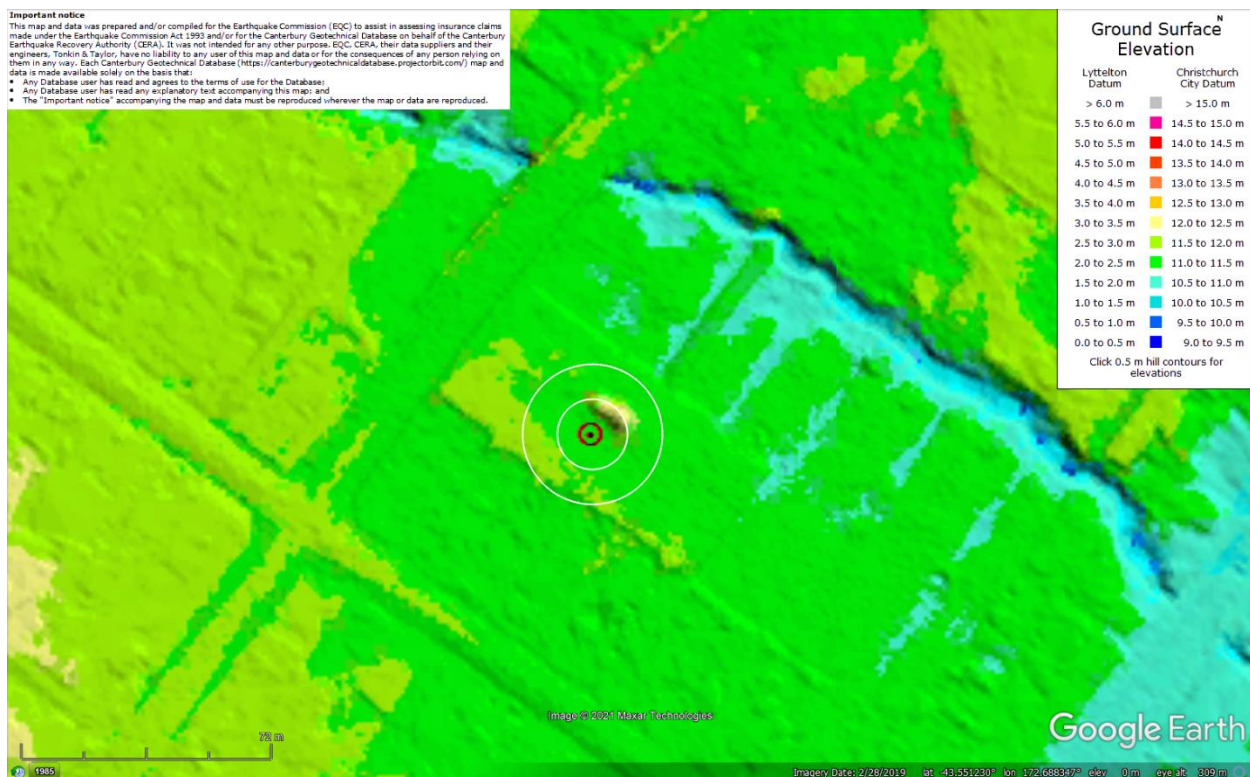
Figure 43: Ground surface elevation according to the Sep-11 LiDAR survey.

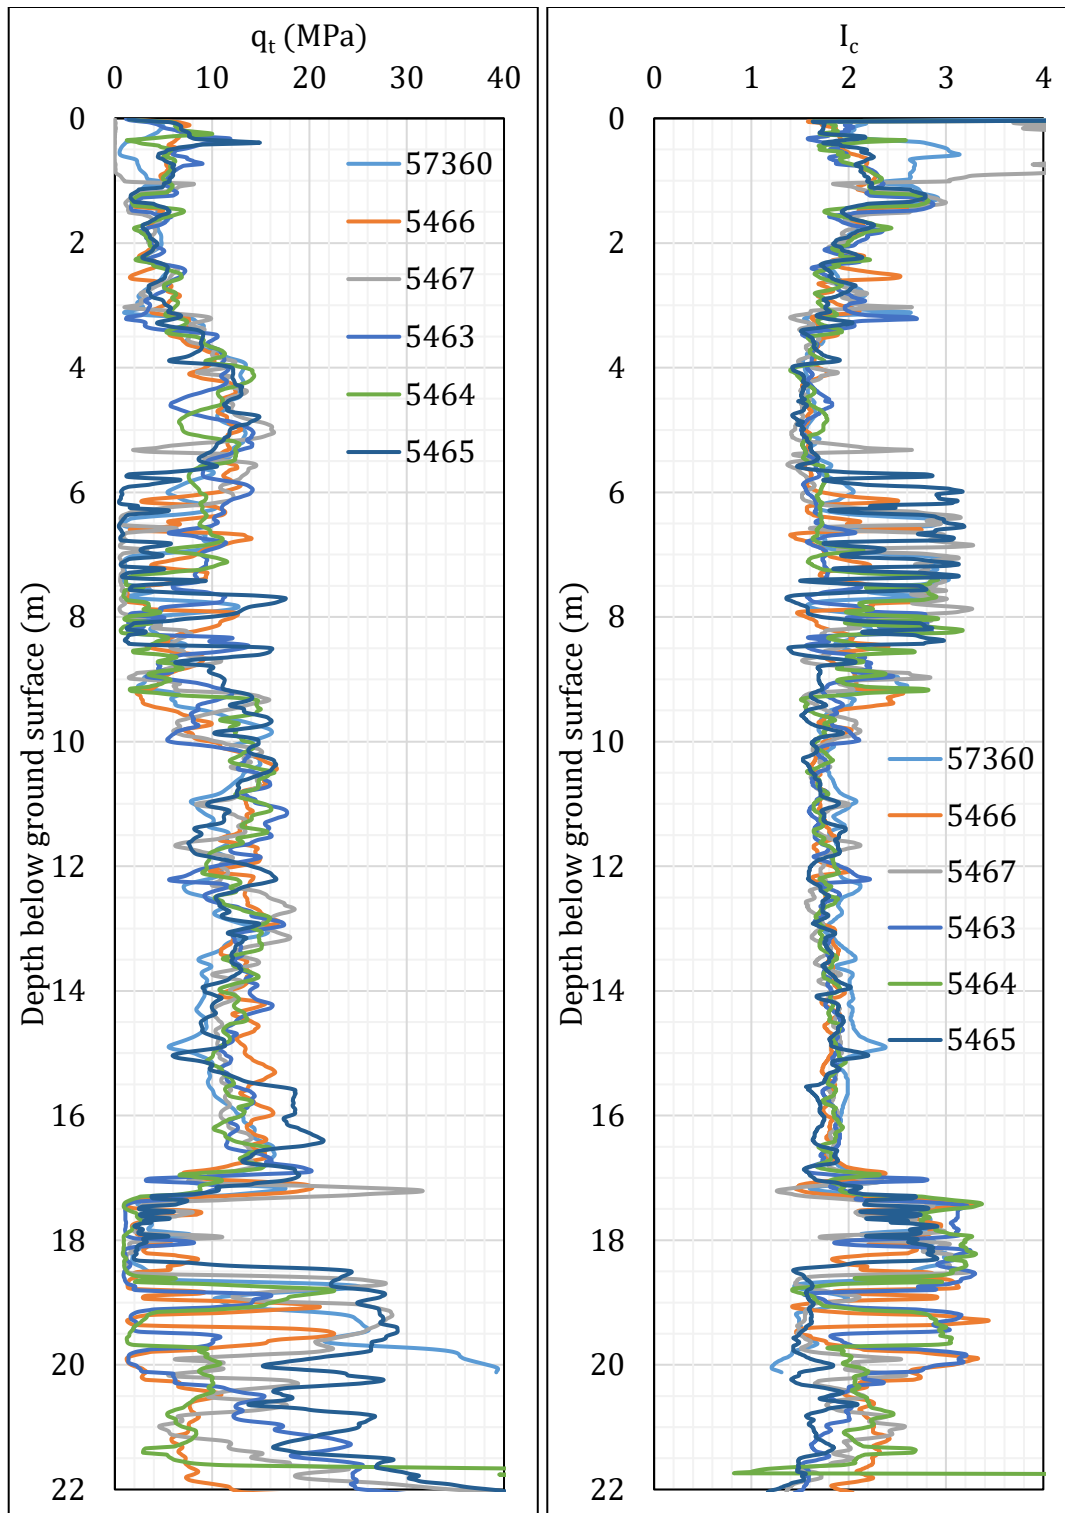
Figure 44:  $q_t$  and  $I_c$  profiles.

**Note 5:** The selection of CPTs for the area considered for settlement assessment (Figure 1) is based on the proximity of the CPTs to the considered areas. In accordance with that, the following table shows CPTs that were used for the volumetric settlement analysis in *Cliq v.3.0.3.2*, a CPT soil liquefaction software developed by GeoLogismiki. (The average volumetric settlements were reported in Table 8.)
