Appendix A.59:

Kensington Ave – CPT 88252

Liquefaction Ejecta Case Histories for 2010-11 Canterbury Earthquakes

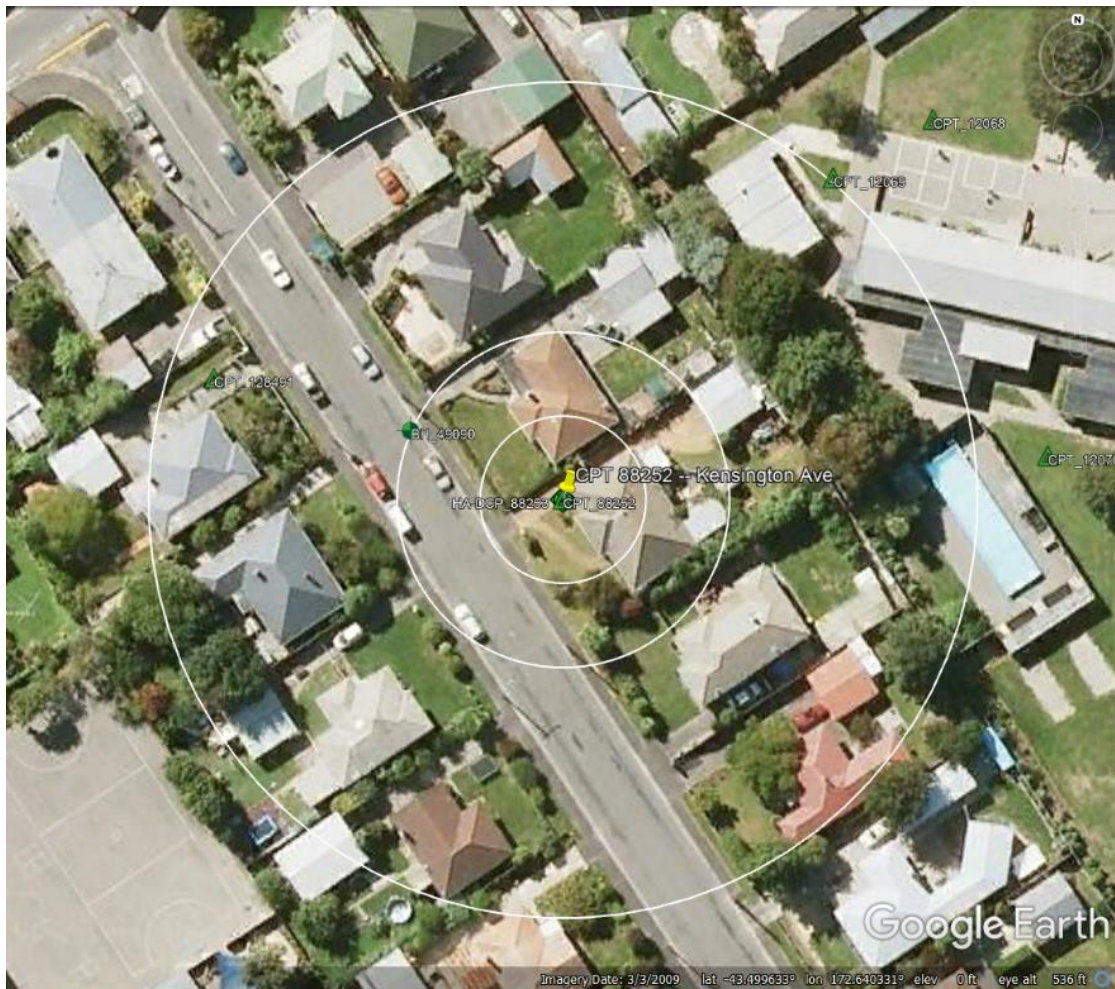
Figure 1: Site plan.

Note: Buffer is the area within a circle of a specified radius with CPT investigations done at its center (172.640665°, -43.499634°).

Note 4: The selection of CPTs for the area considered for settlement assessment (Figure 1) is based on the proximity of the CPTs to the considered areas. In accordance with that, the following table shows CPTs that were used for the volumetric settlement analysis in *Cliq v.3.0.3.2*, a CPT soil liquefaction software developed by GeoLogismiki. (The average volumetric settlements were reported in Table 8.)

Note 5: Based on the borehole log (BH 49090, Figure 1), the groundwater table is at a depth of 1.0 m below the ground surface. Below asphalt, gravelly fill, and silty fill that extend to a depth of 0.4 m, the soil profile consists of (1) fine silty sand, SM, to a depth of 2.5 m, (2) sandy silt, ML, to a depth of 2.9 m, (3) peat, Pt, to a depth of 3.9 m, (4) organic silt, OL, to a depth of 5.6 m, (5) fine silty sand, SM, to a depth of 5.8 m, and (6) sandy silt, ML, to a depth of 6.4 m (the end of the borehole). These soil layers are the Yaldhurst members of the Springston formation. According to BH 154639, a borehole log that is ~ 80 m to the NE from the center of the site, the ML layer is underlain by (7) silty sand, SM, to a depth of 15.65 m (the end of the borehole). Trace shell fragments are found below a 10.6-m depth.

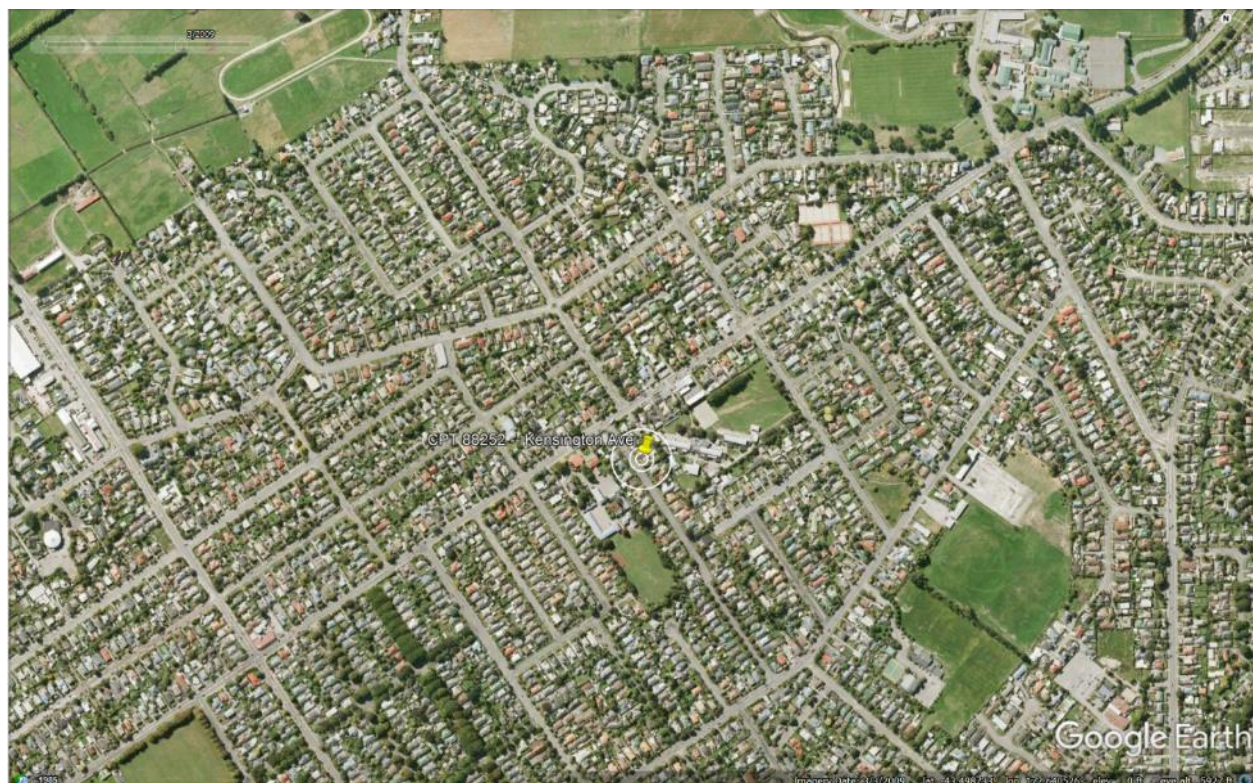
Figure 3: Position of the site relative to nearby buildings, vegetation, and free-face features.

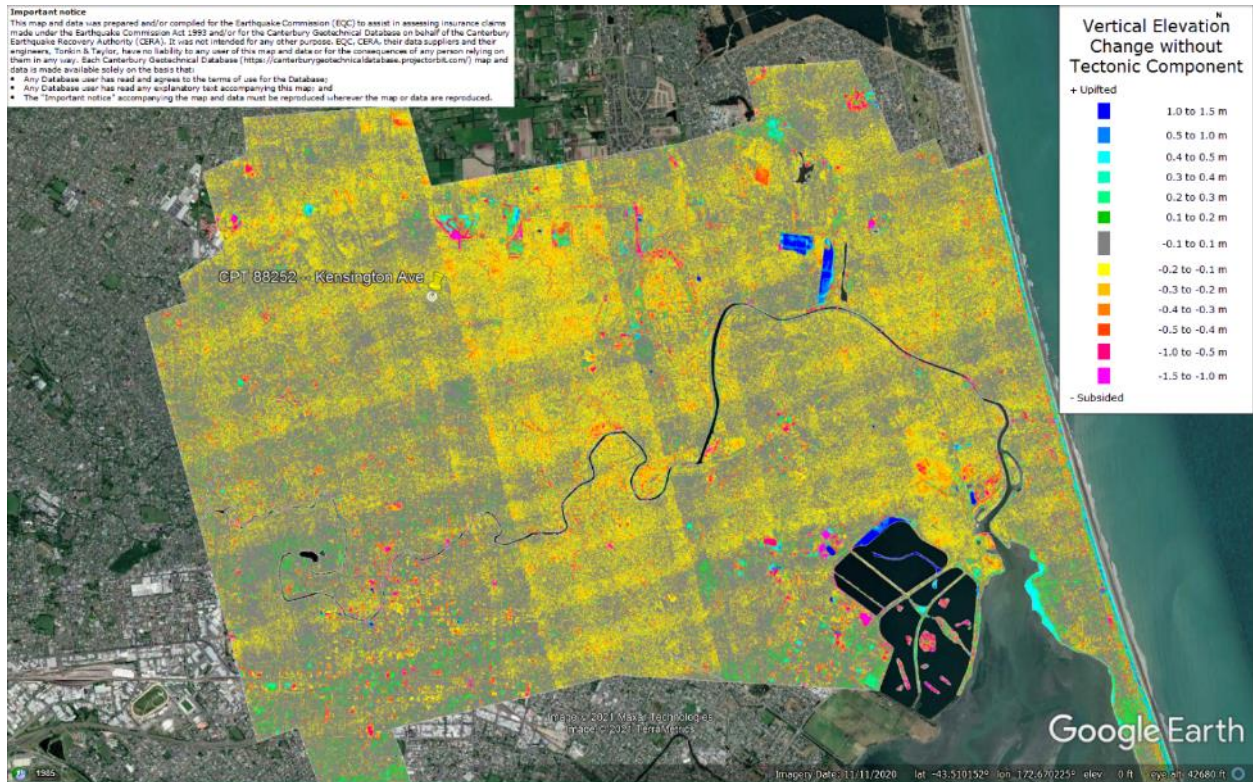
Figure 20: Vertical Ground Movements (Surface – Tectonic) for Sep 2010 Earthquake – the site is not in the apparent zone of overestimated ground surface subsidence.

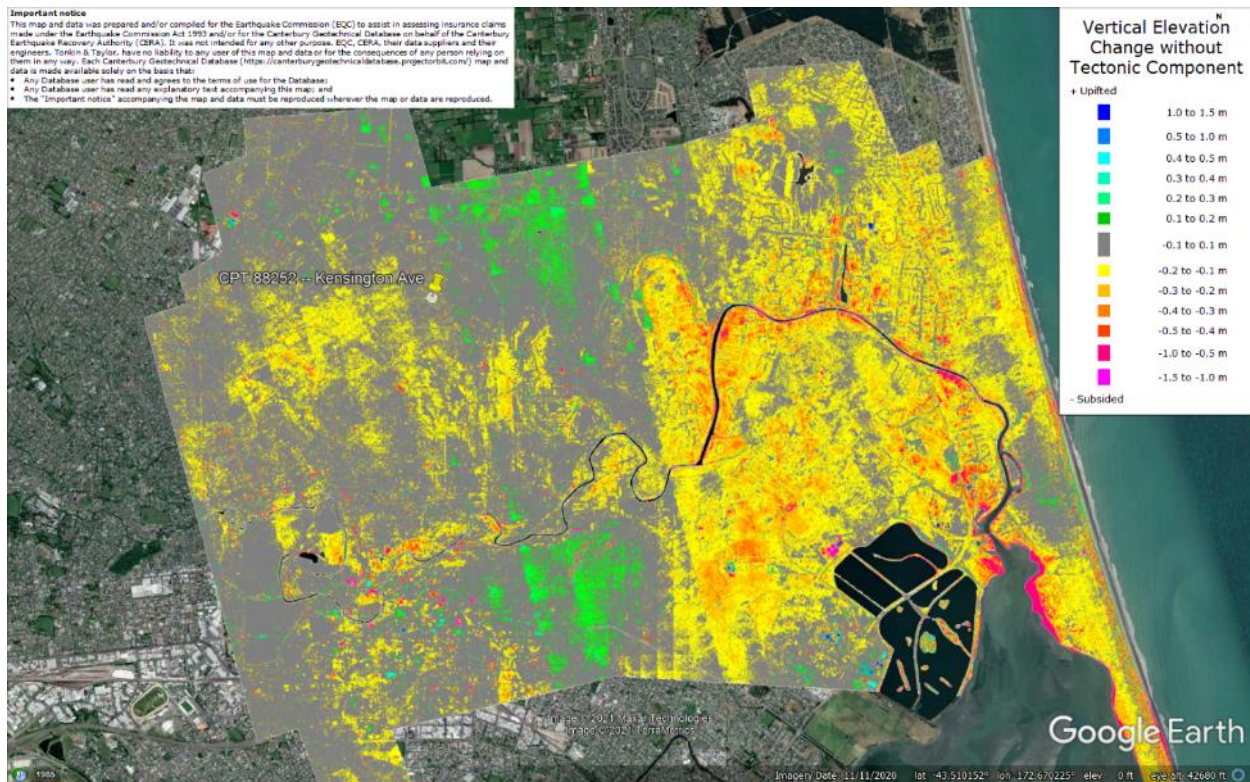
Figure 21: Vertical Ground Movements (Surface – Tectonic) for Feb 2011 Earthquake – the site is not in the apparent zone of underestimated ground surface subsidence.

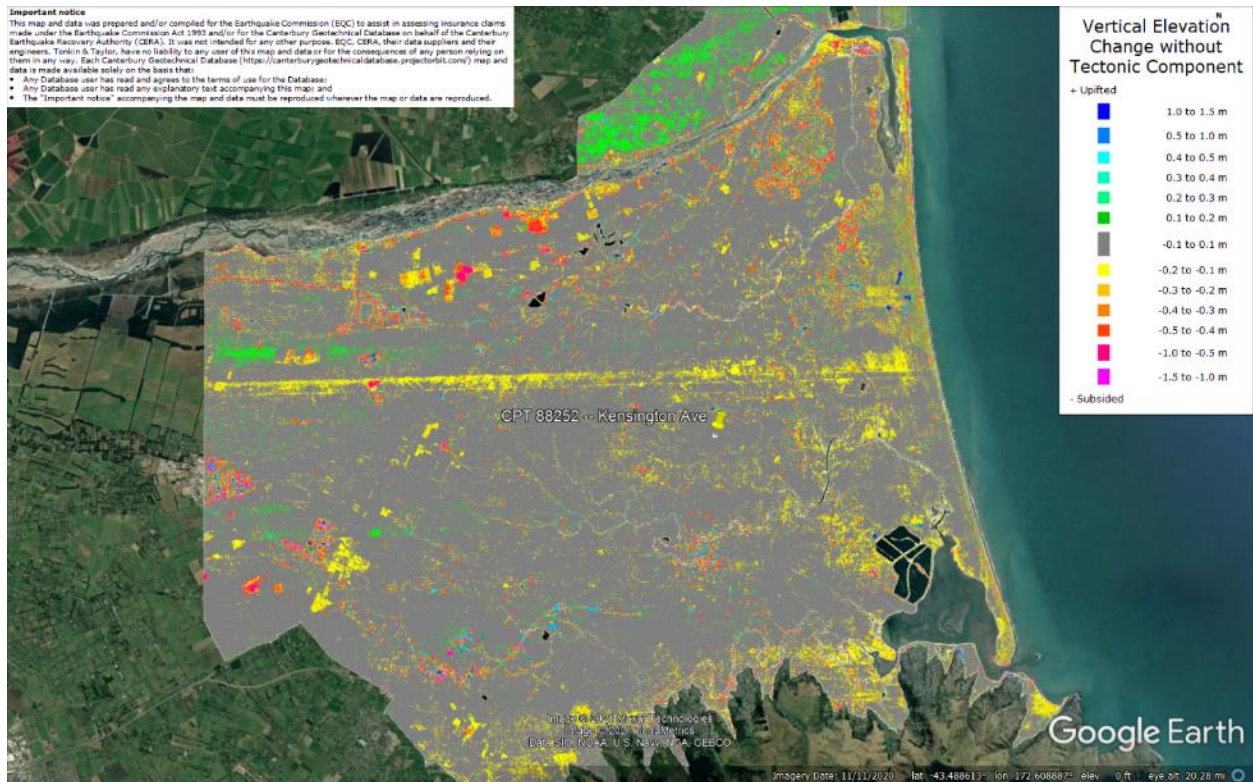
Figure 22: Vertical Ground Movements (Surface – Tectonic) for June 2011 Earthquake – the site is not in the apparent zone of overestimated/underestimated ground surface subsidence.

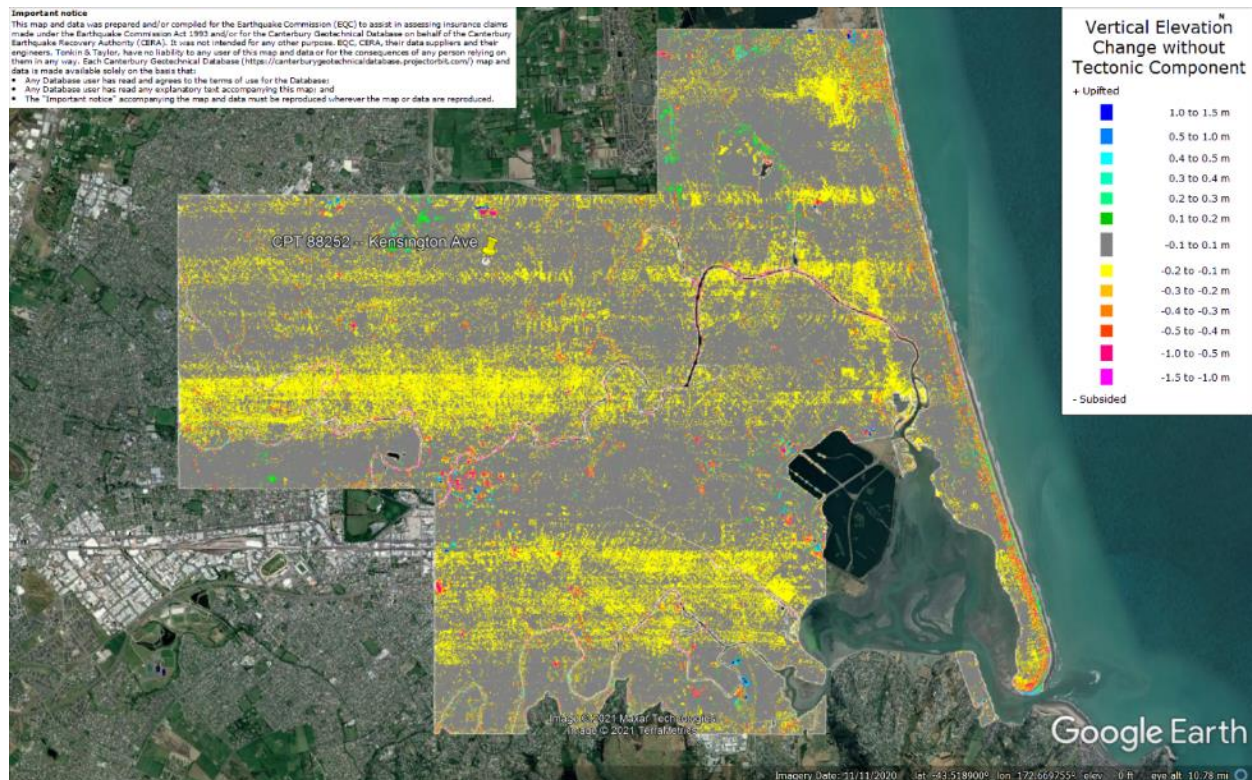
Figure 23: Vertical Ground Movements (Surface – Tectonic) for Dec 2011 Earthquake – the site is not in the apparent zone of overestimated/underestimated ground surface subsidence.

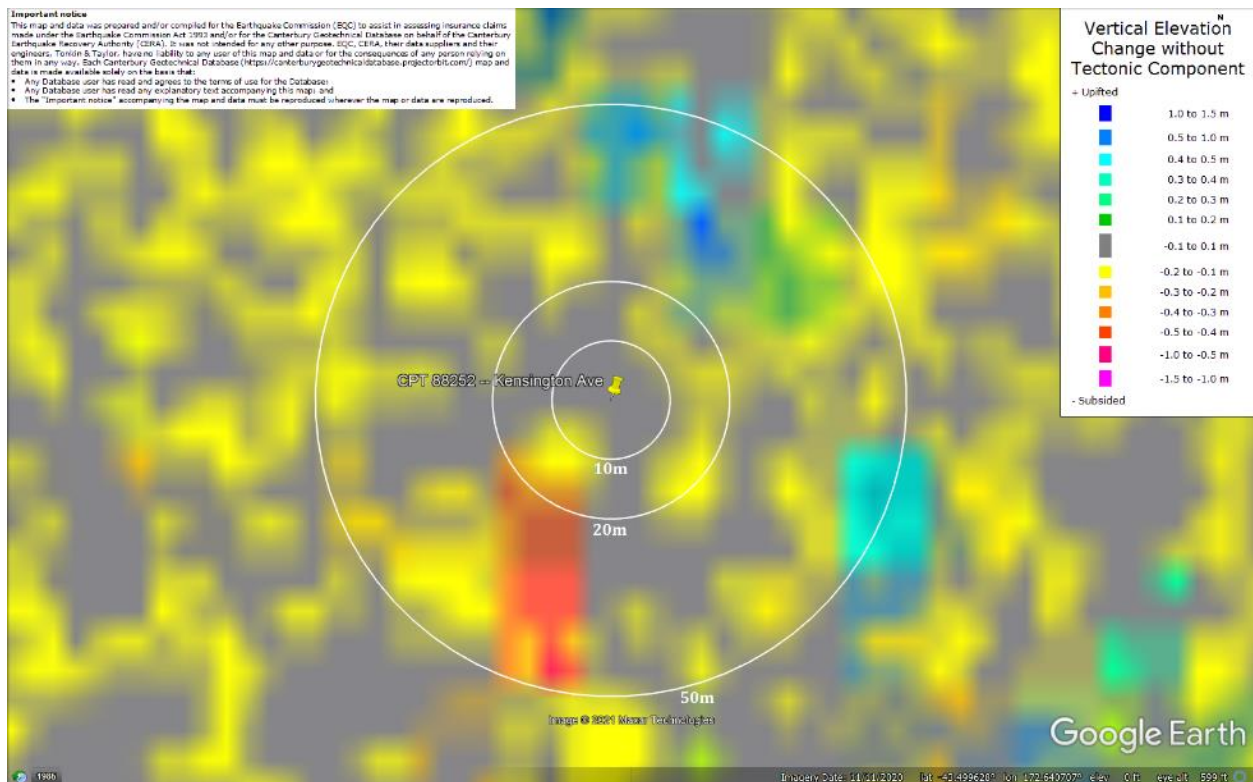
Figure 24: Ground surface subsidence without tectonic component for Sep 2010 Earthquake according to the LiDAR DEM.

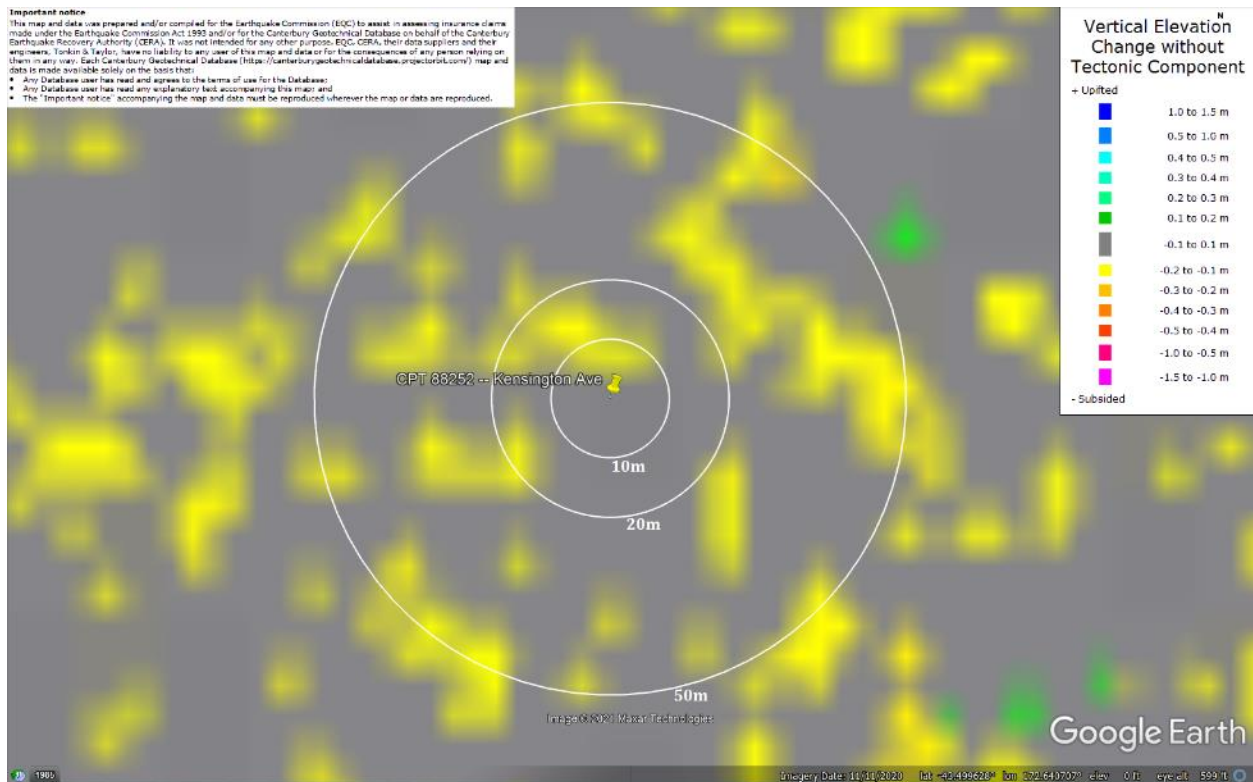
Figure 25: Ground surface subsidence without tectonic component for Feb 2011 Earthquake according to the LiDAR DEM.

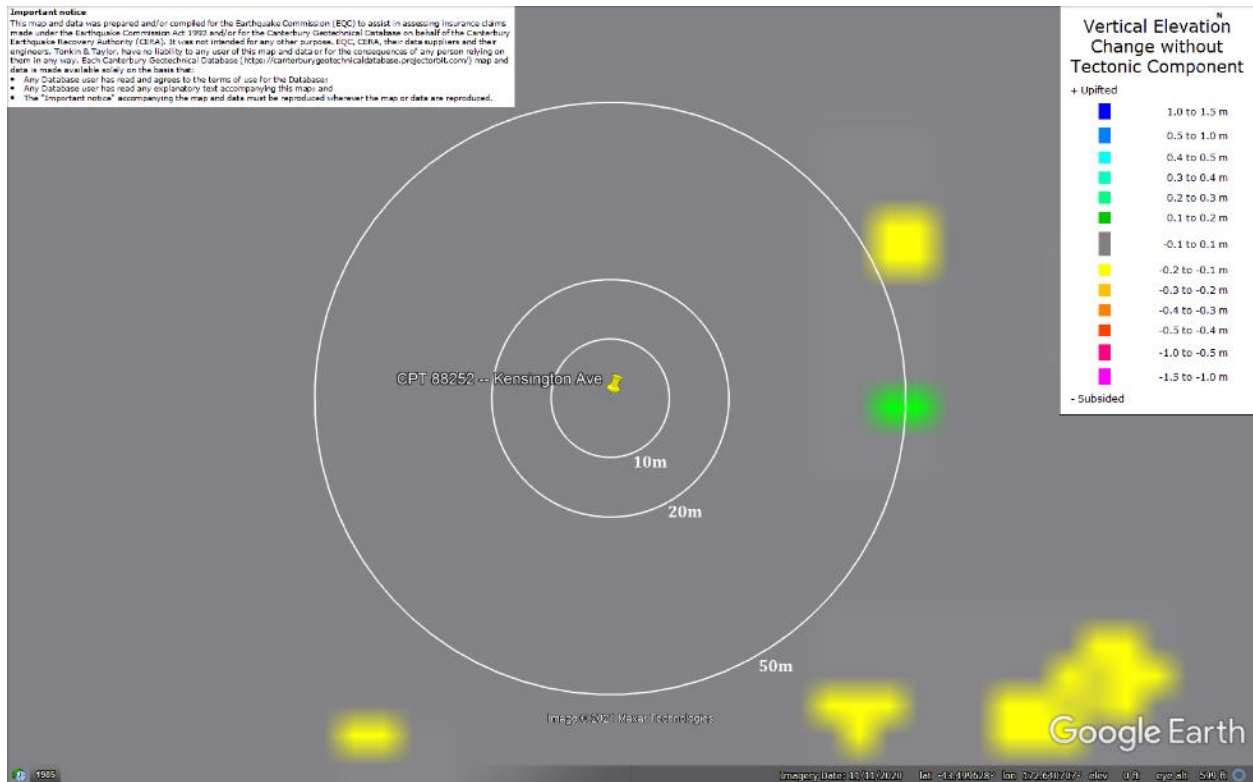
Figure 26: Ground surface subsidence without tectonic component for June 2011 Earthquake according to the LiDAR DEM.

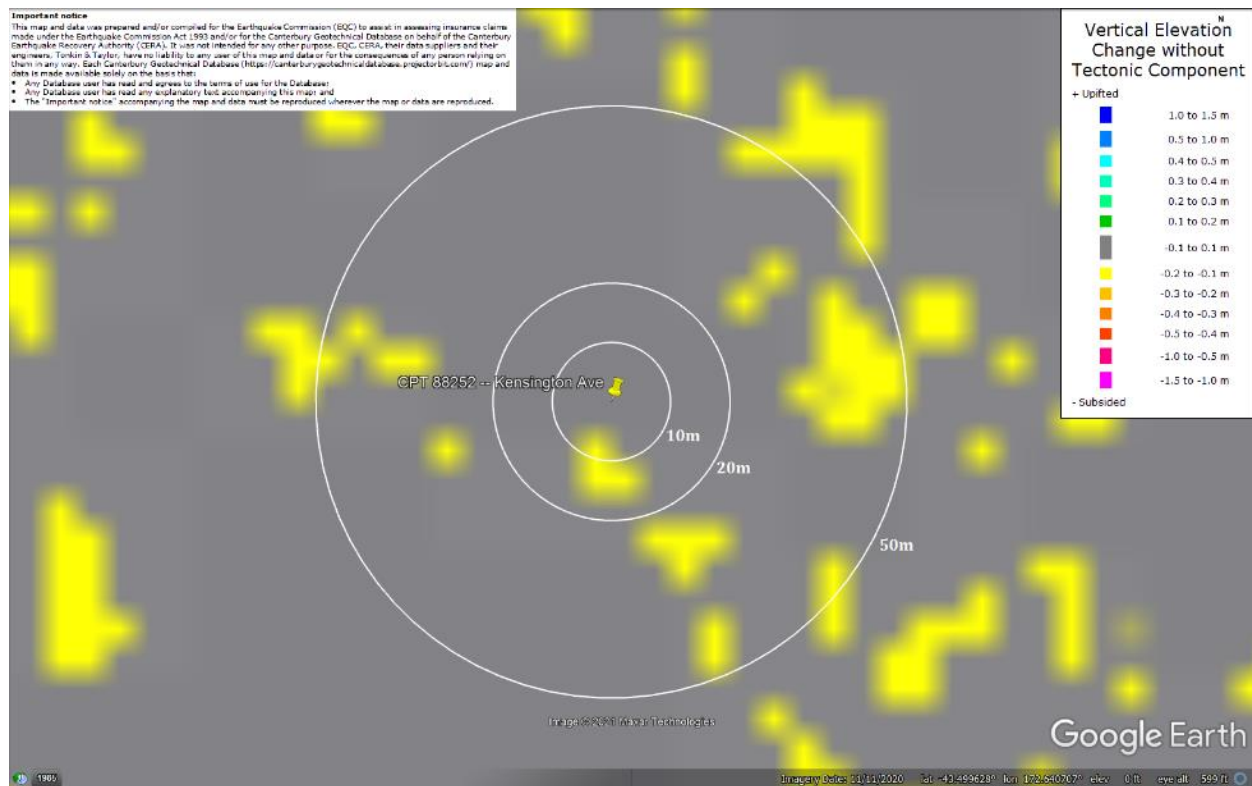
Figure 27: Ground surface subsidence without tectonic component for Dec 2011 Earthquake according to the LiDAR DEM.

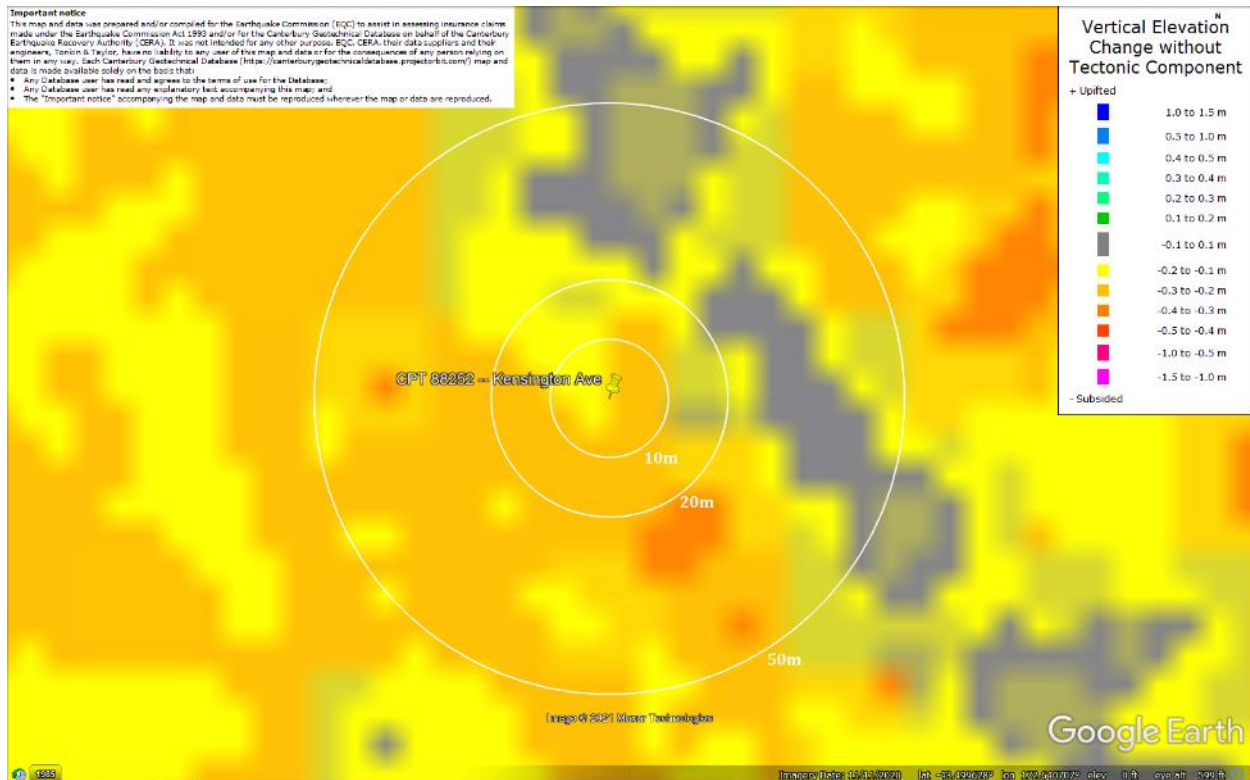
Figure 28: Ground surface subsidence without tectonic component for Canterbury Earthquake Sequence according to the LiDAR DEM.

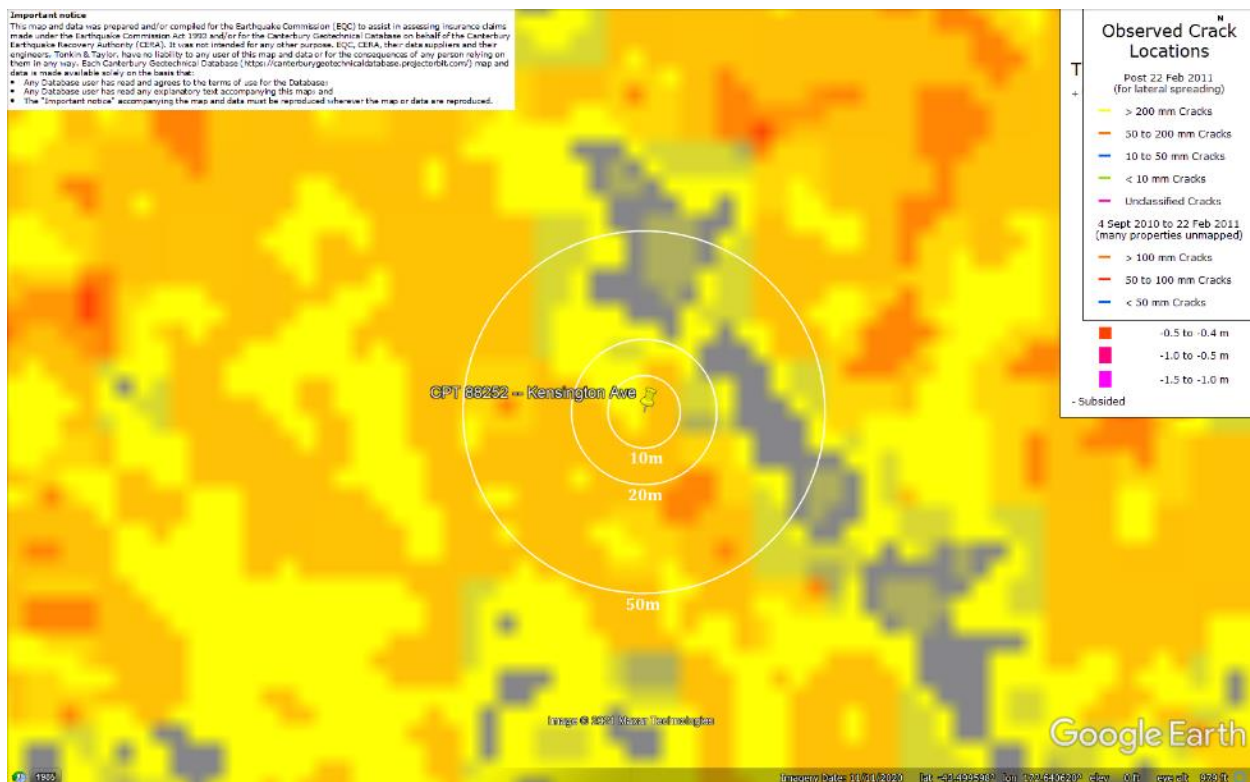
Figure 29: No lateral spreading for Canterbury Earthquake Sequence.

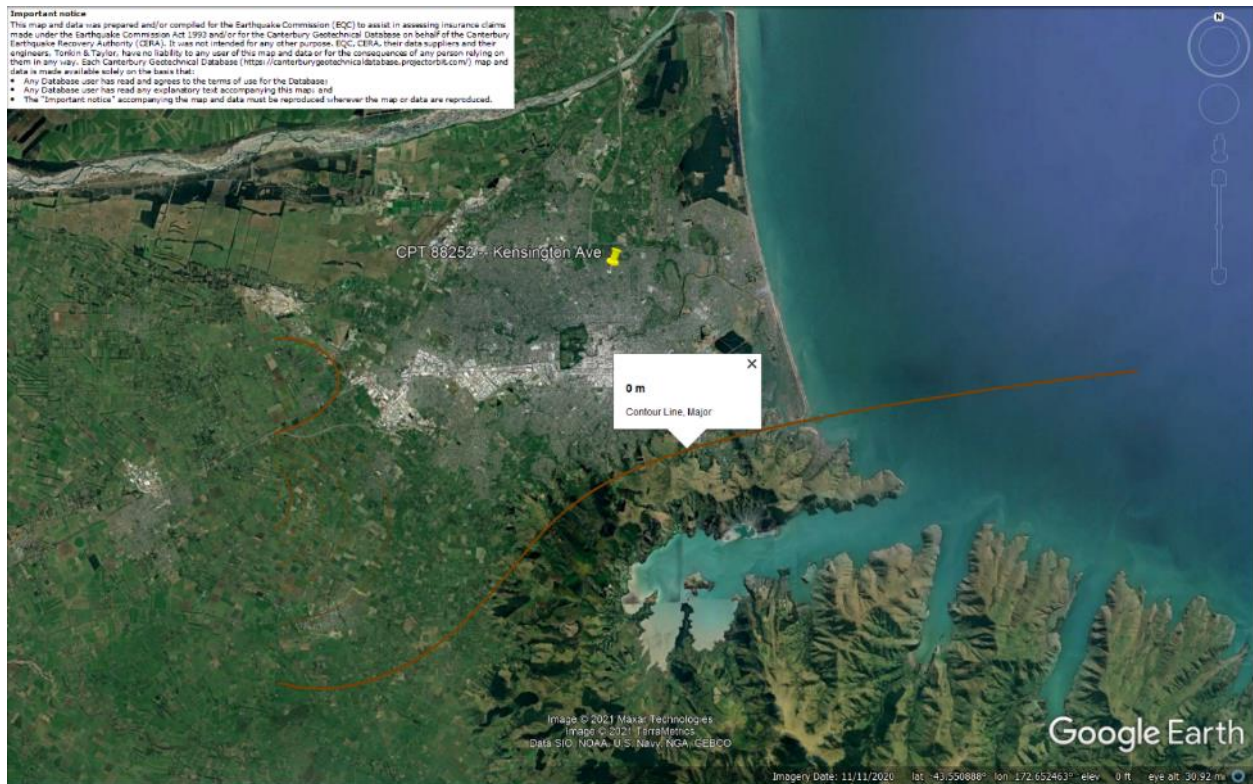
Figure 30: Vertical tectonic movements for Sep 2010 Earthquake.

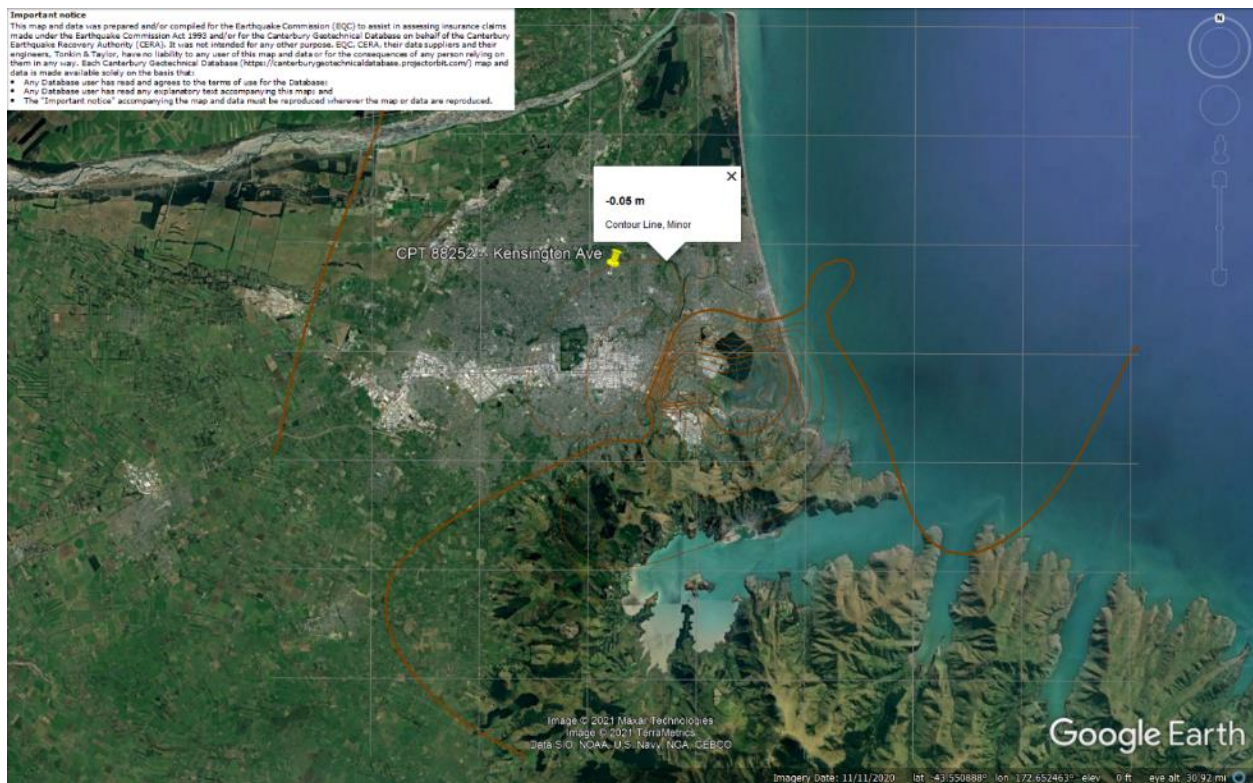
Figure 31: Vertical tectonic movements for Feb 2011 Earthquake.

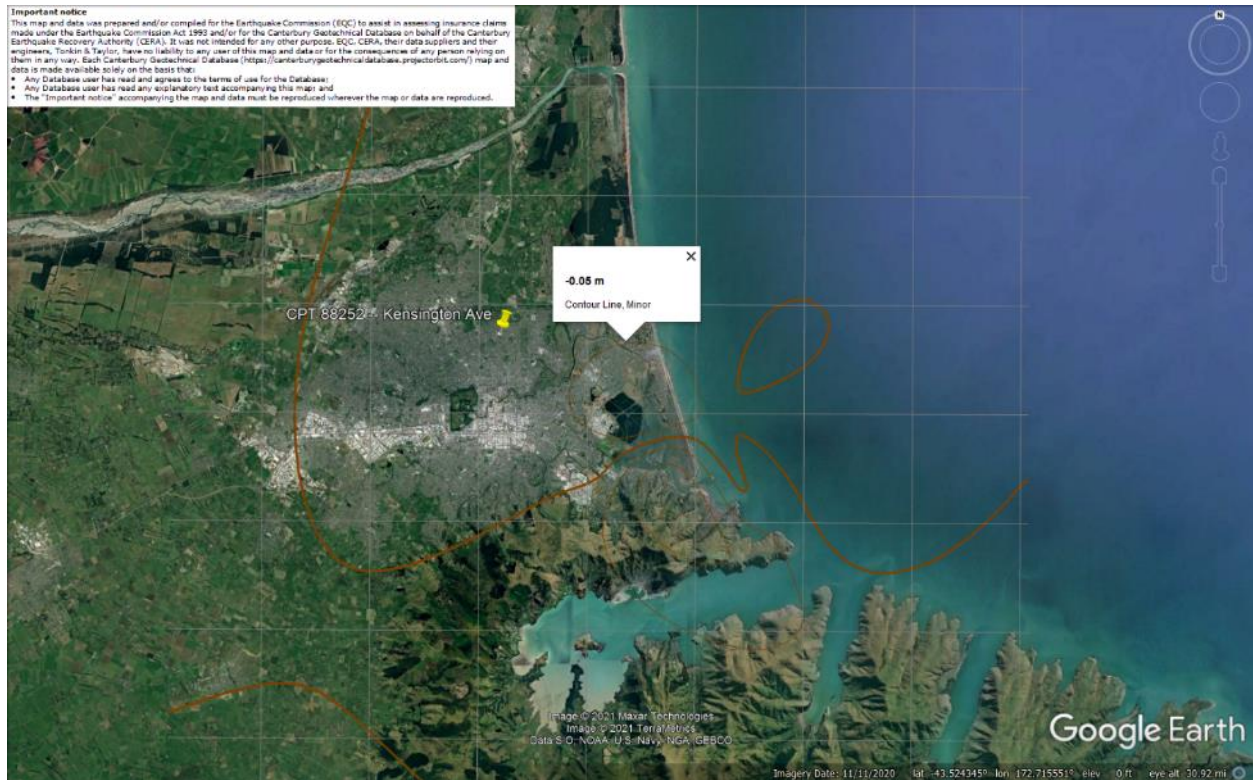
Figure 32: Vertical tectonic movements for June 2011 Earthquake.

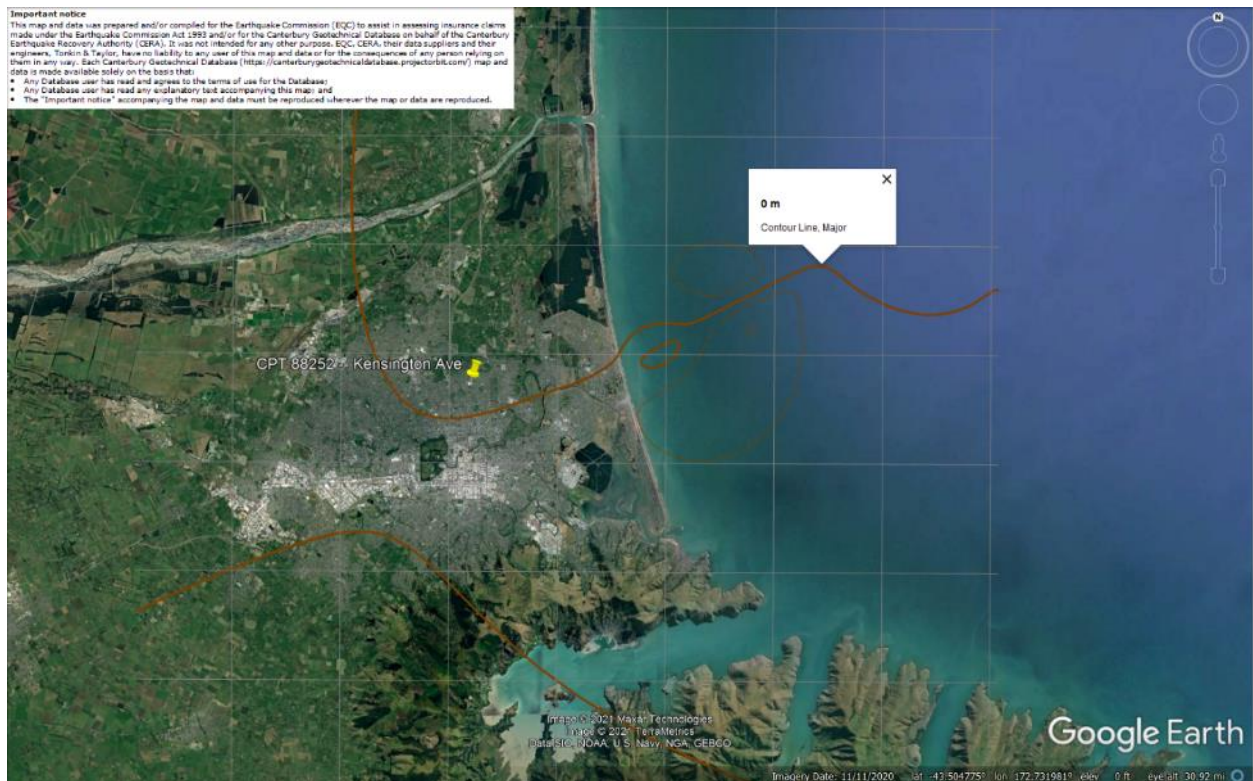
Figure 33: Vertical tectonic movements for Dec 2011 Earthquake.

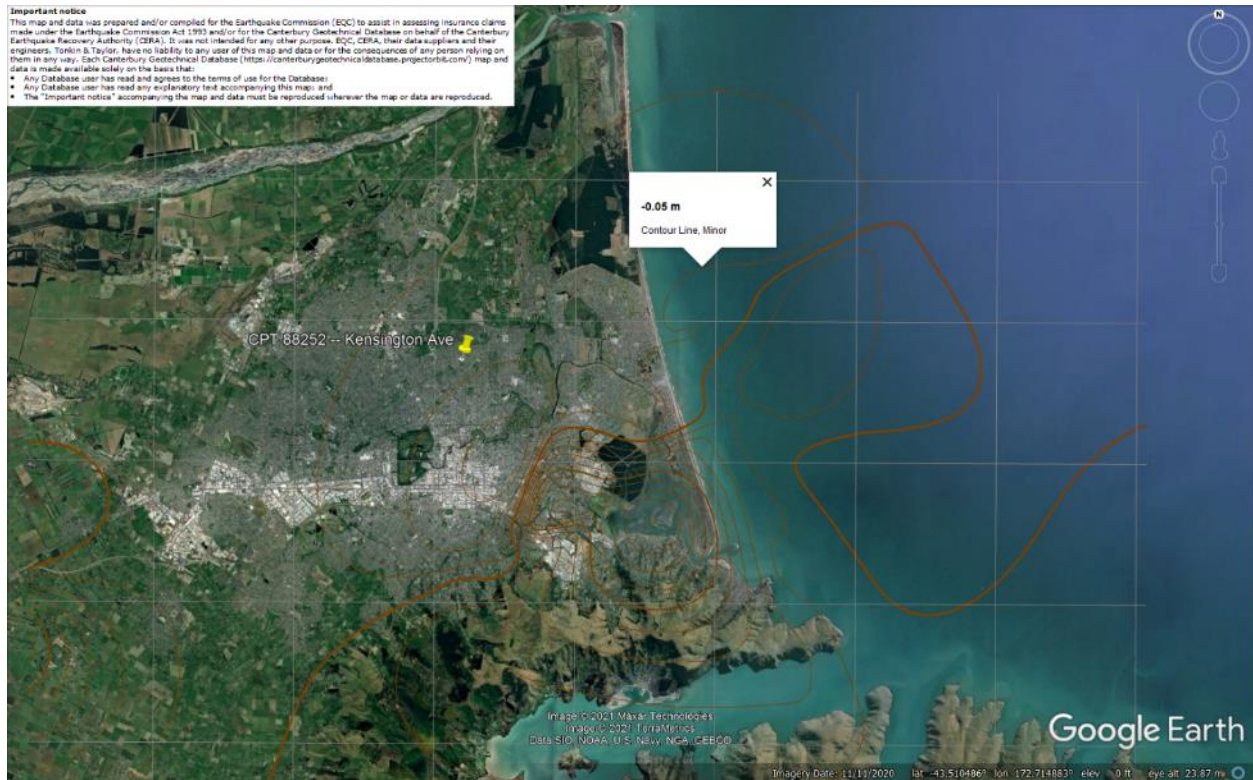
Figure 34: Vertical tectonic movements for Canterbury Earthquake Sequence.

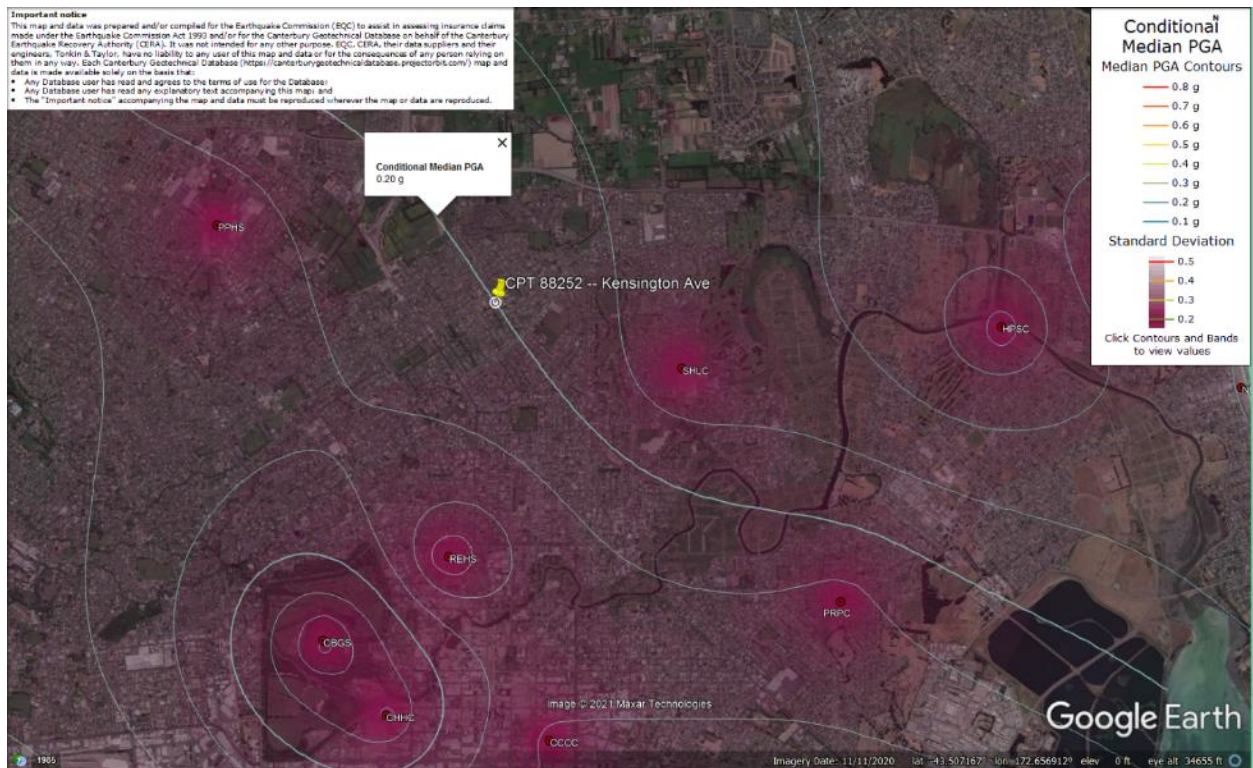
Figure 35: PGA for Sep-10 EQ (st. dev. = 0.325-0.350 ln units).

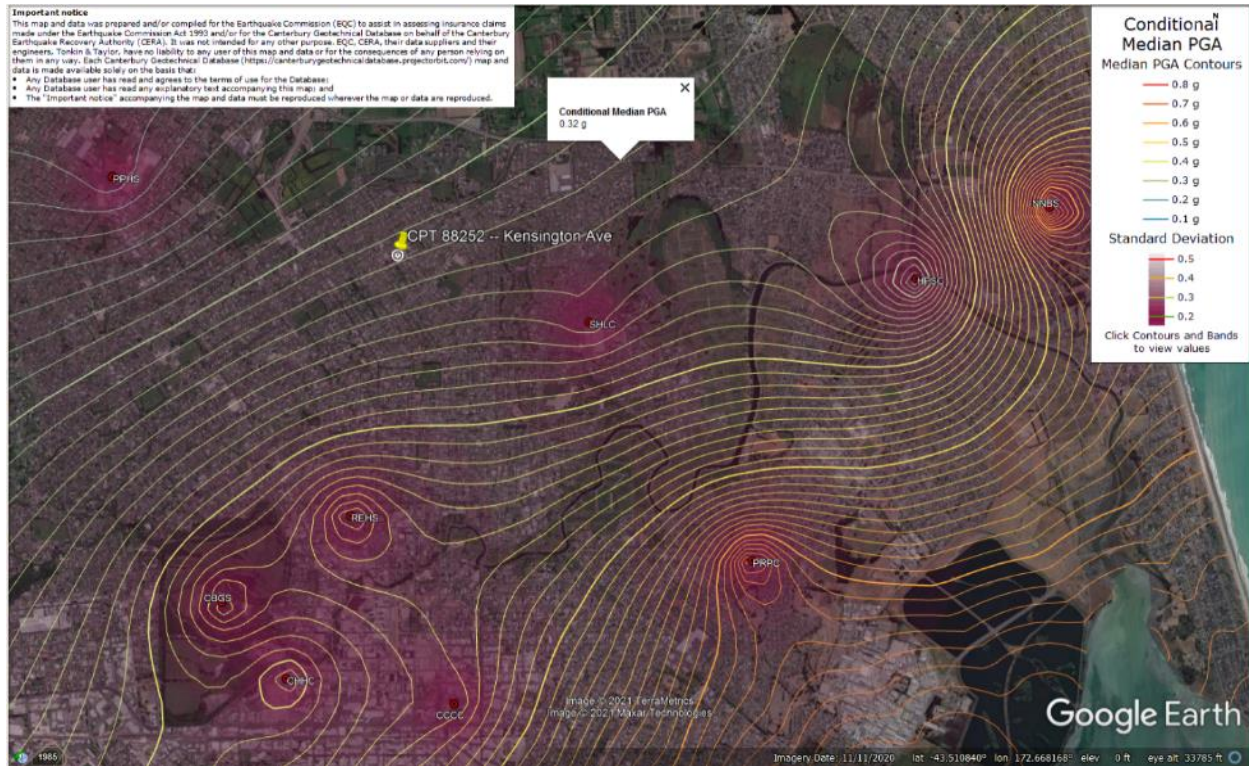
Figure 36: PGA for Feb-11 EQ (st. dev. = 0.350-0.375 ln units).

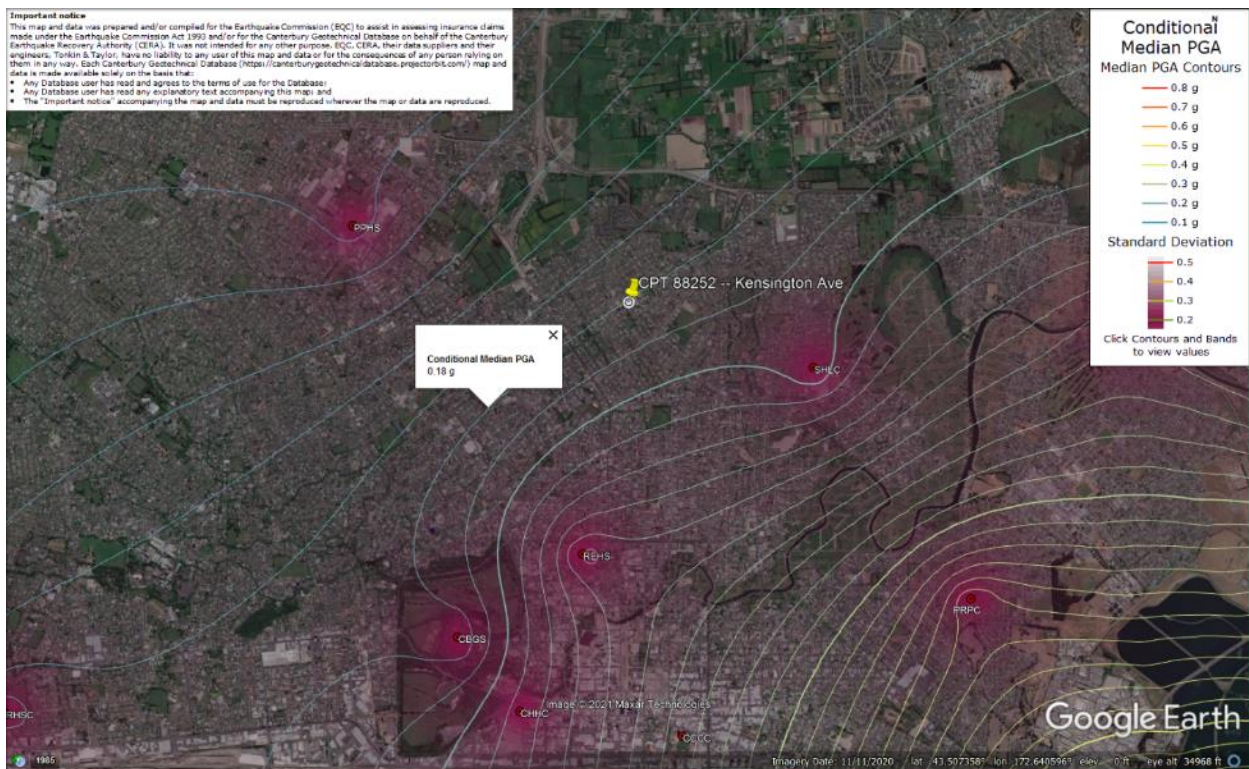
Figure 37: PGA for Jun-11 EQ (st. dev. = 0.375-0.400 ln units).

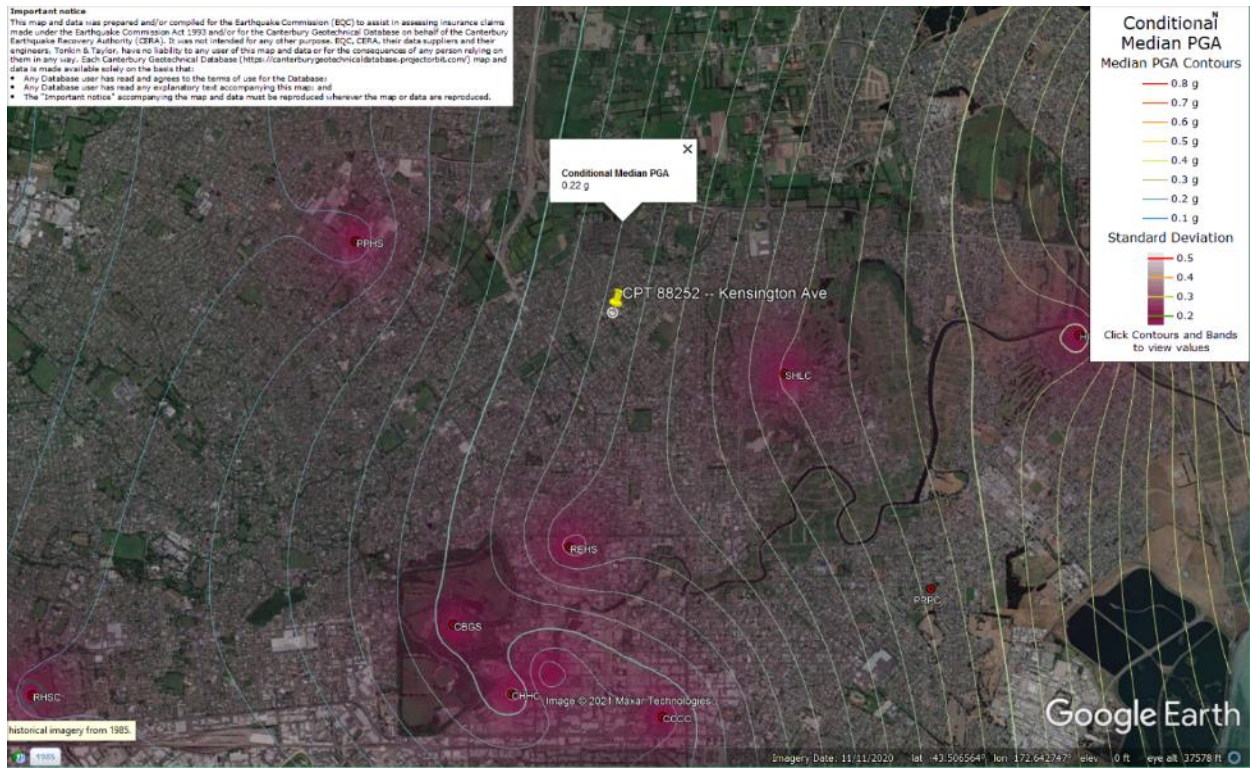
Figure 38: PGA for Dec-11 EQ (st. dev. = 0.375-0.400 ln units).

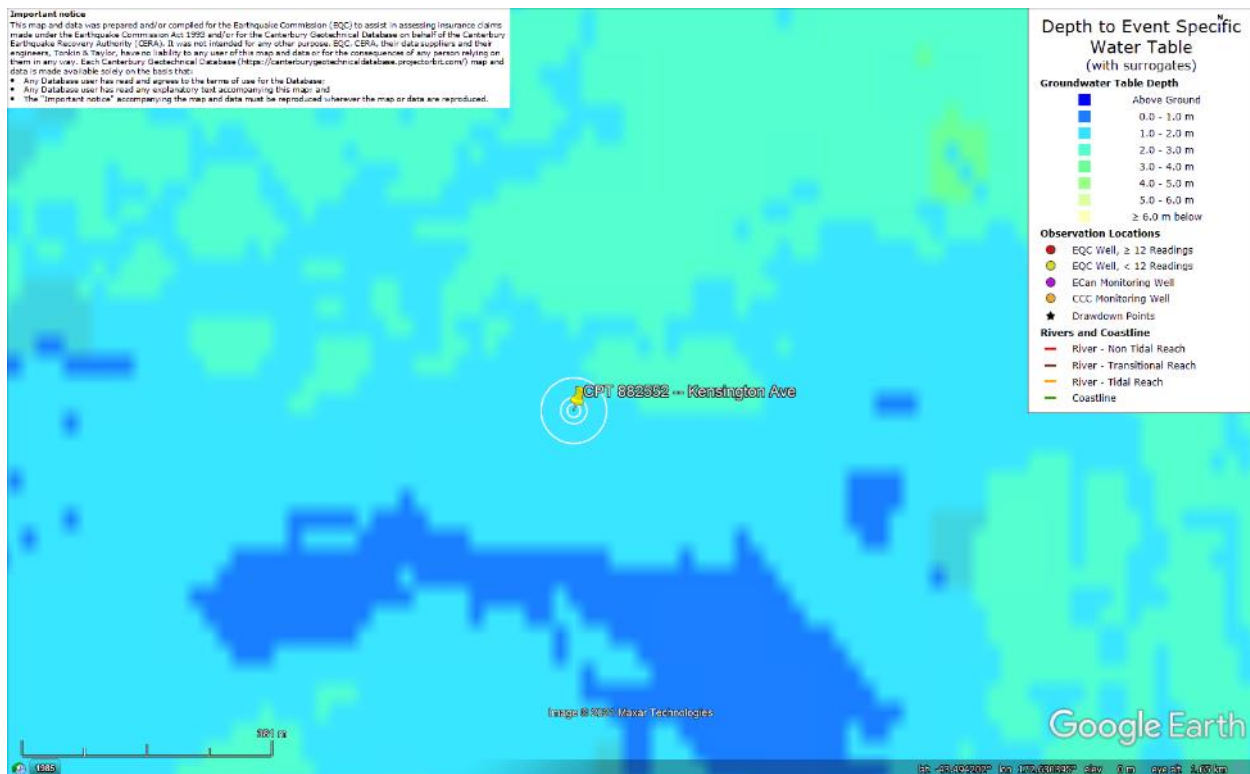
Figure 39: Depth to groundwater table for Sep-10 EQ.
