Appendix A.59:

Kensington Ave – CPT 88252

Liquefaction Ejecta Case Histories for 2010-11 Canterbury Earthquakes

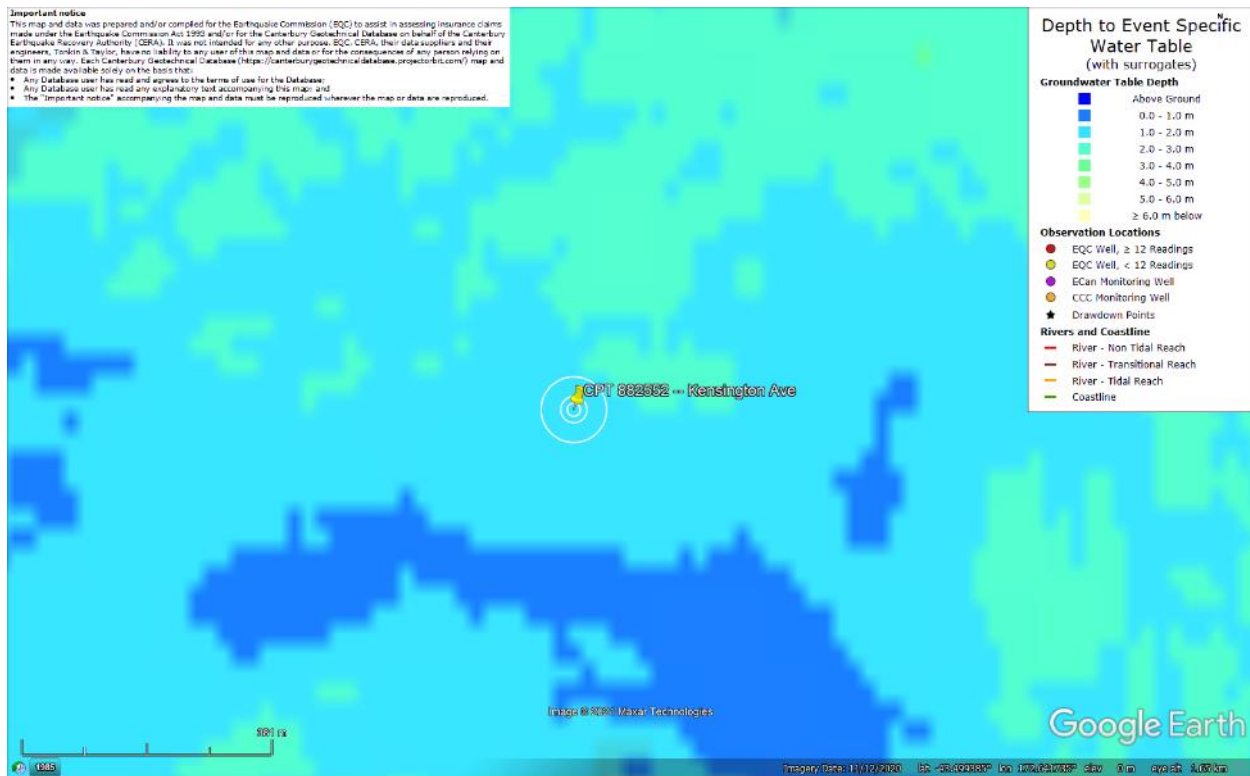
Figure 40: Depth to groundwater table for Feb-11 EQ.

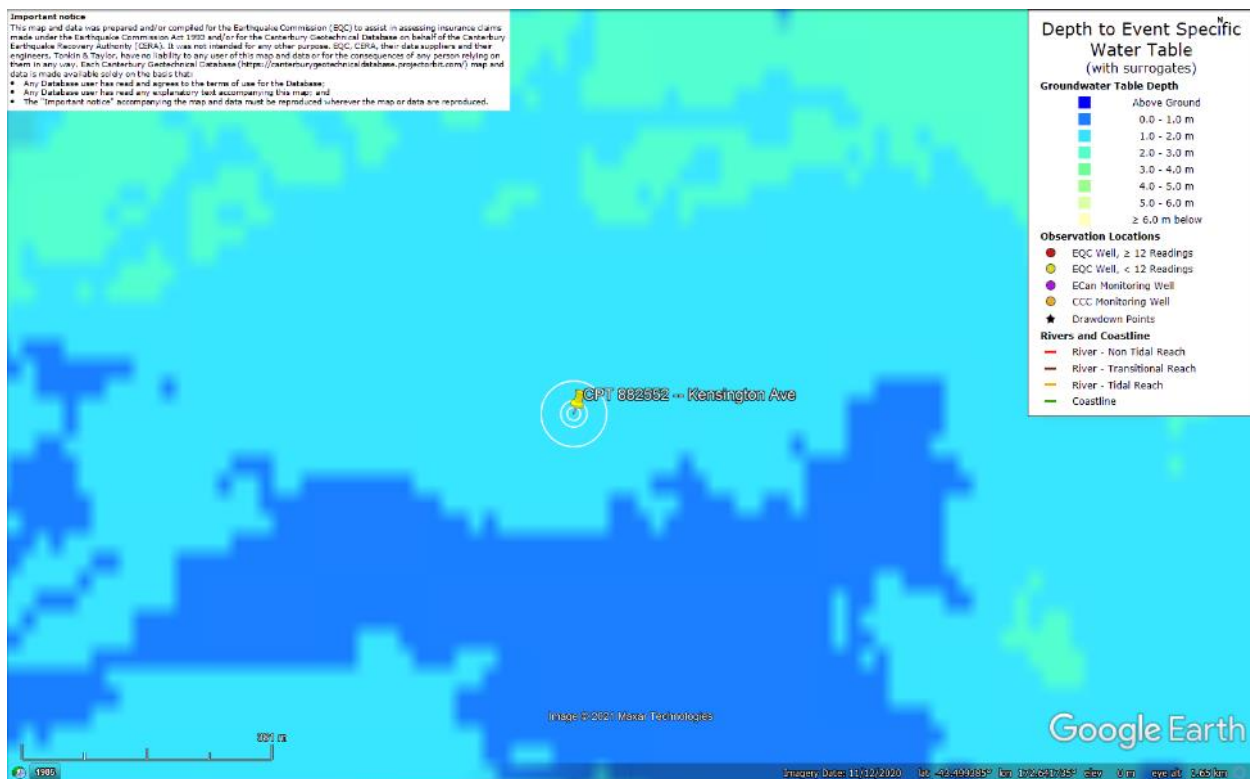
Figure 41: Depth to groundwater table for Jun-11 EQ.

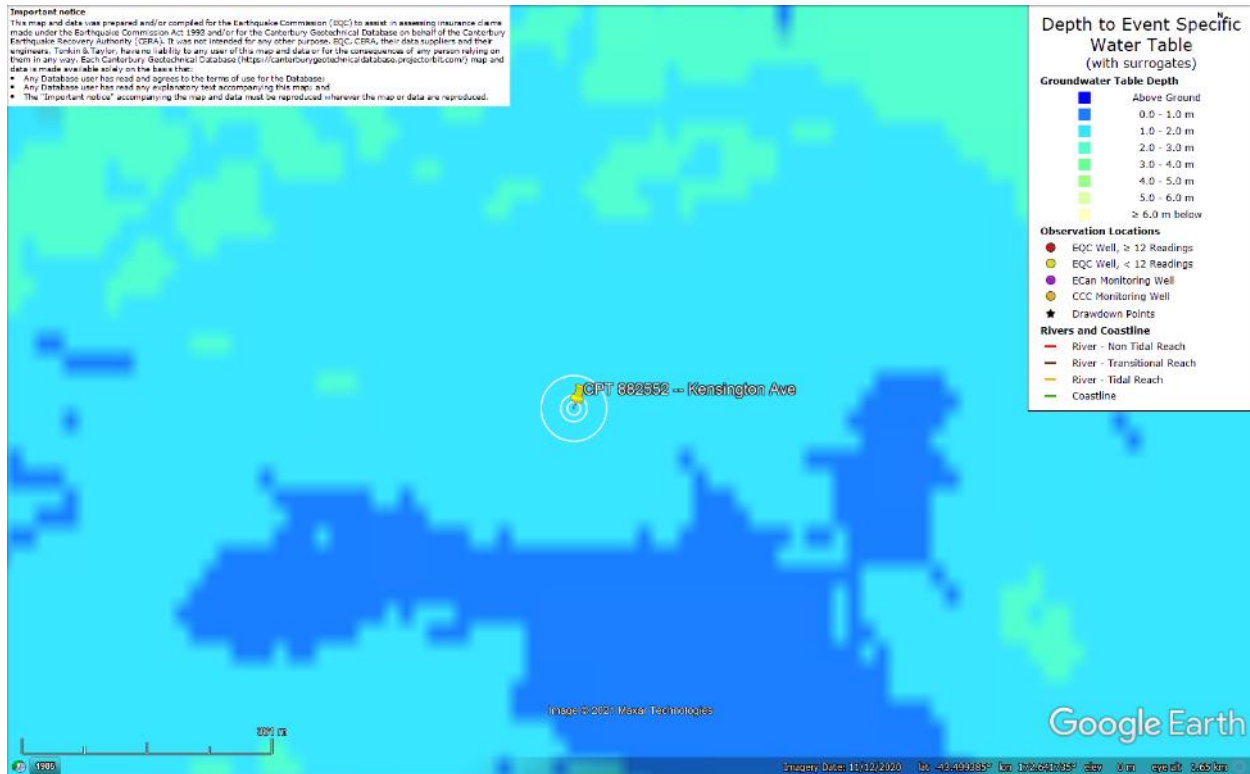
Figure 42: Depth to groundwater table for Dec-11 EQ.

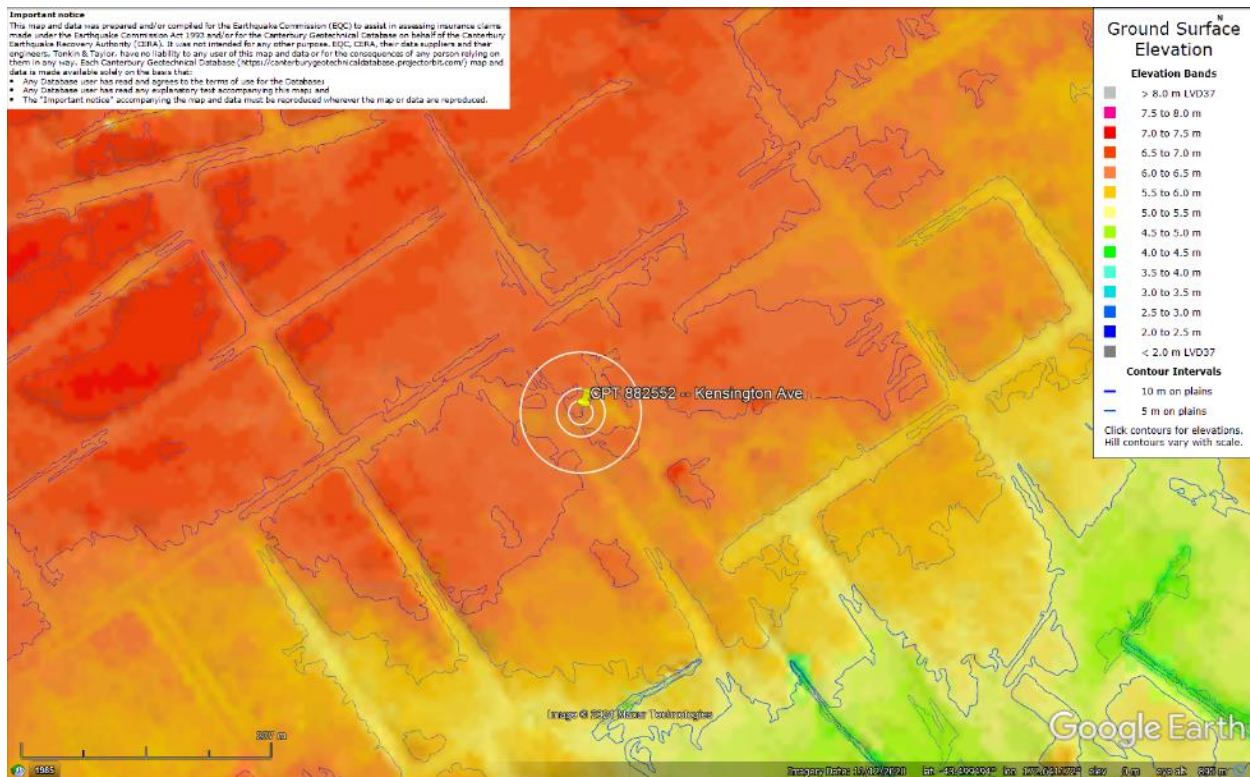
Figure 43: Ground surface elevation according to the Sep-11 LiDAR survey.

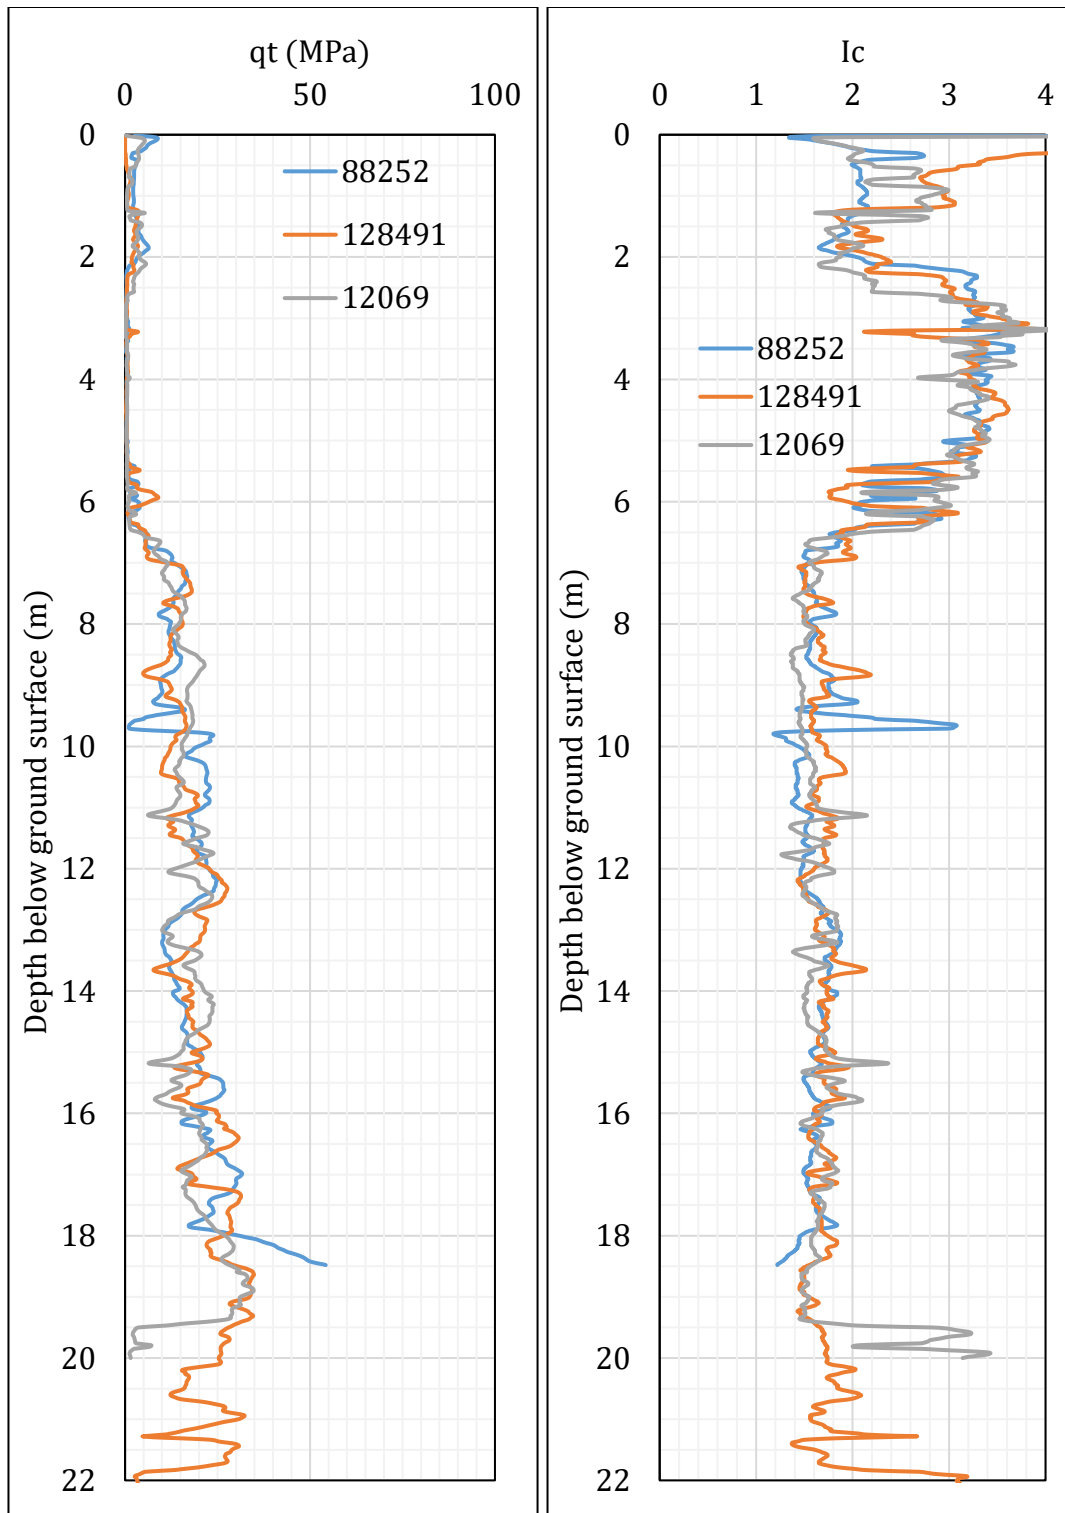
Figure 44: q_t and I_c profiles.

Notes: CPT 12069 does not have pore water pressure measurements; It is assumed that the volumetric settlement below the 18-m depth is negligible for CPT 88252.

Note 5: Based on the borehole log (BH 49090, Figure 1), the groundwater table is at a depth of 1.0 m below the ground surface. Below asphalt, gravelly fill, and silty fill that extend to a depth of 0.4 m, the soil profile consists of (1) fine silty sand, SM, to a depth of 2.5 m, (2) sandy silt, ML, to a depth of 2.9 m, (3) peat, Pt, to a depth of 3.9 m, (4) organic silt, OL, to a depth of 5.6 m, (5) fine silty sand, SM, to a depth of 5.8 m, and (6) sandy silt, ML, to a depth of 6.4 m (the end of the borehole). These soil layers are the Yaldhurst members of the Springston formation. According to BH 154639, a borehole log that is ~ 80 m to the NE from the center of the site, the ML layer is underlain by (7) silty sand, SM, to a depth of 15.65 m (the end of the borehole). Trace shell fragments are found below a 10.6-m depth.
