Appendix A.5:

70 Langdons Rd – VsVp 57142

Liquefaction Ejecta Case Histories for 2010-11 Canterbury Earthquakes

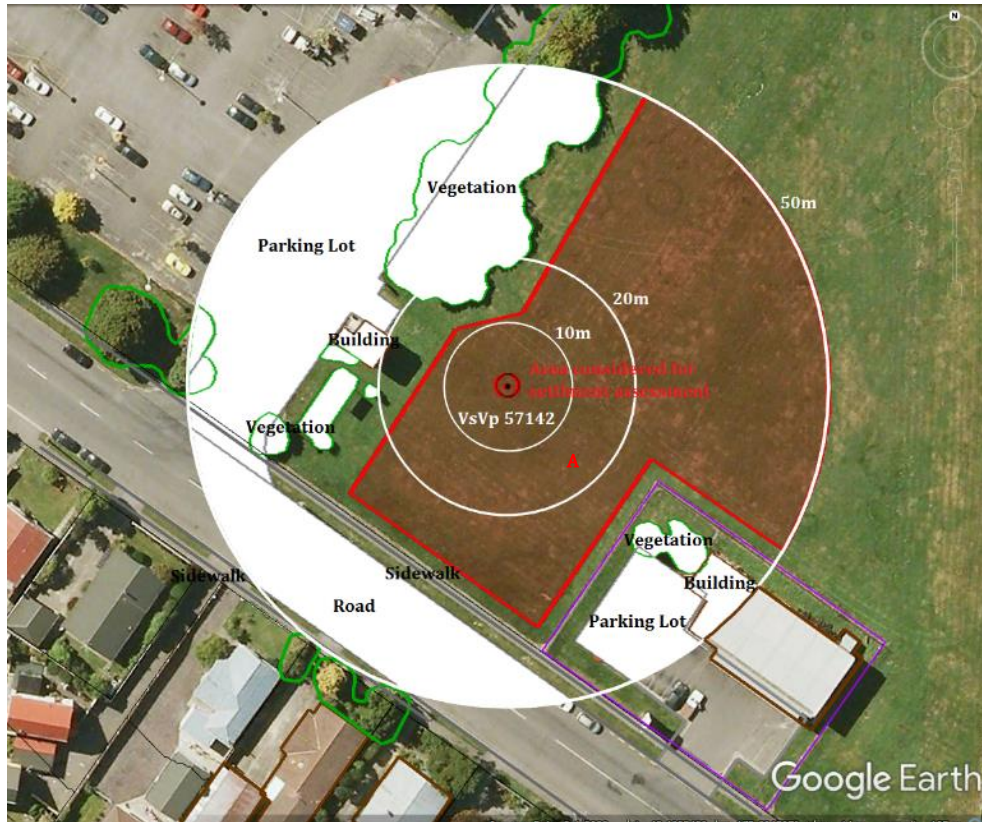
Figure 1: Site plan with areas where LiDAR survey data is considered.

Note 1: The area selected for settlement assessment (Patch A) is free of vegetation, structures, anthropogenic changes, and other important factors that have the potential to influence LiDAR measurements.

where $A_{E,thick,i}$ and $H_{E,thick,i}$ are the area and the height of a thick ejecta layer, respectively, $A_{E,thin,j}$ and $H_{E,thin,j}$ are the area and the height of a thin ejecta layer, respectively, and A_T is the total assessment area for a buffer being considered (Figure 1). The $A_{E,thick,i}$ and $A_{E,thin,i}$ are contained within the buffer.

Note 8: The selection of CPTs for the area considered for settlement assessment (Figure 1) is based on the proximity of the CPTs to the considered areas. In accordance with that, the following table shows CPTs that were used for the volumetric settlement analysis in *Cliq v.3.0.3.2*, a CPT soil liquefaction software developed by GeoLogismiki. (The average volumetric settlements were reported in Table 8.)

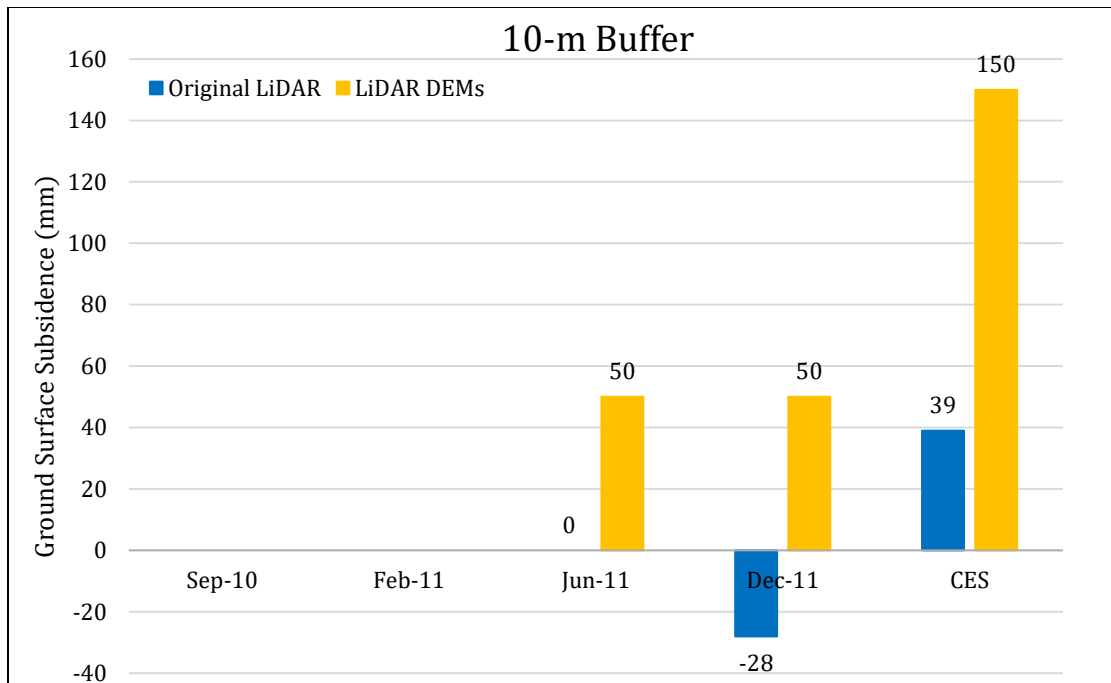
Figure 2: Comparison between ground surface subsidence determined from original LiDAR survey points and ground surface subsidence (50th %ile) estimated using LiDAR DEMs for the 10-m buffer.

Note 2: The ground surface subsidence values determined from original LiDAR survey points are fairly similar to the ground surface subsidence values estimated using LiDAR DEMs for Jun-11 Earthquake, Dec-11 Earthquake, and the CES.

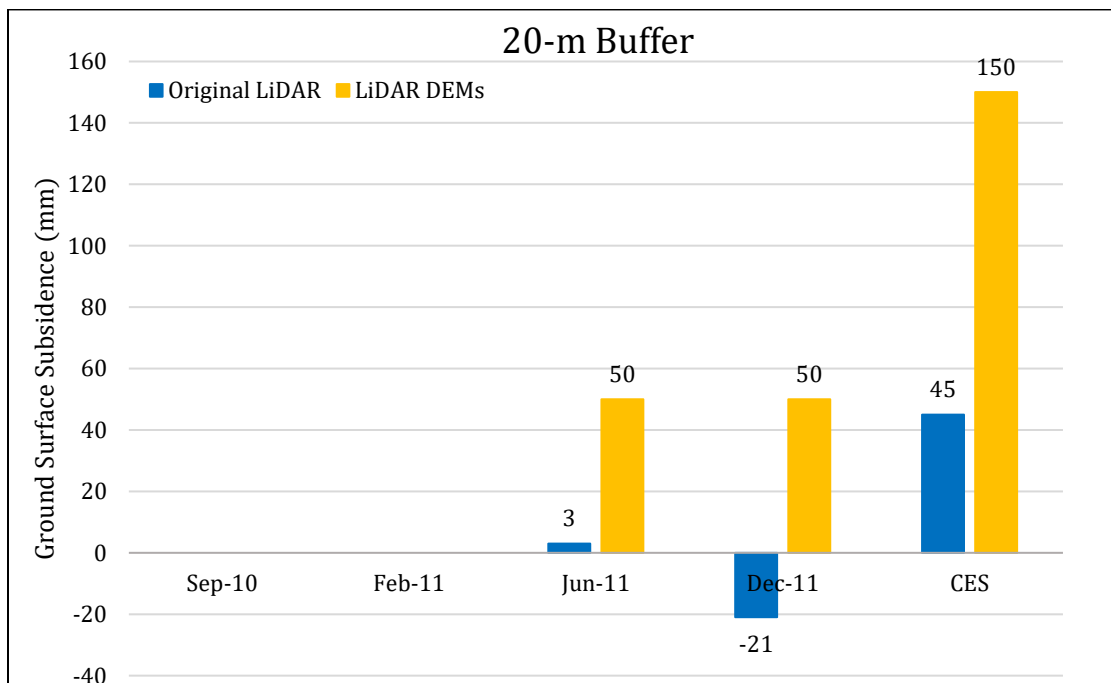
Figure 3: Comparison between ground surface subsidence determined from original LiDAR survey points and ground surface subsidence (50th %ile) estimated using LiDAR DEMs for the 20-m buffer.

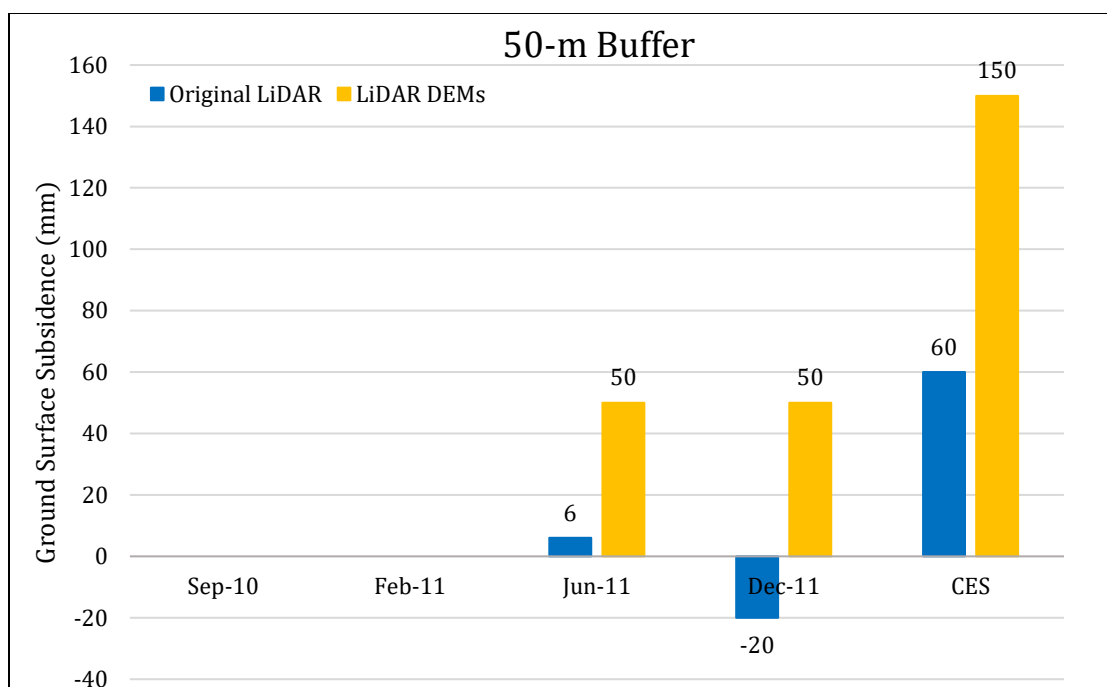
Figure 4: Comparison between ground surface subsidence determined from original LiDAR survey points and ground surface subsidence (50th %ile) estimated using LiDAR DEMs for the 50-m buffer.

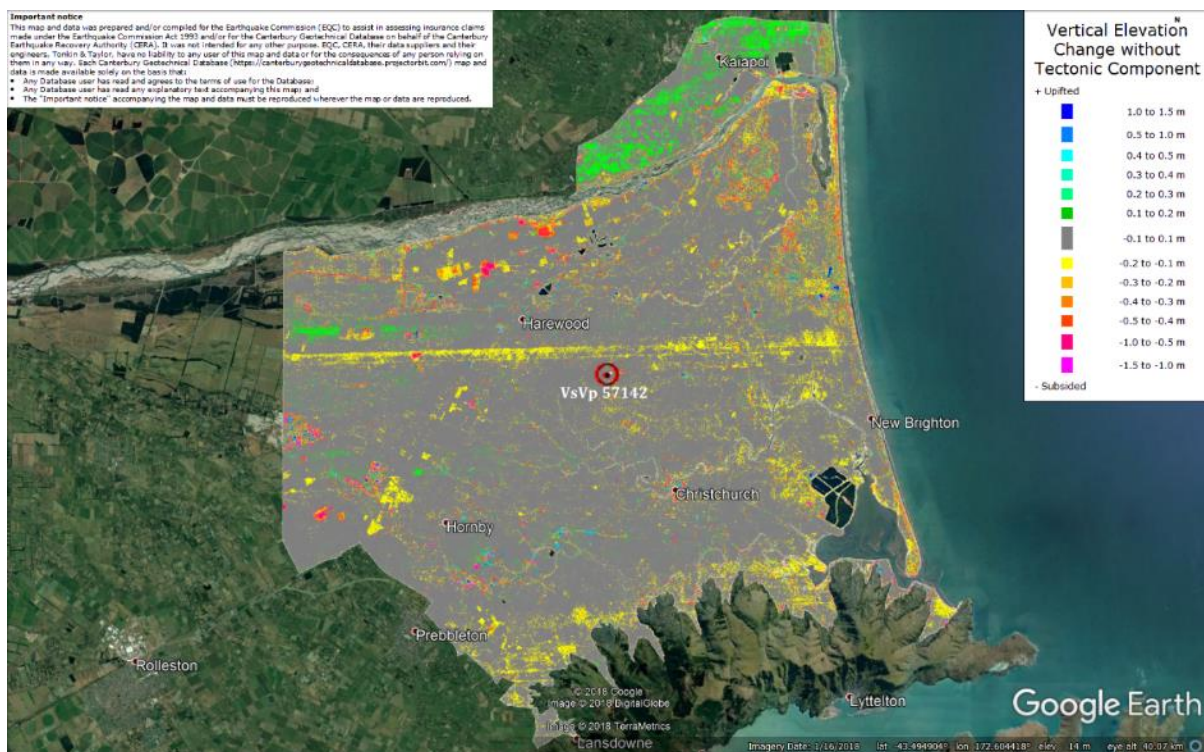
Figure 21: Vertical Ground Movements (Surface – Tectonic) for June 2011 Earthquake – the site is not in the apparent zone of overestimated or underestimated ground surface subsidence.

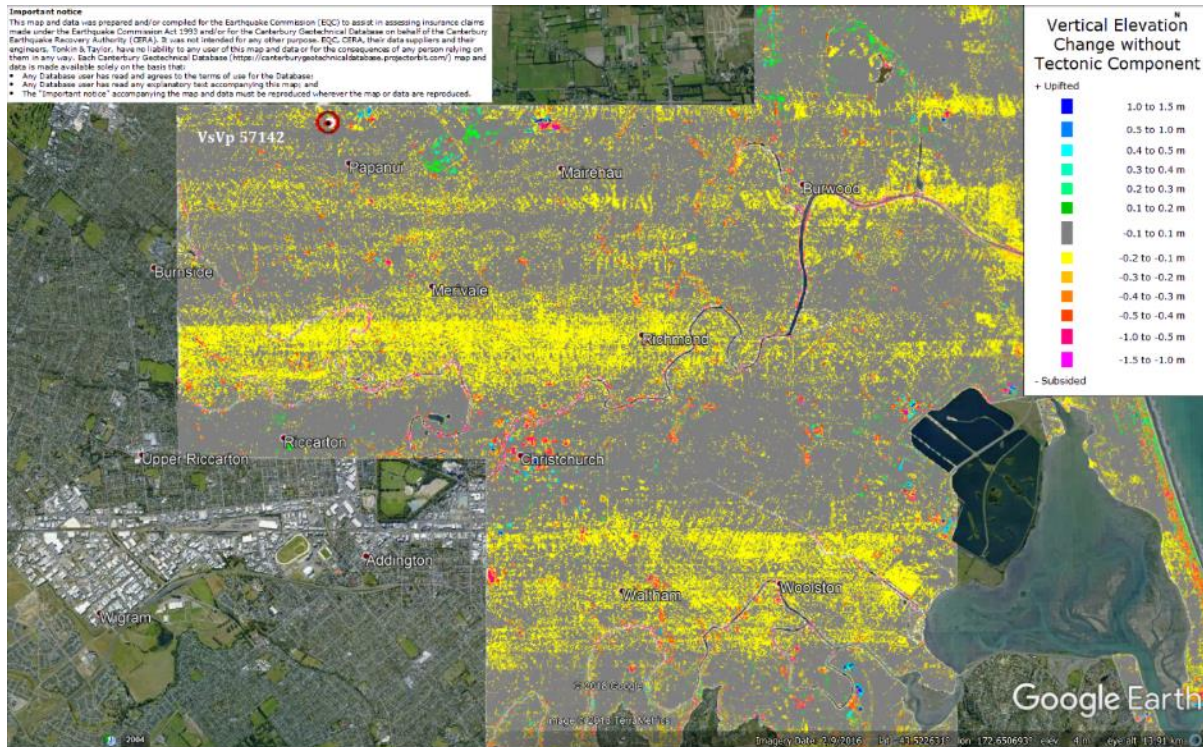
Figure 22: Vertical Ground Movements (Surface – Tectonic) for Dec 2011 Earthquake – the site is not in the apparent zone of overestimated or underestimated ground surface subsidence.

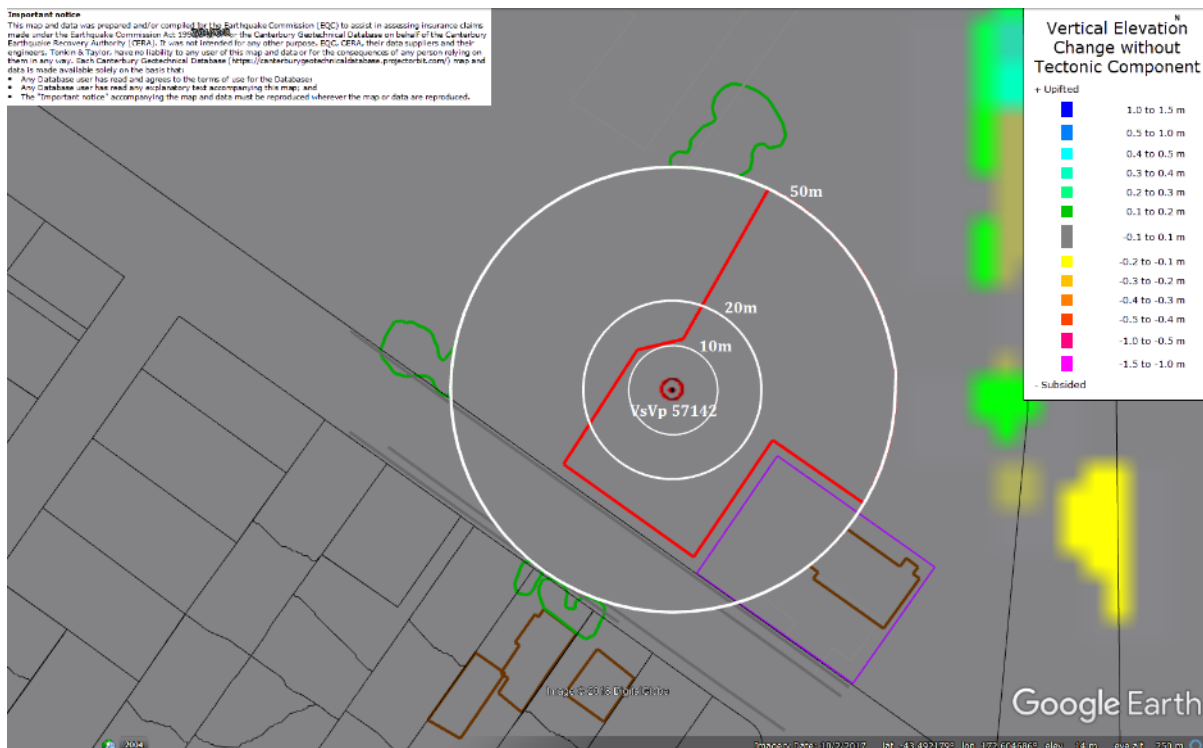
Figure 23: LiDAR DEM-based ground surface subsidence without tectonic component for Jun 2011 Earthquake.

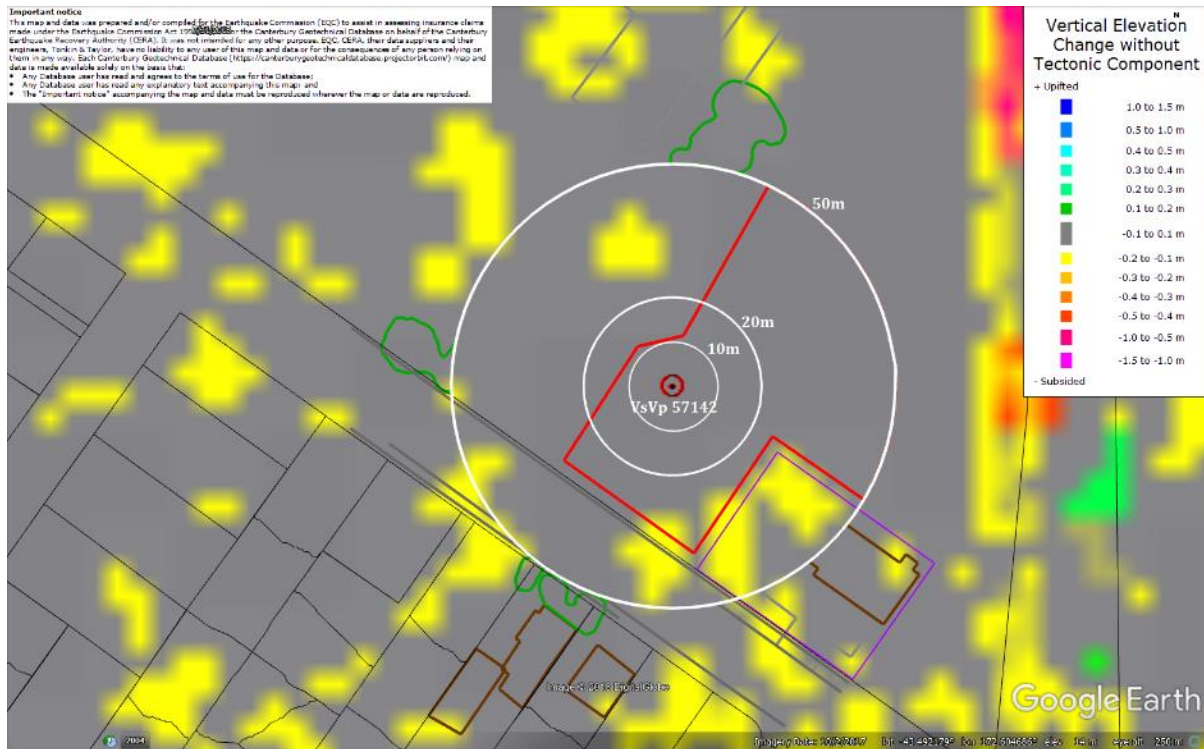
Figure 24: LiDAR DEM-based ground surface subsidence without tectonic component for Dec 2011 Earthquake.

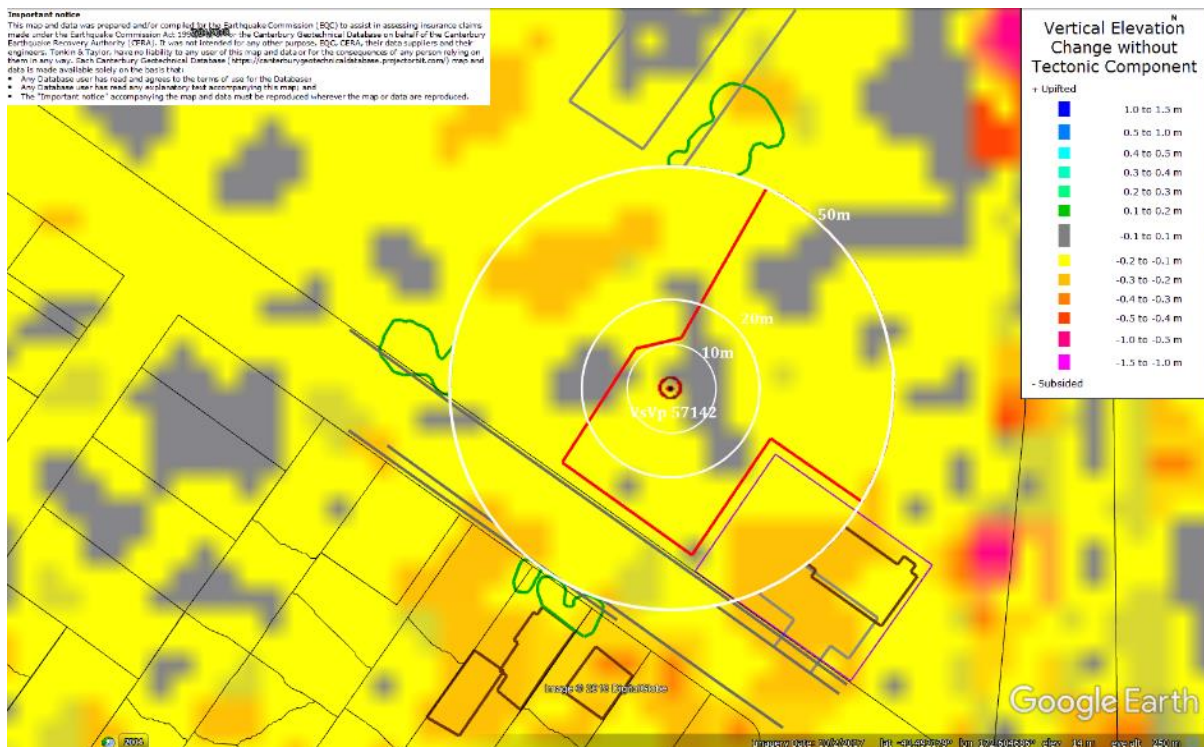
Figure 25: LiDAR DEM-based ground surface subsidence without tectonic component for CES.

Note 6: LiDAR DEM-based ground surface subsidence without tectonic component is not available for Sep 2010 and Feb 2011 earthquake events. The available LiDAR surveys for this site are dated to Jun 2003, May 2011, Sep 2011, and Feb 2012.

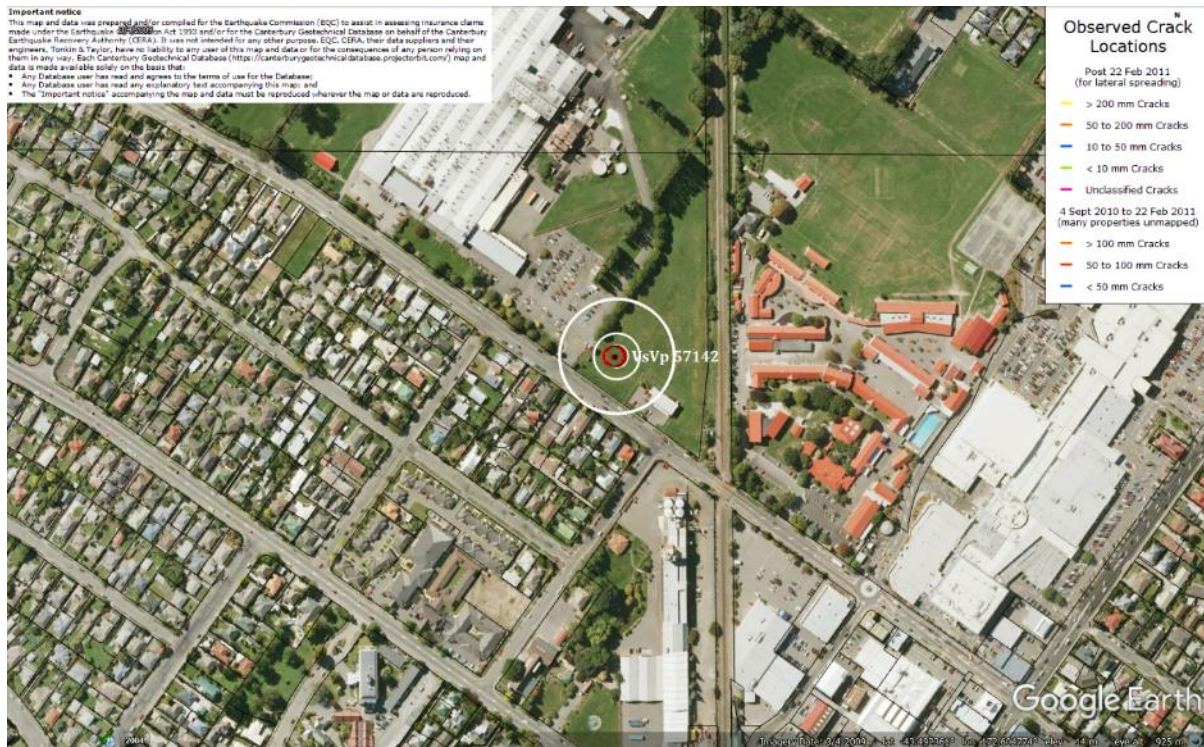
Figure 26: Absence of ground cracks indicating no lateral spreading for Canterbury Earthquake Sequence.

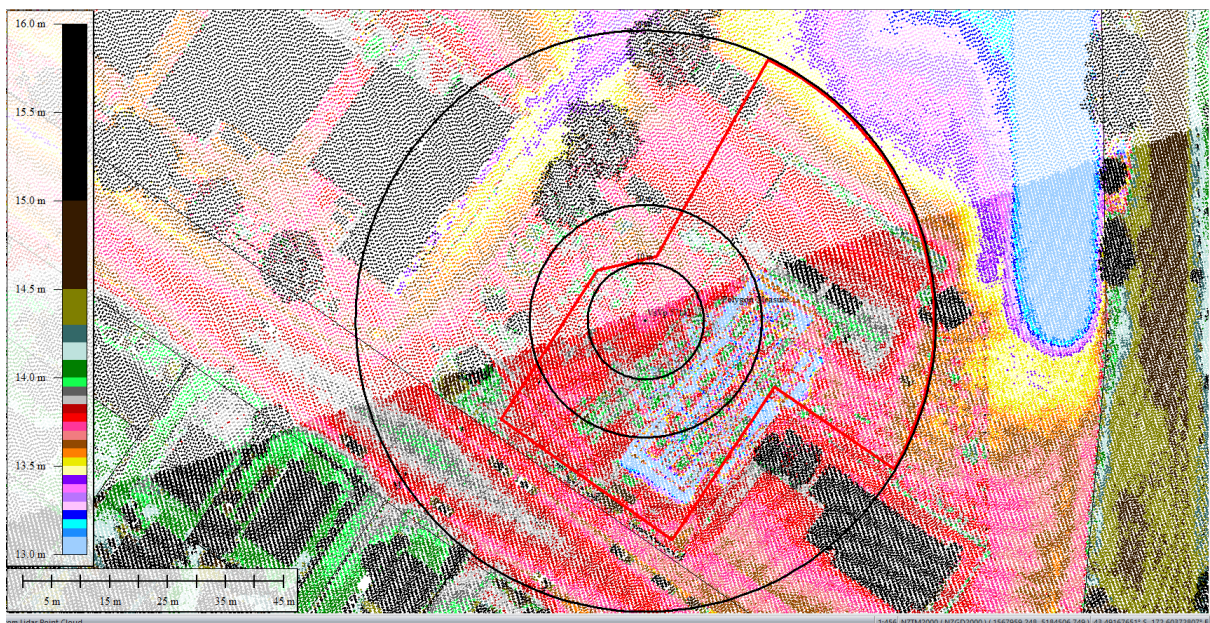
Figure 48: Oct 2015 LiDAR survey (note the change in ground surface elevation due to construction).

Notes: Buffer is the area within a circle of a specified radius with VsVp investigations done at its center (172.604872, -43.492195); Oct 2015 LiDAR survey is excluded from the settlement analysis due to the anthropogenic changes.

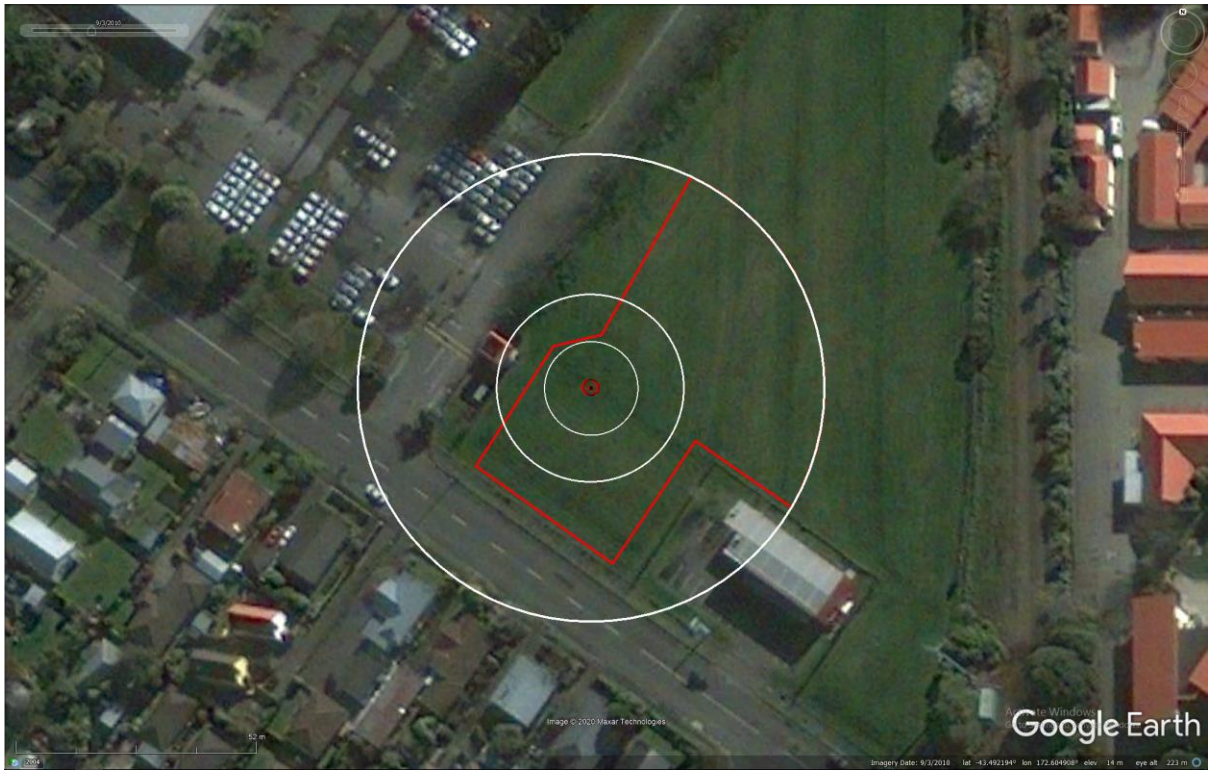
Figure 49: Absence of ejecta for Sep-10 EQ; evidence No. 1 – satellite image.

Note 4: The values in Table 9 are based on aerial photographs (Figures 49, 50, and 52) and liquefaction interpreted from aerial photographs and observations made by inspection teams (Figures 51, 53, and 54). The ejecta-induced settlement using photographs and engineering judgment, $S_{E,P}$, is estimated as

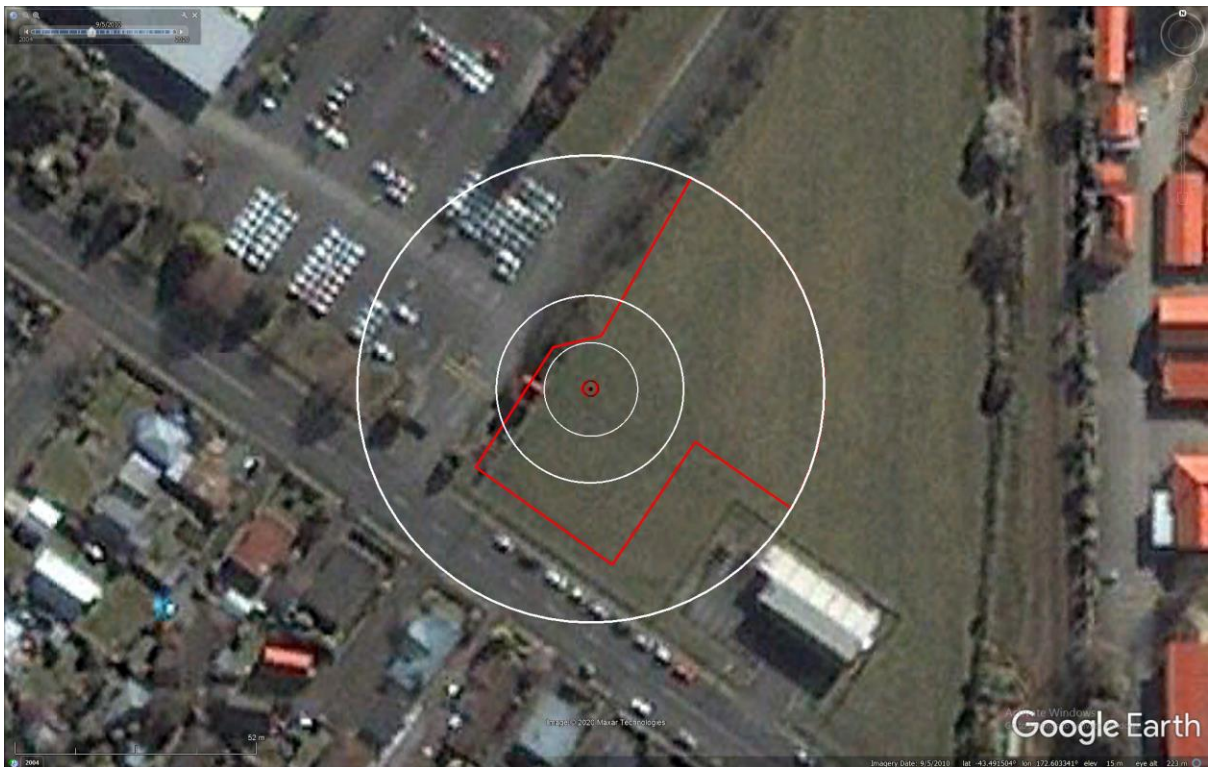
Figure 50: Absence of ejecta for Sep-10 EQ; evidence No. 2 – satellite image.

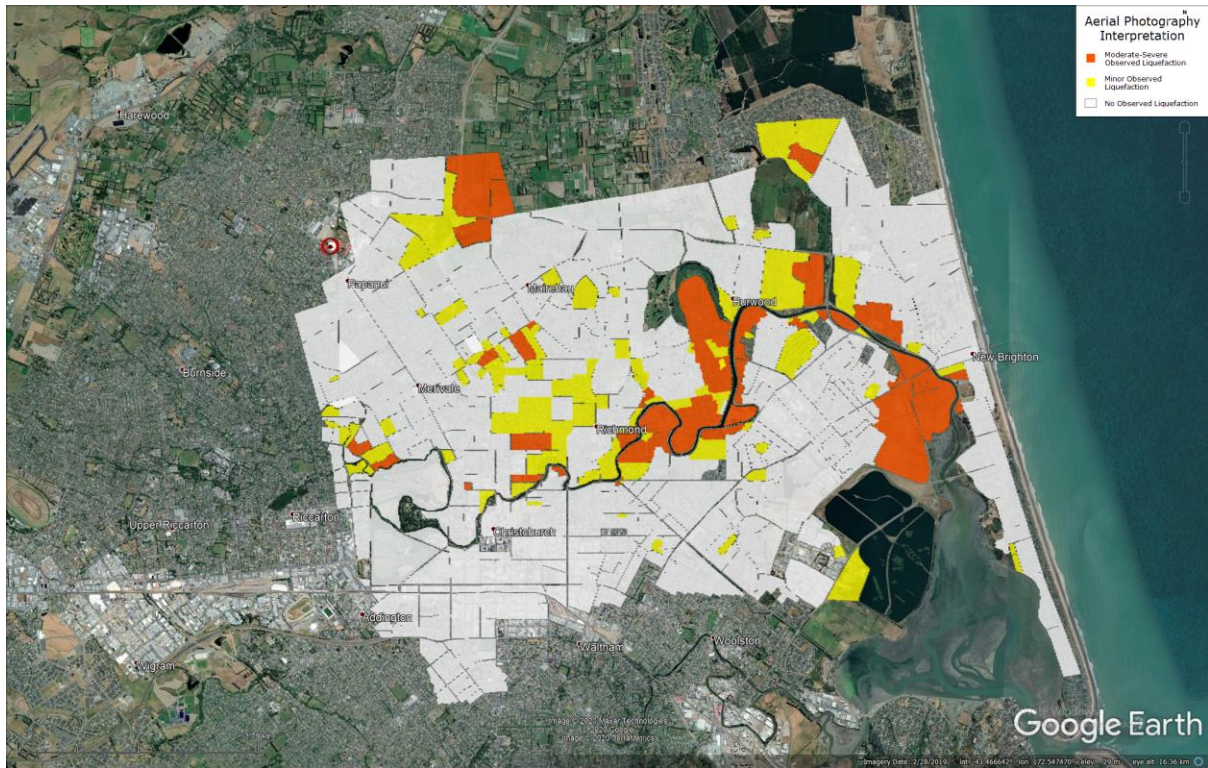
Figure 51: Liquefaction interpreted from aerial photograph for Sep-10 EQ.

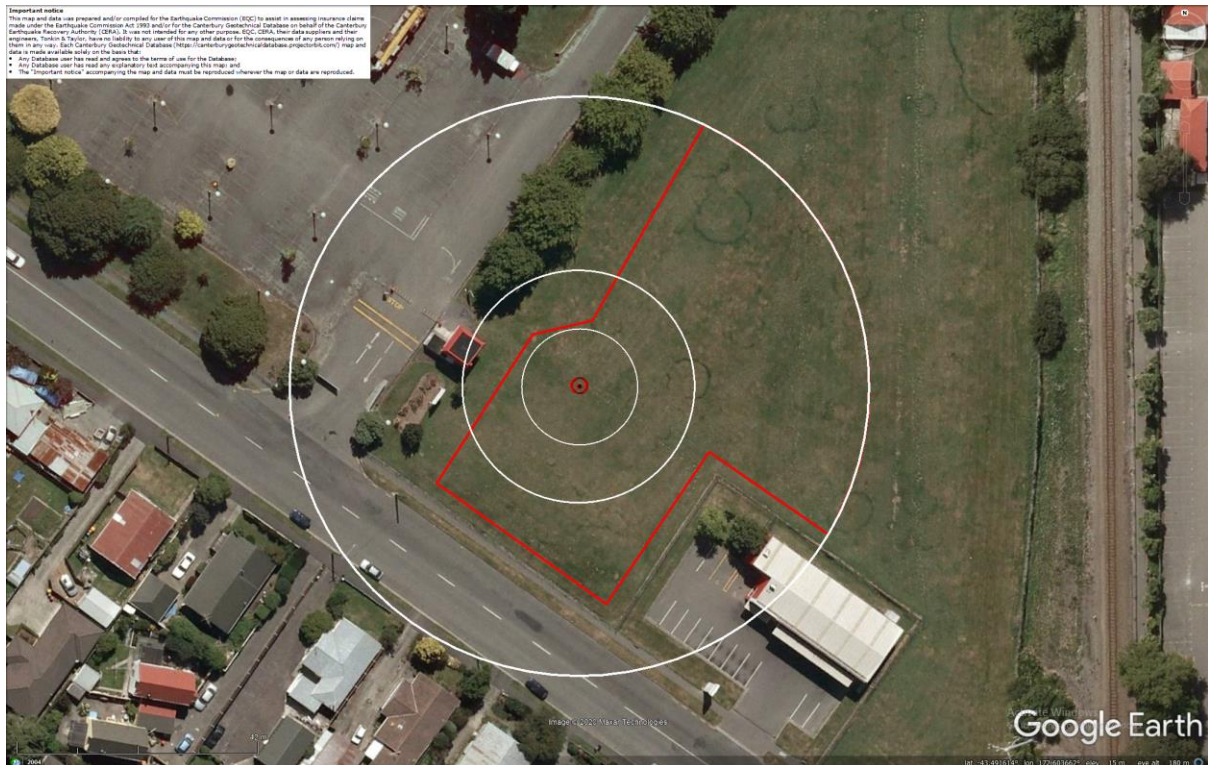
Figure 52: Absence of ejecta for Feb-11 EQ.

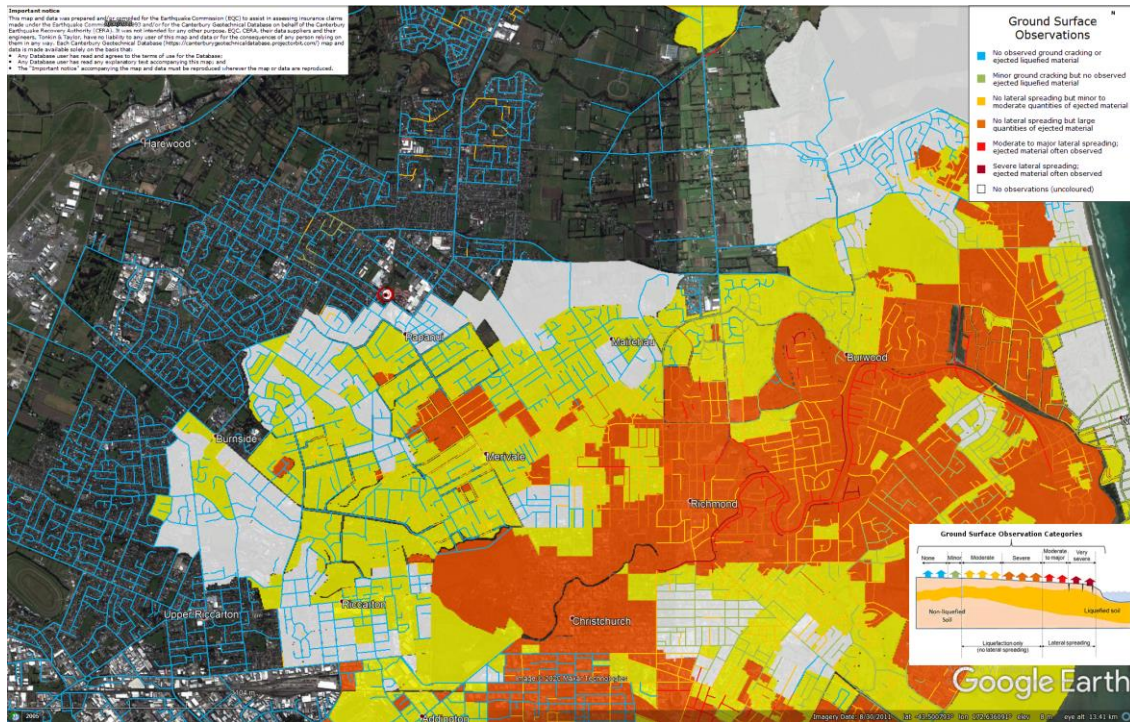
Figure 53: Liquefaction interpretation from aerial photograph and observations made by inspection teams for Jun-11 EQ.

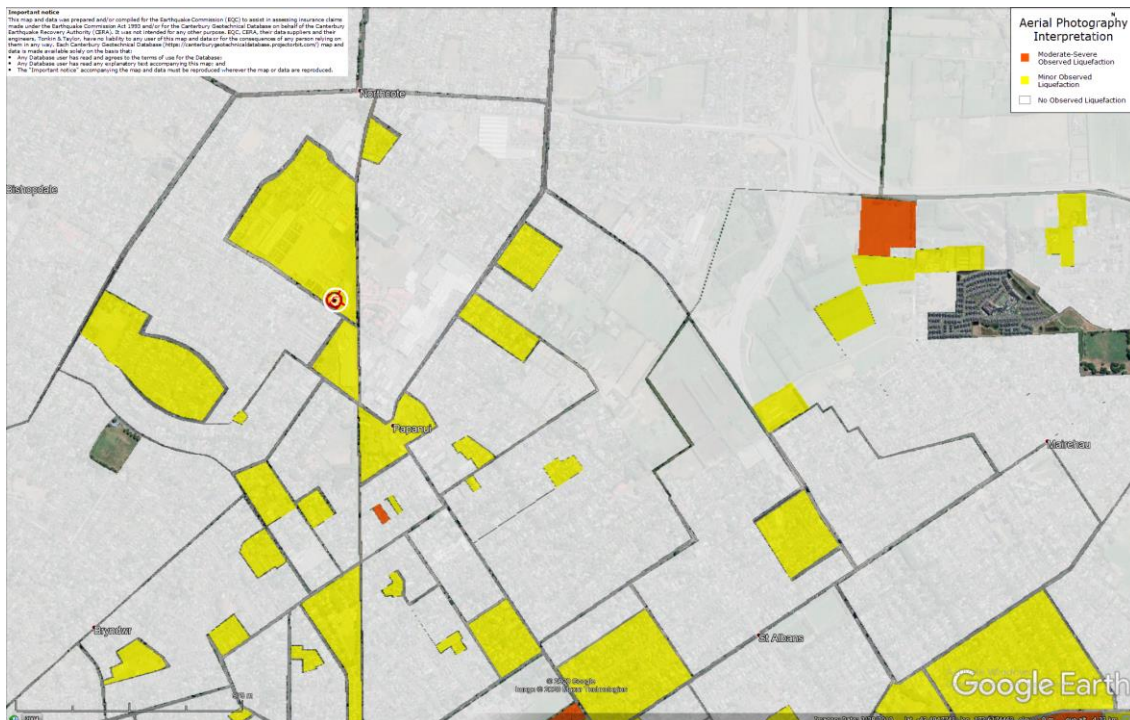
Figure 54: Liquefaction interpretation from aerial photograph for Dec-11 EQ but lack of evidence (e.g., EQC report, aerial and/or ground images) to support minor liquefaction at the site.

or ground photograph for the site for the Jun-11 earthquake, only on-foot rapid inspection of Langdons Rd for liquefaction manifestation at the ground surface following the earthquake. For the Dec-11 earthquake, Figure 54 shows “liquefaction interpreted from aerial photography” as minor even though there is no actual aerial photograph for the site to support the claim. There is also no LDAT property inspection report or ground photographs for the Dec-11 earthquake. However, the seismic demand on the soil profile during the Dec-11 event is not significantly different than that during the Jun-11 event or worse than those during the Sep-10 and Feb-11 events; thus, it is reasonable to assume that the Dec-11 did not cause ejecta at the site.

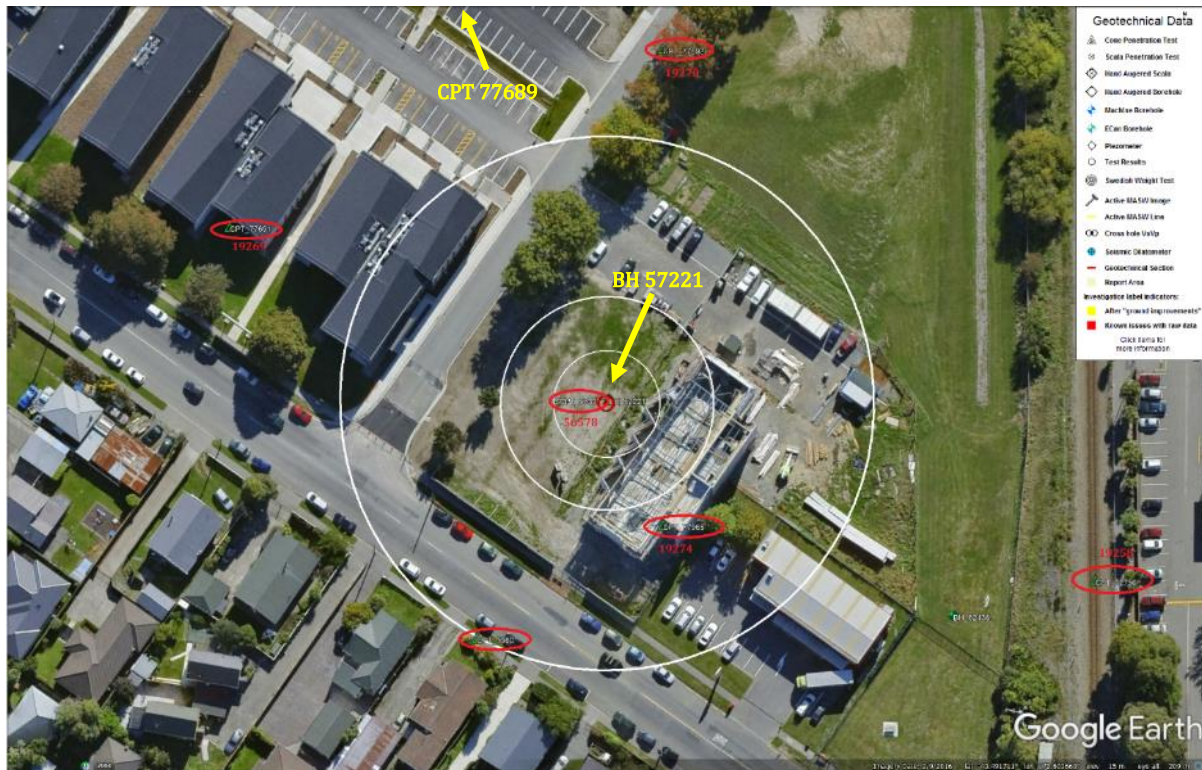
Figure 55: CPT locations.

Note 9: Based on the borehole log (BH 57221, Figure 55), the groundwater table is at a depth of 2.3 m below the ground surface. The soil profile consists of (1) topsoil to a depth of 0.35 m, (2) fine sand, SP, to a depth of 1.0 m, (3) silt, ML, to a depth of 2.3 m, (4) fine to medium sand, SP, to a depth of 6.55 m, (5) silt, ML, to a depth of 12.35 m, (6) sandy fine to coarse gravel, GW, to a depth of 15.0 m, and (7) fine to medium sand, SP, to a depth of 15.65 m (the end of the borehole). All SP, ML, and GW layers are the Yaldhurst members of the Springston formation. The nearby borehole (BH 62436, Figure 55) suggests that an ML layer of the Christchurch formation follows to a depth of roughly 19 m and is succeeded by Riccarton gravel to a depth of 21.75 m (the end of the borehole).

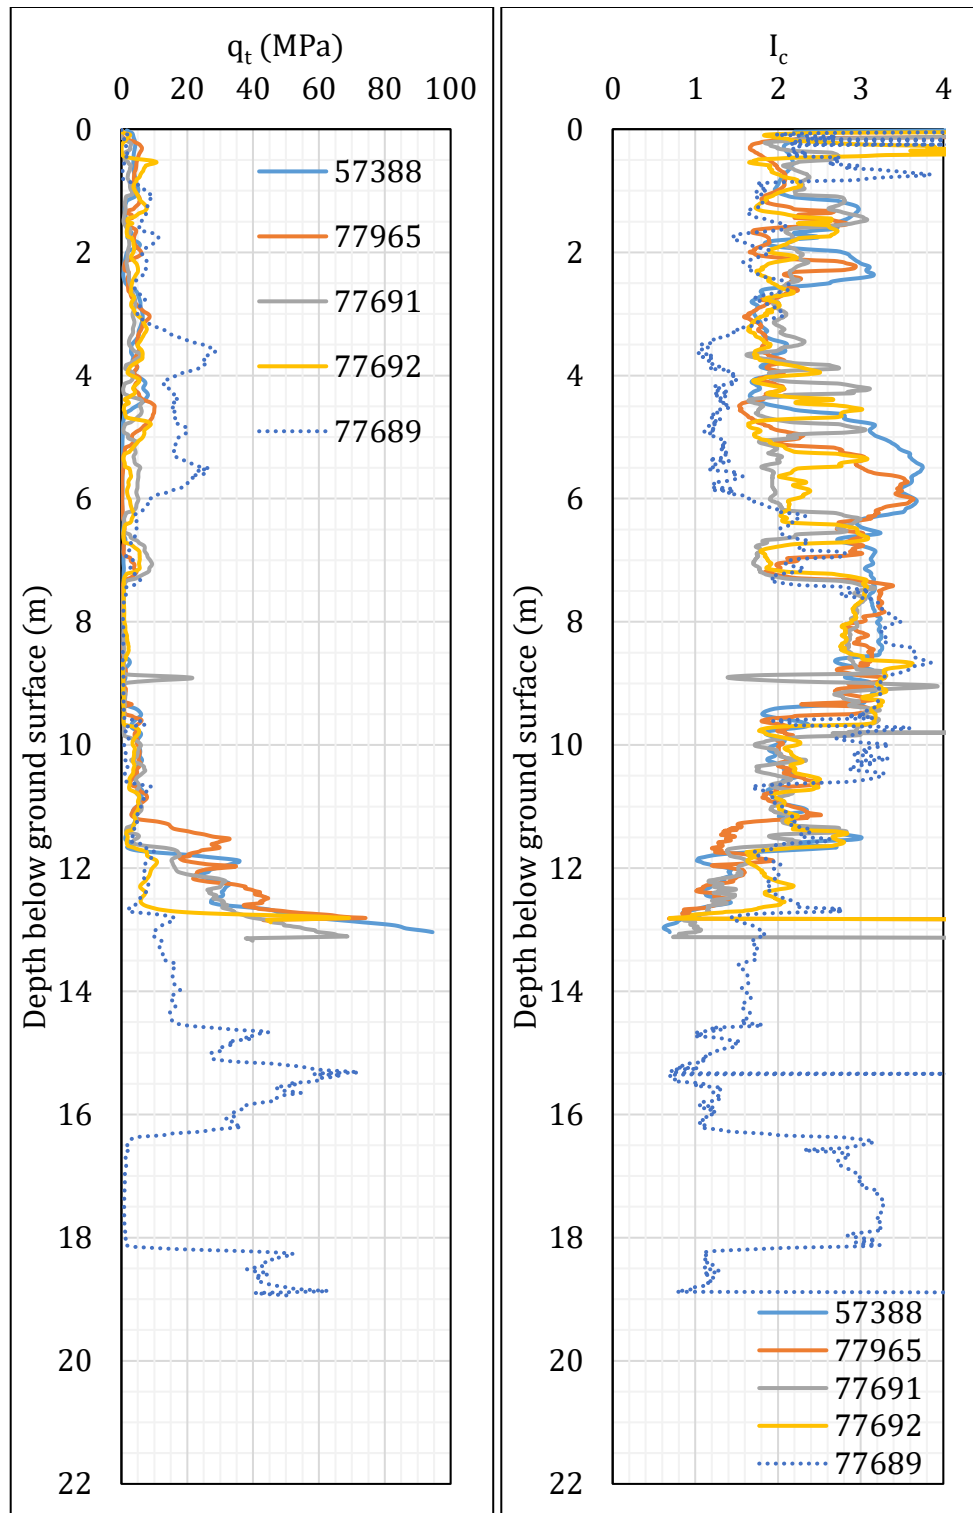
Figure 65: q_t and I_c profiles.
