Appendix A.9:

Vangelis Ln and Fernbrook Pl – CPT 49582

Liquefaction Ejecta Case Histories for 2010-11 Canterbury Earthquakes

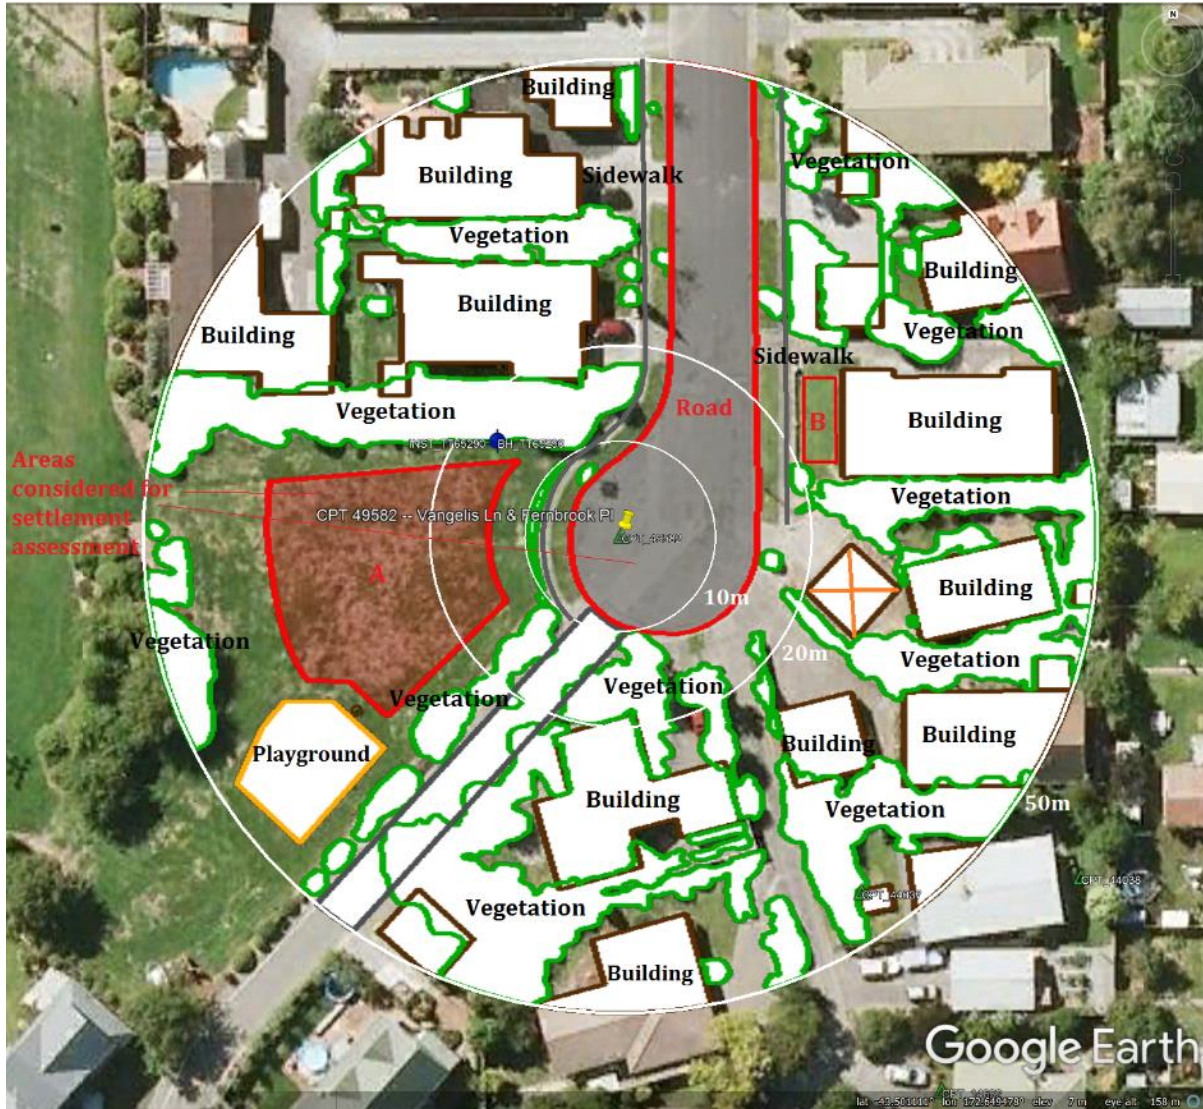
Figure 1: Site plan with areas where LiDAR survey data is considered.

Note 1: Two patches (outlined in red) in free field were initially selected for settlement assessment as areas free of vegetation and structures. Further analyses revealed that Patch A is closer to a CPT than Patch B and has borehole investigations done in its proximity. Hence, Patch A was selected for detailed settlement assessment while Patch B was discarded in detailed settlement assessment. In addition, since significant amounts of ejecta were observed on roads in the CES, Road was considered for settlement assessment. Roads as hard, relatively flat surfaces provide many ground-classified points. Therefore, it is useful to compare settlement estimates on roads with settlement estimates for the patch.

Note 7: The selection of CPTs for the area considered for settlement assessment (Figure 1) is based on the proximity of the CPTs to the considered areas. In accordance with that, the following table shows CPTs that were used for the volumetric settlement analysis in *Cliq v.3.0.3.2*, a CPT soil liquefaction software developed by GeoLogismiki. (The average volumetric settlements were reported in Table 8.)

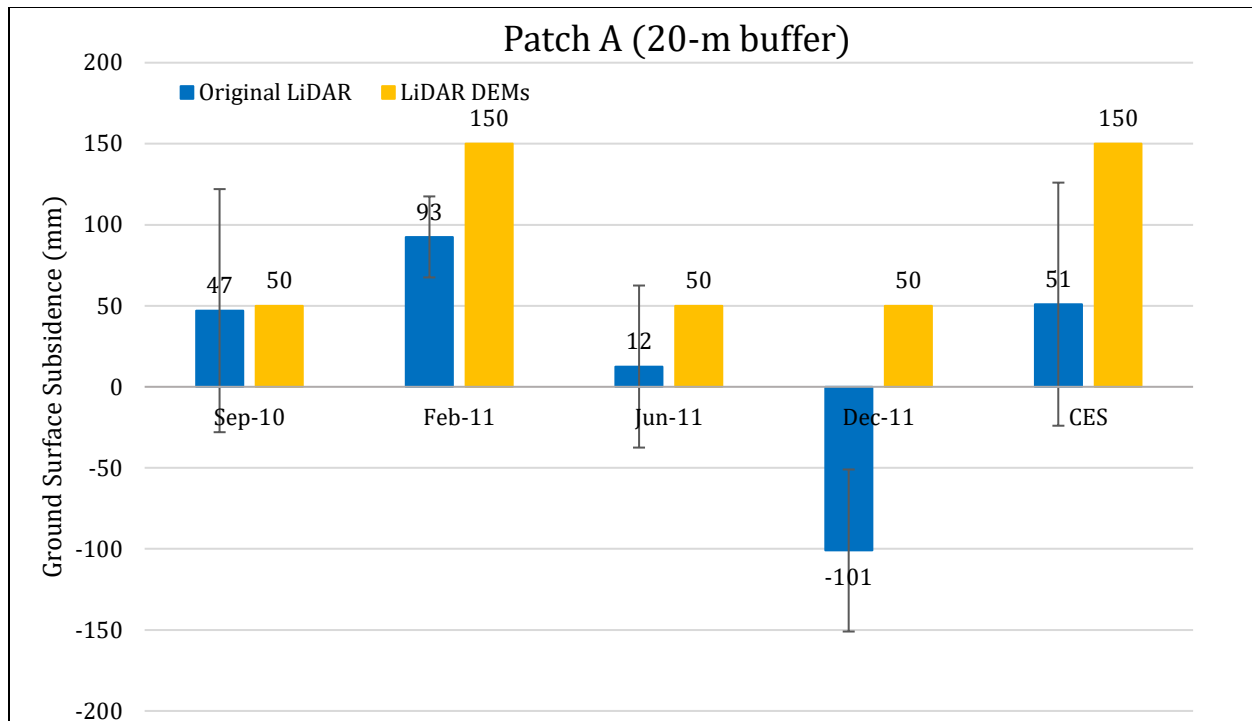
Figure 2: Comparison between ground surface subsidence determined from original LiDAR survey points and ground surface subsidence (50th %ile) estimated using LiDAR DEMs for Patch A for the 20-m buffer.

Note 2: The ground surface subsidence values determined using the original LiDAR survey points are similar to the ground surface subsidence values estimated using the LiDAR DEMs for the Sep-10, Feb-11, and Jun-11 earthquakes, and the CES. The discrepancy between the two approaches is observed for the Dec-11 earthquake.

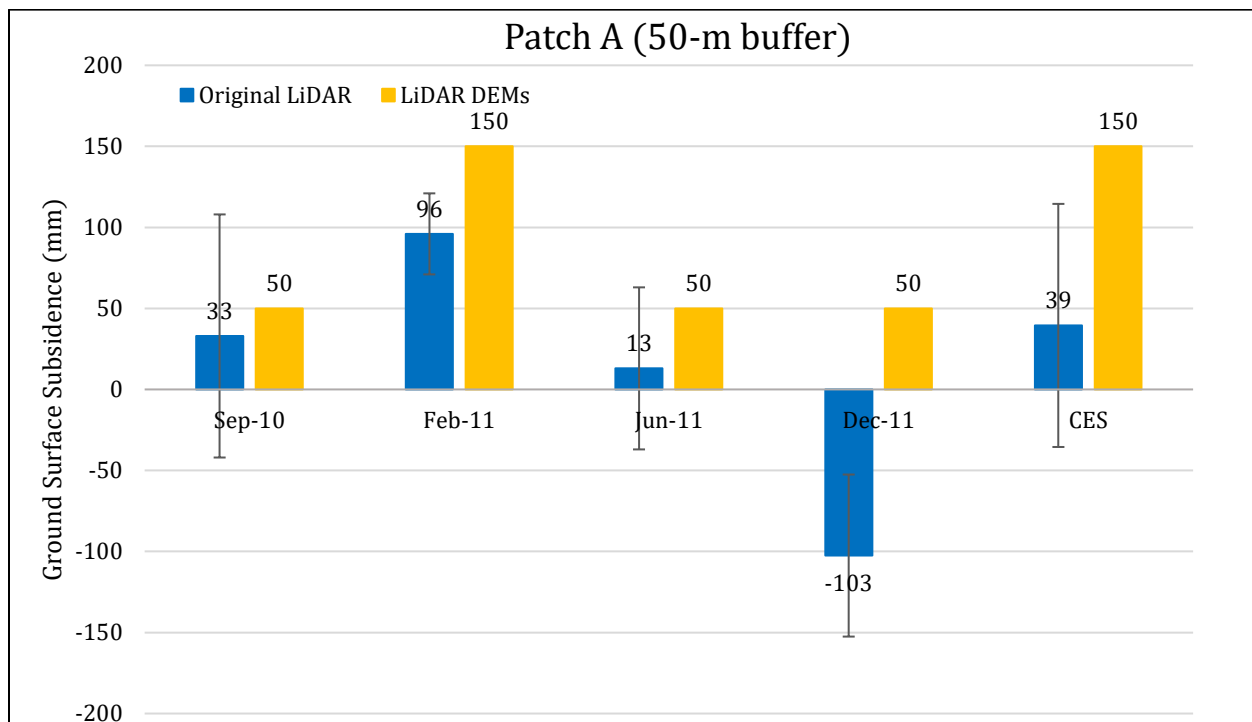
Figure 3: Comparison between ground surface subsidence determined from original LiDAR survey points and ground surface subsidence (50th %ile) estimated using LiDAR DEMs for Patch A for the 50-m buffer.

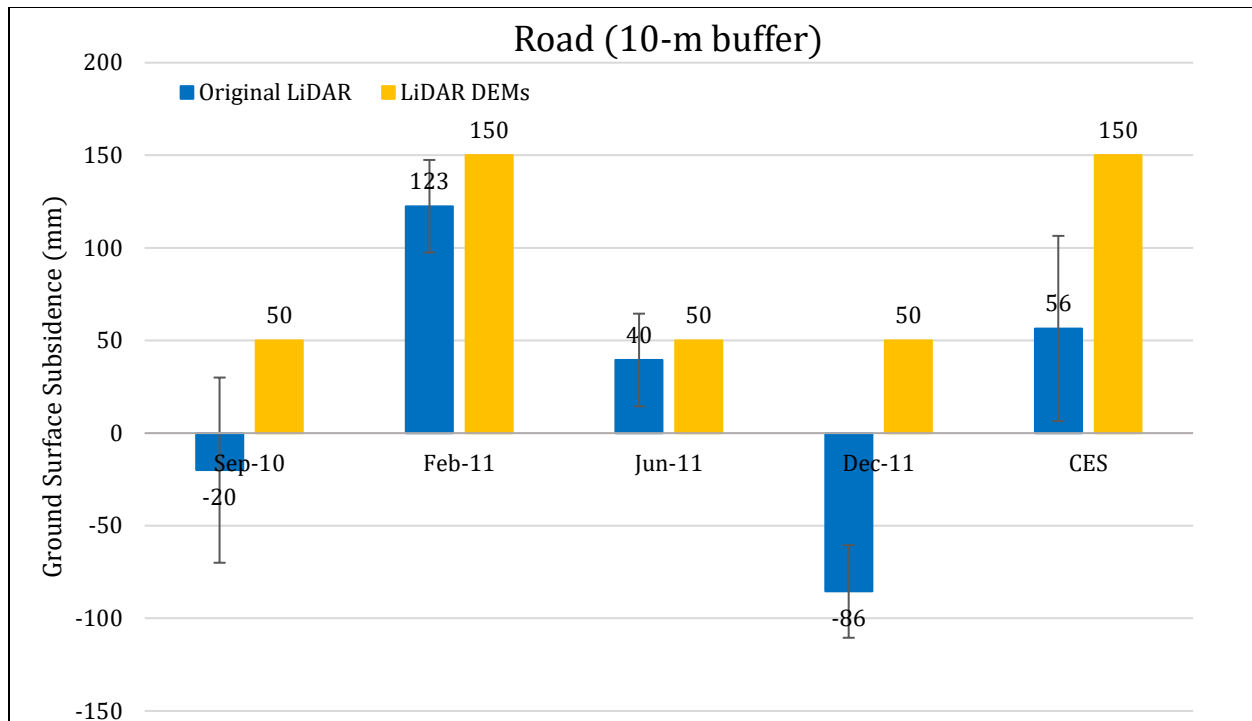
Figure 4: Comparison between ground surface subsidence determined from original LiDAR survey points and ground surface subsidence (50th %ile) estimated using LiDAR DEMs for Road for the 10-m buffer.

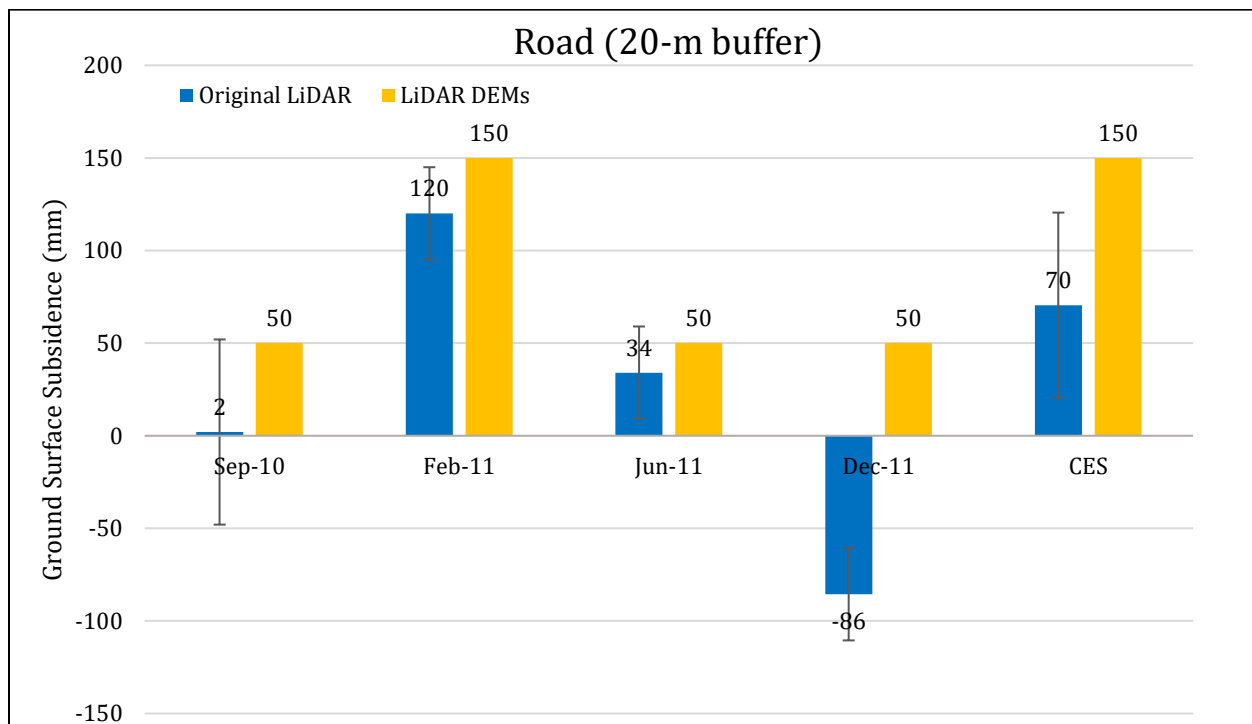
Figure 5: Comparison between ground surface subsidence determined from original LiDAR survey points and ground surface subsidence (50th %ile) estimated using LiDAR DEMs for Road for the 20-m buffer.

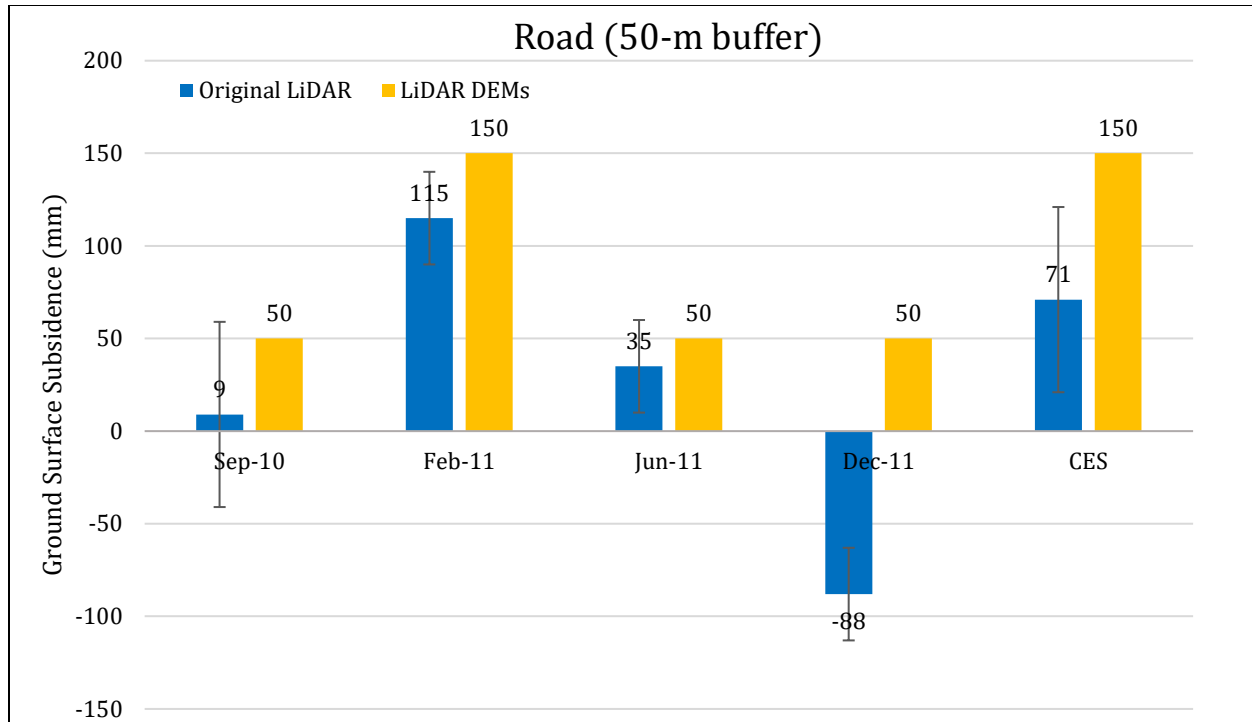
Figure 6: Comparison between ground surface subsidence determined from original LiDAR survey points and ground surface subsidence (50th %ile) estimated using LiDAR DEMs for Road for the 50-m buffer.

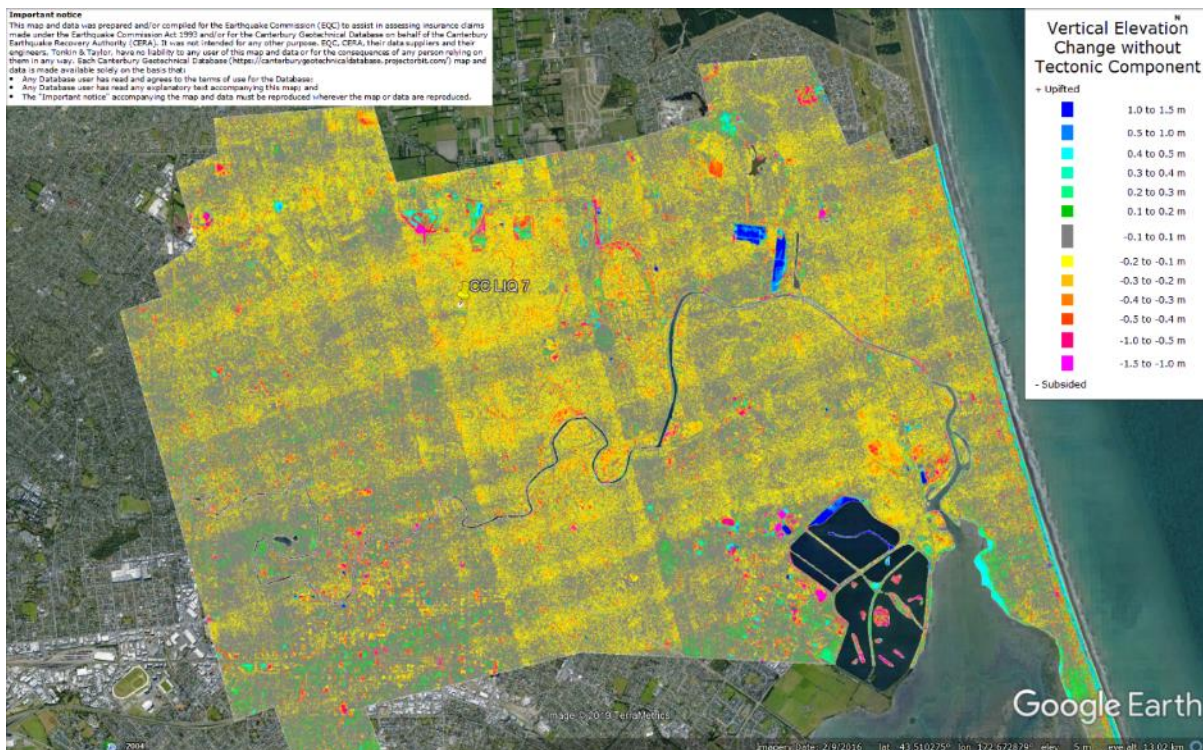
Figure 21: Vertical Ground Movements (Surface – Tectonic) for Sep 2010 Earthquake – the site is in the apparent zone of overestimated ground surface subsidence.

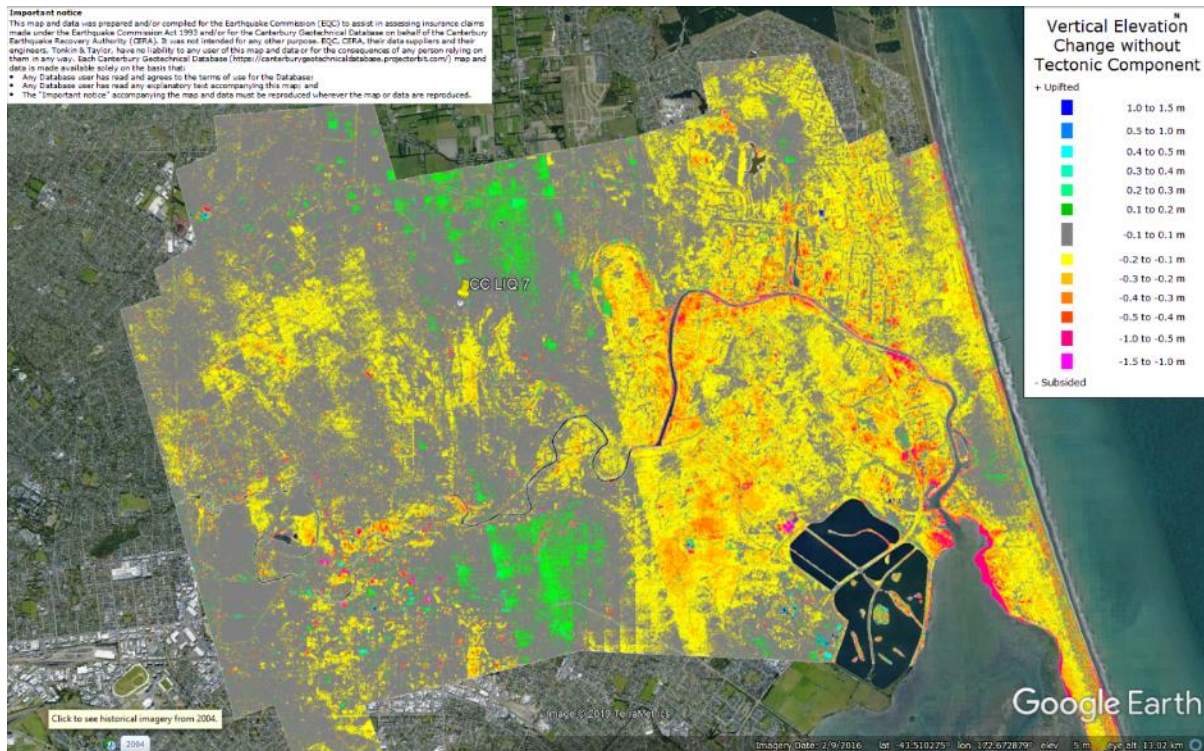
Figure 22: Vertical Ground Movements (Surface – Tectonic) for Feb 2011 Earthquake – the site is in the apparent zone of underestimated ground surface subsidence.

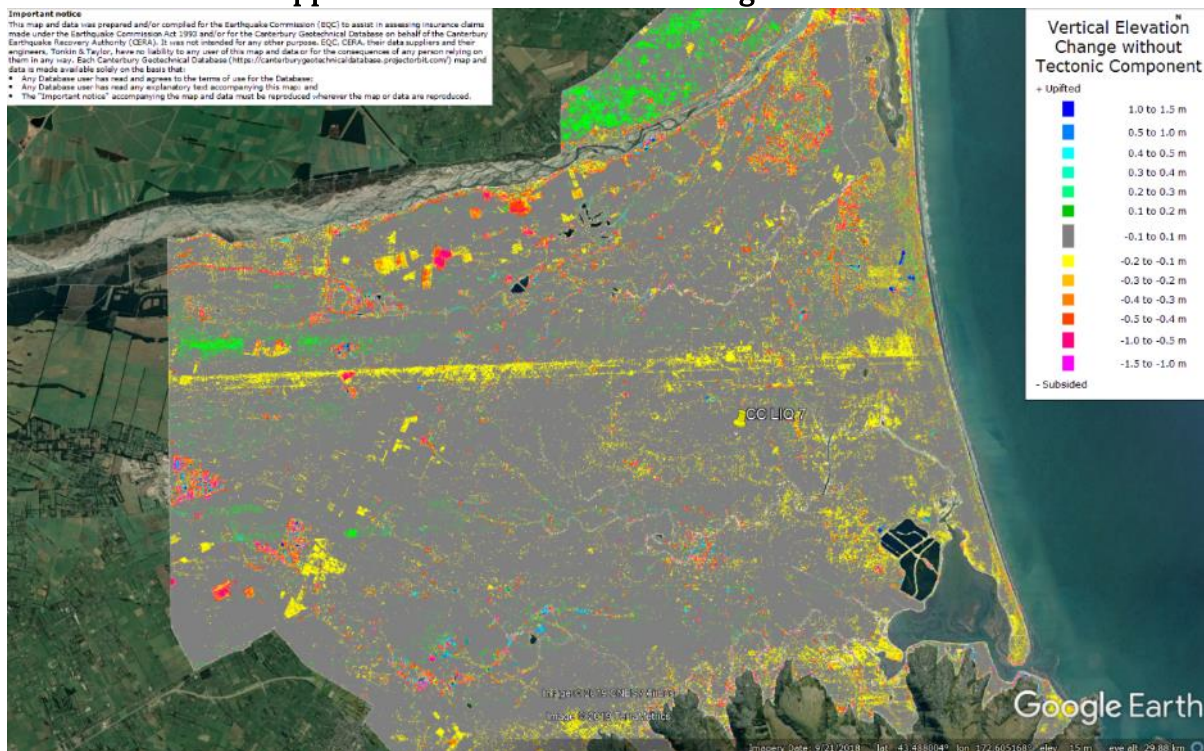
Figure 23: Vertical Ground Movements (Surface – Tectonic) for June 2011 Earthquake – the site is not in the apparent zone of overestimated or underestimated ground surface subsidence.

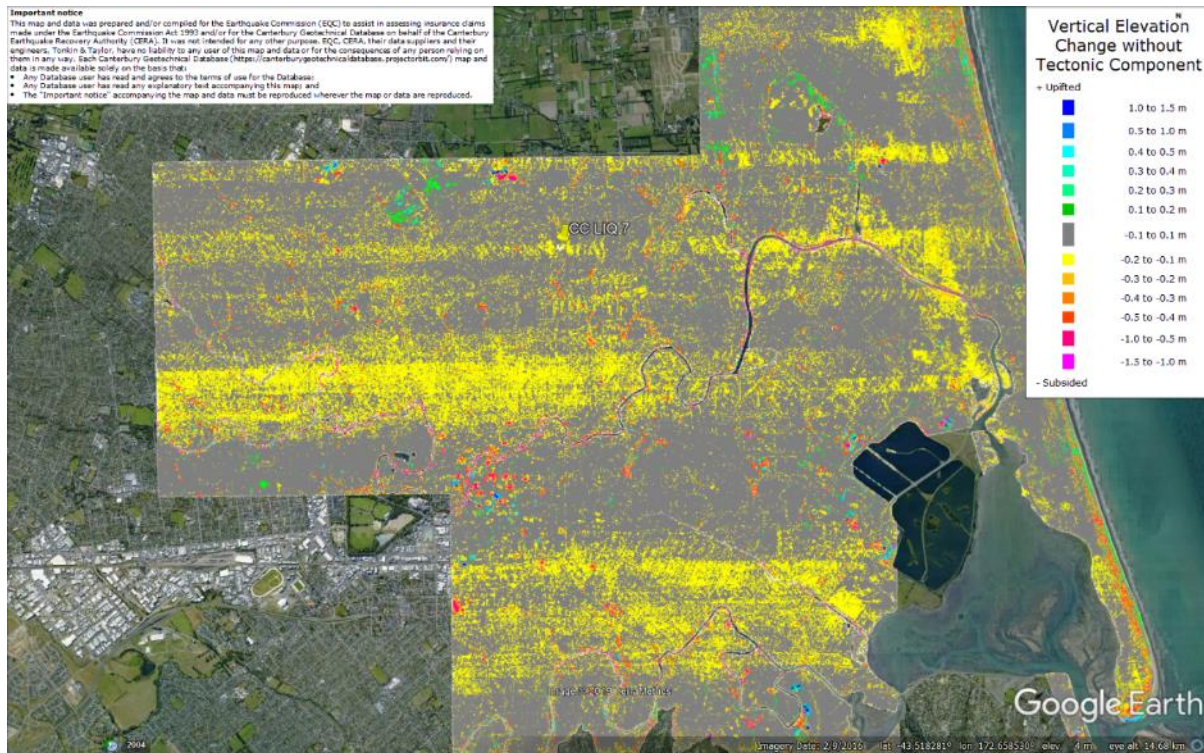
Figure 24: Vertical Ground Movements (Surface – Tectonic) for Dec 2011 Earthquake – the site is in the apparent zone of overestimated ground surface subsidence (i.e., Feb 2012 LiDAR flight error).

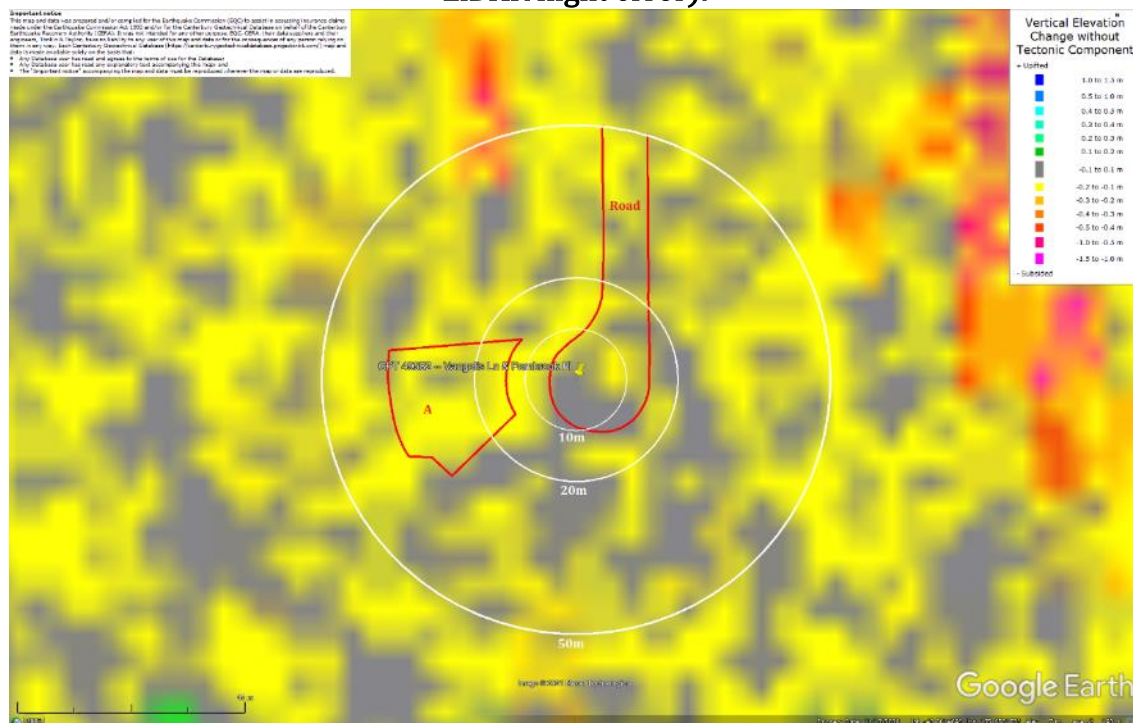
Figure 25: Ground surface subsidence without tectonic component for Sep 2010 Earthquake according to the LiDAR DEM.

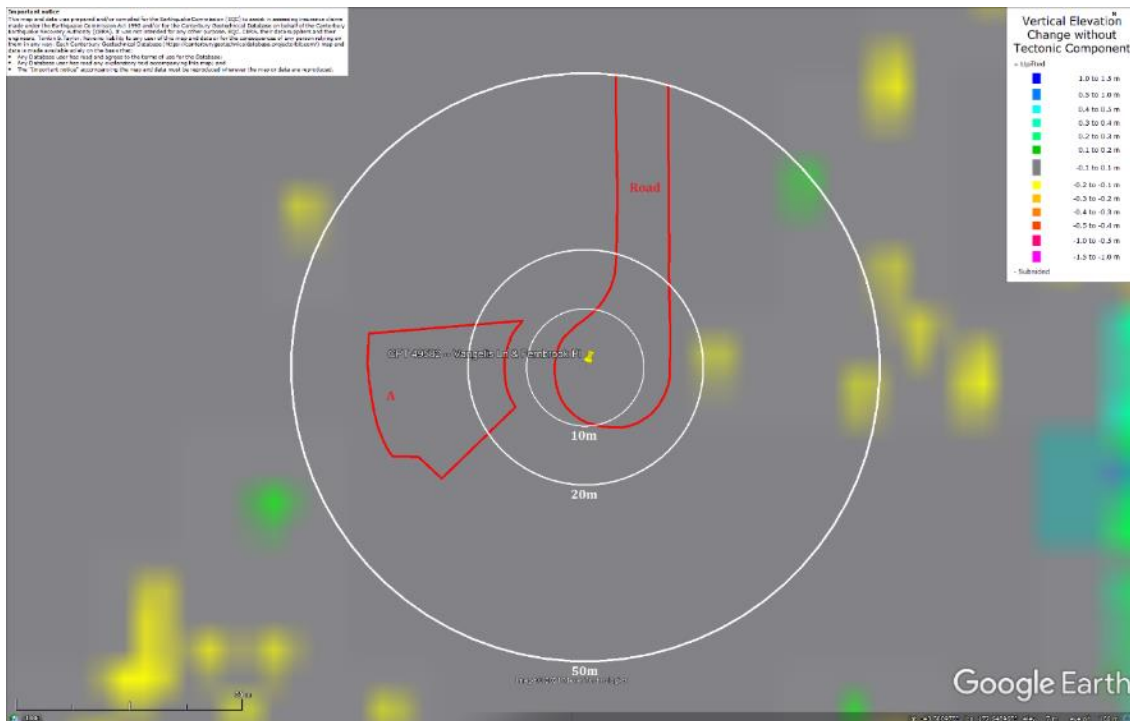
Figure 26: Ground surface subsidence without tectonic component for Feb 2011 Earthquake according to the LiDAR DEM.

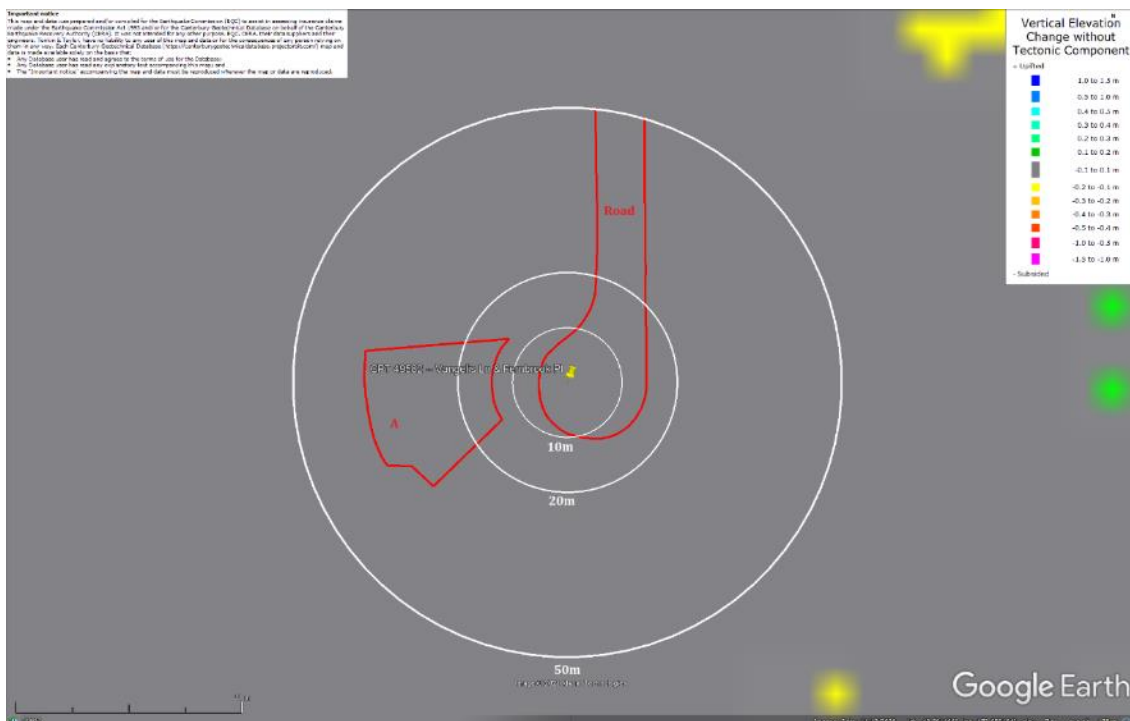
Figure 27: Ground surface subsidence without tectonic component for Jun 2011 Earthquake according to the LiDAR DEM.

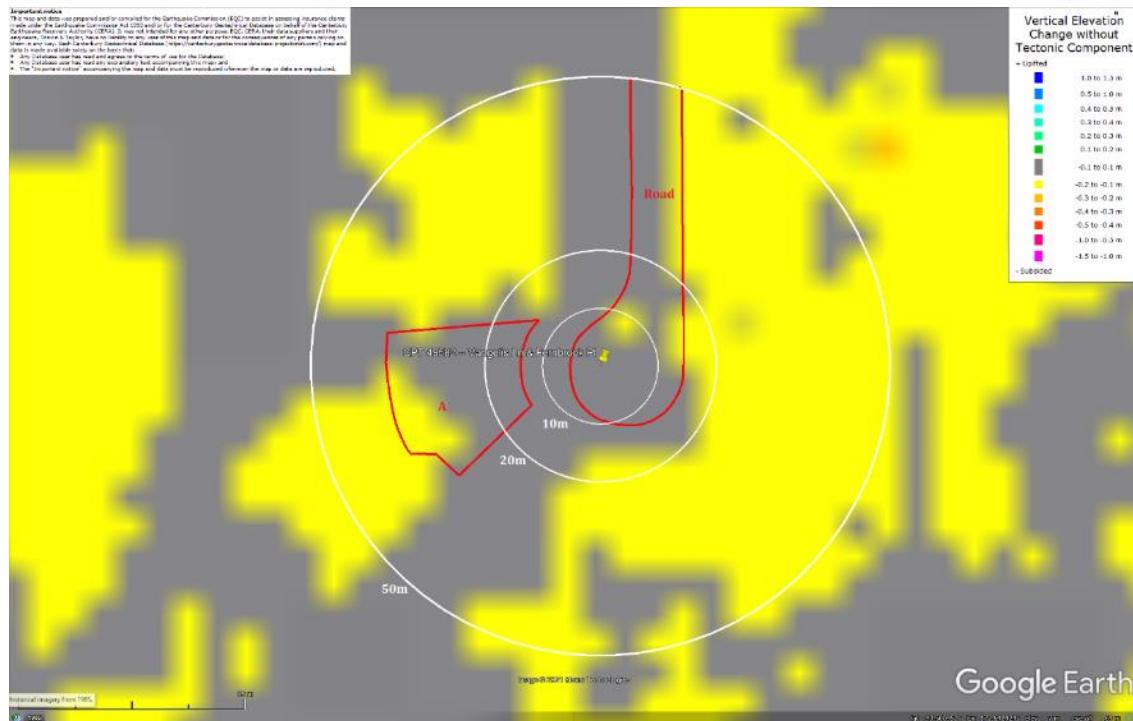
Figure 28: Ground surface subsidence without tectonic component for Dec 2011 Earthquake according to the LiDAR DEM.

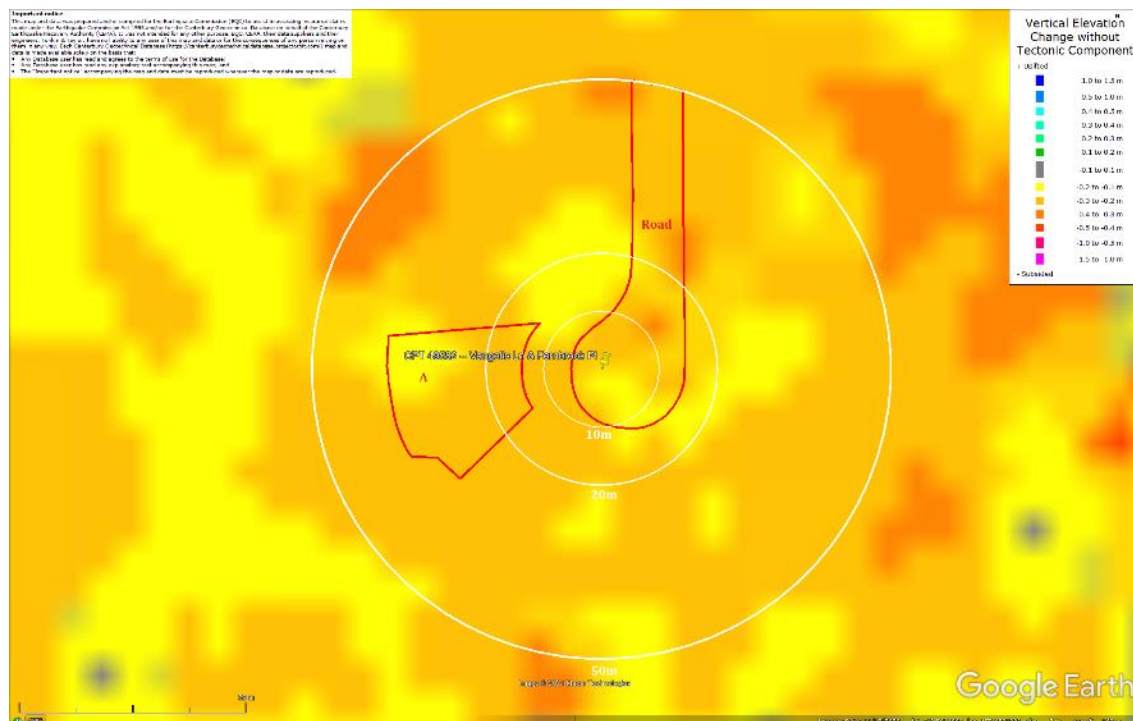
Figure 29: Ground surface subsidence without tectonic component for Canterbury Earthquake Sequence according to the LiDAR DEM.

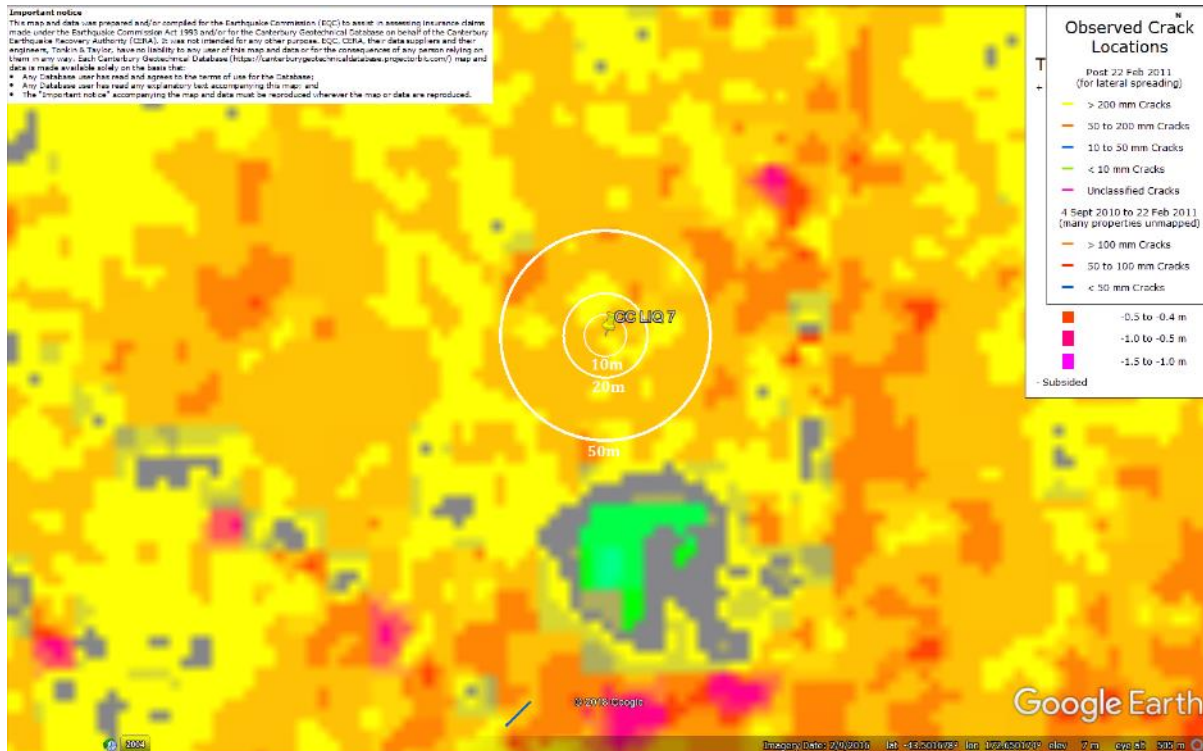
Figure 30: Absence of ground cracks indicates no lateral spreading for Canterbury Earthquake Sequence.

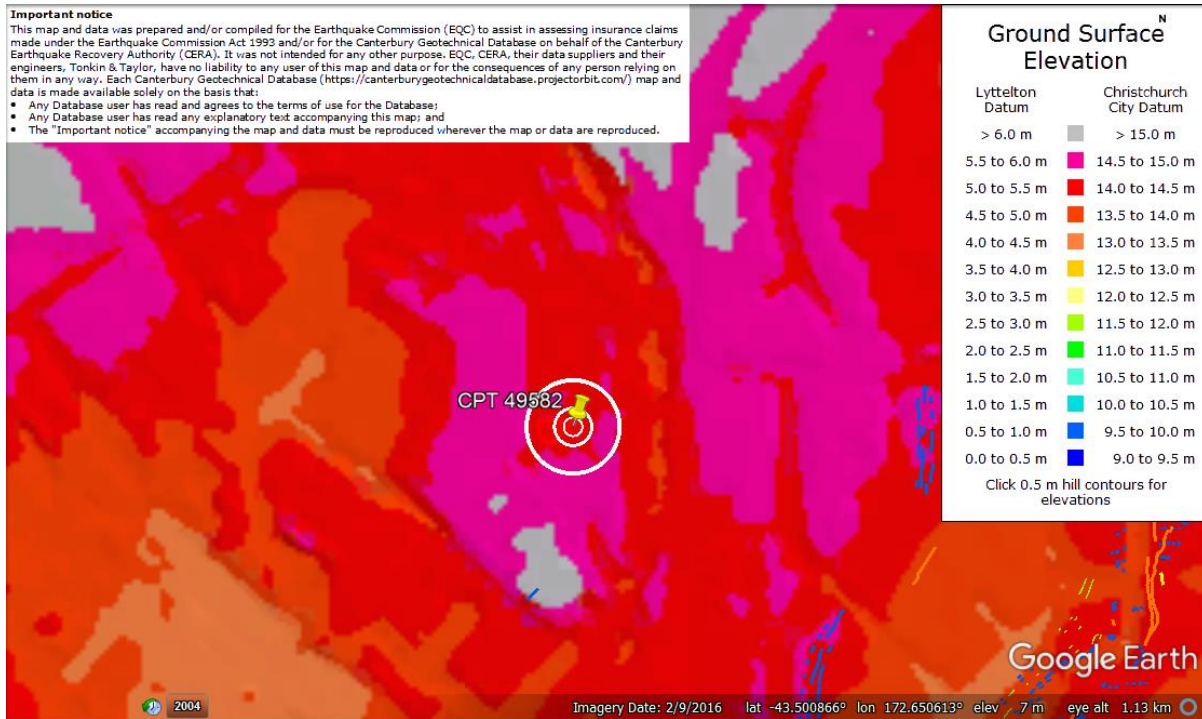
Figure 78: Ground surface elevation difference between the road and properties (LiDAR DEM for Sept 2010).

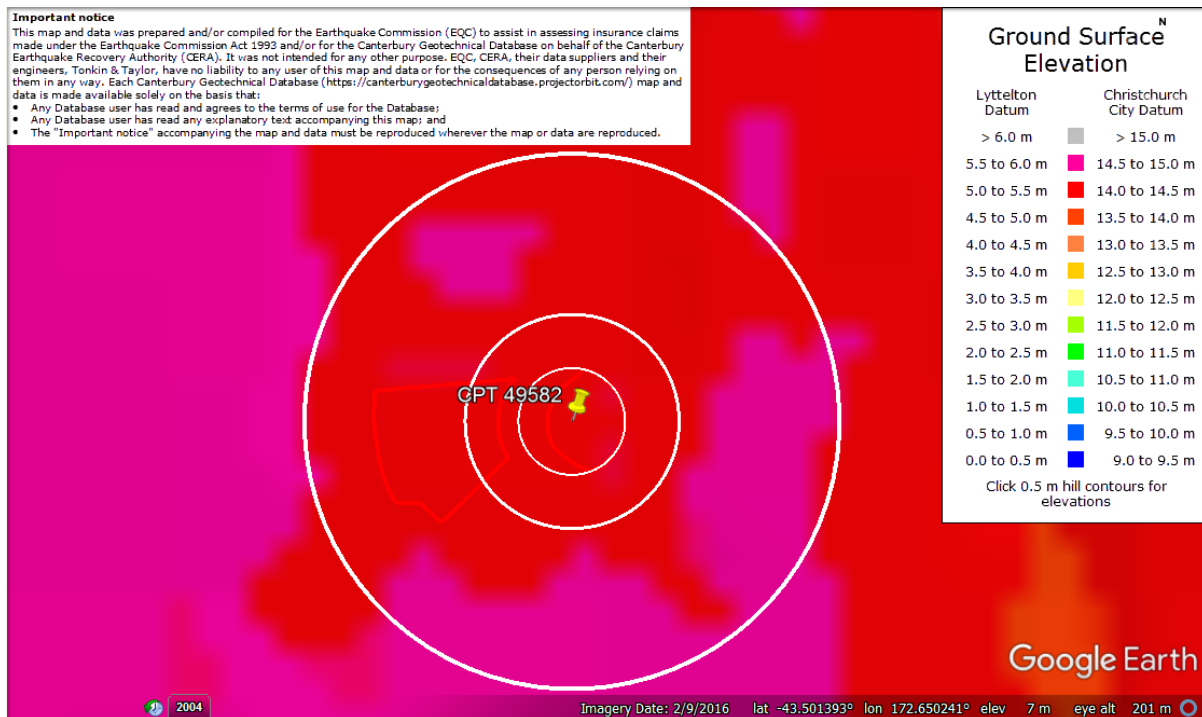
Figure 79: Enlarged view of ground surface elevation difference between the road and properties (LiDAR DEM for Sept 2010).

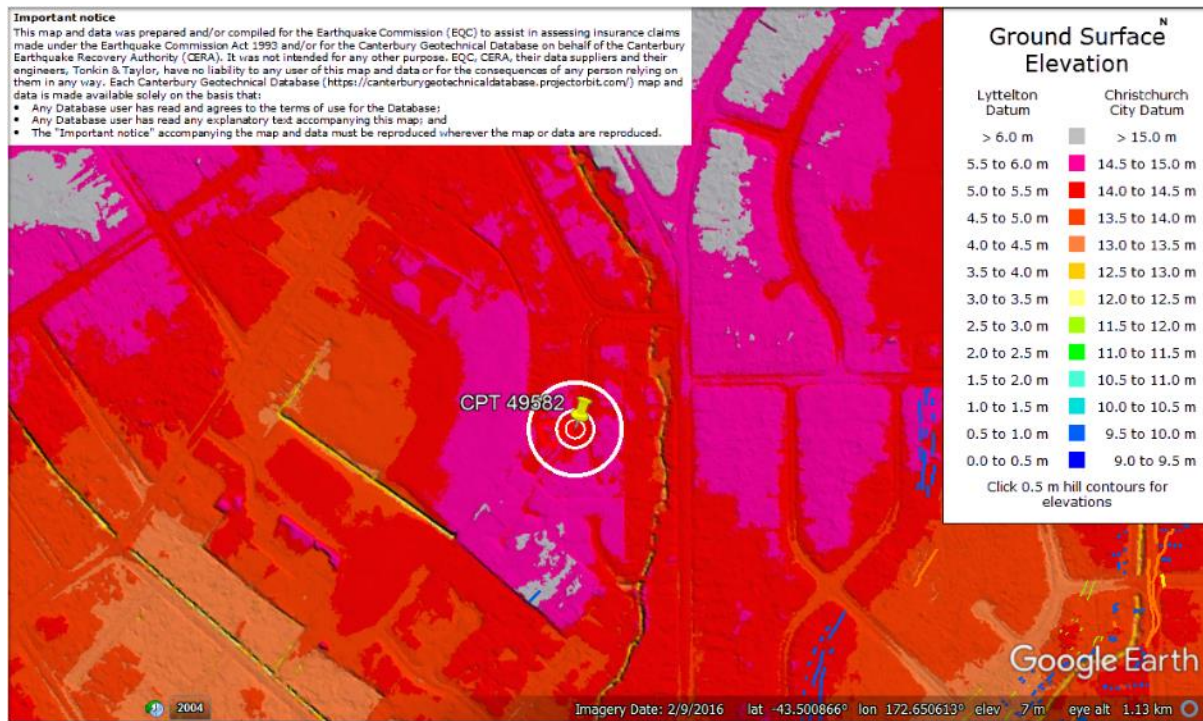
Figure 80: Ground surface elevation difference between the road and properties (LiDAR DEM for Sept 2011).

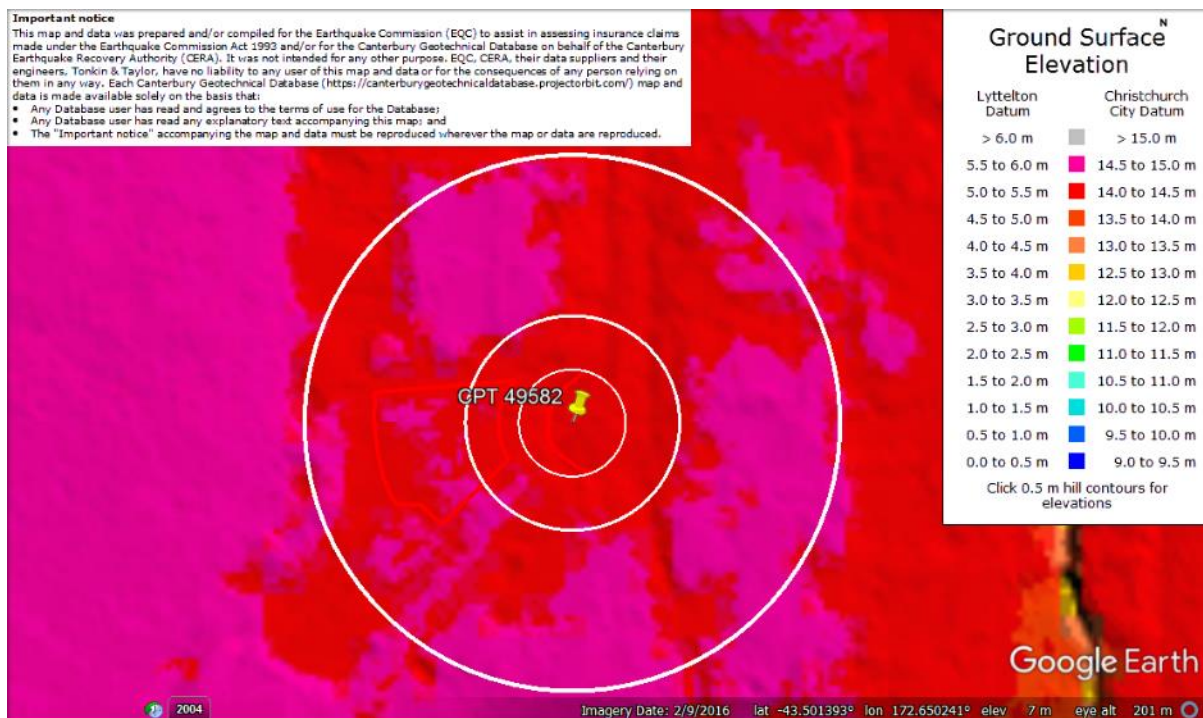
Figure 81: Enlarged view of ground surface elevation difference between the road and properties (LiDAR DEM for Sept 2011).

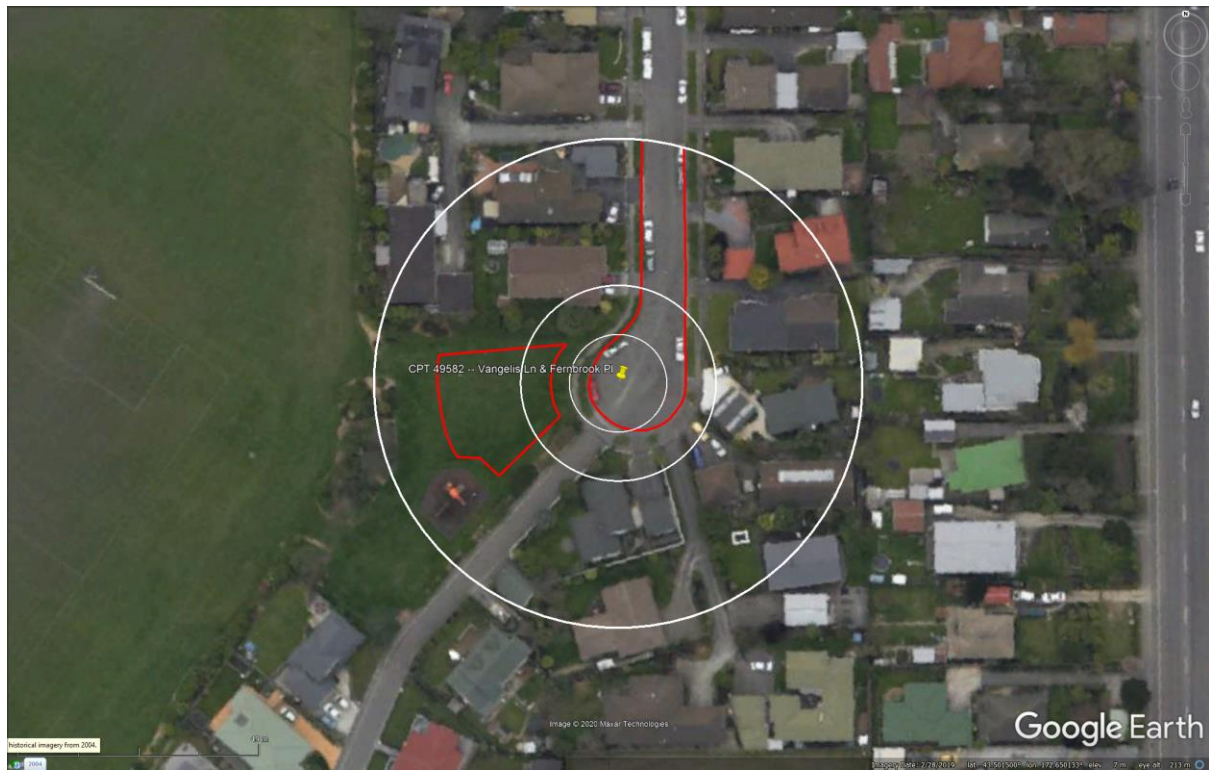
Figure 82: Absence of ejecta at the site for Sep-10 EQ.

Note 4: The values in Table 9 correspond to the coverage area of ejecta outlined in aerial photographs (Figures 82 through 86) and the lower and upper estimates of ejecta height based on ground photographs (Figure 87) and EQC LDAT inspection reports for properties within the 50-m buffer (e.g., some properties settled 0-50 mm globally (minor damage), some properties settled 0-20 mm due to tilting (minor damage) and/or 0-10 mm due to twisting (minor damage), and land experienced cosmetic to significant undulation). The ejecta-induced settlement using photographs and engineering judgment, $S_{E,P}$, is estimated as

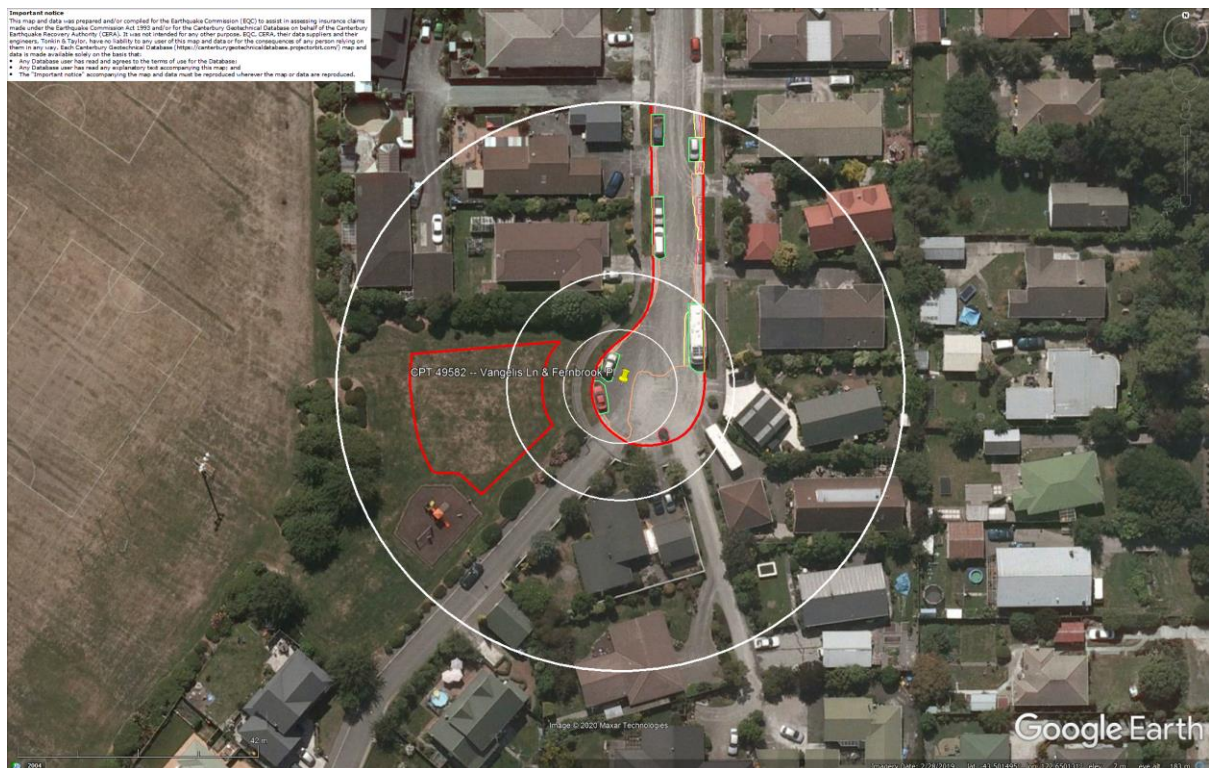
Figure 83: Ejecta outline for Feb-11 EQ.

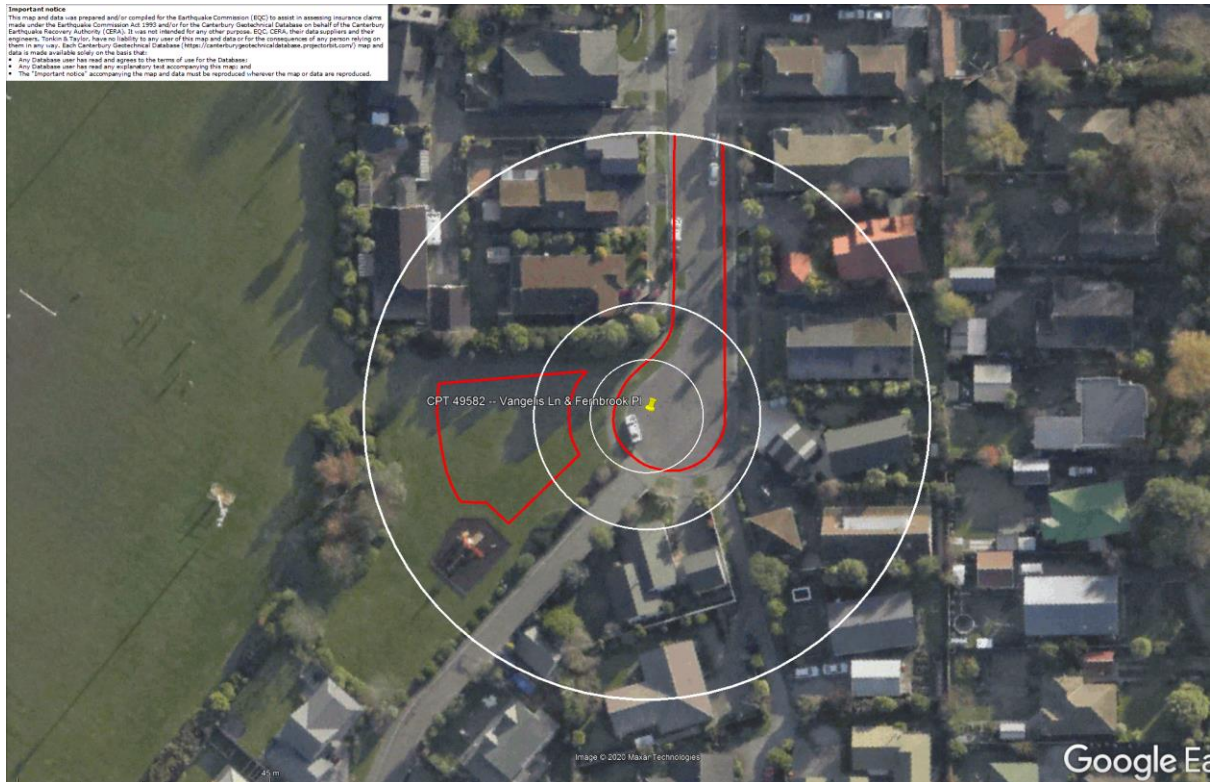
Figure 84: Absence of ejecta at the site for Jun-11 EQ (June 14-15, 2011 aerial photograph).
