Appendix A.9:

Vangelis Ln and Fernbrook Pl – CPT 49582

Liquefaction Ejecta Case Histories for 2010-11 Canterbury Earthquakes

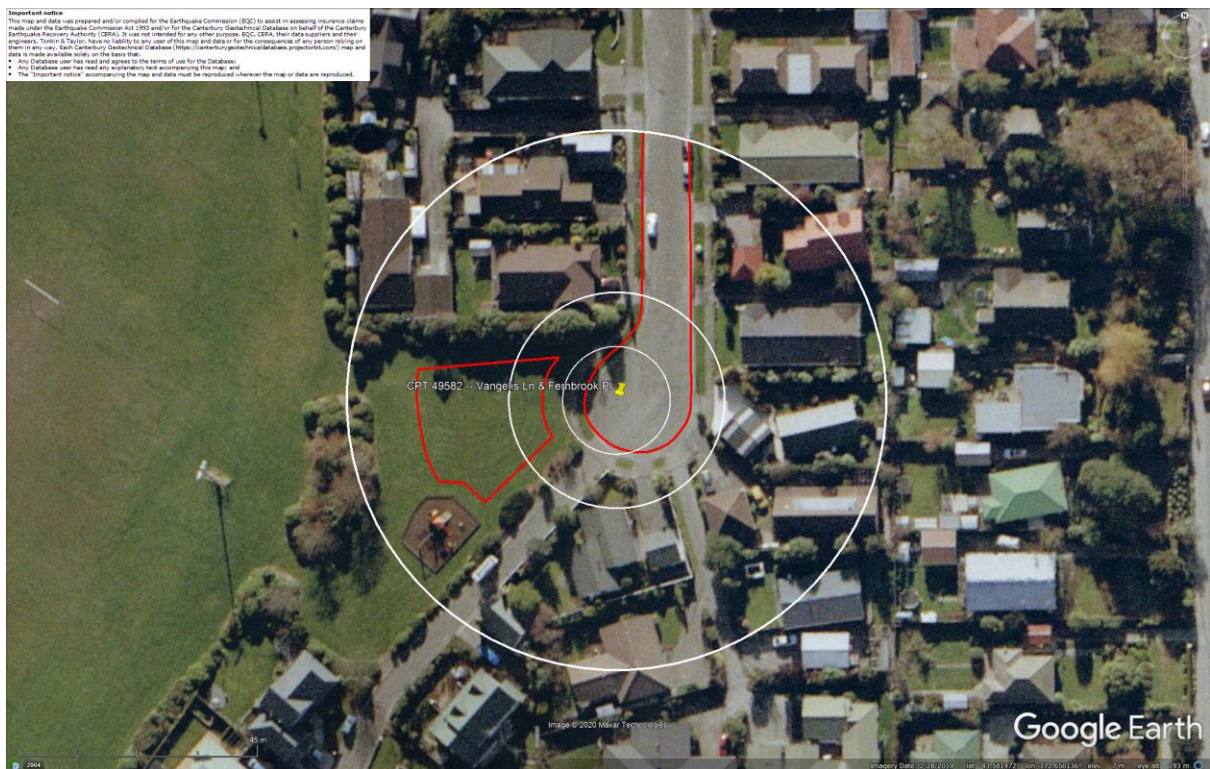
Figure 85: Absence of ejecta at the site for Jun-11 EQ (June 16, 2011 aerial photograph).

Note 4: The values in Table 9 correspond to the coverage area of ejecta outlined in aerial photographs (Figures 82 through 86) and the lower and upper estimates of ejecta height based on ground photographs (Figure 87) and EQC LDAT inspection reports for properties within the 50-m buffer (e.g., some properties settled 0-50 mm globally (minor damage), some properties settled 0-20 mm due to tilting (minor damage) and/or 0-10 mm due to twisting (minor damage), and land experienced cosmetic to significant undulation). The ejecta-induced settlement using photographs and engineering judgment, $S_{E,P}$, is estimated as

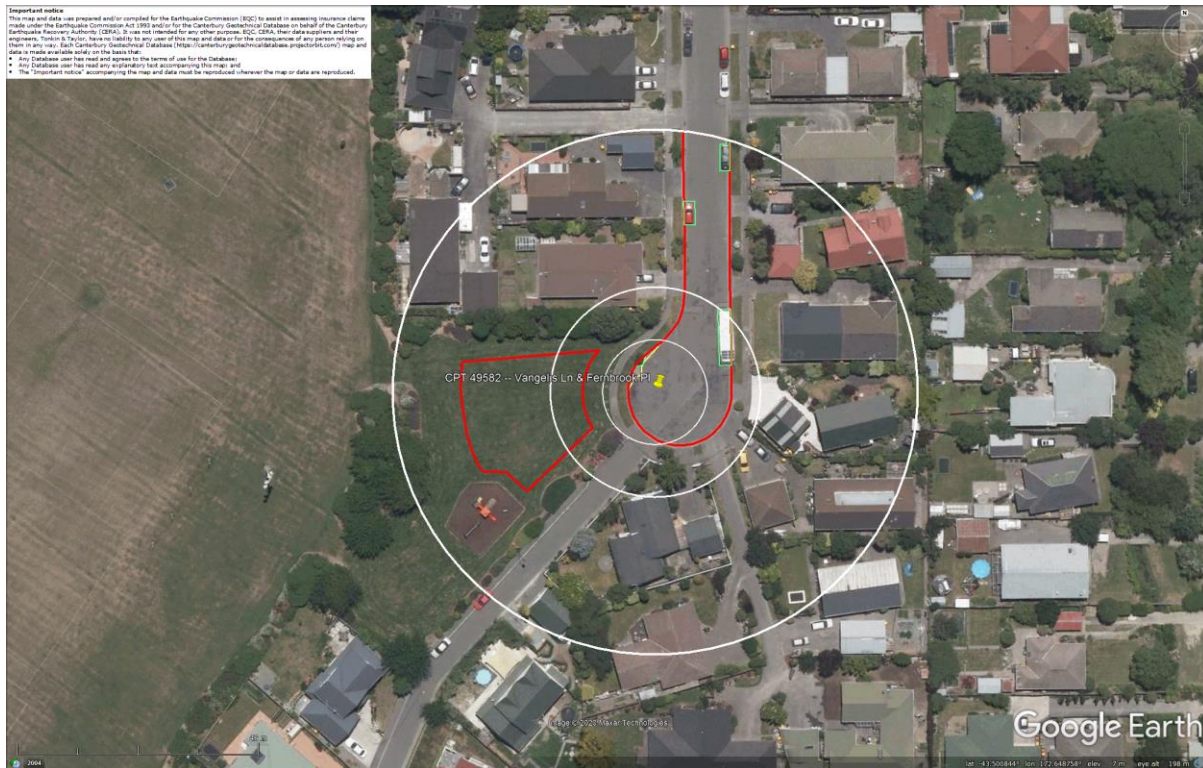
Figure 86: Ejecta outline for Dec-11 EQ.

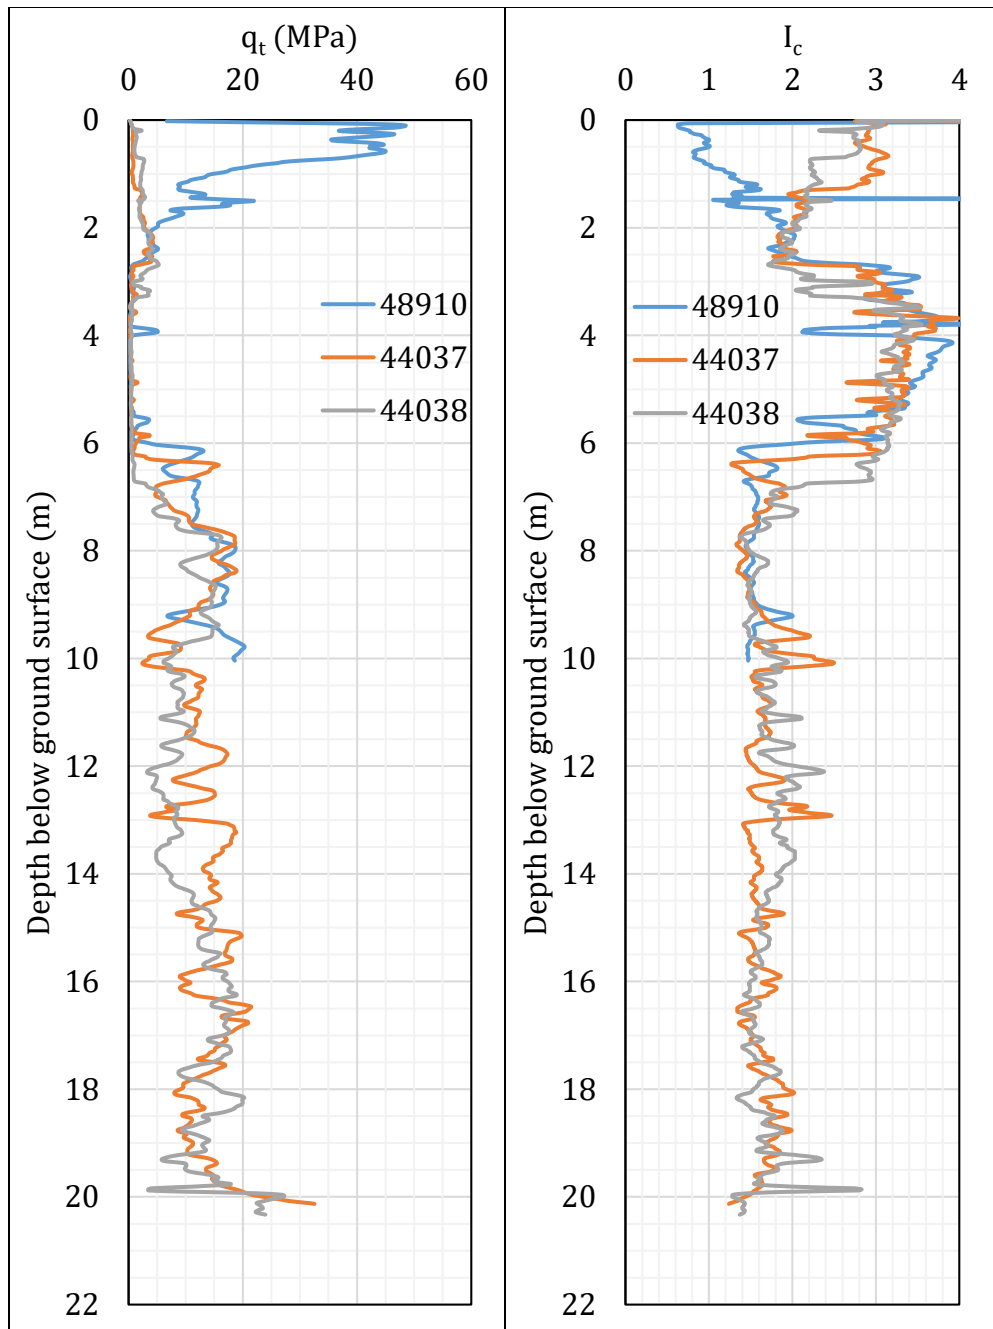
Figure 97: q_t and I_c profiles.

Note 7: The selection of CPTs for the area considered for settlement assessment (Figure 1) is based on the proximity of the CPTs to the considered areas. In accordance with that, the following table shows CPTs that were used for the volumetric settlement analysis in *Cliq v.3.0.3.2*, a CPT soil liquefaction software developed by GeoLogismiki. (The average volumetric settlements were reported in Table 8.)
