Practical Design, Numerical Analysis, and Site Monitoring for Huge Arching Effect during Massive Excavation of Undercut Slope in Open-Pit Mine

ABSTRACT: *This paper reviews a successful case history where applications of numerical predictions for a massive excavation were undertaken for both Class A and Class B predictions. Forming a stable arch across the pit of an open-pit mine is beneficial to the design of an undercut slope. However, predicting the maximum stable undercut width under which the slope does not collapse is a challenging problem in geotechnical engineering. Slope undercutting techniques originally developed for 1g physical and centrifuge models were realized in practice for a full-scale design at the Mae Moh mine, one of the large coal open-pit mines in Southeast Asia, during the period of 2011 - 2017. Numerical analyses, along with in-situ measurements for data assimilation, were applied to test the novel design concept before and during the surface excavation. At the initial stage of excavating the undercut slope, the mine was studied in terms of forming an arch, by conducting a field experiment of a partial undercutting in Area 4.1, which was of monumental size

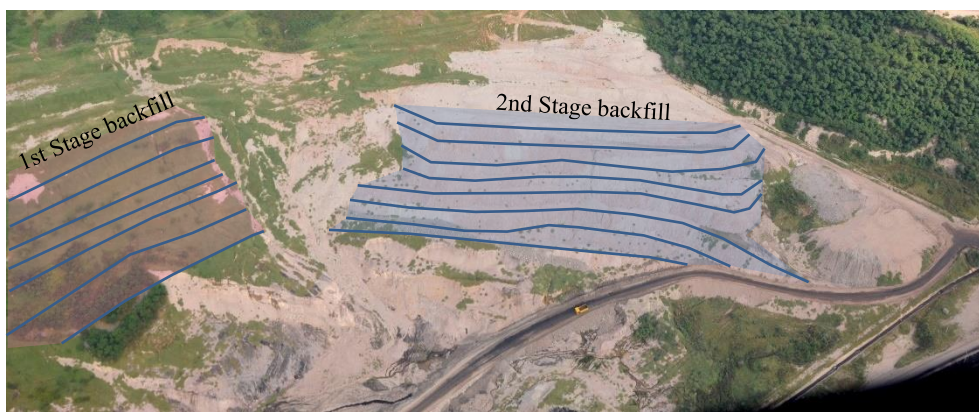
(a) At the beginning of 2nd Stage

(b) Mining elev 192–104 m

(c) Backfilling elev 104–192 m

(d) Aerial view at end of 2nd Stage (as of October 2017)

Figure 13. Sequential excavation of the 2nd Stage in Area 4.1.

The mining sequence of the 2nd Stage is depicted in Figures 13(a) to 13(c). In Figure 13, the daylighted G1 interface and the normal faults in Area 4.1 are represented by green and red lines, respectively. The 2nd Stage was launched by mining the interburden and coal from an elevation of 104-192 msl during the period of 2014 to 2016. At the beginning of 2017, the backfilling of the 2nd Stage began and was completed in October 2017. The undercut face could not be fully backfilled and supported, as presented in Figure 13(c), because of the working space constraints. Consequently, the G1 interface (green line) was still daylighted on the undercut slope face for a length of 190 m.

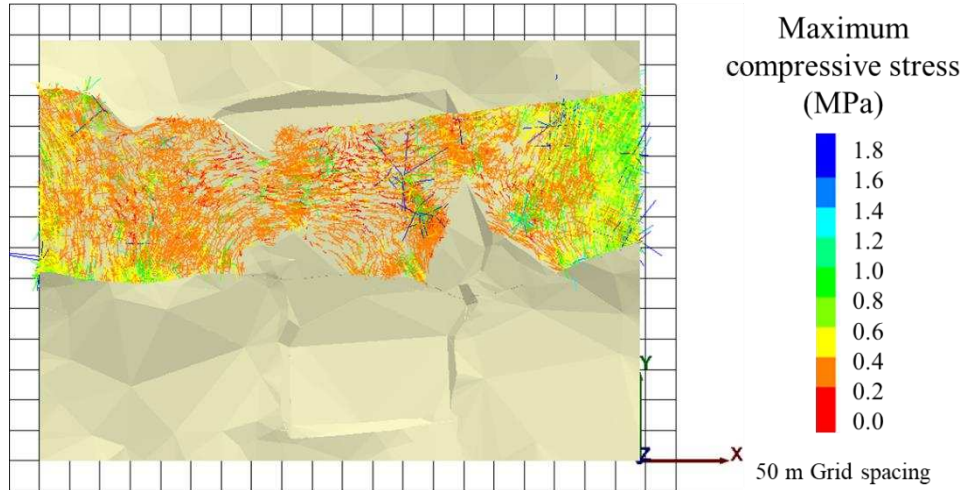
Figure 28. Principal stress trajectories in potential sliding block of 2nd Stage.
