Practical Design, Numerical Analysis, and Site Monitoring for Huge Arching Effect during Massive Excavation of Undercut Slope in Open-Pit Mine

ABSTRACT: *This paper reviews a successful case history where applications of numerical predictions for a massive excavation were undertaken for both Class A and Class B predictions. Forming a stable arch across the pit of an open-pit mine is beneficial to the design of an undercut slope. However, predicting the maximum stable undercut width under which the slope does not collapse is a challenging problem in geotechnical engineering. Slope undercutting techniques originally developed for 1g physical and centrifuge models were realized in practice for a full-scale design at the Mae Moh mine, one of the large coal open-pit mines in Southeast Asia, during the period of 2011 - 2017. Numerical analyses, along with in-situ measurements for data assimilation, were applied to test the novel design concept before and during the surface excavation. At the initial stage of excavating the undercut slope, the mine was studied in terms of forming an arch, by conducting a field experiment of a partial undercutting in Area 4.1, which was of monumental size

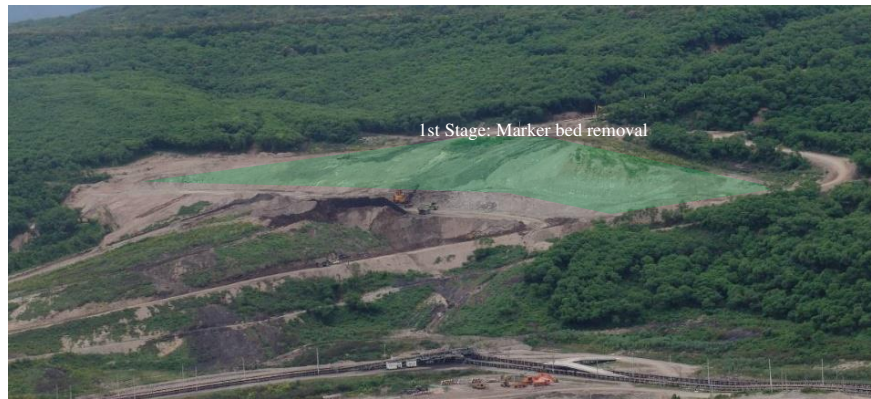
Figure 12. Photographs of the 1st Stage in Area 4.1.

The undercutting in Area 4.1 was periodically photographed for archival purposes; some of the photographs are presented in Figure 12. The mine equipment was moved to Area 4.1 and the site preparation began in April 2011. Three months later, in July 2011, the Marker bed was ready to be excavated; by August 2011, it had been totally removed. The undercutting of the northern part of Area 4.1 began in August and reached an elevation of 170 msl by January 2012. The undercut span was approximately 80 m. The undercutting continued and reached an elevation of 137 msl by April 2012. The undercut width was approximately 90 m. Between May and June 2012, the backfill, comprising 30,000 cubic meters, was placed from an elevation of 115-192 msl. The undercut width was then shortened to 30 m. The undercutting was restarted and continued in the southern direction in August 2012. The 1st Stage was completed in May 2014. Finally, the undercut width had been extended to approximately 100 m by the end of the 1st Stage.

(a) Access road and Marker bed removal in 1st Stage (as of August 2011)

(b) Mining elev 170 m in 1st Stage (as of January 2012)

(c) Marker bed removal and 2nd Stage preparation in 1st Stage (as of April 2014)
