Practical Design, Numerical Analysis, and Site Monitoring for Huge Arching Effect during Massive Excavation of Undercut Slope in Open-Pit Mine

KEYWORDS: Slope Stability, Undercutting, Arching, Open-Pit Mines

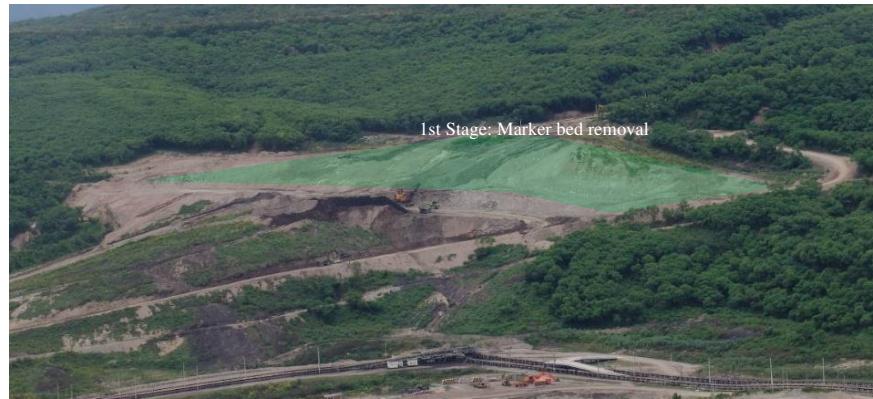
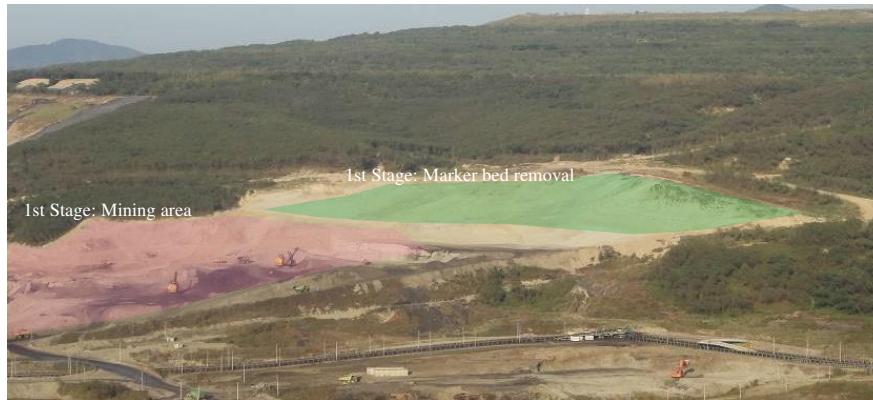
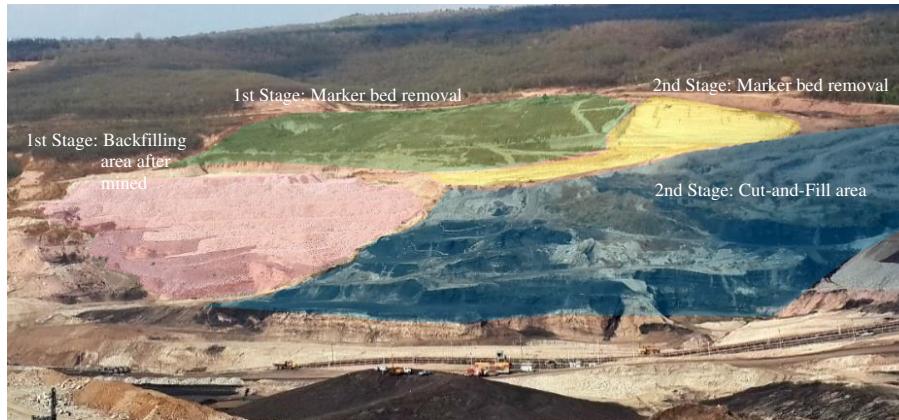
Figure 12. Photographs of the 1st Stage in Area 4.1.

The undercutting in Area 4.1 was periodically photographed for archival purposes; some of the photographs are presented in Figure 12. The mine equipment was moved to Area 4.1 and the site preparation began in April 2011. Three months later, in July 2011, the Marker bed was ready to be excavated; by August 2011, it had been totally removed. The undercutting of the northern part of Area 4.1 began in August and reached an elevation of 170 msl by January 2012. The undercut span was approximately 80 m. The undercutting continued and reached an elevation of 137 msl by April 2012. The undercut width was approximately 90 m. Between May and June 2012, the backfill, comprising 30,000 cubic meters, was placed from an elevation of 115-192 msl. The undercut width was then shortened to 30 m. The undercutting was restarted and continued in the southern direction in August 2012. The 1st Stage was completed in May 2014. Finally, the undercut width had been extended to approximately 100 m by the end of the 1st Stage.

(a) Access road and Marker bed removal in 1st Stage (as of August 2011)

(b) Mining elev 170 m in 1st Stage (as of January 2012)

(c) Marker bed removal and 2nd Stage preparation in 1st Stage (as of April 2014)

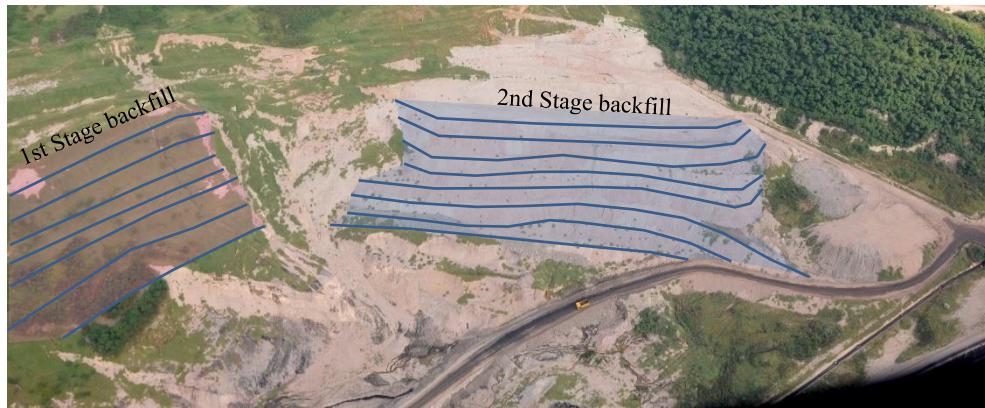
Figure 13. Sequential excavation of the 2nd Stage in Area 4.1.

The mining sequence of the 2nd Stage is depicted in Figures 13(a) to 13(c). In Figure 13, the daylighted G1 interface and the normal faults in Area 4.1 are represented by green and red lines, respectively. The 2nd Stage was launched by mining the interburden and coal from an elevation of 104–192 msl during the period of 2014 to 2016. At the beginning of 2017, the backfilling of the 2nd Stage began and was completed in October 2017. The undercut face could not be fully backfilled and supported, as presented in Figure 13(c), because of the working space constraints. Consequently, the G1 interface (green line) was still daylighted on the undercut slope face for a length of 190 m.

(a) At the beginning of 2nd Stage

(b) Mining elev 192–104 m

(c) Backfilling elev 104–192 m

(d) Aerial view at end of 2nd Stage (as of October 2017)
